Advisory Visit
Dibney River, Co. Down
2nd July, 2010

1.0 Introduction

3.0 Habitat Assessment

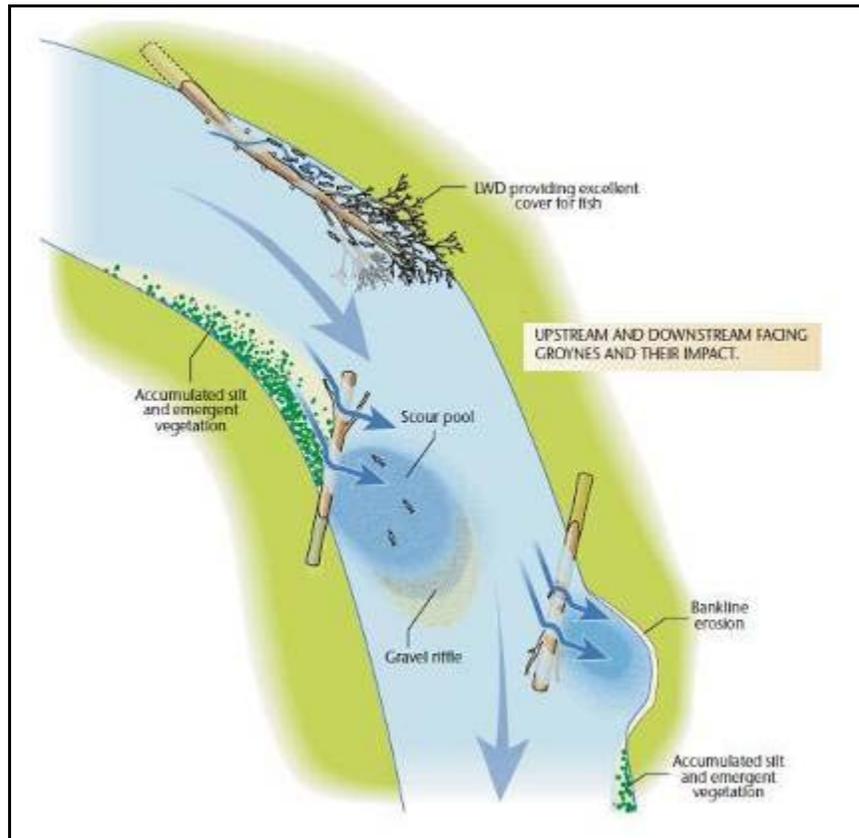
formation of a variety of depths and the sorts and cleans gravel for spawning. Figure 4 shows the effects of differently aligned LWD structures.

Also, simply fixing whole trees parallel to the river bank (Figure 4, top structure) by cabling or hinging them would assist in narrowing the channel and promoting local scour.

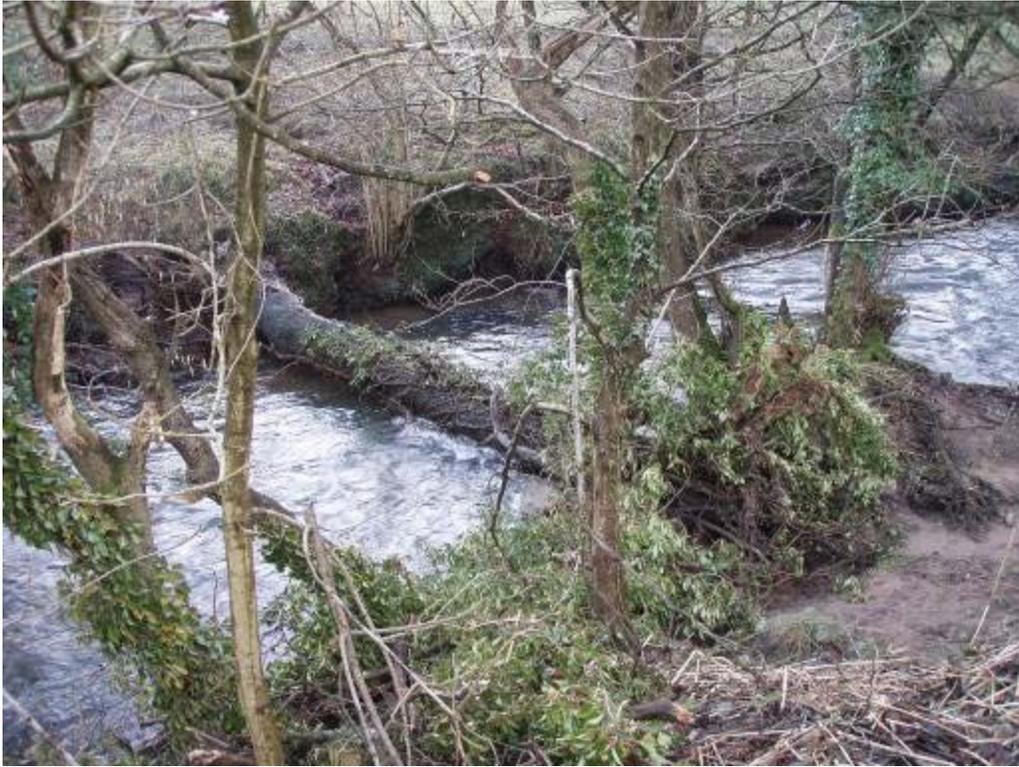
Photo 25 Naturally occurring LWD – this tree has fallen across the channel but remains fixed by its roots and wedged against a tree on the opposite bank. Scour under the trunk has created a deep pool.

Photos 25-27 show the effects of LWD and some methods of fixing it in place. Felling of trees in the wooded section of the Dibney River would provide material for in-stream structures and thin out the dense shading of the channel at this point. Structures like the one in Photo 25 could be mimicked by exposing the roots of trees growing in the embankment, cutting through the roots on the side facing away from the river, then winching the tree over the channel and wedging it against trees on the opposite bank.

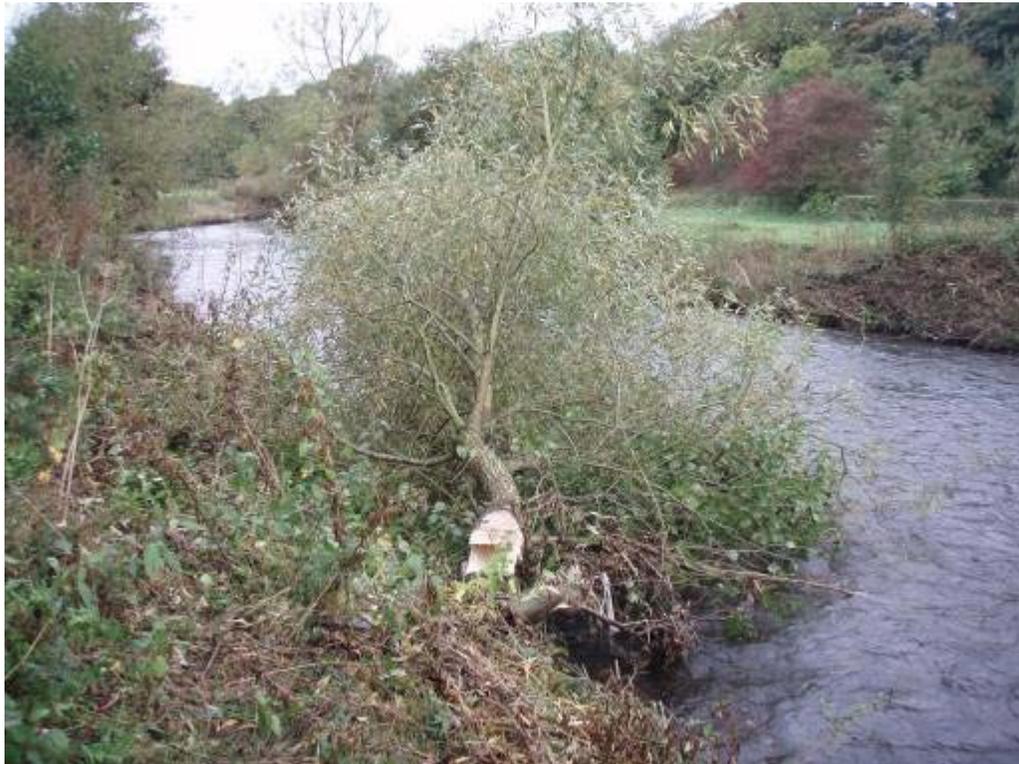
Photo 26 Trees can be partially cut and hinged over into the river channel

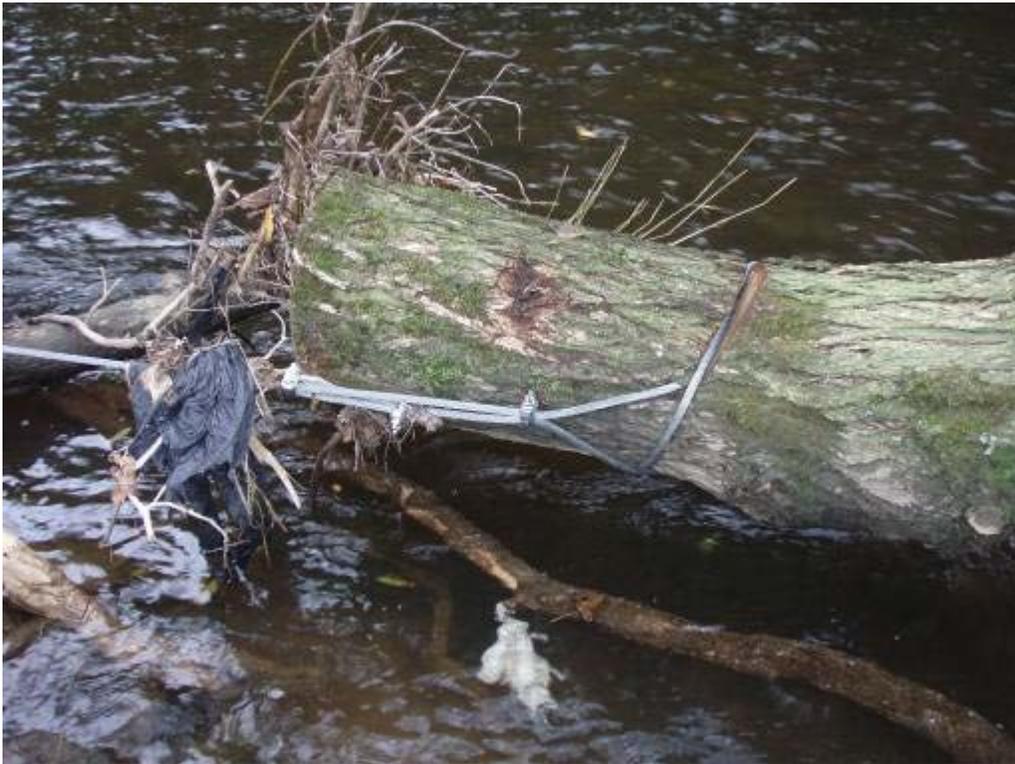
Photo 27 Steel cable used to secure felled trees to their stumps
