WILD TROUT TRUST

Advisory Report

Dolwen Reservoir

May 2020

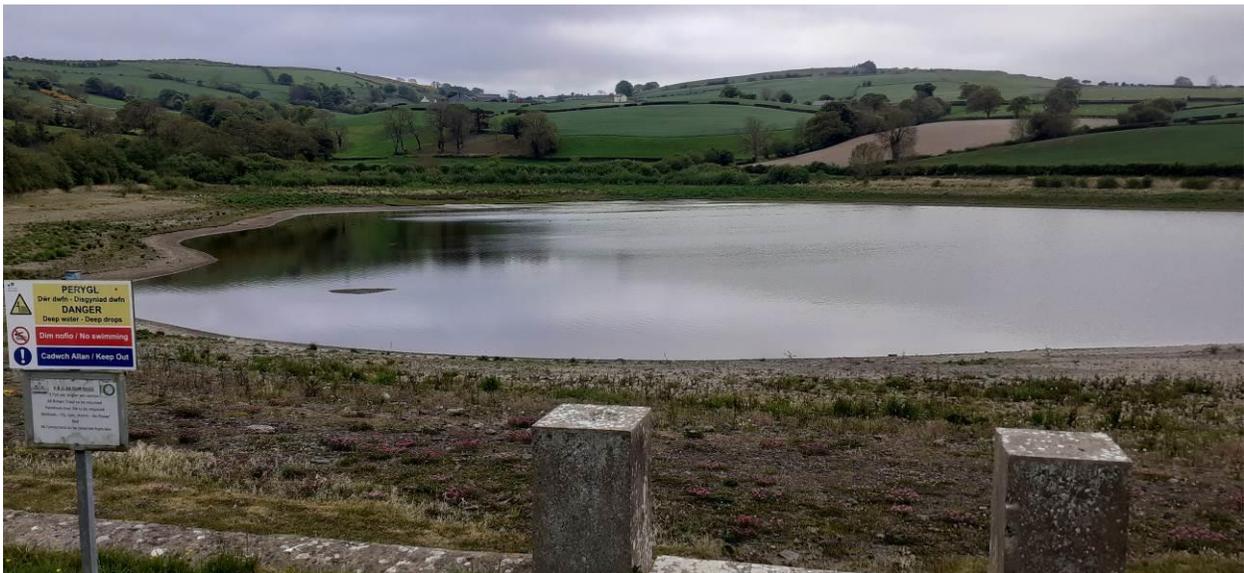
Picture: Gavin Jones

The reservoir overspill is located in the north-western corner and is currently undergoing civil engineering works, during which the reservoir water levels have been drawn down (cover picture, Figure 1). The works are due for completion in autumn 2020. The outflow from the reservoir runs into another reservoir, Plâs-uchaf, about 500m downstream.

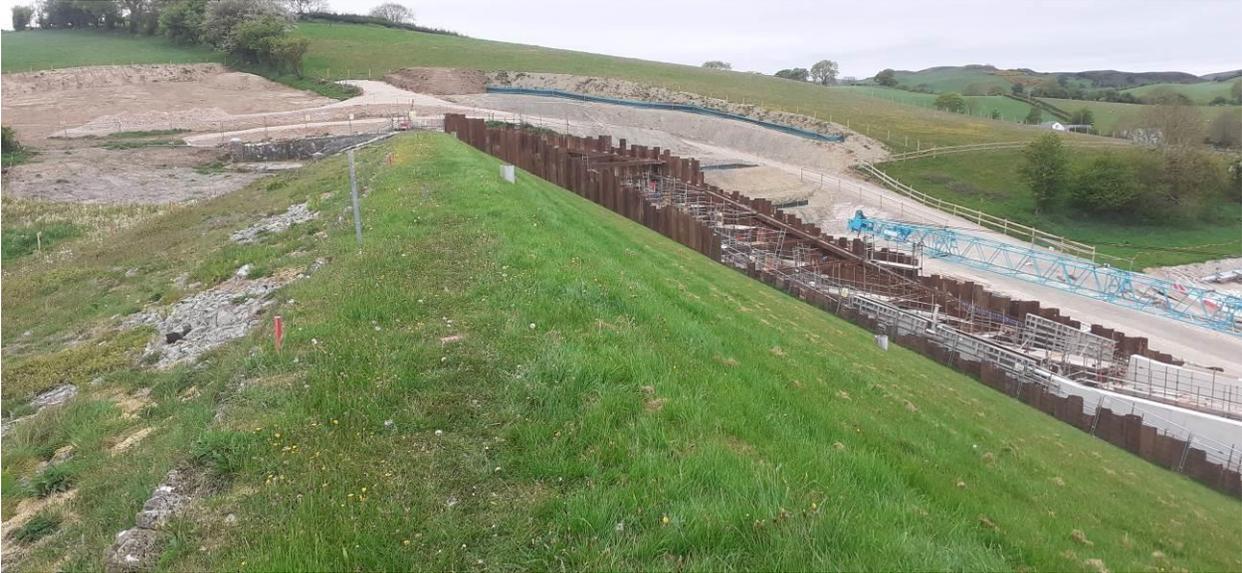
Figure 1 Engineering works on the reservoir spillway

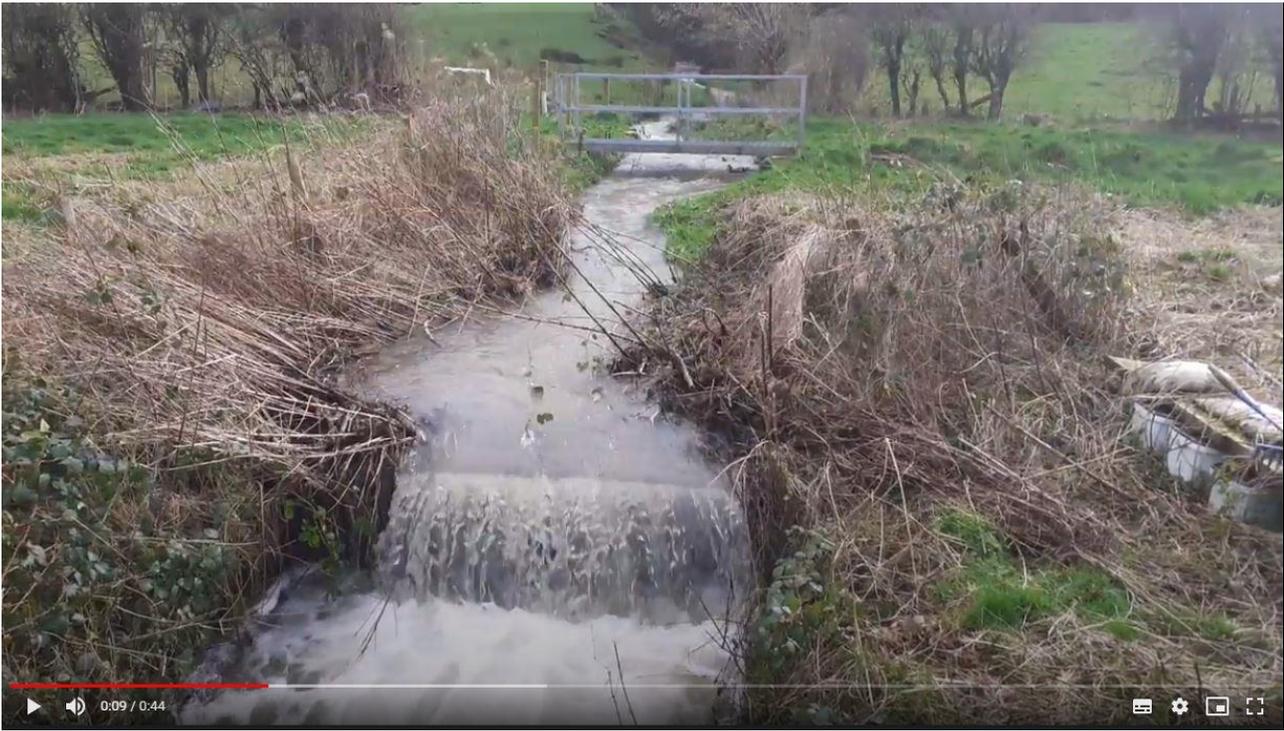
Flows within the feeder stream are seasonal and it often dries up completely during the summer; in contrast it can flow strongly after periods of heavy rainfall, such as last winter (2019/20). Up until recently, access for adult fish into the feeder stream was limited by the presence of a culverted section of stream thought to be part of a sediment trap which had become completely in-filled (Figure 2 - Figure 7).

Figure 2 View upstream to footbridge during high flows (January 2020), showing the downstream headwall of the sediment trap (foreground, acting as a weir).

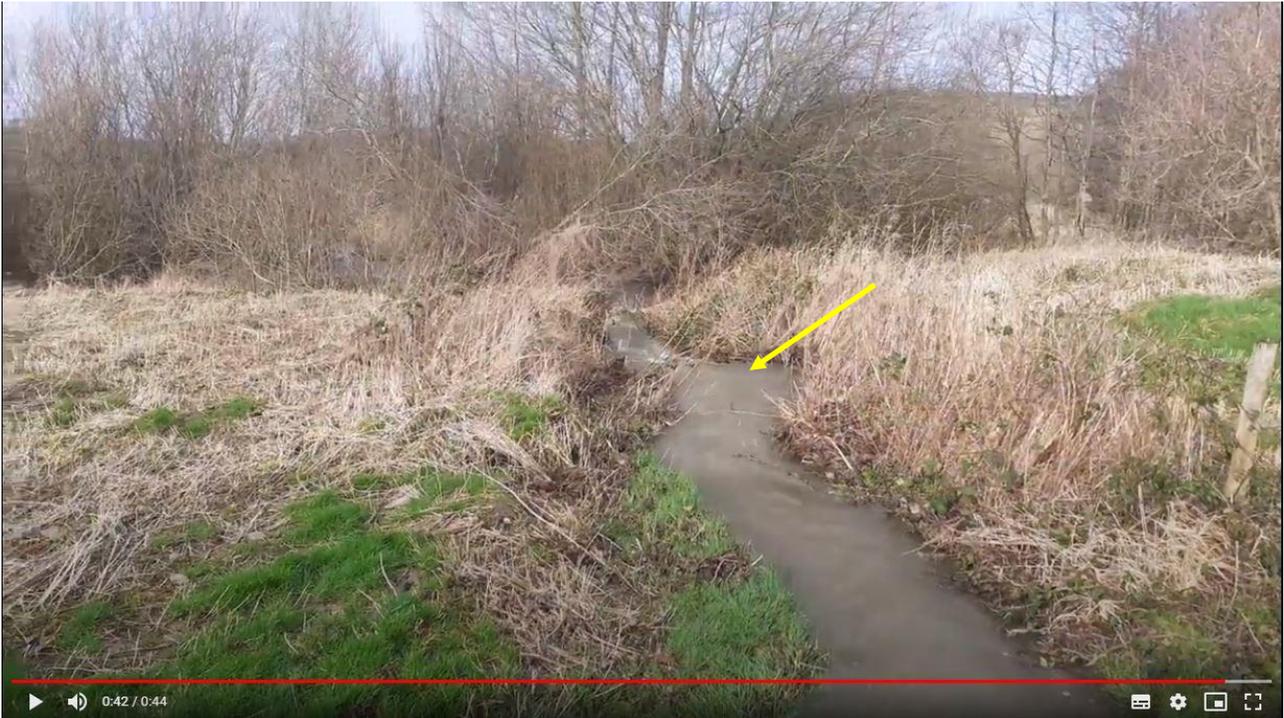
Figure 3 View downstream from footbridge (January 2020), showing location of downstream headwall (arrow)

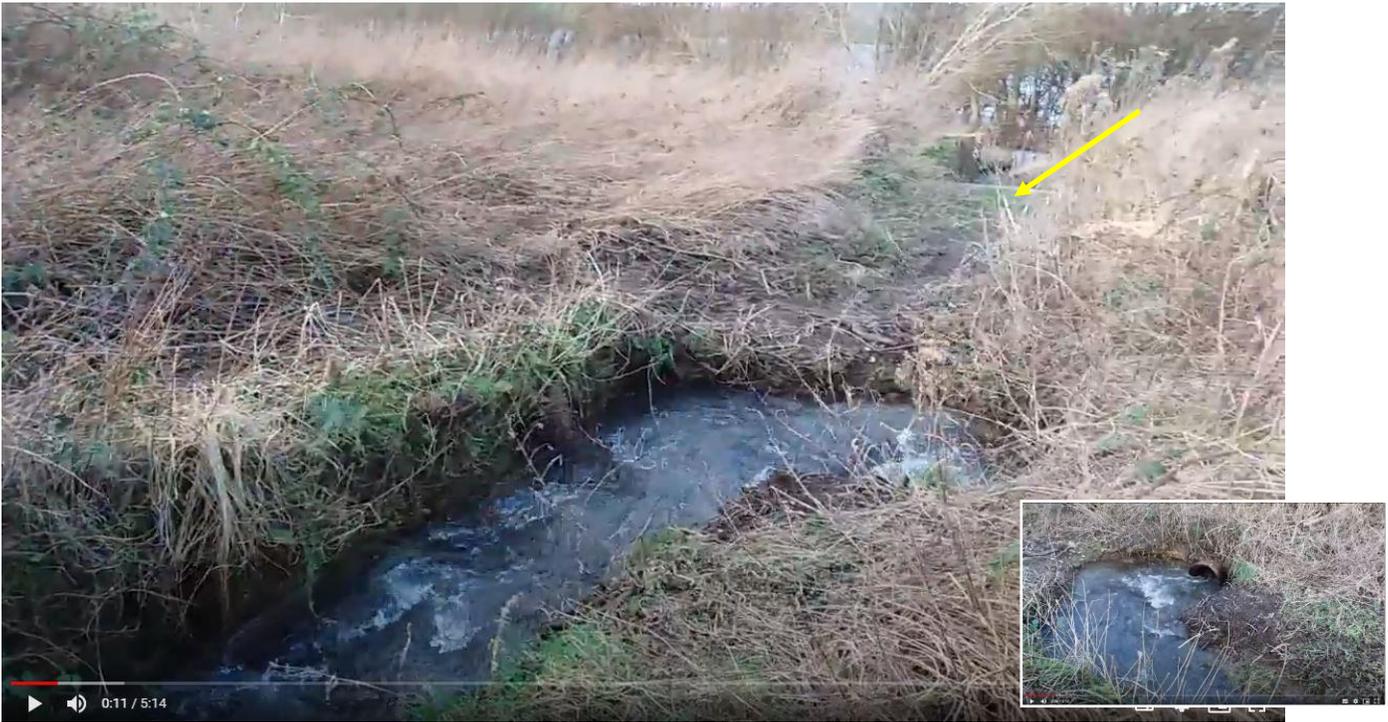
Figure 4 View from a similar position to Figure 3 during lower water conditions showing position of headwall (arrow) and water flowing into a culvert pipe in the right bank (inset).

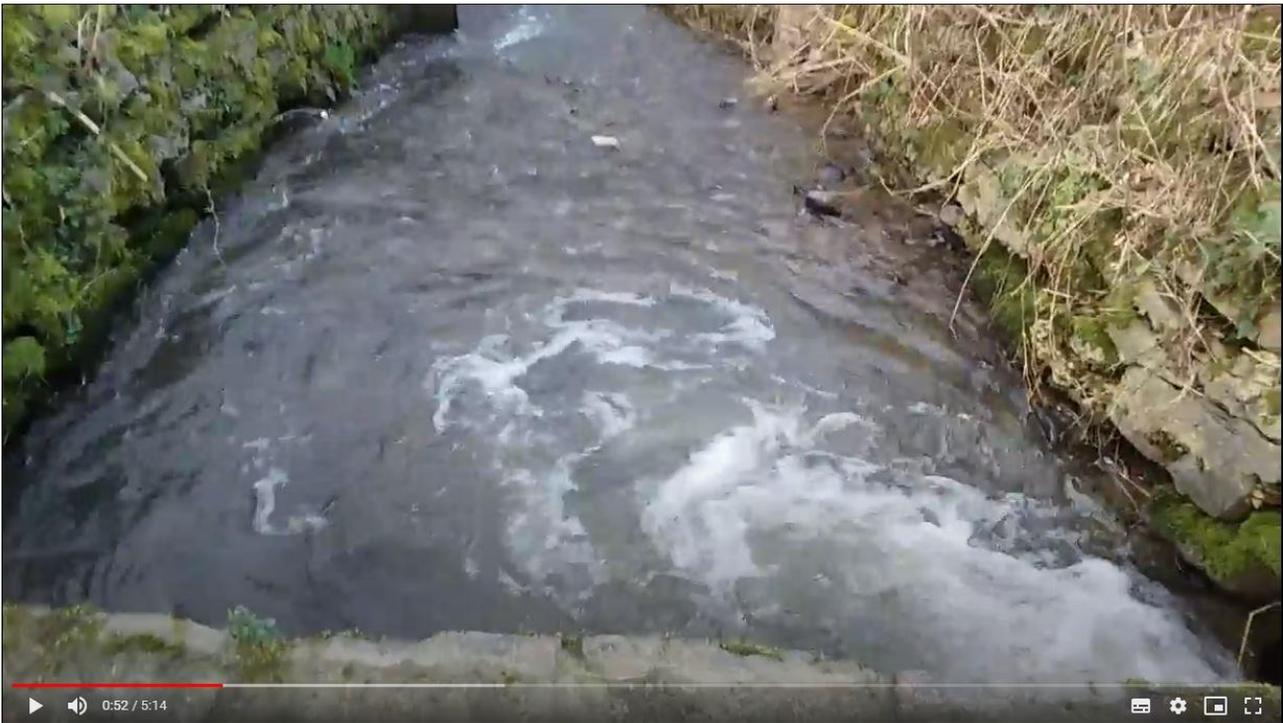
Figure 5 Outflow from the culvert pipe shown in Figure 4 downstream of the headwall. Trout were spawning here at the time the video was taken.

Previously observed spawning in the Figure 5 video shows fish attracted to the flow being flumed through the narrow culvert pipe and a ramp of clean gravel just downstream. These are the type of flow and substrate conditions that need to be mimicked to provide good spawning conditions. In order to do this the channel through the sediment trap needs to be remodelled to pinch the flow and encourage a mosaic of scour and depositional areas. Some suggestions are outlined in recommendations section.

- Remodel the channel of the feeder stream through the gravel trap area by removing the upstream headwall, re-grading the channel into the walled area, introducing large boulders and re-introducing some of the excavated gravel. The aim should be to create a series of pools and narrow flumes of water (Figure 11). The gaps between boulders are important; bearing in mind the observations in Figure 5 (12" culvert pipe?) a gap of around 300mm should be aimed for into each pool.

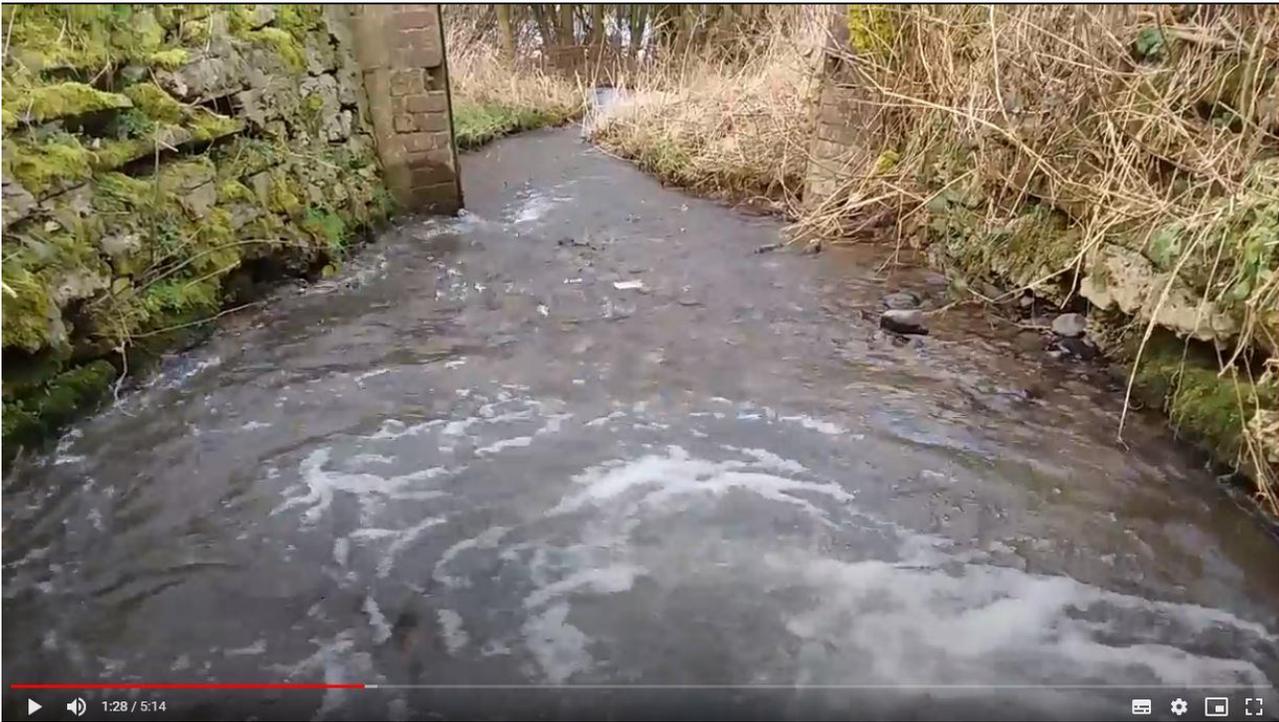
Figure 6 View downstream from the headwall taken at the same time as Figure 4 and Figure 5, showing brick pillars with slots for boards and the reservoir beyond the trees in the background.

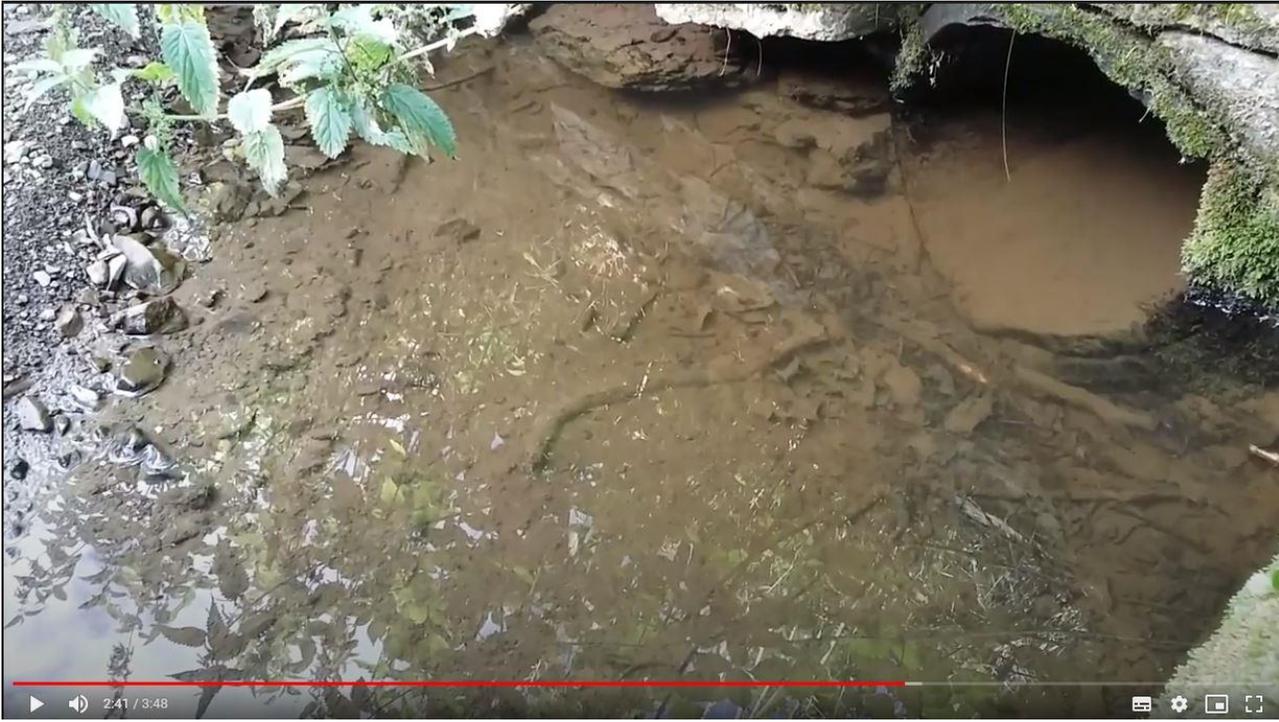
Figure 7 The same culvert pipe outflow as Figure 5 and Figure 6 during summer low flow. Trout fry are present here and similarly directly opposite in the mouth of a similar pipe through the left bank (which is blocked in the above pictures).

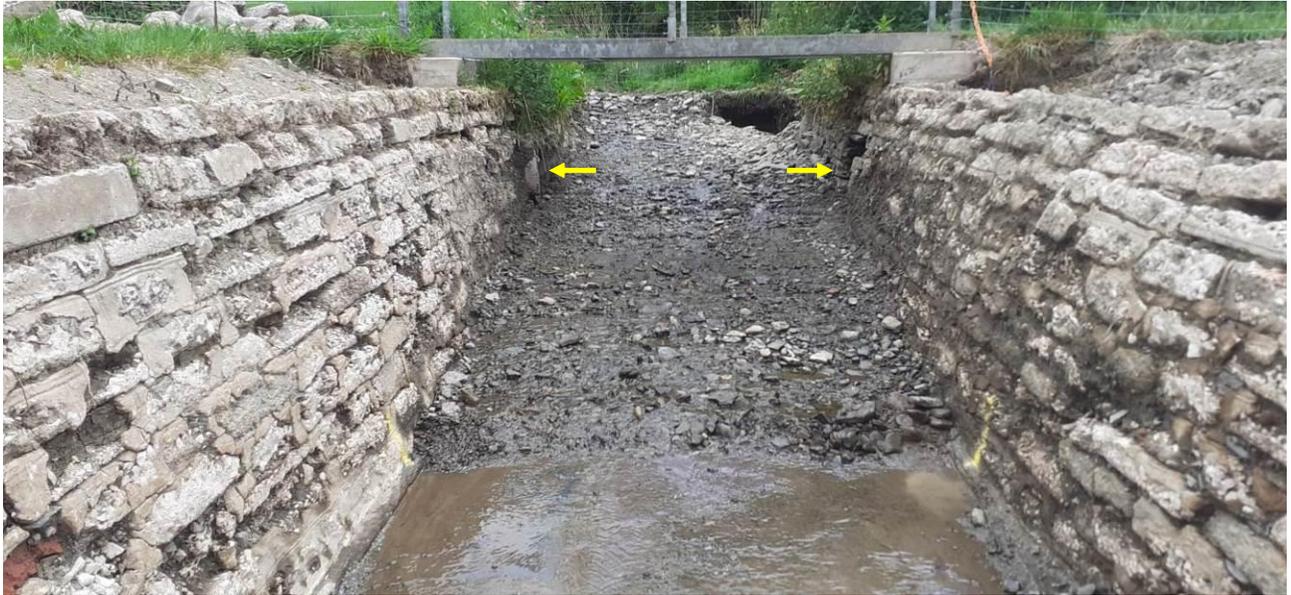
In recent weeks, work has been carried out to remove the downstream headwall of the gravel trap and excavate accumulated sediments down to the originally constructed bed level (which is paved with slate), as shown in Figure 8 and Figure 9.

Figure 8 The sediment trap area currently, following recent excavation works which have exposed the original side walls and paved base of the structure. Reference points relative to above pictures are footbridge and the inflow ends of culvert pipes (arrows). Upstream view.

The work appears to have revealed another headwall at the upstream end of the gravel trap, beneath the bridge. A ramp of gravel has been left in place here either deliberately or because the machine could not access beneath the bridge. It appears that the gravel trap was designed to work by creating a sump between two headwalls where gravel being carried in spates settled out (and could be removed), and lower flows were diverted around the sump via culvert pipes through each bank (presumably to allow maintenance).

The removal of the downstream headwall has potentially increased upstream access for trout to a greater length of the feeder stream. This is subject to closer inspection of the apparently steep drop and ramp of sediment under the bridge in Figure 8; this appears to be a barrier to fish movement as it stands, and the high flows required for fish movement are likely to move the gravel ramp leaving an even more significant migration barrier.

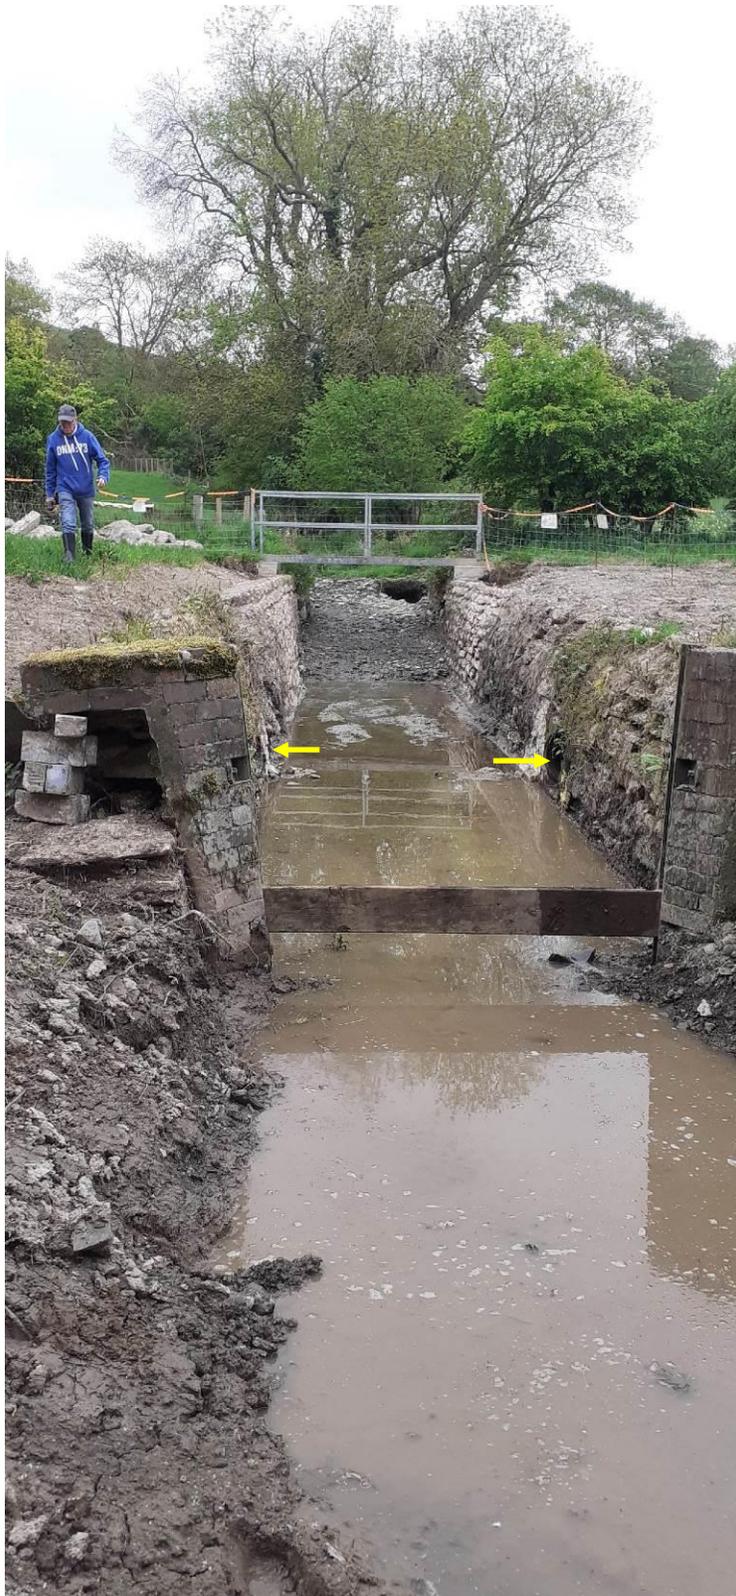
Figure 9 Wider view of Figure 8, showing level board structure, just downstream of former headwall position and culvert outflow pipes (arrows).

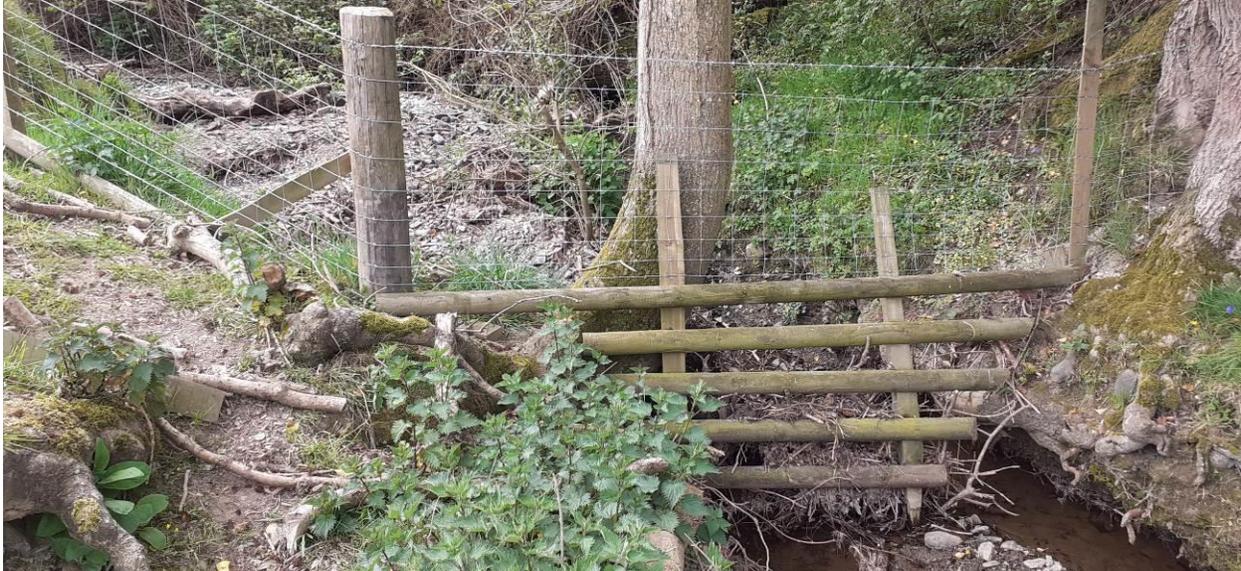
One issue with the fencing is shown in Figure 10 where it crosses the stream. The barrier to stock getting through the fence via the river channel (which is vital to maintain the above benefits) has caused an accumulation of debris which has in turn caused natural stream sediments to settle out upstream. This would not necessarily be a problem if it were a natural woody

dam (they are temporary, usually passable by fish at high flows and the habitat benefits tend to outweigh the negatives), but this situation threatens the integrity of the fence.

Figure 10 Debris dam behind the post-and-rail panel.

To tackle the issue, the barrier under the fence could be replaced with a swinging gate arrangement (see recommendations) which lifts during high flows. However, this is not immune to debris accumulation and would require regular checking to make sure it is not wedged open, allowing livestock access and losing the benefits of the fencing.

- Replace the fixed post-and-rail under the fence in Figure 10 with a swinging gate (Figure 12). Keep an eye on it (and the fence as a whole), especially after floods to ensure it is still impassable to livestock.

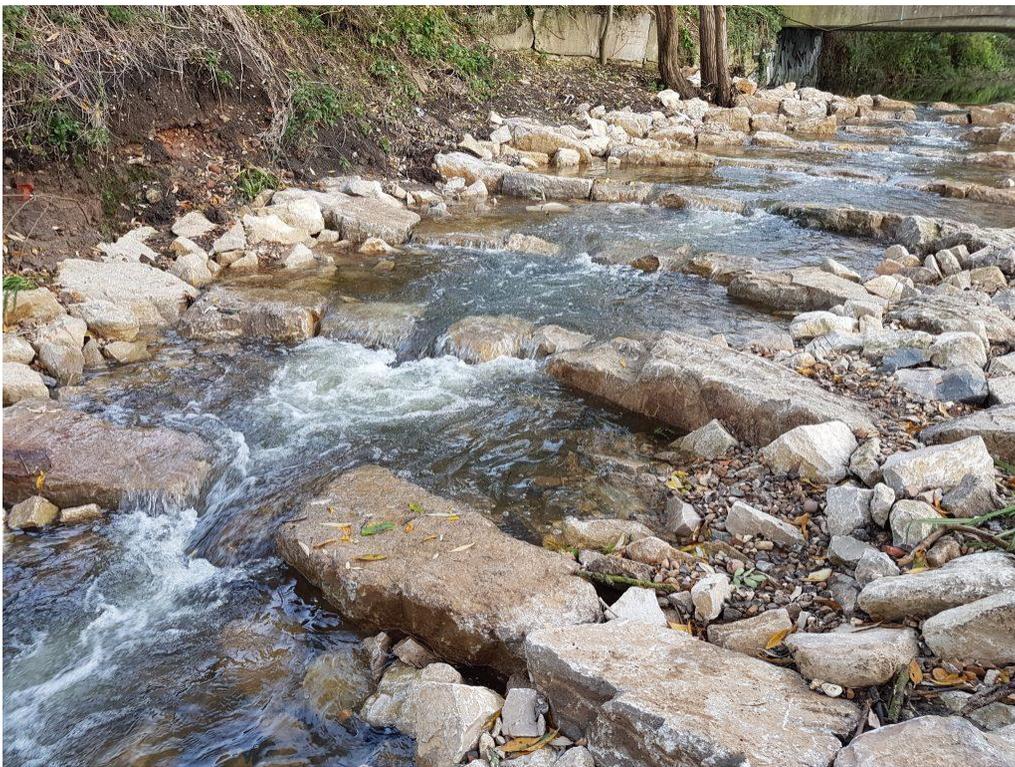
Figure 11 A rock ramp fish pass consisting of crescents of boulders with narrow gaps between and a matrix of mixed sizes of cobble and gravel between. Something similar could be created within the gravel trap, but with more variety in boulder placement and flow pattern.

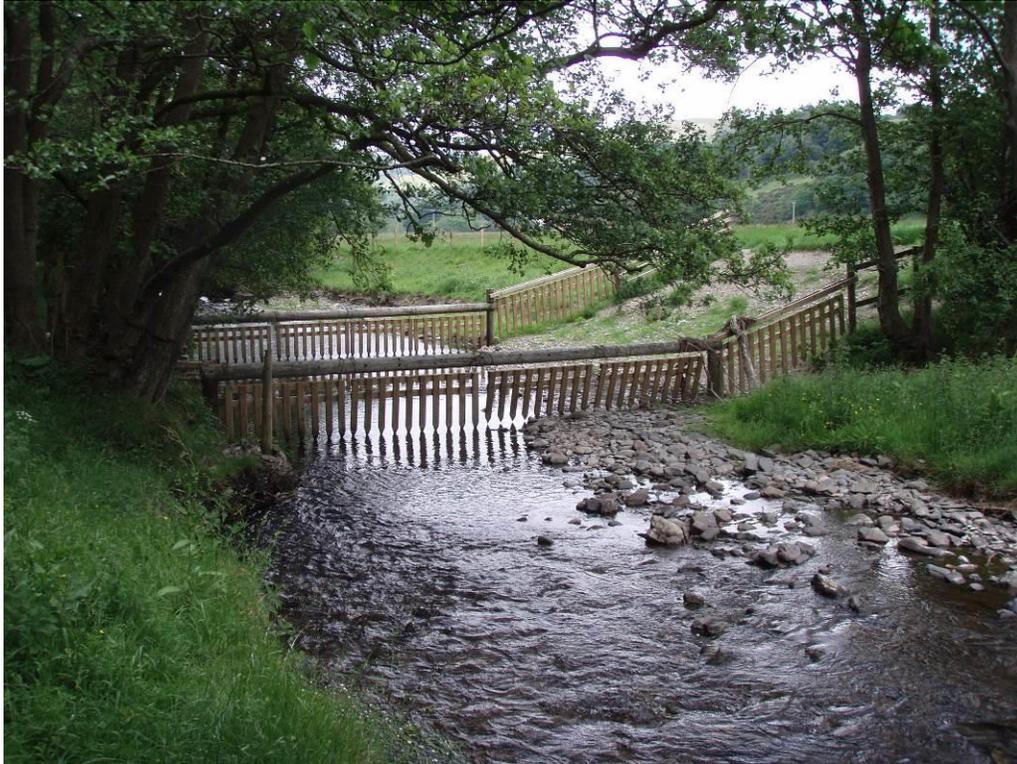
Figure 12 A swinging livestock barrier/drinking area across the Afon Aled. Scaling down a design like this would be appropriate.

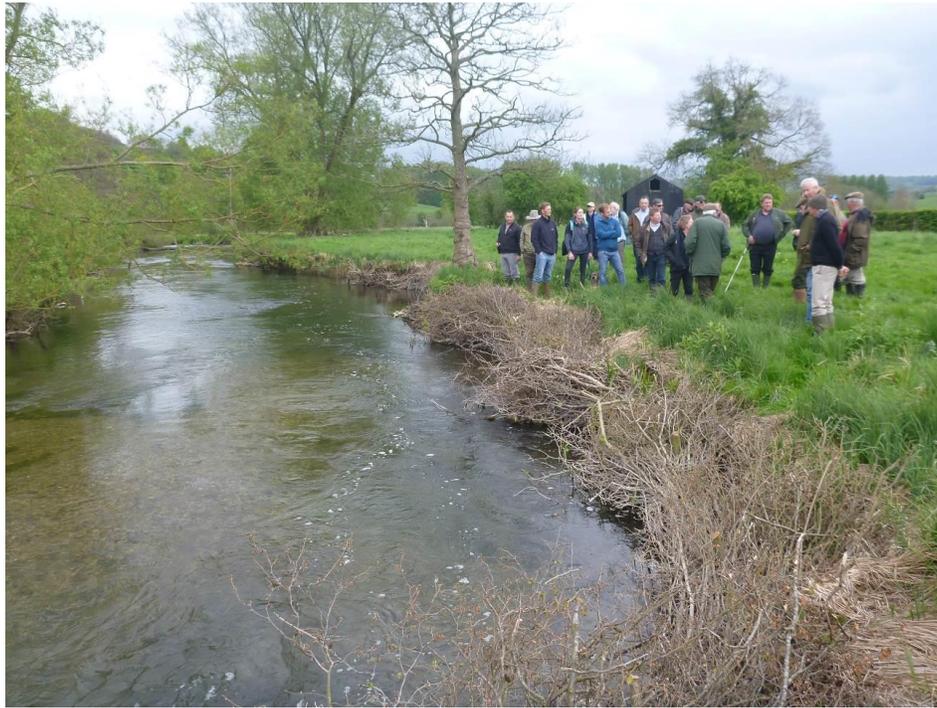
Figure 13 Brushwood fixed in the margins with posts and wire.

- Provide habitat for juvenile fish in the margins of the reservoir around the mouth of the feeder stream (maybe 50m on each side). Large stones, anchored trees/root balls, brushwood bundles or loose mattresses and scrub willows could be used and structured to take account of the normal variation in water levels, for example by having rocks/boulders further from the bank, brushwood structures in the shallower margins and living scrub willow overhanging from the bank.

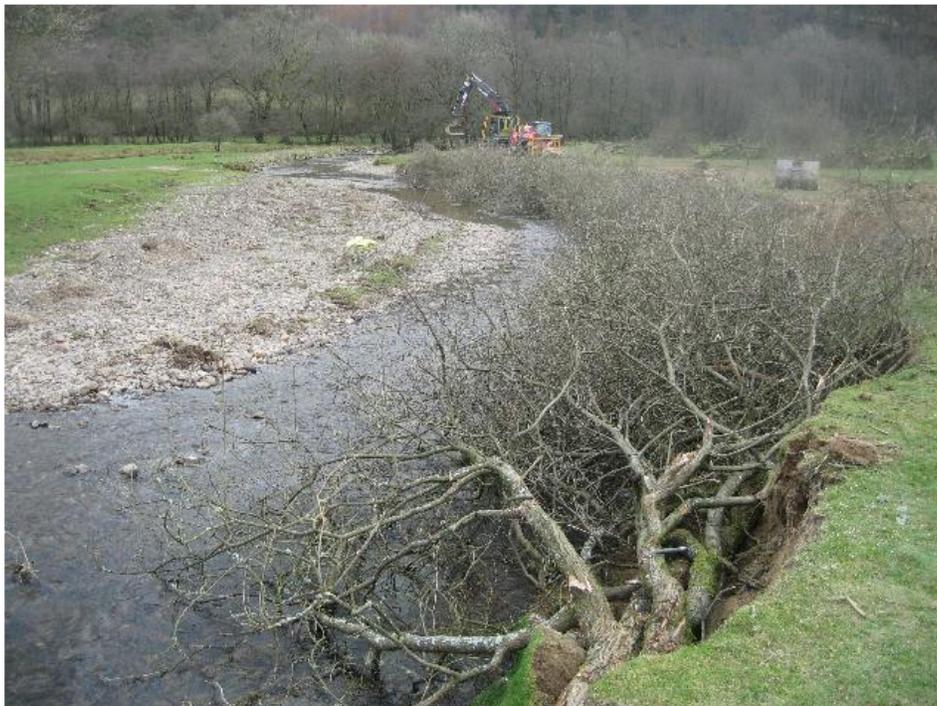
Figure 14 Trees pinned in the margins. Drilled and fixed with re-bar pin. Fence posts and wire could also be used.

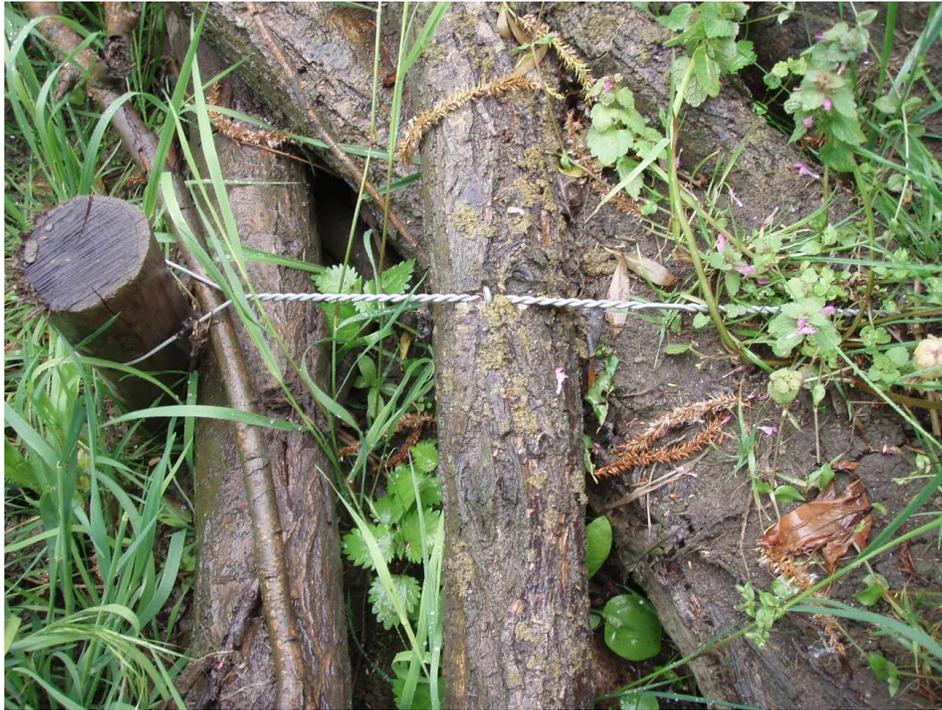
Figure 15 Secure fixing with posts and wire. Drive posts 95%, loop wire around the posts and staple behind each post, twist wire loop in centre (e.g. with screwdriver or 6" nail), drive posts fully (wire may untwist slightly, but prevents snapping), staple on top is optional. NB use mild steel wire (about 2.5 mm), not high tensile.

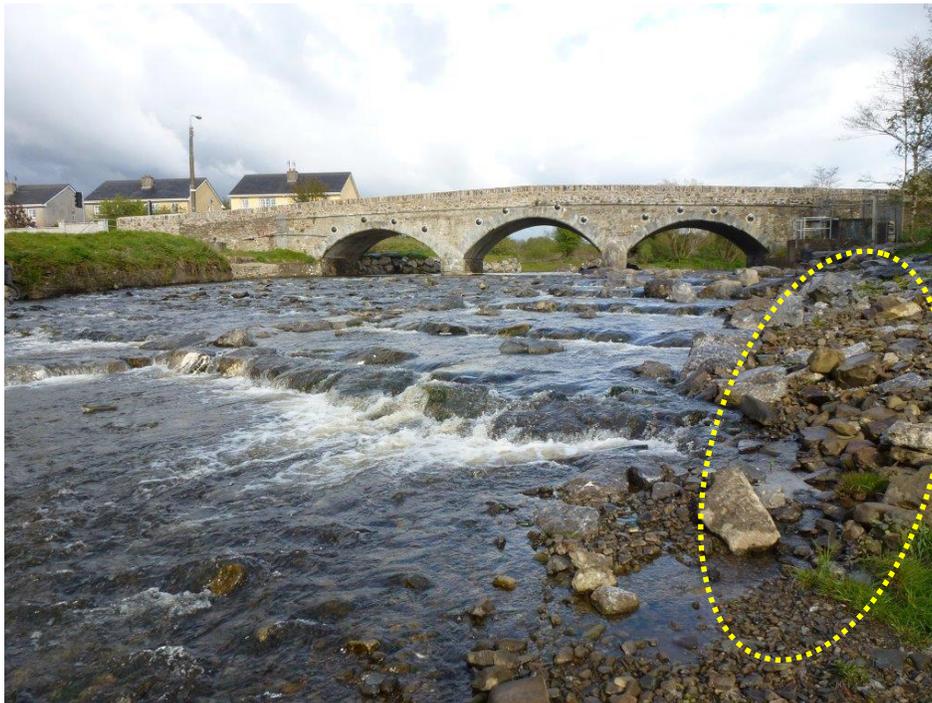
Figure 16 The boulder/cobble margin illustrated here would provide good juvenile trout habitat if submerged in the margins of the reservoir.
