**Advisory Visit**

**River Don, South Yorkshire**

**8<sup>th</sup> January, 2009**

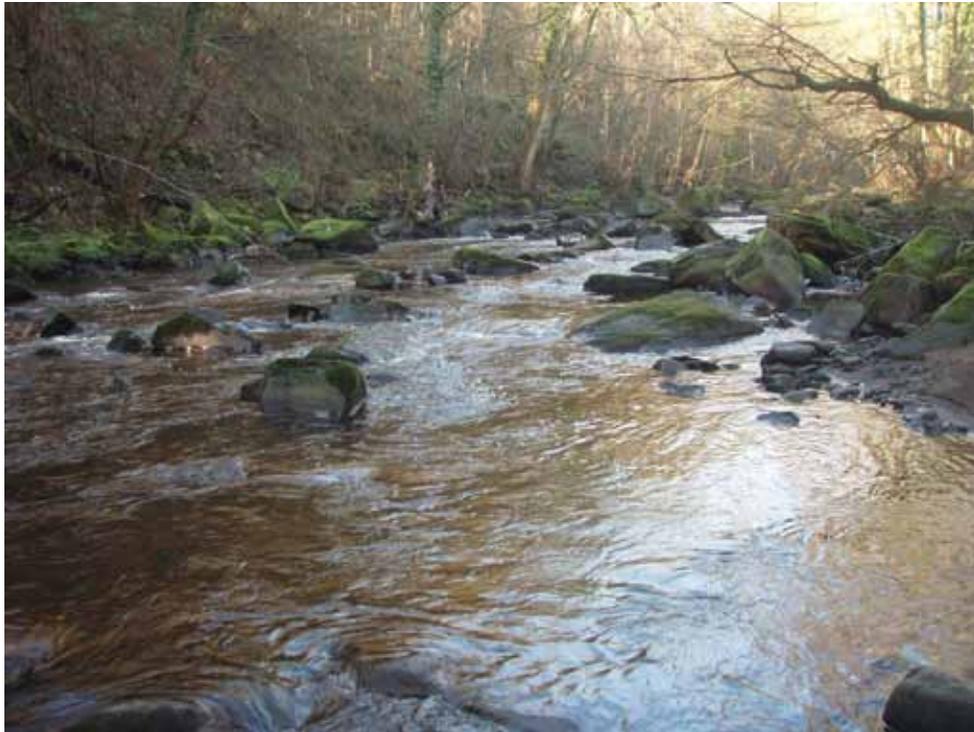
Photo 1 Typical view of the Don at Wharnccliffe

The river here occupies a steep-sided, wooded valley. The river gradient is steep and this is reflected in the instream habitat: large boulders, cascades, pools and runs (Photo 1). Habitat for trout is generally very good with ample adult and juvenile habitat. This is a popular stretch for UDFE anglers and contains good numbers of trout and grayling.

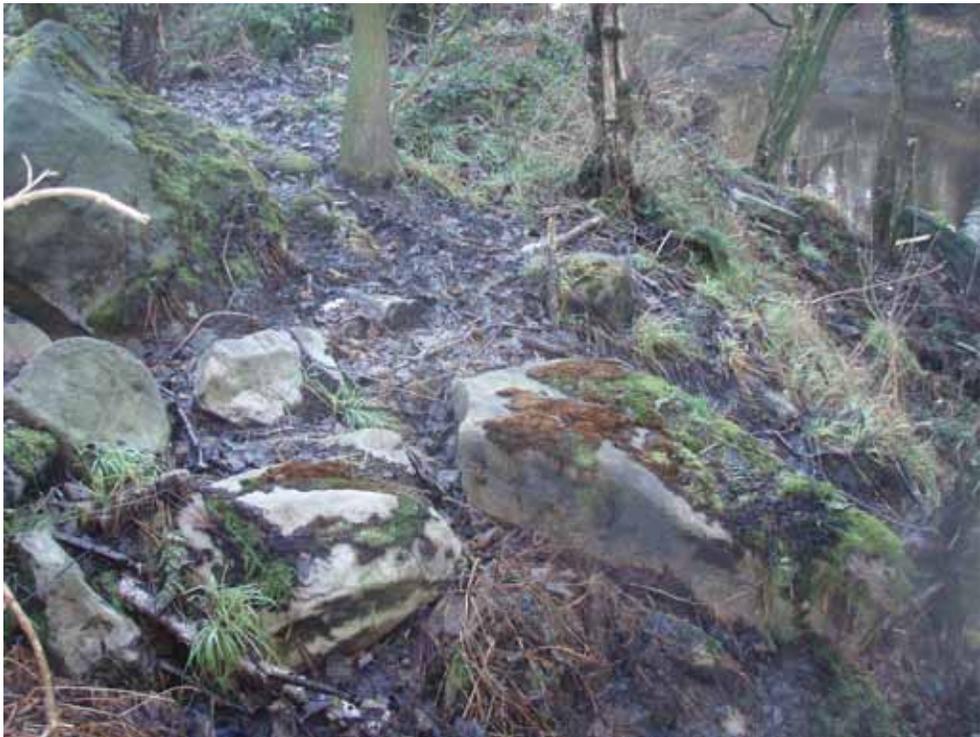
Photo 3 Vegetation possibly affected by run off from the spoil heap

At one point (SK 29560 96482), there appears to be a breach in the willow/birch scrub where run off from the spoil flows into and across the river bank, and affects the vegetation; a number of mature trees have died, and there is little or no understorey of grass, brambles, etc (Photo 3). This is leaving the river bank exposed to erosion during high flows. This is a matter that should be investigated further with the responsible authority (probably the Waste Regulation function of the EA) to prevent the situation deteriorating.

- Check EA fish survey records for this area (if available) to see how successful or otherwise juvenile trout recruitment is. This will confirm whether it is worth improving access and habitat in tributaries.
- Assess the tributary becks for access and habitat quality (spawning), and flow regimes from dams. Identify likely candidates for spawning habitat improvement.
- Contact the EA regarding the run-off from the spoil heaps on the left bank.

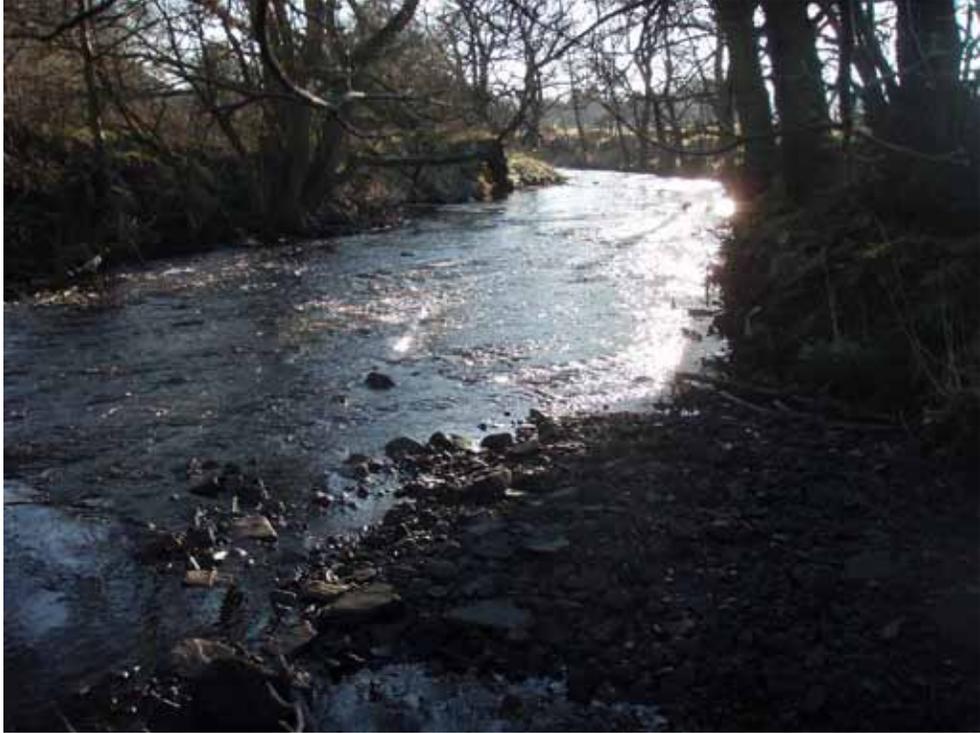
Photo 4 The River Don at Thurgoland

This section of river (upstream of the road bridge) is higher up the catchment and is narrower than at Wharncliffe, and also has a lower gradient to the channel. The banks have a single line of trees between the river and fields used for grazing (Photo 4). The right bank fence was installed by UDFF with a grant from Yorkshire Wildlife Trust and is providing valuable protection to the riparian zone of the river.

Generally this reach of river has little variation in river bed topography: it is shallow, and there is little variation in depth or flow patterns. This is poor habitat for all life stages of trout, and particularly for holding adult fish. A notable exception to this is where a large willow has fallen across the river, creating some valuable habitat (Photos 5 and 6). The scour underneath the tree bole during higher flows has created a deeper pool area downstream of the structure, and thrown up some well-sorted gravels below it; good habitat for adult trout in the deeper water, and good spawning gravels as well – two benefits for the price of one. It is important such LWD is retained.

The key to improving this stretch is to use trees arising from coppicing work to create LWD structures within the channel, to promote scour of the river bed (see section 4.0 Recommendations).

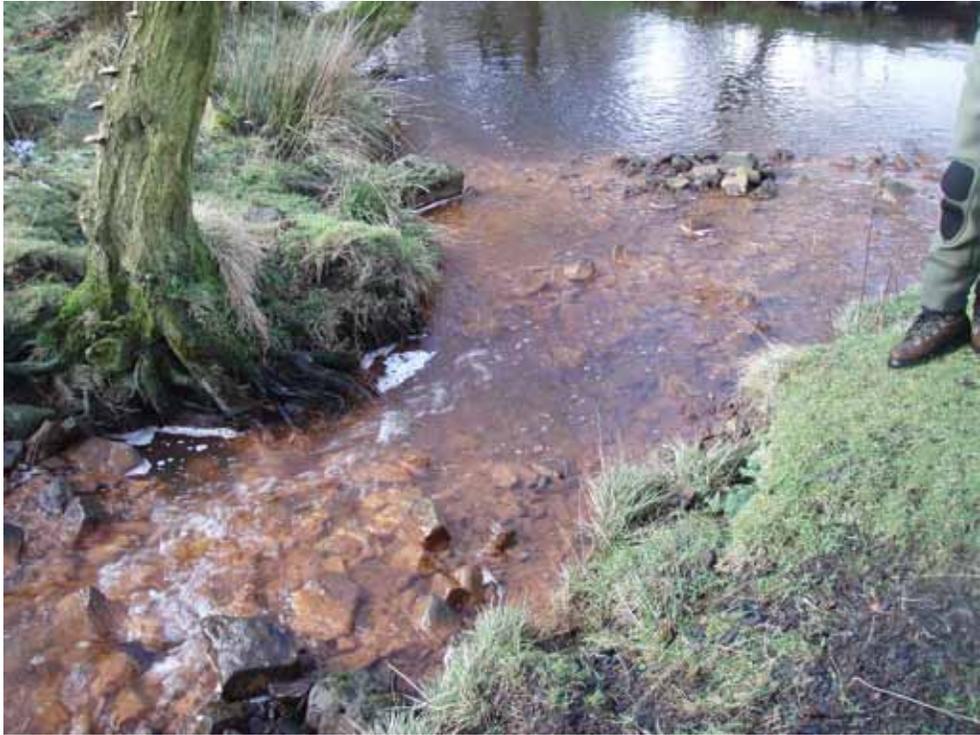
Photo 7 Ochrous minewater in the Cranberry Holes Brook

This section has also suffered minewater input and discoloration from ochre, something which was again tackled by the club leading to works by the Coal Authority to ameliorate the problem. There is still some evidence of the problem in the form of iron ochre in the Cranberry Holes Brook tributary (NGR SK 208 026) and some upwelling in the main river, although UDF members report the problem is generally much reduced (Photo 7).

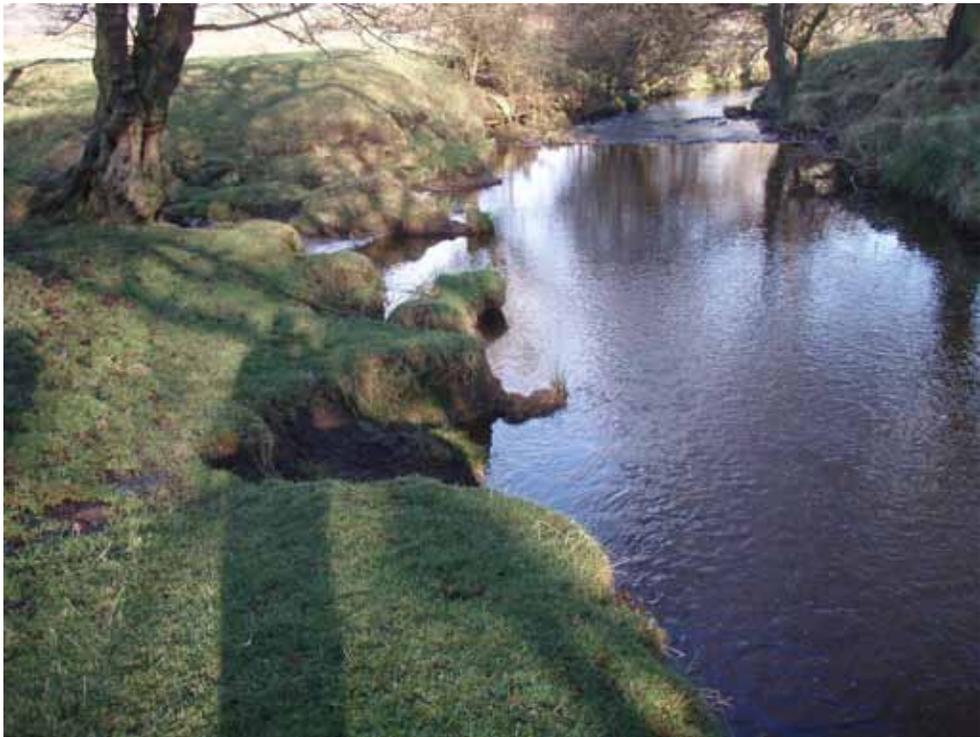
Photo 8 Intensive grazing leading to eroded banks (left bank); contrast with the fenced RHB.

stream habitat in this reach. The most significant of these is grazing of the banks by livestock. This is evident at several locations including the field downstream of the blockstone weir (left bank) (Photo 8), and the two fields downstream of Hazlehead Hall (Photos 9 and 10). There is a distinct contrast between the quality of habitat in the sections where livestock access is restricted (where it is much better), and the sections where access is unfettered.

- Fence off the river banks to prevent livestock grazing the banks, and provide an alternative drinking source. This is particularly recommended on the upper river. The type of fencing required will depend upon what livestock are kept in the fields; cattle can be excluded with a 2-strand barbed wire fence, whereas sheep will require sheep-netting topped with barbed wire. The cost of the latter would be approximately £4 per metre, the former somewhat cheaper. Electric fencing would be cheaper, but requires more regular maintenance (battery changing), and is vulnerable to battery theft. Gates within the fenceline should be provided to allow for managed livestock access to control excessive growth and undesirable plant species on the riverside of the fence.

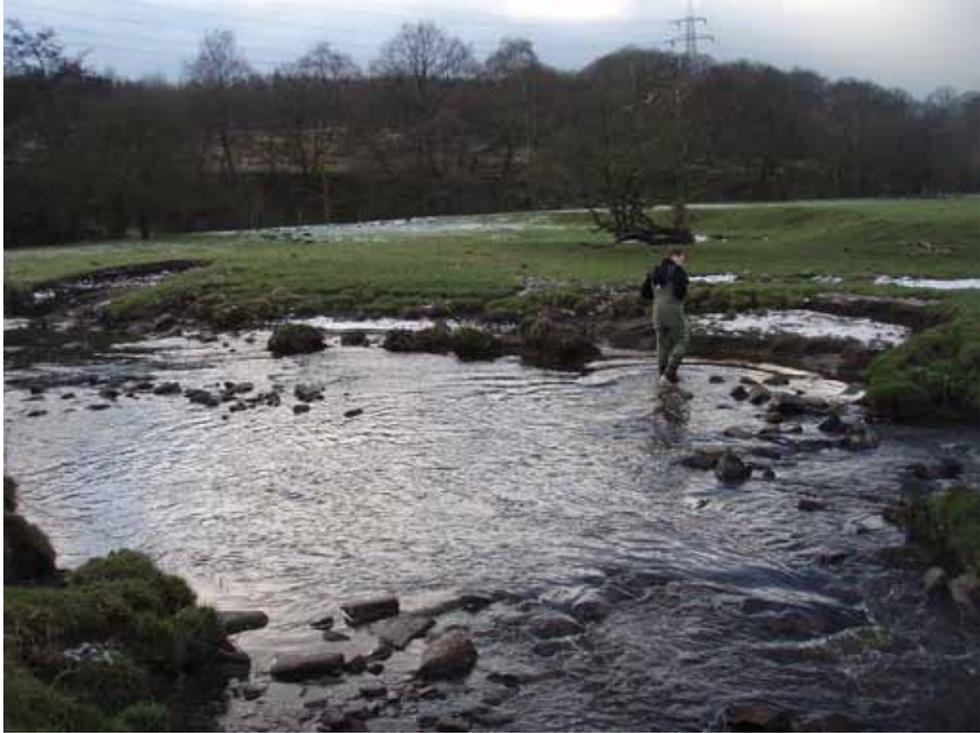
Photo 9 Over-wide, over-shallow – very poor habitat as a result of livestock access to the river

The grazing is leading to over-widening of the channel creating a uniform, shallow depth profile (Photo 9), and 'scalping' of the bank between trees where they are present (Photo 10). This promotes erosion of the bank behind the trees, speeding up their rate of loss. This is of particular concern because, like the Thurgoland reach, many are mature alders suffering from *Phytophthora* disease (Photo 11). Unless some action is taken, it will not be many years before most of the alders on this reach are lost, with the predictable consequences of greatly increased rates of bank erosion.

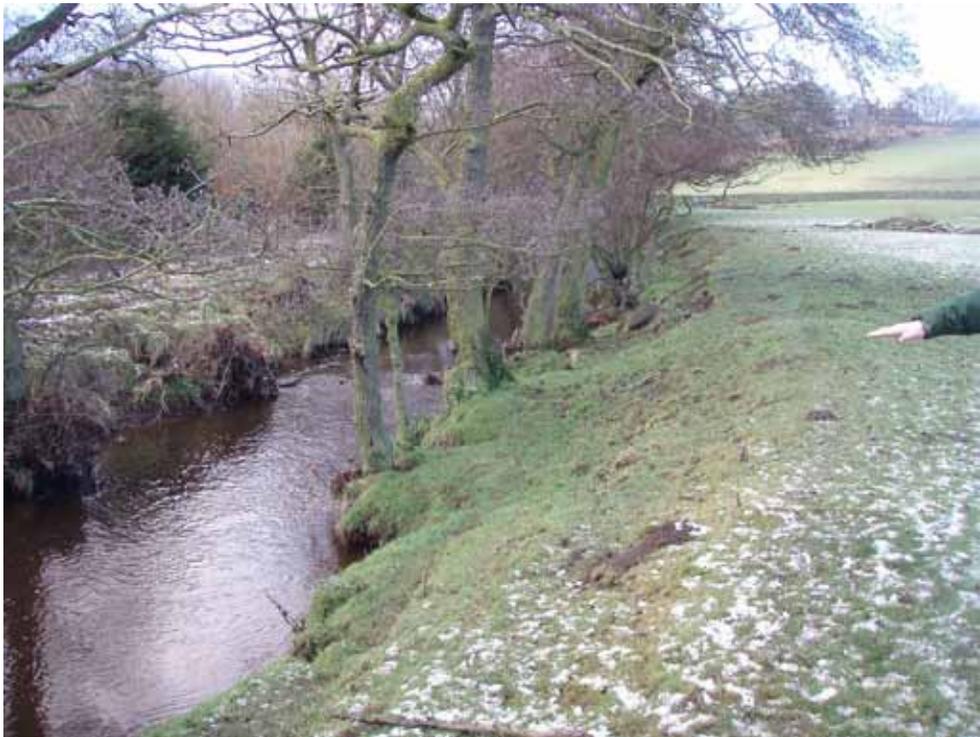
Photo 10 'Scalloping' of the banks between trees

As a consequence of such runaway erosion, the channel will widen and potential spawning habitat will be smothered by fine particulate material. This not only limits recruitment of current non-migratory trout populations, but also denies spawning opportunities if migratory salmonids were ever to be restored to the river. Coppicing of alders, replanting native tree species, and fencing a riparian zone to allow regeneration are the prescriptions required here.

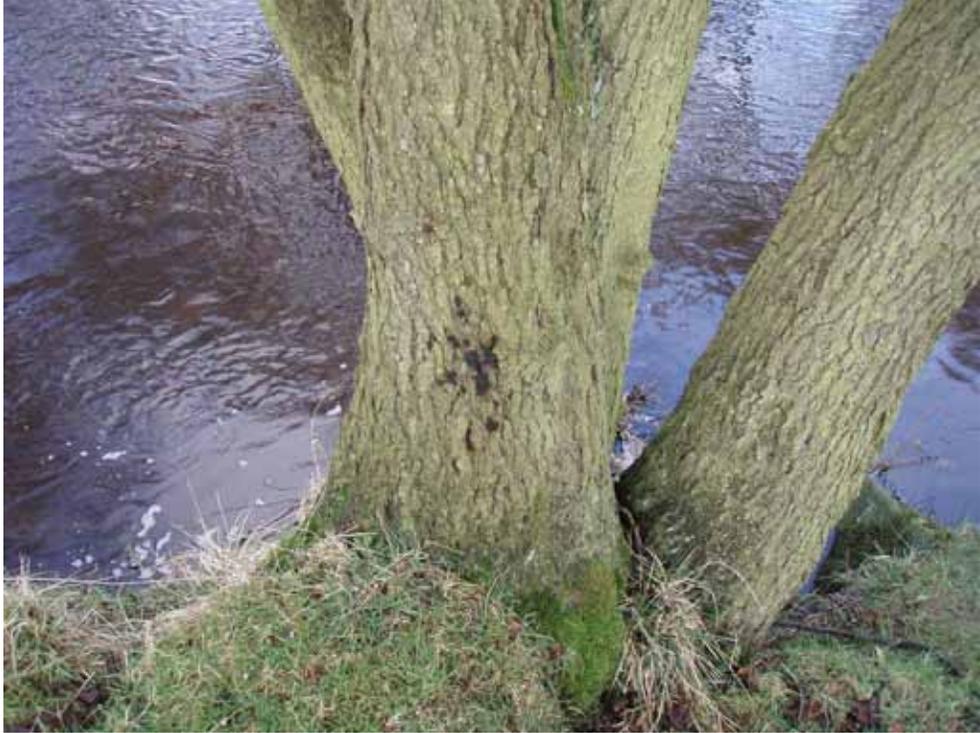
Photo 11 Tarry spots – a symptom of *Phytophthora* disease in alders

Most of the trees are mature alders of a similar size and age, and many are showing signs of the fungal disease *Phytophthora*. This disease will eventually kill the trees, and their loss will probably lead to problems with bank erosion as the root mass deteriorates or is lost with the tree falling. Preventative action should be taken and this should include coppicing alders in the early stages of the disease (this will prolong their life) and planting native tree species to succeed the alders.

- Start a programme of coppicing alders to prevent their loss to *Phytophthora* disease. Ideally a seven to ten-year cycle of coppicing should be implemented, but given the extent of the disease observed it may be necessary to shorten the cycle to five years or less. Some key points of best practice when coppicing are listed in Appendix 1. One of the most important is to protect re-growth from grazing livestock (by fencing); if this is not done the new shoots will be eaten and the tree will die. Rather than coppicing blocks of trees, a random pattern to create a mosaic of light and shade is recommended.

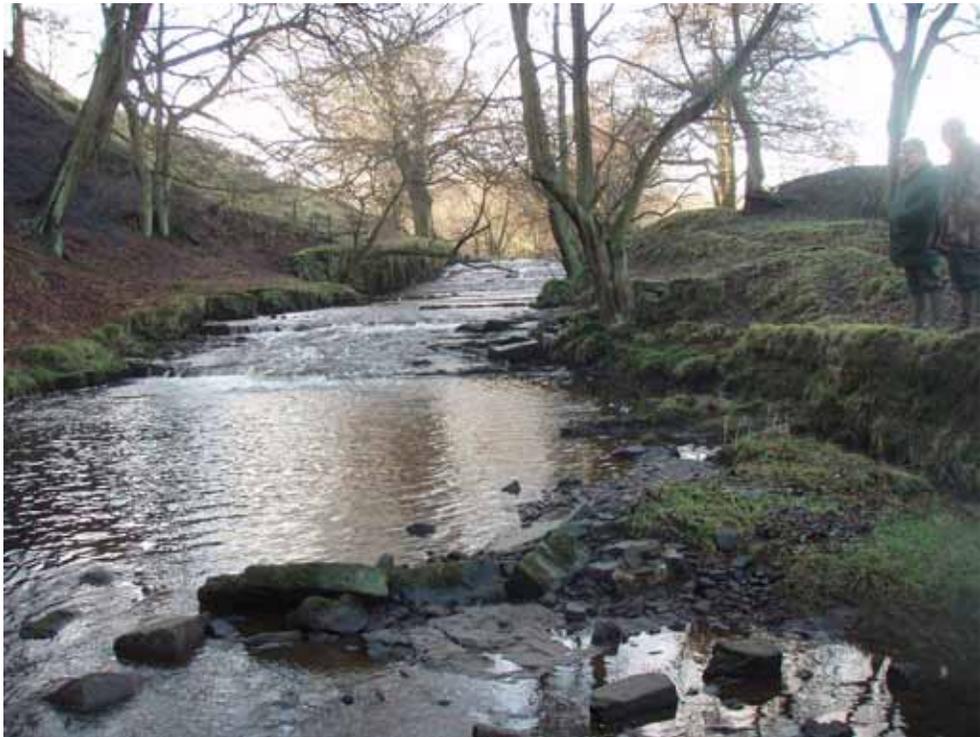
Photo 12 The weir constructed from block stone

The river channel has been modified in the past for milling; there is a weir in this reach (Photo 12), the leat from which would have powered Bullhouse Mill, and there are other weirs on the map further downstream. Weirs fragment fish populations and restrict migration for spawning, feeding, and accessing resting or feeding habitat. If these structures are redundant, their removal would be of immediate benefit to stream resident species like trout, grayling, bullhead and brook lamprey, and in the longer term to migratory species such as salmon and sea trout as they return to the Don catchment.

Consideration should be given to improving fish passage at barriers like the sloping blockstone weir near Bullhouse (Photo 12). Ideally they should be removed, as this will not only facilitate fish passage but improve the ecology of the stream by restoring the slow-flowing impoundment to more natural flow conditions..

Not all obstructions can be removed, and a secondary option would be to look at improving fish passage with fish passes or easements; this would require site surveys and designs from a suitably qualified person. Such a consultant could prepare a preliminary overview of structures in the upper Don, highlighting priorities, options and costs for removal or improvement. It is recommended that UDFE liaise with the EA to see if any such work has been completed in the past, and if not, the possibility of initiating such a study.

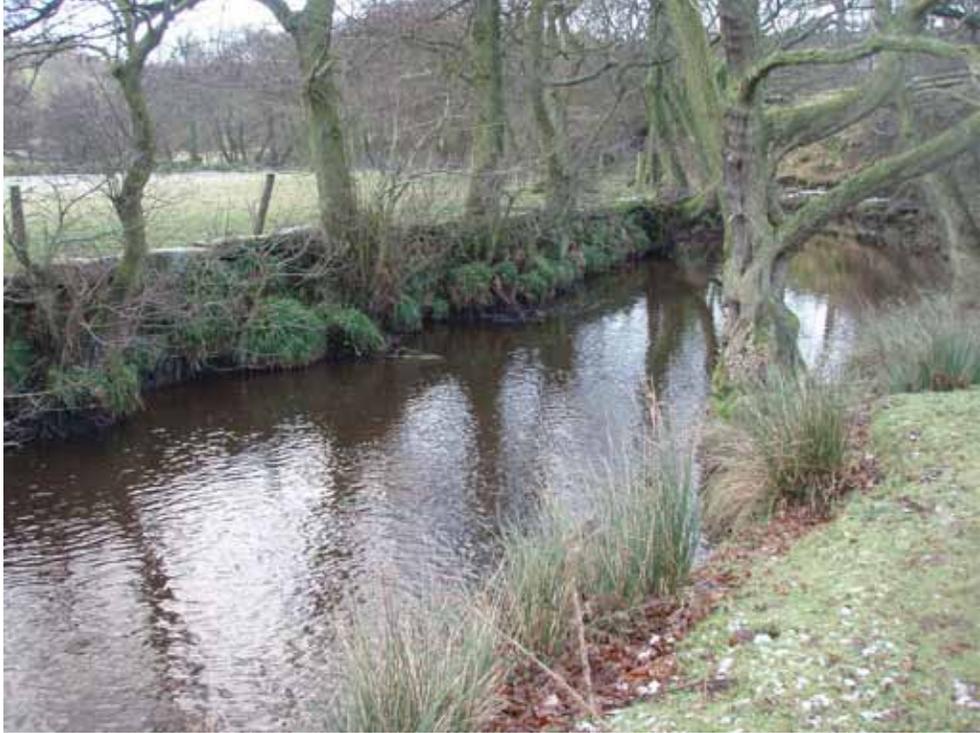
Photo 13 A walled bank (far bank)

The channel has also been modified in places by the construction of bank retaining walls, usually on the outside of bends to revet the bank against erosion (Photo 13). This tends to fix the channel in position for a long time (decades), restricting the natural dynamic river processes of erosion and deposition which create depth variation (the natural pool-riffle sequence);

hence in some such areas the channel is a uniform shallow glide, with relatively poor trout habitat. Use of LWD in these areas can increase the variability of river bed topography and improve fish habitat (in a similar way to the example at Thurgoland – Photo 6).

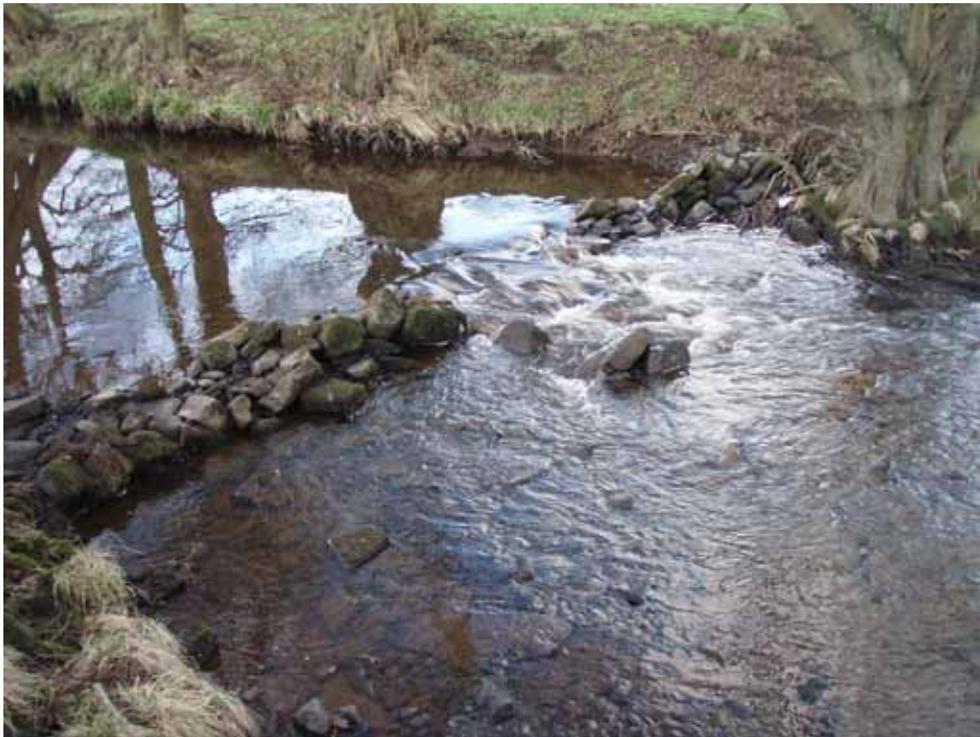
In some areas UDFF have constructed some low stone weirs to create pool habitat (Photo 14). These have been designed to impound water behind them to create depth; this tends to be counter-productive because sediment can accumulate behind the weir leading to a loss of depth, and a smothering of valuable coarse substrates (gravel/cobble) with less desirable fine material (sand/silt). A better method would be to use designs that concentrate the flow downstream of the structure, scouring the river bed; this could be achieved with careful positioning of LWD, or with more engineered structures like K-dams or wedge dams (see recommendations).

Photo 14 Weir constructed by UDFP to retain water levels and depth for adult trout (the centre has collapsed).  
A design to promote downstream scour, rather than retain upstream depths, would be better.

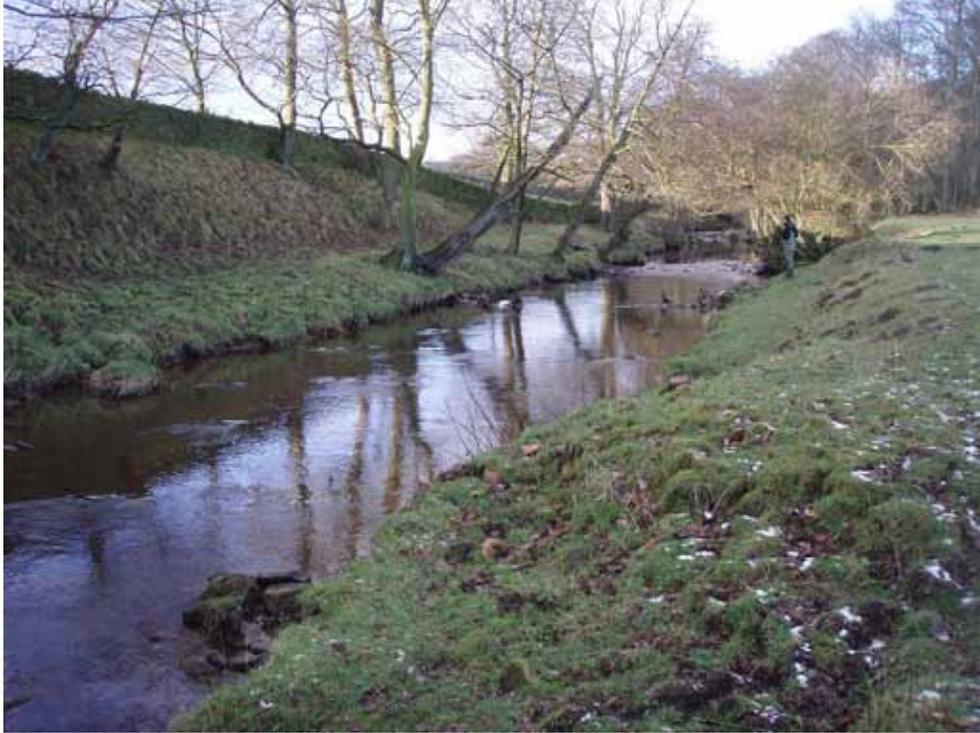
Photo 15 Wide and shallow – poor fish habitat

The areas where the channel is wide and uniform, for example the field below Hazlehead Hall (Photo 15), could be improved by the use of LWD (arising from tree coppicing works) to narrow the channel, and to make groynes for promoting scour of the river bed.

- Woody debris should be introduced to the river channel to create variation in channel width and river bed topography. This can be achieved in a variety of ways including anchoring whole or parts of trees within the channel (Figure 1); using brushwood to provide cover, protect eroding banks and promote channel narrowing; and more engineered structures (Figure 2) like wedge or K-dams, channel constrictors and cross-channel logs and deflectors (Hunt, 1993).

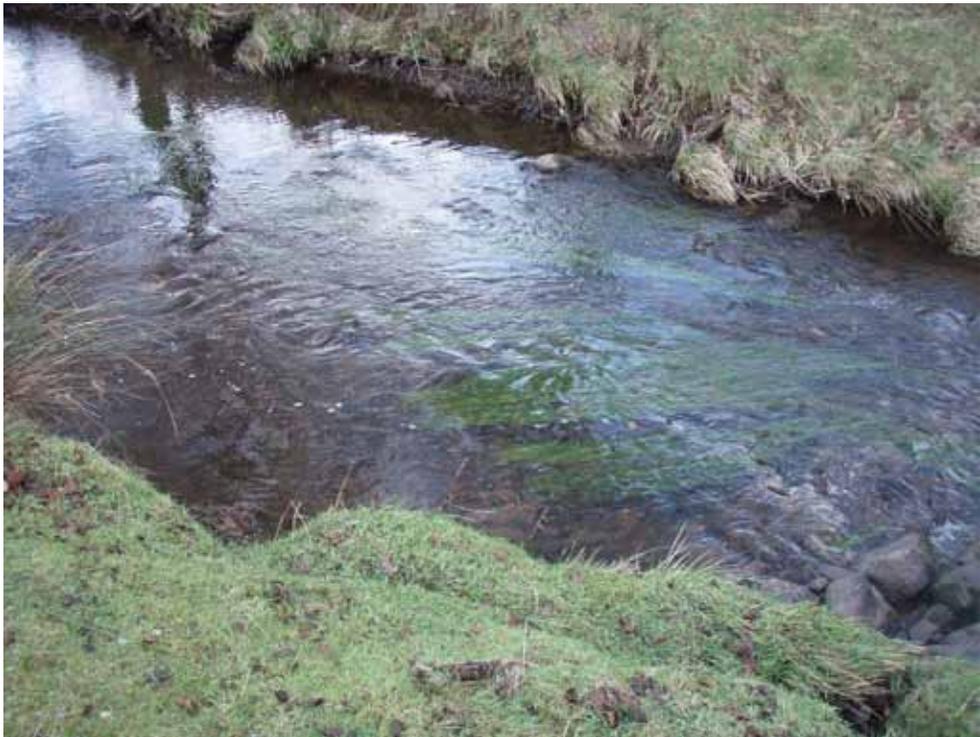
Photo 16 Water crowfoot *Ranunculus* sp. in the upper Don

UDFF have transplanted water crowfoot *Ranunculus* spp. to this reach with mixed success (Photo 16). It has taken in some areas, but in others it has been uprooted during flood events. Cutting the weed back in the autumn after its first season's growth will help prevent it being uprooted in winter floods. Indeed it may be worth regularly cutting back each clump throughout the year (by one-third to one-half) as a precaution against floods in this spatey river.

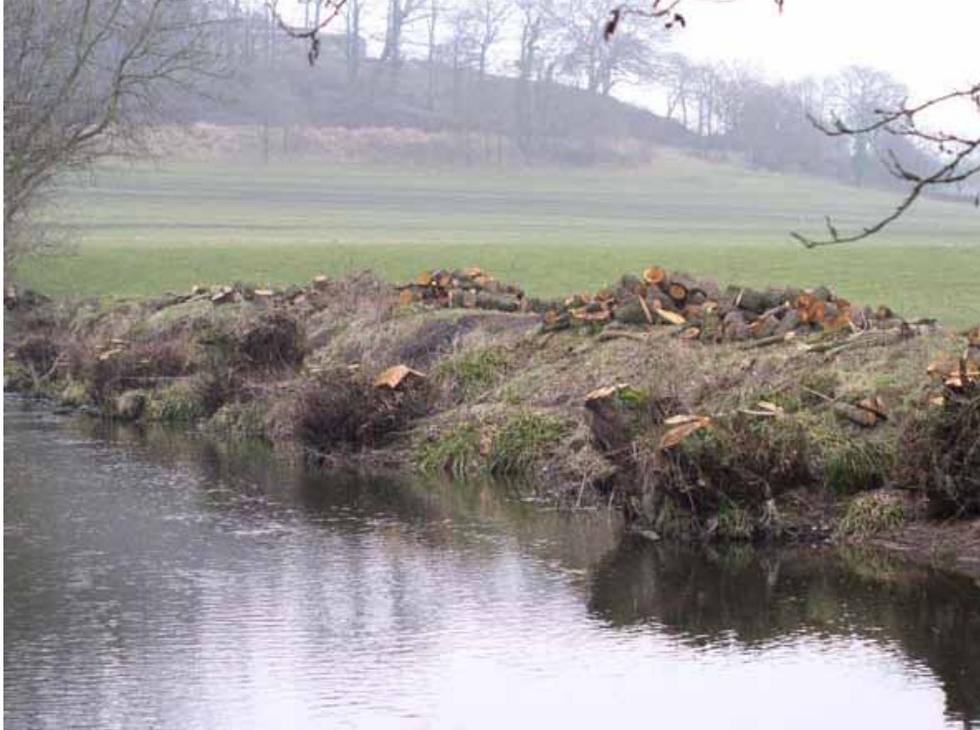
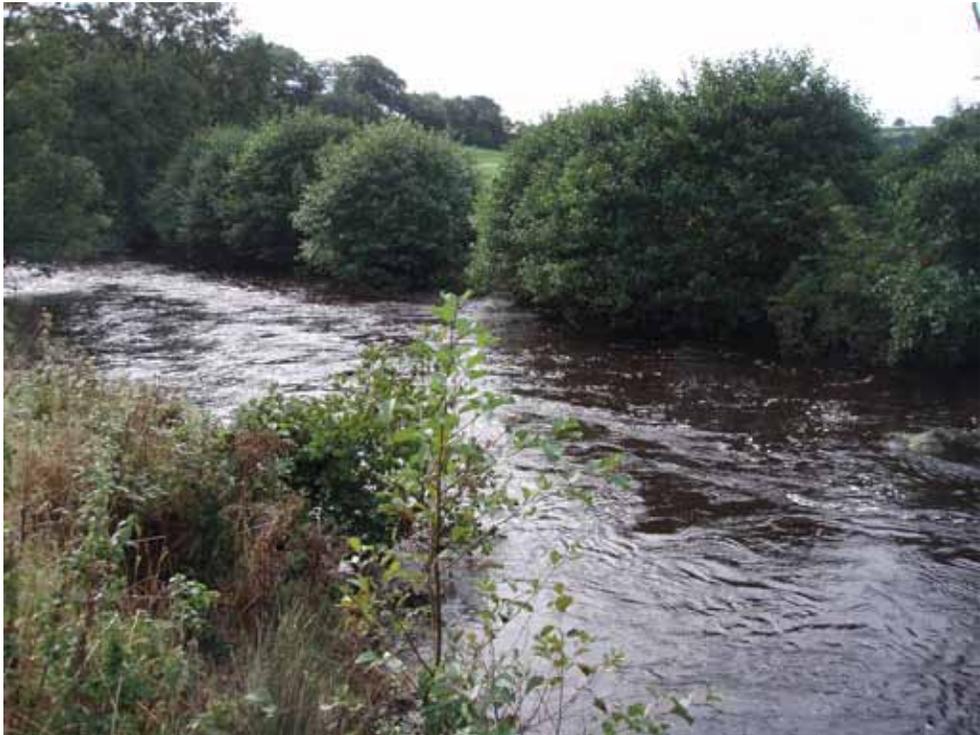
Photo 19 Alders coppiced in 2004 on the River Dane, Cheshire...

Photo 20 ...and the same site in 2008.

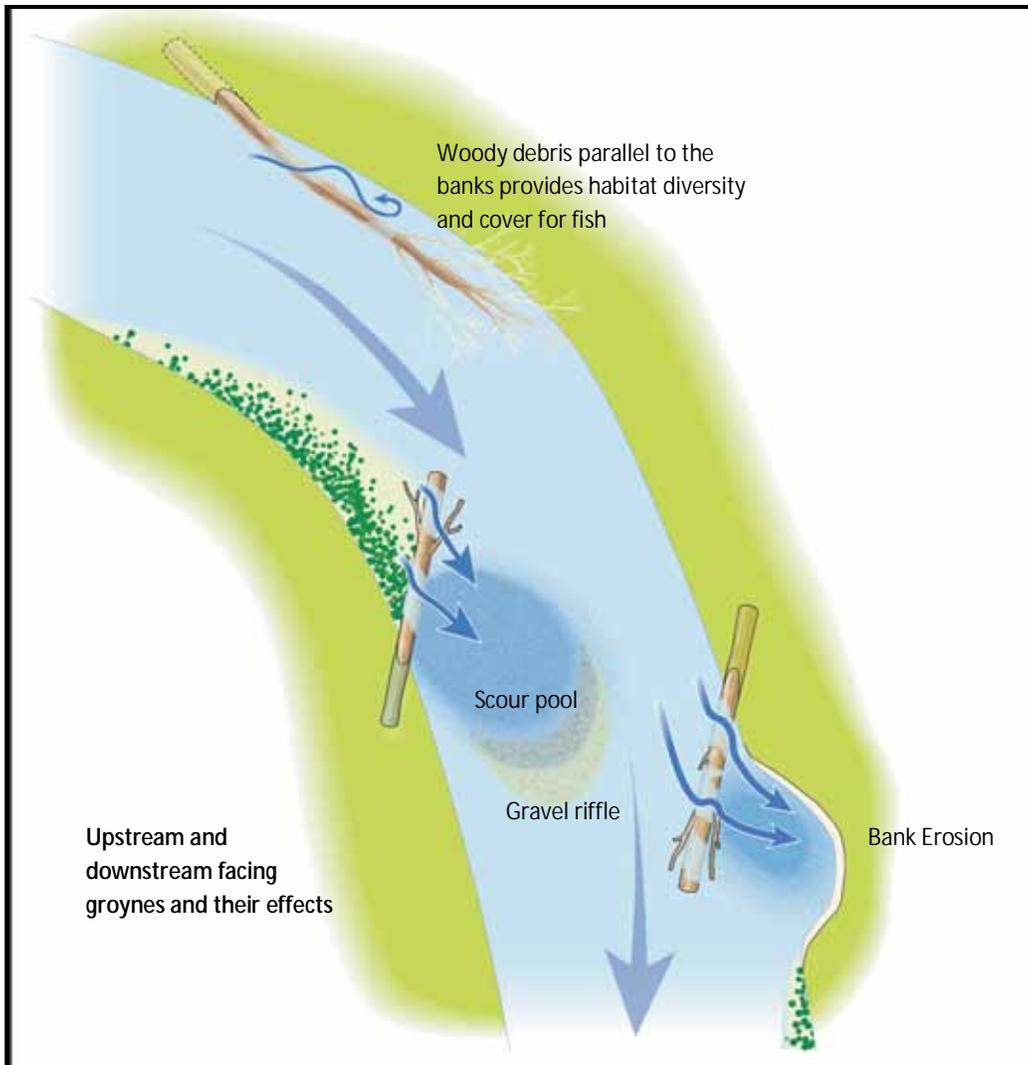
Figure 1 Examples of LWD positioned for channel narrowing, cover and bed scour. Downstream pointing groynes are generally best avoided to prevent bank erosion

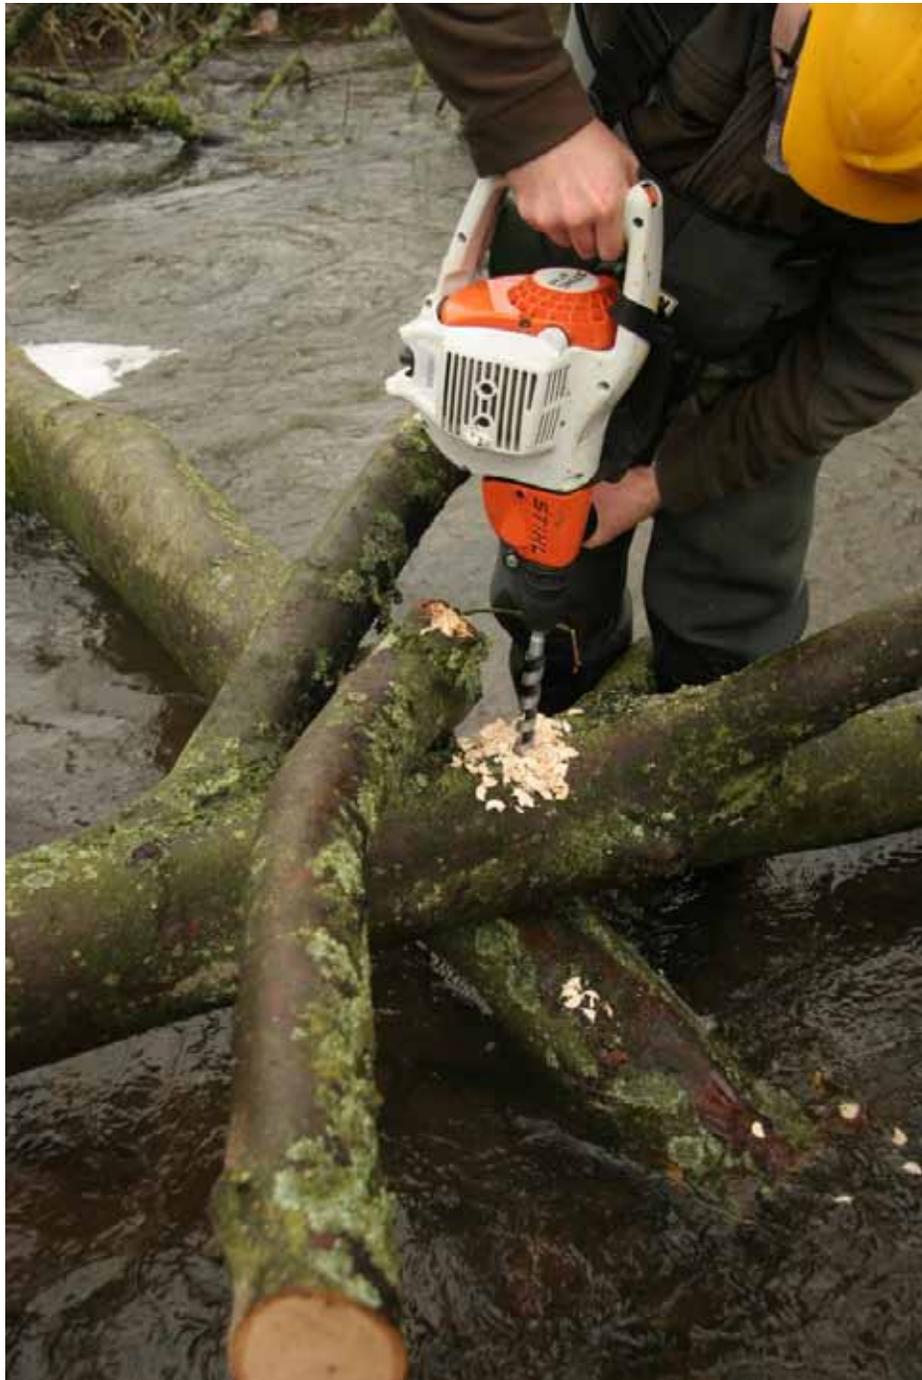
Photo 21 Using a wood auger to bore holes in LWD

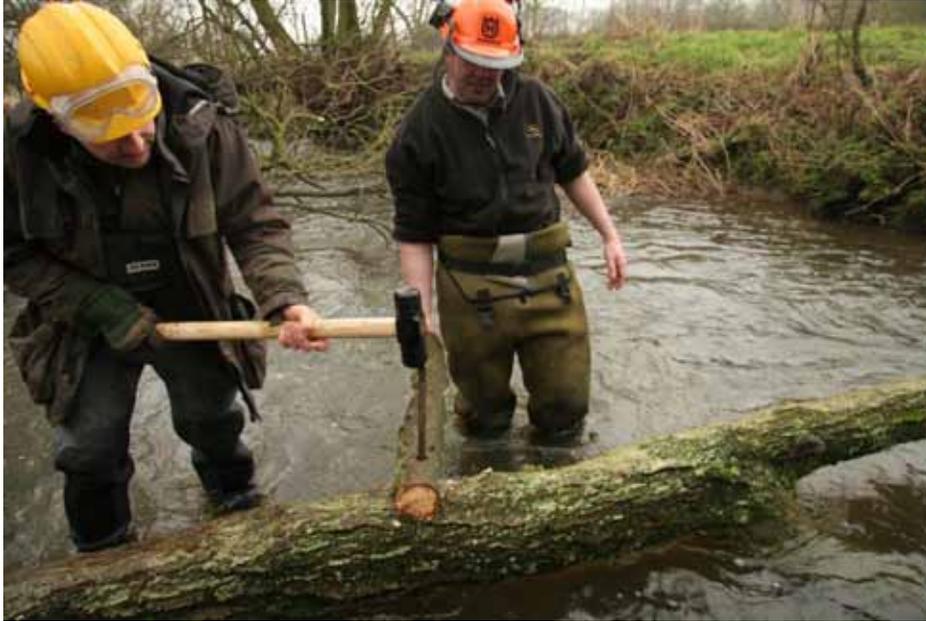
Photo 22 Fixing LWD in position with steel rebar

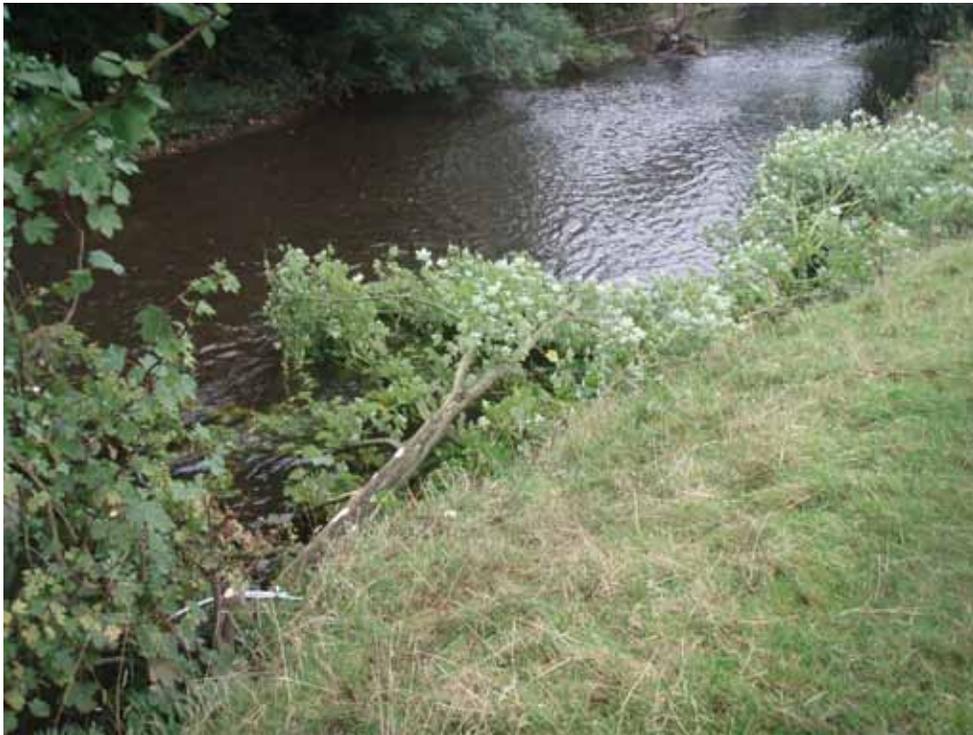
Photo 23 Whole tree anchored alongside the bank with steel cable to a standing tree (River Goyt, Cheshire)

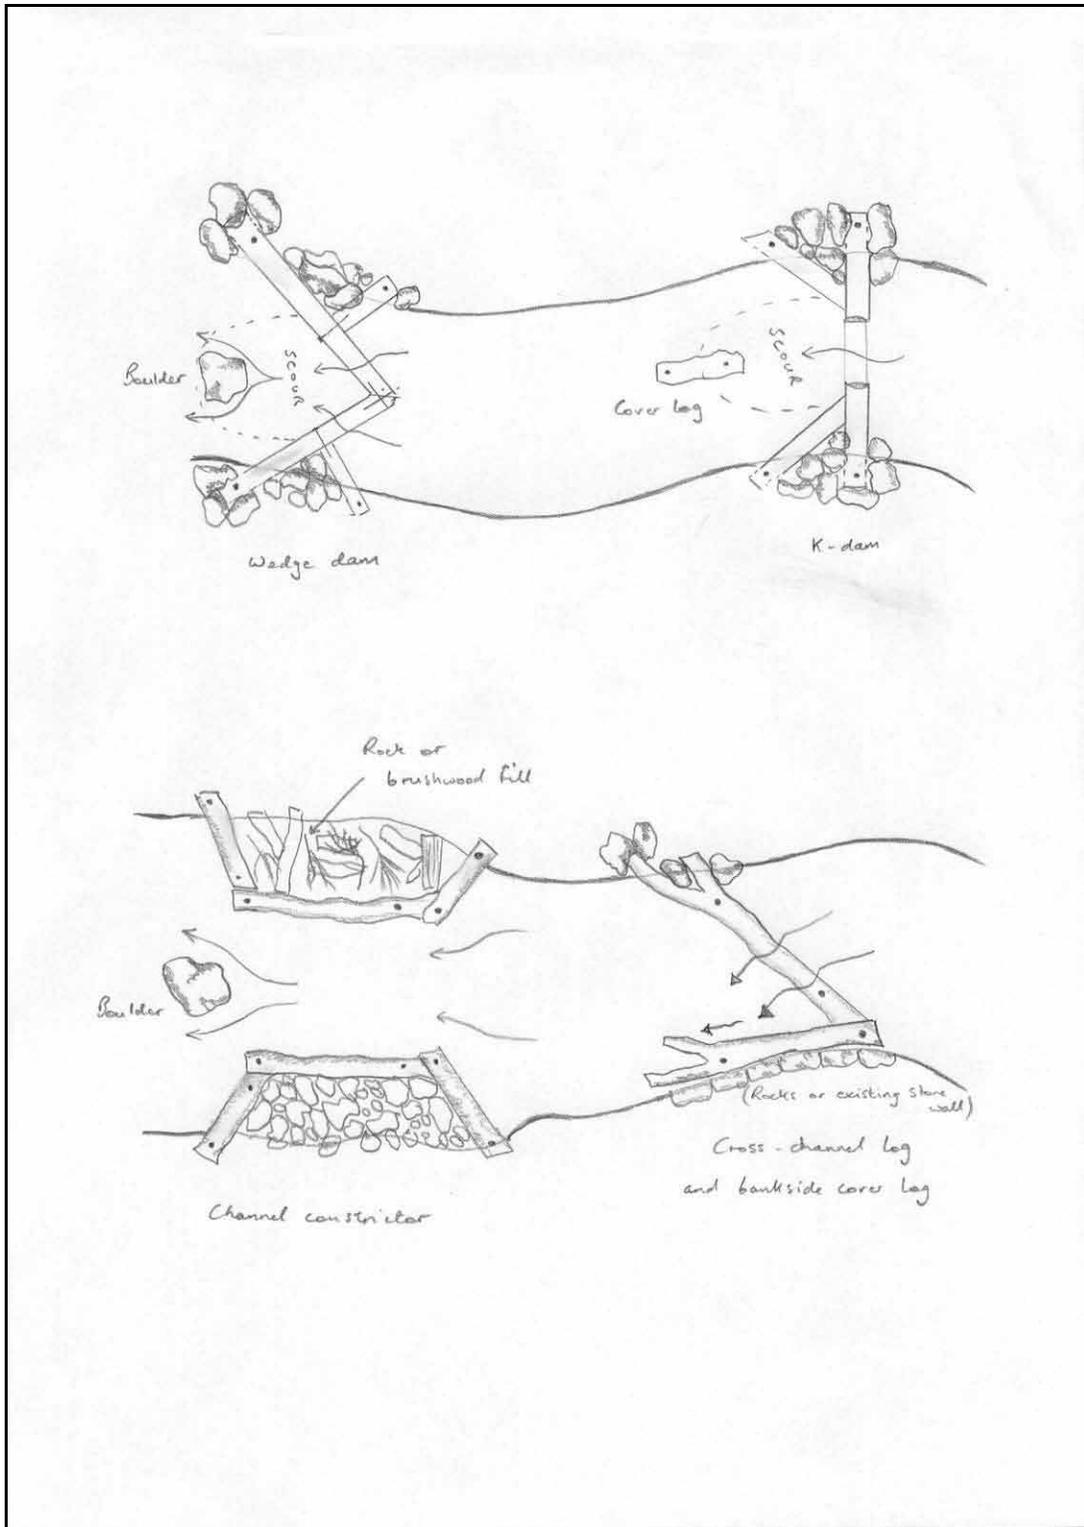
Figure 2 Schematic of more engineered structures – these would be most appropriate where the river is smaller (Hazlehead section).
