## River Douglas II

### Advisory Visit

River Douglas
River	Douglas
Waterbody Name	Douglas - Mid
Waterbody ID	GB112070064780
Management Catchment	Douglas
River Basin District	North West
Current Ecological Quality	Moderate
U/S Grid Ref inspected	SD 58137 08960
D/S Grid Ref inspected	SD 58782 07113
Length of river inspected	2km

Wild Trout Trust Report – Following a Site Visit on 19/08/2019

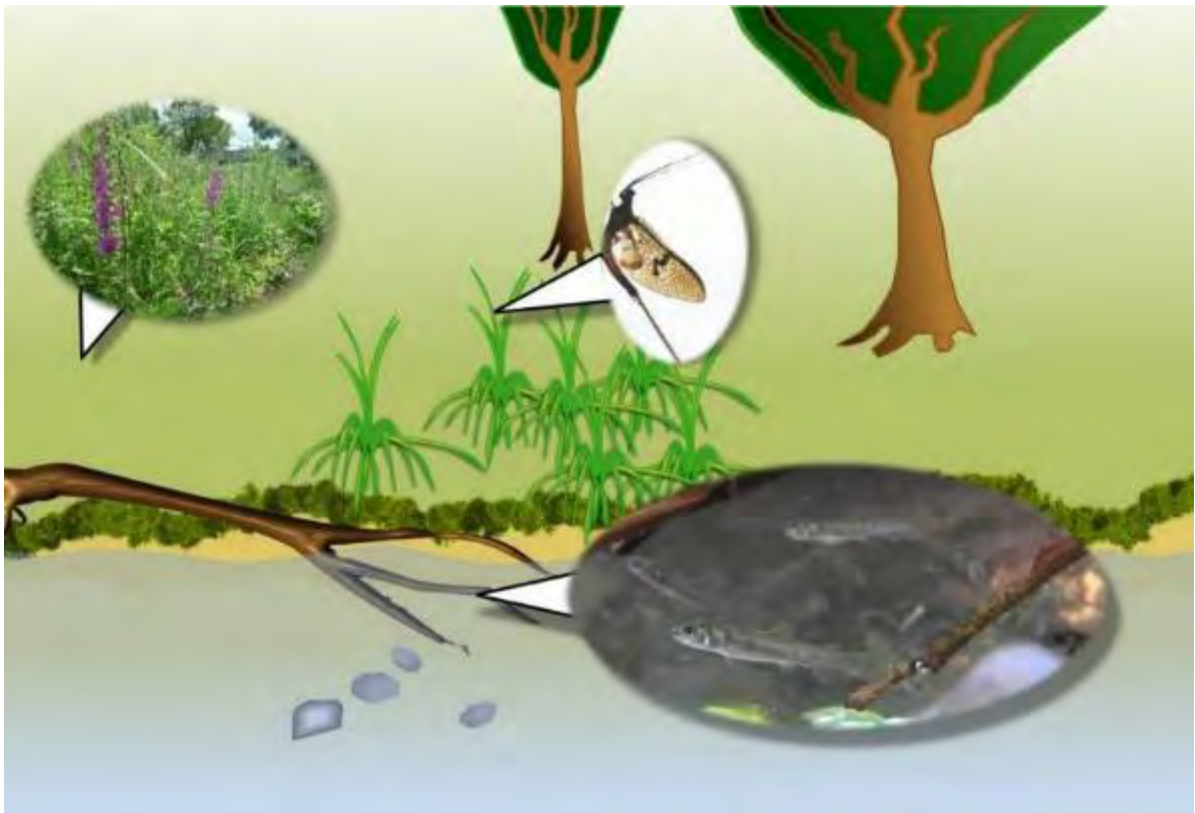
Figure 3: **Larger cobbles and submerged "brashy" cover and/or exposed fronds of tree roots provide vital cover** from predation and spate flows to tiny juvenile fish in shallower water (<30cm deep). Trailing, overhanging vegetation also provides a similar function and diverse bank-side vegetation has many benefits for invertebrate populations (some of which will provide a ready food supply for the juvenile fish).

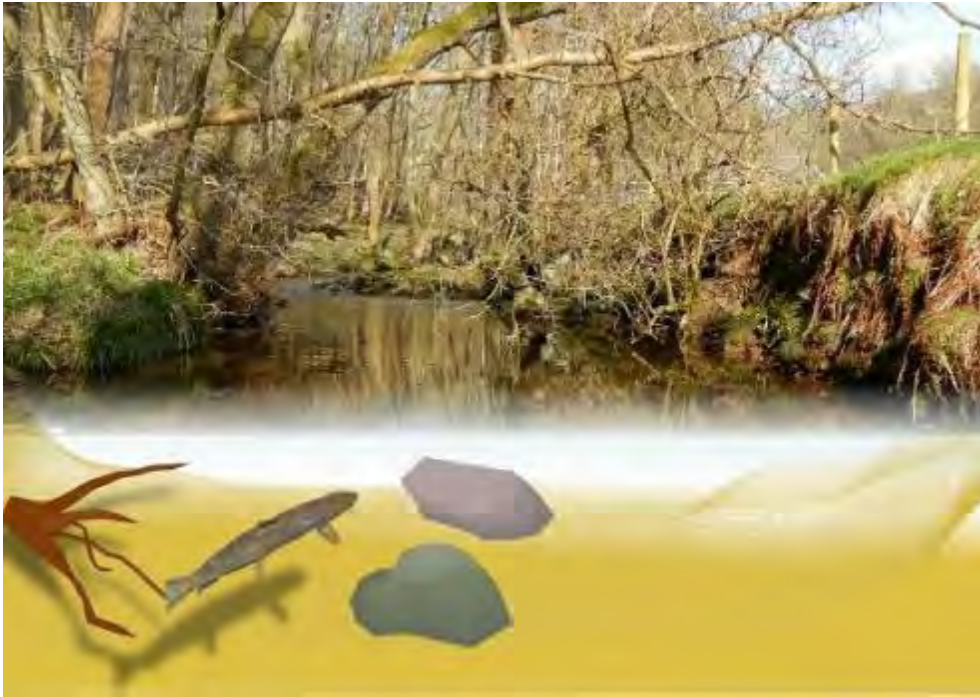
Figure 4: The availability of deeper water bolt holes (>30cm to several metres), low overhanging cover and/or larger submerged structures such as boulders, fallen trees, large root-wads etc. close to a good food supply (e.g. below a riffle and with prey likely to fall from overhanging tree canopy in this case) are all strong components of adult trout habitat requirements.

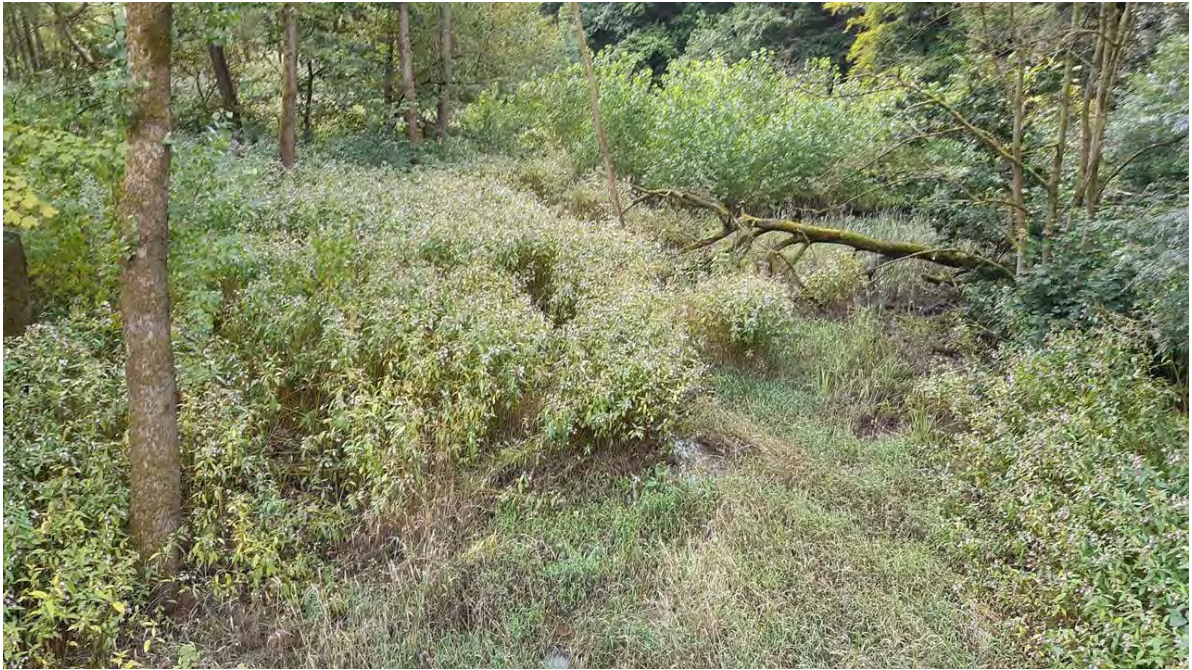
The downstream limit of this visit was the bridge leading down from the gated entry to the plantation at SD 58782 07113 (Fig. 5). This is a wet woodland area with excellent potential to support diverse flora and fauna. Unfortunately, it is dominated by an extensive infestation of the invasive non-native Himalayan balsam.

Figure 5: Looking downstream from the bridge at the downstream limit of the visit

- Continue with (and extend if possible) the current manual control of Himalayan balsam
- Explore opportunities to be included in the programme of releases of the rust fungus biological control agent of Himalayan balsam (particularly in the area around the downstream limit of the reach visited for this report). An initial starting point would be to monitor news items from the CABI website following their journal paper on the proposed modified variety of the fungal agent: <https://www.cabi.org/isc/abstract/20153061506>

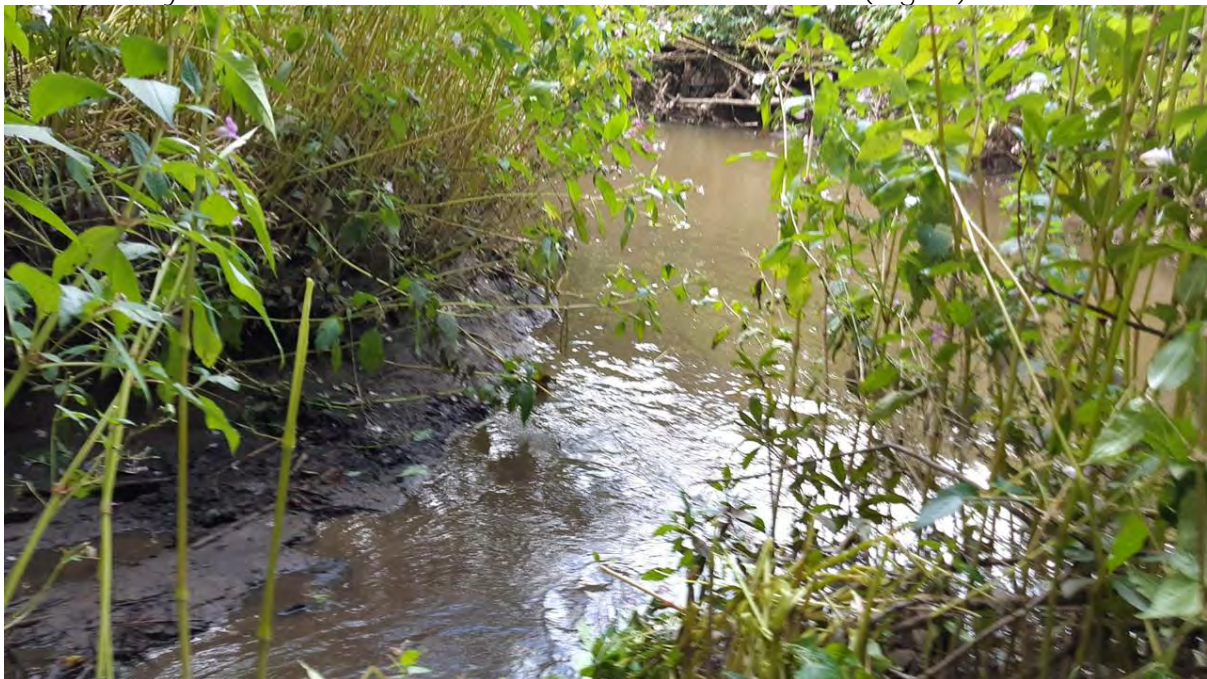
Although subject to apparent intermittent mine-water upwelling, a tributary stream (the Yellow Brook) joins the main River Douglas at SD58759 07073. Unusually in a post-industrial setting, there is apparently good migratory connectivity between the main river and this side-stream (Fig. 6).

Figure 6: Confluence of Yellow Brook & River Douglas. The tributary benefits from an absence of the usual culverting/discharge over a weir into the main river! Himalayan balsam is, however, abundant.

Preserving connectivity with the main river, allowing the continued existence of stable woody material within the Yellow Brook and also protecting the water quality from excessive mine-water (or other polluting) inputs are priorities for this side stream.

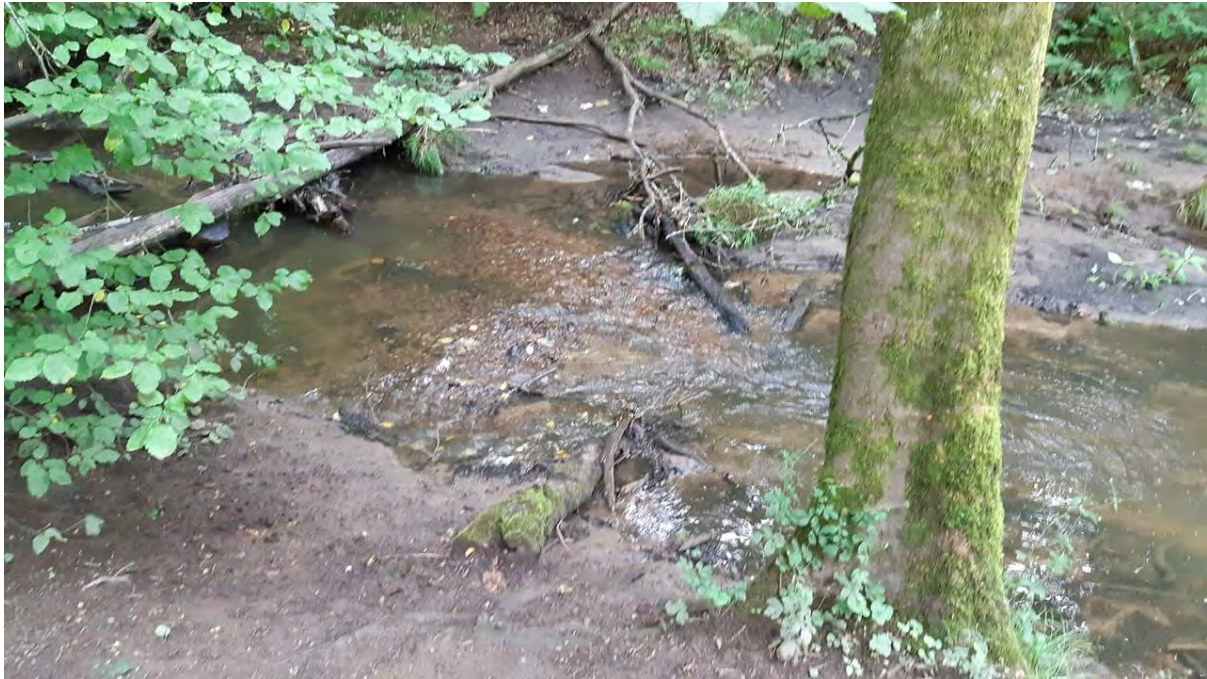
As a result, valuable potential spawning habitat has been created – and shows the potential for the Yellow Brook as a spawning and nursery-habitat resource (Figs. 7 - 9). A more usual silt and sand-dominated characteristic displayed by the Yellow

Figure 7: Stable woody material and recent high flows have created a good quality spawning opportunity at SD58902 07065

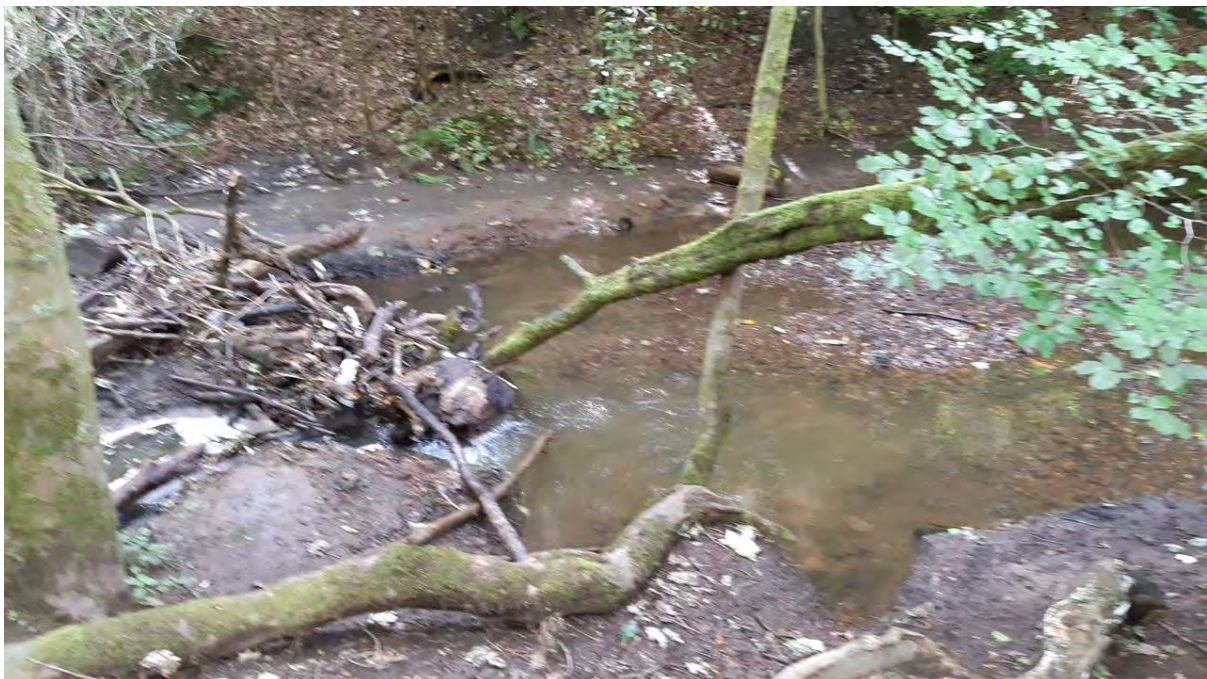
Figure 8: Spawning habitat 20 metres upstream of example shown in Fig.7

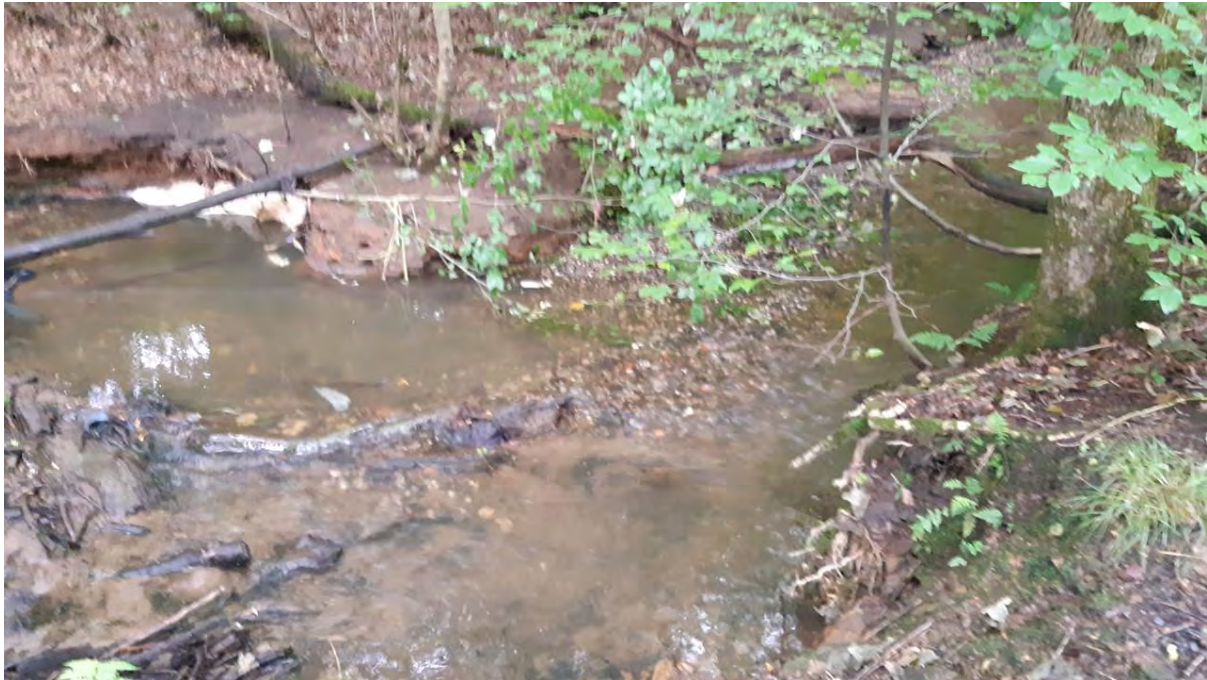
Figure 9: Spawning habitat within 20 metres of the examples shown in Figs. 7 and 8.

This demonstrates the importance of stable woody material in the channel, especially that woody material which, with sufficient rainfall, will create localised scouring action and heap the gravel into loose (silt-free) mounds.

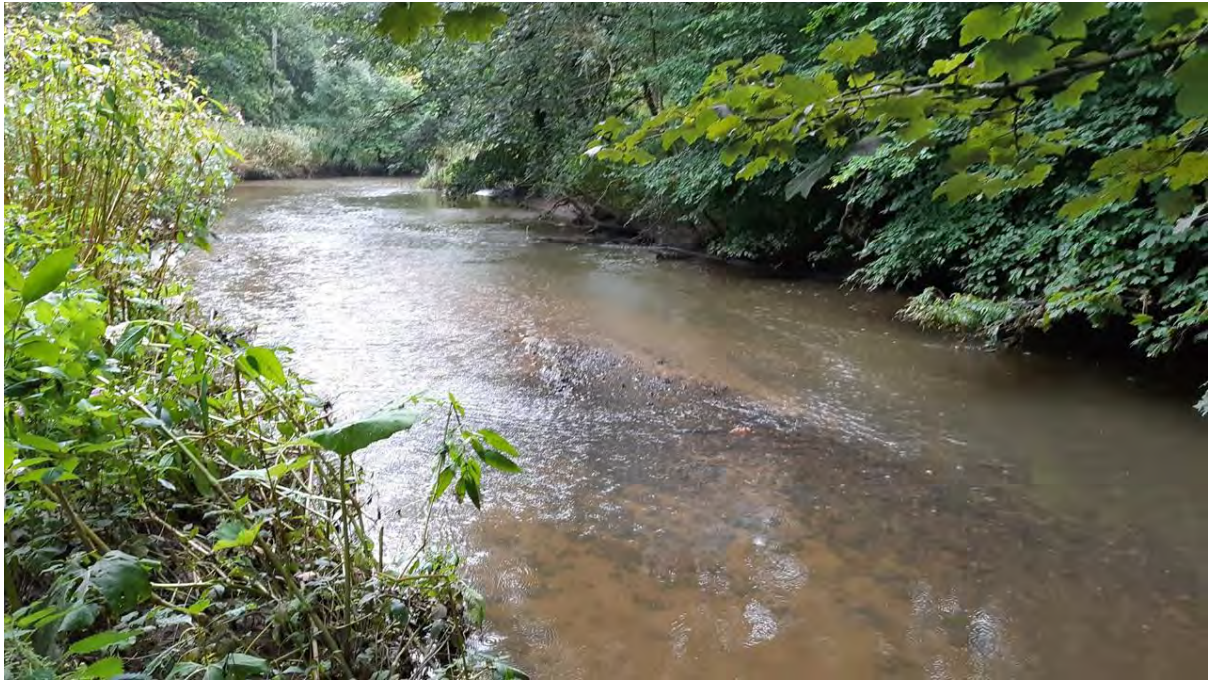
As with the Yellow Brook, on the main River Douglas at SD 58769 03310 the reach is dominated by a sandy riverbed – with some gravels also present (Fig. 10). From the previous Advisory Visit (2010), inputs of soils from heavily-grazed banks were contributing substantially to this high loading of sand and silt. The dominance of Himalayan balsam throughout the upstream catchment also tends to elevate inputs of fine sediment.

Excessive levels of fine sediment have a negative effect upon the spawning success of trout. Efforts to identify and reduce sources of excessive inputs of fine particles will benefit conditions in large sections of the River Douglas.

Figure 10: A substantial proportion of the bed-load at this point is made up of sand. The pores between gravel particles here are blocked with sand. This results in very poor egg-survival for any gravel-spawning fish species, especially trout.

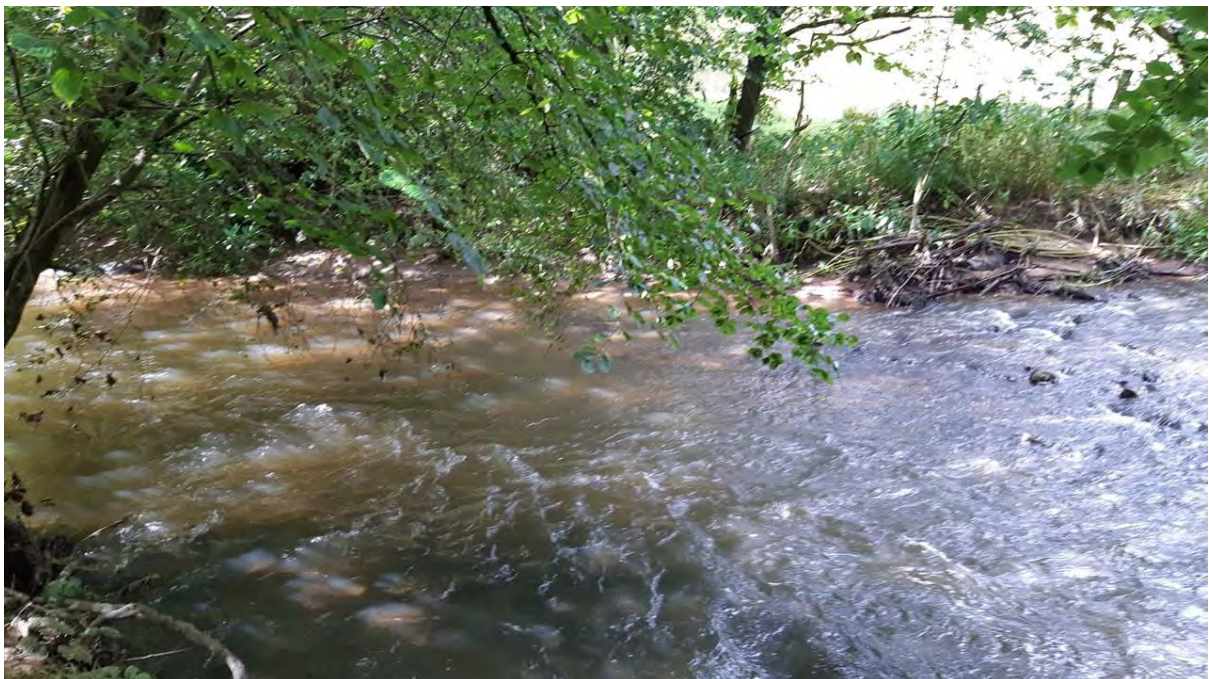
Just upstream of the reach pictured in Fig. 10, a cobble and gravel riffle – combined with partially-submerged and overhanging marginal branches represents high quality habitat for a range of species (including salmonid fish; Figs. 11 and 12).

Figure 11: Cobble riffle (visible right of frame) gives way to a drop-off into deeper water with a high degree of cross-sectional variation in flow and depth. High quality habitat for a range of aquatic species.

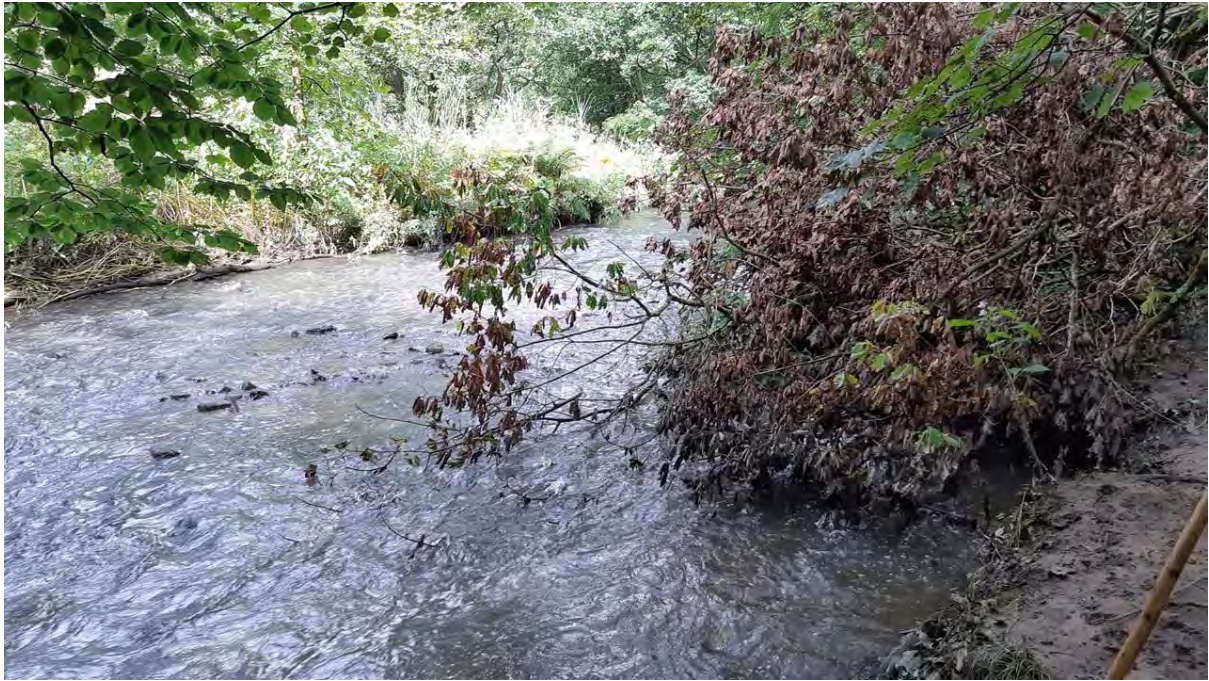
Figure 12: Substantial, dense and complex marginal cover created by stable woody/brashy material. Vital for good overwinter survival of juvenile and adult trout (according to water-depth - with larger fish favouring deeper water)

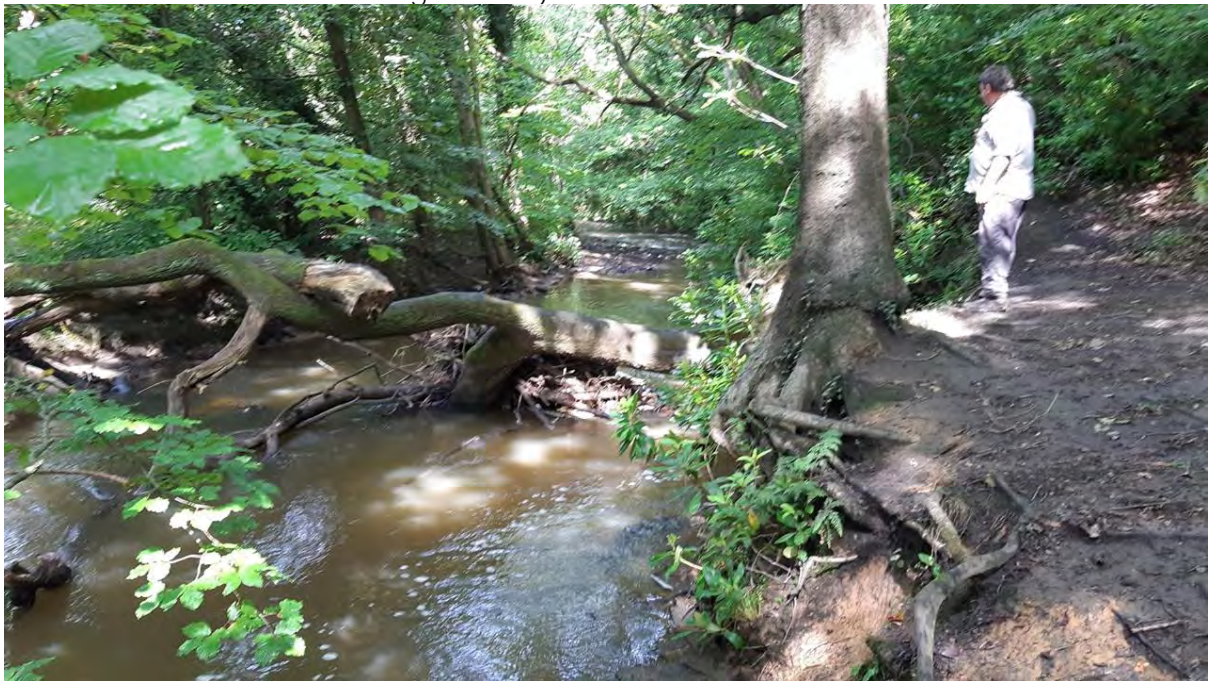
Some of the best possible adult trout habitat features were observed at SD 5873107427 (Fig. 13). The lateral and longitudinal variation in depth and velocity here arises from the cobble and gravel point-bar, meandering character and accumulated coarse and large woody material.

Figure 13: Examples of extensive structural diversity, dappled light/shade, ready supply of digestible leaf-litter, connectivity to the floodplain, localised scour, accumulation of coarse woody material, scour and cover generated by fallen (stable) large woody material. Extremely high quality habitat for trout and a wide range of aquatic fauna. N.B. Water-colour associated with recent rainfall.

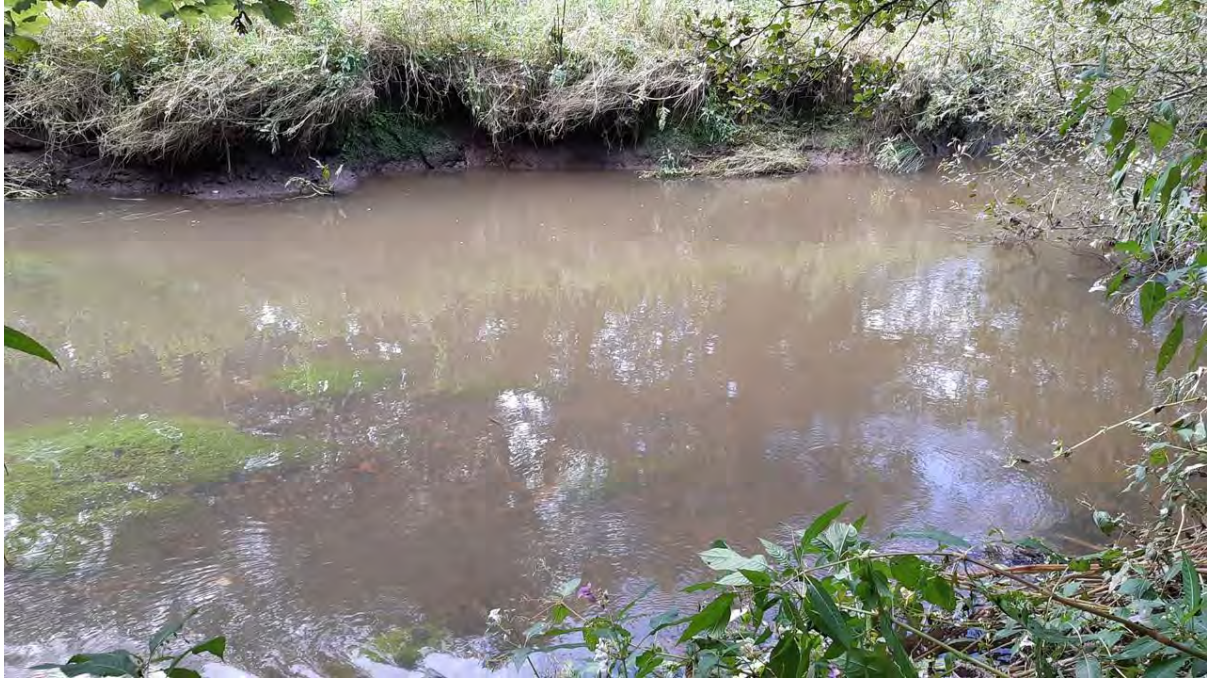
erosion. The sandy soil is very soft and, with riparian vegetation consisting of shallow-rooted plants rather than trees, highly susceptible to erosion. The increased cross-sectional area (caused by the widened channel) has a more uniformly slow flow across the full width of the channel. Accordingly, fine sediment has a greater tendency to settle on the riverbed and smother gravel beds deposited in the reach (Fig. 14)

Figure 14: Wider, slower and more uniform with fragile banks - probably a legacy of previous grazing regimes.

- Undertake some whip planting of locally-appropriate tree species within the previously-grazed reaches (along with Himalayan balsam control to enable establishment and growth of planted trees)

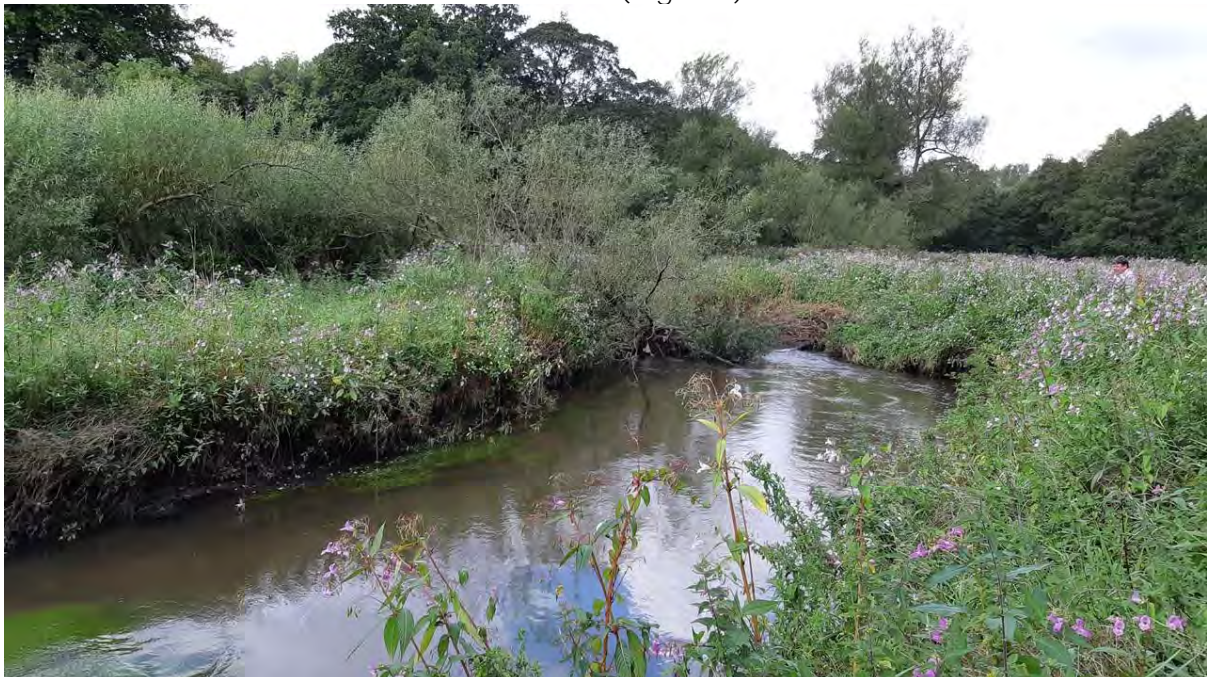
With the apparent cessation of the bank-top grazing previously identified as a source of fine sediment inputs (2010 Advisory Visit), vegetation is beginning to recolonise the banks at SD 58121 08463 (Fig. 15)

Figure 15: The bankside vegetation that is returning following grazing cessation includes native species – but is dominated by the invasive, non-native Himalayan balsam.

However, the rapid domination of Himalayan balsam means that winter storms will still generate significant inputs of fine sediment – due to the annual die-back and shallow-root systems. The return (and expansion) of sapling-growth to the bank-side is a valuable factor – and will create additional cover habitat and leaf-litter input over time. Similarly, existing trailing branches (e.g. Fig. 16) continue to provide cover habitat and patches of shade.

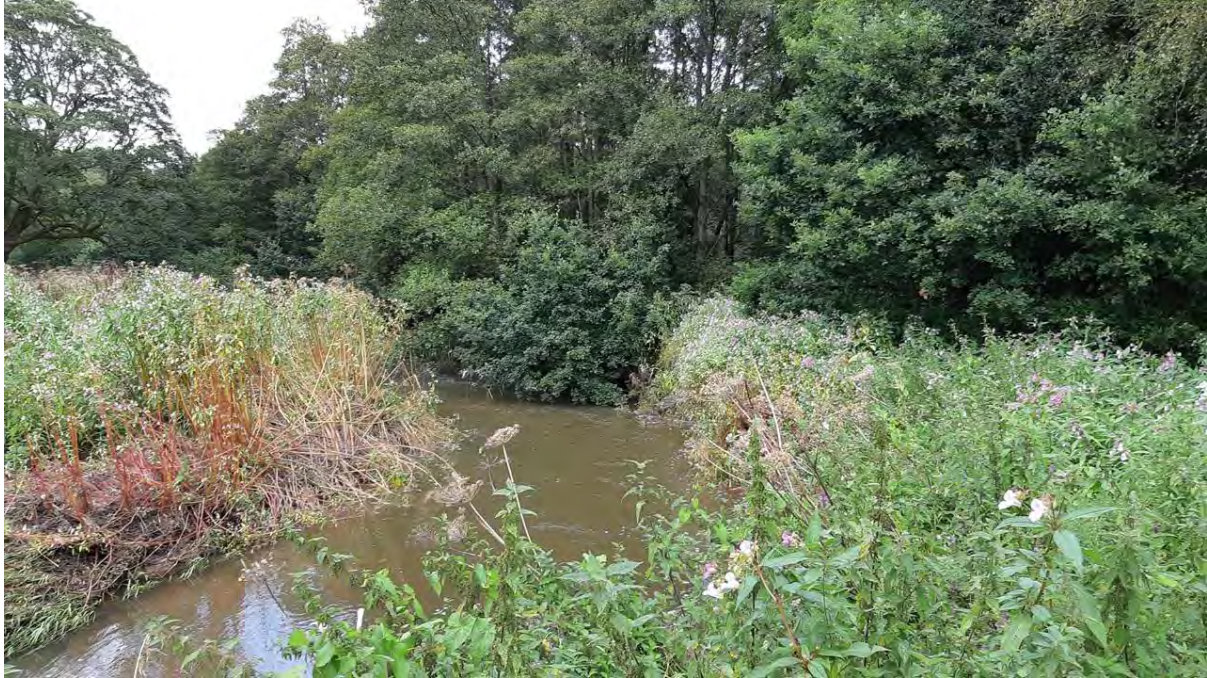
Figure 16: Overhanging, mature tree limbs on the LB (right of frame) at SD 58141 08562.

- **Don't change the current practices that allow overhanging vegetation to develop and persist!** (including the selective pollarding practices noted during the visit)

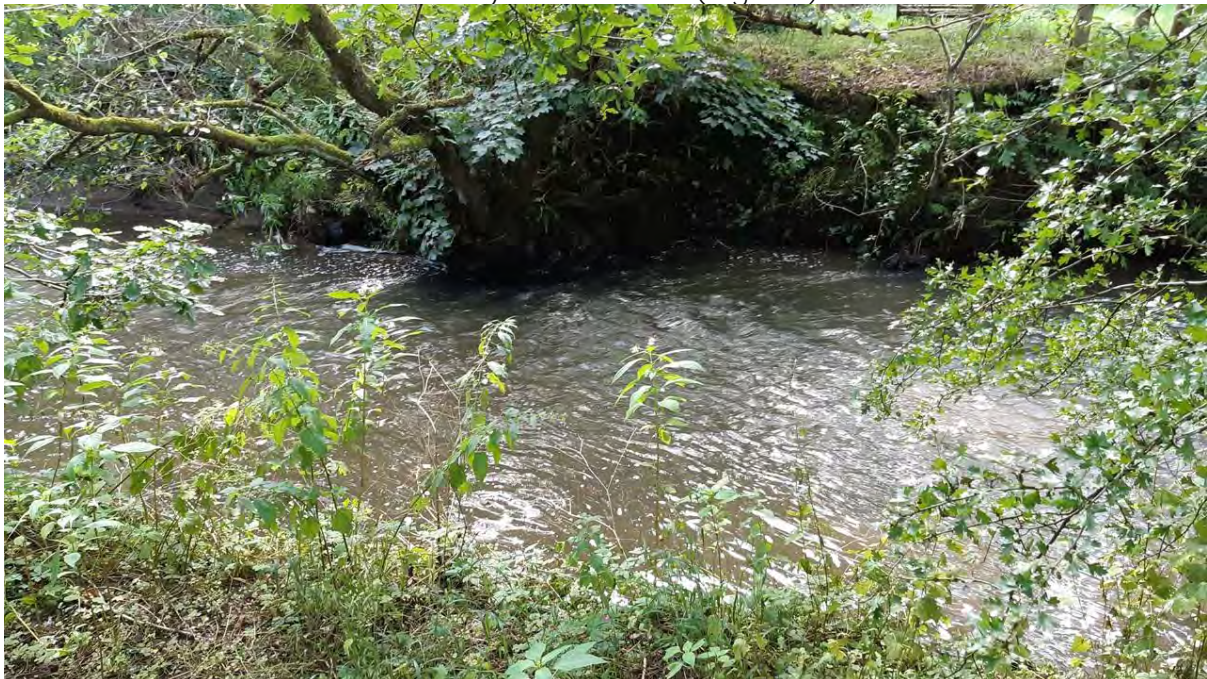
Further upstream at SD 58137 08960 (to the limit of the reach visited for this report) the tree cover increases once again. The potential to create valuable structure from tree root-plates exposed during the natural cycle of tree-growth, senescence and deadfall is clearly visible here (Fig. 17).

Figure 17: Beginnings of new meandering flow in this back-eddy created by an exposed root-plate. The size and shape of these structures creates a tendency to lodge in highly stable orientations. The associated localised scour creates valuable habitat features and cover.
