Advisory Visit
River Douglas
8th December 2010

Introduction

This report is the output of a site visit undertaken by Paul Gaskell of the Wild Trout Trust to the River Douglas on 8th December 2010. Comments in this report are based on observations on the day of the site visit and discussions with the landowner Paul Kenyon, Keith Jolley and local Environment Agency (E.A.) representative Ian Gaskell who provided extensive information on water quality issues within the inspected reaches.

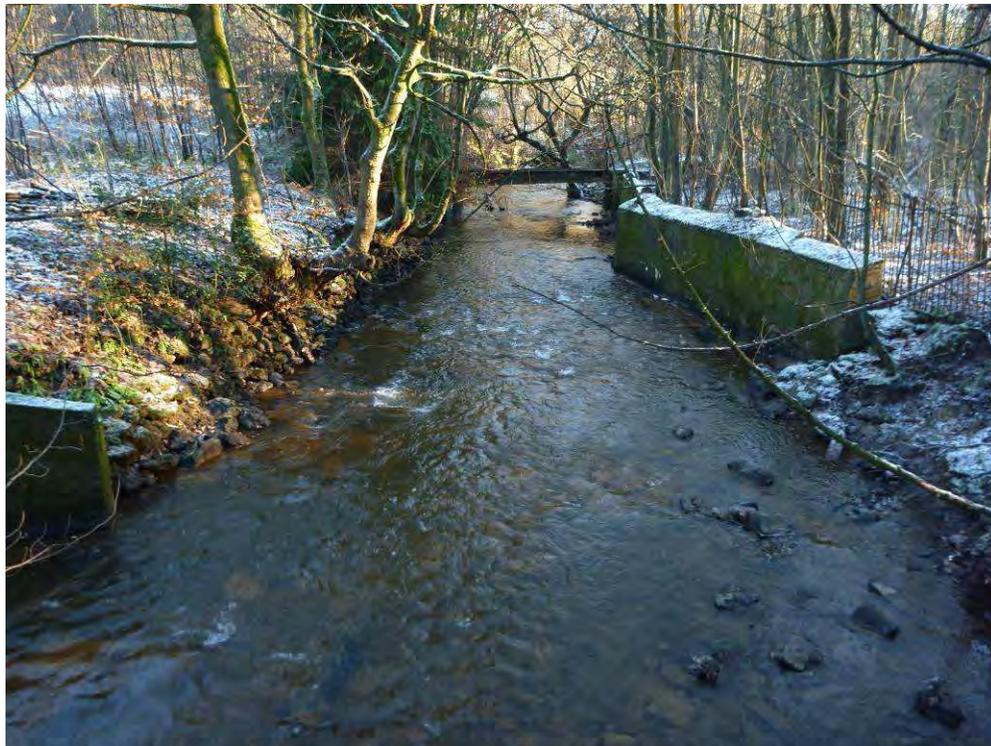
Starting at the upstream limit of **Reach 1** (Fig.1) at SD 58236 08164, a good example of a typical northern English "post industrial" spate stream was evident. The mixture of well developed woodland vegetation and

engineered retaining walls is present on many upland trout streams rising from the Pennine Chain.

Figure 1: Upstream limit photographed from bridge facing upstream (A) and downstream (B).

The cobbled substrate and suitably narrow channel-width combined with sufficient longitudinal bed slope produces a nicely energetic riffle and glide character. Furthermore, a relaxed approach to bank-side tree management has facilitated the development of some excellent habitat features. For example, the tree growing at an angle from within the channel in the background of Fig.1A has promoted some localised scour and current deflection that has produced some lovely variation in depth as well as introducing a more meandering flow within the constraints imposed by the walled far bank. Section 1 is sited within a steep-sided, wooded valley and there are a variety of different particle sizes represented in the substrate, ranging from fine silt/sand up to relatively large cobbles/small boulders. These larger substrate constituents are likely to have arisen from the collapse of various built stone structures in or adjacent to the river. Whatever their source, it is valuable to have this variation – as it produces a greater number of niches available for plants and animal species. It also produces the variation in microhabitat required to support the three key life-stages of trout (spawning, juvenile and adult fish). The river in the area of the upstream limit has in-channel habitat that is particularly suitable for juvenile trout, as well as some holding lies for adult fish. The presence of some shaggy, low, overhanging vegetation e.g. sedge grasses (*Carex spp.*) or low branches and exposed tree roots provides extremely valuable cover for juvenile (and adult) fish. It may be appropriate to augment existing cover with installed brush (section 3.1 “Recommendations”).

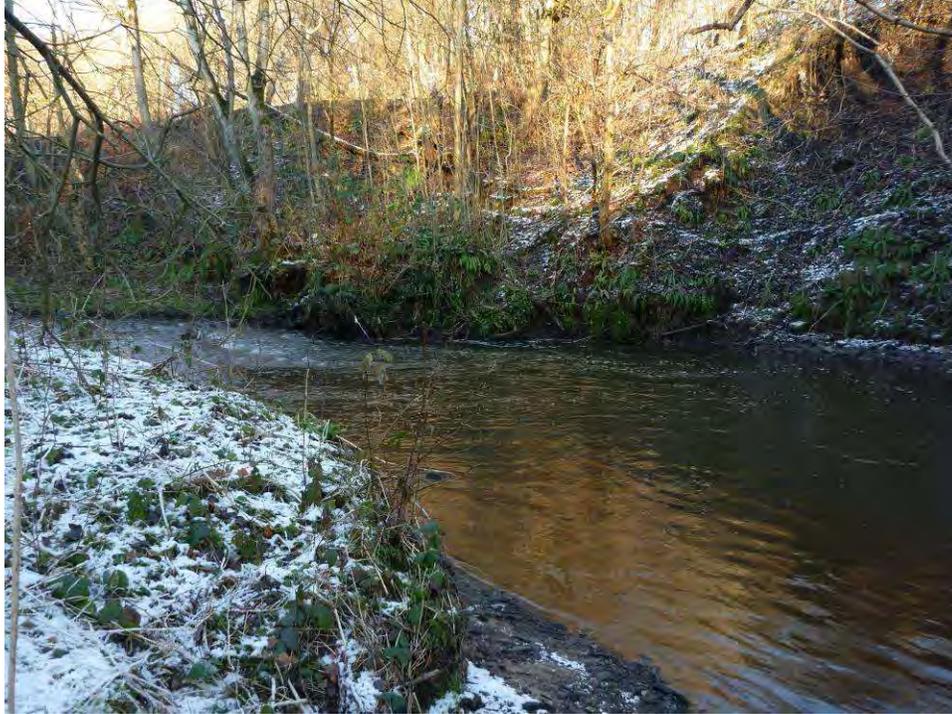
The riffle and associated downstream pool (Fig.2) a little way downstream of the area pictured in Fig.1, represents some excellent habitat features that are particularly suitable for trout. First of all the turbulent riffle is an excellent source of both invertebrate prey and oxygenation of the water. Secondly the mature woodland riparian (bank-side) vegetation, in the absence of retaining wall features, has allowed the natural meandering inclination of the river to be expressed. The resultant deposition of a gravel bar on the inside edge (RHB) of the bend (Fig. 2A, bottom of frame) is combined with the scouring of a deeper “bend pool” on the outer edge (LHB: Fig.2B). Because the “bend pool” is also overhung by exposed tree roots (Fig. 2B) and low-level vegetation (Fig.3), it makes this absolutely superb trout habitat. With a small intervention, the icing on the cake **could be** the up-ramp of gravel at the tail end of this pool (Fig. 3). This has the potential to provide the spawning opportunities that would enable us to tick our third crucial life-stage off the list. However, whilst trout could attempt to spawn

Figure 2: Riffle (A) and associated pool (B) showing excellent habitat features in both streambed topography and riparian vegetation

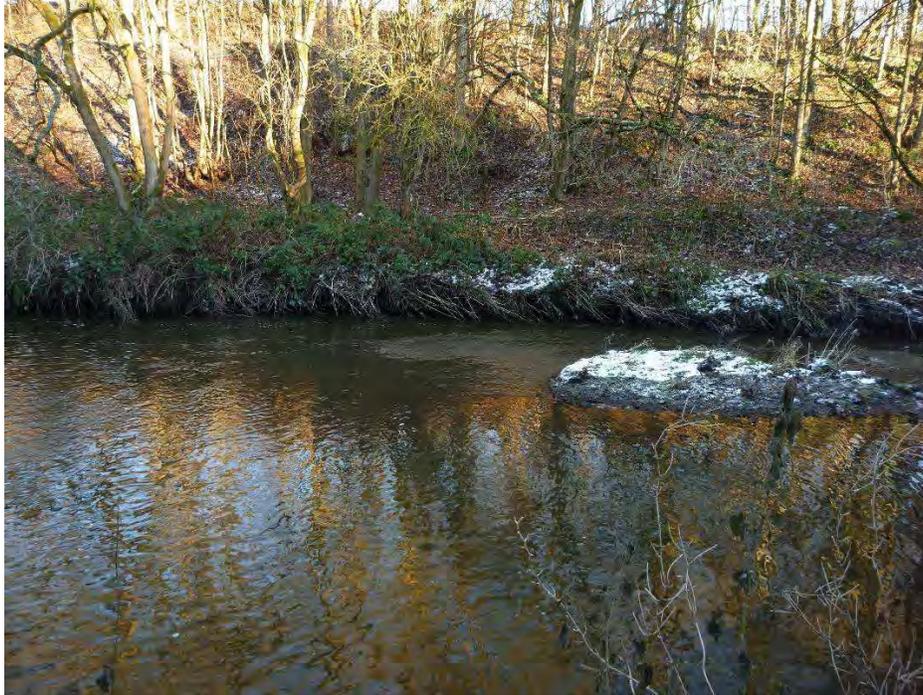
Figure 3: Shallow tail end of the pool pictured in Fig. 2. The shallowing is produced by deposition of gravel (some of which forms the exposed island under these low-flow conditions). Again, excellent riparian vegetation features are evident

on this gravel, it is likely to prove a difficult endeavour (and hatching success rate may be somewhat limited). The reason for this is the relatively poorly “sorted” nature of these gravels (Fig. 4).

The primary bottleneck on this reach is the availability of high quality spawning gravels. Given the lack of access (due to upstream culverting) to the next confirmed spawning tributary upstream (Pearl Brook) – this is a crucial issue. The best opportunity to release this bottleneck is the simple installation of several mid-channel logs pinned in a scattered arrangement to the stream bed on the unsorted gravel ramp featured in Figs. 3 and 4. These could be simple single “mini logs” (Fig.13) or “mini upstream “V”s” (Fig.14)

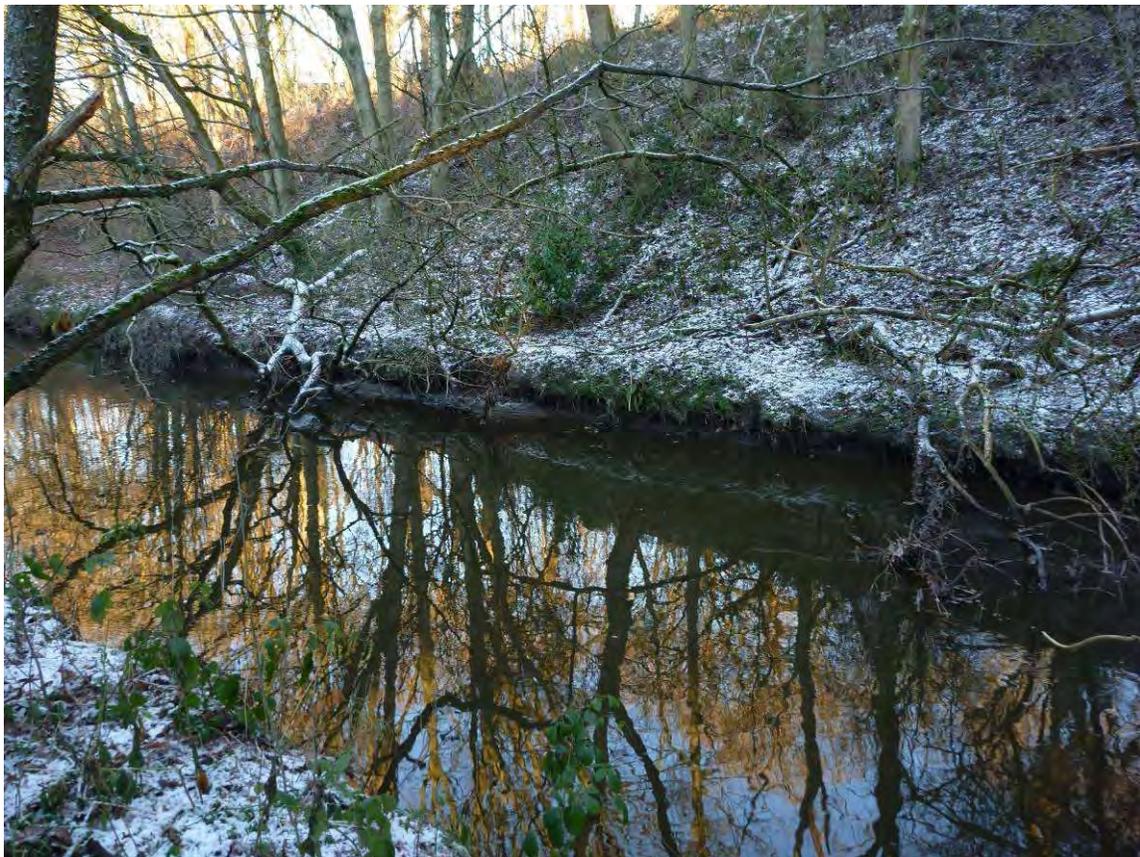
After a gently meandering section downstream from this riffle/pool sequence, the channel enters a long, artificially straightened section (approx 150m long) with slow, impounded flows (Fig. 6). The impoundment is the result of what appear to be the remains of an old weir structure at the lower limit of the straightened channel. The slowing of the current has removed the capacity of the river to achieve the alternating lateral scour and

deposition processes evident in Fig.2. Consequently, the riffle/pool sequence disappears and is replaced by a single long, straight pool. Whilst not ideal, it does provide suitable habitat for adult trout, a provision that is made more attractive by the presence of several partially submerged fallen trees (Fig. 6). These are still attached to their root systems on the bank – and consequently pose little threat of breaking free to cause blockages that would adversely affect the risk of flooding downstream. Features such as this exemplify the high value of submerged large woody debris (LWD) to stream ecology. Increased structural diversity provides cover for adult fish and increases the variety of microhabitats available for all species. Through time, the decomposition of wood also provides food for organisms that have evolved to utilise this resource.

Figure 6: Straightened and impounded reach, but with stable LWD projecting into the margins of the LHB (flow is left to right of frame). Ideal cover for adult fish

It may be possible to reintroduce a degree of cross-sectional variation in both physical structure and current flow by deliberate installation of LWD in a staggered, alternating pattern on both LHB and RHB margins. The additional cover will also provide a greater degree of insurance against

excessive predation of tenuous fish populations (section 3.1 “Recommendations”). A more ambitious project could be considered on the back of capital investments to reduce episodic pollution. In such a case, importation of gravel substrate, combined with LWD flow deflectors, could be used to produce a linear sequence of mid-channel pools and riffles (providing spawning, juvenile and adult trout habitat within the same reach). The LWD would need to be sited so as to help retain imported gravel during spate flows (section 3.1 “Recommendations”). The gradual shallowing towards the tail of this straightened section at the putative former weir (Fig. 7; river bends to the left below the slight impoundment) would help to promote the retention of gravels in combination with the installed structures.

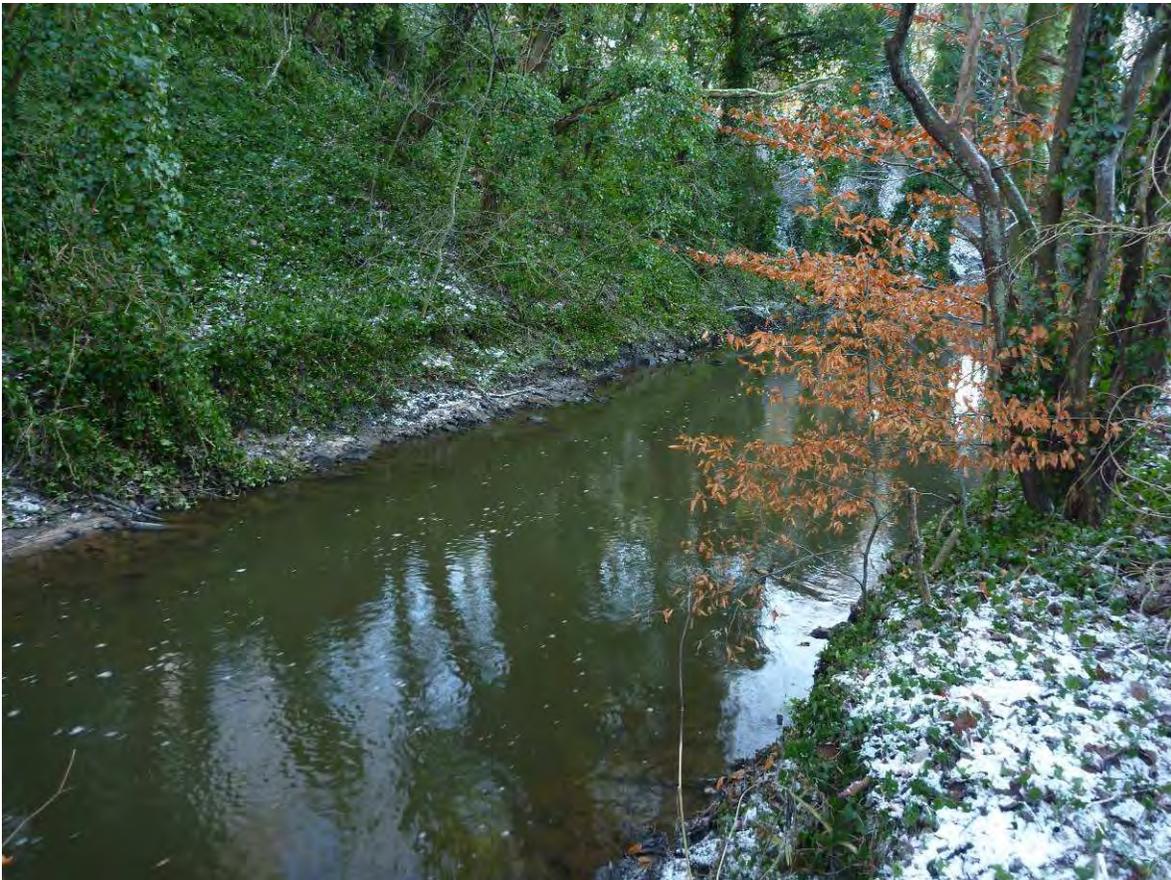
Figure 7: The shallow downstream limit of the straightened section is mostly obscured by trees to the right of the frame.

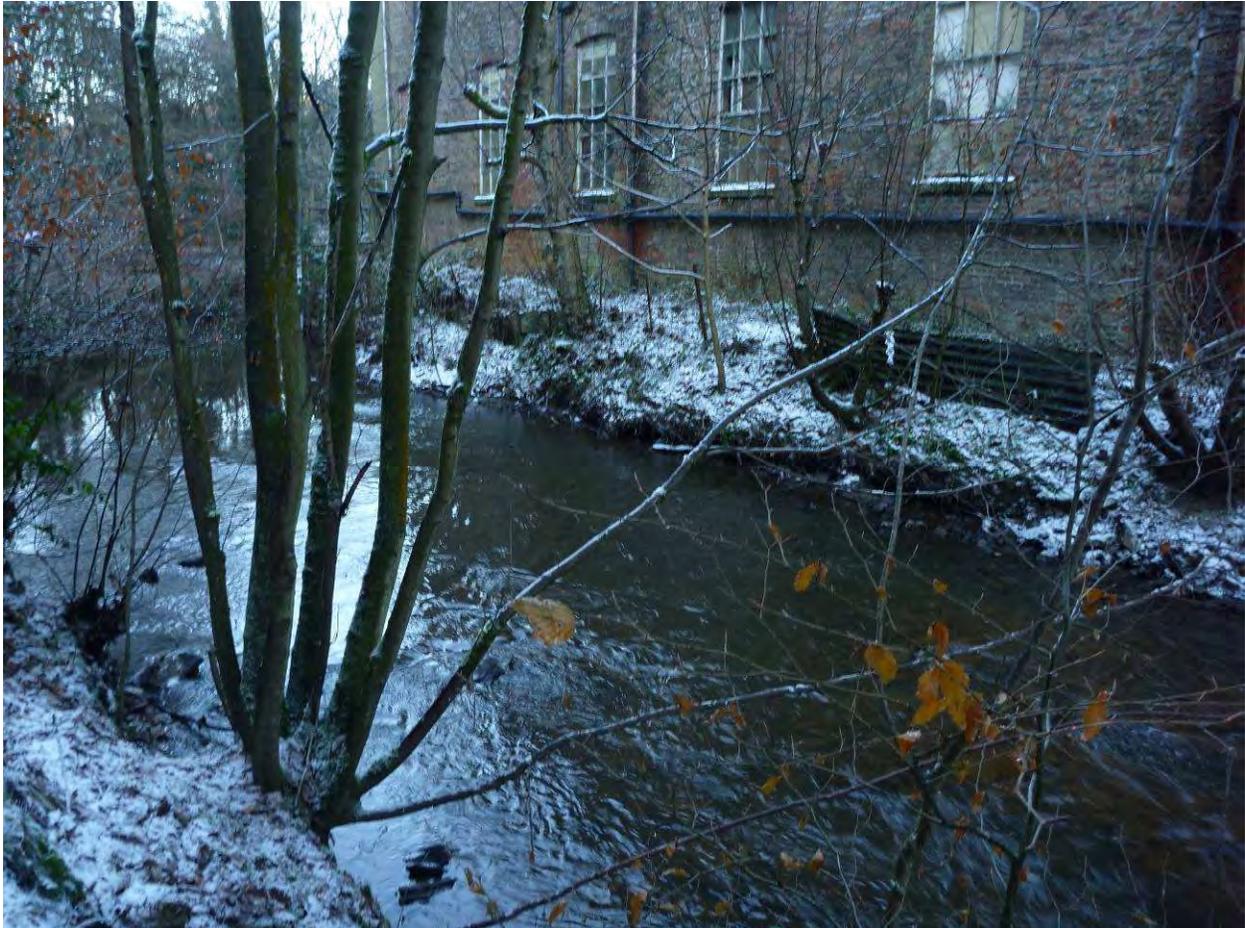
The leftwards bend of the river below the straight section is flanked on the LHB by an old mill building (Fig. 8). This is the effective lower limit of the reach owned by Mr. Kenyon (**Reach 1**). The bouldery riffle that is present in front of the Mill provides some interesting habitat with a variety of substrate sizes represented. Where the full force of the current is buffered by larger

stones and in the margins, there are good opportunities for juvenile trout to thrive. However, as with many post-industrial rivers, the majority of fish movement into the reach will be via downstream drift from stations further upstream. Impassable weir and culvert structures are known to be present between this section and the spawning that occurs in the Calico Brook below this reach. Investigations into the potential to facilitate fish passage are strongly recommended (section 3.3, "Recommendations").

Figure 8: Mill building and the head of the riffle close to the downstream limit of Reach 1

Irrespective of whether connectivity appears in the RBMP, the feasibility and funding for structures that can facilitate the passage of fish is worth investigating. As well as potentially costly solutions such as formal fish pass construction (with compulsory programme of monitoring) or demolition of impounding structures, it may be possible to install simpler "easement" measures to both culverts and weirs (e.g. Fig. 25). Typically, the aim is to break down an impassable vertical "head loss" into several smaller jumps via the creation of one or more "pre-barrages". Local stone or cheap wooden baulks can be anchored in place to achieve this and the notches that allow overspill should be designed so as to produce smooth, non-turbulent plumes of water. Where easements are proposed to be fitted below culvert outfalls, the potential for fish to progress through the culvert must first be assessed. If the in-culvert flow is too fast and shallow for fish to sustain the swimming speed necessary to overcome the obstacle, there is clearly no point in pre-barrage construction unless the culvert itself can be modified. Section 5.1 of the "Upland Rivers Habitat Manual" gives more details on suitable culvert modifications as well as advice on connectivity issues

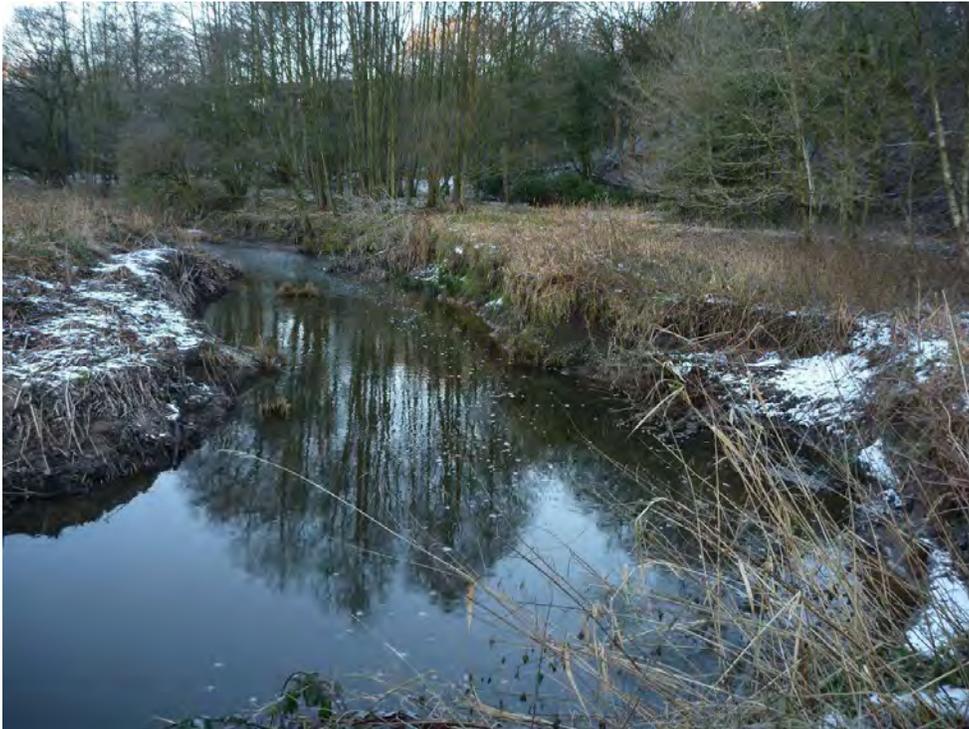
A drive upstream to **Reach 2** took us out of the steep, wooded valley. Here the land on the RHB is grazed by horses right up to the river margin and the river sits in a broad flat floodplain at the valley bottom. Whilst the land on the LHB appears to be ungrazed, there is a lack of bankside trees for much of the inspected reach. Mr. Kenyon indicated that the land here is the product of artificial spoil dumping, which would explain the relative lack of mature woodland on this bank. In addition to a lack of deep root matrices to bind the substrate together, the land here is dominated by extremely soft

sands. With an apparently less steep longitudinal bed slope than **Reach 1**, the combination of all these characteristics results in a more meandering channel (all other things being equal the less steep a river, the more it is likely to meander). Unfortunately, given the relatively unconsolidated nature of the banks, this has led to extensive inputs of fine sand into what, otherwise, would be a predominantly loose gravel bed (Fig. 9). Whilst a proportion of the sand derives from upstream sources, it is apparent that the excessive erosion within the reach is likely to be responsible for the smothering of potential spawning gravel.

Figure 9: Facing upstream towards a section where trees are present on the LHB. Downstream of this location a wider tract of treeless floodplain dominates. The collapse of the soft, grazed RHB and the unconsolidated LHB is evident in the vertical sandy bank-faces in the foreground of the picture

Clear scope for habitat improvements lie in a combination of grazing exclusion and supportive tree planting to produce a well-vegetated “buffer strip” of at least 5 to 8 m width on the RHB. This should be complemented by soft revetment techniques to slow the rate of bank erosion. With these measures in place, sand inputs would be reduced to a level where installations of LWD could best create good spawning habitat. An ideal candidate reach to undertake a trial of these techniques is shown in Fig. 12. See section 3.2 “Recommendations” for specific details on suggested techniques. It would be important to monitor the rate of bank erosion in trial “revetted” reaches, as the overall aim is a slowing rather than a cessation of the process. It is obvious from Figs. 10 and 12 that bank erosion is an important source of gravels as well as sand – and so complete eradication of the process is undesirable. The extent of mitigating works should be tuned to achieve the appropriate balance.

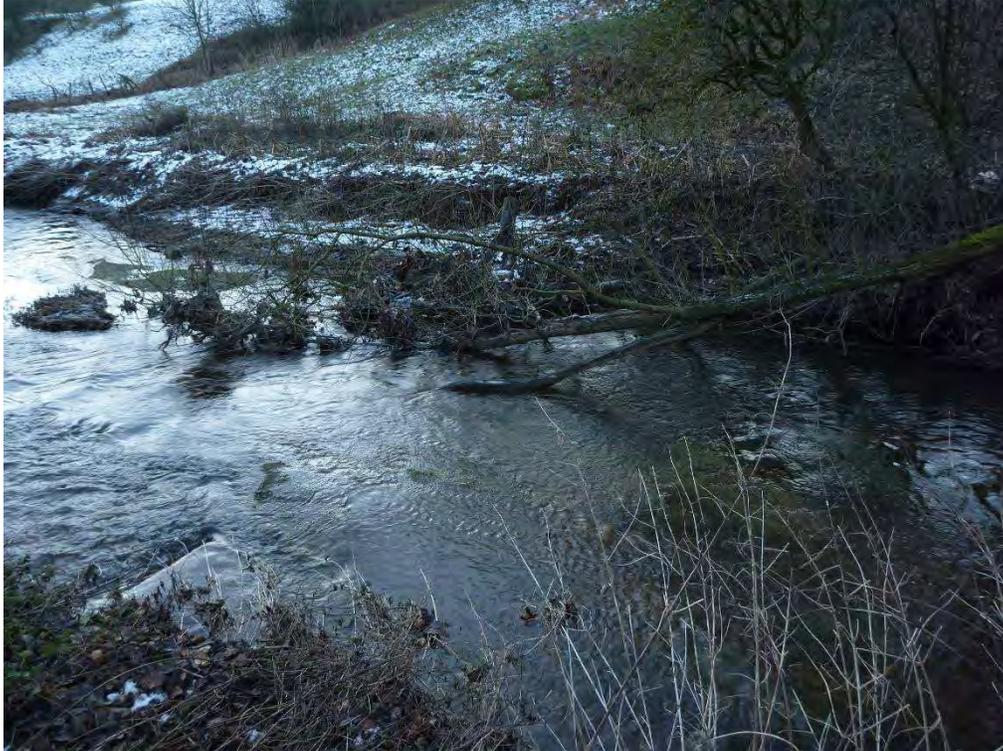
The potential for enhancement is illustrated by the habitat patches formed around natural examples of LWD (Fig.10). Submerged branches have shaped local scour and deposition processes to create a varied “humps and hollows” topography to the stream bed. In addition, finer substrates have been accumulated in the patches where the brash has slowed the current sufficiently. These patches of scour and deposition create far greater variation in microhabitat compared to the more uniform, blanket-like accumulation of sediment of Fig.9. Where habitat is uniform, fewer species are adapted to the smaller subset of available conditions.

Figure 10: Natural LWD creating pinched "scouring flow" on the near bank, whilst promoting deposition of a "point bar" below the previously eroded vertical bank in the lee of the brash. The brash also provides excellent cover for juvenile and adult fish. In addition, good sorting of stream-bed gravels is evident around the submerged branches

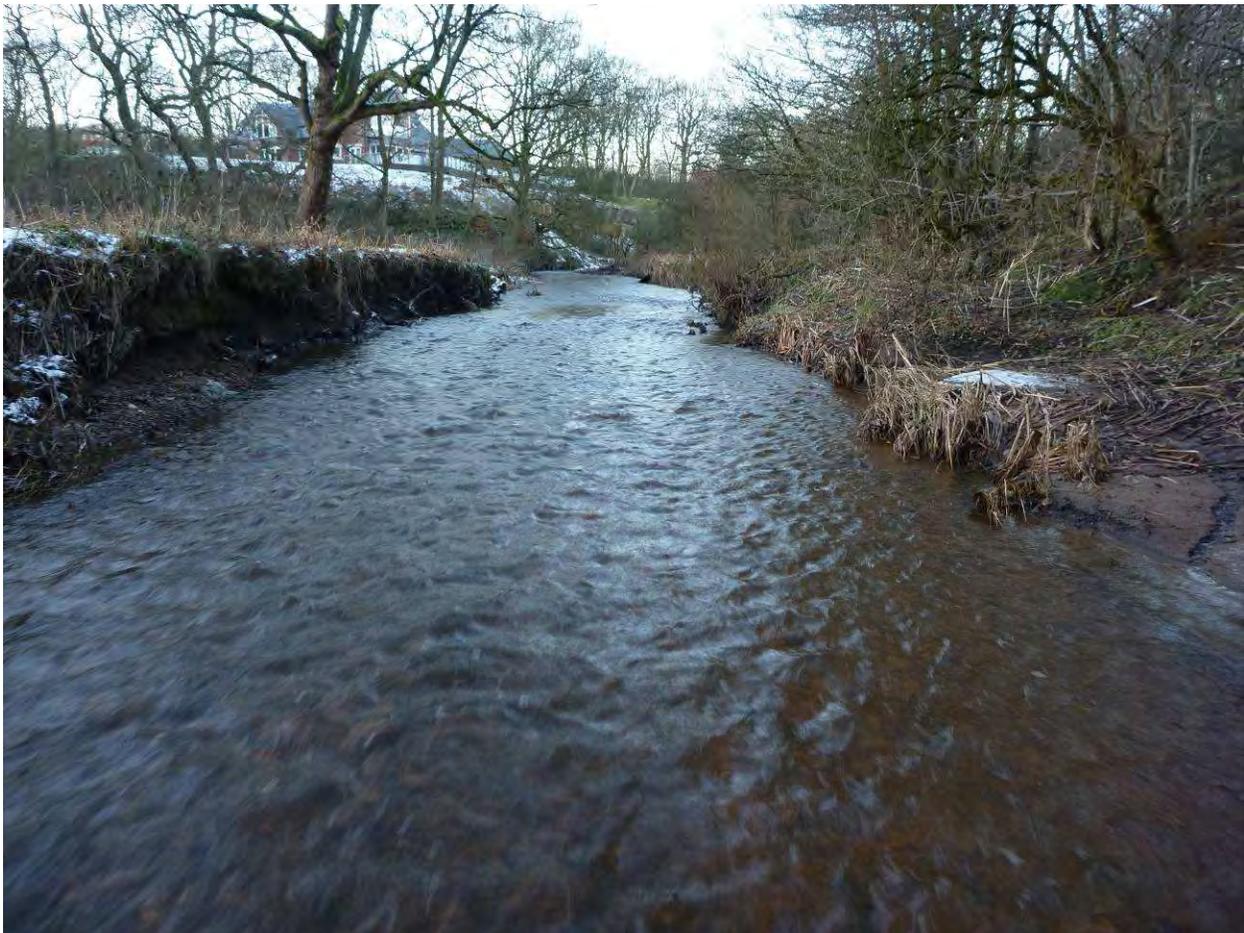
Figure 12: Ideal candidate reach for grazing exclusion and bank revetment (left of frame) along with installation of LWD to produce mid-channel scour-pool habitat with the attendant downstream deposition of well-sorted and irrigated spawning gravels

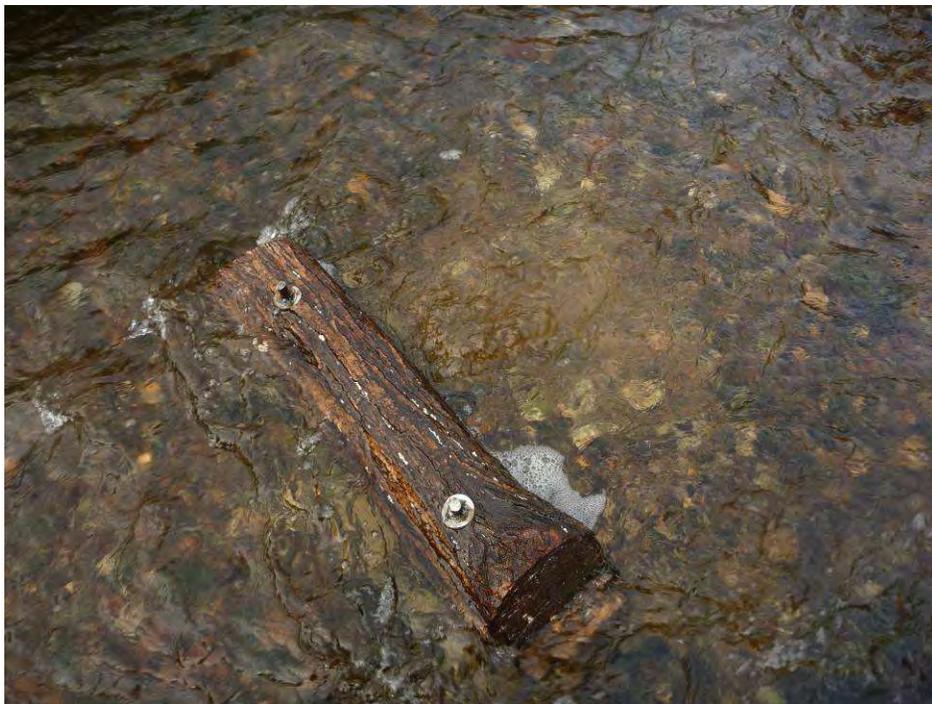
Figure 13: Mini log pinned perpendicular to the current promoting localised scour (in this case "undershot scour" of flows squeezed underneath the log). Note the welded washer caps on the ends of the 2-m long steel rebar pins driven into the stream bed to secure the log. Flow is from lower left to upper right of frame

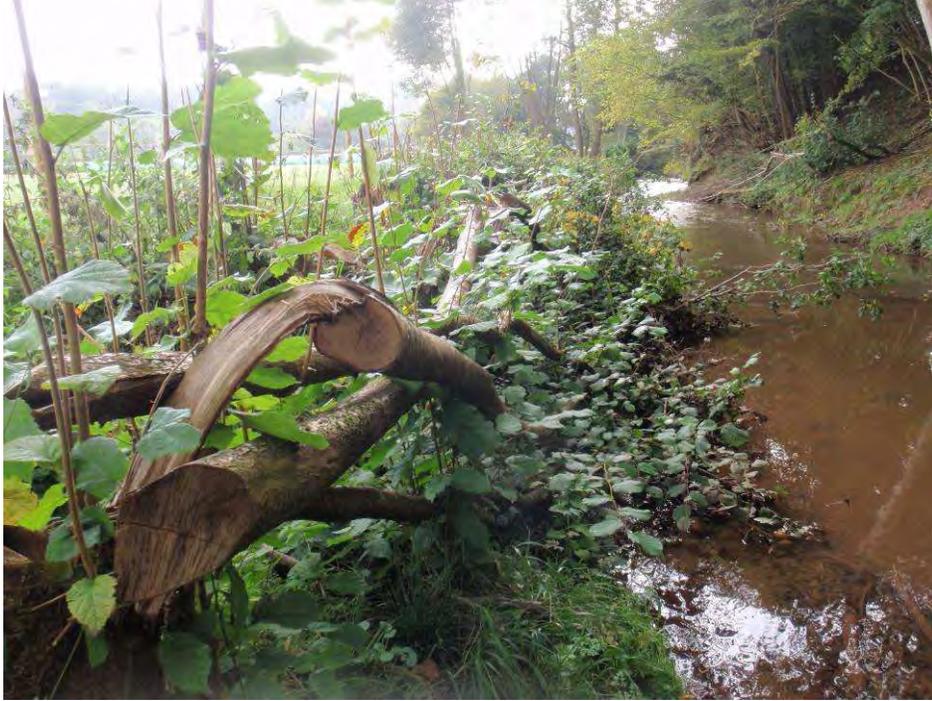
Figure 15: Hinged brush to produce marginal cover for juvenile fish

Although of secondary importance in this instance (due to the presence of some suitable existing cover), it would be important to maximise the survival chances of emergent fry. A simple adaptation of hedge laying techniques to "hinge" bankside scrub vegetation into the margins of the stream where the depth is around 30 cm or less would quickly and easily achieve this (e.g. Fig. 15). Similarly, the generation of additional physical variety (in both structure and current flow) could be achieved in the long, straightened pool section (Figs. 6 and 7) by introducing a series of cabled tree "kickers" on the left and right banks (Figs. 16 and 17). Arranging these in a staggered fashion will promote more meandering flow, whilst arranging in a matching pair on opposing banks will achieve a degree of channel "pinching". Both pinching and meandering the flow are desirable and should be incorporated where possible; providing wider biodiversity benefits in addition to their potential value to wild trout populations.

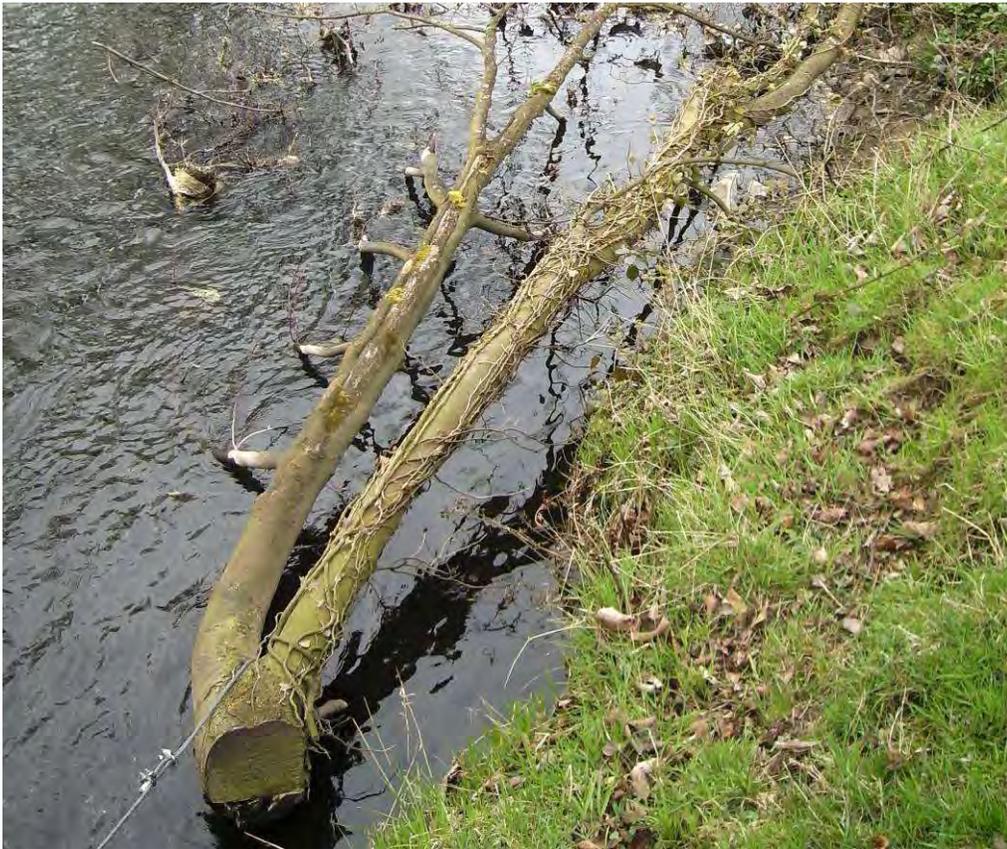
Figure 16: Tree kicker attached to its own stump via 12-mm braided steel cable and cable crimps

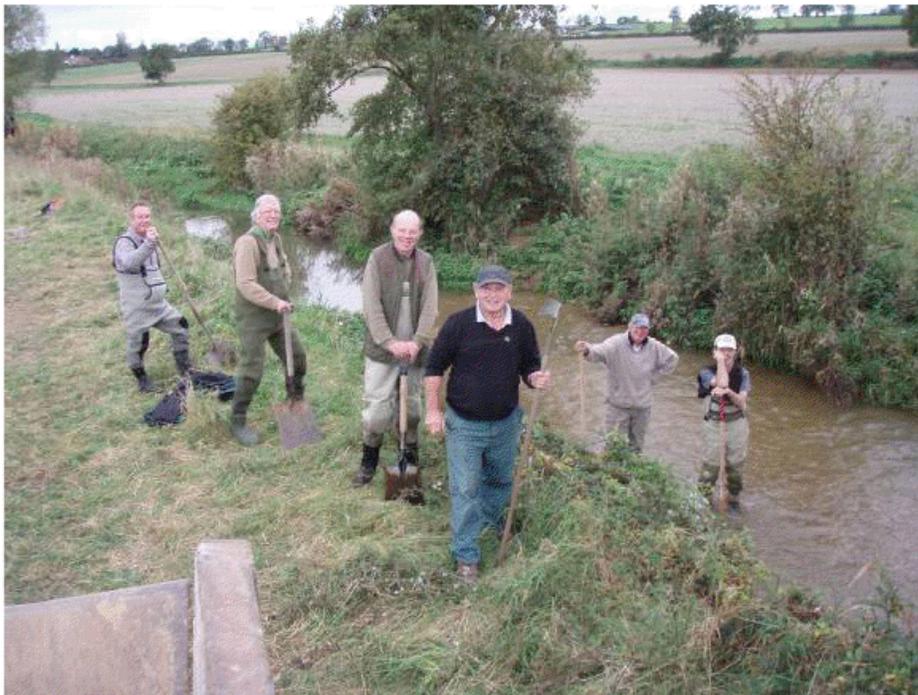
Figure 18: Importation of 20-50 mm gravels to provide spawning substrate

In the event that the required **reduction in episodic pollution risk** can be achieved, a more ambitious approach might be subsequently adopted in the straightened pool section. It might be desirable to import spawning gravel of 20 – 50mm diameter (Fig. 18) and to use installed LWD to retain as well as sort the installed substrate (Figs. 19 and 20).

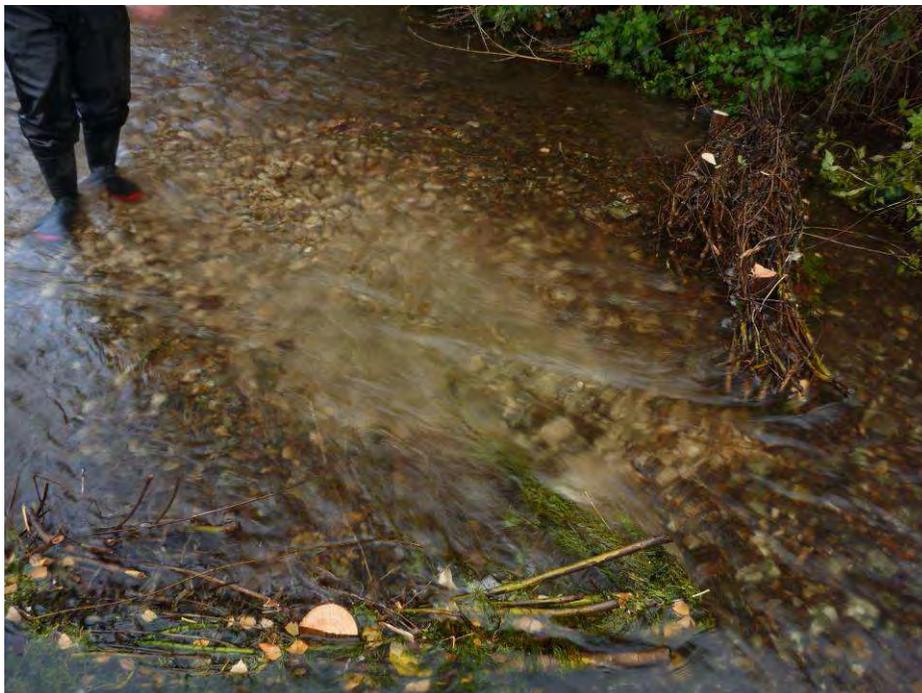
Figure 20: Upstream V (in this case constructed from brush bundles) used to produce mid-channel scour of gravels (pale area). Note that gravel will be trapped and retained on the upstream side of each deflector. This trapping effect can be enhanced by attaching buried reinforcing geotextile (wire mesh) that extends 2- 3 metres upstream from each deflector.

Following the establishment of marginal vegetation and soft revetment, the installation of LWD (e.g. Figs. 19, 20 and 23) to sort gravels would, again, be an enormously valuable solution to the current lack of high quality spawning habitat.

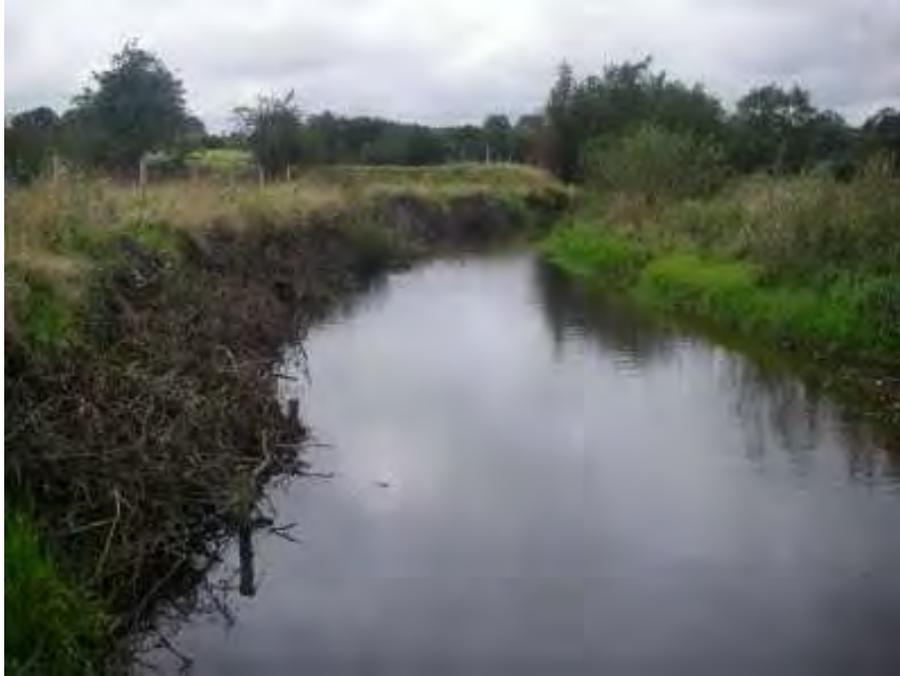
Figure 21: "Soft" brush revetment techniques (left of frame) used to slow erosion as well as providing cover for invertebrates and juvenile fish. The brush is secured between stakes that are driven into the stream bed and river bank using fencing wire.

An improved marginal buffer strip of vegetation could also be augmented by “soft” bank revetment techniques (e.g. Figs. 21 and 22). The extremely high surface area to volume ratio of brush acts as a “brake” on rapid spate flows. Therefore, as well as physically reinforcing the banks, it also prevents damaging eddying and “bouncing” of high speed currents into undefended downstream banks. The braking effect also tends to accumulate sediments and, consequently, further promote re-vegetation of previously eroded banks. A variety of sources of suitable brush are available, and include the arisings from coniferous plantation management, discarded Christmas trees that are collected by council waste-disposal services as well as material that can be obtained on site from existing woodland. Where coniferous brush is available, it is often the preferred material due to its very high density of side branches.

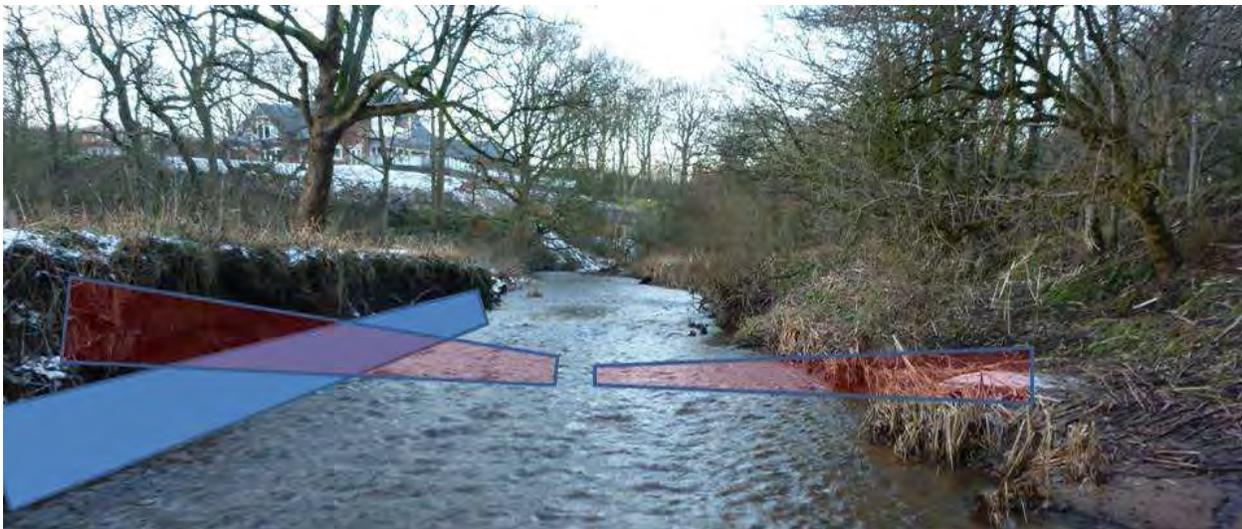
Figure 24: Suggested arrangement of brush revetment (blue shading) and upstream "V" log flow deflector (red shading)

The suggested arrangement for an initial trial section at SD 58144 08600 is given below (Fig. 24):

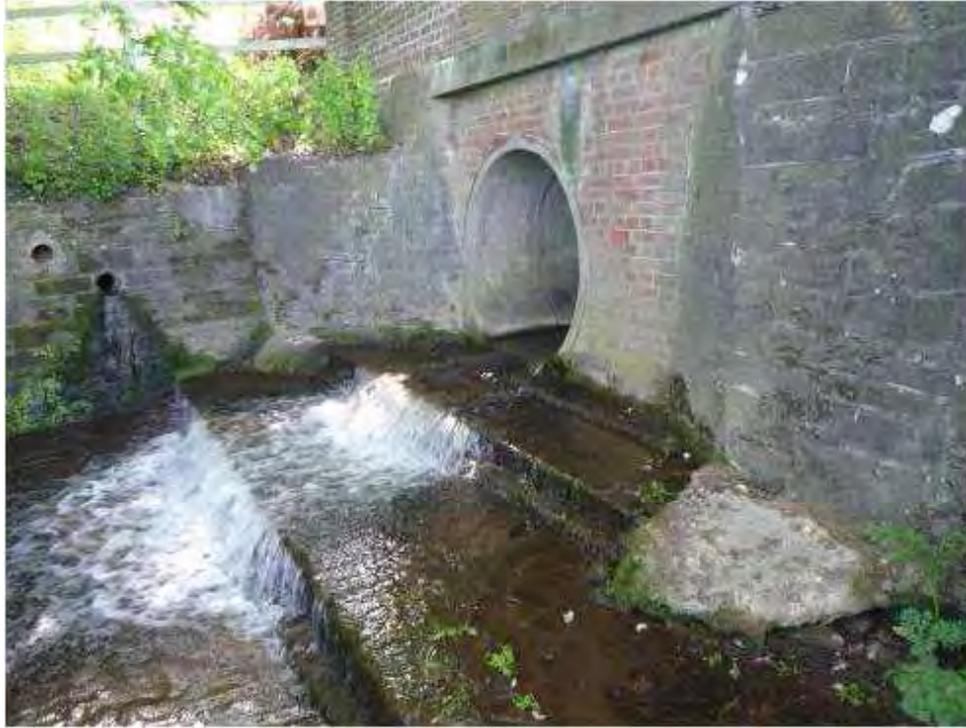
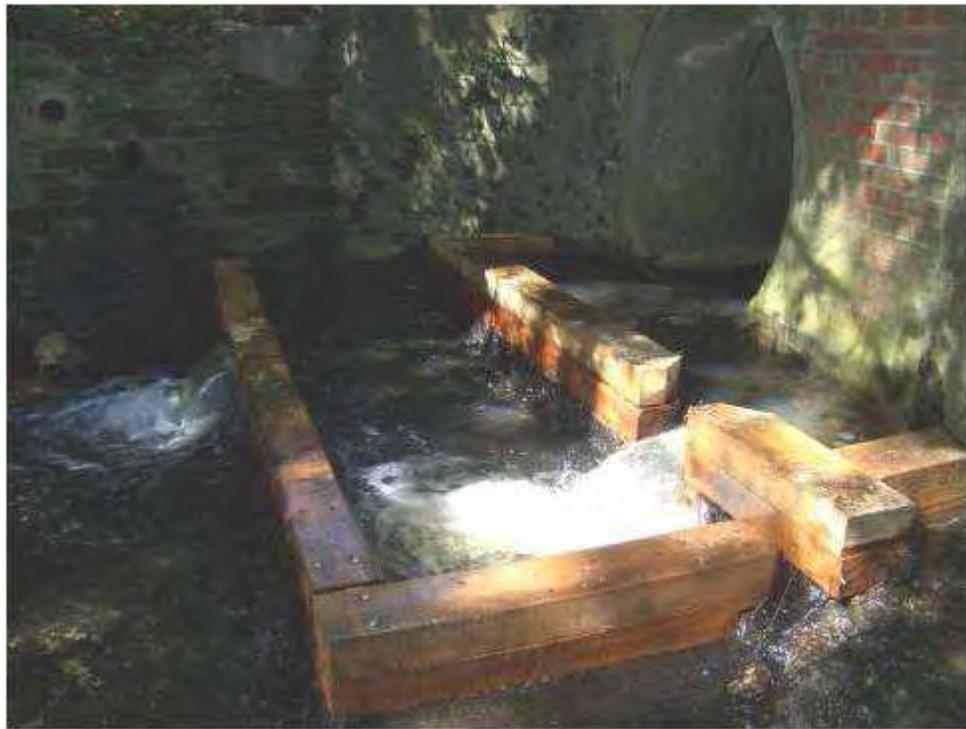
Figure 25: Impassable culvert blocking upstream progress of sea trout (A) fitted with a simple wooden baulk "easement" (B). Note the offset of the notches to provide respite for fish making the leap into the lower pre-barrage pool. Note also the smooth lip and edges of each notch to produce a solid plume of water to help fish to swim up
