Advisory Visit
River Dove, Beresford Dale
May 2015

1.0 Introduction

This report is the output of a site visit undertaken by Tim Jacklin of the Wild Trout Trust to the Beresford Dale Fishery on the River Dove, Derbyshire/Staffordshire on 20th May, 2015, on behalf of the owner, Zachary Levenick. Comments in this report are based on observations on the day of the site visit and discussions with Stephen Moores, river keeper.

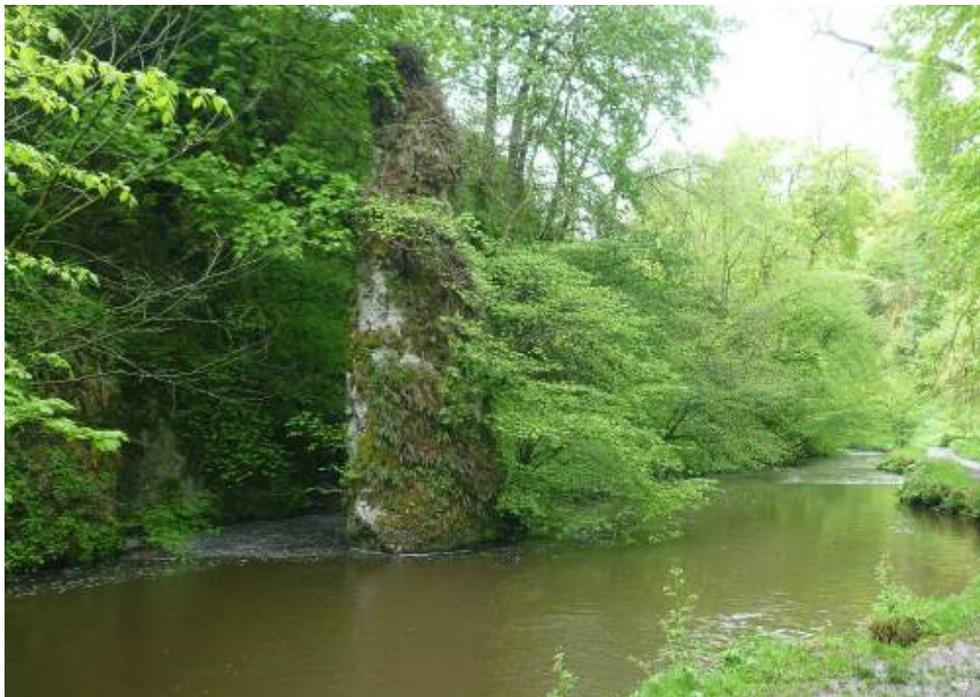
Pike Pool, Beresford Dale

intact downstream of Pike Pool, a pool with a distinctive limestone column mentioned in Cotton's writings (cover photo). Ideally these weirs should also be removed, but due consideration needs to be given to the permissions and consultation required.

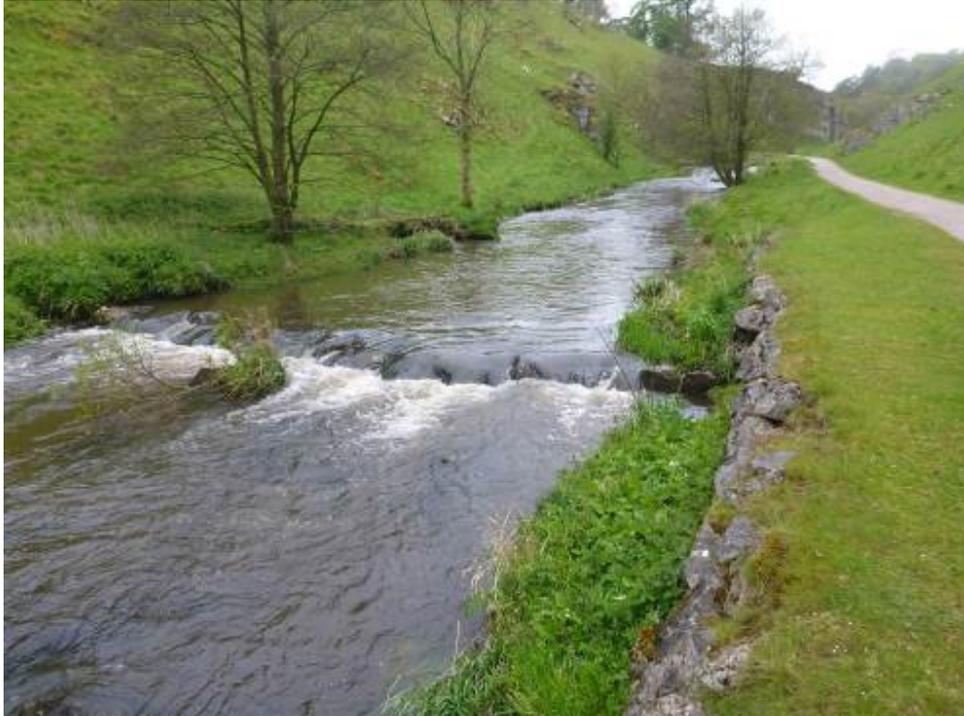
The downstream extent of the visit was where Biggin Dale meets the River Dove (SK1416556965). From this point to the footbridge (SK1307058405) at the head of Wolfscote Dale, the river flows through a narrow, steep-sided, limestone dale. The left bank is owned by the National Trust and the right bank by private individuals. Land use is livestock grazing (sheep) and there is a public footpath running along the left bank (Photo 1).

There are a number of weirs throughout this reach, originally constructed to enhance the fishery by impounding water, in an attempt to create areas of greater depth for holding larger fish (Photo 1). Some of the structures are centuries old whereas others are more recent. With the advent of recent conservation designations there has been considerable debate about the relative merits of the weirs and their effect upon natural river processes.

Photo 1 Typical weir and bank reinforcement in Wolfscote Dale. Note the lack of lateral movement of the river channel, steep valley sides and footpath.

- Plan a project to remove weirs and stone bank protection from sections of the river within Wolfscote Dale. Include the introduction of large woody debris (e.g. tree kickers)(Photos 20 - 22). This would require consultation with and agreement from the National Trust and other landowners; Natural England in relation to the conservation designations and possibly Peak District National Park Authority in relation to planning. Technical input from a fluvial geomorphologist would be required to design a scheme which balances restoration of natural river processes with impact upon recreational access (footpath). Engagement with Trent Rivers Trust would be beneficial.

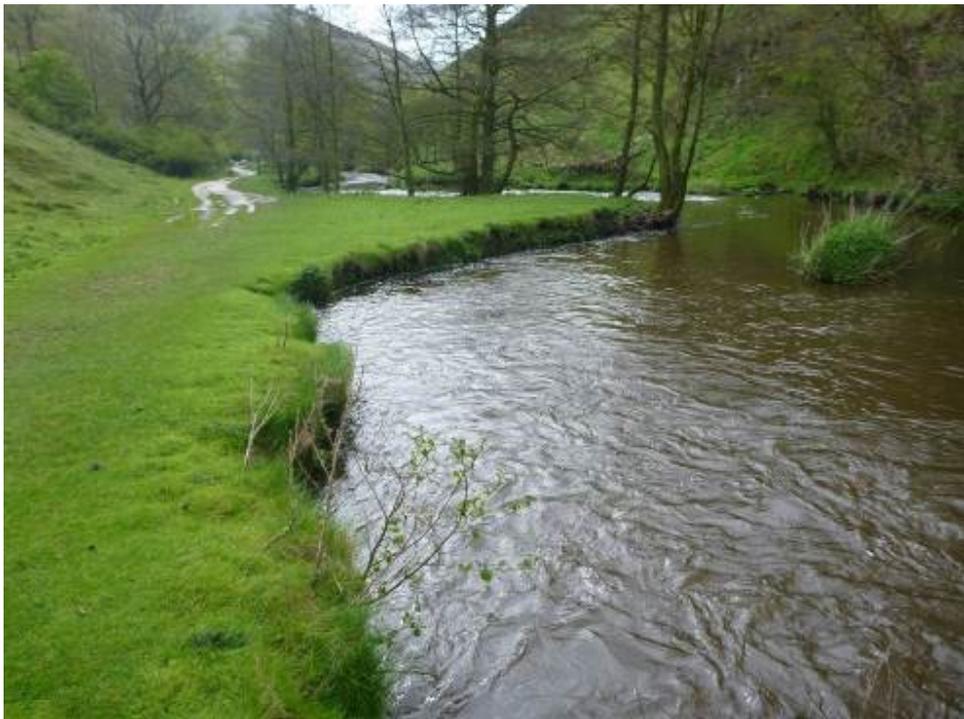
There is also a tendency for bank erosion at the edges of the weir on the downstream side where turbulent back eddies occur; this eventually leads to a breach in the weir, or where it is repaired, the gradual widening and shallowing of the river channel. Often banks are reinforced with stone between weirs to prevent this, limiting the opportunity for natural river processes such as erosion, deposition and meandering to create self-sustaining habitat features (such as lateral scour pools and riffles, Photo 2).

Photo 2 Some natural sinuosity does occur in this reach, creating more variety in depth and flow. This effect could be promoted in other areas by removal of stone bank protection and weirs. The effect of overgrazing and impoverished riparian vegetation also needs to be considered.

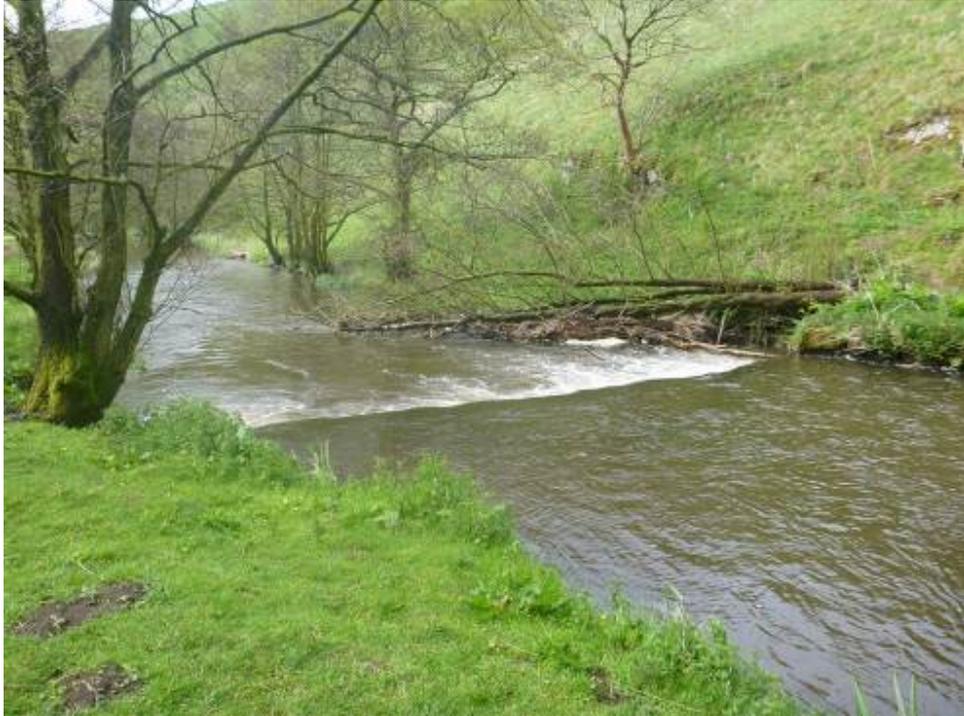
There were one or two examples of large woody debris (LWD) in the river channel (Photo 3), but generally it is lacking. LWD has numerous benefits for river habitat, including localised scour, depth variation, sediment sorting, refuge for fish and invertebrate habitat. Naturally occurring LWD should be retained within the river wherever possible and the urge to tidy resisted. It would be possible to introduce stable LWD structures here, as carried out by WTT in partnership with the National Trust and Leek & District Fly Fishing Association in Dovedale, a short distance downstream. Combining this with removal of weirs and targeted stone bank reinforcement would make sense.

Photo 3 Large woody debris is scarce within this reach. Naturally occurring LWD should be retained and its deliberate introduction be considered.

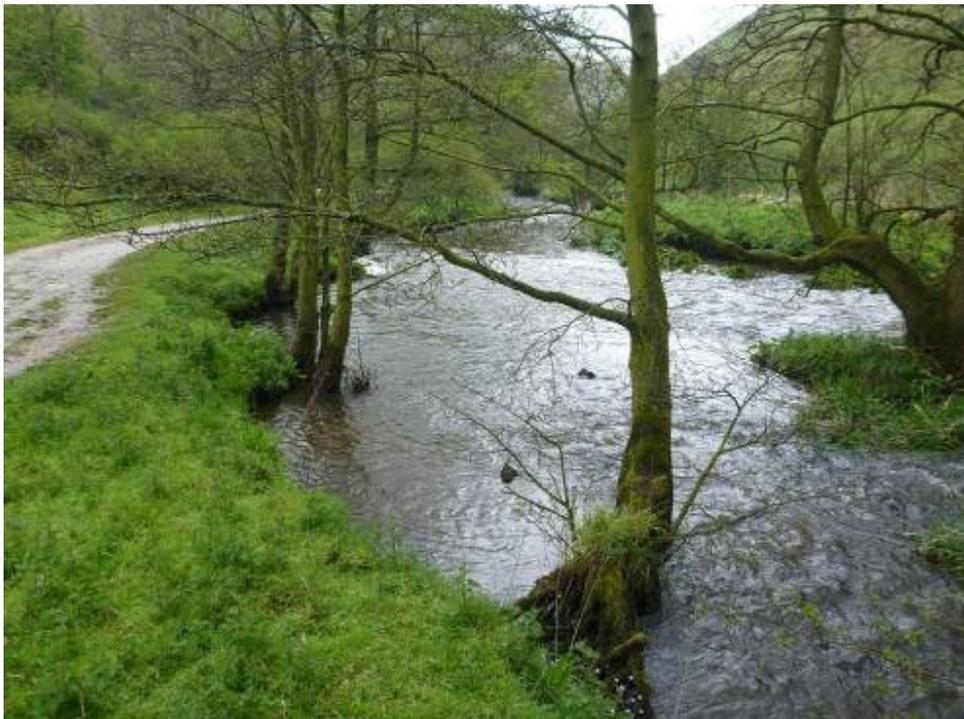
alders) with no taller vegetation or tree succession. The close-cropped grass has a shallow root structure which means the bank is prone to accelerated rates of erosion; this can be seen in Photo 4, where tree root structures are exposed and the bank “scaloped” in between. Eventually such trees are lost and in the absence of any succession, bank stability is reduced and erosion further accelerated. The absence of taller vegetation, bushes and young trees limits low cover over the river margins, greatly reducing trout holding potential and reduces the habitat value of the banks for the winged stages of aquatic insects and other invertebrates. Tree shading is also important in regulating river temperatures (www.luten.org.uk). Reducing livestock densities or fencing out sheep from sections of the river would benefit riparian habitat and opportunities for this should be discussed with the relevant land managers and agreed with Natural England (in the context of features of interest within the SSSI/SAC).

Photo 4 Grazing pressure leads to exposure of tree roots and scalloping of the bank, accelerating tree loss with little prospect of replacement in the absence of tree succession.

- Exclude grazing livestock from the river margins wherever possible to encourage a healthier riparian habitat and the natural regeneration of trees. Specific areas which would benefit include throughout Wolfscote Dale, the meadows downstream of Beresford Lane and between the fishing house and Hartington Bridge.

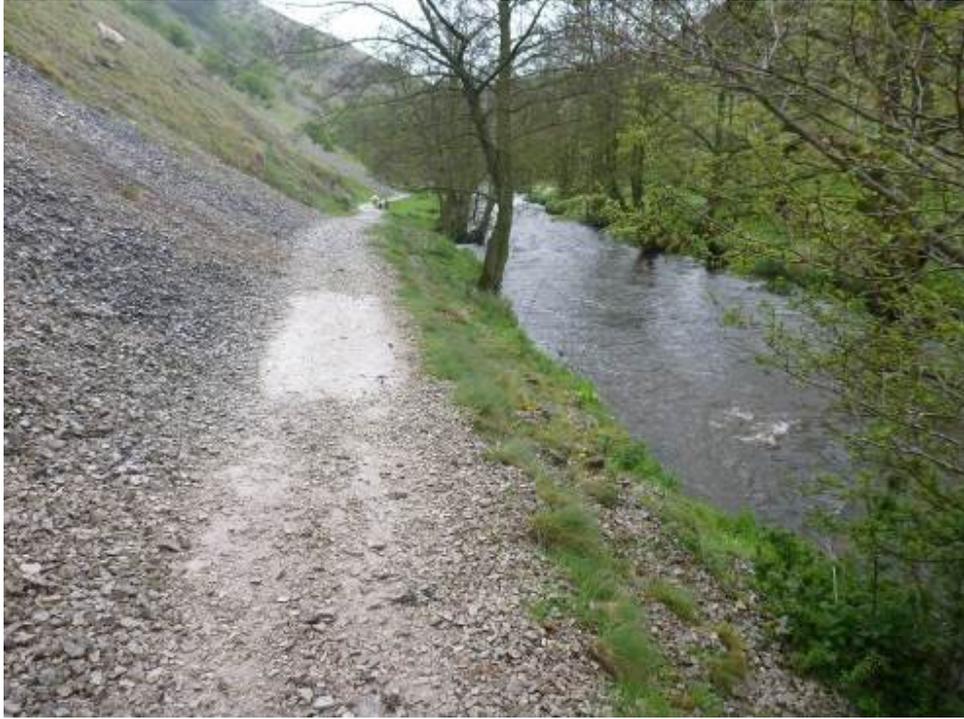
There are numerous scree slopes along the sides of the valley in this section which form a source of coarse sediment supply to the river (important for trout spawning). Many of these are cut-off from the river by the footpath along the left bank and stone bank reinforcement (on both banks), reducing the rate of supply (Photos 5, 6). It would be desirable to re-connect this supply to the river if a way could be found. Simply moving the gravel into the river is unlikely to be possible as it would disturb the angle of repose of the scree slopes. However, changes to the river such as removal of stone bank protection on the right bank could re-connect some scree slopes to the river without compromising access/recreation. This issue and the others above are identified in the recent report by Trent Rivers Trust on behalf of Natural England *River Dove Restoration Plan – Letting the Dove Flow*. This provides a useful starting point for engaging with Natural England and other interested parties to put some of the recommendations into action.

Photo 5 Scree slopes provide a source of coarse sediment to the river (something relatively lacking in the upper Dove), but the left bank footpath interrupts this supply and the multiple weirs restrict its transport and natural deposition pattern.

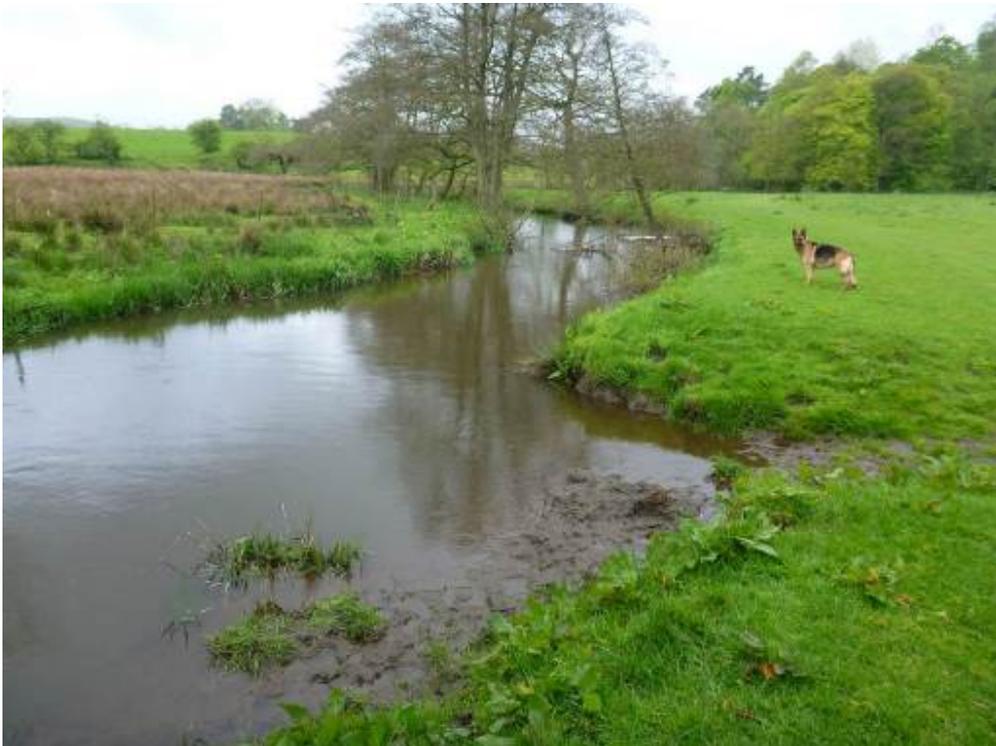
From the footbridge upstream to the end of Beresford Lane (SK1282458624), the valley opens out and the gradient lessens, the river becoming a slow-flowing glide. The downstream extent is impounded by a low weir and this should be removed to give the section more energy. The field on the left bank is unfenced and grazed, whilst the right bank is fenced although it appears some grazing is taking place on the river side of the fence (probably by sheep). The grazing is affecting riparian vegetation and habitat in the same way as described in the previous section and contributing to the over-wide nature of the channel, reducing fish holding potential. Excluding livestock from a wide buffer strip would improve river habitat along this section (Photo 7).

Photo 7 Grazing in the meadows downstream of Beresford Lane restricts the quality of riparian habitat and the fish holding potential. Fencing, planting willow whips (sallows) and tree regeneration would improve this section.

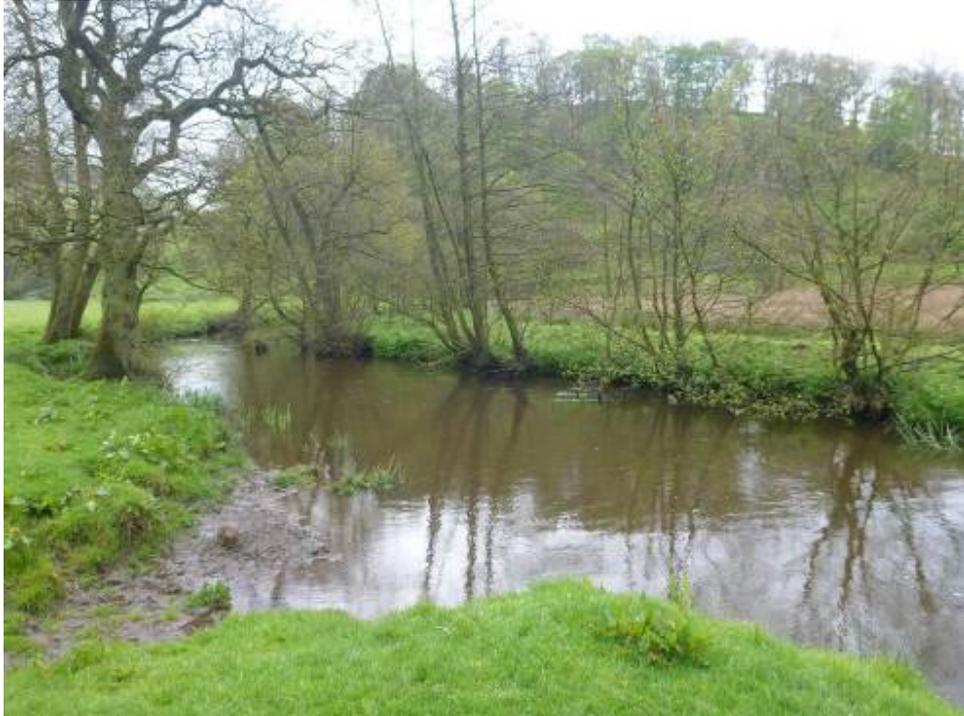
Alder trees are present along the banks, but younger trees are struggling to establish because of grazing pressure. The right bank appears to be better in this respect and there are a number of younger trees (or possibly coppice re-growth) that would be suitable for partially cutting and laying into the margins of the river to improve low cover over the water (Photo 8). As willow is often the first species lost (due to its palatability to sheep), it may be worth trying to reinstate some species diversity amongst the trees by planting willow whips in this area and any areas where cover is lacking and sheep browsing might not be an issue (particularly alongside the footpath, e.g. in areas around Photos 9 - 13).

Photo 8 Hinging and laying alder stems into the river margins would increase trout holding potential here.

- Continue to increase low cover over the water by cutting and laying suitable trees into the margins of the river. Plant willow whips in the river margin along the water line and out of livestock reach.

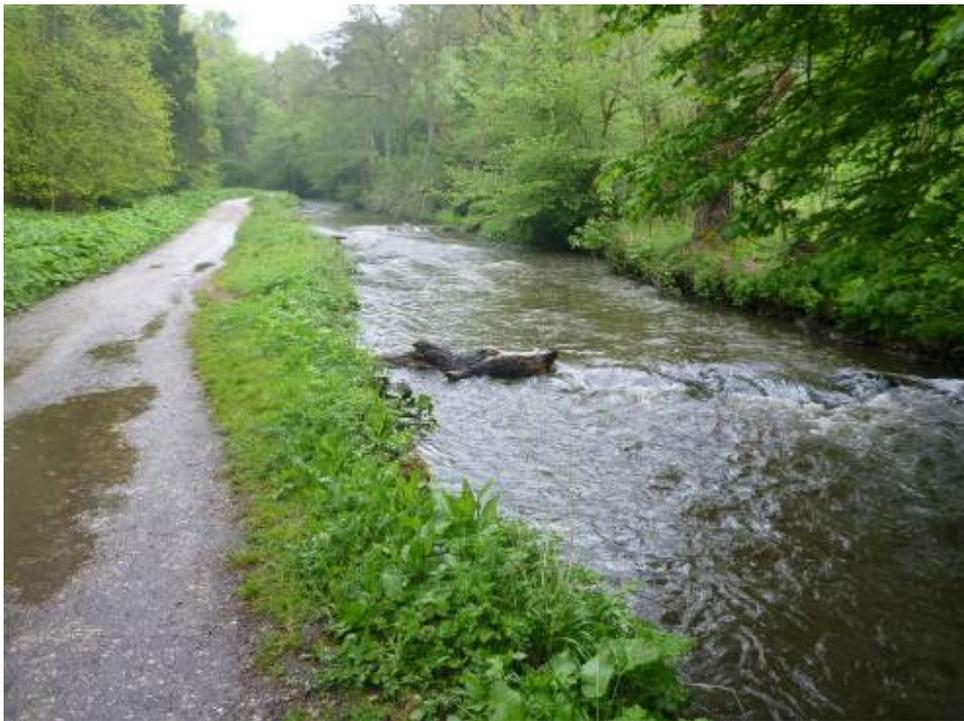
Upstream of Beresford Lane, a number of former weirs have been removed, improving the in-stream habitat by increasing flow velocities, remobilising coarse sediment and creating areas where trout have been observed spawning subsequently (Photo 9). Some of the limestone blocks from the former weirs were crushed and the gravel introduced to the river. The river enters the steep-sided, limestone valley of Beresford Dale here and the public footpath swops to the right bank. The valley bottom is narrow and path is perched on the top of stone bank reinforcement, limiting the scope for its removal. Two weirs (Photo 10) have been notched but otherwise left

Photo 9 Where former weir structures have been removed, the in-stream habitat has improved greatly. Increasing low cover in these sections should be a priority.

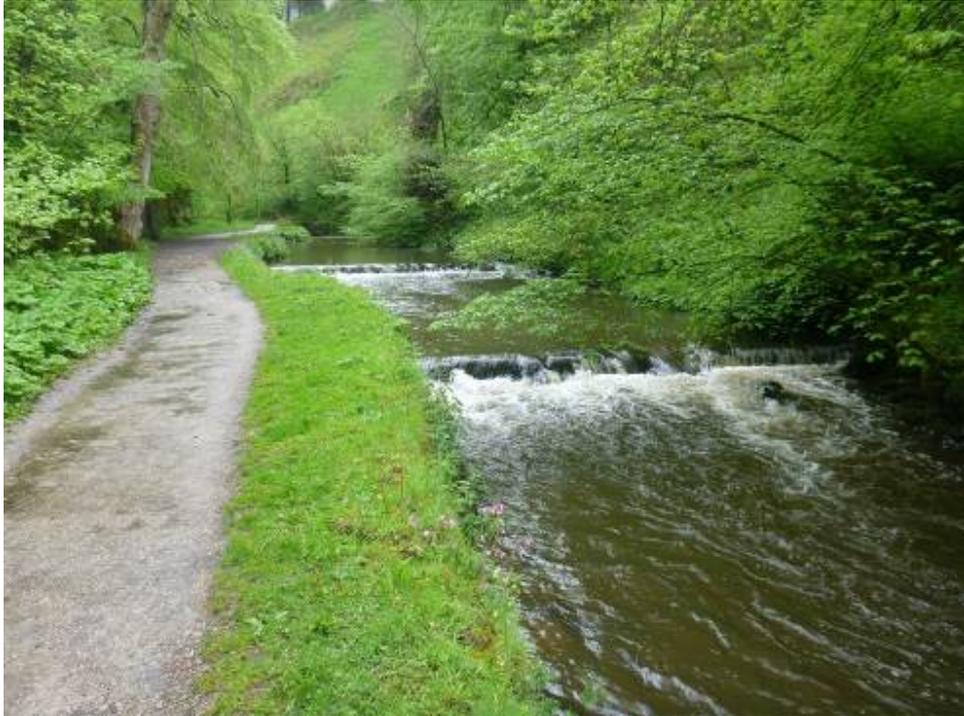
Photo 10 Two weirs immediately downstream of Pike Pool which have been notched but are otherwise intact.

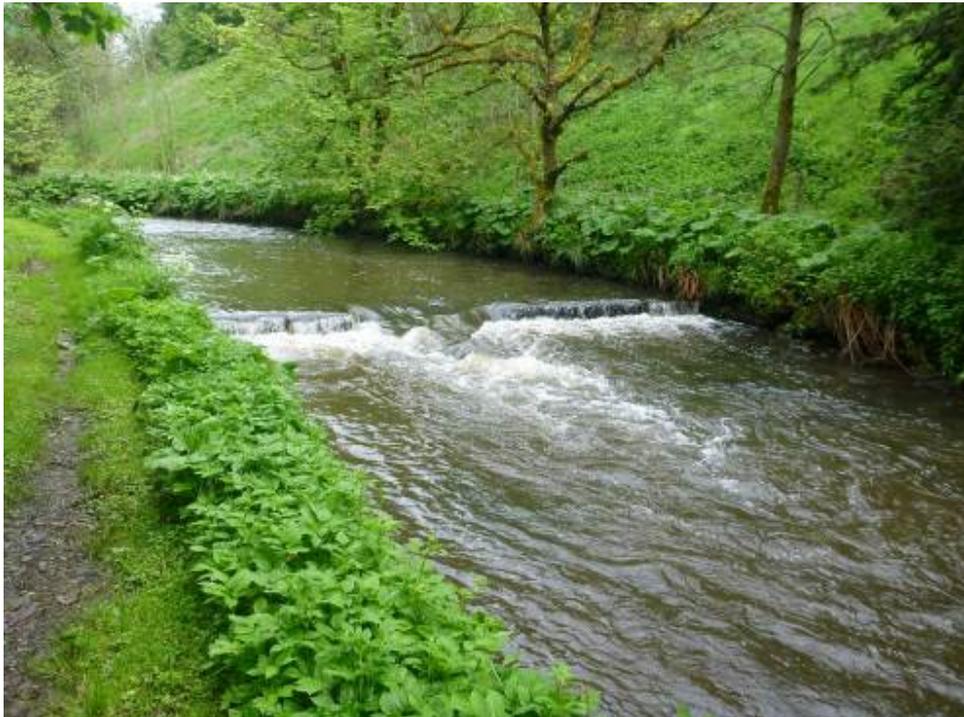
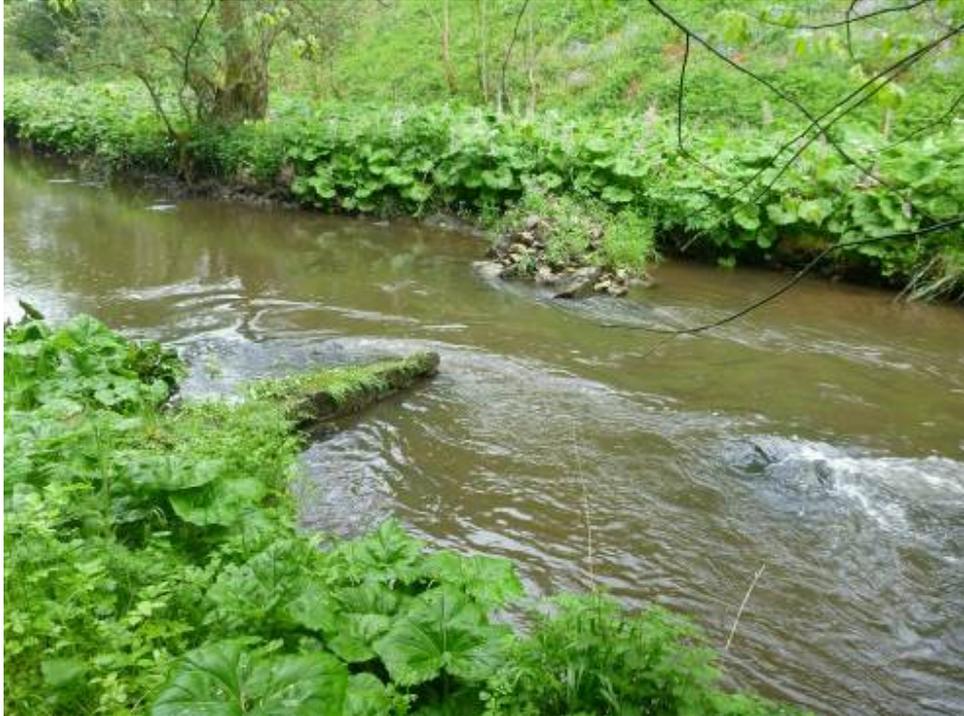
Above Pike Pool, the public footpath crosses to the left bank. The walkover survey continued along the right bank upstream towards the fishing house. The river here has historically been extensively modified for angling. The channel is uniformly over-wide and has near vertical, stone-reinforced banks. A number of weirs formerly impounded water through this section, but were breached at around the same time as those below Pike Pool (circa 2012, Photos 11, 12). The mobilisation of bed sediment here appears less extensive than where the weirs have been removed downstream; also, the channel narrowing that might be expected has not occurred. Some impounding effect from the remains of the weirs is still occurring and it is recommended that the remainder of the structures are removed.

Photo 11 Upstream of Pike Pool, breached weir which could be dismantled further.

Photo 12 As above

- Between Pike Pool and the fishing house: remove the remains of weirs that have already been breached. Plan a project in this reach to remove stone bank revetment and introduce large woody debris, and to replace the stands of snowberry and dogwood with a more natural balance of vegetation. Consultation with landowners and Natural England is required.

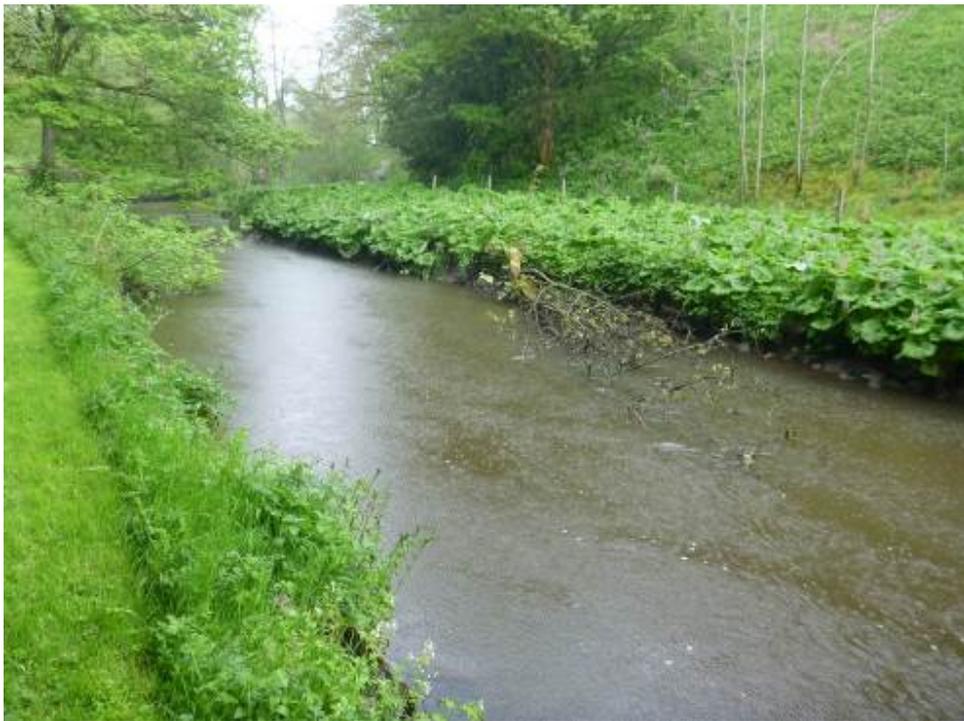
Ideally the stone bank revetment should be removed to allow a more natural regime of erosion and deposition to occur, creating lateral scour pools and depositional side bars. This may not be possible within the narrow confines of the valley here where footpaths could be undermined, but there are some wider areas where it could be trialled. Some limited introduction of woody debris has been carried out by hinging bankside trees (Photo 13) and this should be extended and include larger tree kickers (see recommendations) to help trap sediment and encourage variation in channel width.

Photo 13 Reach above the two weirs in photos 11 and 12. Uniform and wide with stone reinforced banks. The hinged tree is a good start but stone revetment removal and more substantial woody structures are required to trap sediment and create depth and flow variety.

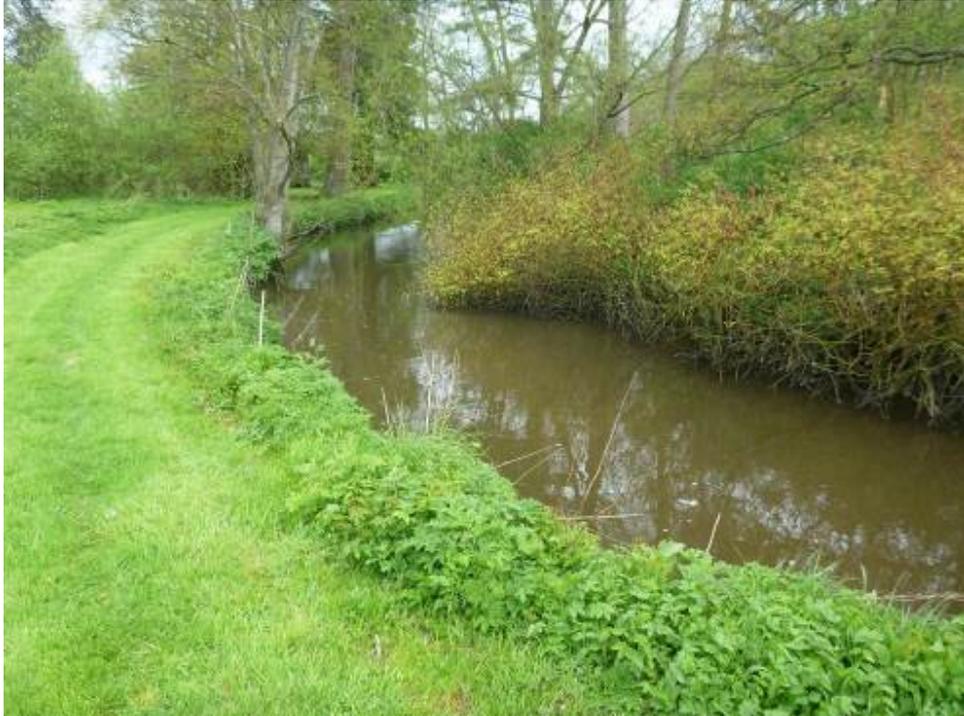
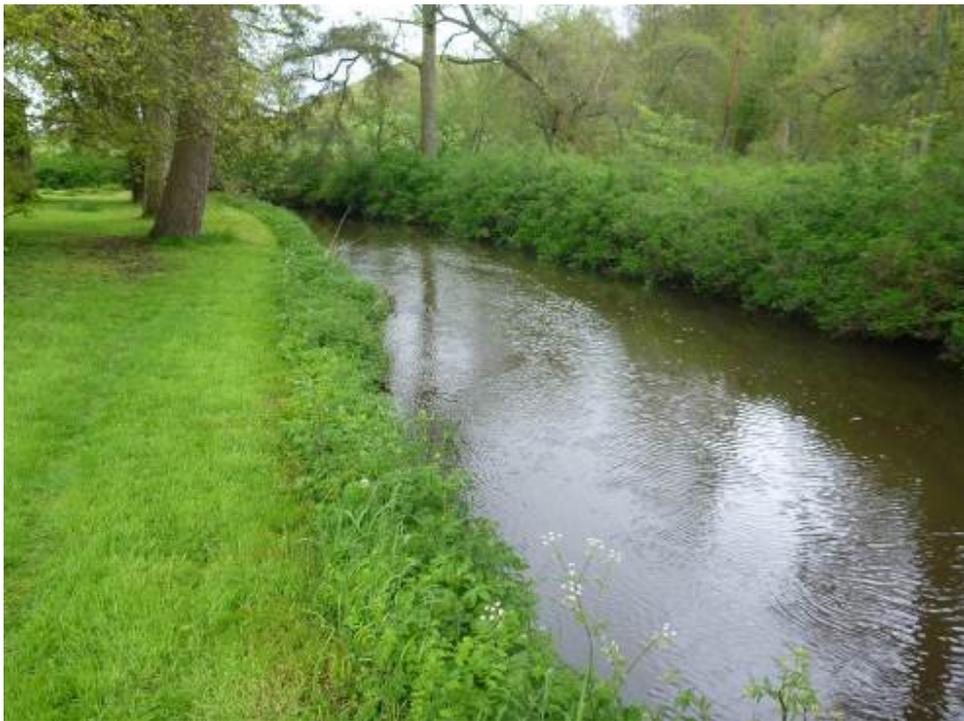
The left bank in the vicinity of the fishing house has dense stands of snowberry *Symphoricarpos rivularis* and dogwood *Cornus sanguinea* (Photos 14, 15). These provide low cover over the water, which is desirable for holding trout, but the extent and density of these plants is excessive and they are shading out other plant species and reducing diversity. Cutting back the snowberry and dogwood is recommended, followed by herbicide stump treatment (with appropriate permission). This would allow a more natural variety of vegetation to be established, including willows, alder,

Photo 14 Dense stands of dogwood on the left bank near the fishing house.

Photo 15 Snowberry bushes along the right bank near the fishing house.

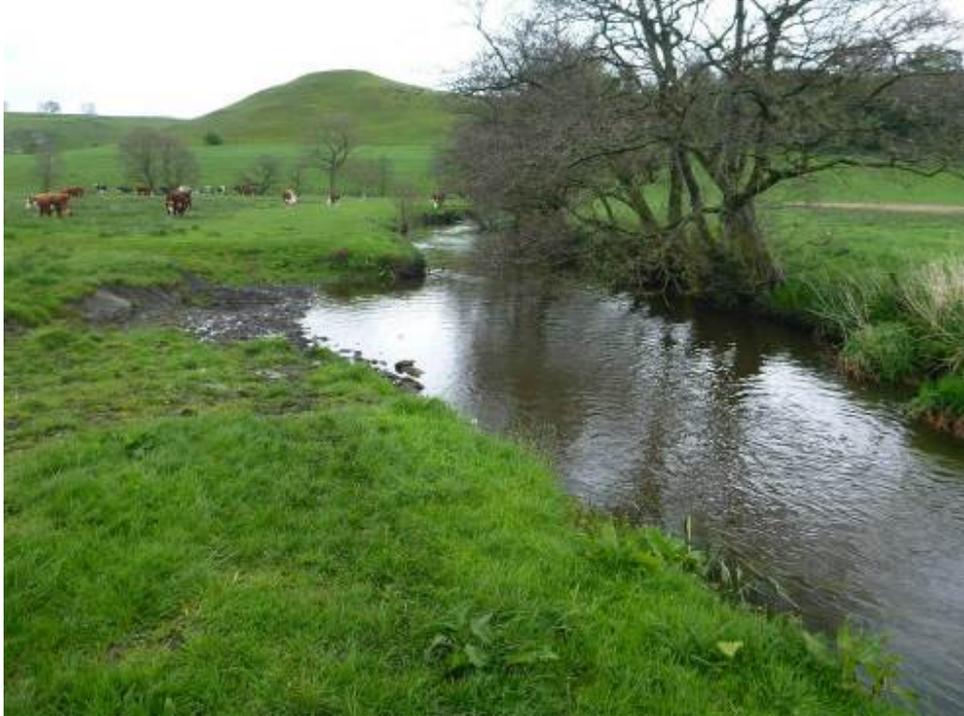
Upstream of the fishing house the character of the river changes. The channel is low gradient and meanders through open meadows grazed by cattle on both banks. The river is predominantly slow-flowing glide habitat, with fine sediment dominating the bed substrate (Photo 16). In recent years three low weirs were removed from this section which has improved the variation in flow patterns and substrate.

access to the river, poaching of the banks creates a fine sediment input to the river (as seen in Photo 16). In the absence of sheep grazing, planting willow whips along the river margin, out of reach of cattle, may again be beneficial in reinstating species diversity, creating low cover and provide material for future hinging into the channel.

Photo 16 Unrestricted grazing access restricts the quality of the riparian habitat and tree succession.

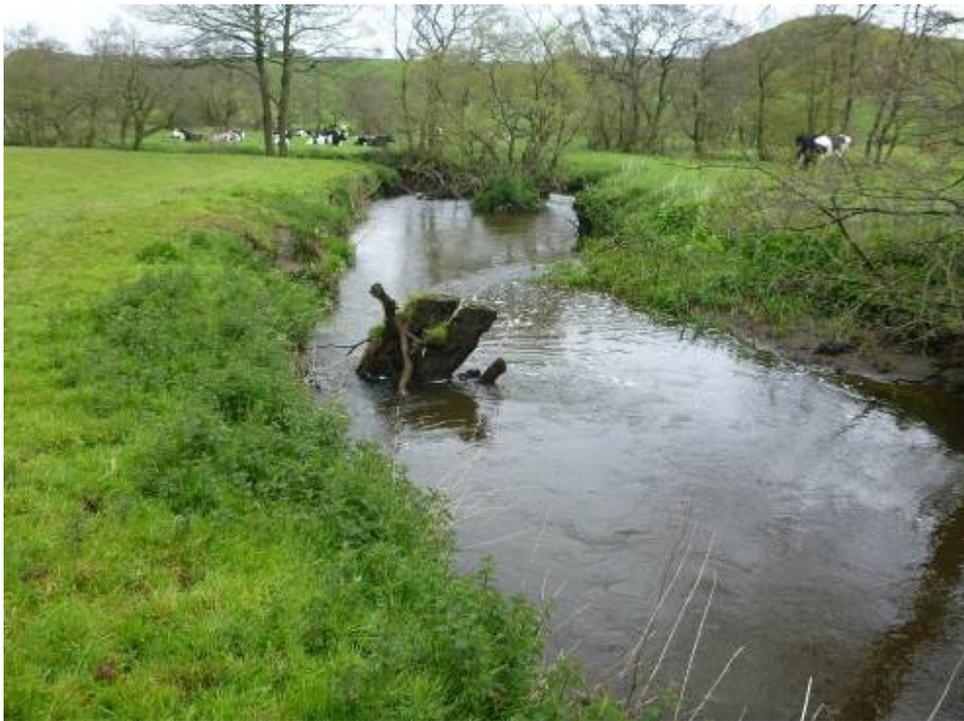
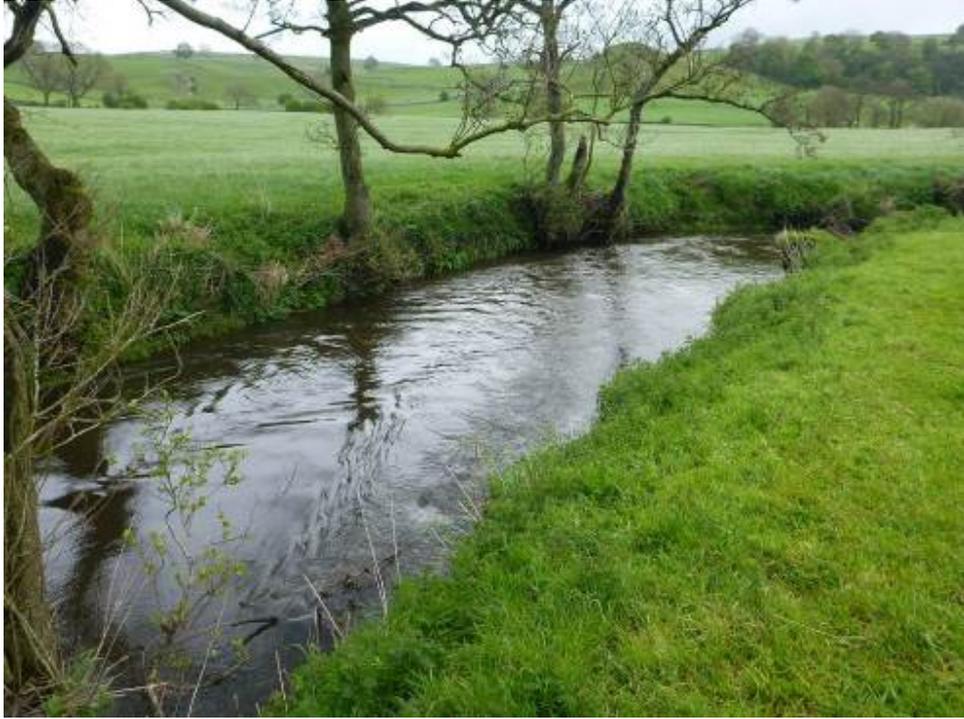
Some areas of gravel have been introduced recently (following the weir removals) and these appear to have successfully created some riffle habitat which is otherwise lacking here (Photos 17, 18). Both trout and grayling have been reported spawning on the introduced gravels. Great care needs to be taken when introducing gravels in this way, particularly in such a relatively low gradient reach, to avoid impounding water upstream and causing fine sediments to settle out (in the manner of the former low weirs). It is recommended that a fluvial geomorphologist is consulted to assess this reach in more detail, building upon the broader scale information in the fluvial audit (Rice & Toone, 2011) and providing recommendations for mitigating the lack of coarser bed sediments in this reach.

Photo 17 Retained LWD and introduced gravels have created some habitat variety in this reach.

Photo 18 Riffle habitat created with introduced gravels.

- Upstream of the fishing house: consult a fluvial geomorphologist on mitigating the lack of coarse sediment in this reach, with a view to creating more riffle habitat.

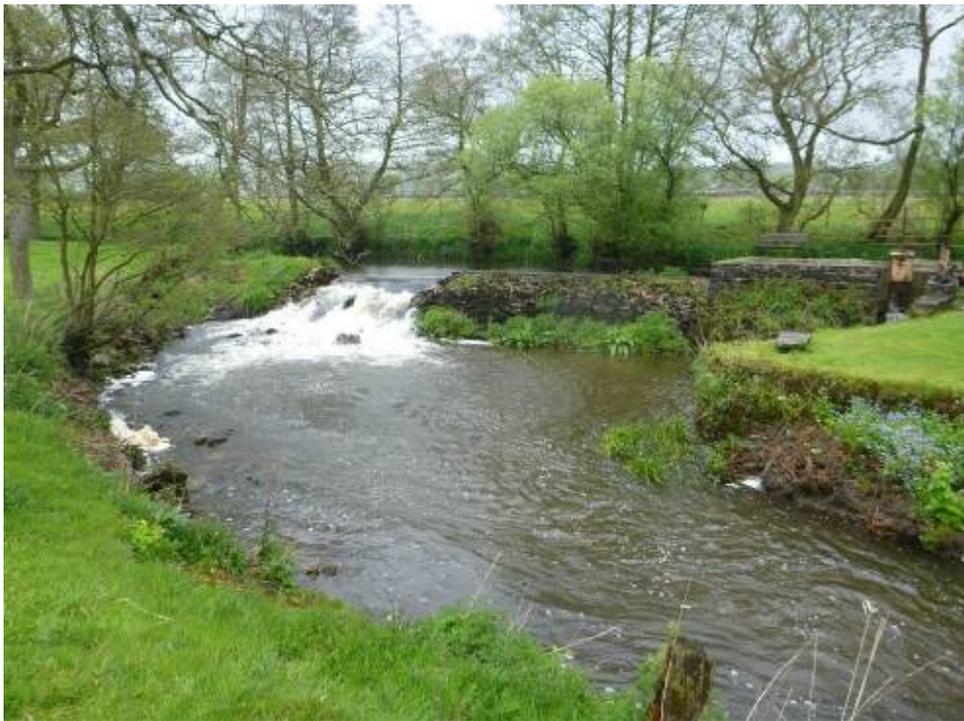
The river banks are relatively steep-sided suggesting that this section may in the past have been dredged to lower the river bed (for land drainage). Along with the former mill weir immediately above this section (Photo 19), which interrupts natural sediment transport processes, this could account for the lack of coarser sediments found in this reach. Rice and Toone (2011) showed that the upper Dove has a relatively fine, mobile bed load derived from the weathering and erosion of silt/mudstones and that weirs interrupt the natural sediment transport process; the mill weir mentioned above is described as a significant barrier to the downstream transport of coarser sediment.

Above the upstream boundary, upstream of Hartington Bridge, the former mill weir was inspected (Photo 19). As noted above, this interrupts sediment transport and is also a significant barrier to the free movement of fish. Adult trout and grayling will move several kilometres to spawn and their offspring will subsequently spread through the river system colonising available habitat. Barriers to this movement reduce the viability and resilience of fish populations to environmental and anthropogenic impacts (such as drought, floods and pollution). The river channel here appears to have been re-routed to a higher point on the valley side when the mill was constructed (to gain head loss for milling), leaving the original river channel abandoned at the lowest point in the valley floor on the present right bank.

Photo 19 Weir at former mill property, upstream of Hartington Bridge.

It would be possible to restore the river to its approximate original channel, circumventing the weir, restoring sediment transport and fish passage and reducing flood risk to the mill property (a private residence). Some flow could be retained in the existing channel to preserve the character and heritage of the mill. Such a project would require careful planning and the consent of all parties affected, but it would be worth exploring the idea.

- Explore the opportunity for removing the barrier to fish passage and sediment transport presented by the mill weir upstream of Hartington Bridge.

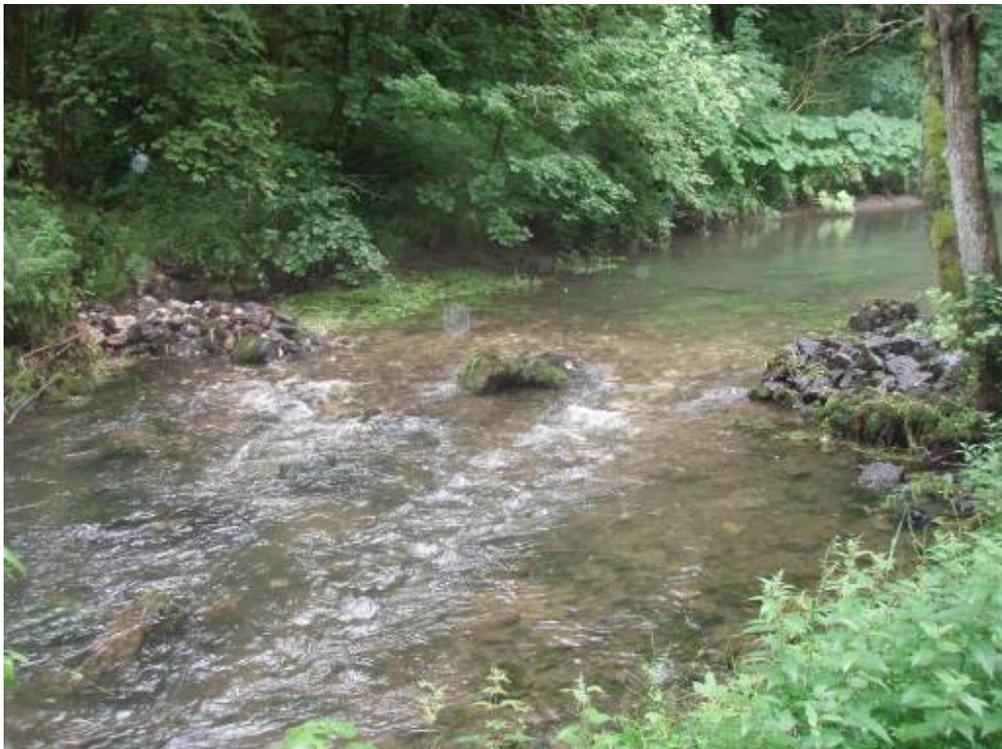
Photo 20 Site of removal of a low weir in Dovedale.

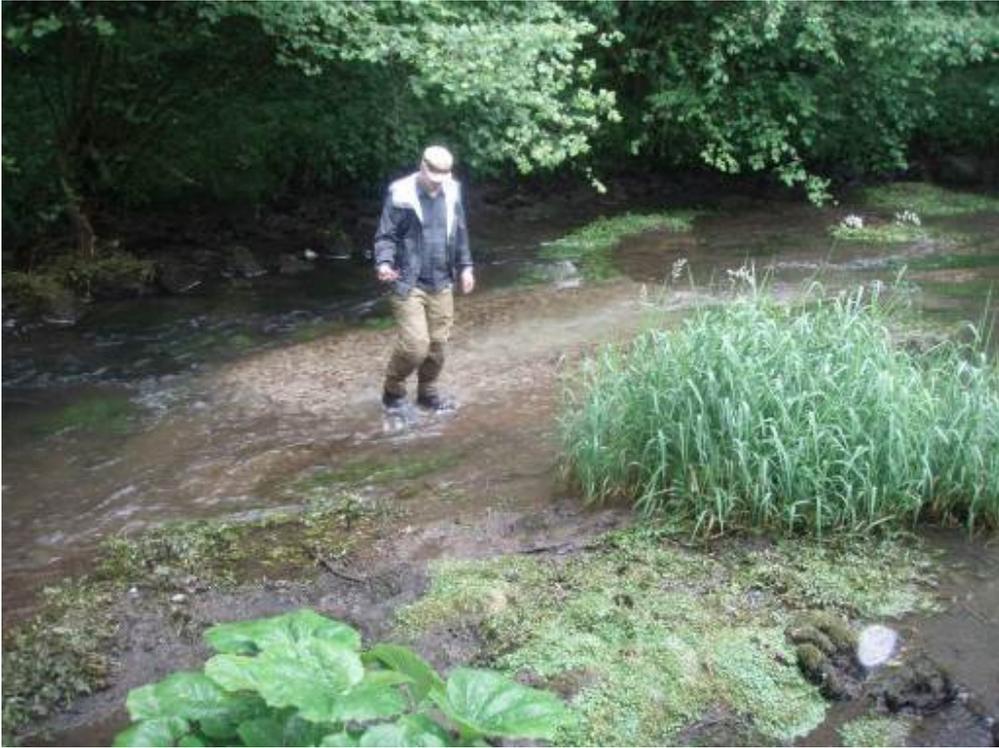
Photo 21 Gravel mobilised and sorted upstream of the above weir removal. Trout spawned in this area subsequently.

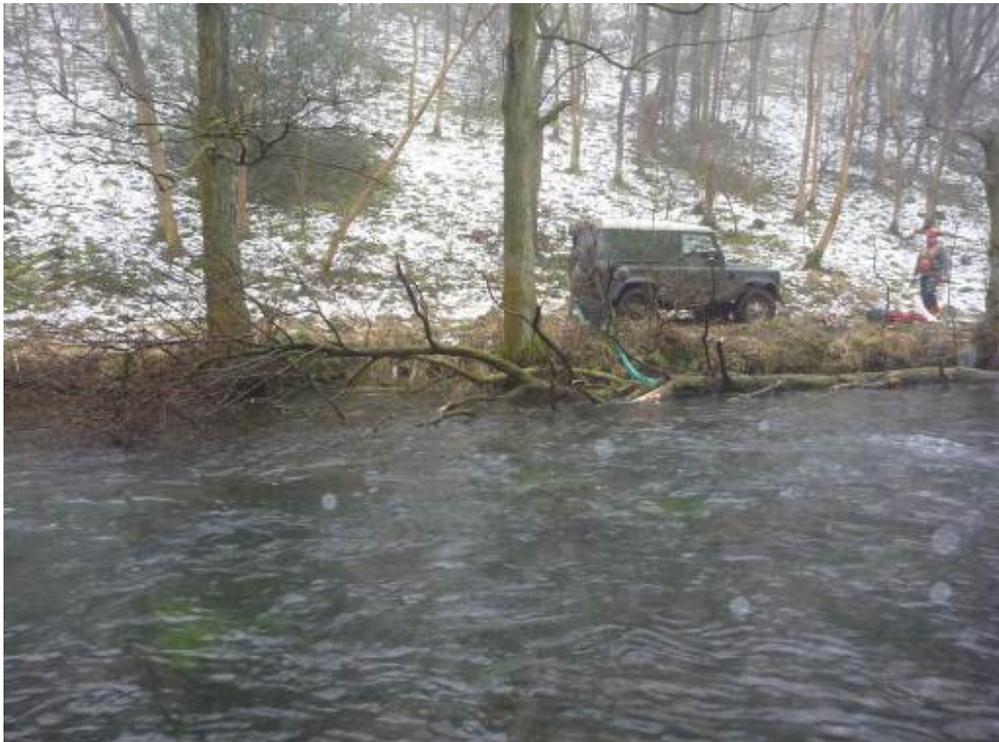
Photo 22 Installing a tree kicker in Dovedale (a cut tree cabled to its stump).
