Advisory Visit

River Dove

Birdsgrove Fly Fishing Club

October 2016

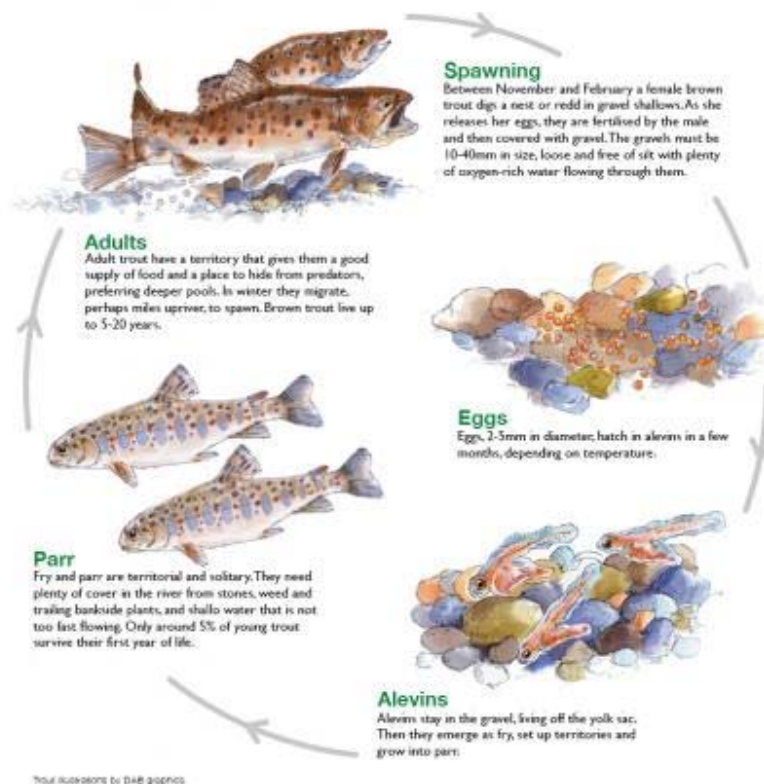
Figure 1

The lifecycle of the brown trout can be broadly divided into three periods: spawning/eggs/alevins, juvenile and adult (Figure 1), each with specific habitat requirements.

The Brown Trout Life Cycle

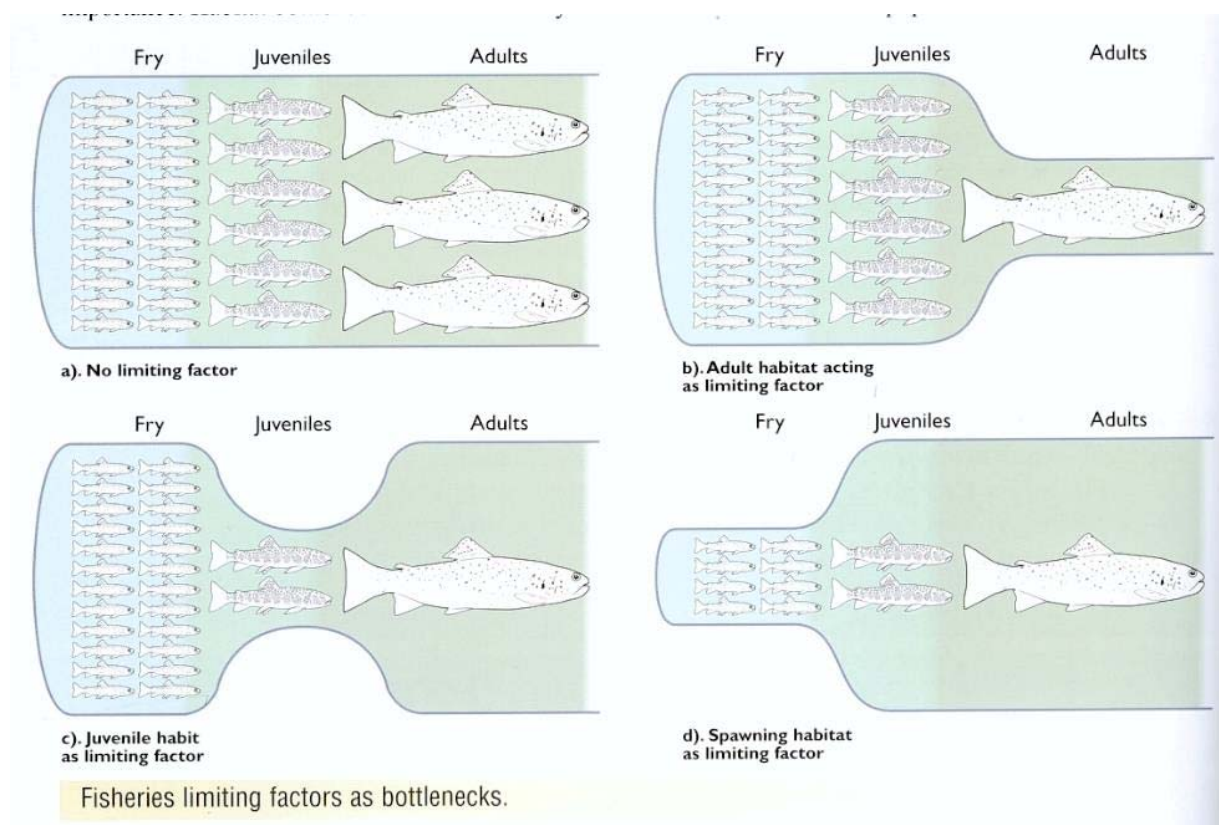
Figure 2

The absence or scarcity of a particular type of habitat leads to a bottleneck in the trout population, restricting the numbers of fish that reach adulthood (Figure 2).

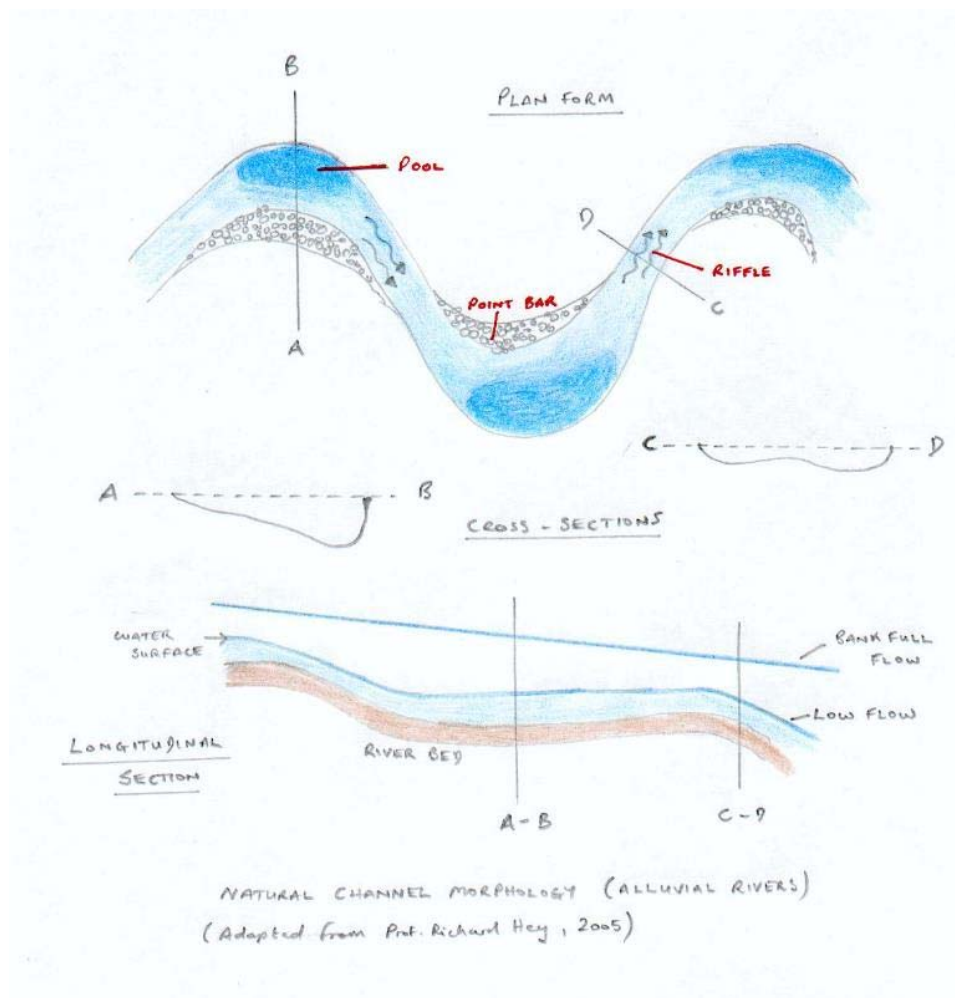
Figure 3

The plan-form of the river on the lower section is relatively meandering, as a river of this size and gradient should be naturally. This is a positive influence on habitat quality because meanders promote the formation of a pool-riffle sequence (Figure 3).

The pool-riffle sequence is intrinsically linked with habitat quality as it provides deeper pool areas on bends (adult habitat) and shallow gravel riffles in between (spawning and juvenile habitat), along with the variety of flow and grading of river bed material integral to habitat diversity.

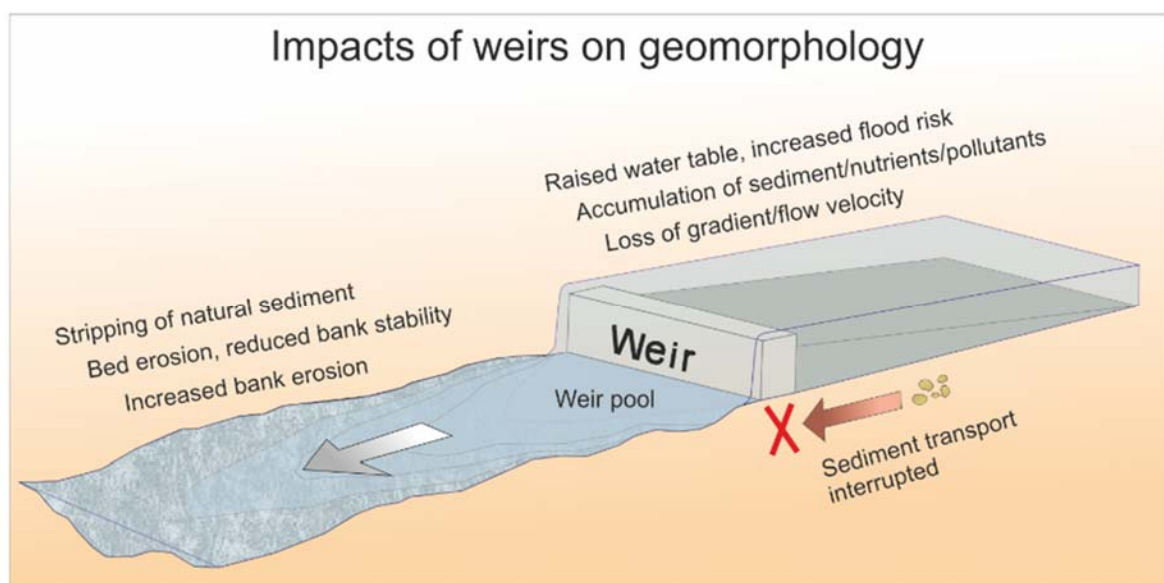
Unfortunately, there are three weirs on the lower waters of the Birdsgrove fishery (Calwich, Gothard and Sidesmill). Weirs have a deleterious effect on trout habitat (Figures 4 and 5) by interrupting the natural movement of sediments (including gravels suitable for spawning) and drowning out habitat diversity upstream. This can impact upon long reaches of water, greatly degrading the impounded reach for flow-loving plant and invertebrate species, many of which form staples of the fly fisherman's sport. Weirs are also obstacles to fish migration, in both directions. Adult trout can be seen struggling to surmount weirs on the Dove during the spawning migration in October/November. There is also growing evidence of heavy mortality of juvenile fish which accumulate above weirs during downstream migrations, a potential explanation being concentrated piscivorous bird predation in these areas.

Figure 4 Weirs interrupt sediment transport, trapping it upstream whilst it continues to be transported away downstream of the weir, leading to a net loss of smaller particles (gravels) there.

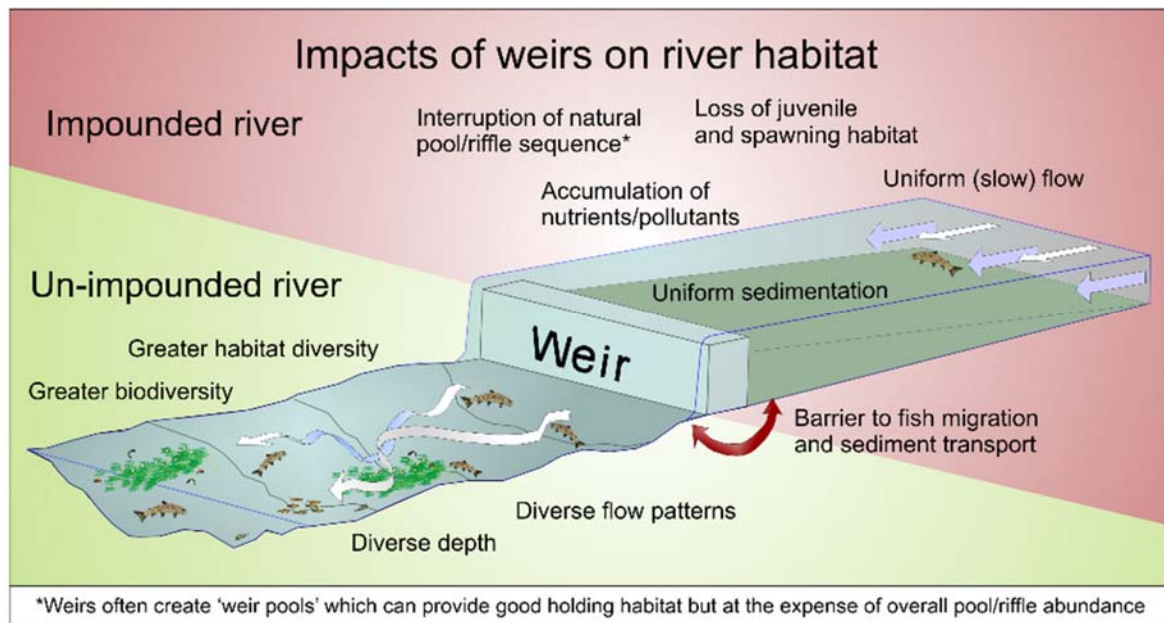
Figure 5: An illustration showing the impact of weirs on river habitat

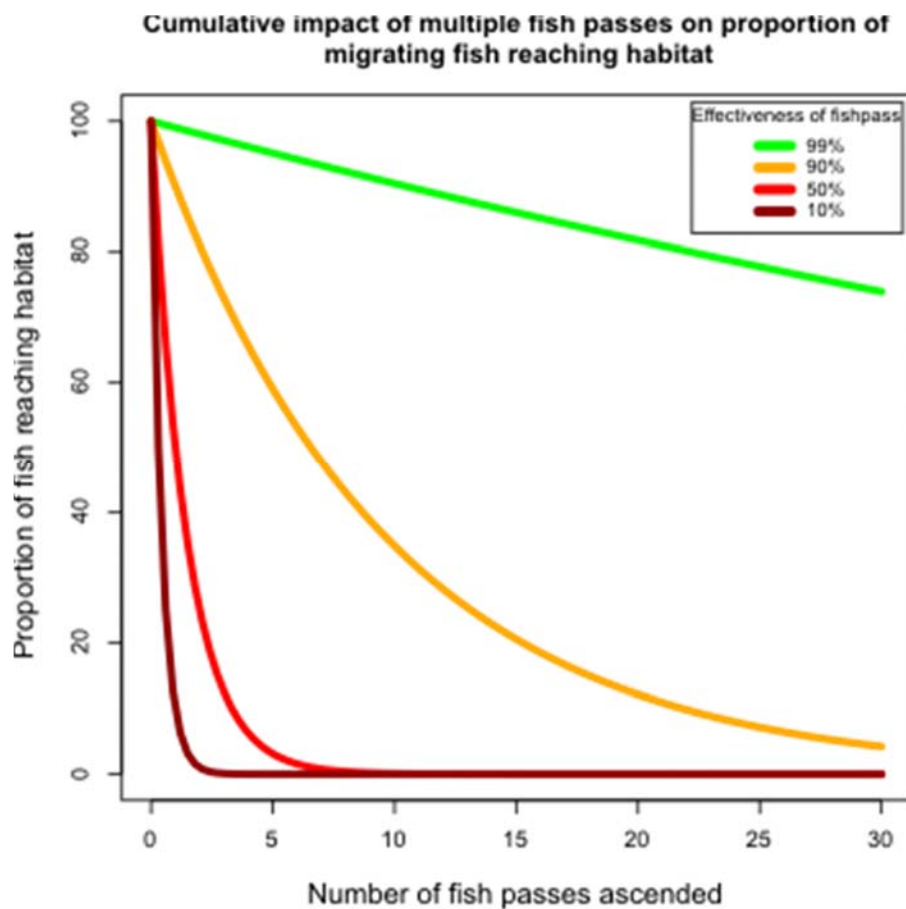
Figure 6: Graph showing the cumulative effect of multiple obstacles to fish passage on upstream migration (courtesy of Dr E Shaw, Catchment Science Centre, University of Sheffield).

To maximise the benefits for river habitat and trout populations, weirs should ideally always be removed. This could be relatively straightforward for structures like Gothard Weir (previously installed by the club) or complex for other structures (such as those with different ownerships, dependent abstractions or integral to other structures). However, tackling the easy wins first will reduce the cumulative effect of multiple weirs on fish migration (Figure 6) and improve habitat in the immediate vicinity.

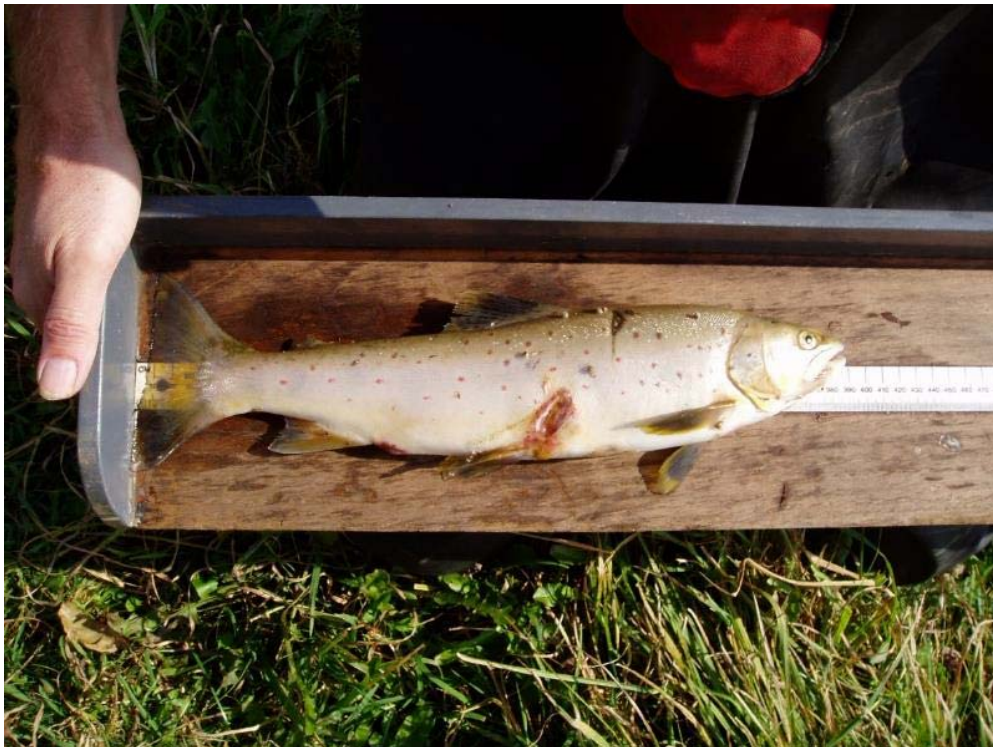
- Annual catch returns from the Grayling Society fishing days on the middle Dove (BFFC and Norbury FC) have shown a significant drop in catch per unit effort in recent years compared with a decade or two ago.
- BFFC report lower catches from downstream beats, although the number of visits to each beat is not currently recorded so no comparison of catch per unit effort can be made between beats.
- Fish with injuries consistent with damage caused by fish-eating birds have been caught by the author during past electric fishing surveys in this area (Photo 1).

Photo 1 Wild brown trout of approximately 40cm found dead on BFFC waters with wounds consistent with bird predation, September 2003.

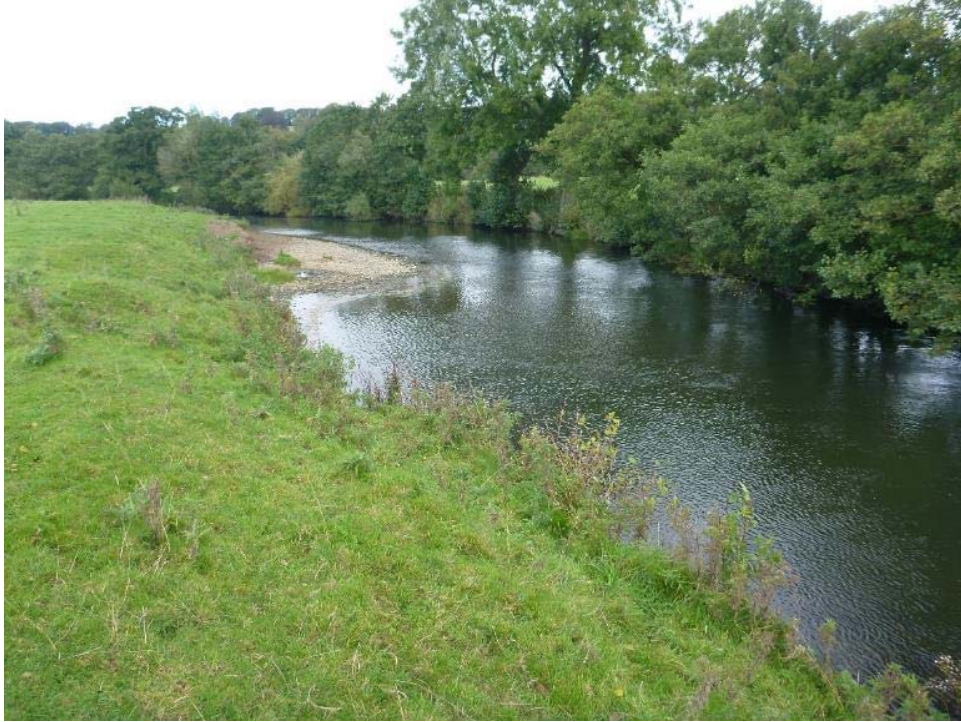
Photo 2 Temple beat. Good tree cover on the true LHB (far bank) contrasts with the grazed RHB, which provides easy angling access but no fish-holding features. Establishing some trees and bushes on the open bank would increase the fish-holding capacity of this reach. To achieve this, fencing and control of balsam would be required in the short to medium term.

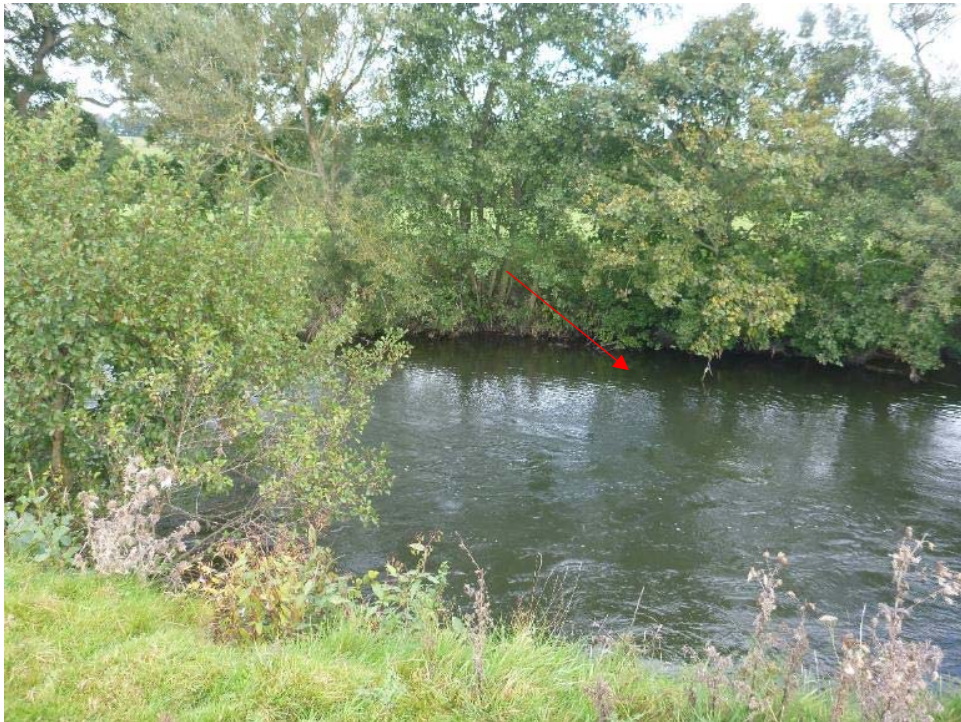
Photo 3 Temple beat. There are opportunities to lay some trees over into the margins on the far bank, improving low cover and creating refuge areas from fish-eating birds.

- Introduce cover to the river by partially cutting and laying suitable trees into the margins (in the manner of hedge laying), or by felling and cabling larger trees to their stumps ("tree kickers"). Ensure that this is not denuding the river bank of tree cover and easing access for fish-eating birds (Photos 36 – 38).

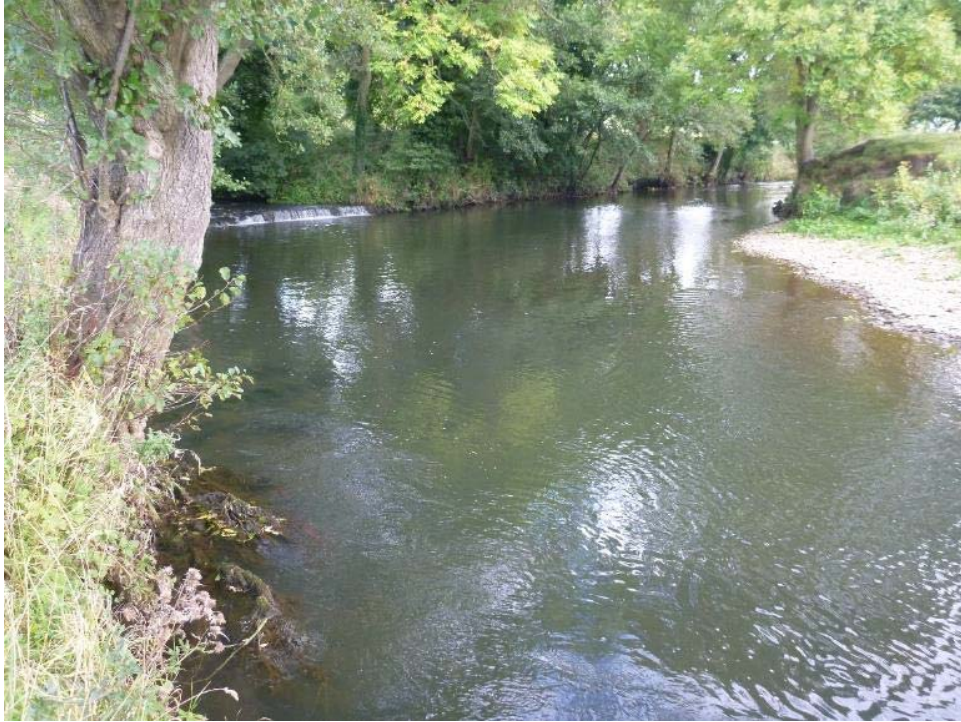
Photo 4 Overflow from leat close to the Temple. Submerged tree roots provide excellent cover but, unfortunately, a history of tree maintenance has denuded the area of lower branches and important, fish-holding cover. Areas like this may be candidates for reinstatement of low cover through selective coppicing.

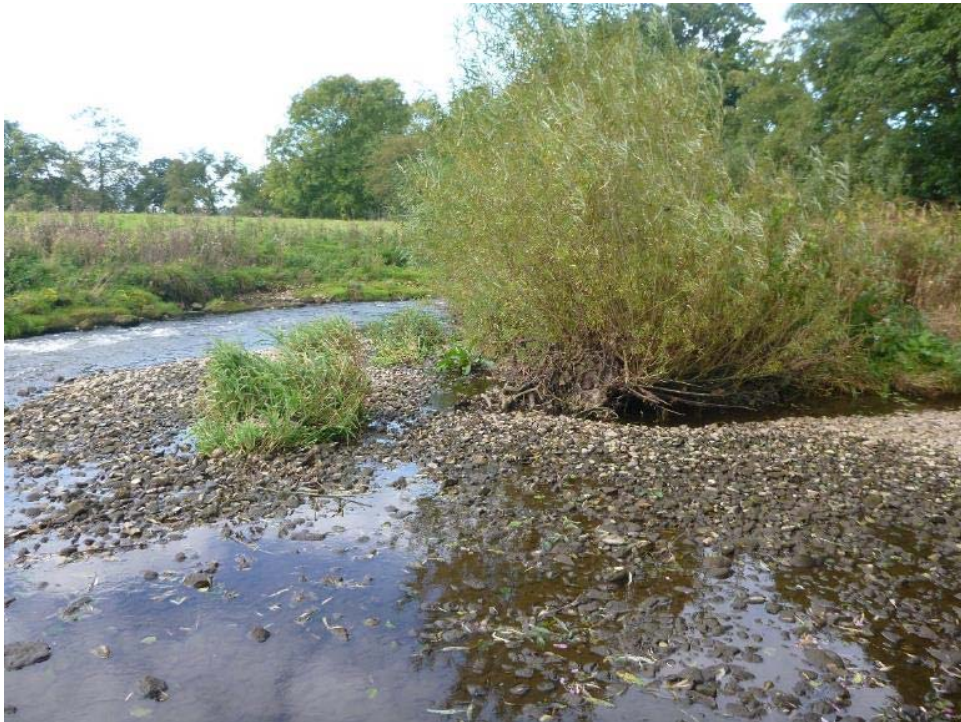
Photo 5 Upstream of the Temple, a gravel bar indicates some natural sediment transport is occurring, creating potential spawning areas.

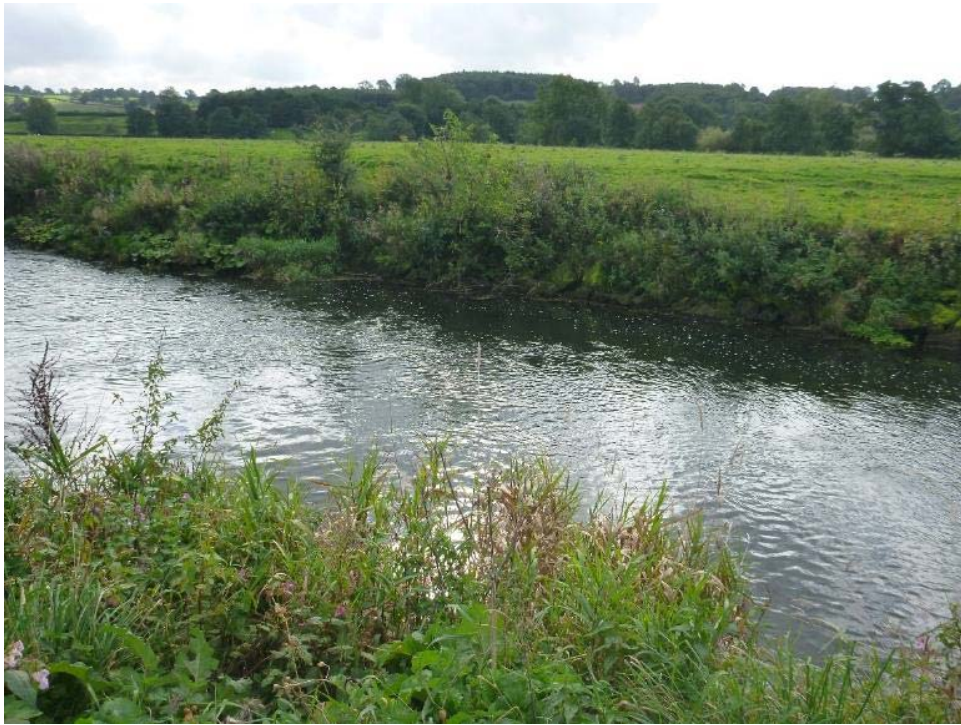
Photo 6 The straight reach downstream of Pastoral Pool has few trees along the LHB and they are prevented from establishing by grazing. Fencing and balsam control is required to establish trees here.

- Management of the riparian habitat to create as wide a buffer as possible between adjacent land use and the river is recommended. Creating new areas of riverside trees and protecting existing stands promotes bank stability, cover, shade and protection from fish-eating birds. Fencing out livestock, balsam control and maintaining access all need to be considered in relation to this.

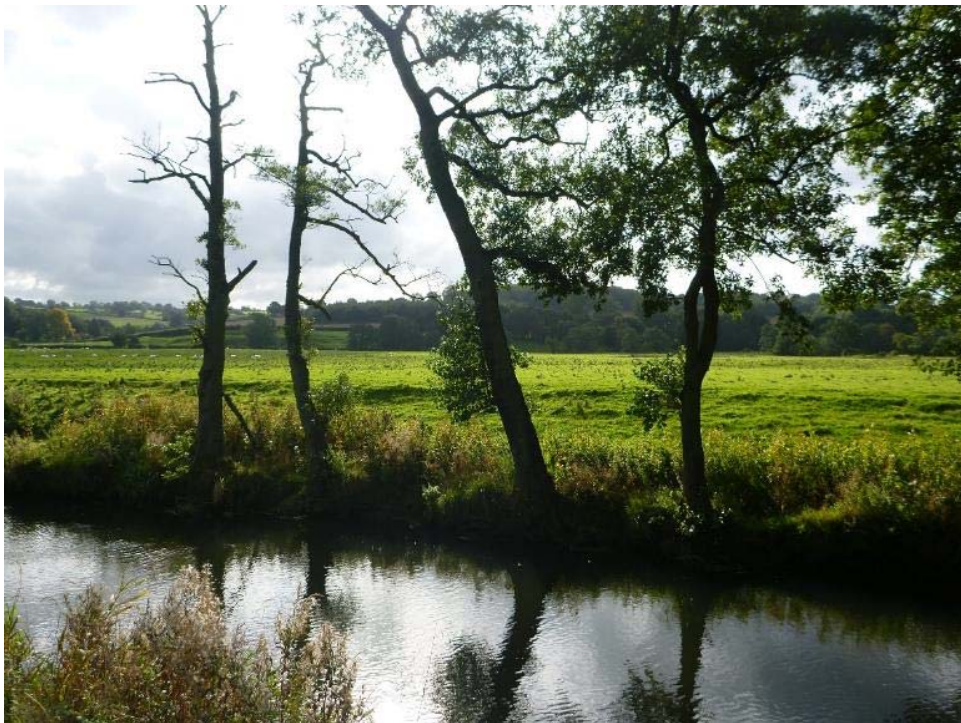
Photo 7 As above. Sickly alders might be saved here by coppicing. Protection from grazing would be required to allow regrowth from the base (note current browse level).

- Coppice sickly alders. Alders displaying the characteristic signs of *Phytophthora* disease (e.g. Photo 7) should be coppiced to retain the root ball within the bank and promote re-growth from the base (which should be protected from grazing).

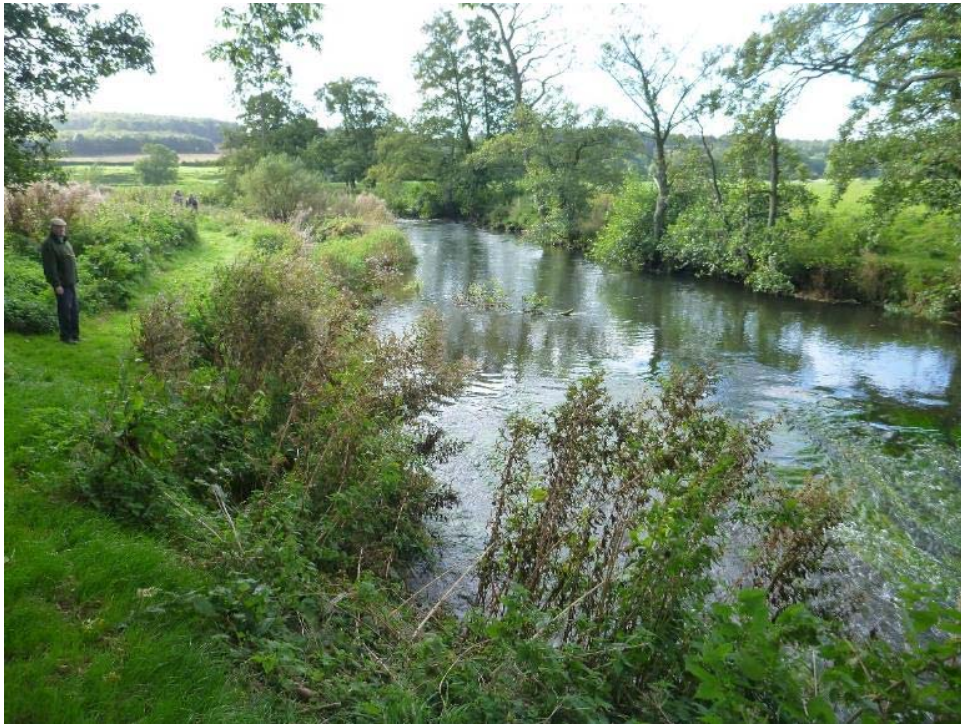
Photo 8 Good habitat at Pastoral Pool.

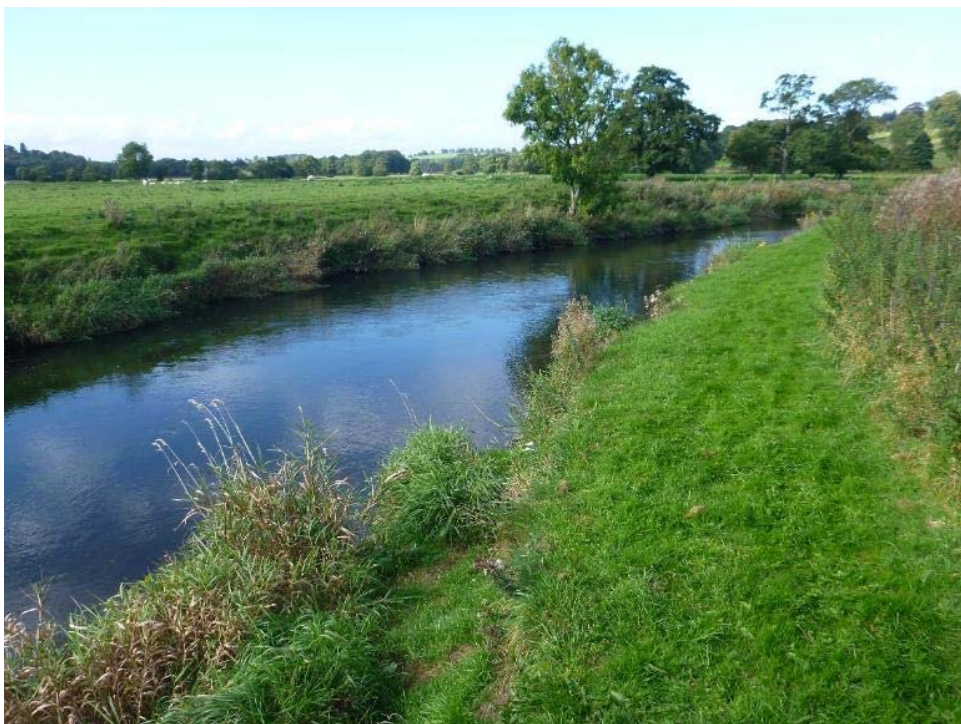
Photo 9 Straight channel lacking cover at Alders Bank, which would benefit from fencing and tree planting.

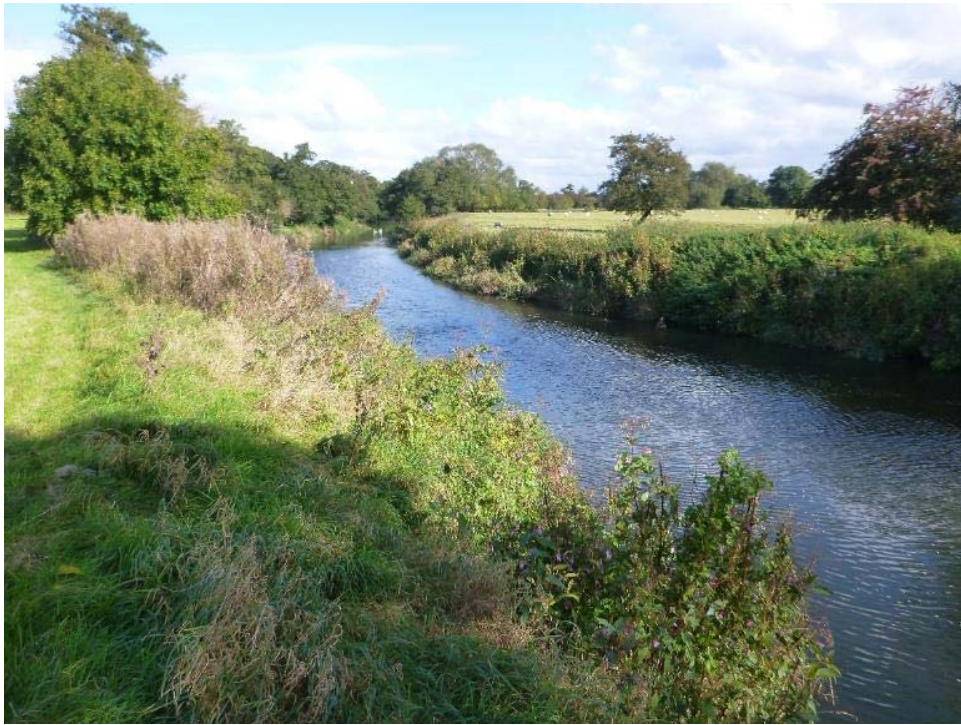
Photo 10 Grove Flats, as above.

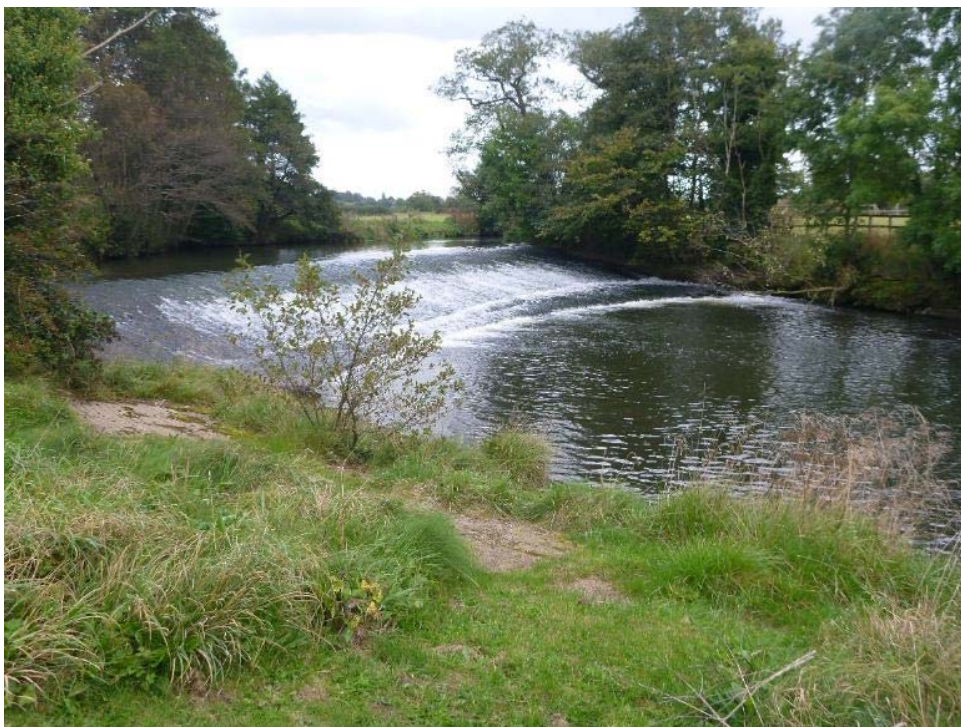
Photo 11 Calwich Weir, a detrimental impact on habitat for several hundred metres upstream and an obstacle to fish migration and sediment transport.

- The largest single issue affecting the quality of river habitat on BFFC waters is the presence of the weirs. Removal of the weirs is the best option to improve habitat. The complexity involved in removing a weir will vary with individual structures. Experience of weir removal in Dovedale (under the Letting the Dove Flow project) has produced a checklist of considerations which is reproduced in Appendix 1 (bear in mind that not everything will apply to each structure).

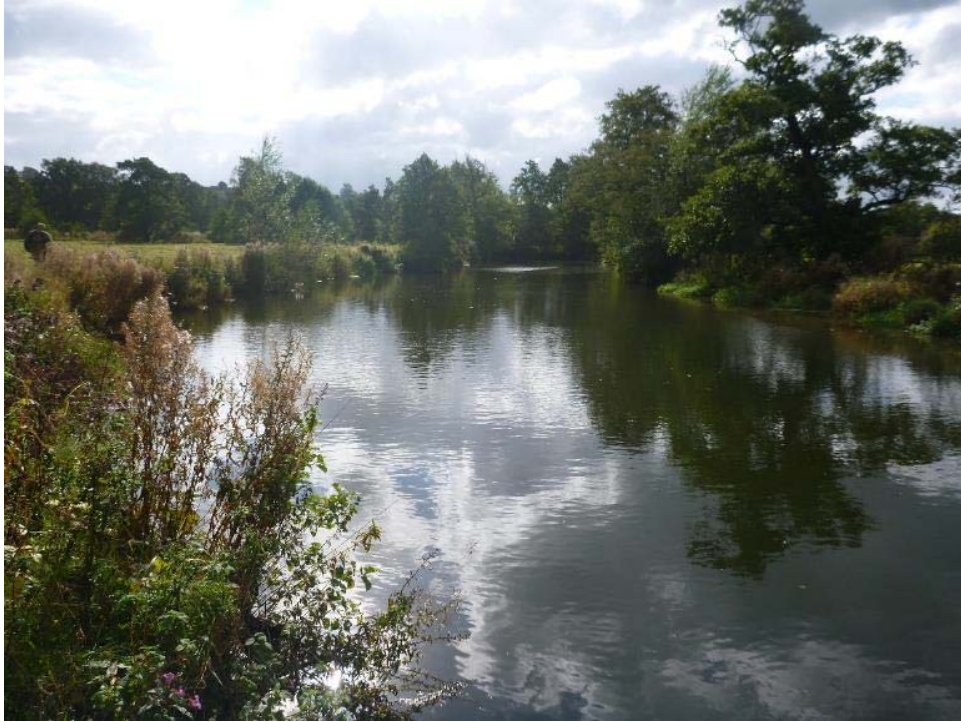
Photo 12 Ponded reach above Calwich Weir, the influence of which reaches as far upstream as Toadhole Pool.

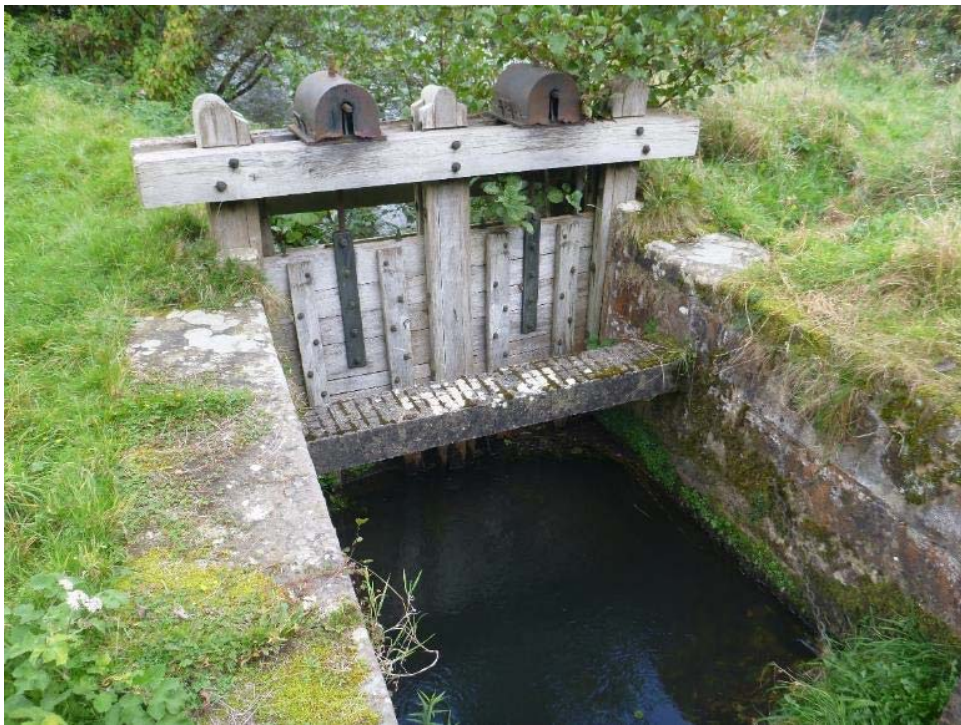
Photo 13 Flow control structure at the head of the leat leading to Calwich Abbey lake. There are at least two weirs along this leat, suggesting a reasonable fall in level along its length and the possibility of removing the leat weirs and reducing the height of Calwich Weir without compromising the flow of water to the lake. Further investigation including a levels survey is recommended.

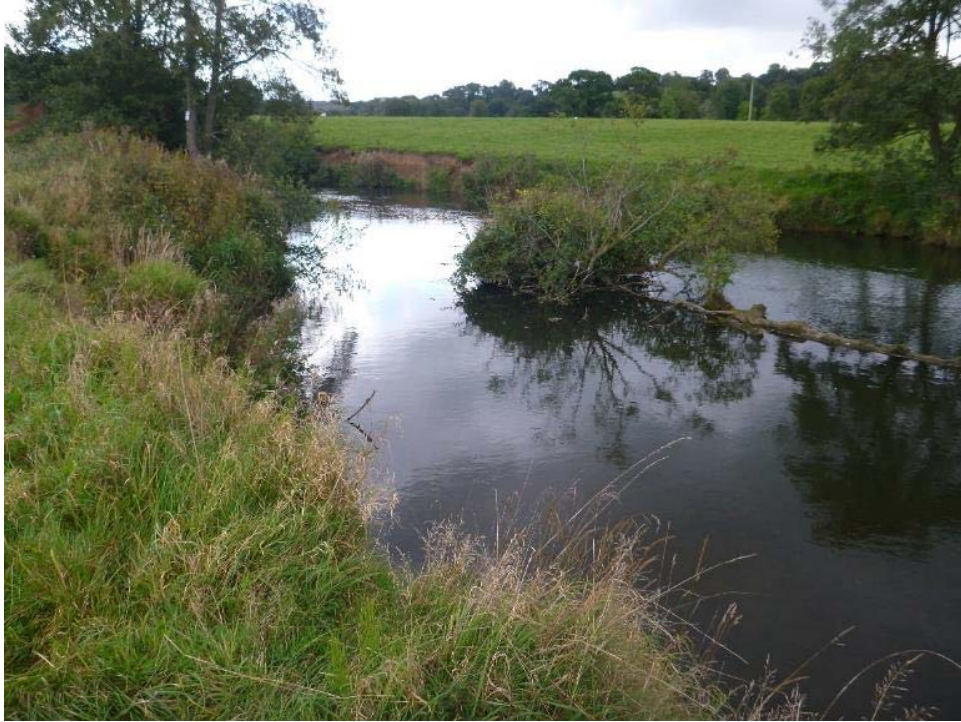
Photo 14 A fallen tree that has come to rest and stabilised in the river channel, creating a valuable refuge area for fish from predation. Features like this should be left in place (Medlock Flat).

- Leave fallen trees in the river to find their own stable position. Create access around these valuable habitat structures, rather than removing them to maintain existing access.

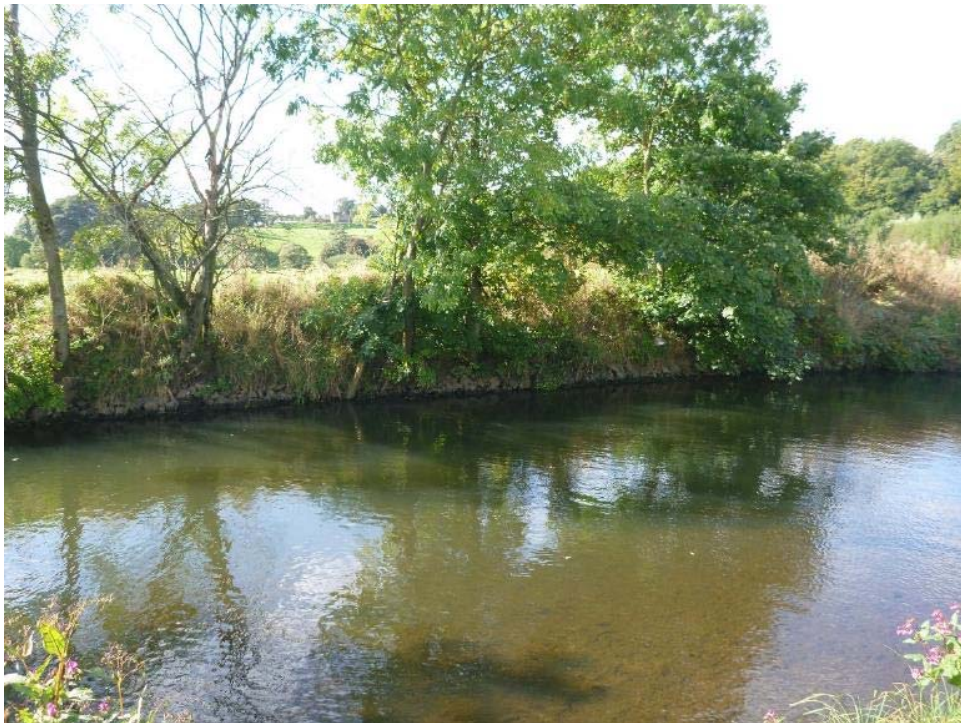
Photo 15 The stone toe of the bank provides stability, but there is limited fish holding cover. Partially cutting and laying trees along the far bank margin would improve the cover here (Stoat's Tail).

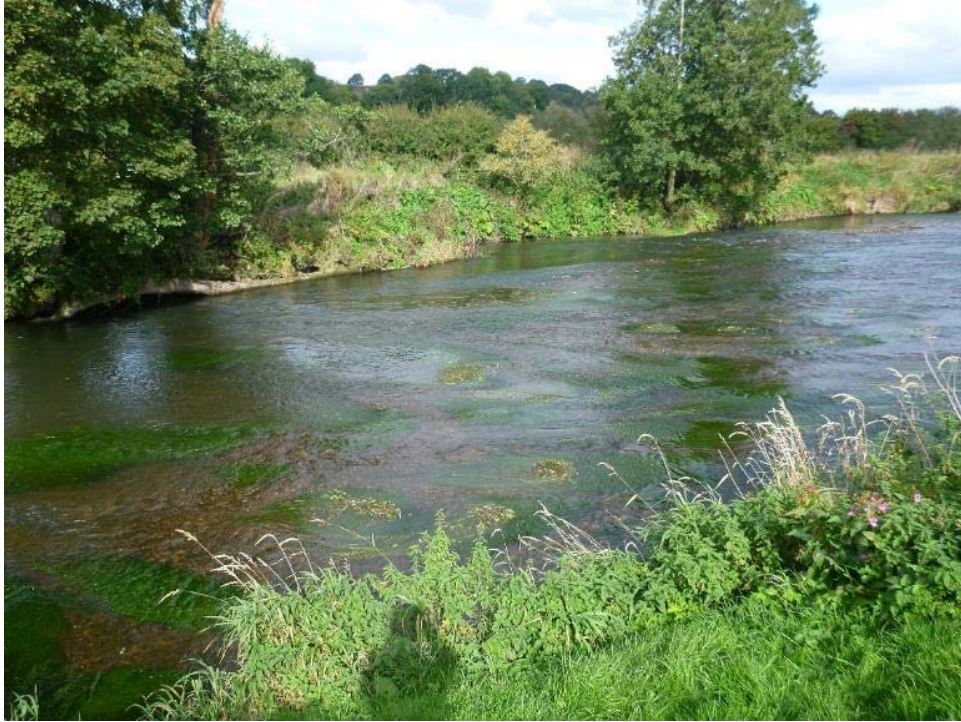
Photo 16 Good juvenile trout habitat is provided by the shallow, gravel run with plentiful water crowfoot in Middle Meadow. Water crowfoot cannot thrive within slow, impounded river sections.

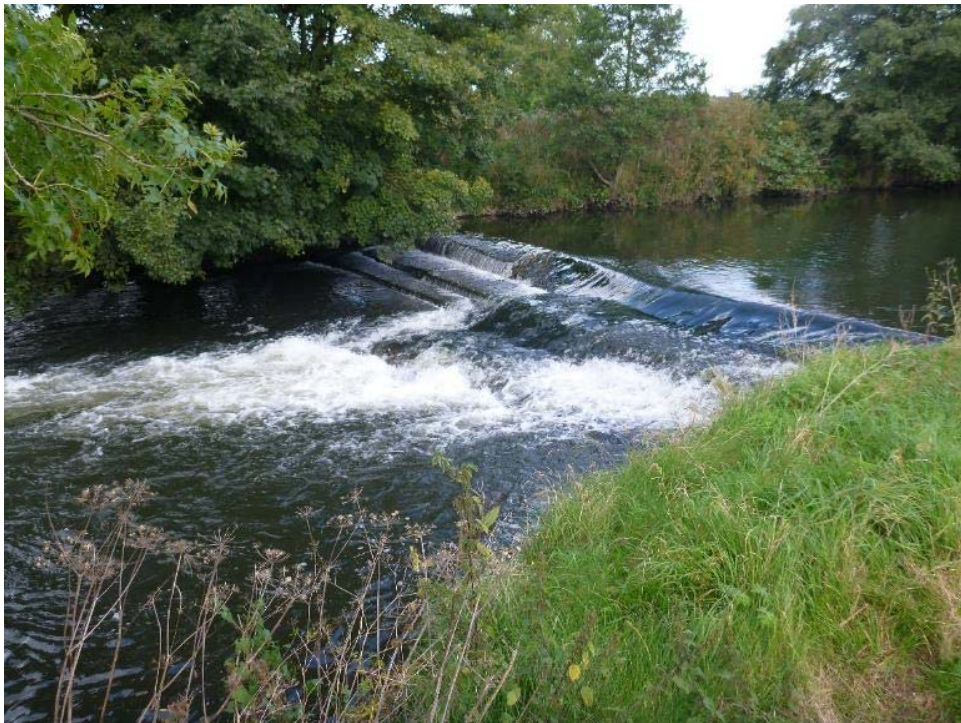
Photo 17 Gothard Weir has a negative impact on river habitat, impounding a reach upstream and promoting bank erosion downstream. Removal of this structure would greatly improve instream habitat and be relatively straightforward. The structure was originally installed by the club and there are no dependent abstractions upstream.

Early observations indicate that the small weir at Rivett's Pool and Gothard Weir would be the most straightforward to remove (noting the comments above about partial removal of the former). These projects are within the capabilities of the club with the support of WTT and it is recommended that these are taken forward. The experience gained could then be used in future to address the larger structures, with the help of suitable partner organisations.

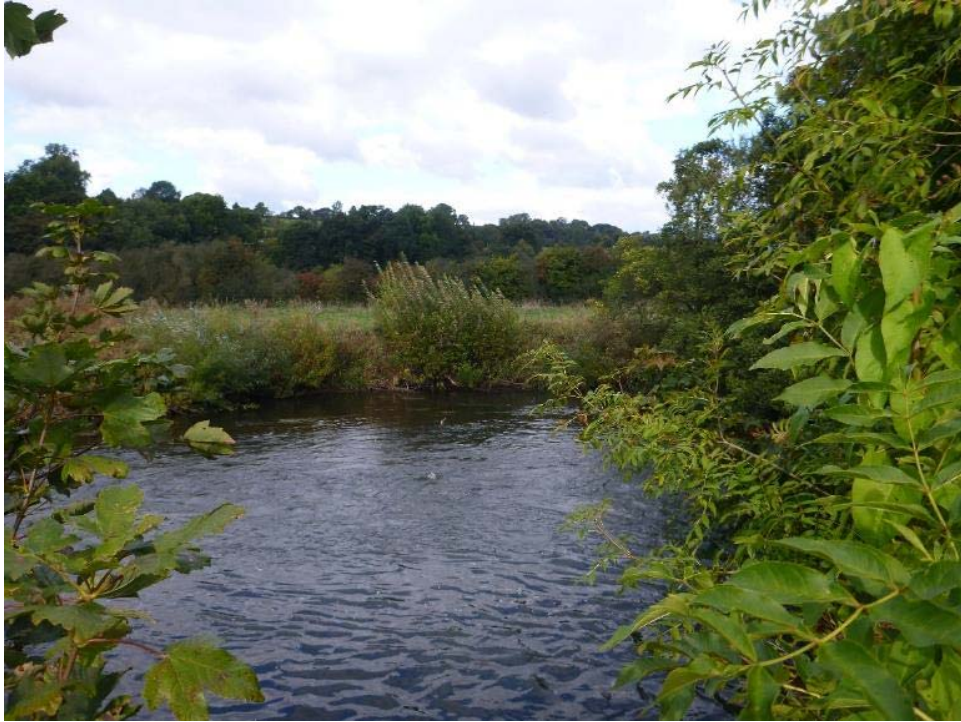
Photo 18 Downstream of Gothard Weir, the left bank erosion has stabilised following willow spiling and fencing works carried out in 2005 (see below).

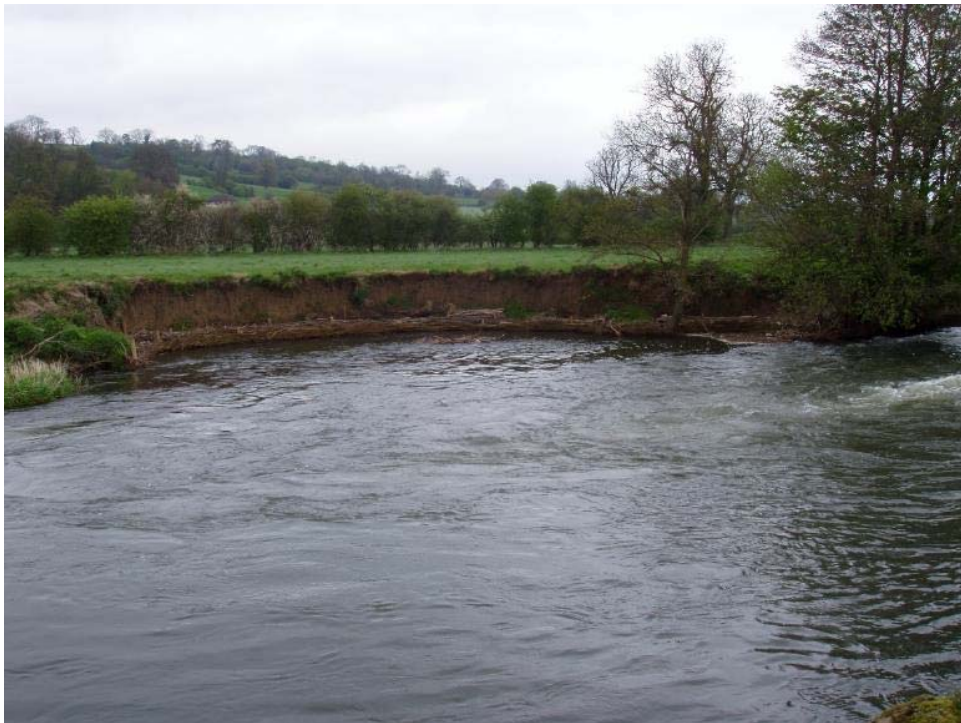
Photo 19 Same area as Photo 18, with newly installed willow spiling work, 28/04/2005.

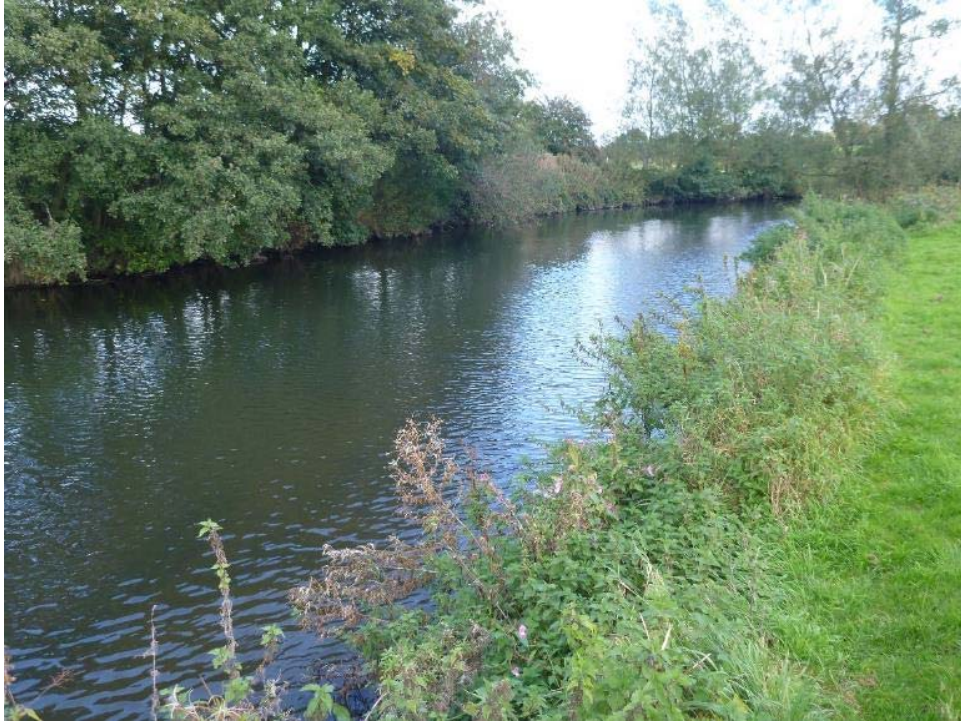
Photo 20 Impounded reach upstream of Gothard Weir

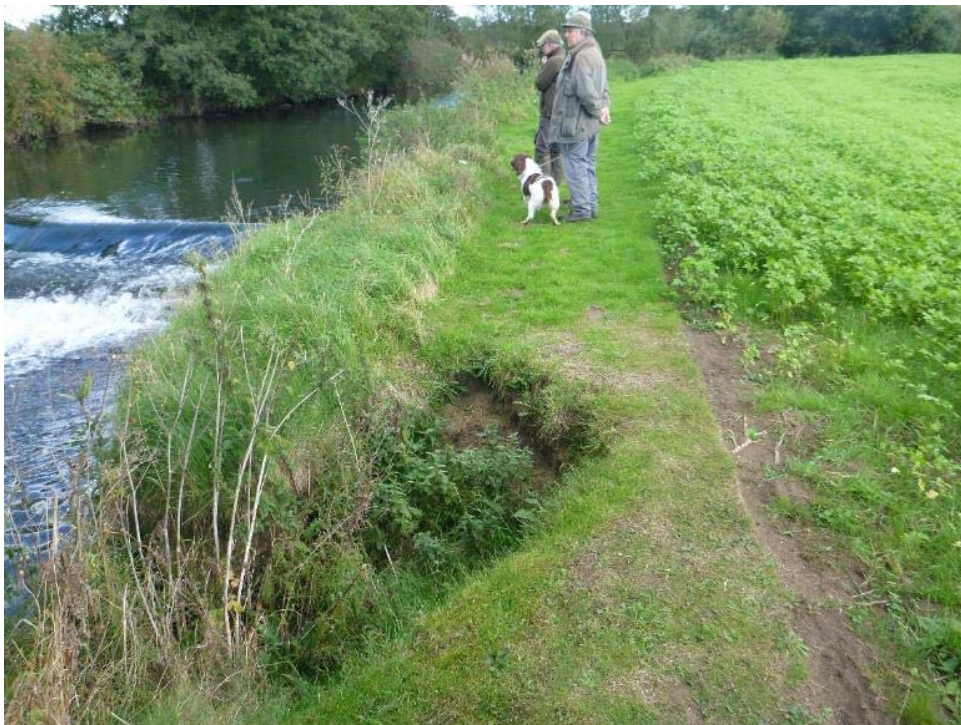
Photo 21 There is little room between the river and adjacent arable land near Gothard Weir. A buffer strip with tree planting would increase bank stability.

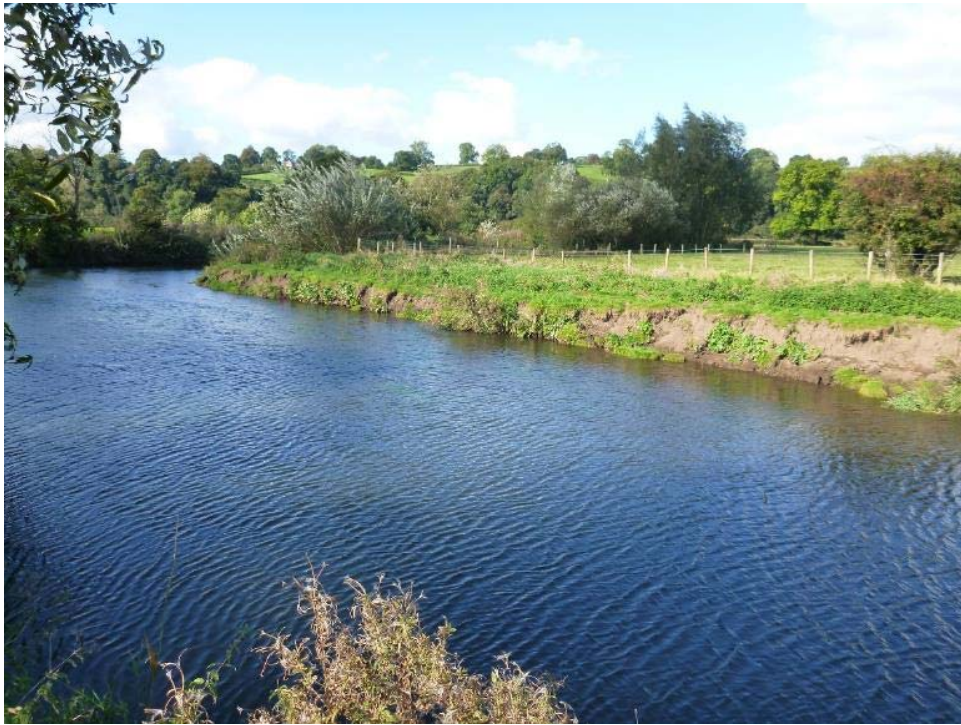
Photo 22 Anomalous bank erosion occurring on the inside of a bend (Lower Horseshoe). This area had willow spiling installed in 2005 (see below), but none is now evident; it is unclear why, although grazing seems most probable.
