Advisory Visit

River Dove

Birdsgrove Fly Fishing Club

October 2016

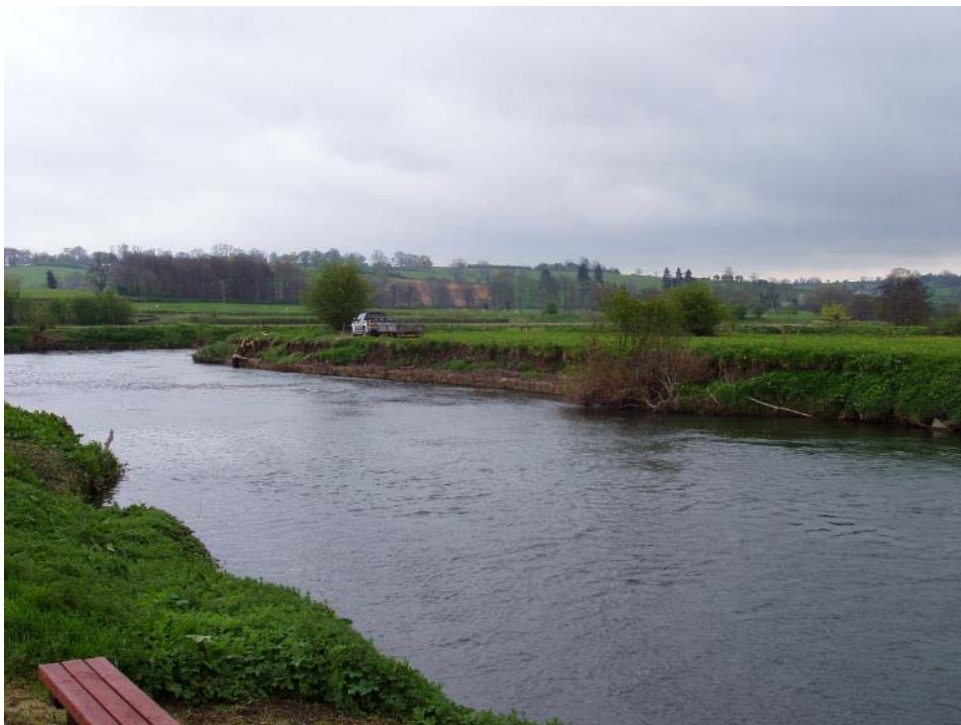
Photo 23 Same area as Photo 22, willow spiling being installed 28/04/2005

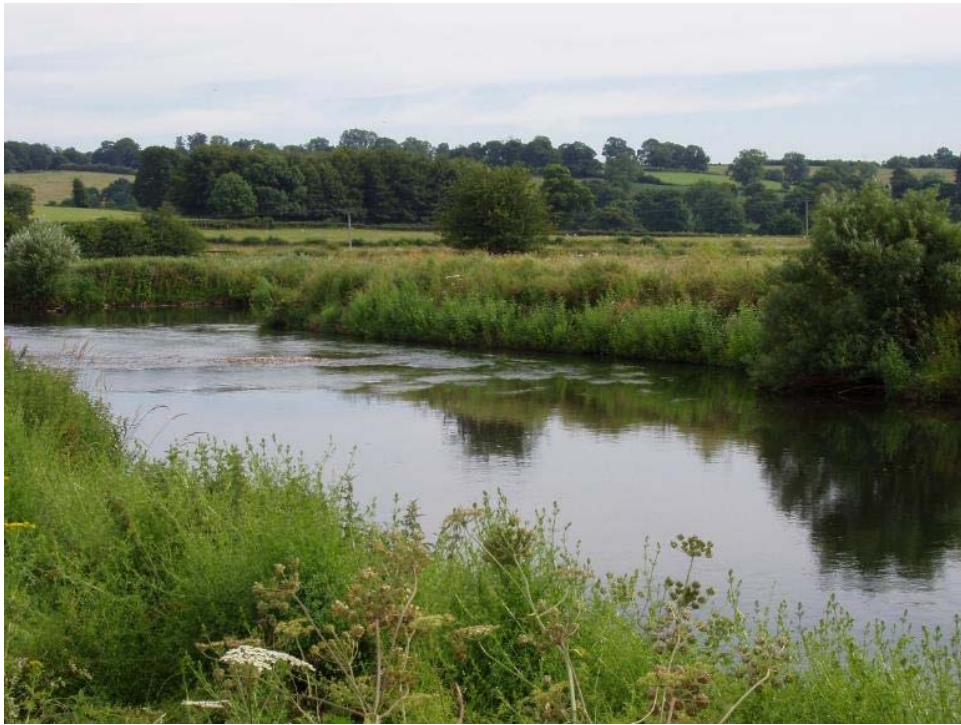
Photo 24 Same area as Photos 22 and 23, 13/07/2005.

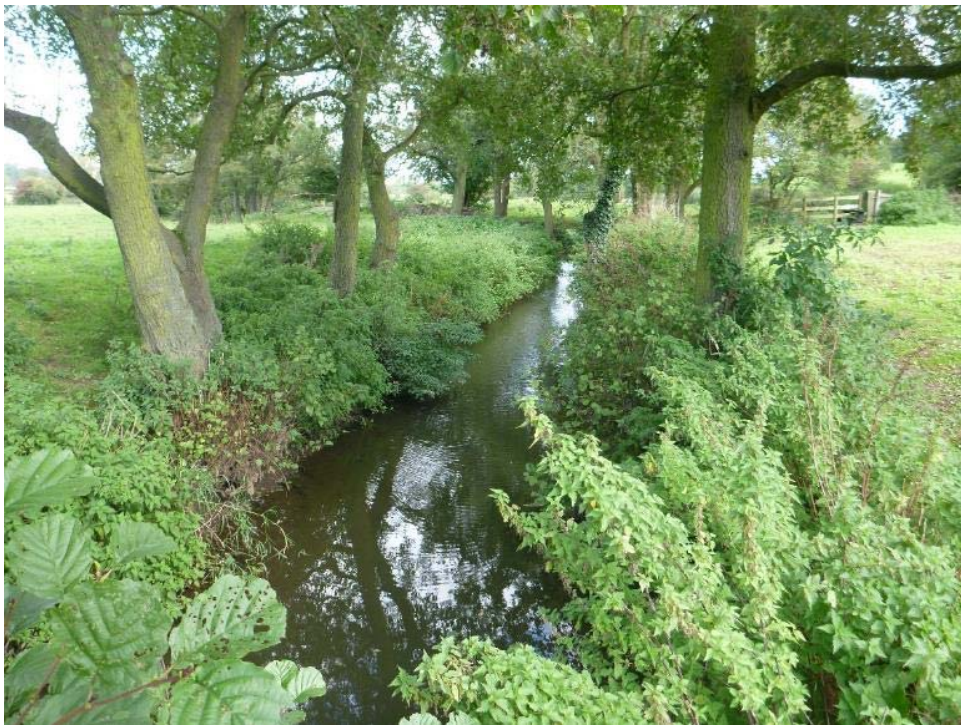
Photo 25 The downstream end of the mill leat which starts at Sidesmill Weir. The slow flow and flat gradient of this channel makes it poor habitat for trout and grayling.

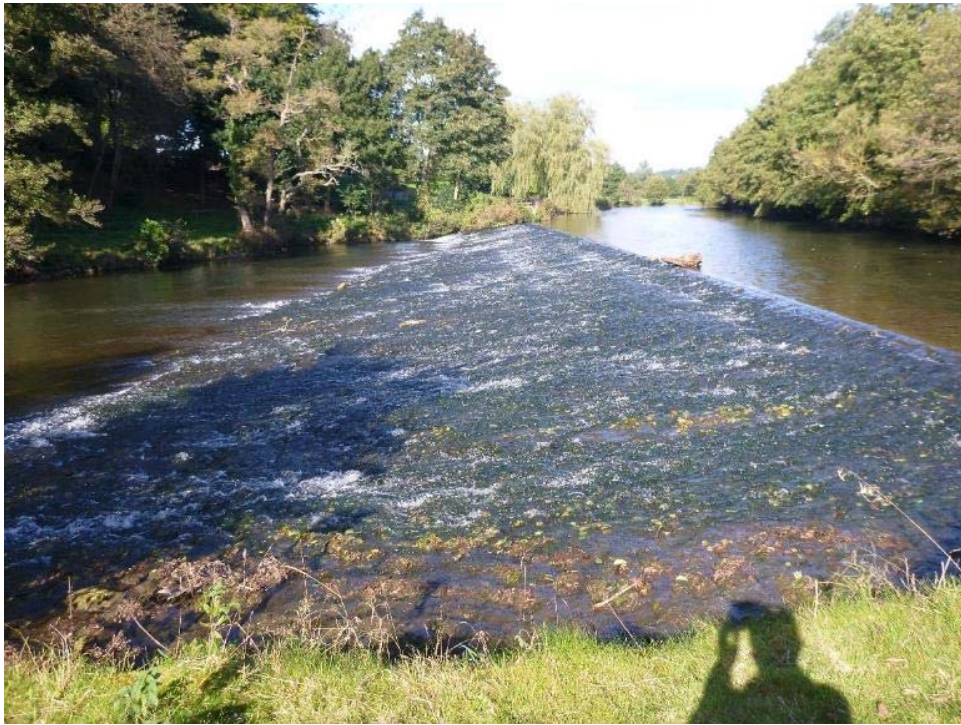
Hanging Bridge (carrying the A523 Ashbourne – Leek road) is sandwiched between two weirs, Corn Mill Weir downstream and Alrewas Weir upstream, with a mill leat running along the left bank. Alrewas Weir is a long-crested diagonal structure (Photo 26) which impounds the river upstream to approximately the confluence with the Bentley Brook, creating a wide, slow-flowing, ponded section (Photo 27). The negative aspects of weirs described above also apply here, but removal of these structures would be challenging given their proximity to the road bridge. Improving fish migration across the structures is however achievable and would improve connectivity between habitats, for example the southern beats and the spawning habitat available in the Bentley Brook (Photo 28).

Photo 26 Alrewas Weir, just upstream of Hanging Bridge.

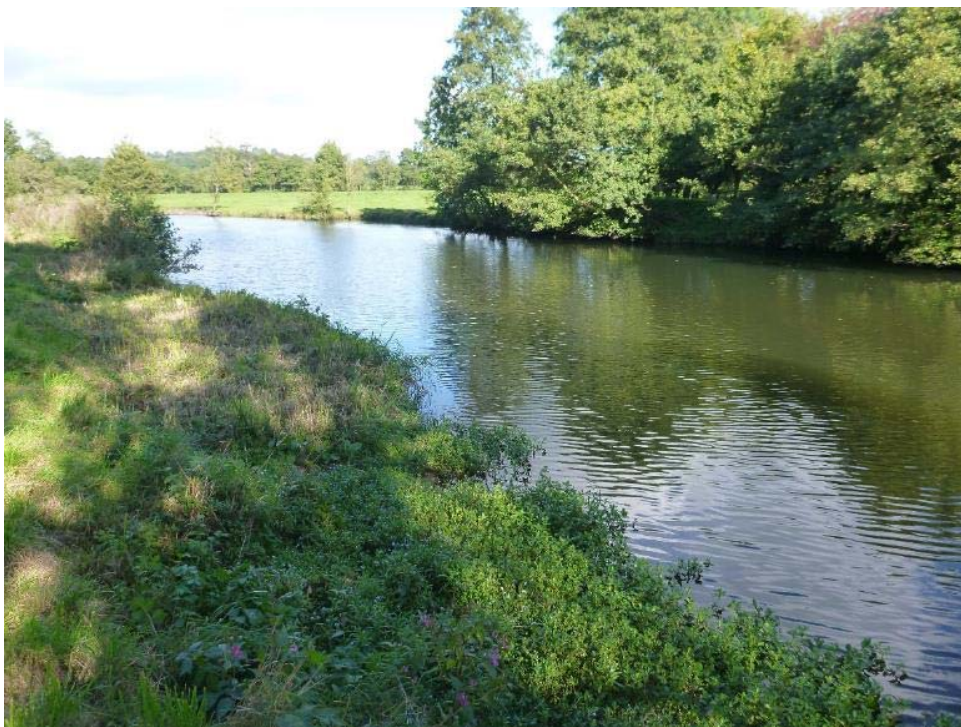
Photo 27 Impounded reach upstream of Alrewas Weir.

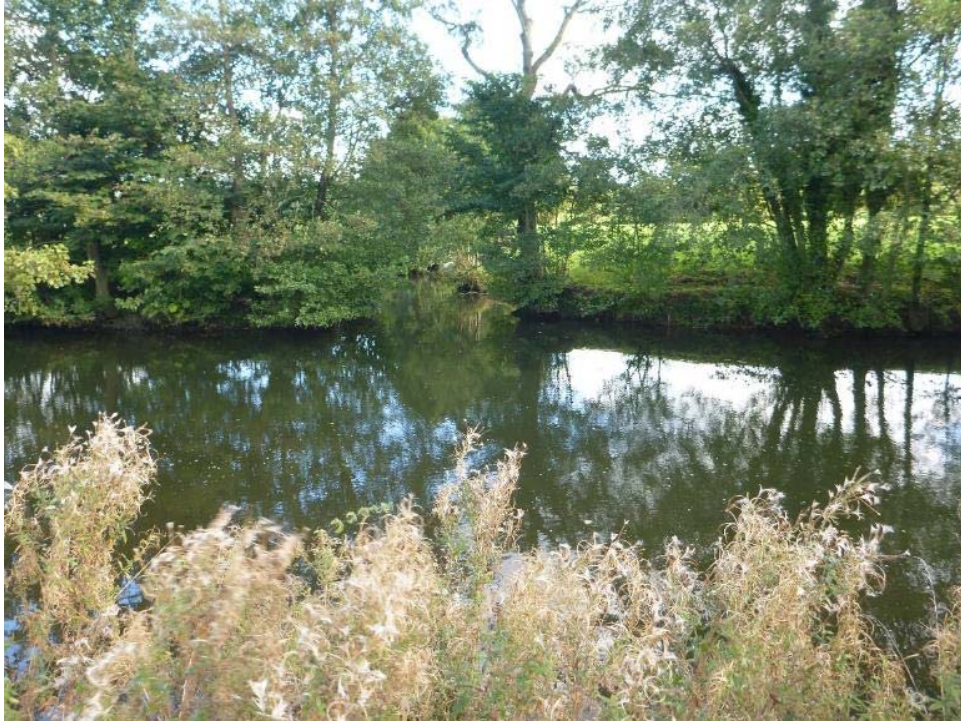
Photo 28 Bentley Brook confluence. Improving fish passage on the main river weirs would improve access to the spawning habitat available in this tributary.

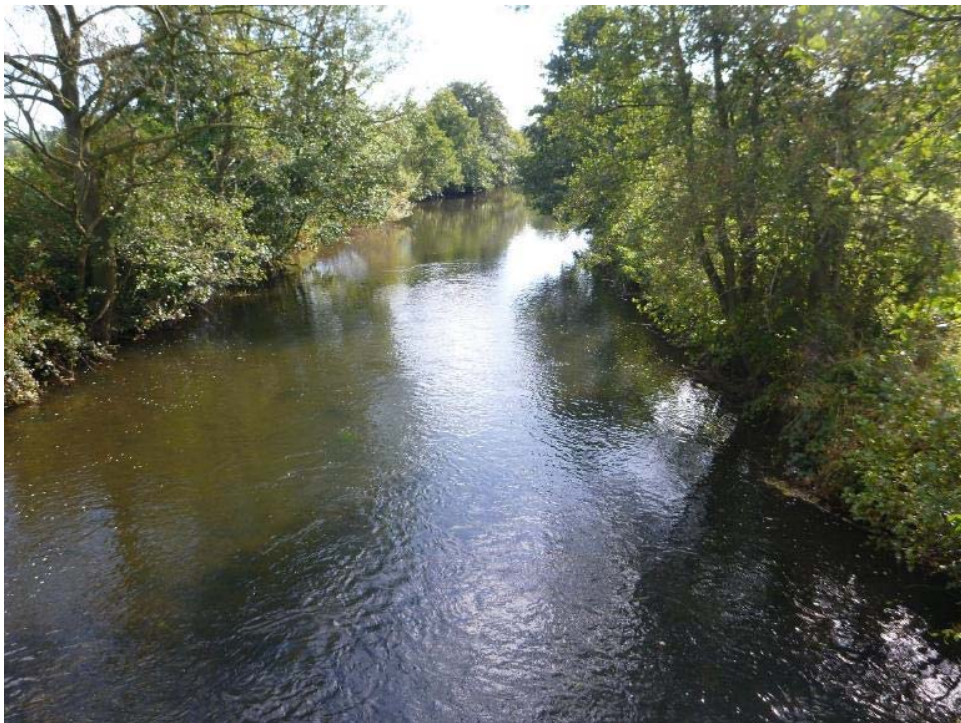
Photo 29 View downstream from Iron Bridge: a long, steady glide with good tree cover in the margins.

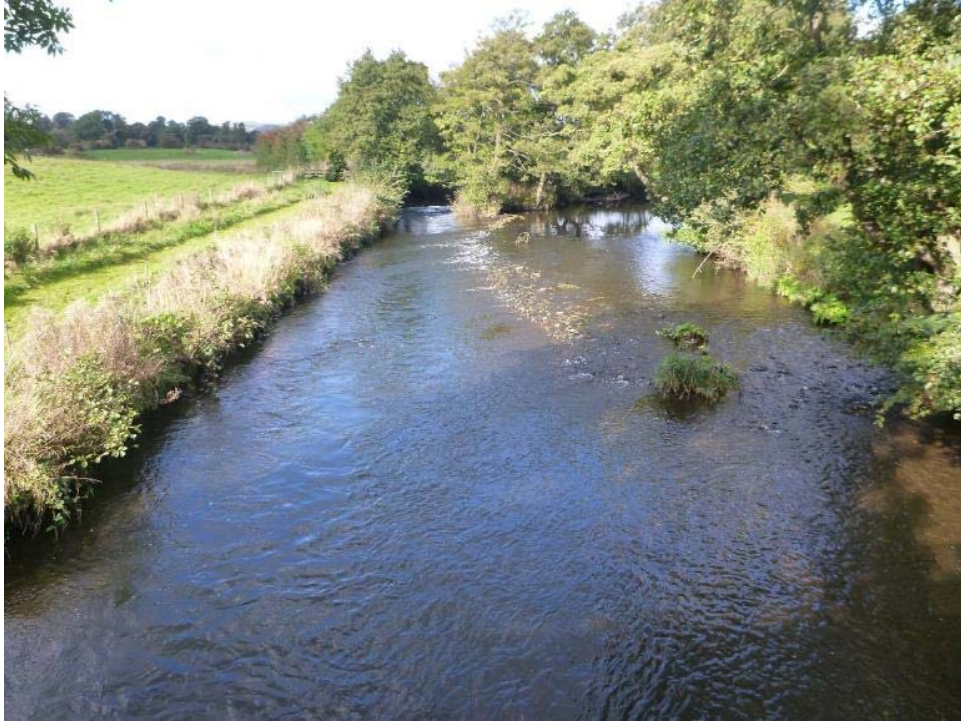
Photo 30 Upstream of Iron Bridge. Note the fan of coarse sediment which has been transported through the straight section upstream and deposited on the inside of the bend.

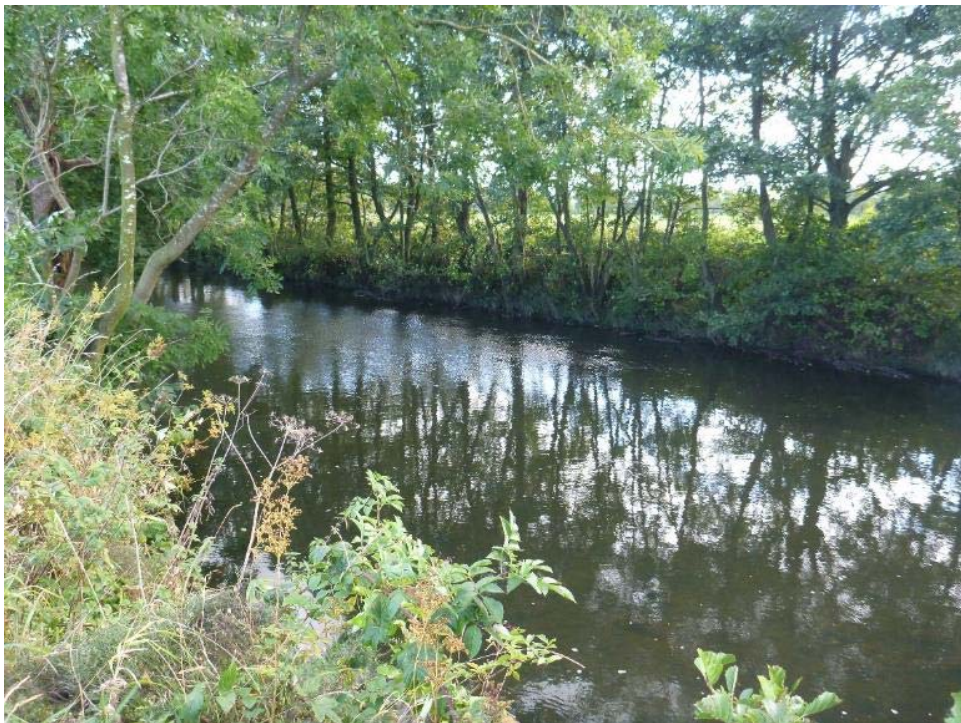
Upstream of Birdsgrove Farm Pool, the channel is artificially straight and of uniform width, the banks consisting of stone walls topped by trees (Photo 31). As noted above, the straightened (steepened) channel has more energy than a natural meandering channel; during high flows it will therefore tend to transport smaller gravels through the reach and have fewer areas of slack water where fish can shelter. There is a right-angled bend at Poacher's End where the energy of the river during high water is sufficiently low to allow gravel to be deposited on the inside of the bend, forming a riffle (Photo 32). Apart from this, glide habitat dominates this section.

Photo 31 Upstream of Birdsgrove Farm Pool, a typical straightened, walled section of channel lined by trees. Plenty of opportunity to partially cut and lay some trees into the margins, taking care not to improve access for cormorants. Laying is recommended on the outside of the main flow for cover (not necessarily into the channel) and laying down to the bed on the inside of the main flow to improve channel morphology (retain substrate).

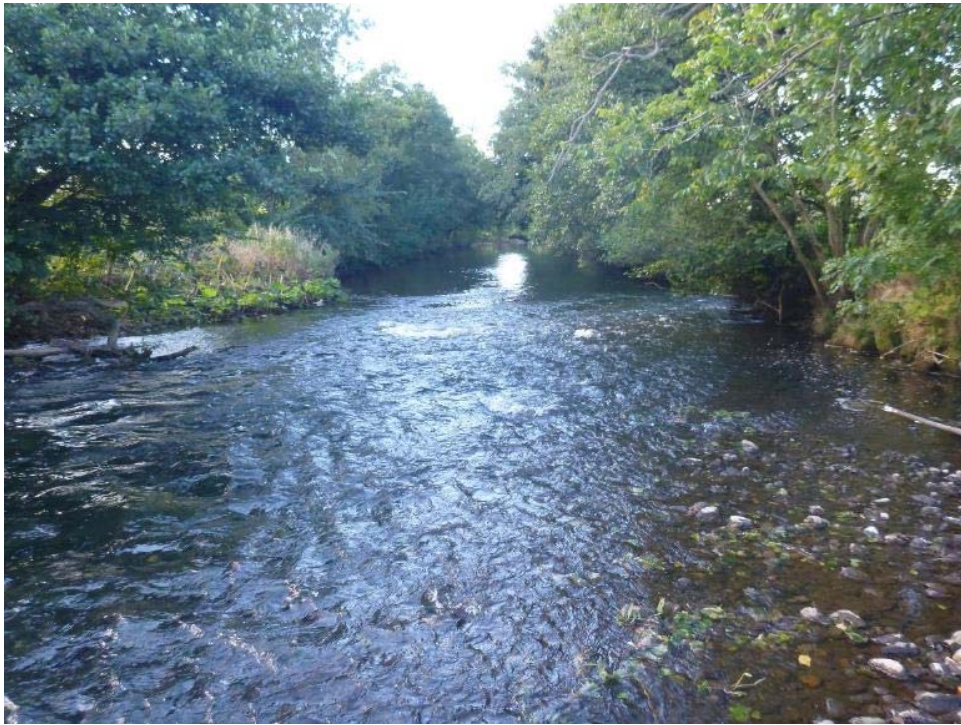
Photo 32 Looking downstream from Poacher's End, a rare riffle formed where gravel has been deposited on the inside of the bend.

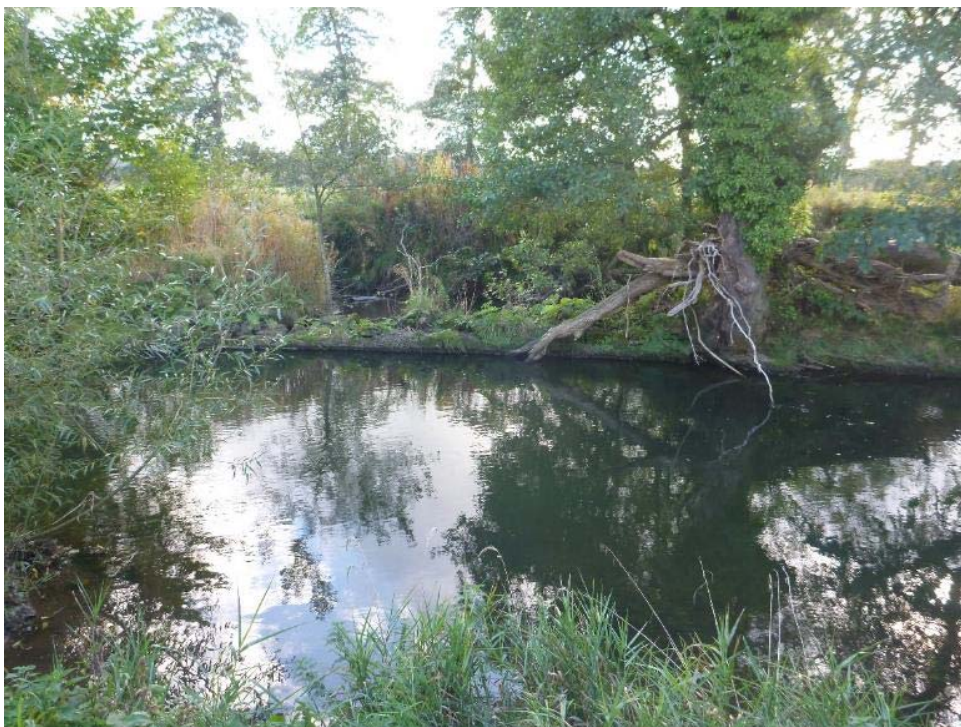
There are a couple of areas where the walled banks have failed, creating backwaters that connect to the main channel during higher flows (Photo 33). These provide some valuable diversity and refuge areas for smaller fish (particularly grayling fry) during floods. These areas should be retained.

Photo 33 Where the bankside wall has crumbled, some valuable habitat diversity is created.

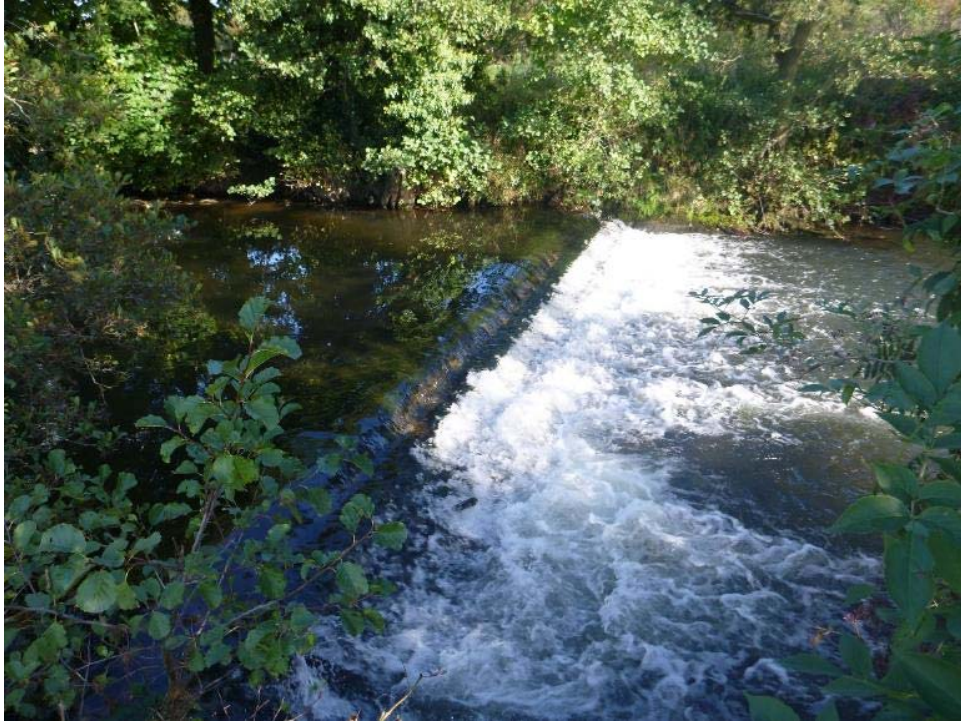
There is a low weir at Rivett's Pool which is impounding sediment upstream and impeding fish migration (Photos 34, 35). Given the artificial nature of this reach and its increased capacity for transporting coarser sediment, it may be better to just partially remove or notch this weir with the aim of reducing the impounding effect, but retaining enough flow diversity to retain smaller gravels for improved spawning opportunities.

Photo 34 Weir near Rivett's Pool

Early observations indicate that the small weir at Rivett's Pool and Gothard Weir would be the most straightforward to remove (noting the comments above about partial removal of the former). These projects are within the capabilities of the club with the support of WTT and it is recommended that these are taken forward. The experience gained could then be used in future to address the larger structures, with the help of suitable partner organisations.

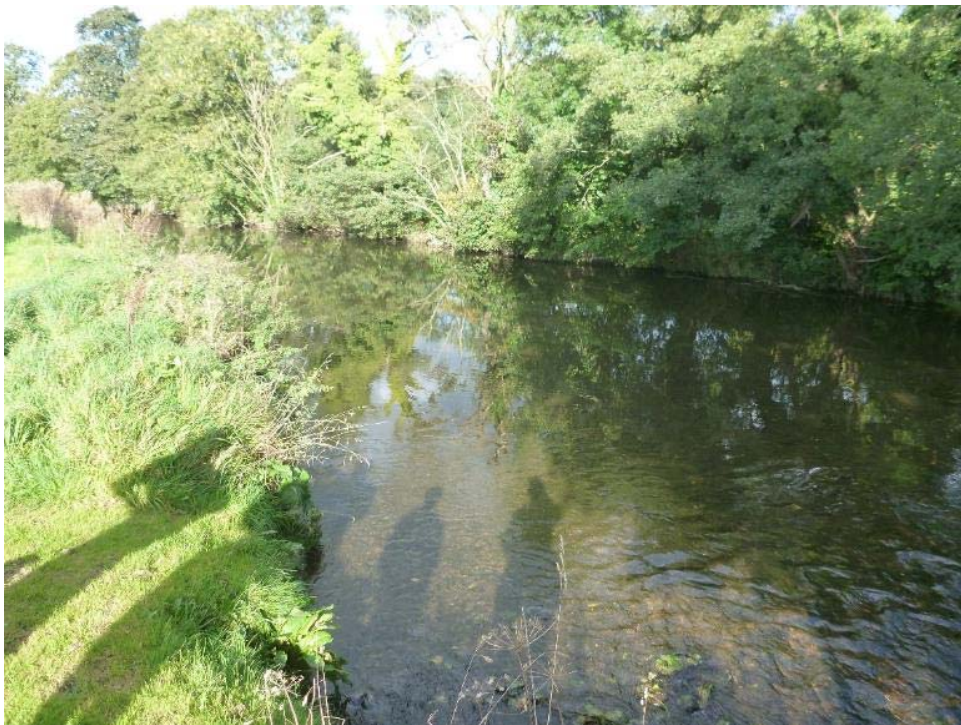
Photo 35 Shallow, impounded section above weir in Photo 34.

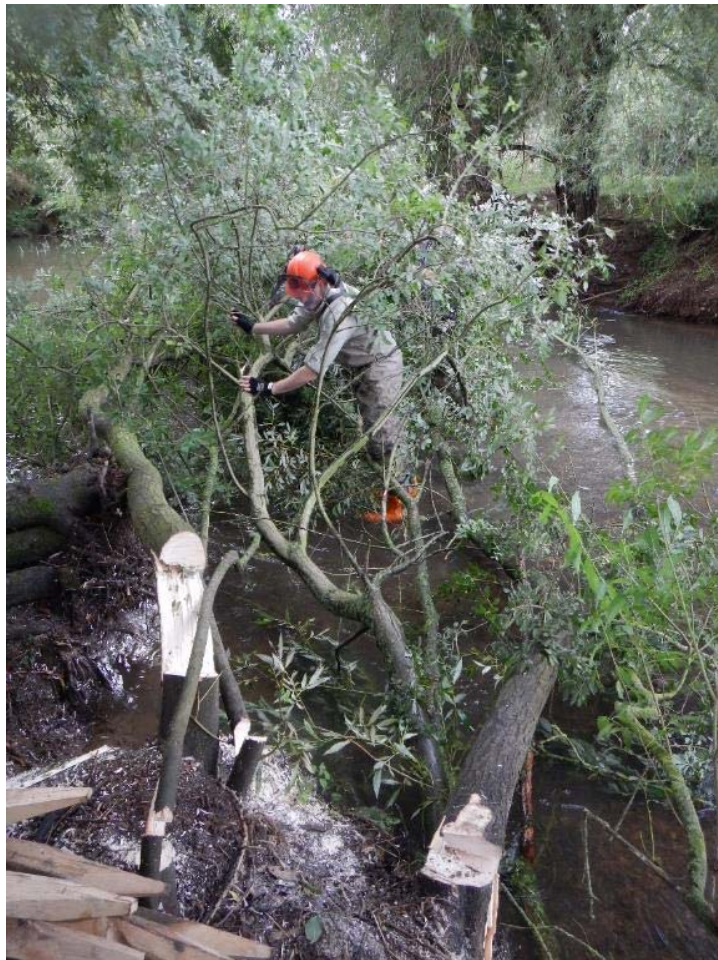
Photo 36 Willow limbs laid into a river margin to provide cover and in-channel structure.

- Introduce cover to the river by partially cutting and laying suitable trees into the margins (in the manner of hedge laying), or by felling and cabling larger trees to their stumps ("tree kickers"). Ensure that this is not denuding the river bank of tree cover and easing access for fish-eating birds (Photos 36 – 38).

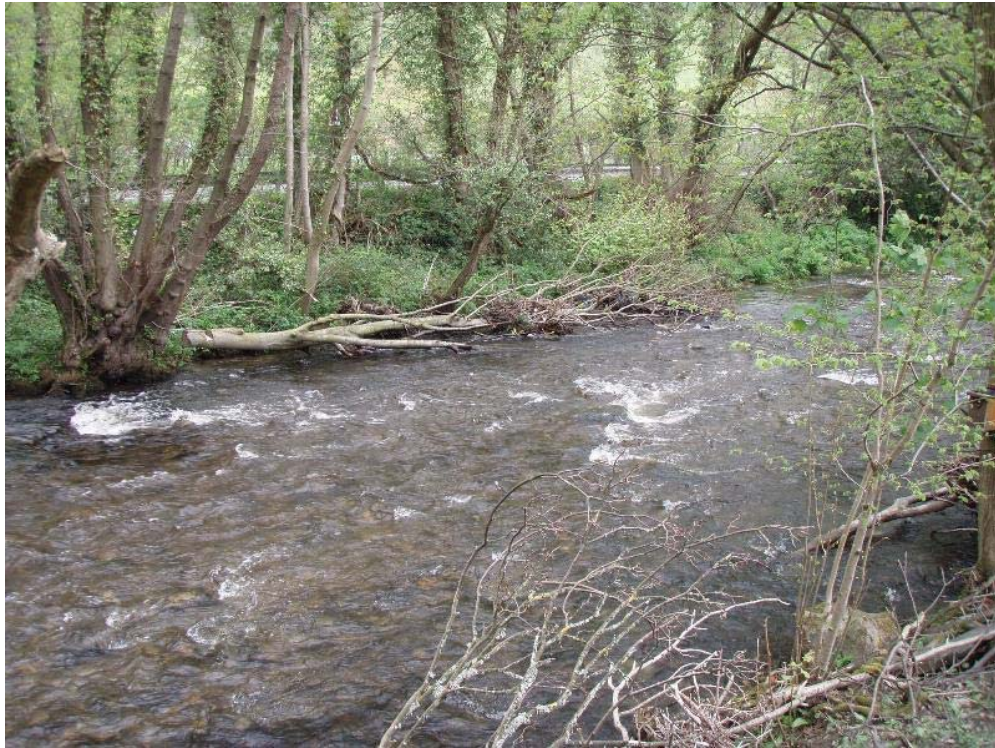
Photo 37 A tree kicker installed on the Afon Ceiriog, Wales, provides a good refuge area for fish from predatory birds..

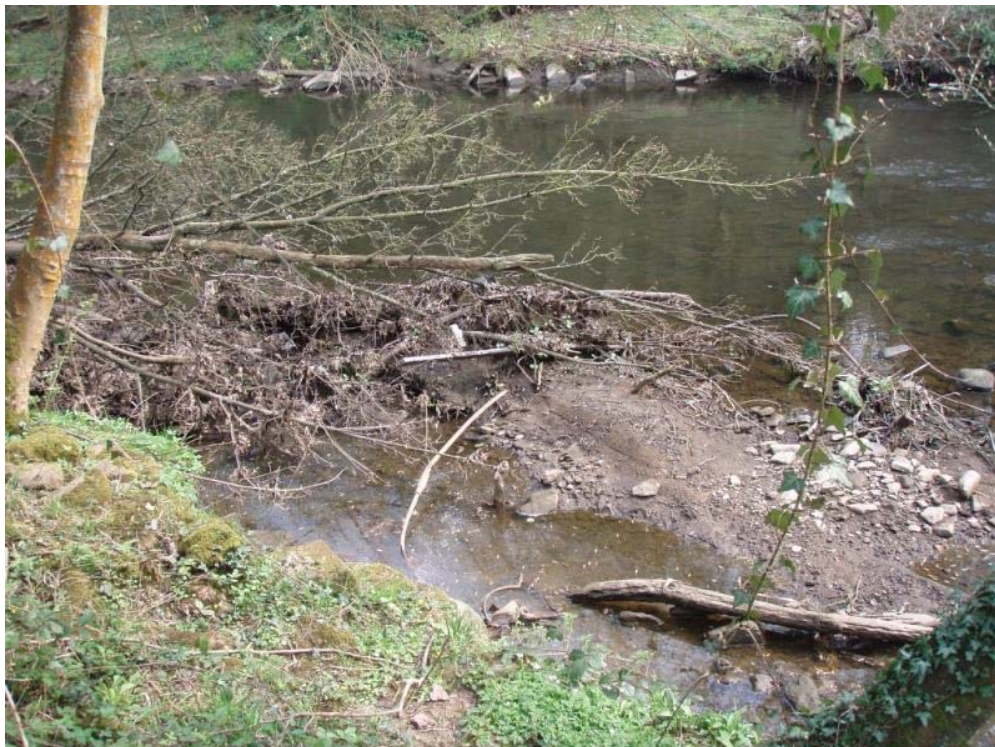
Photo 38 An example of finer sediment deposition in the lee of a tree kicker with channel deepening beyond.
