**Advisory Visit**

**River Dove, Ludwell Farm**

**19<sup>th</sup> June, 2010**

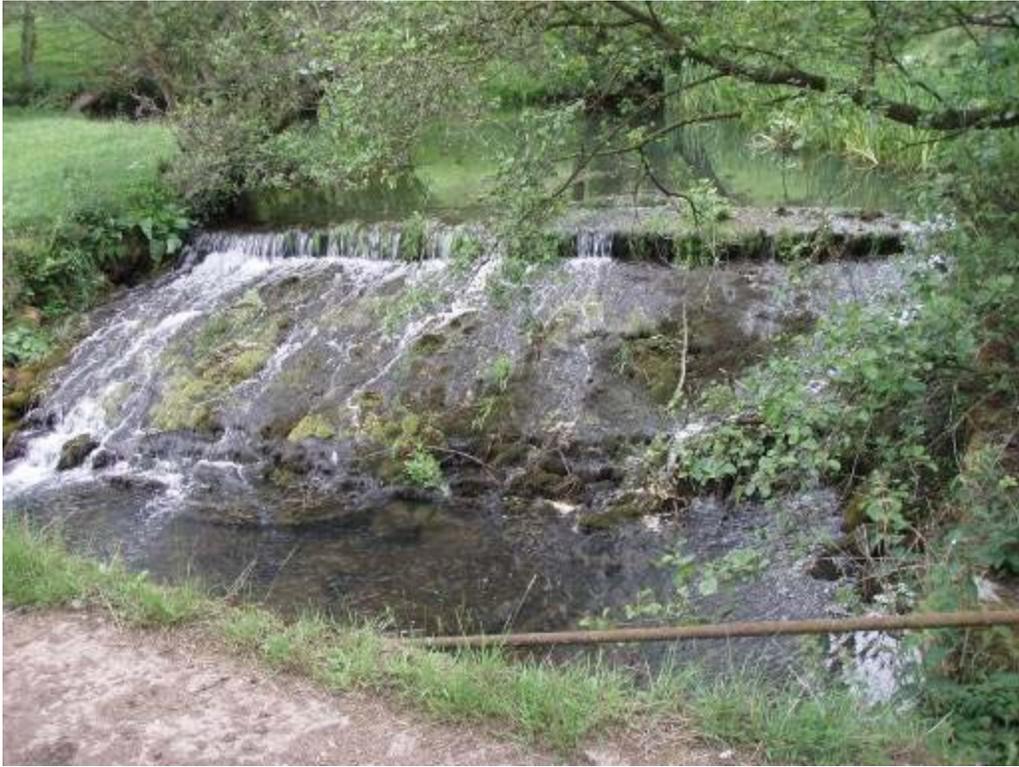
The river is impounded by a weir adjacent to Ludwell Farm. Head loss over the weir is approximately 2 m, with the upstream channel width some 4-5m. The backwater effect of this structure affects approximately 350m of the river upstream, with a significant detrimental impact on in-stream habitat; flow velocity is low, the depth generally shallow and the bed covered with deposits of fine sediment. The weir is also a considerable barrier to the free movement of fish such as trout and grayling which need to access different habitats at different times in their life cycle; for example, spawning, feeding, refuge and over-wintering habitat.

**Photo 1 Weir adjacent to Ludwell Farm**

- The greatest influence on this section of the river is the weir at Ludwell Farm. It is recommended that this structure is removed and the river upstream allowed to re-grade. The accumulation of fine sediment upstream of the weir is a potential problem, and releasing it in one go by removing the weir could affect downstream sections of river. It is recommended that the removal is done in stages, lowering the crest of the weir by about one third of its height each year over three years, until the natural bed level is reached.

Large woody debris structures should be installed in the channel upstream of the weir to moderate the effect of its lowering; these should provide checks to slow the re-grading of the river bed.

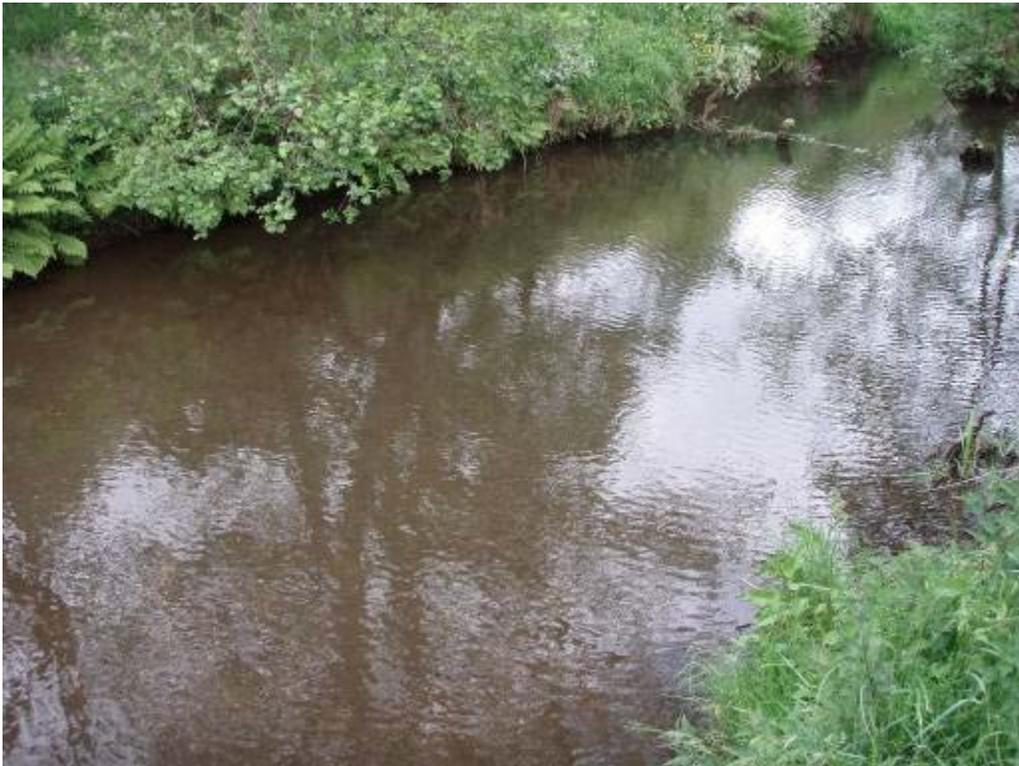
**Photo 2 The impounding effect of the weir produces a slow-flowing, shallow, silty channel for a considerable distance upstream – not good habitat**

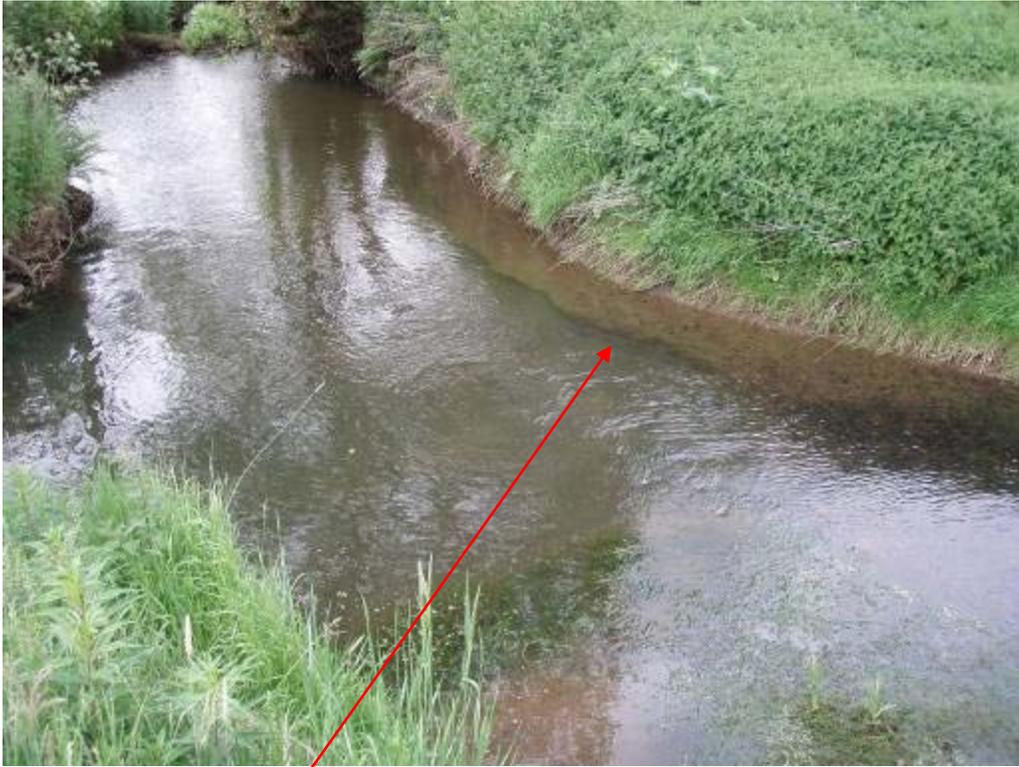
As the backwater effect of the weir diminishes with progress upstream, a pool-riffle sequence occurs and the true nature of the river bed can be observed (Photos 3, 4). The hard bed is composed largely of unsorted alluvial shale gravel, with a large volume of entrained fine sediment present (Photo 5). The river is moderately shaded by riparian trees, particularly alder *Alnus glutinosa*, the submerged root structures of which provide valuable refuge habitat for fish (Photo 4). Many of the alder trees had infections of the mould *Phytophthora*, with some trees in the advance stages of die back.

**Photo 3** The accumulated fine sediments as a result of the weir can be seen at the point where the backwater effect diminishes – a shelf of sediments is visible where the river is cutting down into them.

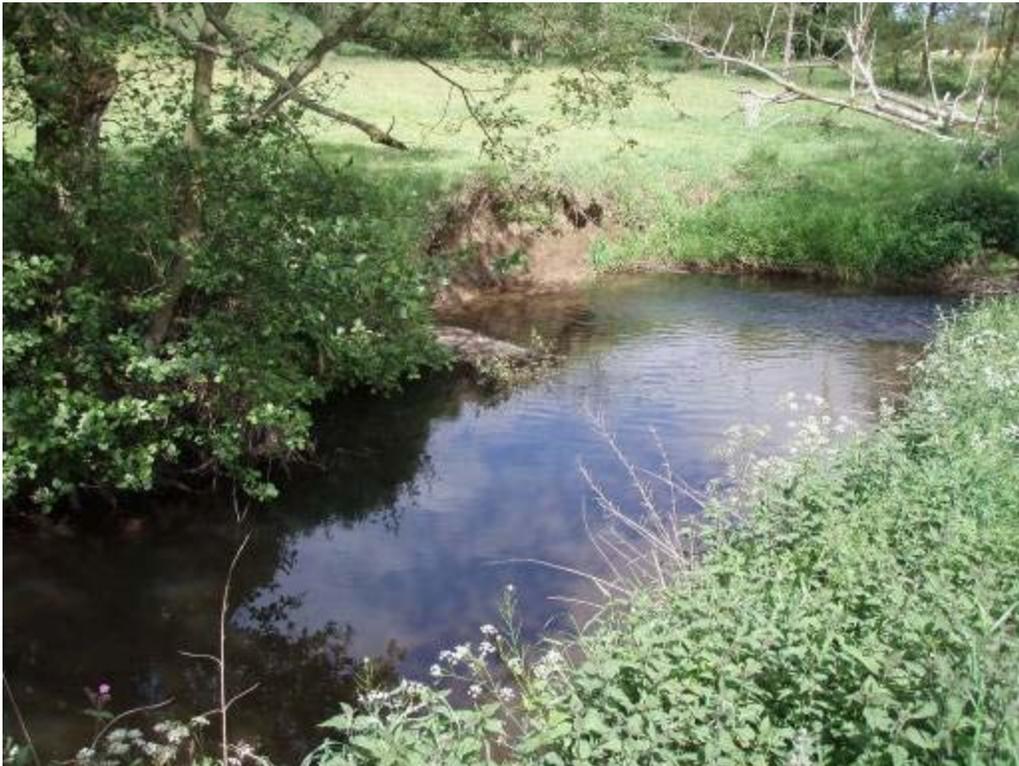
**Photo 4** Further upstream, beyond the backwater effect of the weir, more natural river habitats are evident which favour wild trout, such as riffles and pools with submerged cover like alder roots.

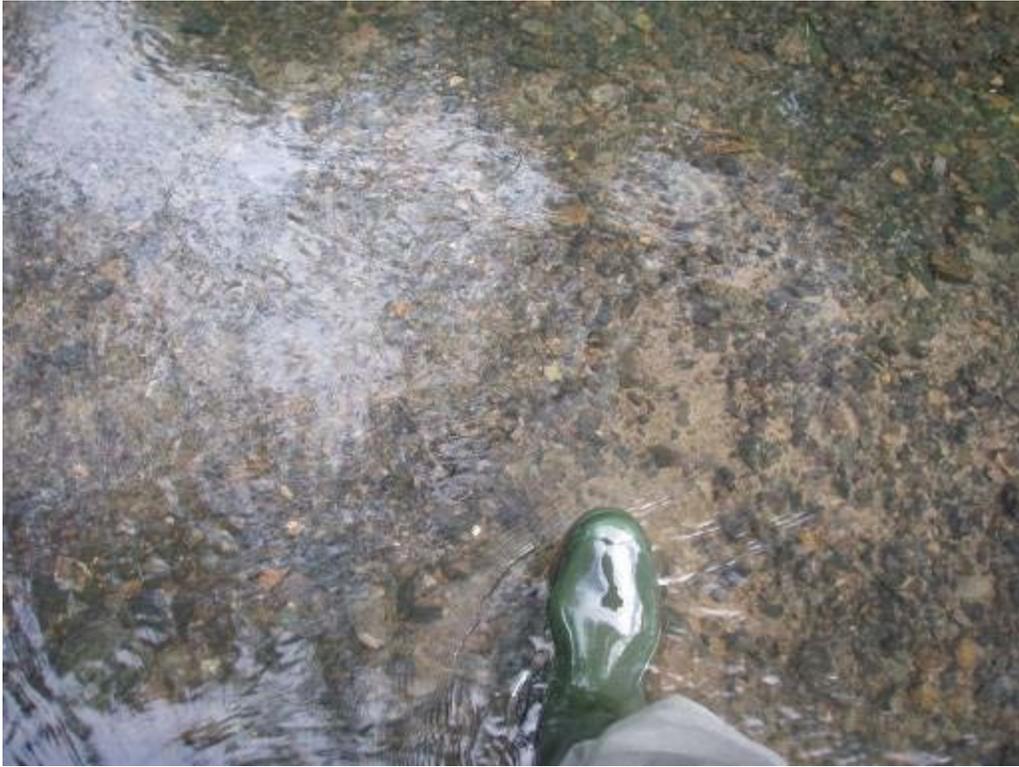
**Photo 5** On riffles, the river bed is comprised of fine shale and gritstone gravel, but with high levels of entrained fine sediment

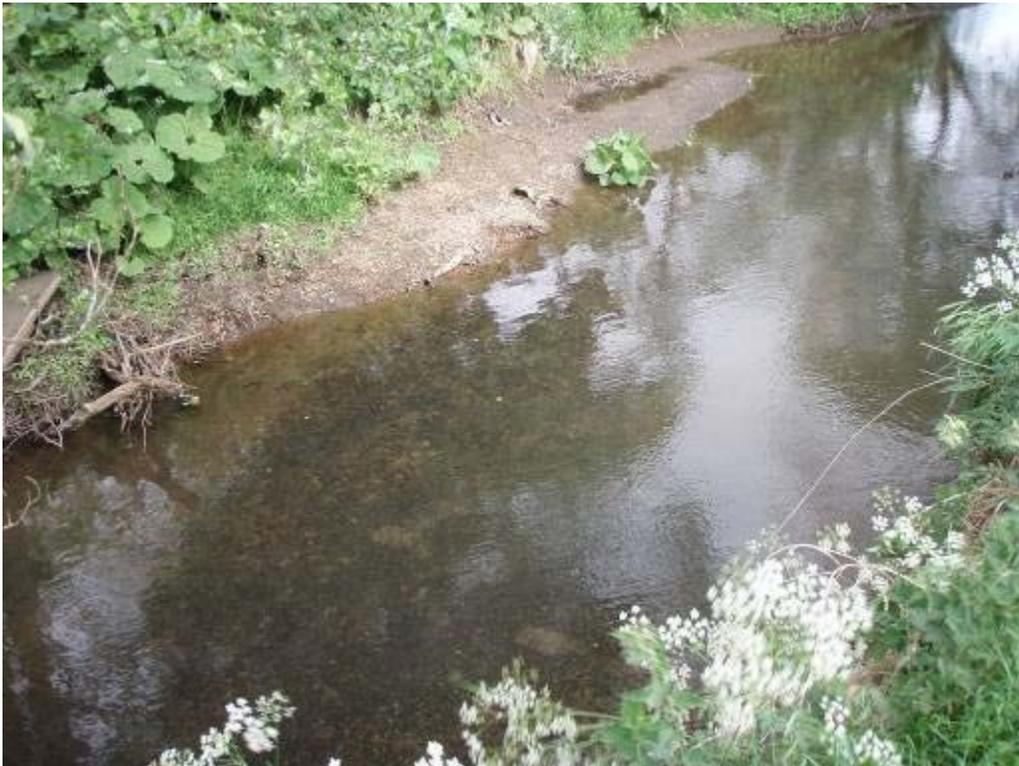
Where the grazing is less intensive, the banks of the Dove are well vegetated; there is some excellent riverside vegetation in places, including wet, spongy margins with wetland plants (Photos 9, 10). Beyond the influence of the weir, good examples of the rivers response to geomorphological processes are apparent, including well developed pool-riffle sequences, the presence of un-vegetated point bars and a meandering planform. Despite this, riffle areas remain relatively uniform, with imbedded, poorly sorted gravel dominating the substrate which does not favour successful trout spawning (Photo 6). The undifferentiated nature of

**Photo 6** Point bars and riffles tend to be relatively unsorted, fine shale which is not conducive to good spawning for trout or grayling.

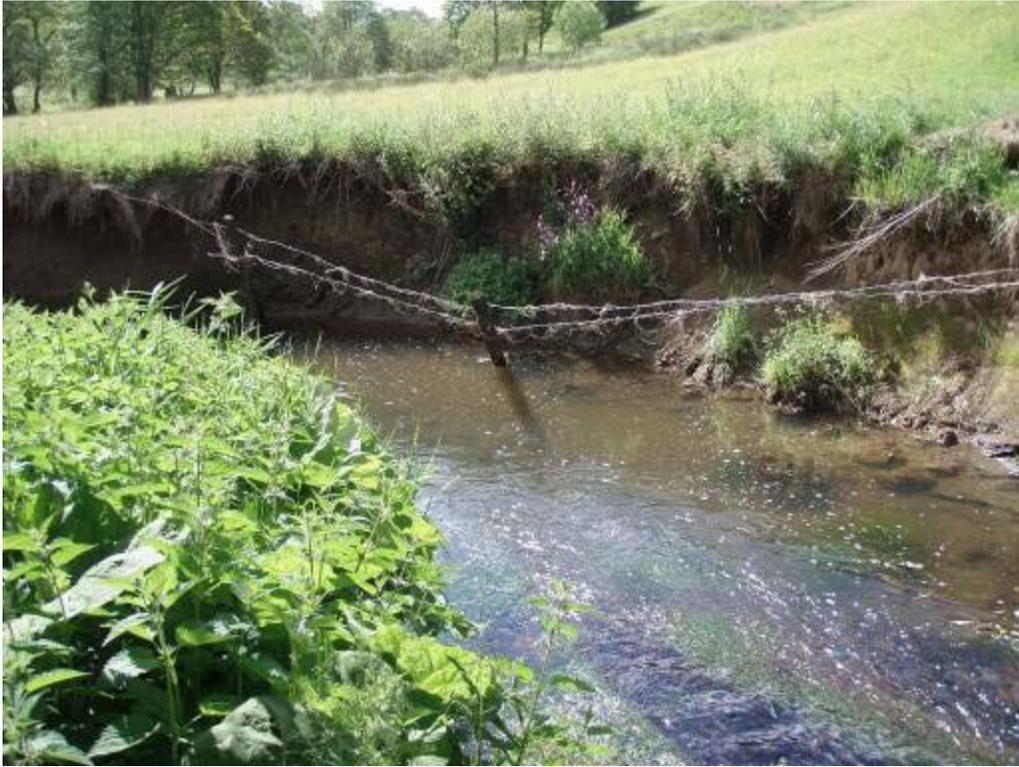
Further upstream, there is overgrazing of sections of the river by livestock. This has caused the loss of valuable fringing vegetation, and localised erosion of the riverbank. In some locations, previously erected fences are now redundant due to localised erosion. It is likely that these fences were erected too close to the water's edge in order to maximise the area of grazing land; as a consequence, the development of coarse vegetation with strong root systems, capable of binding banks together, has not been possible (Photo 7).

**Photo 7** In some areas an insufficient margin has been left between stock fences and the river, resulting in grazing pressure exacerbating erosion and the loss of the fence.

The use of soft bank revetment techniques is recommended for areas where bank erosion is occurring (e.g. Photo 7). These techniques have been used successfully on the River Manifold and have also

provided valuable marginal cover, promoting a notable increase in the numbers of small trout. Ideally these techniques should be carried out in conjunction with riparian fencing to stabilise the river bank and prevent livestock damage.

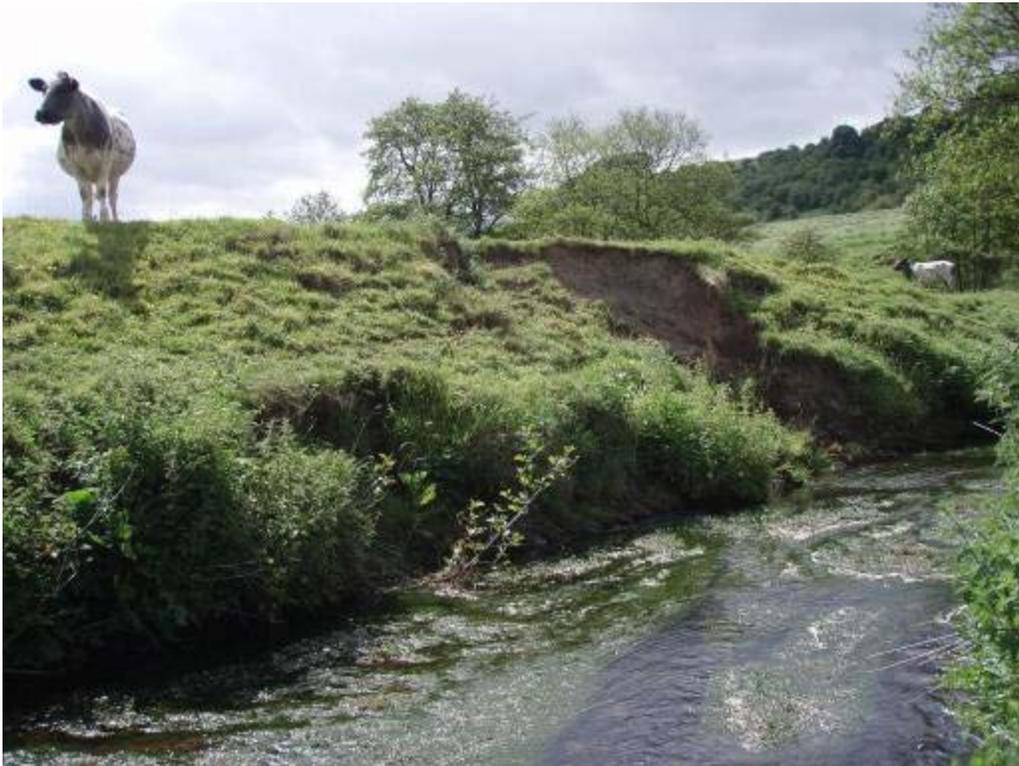
There are one or two areas with better gravel substrates which are more suitable for spawning. These should be protected from livestock access; there is evidence of this starting to occur on one of the best examples (Photo 8).

**Photo 8** A relatively rare (for this stretch) good riffle habitat is threatened by livestock access from the left bank.

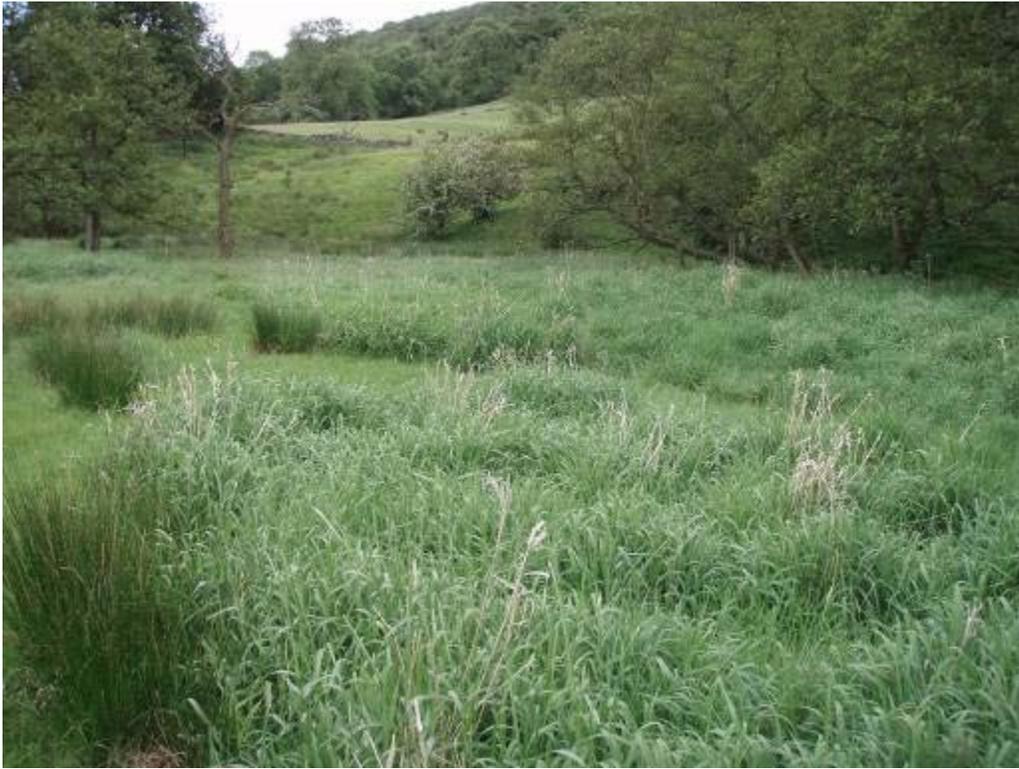
**Photo 9** A superb example of how sensitive land use produces an excellent riparian zone alongside the river which consolidates the banks, provides fringing vegetation cover, protects water quality from run-off from the land, and buffers flows by acting as a “sponge”.

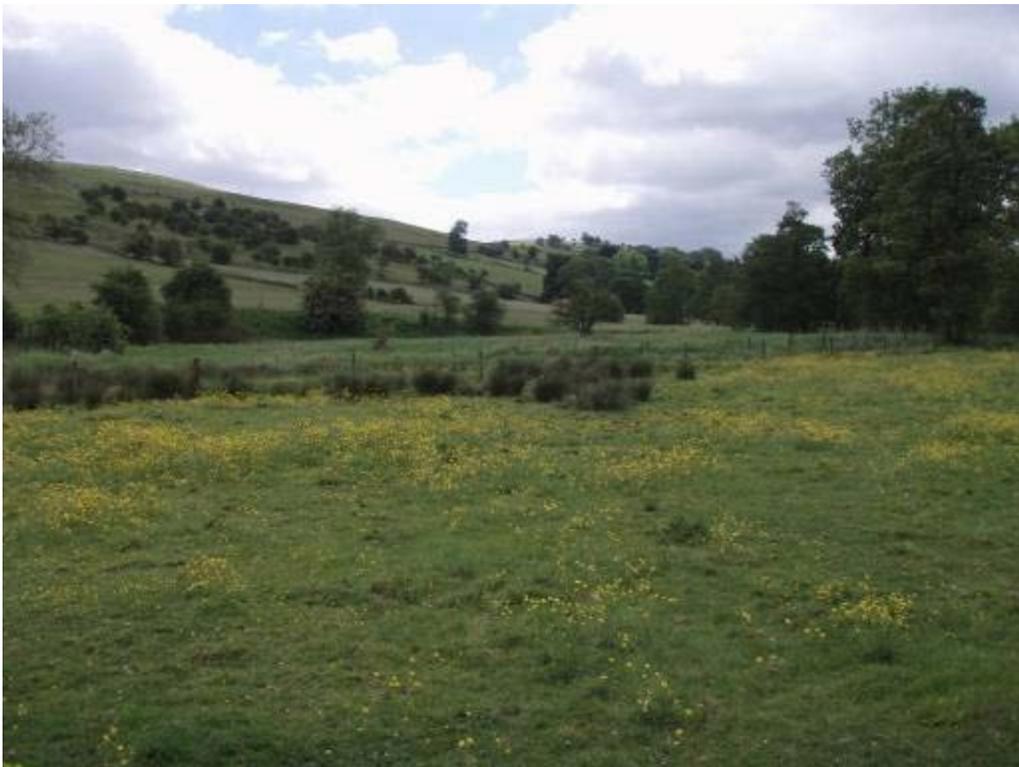
**Photo 10** A wet flush at the base of the valley slope provides some excellent riparian habitat and contrasts with the grazed field in the foreground.

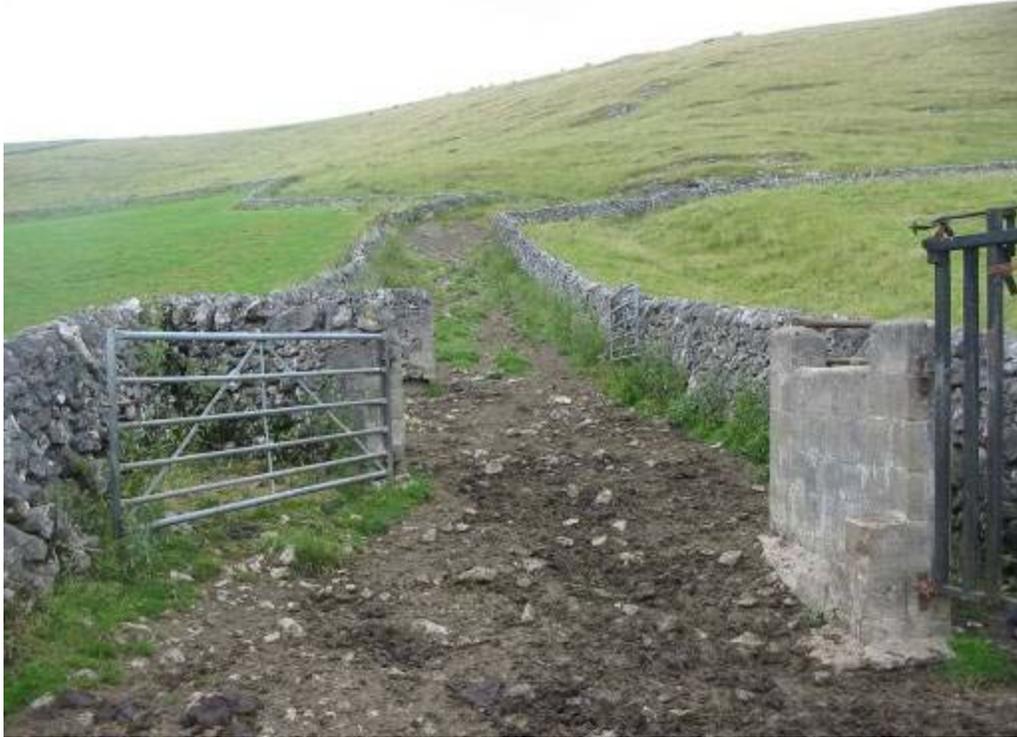
A significant point source of fine sediment is located on the left bank downstream of Bridge End Farm where a narrow track provides access to the river for cattle. This has been recognised as a problem for a number of years and recently an agreement has been struck between LDFFA and the farmers involved to provide an alternative mains-fed drinking area away from the river. Cattle access has been restricted, although the track remains heavily poached and covered with faeces. This area should be monitored to ensure the situation does improve as a result of the agreement, and maybe further steps considered such as diverting rainfall run-off from the track into a soakaway in the field.

**Photo 11 Track on Left bank below Bridge End Farm which is the subject of a recent agreement to reduce fine sediment run-off.**

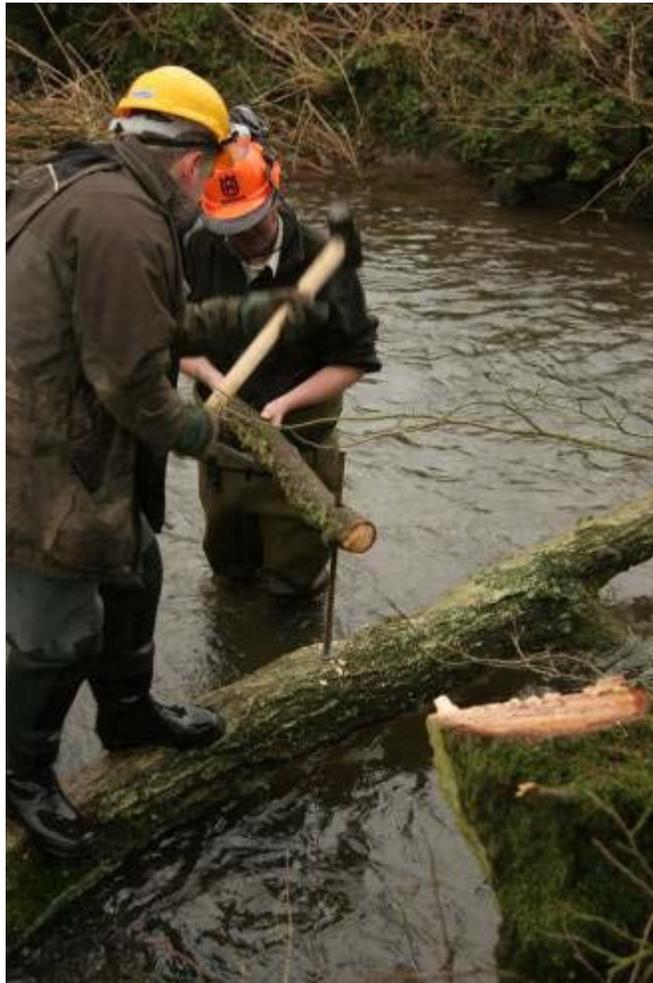
**Photo 12 Installing LWD on the River Hamps**

The introduction of tree trunks, branches and root wads sourced on site (through tree coppicing) or imported from elsewhere will achieve these aims, and have been carried out in association with the Wild Trout Trust on other LDFFA waters (e.g. River Hamps, Dove at Dovedale). The principles of LWD positioning described in the previous advisory visit report on the Hamps for LDFFA are also applicable here.

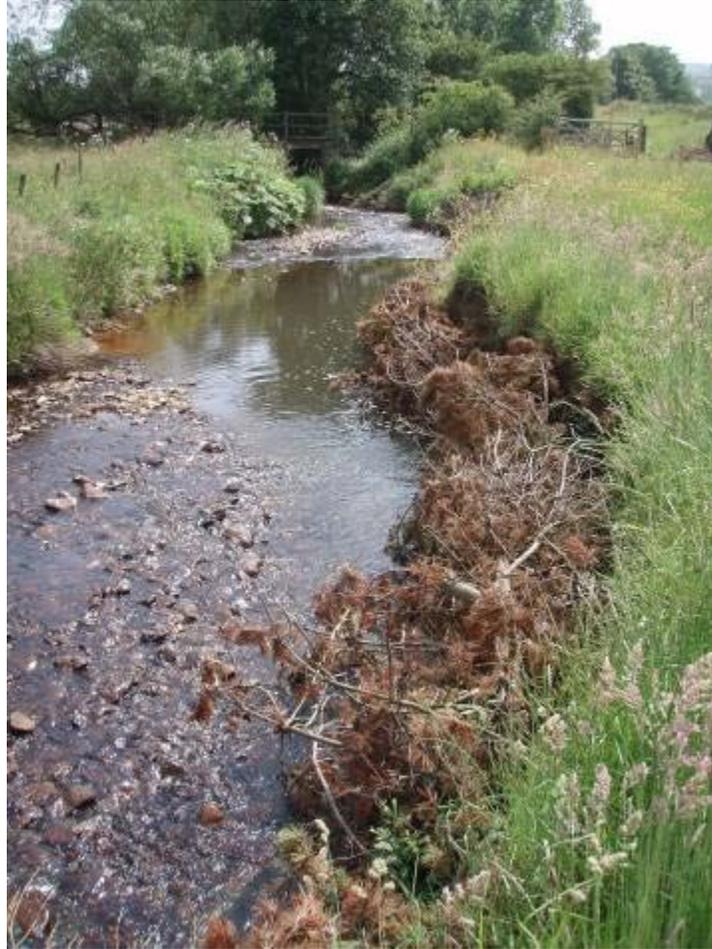
**Photo 13 Soft revetment using brushwood on the River Manifold – this has provided excellent marginal cover for small trout as well as for riverfly species such as the southern iron blue.**
