## **River Dun – Dunerley, Dunbridge**

**Advisory Visit January 2019**

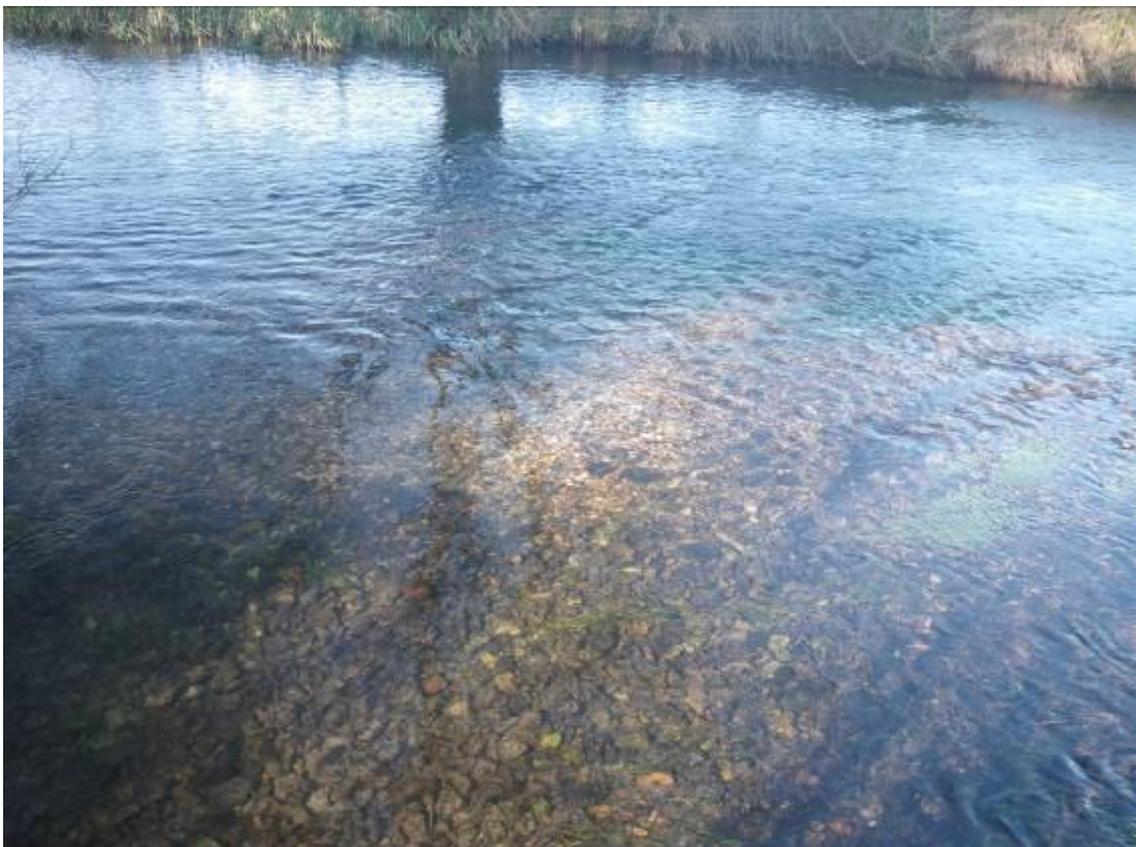
At the very top boundary a small side stream/loop joins the main river from the RB. This stream potentially offers good spawning and nursery habitat and being located at the very top boundary is ideally located for naturally populating wild stocks into the reach below. The section immediately downstream of the loop confluence also supports good spawning habitat with evidence of redds clearly visible (photo 1).

Photo 1. A trout redd immediately downstream of the stream confluence near to the top boundary

The side-stream itself has a comparatively steep gradient flowing over what appeared to be a mainly gravel bed. It will be critically important to maintain lots of cover both in and over the stream. We often recommend tree management to promote more direct sunlight over shallow areas to help boost primary productivity but spawning and nursery sites like this are often best left as a tangle of scrubby tree cover to make spawning adults feel secure and to deter avian predators, giving newly hatched trout increased chances of survival. A very light touch to riparian habitat management adjacent to the loop and known spawning sites is therefore recommended.

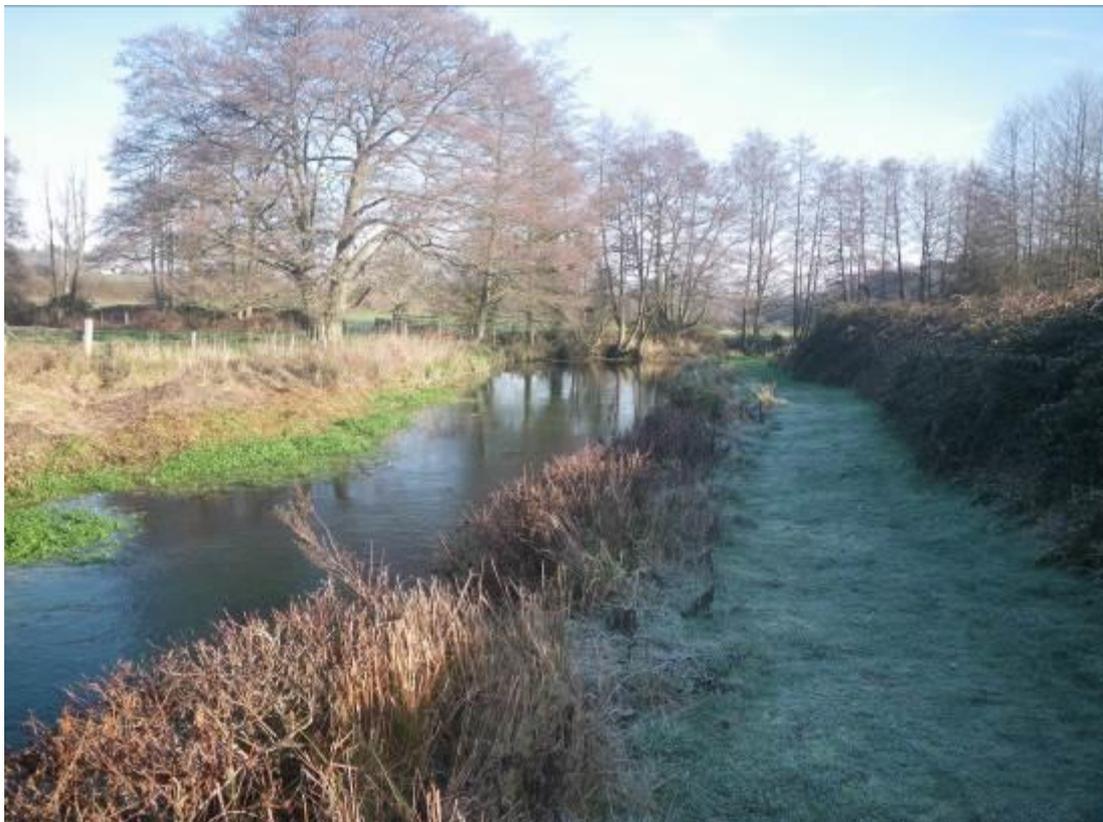
Further downstream, riparian habitat is somewhat compromised by a heavily modified right bank, where in places it appears to have been made up with imported material and is comparatively high and dry, with the toe of the bank lined with a line of tightly coppiced alder hedge (photo 2).

Photo 2. The high right bank flanked by a tightly trimmed "hedge" of trees growing out from the toe of the bank

This RB margin provides complex root systems that will resist erosion, protect the bank and provide cover for fish but represents a very unnatural chalkstream margin. One option here is to "cut and fill" the margin by pushing the shrubby tree line down further into the wetted margin with the bucket of a tracked excavator. This will effectively narrow the channel width and increase mid river flow velocities and peg back encroachment of cress that currently marches in from the LB.

The section of clipped alder hedge adjacent to the RB is unusual on a chalkstream river bank and is potentially a maintenance liability. The bank along this reach is particularly hard and high and this section could be the subject of a significant enhancement project. Work to radically change the profile of the river banks will require a Flood Risk Activity Permit obtained via the Environment Agency.

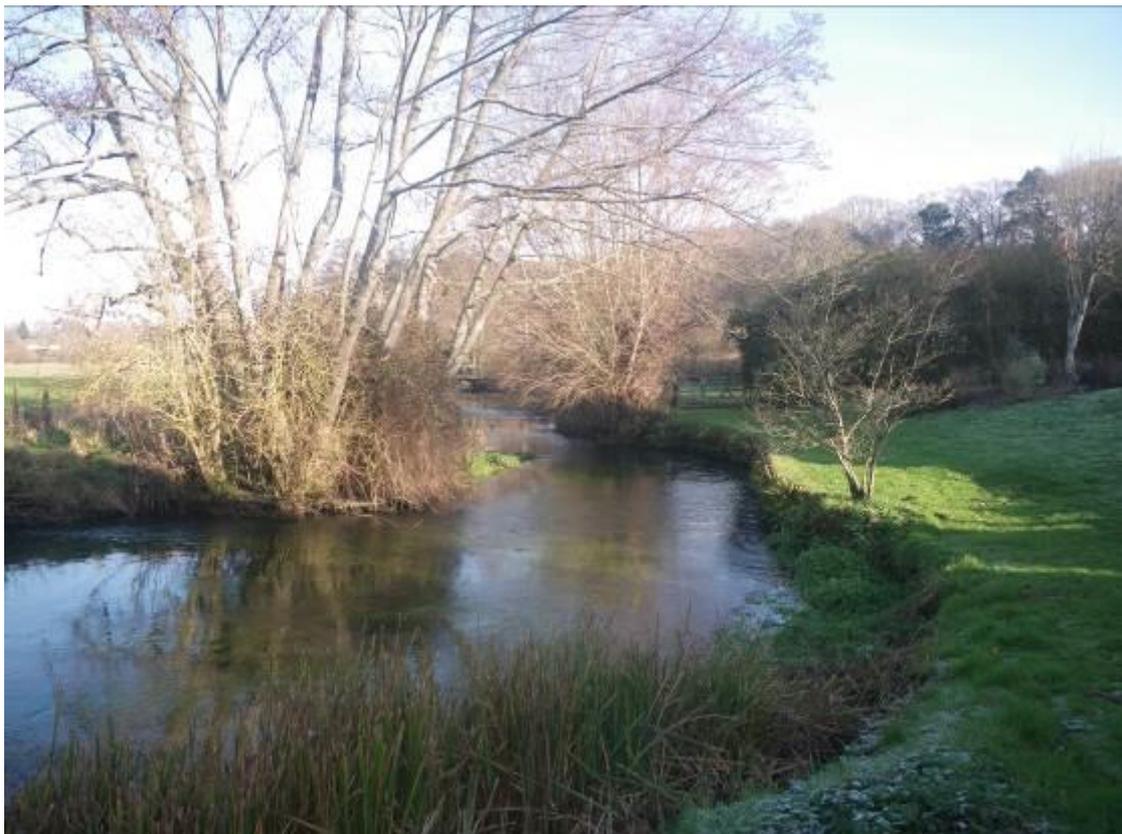
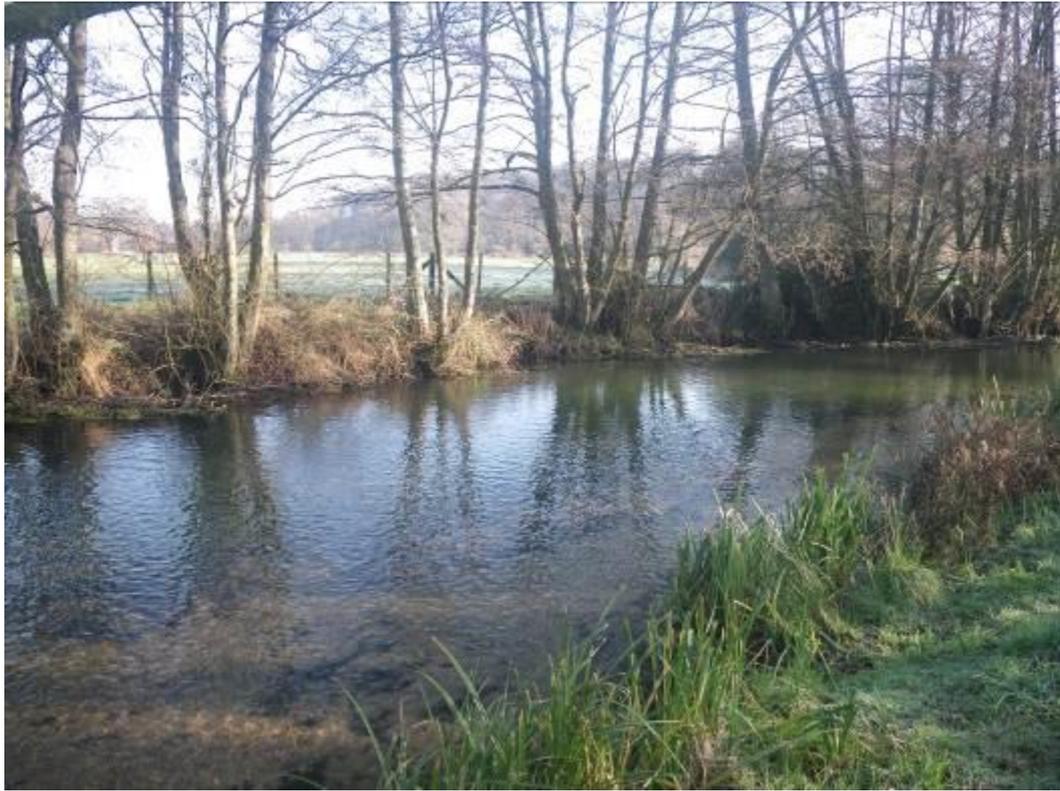
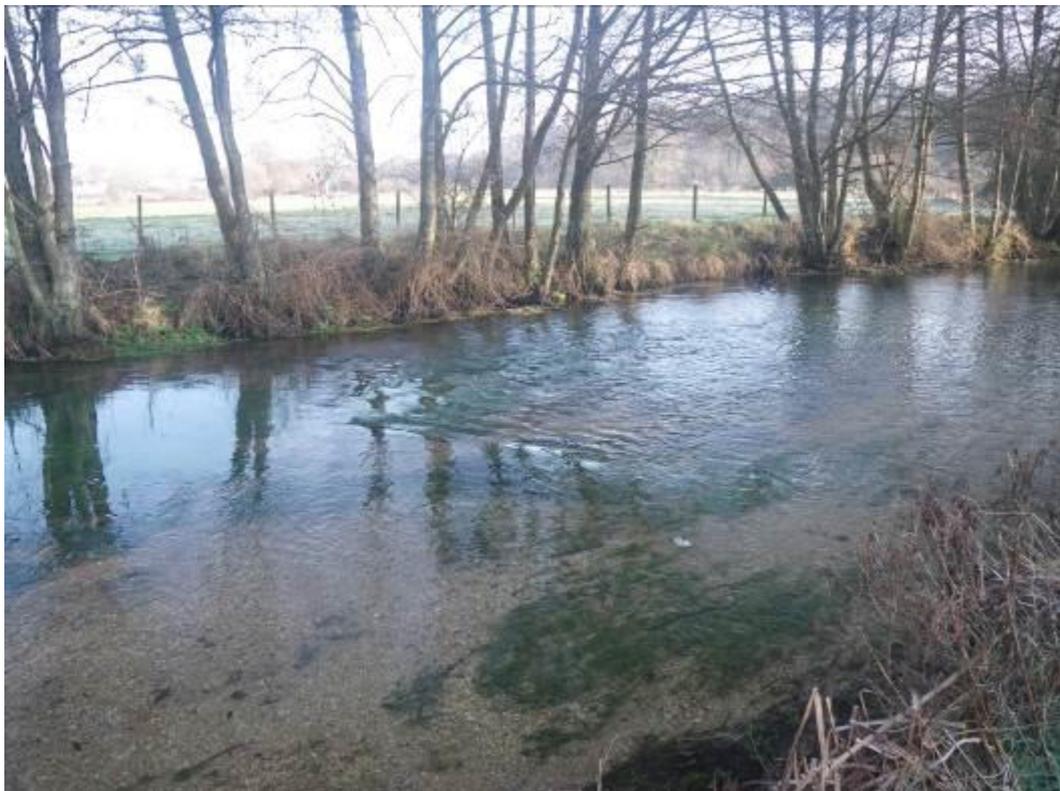
Along the whole of the LB reach there are examples of previously coppiced multi-stooped alder trees that are now very tall and leggy (photos 3, 4 & 5).

Photo 3. One of many multi-stooped alder trees on the LB

Photo 4. The start of a long line of alders, some of which are ripe for hinging into the margins

Photo 5. A combination of coppicing and hinging will improve channel cover and canopy diversity

Some of these trees are ripe for “hinging” into the river margins to create high quality holding lies for adult trout, as well as complex woody habitat for invertebrates. In addition to laying in the odd tree trunk parallel with the bank, occasional stools should be rotationally coppiced to create diversity in the canopy and increase the longevity of the tree and protect its valuable root systems. When coppiced, the new growth forms low-level cover and casts shade in the margins, whilst still allowing shafts of light to hit the river bed in central channel locations. With no rotational coppicing plan, there is always the risk that the trees will get taller and prone to falling, potentially with many falling at a similar time.

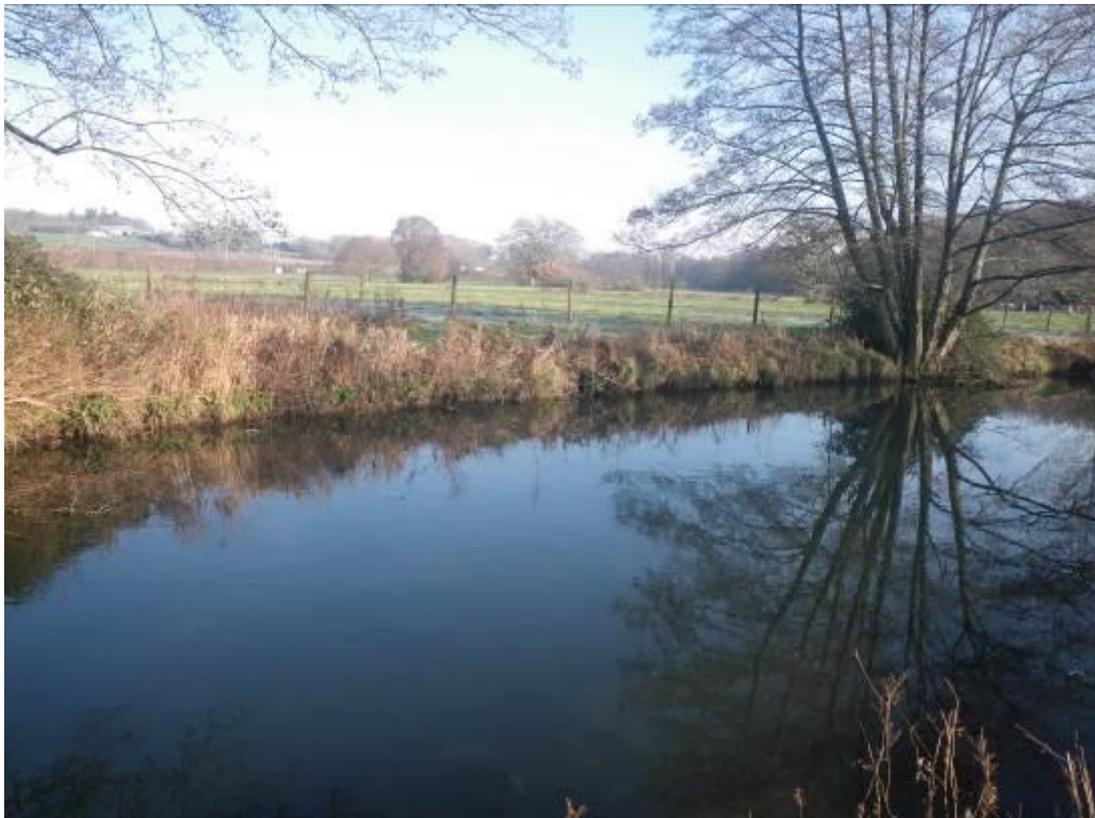
The middle section running down to near the house can be mainly characterised as deep glide habitat which will no doubt be popular with the visiting rods. This section is comparatively deep and slow flowing and although adult trout and grayling will undoubtedly lie up in this reach, it does lack flow pattern diversity. Adult trout will lie up in comparatively sluggish flow, provided they are adjacent to fast flows where a constant supply of food items can be intercepted with the minimum of effort.

Photo 5. A typical example of the middle of the beat where the river is best described as deep glide and lacking in flow pattern variation

This particular reach could benefit from some large-scale woody flow deflectors to promote flow pattern diversity, as well as changes in bed and bank topography. Potentially alder trunks won from coppicing could be utilised to kick the flow patterns from margin to margin and make this section much more dynamic. There were some good examples of flow deflectors that have been previously installed but they really need to be big and bold to be effective.

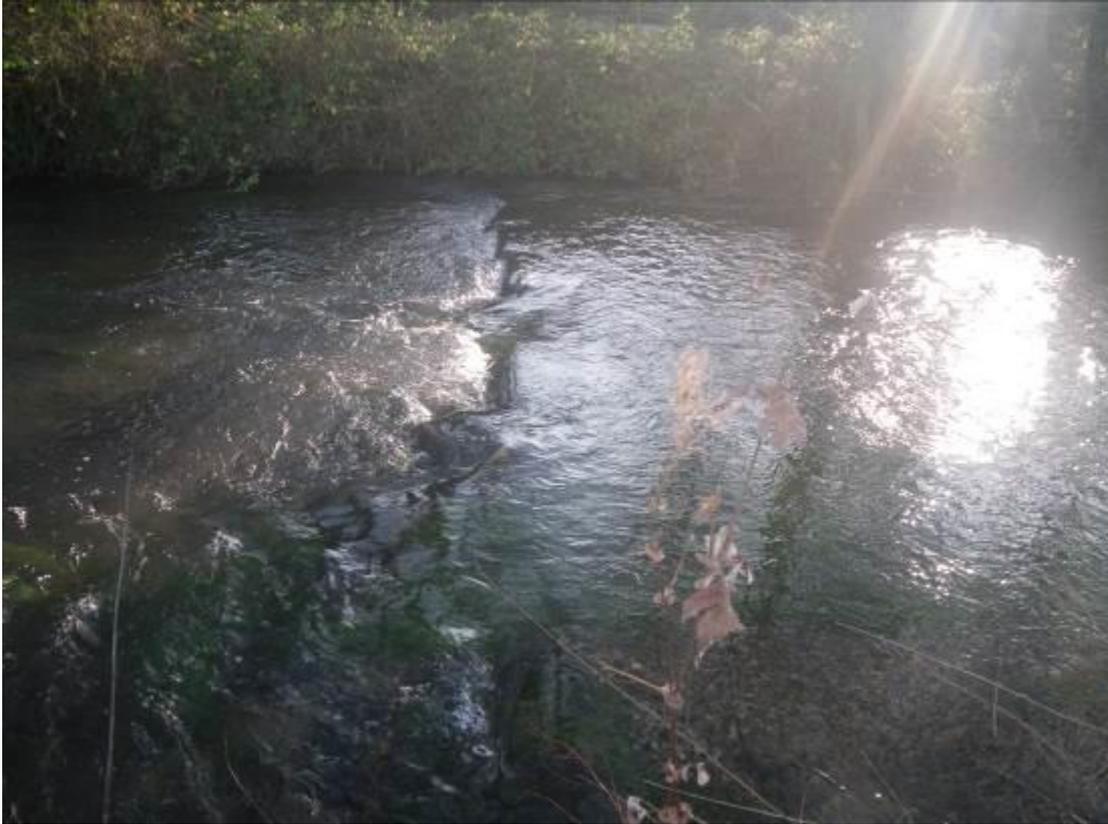
Further downstream, below the footbridge, there was evidence of an old stone or block weir (photo 6). Although this structure is very low, it will be responsible for trapping fine sediments in the reach immediately upstream. These low stone weirs are a common sight on River Test and tributaries and are often referred to as "summer weirs", many having been rapidly built during the drought summer of 1976, to retain water depth upstream. What has subsequently happened in the intervening years is that the upstream depth originally created has been lost through increased deposition, as fine sediments have become trapped. This structure is very low and poses no problems for fish migration but habitat quality

Photo 6. A low summer weir. The bed upstream has regraded and filled with small gravels and fine silt sediments. Removing a central block or two to the original bed level will improve habitat both above and below the structure

in the reach immediately upstream would be improved if the centre of the structure were to be removed. By removing one or two of the central blocks, a downstream flume will be created to maintain a scour pool and high-quality fish holding lie.

The low summer block stone weir could be modified to improve sediment transport and upstream habitat quality.

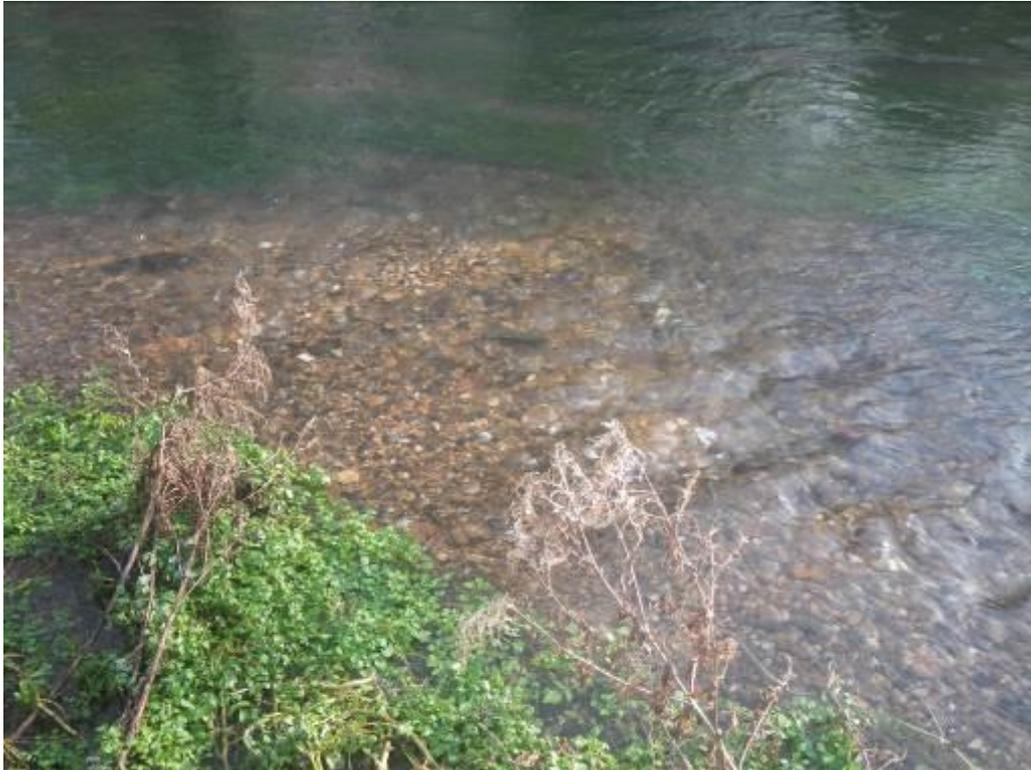
Long sections of the Test and its tributaries are frequently contained within vertically revetted river margins and finding sections where the water depths gradually taper off to very shallow margins is comparatively rare (photo 7). When these very shallow, slow flowing river margins are immediately adjacent to shallow gravel glides, or riffles and contain lots of riparian cover then they usually support good densities of juvenile wild trout. Wild brown trout, as opposed to domesticated stocked trout, are usually fiercely territorial at virtually ever stage of their life cycle. Rivers that contain a varied topography and lots of complex cover, either via fallen woody material, or luxuriant weed growth will generally hold more fish. For trout fry emerging from their gravel nest (redd) into a deep, open section of river will almost certainly result in it ending up as a meal for a larger fish. Very small trout therefore actively seek areas that are hostile to larger fish. Initially, they will gravitate to extremely shallow, slow

Photo 7. A good example of a section of river that supports both good quality parr habitat (shallow riffle under crowfoot beds) and high quality fry habitat in amongst the virtually still water found in the very shallow water just under the cress fringe

This long, comparatively straight section of the Dun would benefit from further tree works to the RB. This is the southern bank of the river and punching the odd hole in the canopy will improve weed growth on this mainly shallow section. The woody materials should then be utilised in a similar fashion to that already successfully deployed to create meandering flow patterns and additional cover which will be particularly valuable in the winter months.

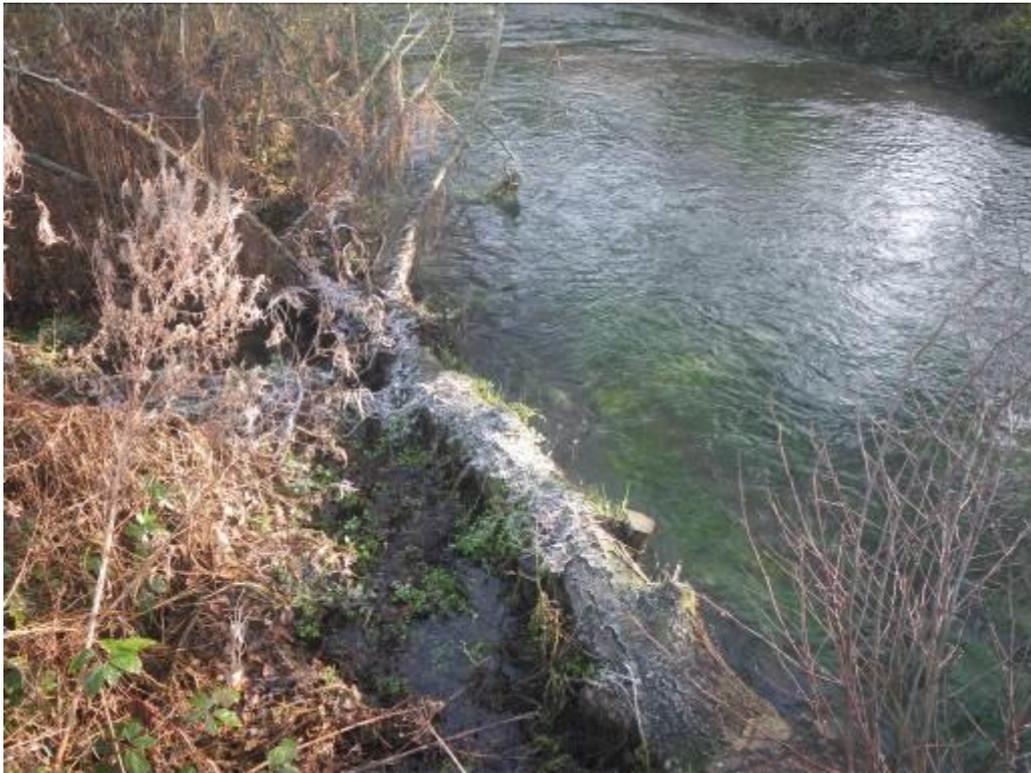
flowing areas to hide, gradually migrating to more central channel lies as they get older and larger. Good quality juvenile trout habitat therefore encompasses a range of habitat types. The bottom reach at Dunerley has this in spades and has been further improved with the addition of whole trees being felled and pegged into the river margins (Photo 8).

Photo 8. A lovely example of good quality habitat where the woody tree complete with its associated brushwood has been nailed into the river bed with chestnut clefts.
