## **River Itchen – Eastleigh River Itchen Fishing Club**

**An Advisory Visit by Nick Lawrence on behalf of the Wild Trout Trust  
November 2017**

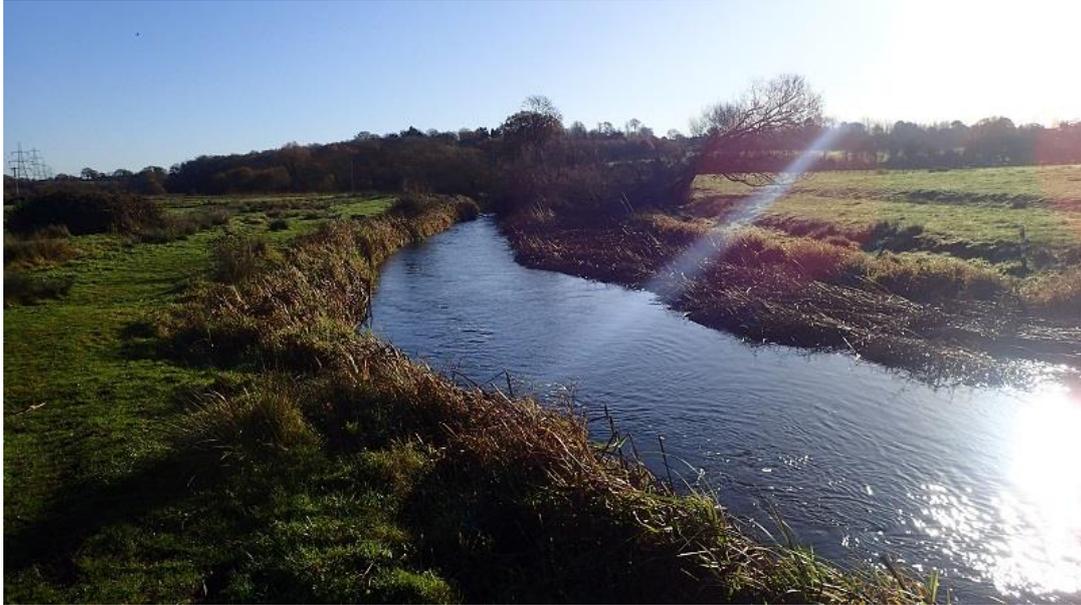
When the visit took place the very top section upstream of the footbridge just above the club's top boundary was one of the most habitat rich areas on the whole reach (Photo 1). A willow from the LB had fallen into the river and pinched the channel by 50%. This had speeded up the flow dramatically and created a long fast run and in time will accentuate the natural meander. This was a prime example of light touch management that when trees fall into rivers they should be seen as a gift from nature and should be left to scour the riverbed and allow the river to narrow naturally. Note the pipe reed, *Schoenoplectus* sp. encroaching from the LB. Potentially this area was sorting gravels and would have been a likely spot for salmonid spawning. Unfortunately, this tree has now been removed, which is to the river's loss. These are exactly the type of practices where raised awareness is key if habitat improvements are to prevail.

Photo 1. View upstream from the bridge on the top boundary, a fallen tree on LB pinching the channel and deflecting flow that was providing a valuable variation in habitat prior to recent removal.

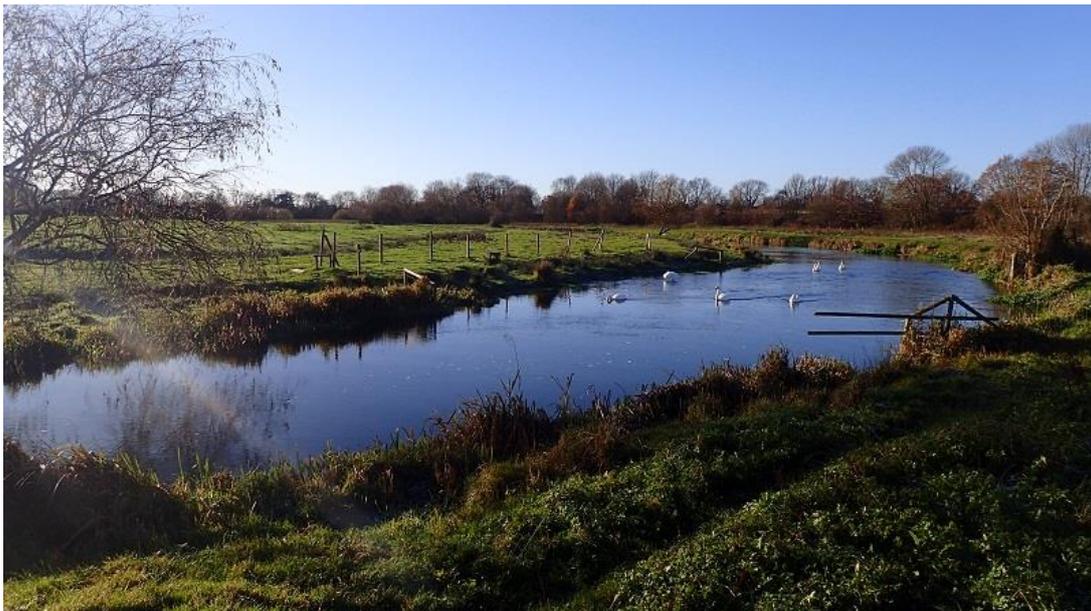
Below this area, the river gradually widens, and problems associated with reduced flow velocities become more evident. Initially, there is a nice scrubby margin on the RB (Photo 2) which provides some rare marginal cover for fish and angler alike and also provides valuable habitat for invertebrates, as well as robust bank defences. The most serious issue impacting the fishery is the distinct lack of fish cover, whether that be marginal plants, low, overhanging tree cover or tree cover *in* the water. The reduced flow velocities associated with the wide channel compound these problems. Photo 2 is a prime example of how the river is overwide compared to Photo 1. In summer, the rampant growth of pipe reed in this reach is testament to its over-wide nature.

Photo 2. Overwide reach on a bend, heavy poaching and grazing evident on the LB, insufficient fenced area in an attempt to limit cattle poaching. Lack of trees and shading.

The first issue that needs to be addressed is fencing the river from cattle grazing. As seen in Photo 2, there has been an attempt to fence part of the bank that has been suffering from excessive grazing and to provide cattle drinking. In time, this will work for this area but there are numerous areas elsewhere along the river that need a similar intervention. Attitudes have changed towards fencing and DEFRA guidance is in favour of actions designed to reduce sediment input. Where animals (cows, sheep & horses) have access, unless they are in low numbers, the whole riverbank should be fenced with as large a buffer area between the grazing and the river as possible: 5-10 meters would be adequate. Either pasture pumps should be installed or sacrificial cattle drinking areas incorporated within the fencing. (Photos 3 & 4)

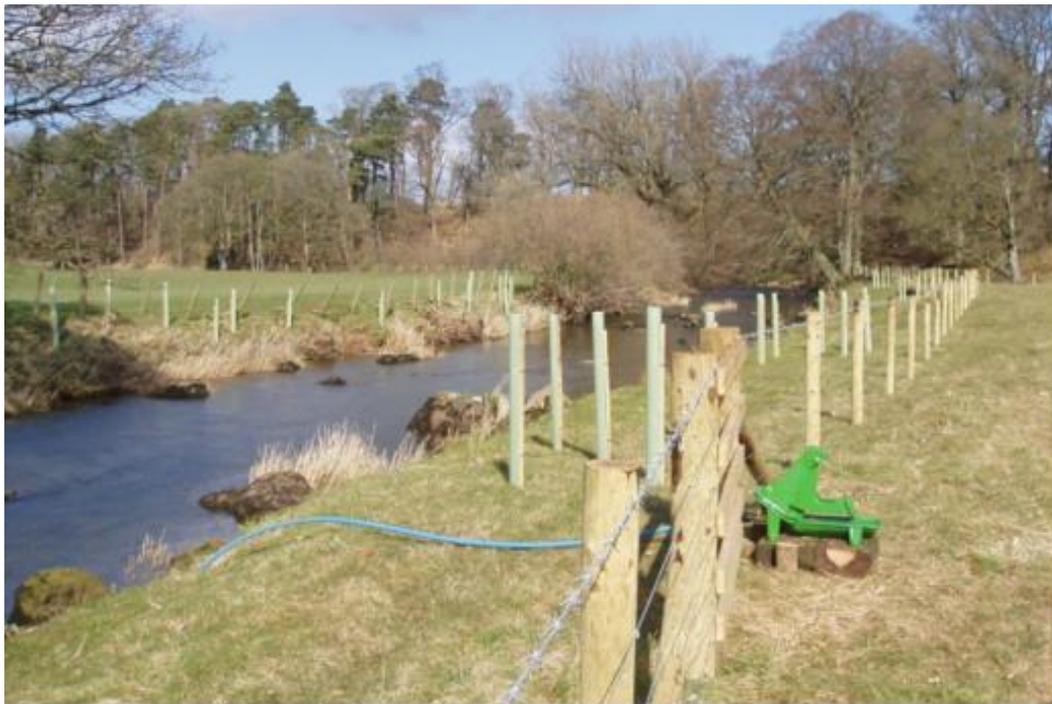
Photo 3. An example of a pasture pump on the river Lyvennet in Cumbria

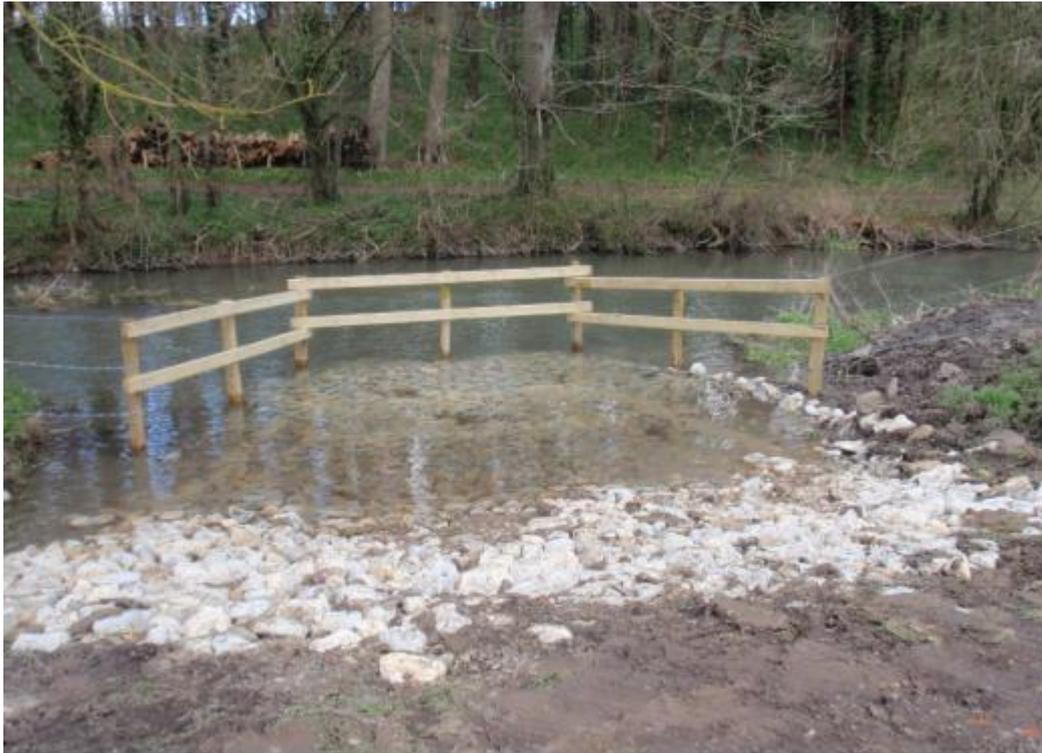
Photo 4. An example of a fenced cattle drinker on the river Coln in Gloucestershire

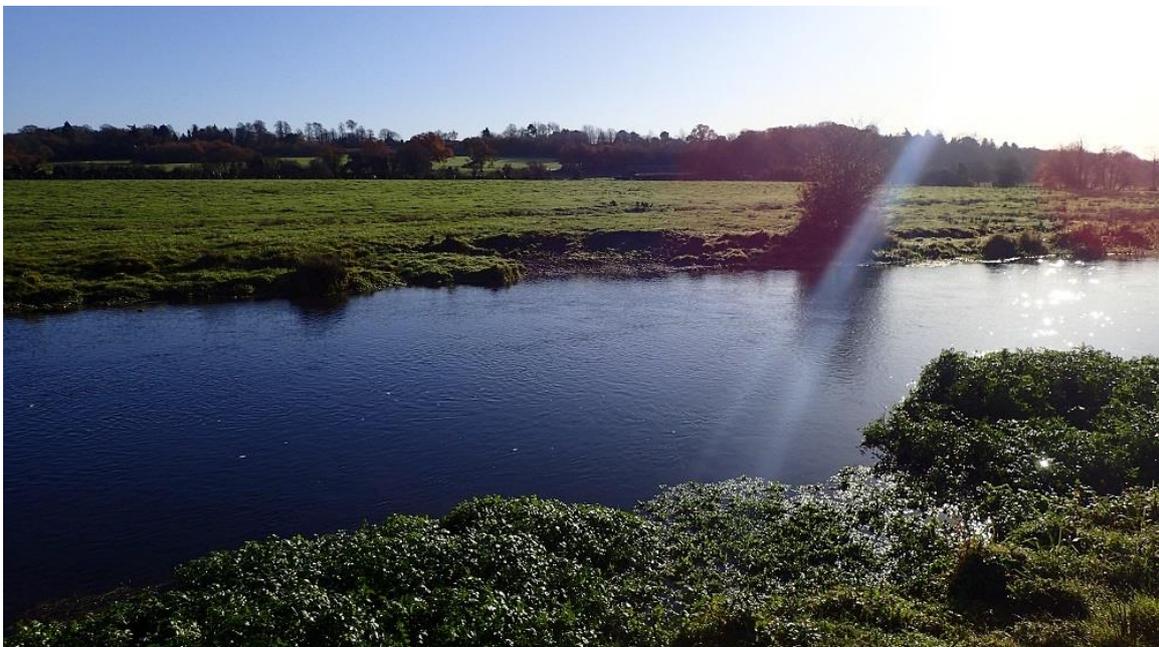
Photo 5. A prime example of an overgrazed margin and poached river bank. This would be a good site for a cattle drinker if a fence was installed.

Photo 5 again reiterates the need for fencing. This picture could have been taken again and again as the LB has some serious bank poaching issues, the RB which is grazed by horses is not much better. Note the lack of marginal growth. The easiest and cheapest fix for establishing marginal plants would be to install coarse woody material or faggot bundles backfilled with brushwood to protect the exposed bank, these areas would then collect silt and enable a marginal reed bed to establish. This could be combined with strategic narrowing with either some brushwood mattresses, or log deflectors (Photo 12 & 13) where the channel is currently overwide to energise flow velocities in the centre of the channel.

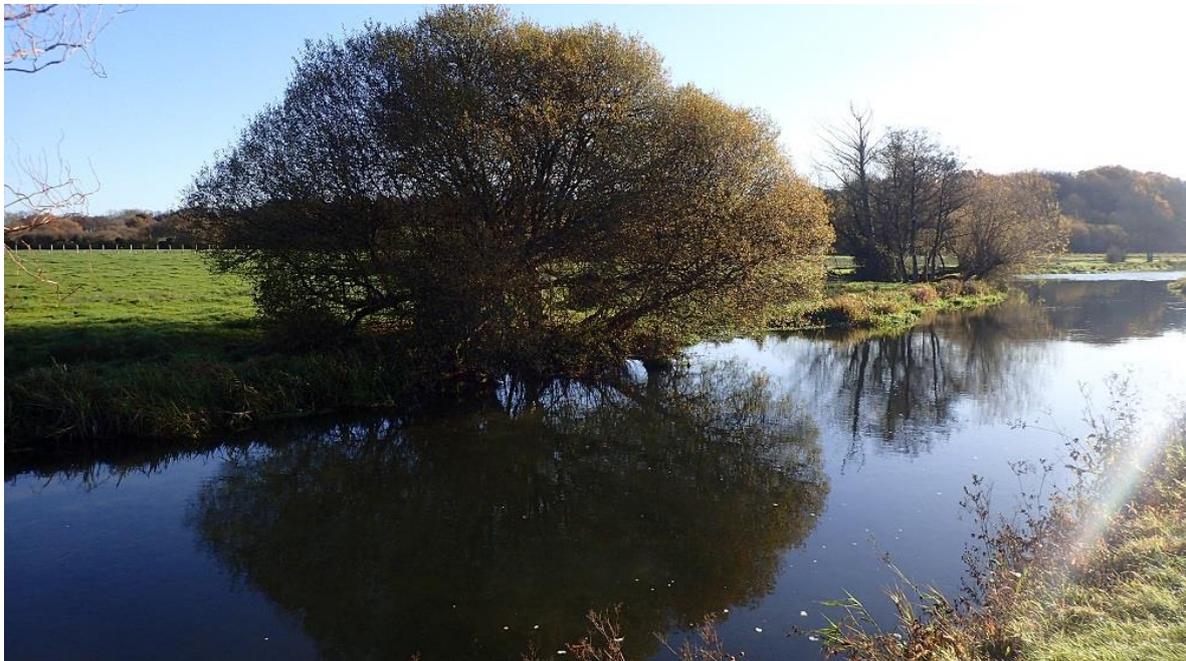
Photo 6. A small oasis of low cover from a Goat Willow.

The low cover issue is really a critical niche of habitat that should be encouraged, as fish of all sizes on this reach have very few places of refuge. Photos 6 & 7 are prime examples of the types of habitat that are required. Of 60 pictures taken on the day, there are really only 2 examples of this; more areas should be encouraged.

These areas could actually be improved further by encouraging some of the lower limbs into the water, hinging some of the low limbs down so they deflect some flow and collect organic matter. This will create more cover for fish, providing a refuge from predators, as well as potential lies for fish to sit while allowing the rest of the tree to grow to produce shading. Shading is vitally important for moderating water temperatures and reducing excessive weed growth; without shading, the environment will be undesirable for cool water fish species.

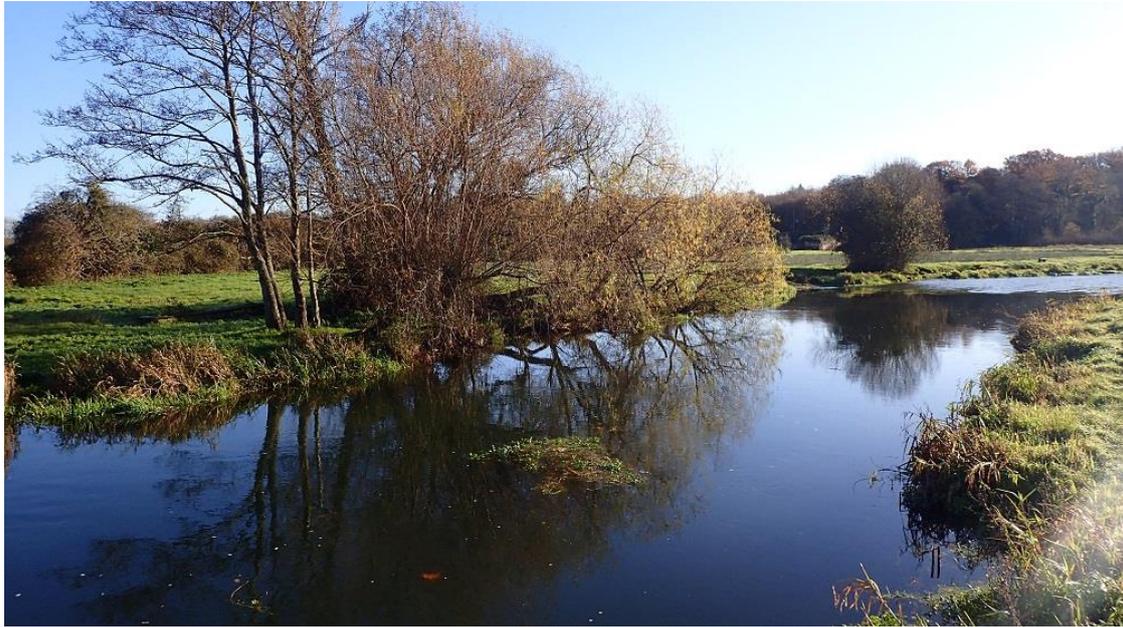
Photo 7. Another example of good low cover on the LB.

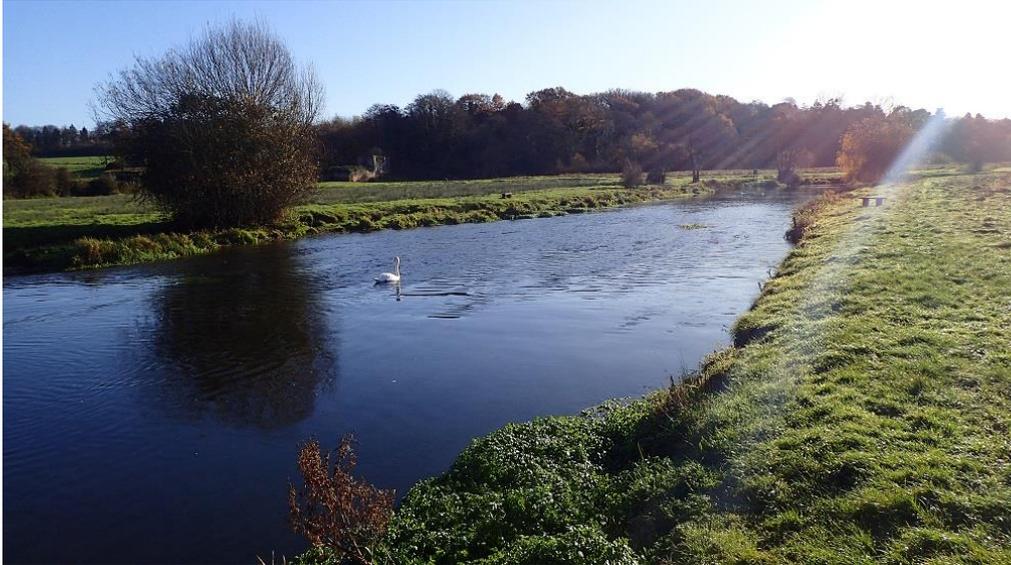
Photo 8 is the only shallow riffle on the whole reach, this area looks like prime wild trout water as well as being potentially the best area for salmonid (and grayling) spawning, but there are still some issues with it. The river is not fenced so there are very few marginal plants, and again no tree cover to provide shading or low cover.

Photo 8. The only shallow riffle on the whole reach but still room for improvement

This area is prime for installing some brushwood mattresses to help encourage marginal plants to establish and provide juvenile fish cover in a spawning area. Some large logs incorporated into these structures would promote scouring of the gravels in typical spawning areas. Ideally, these structures would be staggered so the flow can be pushed from one bank to the other and create some variety in flow patterns. These structures will also help with boosting *Ranunculus* growth, as well as promoting enhanced lies for adult trout.

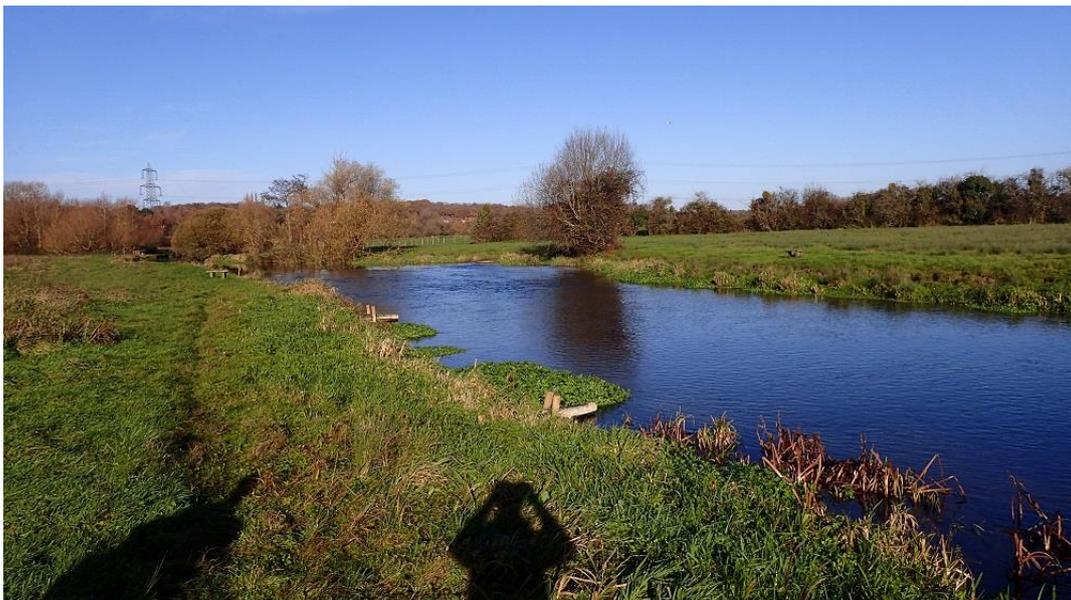
As Photo 9 shows, an attempt has been made to install some flow deflectors, which is forward thinking. Ideally, these should be at larger preferably a third of the river channel (Photo 13) because unfortunately, as they are, they are having little or no effect on the river. Nevertheless, the structures do show that the club is willing try some habitat improvement ideas.

Photo 9. The flow deflectors here are a great idea but need to be far larger to have any influence on habitat quality.

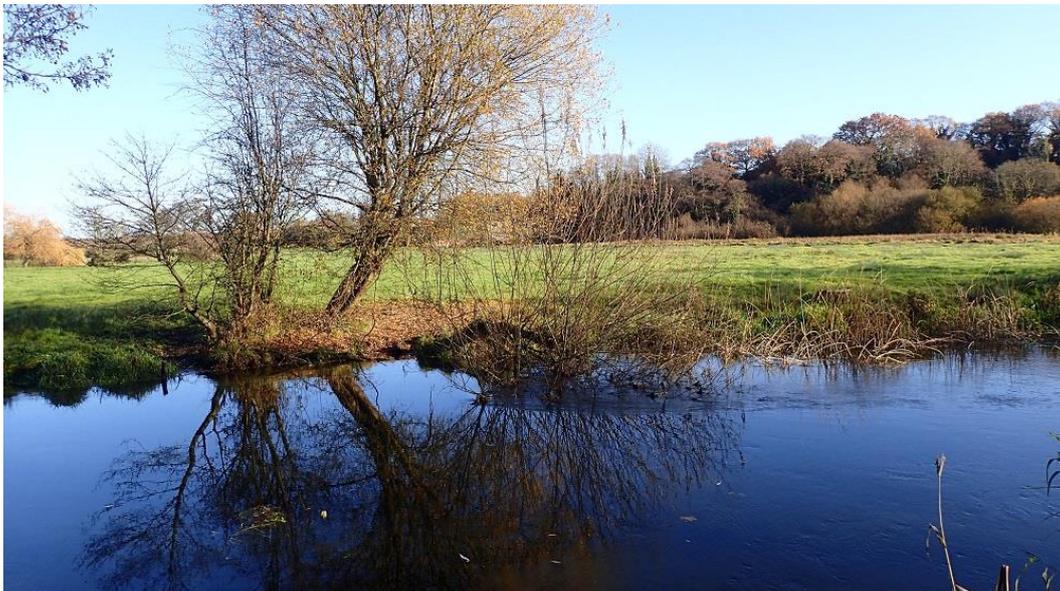
Photo 10 is a close up of what can happen when natural processes are allowed to take hold. This willow has fallen into the river and created a nice oasis of low cover and deflected flow as well as providing the distinct possibility of a large trout lie. In time, the regrowth from this tree could be hinged over to create a larger oasis. These areas should be left to flourish and attempts to create more areas like this should be prioritized for habitat improvements.

Photo 10. Close up of cover shot on LB, fantastic living deflector providing habitat for fish and insects.

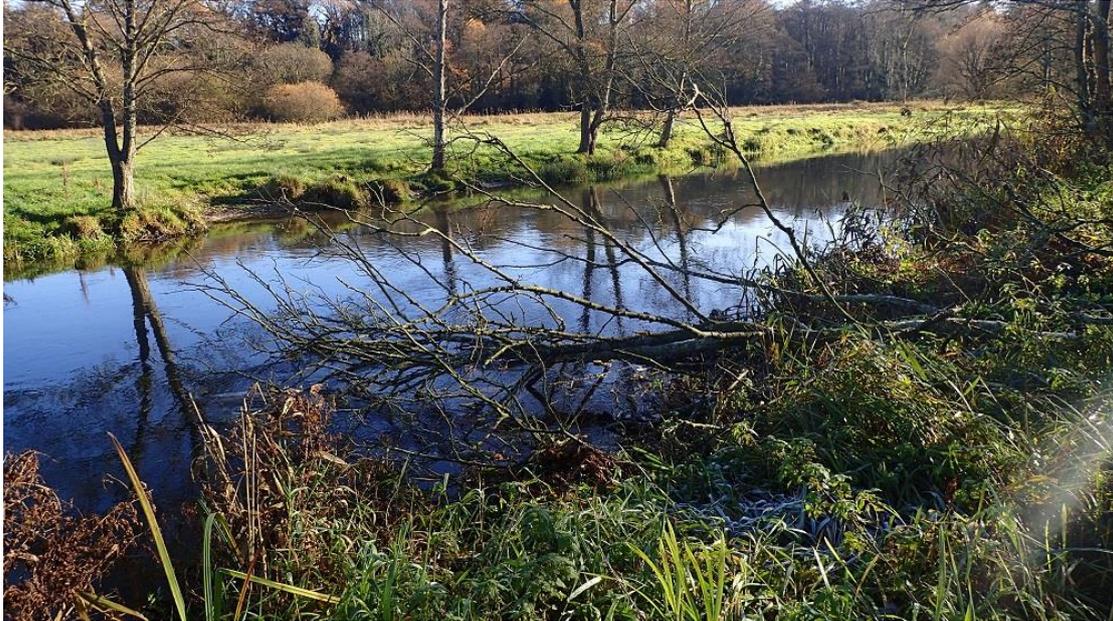
Photo 11. Alder coppice has produced a gift for the river. Perhaps this might need to be cut near the bank and repositioned and then secured with posts and wire.

As the bottom section is not visited that much, the alder coppice has produced a little habitat gift for the river resulting in some low cover (Photo 11). It is not essential to provide angling access to every yard of river bank but creating improved lies for trout, both wild and stocked, will significantly improve the overall fishery performance. If a fallen tree is too much of an obstruction where it lies, then it would be best repositioned to a more favourable location so the habitat can be retained.

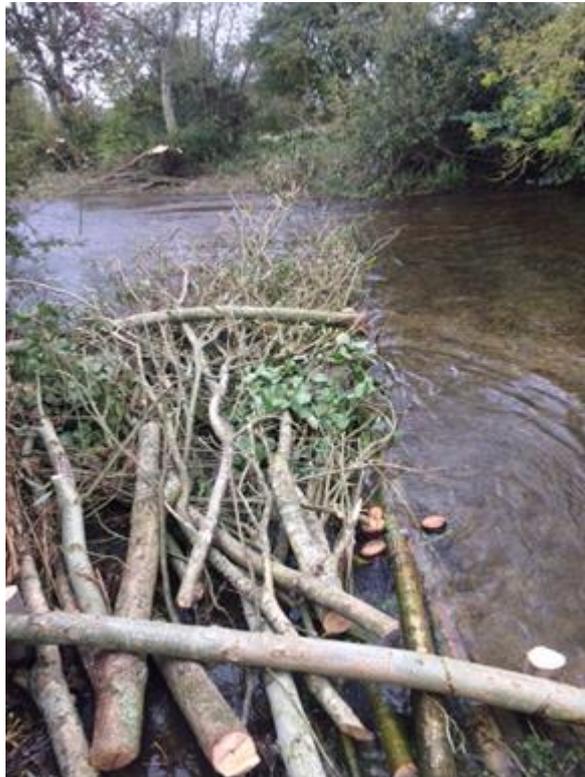
Photo 12. Brushwood mattress constructed with coppiced willow.

than a third of the existing channel width. Photos 12, 13 and 14 show some examples of the type of structures that could be installed.

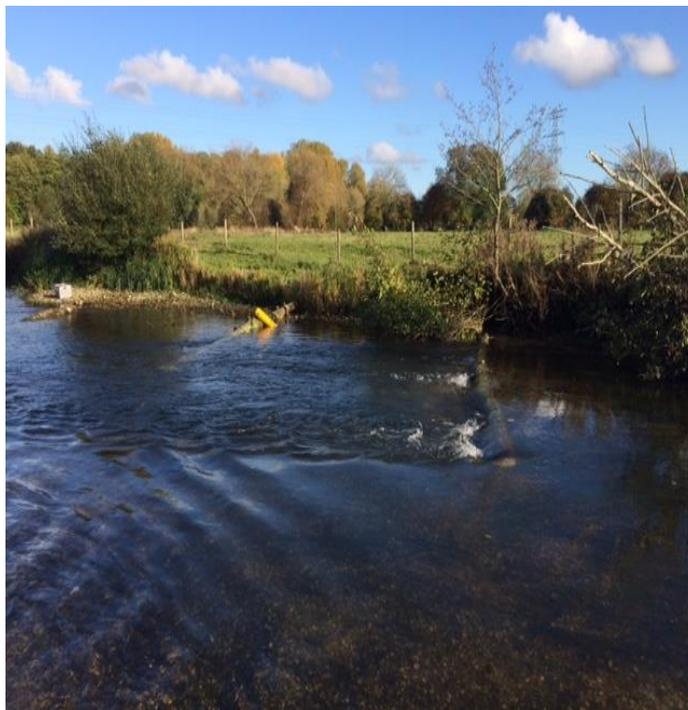
Photo 13. Log deflector.

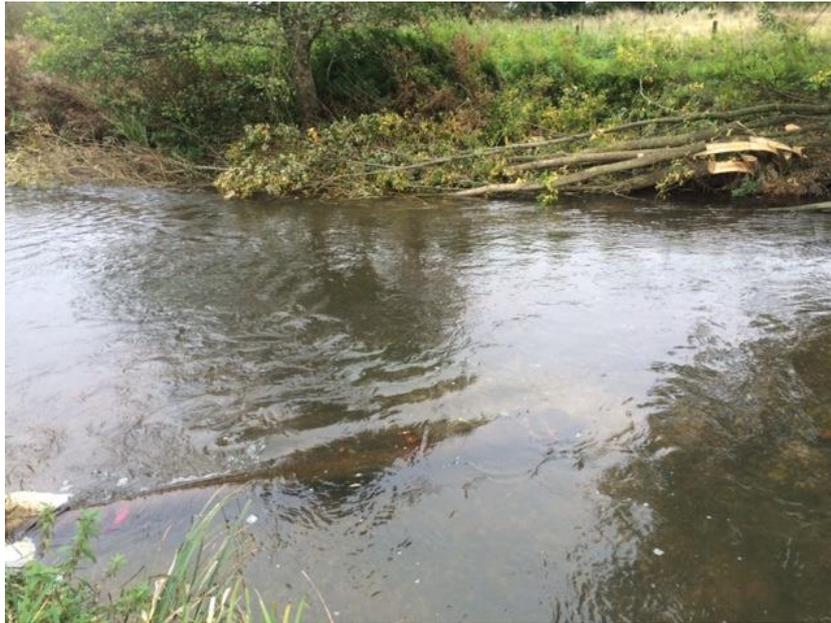
Photo 14. Log deflector combined with folded willow.
