Advisory Visit
River Ecclesbourne
April 2019

1.0 Introduction

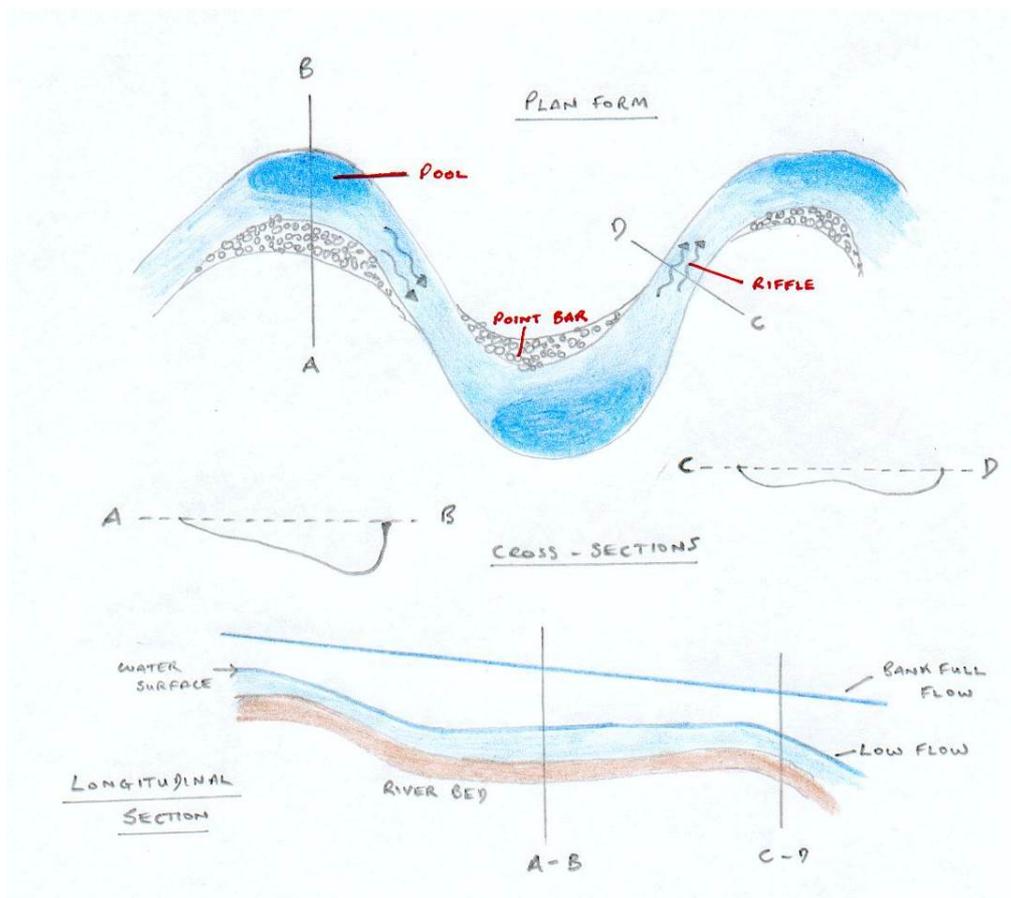
Figure 1 Natural channel morphology in alluvial rivers (adapted from Prof. Richard Hey, 2005).

The section of the Ecclesbourne downstream of the Puss in Boot pub was inspected. The river here has a meandering course and a pool-and-riffle sequence which provide the basic building blocks for good habitat (Figure 1). Meanders are vital as they create deep pools on the outside of the bends (adult fish habitat) and shallow, steeper, gravel-bedded riffles on the straighter sections between bends (fish spawning and juvenile habitat). Many rivers in the UK have been straightened for drainage/flood defence purposes, which reduces the length of the river, homogenises its gradient and depth, and causes long-term detriment to the river habitat; fortunately, this section of the Ecclesbourne has escaped this.

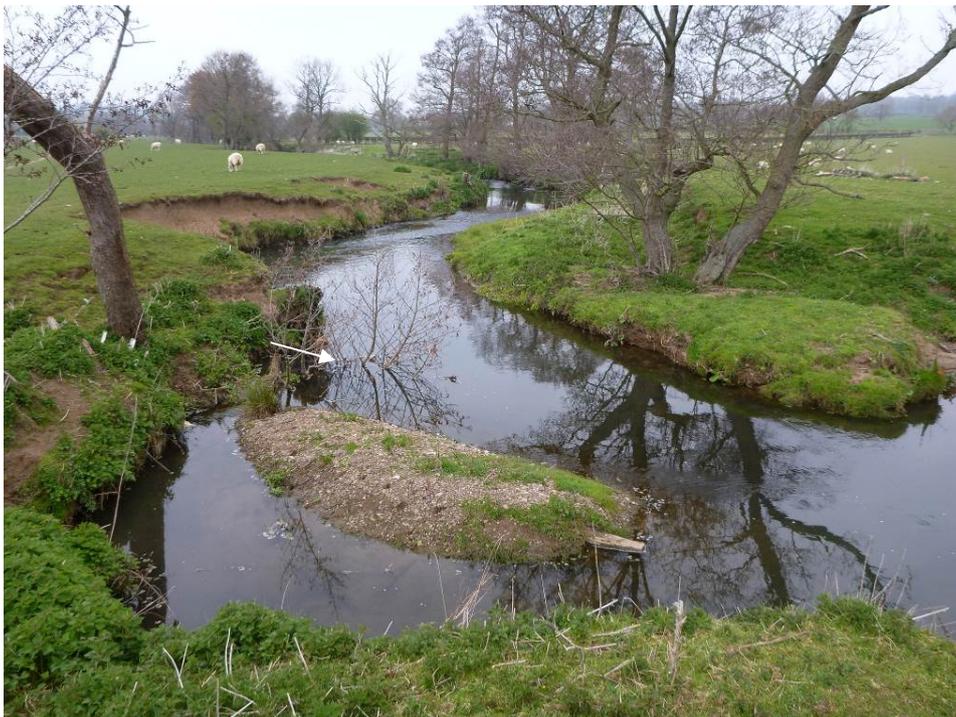
The riparian habitat along the EFFC water is of mixed quality. There are good numbers of bankside trees, but they are dominated by aging alders which

are being lost with very little succession of younger trees to replace them, which is a concern for the medium to long term. Both banks of the section inspected are heavily grazed (by sheep at the time of the visit), which prevents the succession of trees and limits other vegetation to close-cropped grass, reducing bank stability, promoting erosion and greatly restricting habitat quality (cover photo, Photo 1). The grazing and livestock footfall is also contributing to the loss of trees by causing points of weakness in the bank around the rootballs which are eventually washed out by floods.

Photo 1 The sinuous channel and pool-riffle sequence is the basis of good in-stream habitat, but intensive grazing and its effect on riparian vegetation greatly restricts habitat quality. Note the lack of younger trees, other than in the occasional area inaccessible to livestock (arrow) where the tree is unlikely to survive.

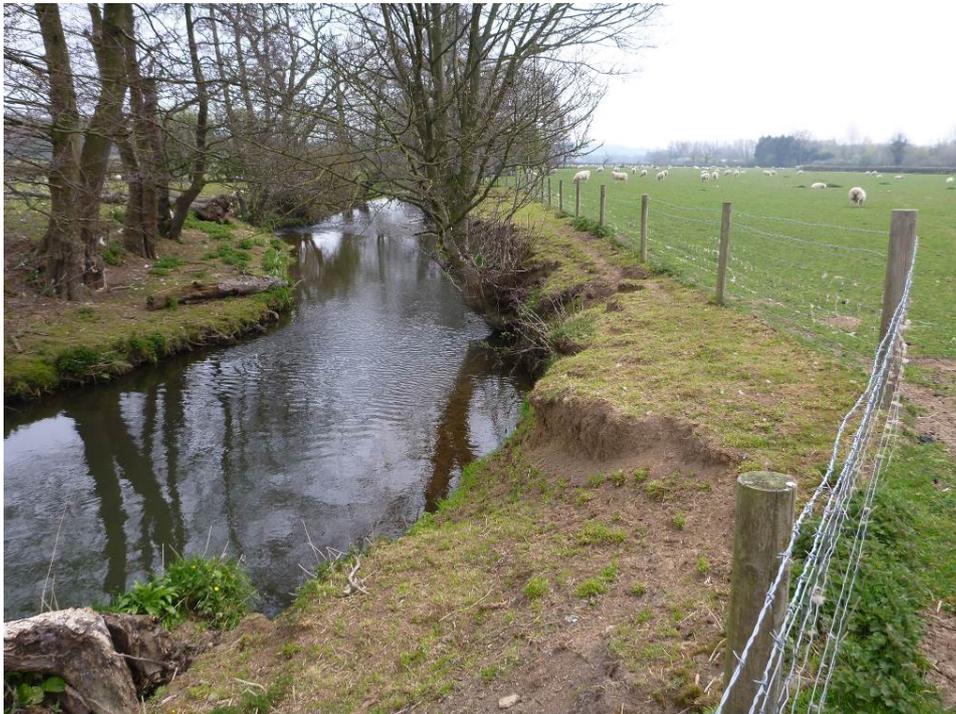
Bankside fencing has been installed along some sections (a previous EA project), but this has not been maintained and has failed in many areas (Photo 2). EFFC report that when the fencing was intact, Himalayan balsam dominated the vegetation on the riverside of the fence. Lack of provision for maintenance of the fence and for management of vegetation re-growth are common pitfalls with riverside fencing projects. Fencing out livestock is undoubtedly one of the most beneficial and cost-effective habitat improvement techniques, but it cannot simply be installed and left.

Photo 2 Existing fencing is not stockproof in most areas and therefore not achieving its aims. In some areas the fence is breached, in others livestock were crossing the river and grazing inside the fence; here livestock were getting trapped on the river side leading to more intensive grazing there than in the field.

The fencing should be repaired and reinstated and responsibility for ongoing maintenance assigned. Vegetation within the fence should be managed to control non-native plants such as Himalayan balsam. The aim should be to create a shaggy fringe of vegetation which overhangs the margins of the river and to allow tree regeneration. Access points for angling should be created to take account of this aim, for example to allow wading between access points rather than cutting paths. Although this may seem restrictive, it will greatly improve fish carrying capacity and is a deterrent to illegal fishing.

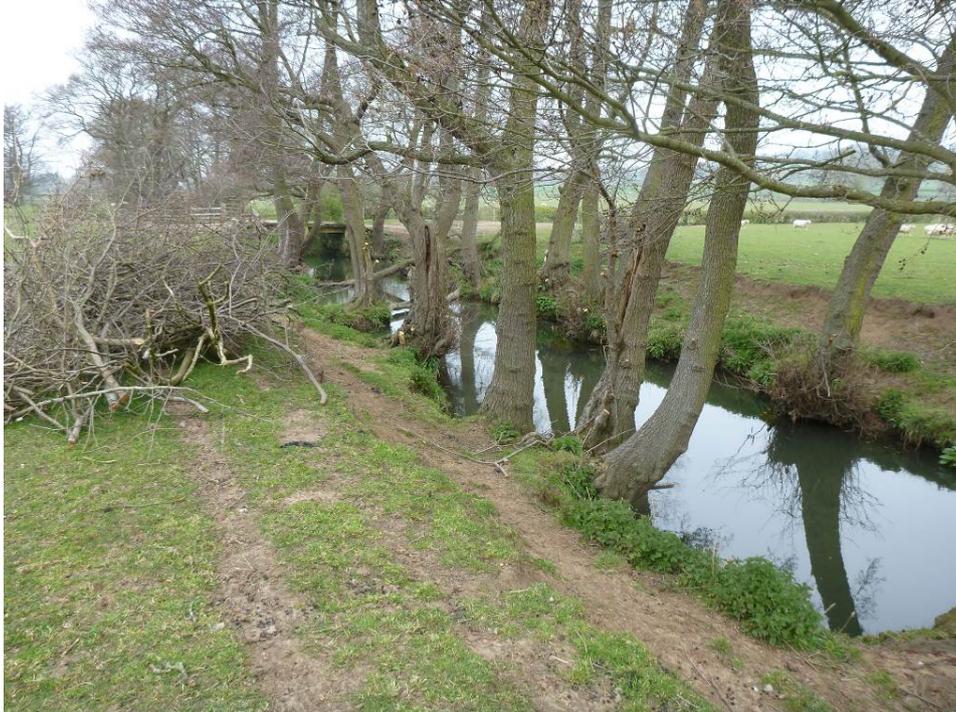
At one point, EFFC have pruned the lower branches of trees to facilitate angling access. This has reduced the amount of low cover over the water and hence the fish-holding potential of this area. The area of pruning was inaccessible for angling previously, but a far better approach would be to 'hinge and lay' the low branches into the water; this would increase cover for fish whilst improving angling access (see Recommendations).

Photo 3 Pruning of low branches over the water has reduced fish-holding potential of this area. A much better approach is to hinge and lay the stems into the channel. Note the sheep tracks immediately behind the trees which contributes to their accelerated loss when the river erodes these unvegetated areas during floods. Coppicing one or two trees in areas such as this would be beneficial (to provide bushy re-growth and low cover), but livestock must be fully excluded to prevent browsing of the re-growth which would ultimately kill the tree.

- Retain woody material in the river channel to provide cover and refuge habitat / resting lies for trout. Good cover is critical in increasing the fish holding capacity of a small river like this.
- Think carefully about tree pruning for angling access and retain low cover and use 'hinging' (similar to hedge laying) rather than removal of low branches (Photo 5). Coppicing a small number of larger alders in selected locations would provide re-growth suitable for hinging in the future – it is essential however that the coppiced stools are protected from grazing.

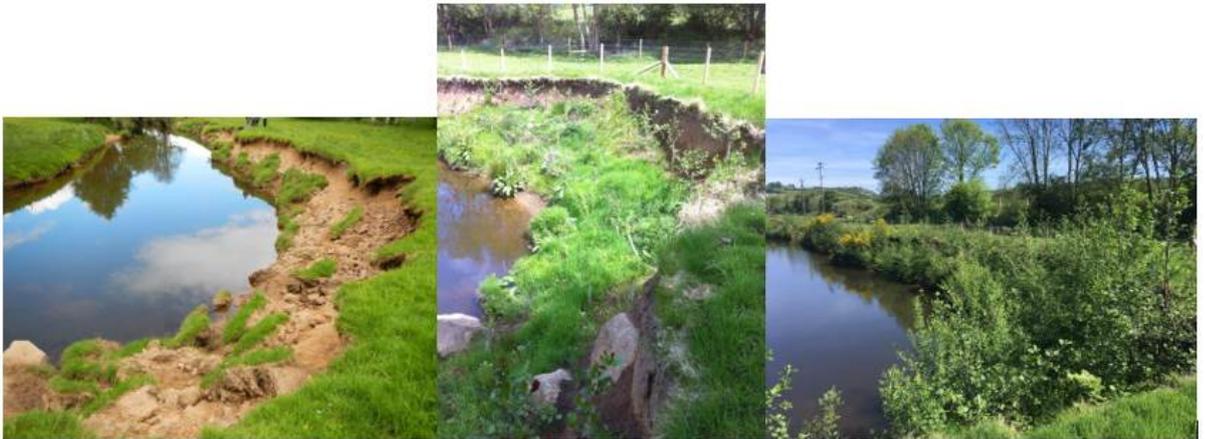
Photo 4 The result of well-maintained stockproof fencing – the same site in 2013, 2015 and 2017 (right to left).

- Repair and maintain the existing fencing along the river and keep it stockproof (Photo 4). Extend the length of river fenced if possible, bearing in mind the requirements for maintenance. Manage the vegetation within the fence to promote a shaggy, overhanging fringe and allow tree regeneration. Control Himalayan balsam and make sure angling access points don't defeat the aim of more shaggy vegetation. Bear in mind that livestock can cross the river (sheep were observed doing this during the visit), so fencing of both banks is required to exclude livestock.

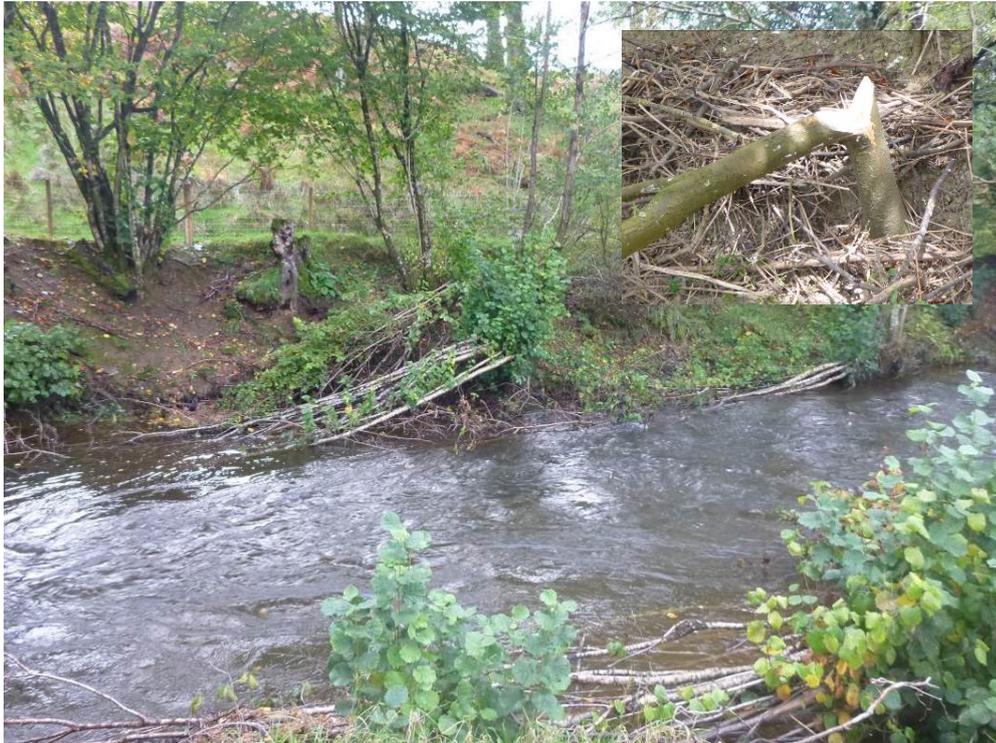
Photo 5 Smaller trees and branches partially cut and laid to create good cover. Inset: example of steeply angled back-cut to create a hinge.
