Advisory Visit for Andrew Bywater

River Eden - Skygarth Farm

24/09/2013

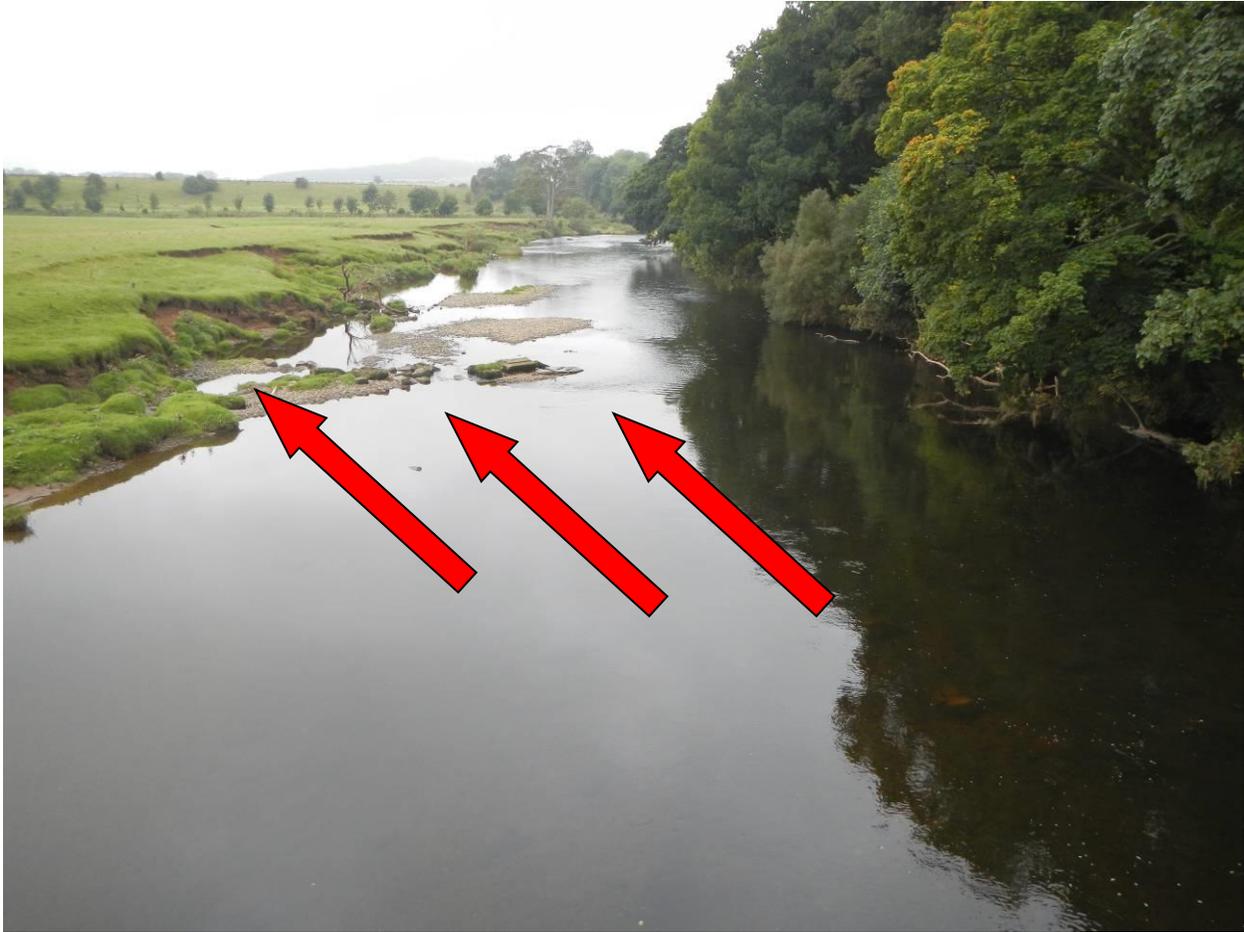
Upon reaching the river, a stark contrast between the habitat quality of the right and left river banks was apparent. The RB borders mature deciduous woodland, with a good diversity of trees and diverse marginal vegetation. Low level and trailing branches, along with large woody debris (LWD) provide excellent shade and cover along the margins and an abundance of fish holding features (Figure 1).

Past attempts have been made to narrow the channel with the use of a downstream facing groyne. While at low flows, the groyne provides some of the desired effect by narrowing the channel (by both the structure, and the deposition it facilitates), and increasing flow velocities and scour within the channel, once the groyne is overtopped it directs additional flow into the already susceptible grazed LB, which has increased the rate of erosion.

Figure 1. Excellent habitat along the right bank, provided by low branches and woody debris. The rock groyne is exacerbating erosion on the already susceptible, grazed left bank (red arrow).

To reduce erosive flows against the LB, it is recommended that the rock groyne located downstream of the footbridge (Figure 1) is removed. While the narrowing effect it creates does provide beneficial reduction in channel width at low flows, it is also working as a downstream flow deflector and turning higher flows which over-top into the LB and increasing erosion.

In place of the groyne softer techniques involving large woody debris and brash could be employed to give similar benefits by increasing deposition along the left bank that could then become vegetated (assuming stock exclusion). This would facilitate a more sustainable, natural channel narrowing, without the risk to the river bank that the groyne poses. Figure 12 shows how 'tree kickers' (trees that have been cut down and tethered into the river margins to provide deflection of flows) can be used to encourage additional deposition along bank.

However, if livestock are excluded from the LB bank and brash/living willow protection installed alongside and downstream of the groyne, the erosion may be controllable.

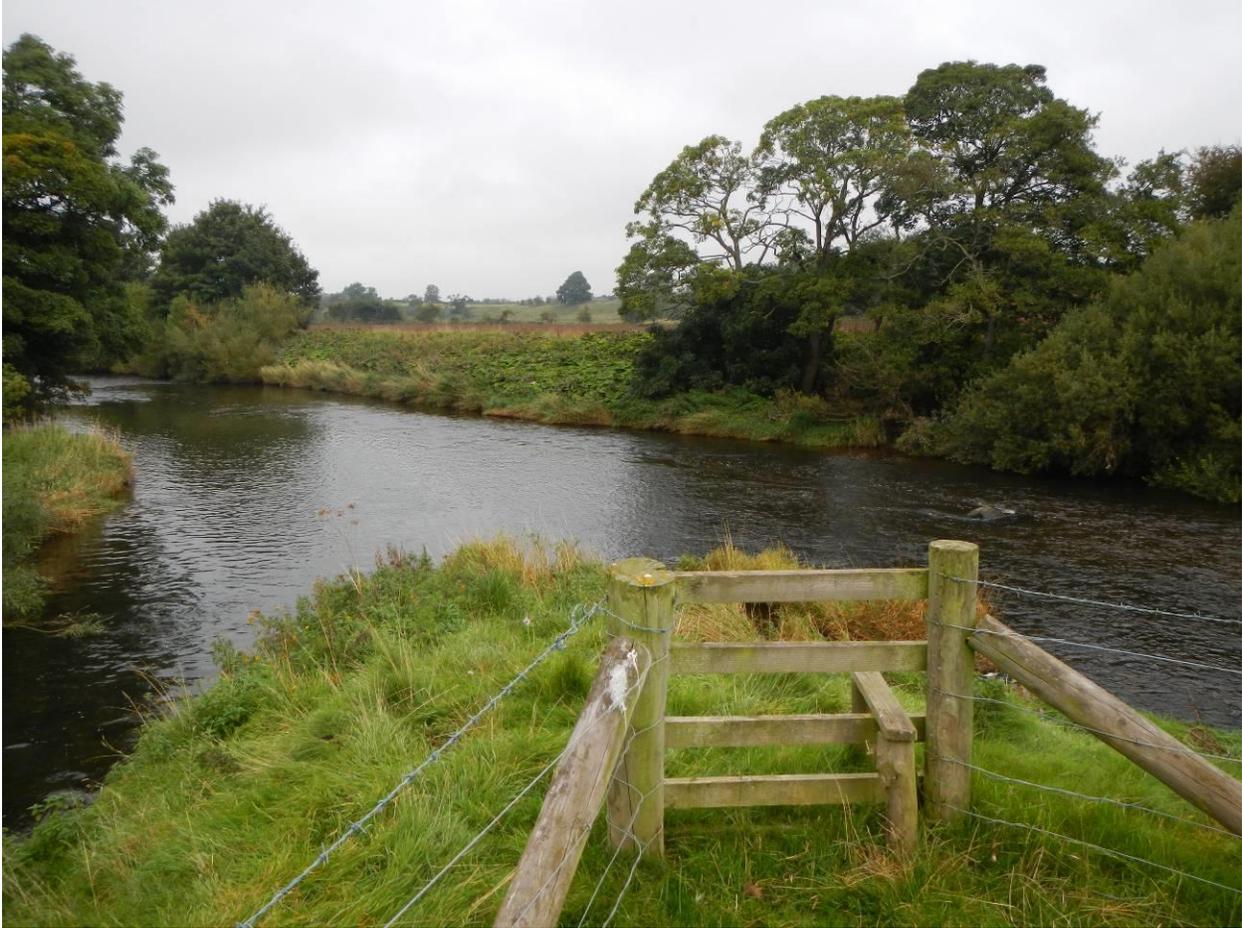
In areas where livestock are excluded from the river bank, a significant increase in the quality and diversity of bankside vegetation can be observed (Figure 2). This not only provides valuable shade and cover habitat for fish and invertebrates, but also increases the integrity and stability of the river bank, greatly reducing the rate of erosion. As a consequence, areas of channel where livestock are excluded from the bank are narrower, due to reduced rates of erosion and natural narrowing through marginal encroachment. This is because, over time, depositional features within the margins of over-wide river sections can become vegetated in the absence of grazing pressure; these features then become consolidated to form the new bank line (see examples in recommendation section). As the extent of this narrowing is governed by the natural erosive forces of the river, it will subsequently maintain an optimal width.

Figure 2. Improved river bank vegetation resulting from livestock exclusion. The quality of vegetation is still less than optimal on the near bank, due to sheep getting through the poorly maintained fence; however, a naturally diverse vegetation structure can be observed on the far bank where stock are completely excluded.

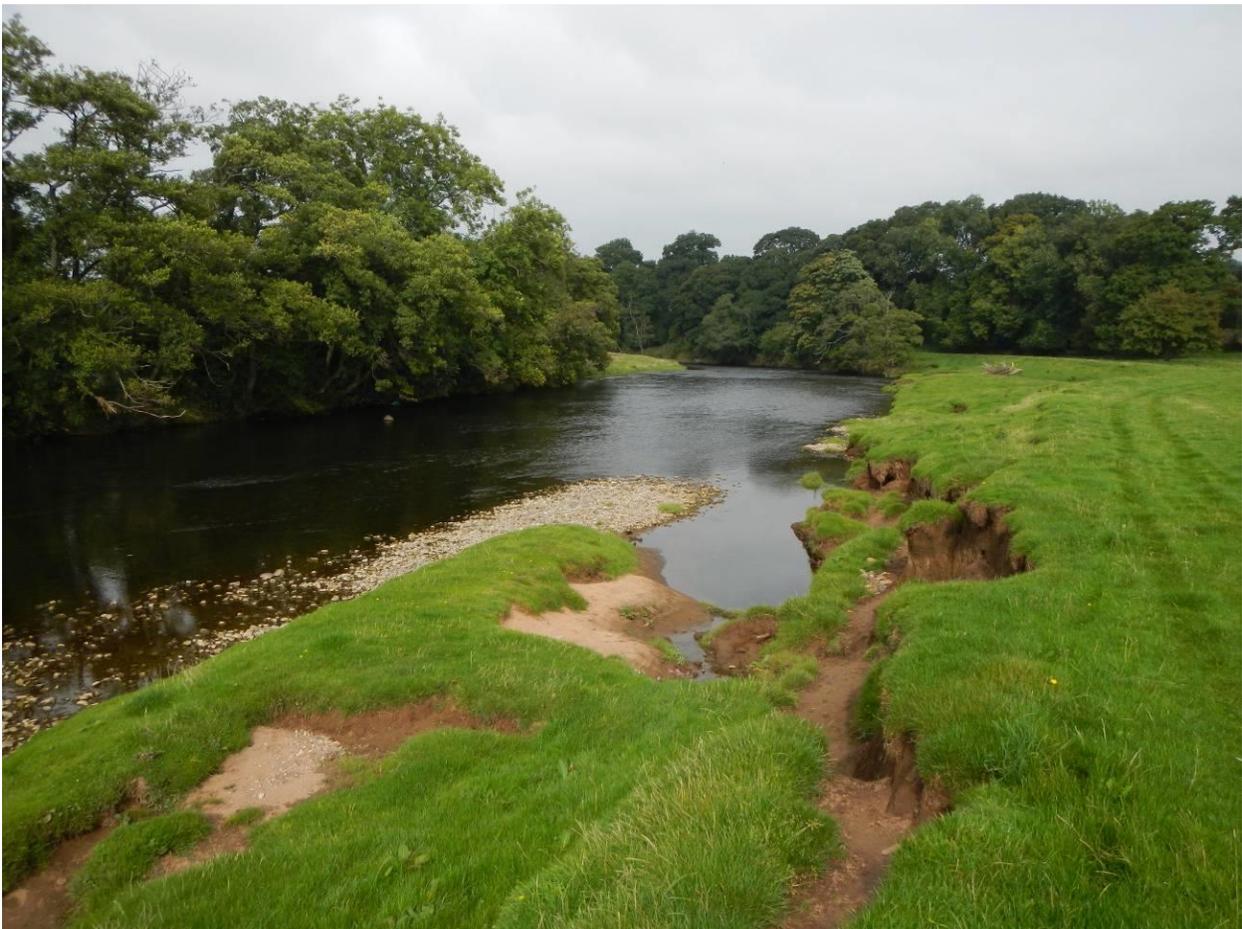
The issues with grazing and channel over-widening continue upstream, where livestock have access to the river bank. In this section the LB is fenced and supports healthy tree and herbaceous vegetation, but the unprotected RB has been heavily grazed, again leading to bank erosion, loss of trees, a significant increase in channel width and loss of channel depth (Figure 3). The wider, shallower channel sections created do provide some habitat for juvenile trout and salmon (*Salmo salar*), but the lack of deeper water significantly reduces the habitat quality for adult fish, and therefore potentially impacts upon angling and the carrying capacity of the reach.

Figure 3. Good tree cover on the far left (LB), with significant erosion issues resulting from stock grazing on the near bank. As with sections downstream, the grazing pressure has accelerated rates of erosion, resulting in channel widening and a reduction in water depth, degrading habitat suitability for larger trout.

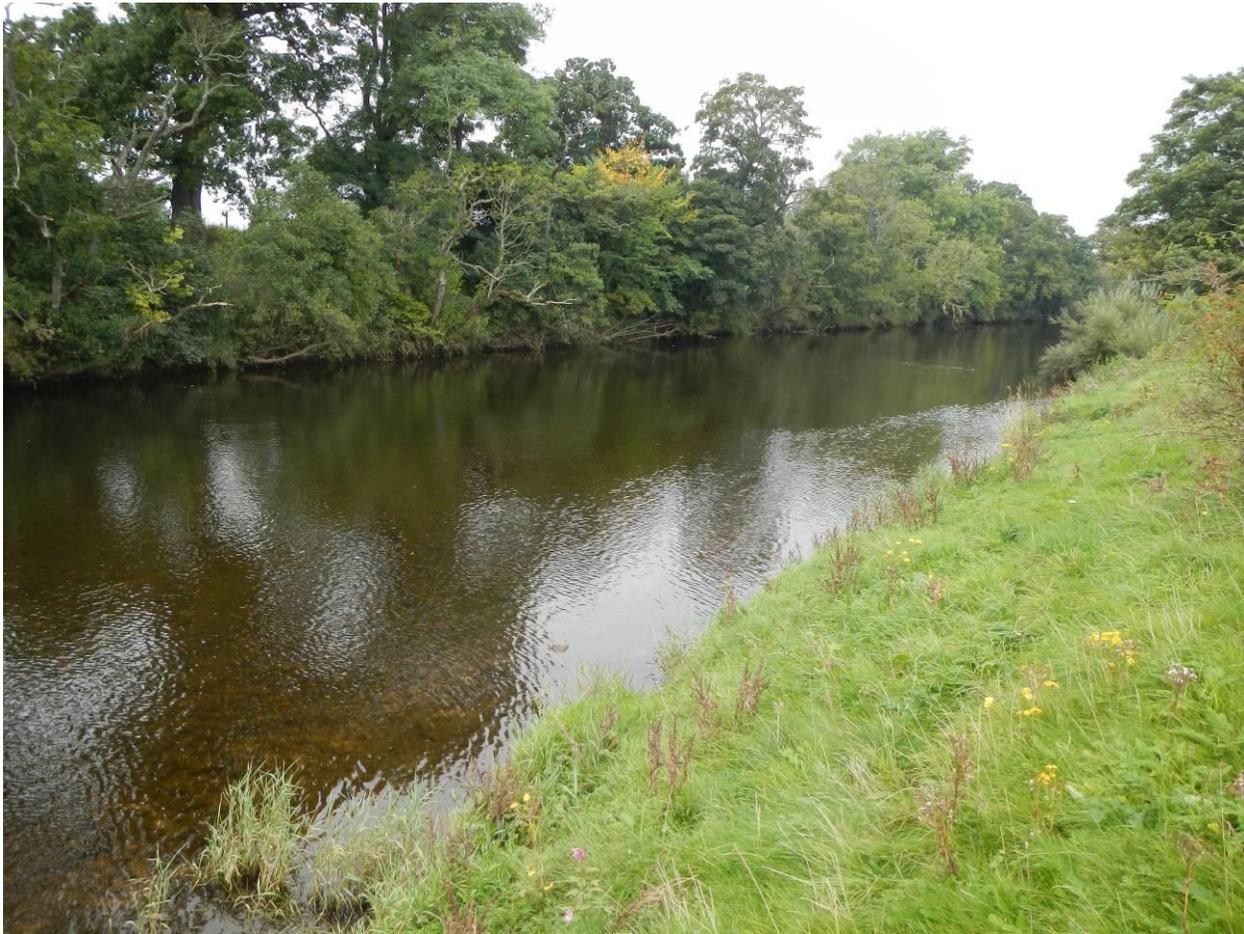
Further upstream, towards Ousenstand Bridge, the channel remains wide, but becomes deeper; however, it is suspected that this is the result of historic channel maintenance and dredging in relation to the bridge, as the channel morphology does not appear natural. The channel is deeper, straighter and wider than river flows would ordinarily maintain, leaving an over capacity channel with little flow diversity. It is, in fact, likely that over time this channel will be capturing and storing a large proportion of bed

The deeper water does provide some of the pool habitat currently lacking in other areas, and there is good tree cover along the LB. As such, the area is likely to hold some larger adult trout. However, due to the poor flow diversity, the quality and variety of habitats is greatly reduced in comparison to a natural channel, and the size range and number of fish that it can support is lower.

Figure 4. Over deep and wide section downstream of Ousenstand Bridge, suspected to be the result of past maintenance and dredging. Good cover along the LB and the availability of deeper water does provide some habitat for larger fish, as does the willow shrub on the RB.

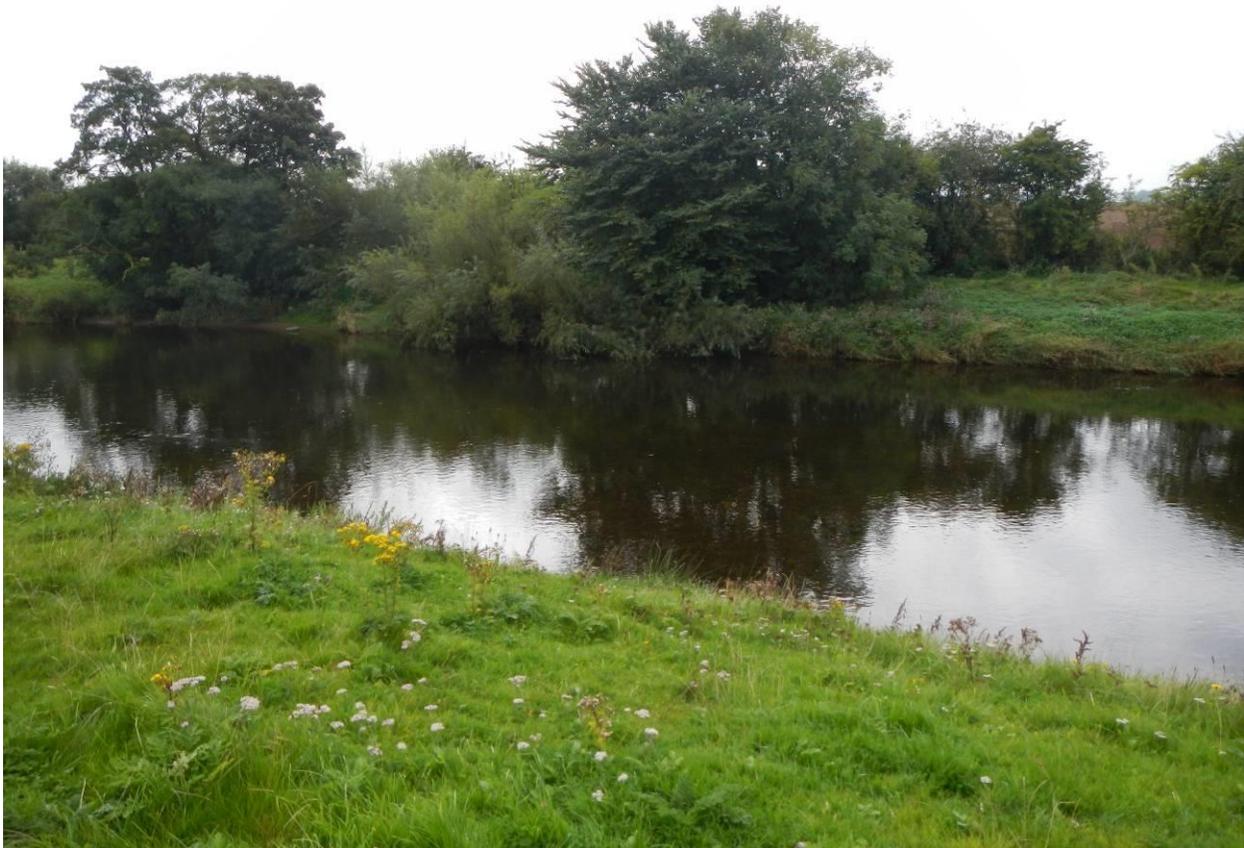
Upstream of Ousenstand Bridge, stock exclusion continues on the LB, and although not alder lined, as downstream, the bankside habitat is of a high quality. A good diversity of herbaceous vegetation lines the bank, providing bank protection and cover, with occasional willow trees and shrubs further increasing cover and providing some increased flow diversity (Figure 5).

Figure 5. Wide section of river upstream of Ousenstand Bridge, with a well vegetated far bank (LB), and correspondingly, no erosion issues. Trailing willow branches provide excellent adult trout cover and greatly enhance the habitat.

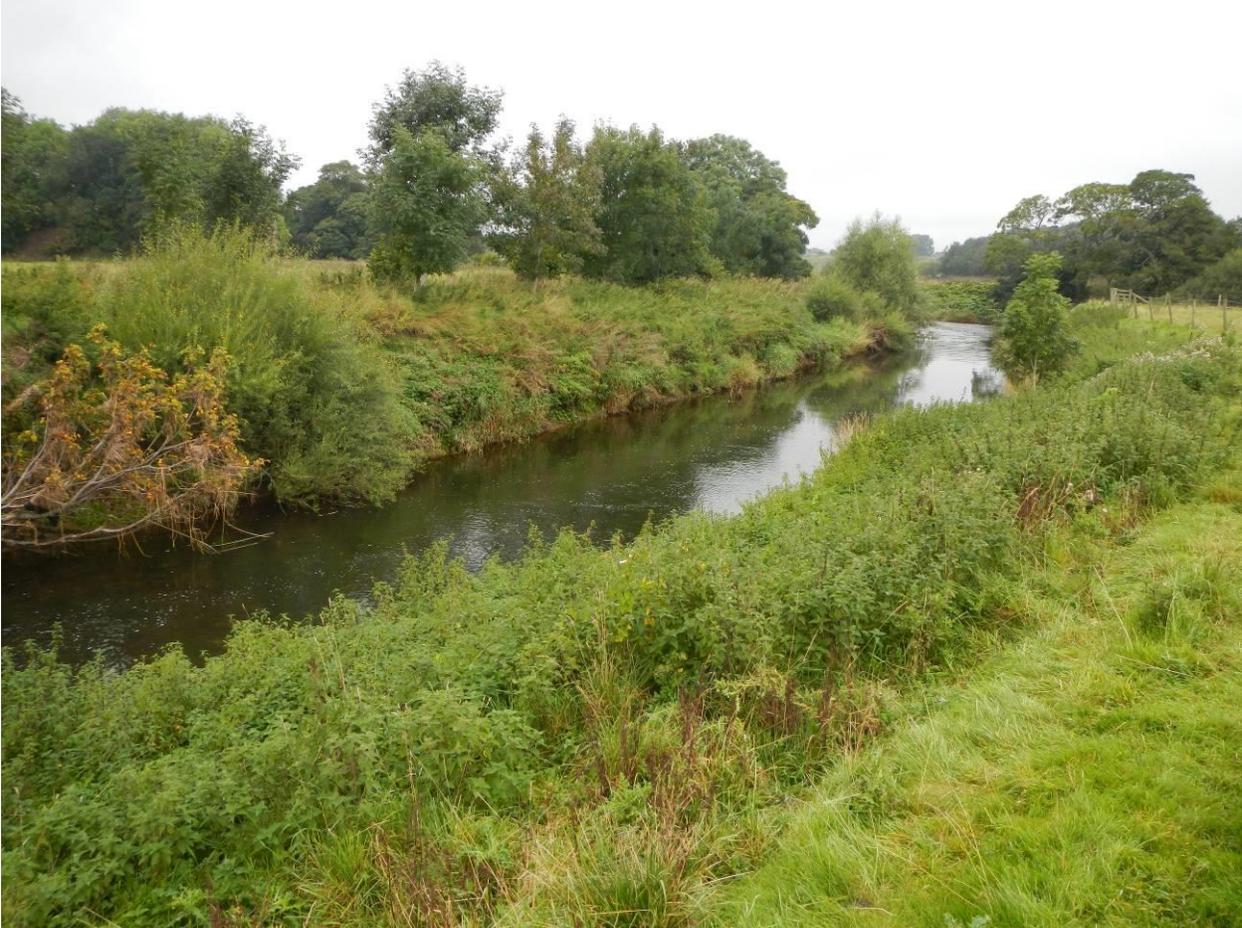
section of river has been significantly altered in the past, as evident by the uniform, straight channel (Figure 6), but also from the historic course that is still present within the adjacent field. The constrained nature of the channel is also likely to lead to further incision of the river into its bed, as being constrained by the unnaturally high banks, the energy of flood flows are no longer able to dissipate across the flood plain, causing increased bed scouring.

Although compromised by the past channel maintenance, habitat within the lower Lyvennet has begun to recover through natural events and is starting to improve. Willow trees along the banks are creating increased flow diversity and facilitating beneficial scour and erosion (natural formation of scoured pools and deposited gravels, as opposed to accelerated bank erosion) while also providing valuable cover and fish holding habitat. Fencing to exclude stock in this section has facilitated good growth of bankside vegetation and greatly reduced the potential for erosion, to the extent that the only area where erosion is an issue is where stock are regularly gaining access through the fence.

Figure 6. The lower River Lyvennet, at its confluence with the Eden. The channel is heavily influenced by dredging and straightening, but is starting to recover some natural features, with willows providing valuable habitat.

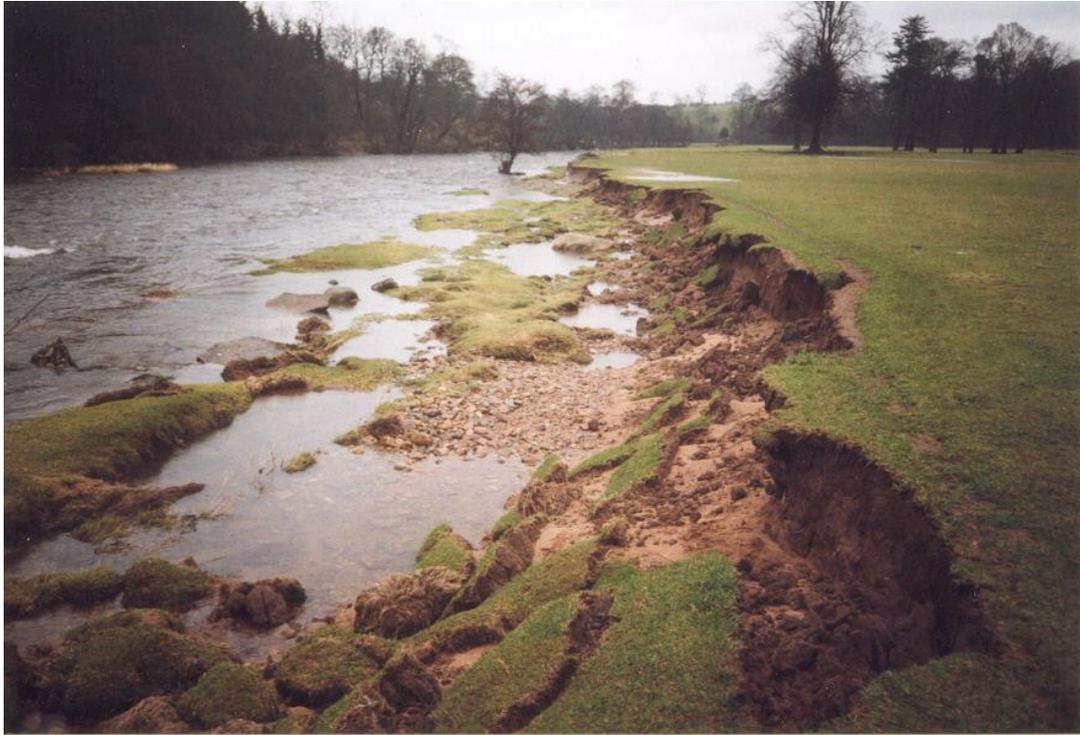
Figure 7. River Eden at Crackenthorpe before riverside buffer fencing to exclude livestock.

Figures 7 and 8, and 9 and 10 show two sections of river bank, before, and after fencing work to exclude livestock from the river – the results are pretty dramatic and a direct comparison can be drawn between those locations and the likely improvements that could be realised in the land shown in figures 1 & 3, if livestock are excluded from the river banks.

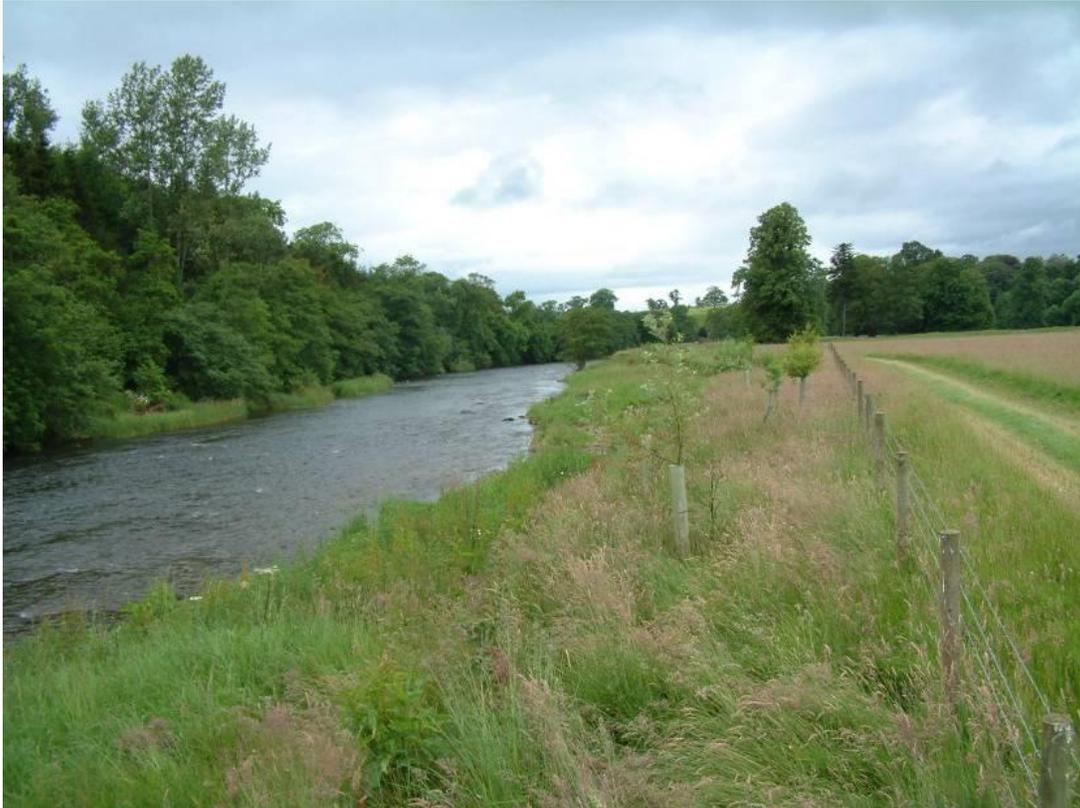
Figure 8. River Eden at Crackenthorpe after riverside buffer fencing to exclude livestock.

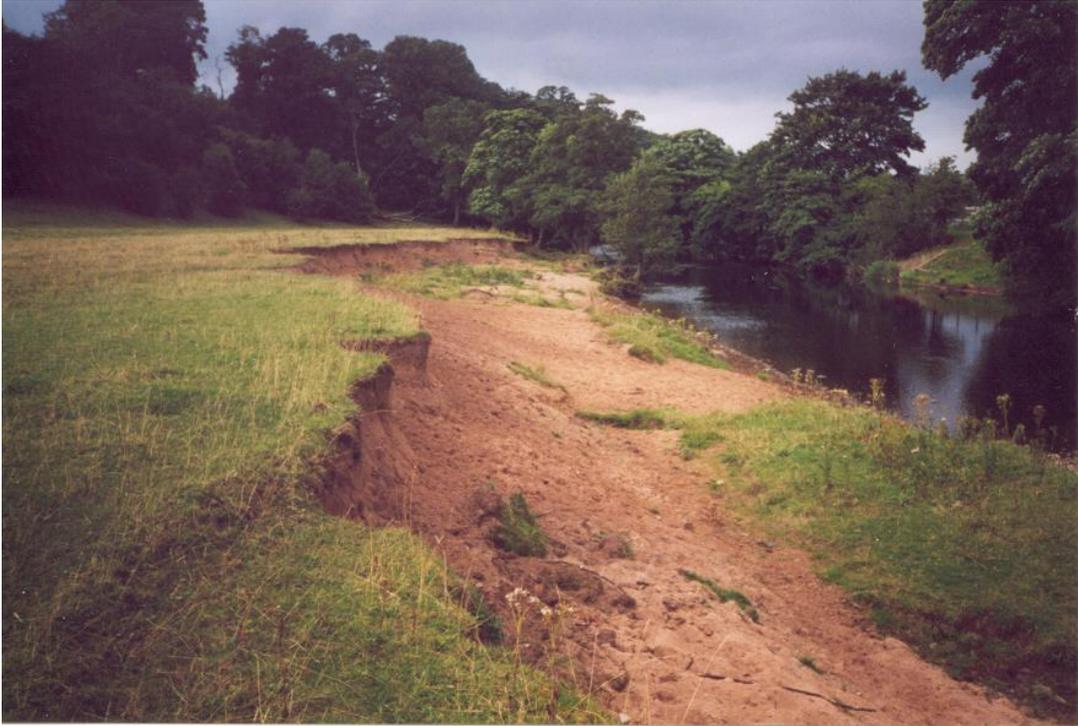
Figure 9. River Eden at Barrowmoor before riverside buffer fencing to exclude livestock.

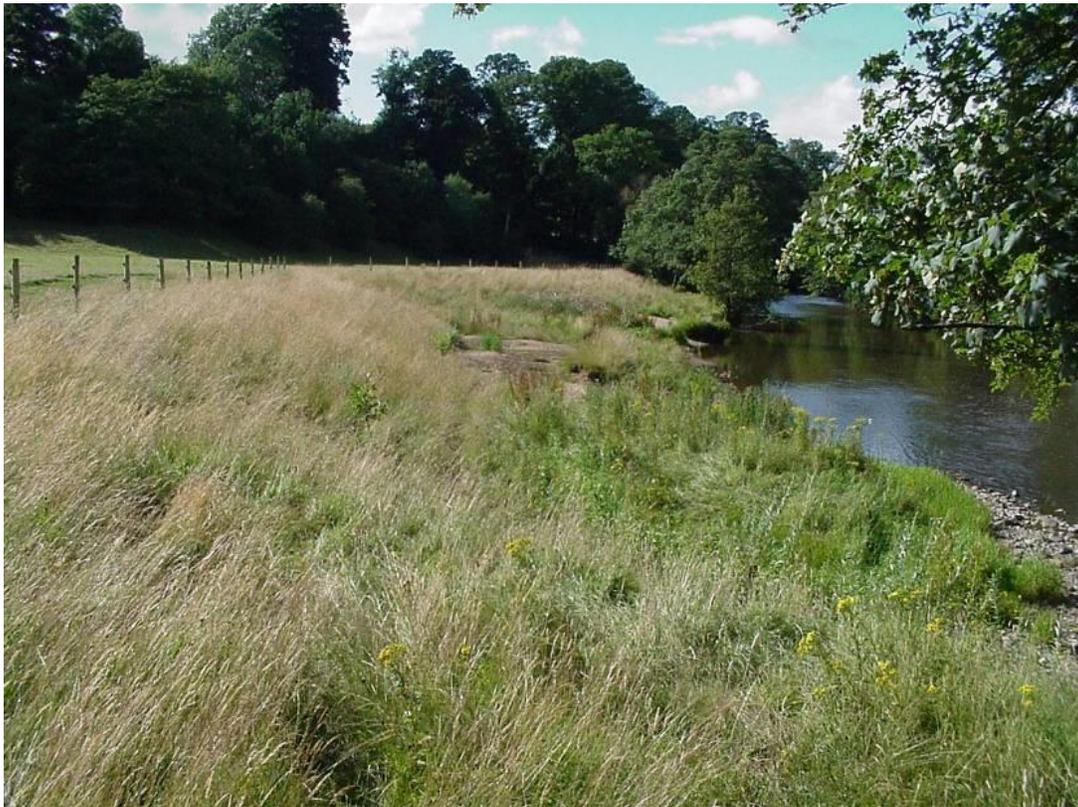
Figure 10. River Eden at Barrowmoor after riverside buffer fencing to exclude livestock.

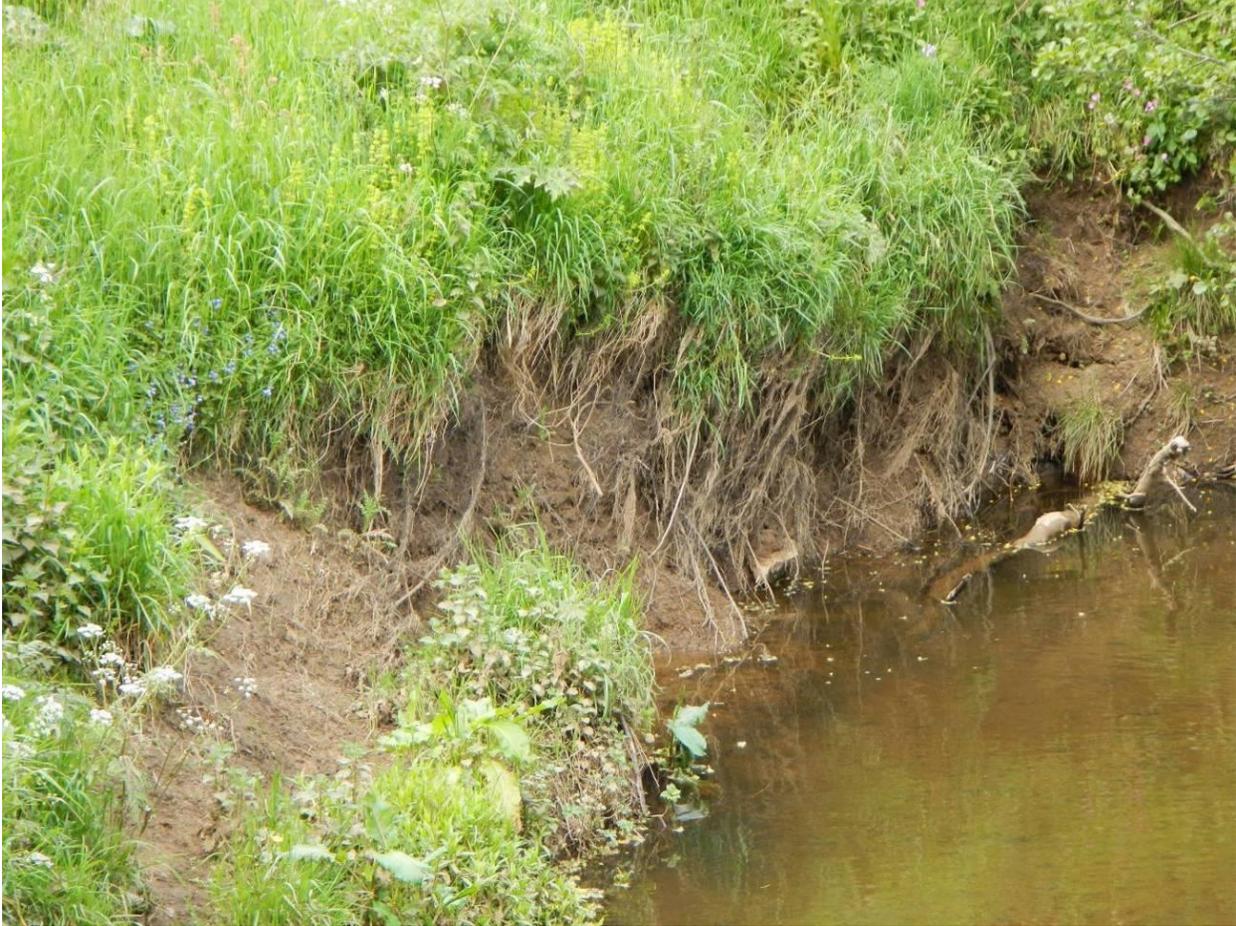
Figure 11 shows a great example of the extensive (40-60cm), diverse root mass that exists underneath an un-grazed turf. If this is compared to the before fencing shots of grazed banks where the root depth is around 5-10cm (Figures 7 and 9), it is easy to see why the more diverse vegetation structure of an un-grazed bank offers far greater protection at the surface and consolidation of the ground.

Figure 7. 40-60cm deep root matrix provided by a diverse un-grazed river margin which is significantly reducing the rate of bank erosion compared to heavily grazed bank.

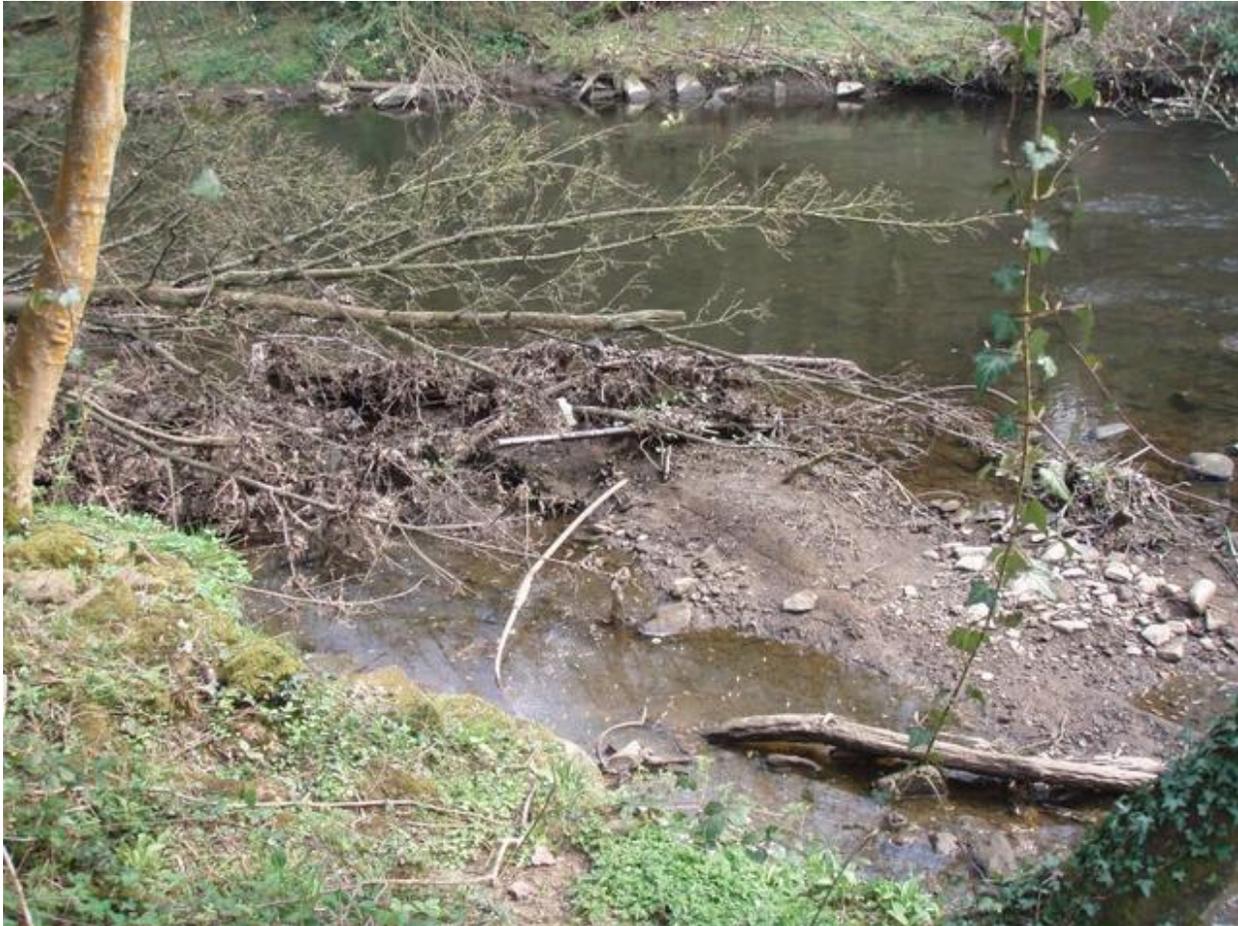
Figure 12. Tree kicker (tethered just out of shot to the left) creating beneficial deposition in its lee and creating a channel narrowing effect, with a significantly lower risk to bank erosion than a groyne. Over time the deposited material is likely to become vegetated and create a new bank line.

Tree kickers and LWD could be used in any other over-wide sections of the river (ideally following stock exclusion from the river banks) to narrow the channel, increase flow diversity and deposition, and provide cover, particularly in the deep, apparently dredged section below Ousenstand Bridge. In this section, kickers on the LB are likely to provide valuable cover and flow diversity, while structure installed on the RB is likely to encourage gravel and sediment deposition. Again, excluding stock from the riverbanks will maximise the benefits that can be gained from these techniques, as it will allow consolidation of any exposed depositional features and natural narrowing.
