Afon Eigiau and Llyn Eigiau - Dolgarrog

An advisory visit carried out by the Wild Trout Trust – June 13th 2013

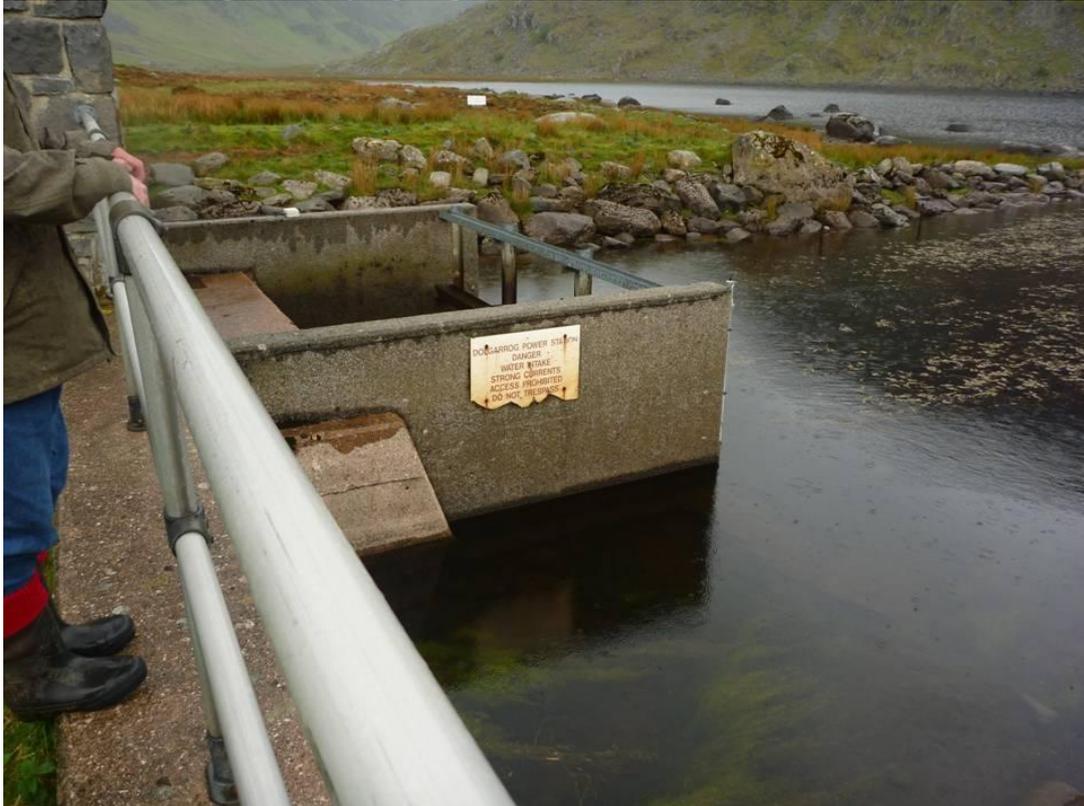
The first feature inspected was the draw-off outlet for hydro-electric generation at SH 72108 64900 (Fig. 2). Since the failure (and subsequent additional dismantling) of the dam, these sluice gates now exert the principle control on the level of water in the lake. Whilst the original damming would have artificially raised water levels, it is locally-believed that the current operation of the sluices impacts on the ecology of the lake. The protocol for the transfer of water imposes a heavily-regulated pattern of water level and, consequently, littoral (shore-line) wetting and drying regime.

Figure 2: Draw-off point for transferring water and associated hydro-electricity generation

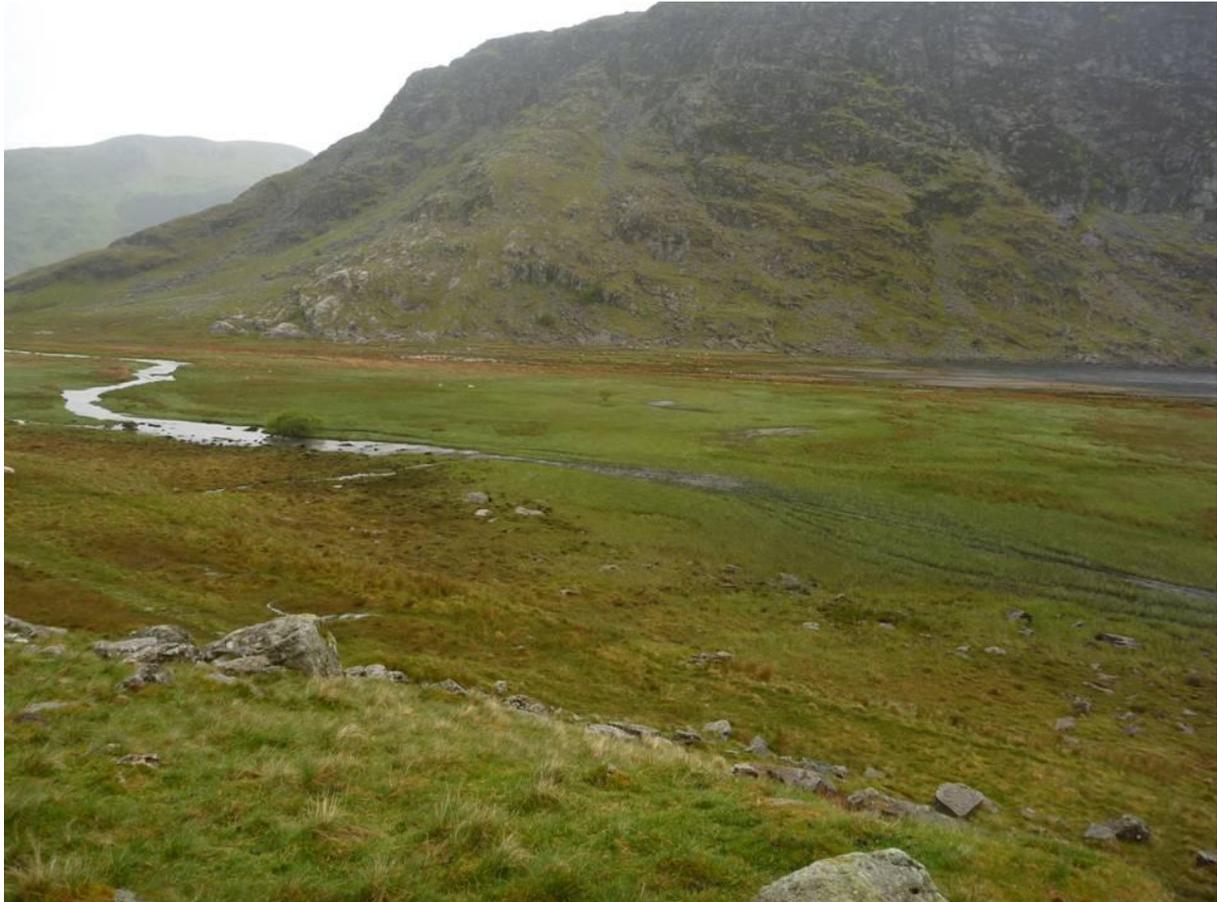
A further potential impact of reduced water levels may be acting on the ability and motivation for larger adult trout to migrate into the Afon Eigiau. The hydrological connection between the lake and the river was relatively indistinct - despite the rainfall that had immediately preceded the site visit (Fig. 3).

Figure 3: Afon Eigiau entering Llyn Eigiau via a diffuse network of vegetated channels

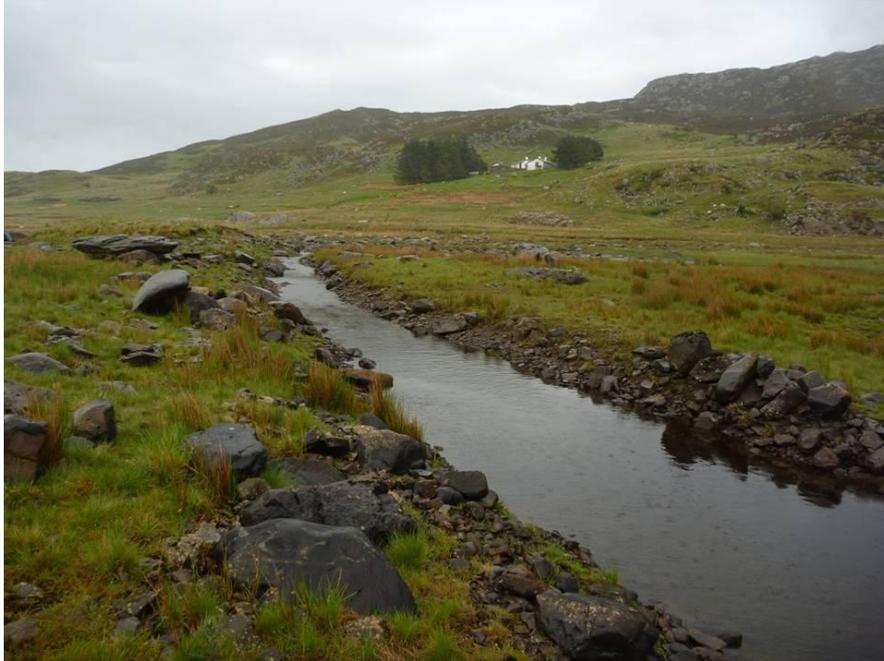
With a reduced wetted-area and the further modification of water transfer e.g. via construction of a new bypass channel (Fig. 4), it is possible that fish may have a less clear "signal" to aid in the location of the feeder stream. There may also be a reduction in the availability of any shoreline gravel spawning that can be supported by wave-action. At the same time, it is unclear as to how water-level changes will also interact with changes in the overall productivity of the lake. The majority of the previously wetted area would have consisted of extensive shallows. Due to improved sunlight penetration, these are always the most productive areas of upland lakes. Consequently, the most productive areas of the lake (in terms of plant-life, invertebrates and fry) would be lost following a reduced water level. This could impose a significant limitation on both the numbers and size of trout that can be supported. This factor, alone, would mean that reducing the total area of the lake is likely to have had a disproportionate effect on trout productivity. As a simple example, halving the area of the lake could easily reduce the population of large trout by much more than half. This is

Figure 4: Recently-constructed bypass channel serving the hydropower system: a further complication for fish migration due to controlling influence on water levels and connectivity between the river and the lake. It is also very poor trout habitat.

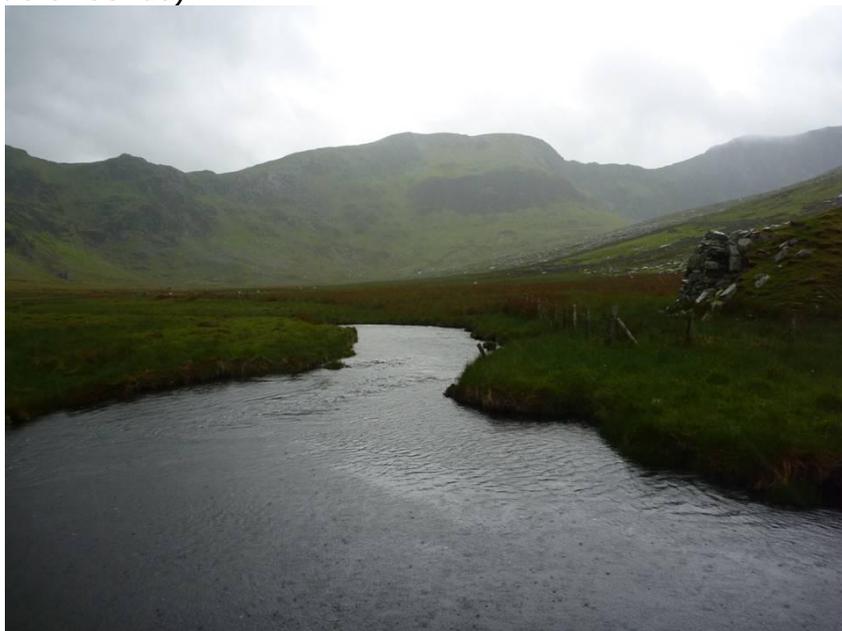
Habitat within the river channel (Fig. 5) can be characterised as supporting features such as a meandering plan-form, riffles and lateral scour pools (deposition of gravels on the inside of bends and noticeable increases in depth on the outside of bends).

Figure 5: The river displays a meandering plan-form and there is quite a good degree of variation in depth, current velocity and cross-sectional profile evident. There is, though, little or no cover for fish.

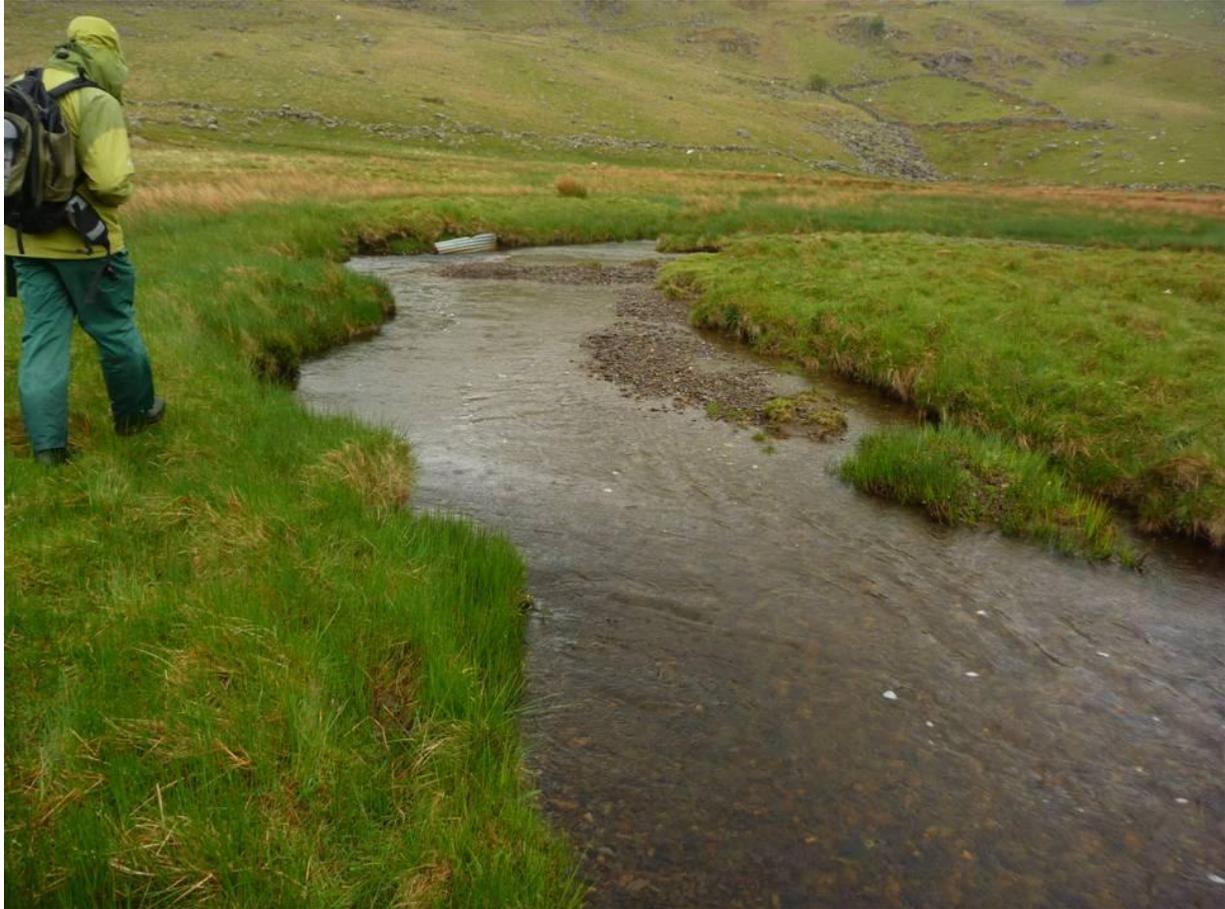
However, the bed material consists almost entirely of mobile gravels between approximately 20 mm and 50 mm in diameter. In addition, although the levels of grazing stock are relatively low, there is no succession of woody vegetation and there are examples of “block failure” of riverbanks (Fig. 6)

Figure 6: The lack of deep root structure (prevented from developing due to even comparatively light grazing at this elevation) is compounding an over-abundance of gravels by promoting low resistance in the riverbanks. Tussocks of grass in the channel (right of frame) and behind the corrugated iron revetment (upper left/middle of frame) indicate that the rate of bank erosion is too fast.

Efforts to slow this process by installing vertical sheets of corrugated metal (Figs. 6 and 7) will make the bank erosion worse immediately downstream (Fig. 6). The metal sheets are, ultimately, not effective at slowing erosion at the point that they are installed; inhibiting plant growth and exposing a vertical face of bare soil once corroded. Such flat and angular structures also increase the average pace of current – as well as promoting strong eddying flows during spate conditions. Both of these factors result in worse erosion of the banks, widening of the channel and further inputs of soil and gravels into the stream.

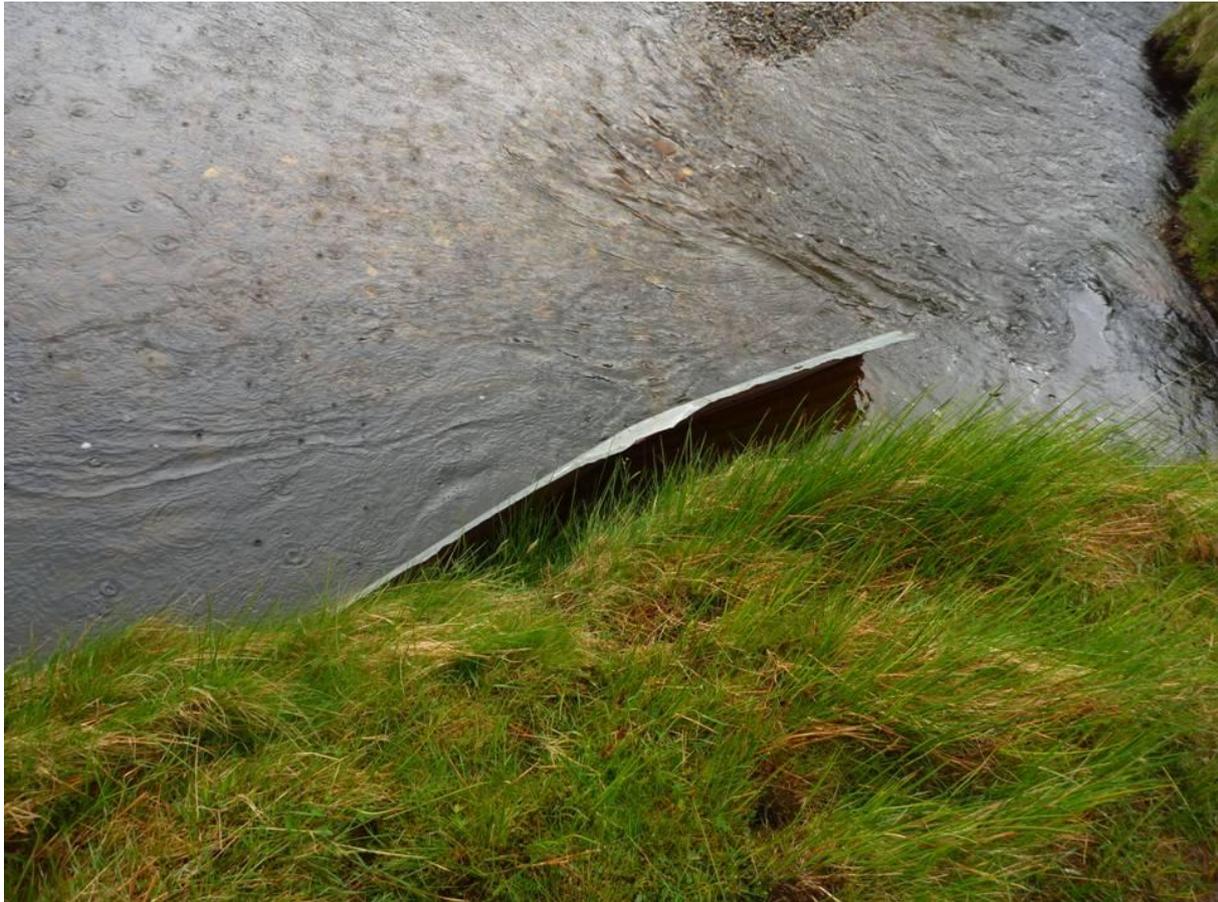
Figure 7: Sheet metal revetment (centre of frame) designed to protect the bank – but clearly causing worse erosion immediately next to it (right of frame)

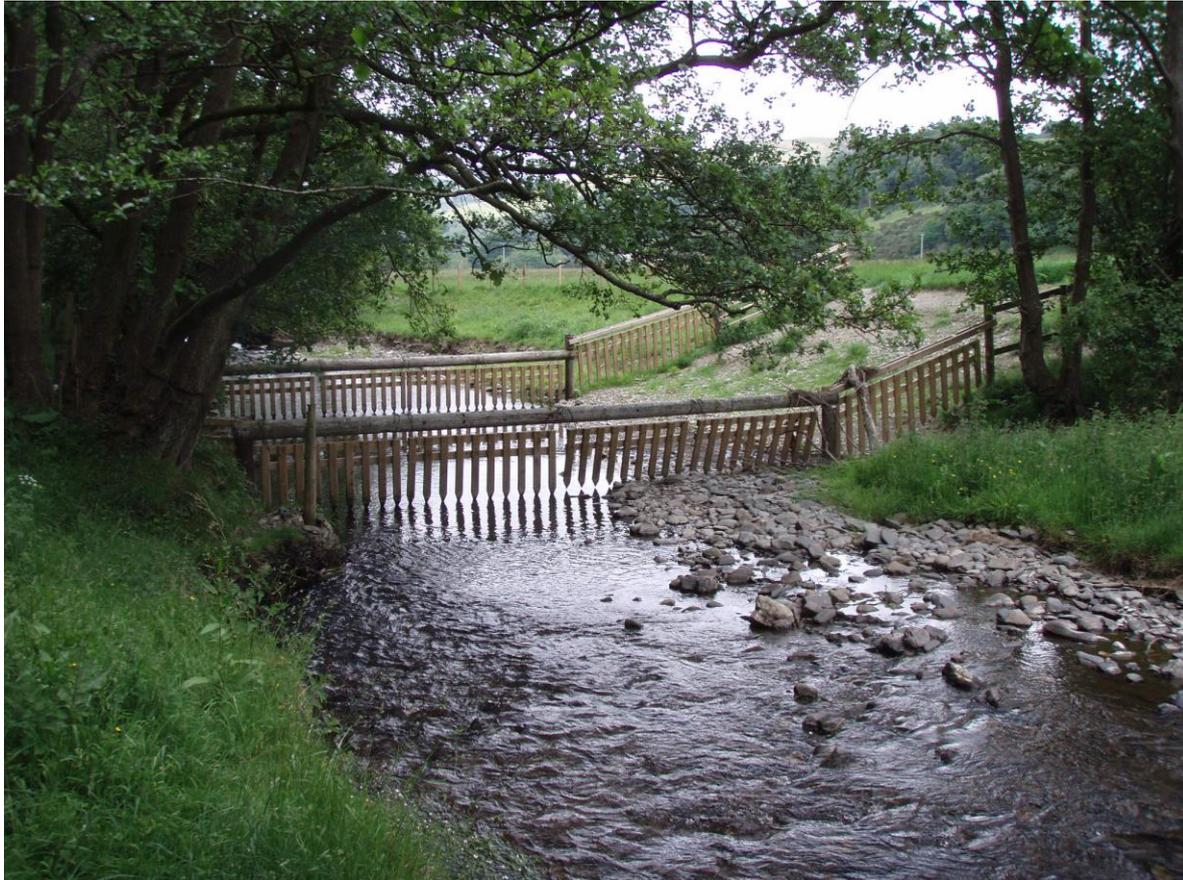
Figure 8: Example of top-hung water gates that would be required at each end of a grazing exclusion. Fencing panels that are orientated at 90-degrees to the river could also be installed in a similar fashion to prevent damage during out-of bank spate flows (or the use of loosely-tacked fencing panels that will break away during floods, and be easily replaced, can be a viable alternative)

- The use of well-anchored “water gates” (Fig. 8) at both ends of a grazing exclusion offer a good insurance against changing water levels that may,

- The presence of both fenced and unfenced areas will also retain the provision of access to drinking water for grazing stock (as well as retaining “nursery” habitat for juvenile trout).
- Fencing that is parallel to the flow of the river tend to remain largely undamaged by out-of-bank spate flows; whereas the installation of sacrificial “breakaway” panels (or even top-hung panels; Fig. 8) that are orientated at right angles to the flow can reduce maintenance requirements following flooding
