Advisory Visit

River Elwy, Conwy, North Wales

14th September, 2008

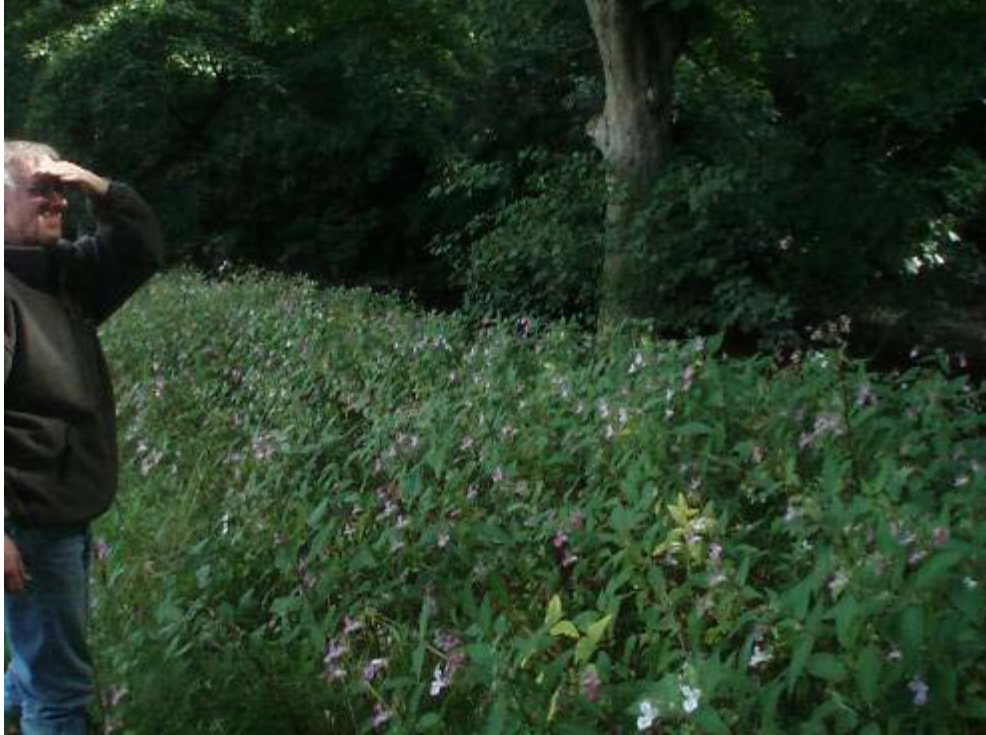
The river was walked from the footbridge at the upstream limit of the fishery (SH 914696) in a downstream direction. The road runs close to the RHB here on the outside of a bend in the river. Here the bank is steep and has been heavily engineered with steel pilings and gabion baskets to prevent erosion undermining the road. The left bank has mature sycamores and alders at regular intervals. Land use on both banks throughout the reach was for livestock grazing. There is a lot of Himalayan balsam (*Impatiens glandulifera*) present here, and throughout the rest of the fishery (Photo 1).

Photo 1 Himalayan balsam – common throughout the fishery

It tolerates low light levels and, in turn, tends to shade out other vegetation, impoverishing habitats. Being an annual plant it dies back in winter leaving large areas of bare bank vulnerable to erosion. Its presence along riverbanks is therefore undesirable.

- Control Himalayan balsam. This can be achieved by physical or chemical means:

The main method of control, and usually the most appropriate, is pulling or cutting plants before they flower and set seed. Working parties are the best means of doing this.

Himalayan balsam can be controlled with a weedkiller based on glyphosate, such as Roundup. Glyphosate is a non-selective, systemic weedkiller that is applied to the foliage. It is inactivated on contact with the soil, so there is no risk of damage to the roots of nearby plants, but care must be taken that the spray doesn't drift onto their foliage. Glyphosate is most effective when weed growth is vigorous. This usually occurs at flowering stage but before die-back begins; with most weeds, this is not earlier than mid-summer.

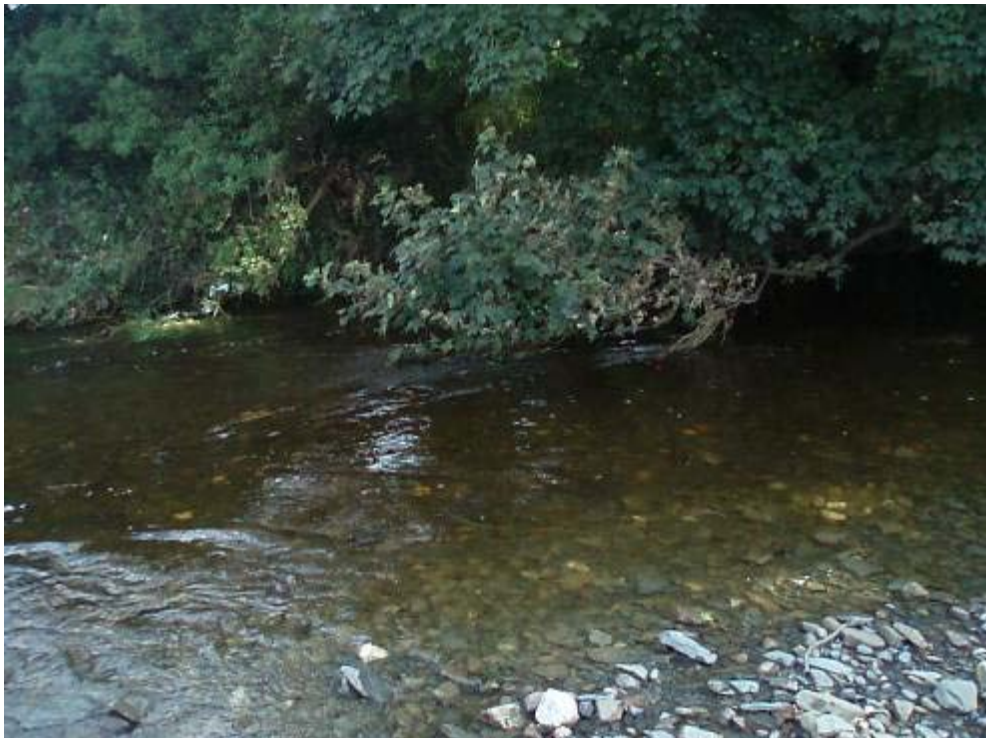
Photo 2 Clean gravel at the head of a riffle and low overhead cover – ideal spawning habitat

Another important aspect of spawning habitat is the presence of cover for adult fish to provide security from predation during spawning in shallow water. Woody debris or low, overhanging branches can greatly enhance the likelihood of fish using a particular area for spawning (Photo 2).

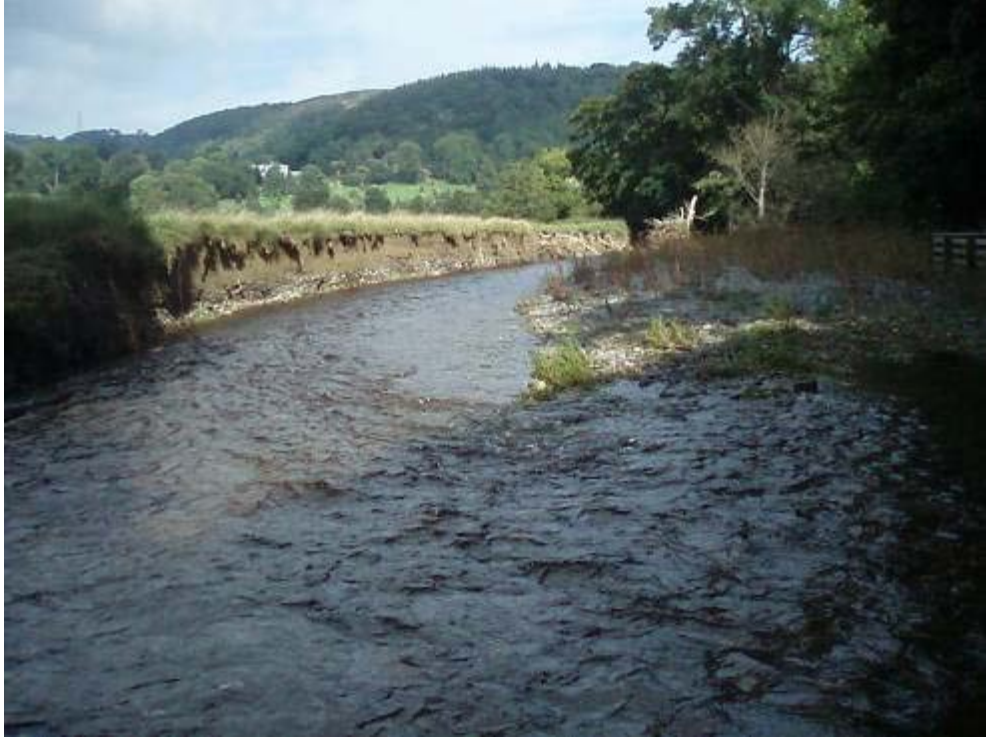
About halfway down the first LHB field from the upstream access, the mature trees give way to an open bank with an eroding river cliff (LHB) and large gravel shoal opposite (RHB) (Photo 3). A livestock drinking area has been left 'high & dry' on the right bank by the deposition of gravel in this area. At the downstream end of the river cliff a large mature tree has fallen from the LHB into the river (Photo 4). The presence of the tree in the river has caused localised scour of the river bed, creating deeper areas suitable for holding adult fish (Photo 5).

Photo 3 River cliff (LHB), gravel shoal and isolated livestock drinking area (RHB)

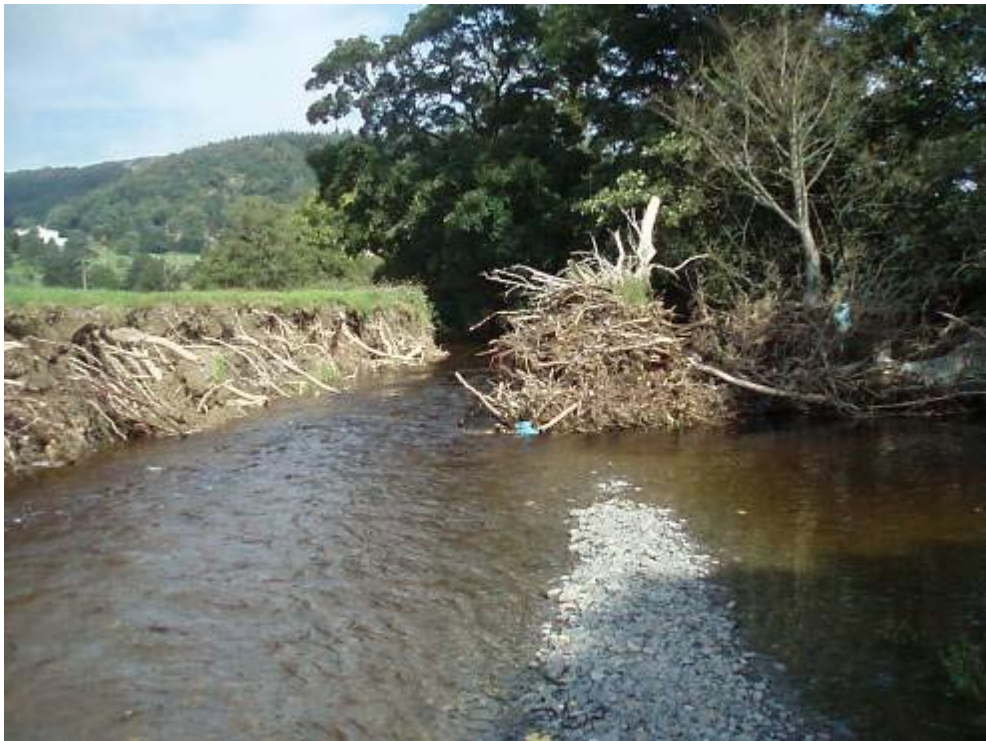
Photo 4 Mature tree lost from the LHB

- Where there is a single tree line along a river bank, tree planting behind this should be considered to provide a succession of mature trees in the future. This will insure against severe erosion developing if a tree falls in the river leaving an exposed bank. This is particularly important on the outside of bends, and where alders are present as these are vulnerable to *Phytophthora* disease. There may be grants available to landowners under agri-environment schemes (e.g <http://www.forestry.gov.uk/forestry/infd-5z8jqk>).

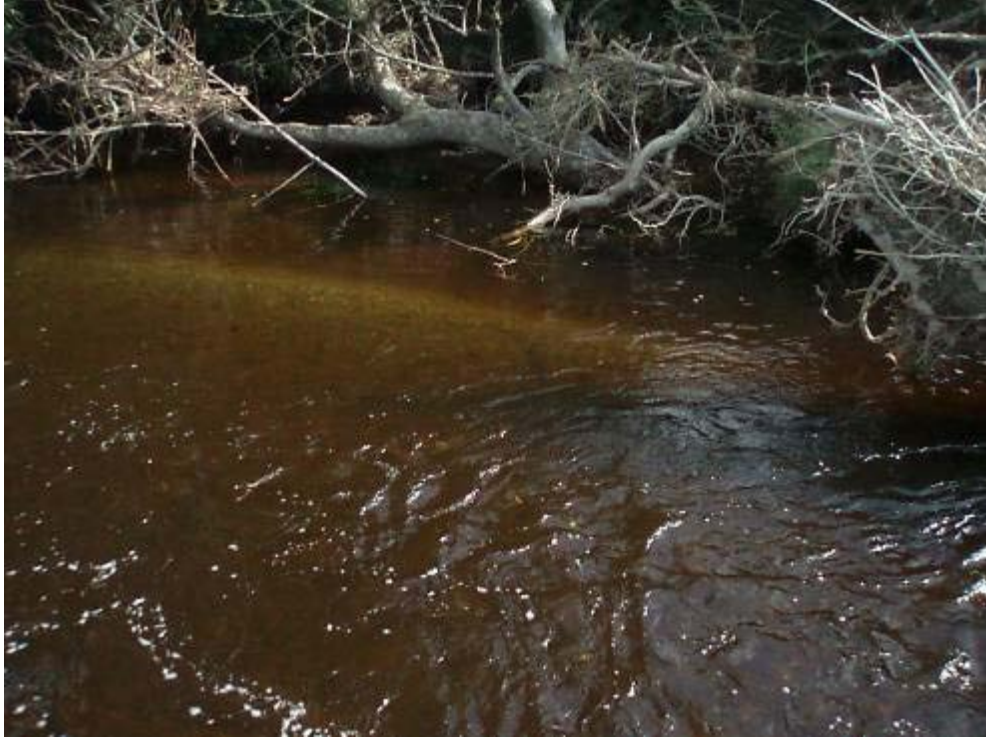
Photo 5 Scour and sorting of gravels caused by the presence of large woody debris in the channel

- The club should adopt a policy of retaining LWD in the river channel wherever possible. The West Country Rivers Trust provides a useful guide to the management of natural LWD:

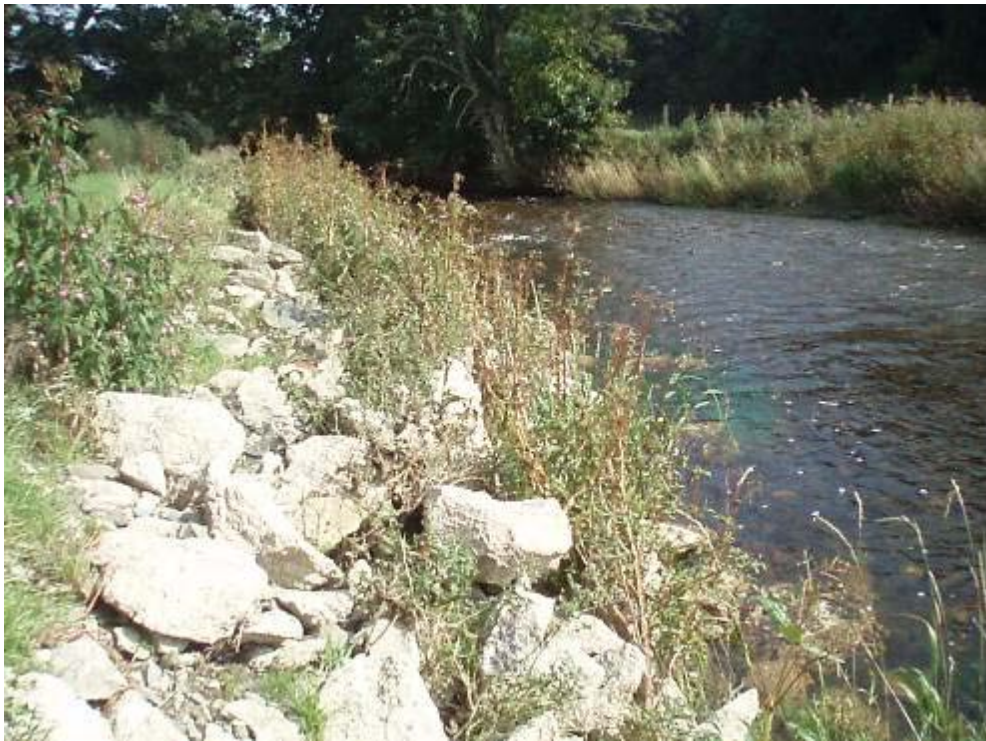
A large proportion of the banks of the fishery (particularly the LHB) have been reinforced with rip-rap comprising boulders and concrete blocks. Some of this dates back many years (as evidenced by the trees growing through the stonework), and some is very recent (within the last year). This reinforcement has been carried out by local farmers concerned about erosion and loss of land (Photos 6 and 7).

The extensive use of rip-rap has limited the opportunity for the river to create pool areas through erosion on the outside of bends, and has compromised the value of the bankside habitat for species such as water voles, otters and burrow-nesting birds such as kingfishers and sand martins.

Photo 6 Concrete block rip-rap used to reinforce the river bank

- Where extensive stone revetment has been installed along sections of wide, shallow river, it may be possible to create more depth variation by constructing groynes similar to those in Photo 10. LWD should also be encouraged in these sections, as this will promote scour of the river bed and depth variation. Planting willows (goat willow *Salix caprea* and grey willow *Salix cinerea*) amongst the rock revetment will also help to provide cover for all trout life stages along the river margins.

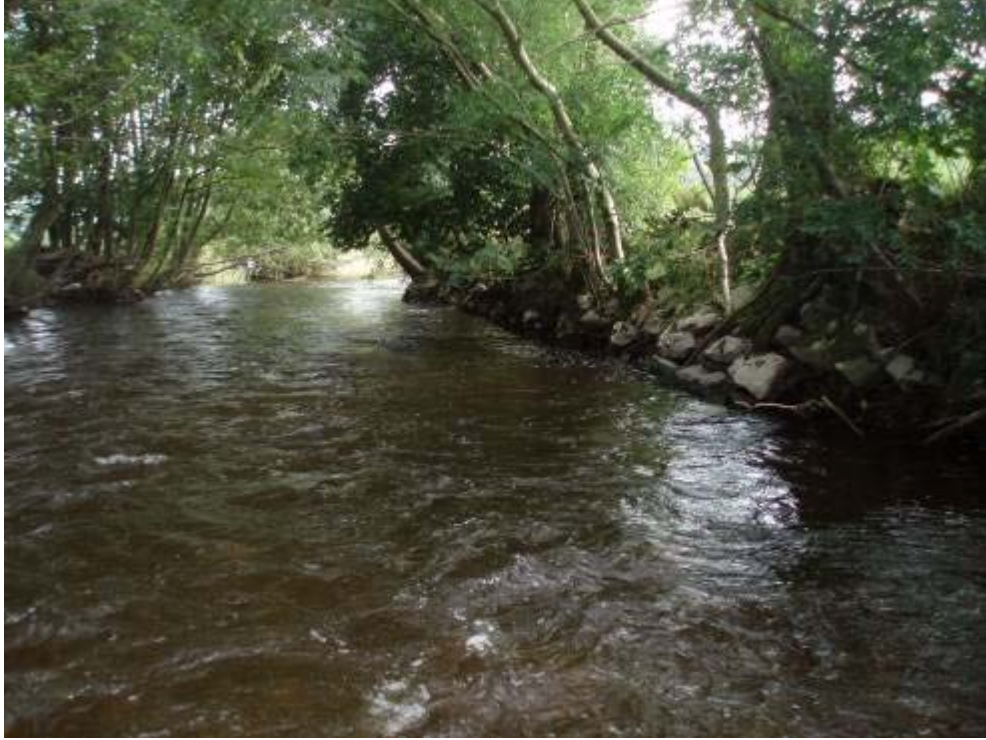
Photo 7 Older stone revetment with tree growth

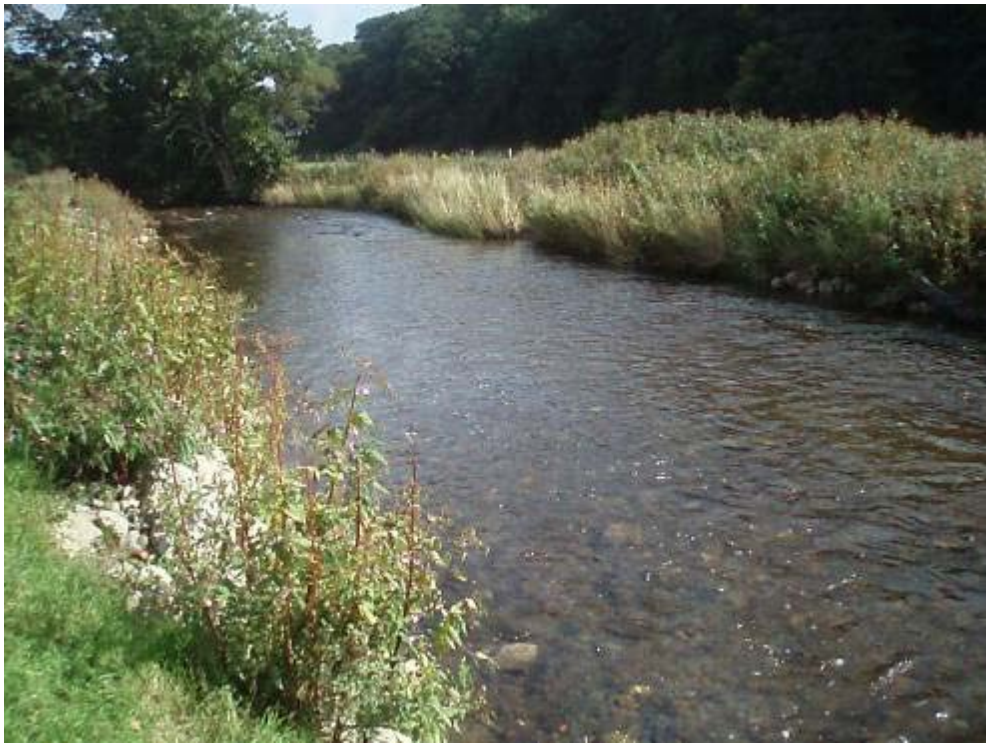
Photo 8 Shallow glide area with little depth variation

Throughout the fishery there is a relative lack of pool habitat, the reach being dominated by riffle and glide; this will tend to limit the capacity of the reach for holding adult trout (and sea trout and salmon). The water level was up by around 10—12" on the day of the visit, so many of the glide areas observed would be very shallow or exposed at low water (Photo 8).

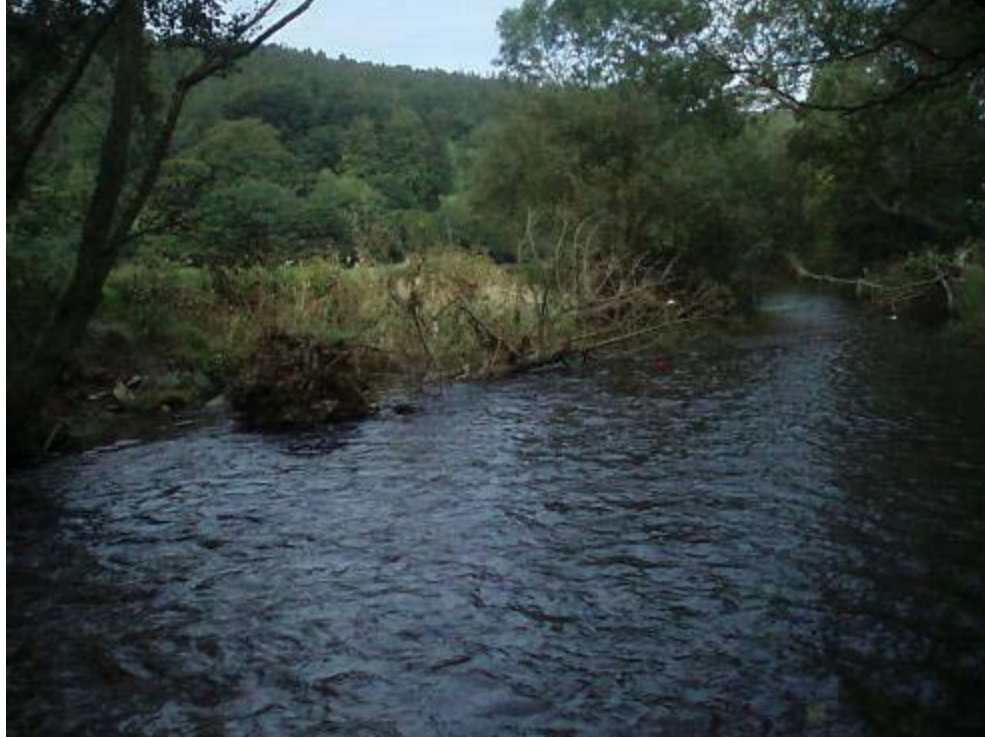
Photo 9 Valuable LWD in the river channel. Repositioning and securing is more desirable than removal

It appears that much of the LWD removed previously from this section of the river was carried out by local farmers. The key issue here will be liaison with the farmers over the management of LWD. Where LWD is causing flows to erode banks, repositioning it to protect the banks rather than removal would be a better option (Figures 1 and 2).

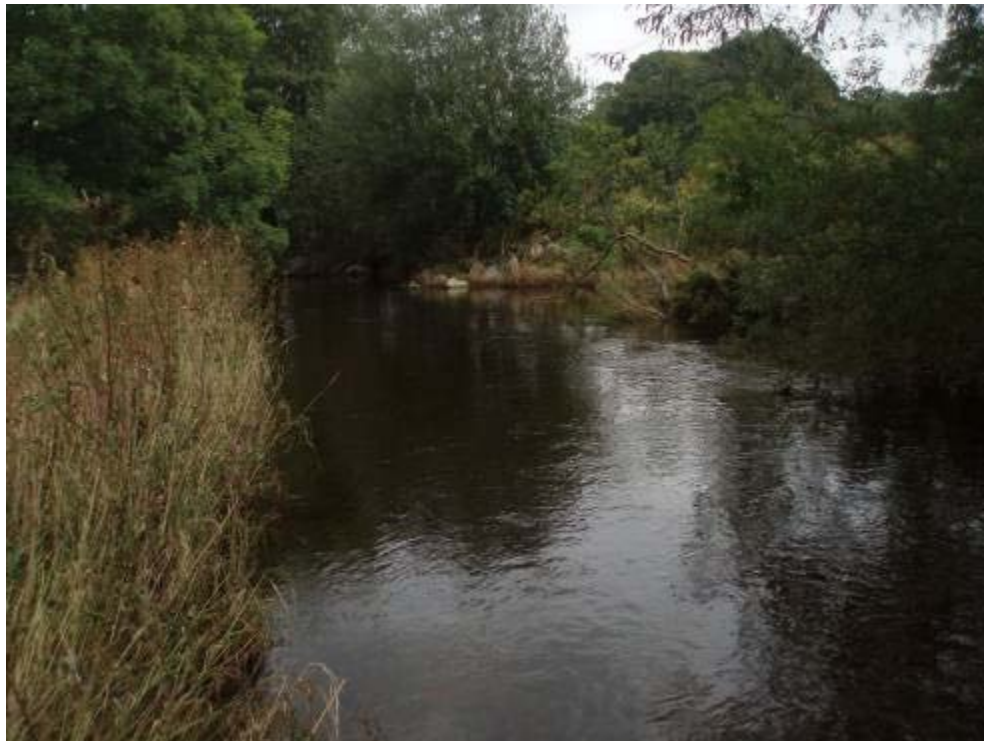
- There is sharp bend in river and erosion on the outside of the bend has created depth. There is limited opportunity for this process because of the extensively rip-rapped banks throughout the fishery.
- There is large woody debris (LWD) present which has created localised scour of the river bed. There is not much LWD present in the river as it is often removed by the local farmers (Photo 9).
- There are some stone groynes in one part of the lower fishery which have promoted some bed scour (Photo 10).

Photo 10 Stone groynes on the RHB creating bed scour and increased depth

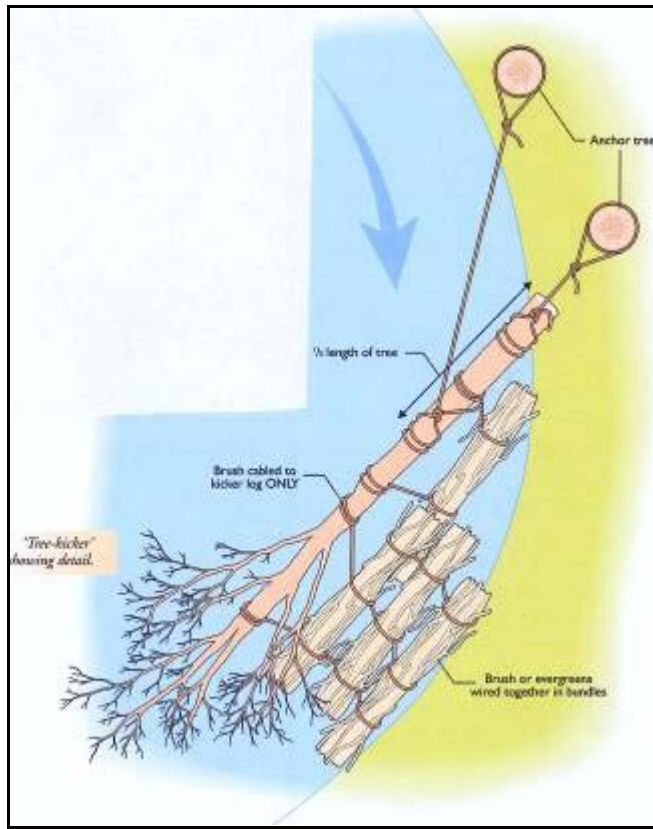
Figure 1 A 'tree kicker' – a method of securing LWD in high energy streams to protect banks from erosion

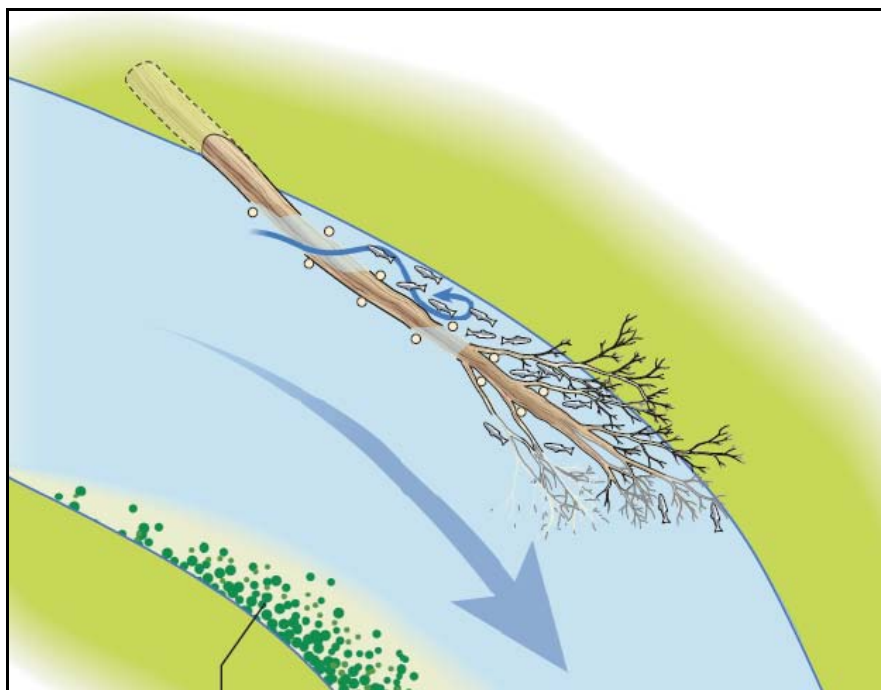
Figure 2 Fallen tree secured parallel to the bank to provide erosion protection and fish cover
