River Enborne, Wasing Estate

Advisory Visit April 2017

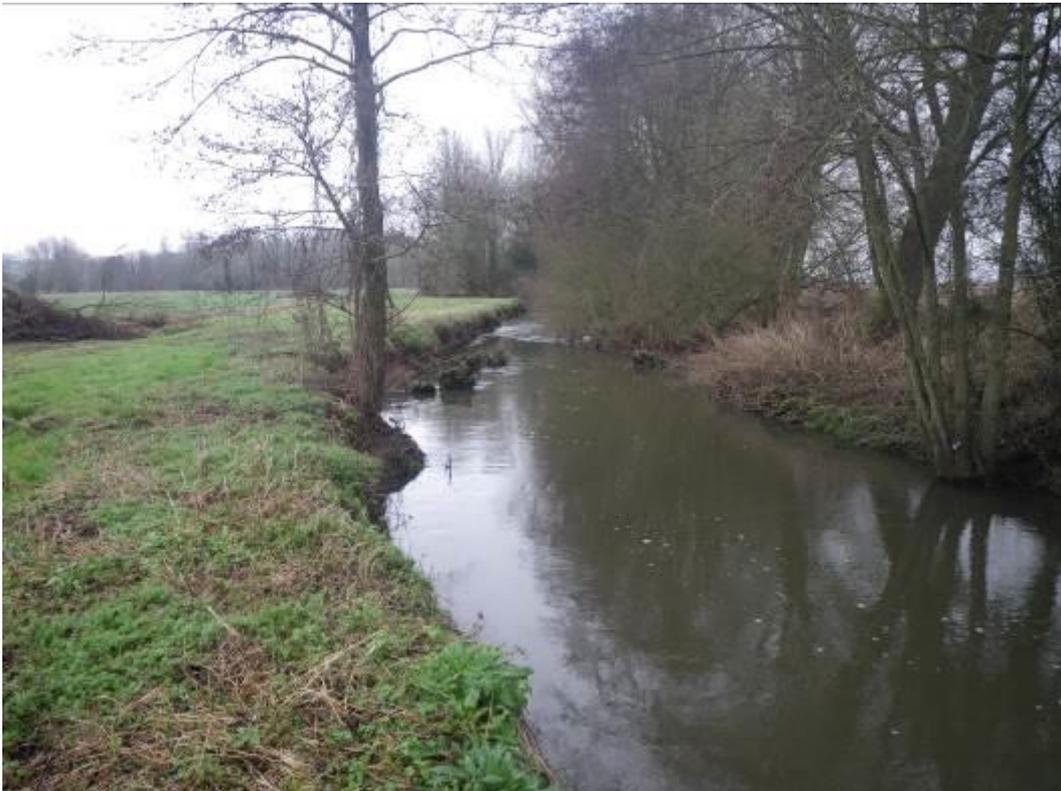
Much of the river bed sits within an incised channel and it was clear from the shape of the banks that the river has been historically subjected to intensive drainage work, presumably in an attempt to improve production from local fields (photo 1), which border the river for much of its length. However, the river channel still retains a meandering planform and the relatively steep bed slope, coupled with a gravel-rich substrate (photo 2 & 3) and lots of fallen woody material (photo 4), has helped to re-shape the river bed. This combination of the river's physical characteristics has facilitated the formation of an incredibly valuable series of pools, riffles and glides (photo 5, 6 & 7).

Photo 1. Much of the lower Enborne has been dredged in the past to facilitate improved agricultural drainage.

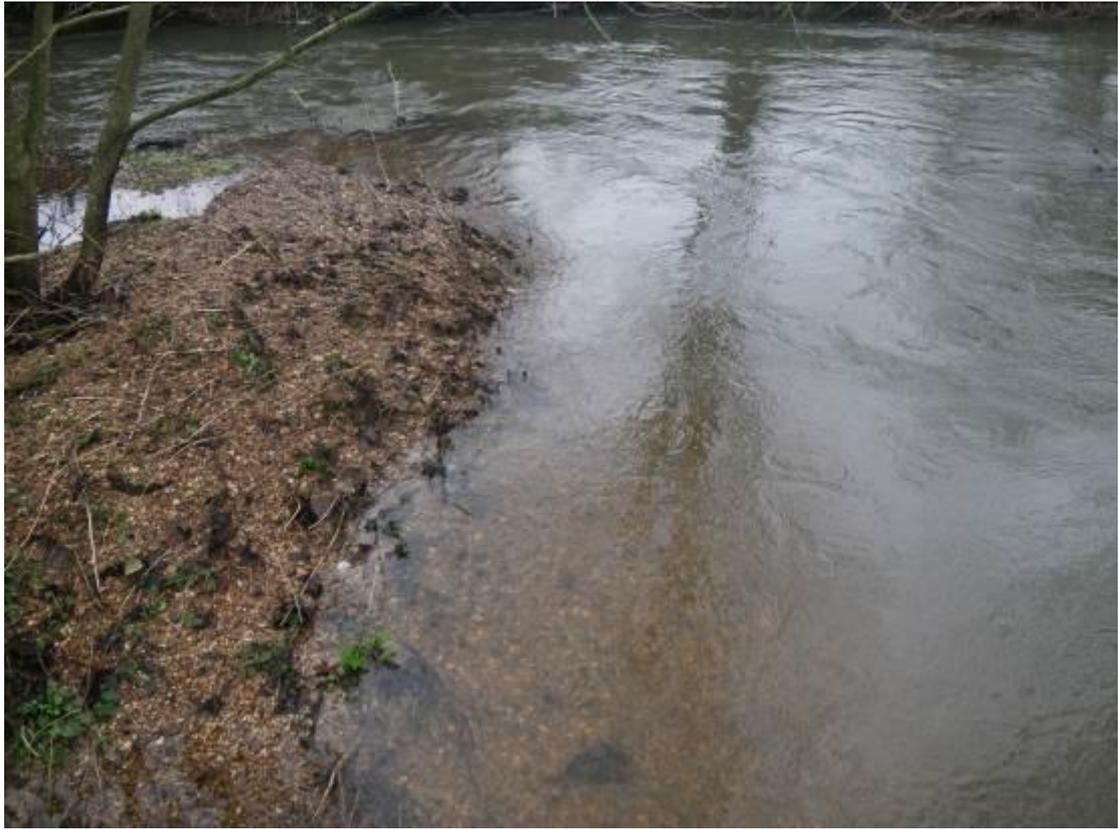
Photo 2. Evidence of the gravel-rich nature of the river bed, which is particularly prominent in the lower half of the fishery.

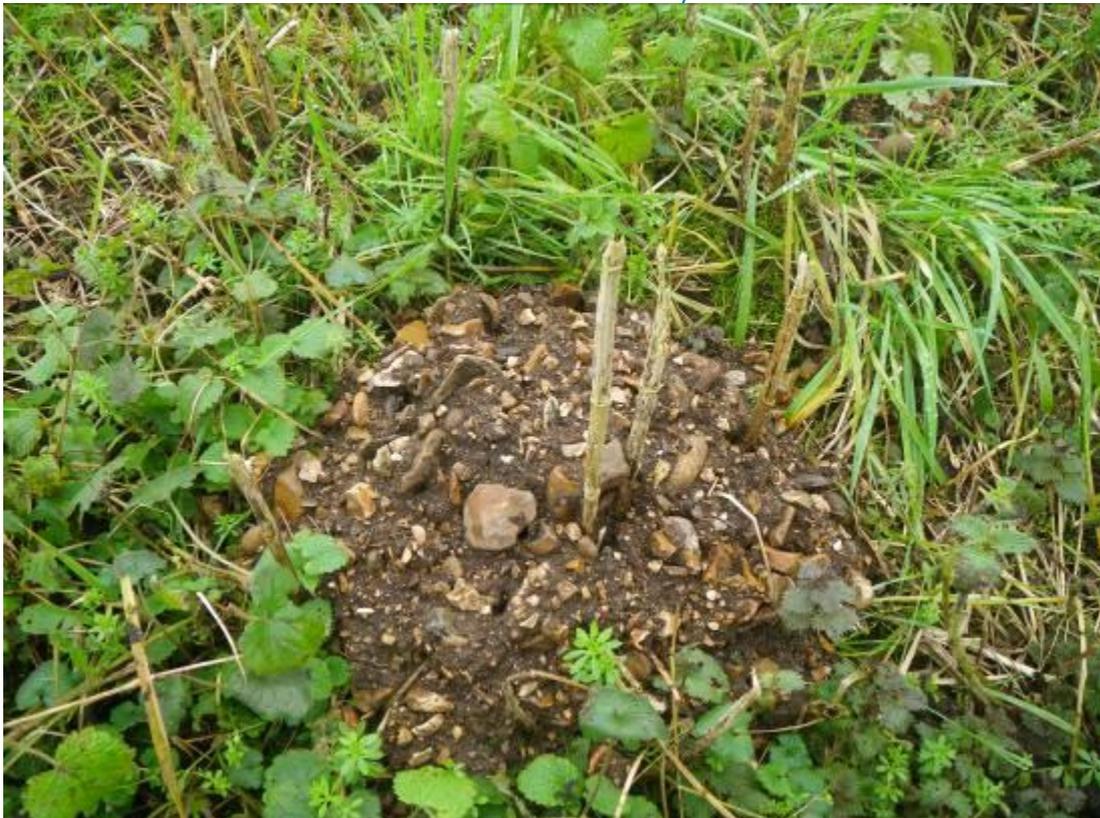
Photo 3. Mole hills on top of the bank clearly depict how much gravel was removed from the channel during past drainage works. The whole flood plain is rich in alluvial gravel deposits and bank and bed erosion has freed up gravel deposits to create high quality spawning habitat.

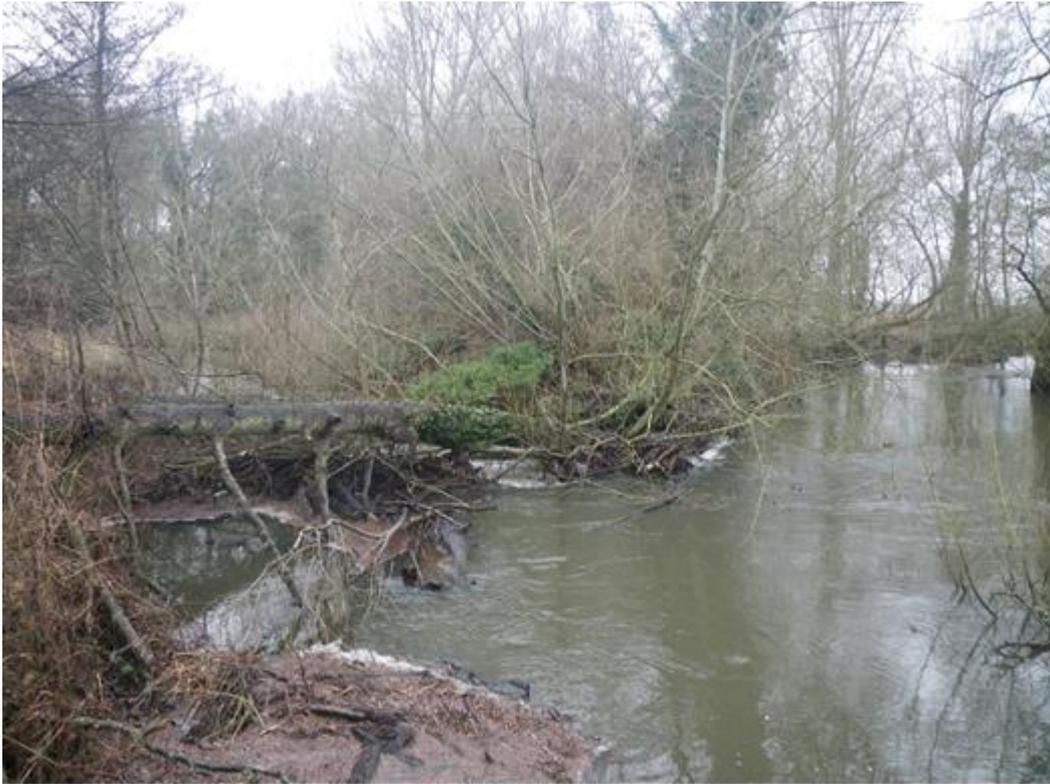
Photo 4. One example of several fallen trees that promote the creation of deep pools and shallow gravel runs, highlighting the critically important benefits associated with fallen woody material.

Where large woody tree trunk dams have developed, pinning the main bulk of the trunk to the bed, or gently moving and trimming out the odd small gap is all that's required. Likewise, with the wispy brash cover; retaining as much cover, particularly over river margins is imperative if the trout population is to remain comfortable and adequately protected from predators. The fallen woody material is also a critically important habitat component for many species of aquatic invertebrate and is essential for any high quality fly-fishery.

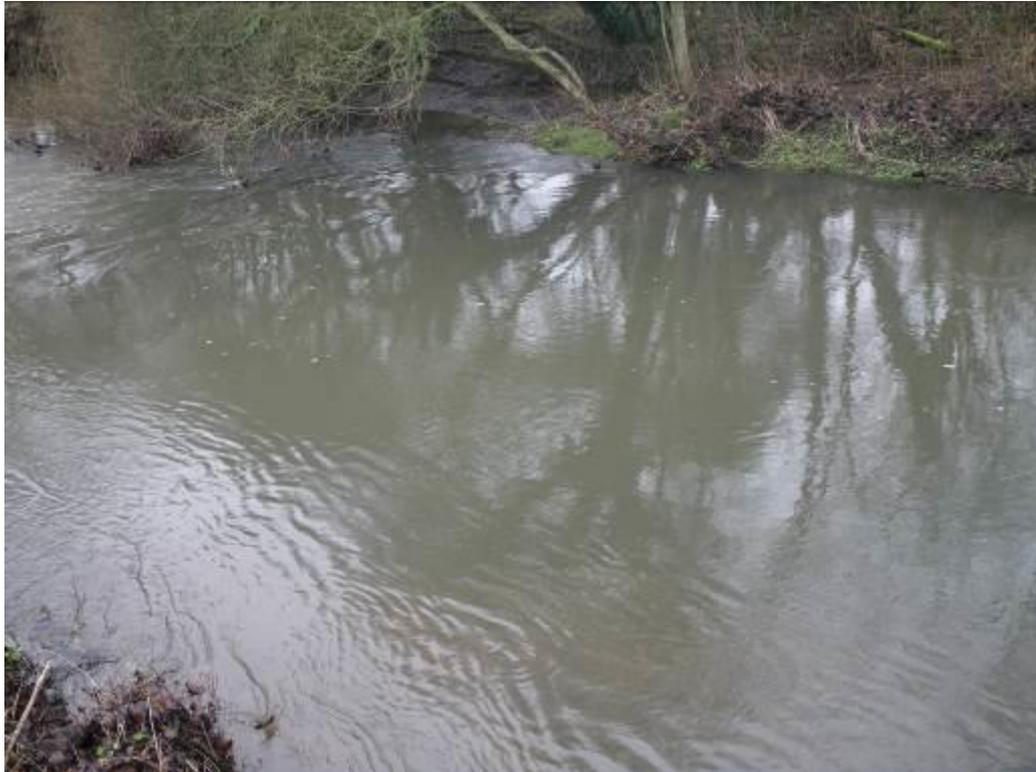
Photo 5. The tail of a typical pool, flowing over a gravel rich bed and on into a broken riffle. Potentially a high quality spawning location for brown trout

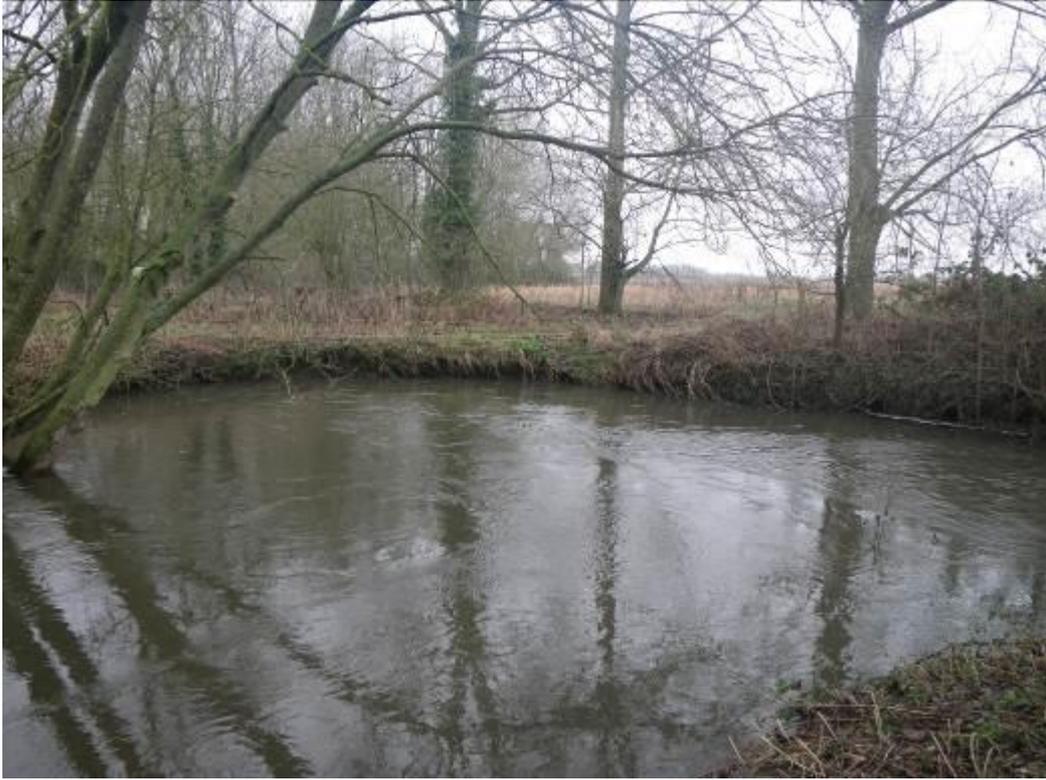
Photo 6. A typical pool formed on the outside of a bend and providing quality holding habitat for large adult trout.

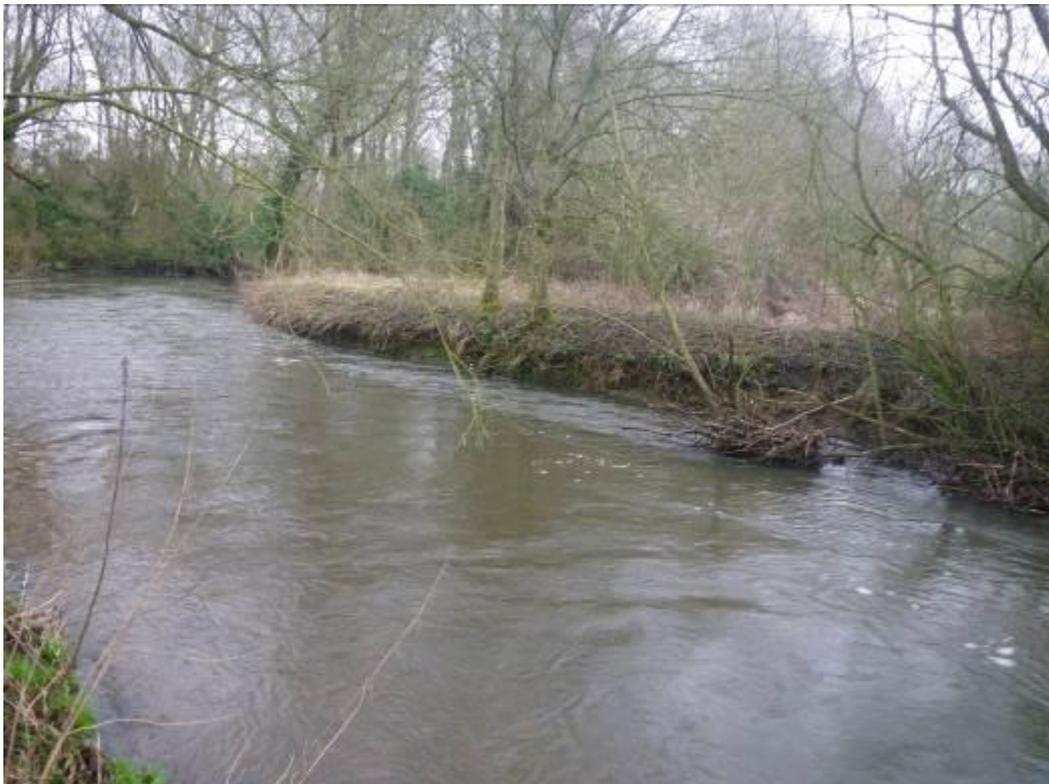
Photo 7. Another example of high quality spawning habitat with a broken shallow riffle below, potentially providing ideal nursery habitat immediately d/s for post-emerging fry.

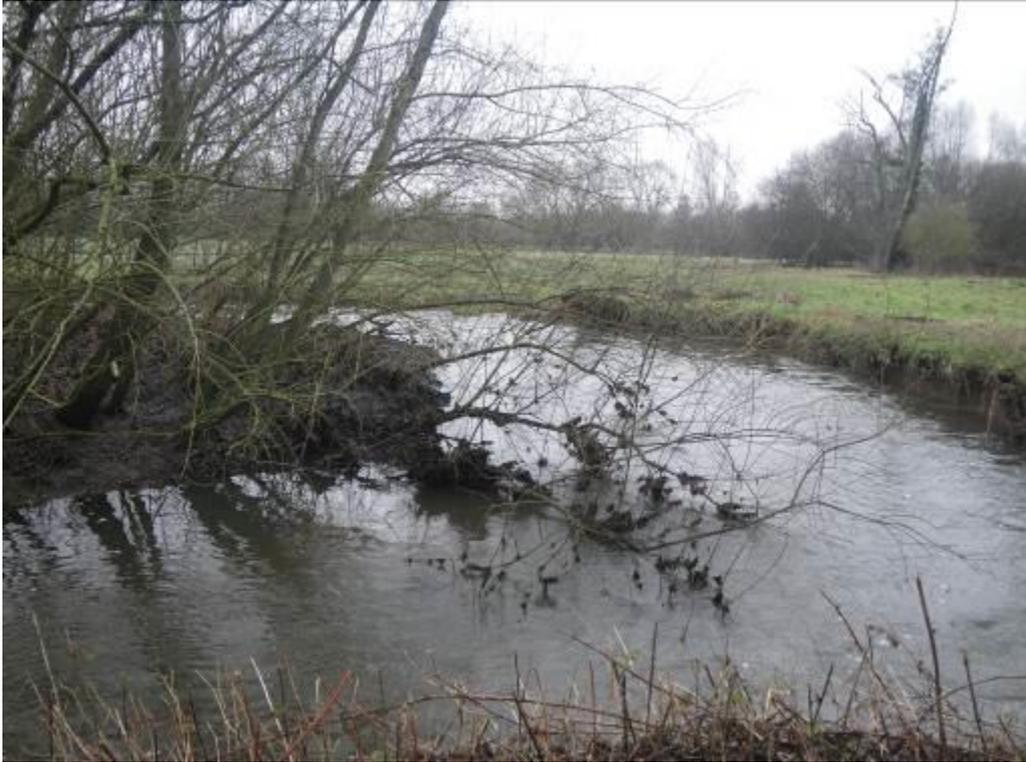
As well as examples of large woody material promoting bed and bank scour, there were numerous examples of marginal brushwood, either overhanging or fallen into the channel (photo 8 & 9). In moving to a managed fishery, the temptation is to remove most of this material to facilitate access for casting but it will be of critical importance to ensure that the flow diversity and cover provided by the woody material is retained wherever possible. Striking the balance between providing cover for fish and access for angling will be the key to the success or failure of any plans to develop the lower Enborne as a high quality wild trout venue.

Photo 8. The trailing brushwood on the inside of the bend will help to encourage sediment deposition there and promote bank erosion on the undefended outside of the bend. Light bank erosion where fresh gravels are mobilised is considered to be a healthy natural process.

- Retain as much brash and brushwood in marginal zones as possible. This is particularly important adjacent to riffle habitats.
- Market and manage the fishery as a wild trout, catch and release fishery.

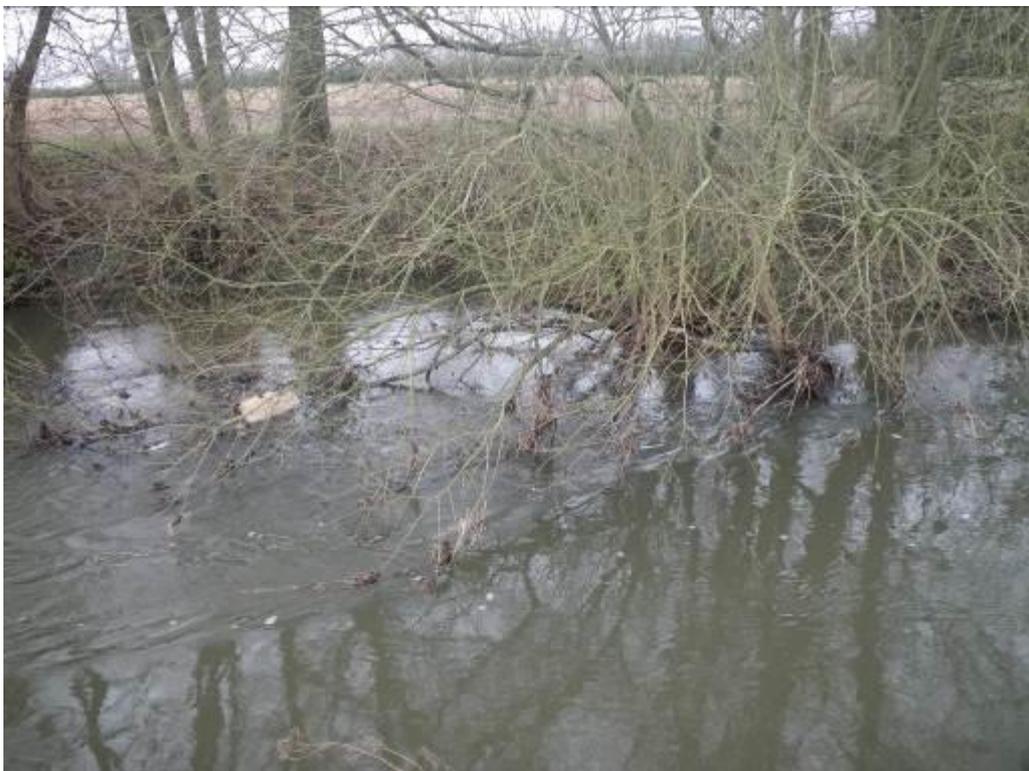
Photo 9. Another example of low-level brushwood cover. The very outside branch could be trimmed off to facilitate a cast but it is essential to retain the bulk of the marginal cover.

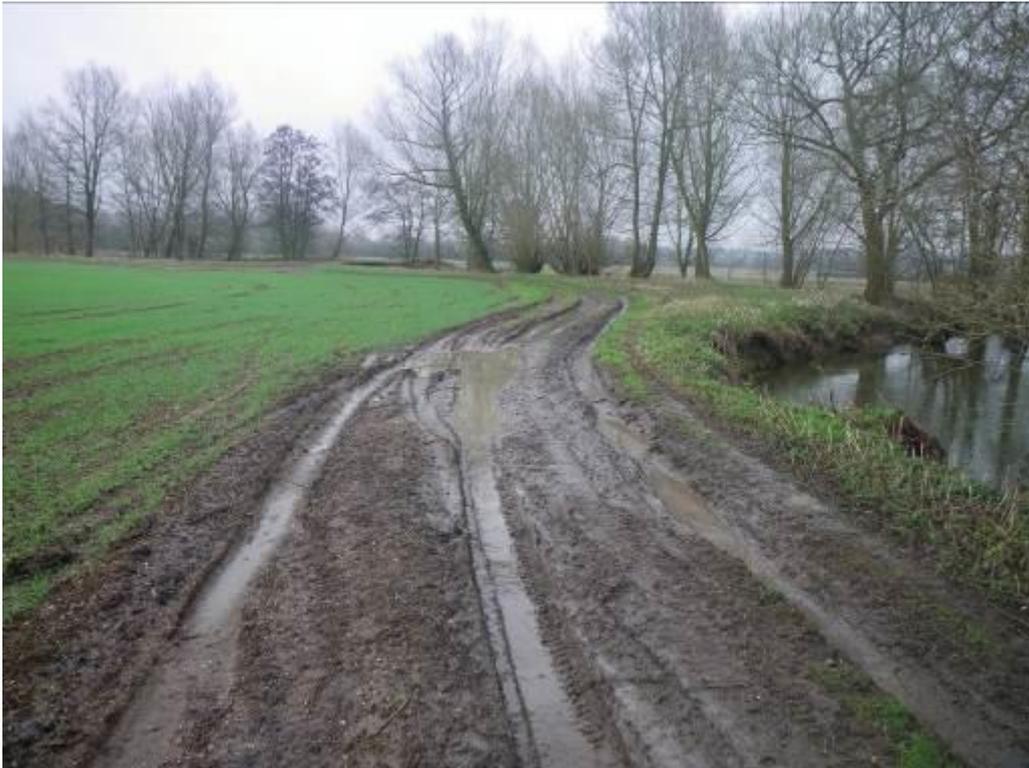
Long sections of the LB are vulnerable to erosion due to the encroachment of agricultural practices, leaving the river bank devoid of a substantial buffer zone (photo 10 - 12). This was of particular concern on some of the sections currently under arable production. As well as leaving the margins vulnerable to erosion, the lack of any substantial buffer areas is also providing pathways for nutrient rich sediments to run over-land and straight into the river channel. The problem is exacerbated by the location of the access track, leaving no room for the development of any vegetated buffer. Diffuse pollution associated with agricultural run-off is known to be a major factor in rivers failing to meet targets set under the Water Framework Directive.

Photo 10. Access track is too close to the top of the river bank

Opportunities to further improve and protect the fishery largely rely on changes to the way the adjoining land is managed. Increasing the width of river side buffer zones is recommended as a priority, as is moving any access tracks away from the top of the banks and intercepting any pathways for damaging sediment rich run-off.

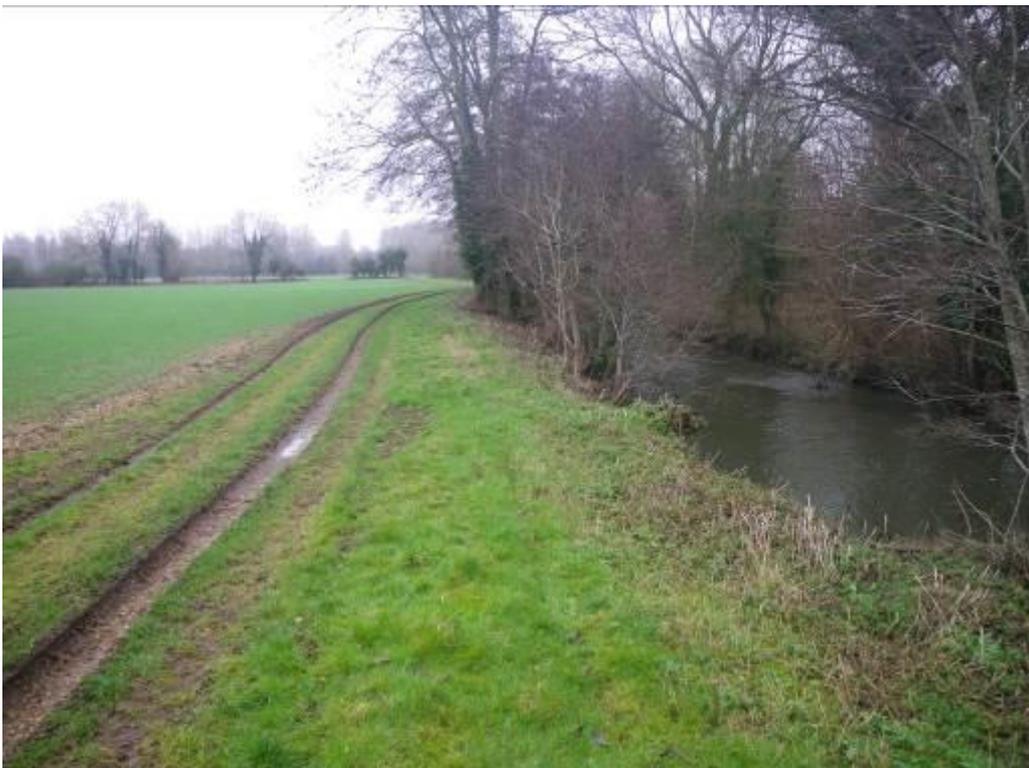
Photo 11. A large arable field adjacent to LB. Ideally a much wider buffer zone of at least 20m is required to intercept over-land run-off.

- Identify and address problems associated with diffuse pollution and surface water pathways capable of carrying nutrient rich sediments directly into the stream. A combination of wider buffer zones, contour tree planting and strategic bund creation to intercept flow into soak-away areas would represent best practise. To be effective buffer zones should be at least 20m wide, especially on sloping field margins

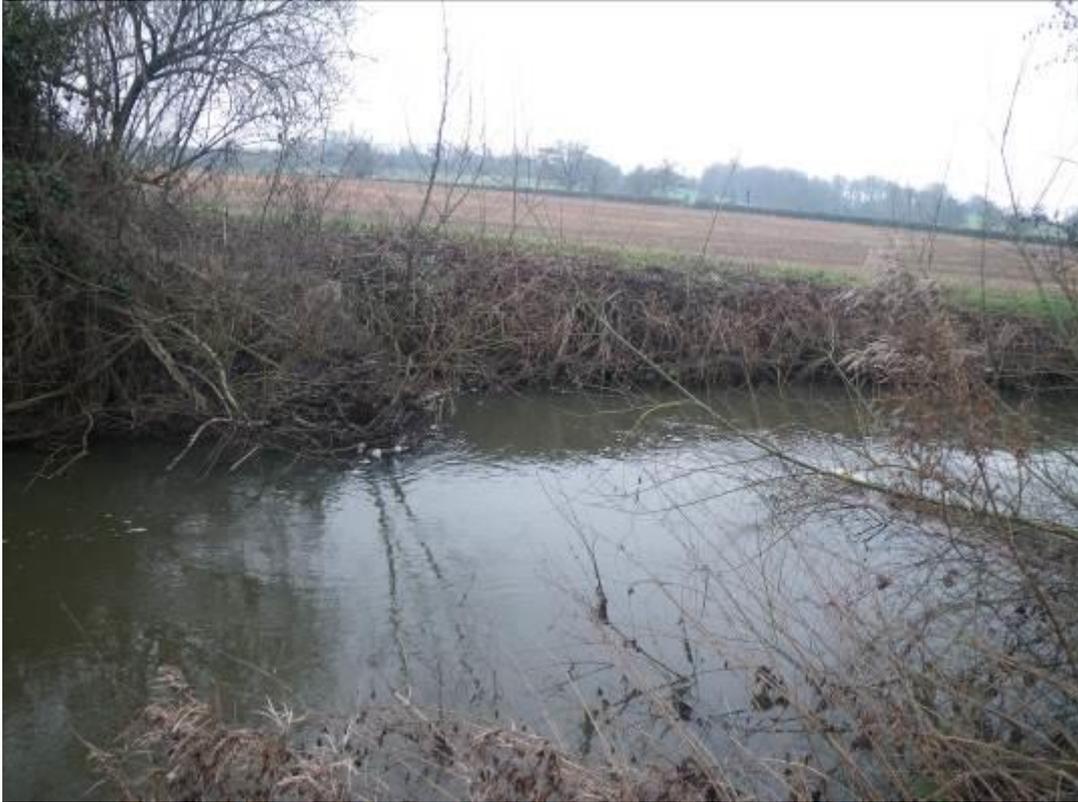
Photo 12. Wide buffer zones are even more important at the bottom of sloping fields as in the case of this field adjacent to the RB.

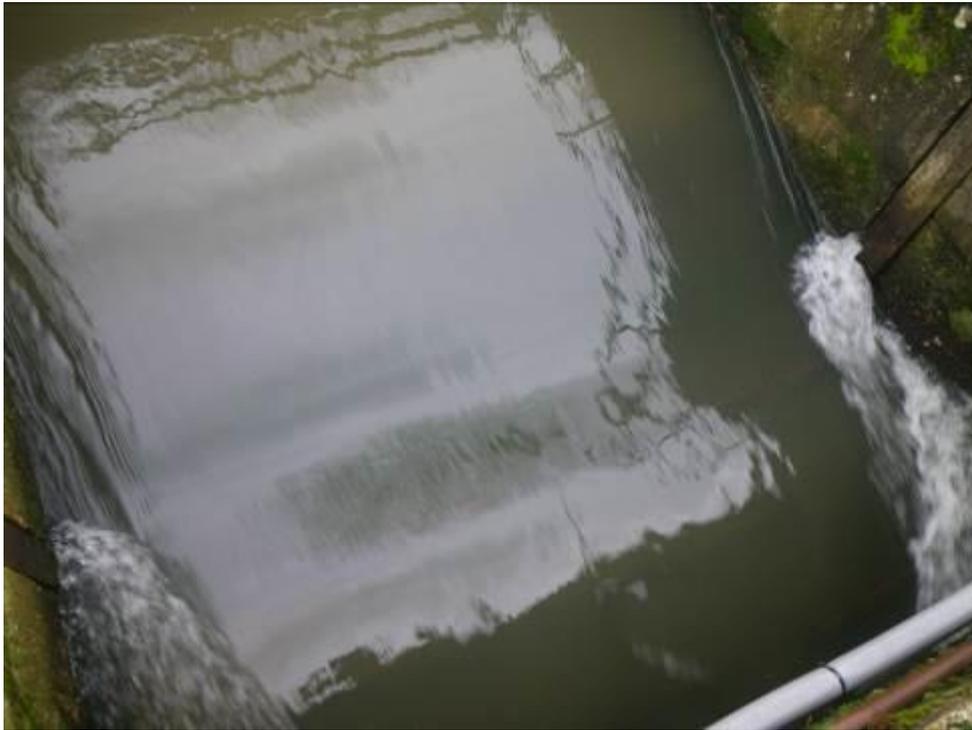
Located approximately half way along the fishery adjacent to Shalford Farm is an Environment Agency flow-gauging weir (photo 13). This structure is adversely impacting on habitat quality, particularly in the 200m of channel running u/s of the structure, where its impounding nature has led to the loss of the pool and run sequence and the deposition of fine sediments (photo 14). It would appear that the EA have made some attempts at improving access for migrating fish at this structure with the addition of baffles being bolted to the downslope of the crump weir. It is likely that larger adult trout will now be able

to pass upstream on spawning migrations. However, the structure still represents a significant barrier to migration for smaller trout and potentially a range of other species.

Photo 13. EA controlled flow gauging weir with baffles bolted to the face.

The EA gauging weir is adversely impacting on local habitat quality. Alternative technology is available for flow gauging and encouraging the Agency to upgrade

their flow-gauging facilities without the use of an impounding crump weir is recommended.

- Question the need for the crump weir style flow gauging weir and push for alternative technology so that the weir can be removed.
- Move but do not remove fallen woody material that is deemed to be causing a local issue; elsewhere, leave it to establish naturally.

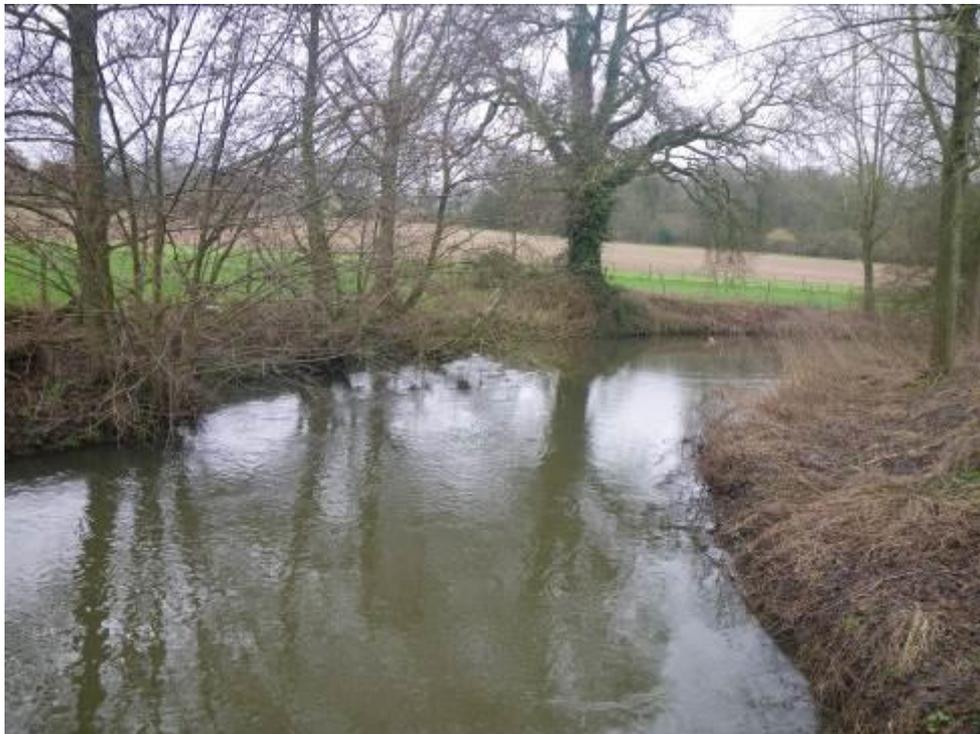
Photo 14. The natural bed slope in the reach running immediately above the gauging weir is drowned out by the impoundment.

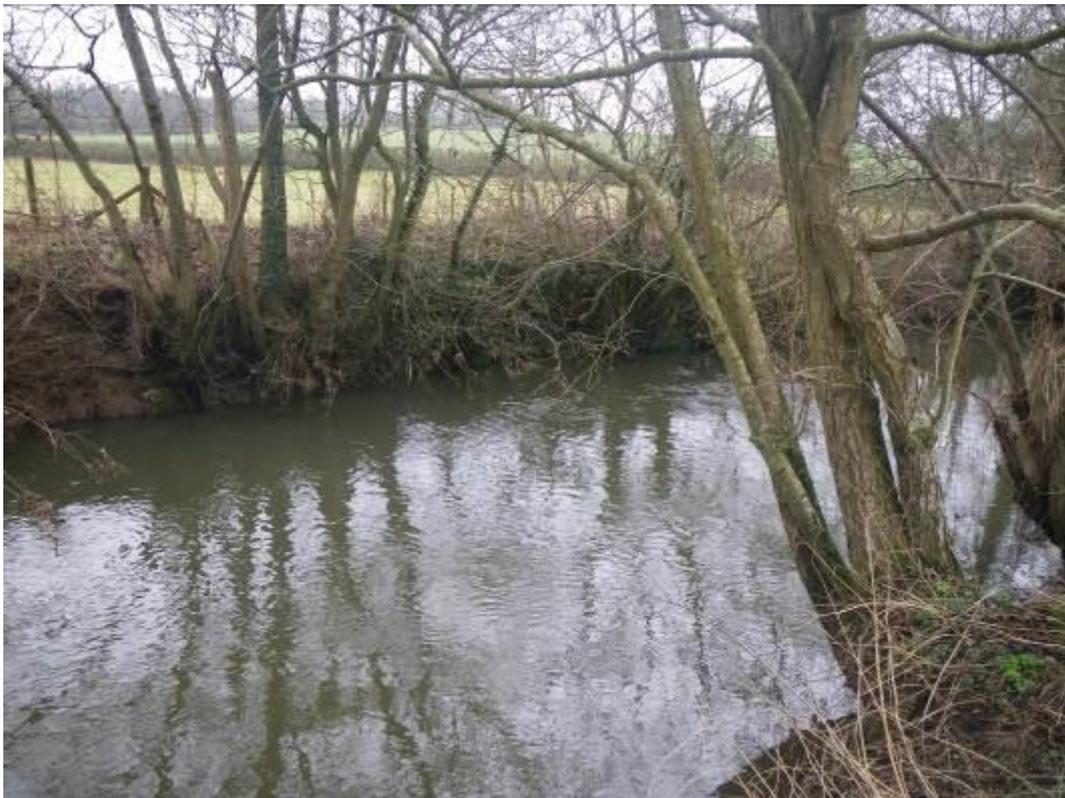
Further u/s still, the river channel appears to take on a different character with a subtle change in local geology. Here the banks are heavily lined with mainly alder (*Alnus glutinosa*) trees (photo 15). It was also apparent that the toe of bank was devoid of any semblance of gravels, so prevalent in the reach downstream of Shalford Bridge.

Photo 15. Large numbers of mainly alder trees line both banks in the impounded reach running upstream of Shalford Bridge

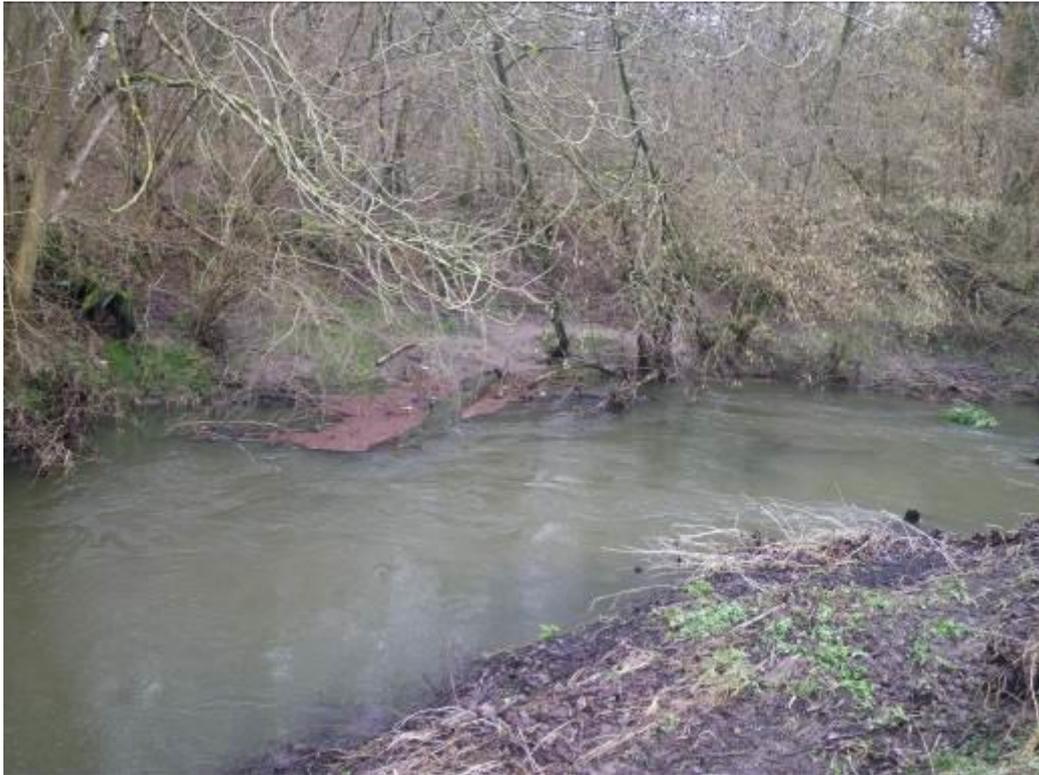
Despite the apparent lack of gravels, the presence of so much fallen woody material and the steep gradient still provided some good quality habitat for trout in the reaches further upstream. It is assumed that some seams of deposited gravels were prevalent in the reach above. Despite an apparent lack of high quality spawning sites, the reach still looks as if it should support good numbers of adult fish (photo 16)

Photo 16. Upstream sections still appear to have the potential to hold significant numbers of adult trout, which was confirmed during a pike cull carried out several years ago using electric fishing equipment.
