**Advisory Visit**

**River Erewash, Stanton Gate**

**19<sup>th</sup> August 2008**

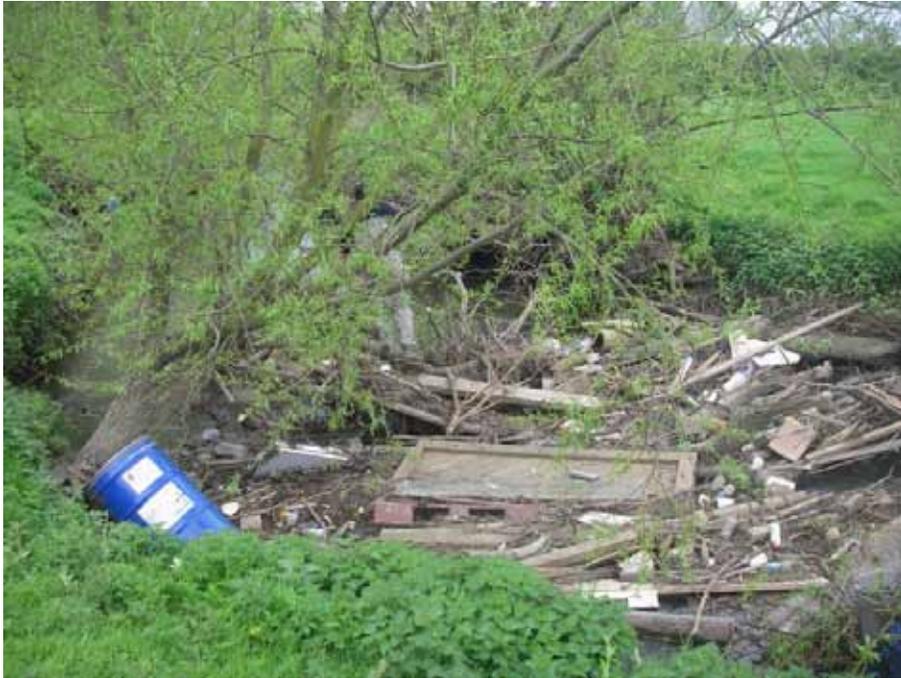
Volunteers from the River Erewash Restoration Project have carried out a tremendous amount of work on the river clearing litter, rubbish and debris from the channel (Photo 1). This has greatly enhanced the appearance of the river and raised its profile locally as an asset to the area.

Photo 1 Example of the problems that have been tackled by the Erewash Restoration Group

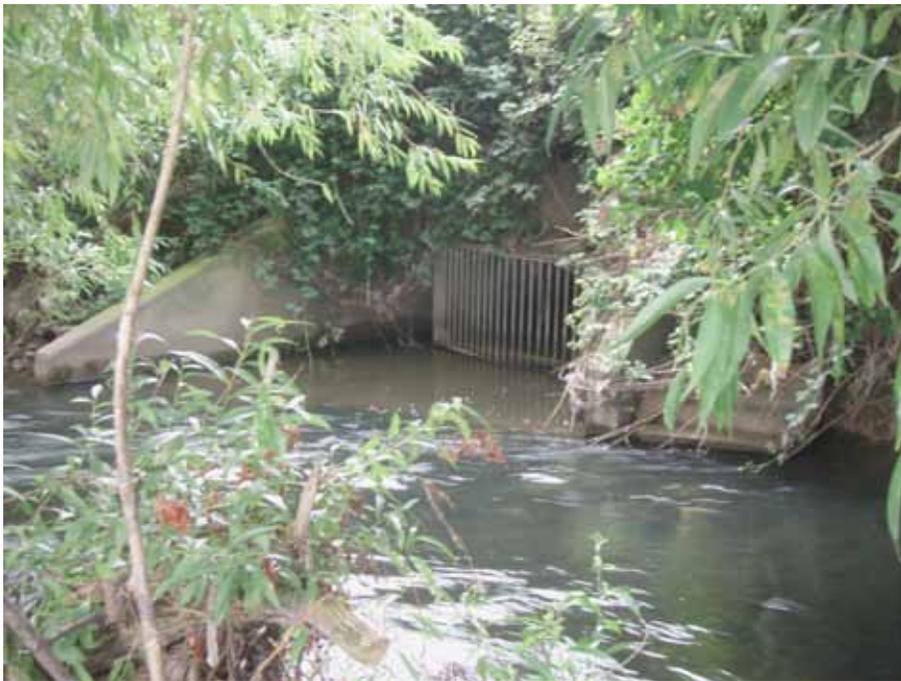
Photo 2 Combined Sewer Overflow (CSO) discharge point on the River Erewash

Most sewerage systems incorporate combined surface water/sewage overflows (CSOs), which act as safety valves when there is heavy rainfall which generates a volume of effluent the STW is unable to cope with (Photo 2). In these cases the effluent is discharged untreated directly to the river,

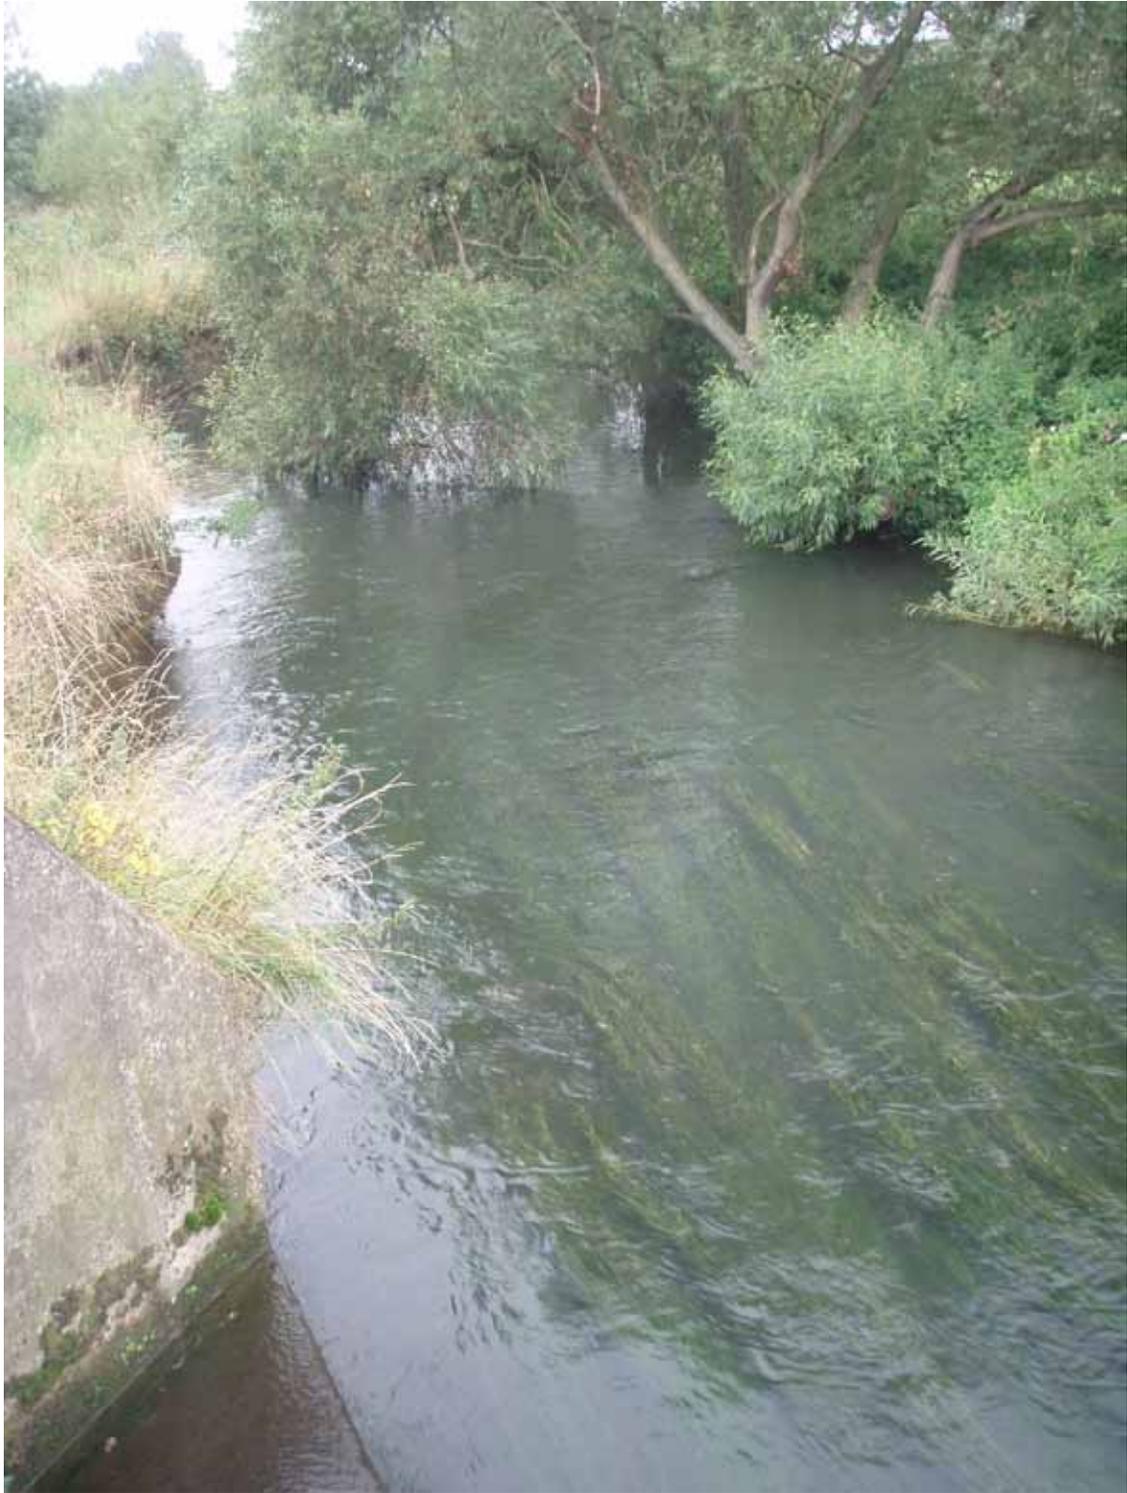
The visit began at Stanton Gate where there was good instream habitat in the form of riffles supporting good growths of water crowfoot (*Ranunculus* sp.), deep pools and glides (Photo 3). Bankside trees and bushes were present at intervals, providing excellent low cover over the water. A flood bank was present on the left bank of the river, but it was set well back from the river and a large area of wet grassland was present, probably to act as a storage area for flood flows (Photo 4).

Photo 3 Good instream habitat: watercress, low overhanging cover, and a variety of depth and flow

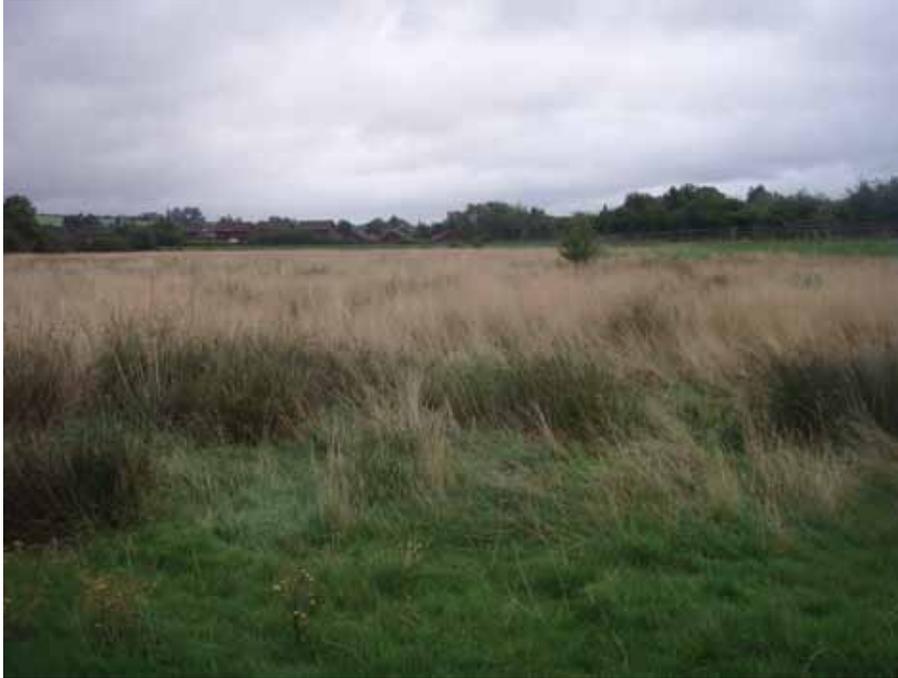
Photo 4 Flood storage area on left bank downstream of the M1. The river is behind the camera, and the set-back flood bank is visible bordering the field on the left of the picture.

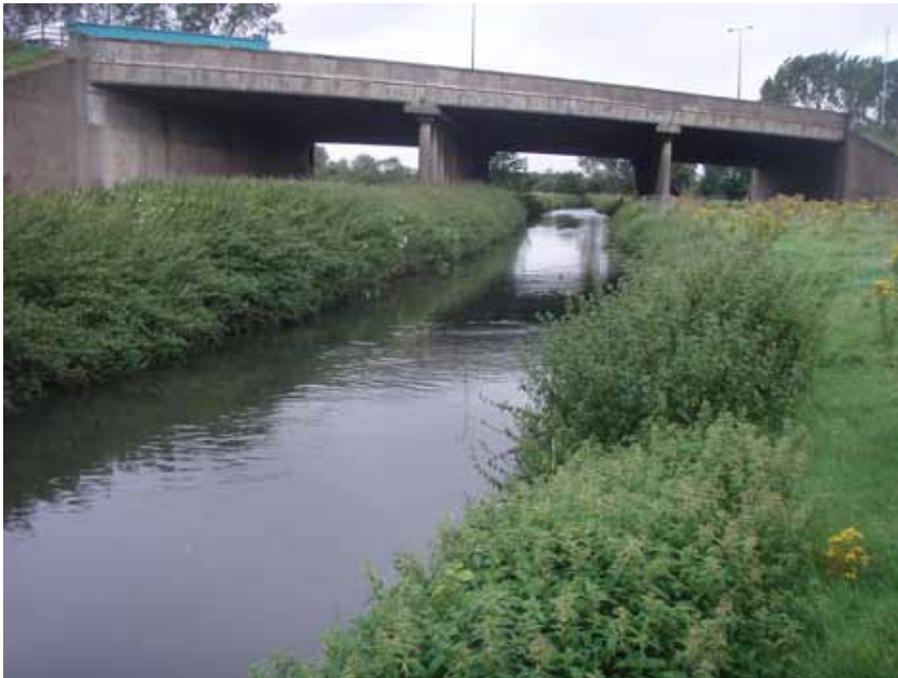
Photo 5 Straightened, concrete-lined channel under the M1 motorway.

A short distance upstream the M1 motorway crosses the river and beneath the bridge the river channel has been straightened and lined with concrete blocks for approximately 200 m (Photo 5). Road drainage enters the river downstream of the bridge via an outfall with a flap valve.

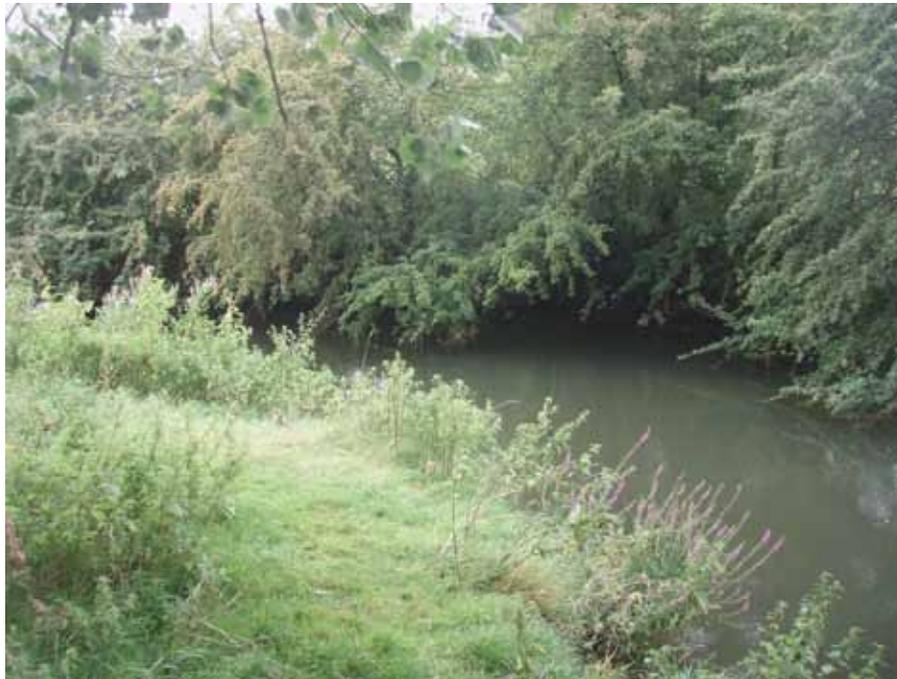
Upstream of the motorway a number of hawthorns were situated on the outside of a meander, overhanging the river (Photo 6). These provide valuable low cover over the river, which is ideal habitat for adult fish of many species including barbel, chub and trout. At similar sites on the river the Restoration Project volunteers have cut back the overhanging branches to give clearance beneath, and prevent the accumulation of litter and sewage storm overflow debris. The dilemma here is how to manage the litter problem without removing valuable fish habitat. It may be possible to use floating rope booms at selected locations to intercept the debris where it can be easily removed before it reaches overhanging trees and bushes.

Photo 6 Overhanging branches - traps for debris but vital fish habitat

- Leave the low branches on overhanging trees and bushes and try using rubbish booms to intercept debris upstream of these locations. Locate the booms in areas where they can be easily accessed for debris removal. Angling the booms across the river may help funnel material towards one bank for collection.

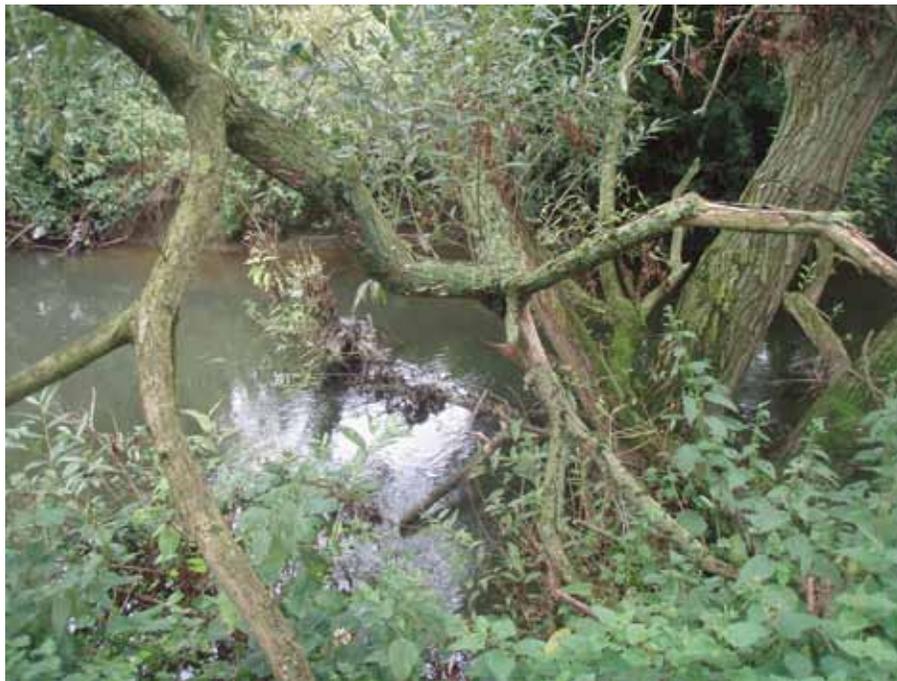
Large woody debris (LWD) is present in two or three locations where the boughs of larger willow trees have cracked and leaned into the water, providing excellent habitat (Photo 7). LWD has been shown to be extremely important in several respects:

Photo 7 Large Woody Debris (LWD) - excellent habitat

- The club should adopt a policy of retaining LWD in the river channel wherever possible. The West Country Rivers Trust provides a useful guide to the management of natural LWD:
  1. Is the debris fixed, if yes then continue to 2, if not continue to 5.
  2. Is the debris causing excess erosion by redirecting the current into a vulnerable bank? If yes then go to 5 if not then go to 3.
  3. Would fish be able to migrate past it (take into account high river flows). If yes got to 4, if no go to 5.
  4. **Retain the woody debris in the river.**
  5. **Extract the debris.**

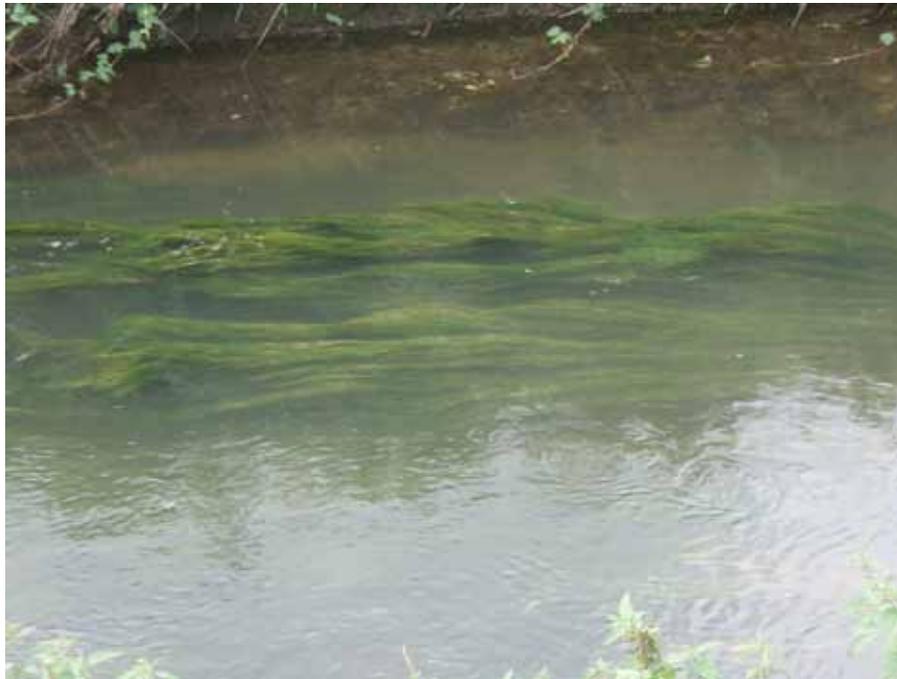
Photo 8 Fennel pondweed (*Potamogeton pectinatus*) replaced water crowfoot in the proximity of the STW outfall; a sign of nutrient enrichment.

The Nut Brook joins the Erewash at National Grid Reference (NGR) SK 4829 3892. Above the confluence it was noticeable that there were fewer instream features such as riffles and pools in the Erewash; most of the river was a steady glide. The predominant submerged aquatic weed also changed from water crowfoot (*Ranunculus* sp.) to fennel pondweed (*Potamogeton pectinatus*, Photo 8), a sign of nutrient enrichment, probably because of the discharge Hallam Fields STW outfall a short distance upstream (Photo 9).

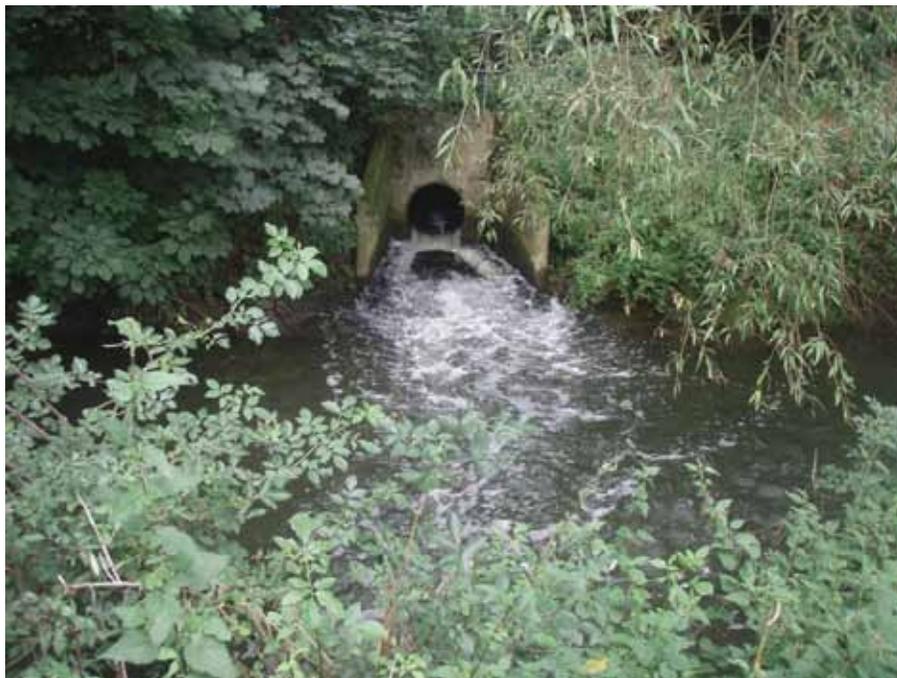
Photo 9 Hallam Fields STW outfall

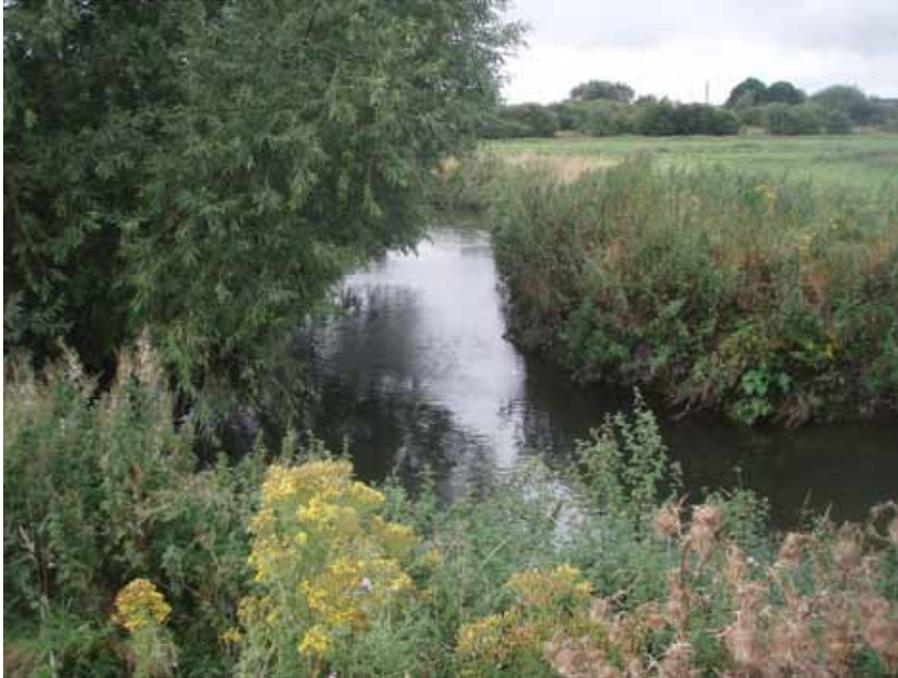
The river channel in this area was incised (water level is well below the level of the surrounding land – Photo 10), and the shape of the channel in cross-section is trapezoidal. This suggests the river has been the subject of

Photo 10 Showing the incised channel, with steep banks even on the inside of meanders

engineering works in the past for land drainage or flood defence (Photo 11). The banks and bed of the river appeared to comprise hard clay, and there was little gravel on the river bed. Where gravel was present, areas of scour showed it was a thin layer overlying the clay.

- Introducing gravel to create spawning areas in the main river is desirable, but this is likely to be impractical because of the incised channel and high peak flows which are likely to mobilise the gravel and wash it away. Reprofiling of the channel cross-section would probably be necessary to reduce the power of peak flows in areas where gravel was introduced.

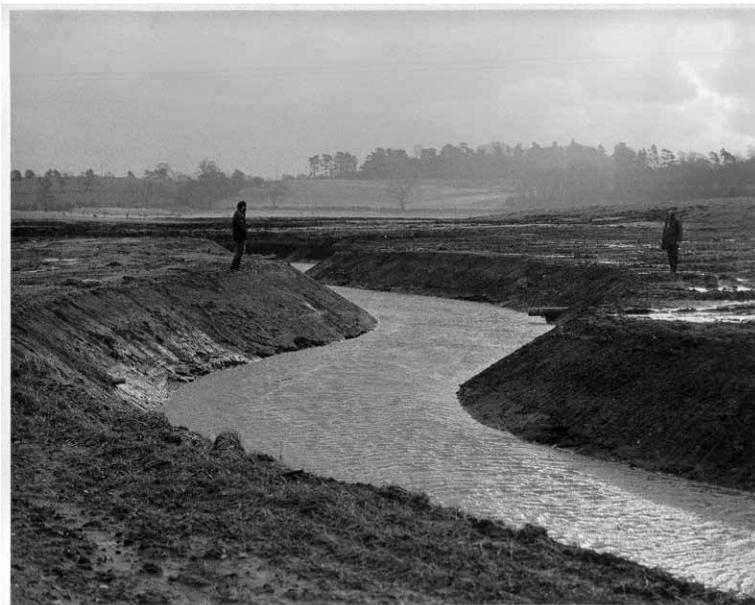
Photo 11 An example of 1970s river engineering works creating an incised channel with a trapezoidal cross-section and the loss of pool and riffle habitat structure (River Sow, Staffordshire).

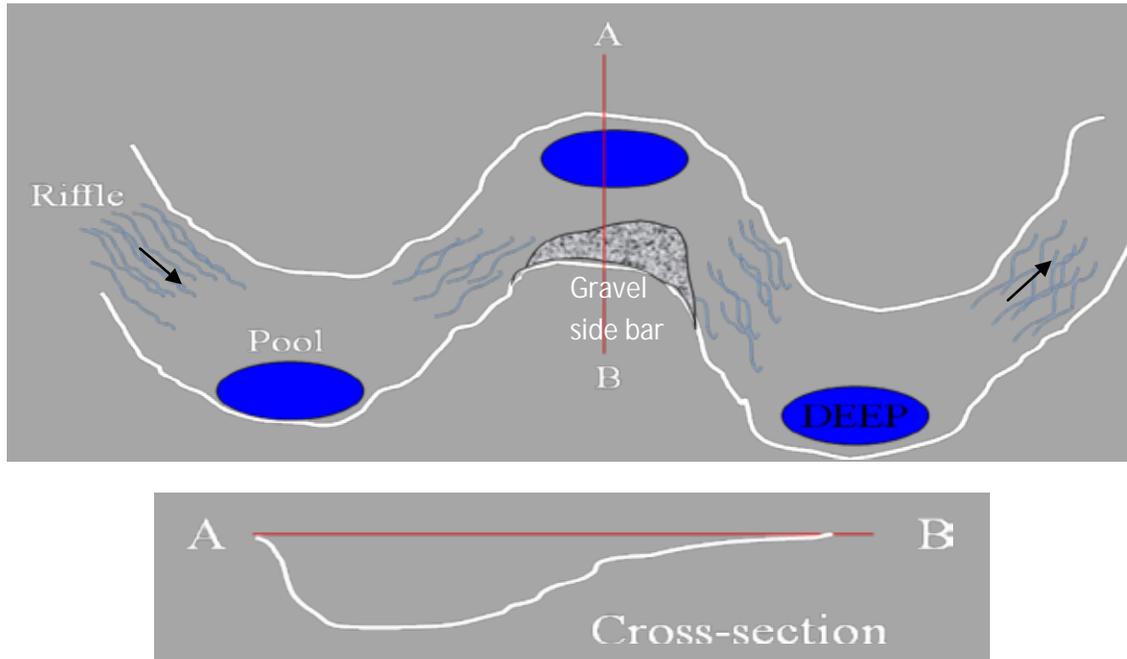
Figure 1 A schematic representation of pool and riffle sequence, and the associated channel cross-section. Pools tend to form on the outside of bends where there is scour, and deposit the gravels in riffles downstream.

Ideally the banks of the river should be reprofiled to recreate a more natural cross-section with a shallow profile on the inside of bends (as illustrated in Figure 1). This would encourage the deposition of gravel on the inside of bends. Works of this nature would require the movement of substantial quantities of earth and be expensive.

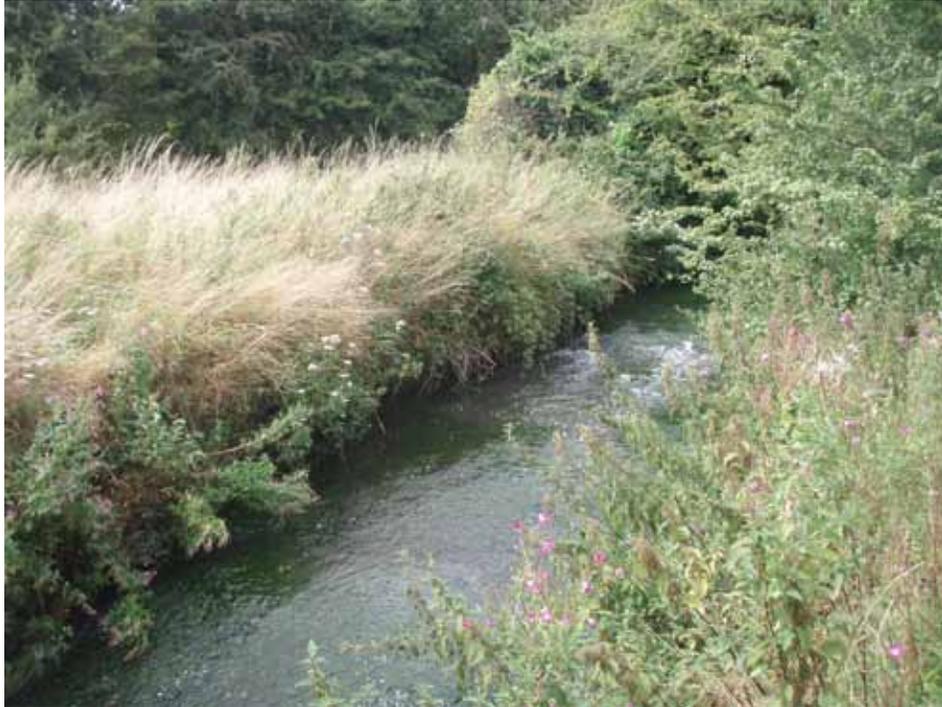
The Nut Brook was inspected between the railway crossing and the Erewash confluence. Water crowfoot (*Ranunculus* sp.) was prolific, and there was

good bankside cover in the form of overhanging grasses, nettles, etc. and low bushes and trees (Photo 12). There were some areas of flow variation where debris had lodged across the channel. Himalayan balsam was more prolific here than alongside the Erewash.

Photo 12 The Nut Brook

From this brief assessment, it appears the Nut Brook has more favourable habitat for trout recruitment than the main river. Introduction of gravel riffles may be feasible here, but it is first necessary to know the distribution of trout and where such actions would be best targeted.

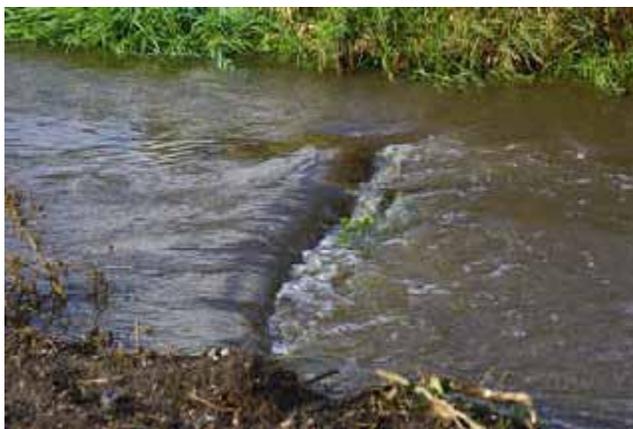
Photo 13 Example of log installed to create localised scour and improve gravels

It may be possible to introduce gravel to the smaller channel of the Nut Brook, as mentioned above. LWD could be used to create localised scour of existing gravels to improve spawning conditions (Photo 13). This should be positioned pointing upstream to avoid bank erosion.

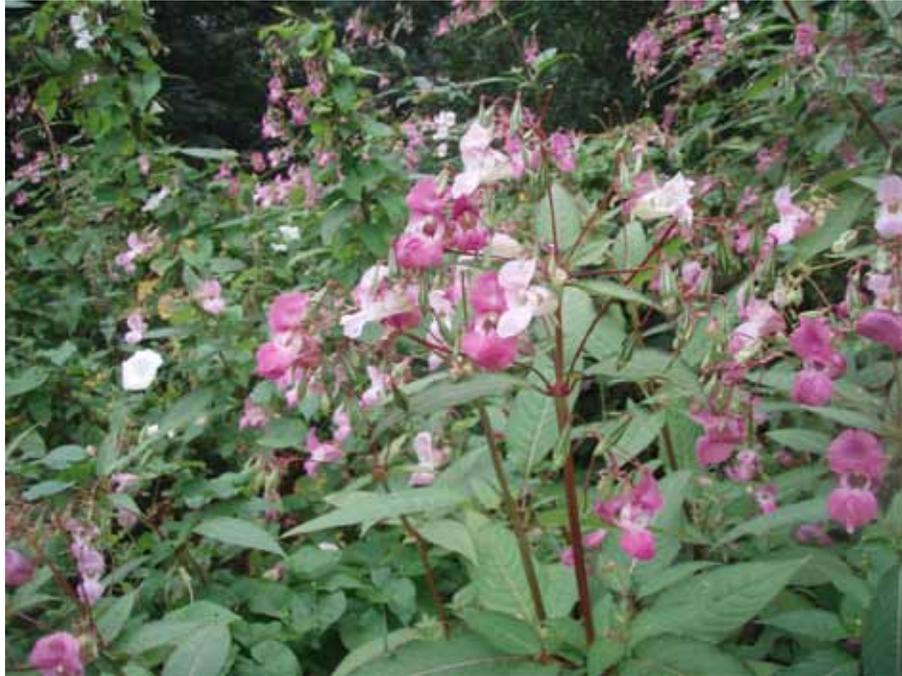
Photo 14 Himalayan balsam in flower

- Control Himalayan balsam. This can be achieved by physical or chemical means:

The main method of control, and usually the most appropriate, is pulling or cutting plants before they flower and set seed. Grazing access appears to be controlling balsam on some sections of the river. In areas inaccessible to livestock, physical or chemical control is recommended.

Himalayan balsam can be controlled with a weedkiller based on glyphosate, such as Roundup. Glyphosate is a non-selective, systemic weedkiller that is applied to the foliage. It is inactivated on contact with the soil, so there is no risk of damage to the roots of nearby plants, but care must be taken that the spray doesn't drift onto their foliage. Glyphosate is most effective when weed growth is vigorous. This usually occurs at flowering stage but before die-back begins; with most weeds, this is not earlier than mid-summer.
