Advisory Visit

River Erewash, Toton

4th March, 2009

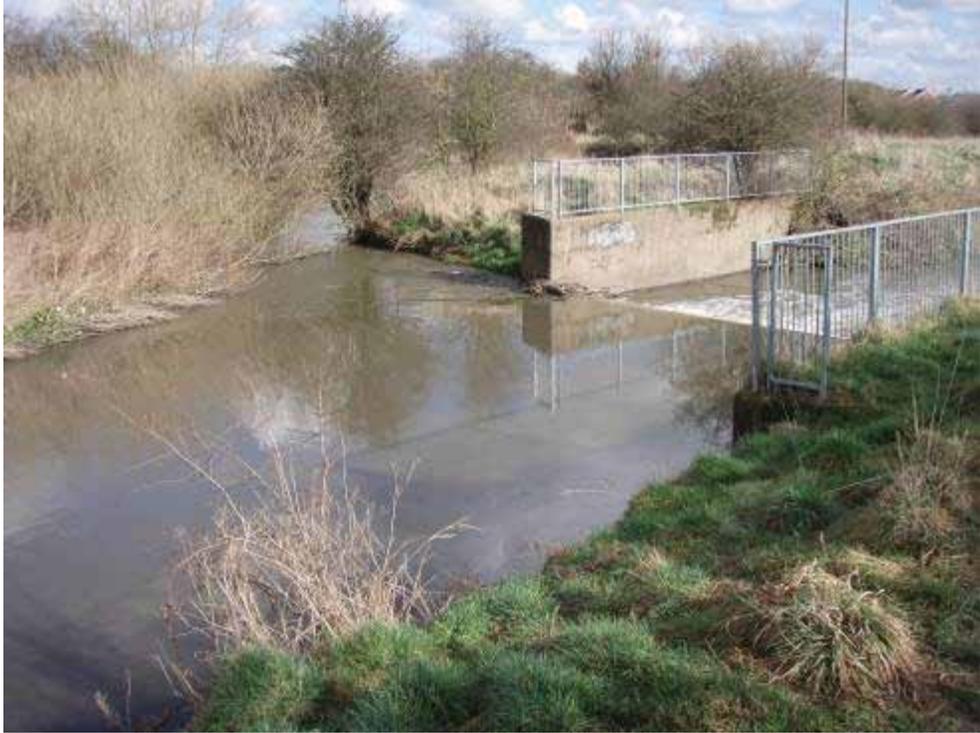
The section of river inspected was between the footbridge at National Grid Reference (NGR) SK 4923 3444 and the A6005 road bridge (NGR SK 5029 3416). Just downstream of the footbridge there is an overspill weir into a flood relief channel which takes some of the flow away from the main river channel (Photo 1). The flood relief channel rejoins the river a short distance downstream of the A6005 bridge, and for its length forms the boundary between Nottinghamshire and Derbyshire, and also between Broxtowe Borough Council (Notts.) and Erewash Borough Council (Derbys.). The section of the main Erewash here is within Broxtowe and Notts. and there are plans to create a Local Nature Reserve which will encompass this part of the river.

Photo 1 Overflow weir showing main river channel (left) and bypass channel (right)

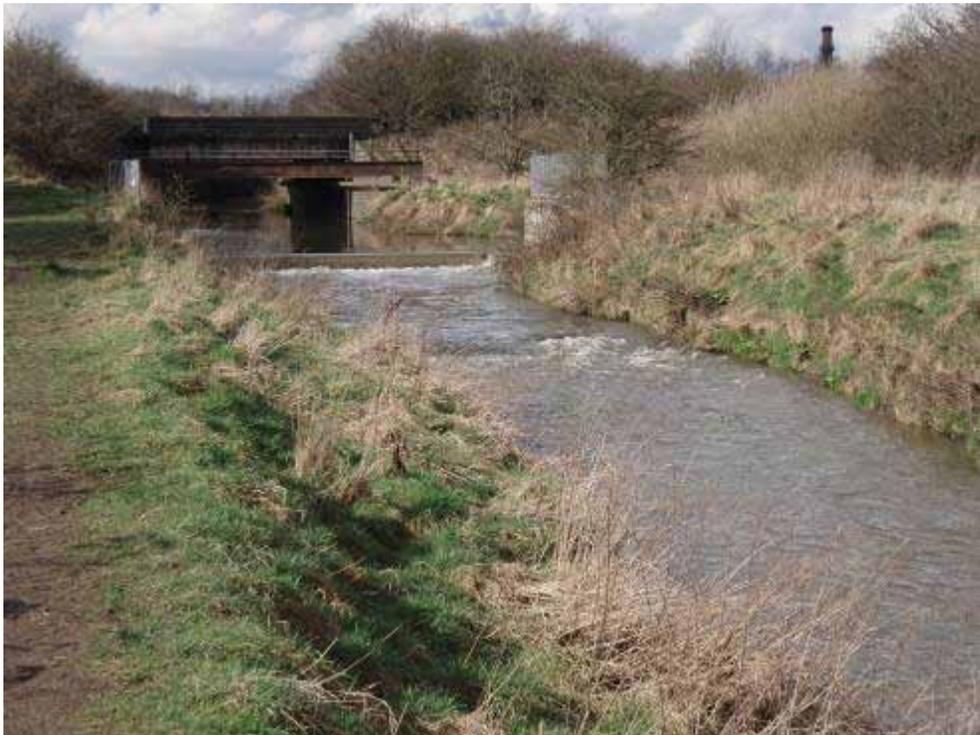
Photo 2 Overflow weir – view from bypass channel RHB

The overspill into the flood channel is situated in this section, and the weir structure was lowered about 4 years ago to maintain a permanent flow of water over the weir. Previously the weir only over-topped at high flows resulting in fish becoming stranded in the flood channel when flows dropped. Mick Martin has expressed a concern that the reduced flow in the main channel resulting from lowering the weir maybe affecting the quality of the habitat.

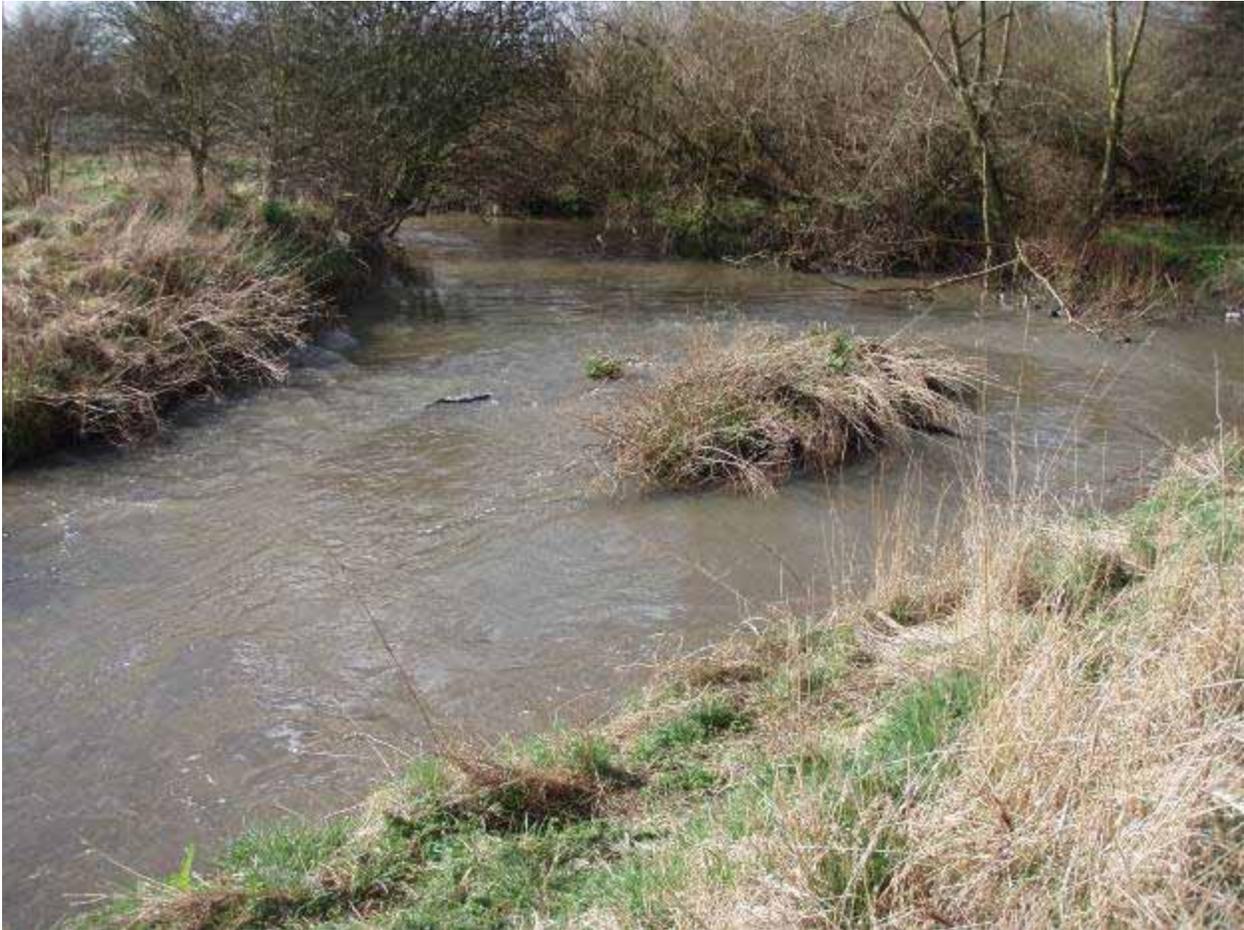
The upstream section of the main river channel, in the vicinity of Greenwoods Community Centre, has a meandering plan-form and some good in-river habitat. There is a pool-and-riffle sequence, variation in channel width and depth, midstream islands, gravel shoals and point bars, well-vegetated banks, earth cliffs, and some large woody debris (LWD) in the channel (Photos 3 - 5). It is from this area that the recent captures of trout have been reported.

Photo 3 Good habitat: well-vegetated banks, midstream island, pool and riffle sequence

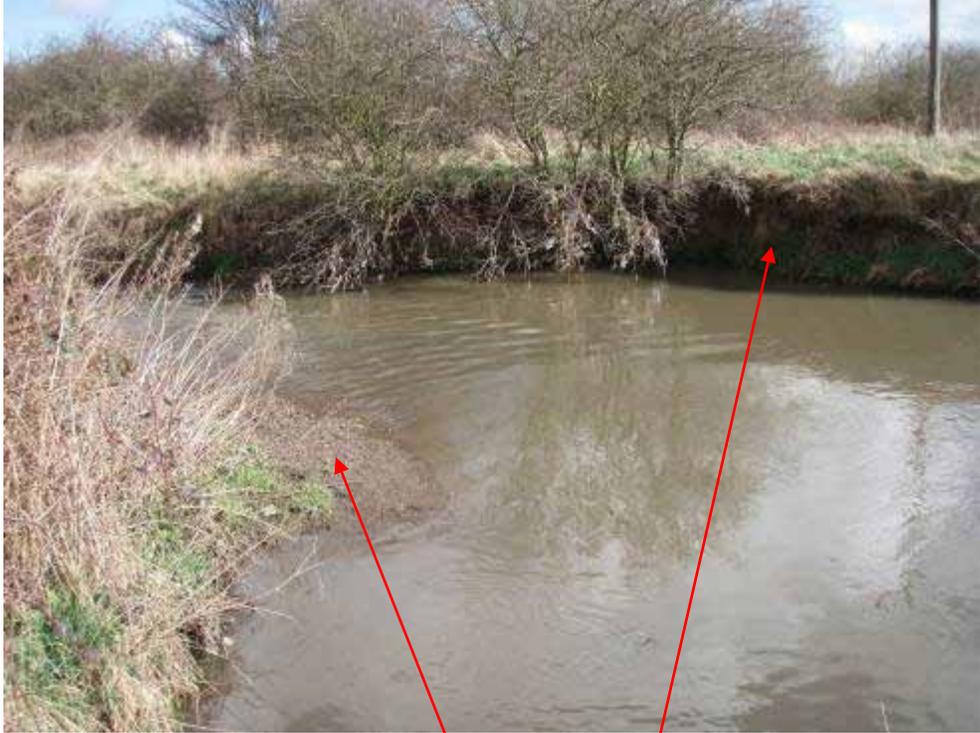
Photo 4 Gravel side bar and earth cliffs

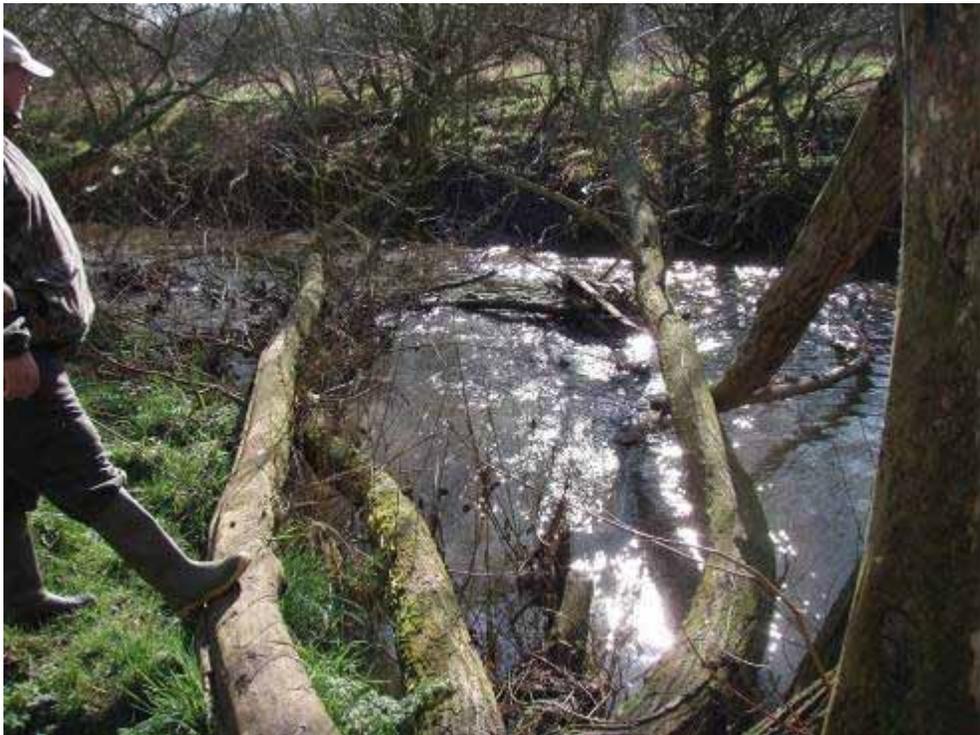
Photo 5 Large woody debris in the river channel – excellent habitat

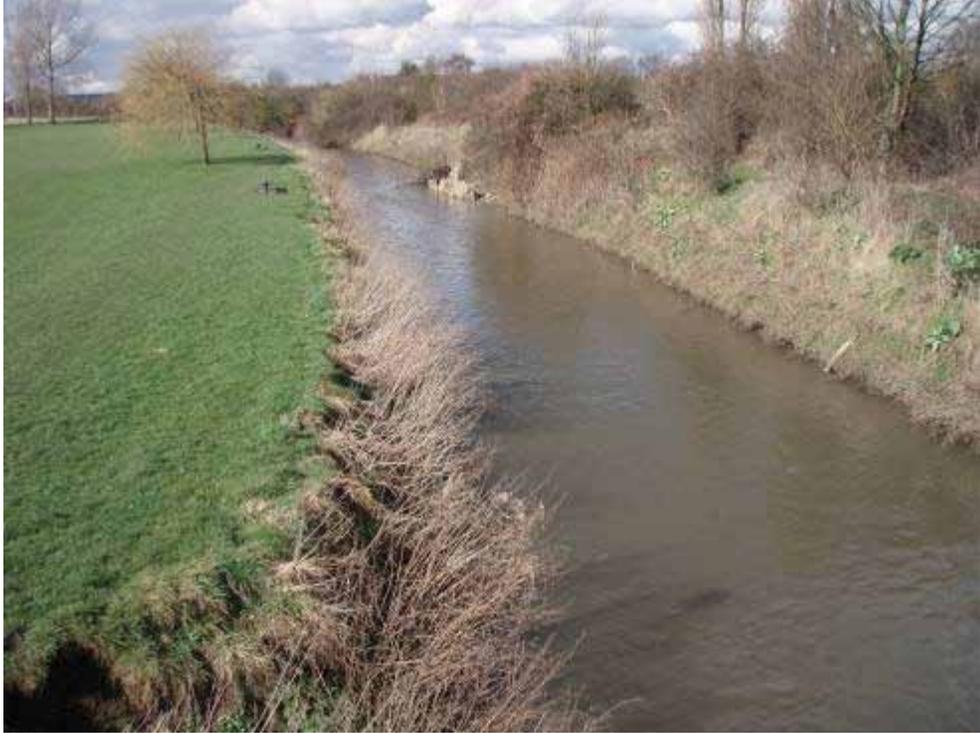
In contrast, the downstream section (below the Community Centre and the footbridge at Carrfield Avenue), has relatively poor habitat (Photo 6). The river channel is straight, uniformly wide, and has little depth variation. The banks are steep and there are few trees present apart from one section of hawthorn.

Photo 6 Downstream section of the main river channel – uniformly straight, wide and shallow – poor habitat

The left bank downstream of the footbridge is adjacent to the playing fields and has been maintained (regularly mown and fertilised) as if it were a football pitch (Photo 8). This could easily be changed to an annual cut on a wide buffer strip (10m +), to vastly improve the wildlife value of this river bank. The same comments apply to the right bank of the Erewash main channel on this playing field section (Photo 6).

- Create a wide buffer strip (10m or more) alongside the bypass channel and the river adjacent to the playing fields by changing the mowing regime to an annual cut.

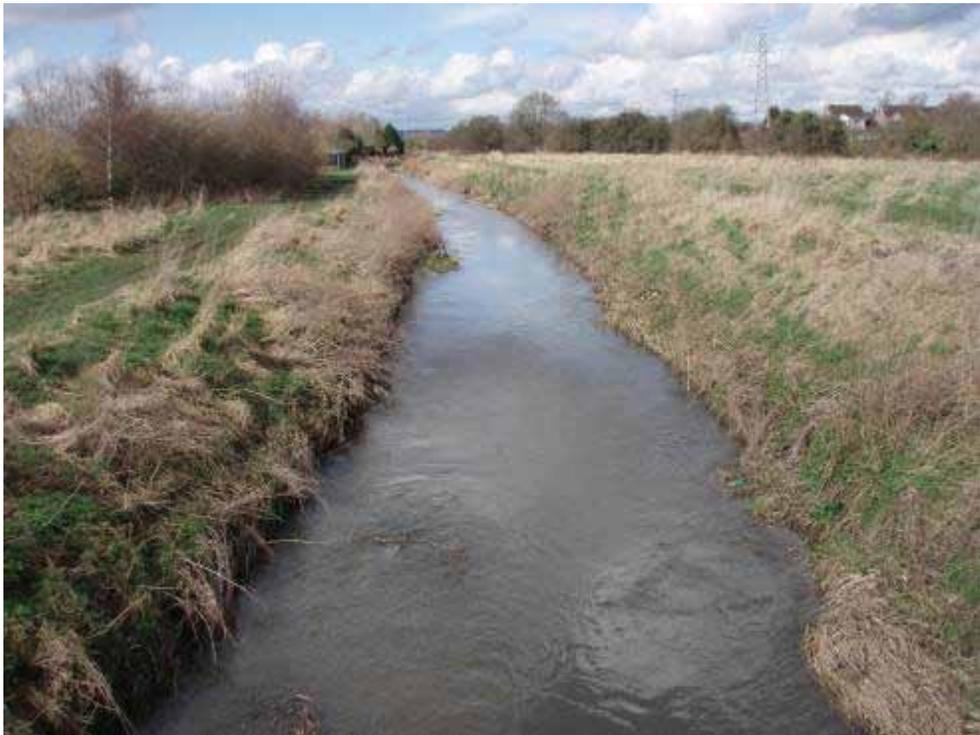
The upstream section of this channel, from the overspill weir downstream, is straight with a uniform width and depth as would be expected from an artificial channel (Photo 7). Below the footbridge (path linking Carrfield Avenue and Cleveland Avenue), the channel shows some more natural features: bends, gravel riffles and side bars, and pools (Photo 8). It may be that, prior to the creation of the flood relief channel, the upstream section of the main river channel and the downstream section of the existing flood relief channel formed the previous course of the river.

Photo 7 Bypass channel looking upstream from footbridge – a uniform channel

- The straight sections of river could be improved in a number of ways depending upon the resources available. These include the installation of flow deflectors (relatively cheap – could be done by volunteers; Figure 1), the creation of vegetated ledges (berms) to narrow the channel (more costly – would probably require contractors; Figure 2), and re-meandering the channel (expensive – probably only likely as part of a larger scheme, e.g. a flood defence capital project). The River Restoration Centre provides a manual of techniques (www.therrc.co.uk/rrc_manual_pdf.php) which have been tried in similar situations and could be adapted to suit this site.

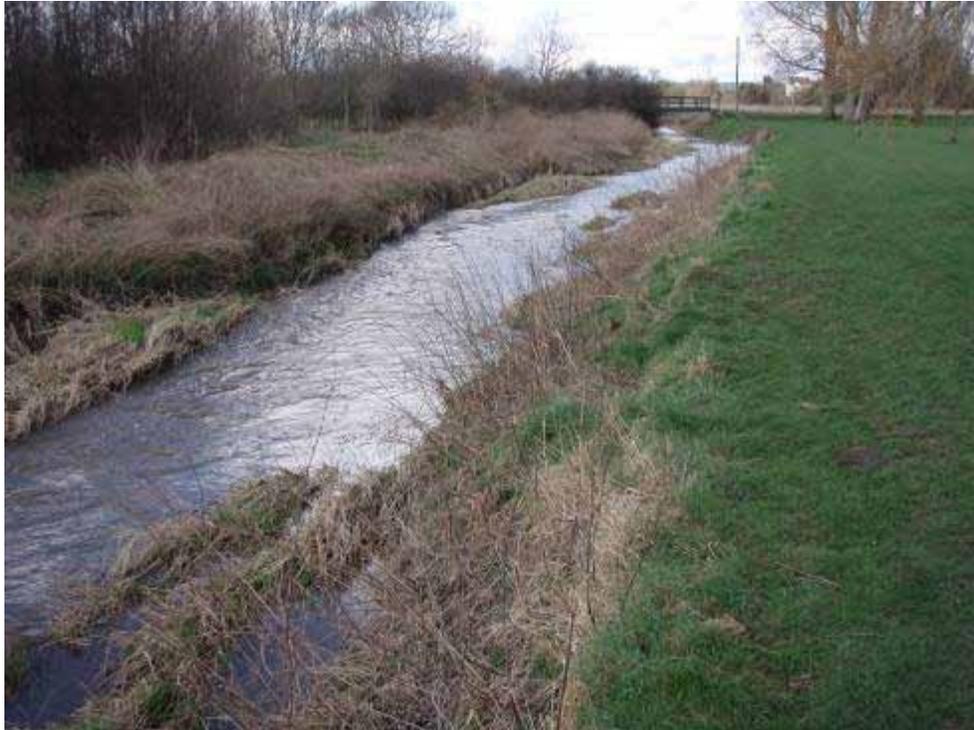
Photo 8 Bypass channel downstream of the footbridge – more natural river features are present. The mown bank would benefit from a more relaxed maintenance regime.

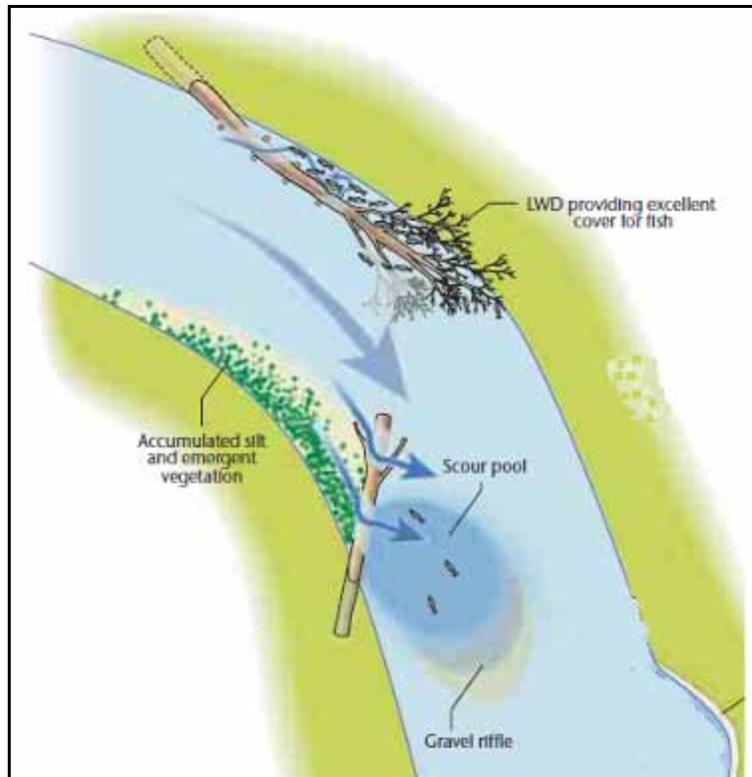
Figure 1 Effects of flow deflectors – creating variation in channel width and depth

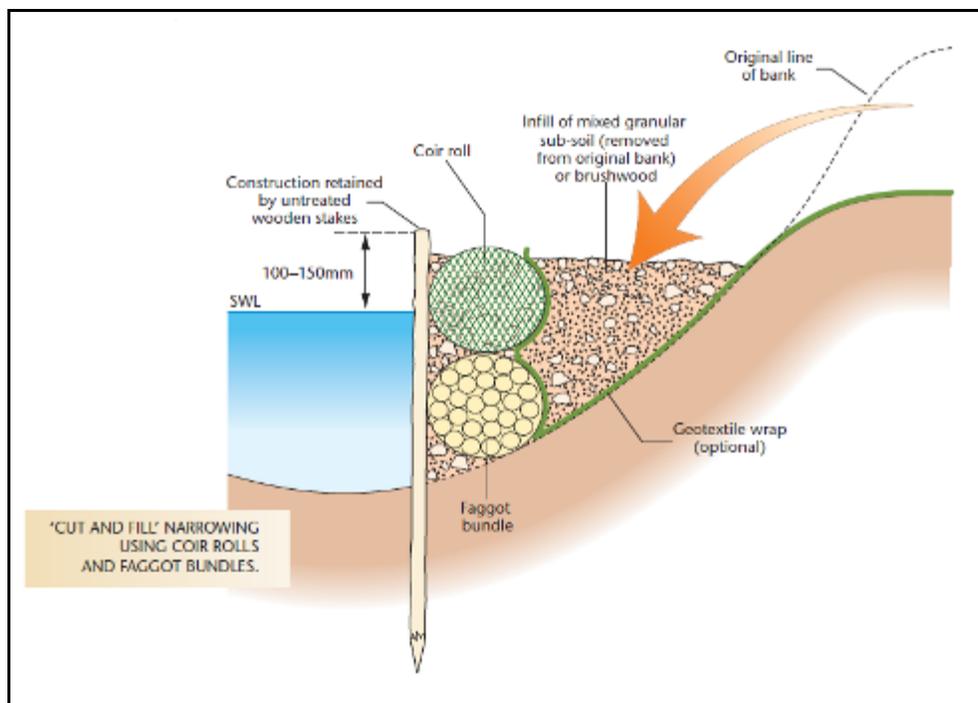
Figure 2 Example of method of creating an marginal shelf or berm

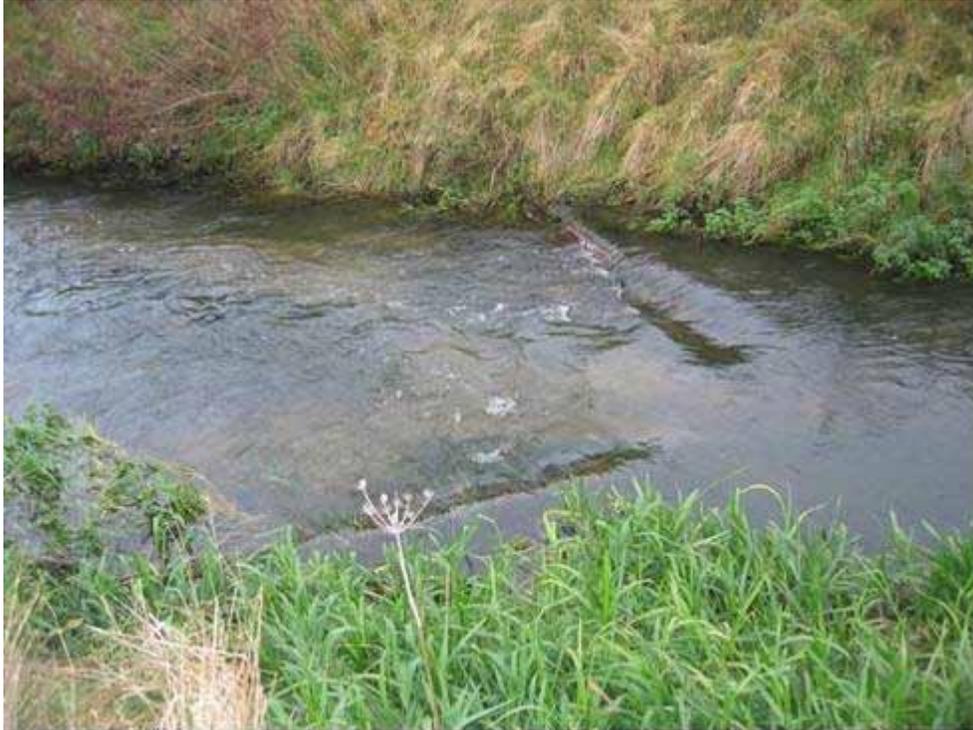
Photo 9 Paired flow deflectors scouring a deeper area in the centre of the channel – these could be used on the bypass channel.
