## **Fenay Beck Part I: Advisory Visit for Calder & Colne Rivers Trust**

**Report by the Wild Trout Trust Arising from Visit on 20/06/2017**

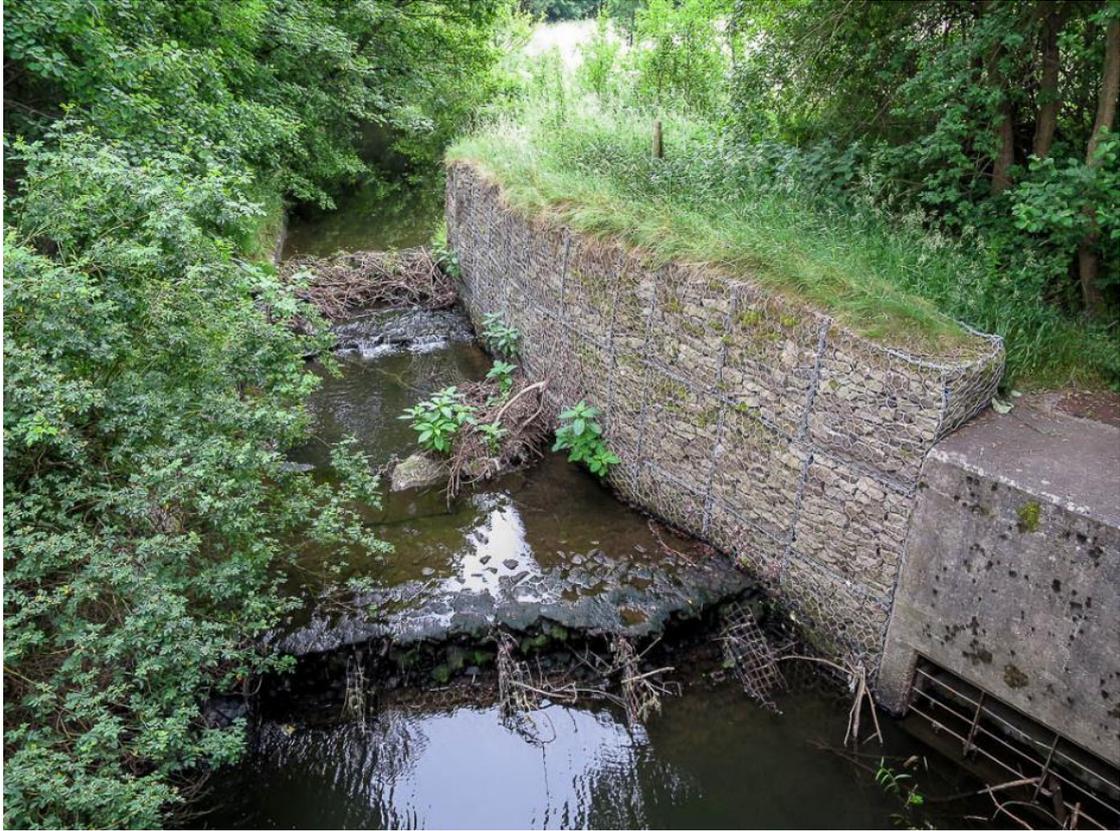
At the upstream limit of the visited reach, a significant impounding structure and physical barrier to fish-movement was noted (Fig.1). The Beck at this location was significantly altered in the past in order to divert the river under the main A629 road in a manner intended to reduce flooding for a housing development. Although exact dates for this work were not known by local residents, estimations of around 60 years ago were common.

**Figure 1: Degrading weir structure at the upstream limit of the site visit for this report at SE 18160 15535. Now a maintenance liability and health and safety issue.**

The impounding structure is showing signs of damage, and the gabion walls on the LB appear to be relatively recent repair works. Although the effects of barriers like this on famous migratory species such as salmon are relatively widely known, there are many further under-appreciated impacts.

Here, the potential to remove or reduce the impounding effect of the specific weir at SE 18160 15535 needs to be assessed while taking account of any potential impacts of such works on the safety of the road bridge and the flood risk to housing. Those considerations are worth investigating, since the impact of this, and other, impoundments is substantial. It is particularly important to note that the addition of an engineered fish-pass to this structure would *not* address the majority of the most significant impacts. Liaising with Environment Agency Fisheries and Biodiversity staff who would process any application by the Highways Agency/any other responsible body to repair bridge footings could be invaluable. The consenting officer(s) for such works could insist that the repaired bridge becomes a stand-alone structure that is not reliant on the weir.

- Removal (complete if possible, partial if not) of weirs on the Fenay Beck. (will require expert geomorphological advice).
- Design and construction of a channel that incorporates natural geomorphological processes and results in a greatly-reduced barrier to migration to tackle the series of v-notch weirs at SE 17960 16052
- Purchase of stem-injection kit and the appropriate professional training and certification of Calder & Colne Rivers Trust volunteers/personnel in its use for controlling Japanese knotweed (particularly valuable while the infestation is still relatively localised and limited)

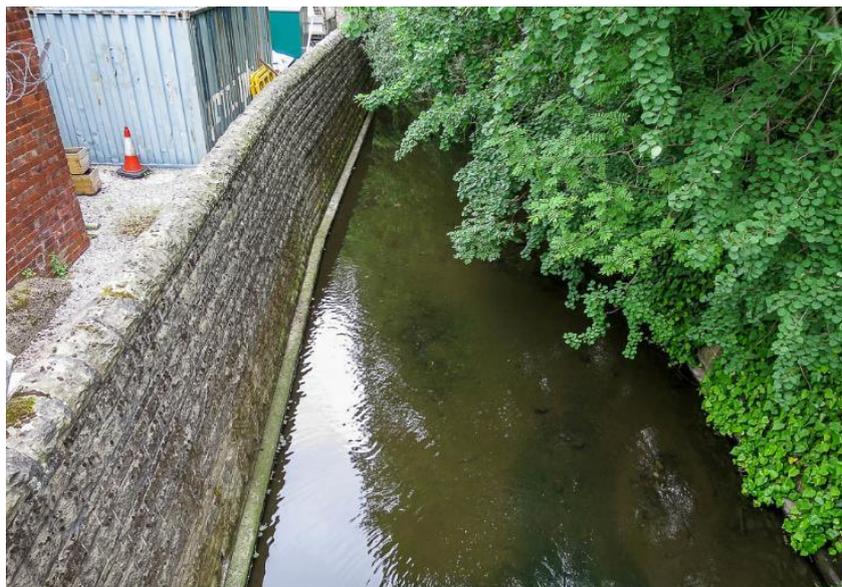
Weirs dramatically reduce spatial and temporal variation in habitat. By reducing the ability of rivers to transport riverbed material downstream – a river loses its capacity to both create habitat and for that habitat to change over time. Holding water back behind weirs and straightening channels (e.g. Fig. 2) also removes important variation in water depth and velocity – both of which are further important sources of habitat diversification.

**Figure 2: Even downstream of the weir pictured in Fig. 1, the artificial straightening of the channel has made the habitat highly uniform (photographed at SE18152 15573)**

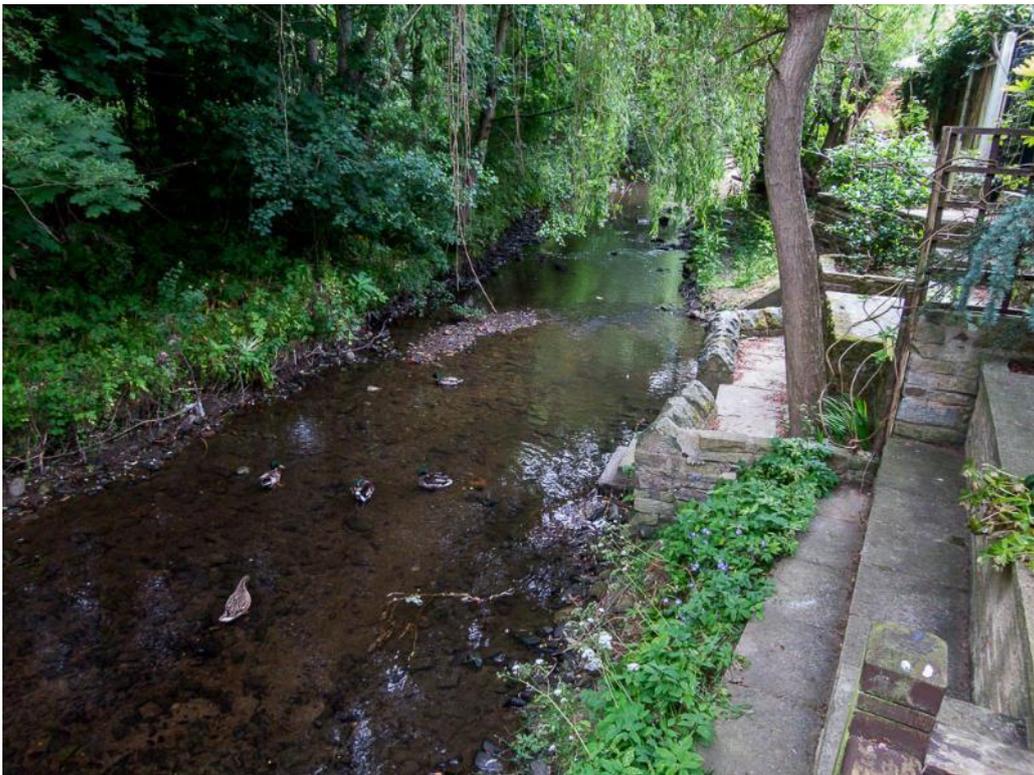
**Figure 4: General lack of low-level vegetation cover, but also relatively limited Himalayan Balsam infestation. Efforts to reduce and control such infestations at this stage would be very worthwhile – especially if action would otherwise be delayed until catchment-scale control could be undertaken.**

- Hand-pulling of Himalayan balsam (can be heaped and composted effectively *in-situ* (well back from the high water level) to avoid the need for treatment as biohazardous waste implied by transporting off site). The comparatively low level of infestation may make it feasible to undertake removal of these plants systematically from source, working downstream

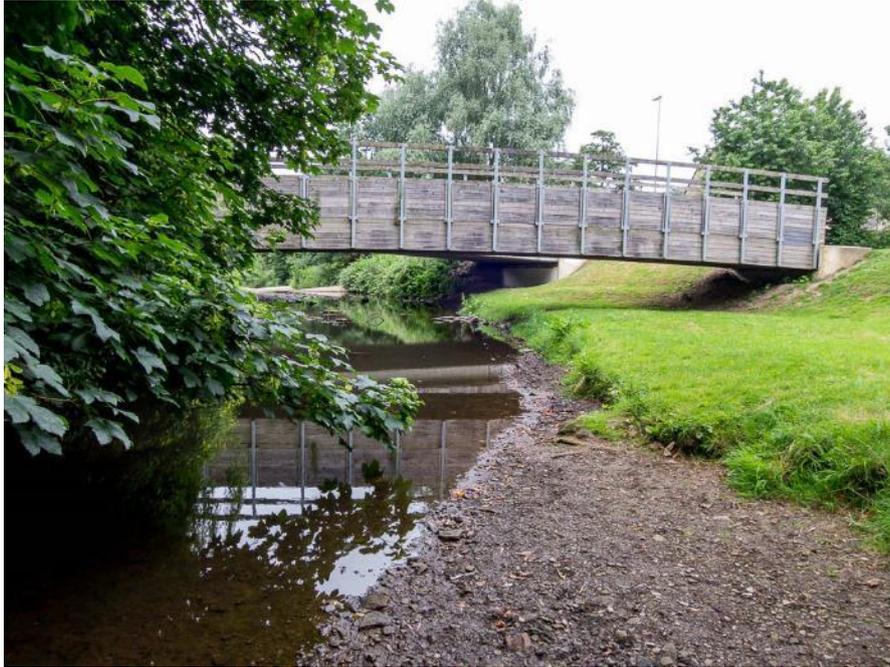
Extensive channel modification (again somewhat calling into question the relevance of the hydromorphological designation under the WFD assessment) was evident around SE 17960 16052. Here, turf-mowing, artificial channel walls and impoundments all combine to reduce habitat quality (Fig. 5). A large signal crayfish was observed in this reach – an invasive species that reduces invertebrate diversity and can also destabilise riverbanks when they occur in high densities. Signal crayfish can also be infected with a fungal plague to which they are resistant – but which is fatal to native white-clawed crayfish. However, at this time, there are no established means of reducing the densities of non-native crayfish – with conflicting accounts on the effects of trapping being reported to date. Taking actions to minimise the chances of transferring crayfish plague between watercourses is probably the most useful policy in response to known infestations.

**Figure 5: Good overhanging cover, but a lack of unmanaged marginal vegetation and heavily modified channel with significant impoundment limits the habitat diversity in this reach.**

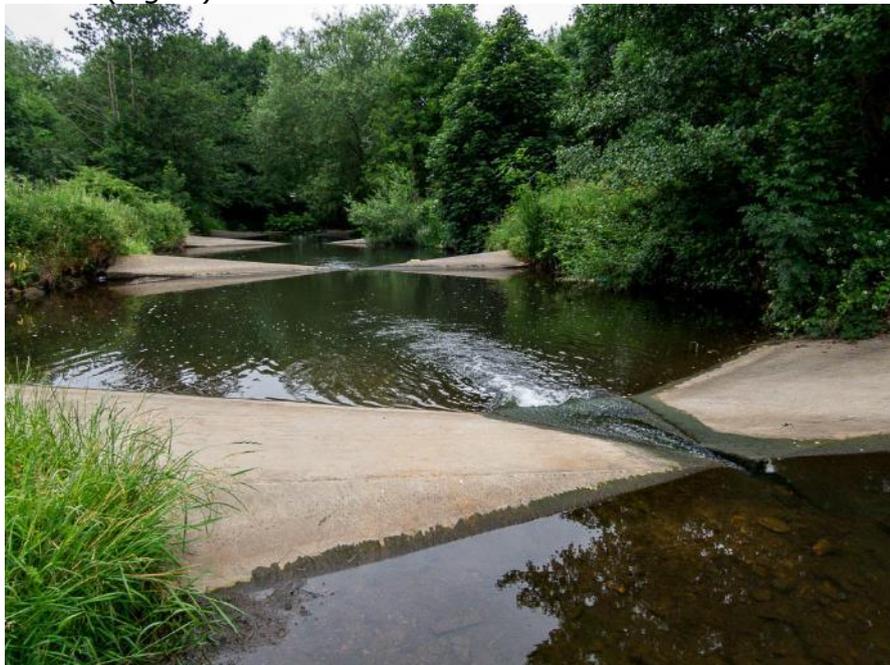
A series of four unusual weirs with a shallow v-shaped profile have been constructed to produce a stepped section of channel between SE 17960 16052 to SE 17941 16086 (Fig. 6)

**Figure 6: Four V-shaped weirs in a stepped series photographed at SE17960 16052.**

Although the purpose of this series of structures is unknown, it results in poor, impounded habitat for a significant distance upstream. In addition, these structures pose a serious obstacle for fish passage through the series of stepped pools. It is possible that part of their function is to hold back a head of water in the upstream section and also to act as bed-check weirs installed to cope with the increased gradient following the straightening of the channel. Channels become effectively steeper when straightened, because they undergo the same vertical change over a shorter distance compared to the longer, meandering channel.

With sufficient investment, it may be possible to design and install a suitable combination of channel features that could make this stepped section into more valuable, connected habitat. The requirement for topographical surveying and flow/geomorphological modelling prior to undertaking what would be a relatively technical construction phase means that this would not be a low cost, low-tech solution. However, it is always crucial to pursue a genuinely meaningful solution rather than an option that falsely indicates that real progress has been made.

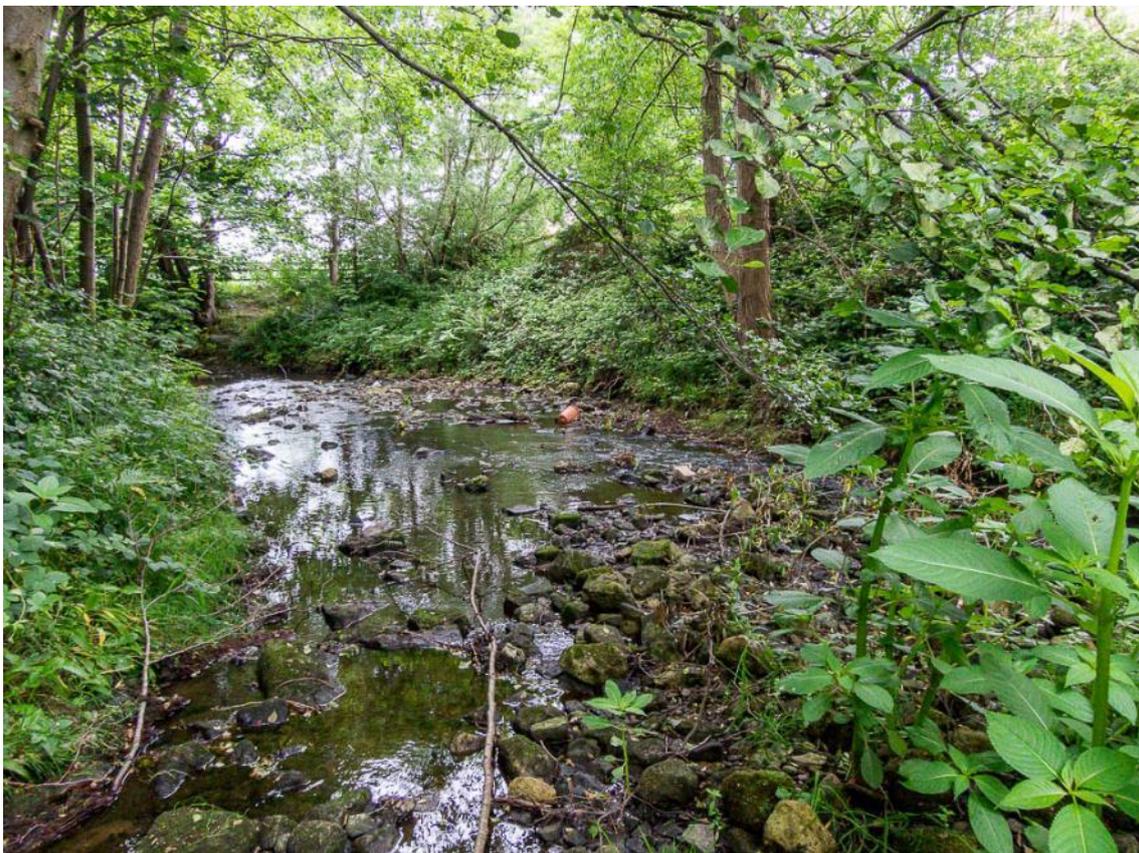
Directly below that series of four weirs there is some of the best habitat encountered during the visit (Fig. 7).

**Figure 7: Although some Himalayan balsam is present, the greater variety of substrate size and more meandering planform produces much better habitat than the impounded reaches upstream. However, the interception of gravels by that series of impounding structures is, nevertheless, a negative impact on these downstream reaches too.**

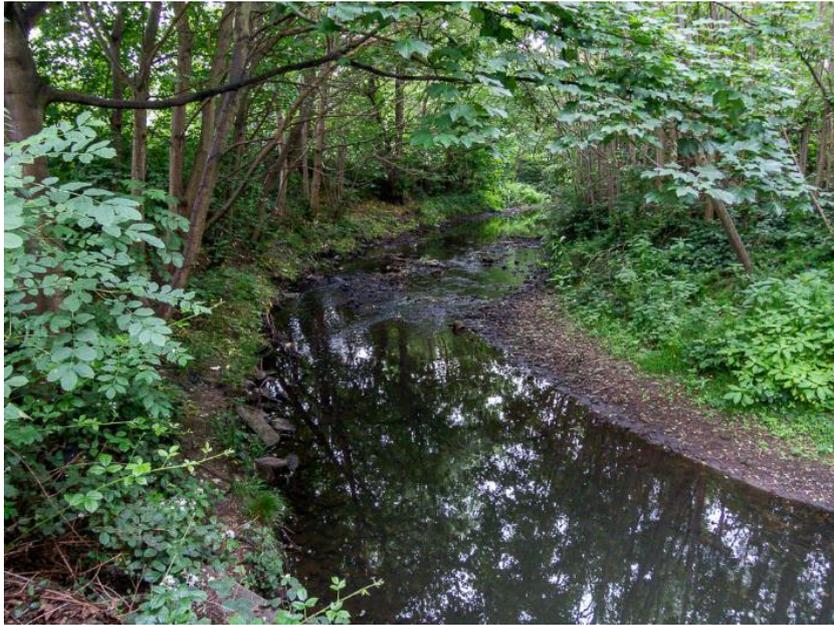
Adult trout habitat in the form of lateral scour pools (i.e. deeper water forming on the outside of bends in the river) was evident in spite of historic channel modifications. For instance, the deposition of material on the inside of a bend –

and increased depth on the outside – can be seen in Fig. 8 taken at SE177707 16662.

**Figure 8: Some valuable habitat features have formed where a lack of impoundment allows the river to deposit and scour material according to the variation of current velocity over its full cross-section. Again, a general lack of lower, overhanging or partly-submerged cover is a notable opportunity for improvement – and its absence may be due to current maintenance programmes.**

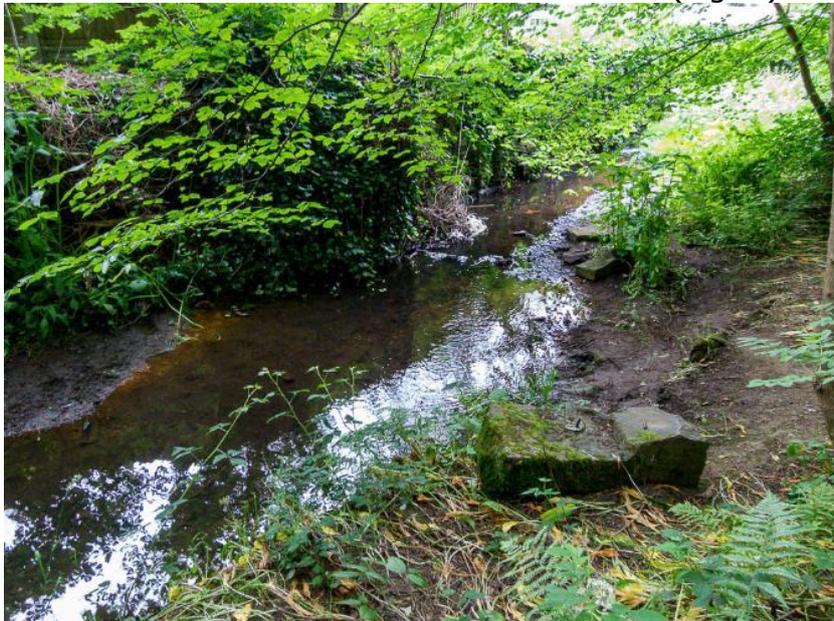
The channel splits into two, widely separated branches (and the beck becomes locally-known as Roundwood Beck) in the area of Dalton Green. One site at SE17595 16748 was monitored by the author and Martin Smith (and family) during the Calder and Colne Rivers Trust “bioblitz” event (Fig. 9).

**Figure 9: One of the “Bioblitz” sampling points on Roundwood Beck. Extremely high numbers of blue-winged olive nymphs and several flat-bodied mayfly species – along with “true” mayflies of the Ephemeroidea were recorded. The presence of many invertebrate taxa that are known to be sensitive to organic pollution indicates high water quality at this point.**

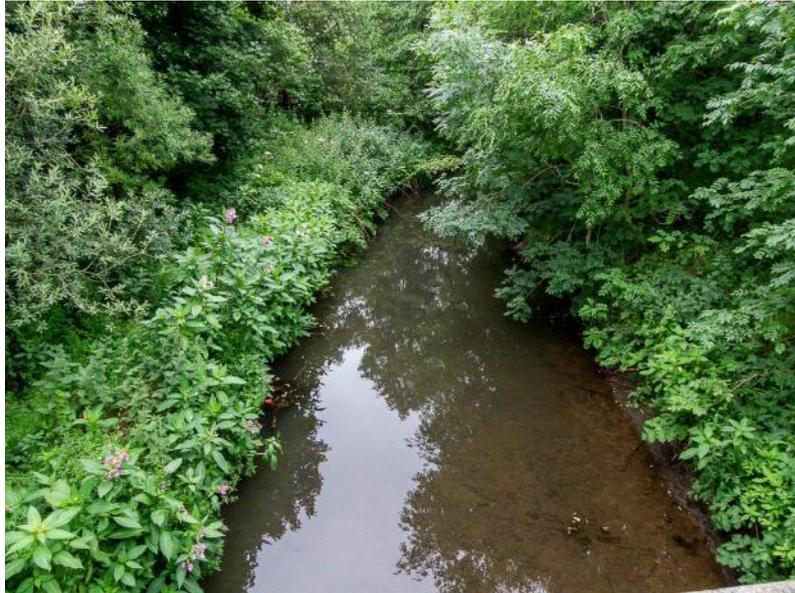
Impacts of impoundment and engineered channels are common within these middle reaches of the Fenay Beck (e.g. Figs. 10 and 11).

**Figure 10: Photo off Albany Bridge at SE 17506 17167. Uniform straightened channel with silt deposition over the full cross-section (due to impounded flow and artificially large, uniform cross-sectional area. More balsam evident here than in some other visited reaches.**

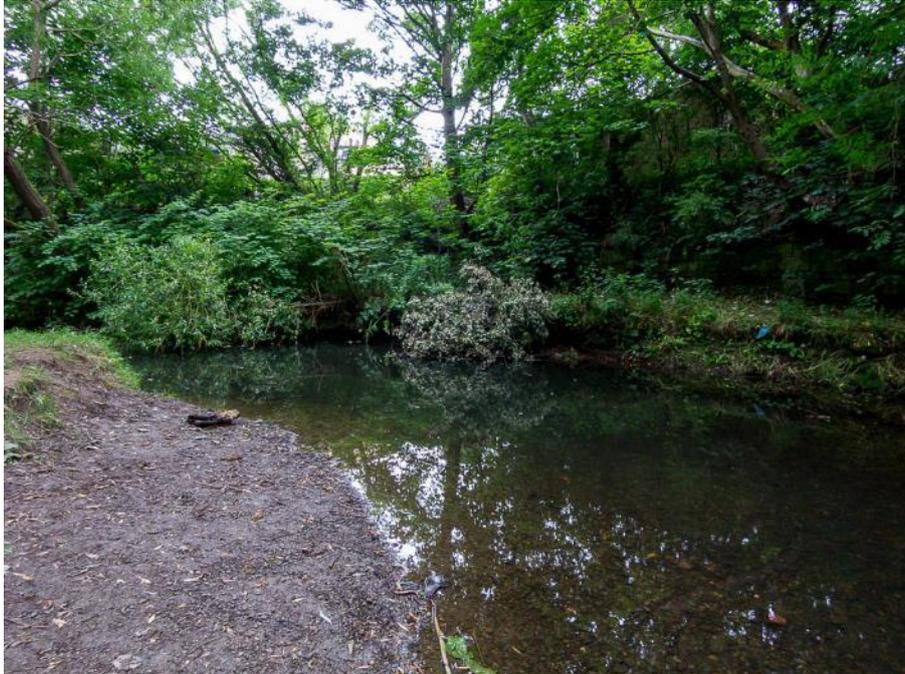
Examples of valuable habitat were observed during the visit – and should be used to inspire management of the river corridor to promote more instances of similar habitat. A good example is the cover habitat provided by the fallen willow photographed at SE 17354 17168 (Fig. 12).

**Figure 12: Fallen willow and overhanging woody vegetation – vital habitat that is rarer than would be ideal from the perspective of biological diversity**

Low, trailing and partially-submerged complex cover such as tree crowns, feathery root masses and trailing herbaceous vegetation are excellent protection from predators for juvenile fish – including trout. At the same time, it also provides shelter from spate conditions for all weaker-swimming species while creating and maintaining deeper areas and cool-water refuges during hot weather. This is another example of physical complexity in the habitat which provides a greater variety of niche opportunities. Where suitable colonisation routes and opportunities exist, that greater range of niches can become occupied by a wider range of species of flora and fauna.

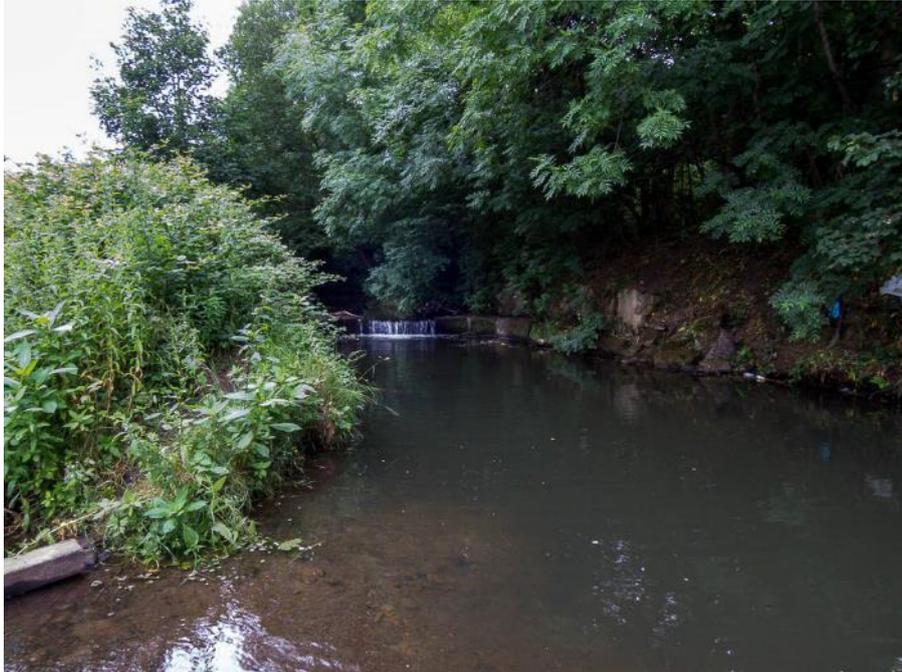
Amongst the most significant impacts of habitat simplification and impoundment was noted between the small step weir at SE17321 17236 (Fig. 13) and the downstream limit of this visit at Dalton (SE 17072 17408). Throughout this section, the lack of flow produced by changes to the channel cross section – and the loss of gradient imposed by multiple impoundments – have seriously reduced the habitat quality. The invasive, non-native plant Japanese knotweed was noted at SE 17224 17257 (Fig. 14) – a cause for concern because of the greater difficulty in achieving control (compared to Himalayan balsam). The extensive, spreading root (rhizome) system of Japanese knotweed – and its ability to grow new plants from very small fragments – make removal of this plant a specialist task. That task is also regulated by specific and essential licensing and legislation. See the Recommendations section for advice on achieving control of Himalayan balsam

**Figure 13: Step weir, part of an extensively impounded reach.**

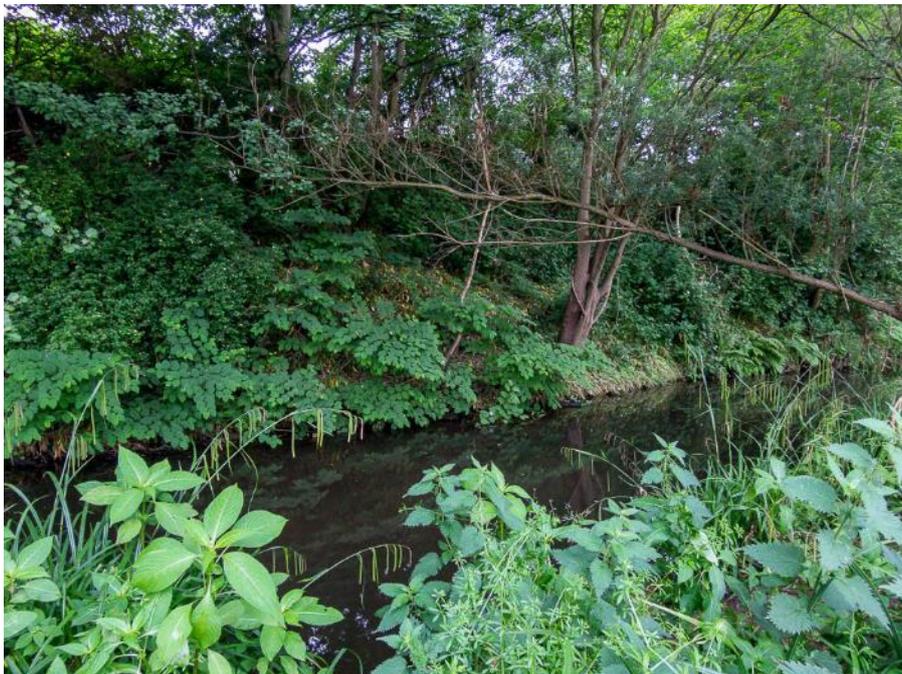
**Figure 14: Japanese knotweed stand on the opposite bank and balsam on the nearside**

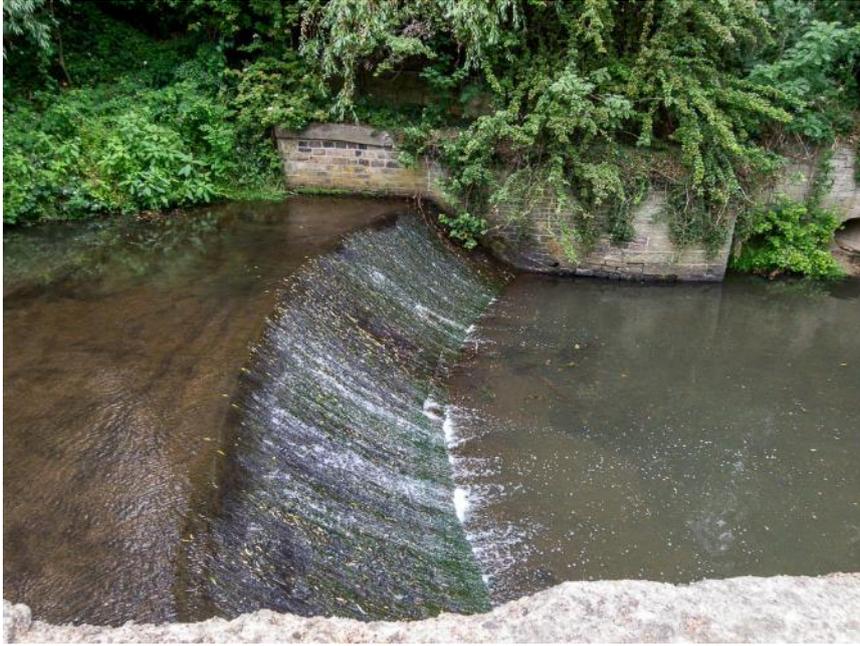
The large weir at SE17098 17319 creates a hugely significant barrier and impoundment (Fig. 15). The height of this weir has a profoundly negative impact on the Fenay Beck (a relatively small watercourse), reducing the effective bed-slope. A stream's gradient is probably the factor which generates the greatest potential for recovery in many of these Pennine streams. It is through energised flow downhill that riverbed material is sorted, deposited and remobilised to create

high quality habitats. Large impoundments take away those streams' greatest source of recovery from their post-industrial condition.

**Figure 15: Weir at SE17098 17319 a severe impact on the ecological potential of the Fenay Beck**

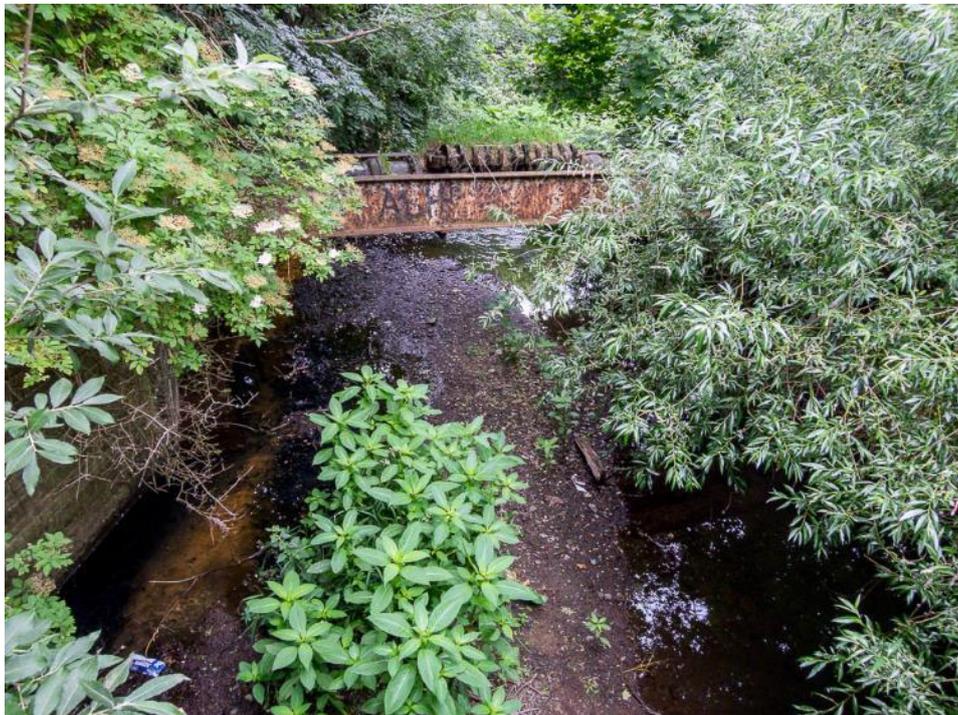
The downstream limit of the reach visited for this report was photographed at SE17072 17408, Briggate Bridge (Fig. 16). Although Himalayan balsam is visible and there was a limited amount of (inert but with the potential to smother) insoluble ochre, the value of gradient is also evident. With gradient and associated flows that can redistribute bed material, the greater physical variety created in this reach in the absence of impoundment is notable.

**Figure 16: Himalayan balsam and ochre, but also a significantly more varied structure to the cross-sectional depth and flow velocity profile in the absence of impoundment**

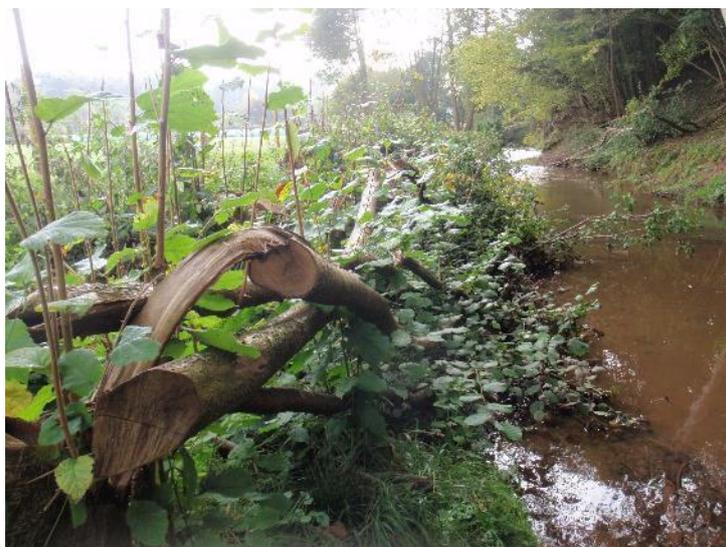
- Planted whips or existing saplings of suitable sizes could also be selectively hinged (or “laid”) into the margins of the beck to provide shelter from predation and spate flows for juvenile fish (Fig.17). Some localised bed-scour can also be encouraged by material laid into the margins in this manner.

**Figure 17: Hinging or laying of saplings to create marginal cover (in this case using hazel – but many suitable species exist)**
