**Ford Green Brook and Lyme Brook:
Opportunities to Improve Habitat
(incorporating volunteer-contribution potential)**

Report and Proposal by the Wild Trout Trust – 15/03/2016

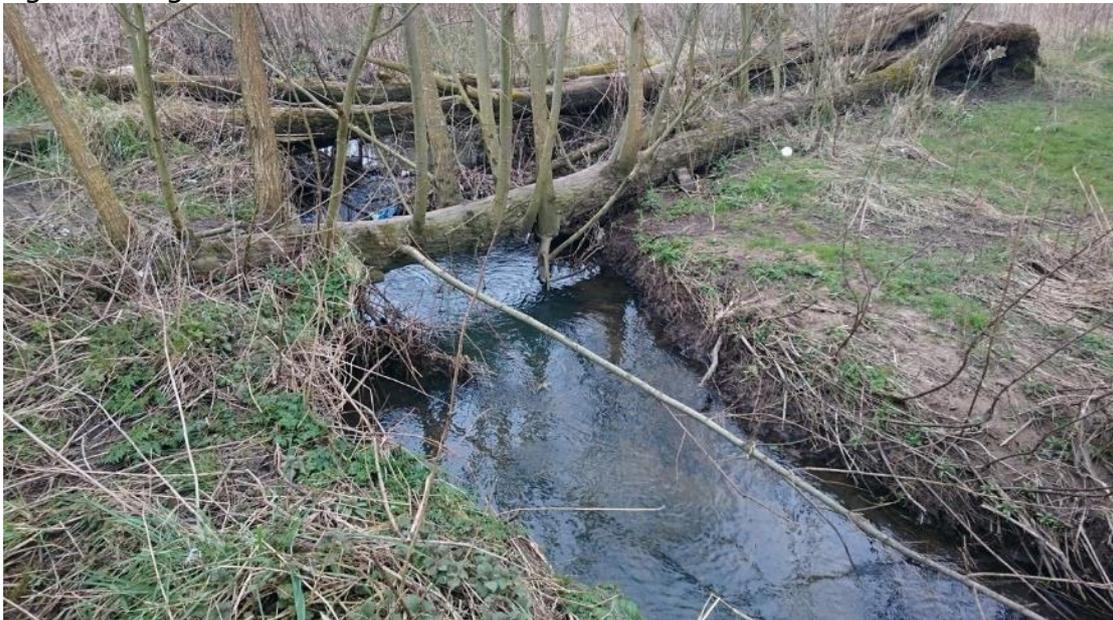
Figure 1: Ford Green Brook at the upstream limit visited (SJ 88759 51461) – benefiting from stable large (living) woody material.

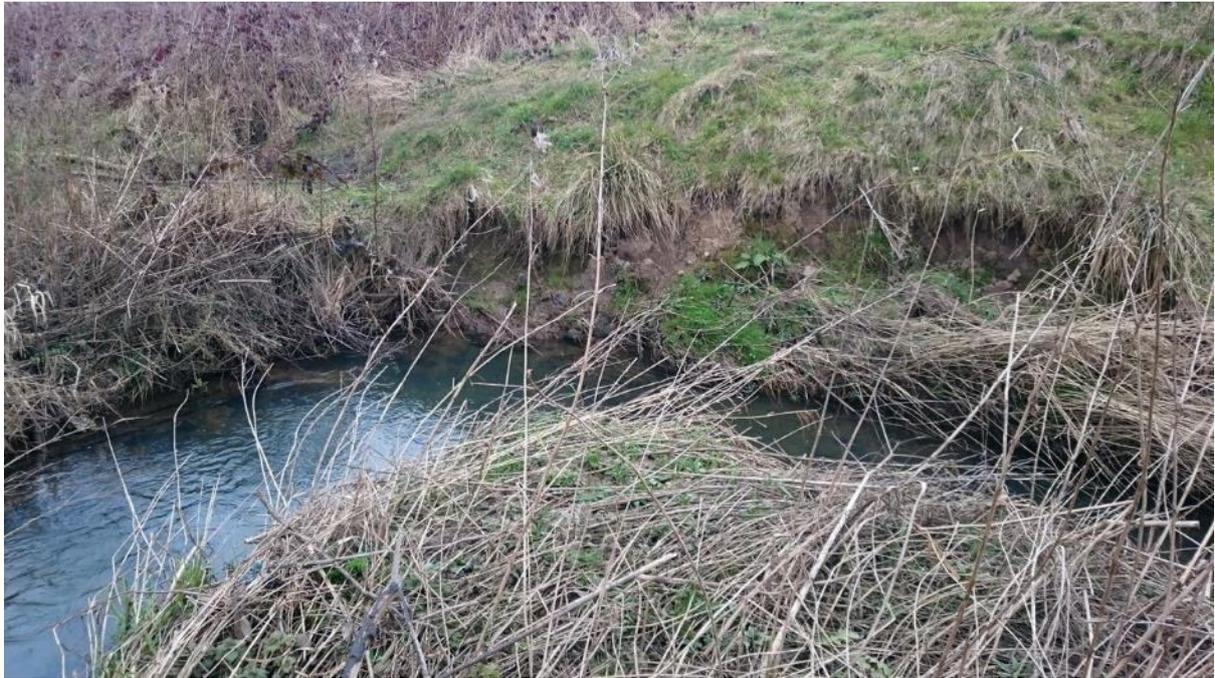
Figure 2: Just downstream of location shown in Fig. 1, a meandering channel with lateral and longitudinal variation in depth (up to approx. 60 cm deep) and diverse current velocity - fringed with a variety of rough, scrubby vegetation. Structurally valuable - but apparently suffering from organic enrichment.

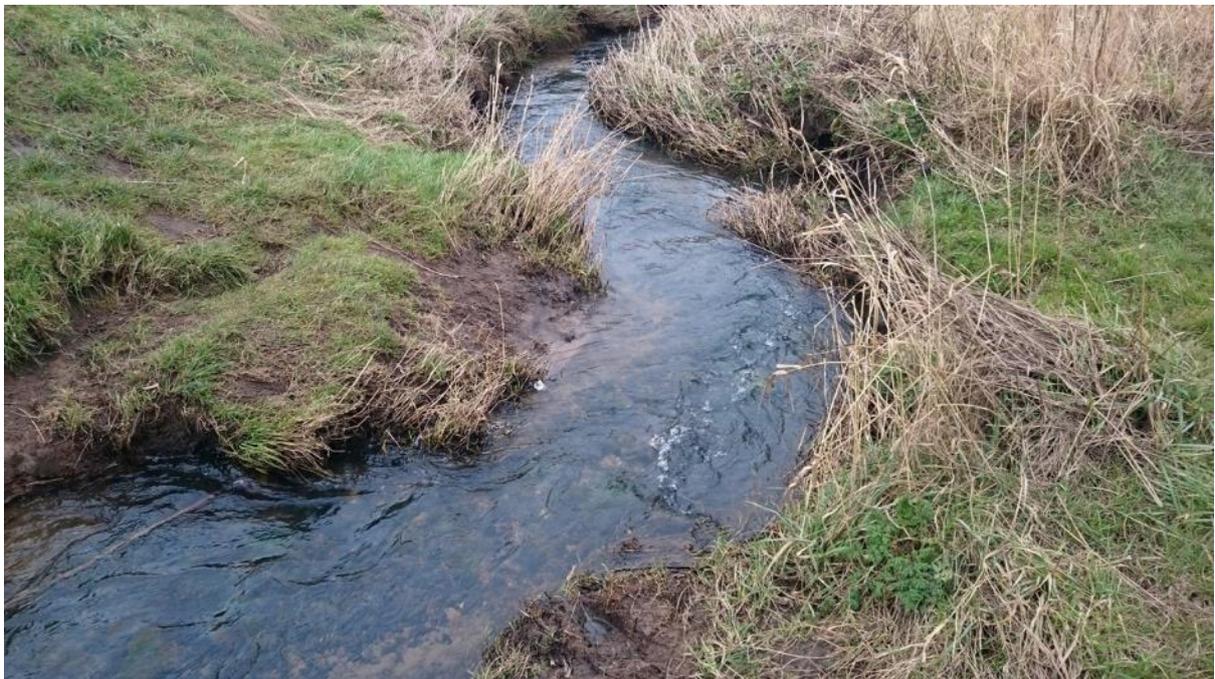
Figure 3: Approximately 50 metres downstream from location shown in Fig. 2, a gravel riffle and meandering channel. The rough heathland vegetation appears to be only very lightly managed as part of Whitfield Valley nature reserve. There are some light, localised impacts on vegetation and banks from foot-fall – but this may actually provide an overall benefit to structural variety. This is very different from uniform trampling/over-grazing impacts over long reaches of river.

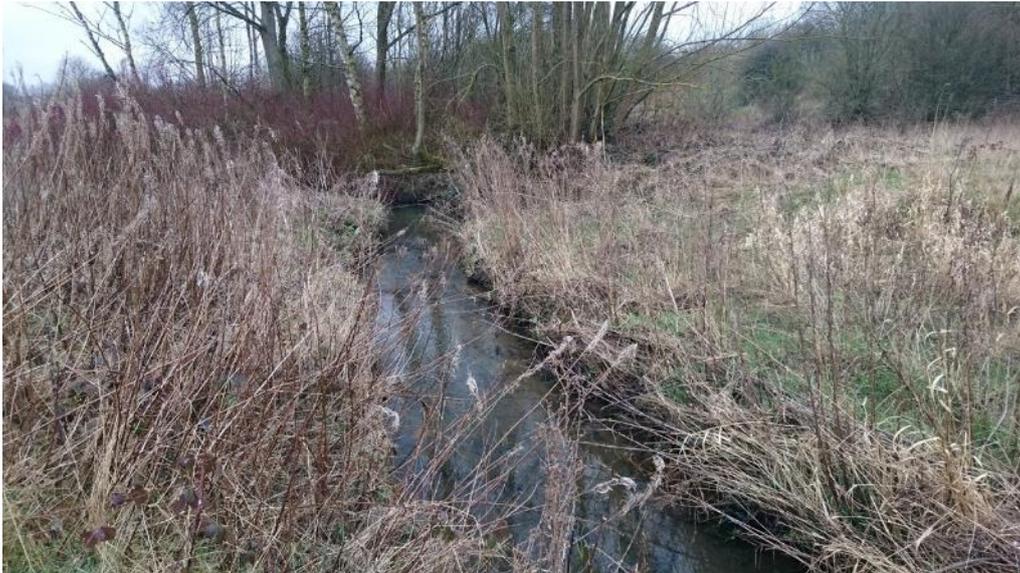
The management of the area as part of a nature reserve (Whitfield Valley) is evident in the good representation of different riparian habitats. Figure 4 shows

tall grass/scrub contrasting with a copse of riparian trees – giving variety in cover and structural form (without being over-managed or too “tidy”).

Figure 4: Variety in marginal cover and structure at SJ 88759 51430.

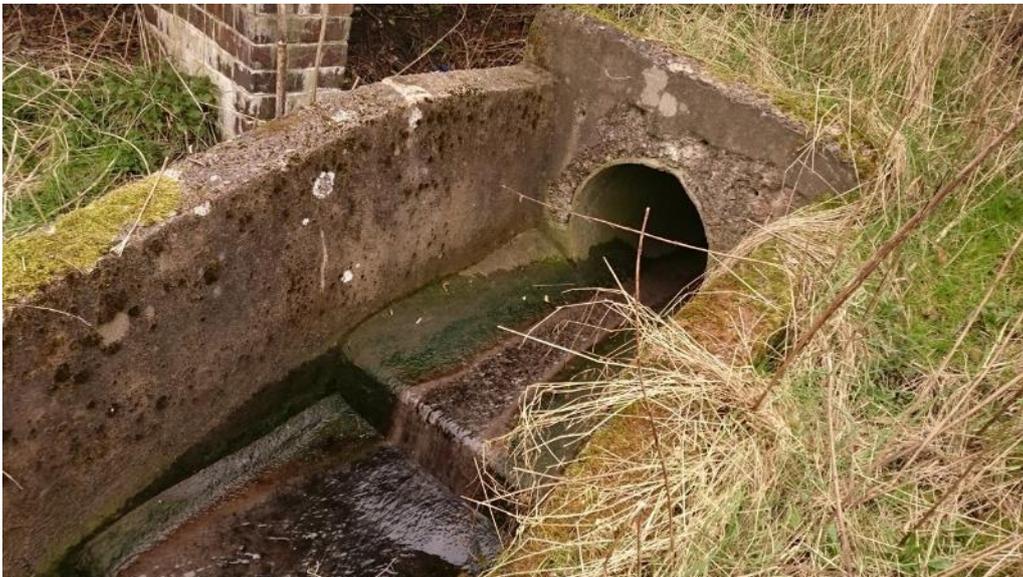
Although a drainage outfall was noted at SJ 88815 51306, there was no overt indication that it was operating significantly outside of designed/consented parameters (note the lack of extensive rag waste Fig. 5).

Figure 5: Outfall at SJ 88815 51306. Algal growth may indicate some nutrient enrichment. Whilst not particularly obvious, there was a subtle sign of potential “grey water” previously discharging from this outfall. This could indicate a blockage or misconnection and it would be worth maintaining a watching brief on this.

It may be worth investigating current consent levels for organic nutrients – as well as other potential sources in the catchment. It is possible that the combined effect of multiple outfalls carrying nutrients into a stream with such small potential for dilution would elevate the nutrient status within the Ford Green Brook. The filamentous green algae can be easily seen on riffles throughout the reach (e.g. Fig. 6).

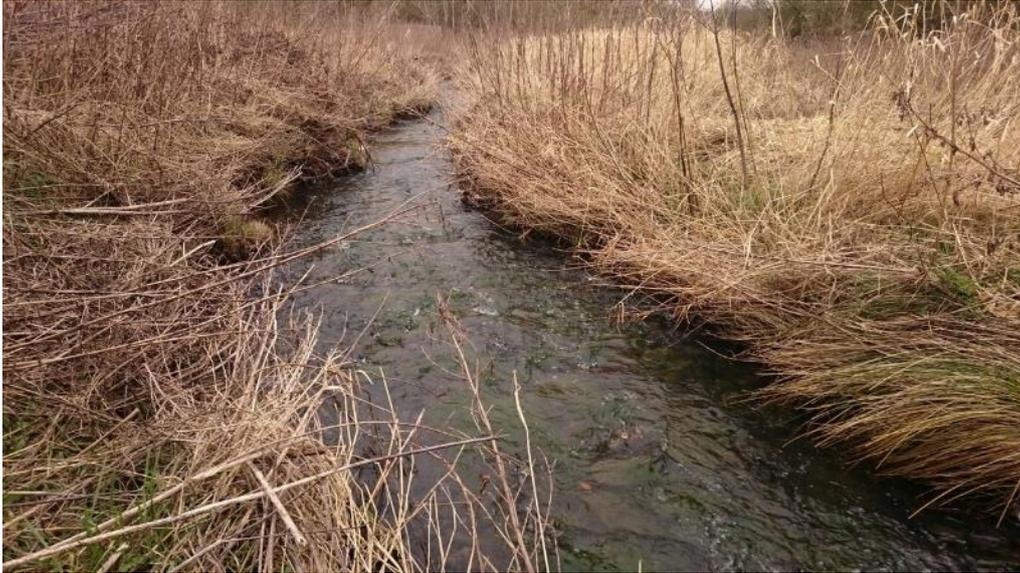
Figure 6: Filamentous green algae growth covering cobbled substrate (in this case just below the outfall shown in Fig. 5). This type of growth - and associated organic-pollution-tolerant invertebrates - is common throughout the reach.

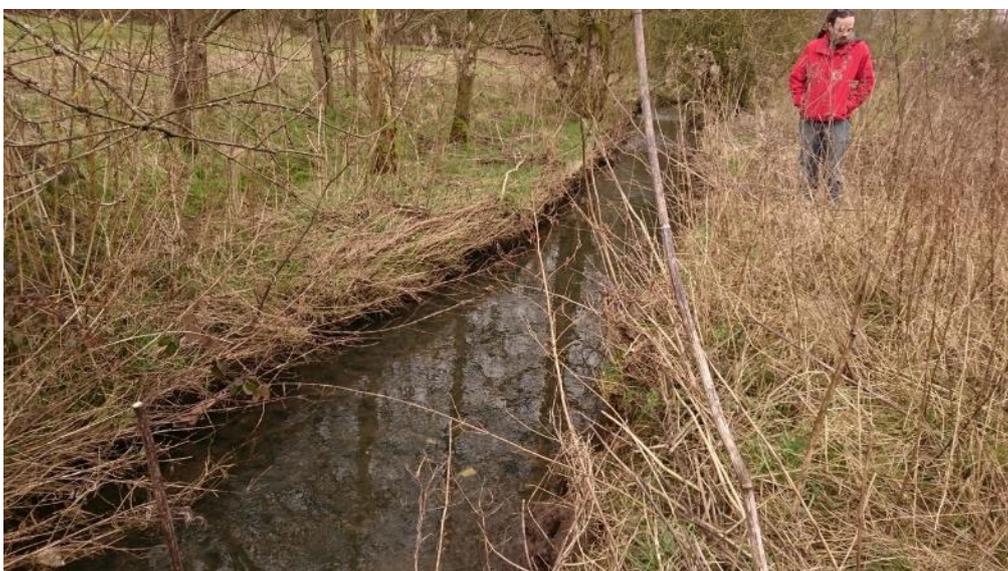
Some poorer habitat was noted within the straightened section of the brook as it is diverted around the lake within the reserve (Fig. 7). This is a relatively short section – although it could still be beneficial to increase diversity and “patchiness” of flow-depth and substrate particle-sizes. Since the course of the stream is constrained by the existence of the lake and associated access footpaths, re-meandering the brook is likely to be unfeasible. Instead, it may still be possible to create variation in depth via a longitudinal series of scour-pool and riffle “steps” by introducing small “log-jam” or comparable, stable woody material features.

Figure 7: Straightened channel and more uniform habitat adjacent to lake.

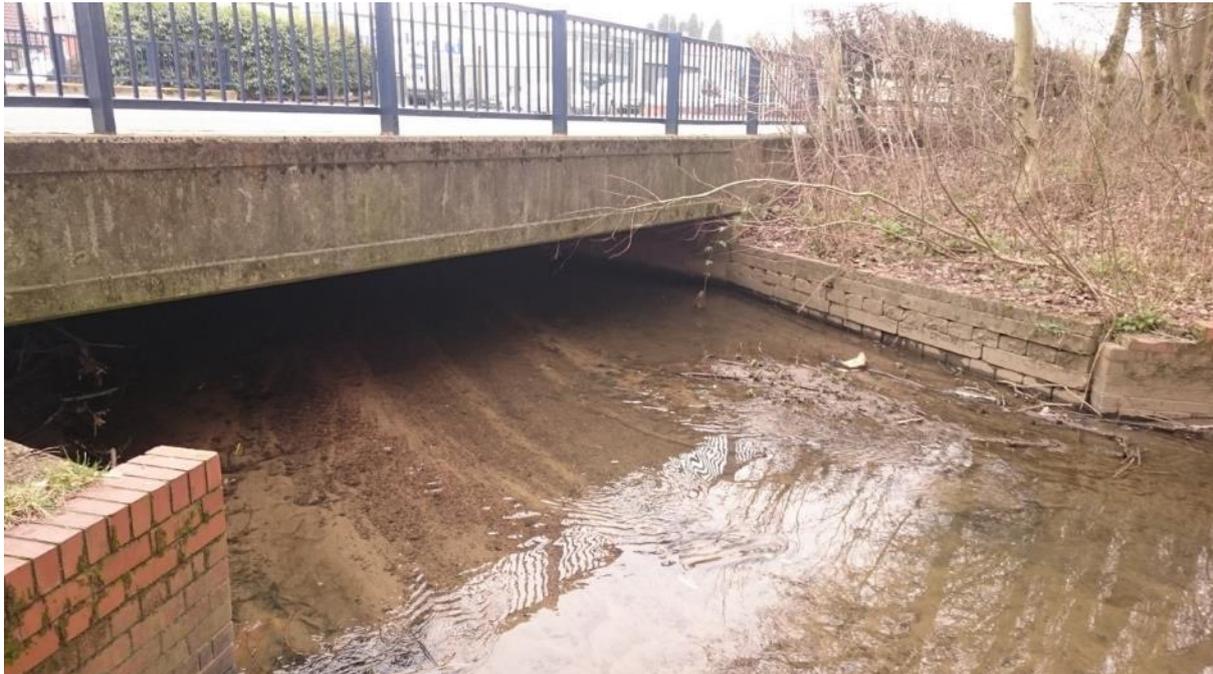
Evidence of the sandy upstream catchment – and the erosion/transport of fine sediment – can be seen beneath the B 5051 road bridge at SJ 88814 50904 (Fig. 8).

Figure 8: Fine sediment deposition in artificially-wide channel (built to accommodate bridge). It is likely that the invert level beneath the bridge also does not match the natural longitudinal bed-slope of the brook - compounding this "sediment trap" effect.

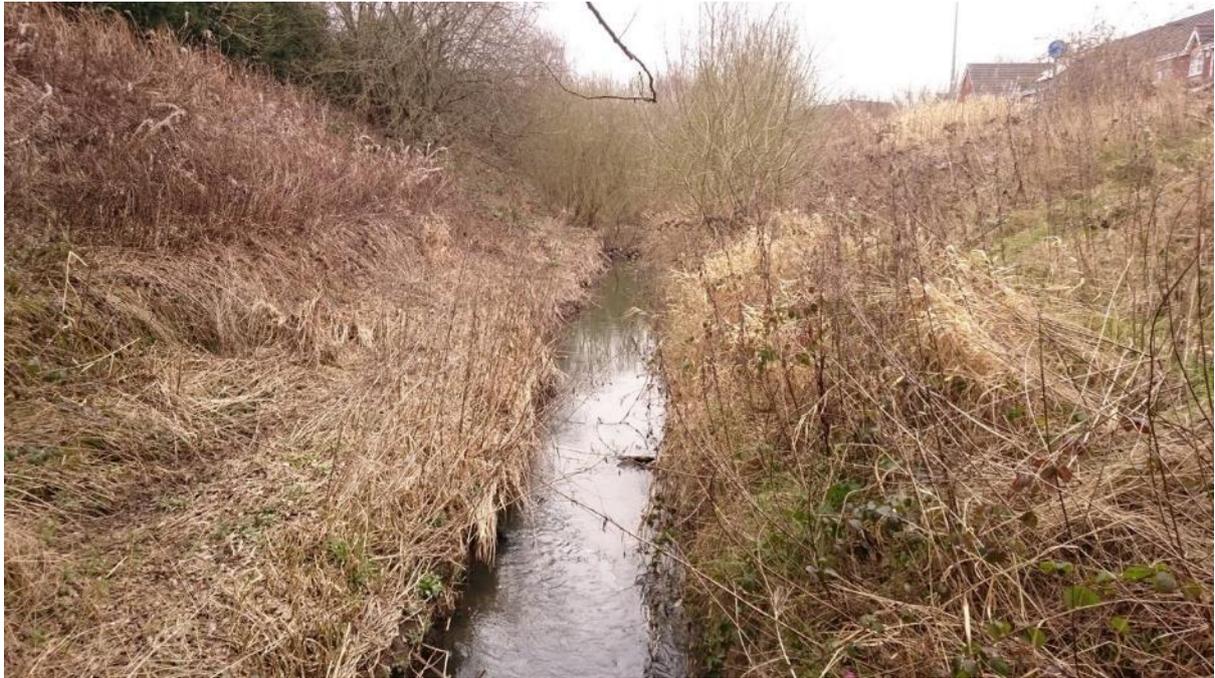
Figure 9: Straightened, narrow section adjacent to housing at SJ 88888 50811.

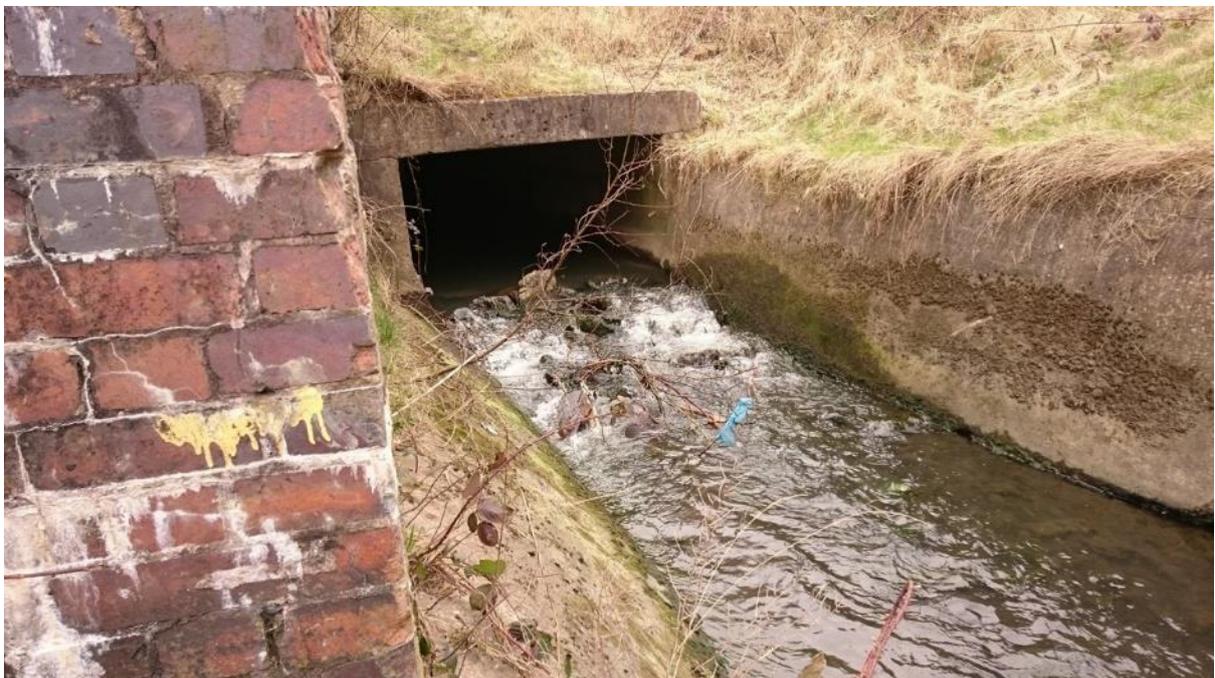
Progressing downstream, the brook passes through an extensively straightened reach adjacent to housing (Fig. 9) before passing through an industrial estate (again, straightened – but not pictured due to lack of access). It then emerges from a culvert that consists of a wide (dry) flood channel and a smaller culvert exit that discharges over a rocky "ramp". This ramp may, potentially, allow a proportion of fish to access the upstream reaches of the brook (Fig. 10).

Figure 10: The main-flow carrying culvert exit at SJ 88925 50657. Note the rocky “ramp” that may provide some assistance to fish attempting to ascend this barrier. The flood channel of this culvert (out of the left border of the frame) is much larger – but dry under normal flow conditions.

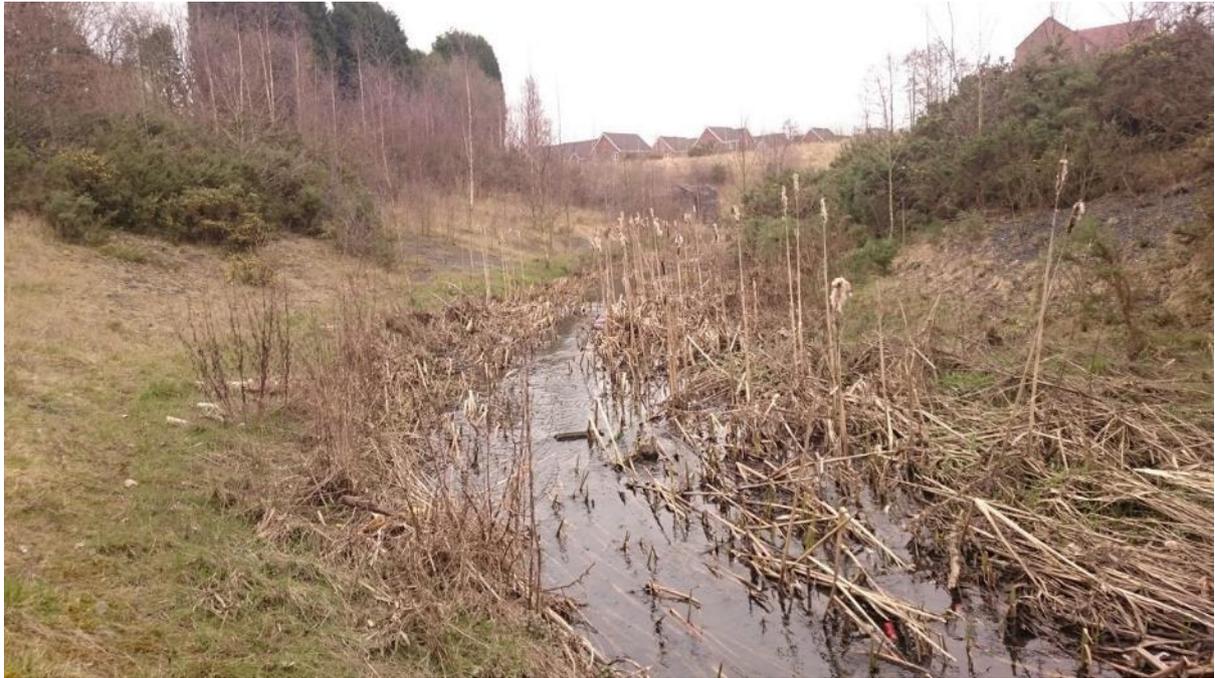
Conditions that are typical of the reach below this culvert are shown in Figs. 11 and 12. The combination of physical habitat and the likelihood of nutrient enrichment (based on observations upstream) mean that this section is unlikely to be suitable for trout.

Figure 11: Low gradient, wide channel with extensive in-channel emergent vegetation (residential area that extends into the area pictured in Fig. 9 visible in background). The birch scrub that is recolonising the valley slopes is supporting abundant bird life.

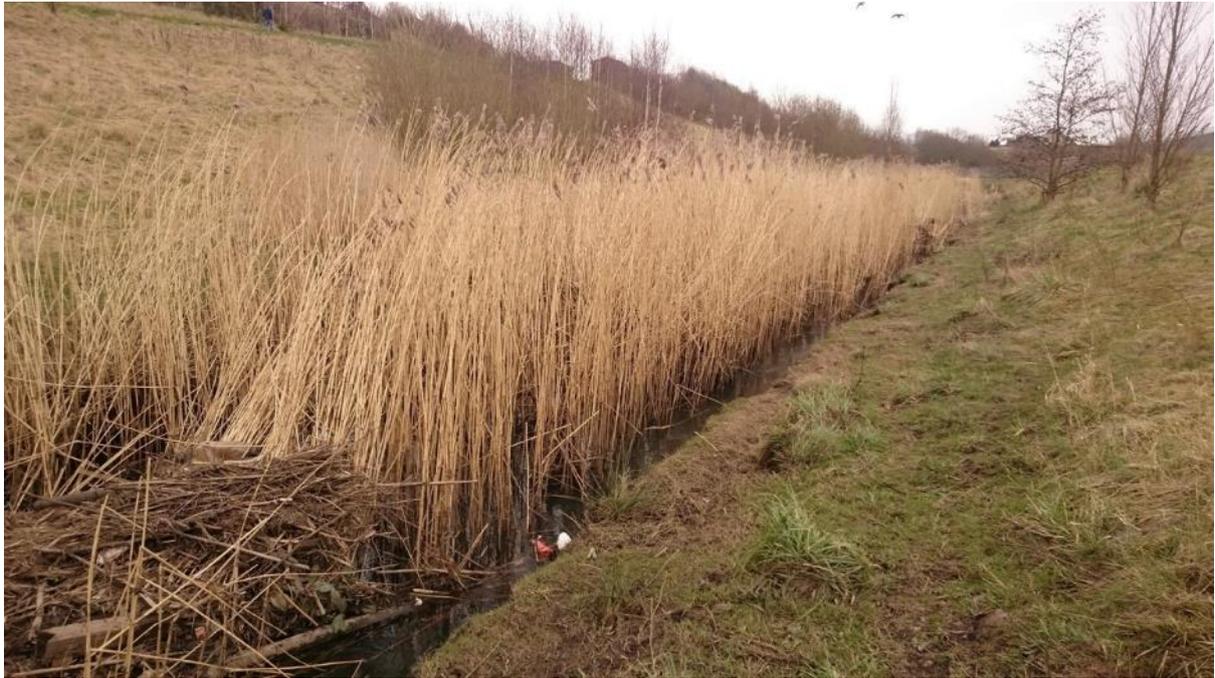
In some sections the channel is likely to be very difficult for fish to move up and downstream (particularly in high summer) due to the choking of the channel with emergent vegetation (Fig. 13).

Figure 13: Channel choked with emergent vegetation (likely to be a variety of *Phragmites sp.* reed).

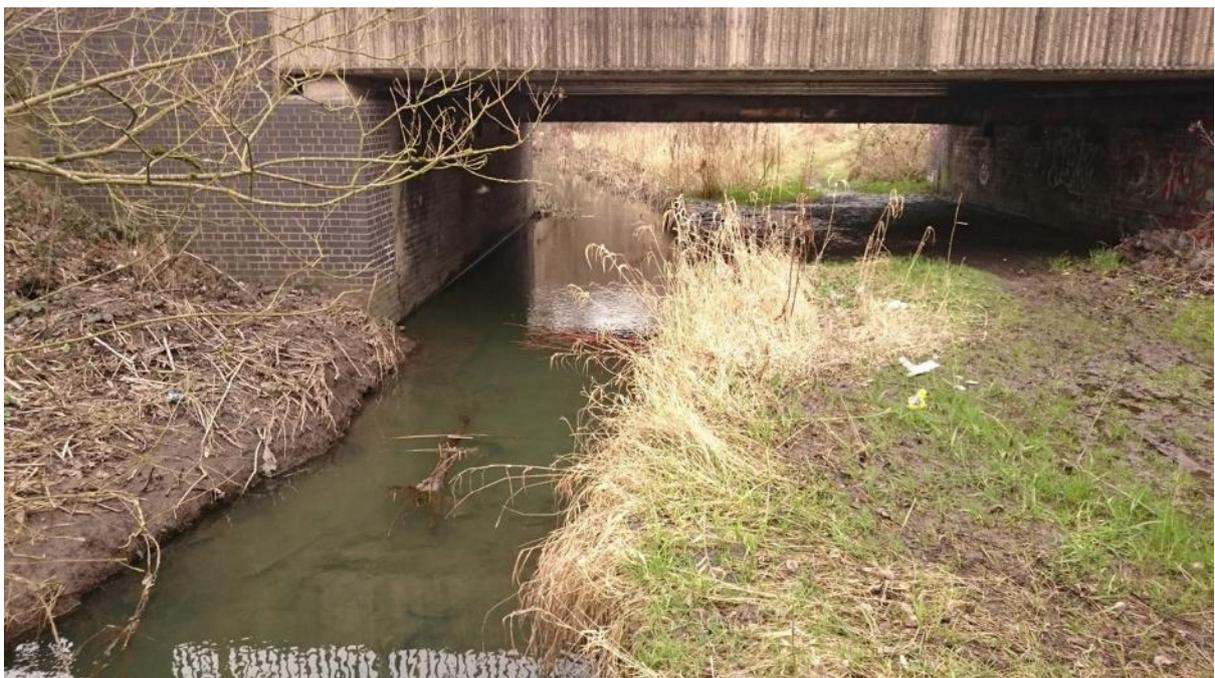
Figure 14: Ford Green Brook crossing under the A53 at SJ89594 50192.

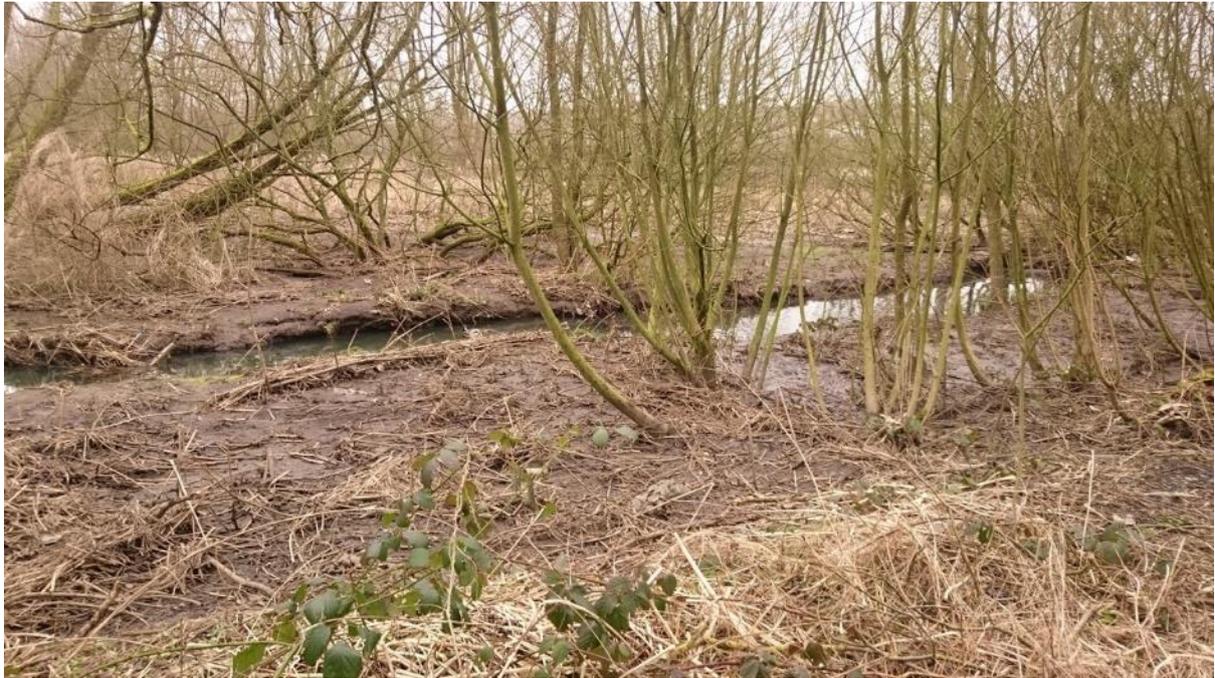
Further downstream the brook crosses beneath the A road (Fig. 14) and passes into an area of wet woodland bordered by residential property, local road networks and a dismantled railway. The woodland also contains pond and stillwater habitats (at least one of which appears to support a coarse fishing amenity). Again, the likely nutrient status and habitat structure make this unwelcoming habitat for trout and other flow-loving fish (Fig. 15).

Figure 15: Wet woodland/low-lying floodplain at SJ 89501 50223 (the catchment here is dominated by soft, sandy soil).

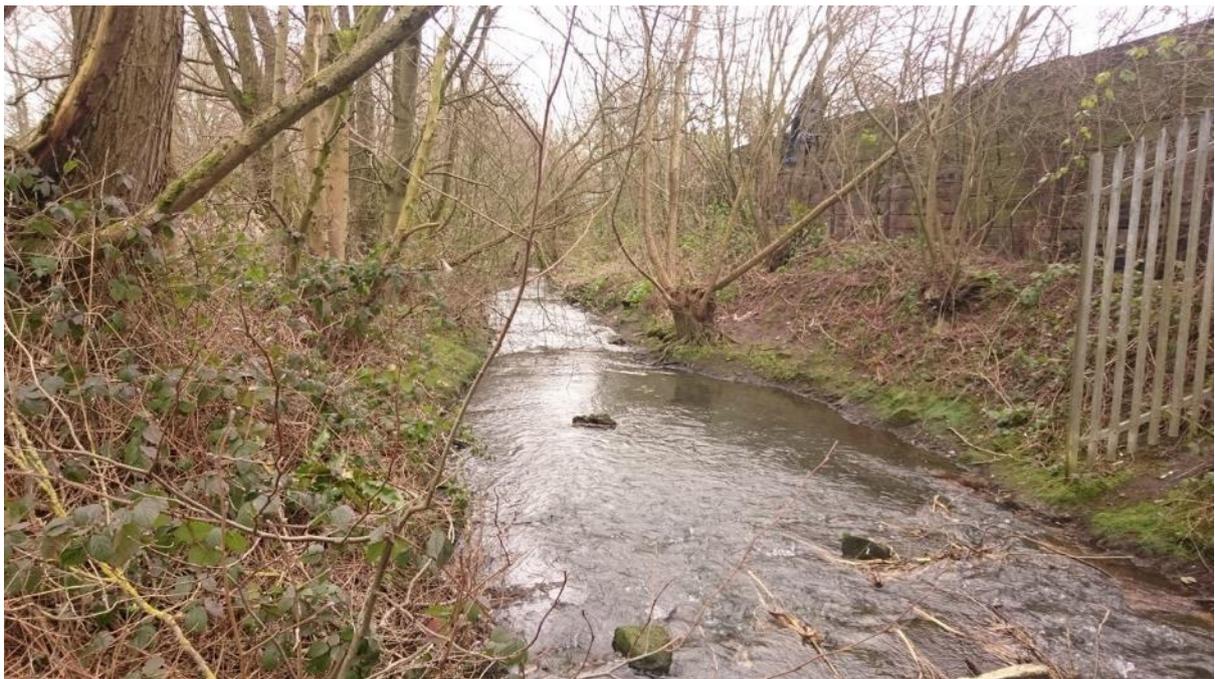
Downstream of this low-gradient section, some of the most promising habitat for trout and other rheophilic species was noted (Fig. 16). However, in terms of the scope for volunteer-led habitat works, there would not be much to improve here. The existing riparian woodland and in-channel structural variety already provides good trout habitat. Again, the true limiting factor is likely to be water quality.

Figure 16: Trout stream habitat at SJ 89687 50130 naturally arising in response to steeper gradient and relatively mature riparian woodland (with obvious coppicing management in place). This habitat is developing into higher quality environment for trout - even though constrained by walls and probable historic realignment of the channel.

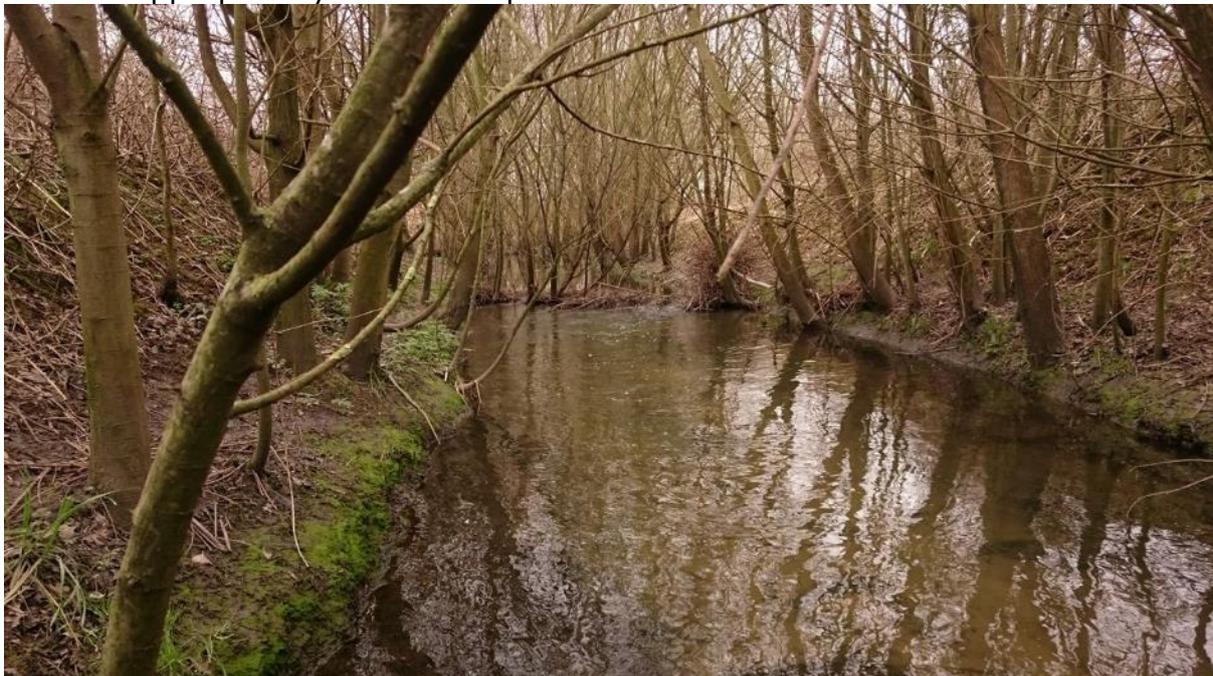
Figure 17: Good example of naturally-occurring, in-channel large woody material; as well as very uniform riparian tree canopy structure at SJ 84069 46190. Rotational coppicing here would stagger the height and density of the tree canopy – as well as providing a ready source of stable, in-channel woody material.

There is some potential for specialist intervention (e.g. Fig. 17) in the form of light rotational coppicing and introduction of stable woody debris (from arising material). This work would not be suitable for volunteer parties - due to the difficulty of access and deep, soft riverbed - and would be best undertaken by two or three appropriately-accredited professionals.

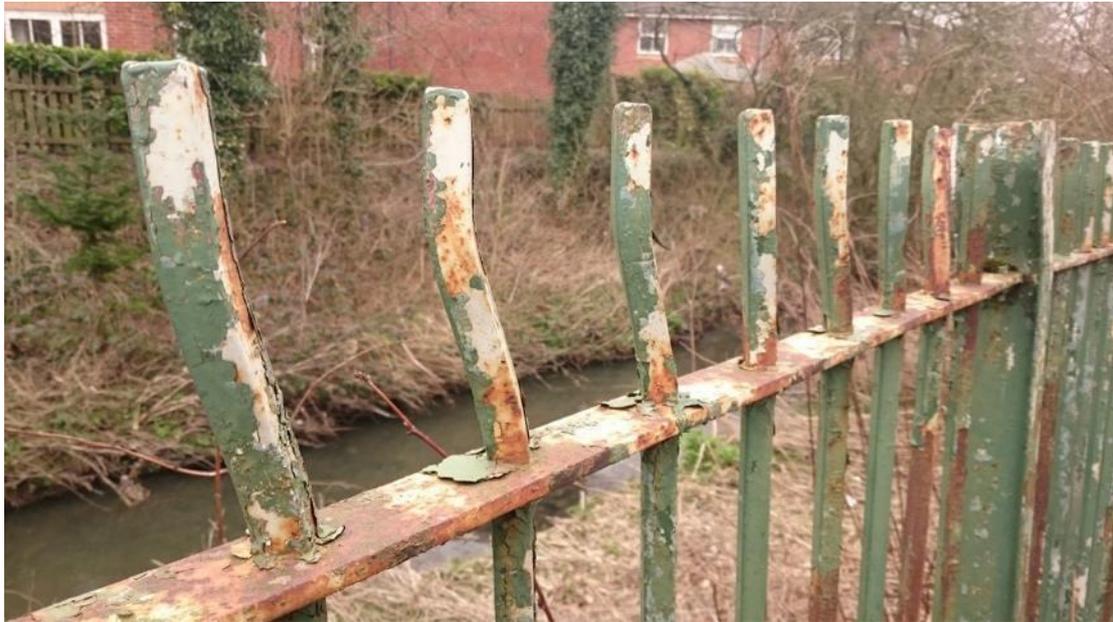
Figure 18: Railings separating the footpath from the Lyme Brook at SJ 84255 46066. One or more panels of this fencing would need to be temporarily removed in order to provide access to perform any in-channel or riparian vegetation works. Note the tight constraints of footpath and housing either side of the brook.

Further downstream there is a straightened section that is bounded on its LB by housing and on its RB by a footpath. There is some scope for introduction of stable woody material (and some existing pollarding and other tree management was noted to be ongoing – possibly as part of local council maintenance). The constraints of the site would mean that re-meandering is likely to be unfeasible. In addition, any work that needed to be carried out would entail un-bolting the fence railings that currently separate the footpath from the brook (e.g. Fig. 18).

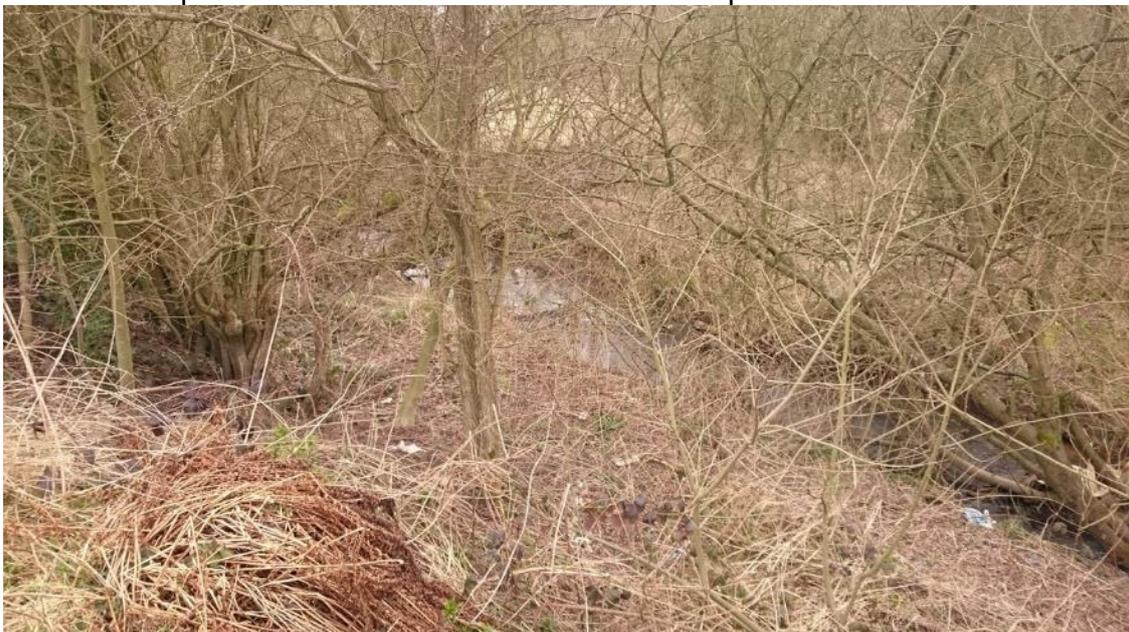
This section was divided into a natural, meandering channel in woodland (upper reach) and an extensively-straightened channel within amenity park-land (lower reach). Figure 19 typifies the habitat found in the upper reach and it is recommended that no significant interventions be undertaken. Aside from maintaining vigilance over potential invasive plant colonisation/removal of same, there are probably more benefits associated with a benign neglect than there would be with proactive alteration of habitats and species.

Figure 19: A good candidate reach for leaving nature to its own devices pictured at SJ 83495 47304.

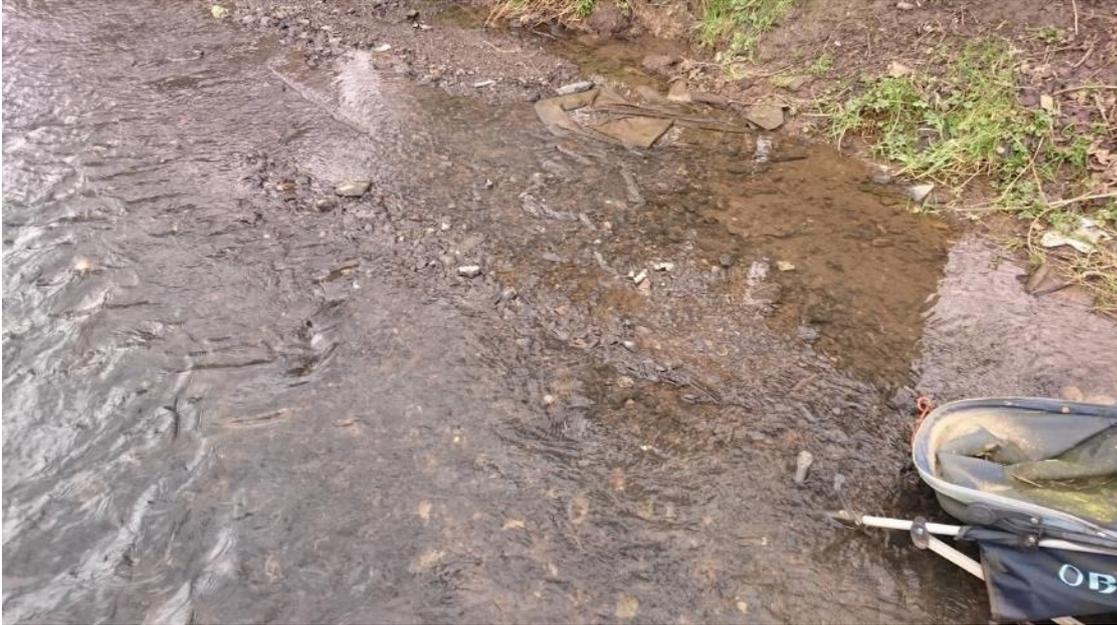
A very thin seam of shale gravel was noted at (Fig. 20). Whether this could support successful trout spawning is very difficult to say. While it is far from ideal, any existing populations would need to already be well-adapted to using the available resources within the Lyme Brook. If the provision of opportunities specifically for wild trout to potentially thrive in the Lyme Brook is a priority, then the section pictured in Figs. 20 and 21 may be considered as potential areas for gravel introduction. In such a case, it would be necessary to also install woody material that would act to focus river flows so as to produce localised patches of relatively silt-free gravel.

Figure 20: Thin seam of gravels at SJ 83495 47273. The compaction of gravel particles (with the associated reduction in clear "pores" that would allow water to flow easily between gravel grains) is associated with poorer egg survival for species such as trout.

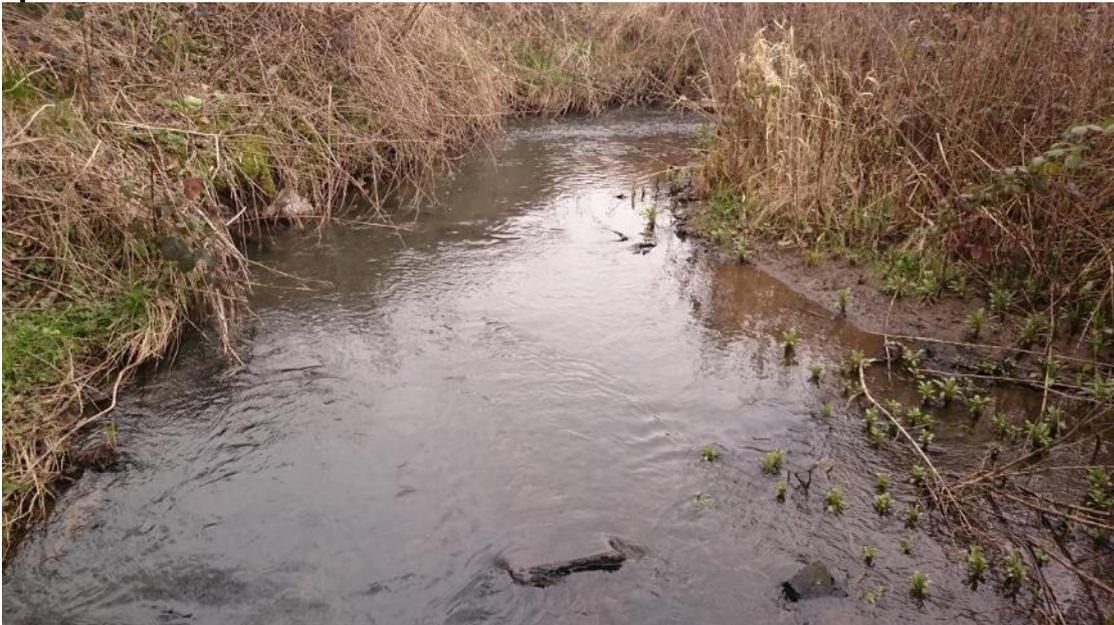
Figure 21: Facing upstream from gravel photographed in Fig. 20. There may be potential benefits to introducing additional gravel and woody material in this location (to provide a potential spawning resource).

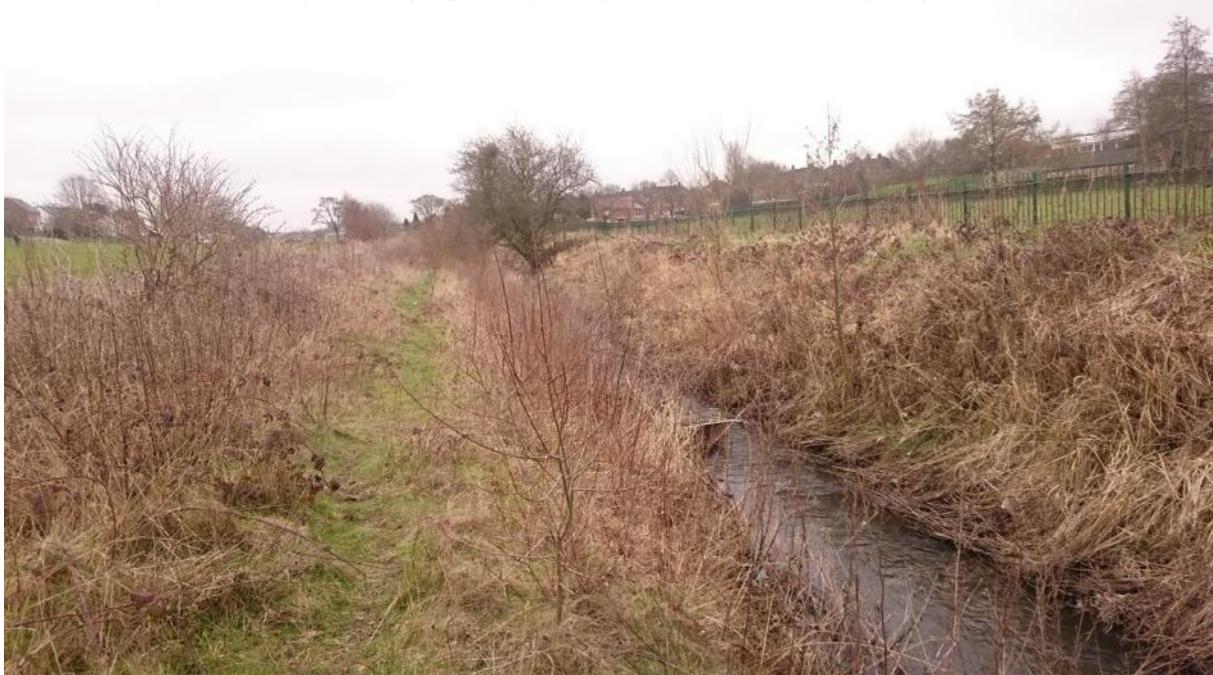
Further downstream – between SJ 83495 47273 and SJ 83681 47056 there are clear opportunities to improve the habitat within the brook for a range of species. The nature of the surrounding land, available access and obvious channel realignment (to produce a straight drainage channel e.g. Fig. 22) all point towards relatively simple remedial measures. The uniform habitat produced by the artificial straightening can be improved by using the same approaches used on the Lyme Brook in Lyme Valley Park (e.g. <https://youtu.be/xzZI6Ocjf-k>).

Figure 22: Straightened channel passing through amenity parkland – the character pictured in this section is largely invariant between SJ 83495 47273 and SJ 83681 47056. Consequently, the same measures prescribed and completed throughout a similarly-straightened section of the Lyme Brook are appropriate here.
