**Advisory Visit**

**Foston (Kelk) Beck, East Yorkshire**

**September 2012**

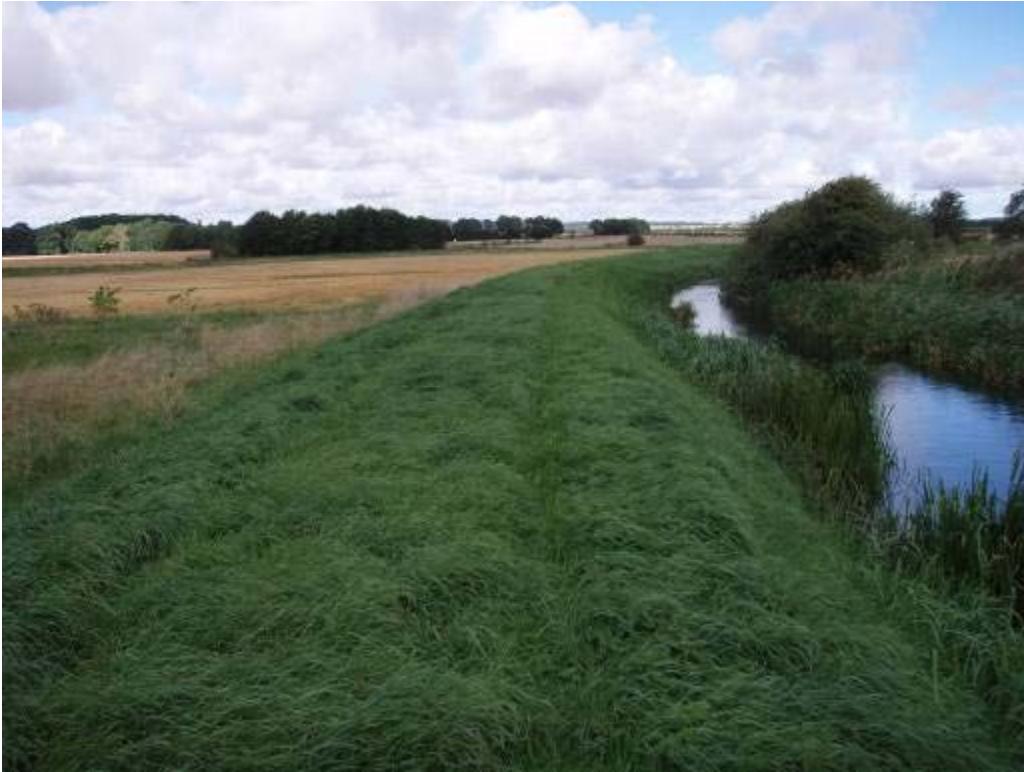
**Photo 1** The Beck is in a perched channel above the level of land to the west (left of picture)

The channel here is artificial, being perched at a higher level than the land on the right (west) bank (Photo 1). There are two drainage systems here, a high level system that drains land on the left (east) bank into the river and a low level system of ditches and drains for land on the west bank; in some cases drainage channels from the east pass underneath the river in culverts and feed into the low level system (e.g. Creyke Dike, TA0894856012, Photo 2).

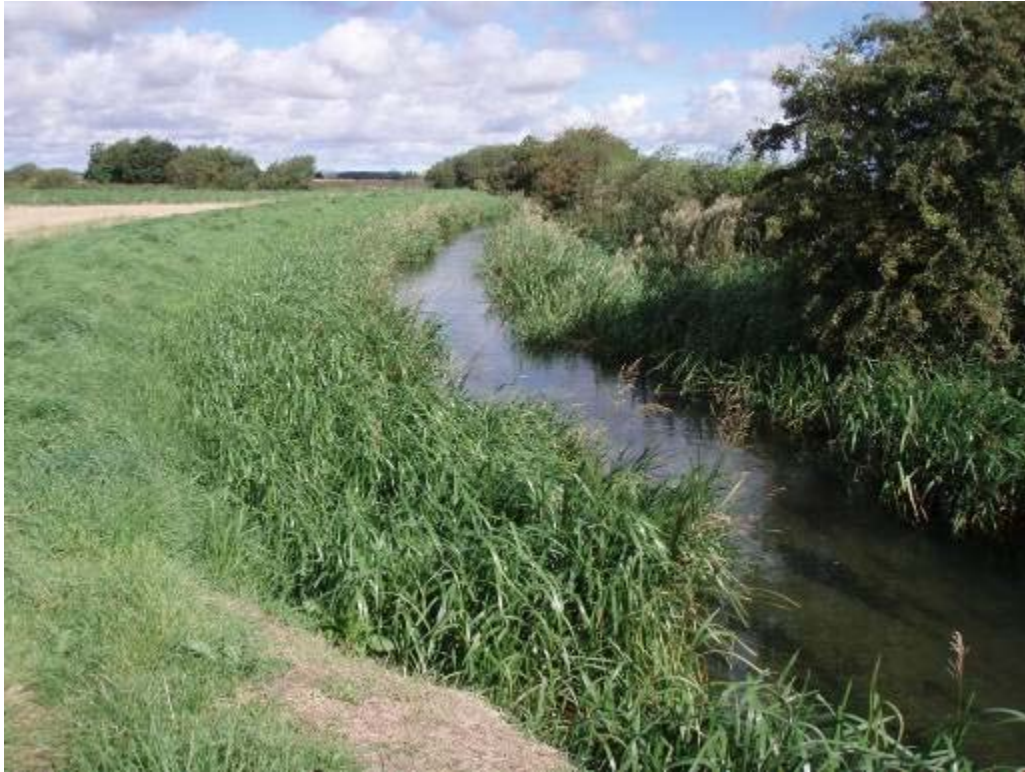
**Photo 3** Reed sweet-grass (*Glyceria* sp.) in the margins, open water in the centre channel. Bushes on the true left bank (right of picture), but absent from the opposite bank for machine access.

The channel dimensions are uniform, with a trapezoidal cross-section and steep banks. The margins of river are colonised with emergent plants, largely reed sweet-grass (*Glyceria maxima*), whilst the mid-channel is open water (Photo 3). Submerged aquatic plants are abundant in the open, flowing water and water crowfoot (*Ranunculus* sp.) predominates (Photo 4). The river bed substrate is comprised of fine sediments (silt, sand and fine gravel). A number of trout were observed in the size range approximately 10" to 18", probably a mixture of wild and introduced fish (Photo 5).

Presently it appears that the majority of the marginal emergent plant growth is removed annually. This could be changed to leave uncut areas, either as a continuous strip along one bank, or preferably in sections on alternating banks to provide a sinuous clear channel. Blocks of vegetation could also be left uncut on both banks directly opposite each other, to create pinch points and promote localised bed scour. Discussion with the Environment Agency Biodiversity and Operations Teams, Natural England, landowner and wildlife interests is recommended to try and find a balanced approach which would allow more marginal cover to be retained during the winter period.

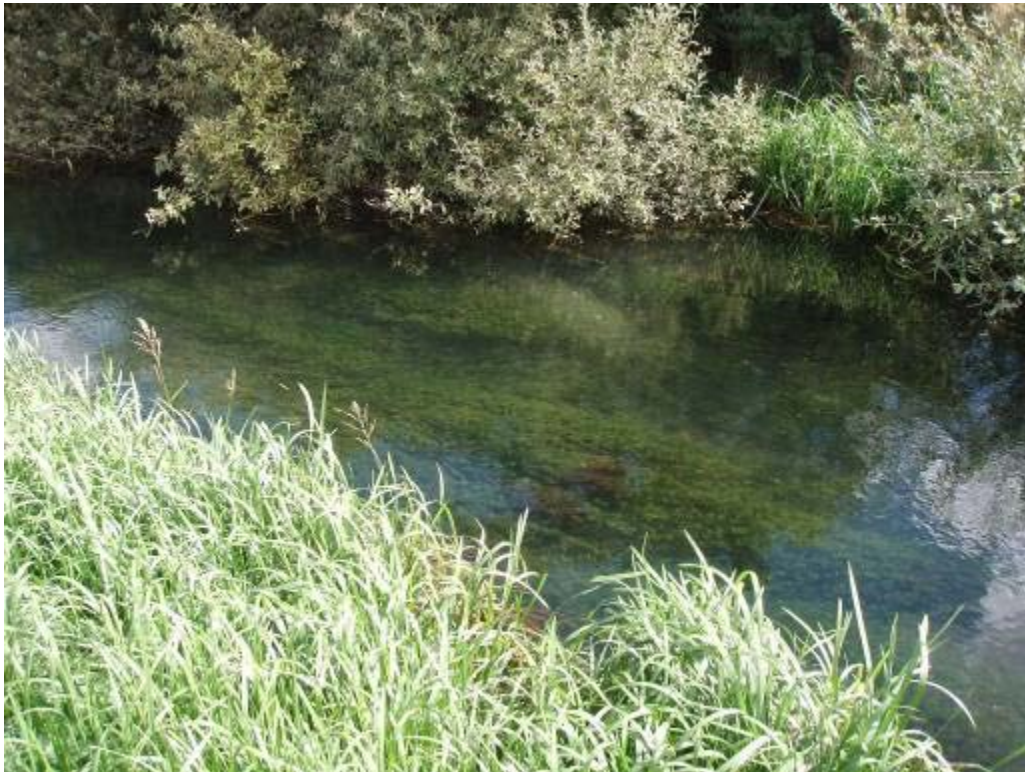
**Photo 4** Low cover over the water provided by willow bushes – excellent trout holding habitat.

The trees and bushes on the left bank are valuable features, improving the diversity of habitat along the Beck. The low, overhanging branches provide low cover, creating lies favoured by adult trout (Photo 4); they also moderate marginal reed growth and its requirement for maintenance. Trailing submerged branches and roots also provide dense refuge cover for juvenile trout which is very important for successful over-wintering. The bushes are also valuable for fly life, for example providing perches for newly emerged duns to shed their skin before mating and returning to the river for egg laying. Other groups of aquatic flies in addition to upwings (Ephemeroptera) will also use the bushes, as will terrestrial species of angling interest (e.g. hawthorn flies).

The trees and bushes along the left bank should be retained and the low, overhanging cover shown in Photo 4 encouraged. Subject to landowner permission and maintenance considerations, establishment of low-growing tree species (sallows) is also desirable on the right bank and could easily be achieved by planting cuttings.

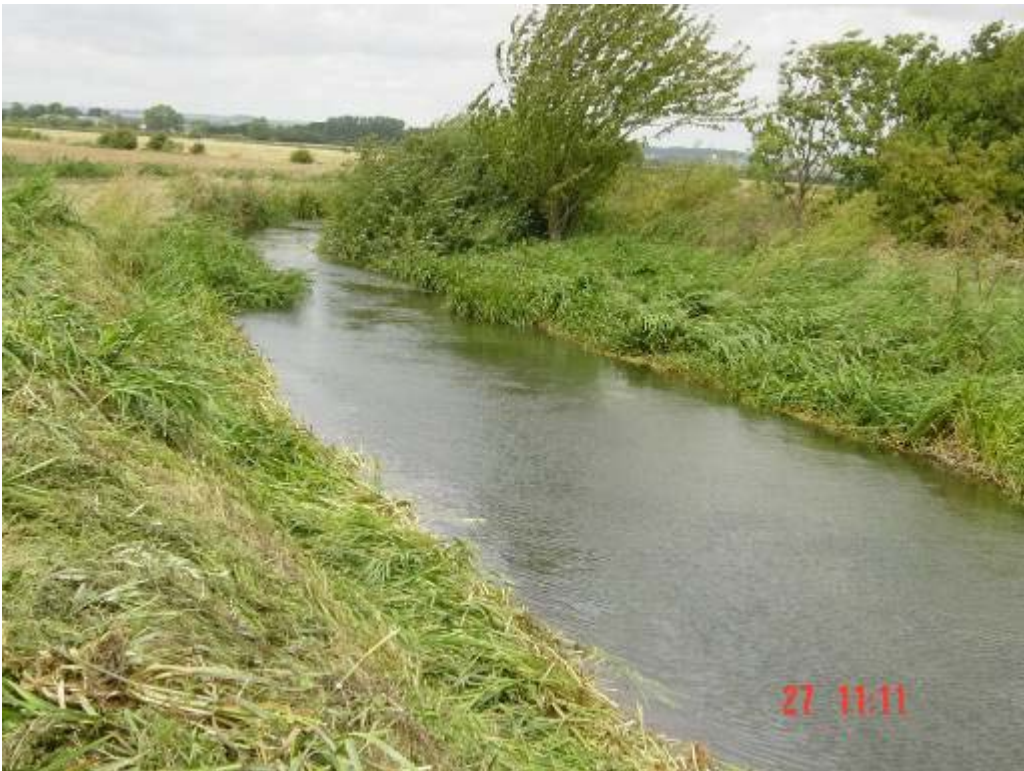
**Photo 6 Showing the extent and nature of weed cutting carried out annually (Photo: Alan Mullinger)**

An annual winter weed cut is carried out by the Environment Agency (at the request of landowners) on this section of the Beck; this involves removal of emergent vegetation from the margins of both banks of the channel using an excavator and weed-cutting bucket (Photo 6). The machine works from the right bank, hence the presence of trees and bushes only on the left bank. Foston Mill, a short distance downstream, impounds the river and incorporates a flow gauging station; the flow data indicate river levels are higher for the same flow during the summer months when aquatic weed growth is greater.

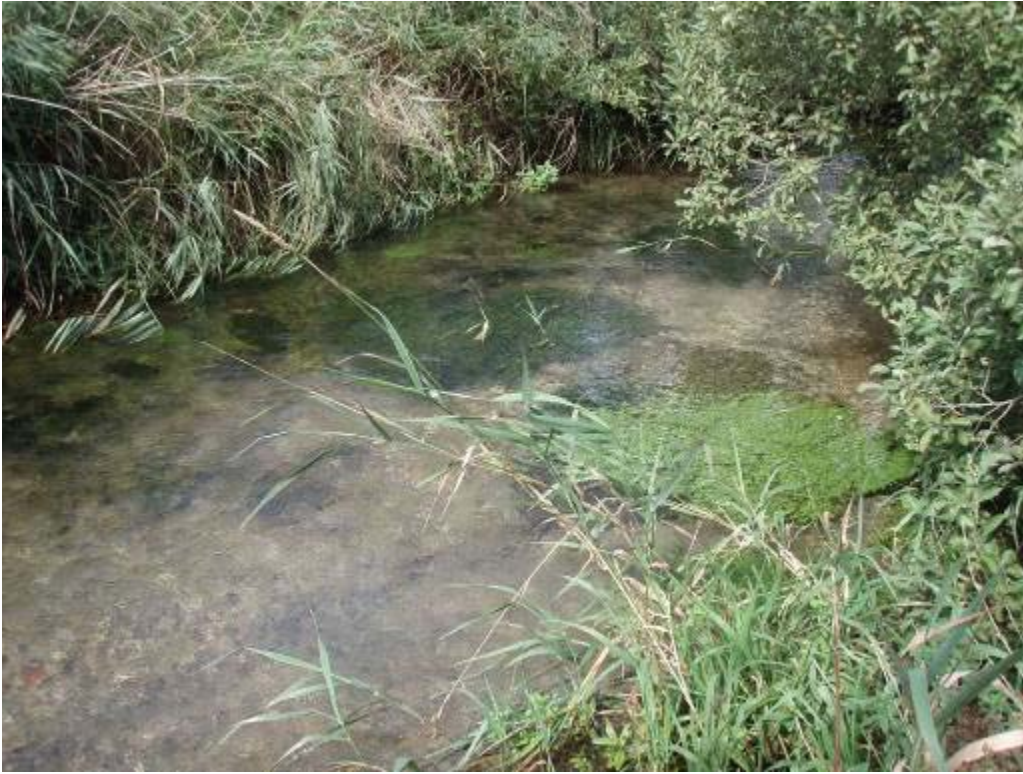
**Photo 7** Faster flow, well-sorted gravel bed and good cover from shaggy margins and overhanging bushes – great trout habitat, especially for spawning and juveniles.

The Beck was inspected downstream of the railway bridge. Here the gradient of the channel was greater, producing shallow riffle habitat with a coarser gravel and exposed chalk substrate, gradually giving way to deeper glide habitat with progress downstream (Photo 7). The area is known to be used by trout for spawning and to hold reasonable numbers of wild trout. The channel cross-section remains artificial and trapezoidal, but mechanised vegetation maintenance is no longer carried out here. The right bank has a steep profile, but the left bank has developed a low, soft berm with a diversity of aquatic plant species; along with the generally more shaggy nature of the banksides, this provides excellent riparian habitat benefiting a range of species including juvenile trout (Photos 7-9).

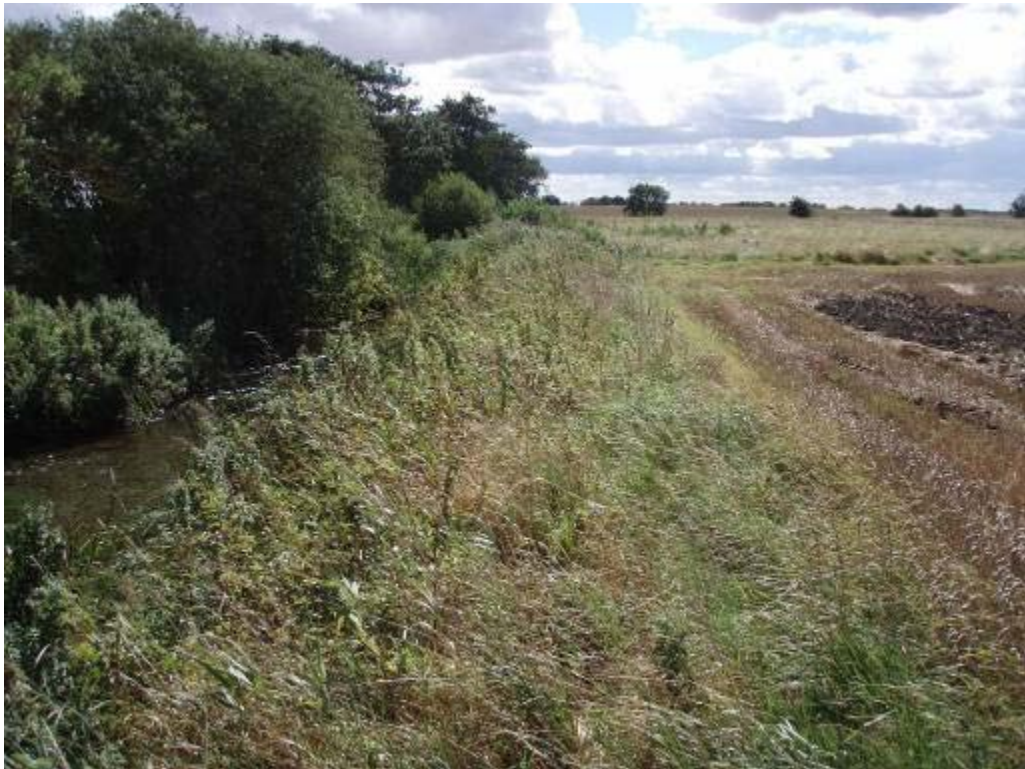
**Photo 10 Looking downstream along the right bank – scope for re-profiling and pinching the river channel in places (see Photo 12).**

Overall, the in-stream habitat on this section is good, apart from the depth profile which is uniform and shallow. In the context of the wider river, this may be no bad thing given that shallow, fast flowing habitat is at a premium. However, creating a few deeper areas by promoting localised bed scour would improve in-stream diversity; a good example is shown in Photo 12. There are a number of ways of achieving this, including introducing woody debris, narrowing using D-groynes, installation of flow deflectors or re-modelling the cross-sectional profile of the river. The latter is probably the most effective and beneficial method and could be achieved by using an excavator to push the existing bank line out into the river then re-profile on the landward side; this retains intact the existing marginal habitat and is quick and easy. A similar method has been used on the Avon Stream Project and locally on the Costa Beck. The channel in this section of the Beck does not appear to be perched, so altering the channel profile should be possible (Photo 10).

- Create depth variation by encouraging localised bed scour.

Various techniques using flow deflectors, woody debris and channel narrowing are detailed in the WTT Chalkstream Habitat Manual ([www.wildtrout.org/content/wtt-publications](http://www.wildtrout.org/content/wtt-publications)), but perhaps the most cost effective and least disruptive technique here would be pinching the channel using an excavator to push in the margins and backfill (Figure 1).

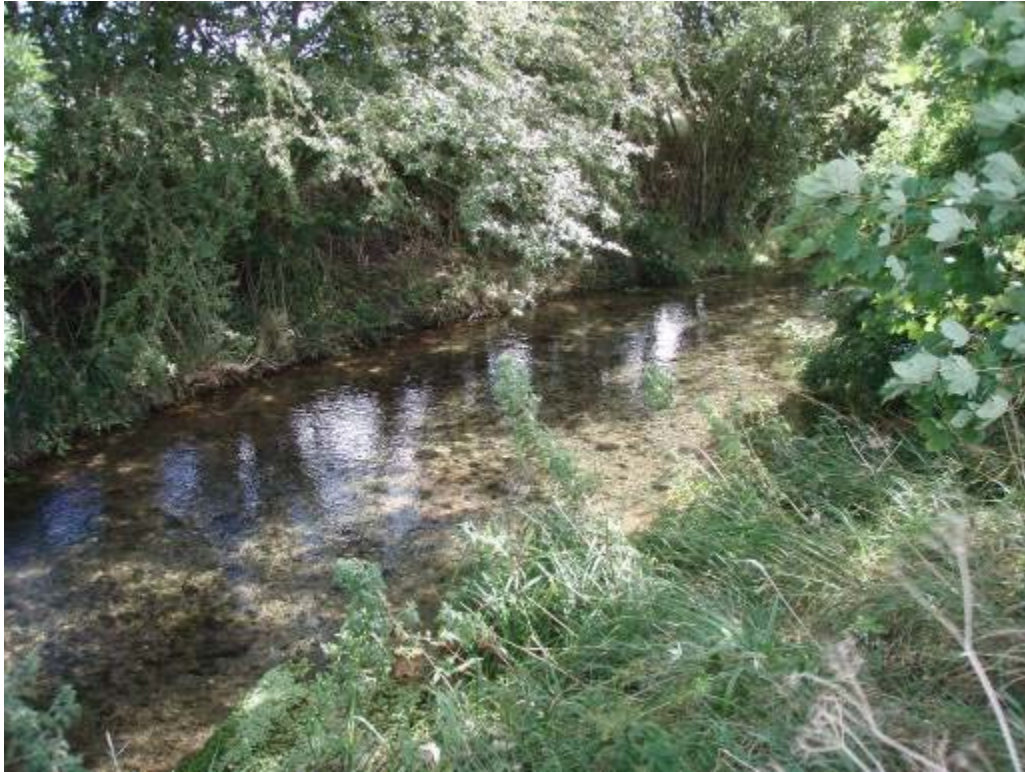
**Photo 11** Dense hawthorn growth on the left bank is over-shading the channel here and should be thinned.

There are more trees and bushes along this section and they are present on both banks. Generally these are beneficial in providing shade, low cover over the water and habitat for invertebrates (trout food), but there are some sections on the left bank where hawthorns have been managed as a hedge; here there is a danger of overshading becoming a problem, with associated widening and shallowing of the channel (Photo 11). Thinning the hawthorns in these areas is recommended; the arisings can be used to create superb in-stream structures for channel pinching and juvenile trout cover.

- Thin the dense stands of hawthorn to allow light to the overshadowed sections (Photo 11). Peg the material arising into the river margins to create excellent juvenile trout habitat.

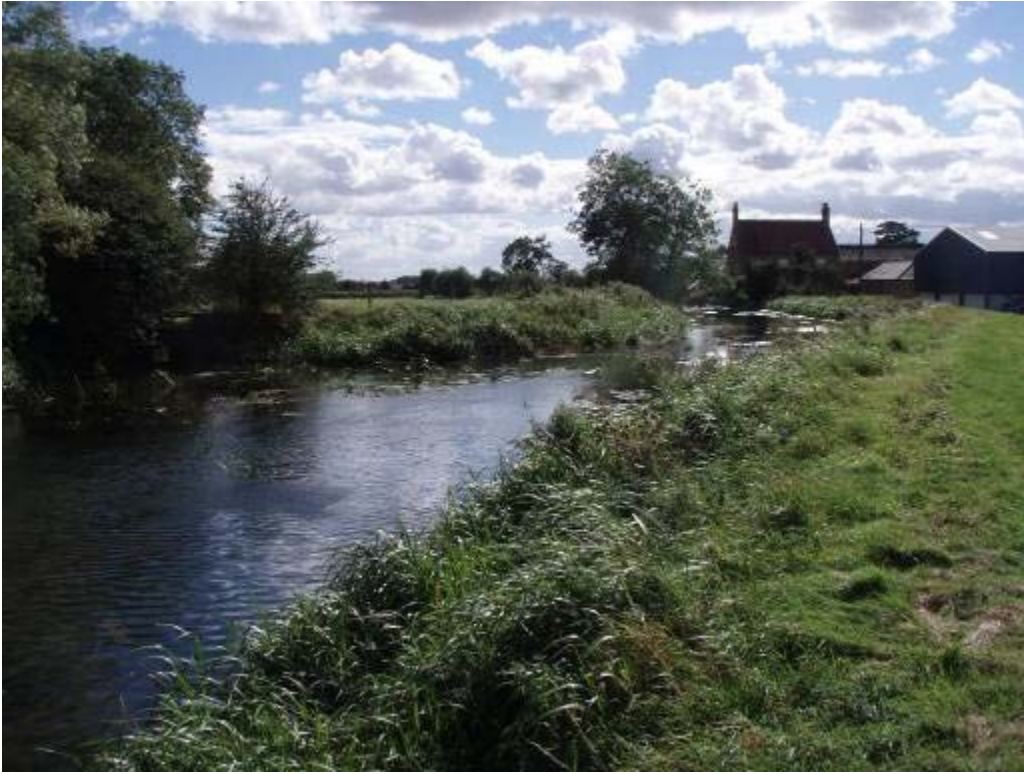
**Photo 13 View downstream to Lowthorpe Mill**

Lowthorpe Mill (Photo 13) impounds the river behind a weir and there is also an overspill channel on the left bank. The head of water here is no longer used and it is understood that options for improving fish passage and reducing silt accumulation are being considered by Royal Haskoning on behalf of the Environment Agency and Natural England; EYCRT have also provided comments. It is beyond the scope of this report to consider this issue, but important to bear in mind that any reduction in the height of the impoundment may impact upon recommendations upstream.

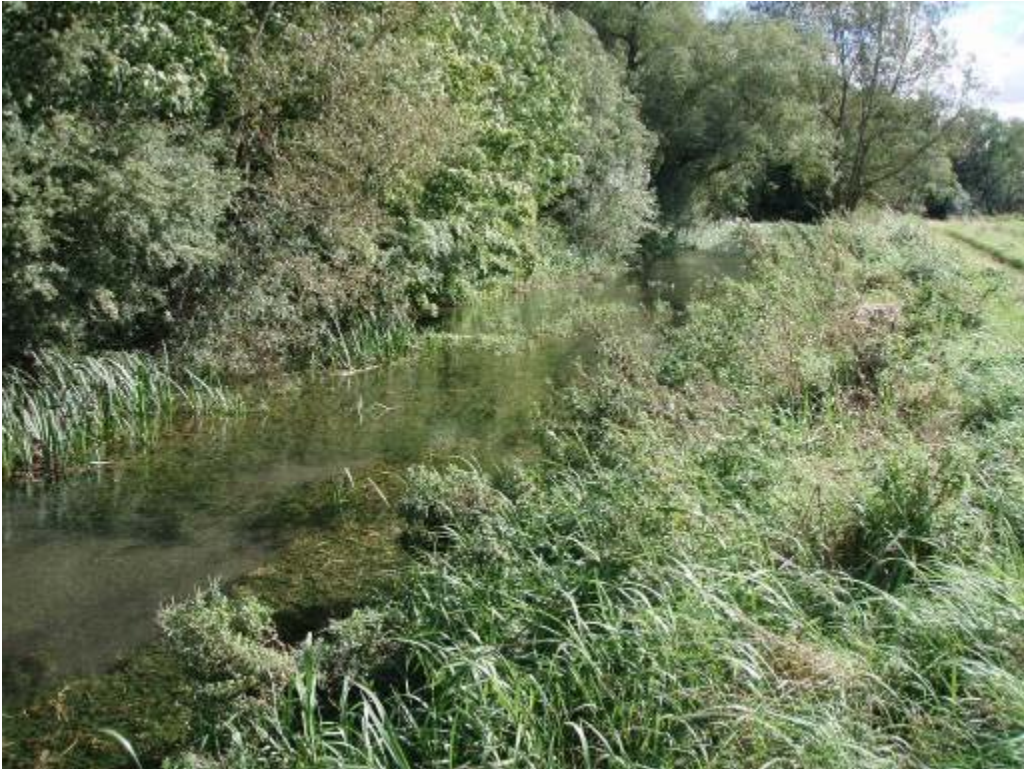
**Photo 14 Impounded reach above Lowthorpe Mill**

Upstream of the mill, the impact of the impoundment can be seen where fine sediment has settled out on the river bed and aquatic vegetation comprises species favouring slower water, such as emergent plants, mares tail (*Hippuris vulgaris*) and water parsnip (*Berula* sp.) (Photo 14). The land on the right bank is low-lying and possibly beneath the level of the channel suggesting the course was moved to the valley side to provide the fall for the mill. With progress upstream the river appears to occupy a more natural position.

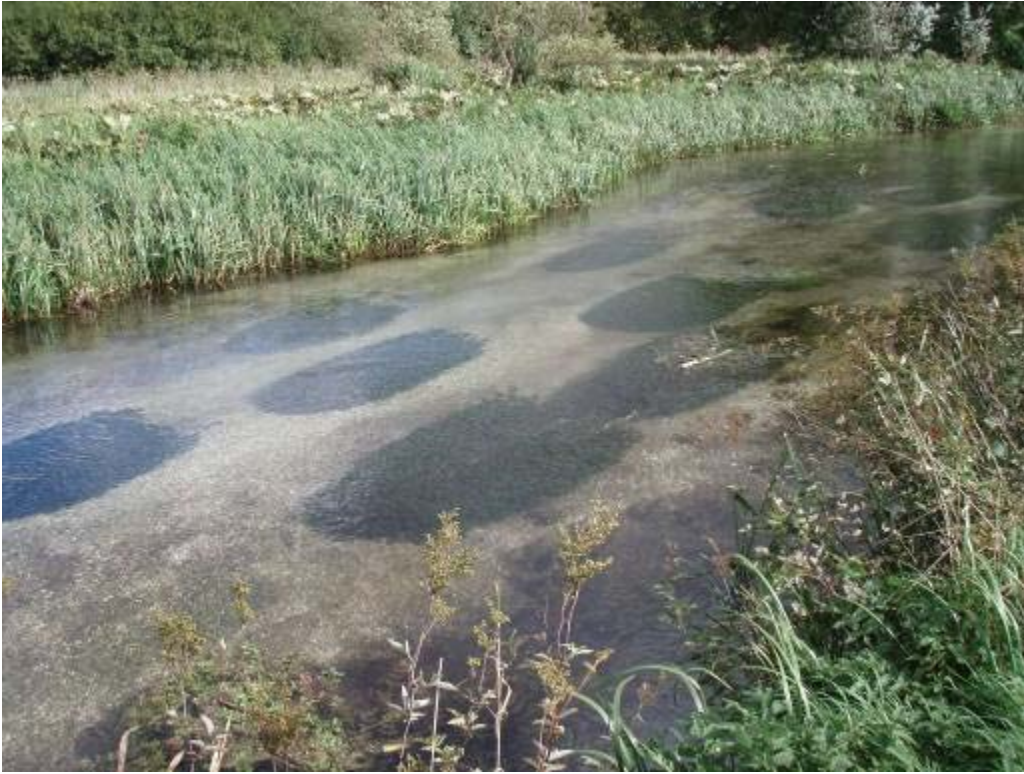
**Photo 15 Transplanted water crowfoot doing well in a shallow glide**

Work has been carried out in several areas to narrow the river channel, by creating a new bank line with brushwood bundles or logs and back-filling (Photos 20, 21). These have been successful in locally pinching the channel and increasing flow velocities, allowing water crowfoot (*Ranunculus* sp.) to establish following transplanting. Further measures like this would be beneficial, but are only likely to succeed in areas unaffected by weir impoundment, or where impoundments are reduced/removed. Water crowfoot has been successfully established by planting, for example in the shallow glide area downstream of Newroad Bridge (Photo 15).

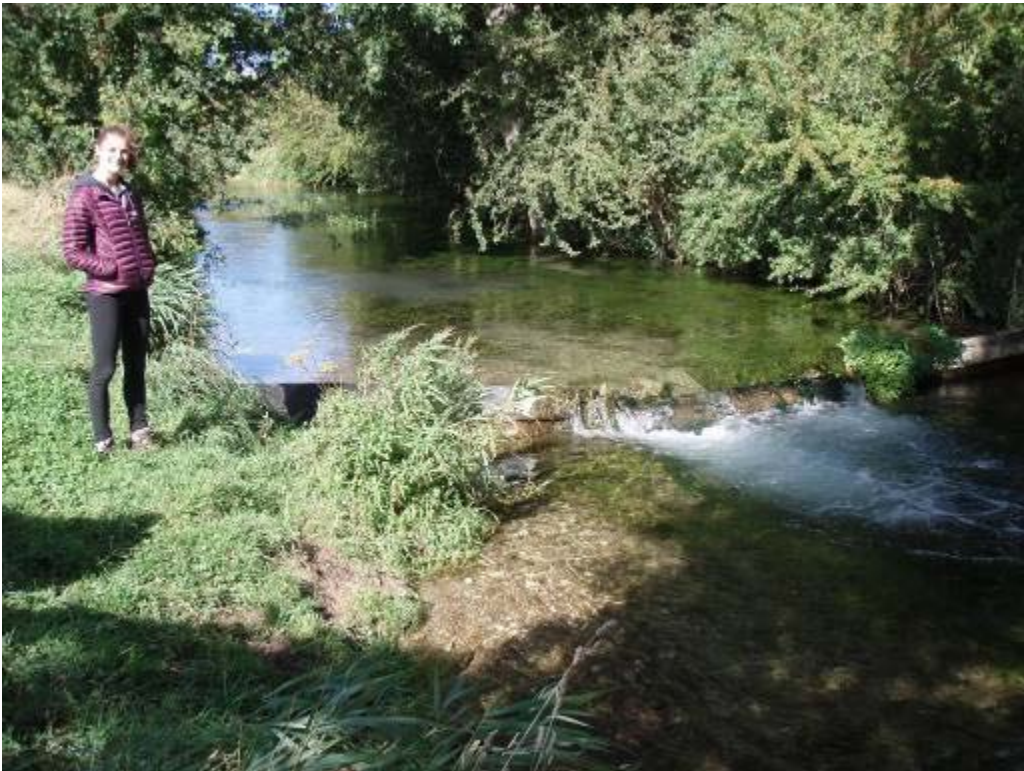
**Photo 16 Weir**

There are about six weirs throughout this section which used to be made of stone with a fixed crest height (Photos 16, 17). These were replaced in recent years by the fishing club with RSJs and boards, allowing the crest height and upstream water levels to be managed according to flows. Boards are removed during periods of good flow (as during the current exceptionally wet year) and replaced when flows are low (as during the previous two drought years).

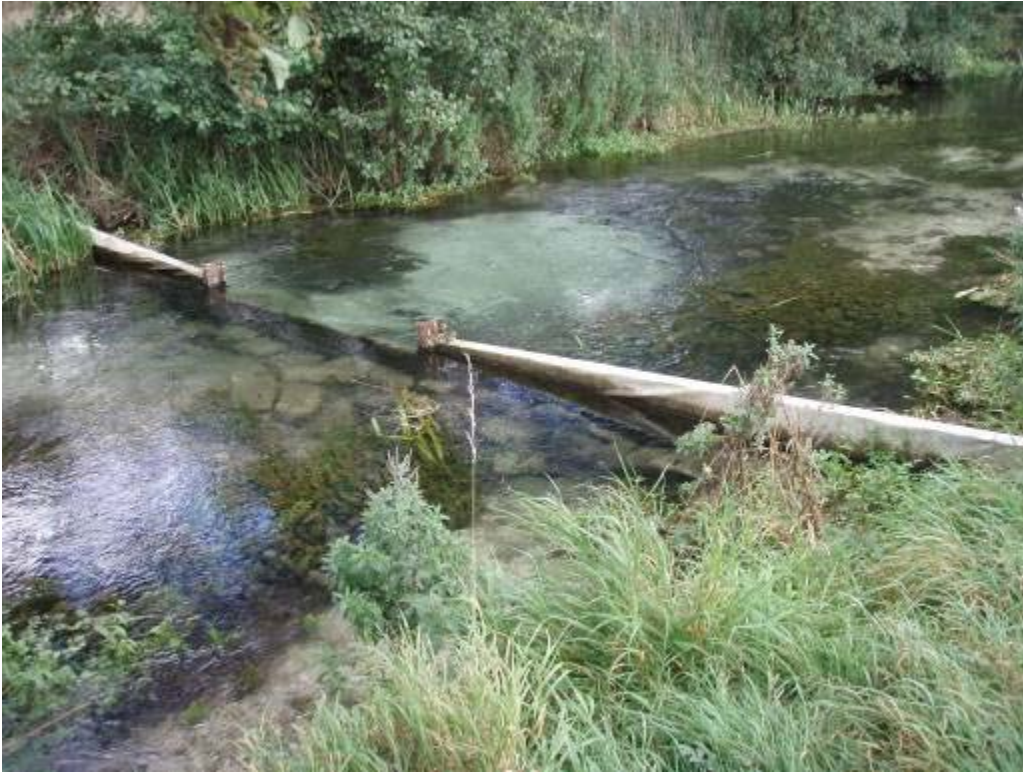
**Photo 17 Weir downstream of Newroad Bridge showing removable boards and deep scour pool downstream**

Localised downstream scour pools are present to varying degrees depending upon the height of the weir “wings” and size of the central notch. Individual weir height also determines the extent of impounded water upstream and the associated habitat of finer bed material (silt) and plant community (mares tail, emegents). Upstream of Newroad Bridge (TA084613), the in-stream habitat is largely influenced by weir impoundment, whereas downstream there are longer stretches between weirs and more varied depths, river bed composition and plant species.

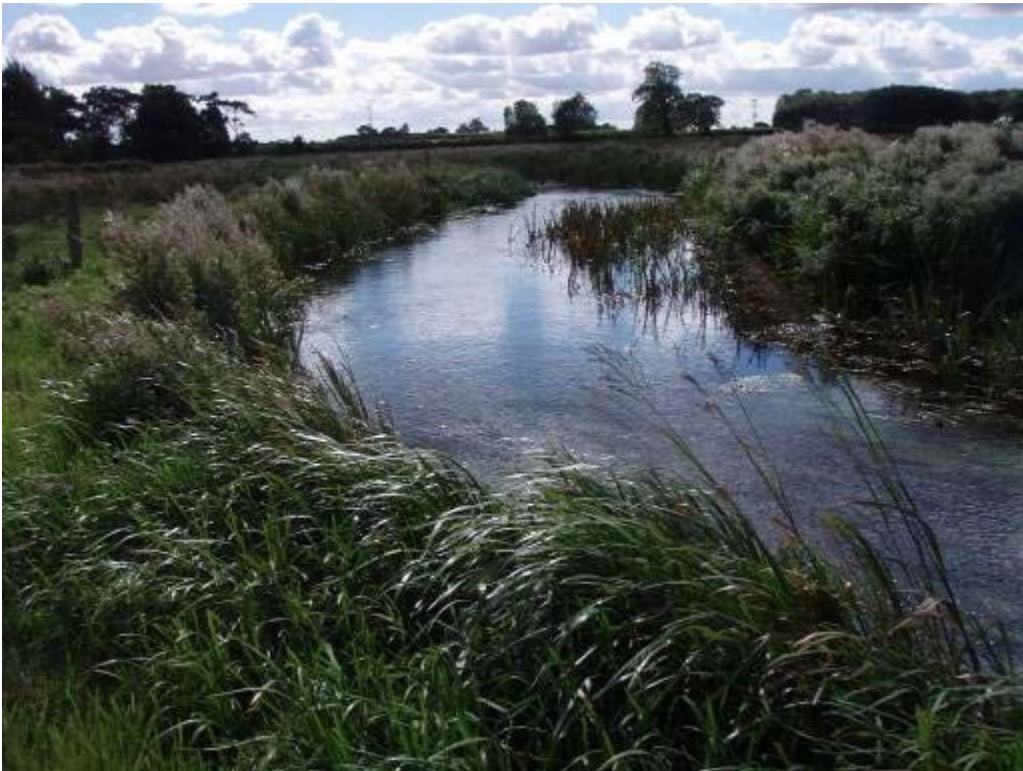
**Photo 18 Section upstream of a weir similar to the one in Photo 17 (upstream of Newroad Bridge).**

for trout spawning) and requires intervention to prevent the channel from becoming choked with emergent plants. Hand cutting of vegetation is carried out on this reach (Photos 18, 19) and occasional, supervised mechanical cutting by the EA upon request of the fishing club. Removing or reducing the height of the weirs and narrowing the river channel is the usual prescription for in-stream habitat improvement in these circumstances and there is certainly scope for this here, but with certain caveats. The land alongside the river upstream of Newroad Bridge is a SSSI for lowland fen, marsh and swamp, currently in *unfavourable declining* condition. The importance of river water levels to the SSSI status should be determined before any changes are made.

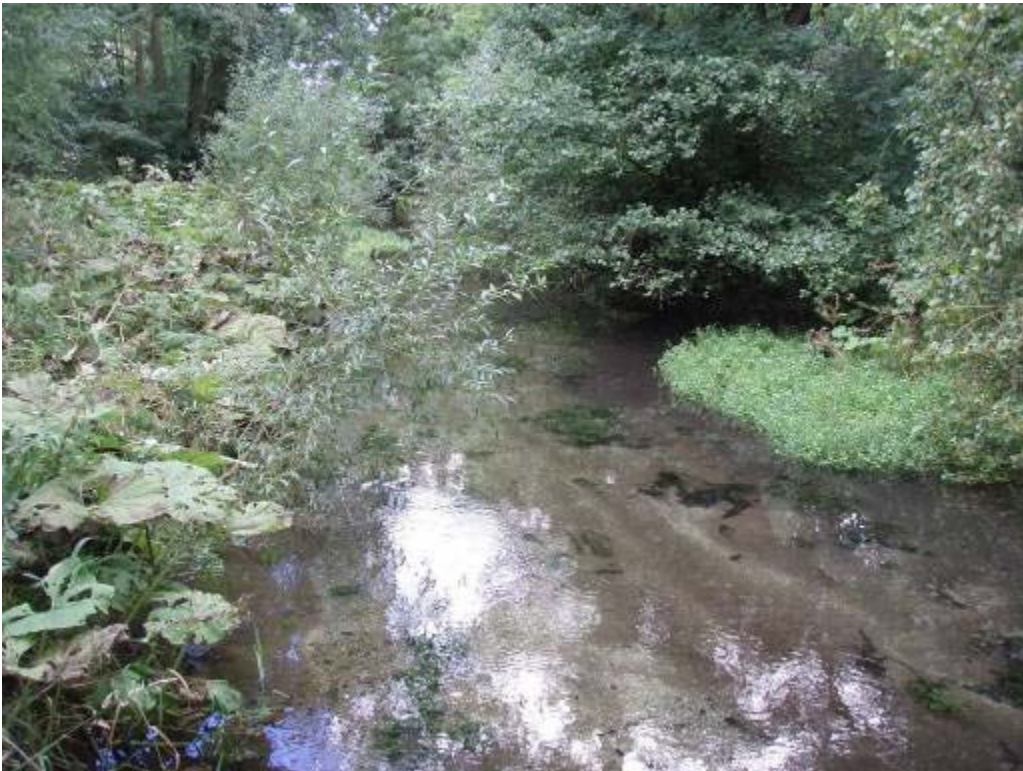
**Photo 22** The wooded section at the upstream end. Shading has restricted in-channel plant growth leading to a wide, silty channel.

The most upstream section visited was alongside Neat Holmes Wood. Shading of the channel by riparian trees is affecting in-stream habitat here, limiting the growth of aquatic and marginal plants and rendering the channel over-wide, shallow and prone to accumulating fine sediment (Photo 22). There is ample scope for thinning trees here and introducing large woody debris (whole trees) into the channel. This would increase light penetration, create localised scour, grade river bed material and provide cover for juvenile trout. Natural England are reported to favour removing sycamores and poplars from the wood, so a mutually beneficial project may be possible. A similar project was carried out successfully on the River Bure in Norfolk.

- On the upstream section in Neat Holmes Wood, thin out trees alongside the river and introduce large woody debris to the channel. A

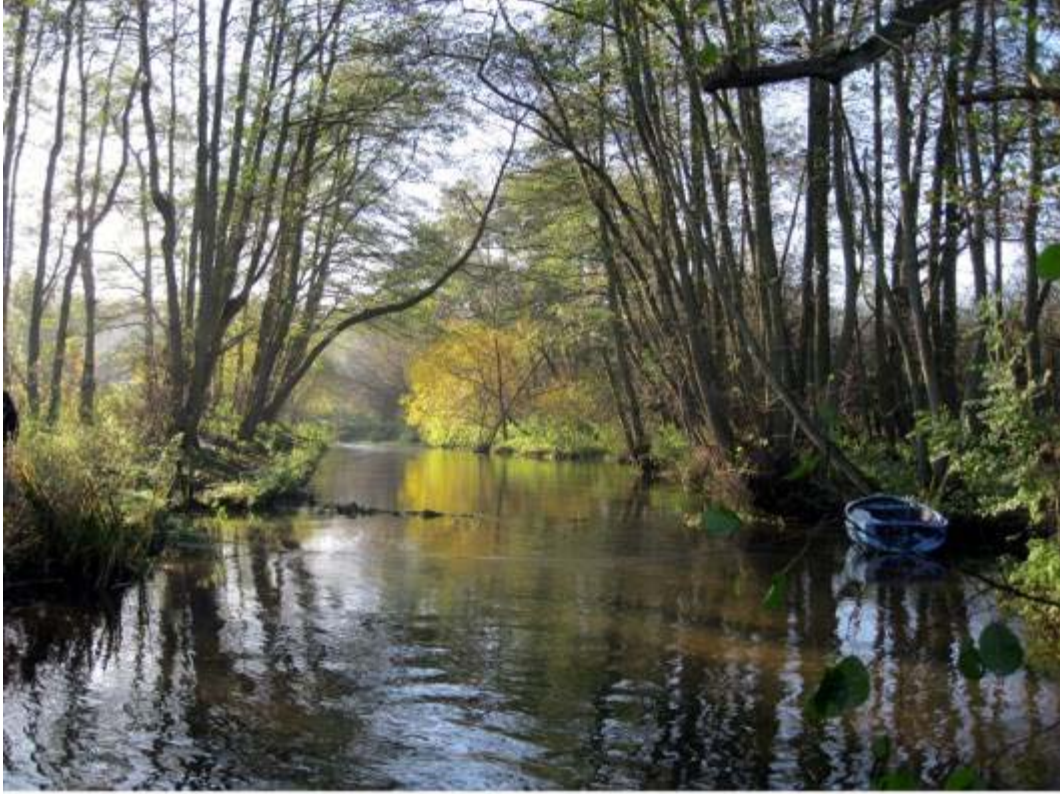
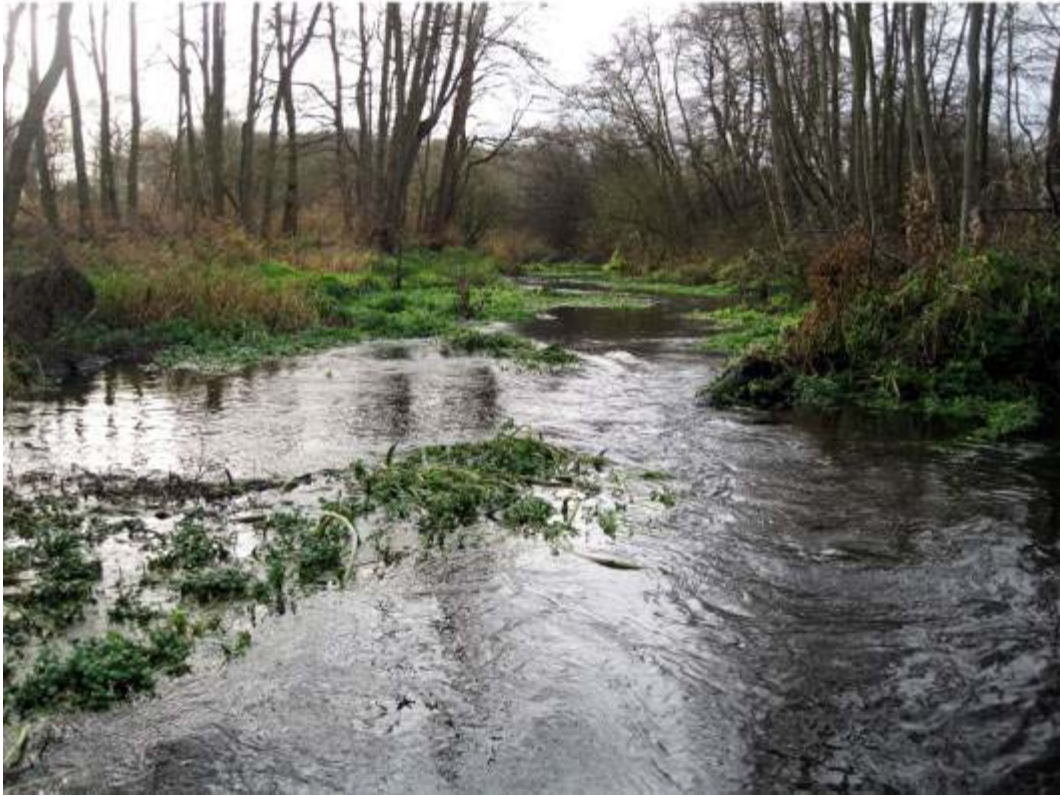
Photo 24 Before (above) and after pictures of woody debris work on the River Bure, Norfolk.

very similar project on the River Bure was carried out by the National Trust and partners (Photos 23, 24).
