River Frome - Notton

Advisory Visit December 2018

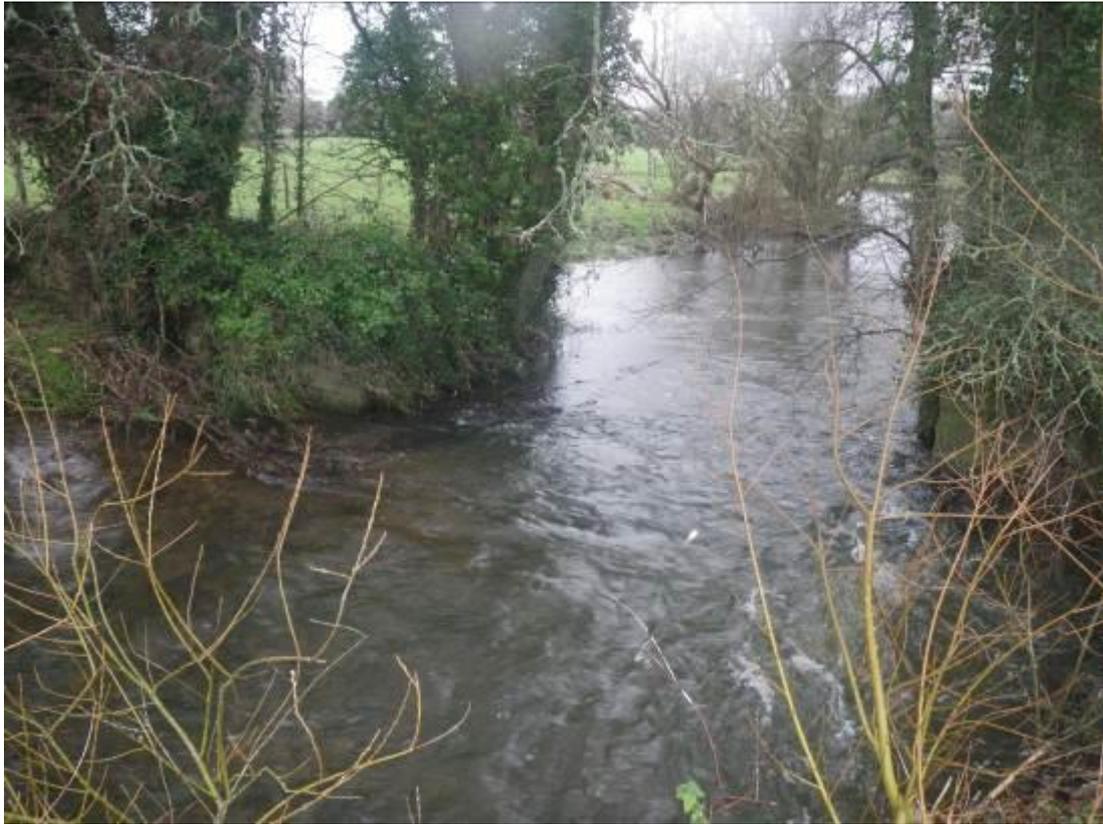
The very bottom 250m of river, lying between the remains of a derelict water level control structure (photo 1) and the bottom boundary at Notton Bridge, is the most impoverished of the entire fishery. The meadows bordering the river here are used as pony paddocks (photo 2) and intensive grazing pressures on both banks results in a lack of any significant vegetated buffer zones, leaving the banks vulnerable to erosion (photo 3). Stock fencing is present in some locations but is either of poor quality or located far too near to the top of the bank.

Photo 1. Site of an old water level control structure.

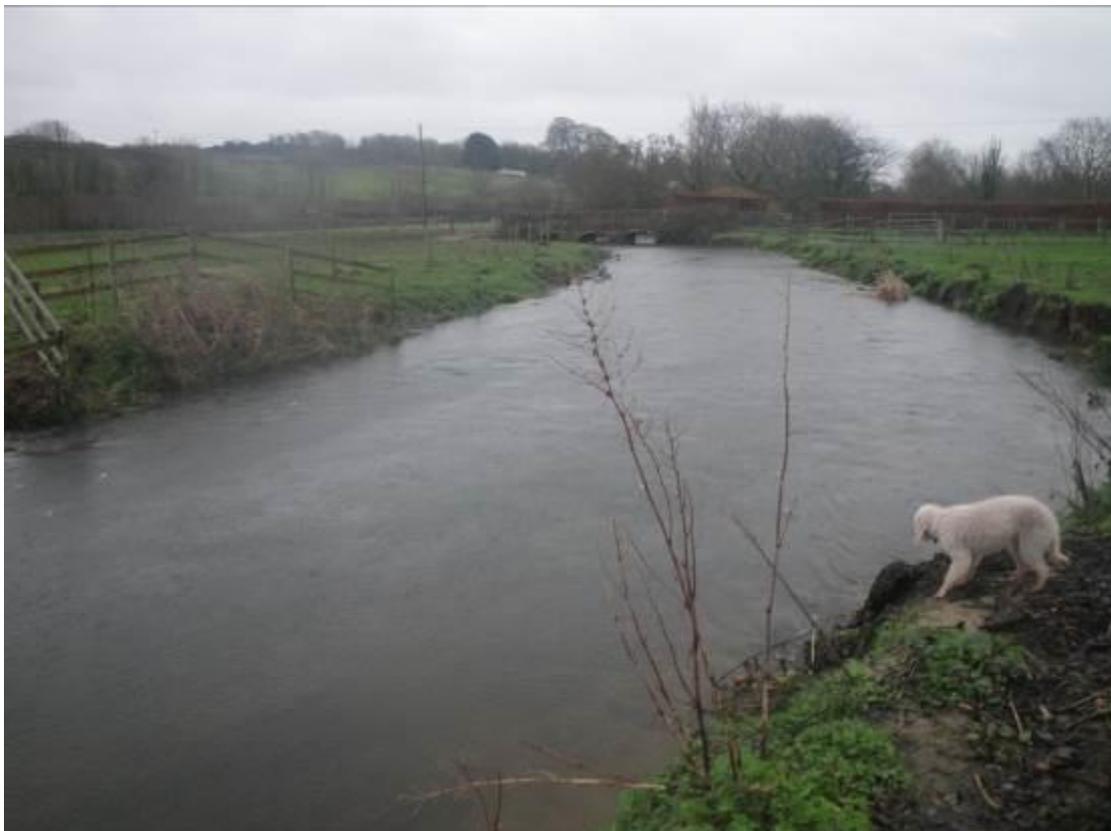
Photo 2. Top boundary above Notton Bridge where grazing pressures to both banks are exacerbating bank erosion, resulting in an over-wide channel and loss of in habitat diversity.

- Open up a dialogue with your riparian neighbours over measures designed to reduce sediment loads and bank erosion. Grants for new stock fencing might be available but wider buffer zones are needed.

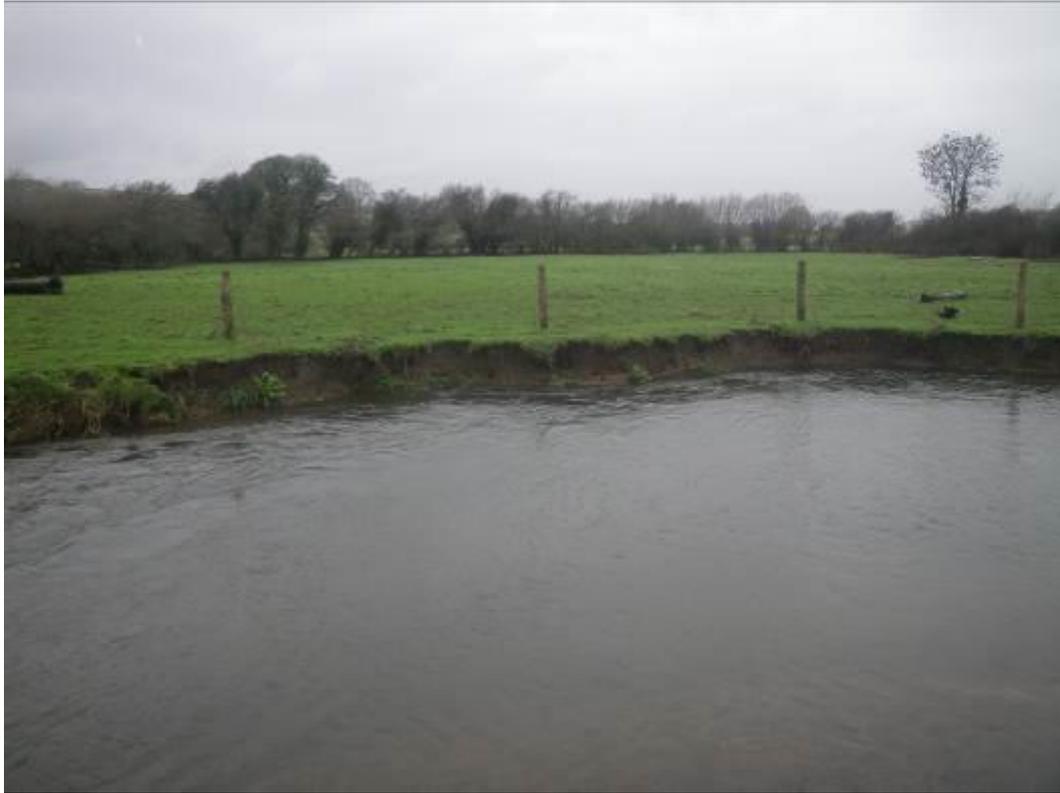
In this particular section, the river is comparatively wide, with mainly vertical eroding banks (photo 3). Although it was not possible to inspect the river bed here, it is likely that any bed gravels present will be heavily infiltrated with fine sediments, potentially reducing wild trout and grayling productivity.

Photo 3. Heavily eroding LB margin. A lack of bank-top vegetation with associated complex root systems is leaving the banks on the outside of the bends vulnerable to failure.

- Consider planting some low scrubby tree species such as willow and thorn species into the toe of eroded river banks to improve bank stability and create improved holding opportunities for adult trout. Concentrate on areas with access to direct sunlight.

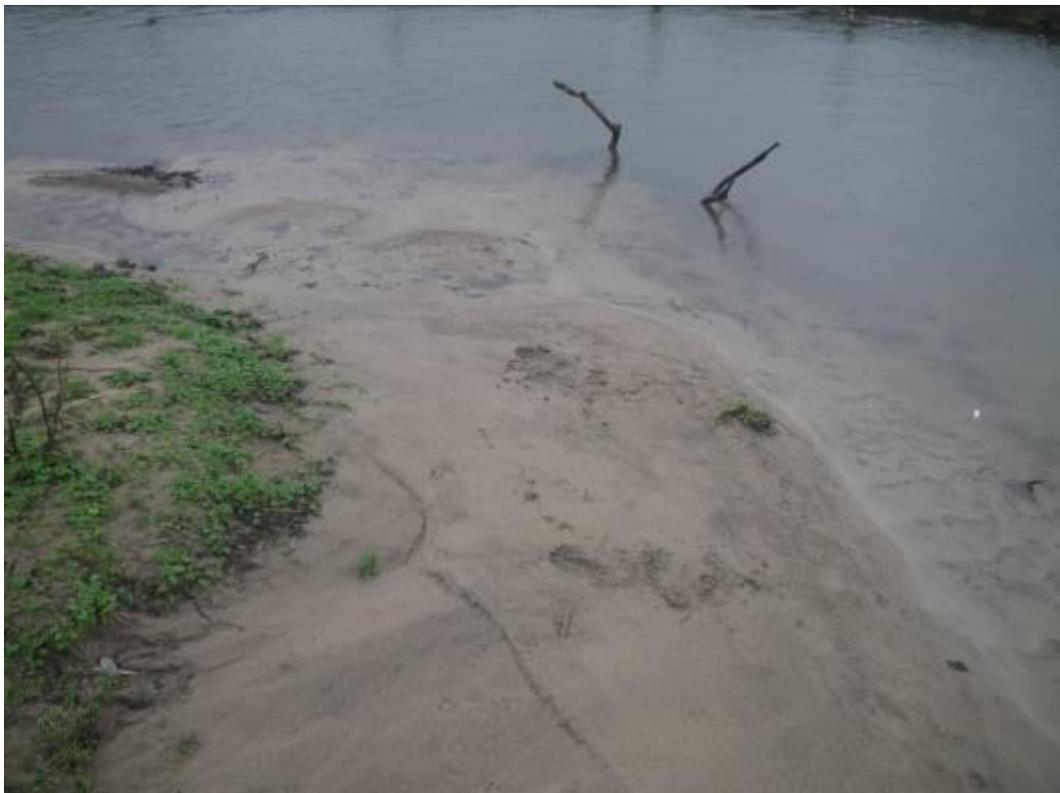
The soft and friable nature of the local top soils is evident in numerous locations. As a result, the Frome in this reach appears to be heavily impacted by siltation. Although the valley floor appears to be mainly set aside for permanent pasture, the comparatively steep valley sides are also used for arable production. It would appear that large amounts of soil are frequently mobilised, washing off of the valley sides via ditch systems and over-land pathways, to eventually smother sections of river bed with nutrient-rich silts. Any natural areas of low-flow velocity (e.g. inside of meander bends) were smothered in heavy deposits of fine sediment (photo 4).

Photo 4. Fine sandy sediment appears to be regularly deposited in any areas of low flow velocity.

- Spend a day in the autumn breaking up and cleaning gravels to help boost local egg to fry survival rates.

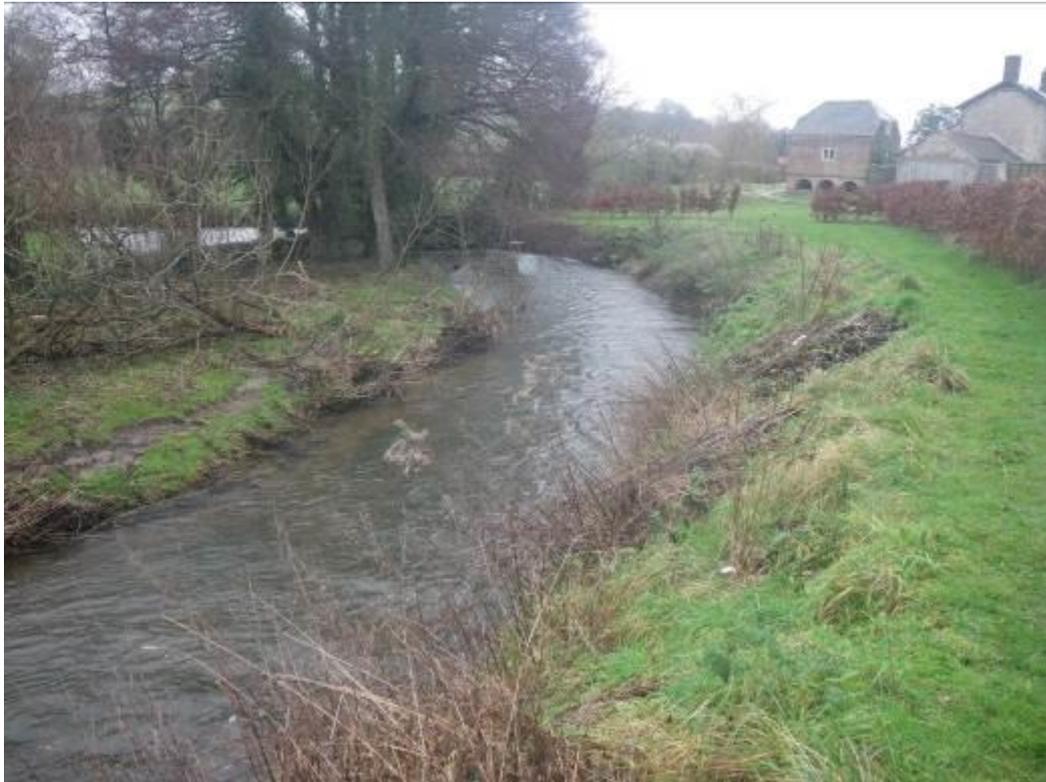
The reach immediately upstream of the old water level control structure looks to have been re-aligned in the distant past. It is possible that this section was diverted and banked up in connection with the old structure. Fortunately, the invert of the structure does not impound the reach above and this section now supports a long shallow run (photo 5). The slightly squeezed cross section also helps to maintain vigorous flow velocities throughout this reach, which in turn provides some good quality juvenile (parr) trout habitat.

Photo 5. Shallow run above the old structure provides high quality parr habitat. Marginal vegetation should be allowed to develop to provide enhanced winter cover.

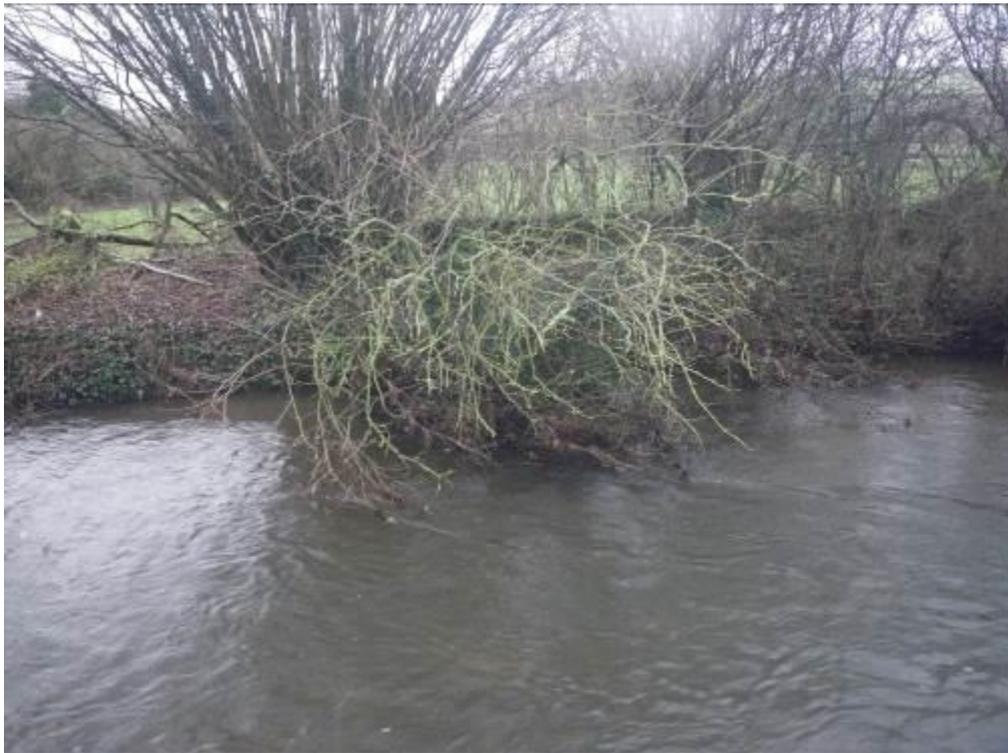
Photo 6. Old hazel coppice now providing some valuable marginal cover for trout.

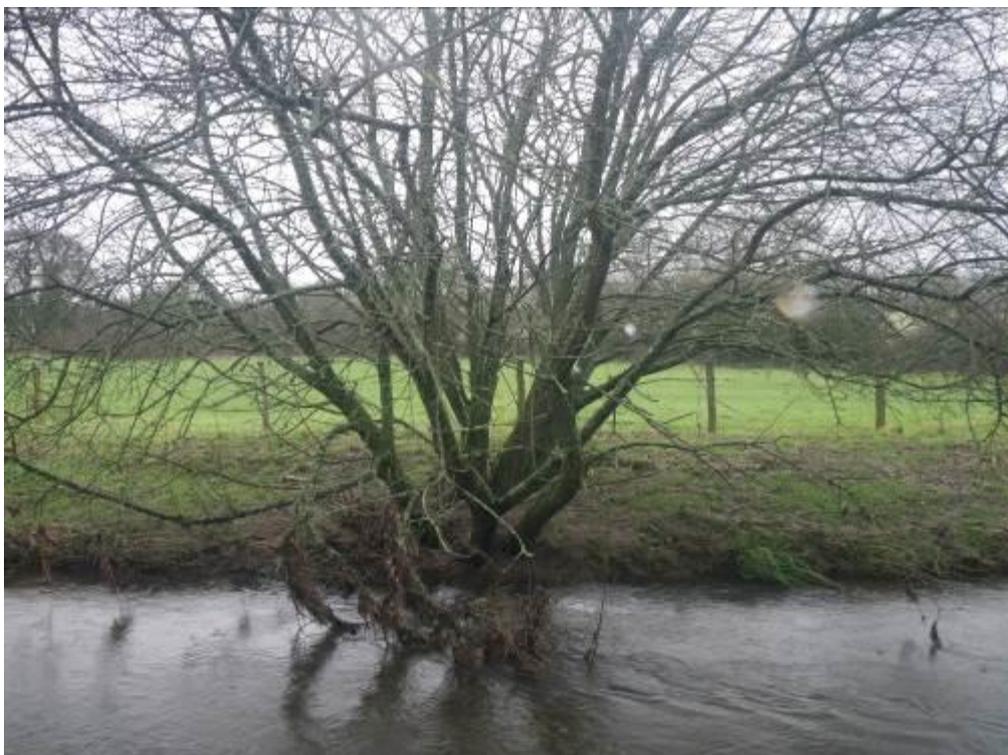
Photo 7. Sallows make excellent bank-top trees and in this example provide valuable in-channel cover.

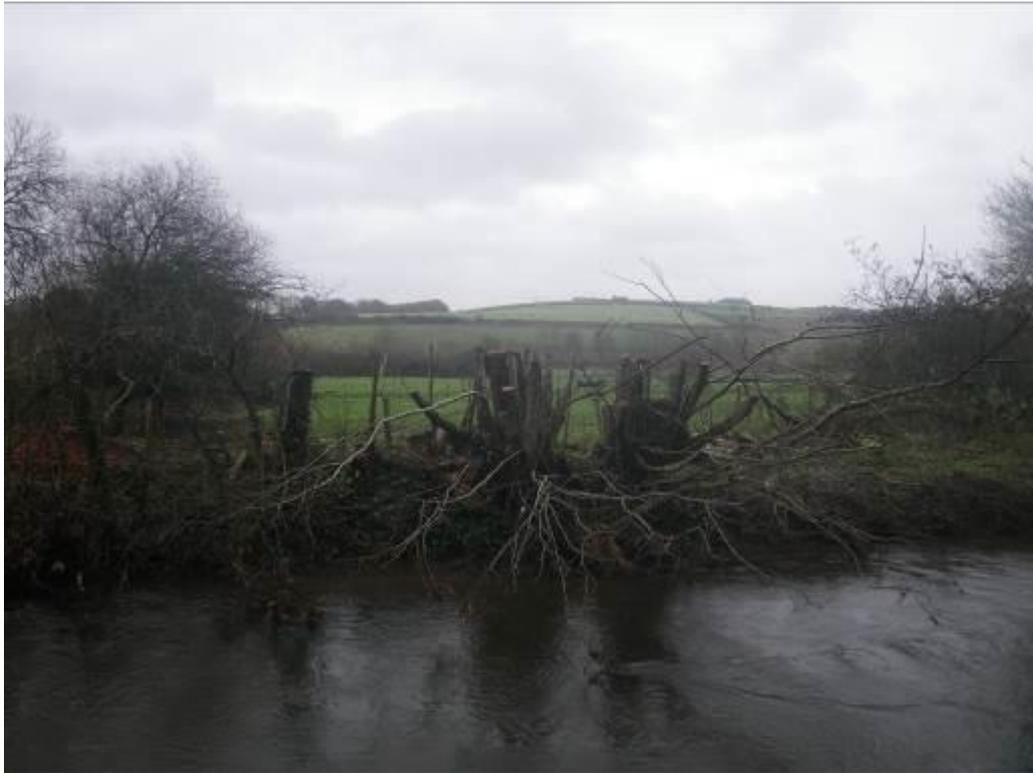
There are a few examples of poorly executed coppicing work (photo 8). Coppicing can be a valuable technique for creating multi-stooped trunks which when allowed to re-grow can provide low, bushy cover at water level. When coppicing, it is important to cut the branches at an acute angle as close to the main trunk as possible.

Photo 8. Leaving the low branches to provide a fringe of cover at water level is to be encouraged but branches that are to be coppiced should be cut back close to the original stool.

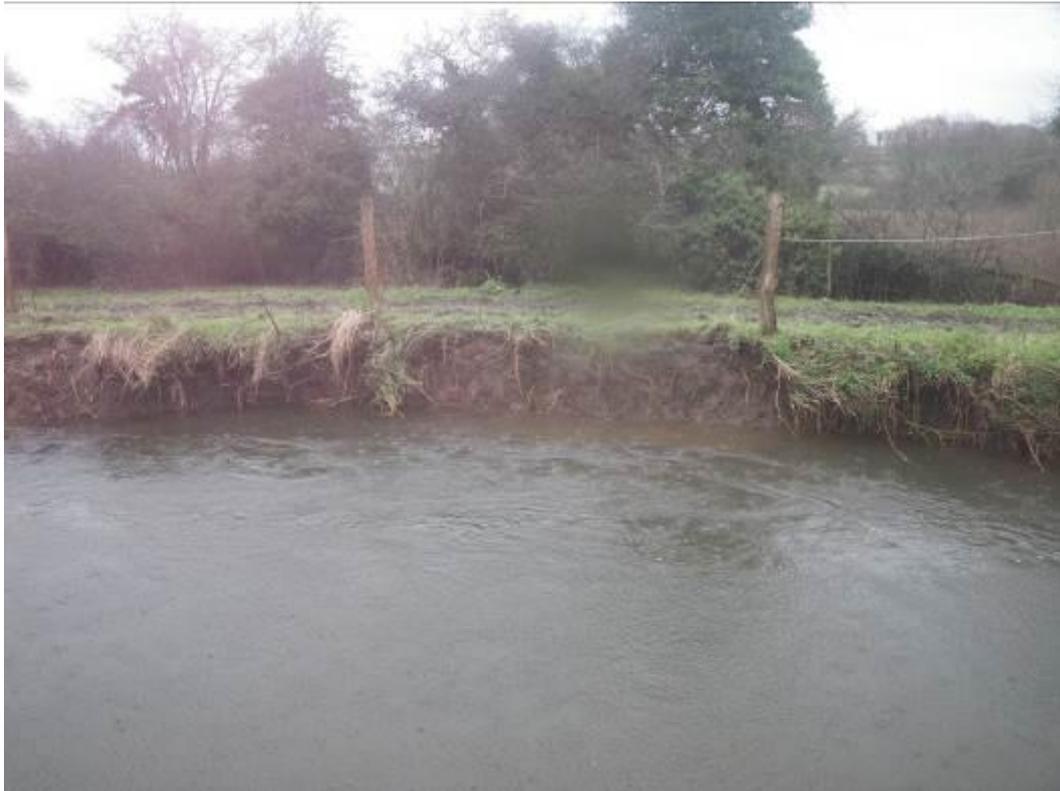
In one particular location adjacent to the LB, the field narrows to a gate access very close to the river (photo 9). The stock fencing is in poor condition here and the river bank is eroding back. As this is such a vulnerable site and is located next to a narrow access point then it would be advisable to protect the river bank with a brushwood shelf, which if fenced off could allow a vegetated toe to develop.

Photo 9. A narrow strip of land used as an access point immediately adjacent to an eroding bank. This is an area where some intervention is required.

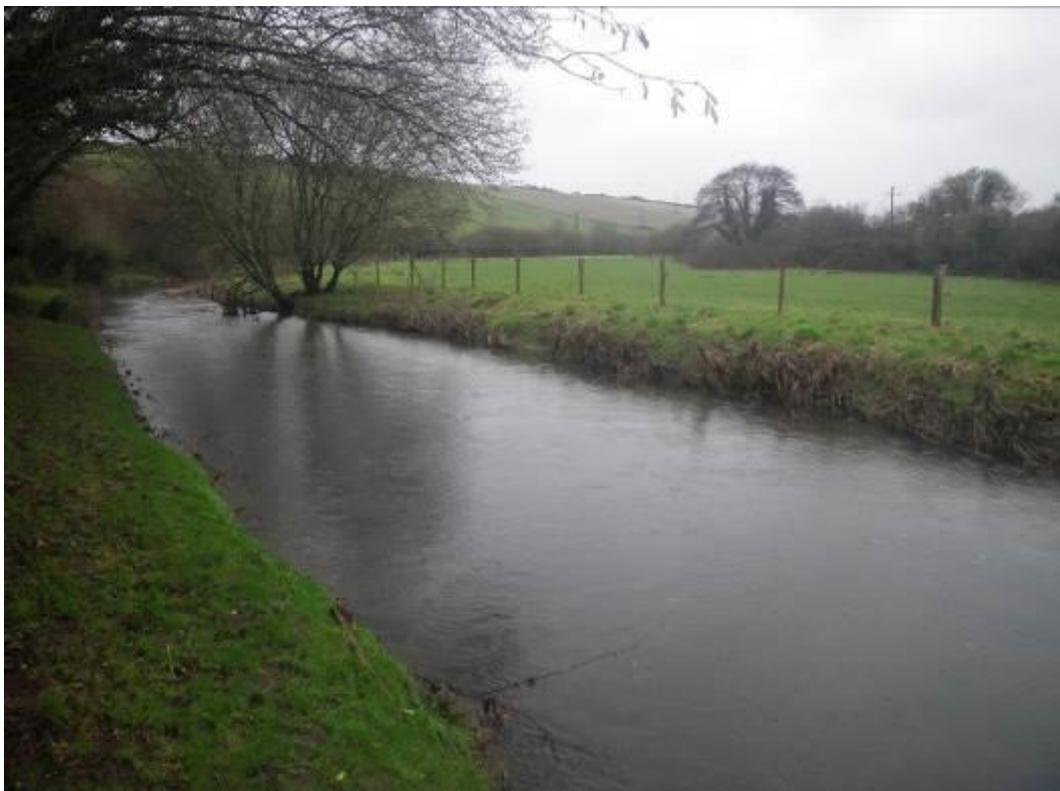
In some locations the river channel is comparatively uniform in shape and lacks any flow pattern diversity (photo 10). Sections like this would benefit from the installation of large woody flow deflectors which when installed correctly can help to kick the flow patterns from one side to another. These diverse flow patterns are valuable because they help to sweep fine sediments from one location and safely lock them up in others, eventually creating a much more diverse shape to the river channel and ultimately promoting a more ecologically dynamic environment.

Photo 10. A long, straight uniform glide. A section like this would benefit from the installation of large woody flow deflectors. The tree on the far bank is ripe for "hinging" into the channel.

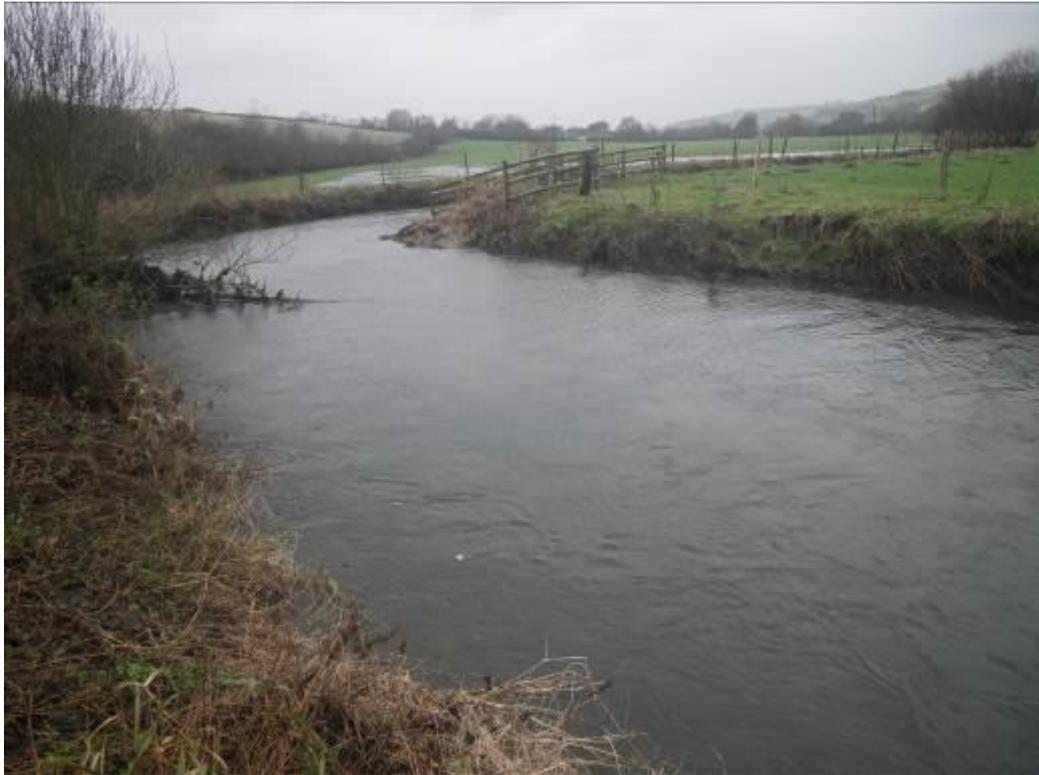
There are some good examples of naturally fallen woody material (photo 11), helping to support some high-quality habitat for invertebrates, aquatic plants and fish.

Photo 11. A useful woody branch has fallen into the RB margin and is now helping to create diversity in flow patterns and potentially altering the physical shape of the river bed to create a high-quality lie for an adult trout.

- Take a relaxed approach to fallen woody material. Only move it and re-secure it when it is essential to avoid excessive bank erosion. The WTT can help with a training day via a WTT Practical Visit (PV).

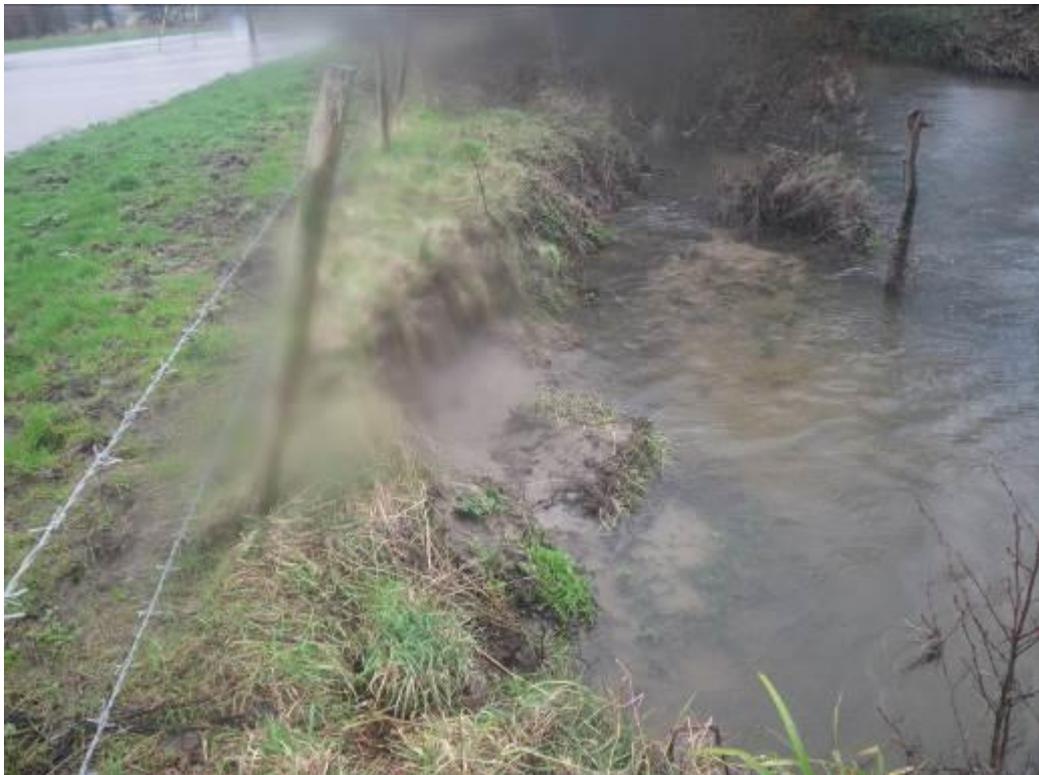
Photo 12. Another example of poorly located fencing allowing bank top grazing to occur and ultimately leading to bank failure.

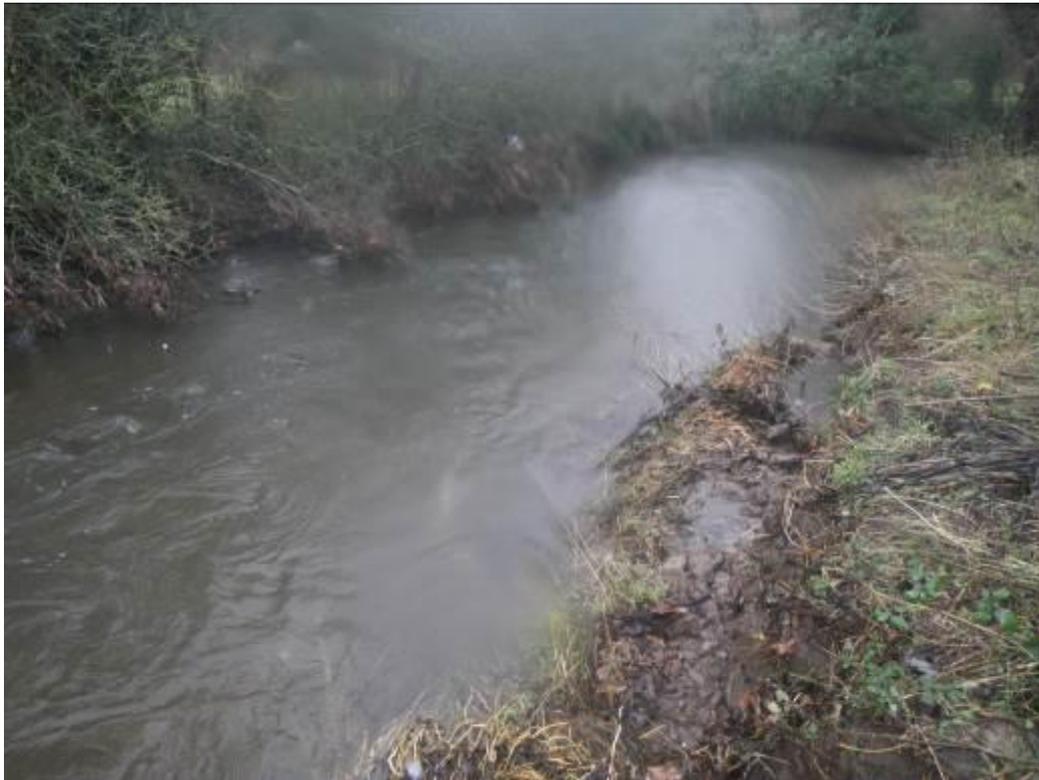
There are some good examples (photo 13) of where livestock is permanently excluded and the combination of well-established tree root systems on the outside of the bend and a sward of herbs and grasses on the inside is promoting an energetic channel that looks to be an ideal adult trout habitat. It was noted that the even where livestock is excluded, the amount of vegetation growing on the bank tops is thin, even where light penetration was good. This is thought to be due to extensive summer nettle and balsam growth which is leaving bank tops vulnerable to winter erosion and reducing plant species diversity.

Photo 13. High quality trout habitat.
