Gledhow Beck (Tributary of Meanwood Beck/River Aire), Gledhow Valley

Advisory Visit

Gledhow Beck (Meanwood Beck Catchment)
River	Gledhow Beck
Waterbody Name	Not specifically captured as a channel – Sits within the catchment specified for “Meanwood Beck (Source to River Aire)”
Waterbody ID	Meanwood Beck Waterbody ID is: GB104027062900
Management Catchment	Humber AWB
River Basin District	Humber
Current Ecological Quality	For Meanwood Beck (Source to River Aire) – Moderate
U/S Grid Ref inspected	SE3131337137
D/S Grid Ref inspected	SE3167236662
Length of river inspected	0.4km

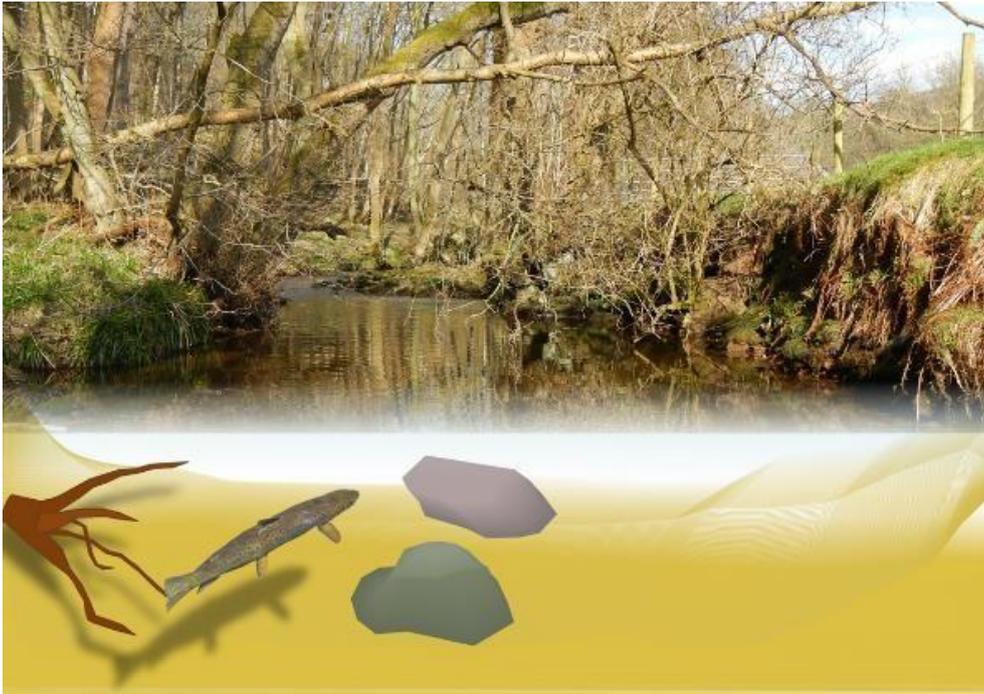
Figure 4: The availability of deeper water bolt holes (>30cm to several metres), low overhanging cover and/or larger submerged structures such as boulders, fallen trees, large root-wads etc. close to a good food supply (e.g. below a riffle and with prey likely to fall from overhanging tree canopy in this case) are all strong components of adult trout habitat requirements.

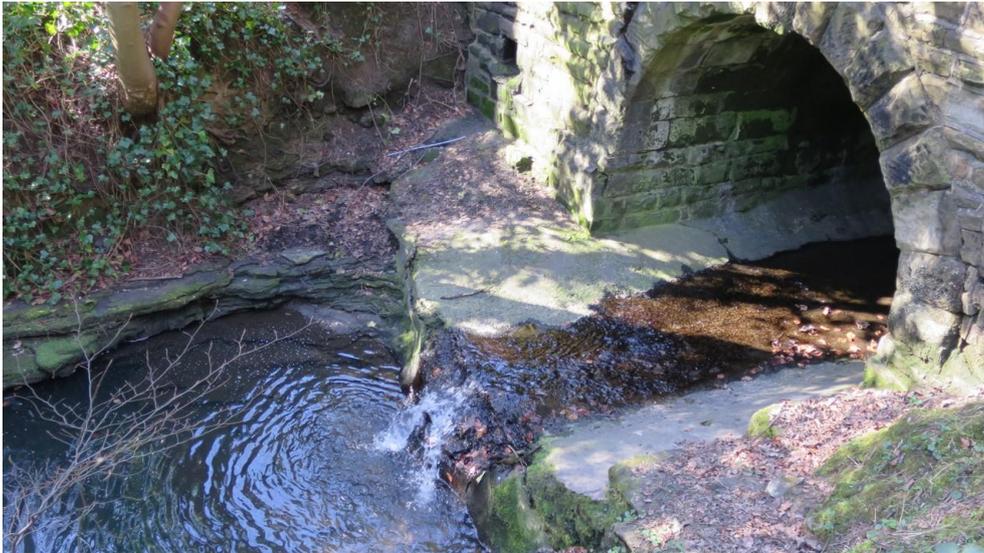
Figure 6: Culvert beneath the bridge at the upstream limit of this visit. Shallow/laminar flow in the base of the culvert that discharges over a vertical lip makes this a serious barrier to fish movement.

The great extent of culverting upstream of this section makes it difficult to estimate the value of improving the ease of fish passage at this barrier under the present circumstances.

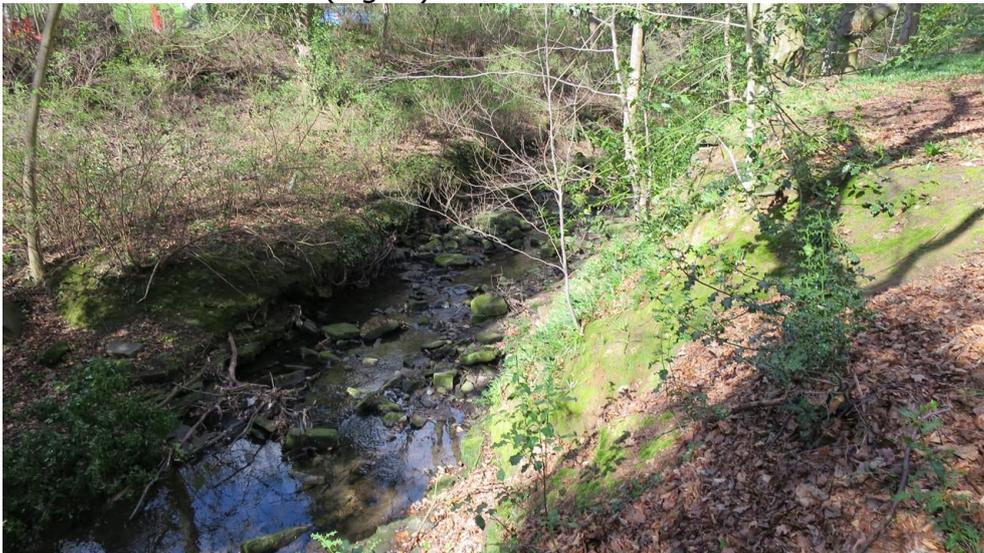
Although the banks show evidence of historic reinforcement with stone, the presence of mature surrounding woodland is a great boon for biodiversity within and around the watercourse (Fig. 7).

Figure 7: Woodland surrounding the beck and providing a degree of buffering from the adjacent road. Himalayan balsam and Japanese knotweed were not noted within the beck corridor during the site visit – a quite rare and biologically-valuable situation on most watercourses – particularly those within areas of urban/suburban development.

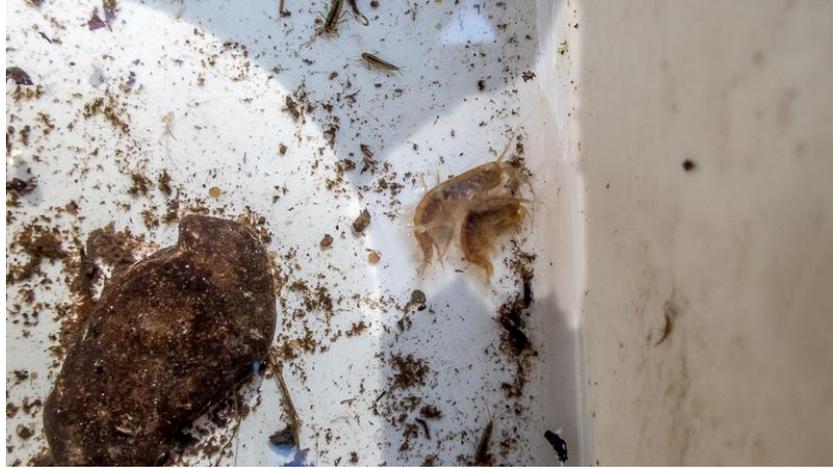
Figure 8: Pre-copula pair of *Gammarus sp.* (freshwater shrimp) and multiple *Baetis sp.* (olive mayfly) nymphs.

There was a great abundance of freshwater shrimp – which feed by shredding up deciduous leaf litter and are moderately sensitive to organic pollution. Although hoglouse were observed (which are much more tolerant to organic pollution), they were greatly outnumbered by shrimp – that ratio gives a quick, shorthand assessment of the severity and frequency of organic pollution events. In samples where hoglouse greatly outnumber freshwater shrimp, it is a strong indication of ongoing organic enrichment and reduced dissolved oxygen levels.

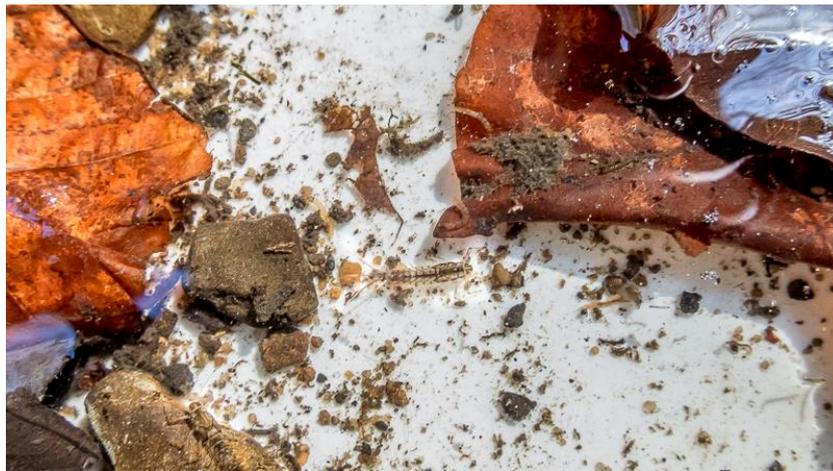
Figure 9: *Baetis* nymphs close to hatching into adults (centre of frame and lower left of frame) plus Chironomid (non-biting midge) larvae mid right of frame (thin orange/pink larvae against white tray background) and upper mid frame (on edge of leaf)

However, just the brief (and in no way quantitative) kick sampling with a small net and stone-turning revealed only invertebrates of “medium sensitivity” to reduced oxygen/enriched nutrients levels. No invertebrates that are known to be “highly sensitive” to organic enrichment were observed. This indicates either episodic pollution causing dips in dissolved oxygen or a more continuous input of some organic nutrients.

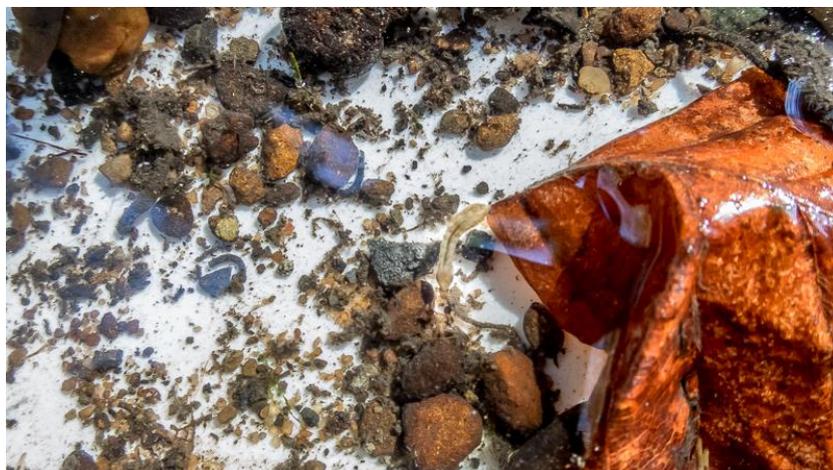
Figure 10: Simuliid larva (centre frame on leaf edge)

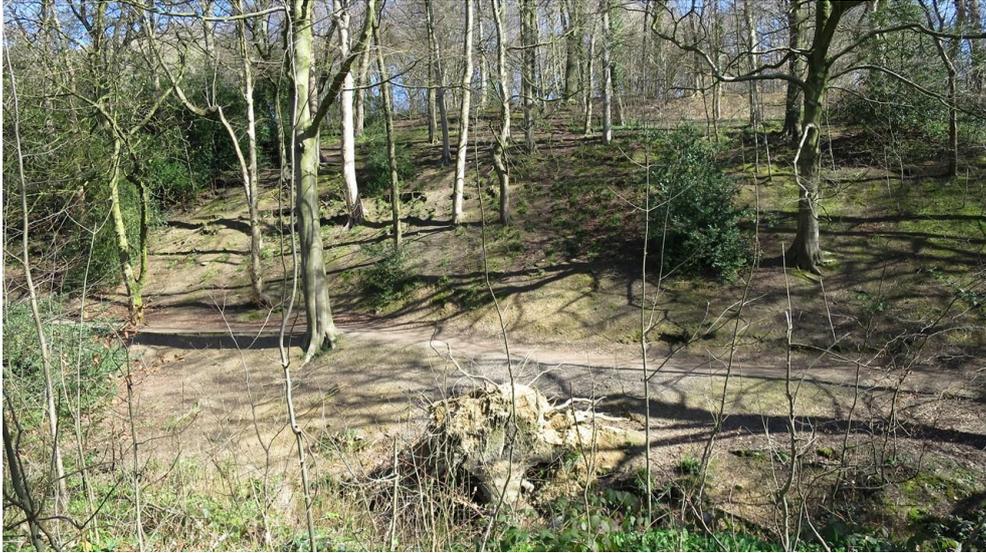
It would be beneficial to reducing fine sediment inputs derived from road drainage and, potentially, of fine topsoil washed from the wooded valley-sides. Some suggested actions are included in Section 3 “Recommendations”.

Figure 11: Topsoil runoff pathways visible where understory vegetation has been eradicated due to footfall (with a contributing influence of dense shading)

- Proceed with (already planned) “Fascine” installation along the contour lines of the valley to both help to intercept surface runoff from the woodland valley AND reduce the amount of understory vegetation erosion due to footfall/dog access on steep slopes. Some very relevant information on fascine impacts on slope stabilisation and runoff interception can be found on the section labelled “Erosion Control” in the following guide: <http://slowtheflow.net/wp-content/uploads/2016/12/Understanding-the-Hebden-Water-Catchment-LOW-RES.pdf>.

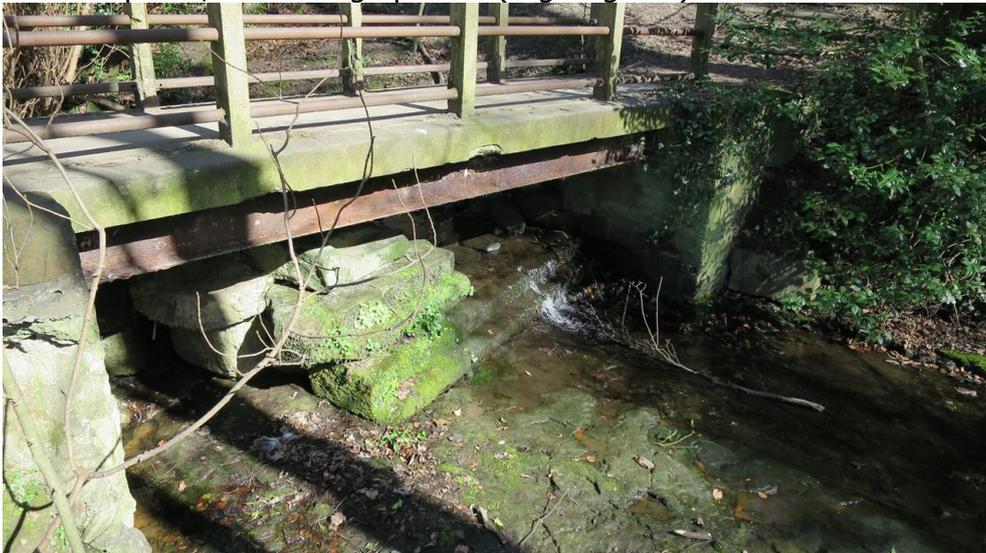
Figure 12: Older structure beneath footbridge at SE 31361 37065 – causing a complete barrier to upstream migration and increasing the erosion of bed material to expose bedrock

Barriers obviously interrupt the free fish passage that allows repopulation following pollution incidents (and also constrain the size of breeding populations by preventing access to potential mates). Additionally, the interruption of gravel and cobble material means that material that is eroded from the bed below such barriers is not continually replaced by material from upstream. Consequently, the physical complexity of the habitat is reduced and provides fewer potential niches for different species to occupy.

- Seek permission to remove the small weirs creating the silt-traps directly upstream of Gledhow Lake (and the potential to notch or bypass the weir below the footbridge at SE 31361 37065) to reinstate more diverse channel morphology

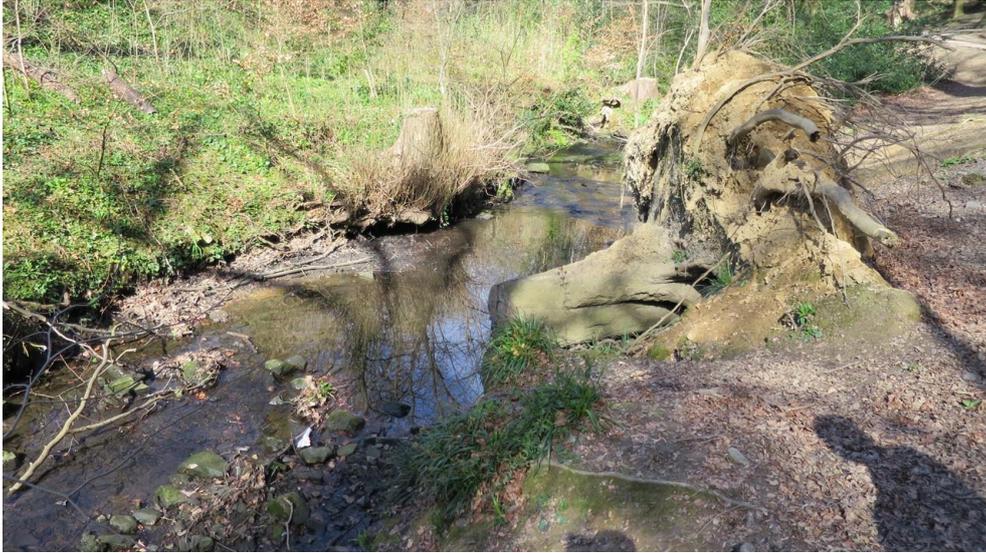
There were positive examples of pragmatic management practices – such as leaving structurally-beneficial portions of downed trees in place (following the removal of upper sections that had damaged overhead lines). Once the infrastructure-damaging portions had been removed, valuable root-plate and, stable, main trunk sections were left in place. The result is a more diverse stream-bed (via localised scouring effects) as well as increased cover habitat and physical niche opportunities at SE 31385 36974 (Fig. 13).

Figure 13: Leaving the root plate in place and allowing for bushy regrowth of locally-coppiced trees is allowing some positive structural diversification. It should be noted that a policy of extensive/blanket tree coppicing would, however, result in ecologically-negative impacts. Small, patchy interventions will be much more valuable for promotion of biodiversity.

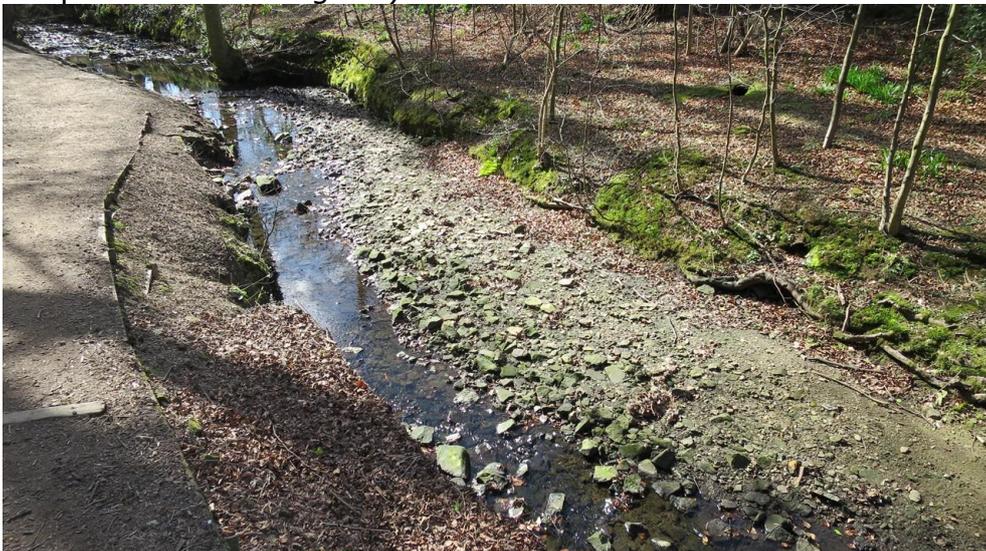
The relatively steep longitudinal gradient promotes recovery of more diverse channel profiles via the inherent redistribution of bed material (which is further promoted by stable in-channel structure such as fallen trees). An example of a deposited gravel and cobble "point bar" shows the beck recovering some semblance of a naturally meandering profile following historic reinforcement and constraint of the beck's path (Fig. 14; approximately twenty metres downstream of the root plate shown in Fig. 13).

Figure 14: Obvious "point bar" on the RB naturally creating a deeper, "low flow" slot towards the LB while producing a shallow incline of gradually decreasing depth towards the RB. The gabions on the LB are clearly designed to protect the footpath and the ongoing stability of that structure could be augmented by strategic tree-planting to create a more resilient matrix of bank material – and would also create enhanced habitat.

- Consider using bioengineering (e.g. goat willow planting) to reduce the need for gabion replacement/maintenance at the location shown in Figure 14.
- Allocate future silt-trap funds to ongoing periodic removal of a comparable amount of silt from the lake (in addition to funds already won to redistribute silt within the lake footprint)

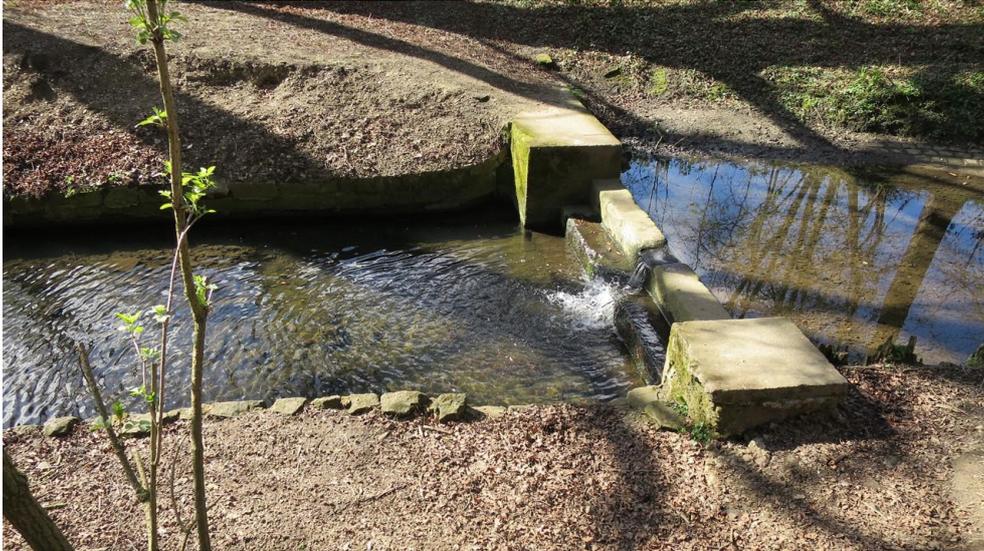
This is what creates such a negative impact on the habitat within the engineered silt-trap structures just upstream of the on-stream lake (Figs. 15 and 16).

Figure 15: A series of stepped silt trap/settling ponds at SE 31314 36897 directly upstream of the onstream lake are designed (with a need for ongoing, periodic removal of deposited material) to reduce the rate at which the lake fills in with sediment.

Not only are the cross-sectional profiles within these open-topped "tanks" much more uniform and trapezoidal, but there is little to no variation in flow velocity throughout the full width of the channel. It is important to stress that each variation in flow depth, flow velocity - and the associated changes in substrate particle-size - are the physical variations that create a wide variety of opportunities for a wide range of species.

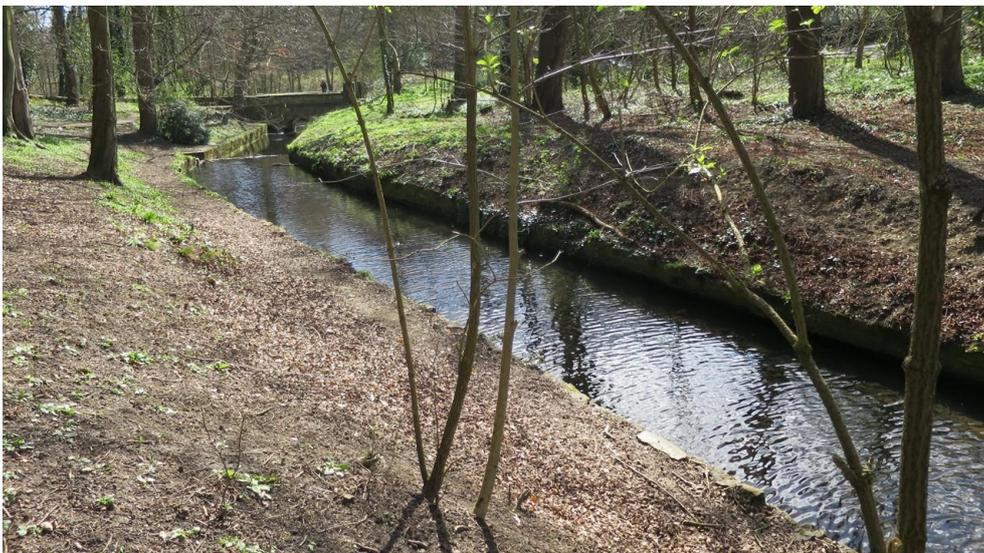
Figure 16: Looking downstream along the lower silt trap section towards the bridge that marks the beginning of the channel widening out into Gledhow Lake. Note the uniform "box-shaped" channel

The lack of flow energy and structural diversity is what dramatically reduces the value of the habitat within each of the silt-trap/settling pond structures designed

to intercept silt and leaf material upstream of Gledhow Lake. Each impounding weir is also a barrier to free movement of fish (and other aquatic life) that prevents access to mates within the full breeding population as well as access to the full range (and amount) of habitats required to complete lifecycles in many species.

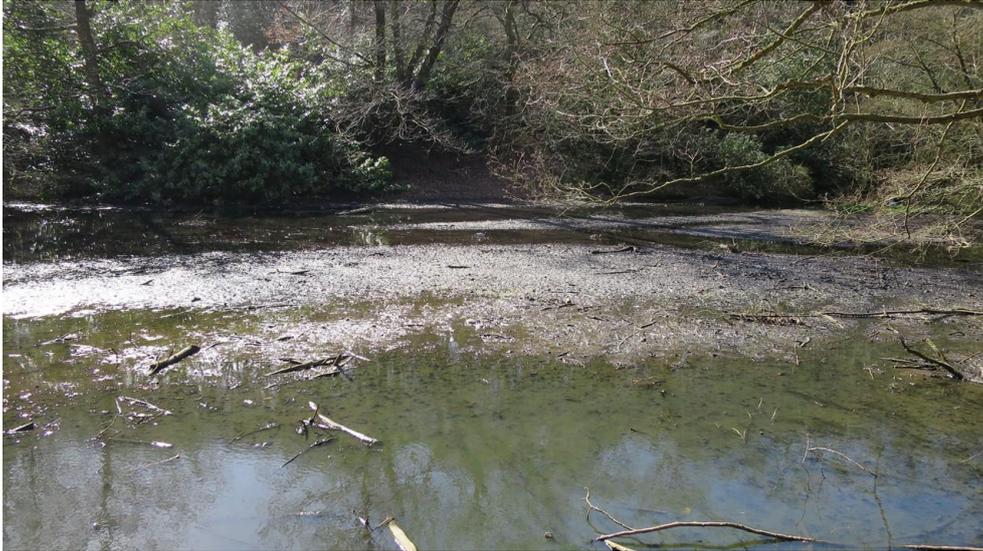
As the channel widens out into the on-stream lake (created both by an increased cross-sectional area as well as a large impounding weir), flow velocity drops to around zero. The physics of that mean that it is inevitable that fine sediment will fall out of suspension and begin to build up on the lake bed.

Figure 17: Fine silt accumulation in the lake - despite upstream sediment trapping weirs

In the presence of hugely increased cross-sectional area and the removal of any longitudinal gradient by impoundment - there is no action that can reverse the results of those conditions. Silt and vital leaf-litter will build up inexorably over time.

Consequently, the more effective way to reduce silt inputs into the lake would be to intercept particulate runoff from roads (where possible) and also to reduce and intercept more particulate runoff from the surrounding, woodland valley. This could be coupled by spending funds required for periodic silt-trap cleaning on removing/redistributing silt within the lake. When coupled with removing the impoundments used to create the current silt-trapping system, substantial benefits to the beck ecosystem could be won.

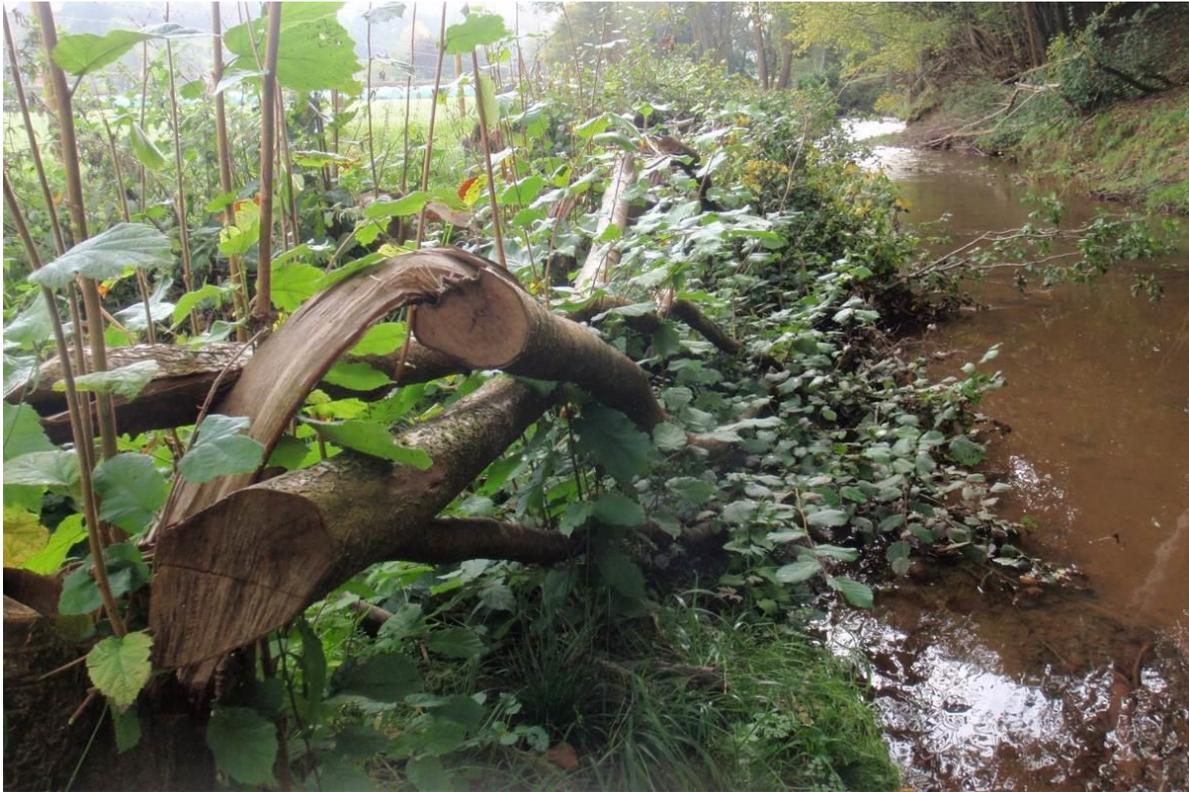
Figure 18: Hinged sapling growth (in this case hazel) used to create cover habitat in stream margins.

- Explore opportunities to “hinge” or “lay” (in the manner of hedge-laying) scattered patches of sapling-growth into the channel (e.g. Fig. 18) to promote some bed redistribution during high-flow conditions
