Great Stour – Tonford Fishing Club

An advisory visit carried out by the Wild Trout Trust – April 2010

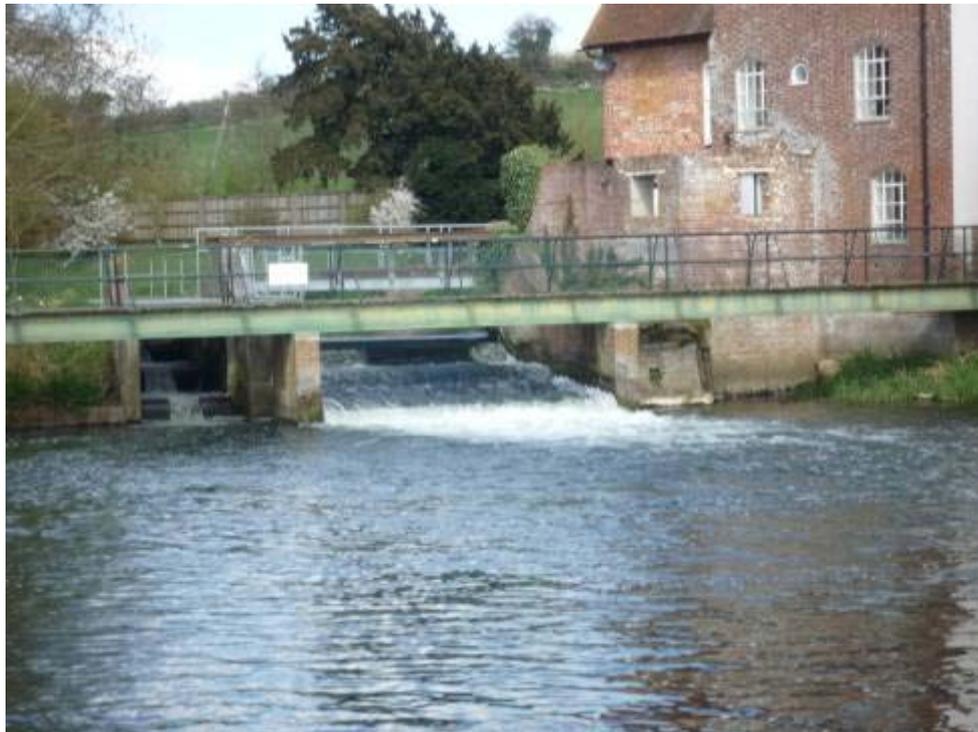
The top beat of the fishery is delineated by a large weir at the top boundary. It is presumed that this was an old milling structure. To facilitate access for migratory salmonids a "pool and traverse" type fish pass has been constructed adjacent to the main impoundment. Flow through the pass appeared to be very low compared to the main structure. This may change when flows increase and this is when most fish will migrate.

Weir pool forming the top boundary of the fishery. The attractant flow from the fish pass appears to be extremely low and will affect the efficiency of the pass.

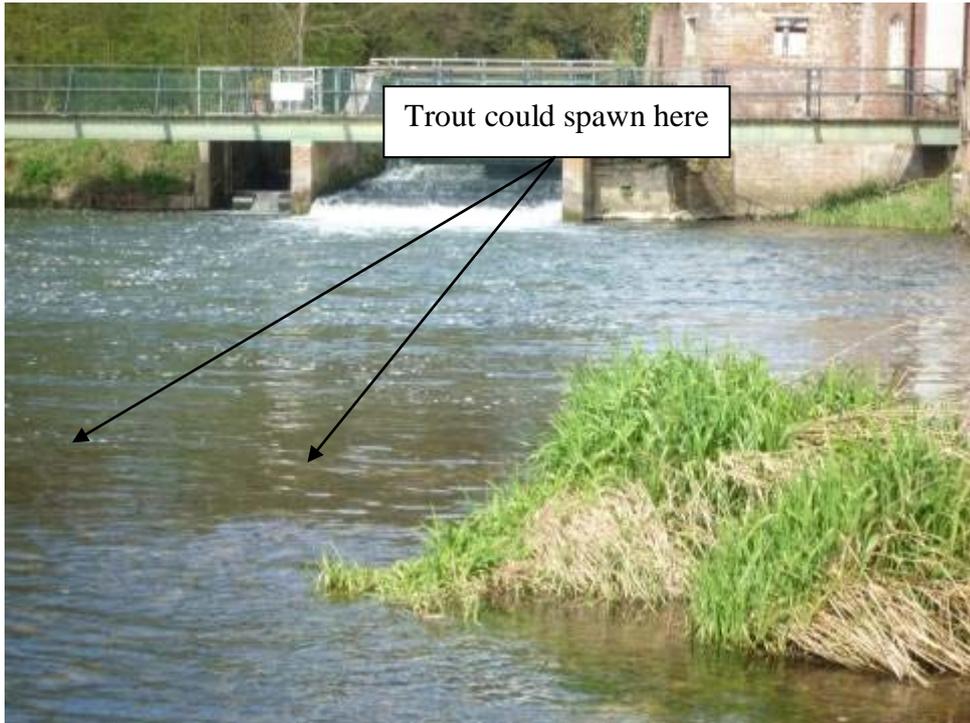
Gravel quality and size appeared to be ideal for trout spawning, however, the gravels were compacted and heavily loaded with sediments which can severely impact on spawning success. Healthy beds of water crowfoot (*Ranunculus sp*) flourished where the bed was firm and the flows strong, providing some excellent cover for both adult and juvenile trout, as well as an important habitat for aquatic invertebrates.

The glide at the bottom of the weir potentially provides a good location for spawning

Significant improvements in spawning success can be achieved by ensuring that gravels on likely spawning locations are broken up and cleaned prior to winter spawning activity. Gravels on rivers like the Stour can become heavily compacted and laden with organically rich sediments. By breaking the surface crust and blasting out the silt with spikes, rakes and water pumps, trout egg survival can be substantially increased.

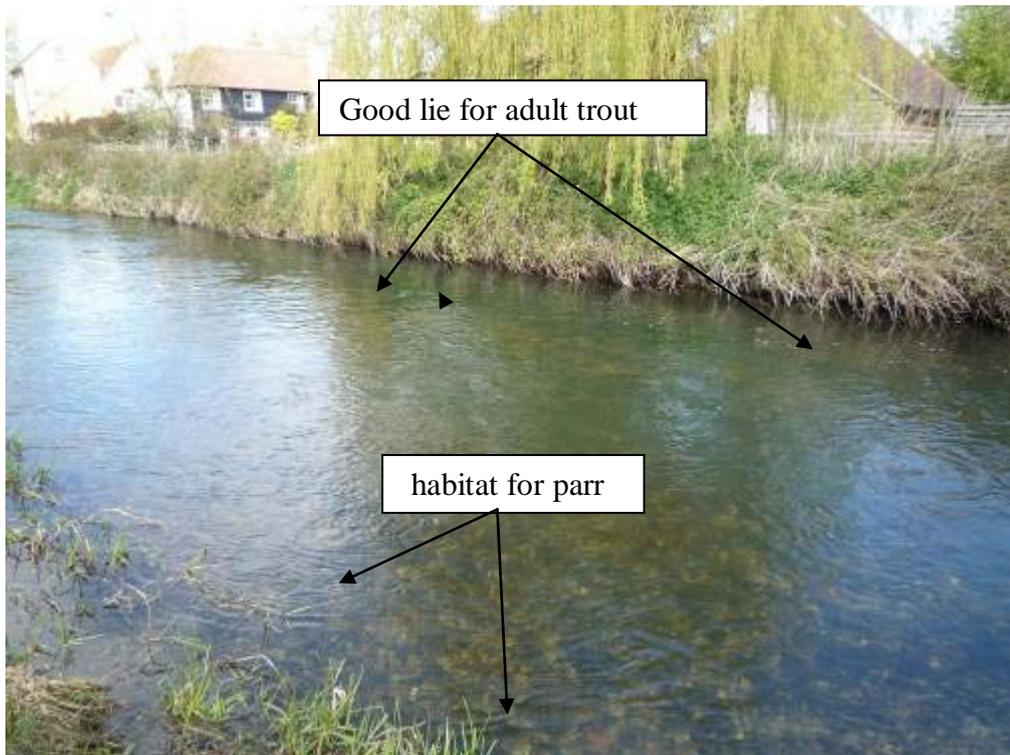
Shallow run below the weir should support juvenile trout but needs more cover

The holding potential of the reach running down to the bridge could be improved with the addition of some low level marginal cover. This is discussed in more detail in the conclusion and recommendations section of this report.

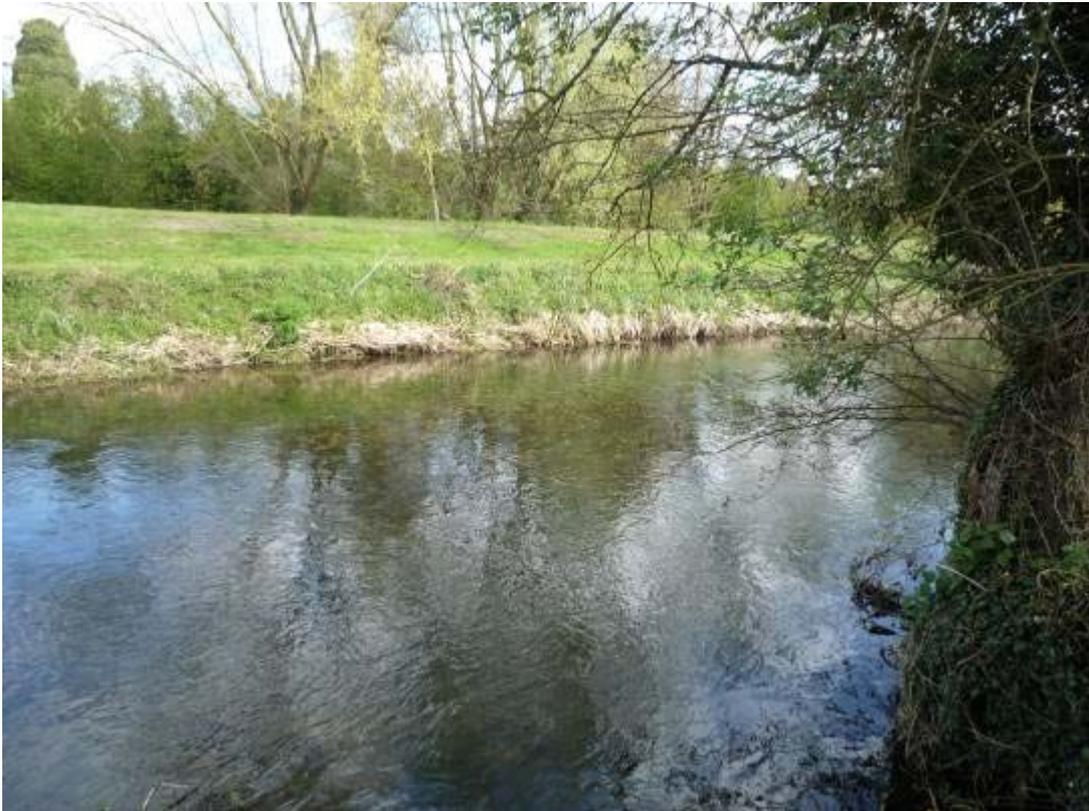
The section of LB would hold more fish with the provision of some low scrubby cover tree cover.

There are significant opportunities to promote improved lies for trout and coarse fish by undertaking a programme of tree planting. Pushing in stakes of goat willow at water level will provide some much needed low scrubby cover. The willows will provide cooling shade during long hot dry spells, an external food source via terrestrial invertebrates and a refuge from fish-eating predators.

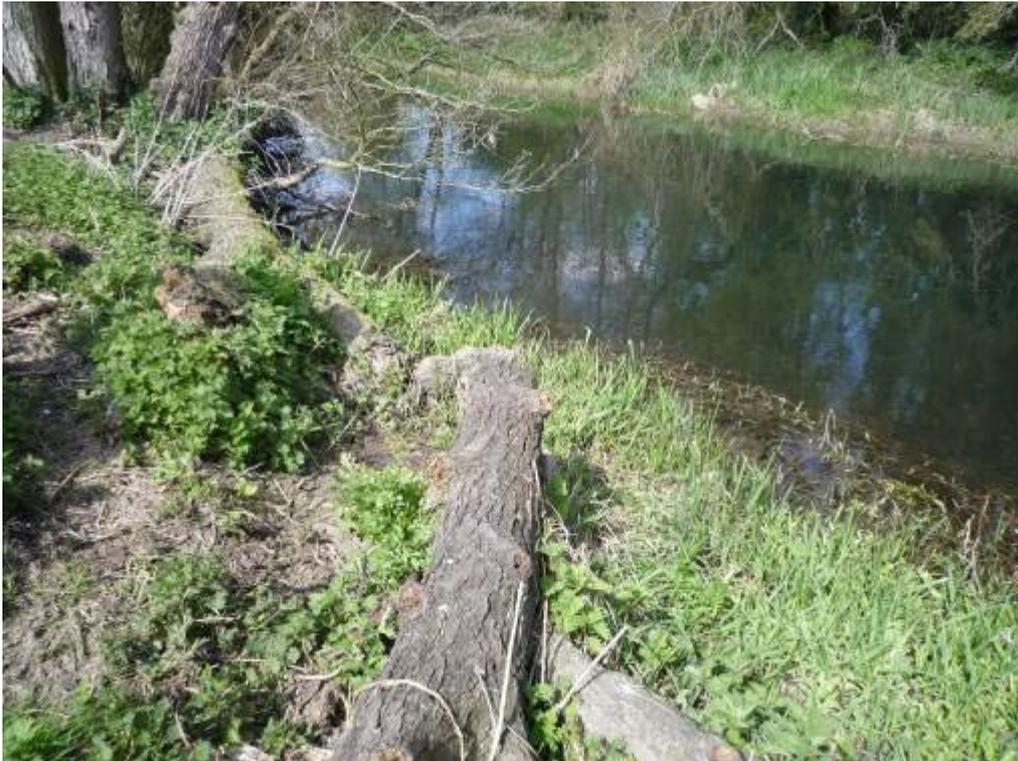
Large pieces of woody debris could be usefully pegged into the channel to provided more in-channel diversity and improved habitats for trout.

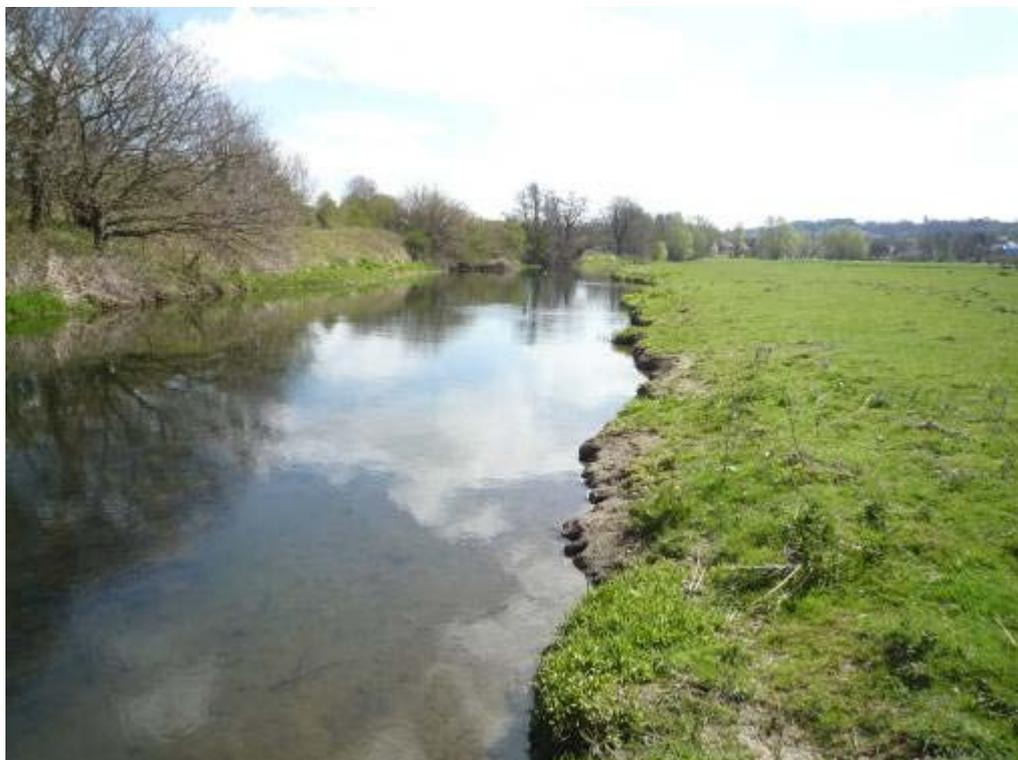
From the access bridge downstream the channel becomes progressively wider and deeper, with a corresponding reduction in water velocities. This section provides virtually no habitat for spawning, or for juvenile trout and only very limited habitat for holding adult fish. It is evident that that this section of channel has been extensively dredged in the past and its ability to recover is heavily restricted by the excessive grazing pressures on the RB. The lack of any significant channel gradient, probably exacerbated by the impounding structures located in Chartham, present a real challenge in terms of providing any quality habitat for trout.

Heavily degraded river channel. Too wide, too silty and ripe for large scale restoration

Rehabilitating this section of channel is possible but potentially very expensive. Excluding the livestock from the bank (with the provision of dedicated drinking bays) will help, as will a programme of tree planting. However, what is really required is a radical narrowing of the channel and (in selected areas) either redistributing existing bed material or raising the bed using imported gravels. A project of this nature and scope may well be too ambitious for a small fishing club but might fall within the scope of a partnership project involving the Environment Agency, the land owner, the club and the WTT. This is discussed in more detail in sections 5 and 6 of this report.

An even better solution would be to explore options for wholesale restoration. This will involve radically narrowing the channel by creating a new reveted margin and back filling with a matrix of woody brushings and imported gravels. A project of this size and scope would potentially be expensive and will require flood modelling to ensure no detrimental impact to the properties located on the LB. It is recommended that the club opens up a dialogue with the EA to explore options for a partnership project. This section is a complete blank canvas and is ripe for enhancement.

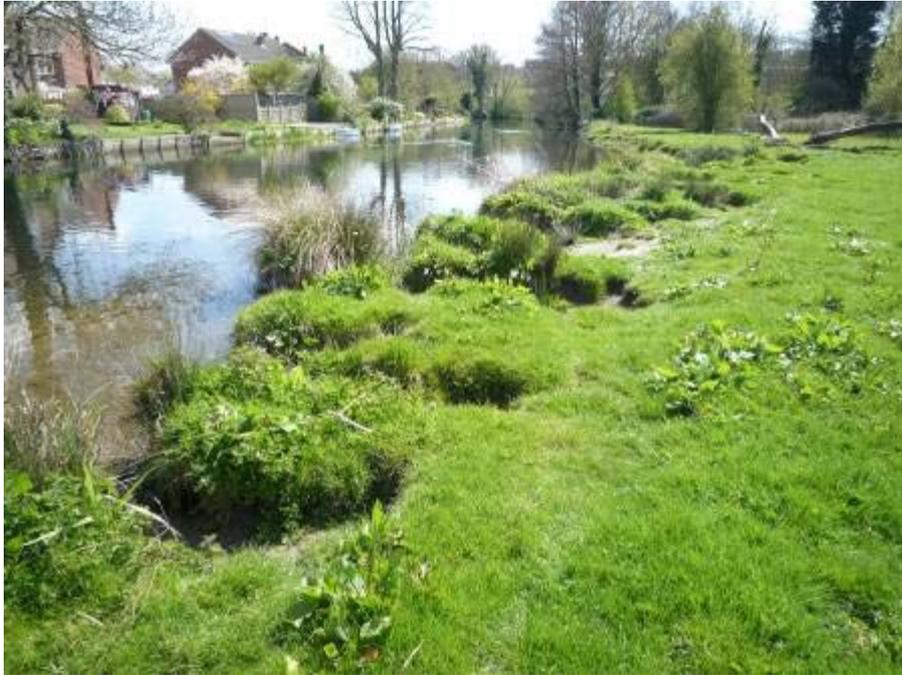
A short section of channel lying downstream of a road bridge was also inspected. The channel here was also very wide, slow flowing and heavily influenced by a water level control structure. The LB margin was bordered by a series of house gardens and in several places the banks have been defended to protect gardens from erosion and provide mooring facilities for small boats. The RB margin was badly damaged by cattle poaching.

Section of channel downstream of the roadbridge. Chronically poor quality habitat on both margins and in the centre of the channel

This section of river could be improved but the formal gardens backing onto the channel will always compromise efforts to enhance habitats on this comparatively short section. Resources spent on improving the fishery should probably be directed towards the top and bottom beats rather than this central section.

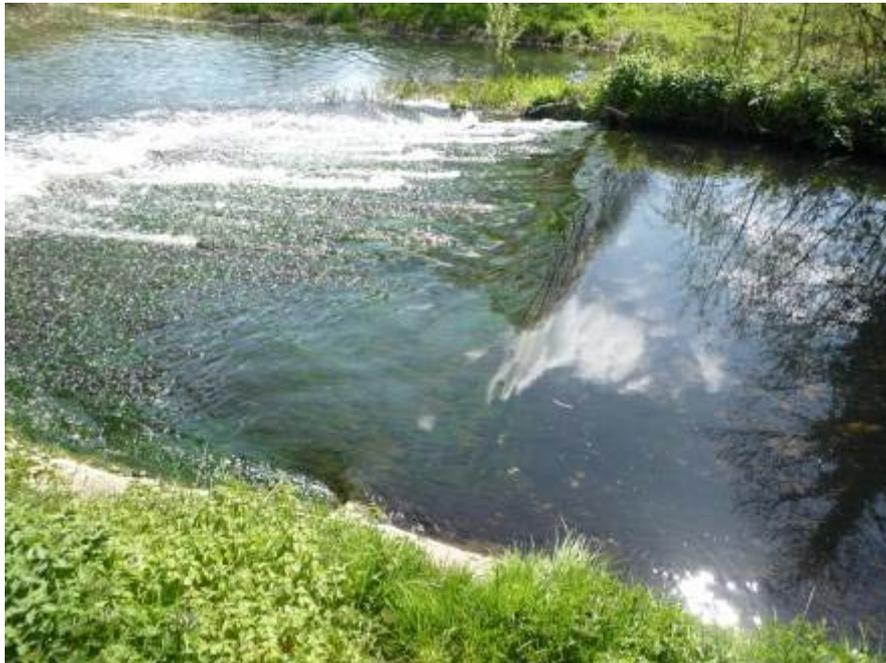
It is understood that this section has not been stocked recently and that fishing effort is comparatively light. The public footpath which runs parallel to the LB of the river is seen by the club as an issue and there are fears that poaching pressures may be excessive along this section. From the centre of the village the river is divided into two channels with the northern channel forming part of the fishery. There is a short section of this channel running down to a water level control structure. Access to the banks here is good and there are some reasonable sections in terms of habitats for flow-loving fish species. The weir itself is of the "crump" design is not considered to be a complete block to fish migration but may prove to be difficult for small trout and coarse fish.

Crump weir may fragment fish populations on this reach

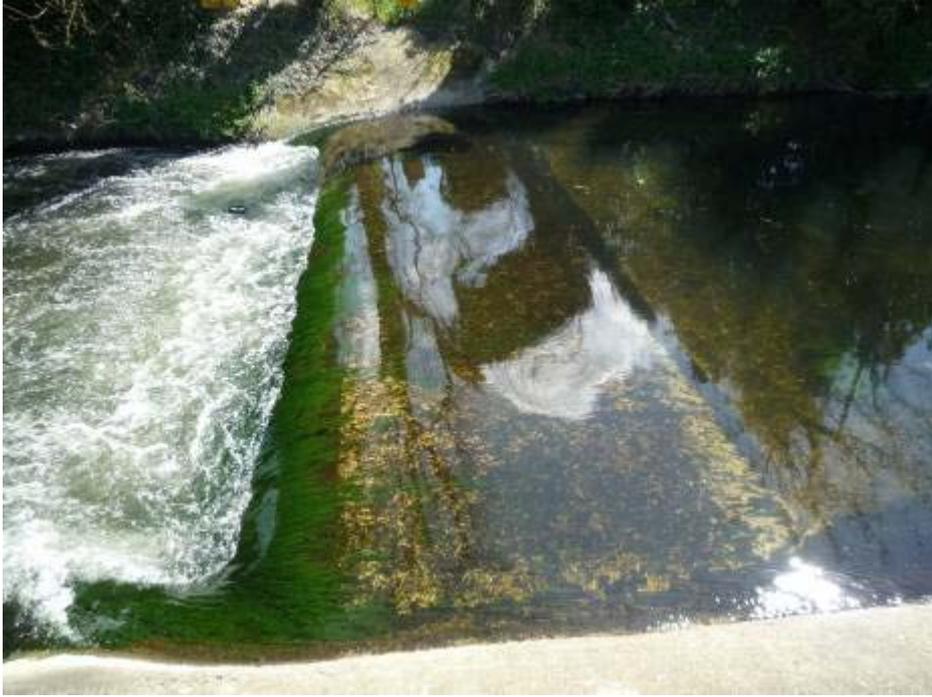
A further 3-400m downstream is an EA flow gauging weir. The gradient of the river through this reach is sufficiently steep for this structure not to be causing a significant problem by backing up the river and drowning out upstream habitats. The weir is likely to cause problems for some small fish wishing to migrate upstream. This is disappointing, given the potentially strong migratory component of the wild trout stocks within this river.

Flow gauging weir near the bottom boundary

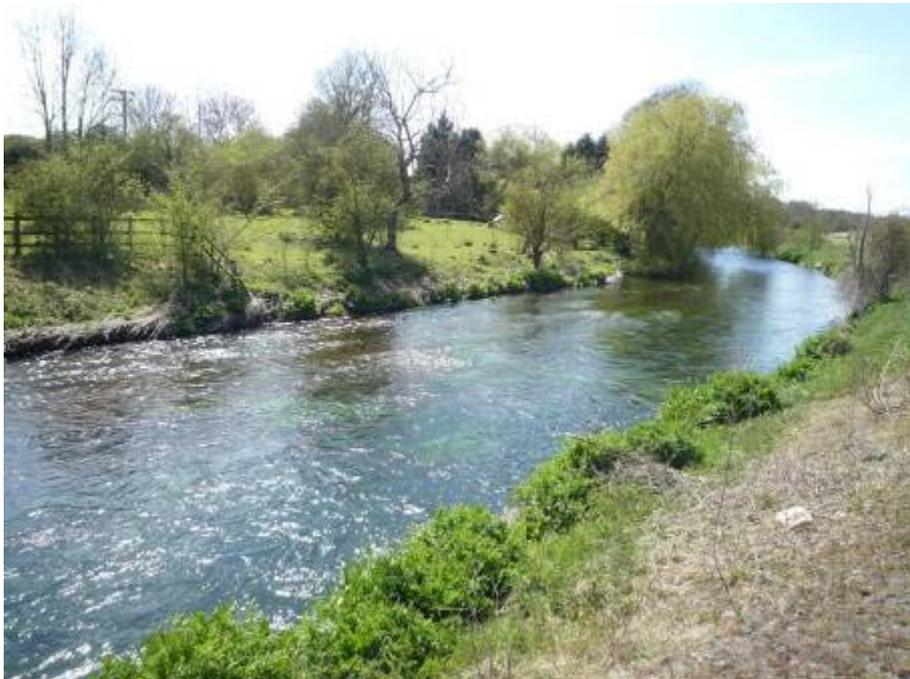
The section below the gauging weir down to the bottom boundary provides some of the best spawning and nursery habitat available on the fishery. The channel is a little wide and uniform in places and the bed comparatively flat. However, the excellent gravel substrate, steep gradient and prolific water crowfoot growth provides a good habitat for both juvenile and adult trout. Further improvements to this section could be made through the introduction of large woody debris flow deflectors to help scour and sort river bed gravels. This is discussed in more detail in section 5.

Excellent trout habitat on the bottom reach

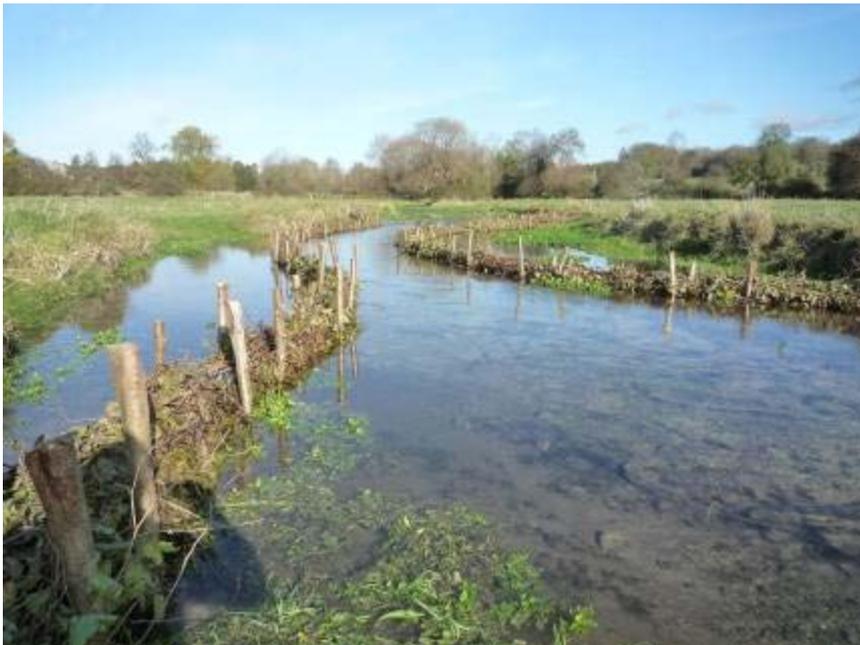
Narrowing an over-wide river to increase water velocity and create improved in-channel habitats

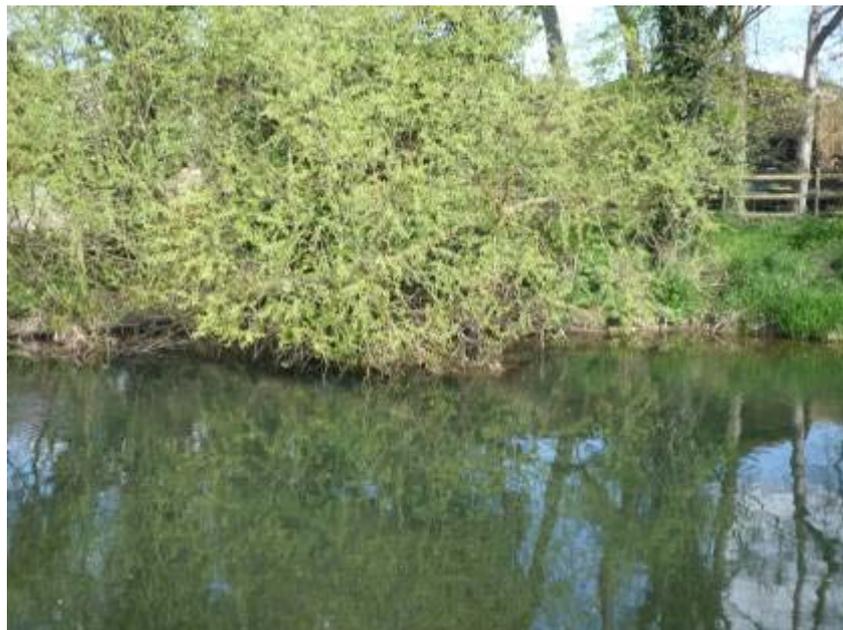
Low scrubby cover on the top beat – more of this habitat is required throughout the fishery

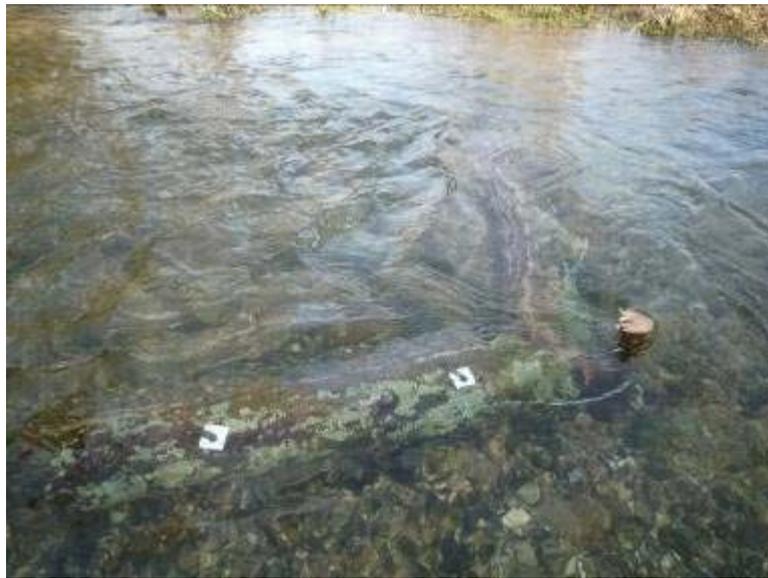
Two pieces of LWD configured to form an upstream "V". Structures like this scour local pots in the shallow bed and promote a clean, loose ramp of gravel downstream.

This method is extensively used by the WTT as it not only helps to boost spawning success but also provides holding habitat and cover for a range of fish species. As the wood rots it also provides a primary source of food for aquatic invertebrates.

An alternative method to gravel cleaning is to position and secure pieces of large woody debris to clean and sort gravels by forcing water down and through the surface crust. This technique is particularly useful on wide flat sections of river.

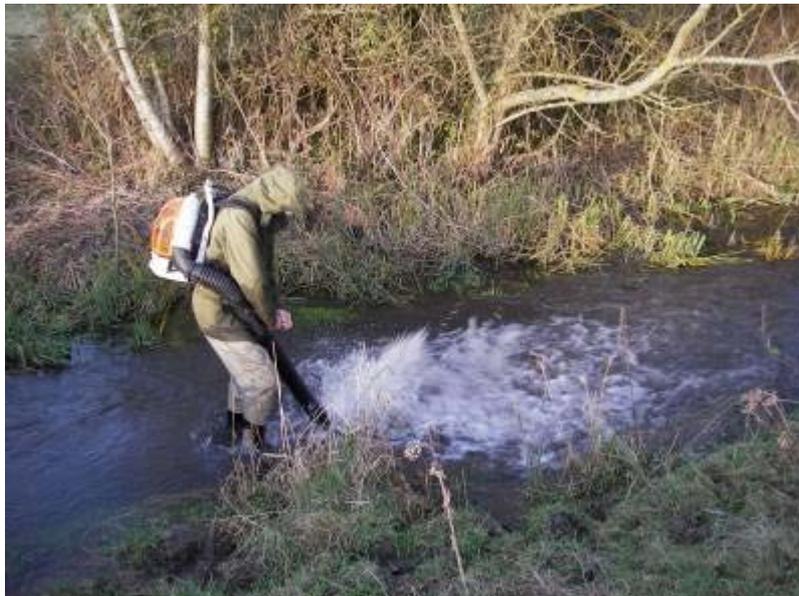
Gravel cleaning can significantly boost spawning success on rivers with compacted gravels
