Advisory Visit

River Hamps, on behalf of Leek & District Fly Fishing Association

12th July, 2008

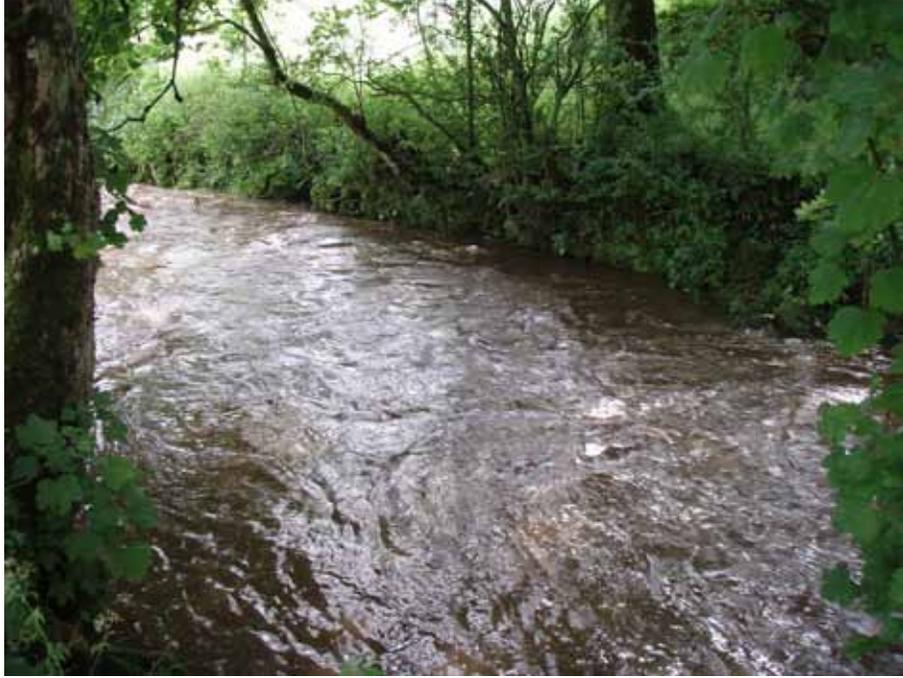
This section of river is characterised by stone pitching against one or both banks of the river (Photo 1). This bank reinforcement is obviously many decades old (probably pre-Victorian), and has mature trees growing on and though it; it is likely to be associated with the milling which historically occurred in this area:

The stone walls laterally constrain the river within a fixed channel, restricting the natural processes of erosion and deposition. This can be seen by looking at the planform of the river from maps or satellite photos (see Google maps), and comparing this section with the more meandering reach downstream of Dukes Lane. Where it is between stone walls the river tends to lack meanders and bends, and hence lacks pool habitat. Pools form on the outside of bends where erosion takes place, and the resulting material is deposited on the inside of bends creating gravel side-bars and riffles.

Much of the river habitat upstream of Dukes Lane is therefore shallow and rocky, and whilst this provides good habitat for juvenile stages of trout there is a dearth of deeper areas which would be suitable habitat for adult trout.

Photo 1 Stone pitching on the banks of the river

5.5 It is recommended that pool habitat is created on the walled section of river upstream of Dukes Lane. Ideally this would be achieved by the removal of the stone revetment allowing the river to create features through natural processes. This has the disadvantages of being likely to be unpopular with landowners, disrupting the good tree cover that is inextricably linked with the stone revetment, and taking a long time to achieve the desired objectives.

If the revetment remains in place, more pool habitat can only be achieved by the construction of some type of weirs or channel constrictors. This is potentially a controversial suggestion, because the construction of weirs in a natural river channel is not generally beneficial to the overall geomorphology and biodiversity of the river. However given the above circumstances, it is felt justified to recommend carefully designed and positioned structures of this kind.

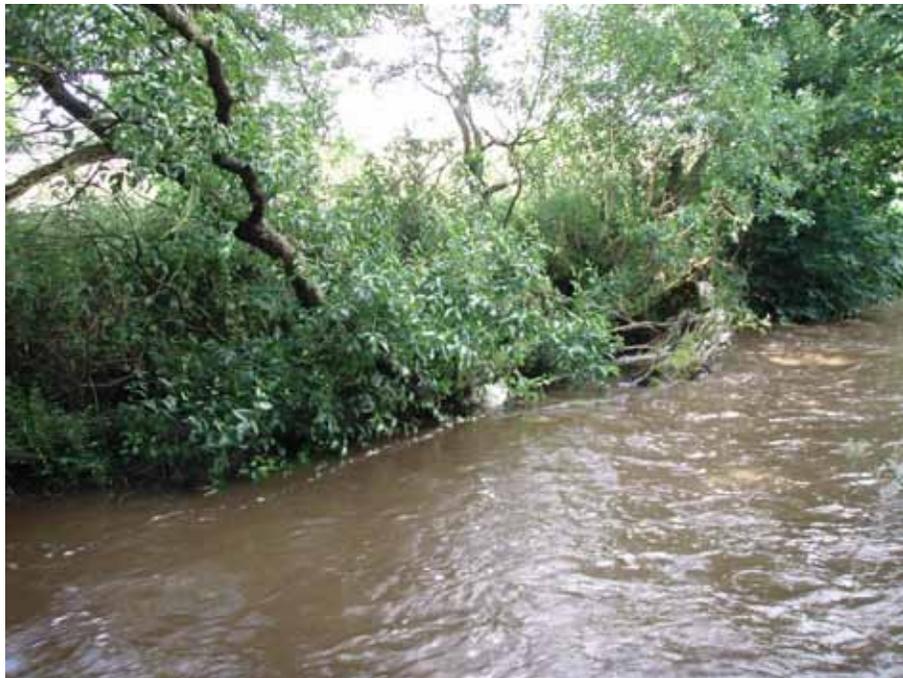
Near Papermill Farm (SK 06546 50747) there is stand of snowberry on both banks, and just upstream is a nice example of some Large Woody Debris (LWD) in the channel where some bay-leaved willows have 'hinged' into the channel but remained attached to their stumps (Photo 2). This is exceptional and there is generally little LWD in the river channel in this reach.

Photo 2 Natural LWD in the river channel

- Adopt a policy of retaining natural LWD in the river channel unless it is causing significant problems. The West Country Rivers Trust provides a useful guide to the management of natural LWD:

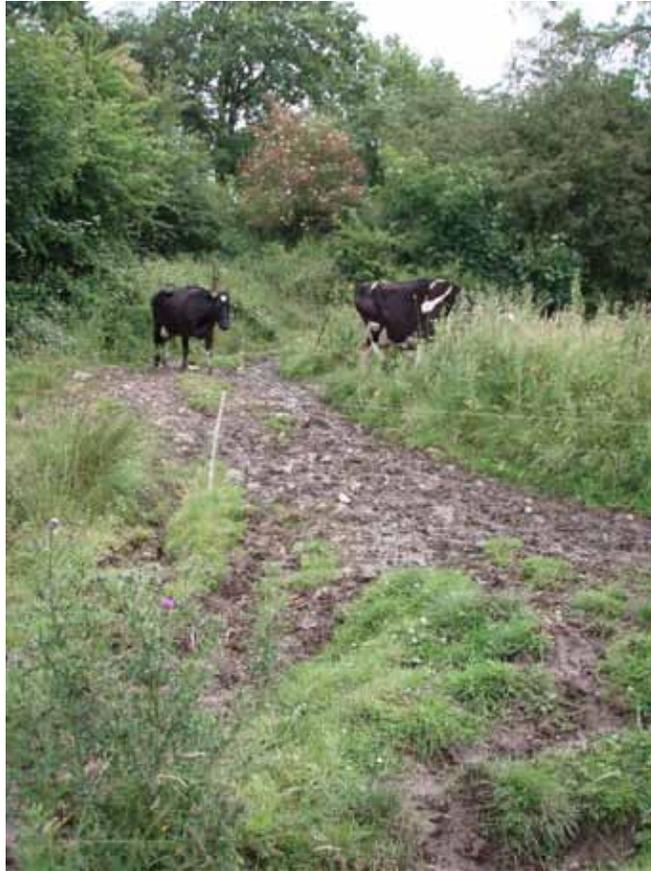
There are cattle crossings across the river (at SK 06459 50752 and SK 06361 50868) where the dairy herd from Papermill Farm cross the river regularly. Both are reinforced with concrete, but the steep access track to the upstream crossing has previously been a source of organic enrichment to the river when rain has washed accumulated cattle faeces down the track and into the river (Photos 3 and 4).

Photo 3 Steep track from Papermill Farm leading down to cattle crossing (below)

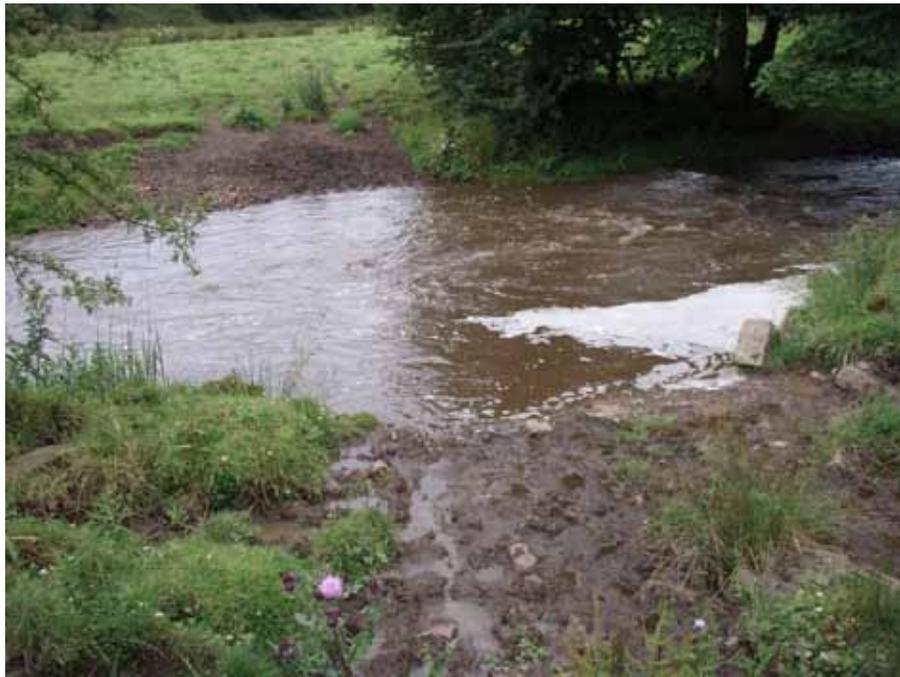
Photo 4 Cattle crossing - a source of organic enrichment

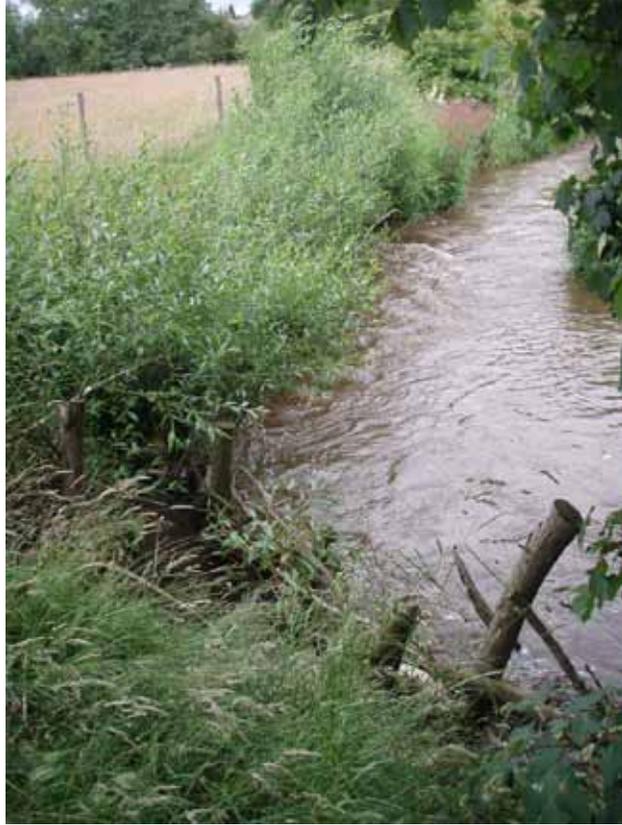
The meadow upstream of this tributary is fenced on the right bank, and there has been some willow spiling carried out on the outside of a bend to protect it from erosion (Photo 5). Progressing upstream the margin between the fence and the river widens and there is an excellent strip of tall marginal vegetation alongside the river, comprising rose bay willow herb, meadowsweet, butterbur, cow parsley and tall grasses (Photo 6).

Photo 5 Willow spiling on right bank upstream of Papermill Farm

In the areas where willow spiling has already been installed, this would benefit from laying to the level of the top of the bank to prevent water pressure blowing-out whole trees in floods, and to fill in existing gaps between the trees. Further willow spiling is not recommended (e.g. on the lower section of the fishery) because its vigorous growth may mask earth banks used by nesting birds, and it incurs a burden for future maintenance.

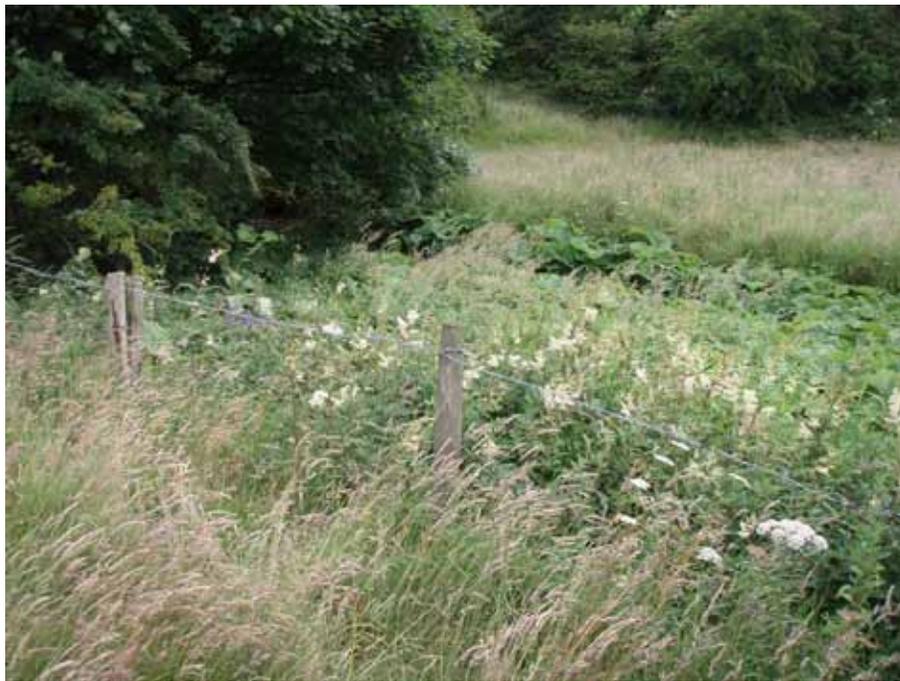
Photo 6 Excellent riparian vegetation

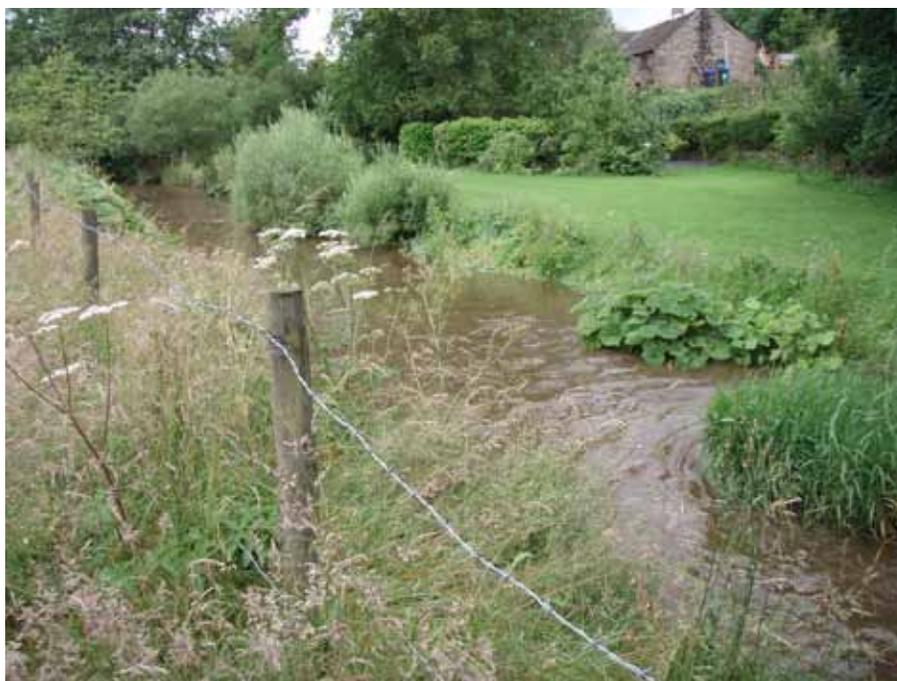
The right bank fence and marginal vegetation continues into the next meadow, opposite the private house and garden on the left bank, although the fence is closer to the watercourse. Just downstream of the house the river turns a sharp right and creates another deep pool: valuable adult trout habitat. There are some nice low-growing small willow trees on the left bank in the garden providing some good low cover over the river (Photo 7).

Photo 7 Low cover provided by willow trees (far bank) and a good, although narrow, strip of marginal vegetation (near bank)

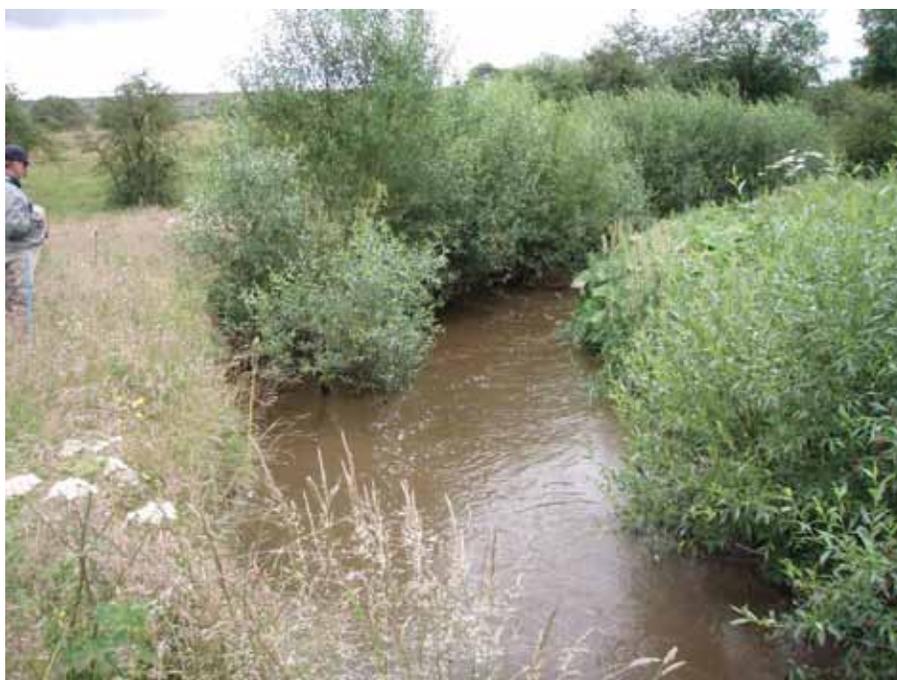
Photo 8 Willows planted on the outside of the bend and protected by electric fencing to arrest erosion

On the right bank between the private dwelling and the embankment, willows have been planted on the outside of a bend in the river to protect the bank from erosion. The willows have become well-established and are perhaps 10 ft high in places. The LADFFA top boundary occurs about halfway along the steep embankment upstream of these willows.

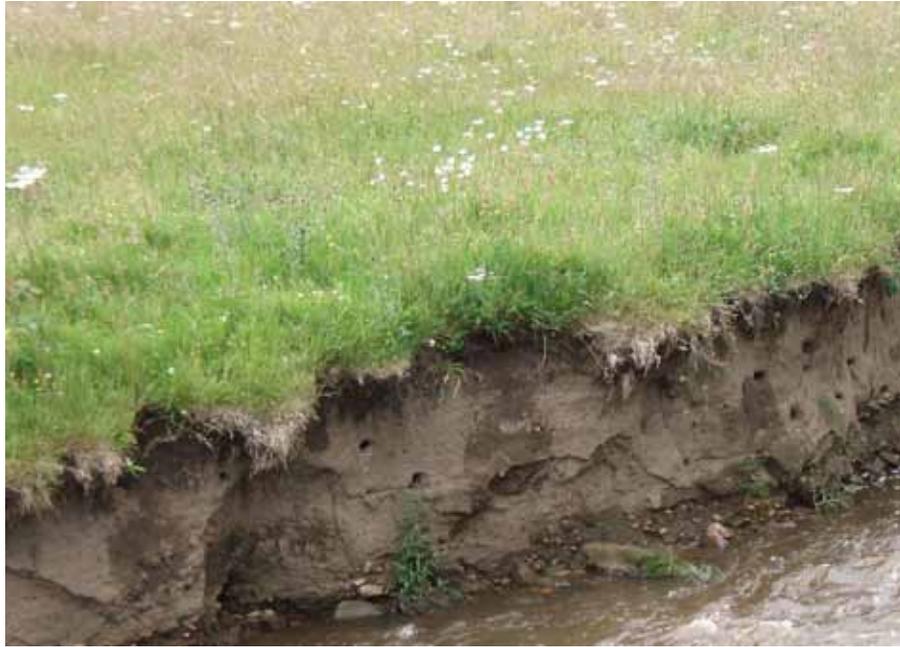
The left bank is not fenced and is accessible to livestock right up to the water's edge. In limited areas cattle have access into the river to drink (for example just below the large pool downstream of Dukes Lane bridge), but for the majority of the length the high vertical banks prevent stock access to the river. Stock grazing to the fall of the bank has restricted the growth of marginal vegetation on the left bank, and left it more vulnerable to increased rates of erosion. The increased rate of erosion has led to an overwidening of the river channel in some areas. There are numerous areas of vertical earth bank, and some of these are utilised by kingfishers for nesting (Photo 9).

Photo 9 Earth bank with hole used for nesting

Caution should be exercised not to damage areas of earth cliff used by nesting birds such as kingfisher. Professional advice should be sought regarding this.

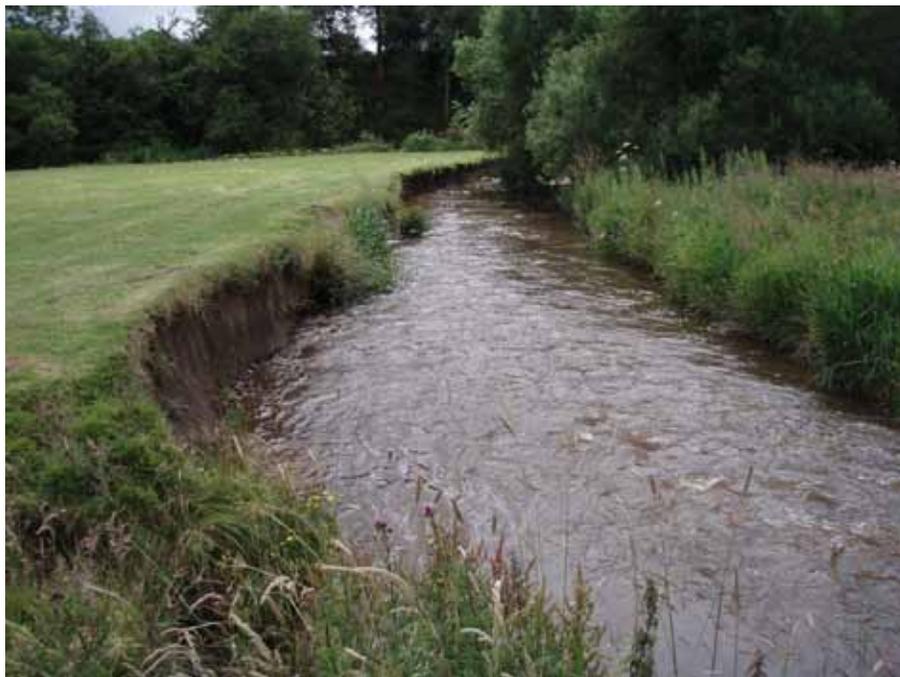
In some areas, the vertical earth banks and grazing have lead to a lack of cover for trout in pool areas. The lack of cover in these areas prevents adult trout from utilising otherwise suitable areas with a good depth, and leaves them vulnerable to predation, particularly by goosander (Photo 10).

Photo 10 Contrast between banks with and without livestock access

- 5.2 Fence the left bank downstream of Dukes Lane. A fence well back from the edge of the river would improve marginal vegetation and help to increase the stability of the bank. The fence could be a permanent two-strand barbed wire fence, or electric fencing which would be cheaper, but require regular attention. It is recommended that the club liaise with Andrew Heath of the Trent Rivers Trust who can advise on landowner liaison and Catchment Sensitive Farming grants for riverside fencing.

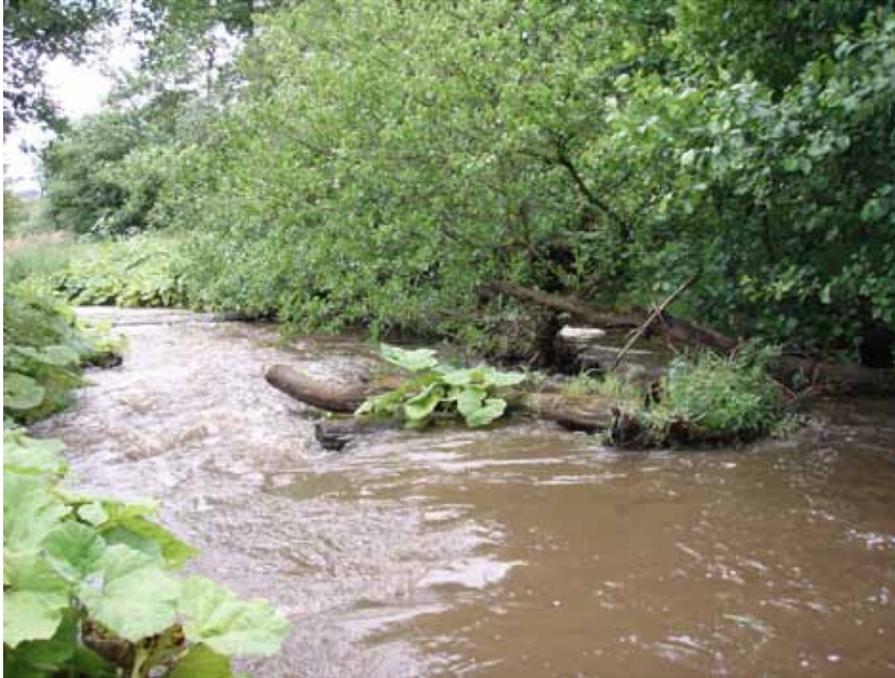
There are one or two areas with LWD in the river channel, but generally it is lacking in this reach. LADFFA tend to remove fallen timber from the river

Photo 11 LWD in the river channel

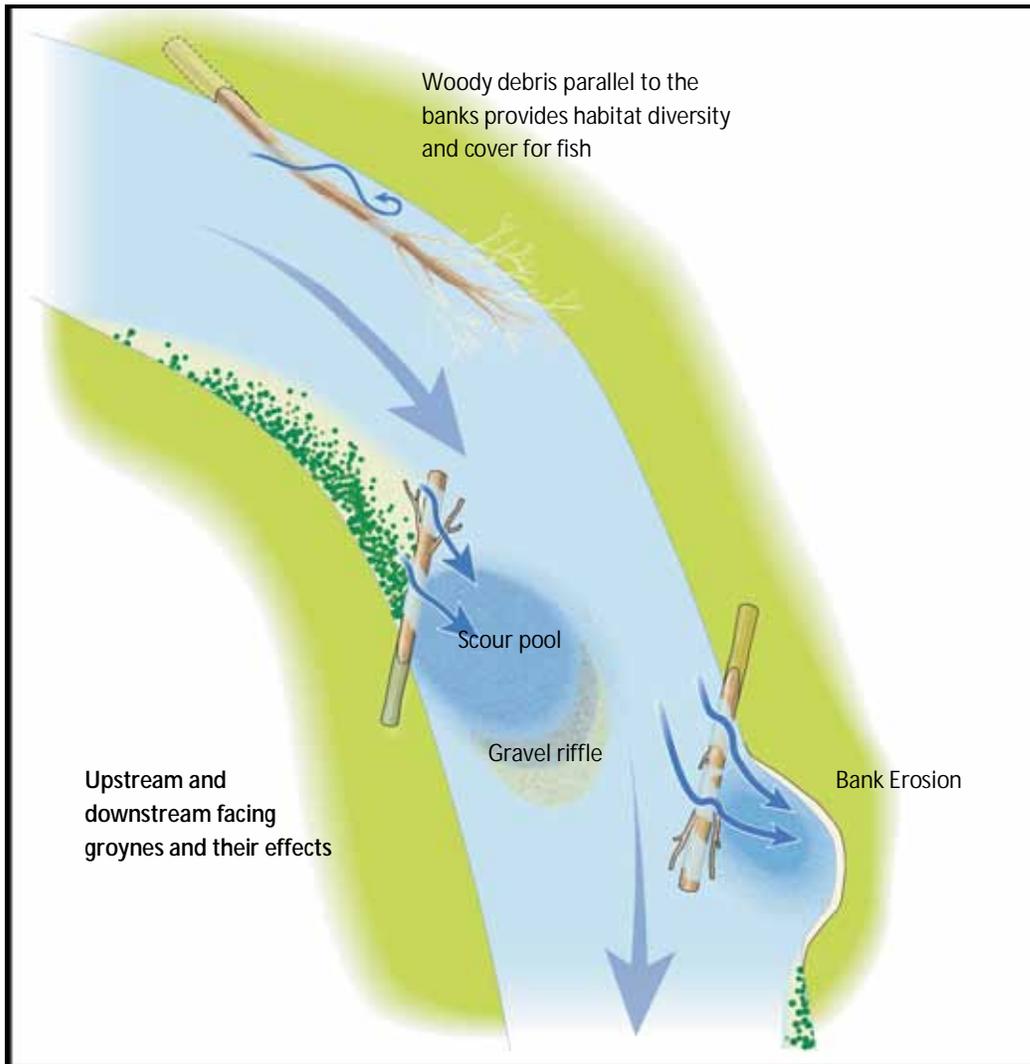
- Deliberately introduce LWD to the river in selected areas to improve habitat diversity and cover for fish. There are abundant opportunities for hinging selected trees into the river on the more heavily shaded section of the river (upstream of Dukes Lane). This involves partially cutting through the trunk and pushing the tree over, leaving it attached to the stump (mimicking the effect seen in Photo 2). Woody debris groynes can be fixed parallel to the bank, or facing upstream (see diagram). Downstream facing groynes are not generally recommended as they may cause bank erosion.

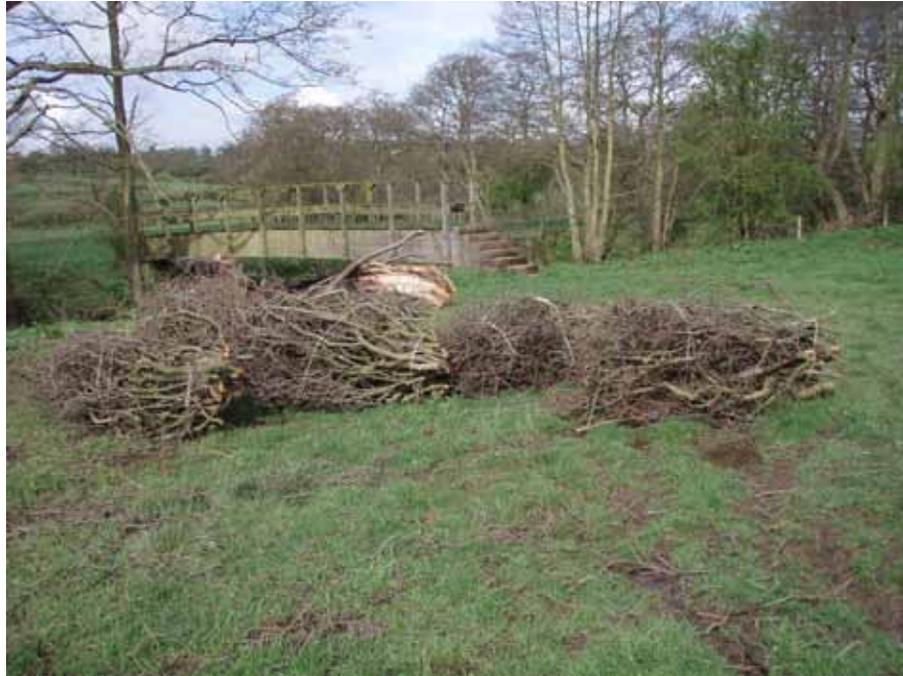
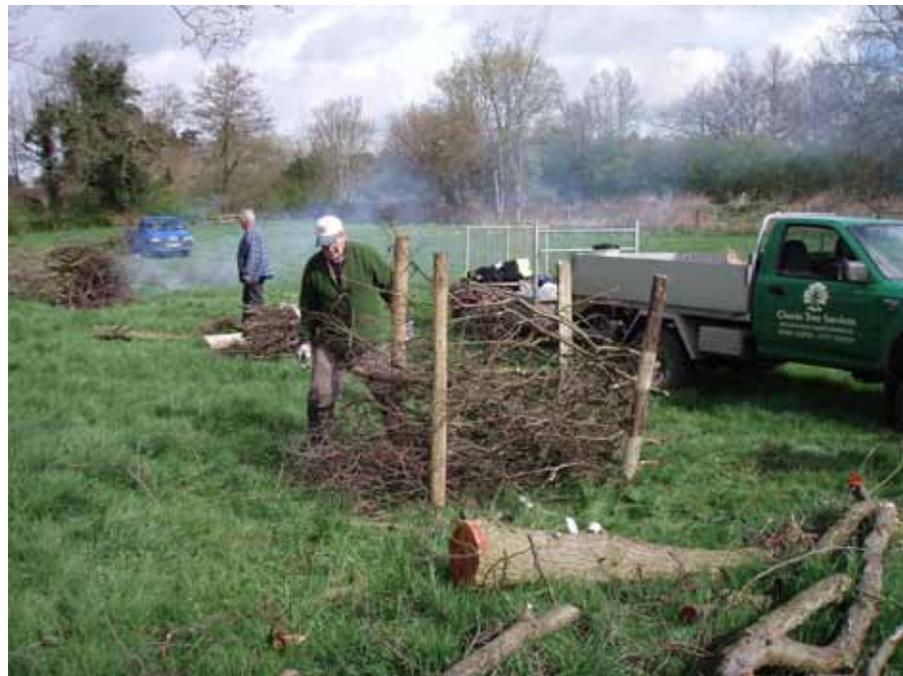
- Introduce brushwood to the river in to provide refuge for fish from goosander predation. Brushwood could be cut locally or sourced from trees being introduced to the channel as LWD. Brushwood bundles can be staked alongside banks and may also provide additional benefit by

Photo 12 Brushwood bundles can be easily constructed by working parties

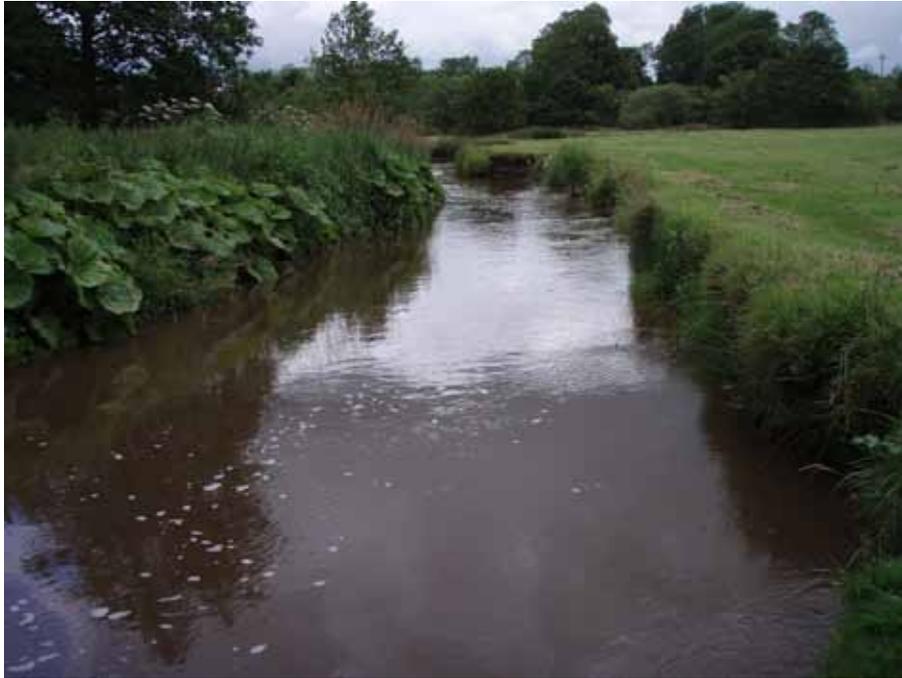
Photo 13 Example of location which would benefit from increased instream and overhanging cover on the grazed bank.

- 5.3 Introduce low cover against the left bank in selected pool and glide areas downstream of Dukes Lane (e.g. Photo 13). It is suggested this could be achieved using a combination of logs and brushwood fixed along the base of the vertical banks just at or slightly beneath summer water levels (see Figure 1). This needs to be done in combination with fencing, and willow whips could be planted on top of the bank. It is recommended these are goat willow (*Salix caprea*), grey sallow (*Salix cinerea*) or bay-leaved willow (*Salix pentandra*) which can be pruned to create low bushy growth, rather than taller species. Cuttings from local plants are recommended.

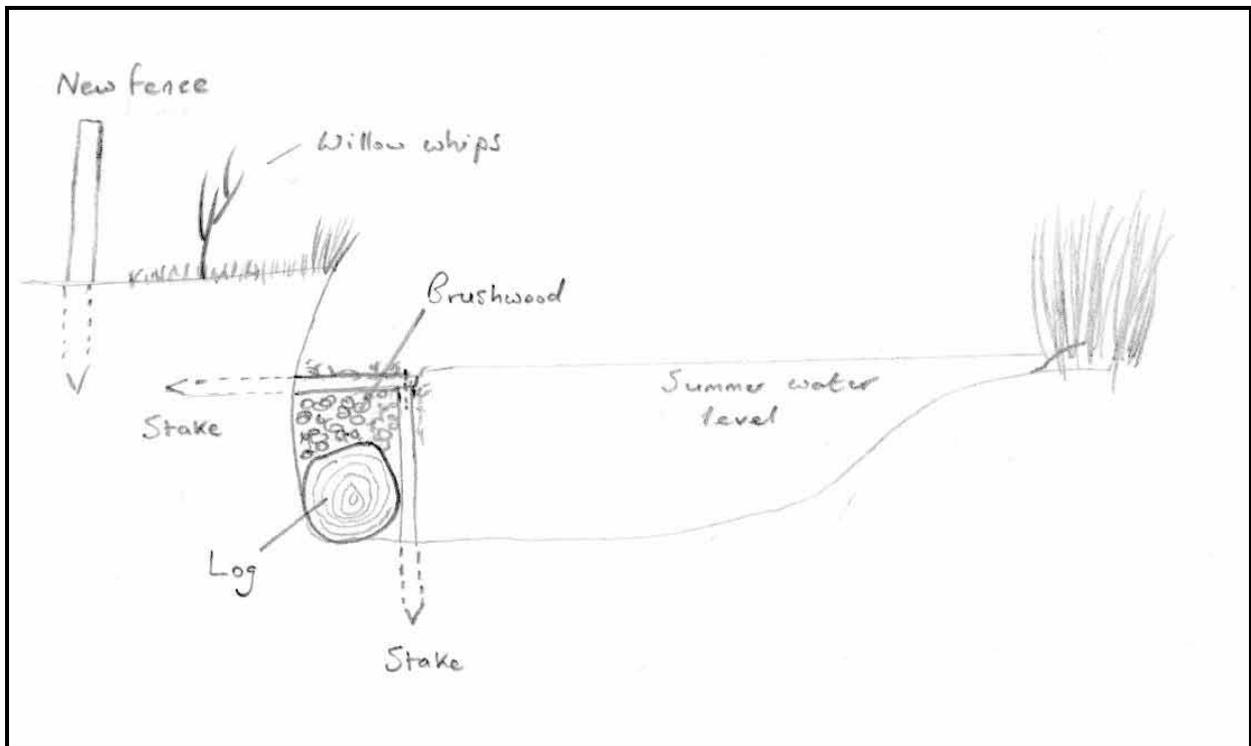
Figure 1 Log and brushwood narrowing, cross-section view

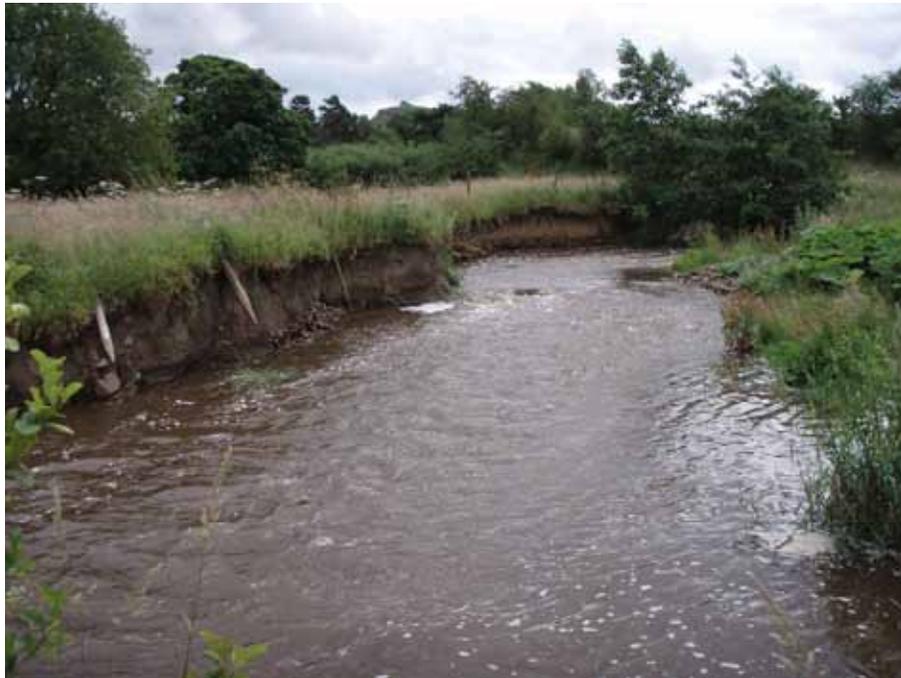
- 5.4 Stabilise quickly eroding banks in selected areas. There are a small number of areas where erosion of the river banks is taking place at a rate above that which is considered natural or desirable (Photo 14). These areas would benefit from stabilisation to prevent over-widening of the river channel. 'Log and Christmas tree' type revetment is recommended in these areas. Professional advice should be sought regarding this. The same comments regarding nesting birds as above apply.

Photo 14 Area of rapidly eroding bank

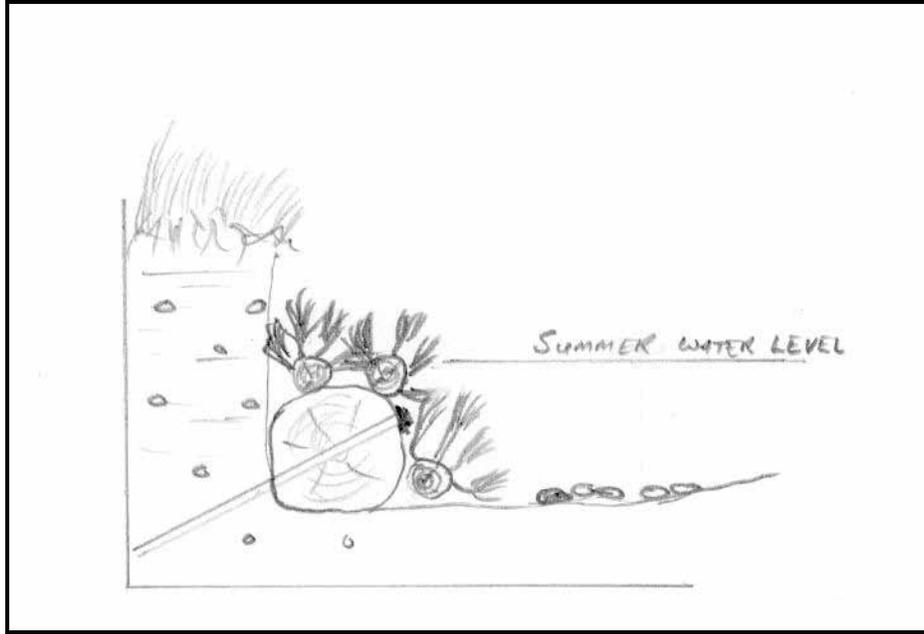
Figure 2 Log and Christmas tree revetment, cross-section
