## **Harting Stream – Hill Ash Farm**

**An Advisory Visit by the Wild Trout Trust August 2014**

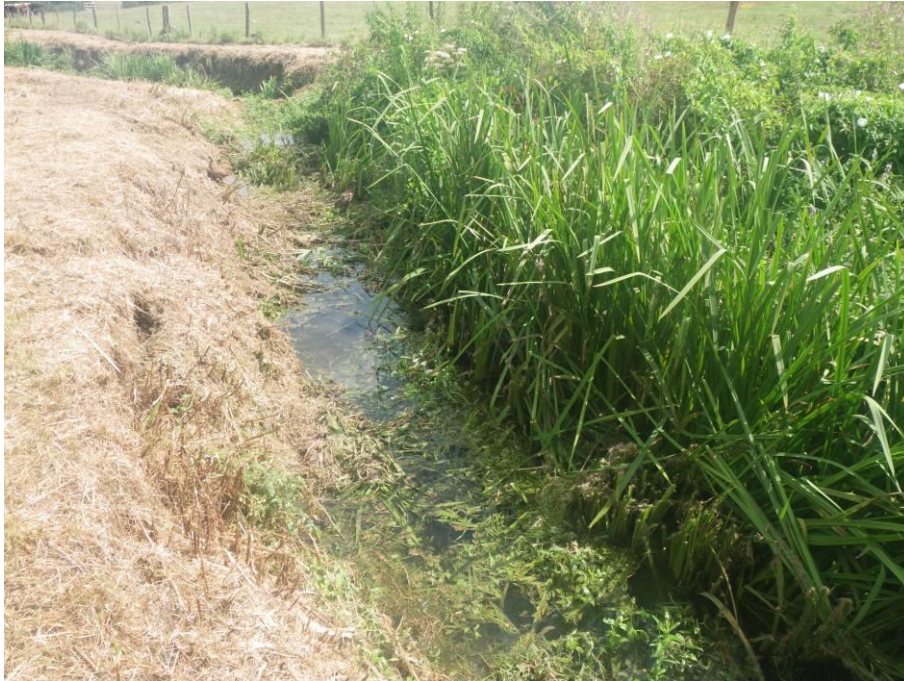
The course of the stream on leaving the woodland is mainly straight. Here the channel has been heavily dredged and straightened, presumably for land-drainage purposes. Very little tree shading currently exists along this section. Previous dredging activity has provided a sink for soft sediments and with high light levels the result is a channel choked with emergent branched burr reed (*Sparganium erectum*). At the time of inspection, the banks had been heavily trimmed in an attempt to open up the reach.

Photo1. Typical section of the Harting Stream where a combination of channel modification, heavy nutrient loading and lots of direct sunlight has created more of a low-flow ditch-like habitat than a small stream environment.

- Undertake some tree planting with low scrubby native species such as thorns and goat willow (sallow) on the south bank to promote channel shading.
- Consider pegging in woody debris into the existing shaded sections of channel to provide enhanced cover. Details of how this can be achieved can be found in the WTT habitat management manuals which can be accessed via our web site [www.wildtrout.org](http://www.wildtrout.org)

- When mowing or strimming, leave as wide a buffer strip as possible adjacent to the top of the existing stream bank.
- There is the opportunity to completely remodel the existing channel by either modifying the physical shape of the banks, or by creating a new, naturalistic meandering channel running parallel to the currently heavily modified channel. With either option, it is recommended to draw on expert help to design a scheme to ensure

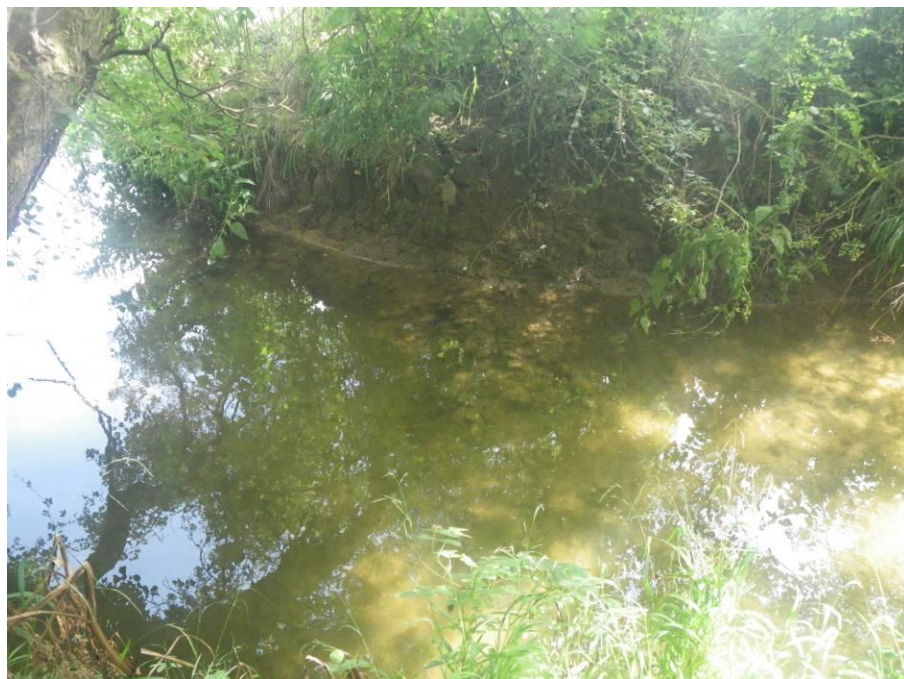
Photo 2 A pool habitat under overhanging shade provides a safe refuge for fish and a hostile environment for emergent plants but with some clues as to how the channel could be managed more sustainably.

Sections of channel that are currently shaded and free from reed encroachment could also be further improved through the provision of more in-channel cover. Large pieces of woody debris (LWD) can provide cover and promote river bed scour, thus providing important holding habitat for adult fish such as brown trout and chub.

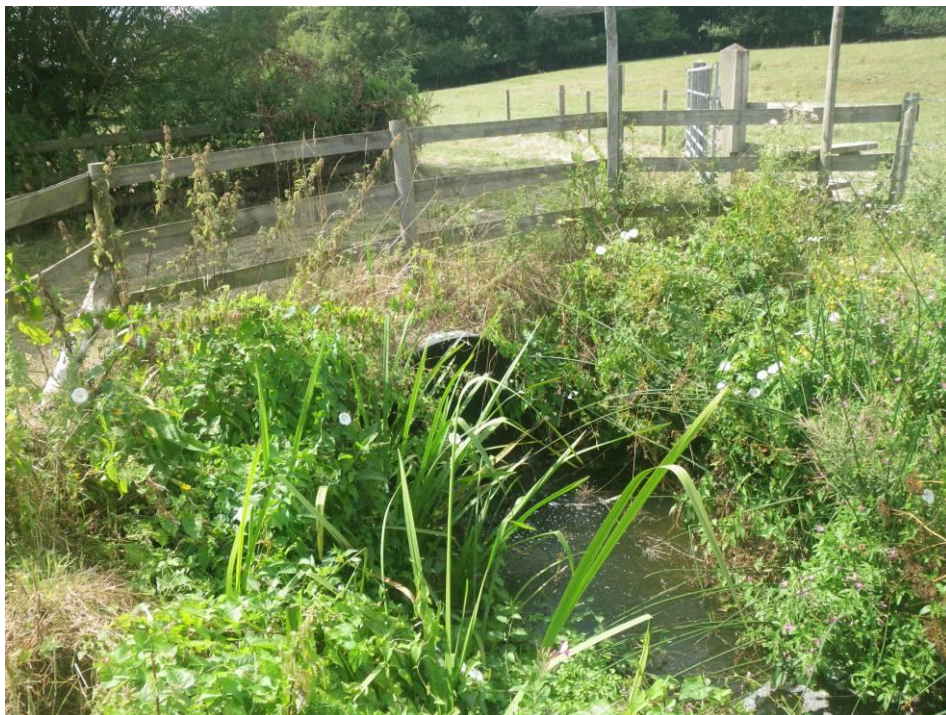
Approximately halfway along the straight section the stream passes through a short section of culvert pipe, which was installed to facilitate a stream crossing. Culvert tubes are often very hostile environments for both fish and mammal migration. The increased water velocities generated by the pipe constriction often erode the stream bed downstream of the pipe exit, often leading to a small weir forming. Small fish wishing to migrate upstream have to try and jump into the tube and then negotiate the increased velocities generated by the pipe constriction before making upstream progress.

The culvert is also having an adverse effect on in-channel habitat in the section above by impounding the reach, slowing upstream water velocities and promoting sediment deposition.

Photo 3. Culvert pipe crossing is adversely impacting on fish migration and habitat quality.

Increased flow velocities can also be generated by removing the culvert and replacing it with a clear span bridge. The small stone weir structure installed just downstream of the irrigation pump pick-up is also backing up flow and reducing velocities.

- Consider the replacement of the culvert crossing with a clear span bridge.
- Take opportunities to reduce any backing up of the channel by removing the bed impoundment downstream of the abstraction pump.

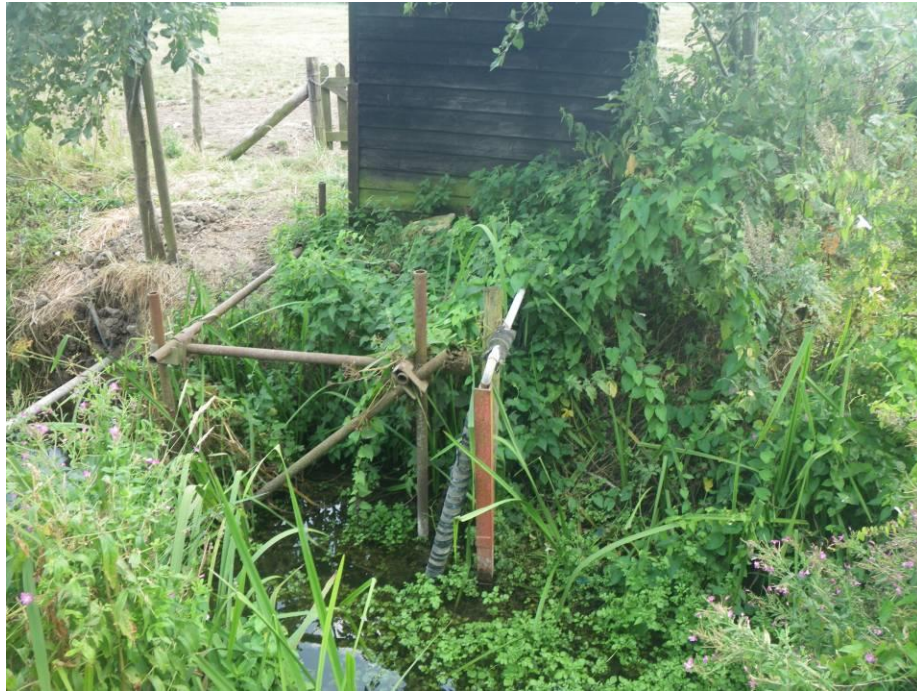
A similar problem is being caused by a low impoundment which is located immediately downstream of an abstraction point (photo 4). The low weir has obviously been installed to back up water levels to provide sufficient water depth for pumping. A better solution would be to lower the stream bed adjacent to the pump to create depth and flume the water through the deeper section by pinching the neck of the pool (immediately upstream of the abstraction point) with a wooden groyne or flow deflector.

Photo 4. Abstraction point where the stream levels are currently impounded.
