# **River Hipper: Advisory Visit**

Paul Gaskell Wild Trout Trust 17/05/2016

Chesterfield Borough Council: Hipper
River	River Hipper
Waterbody Name	Hipper – Source to River Rother
Waterbody ID	GB104027057660
Management Catchment	Don and Rother
<b>River Basin District</b>	Humber
<b>Current Ecological Quality</b>	Moderate
U/S Grid Ref inspected	SK3605470328
D/S Grid Ref inspected	SK3551470173
Length of river inspected	~750m in total

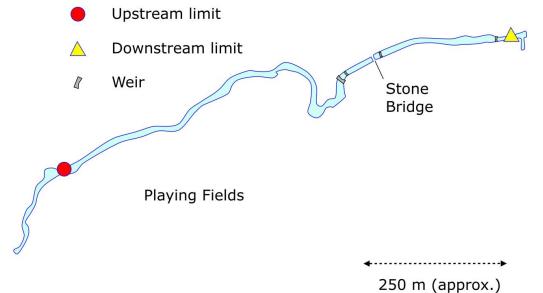
Upon walking the reach, there are two main impacts that are immediately apparent. Firstly, the historic realignment of the channel (Fig. 1) has produced a series of long, artificially-straight sections (punctuated by one substantial bend that has formed on the downstream side of a very large weir).

Figure 1: Planform of the visited channel reach.

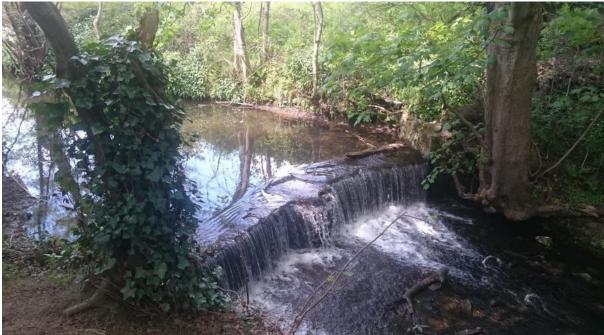
Secondly, there are numerous weirs (both small and much larger) that impound the flow and also act as barriers to migrating fish. The close proximity of these barriers to each other will inhibit gene-flow between individuals that would, otherwise, likely belong to the same (resident) breeding populations. In combination, the impoundments and disruption of breeding-population structure reduce habitat quality and also constrain the resilience and adaptability of resident fish populations (including trout). These barriers are detailed in Figs. 2-7 as follows:

Figure 2: Low concrete weir at SK 36054 70328.

- The first phase of work to address impoundments should, therefore, concentrate on the removal of the weir at SK 36054 70328 (Fig. 2)
- Assessments of the potential impacts arising from removing the weirs at SK 35919 70335 and SK 35866 70287 should be explored in parallel with that phase of work

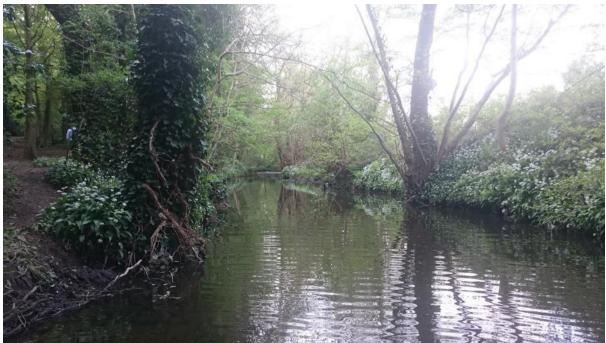
Figure 3: Impoundment resulting from weir in Fig. 2. (photographed from crest of the weir facing upstream). The upstream limit of the impounded reach was found to be at SK 35974 70335.

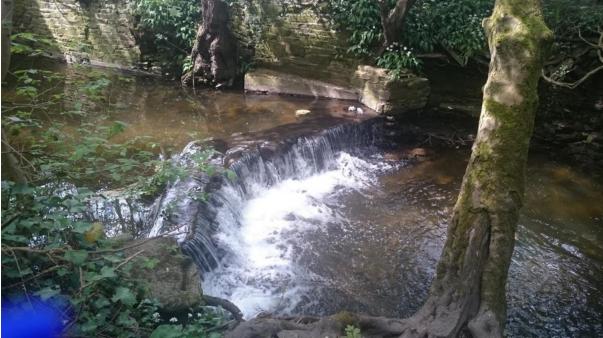
Figure 4: Weir at SK 35919 70335 – functionally redundant in terms of diversion of water.

- The smaller, redundant weirs can be removed with relative ease and lower investment (verification of the impacts on the bridge would be required for the structures pictured in Figs. 4 & 5).

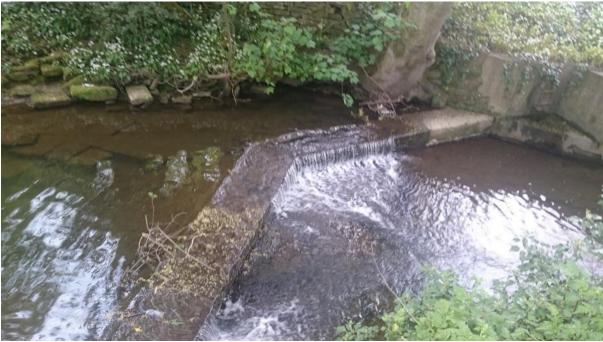
Figure 5: Low weir at SK 35866 70287. It is noted that between this weir and the one pictured in Fig. 4 that there is a stone bridge (Fig. 6). It would be necessary to consider potential effects of alterations to either/both weirs on the condition of the bridge.

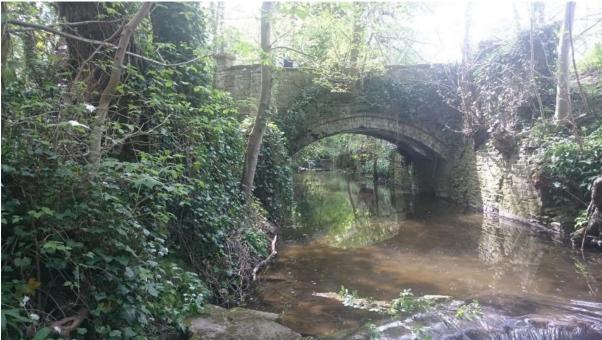
Figure 6: Bridge between the weirs pictured in Figs. 4 & 5 (note crest of Fig. 4 weir in lower right of frame).

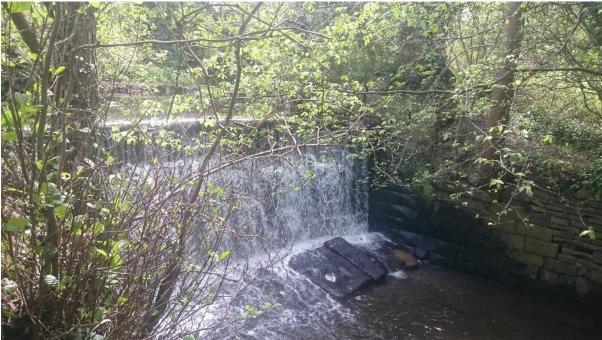
Figure 7: Huge weir relative to channel size at SK 35861 70273. This is less than ~20m upstream from the weir pictured in Fig. 5. It is located just downstream of the pronounced bend and wide pool in the middle of Fig. 1 and feeds a reservoir via a (partially-culverted) leat. As well as its ongoing function of feeding the reservoir, the removal of this structure is complicated by the likelihood of significant changes to the path of the upstream and downstream channels.

- The large weir (Fig. 7) would require a detailed consideration of potential options with the strong adherence to the guiding principle that the very best solution should be creatively-sought. The cost of any intervention on that weir will be considerable so it needs to deliver the maximum ecological benefit alongside optimally accounting for the amenities associated with the structure.

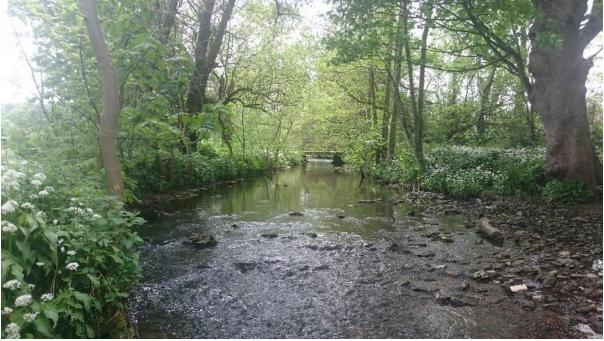
The historic realignment of the channel to conform to the surrounding land-use (in addition to diversion of flow via weirs and leats) has been achieved and maintained by a clever form of bioengineering. In addition to any use of stonework to delimit channel width and path, a line of trees has also been used to consolidate the LB and RB. This is an extremely stable condition – and is further exacerbated by the normal practice of removing fallen timber from channels in public parks. When combined with the serial impoundments along this reach, these effects substantially limit the ability of the channel to form structurally-variable habitats.

This is especially notable with respect to the natural range of cross-sectional profiles that would otherwise be expected throughout a reach of this length. The formation of deeper scour pools on the outside of bends – with shelving "point-bars" of gravel and cobble on the inside of bends is an essential process for providing a diverse range of habitats for micro and macro flora and fauna. Fallen timber promotes this process – as well as the dynamic retention (i.e. a patchy slowing of rate of loss/turnover) of leaf-litter; an essential resource for aquatic foodwebs. Because of the artificially-designated channel width, there is a tendency for over-wide and uniformly shallow reaches to form (Fig. 8). Although this shallow, cobbled habitat is a vital component of a healthy river – where it is over-represented at the expense of other types of habitat for juvenile fish will be compromised when there is inadequate submerged cover from predation. This latter effect is another by-product of removing natural inputs of (stable) large and coarse woody material.

Figure 8: A typical straight and overwide/uniformly-shallow reach produced by the single line of trees on both LB and RB as part of historic channel modification/realignment.

There would be ecological value in the secure installation of woody material to mimic the natural processes that are lost through the removal of natural inputs. Some examples of beneficial effects include:

- Provision of cover from predation
- More variable channel structure/cross sectional profiles
- Localised increases in retention time of leaf litter (and associated components of the aquatic food-web)

Ensuring the stability of such introduced material would avoid increasing flood risk due to timber being washed downstream during spate conditions.
