River Hipper: Project Proposals

Wild Trout Trust

15/08/2016

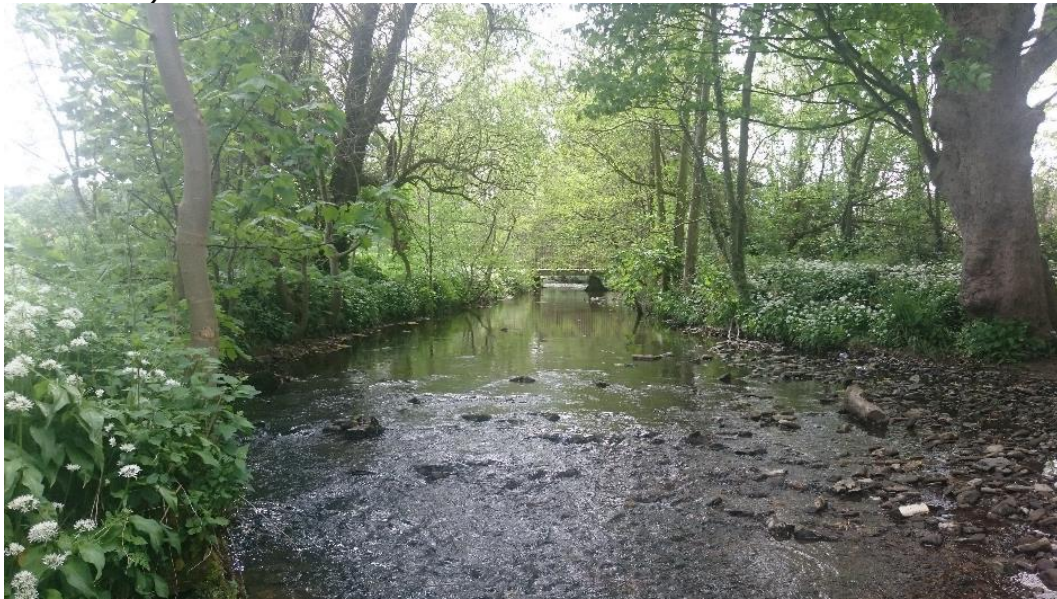
Figure 2: Typical channel characteristics in Reach 3. Both sinuosity and scour-pool habitat creation would be enhanced by large woody material introduction.

Figure 2 represents typical channel conditions under normal flows. The channel would benefit from stable introductions of woody material. This could be in the form of hinged saplings (e.g. Fig. 3) to provide coarse/brashy refuge habitat for juvenile fish, cold-water specialist invertebrates (benefiting from the cooling effect) and all detritivores (benefiting from the retention of coarse particulate organic matter).

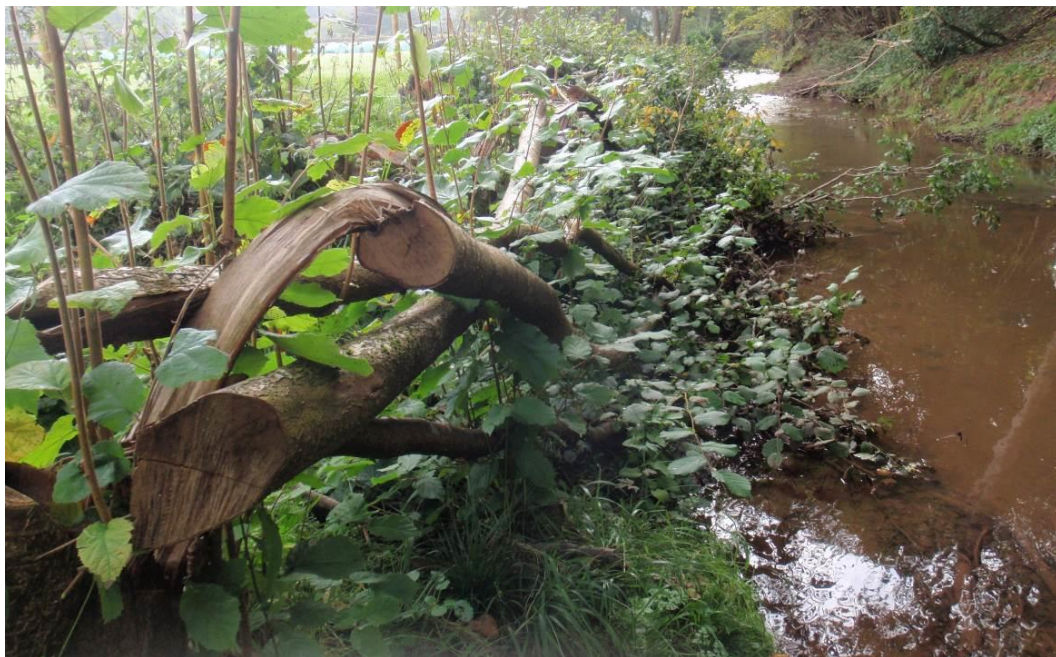
Figure 3: Hinged saplings, in this case hazel, laid into the margins of a stream to provide valuable shade, shelter and a food resource for detritivores. The technique is essentially the same as that used in hedge-laying and can be carried out using hand-tools.

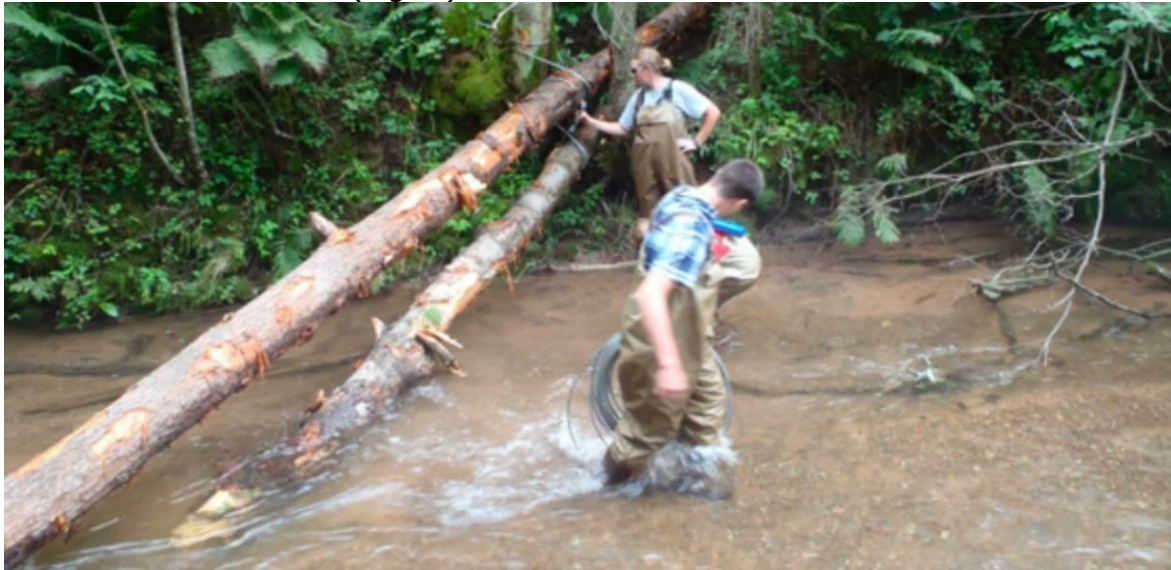
Figure 4: Illustration of how the angle of an individual log (here the picture includes two logs) from high on the bank provides clearance between the underside of the timber and the riverbed during spate flows. The length of timber on the bank can be much shorter (e.g. flush with the anchor tree). NB this is not an illustration of anchoring methods or proposed lengths of timber.

The lack of scour-pool habitat could be addressed by introducing and stabilising some larger woody material. Ideally, timber that rests on the bank-top at its root-end would be angled down into the water and lodged at the toe of the opposite bank (e.g. Fig. 4). Secure anchoring would be achieved by cabling the thick end of the trunk (braided steel cable and cable crimps) to a secure anchor point – ideally either its cut stump and root-mass or another tree. The far end could be pinned to the riverbed or opposite bank using either steel rebar pins or wooden stakes as appropriate.

In addition, secure placements of timber (as shown in Figs. 4 – 6) would also provide valuable habitat by contributing to the riverbed structural formation processes. For this reach – a maximum of 3 timber introductions would be proposed. Planting of tree cuttings (with, for example, goat willow) would be beneficial if carried out in blocks of around 8m – 10m upstream to downstream extent and a maximum width of around 3m. Such blocks (maximum of 6) should be staggered on alternating banks so as to introduce a degree of meandering flow. Some management of the existing tree canopy may be necessary in order to promote successful establishment of planted tree cuttings. Targeted felling of large, veteran trees (coppiced and allowed to re-grow) would generate beneficial

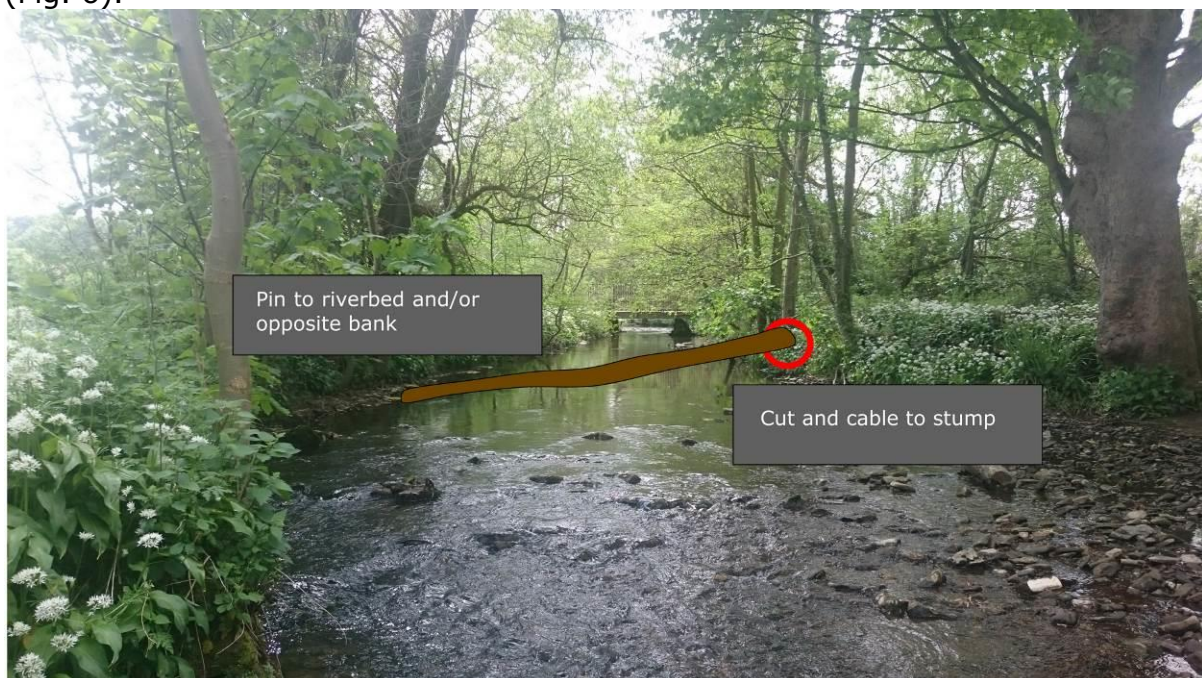
Figure 6: Secure timber example - note how the clearance beneath the trunk prevents blockage of watercourse.

An example of one opportunity to apply this technique on Reach 3 is given below (Fig. 6).

A maximum of 8 such stable timber introductions and a maximum of 10 areas (max 5m x 2m) of hinging are proposed for Reach 3. In the event that satisfactory effects are achieved with fewer structures, then the remaining "quota" of structures would not be completed.

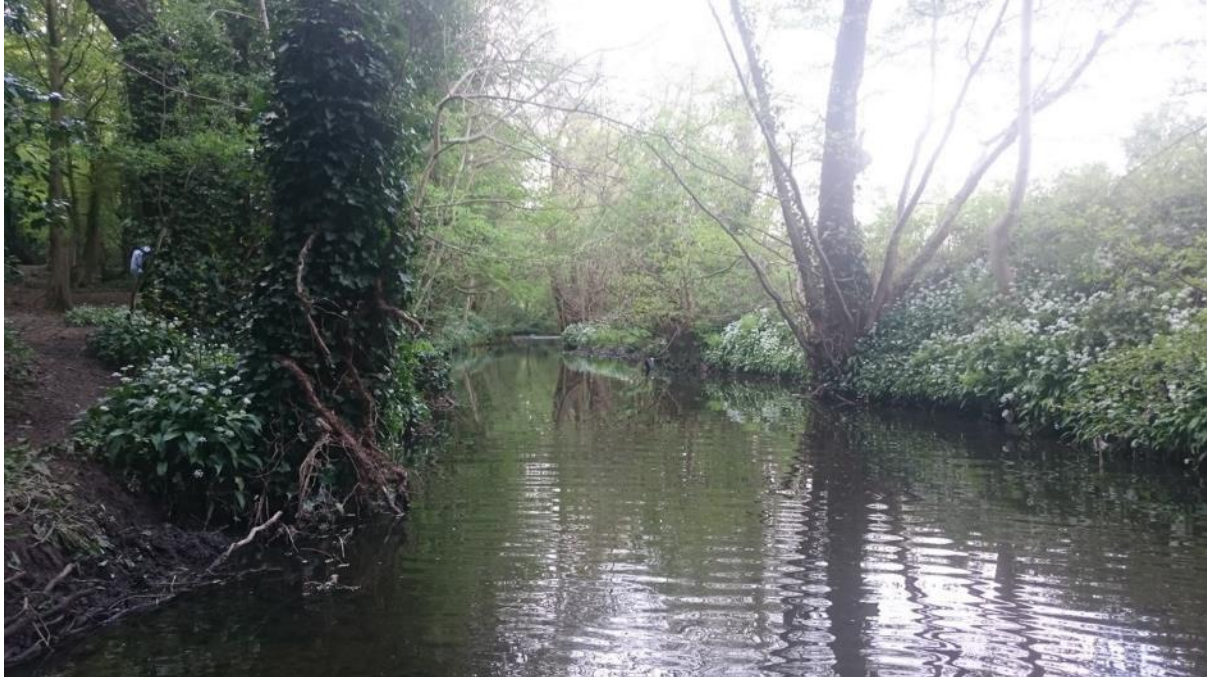
Figure 8: Impoundment resulting from weir in Fig. 7. The upstream limit of the impounded reach is at SK 35974 70335.

The second phase of works will maximise the benefits of the weir removal and can be carried out as partnership work between the Wild Trout Trust and local volunteers. It will be necessary to wait for the natural width/wetted perimeter under normal flow conditions to be established following the removal of the weir (ideally allowing at least one high flow event). After that time, the natural re-shaping of the channel can be reassessed and, if necessary, augmented using techniques such as planting of tree cuttings/whips (best carried out between December and mid-March). This will help to provide variety in the resistance to erosion of the new, narrower, bank-line. In subsequent years, a portion of the sapling growth can be hinged into the water to provide excellent marginal cover habitat. Allowing a spate event to pass down the river will give very good guidance on appropriate dimensions of the upstream "post-weir-removal" channel.

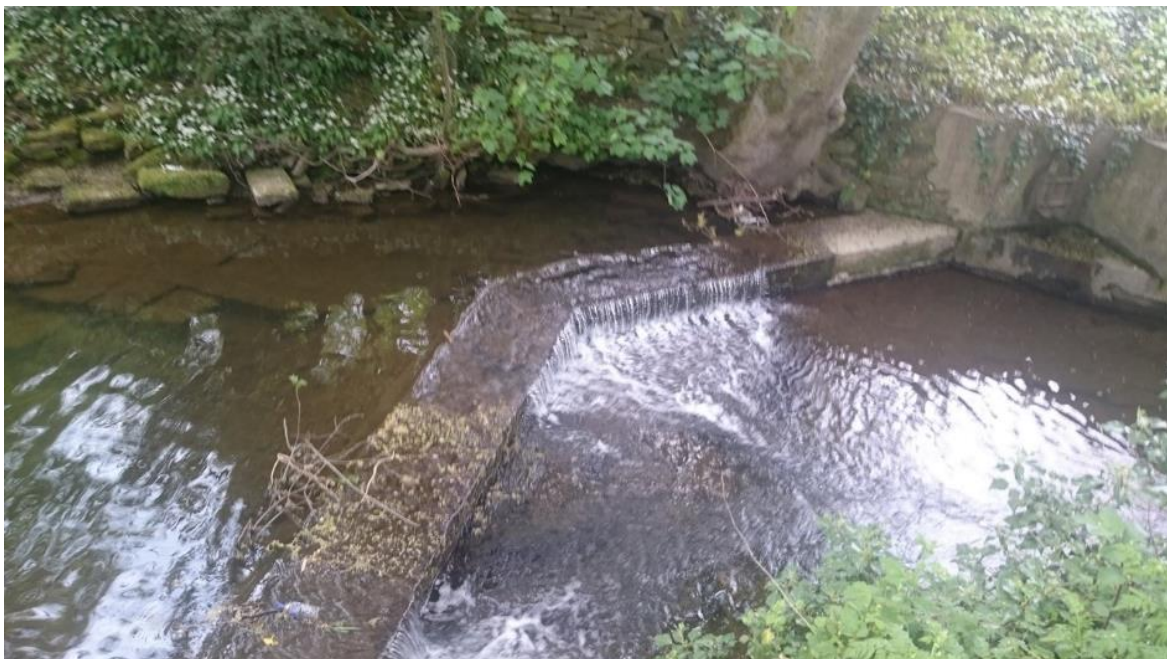
Figure 10: Low weir at SK 35866 70287. Sited on bedrock – so there is more limited potential for structural issues arising from removal at this point.

Of the three reaches, this section would require the most detailed consideration ahead of any works taking place. The removal of weirs at SK 35919 70335 and SK 35866 70287 (Figs. 9 and 10) would first require the quantification of the likely impacts on channel stability – and the stability of the stone bridge crossing the river just upstream of the weir at SK 35919 70335. This assessment could potentially be contributed by Chesterfield Borough Council as part of a partnership project.
