River Holme: Advisory Visit

Paul Gaskell Wild Trout Trust (WTT) 25/08/2016

River 2015, Holmfirth
River	Holme
Waterbody Name	Holme from source to New Mill Dike
Waterbody ID	GB104027057600
Management Catchment	Aire and Calder
River Basin District	Humber
Current Ecological Quality	Moderate
U/S Grid Ref inspected	SE1392108006
D/S Grid Ref inspected	SE1439208481
Length of river inspected	1km

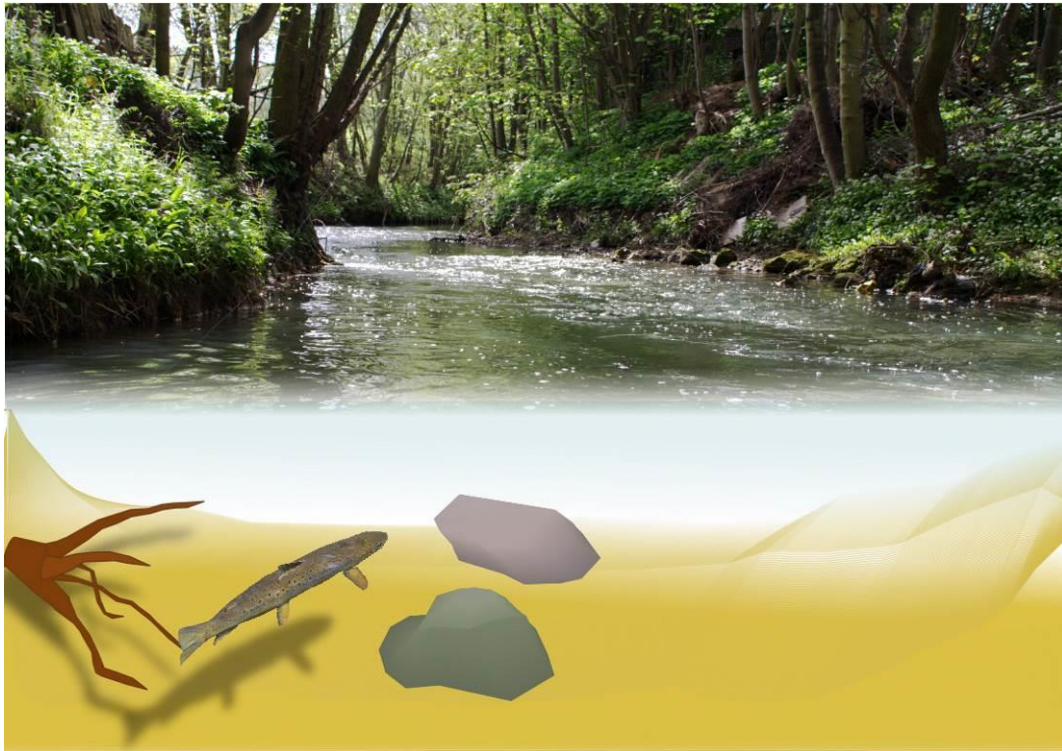
Figure 4: The availability of deeper water bolt holes (>30cm to several metres), low overhanging cover and larger submerged structures such as boulders, fallen trees, large root-wads etc. close to a good food supply (e.g. below a riffle in this case) are all strong components of adult trout habitat requirements.

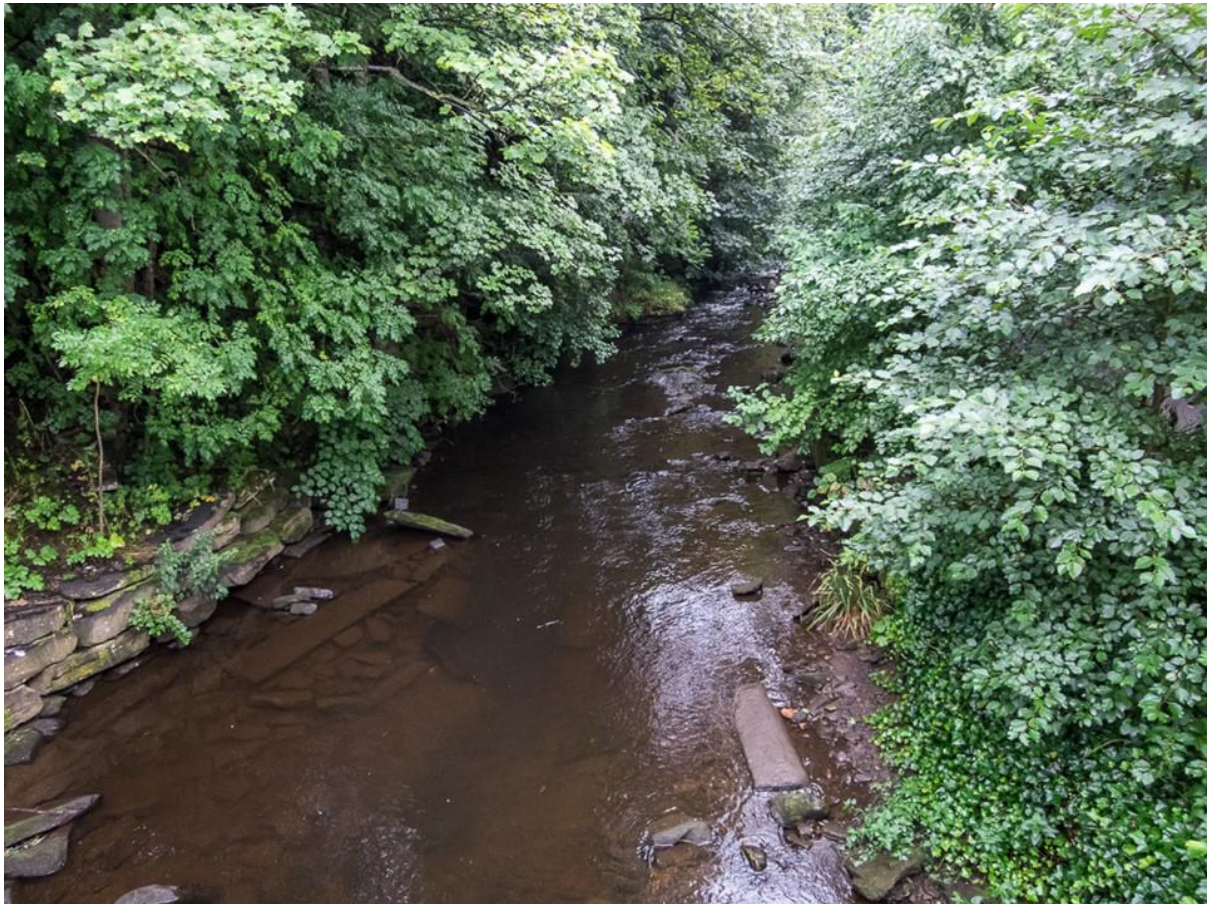
The downstream limit of the watercourse inspection for this report was at National Grid Reference (NGR) SE14392 08481 (Fig. 5). The beneficial existence of a relatively steep longitudinal gradient (increased potential for riverbed

redistribution) and the presence of mature riparian woodland (provision of shade and support for foodweb interactions spanning aquatic/terrestrial boundary) are evident.

Figure 5: Mature woodland and beneficial impacts of relatively steep gradient. These contribute some mitigation for the realignment of the channel and armouring of the banks. Examples of dressed stonework that the river has washed out and repositioned can be seen.

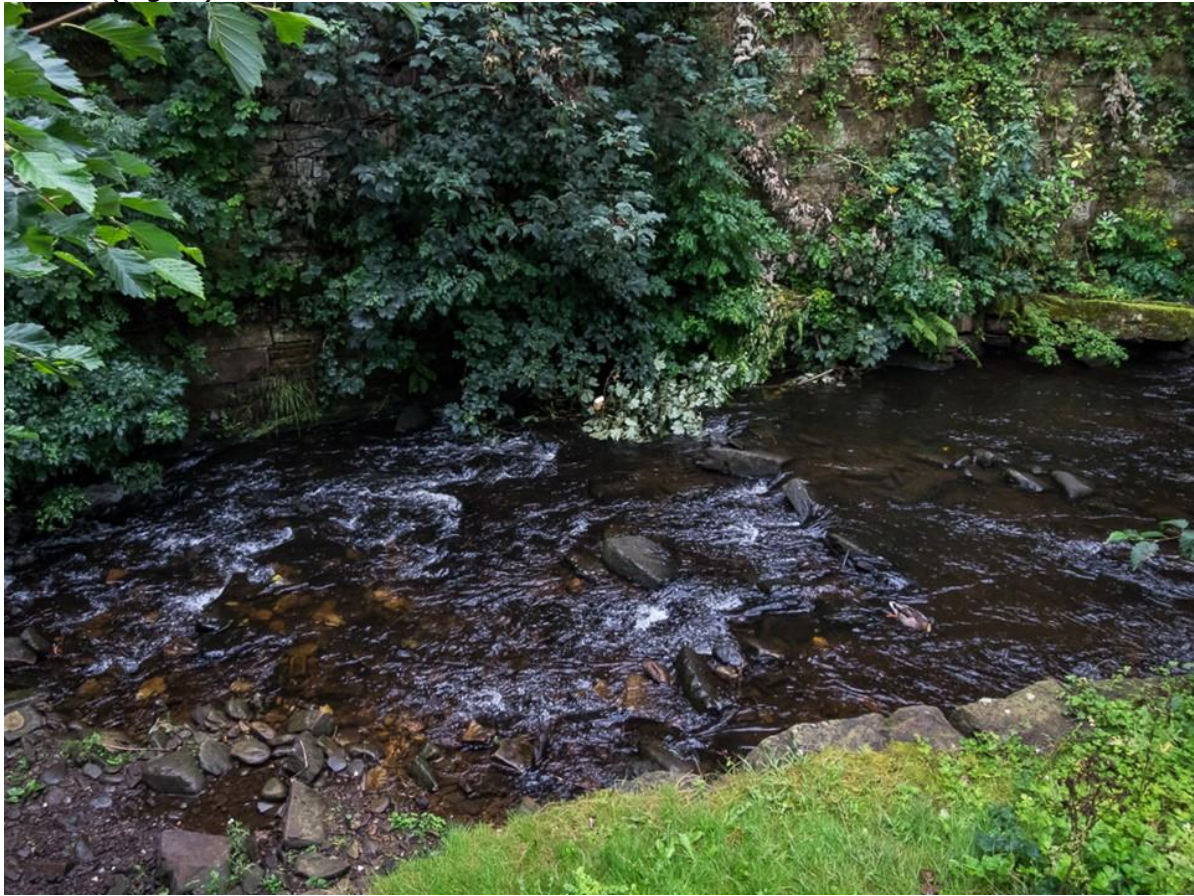
Good structural variety within the channel is certainly evident at SE 14389 08446 (Fig. 7).

Figure 7: Gradient and a variety of sizes of rocky substrate are coupled with some important trailing/overhanging vegetation cover to produce some high quality habitat features within this modified channel. There is a nice mixture of shade, dappled light and open water here also.

However, the presence (at this point and throughout the visited reaches) of artificial retaining walls have the effect of cutting off the natural supply of gravel to the system. One of the vital functions of the dynamic, lateral shifting of a river across its natural floodplain is the inputs of gravels and other substrates. When the channel is locked in place, that process is cut off. Supplies of finer particles (i.e. those within the sand/silt fraction) tend to continue to be delivered due to the drainage of tarmacked surfaces and associated particulate runoff in the surrounding, urbanised, catchment. Overall, then, the gravel component of the riverbed will tend to become under-represented over time. That condition is compounded by the presence of weirs that intercept bed material as it is transported downstream – which is problematic for gravel-spawning species such as trout.

Although re-establishing natural regimes of bank erosion is probably not practical within the most heavily urbanised reaches, some “seeding” with locally-appropriate gravel may be appropriate in future (by way of mitigation for the bank armouring). Coupled with tackling the impounding structures, that could be an excellent way of building in resilience to climatic and other environmental changes for self-sustaining populations within the Holme. Figure 8, at SE1437808416, displays some excellent nursery and adult fish habitat, but the combination of a straightened channel (reducing the ability of the channel to retain deposits of gravels) and reduced gravel inputs puts this habitat at risk of a spawning bottleneck.

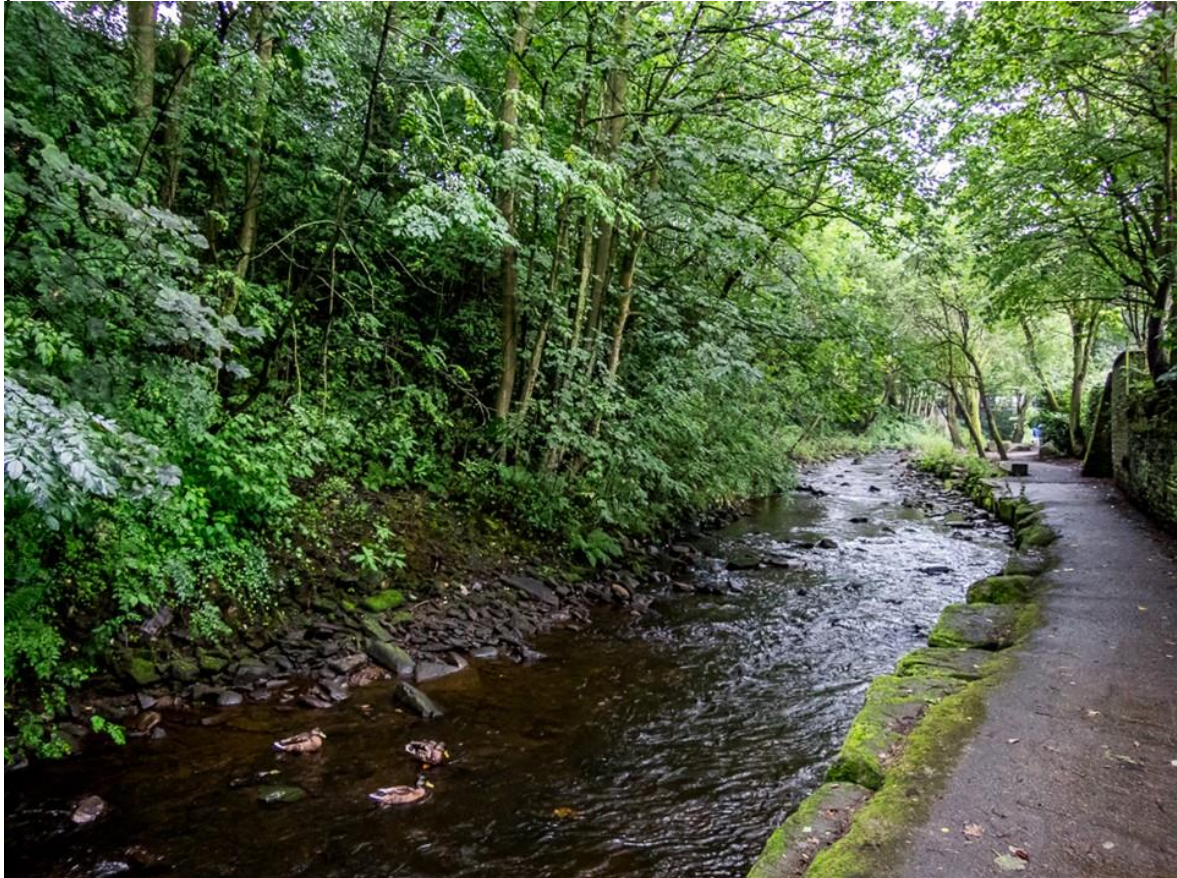
Figure 8: Good examples of deep scour pool habitat, boulders and cobble “point-bar” deposition. However, the restricted supply of gravel due to armouring of banks against erosion and the “straighter than natural” channel combine to produce a relative lack of spawning substrate. Note the valuable woodland canopy on the RB (left of frame).

Outside impounded reaches, where rivers have appreciable gradient and mobile substrate, the formation of depositional features such as “point bars” is evident (e.g. Fig. 8). These are shingle, cobble or (in the most powerful rivers) boulder “beaches” that form on the inside of bends. In Figure 8 there is an obvious point bar above and to the left of the ducks – with another one in the background towards the top right of the frame. One, probably unexpected, benefit of armoured banks is that (while they remain intact) their resistance to erosion compels the river to dig downwards on the outside of bends. This process of point bar deposition (inside of bends) and downwards scour (outside of bends) in combination is known as “lateral scour”. It is the driving force behind the ecologically-valuable variation in depth, substrate particle-size and current

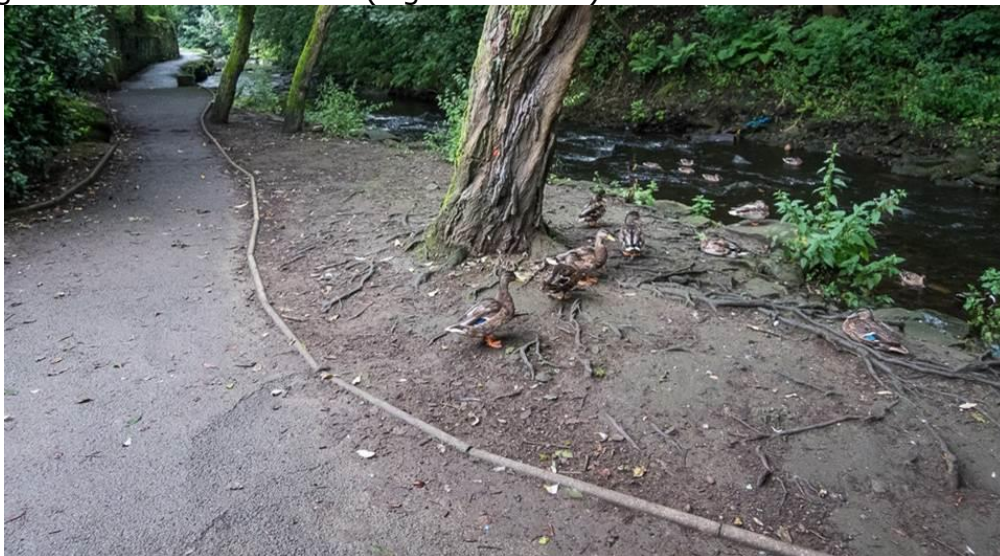
A further problematic factor (for both aesthetic amenity and as a pathway for sediment runoff) is the denuding of previously vegetated areas due to waterfowl grazing and associated footfall (Figs. 9 and 10).

Figure 9: Bare earth exposed due to feeding waterfowl (note orange dye mark on tree – presumably identifying it as suitable for removal by the local council)

This activity and associated impacts are greatest between grid references SE 14363 08389 and the footbridge at SE14328 08346. It may be possible to reduce the potential for this area to act as a sediment runoff pathway by excluding wildfowl and undertaking planting of appropriate species. However, this requires sufficient “buy in” and understanding by the local community. Again, suggestions are given in Section 3 “Recommendations”.

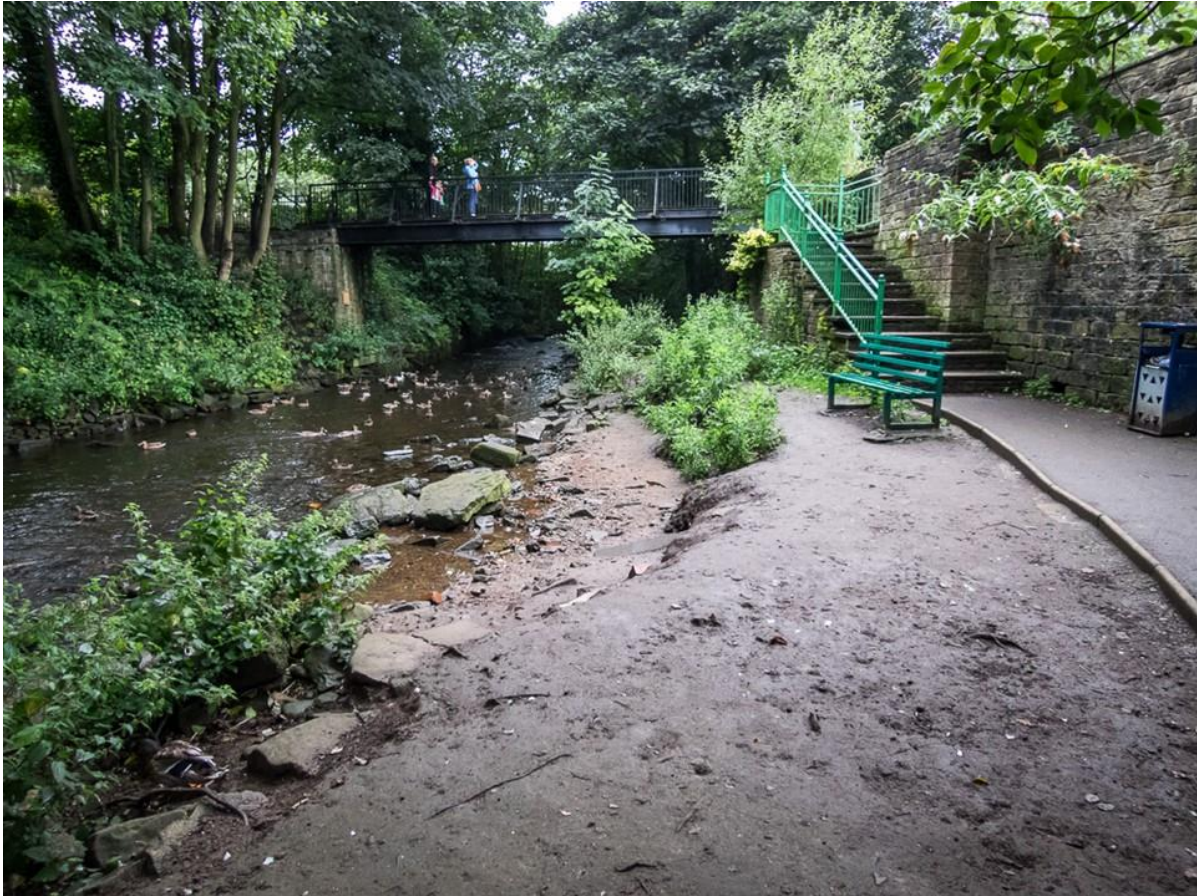
Figure 10: Further destruction of herbaceous vegetation due to waterfowl grazing and associated pedestrian access. The popularity of feeding the ducks from the bridge is demonstrated in the background.

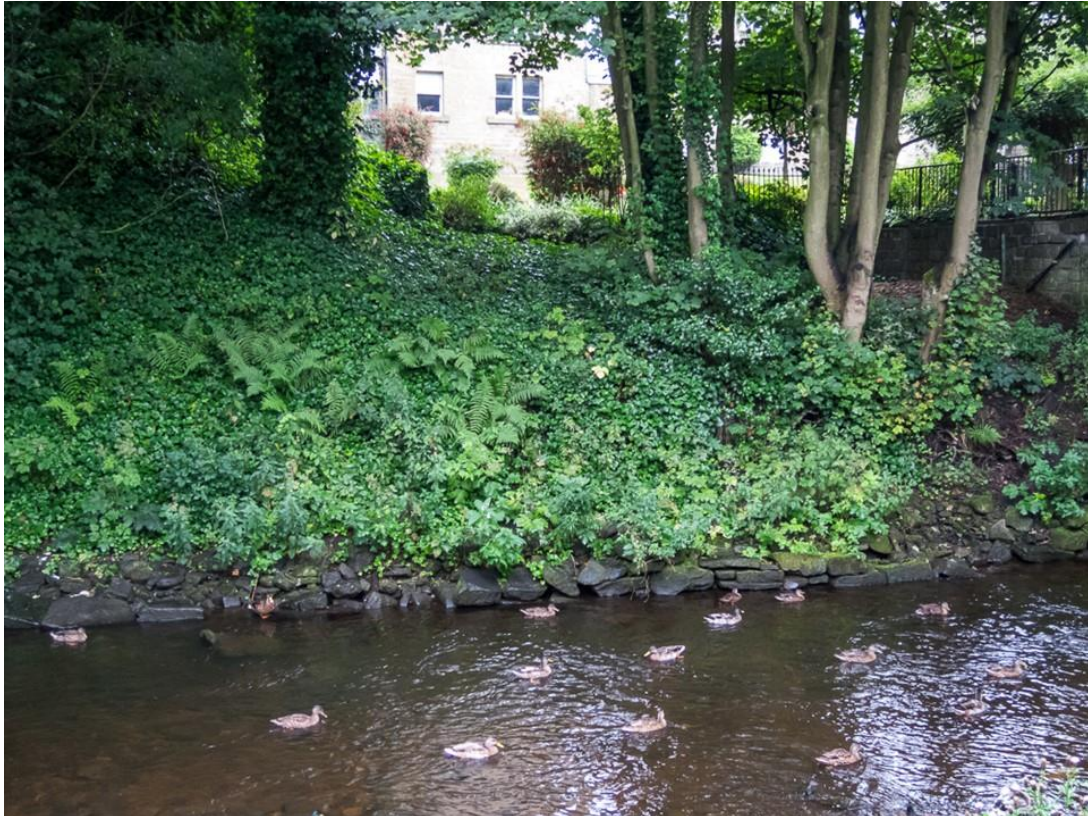
A very prominent effect of variation in tree canopy structure was evident at SE14328 08346 (Figs. 11 and 12). The Figure 11 photograph shows a much more vigorous growth of understory vegetation compared to the more densely-shading high tree canopy of Figure 12. Now, it is important to recognise the value of areas of dense shade (particularly for the cooling effects noted earlier in this report). However, the response of the understory vegetation to patches of increased daylight shows that there will be value in creating a patchwork of similar openings in the canopy.

Figure 11: Relatively lush and varied understory vegetation associated with an opening in the tree canopy (N.B. grass clippings dumped at the top of this slope were noted to be a source of pollution and should be challenged informally and then, if necessary, under the Control of Pollution Act 1974.

The key consideration is to avoid being too heavy-handed and too uniform with the canopy-management interventions. The previously-suggested 10-year rotational coppice should give the desired results here – and some of the arising material from those tree works may be used to enhance overwintering habitat within the channel (Section 3: “Recommendations”).

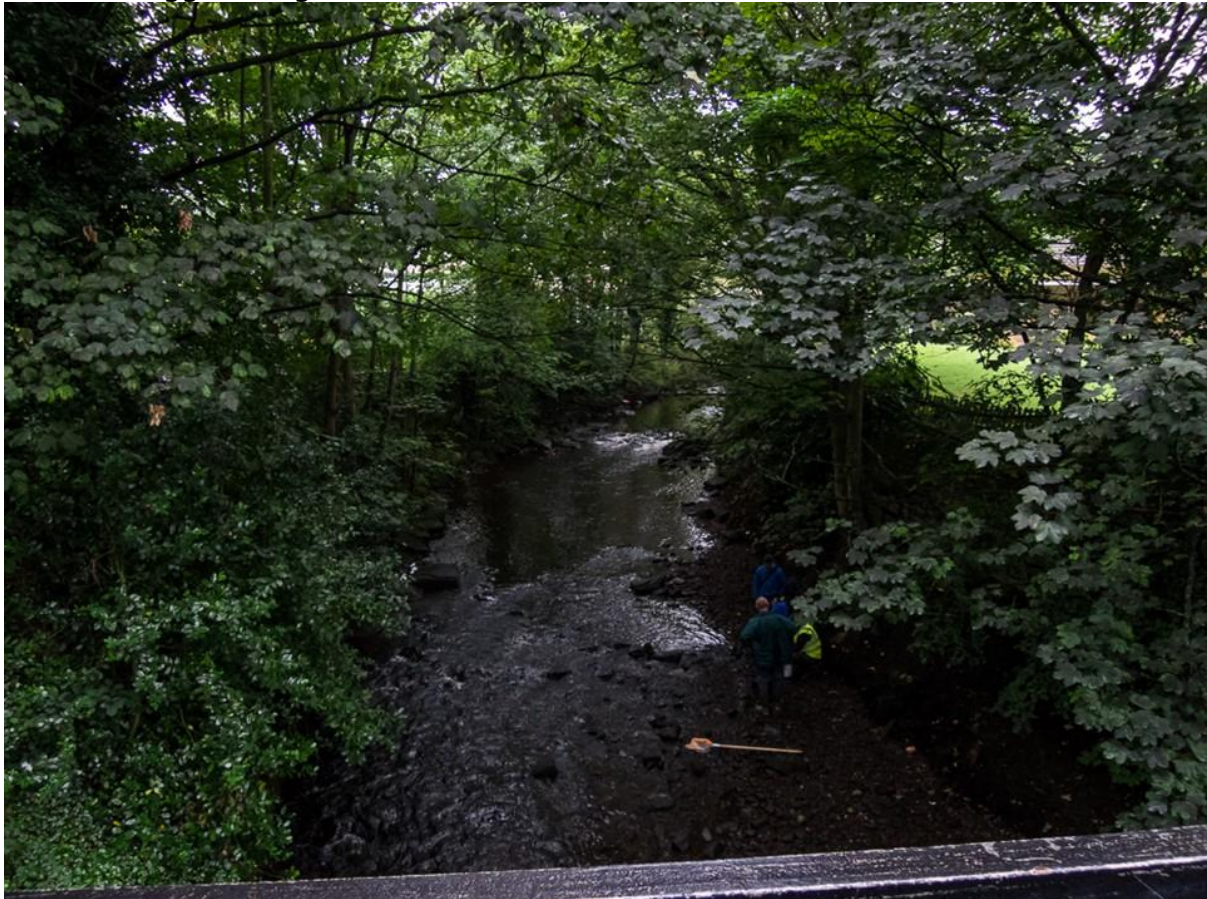
The presence of several substantial road bridges (and even the construction of buildings over the river for short sections) means that there are some areas of complete shade within the surveyed reach. Consequently, as long as the trees are allowed to re-grow (and to continue to provide leaf-litter inputs to support food webs), there will be benefits to extending the rotational coppicing throughout the visited reaches. For instance, the very uniform shading directly upstream of the footbridge at SE14328 08346 would benefit from the creation of a more staggered age-structure to the trees.

Figure 13: Uniform and extensive shading. While retaining some patches of shade, there will be benefits from light rotational coppicing to produce more variation in canopy height and density.

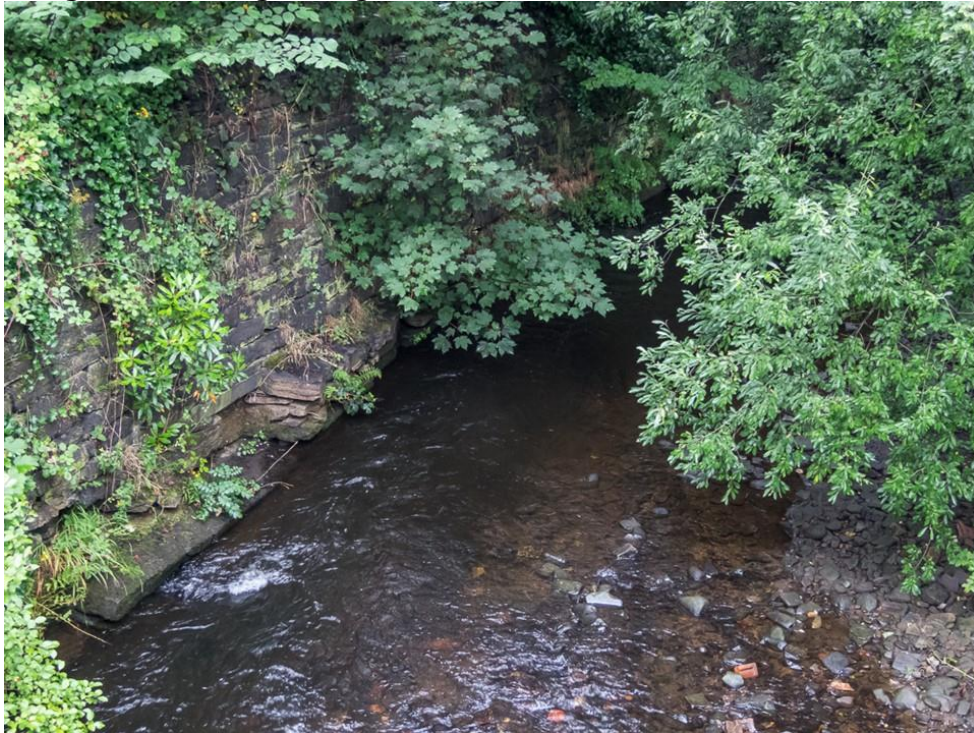
In contrast, the examples of extremely valuable low, overhanging cover at SE14264 08306 (Fig. 14) should be diligently protected (and certainly excluded from any trimming/coppicing works undertaken to manage the high canopy). It is also noteworthy that the collapse of a weir that previously impounded this section (at SE 14284 8307) has now allowed the formation of a point bar and the regeneration of some cross-sectional variation in depth and flow velocity in the reach (also Fig. 14).

Figure 14: Lateral scour/point-bar deposition and excellent low, overhanging cover that should be protected during any vegetation-management works.

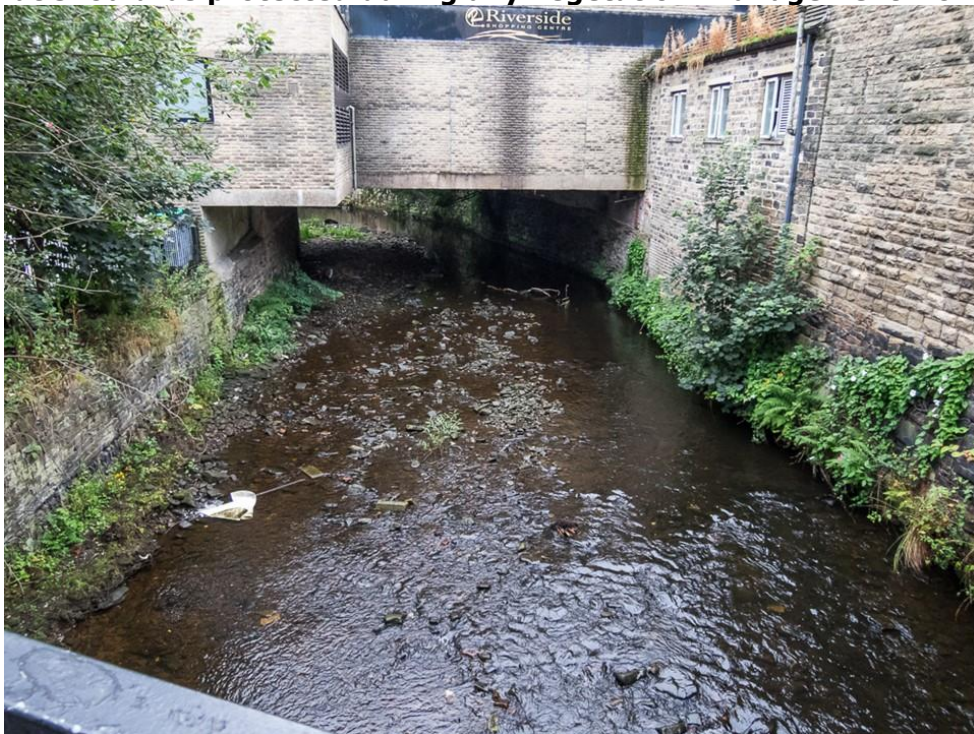
In contrast, the historic channel modifications have left an overwide and over-shallow/uniform channel directly upstream of the footbridge at SE14264 08306 (Fig. 15). This was also the first noted example of a small stand of Japanese knotweed (*Fallopia japonica*), an invasive plant species that is more difficult to control than Himalayan balsam. It can also cause significant damage to buildings due to its extensive rhizome (root) system and ability to find, exploit and expand small fissures in rocks or stonework. In its native range, it has evolved to grow

Figure 15: Overwide, over-shallow and uniform. If the whole reach was dominated by this type of habitat - it would represent a significantly degraded system. However, when present as a short section such as this, it may provide a specialised habitat for species adapted to periodically dry channel conditions.

Note Japanese knotweed lower right of frame and complete shade provided by building spanning the river channel in the background.

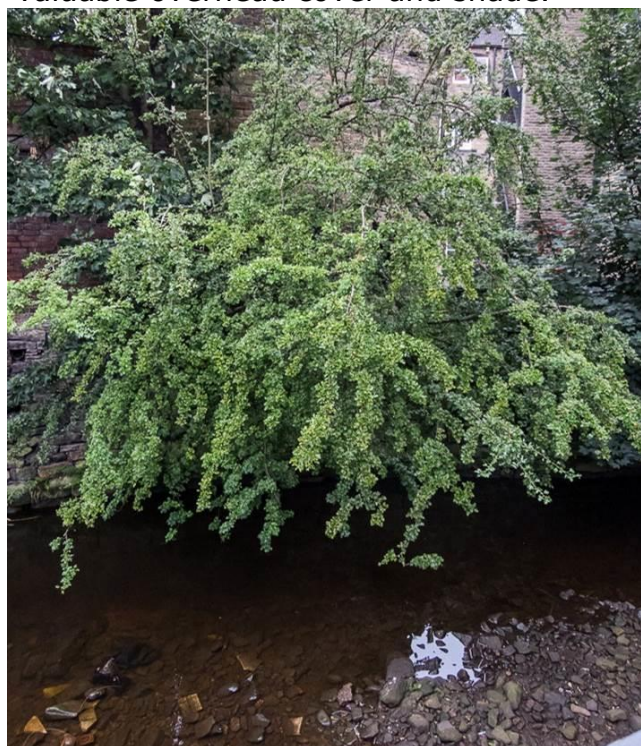
Another example of important choices of options for tree canopy management was noted at SE14244 08270 (Fig. 17). Here, a riverside tree is providing a patch of extremely valuable overhead cover and shade.

Figure 17: Valuable shade and cover close to the surface of the river. If there is pressure to manage the shade or impact that this tree is having on the riverside properties – it is essential to explore ways of achieving that while preserving the cover it is providing to the channel via its lower/overhanging limbs.

There may be current or future pressures to remove this tree due to its influence on the riverside properties. In such a case, it would be important to consider the significant beneficial effect that the low, overhanging limbs are providing to the river ecosystem. Interventions that could retain this benefit at the same time as

managing any potential impact on buildings or infrastructure should be fully explored and implemented.

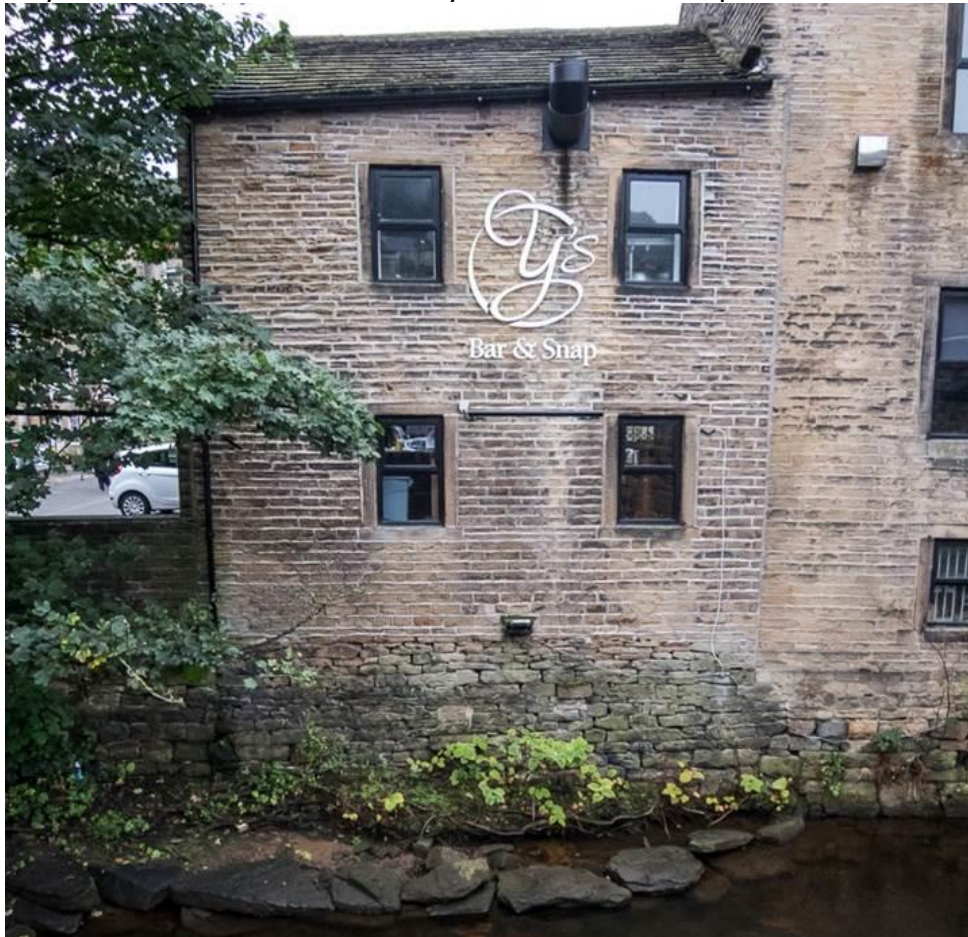
Another stand of Japanese knotweed was observed at “Y’s Bar and Snap” (Fig. 18). Naturally, given the previously-highlighted potential for the plant to break through structural walls, floors and foundations, the treatment of this will be essential for the business-owner in question. The excellent engagement and involvement of local stakeholders (including riparian businesses) that River 2015 has already achieved will be extremely useful in this respect.

Figure 18: Knotweed at base of wall of Y's Bar & Snap at SE14244 08261; a significant concern to the business ownership.

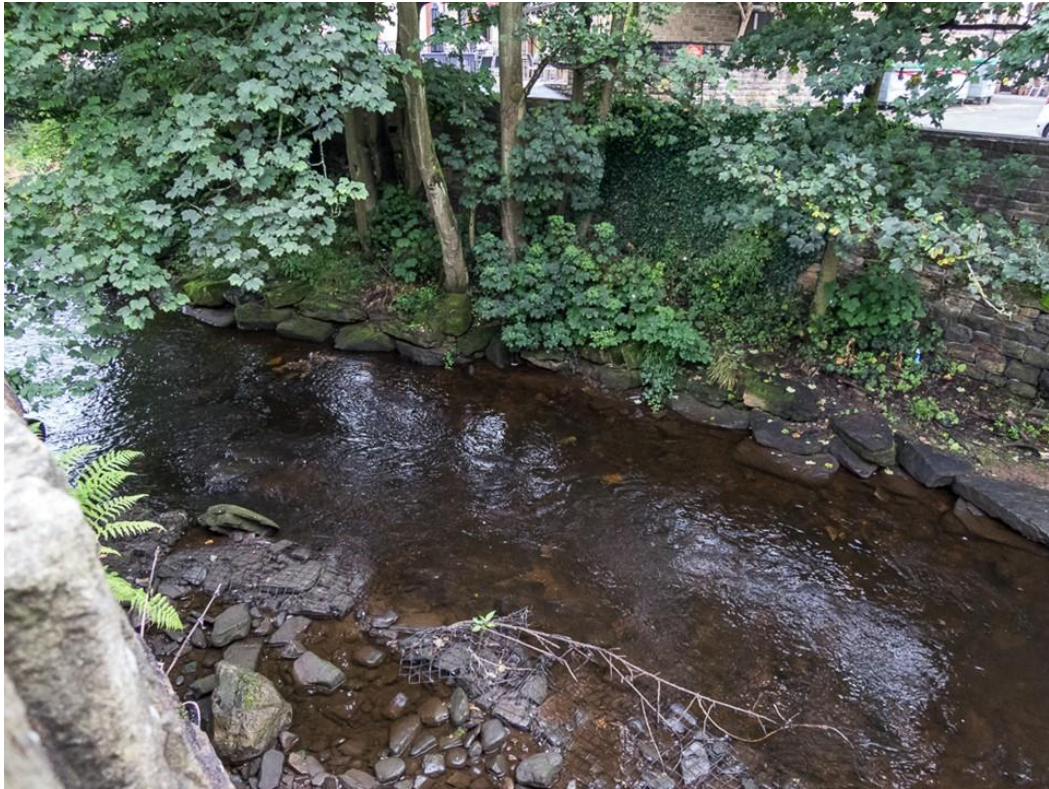
The channel at this location may be a good candidate area for the introduction of some stable, in-stream cover. Previous modifications to the channel include gabion baskets that are now degrading and there is a general lack of good submerged cover for young fish and invertebrates (Fig. 19). At the same time, the presence of multi-stemmed trees that form part of a berm on the LB (Fig. 20) could provide both raw material and a suitable anchor-point for a “tree kicker” type habitat feature. A detailed guide to tree kickers, their installation and performance is given in this short WTT video: [http://www.wildtrout.org/content/how-videos#tree kicker](http://www.wildtrout.org/content/how-videos#tree%20kicker)

Figure 19: Degrading gabion structure and opportunity to increase submerged cover habitat a few metres upstream from SE14244 08261

- Seek opportunities to install tree kickers using material arising from canopy works – particularly in the region of SE14244 08261 (Fig. 28 shows a sizeable example, but refer to guidance video link given after this figure).

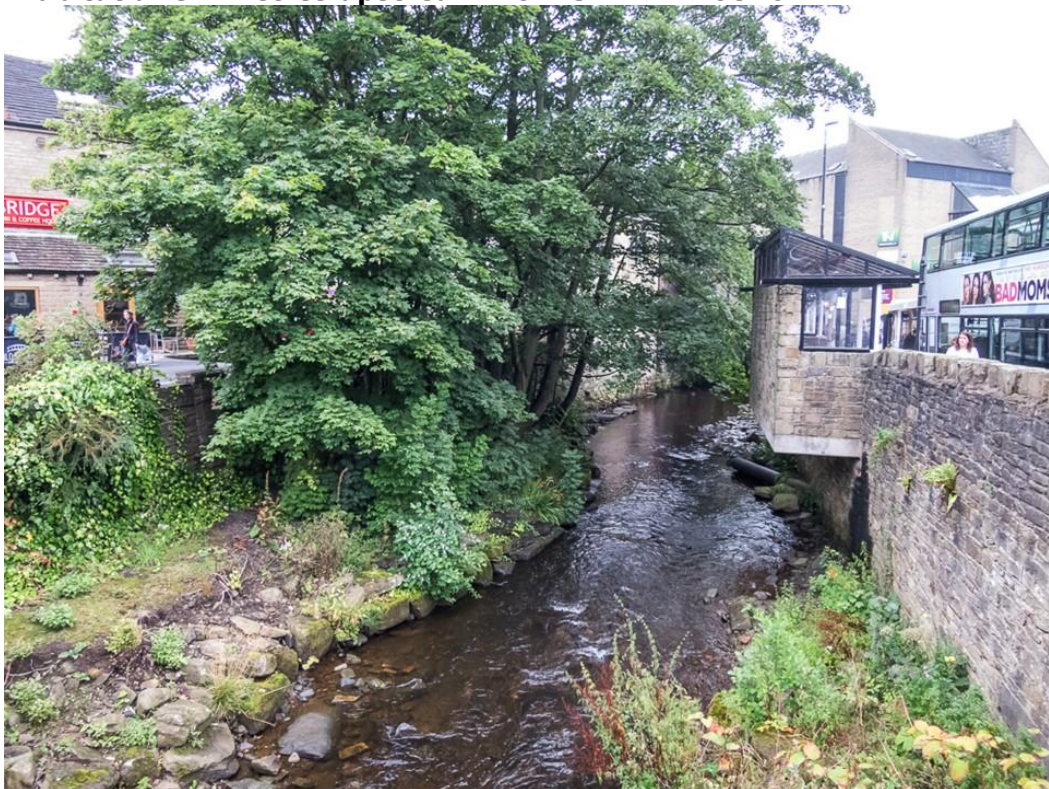
Figure 20: The area pictured in the previous figure is in the background here. The degrading gabions are visible on the RB (right of frame, background) and the multi-stemmed trees on the LB-berm are readily visible.

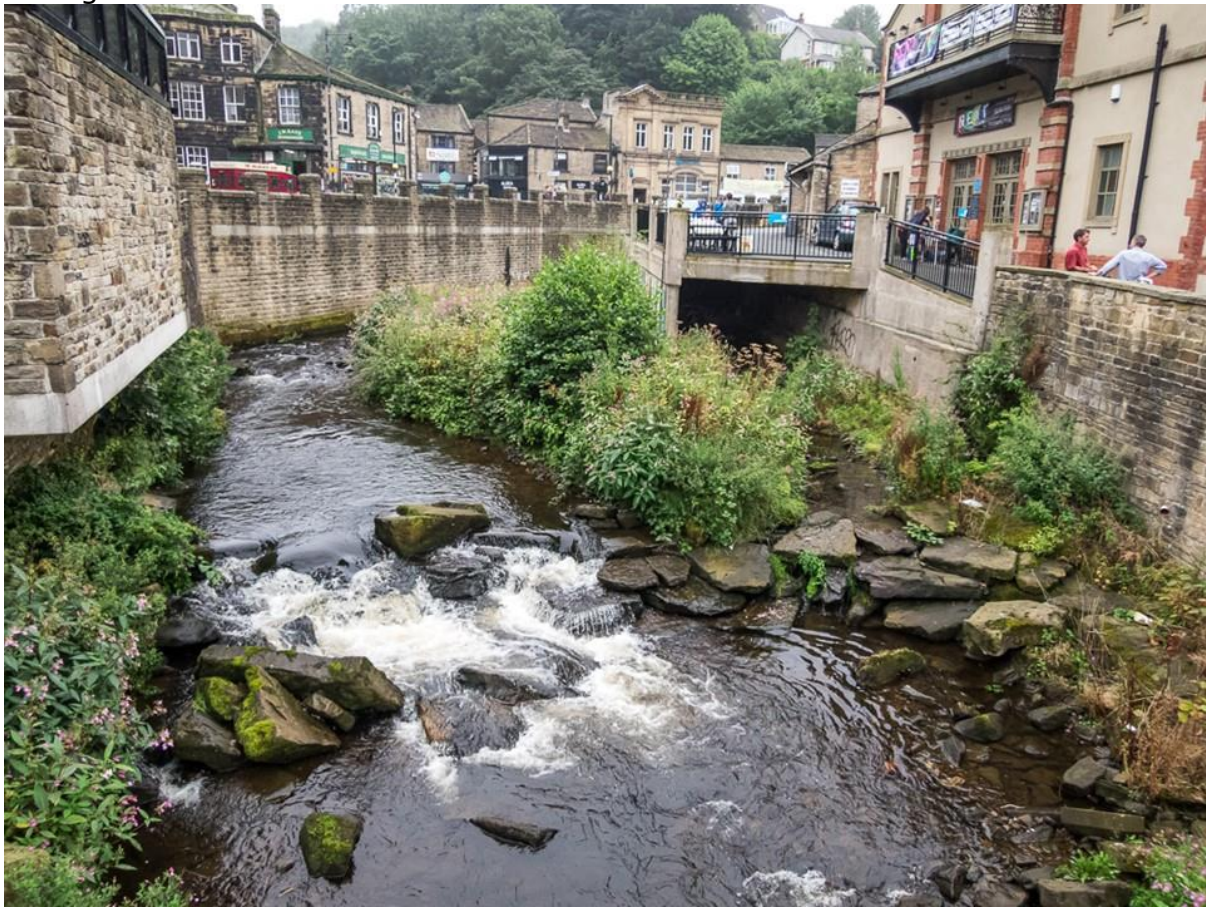
A collapsing weir was noted and photographed from SE14248 08226 (facing upstream; Fig. 21). With reference to the previously-highlighted importance of geomorphological processes (as well as access to habitat), the gradual and

ongoing degradation of this structure is having a very positive benefit to the ecological status of the river Holme.

Figure 21: Collapsing weir - which will continue to improve both the habitat and also connectivity (i.e. ability for species that migrate between different areas of river systems in order to complete their lifecycles) of the River Holme and wider catchment.

For this reason, enacting suggestions from local stakeholders to build weirs higher for various visual amenity values would have extremely negative ecological consequences.

- Encourage the continuation of natural degradation of previously-impounding structures (weirs) and avoid re-instating or increasing the height of impoundments in future

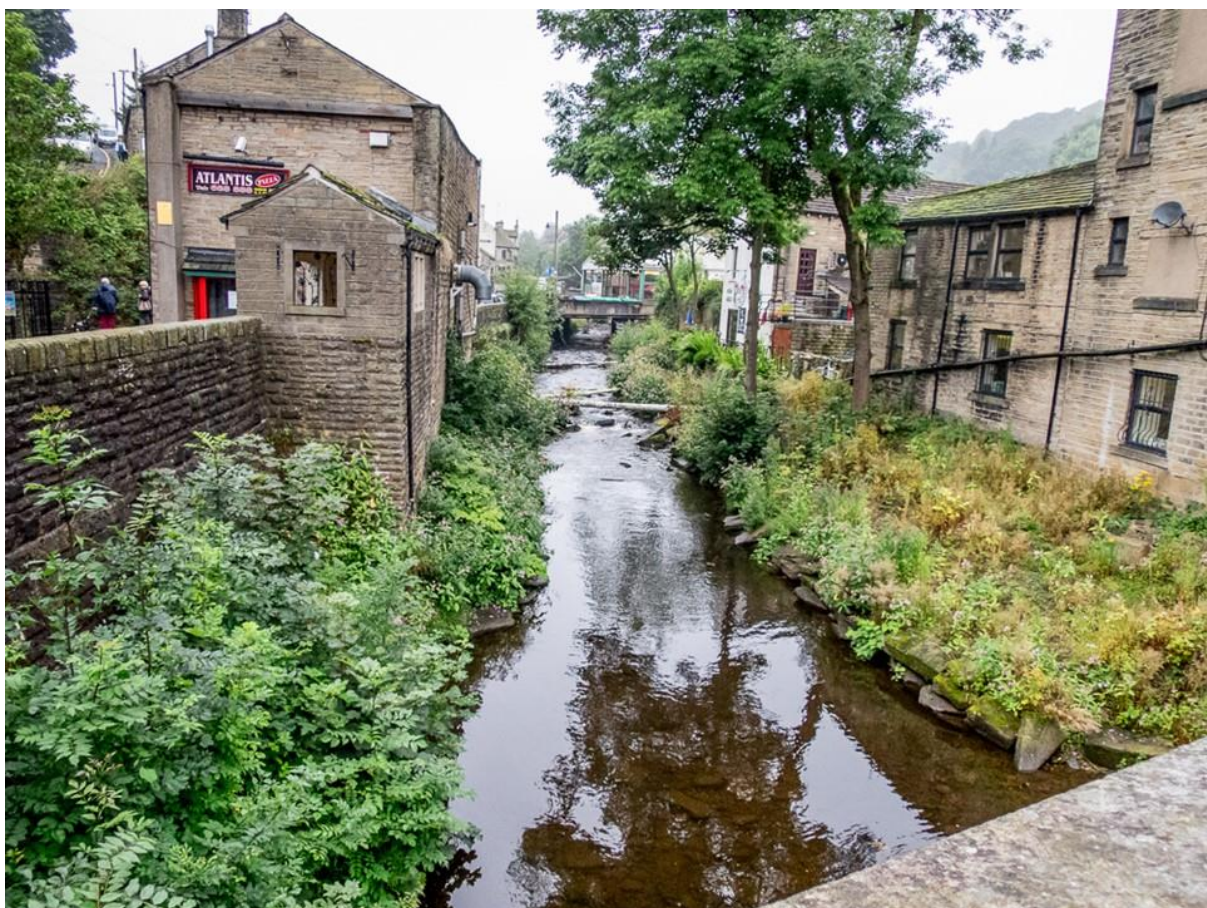
One of the reasons behind suggestions to re-instate, increase the height of or build new weirs is the suggestion to “drown out” the visible service pipes that cross the river just upstream from the bridge at SE14220 08153 (Fig. 22).

Figure 22: Exposed pipes and varied low-level vegetation at SE14220 08153

As well as the previously-highlighted (substantially-negative) aquatic ecological impacts of doing this, there is also a significant consideration of the new height of the water which would drown out the currently varied and attractive riparian vegetation. The loss of that riparian vegetation not only impacts on the visual amenity, but also the potential for valuable ecosystem processes such as photosynthesis and interception/absorption of pollutants (both waterborne and airborne). An impoundment of that height would also have potentially highly

significant implications to flood risk for the properties upstream of a new weir of that size.

A better compromise (assuming that the pipes cannot be de-commissioned and removed) would be to explore the potential to paint in a more muted colour and also establish native climbing plant growth; possibly ivy (*Hedera helix*). The evergreen status of ivy would maintain a year-round pleasant appearance as well as providing additional ecological niche opportunities for invertebrates.

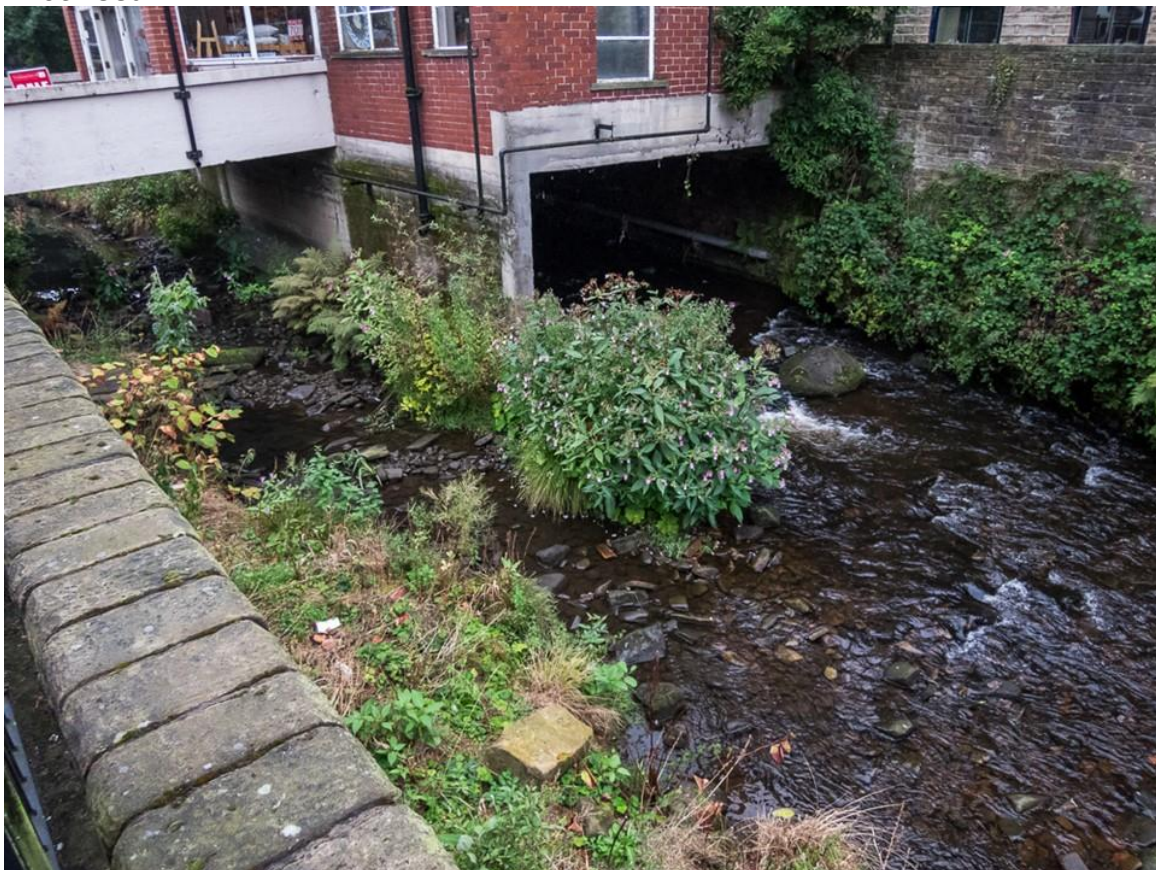
More knotweed was noted at SE14134 08121 at "The Pattern Principle" (Fig. 23) and also nearby in the footings of Holmfirth Mills (Fig. 24). In both cases, the same considerations as previously raised in this report apply. With the generally more widespread presence of Himalayan balsam (currently), there is a danger of overlooking the opportunity to reduce the amount of funding required to achieve control of the (much more technically difficult to control) Japanese knotweed infestation.

Figure 23: Japanese knotweed (left of frame) as well as Himalayan balsam (centre frame) at The Pattern Principle.

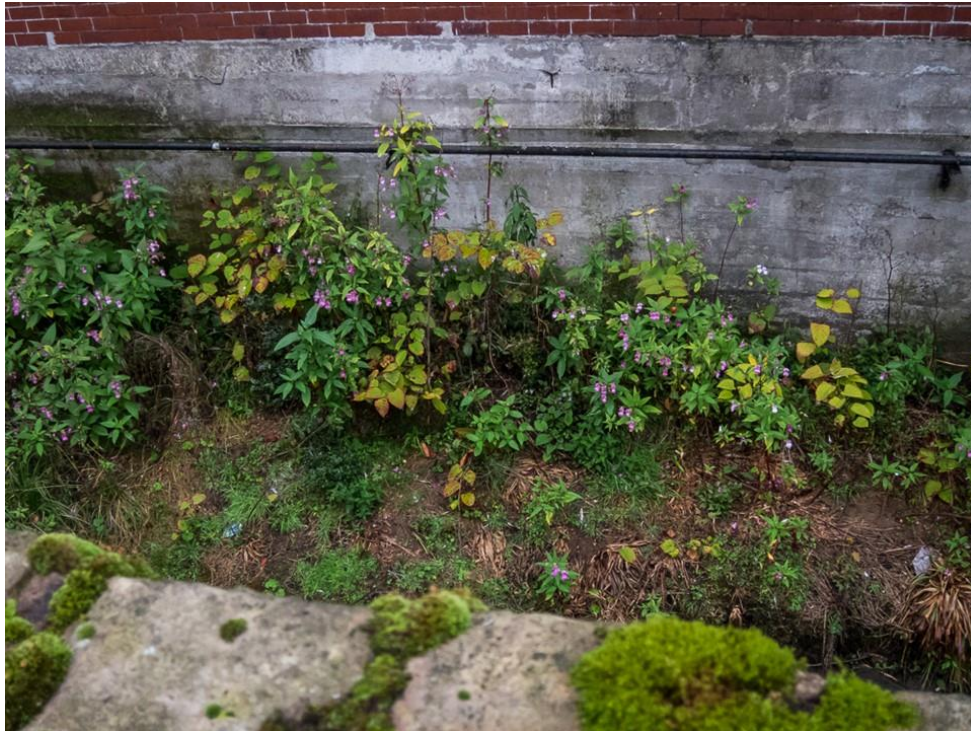
Figure 24: A (currently small) infestation of Japanese knotweed at Holmfirth Mills.

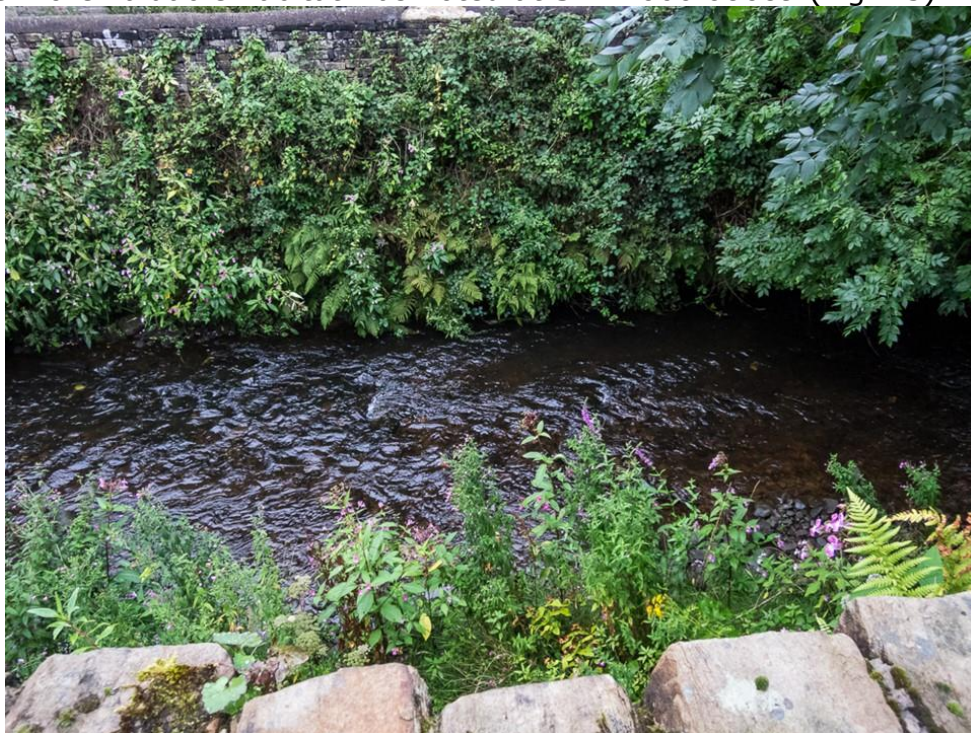
Although constrained by high, vertical walls, some of the impacts of channel modification have been naturally mitigated by combined effects of geomorphology and natural succession. An example of where gradient, channel width and the opportunistic colonisation of channel stonework have combined to produce more valuable habitat was noted at SE 14060 08089 (Fig. 25)

Figure 25: Some diversity in flow depth and velocity (as well as more varied trailing and overhanging riparian vegetation) has naturally emerged and provided a little mitigation for the historic channel modification.

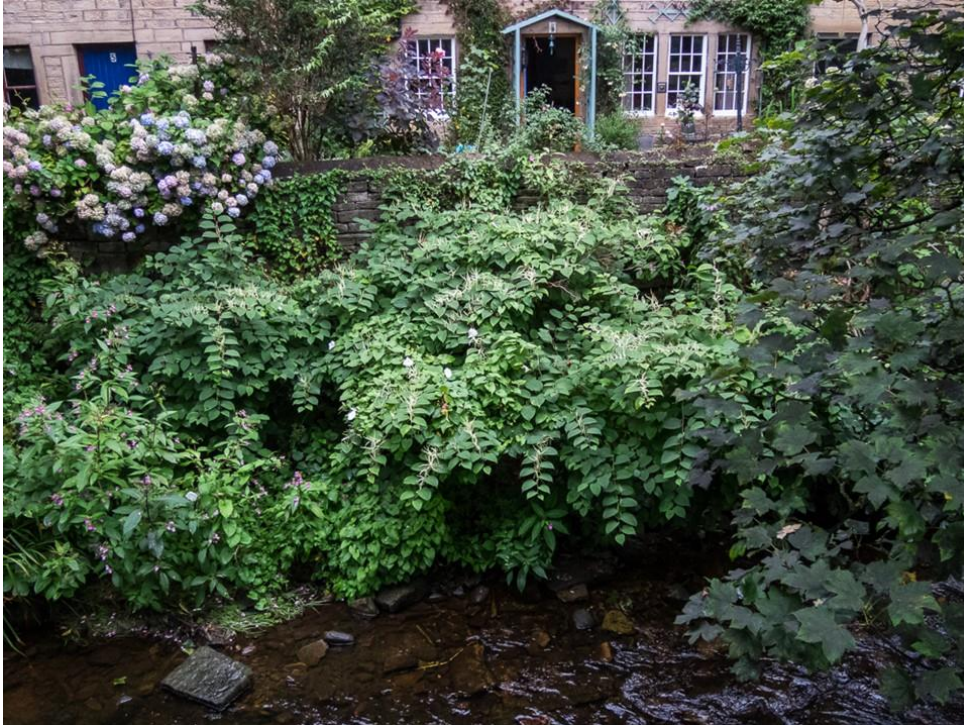
In contrast a large, and vigorously growing, knotweed stand was noted at SE14039 08069 (outside houses number 4 and 5 on what is thought to be Lower Mill Lane; Fig. 26).

Figure 26: Large stand of lush Japanese knotweed growth. The houses in the background are conceivably within reach of the extending rhizome system from this stand.

While both of these stands of knotweed are clearly much larger than the other, developing, infestations downstream, they are still feasible to tackle via stem-injection. Although this will not guarantee eradication, it is a cost-effective way of achieving control. Until the development of specific stem-injection technology, the alternative cutting, spraying and control/disposal of biohazardous waste (and the need for multiple repeat treatments) methodology was far, far more expensive.
