River Holme: Advisory Visit

Paul Gaskell Wild Trout Trust (WTT) 25/08/2016

River 2015, Holmfirth
River	Holme
Waterbody Name	Holme from source to New Mill Dike
Waterbody ID	GB104027057600
Management Catchment	Aire and Calder
River Basin District	Humber
Current Ecological Quality	Moderate
U/S Grid Ref inspected	SE1392108006
D/S Grid Ref inspected	SE1439208481
Length of river inspected	1km

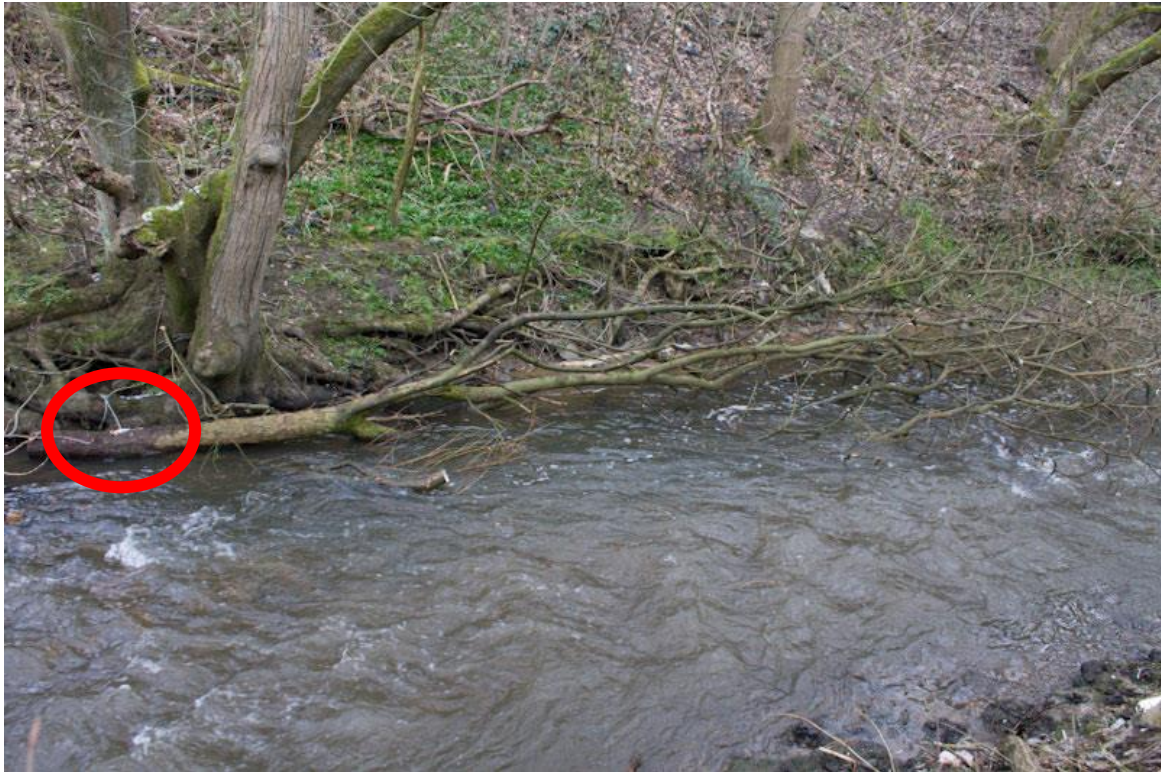
Figure 28: Newly-installed tree "kicker" (attached to a secure anchor point using braided steel cable; circled).

- Seek opportunities to install tree kickers using material arising from canopy works – particularly in the region of SE14244 08261 (Fig. 28 shows a sizeable example, but refer to guidance video link given after this figure).

A guide to installation and the typical effects of a tree kicker can be seen in this video: [http://www.wildtrout.org/content/how-videos#tree kicker](http://www.wildtrout.org/content/how-videos#tree%20kicker).

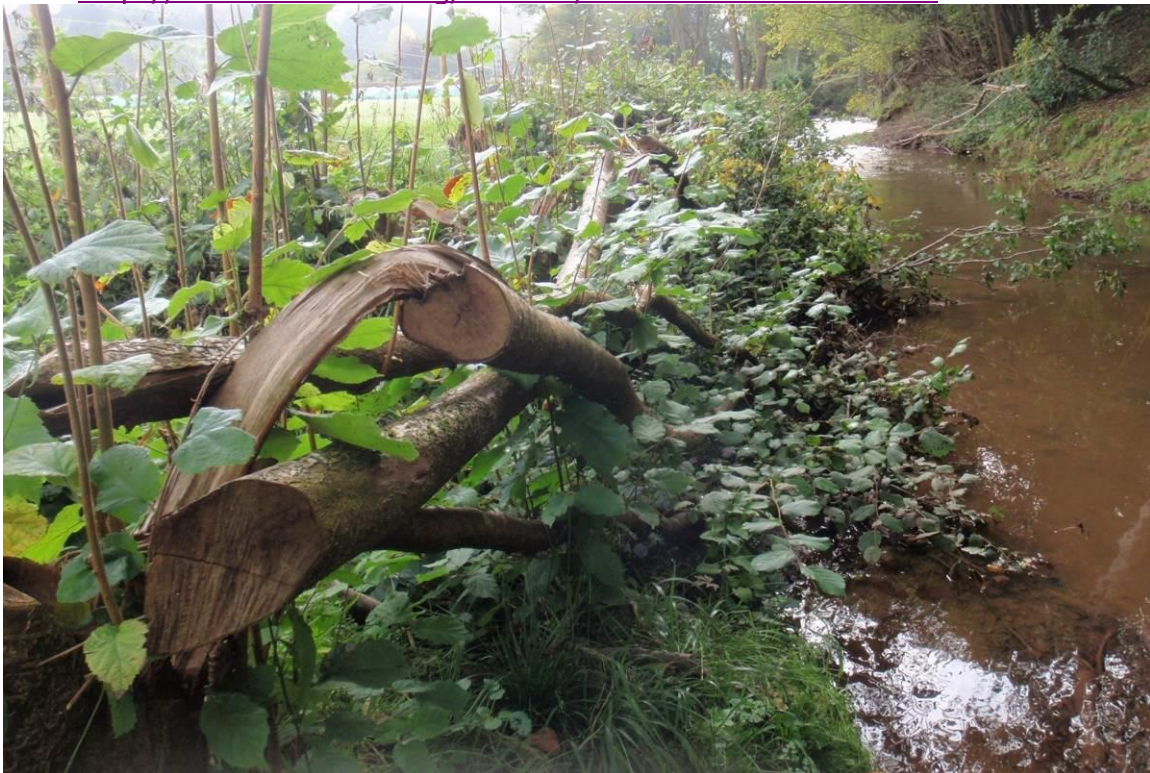
Figure 29: Hinging or laying of saplings to create marginal cover (in this case using hazel).

- Seek opportunities to hinge (lay) saplings into margins to produce refuge habitat (e.g. Fig. 29)
- Coupled with a diversification of light/shade via tree-canopy management in the region of SE14328 08346, it may be possible to plant and then protect (via waterfowl-grazing exclusion) appropriate riparian vegetation (e.g. Fig. 30)

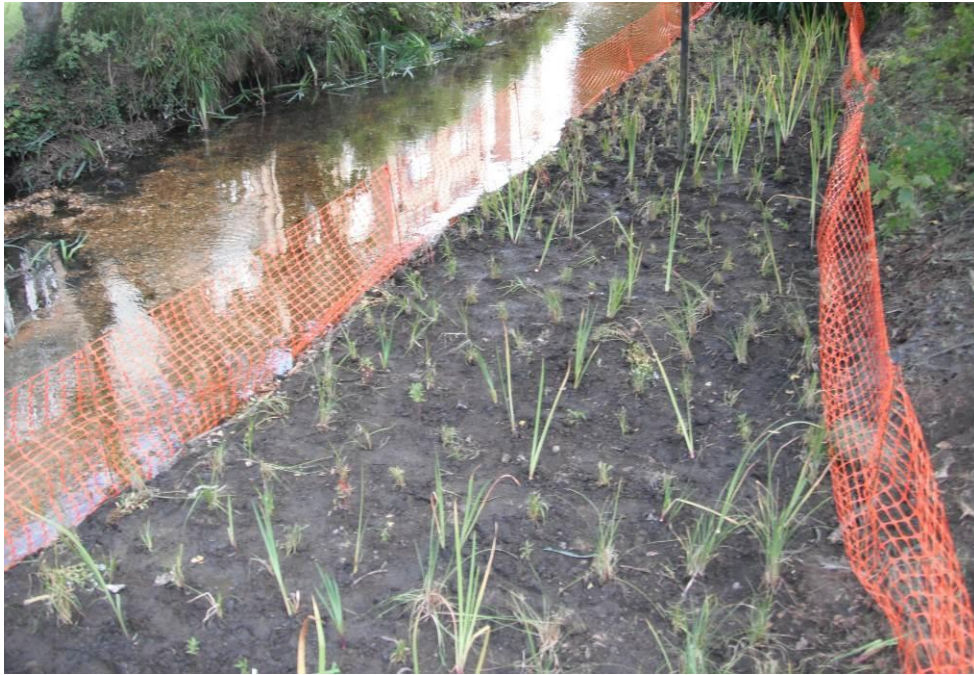
Figure 30: Successful establishment of waterside flora by the South East Rivers Trust, River Wandle – including exclusion of waterfowl grazing (more extensive measures may be required in Holmfirth, and there is a risk of vandalism with initiatives such as this).
