Advisory Visit

Rivers Colne and Holme, Huddersfield (Greenstreams)

22nd June, 2010

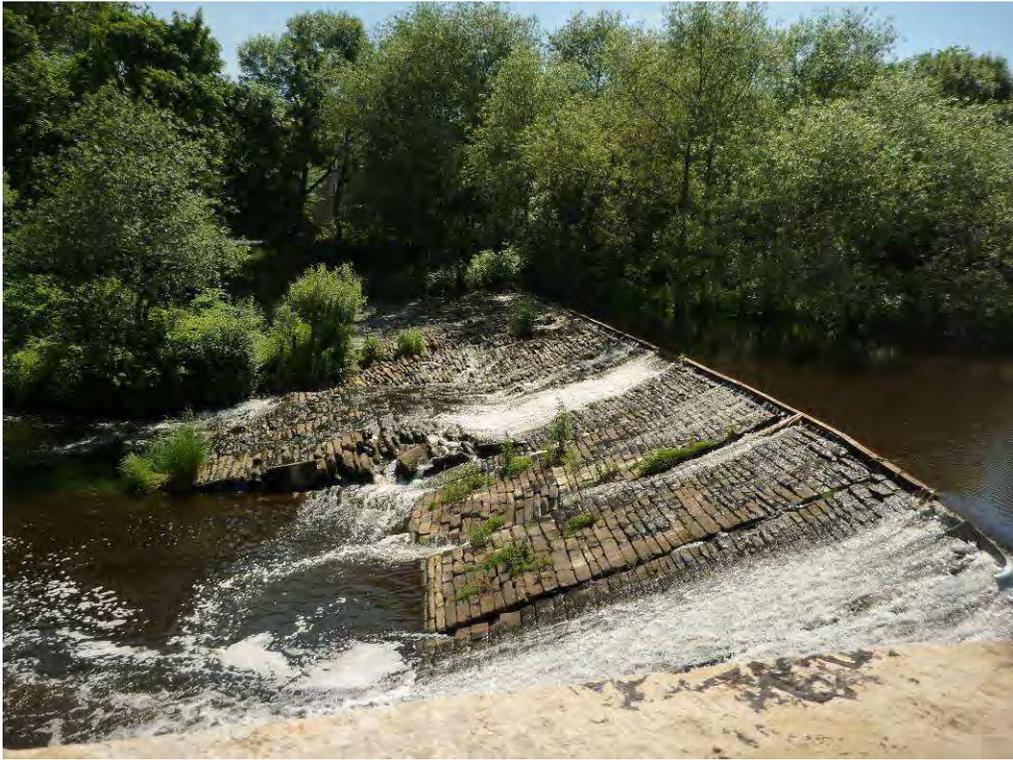
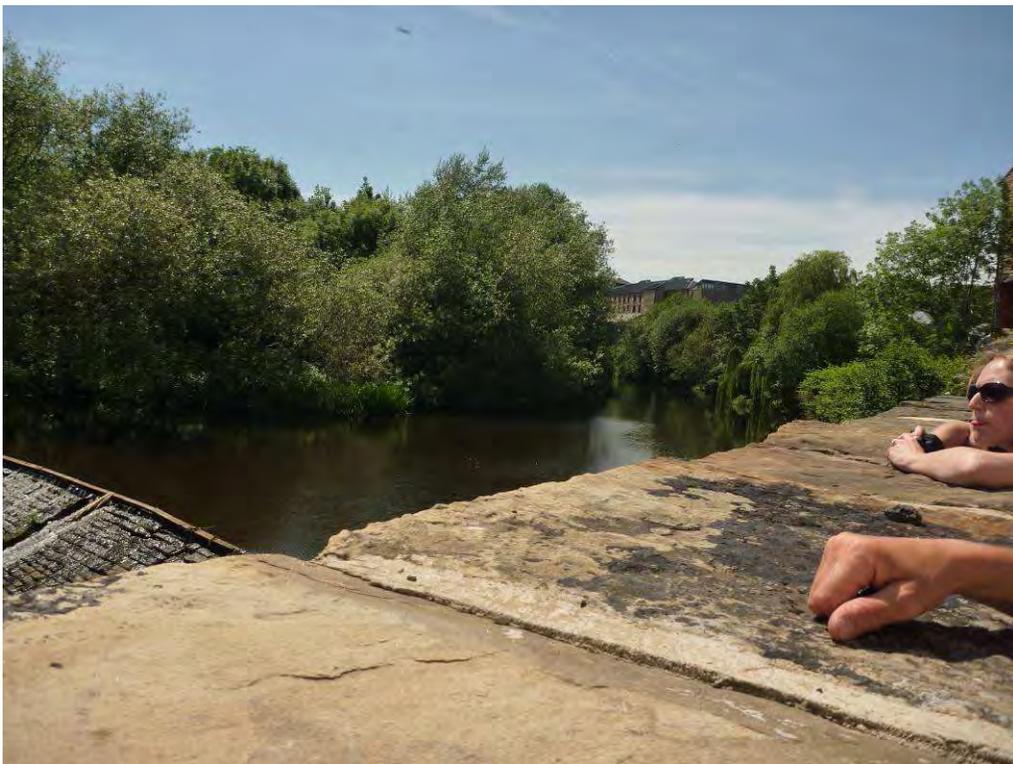
The river between Somerset Bridge and Snow Island weir (SE 15108 16248 to SE 150424 16215) is typical of many urbanised upland rivers. Specifically, the fragmentation of habitat due to one of several large weirs in the area is clearly evident at Snow Island (Fig. 2A). In order to ensure resilient and self sustaining fish populations, it is important to maximise the potential for movement between high quality patches of habitat. This is beneficial, not only because it meets the changing habitat needs during each life stage of fish (spawning, juvenile and adult), but also by providing escape routes from pollution episodes. Furthermore, the reduced flow velocities and increased siltation upstream of large weirs (Fig. 2B) provide poorer habitat for a range of aquatic invertebrates and fish alike. The loss of physical variety in the

Figure 2: Barrier to fish passage (A) and upstream habitat homogenisation via reduced flow velocity and increased siltation (B)

micro-habitats due to siltation and reduced flows tends to favour fewer species, rather than a broad diversity. In many cases, this impacted habitat due to weir impoundments is compounded by straightening of the channel by vertical retaining walls. However, one of the many redeeming features of these upland rivers is their relatively steep gradient and corresponding fast turbulent flows. Away from the impounding effect of weirs this can, over time, enable the river to re-establish a more varied and meandering river bed. Recovery happens by a process of erosion and deposition of bed material in the channel between the retaining walls. In rivers that are fortunate to have these sufficiently energetic spate flows, vital variation in the habitat is provided by the formation of "point bars" of gravel and cobbles deposited at the sides of the channel (Fig. 3). These bars are a little like shingle beaches and help to provide variation in both depth and current speed. The resultant shallow inner edge and deepened outer edge of the cross section is termed "lateral scour" and is a key mechanism in the production of natural river meanders.

- Obtain specialist advice (e.g. Adrian Fewings or Greg Armstrong of the E.A.'s national fish pass team - contact numbers available via the E.A. enquiries line: 08708 506 506) on easement options for weirs at Snow Island and Queens Mill Road (see section 5.1 of the Upland Rivers Habitat Manual for further guidance on fish passage easements: http://www.wildtrout.org/images/PDFs/Upland_Manual/uplands_section5.pdf)

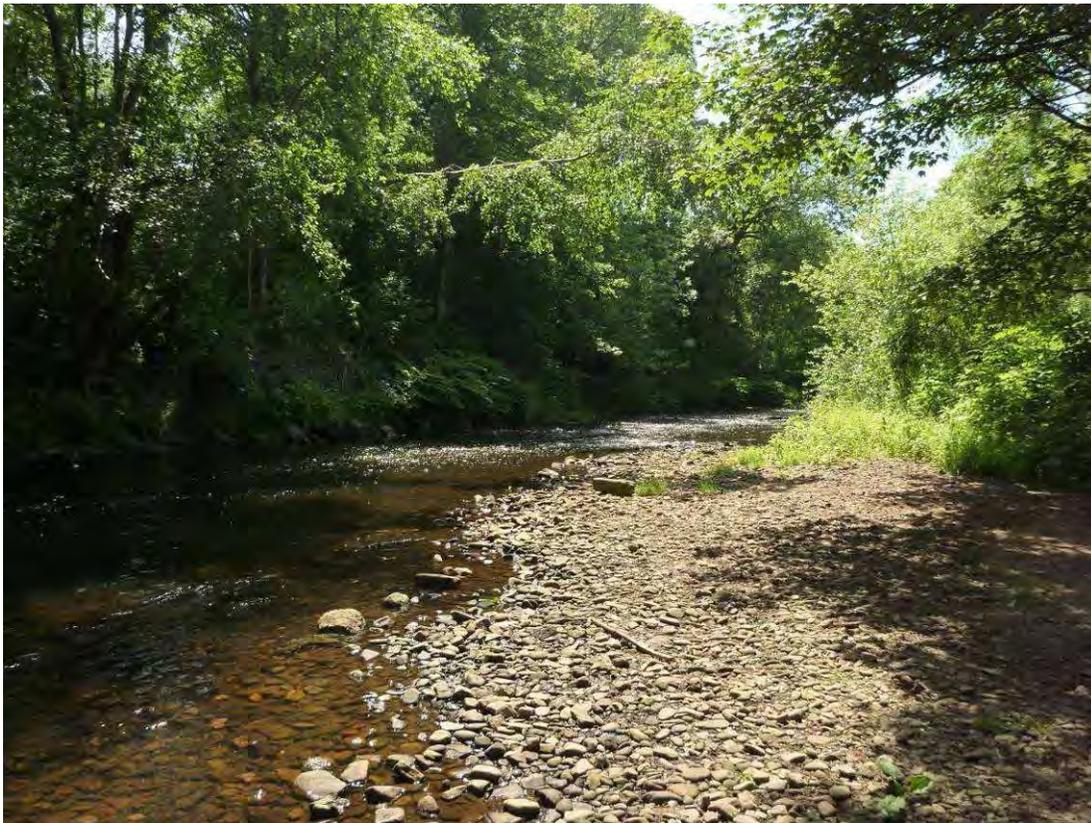
Figure 3: Lateral scour just upstream of Somerset Bridge with point bar (centre and right of frame) and scoured bend (left of frame). Picture taken under summer low flow conditions facing upstream

Despite the spontaneous regeneration of some habitat variation by a little deposition and lateral scour, there is a lack of really high quality scour-pool habitat in this reach, upstream of Somerset Bridge. In other words, the natural processes of recovery can only achieve so much given the constraints imposed by past engineering of the channel. The limited recovery is probably not helped by a general lack of debris any larger than cobbles (20 to 30-cm size-range). In systems that have either large boulders or naturally-occurring fallen trees, significant localised scouring of the stream bed provides really excellent adult trout habitat – as well as producing mounds of prime spawning gravels. Fallen tree material, termed Large Woody Debris (LWD), is a particularly valuable component of high quality trout streams because of the multitude of benefits it provides. As well as the pool scouring/gravel cleaning processes, LWD offers overhead shelter to help fish avoid predators and is also excellent habitat for a range of aquatic invertebrates. Unfortunately from an ecological perspective, LWD is often removed from rivers – usually with uncertain consequences. The West Country Rivers Trust provides a useful guide to the management of natural LWD:

- Consider light rotational coppicing of the woodland bordering the riverside path reaches (Section 3.5)
- Consider installing secure LWD to promote localised scour upstream of Somerset Bridge (Section 3.1) and also along the riverside path reaches (Section 3.5). This could be undertaken in a design and delivery partnership with Environment Agency Fisheries and Operations Delivery staff along with the WTT. Examples of useful features are given below:
 - Pinching down the channel below riffle at SE13977 15381 (Fig. 14)

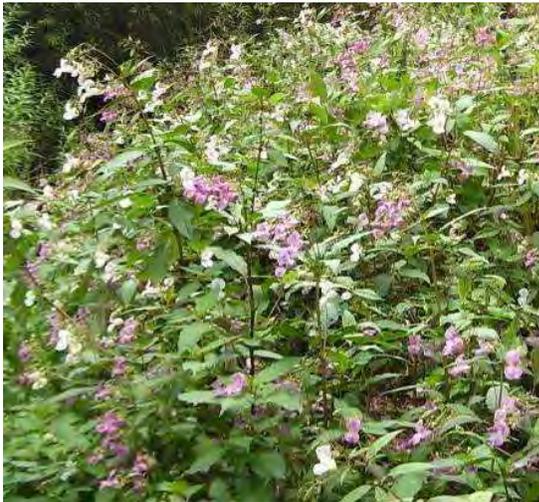
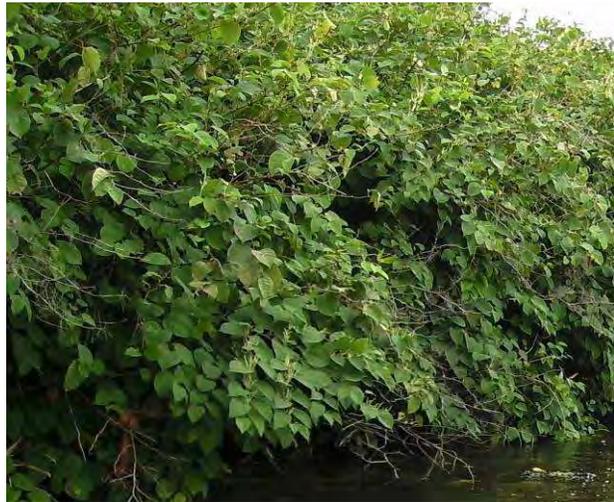
Within this reach and many others on the Colne and Holme (according to discussions during the visit) both Himalayan Balsam (*Impatiens glandulifera*) and Japanese Knotweed (*Fallopia japonica*) are well established invasive plant species on the banks. With Greenstreams' existing environmental

- Himalayan Balsam outcompetes native flora (and hence reduces the diversity of the associated invertebrates) before dying back in winter
- Winter die-back promotes erosion of bare earth banks during winter spates – choking spawning gravels and killing fish eggs and smothering some species of invertebrate
- Plants produce up to 800 seeds that are spread via exploding pods. Each seed may be catapulted 6 to 7 m away from the parent plant, so the plant can spread very effectively and very quickly
- Japanese knotweed spreads vegetatively via underground root systems (rhizomes) but also dies back during winter – having outcompeted native flora
- A fragment of rhizome weighing only 0.8 g and about the size of a thumbnail is capable of producing a whole new stand of knotweed and rhizome systems typically extend 7 m from any individual stem visible above the soil surface

Figure 4: Himalayan balsam (left) and Japanese knotweed (right)

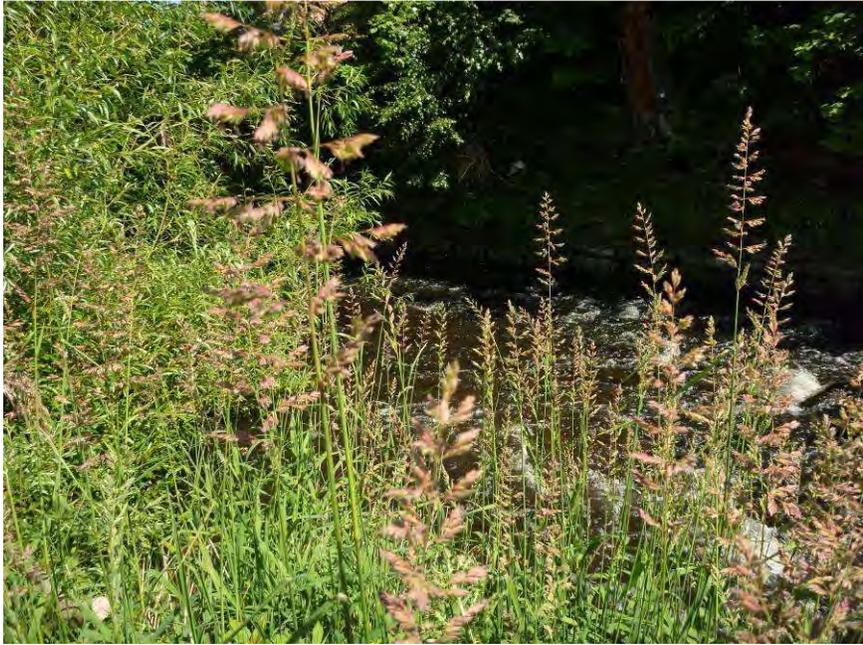
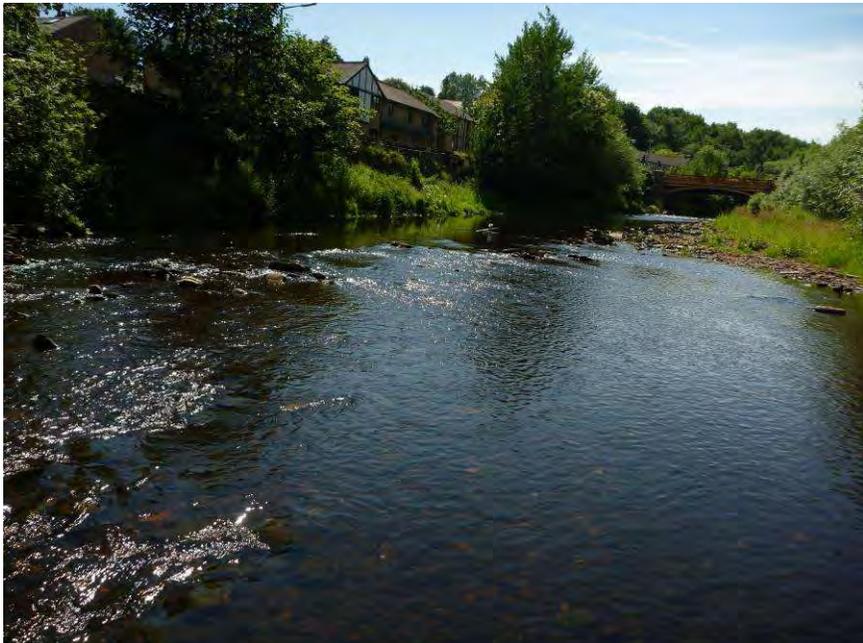
Figure 5: Energised riffle flows at the breach (A) and upstream (B) of the weir at SE14778 15881. A fantastic boost to habitat quality as well as connectivity that would not be achieved by any bypass measures

Spontaneous breakdown over time of this weir on the Colne is an ideal showcase for the habitat benefits that accrue from reducing the impounding effect upstream of the weir (Fig.5).

The energised current upstream of the weir and the downstream migration of large blocks of stone from the weir structure are forming some excellent habitat for both juvenile and adult trout as well as a range of aquatic invertebrate species. Silt that would previously have been trapped amongst the bed cobbles upstream of the structure has been scoured out, to accumulate in a more "patchy" fashion downstream. A formal "fish pass" solution to weirs simply does not provide these habitat enhancements. Although fish passes can be a vital means of providing connectivity where the head of water must be maintained by a weir, they should not be the default option when seeking to improve ecological status of a watercourse. If it is possible, allowing redundant weirs to degrade naturally over time is one of the best available ecological enhancements – both in terms of connectivity and habitat quality. If the appropriate consents and permissions can be obtained (i.e. from both the owner/operator of the structure and surrounding land, the Environment Agency Development Control and Flood Risk Management teams as well as any other potentially affected parties), then work to gradually lower and remove weirs is another excellent opportunity for habitat improvement. Of course, in many cases, there may be no practical alternative to bypassing or easing passage over an otherwise unchanged structure. See recommendations (Section 4) for some starting points for tackling both connectivity and habitat improvement in relation to weirs.

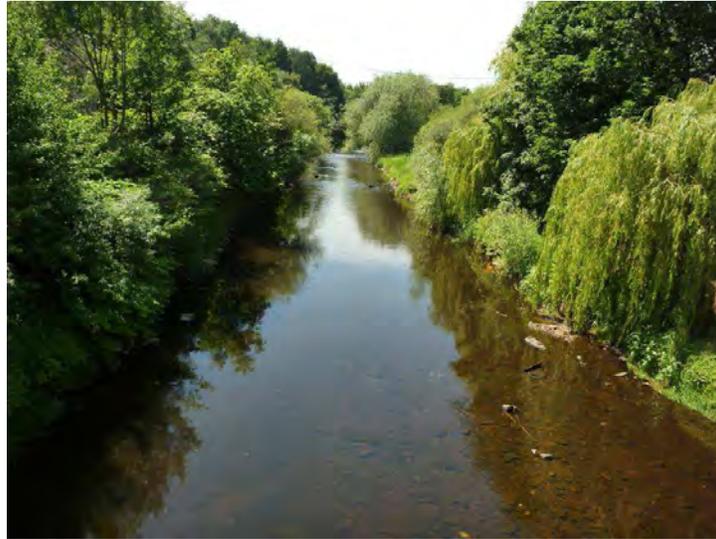
The section upstream of Kings Bridge (Fig. 6) is an example of how artificial straightening and widening of river channels may reduce the potential for lateral scour. As a consequence, the habitat is relatively uniform and generally lacks the necessary cover to help fish avoid predation. This is, however, a relatively short section and a nice riffle is present below the bridge structure itself. The depth and flow characteristics would potentially be suitable for juvenile life stages of fish (including trout and grayling). The introduction of stable additional marginal cover (for example in the form of

Figure 6: Channel upstream of Kings Bridge SE 14691 15816; straightened and uniformly wide with little depth variation

tree "kickers"; Fig. 7) may increase the value of this section as a nursery/overwintering site for fish.

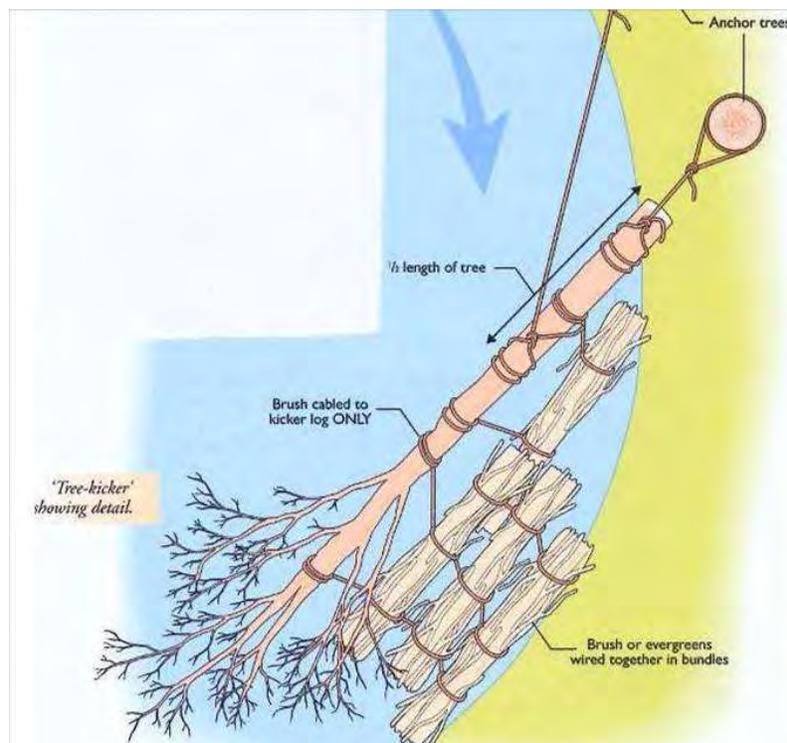
Figure 7: Schematic example of tree "kicker"

- Single log and brush side “berms” (in contrast to the pair of berms shown in Fig. 14) with additional brush nailed to tops and outer edges of logs could also be used on the LHB beneath the gantry at the base of the vertical walls shown in Fig. 10
- Tree kickers (Figs. 7 and 8) can also produce a similar effect to side berms, therefore combinations of side berms and/or kickers may be staggered along both RHB and LHB to produce some instream meandering flow within an artificially straightened channel
- Promoting localised scour, gravel sorting and marginal cover at Somerset Bridge(Fig. 15)

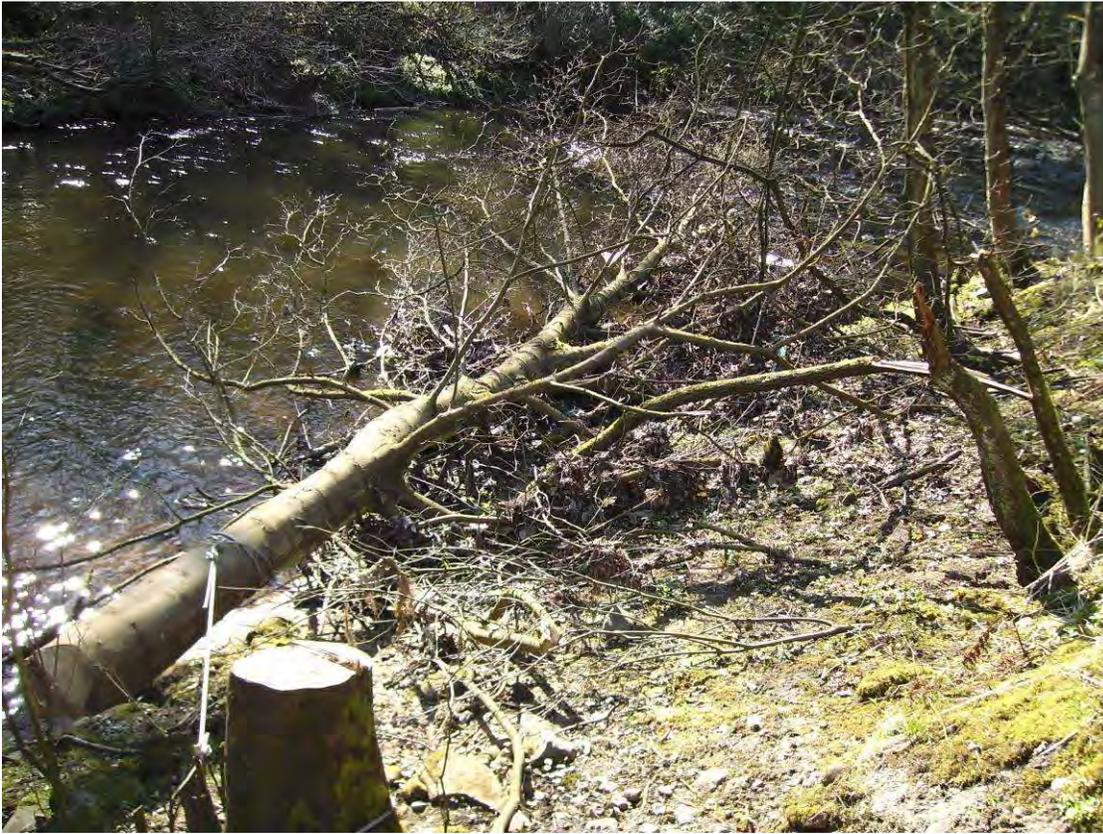
Figure 8: Tree kicker installed on Derbyshire's river Goyt. Trunk is anchored to its stump via 12-mm braided steel cable

Tree kickers may also promote a small but potentially significant amount of “gravel sorting” during high flow events. Bed sediments are said to be “unsorted” when the gaps between larger sediment particles, e.g. gravel or cobbles, are filled with sand and other fine sediments. Conversely, sediments that occur in mounds of similar particle sizes are said to be sorted. Trailing branches and tree trunks focus the flow of water onto the stream bed and can remobilise fine silt, gravels or even larger particles. Because large particles fall out of suspension in faster flowing areas than the slow flows that allow silt to settle, localised scour and re-deposition tends to “sort” the accumulated mounds of sediment into groups of similarly-sized particles. Well-sorted and well-irrigated gravels are essential for survival of trout eggs in the gravel beds following spawning.

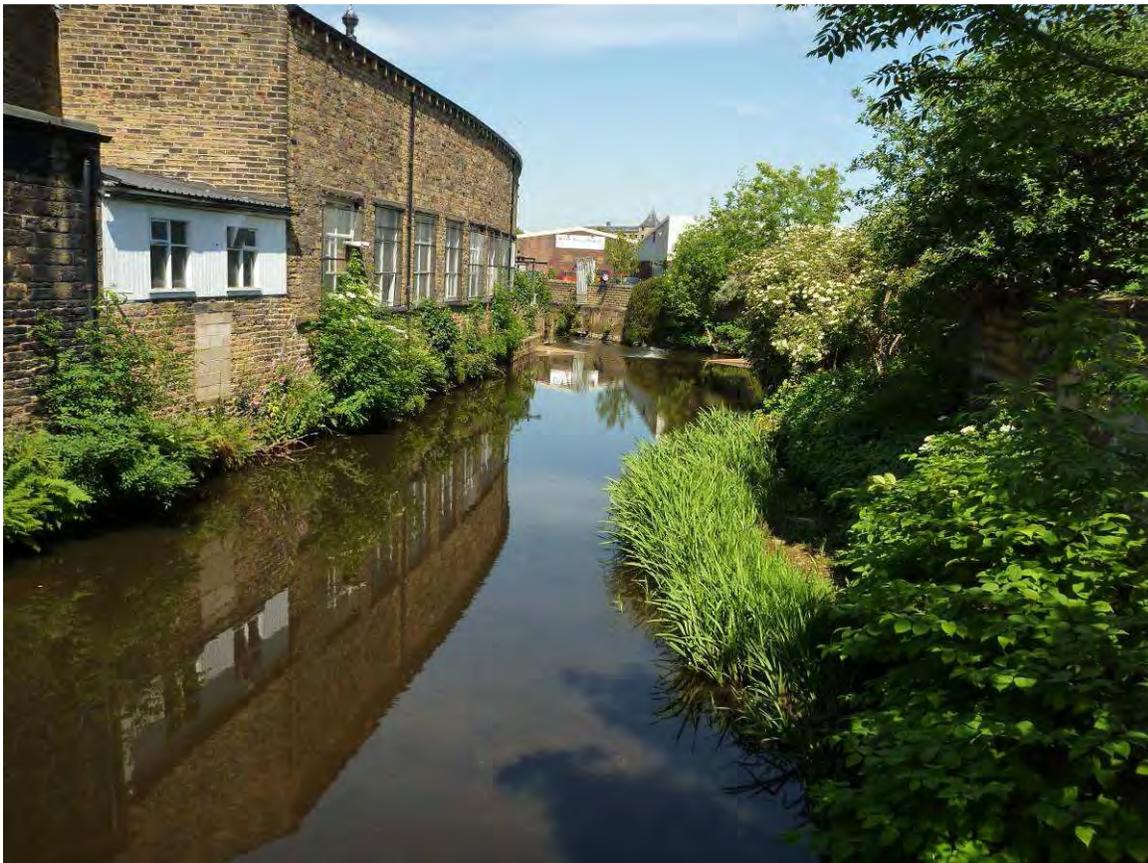
This section is impounded by at least one weir and it would be beneficial to prioritise either relatively cheap “easements” to fish passage, full formal fish pass installation or weir lowering/removal as appropriate. Given the risks of erosive damage to supporting walls – it may be that facilitating fish passage with only minimal lowering (if any) of the weir is most appropriate here. The impounding effect of the weirs can be seen below (Fig.9) – as can the very beneficial low-hanging vegetation on the LHB and the good wetted margin and emergent vegetation on the RHB. For adult trout, the most useful overhanging vegetation to use as shelter should be less than approximately 30cm from the water surface, so the vegetated wall is providing a vital resource. Conversely, emergent vegetation and associated roots can be vital habitat for juvenile fish and aquatic invertebrates alike.

Figure 9: Facing downstream - a weir is just visible in the background of the frame. Valuable marginal vegetation fulfilling both adult and juvenile fish requirements is in evidence on both LHB and RHB and large(!) adult trout and grayling were observed during the site visit in this reach.

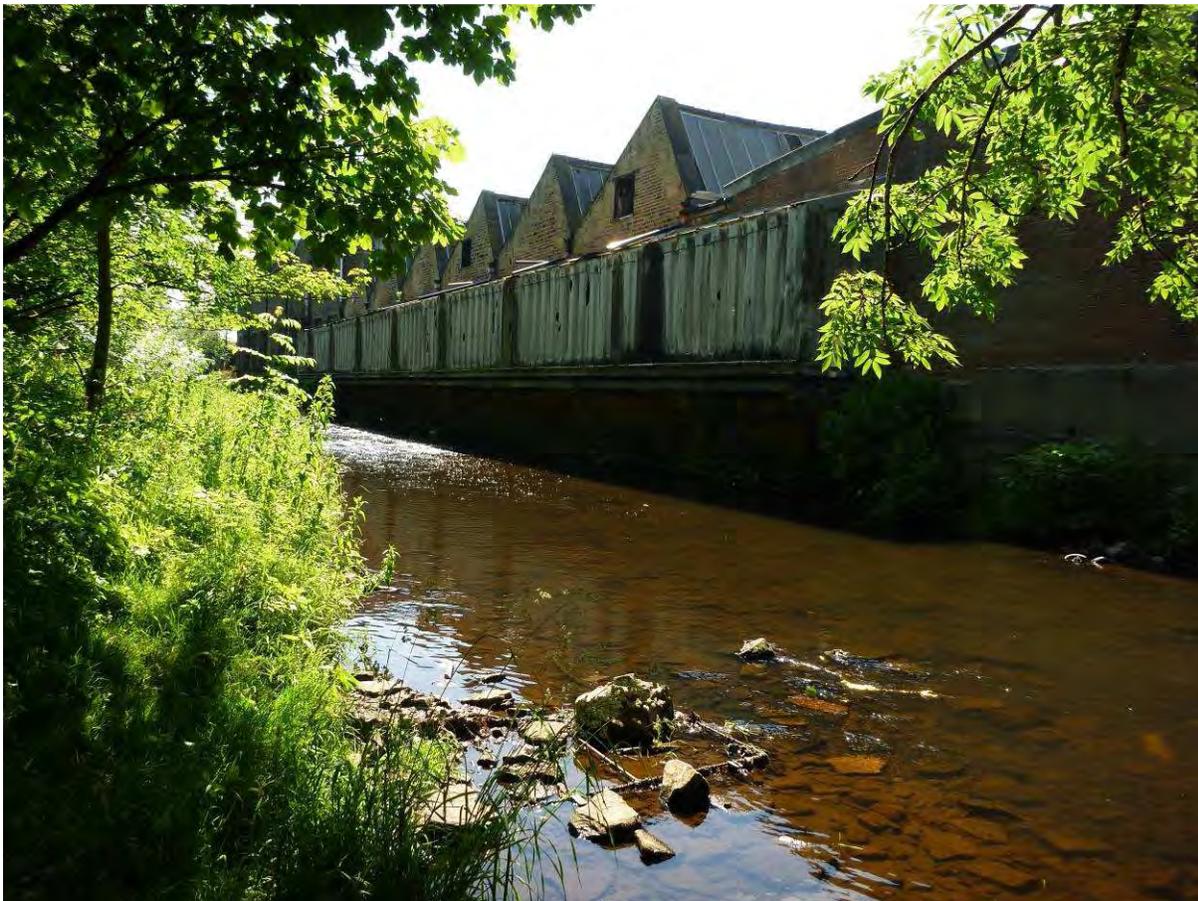
Some good quality habitat and several fish were observed during the visit in this reach. Much of the section is bordered on its RHB by a steep woodland valley side. A large number of trees in this section were of a similar age and would, perhaps, benefit from some light rotational coppicing to improve variety in the age/size structure. A fringe-benefit of such works would be the convenient provision of raw LWD material for any habitat works that may be desirable. By contrast, the LHB was largely delimited by the walls of industrial units (the footings of which often standing vertically down into the water; e.g Fig. 10). However, some useful shading by gantries that overhang the river may provide a small cooling effect for fish during full sunshine, low-water conditions in midsummer.

Figure 10: Good marginal vegetation (RHB) and vertically walled opposite margin (LHB). Note shaded margins produced by gantry (photo facing upstream)

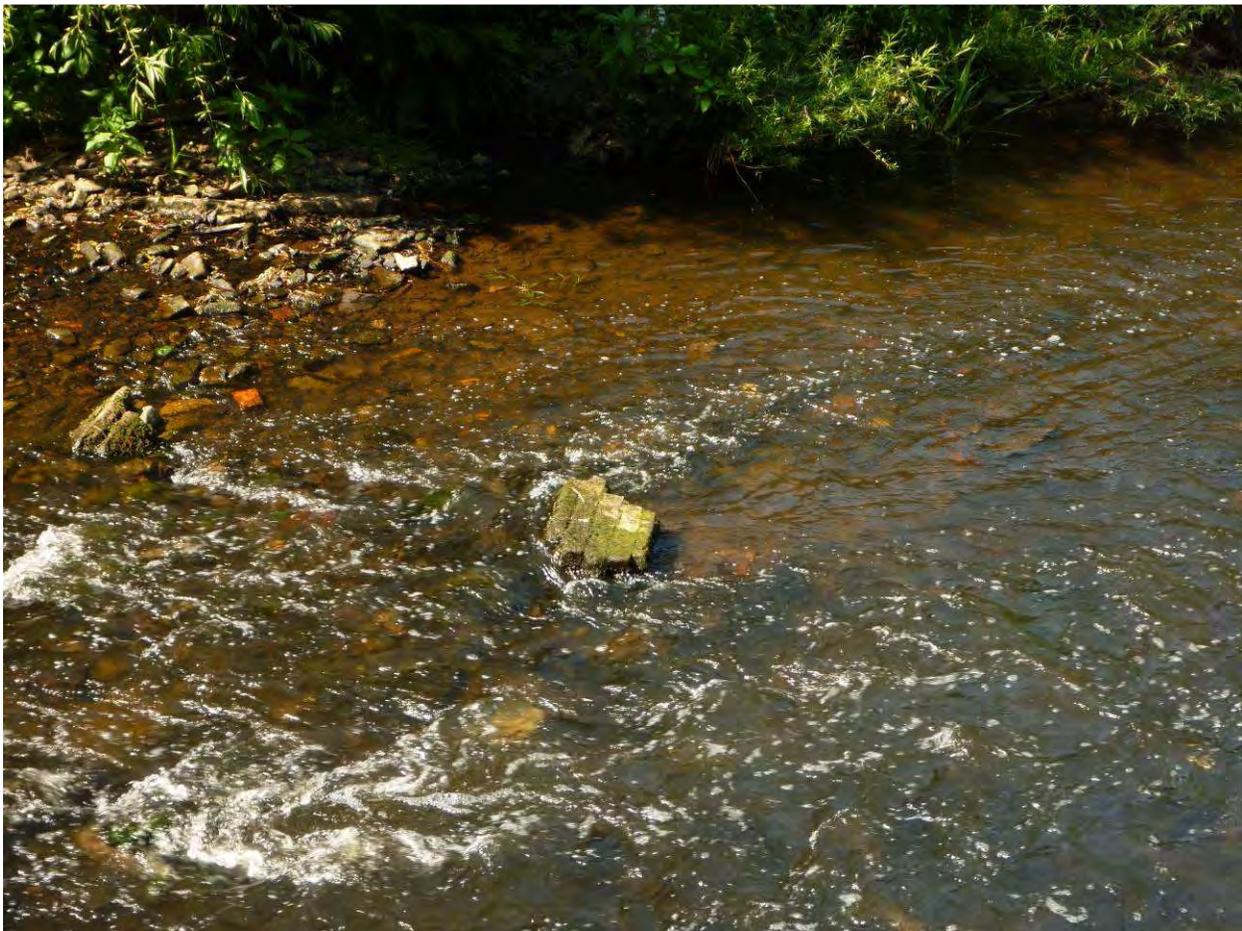
Although straightened in parts, this reach of the Holme possesses a linear pool and riffle structure and is perhaps less severely affected than some straightened sections of the Colne below the confluence with the Holme. It also benefits from several changes in direction (i.e. is not especially extensively straightened). The good quality instream habitat could also potentially be a result of the steep aspect of the LHB maintaining a channel that is sufficiently narrow to generate stream bed erosion and deposition. Another positive feature in this section is the presence of some larger stoney substrate (of various natural and man-made sources!) that has generated useful local bed scour (Fig. 11).

Figure 11: Large brick "boulder" on a riffle. Note the effect on the surface foam and especially the scour hole downstream (i.e. to the right) of the "boulder". Excellent and vital variation in both flow and depth is generated As well as generating localised scour and producing respite for fish from the full force of the current, boulders can act as vital interruptions to the line of sight of territorial fish like trout. Clusters of boulders are especially valuable both in terms of producing scour and enabling a higher number of adult trout

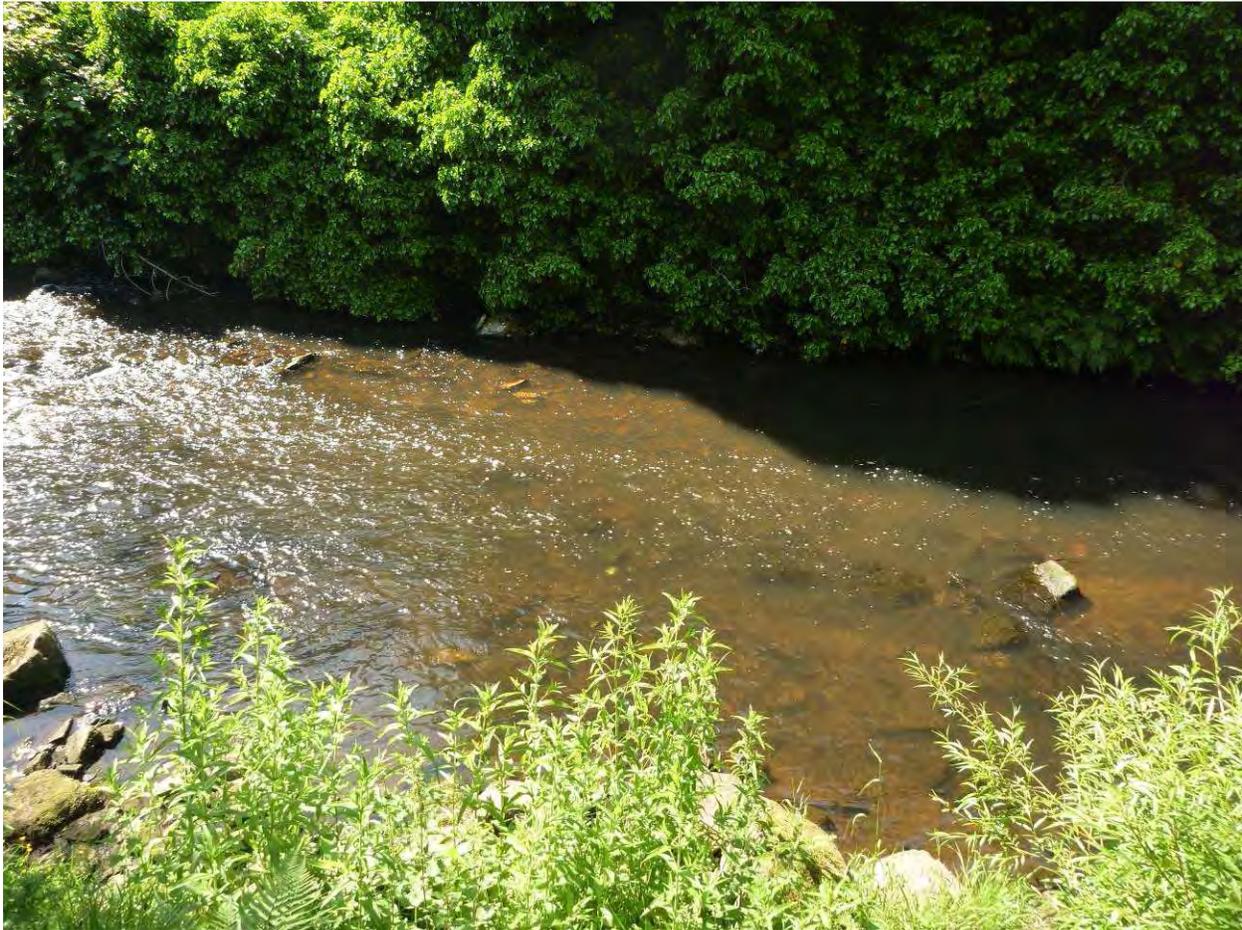
territories to exist in a given area of stream (Fig. 12). Again, the variety in substrate particle size from patches of silt and sand through to large boulders is also vital in supporting a diverse range of aquatic invertebrates.

Figure 12: Boulder clusters (centre of channel to the right of the frame) can increase the capacity of a riffle to hold adult trout as well as offering great habitat for a range of invertebrates - for example as stable substrate for caddis larvae to anchor cases during pupation. Many of these boulders were originally dressed pieces of gritstone used in weir or wall construction

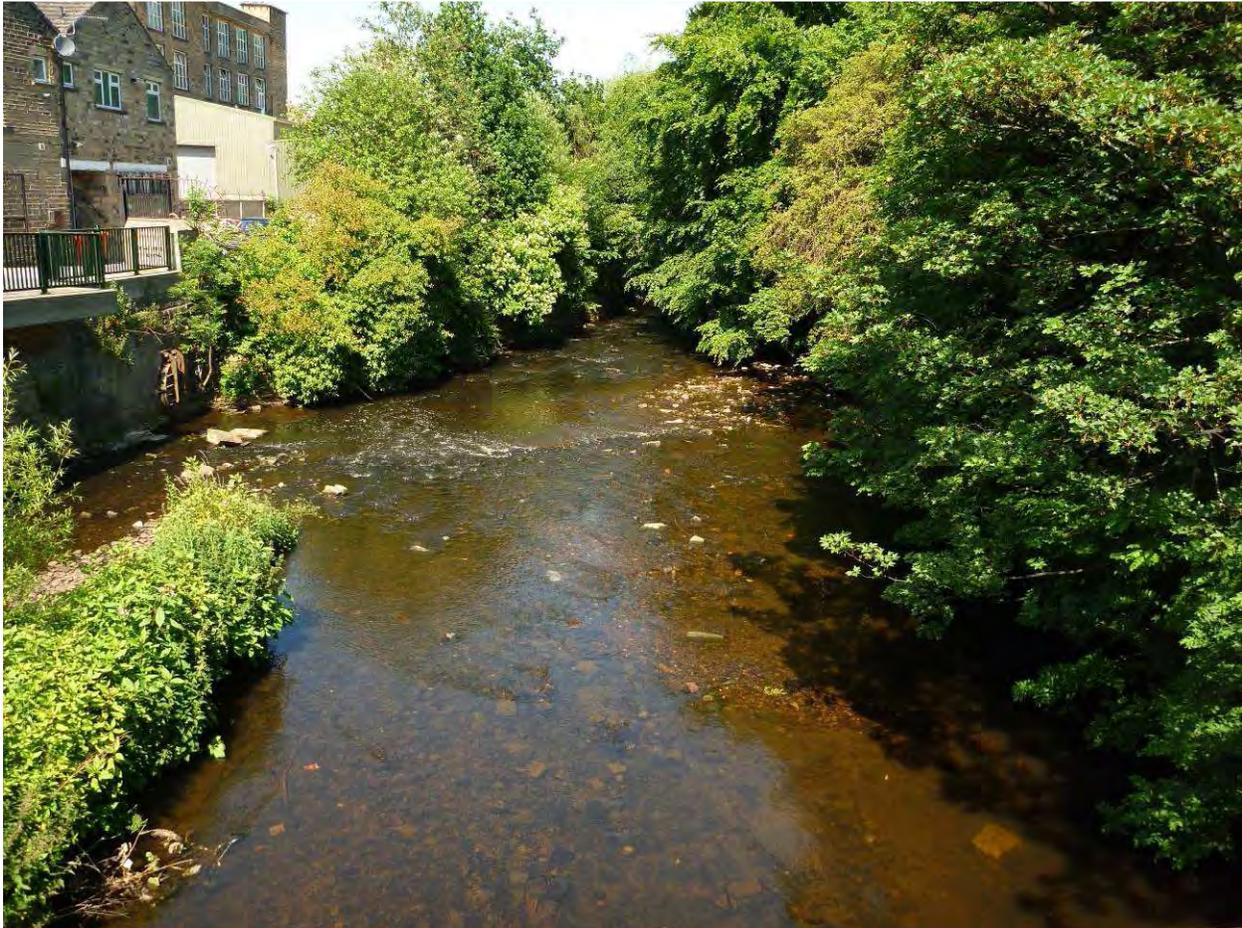
Special mention is made of the spawning habitat in this section (Fig. 13). Several factors combine to make this an absolutely vital "engine room" for healthy trout and grayling stocks in the Holme/Colne system. Firstly, and most importantly, are the clean mounds of sorted gravels that have formed at the tails of pools below the bridge. It is likely that water is flowing right

through these gravels, providing the constant supply of oxygen required by trout eggs if they are to survive and hatch. Secondly, there is an abundance of overhanging vegetation that fish getting ready to spawn can hide beneath between breeding attempts. Thirdly, the lack of easy access for the public to

Figure 13: Brighter orangey areas of gravels are visible towards the right of the frame close to and amongst the dappled shade from vegetation on the RHB. These mounds appear to be deposited material derived from the scour pool just upstream in the bottom right of the frame (in the area surrounding the pale square block of submerged debris)

this section of the channel may be important in avoiding damage to eggs developing in the gravels. A lack of undue disruption to the fish themselves during spawning may also help this area to achieve its full contribution to sustaining wild trout and grayling stocks. Potential disruptions or damage could be the result of, for example, families paddling or dogs being exercised within the channel. Also, in future years, with the vital work planned by the Calder and Colne Rivers Trust to bring migratory fish back to the system, these areas will become vital for any salmon spawning efforts. Therefore,

great care must be taken when considering how to arrange and sustain appropriate public access to the green spaces of Huddersfield. The existing restriction to physical access into the channel, whilst elevated views are afforded from the bridge is a good (if accidental) strategy. Appropriate interpretive signage may also be useful. Consider relatively cheap, easily replaced materials and treat as a consumable in urban areas. Don't use materials with scrap value.

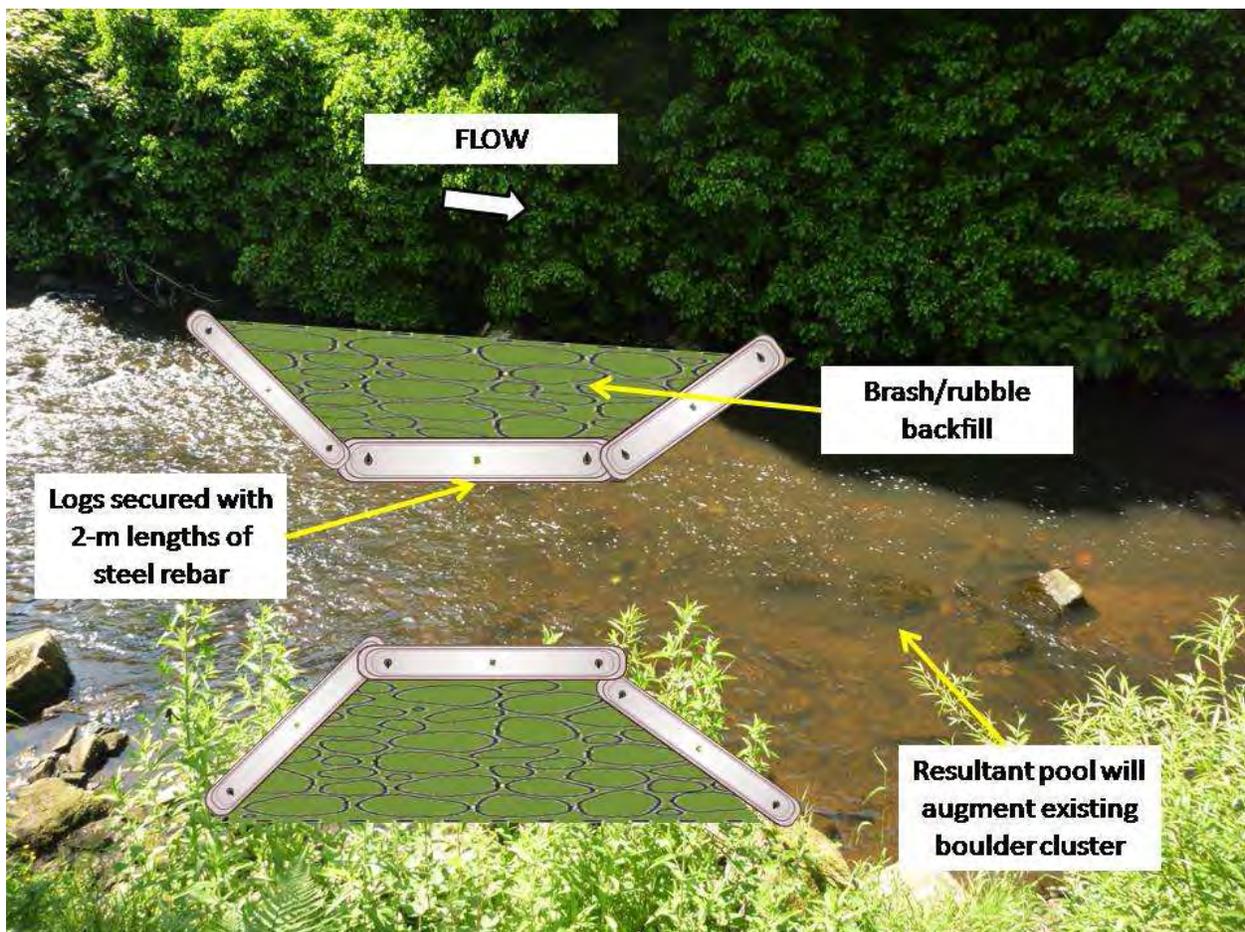
Figure 14: Suggested paired log and brush berm structures for amplifying bed scour. N.B. brushings can be nailed to logs used in construction in order to provide additional cover for juvenile trout

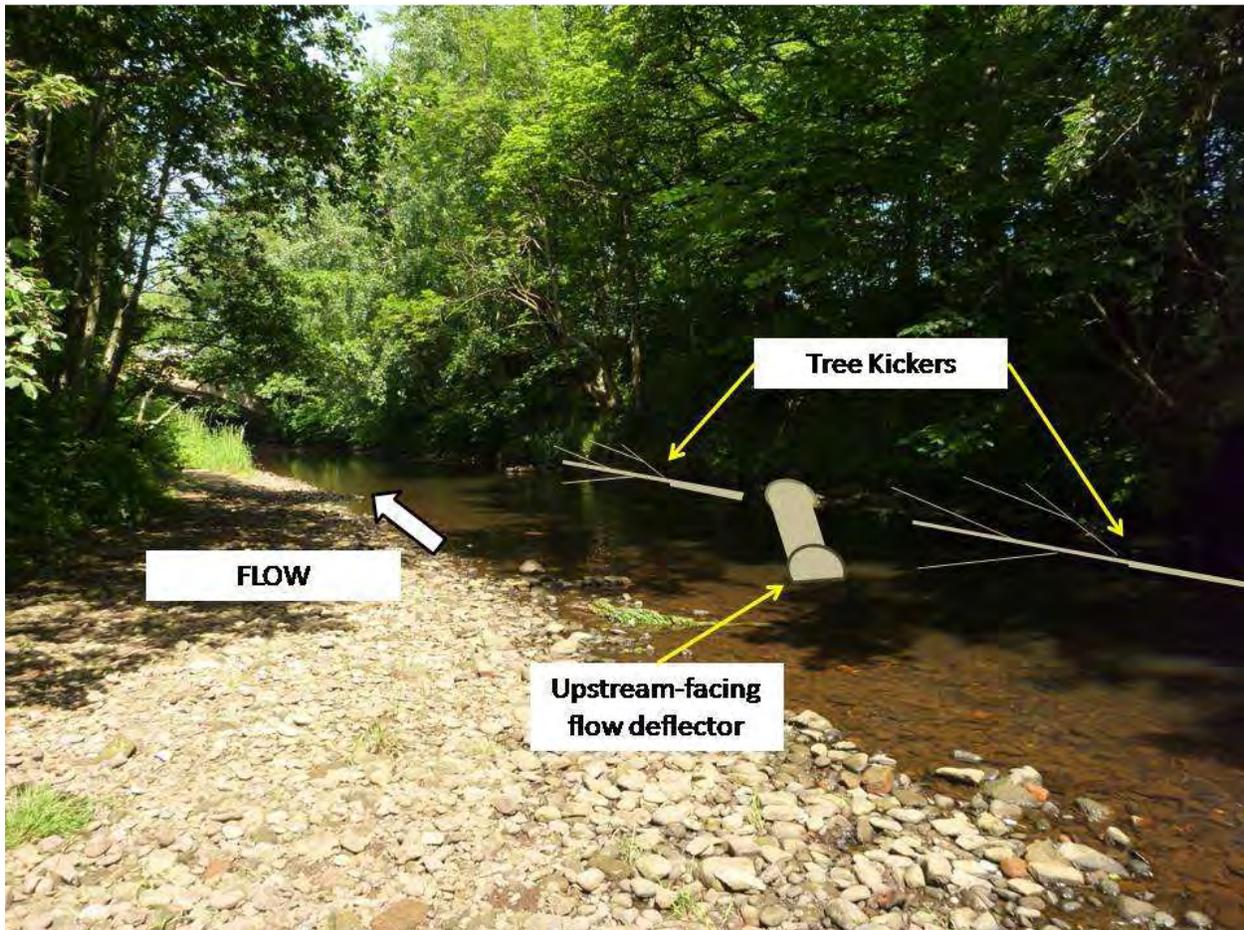
Figure 15: Log flow deflectors (anchored using 2-m lengths of steel rebar) used to promote localised scour could be used at 10 to 15-m intervals along the RHB. Interspersing log flow deflectors with tree kickers would provide additional cover for adult and juvenile fish
