## How Capel Brook

An advisory visit carried out by the Wild Trout Trust – July 2010

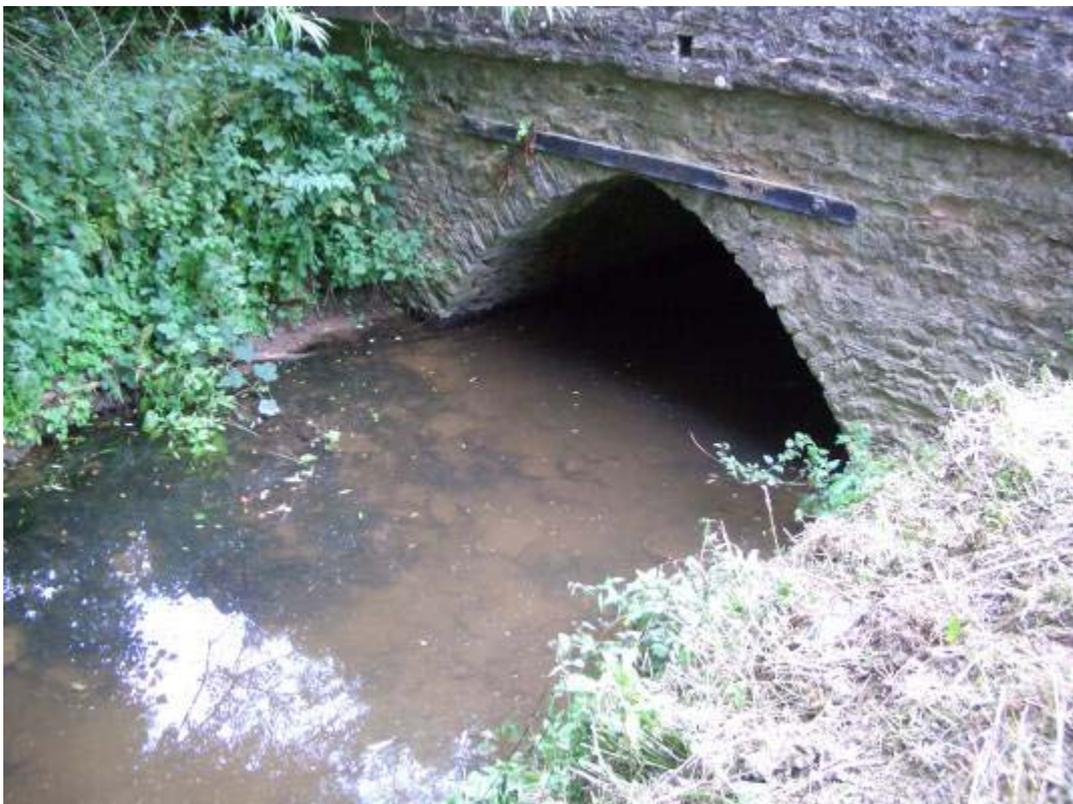
One such area where some cover and shade were on offer was under the bridge near to the top boundary of Mr Day's property.

Several small brown trout were seen adjacent to the old bridge. Trout often lurk under bridges as a shaded refuge from predators

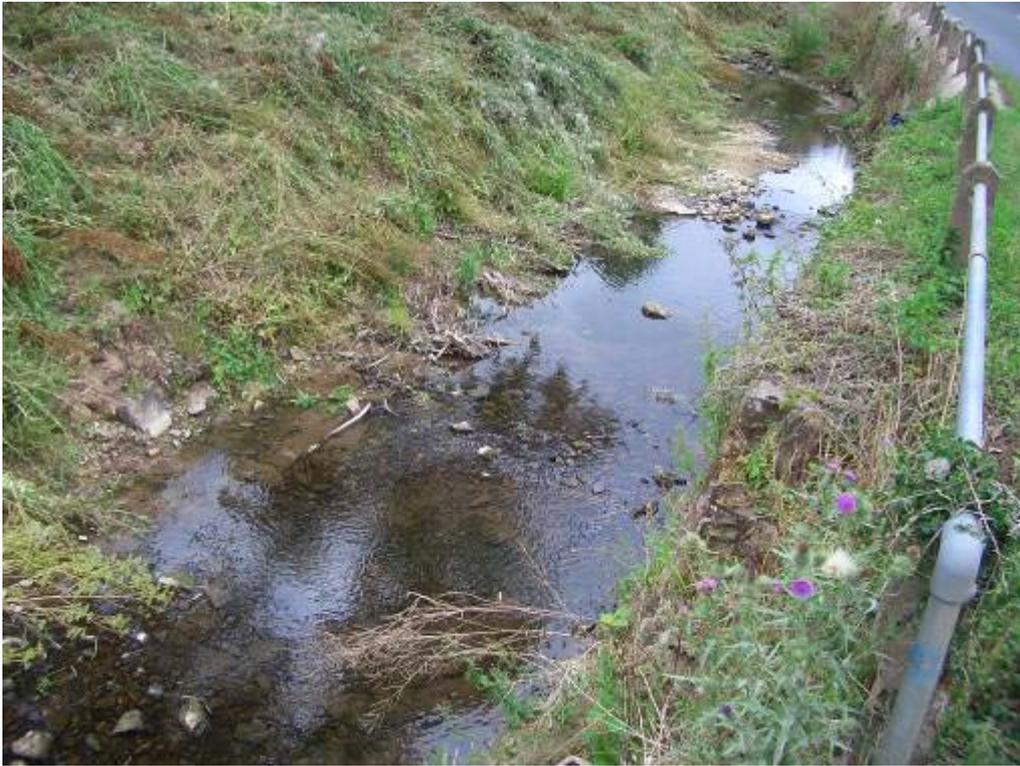
Just above the land holdings of Mr Day, the stream runs parallel with the main road. Here the stream had been subjected to some quite intensive marginal

clearance from both banks. Not surprisingly no adult fish were observed within this section due to the lack of any suitable pool habitat or overhead cover. The bed substrate was mainly gravels, with occasional larger stones and cobbles dotted on top. Habitat here was potentially very good for winter trout spawning and for juveniles, although the lack of any significant overhanging cover may deter fish from using this location.

Section adjacent to the main road. The lack of any low, overhead cover will restrict the habitat potential of this reach for trout

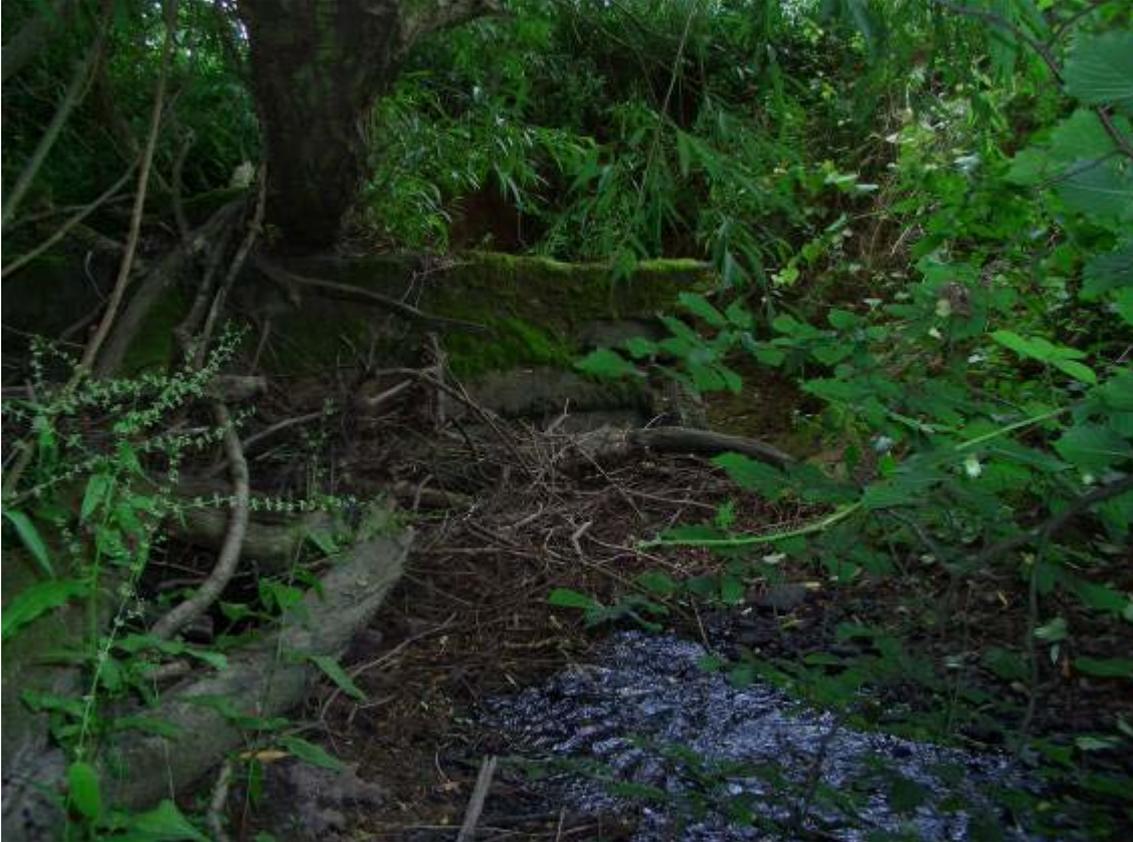
A stark contrast to this reach was observed a short distance upstream, where the stream runs alongside some meadows bordered by a thick fringe of mature trees. The river here lies within property owned by Mr Clay. The banks and margins of the stream through this section were largely unmanaged and the channel was extensively overgrown and shaded, mainly by mature alder, thorn and willow trees. A conversation with Mr Clay's game keeper revealed the presence of an old concrete structure that was presumably constructed to facilitate a redundant abstraction. The structure was semi derelict and although it was still impounding the channel, the stream had partially bypassed the weir by eroding a notch around one side.

An old concrete weir and a half fallen willow where the stream is finding a new way through. How many structures like this are blocking trout migration on the How Capel Brook?

- Work with local landowners, the W&UF and the EA to identify weirs and structures that currently fragment habitat and fish populations. The removal or lowering of impoundments will dramatically improve the ecological value of the stream.
- Maintenance regimes adjacent to the stream should be light. Never undertake marginal clearance on both banks at the same time.
- Try and promote low scrubby shade over deeper pool areas and encourage direct sun light onto shallow riffle areas.

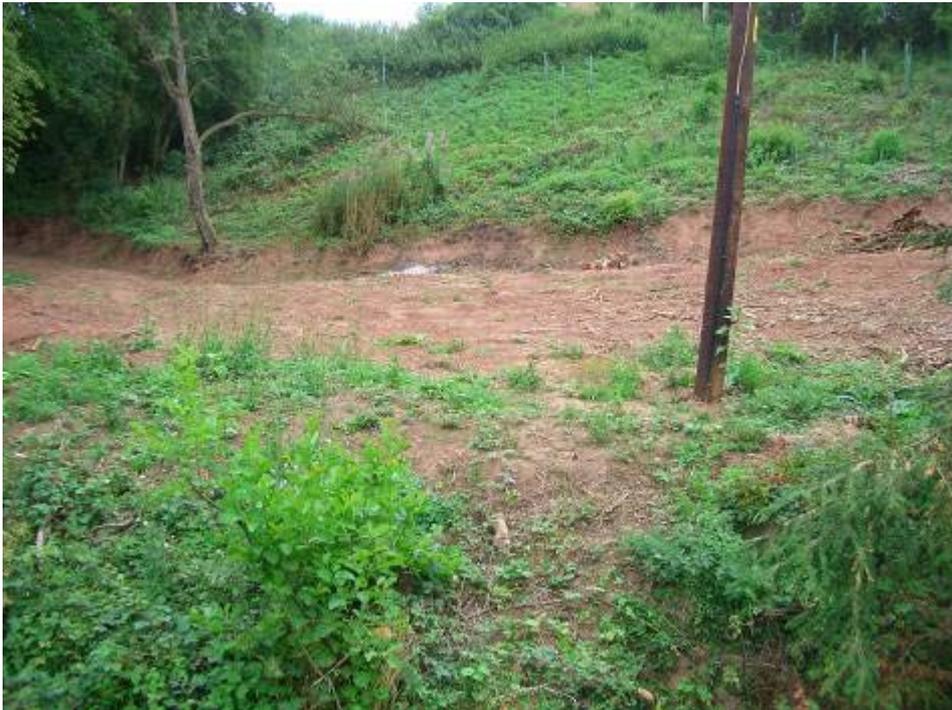
It was also noted that a small composting area had been created adjacent to the left bank. Leachate arising from cut grass or decaying vegetation is extremely polluting, having the ability to drastically reduce the dissolved oxygen content of

water. Composting areas, even of a very modest size, should be located well away from any watercourse.

Seeding the newly exposed track will reduce the amount of suspended sediments running off the slope and into the stream

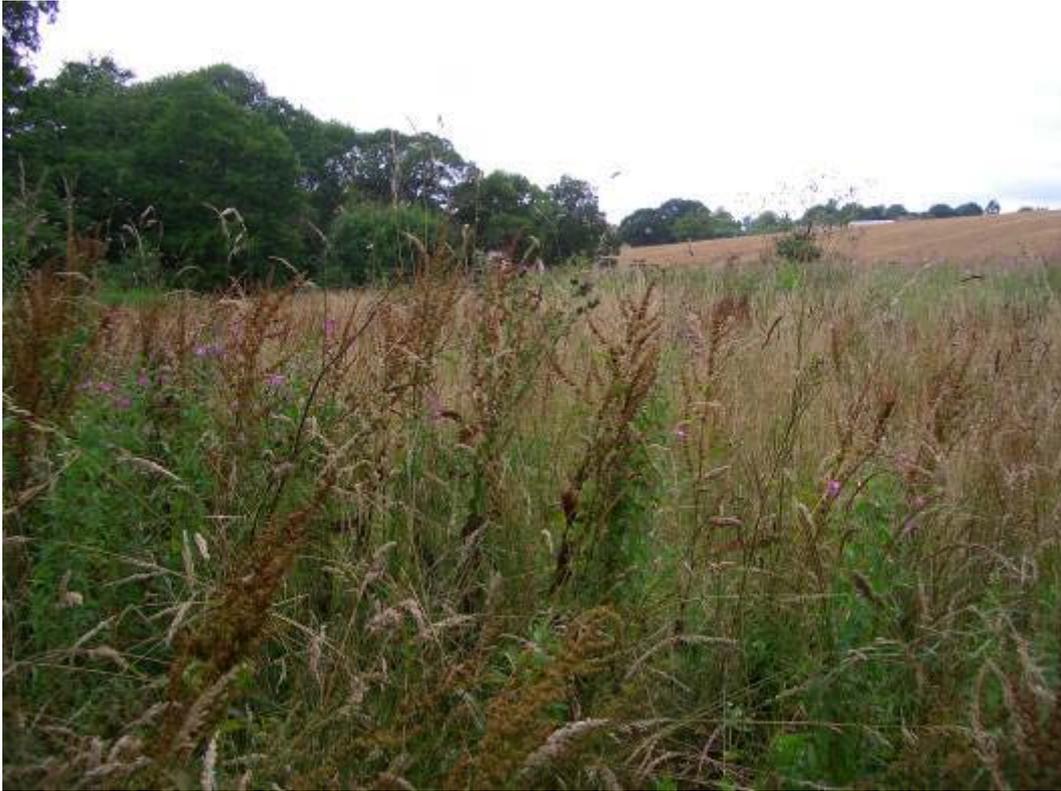
This wide buffer strip not only provides a valuable habitat in its own right, it also protects the stream from the adverse effects of nutrient rich sediments running off the cultivated slopes above.

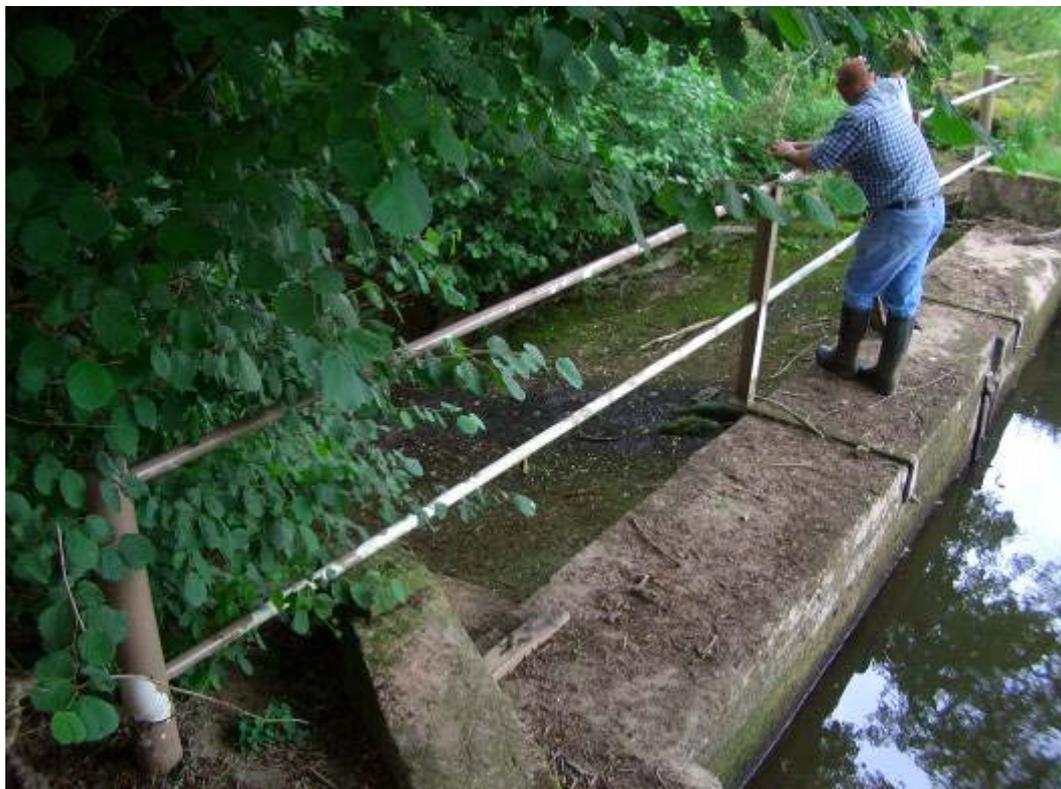
Two further sections of the Brook were inspected. On the first section there was an excellent example of a buffer zone protecting the river from the arable farmland lying further up the valley side. It is not known if this buffer strip complements a land stewardship agreement but if there were buffer zones of this size bordering every section of Wye tributary then the system would be in much better shape. Unfortunately, although the land care issues were well addressed, the channel was heavily influenced by the presence of a very large impounding structure. It was not clear exactly what purpose this weir serves but the adverse effects on upstream habitat was evident. A structure with a head loss of this magnitude will also be a complete block to fish migration on this stream.

A massive concrete weir fragmenting populations and habitat on the How Capel Brook

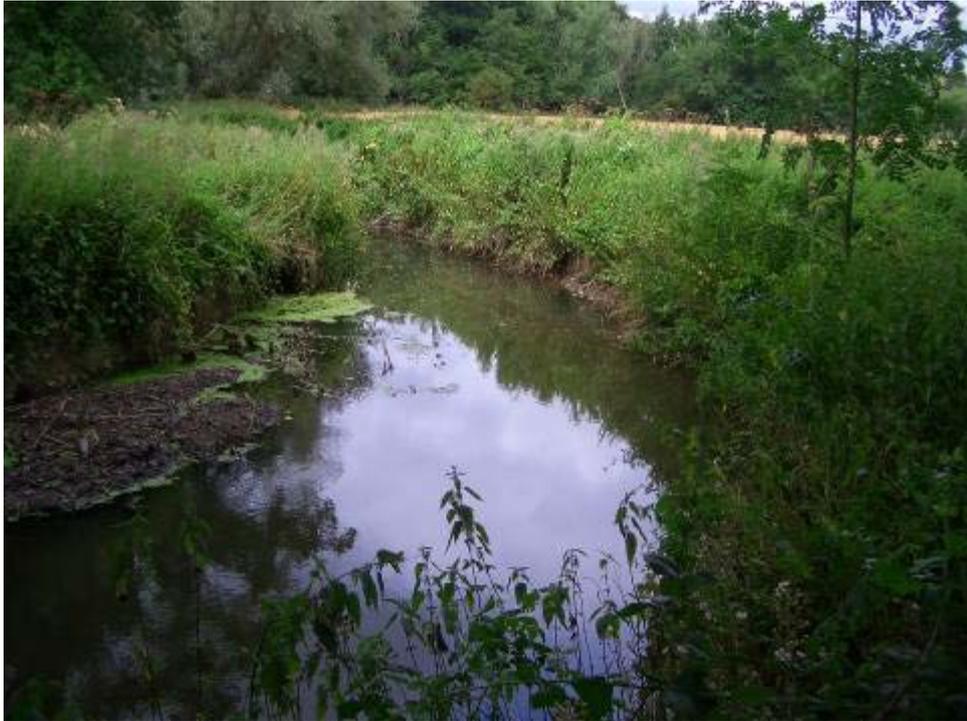
A view of the How Capel Brook looking upstream of the weir. Here the channel is deep and sluggish, with a barely detectable flow over a bed of deposited soft sediments. Poor habitat for flow loving fish species.

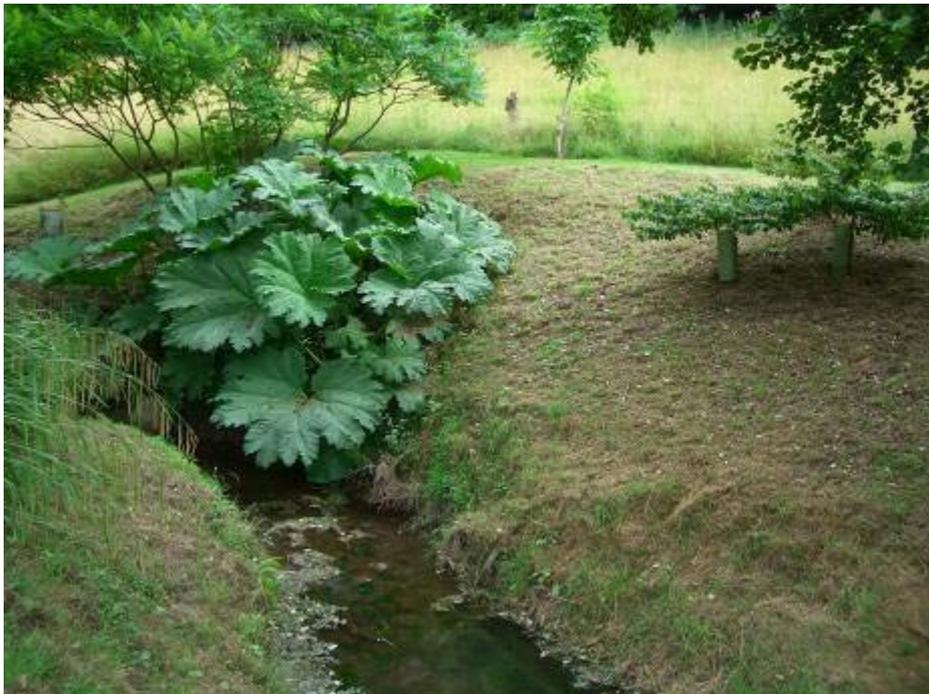
One of the last sections of channel inspected flowed adjacent to a large off-line lake. Here the channel forms part of some formal gardens and was subjected to some fairly intensive marginal maintenance in places, as well as some ornamental planting regimes.

Mowed margins and gunnera on the banks of stream.

When small streams run adjacent to formal garden areas there is always the temptation to incorporate the maintenance and planting regimes in line with plans for the wider garden. Unfortunately many non-native plants and tightly trimmed or mown banks are not conducive to protecting stream banks during high flow conditions. Fringes of wild native plants and extensive in-channel cover afforded by root bolls, fallen branches and patches of low scrub are not always desirable in garden locations but are extremely important for the ecology of our streams and rivers.

- On sections where the stream enters formal garden areas, avoid marginal planting with non native plants and protect margins with attractive emergent plants such as sedge and yellow flag iris
