Hunt's Stream (Wylfe Carrier)

Advisory Visit October 2018

Key Findings

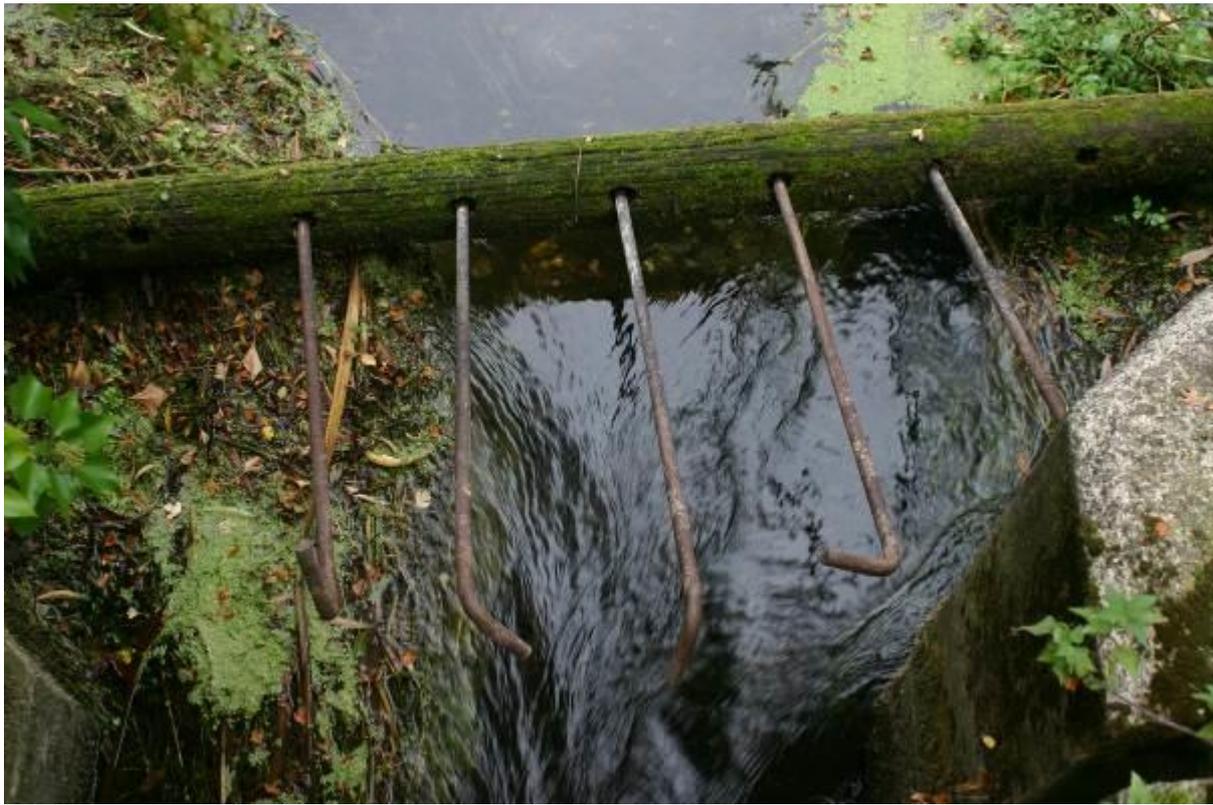
Like all chalkstream carriers, the amount of flow entering the Hunt's Stream is dictated by a water level control structure (photo 1) constructed to be contiguous with the LB of the main river. The hatch structure is square sided and has grooves to accommodate drop boards, as opposed to any controllable hatch gate. The structure also has a crude but probably highly effective adjustable weed rack constructed from a timber pole and retractable rebars. At the time of the inspection there did not appear to be any drop boards located in the structure, therefore taking its maximum available flow share from the main river. There is a secondary high level spillway that will take additional flow into the Hunt's Stream when the main river is at bank-full flows. The structure was considered to be passable for fish.

Photo 1. The offtake structure at the head of the Hunt's Stream. Note the adjustable rebar weed rack with all pins fully drawn.

- Explore options for rebuilding the offtake structure to take a more naturalistic flow regime to encourage winter flushing of fine settled sediments. Make a full assessment of possible impacts to the main channel before making any decisions.
- Liaise with the EA and NE over the possibility of removing the hatch structure, including the stone/concrete invert, to improve sediment transport and fish migration through the reach as a whole.
- Tackle the encroaching willow with increased maintenance effort but be sure to leave plenty of low, water level cover, especially over potential holding pools. Undertaking the control of the willow on a rotational basis will ensure important cover is maintained.

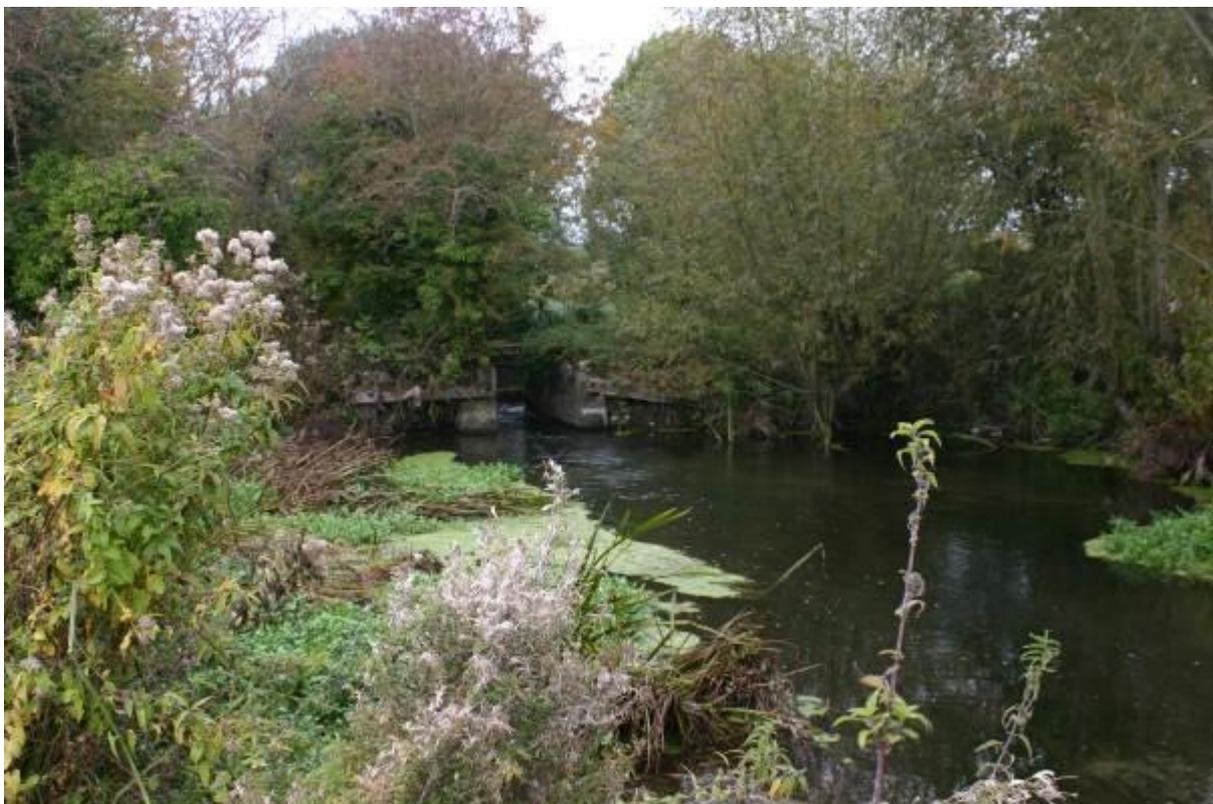
Photo 2. The hatchpool at the head of the stream provides high quality lies for adult trout.

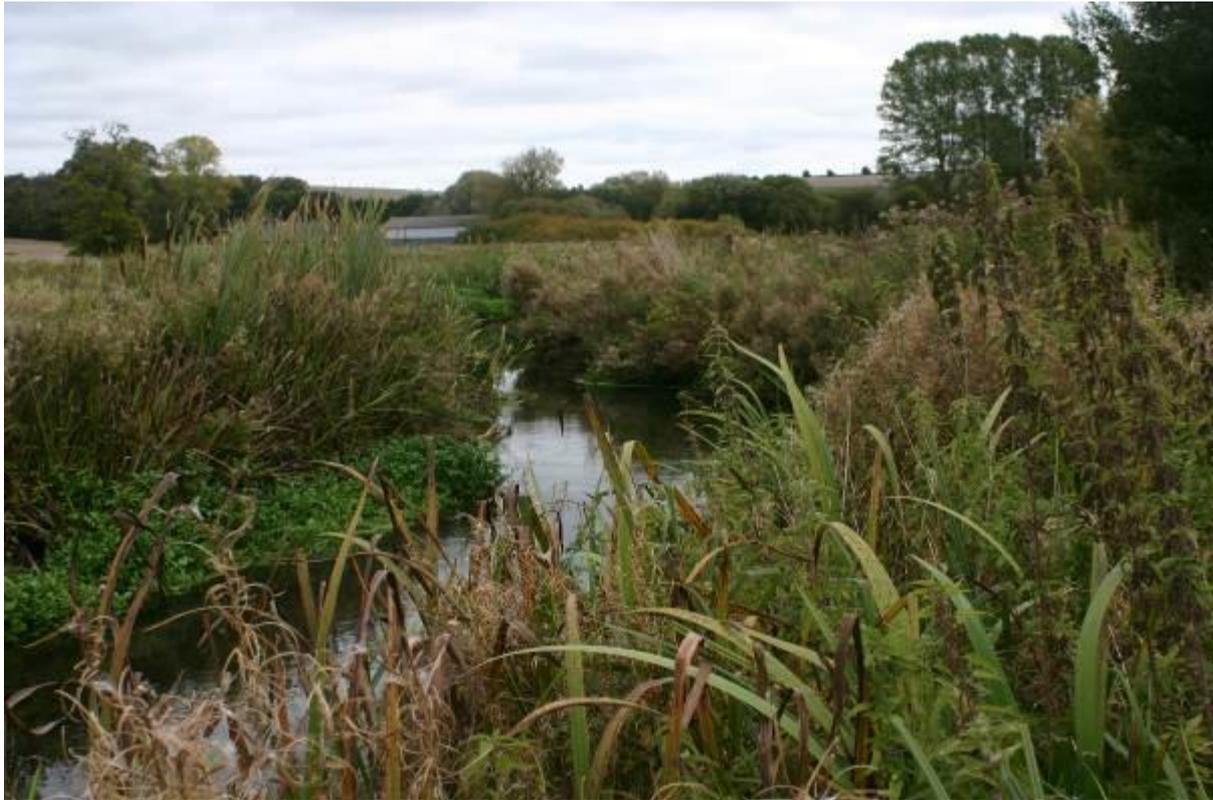
This meandering planform is typically also associated with a gentle bed gradient and this is also evident in this location, with the upper reach being mainly deep and slow flowing and lined with emergent reeds (photo 3 and 4), including Norfolk reed *Phragmites australis*, branched burr reed *Sparganium erectum*, reed-sweet grass *Glyceria maxima* and reed canary grass *Phalaris arundinacea*. This luxuriant marginal vegetation provides wonderful bank protection and diverse habitat but also poses some difficulty in terms of accessing the fishery. However, it is important to maintain a comparatively narrow channel width here to ensure that mid-channel water velocities are maintained.

Photo 3. The meandering upper section provides good holding habitats for adult trout

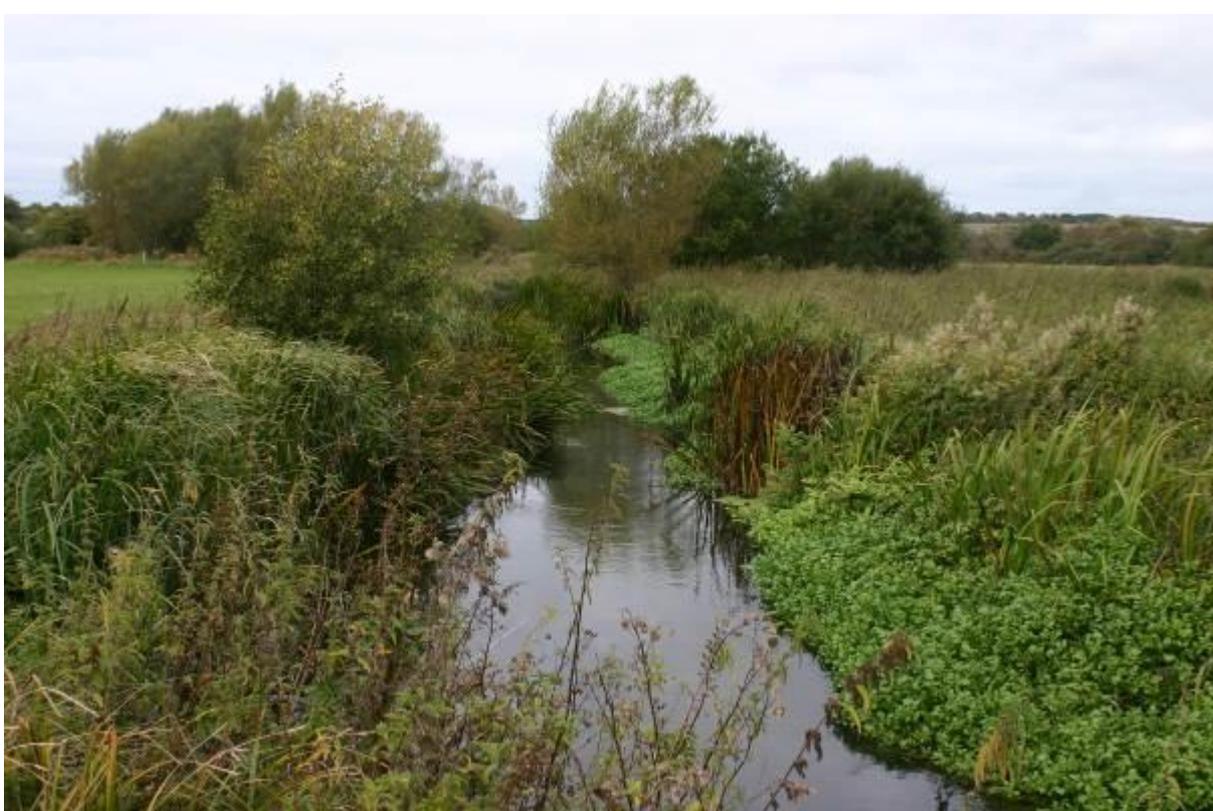
Occasional goat willows *salix caprea* punctuate the more open sections to provide the odd section of channel shading, which helps in part to restrict the dominance of the emergent plants and in some cases also provides good quality low-level cover for fish.

Photo 4. The odd goat willow punctuates the reach and provides some modest shading.

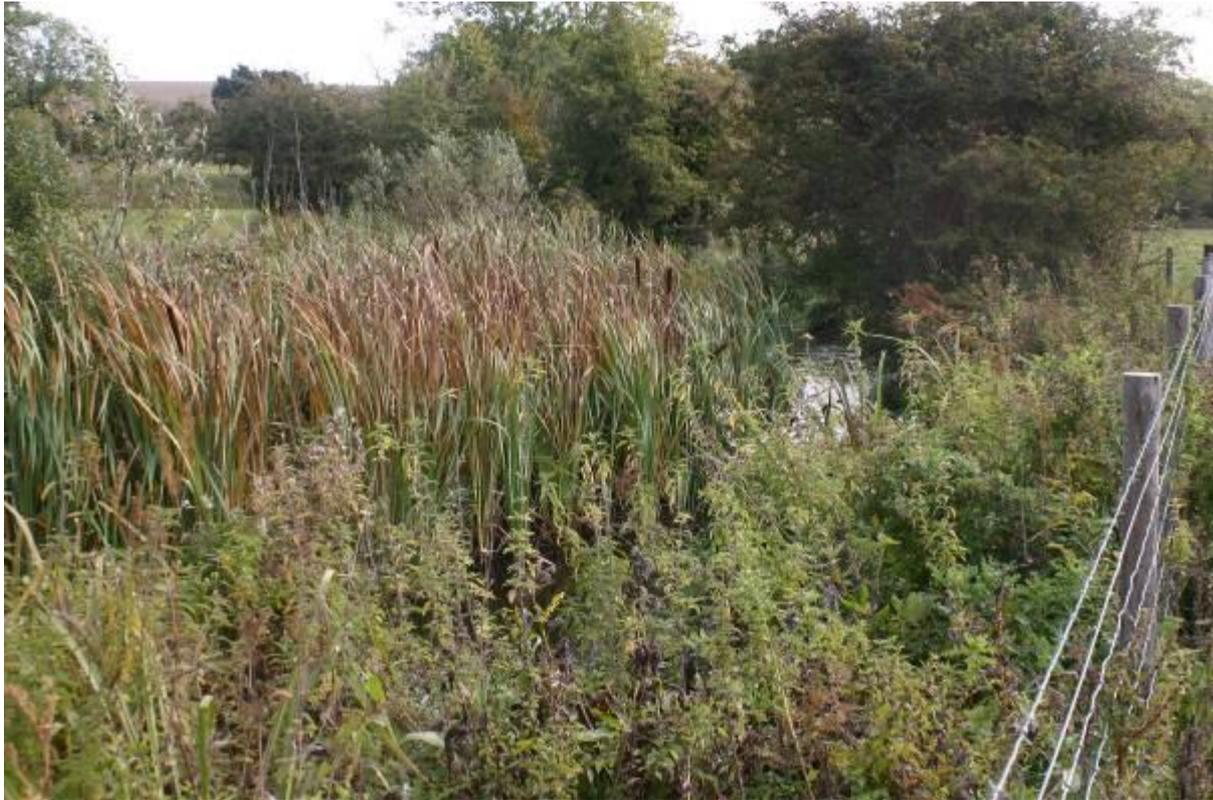
A short distance downstream there is also a bed of bulrush, or great reedmace (photo 5) *Typha latifolia*. This plant is typically found lining the margins of lakes and ponds and is not normally associated with the margins of flowing chalkstreams. The encroachment of this plant into the channel is usually naturally controlled by flow velocity but in a low flow year, this plant, along with the Norfolk reed has the capacity to encroach into quite deep water. All of these species of emergent reed and rush are valuable marginal plants but care should be taken to ensure that they do not become established in central channel locations. Emergent plants can be relatively easily grubbed out with hand tools if absolutely necessary but again it is important that a squeezed channel cross section is maintained to keep soft sediments rolling through the reach.

Photo 5. A thick bed of great reed mace lines the inside of a sweeping bend, helping to trap sediment and providing high quality habitat for invertebrates and birds such as various warbler species. Established beds of emergent plants on the inside of meander bends help to accentuate channel sinuosity and will encourage bed scour and faster water velocities on the outside of bends.

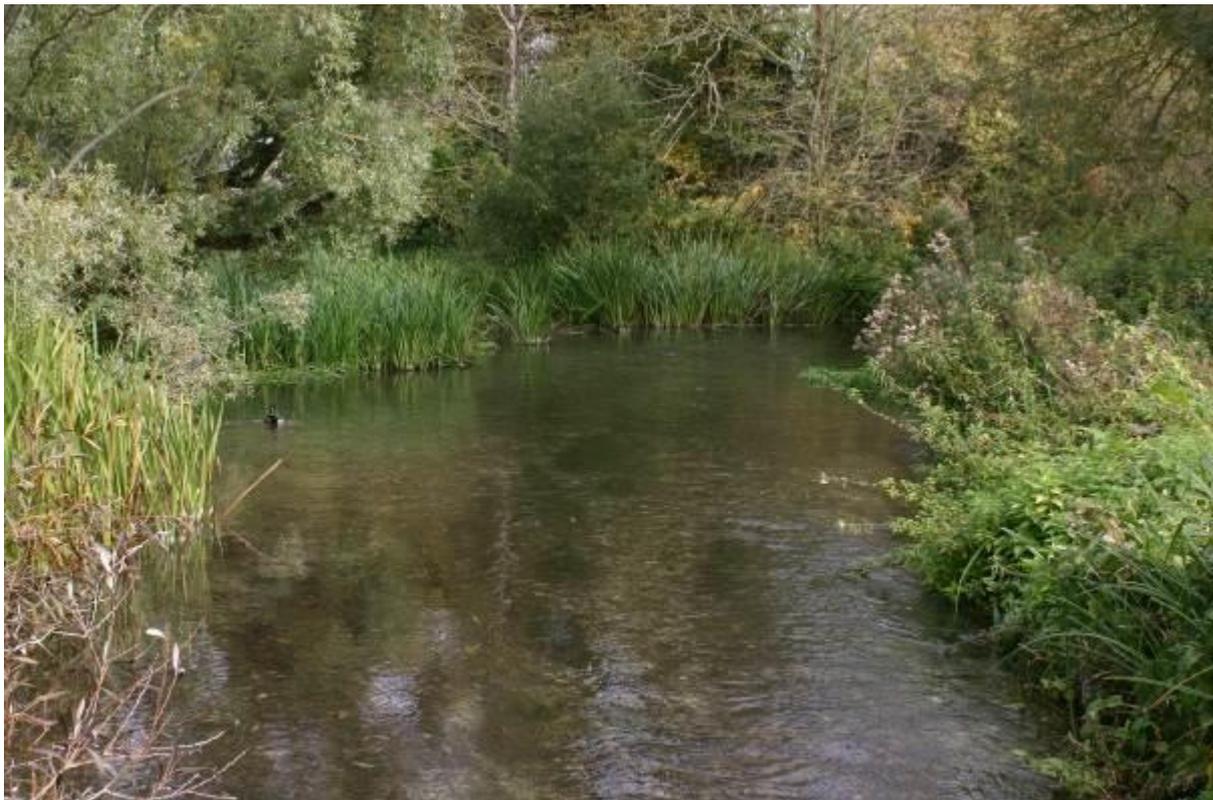
Habitat quality through some of the middle reaches of the Hunt's Stream is compromised via a combination of impacting factors. The ford crossing (photo 6) may have been located at a naturally shallow point at some stage in the past but it is more likely that it has been constructed from imported material, artificially raising the bed and resulting in increased upstream fine sediment deposition. The invert of the downstream hatch structure will be having a similar effect, which will be even more pronounced when drop boards are in position.

Photo 6. The Ford is likely to be made up from imported material and will be contributing towards fine sediment deposition in the reach above.

The bed slope through the entire reach of the Hunt's Stream appears to be quite modest but effective sediment transport is also compromised by having two artificial steps in the river bed, one associated with the ford crossing, which has presumably been augmented from imported materials and the second at the hatch structure located further downstream. If the ford is still in use then the only option would be to construct a clear span bridge. The club could improve sediment transport by removing all of the boards in the hatch structure, and even better, remove the supporting invert as well to restore the natural bed gradient. It is recommended to consult with the EA and NE before making any long-term plans for the structure. There is little point in lowering the ford height unless there is also a commitment to remove the hatch invert. If the hatch were to be removed the attractive holding pool downstream of the structure could be maintained by installing opposing woody flow deflectors to create a narrow flume.

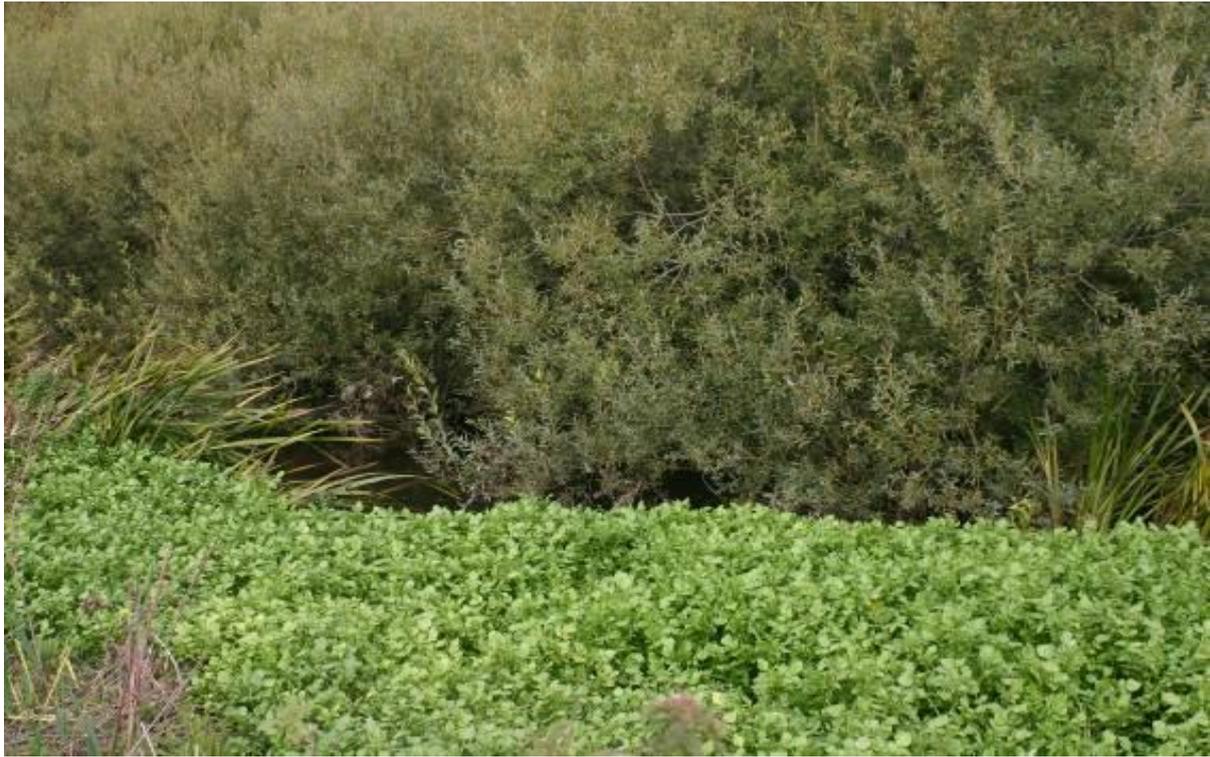
Several sections of river upstream of both the ford and the hatch clearly demonstrate that these areas are collecting zones for fine sediments that rarely get flushed through. In turn, this has created an ideal environment for encroaching emergent vegetation (photo 7). Difficulties in maintaining the fishery have also arisen due to the encroachment of what looks like either hybrid willow, or possibly native white or crack willow formed into LB revetment, either via willow spilling or live willow faggot work (photo 8). Areas where so much live willow has been planted will require periodic maintenance work to avoid excessive channel shading and encroachment.

Photo 7. The combination of lots of settled sediments, ideal for emergent plants and the encroachment from the left bank of willow has resulted in lost "open" channel. It is possible to peel back the raft of fool's cress and water parsnip back onto itself with a chrome/turn-down rake to maintain a narrow open channel. The willow also needs to be pegged back in places.

- Peel back encroaching fringes of marginal emergent plants and fold back to form a soft, boggy margin. Be sure to maintain a channel that is sufficiently narrow to maintain swift central channel water velocities.
- Note that before undertaking works, Environmental Permits may be required from the Environment Agency.

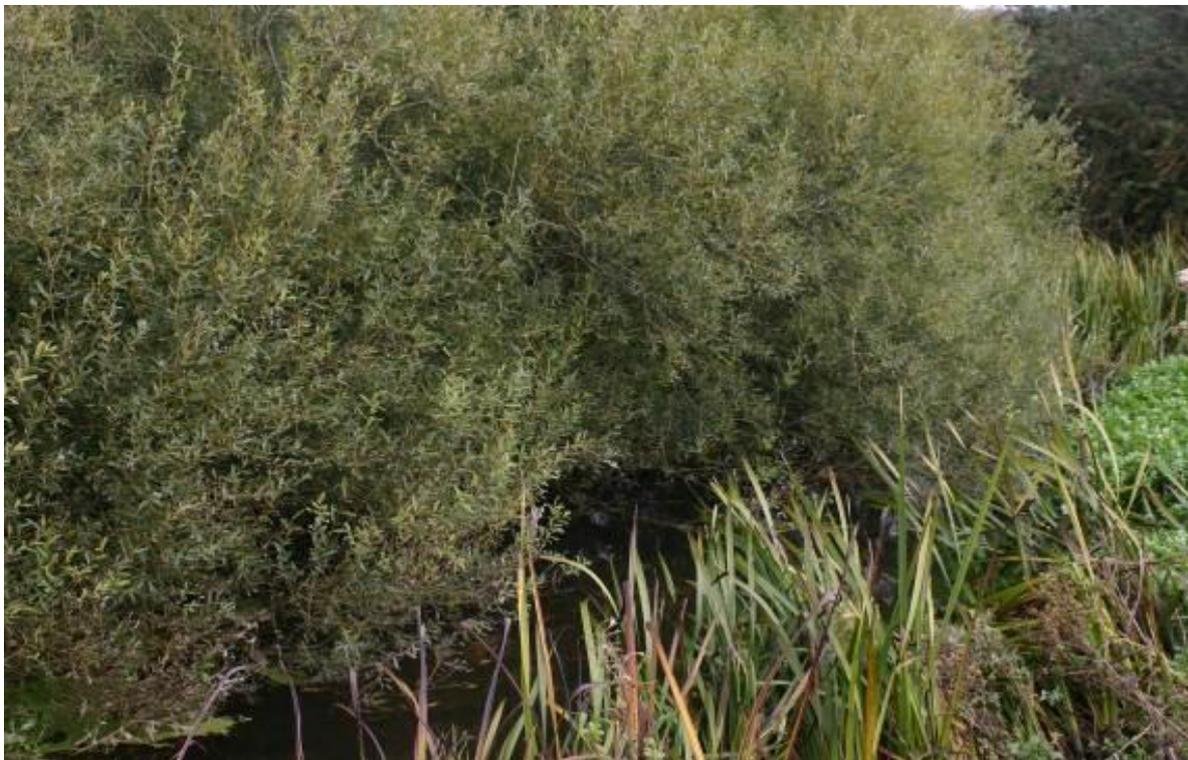
Short linear clumps of low-level tree shading via native goat willows are considered to be extremely valuable but long sections of linear willow scrub, which currently dominate some sections require maintenance. Ideally the reach should support a mosaic of tall landscape trees that help restrict too much scrub, interspersed with the odd low-level willow that casts marginal shade and

Photo 8. Excessive willow encroachment is possibly the result of past revetment work using live willow

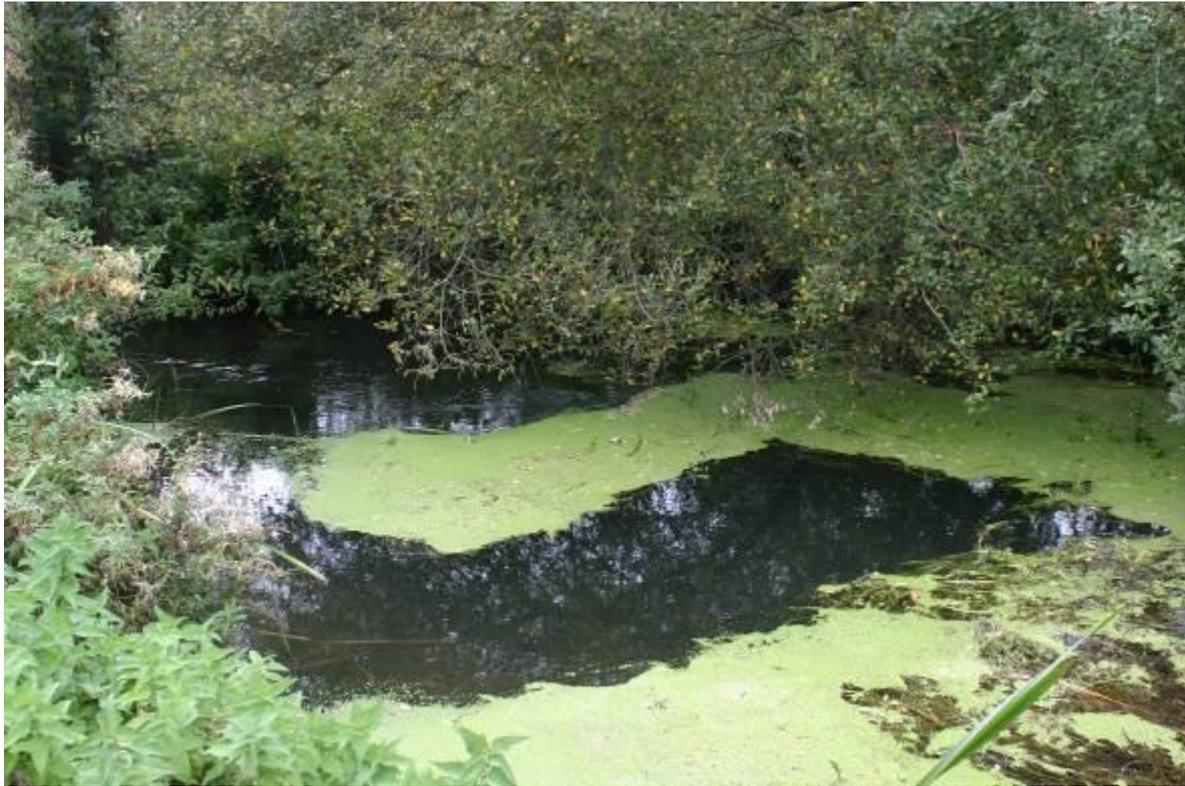
In some areas the combination of the flat bed gradient, compounded by the raised bed levels at the ford and the hatch invert have left flow velocities so low that rafts of duck weed (*Lemna sp*) were forming (photo 9) behind any debris that was partially blocking the channel. It should be recognised that at the time of the river inspection the flows entering the Hunts Stream were extremely low, however, rafts of surface duck weed is a clear indicator that habitat quality for flow-loving species like brown trout and grayling is likely to be very poor.

Photo 9. The formation of rafts of duck weed indicate stagnant water

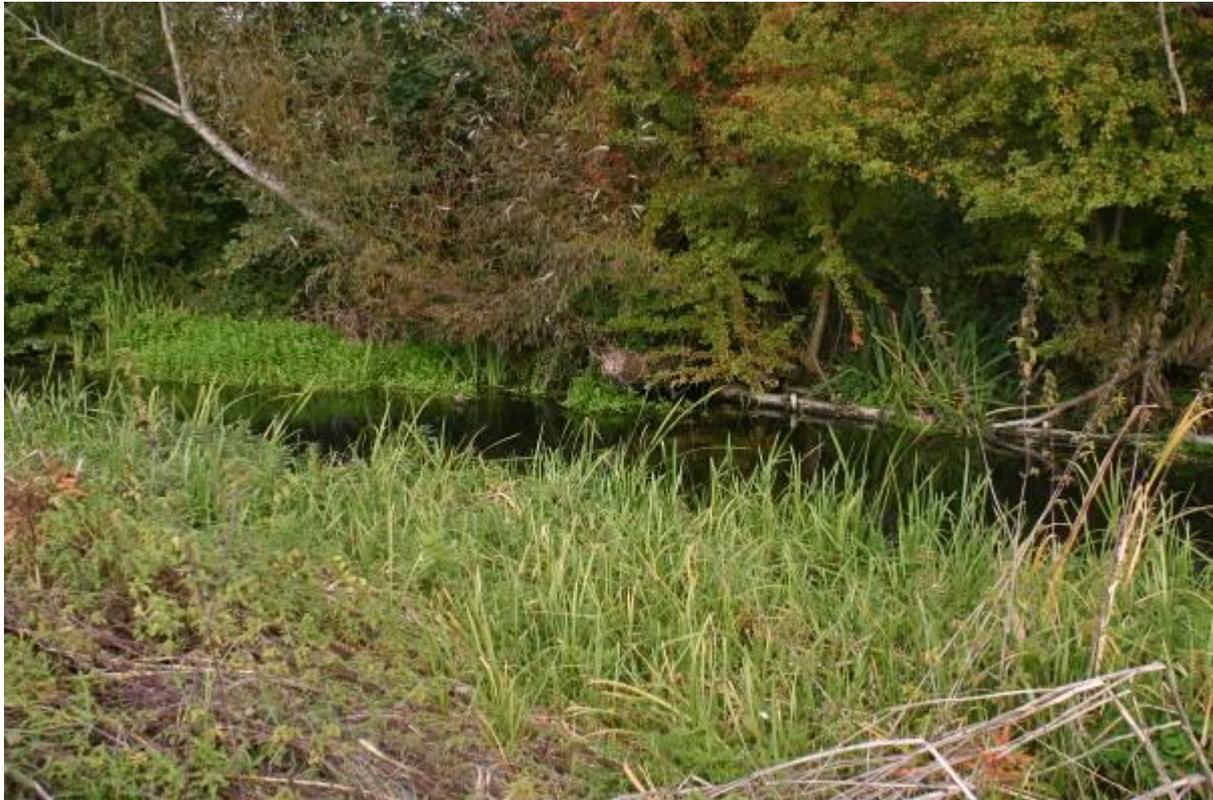
Further down the reach, the combination of just the right amount of maintenance work has resulted in some lovely water that will be attractive to both adult wild trout and the angler alike (photo 10 and 11).

Photo 10. Good quality holding water for adult trout.

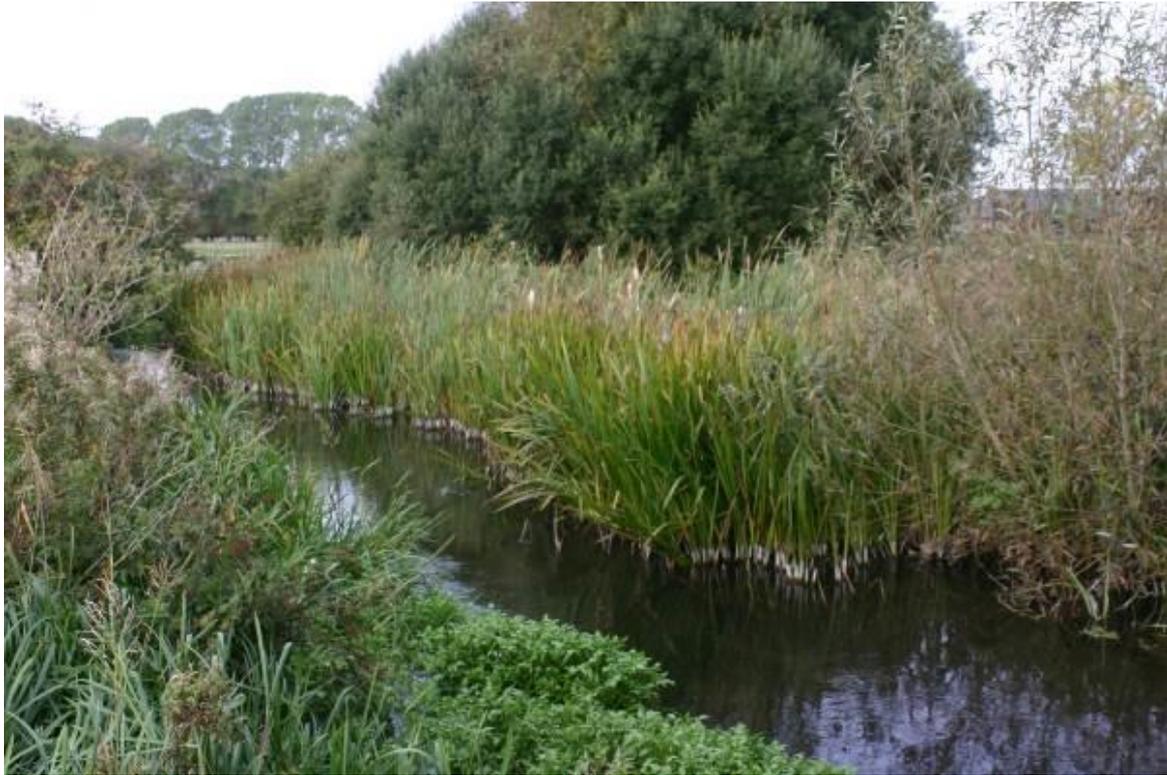
Photo 11. The slightly squeezed channel width is generating sufficient flow velocity to make this reach a decent holding area for adult trout. Pulling the water through faster by lowering the hatch invert would potentially drive the bed down over time and make it even more attractive for trout to hold.

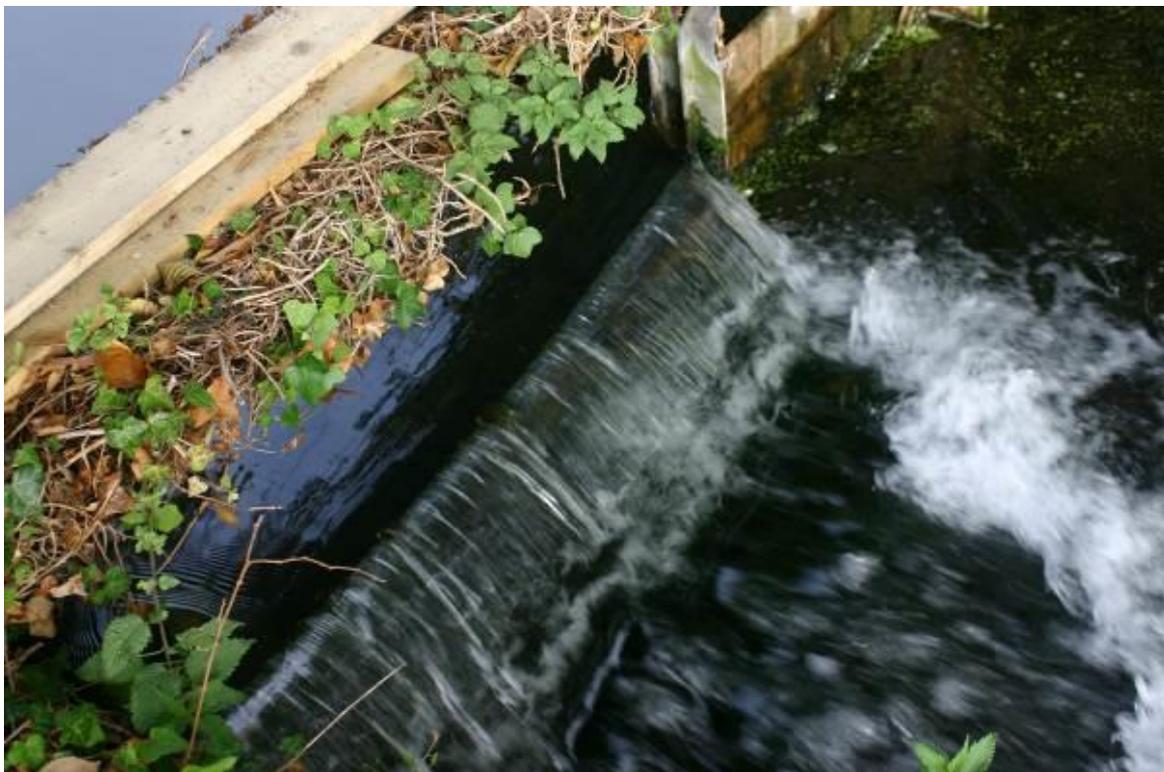
The refurbishment of boards for the hatch structure (photo 12) is likely to split opinions in terms of its value in maintaining a high quality environment. It is not clear what purpose the hatch serves, unless it is a replacement for an old water meadow drowning structure. It is possible that the value of this structure has been assessed as part of a Water Level Management Plan associated with the local SSSI. Before making any long term plans for how this structure is managed it would be advisable to consult with Natural England to make sure the structure hasn't been identified as being of critical importance to the future management of the SSSI. In terms of in-channel habitat and the overall health of the carrier as a whole, it would be better if it was completely removed.

Photo 12. The refurbished hatch structure with new boards and potentially more waiting to be used. Note the shallow erosion apron making it extremely difficult for fish migration.

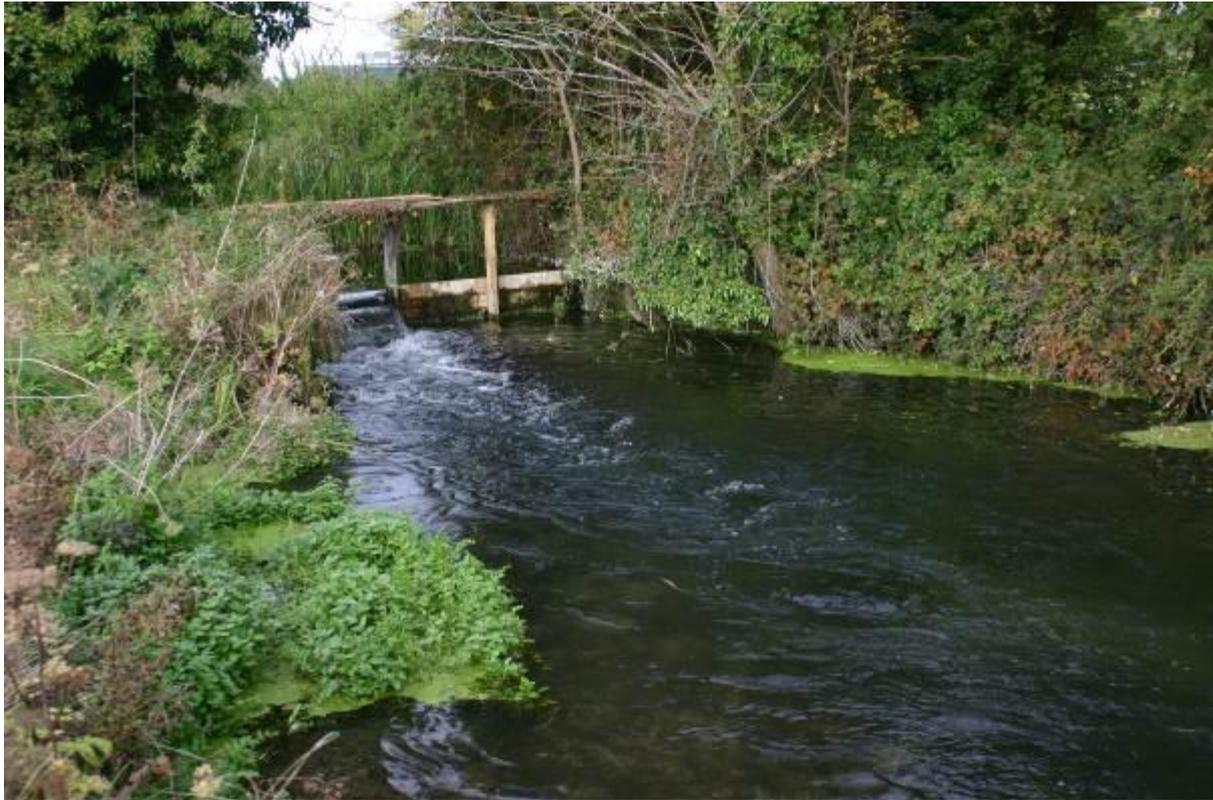
Although the head of water dropping over the boards provides a localised improvement downstream by scouring away fine sediment and providing good trout holding via increased depth and flow through the pool (photo 13), the structure will be adversely impacting on a long section of channel above. The structure with boards in place will also arrest any upstream fish migration, potentially corralling fish into this area that might otherwise redistribute into favourable upstream lies. This is likely to be more of an issue in the last month of the season when fish will be looking to move up on spawning migrations. Although the height of the impoundment is modest, the lack of depth immediately below the boards caused by the wide hatch invert will make navigation over this structure very difficult for small and medium sized trout.

Unfortunately the short section of high quality habitat created by the extra flow power is a high price to pay for the negative impact on a substantially longer section of channel above the structure. The lack of fine sediment transport in the carrier as a whole is at the very heart of why there is too much plant encroachment. A lack of anything resembling a natural winter flushing flow, due to the throttle at the off-take structure, in combination with the bed impoundments exacerbate the siltation problem.

Photo 13. The structure is maintaining a high quality trout lie downstream but at what cost to the reach as a whole?

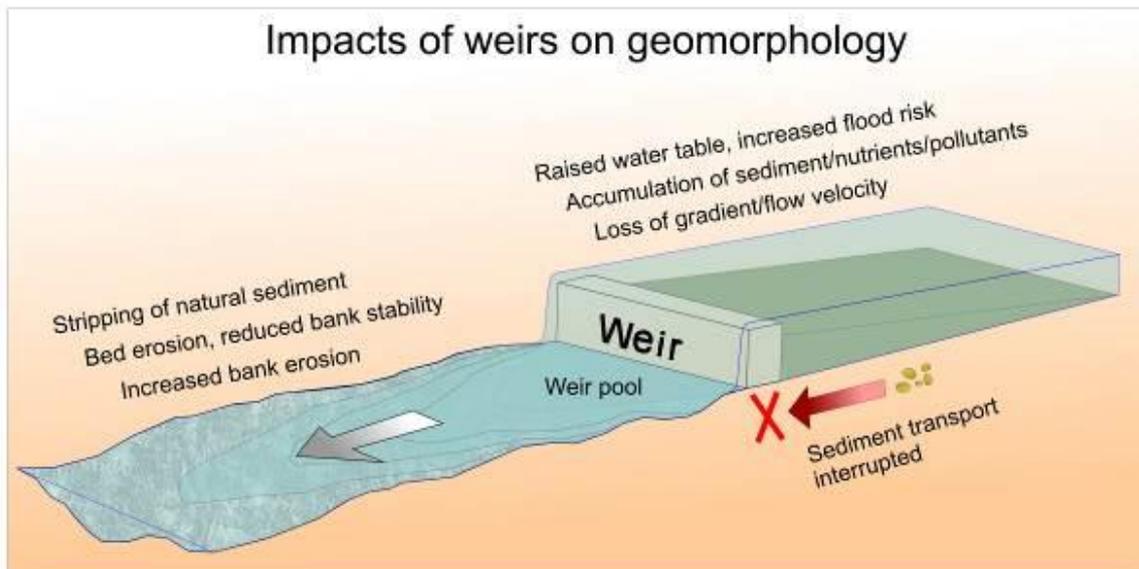
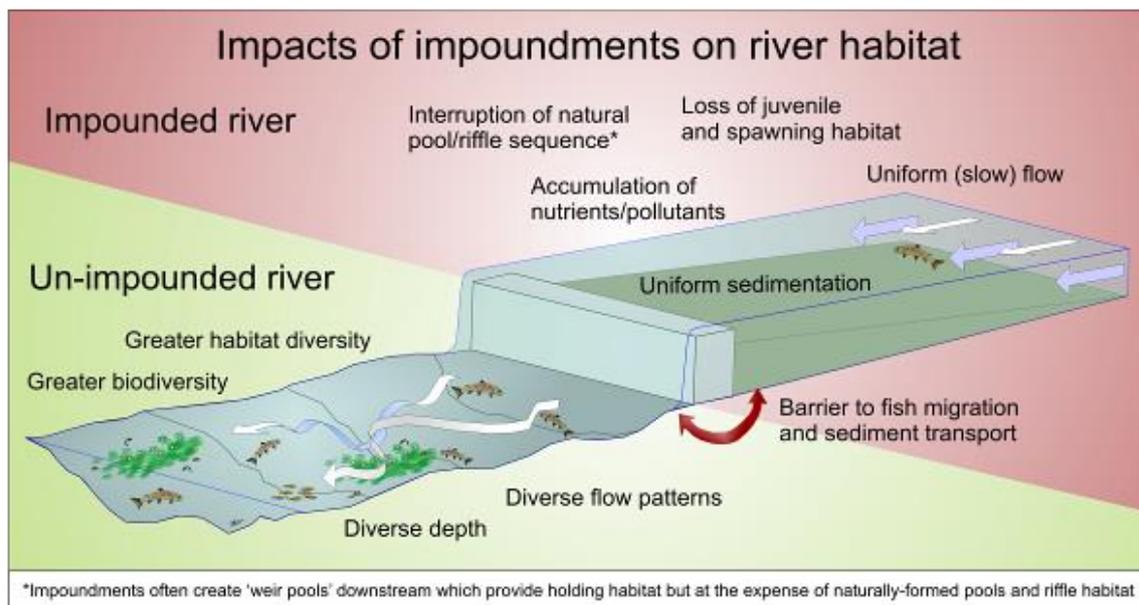
The two schematic drawings below encapsulate the impacts that weir structures have on the physical shape of a river channel as well as its ecology.
