Advisory Visit for Ilkley Angling Association

River Wharfe

19th July 2013

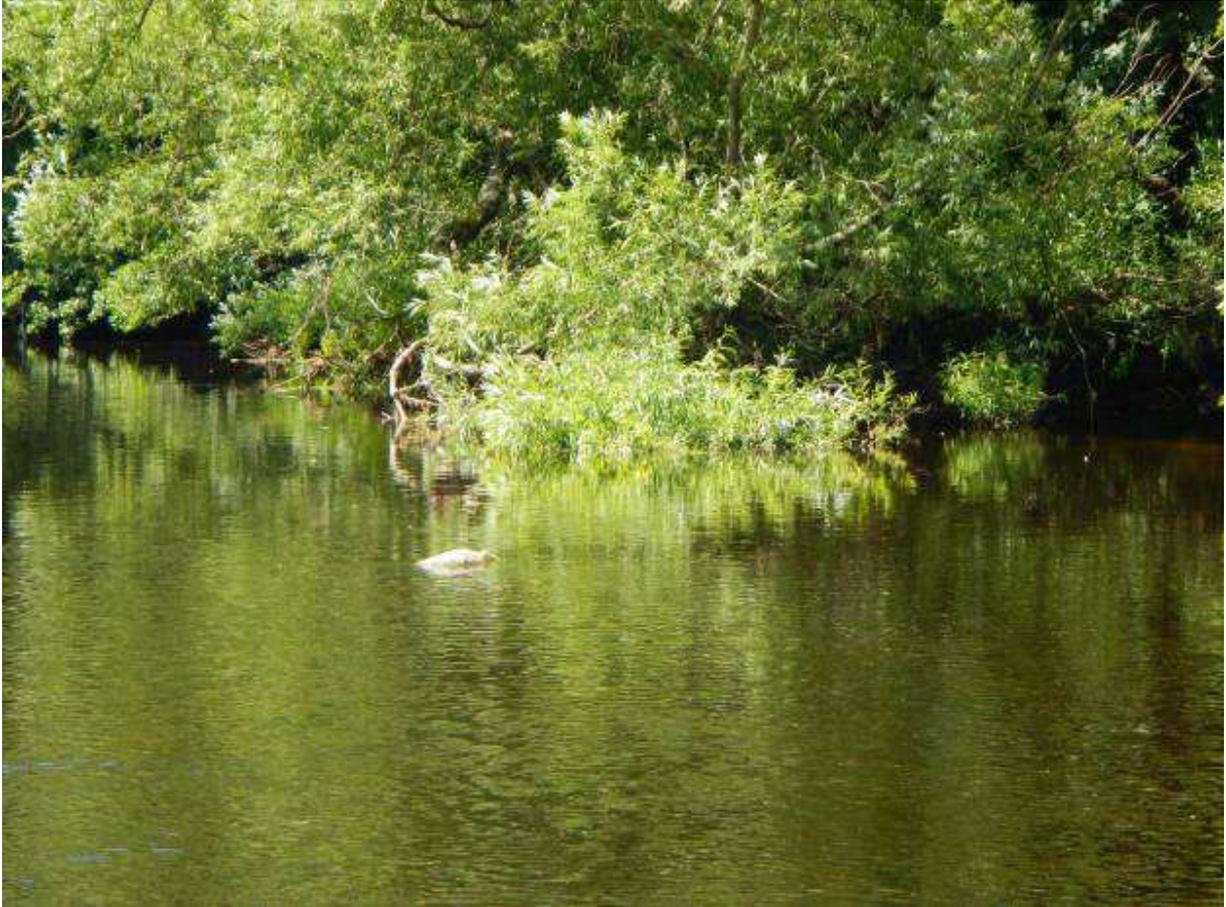
Although naturally a freestone type river, often occupying a wide channel (often with exposed gravel and cobble features along the margins and a general lack of aerial cover, particularly at lower flows), low level cover was present in many areas, providing valuable shade and shelter, even on some of the straighter sections (Figure 1).

Figure 1. Valuable cover and provided by a fallen (living willow) branch. This is the sort of feature that can be recreated by branch laying (see recommendations section).

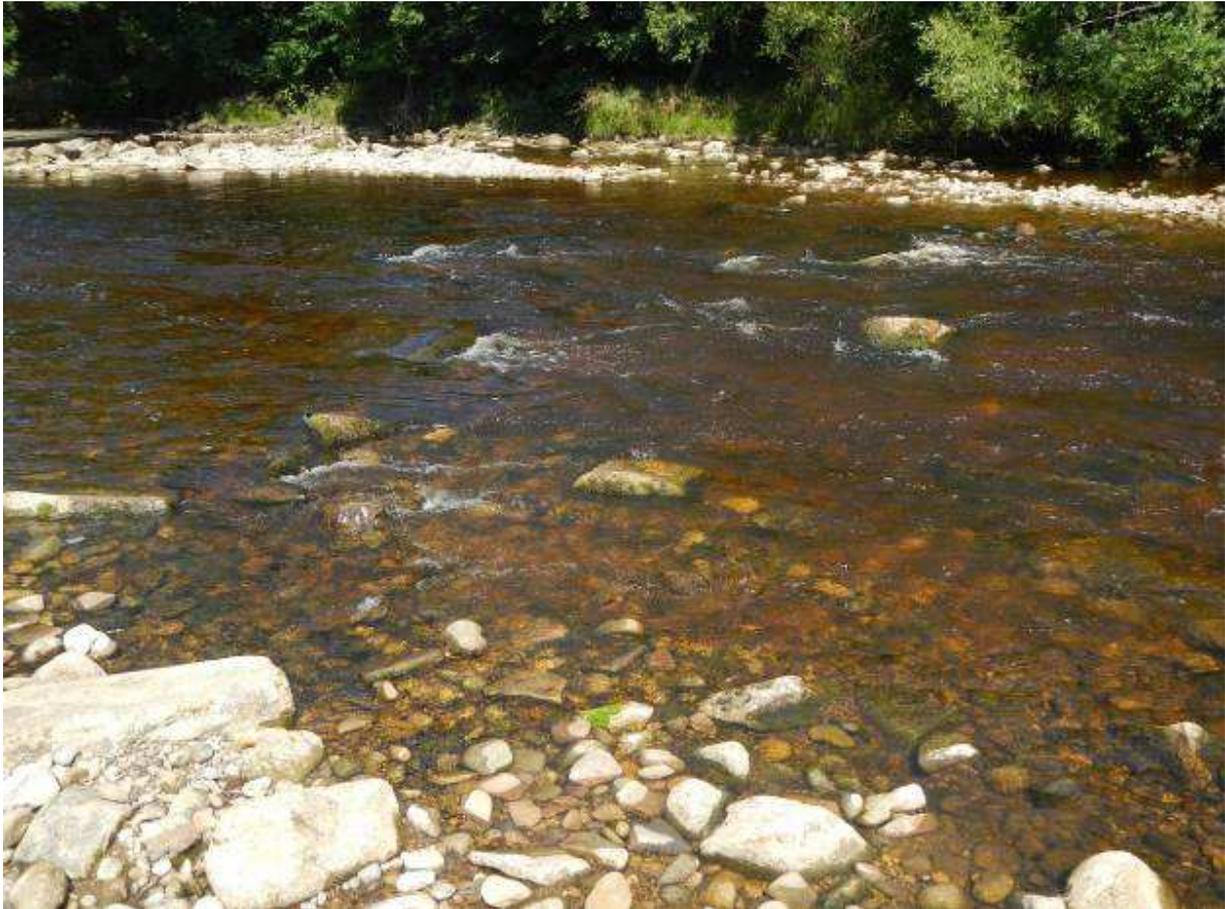
In areas where the wetted channel does not reach the banks, and marginal vegetation and trees do not overhang or trail in the water (again, particularly in lower flows), in-channel features and the flow diversity they provide become the primary cover and fish holding features, along with deeper water areas (predominantly in the case of larger fish). Interestingly, deeper areas of water are often associated with in-channel structure, as they are in most cases created and maintained by the scouring effects of flow around those features. This is why any large structures within the channel should be retained where at all possible (e.g. fallen and trailing branches, and natural depositional features such as gravel bars and boulders) (e.g. Figure 2).

Figure 2. Valuable shallow water habitat. The margins provide refuge for fry, while the mid-channel boulders provide lies for parr and older trout (again, these features can be recreated in other areas).

Large boulders could also be placed within the channel to recreate the features shown in figure 2, the exact location of these should be carefully planned first, with the location assessed by someone with relevant experience of in-channel structures to ensure that they do not result in detrimental erosion or deposition. Poorly placed boulders can often either wash out or even become buried due to the resulting scouring and deposition they create.

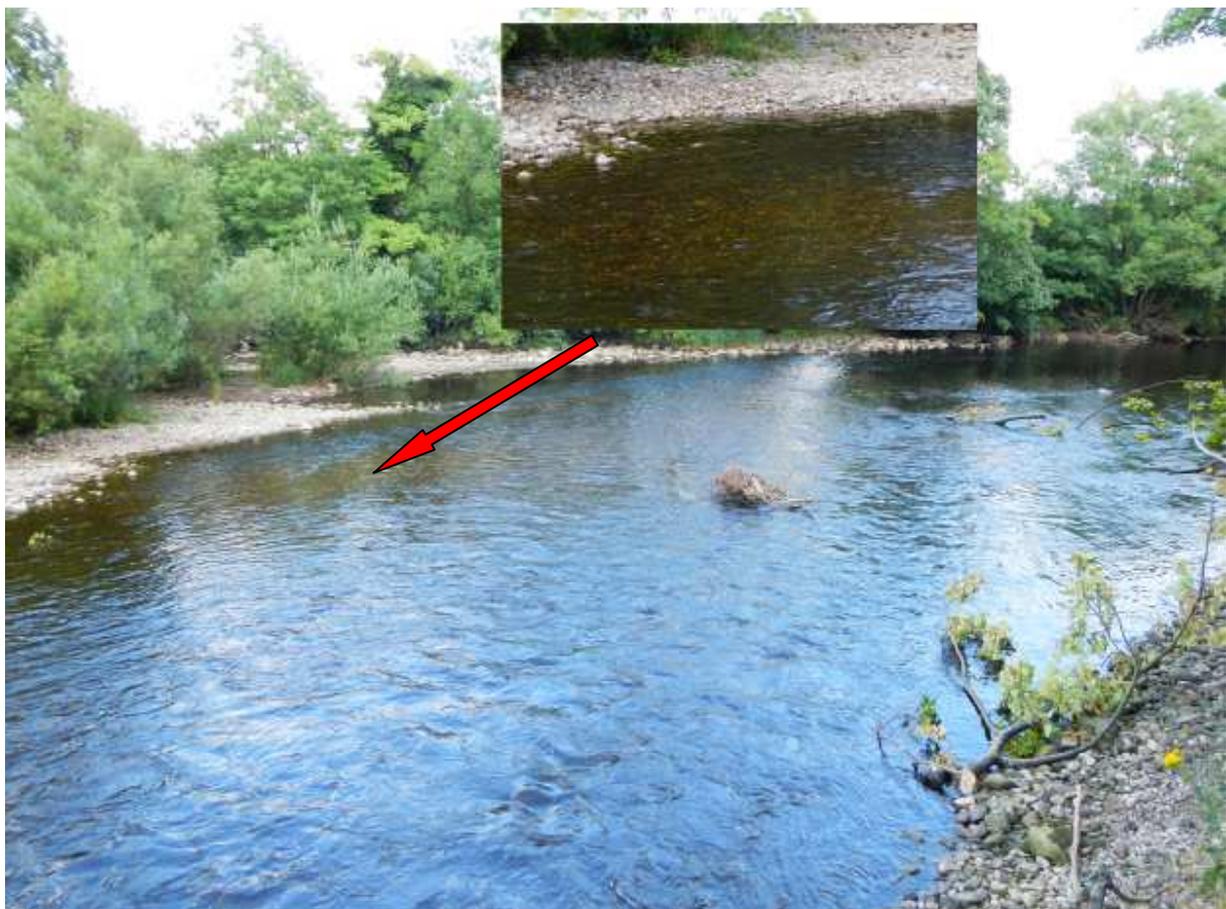
This makes the tributaries (and not just the ones along Ikley AA waters) a more likely source of the River's juvenile trout population, as is the norm on larger dynamic river systems. However, promotion of the in-channel structure, in-channel meandering and the increased scour and deposition previously discussed is likely to aid in retention of finer substrate within the wetted channel by creating pools and lower velocity areas to dissipate the flow energy, and could enhance trout and grayling spawning. A good example of this can be seen in figure 3 where despite being in a relatively narrow, steep gradient section of the river some trout spawning sized substrate has been retained.

Figure 3. Area of relatively fine gravel, with potential for trout and grayling spawning.

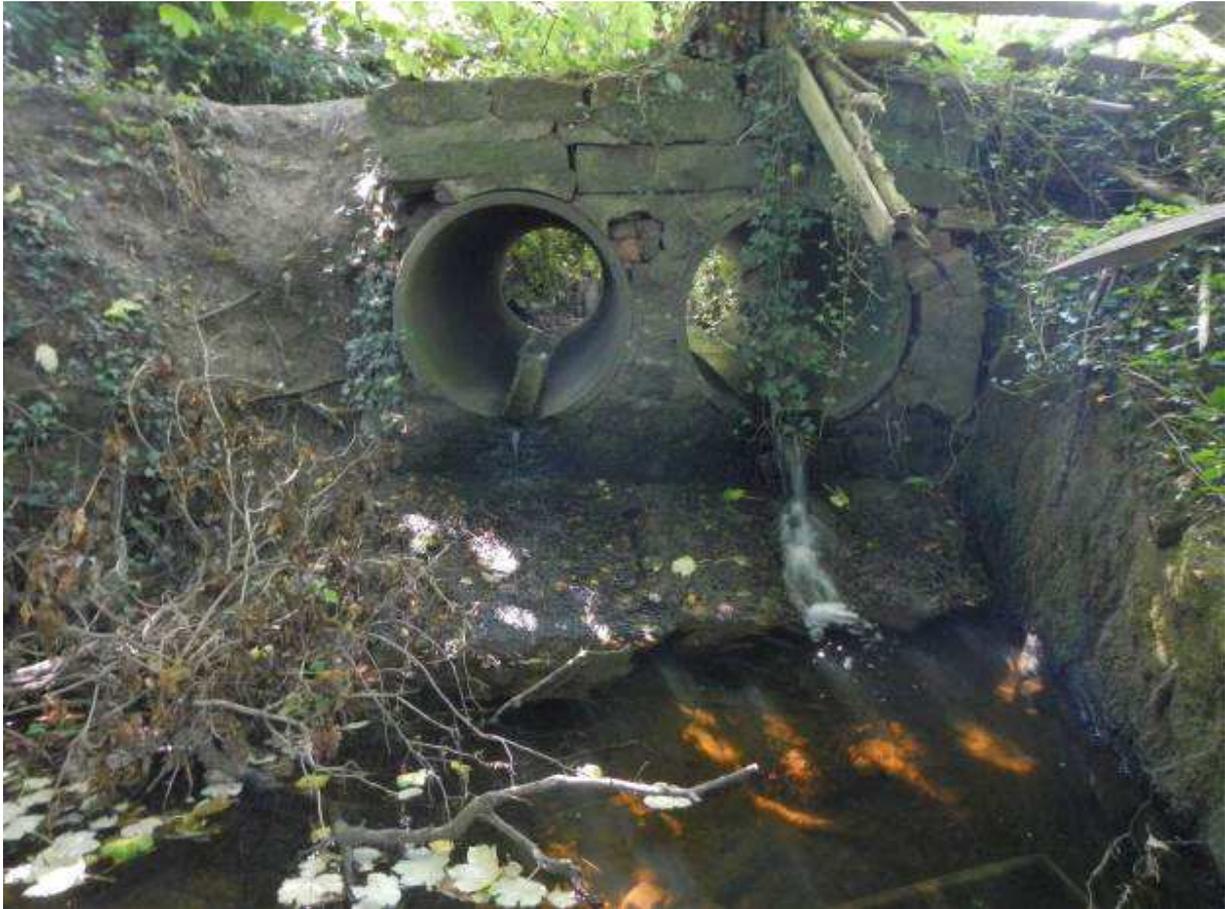
Figure 4. Perched culvert making access to the Backstone beck impossible until rising river levels increase the tail-water level and begin to decrease the height differential. This does not necessarily mean that main river trout will not run the beck, when conditions allow, or remove the potential for resident beck fish contributing to the River Wharfe population.

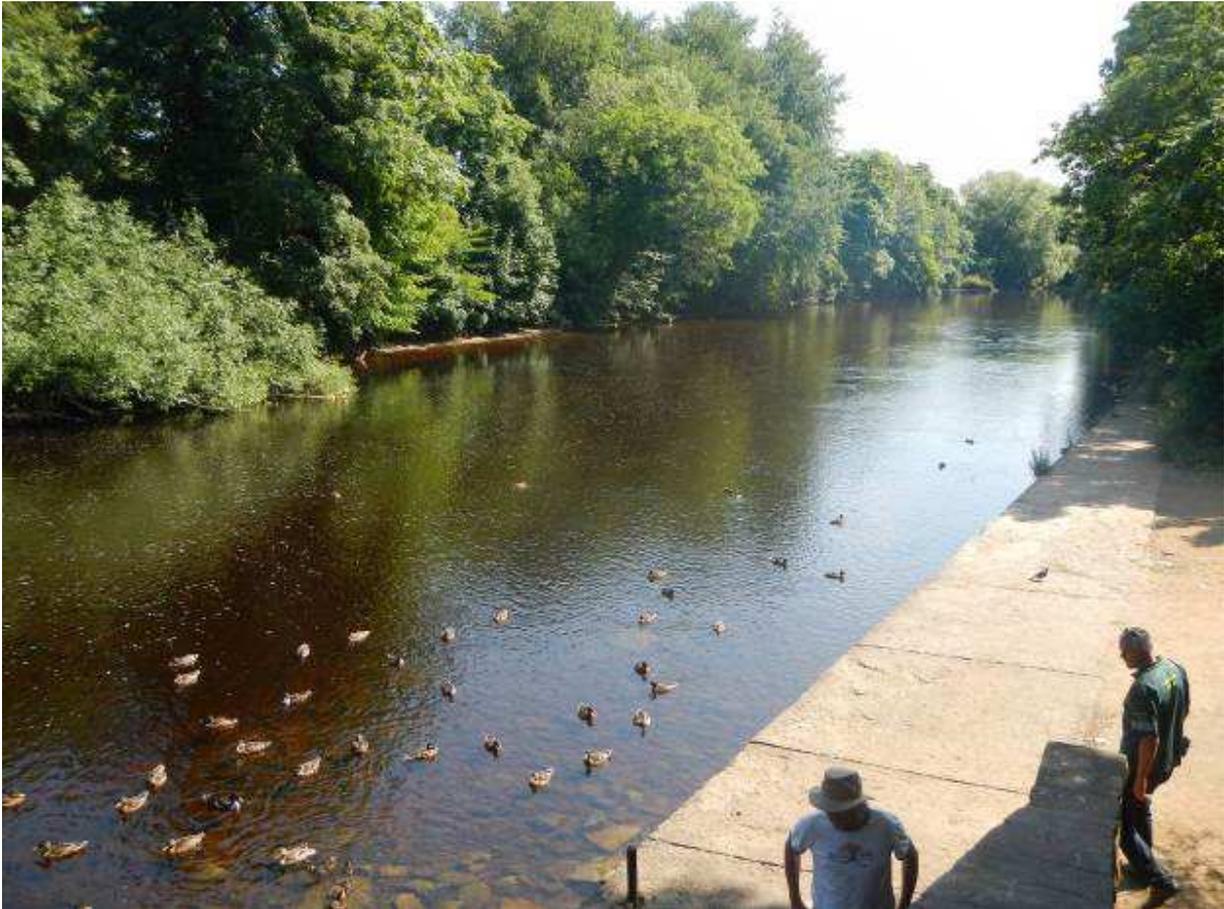
The impact of the old boating pond weir that washed out between the upstream limit and New Brook Street Bridge can still be observed by the relatively uniform channel and lack of features that persist to this day (Figure 5). This is due to the years of relatively uniform gravel accumulations that occurred within the low energy impounded section upstream of the weir, as in effect, all weirs act as sediment traps. It is to be hoped that over the years, natural bed adjustment, assisted by bankside trees and depositional features should improve this, but it could be a slow process.

Figure 5. Very uniform section of water, with little holding potential for large trout, other than the trailing willow to the left of shot. More trailing willows throughout this section and other in-channel structures could increase the number of fish it holds.

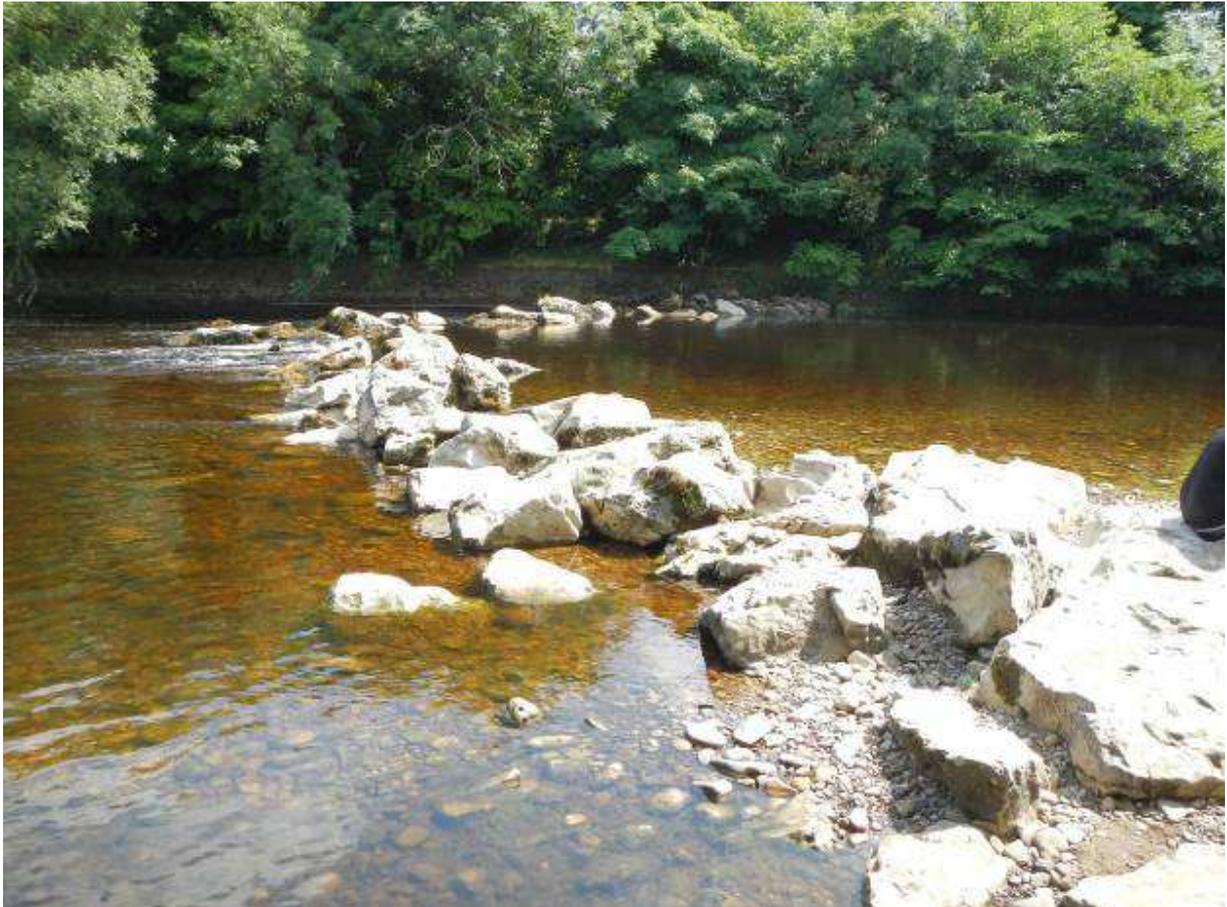
The other weir is the fishing weir located approximately at the mid point of Ilkley AA waters (Figure 6). This weir is also in a relatively dilapidated state of repair, which is actually a good thing for the fishery as it reduces the obstruction that it poses to fish movements, reduces the level of impoundment to the river and should at least allow some transport of bed materials. However, the benefits the weir provides through increased water depth upstream is, and always has been limited by the gravel accumulation that it causes in that area.

Figure 6. Downstream facing weir. Ideally this structure would have been created facing upstream and had a notch in the middle to allow bed material to pass through the section and create beneficial scouring.

Best practice would be to take out the weir and redistribute the boulders throughout the impacted and uniform channel sections, to enhance the habitat without the negative impacts.

In the case of the existing boulder weir (Figure 6), it would be beneficial to remove the central 1/4 - 1/3, to allow the natural gravel transport processes to resume, and to reduce the impoundment and shallowing effect that is ultimately occurring upstream; however, this would be a large scale task requiring large plant, so may not be feasible/cost effective. The obvious compromise would be to ensure that no repairs are undertaken to the weir, and that the centre is allowed to wash out naturally in future events. It is also recommended that if any future in-channel works are undertaken, techniques that work with the natural riverine process are employed.

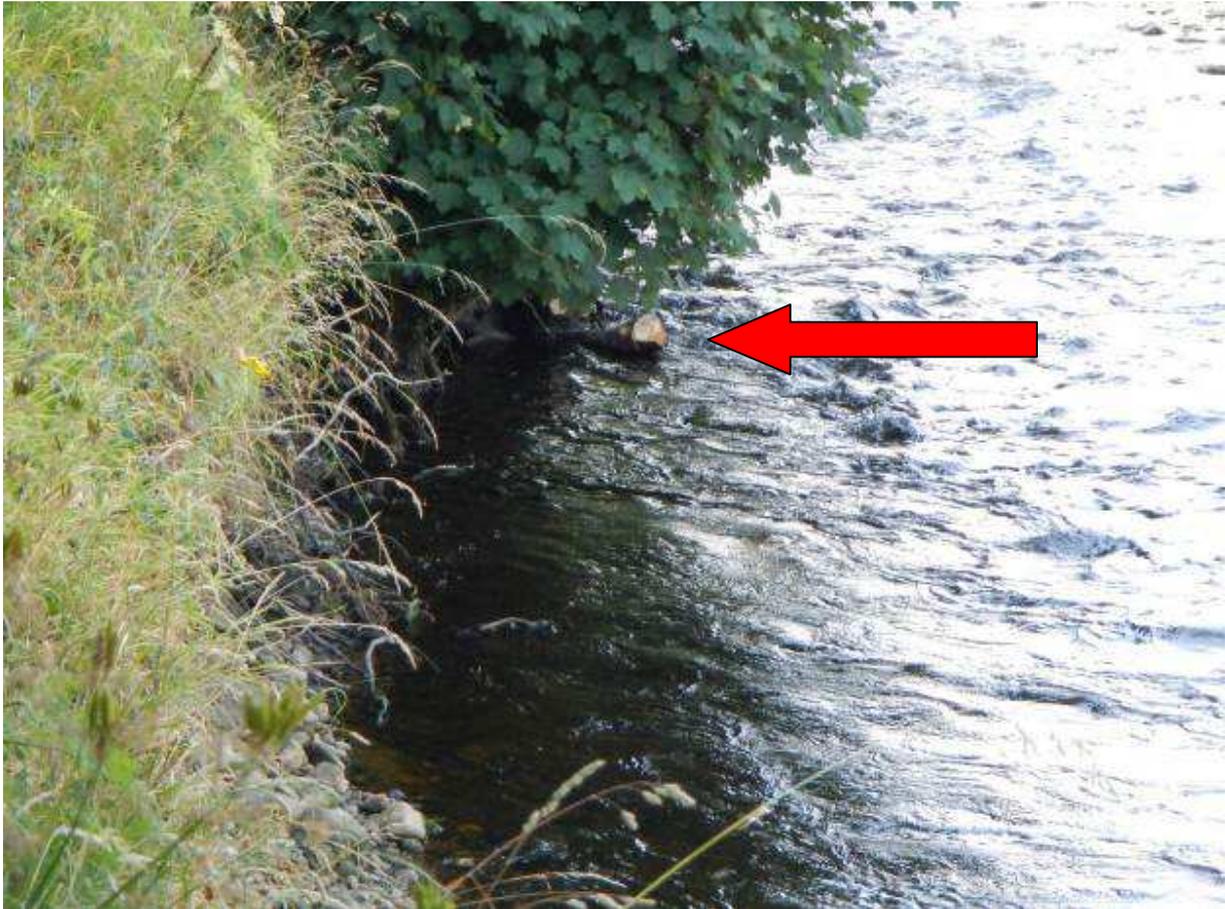
It was apparent during the walkover that tree cutting/pruning had been undertaken relatively recently on the river (Figure 7). This has removed valuable fish cover, and reduced the potential for beneficial scouring and pool/deeper water that the branches would have created in high flows. The branches would in fact have been far better left in place.

Figure 7. Pruned tree branches that would have been better left alone to provide fish valuable cover, or hinged/tethered to trail into the water.

While tree maintenance and branch pruning is often undertaken with the best of intentions, it can significantly degrade the habitat, and often results in loss of fish from that area, making the whole exercise futile. It is far better to retain the features, accepting that although fishing may be trickier, the greater numbers of fish that the river will hold as a consequence (to fish for at some point, and to contribute through spawning) more than justifies the inconvenience. In addition, if left in situ, the impact such tree features have on angling on a large river like the Wharfe is likely to be negligible anyway.

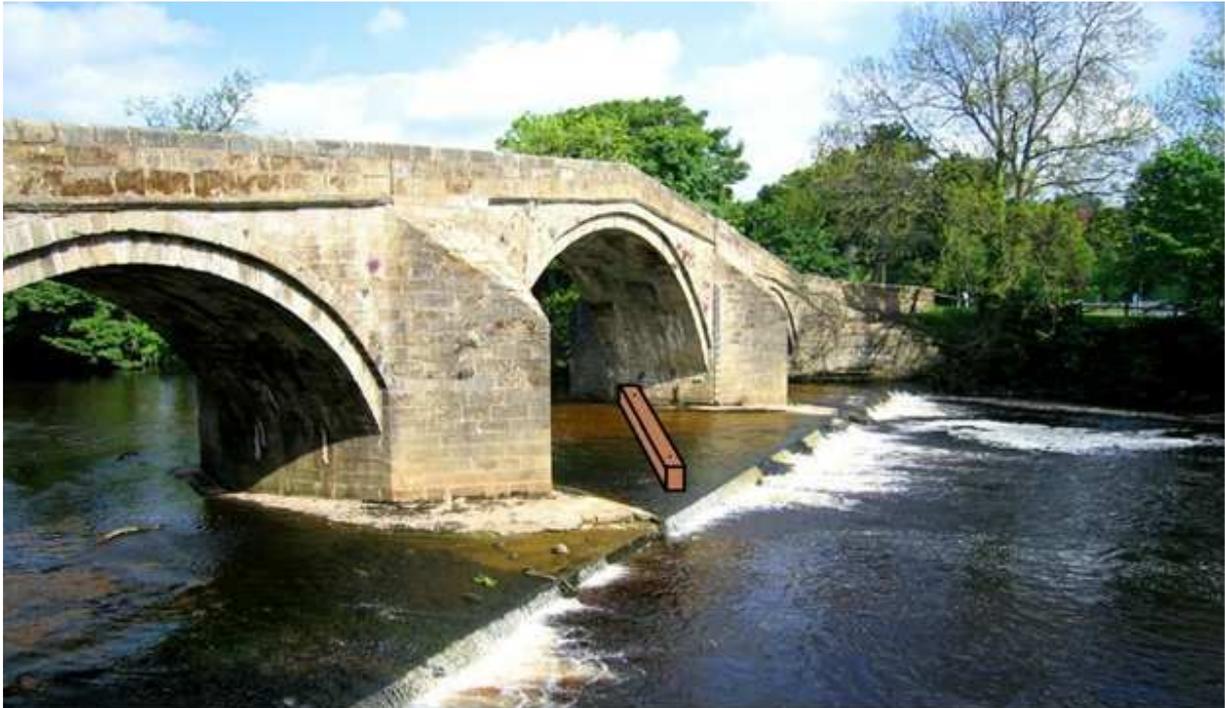
Figure 8. A simple diagonal baulk located in the centre bridge arch would increase water depth and aid fish passage.

It is possible that fish passage over the bridge footings at the upstream limit of Ilkley AA waters could be significantly improved. As removal of the structure is infeasible, a rock ramp type easement could be installed at the downstream side of the bridge footings to significantly improve fish passage. This would be an ideal, but expensive option and is likely to require collaboration with the EA or local rivers trust. If this is not feasible due to funding restrictions, an alternative short-term option may be to install baffles, or a diagonal baulk to the bridge apron. This would not be as good as the rock ramp option, but could lead to a significant enhancement

compared to the current situation. Baulk and baffle arrays have to be designed to the specific flows and hydraulics of a structure to gain optimal effect, but examples of the two techniques can be seen in figures 8 (simple diagonal baulk to concentrate flows and increase depth) and 9 (baffles, which could be installed in any of the three bridge arches). The WTT or Environment Agency could assist with design of such structures.

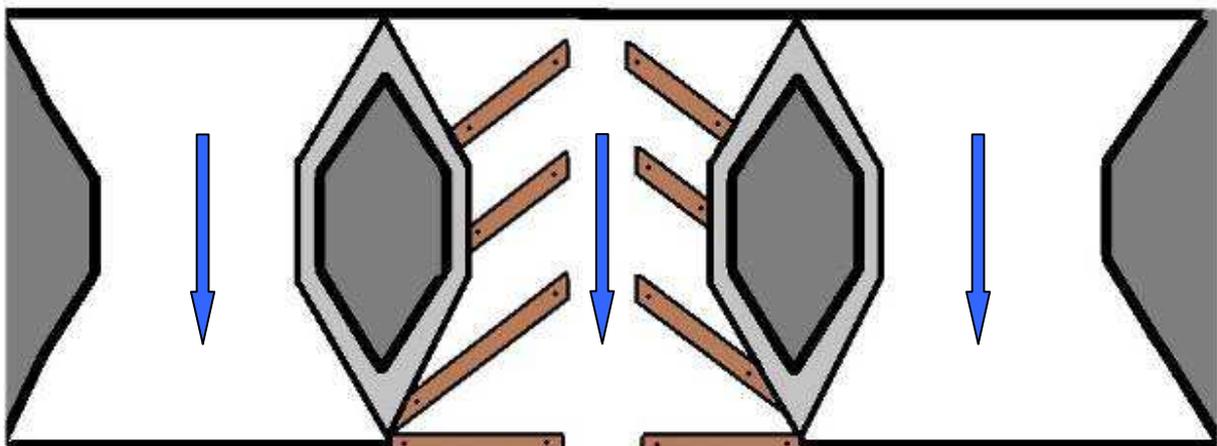
Figure 9. Juxtaposed, upstream baffles would increase water depth and provide resting areas to assist fish in passing the bridge footings.

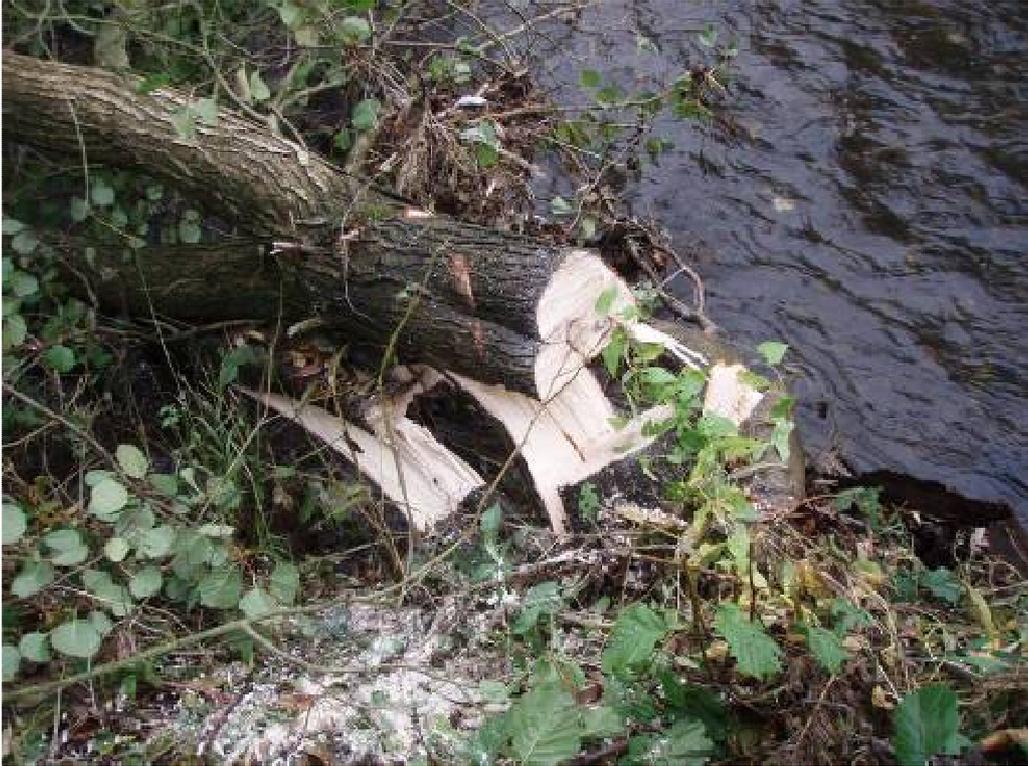
The process involves cutting part way through the stem/trunk (a bit at a time) until it can be forced over into the channel (Figures 10 & 11). Care should be taken to limit the depth of the cut to that which is required to bend the limb over, to retain maximum strength and health.

Figure 10. Hinged willow.

Where trees are already established along the bank side habitat improvements can often be attained through laying some, or all of the branches/trunks down into the watercourse to increase low cover and structure within the channel. This method is generally limited to species that can be easily manipulated without snapping (e.g. willow, elm, hazel, hawthorn and small alder). For this reason, small to medium shrubs tend to work best, although quite large willow can be successfully laid.

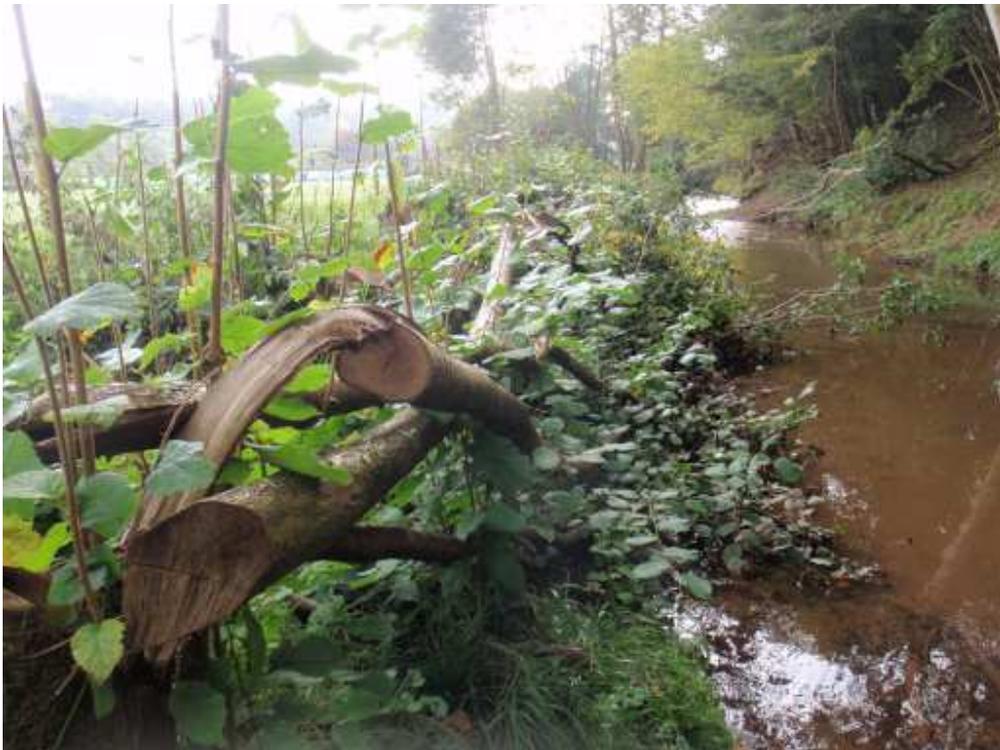
Figure 11. Hinged hazel.

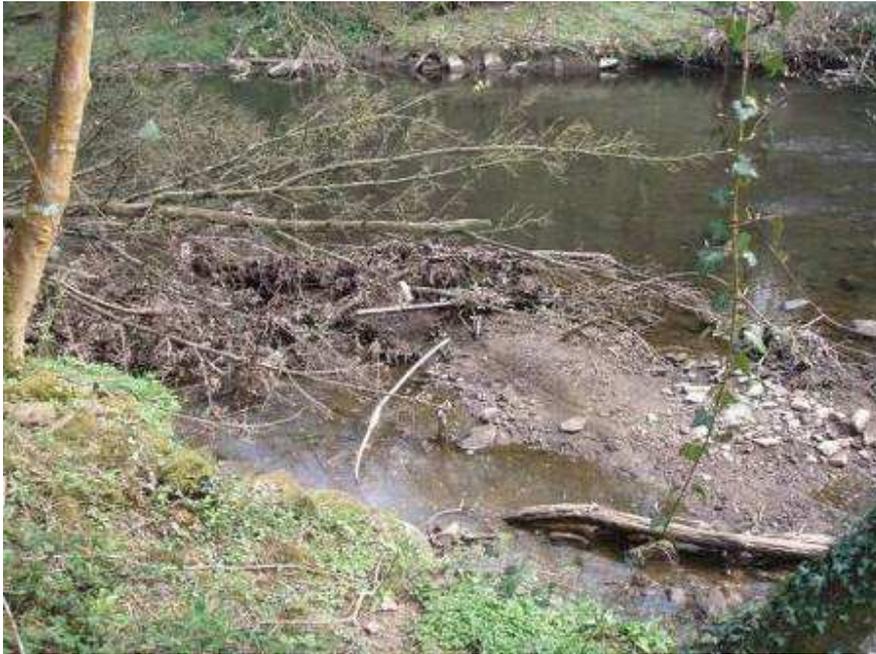
Tree kickers can be created by tethering felled trees and branches to their stumps, (Figures 12 & 13). These would provide cover and shelter from flows for fish, while also increasing valuable flow diversity and creating areas within the river margins for sediment storage, which will ultimately create areas of narrowing, that may then vegetate, or can be planted to increase channel sinuosity.

Figure 12. Note the narrowing effect through significant gravel and sediment accumulation (centre and right of shot) in the sheltered area downstream of the tree kicker. This same area provides significant shelter for smaller fish in high flows.

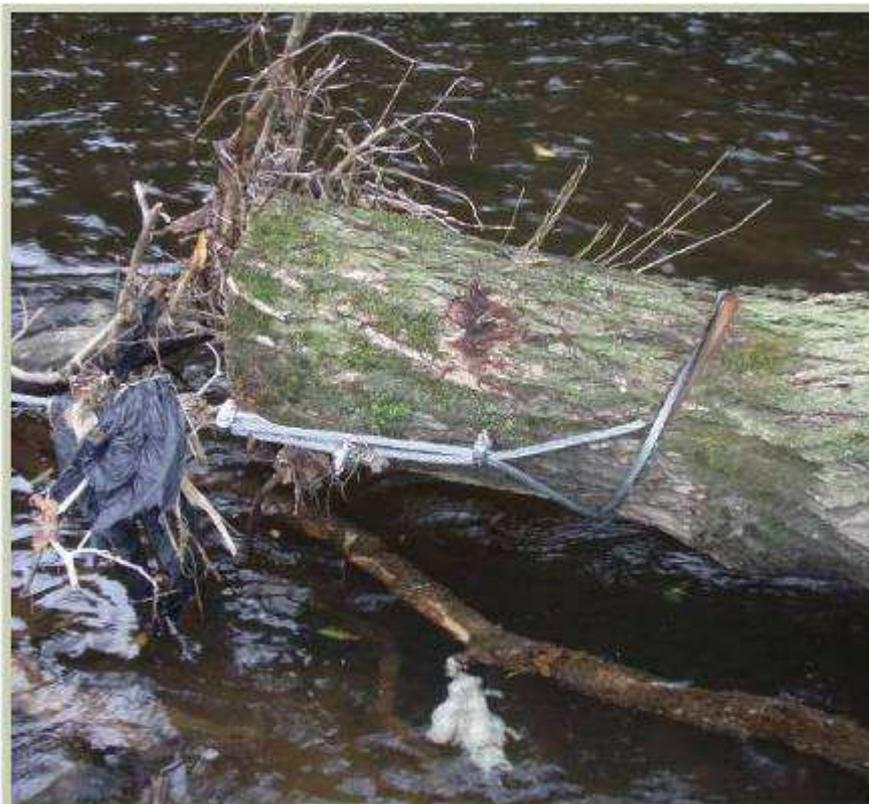
Figure 13. Cabling for a tree kicker.
