Advisory Visit

River Irwell

5/5/2011

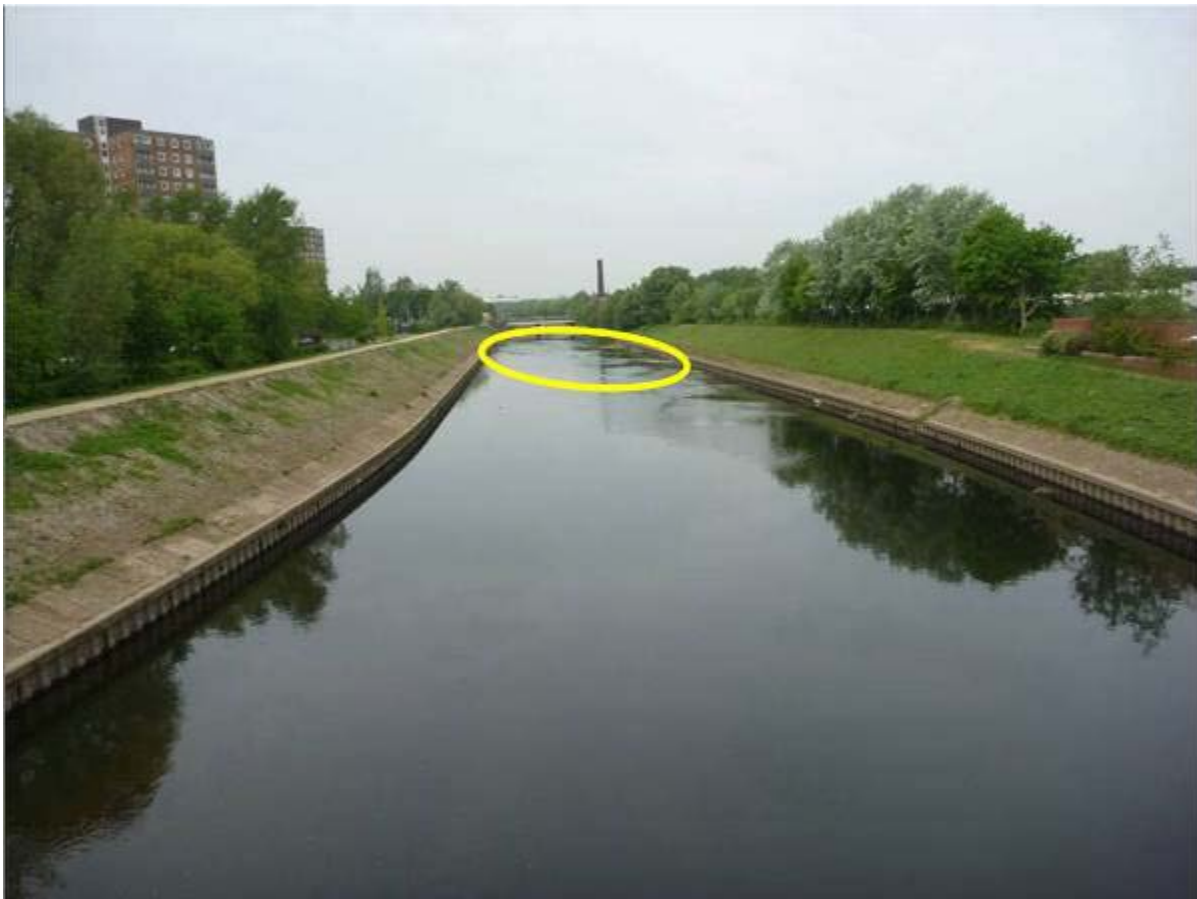
This Salford city centre location is typified by the extensively engineered, straightened channel embedded within steep flood banking (e.g. Fig. 1). Steel and concrete pilings are used to define the dimensions of the watercourse at the toe of the embankment and part of the original path of the riverbed (the beginnings of what was a long meandering loop) is visible as a row of boulders and cobbles crossing the contemporary channel at roughly 45 degrees (also Fig. 1).

Figure 1: Engineered channel with old riverbed just visible (ringed) under low flow conditions during visit

Members of SFA report huge peaks in coarse fish numbers (as well as trout) on certain occasions in this section. During the visit specimen bream and carp were clearly visible in sizeable shoals. However, dramatic crashes in fish numbers also occur. These could be due to episodic pollution events (and there are certainly fish kill incidents reported). However, crashes are also suggested to be related to huge spate events discharging down the smooth, uniform channel. An obvious improvement to the chances of retaining all species of fish during spate flows would be to securely anchor marginal cover using heavy duty masonry drilled anchor points (expansion bolts). Suitably-sized trees anchored parallel to the bank on short steel cables would provide valuable calm spots of water even in the fiercest spates (section 3). Due to the city centre location, detailed consultation with Development Control and Flood Risk Management personnel from the E.A. would be obligatory.

Another fundamental improvement would be to ensure the best possible longitudinal connectivity (so that fish can move as far up and downstream as possible) via bypassing or reduction/removal of structural barriers throughout the system. Concentrating on strategic improvements to connectivity is likely to be far more productive than the creation of spawning habitat suitable for trout and salmon in these lower (currently periodically polluted and physically unsuitable) reaches. The guiding principles for strategic prioritisation of barriers are to assess a combination of the length and quality of habitat that become available when each barrier is tackled. The top priority goes to barrier removals that give access to the greatest amount of spawning and nursery (or otherwise high quality) habitat. It is, therefore, important to factor in planned habitat improvements when assessing habitat quality during this process. The planned fish pass scheme in the reach above Littleton Bridge (NGR: SD 81665 00455; Fig. 2) could

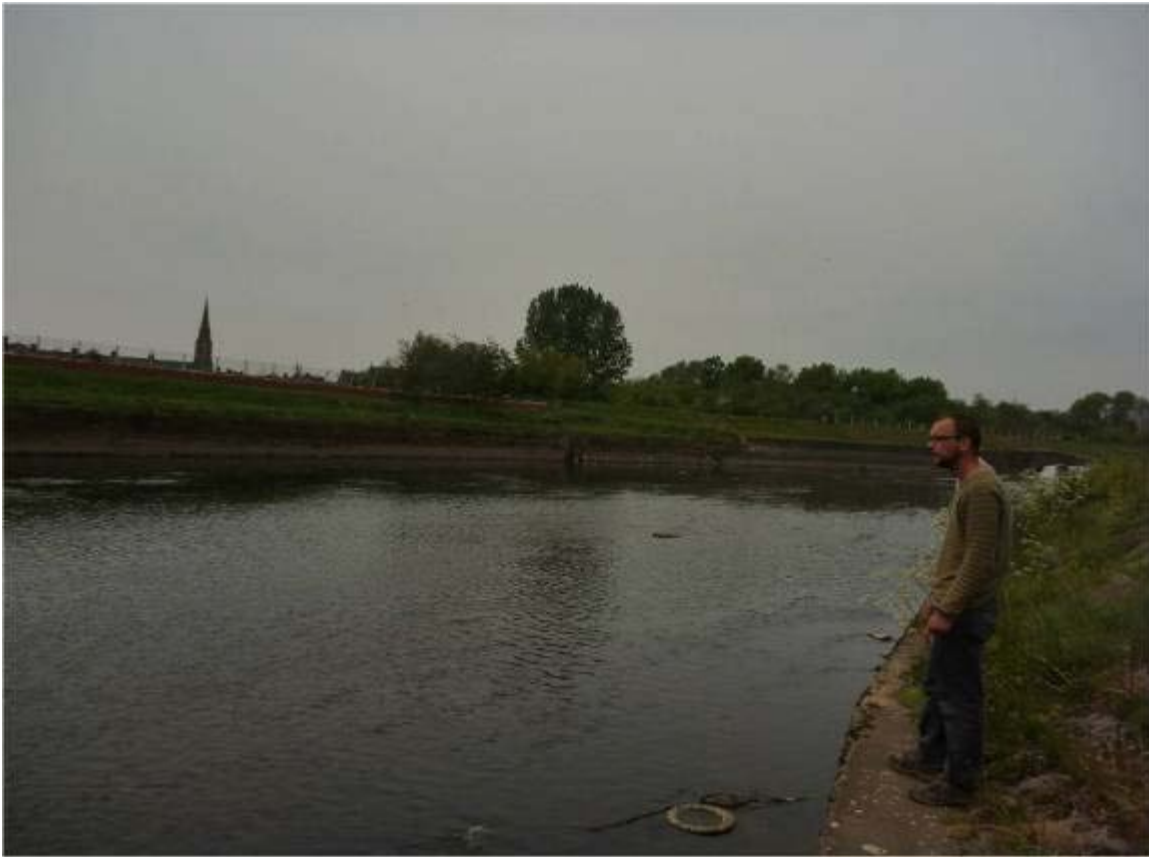
Figure 2: Section below weir (just visible middle right of frame) and above Littleton bridge (out of frame to left). The same issues exemplified in Fig. 1 are evident here with additional emphasis on the value of habitat improvement that would increase the value of fish pass installation

potentially be enhanced by undertaking the simple improvements to marginal habitat suggested above and in section 3 (Recommendations).

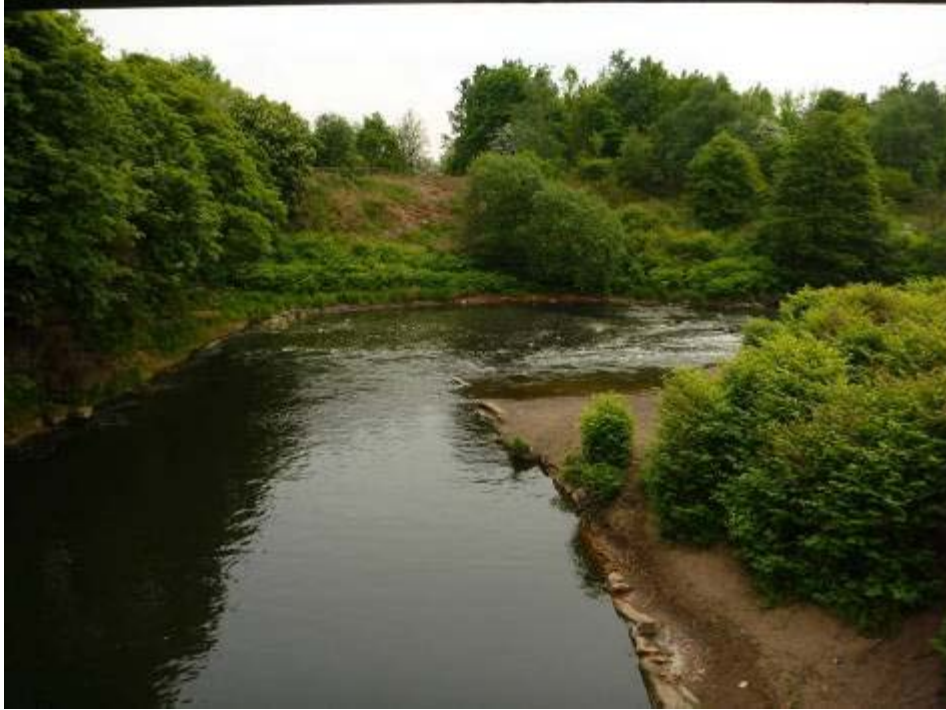
Although suffering from extensive invasive plant infestation (e.g. knotweed to right of frame in Fig. 3), the channel morphology in this section is markedly different from that in Reach 1. For example, the plentiful supply of large cobbles and pebble/gravel substrate, steeper longitudinal slope and appropriate channel width combine to produce some valuable scour and depositional processes. Examples of gravels deposited on the inside of river bends to form “point bars” (Fig. 4, lower right foreground) and mid-channel gravel spits (Fig. 4, mid right background) show these processes in action. Such spatial variety produced by these processes benefits plant, invertebrate and fish communities by providing a broad range of micro-habitats that can support a greater range of species. Even within a single species, the existence of structural variety can meet the varying needs of that species

Figure 3: Deep bend pool (adult fish habitat) below riffle and pool tail photographed from SD 76992 04483. Note Japanese knotweed stand and compacted earth bank to the right of the picture

across different stages during its individual lifecycle. An obvious example when considering trout lifecycles would be the existence of spawning, nursery/juvenile and adult fish habitat within a short spatial range. To this end, the value of spawning gravels for trout (and in future salmon?) could be enhanced by the installation of structure that promotes localised vertical scour of the stream bed (section 3). Similarly, additional marginal brush cover would be of great benefit to juveniles of all fish species – especially when provided adjacent to spawning habitat. Looking to the future, the size range of river bed particles that are mobilised and deposited in this reach would encompass those larger gravels/cobbles favoured by larger migratory fish such as salmon and large sea trout.

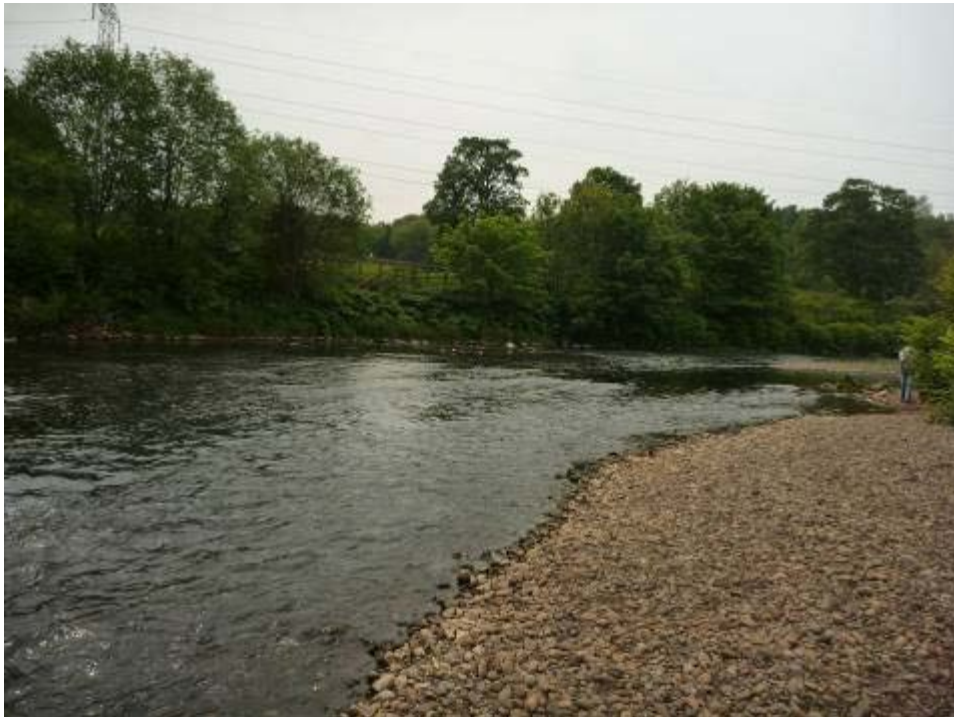
Figure 4: The tail of the pool/head of riffle just upstream of the bend pool pictured in Figure 3. Note shingle point bar (right foreground) and mid-channel spit (right background) formed by natural erosion and depositional processes.

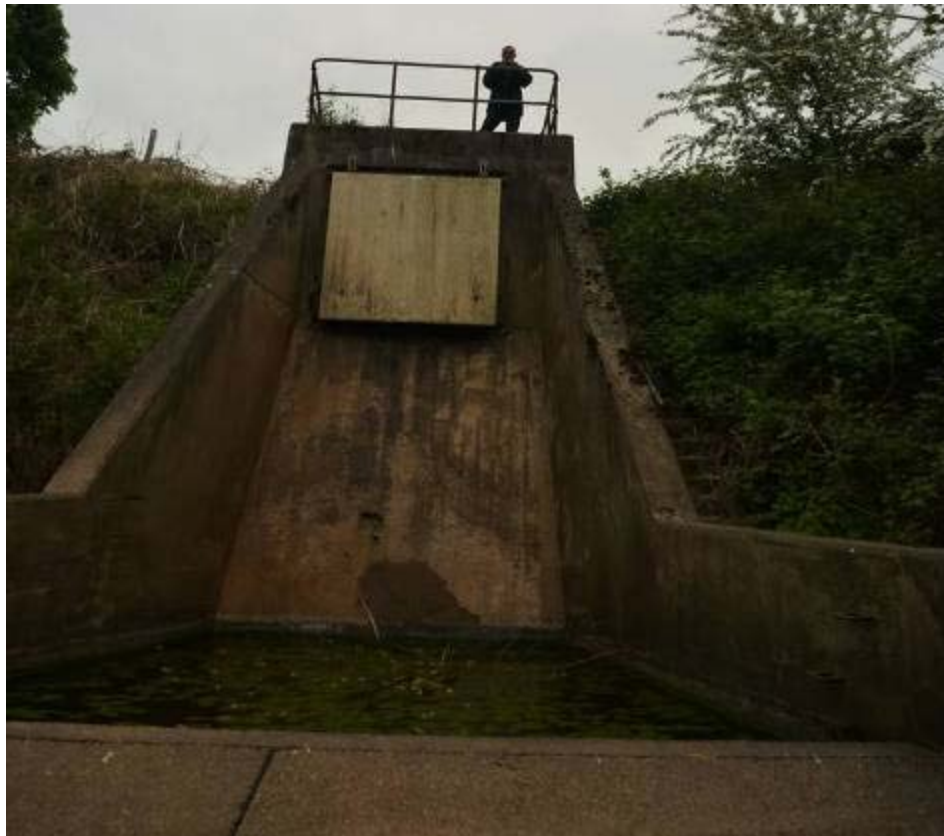
Not far from the reach pictured above, there is a pertinent reminder of one of the major issues faced by the Irwell. As one of the 300 or so consented discharges the scale of the influence potentially exerted by these inputs is brought home by photographs such as Figs. 5 and 6:

Figure 5: Large Combined Sewer Outfall (CSO) at NGR: SD 76551 04705

Clearly, the potential stresses that each of these treated effluent and CSO discharges can place on the Irwell are enormous. However, modest (or preferably significant) improvements in the performance of such outfalls and treatment plants will all translate into significant benefits for the river's ecology. This is a simple function of the sheer volume and frequency of discharges into the river.

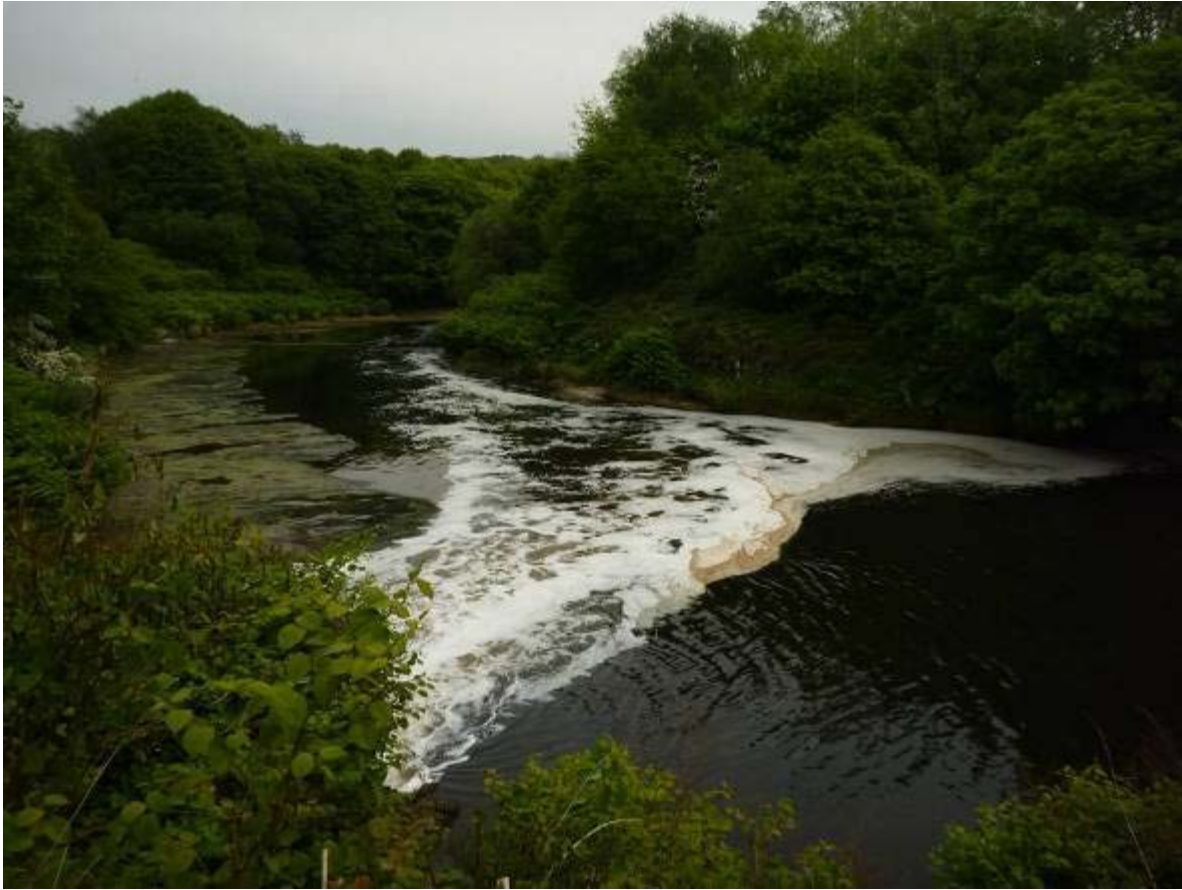
Figure 6: Treated effluent discharge at SD 76938 04516 - benefitting from recent investment in the plant and treating a huge volume of the Manchester conurbation's sewage - but clearly a significant factor in the nutrient and water quality status of the River Irwell (the river is ~ 35 m wide at this point)

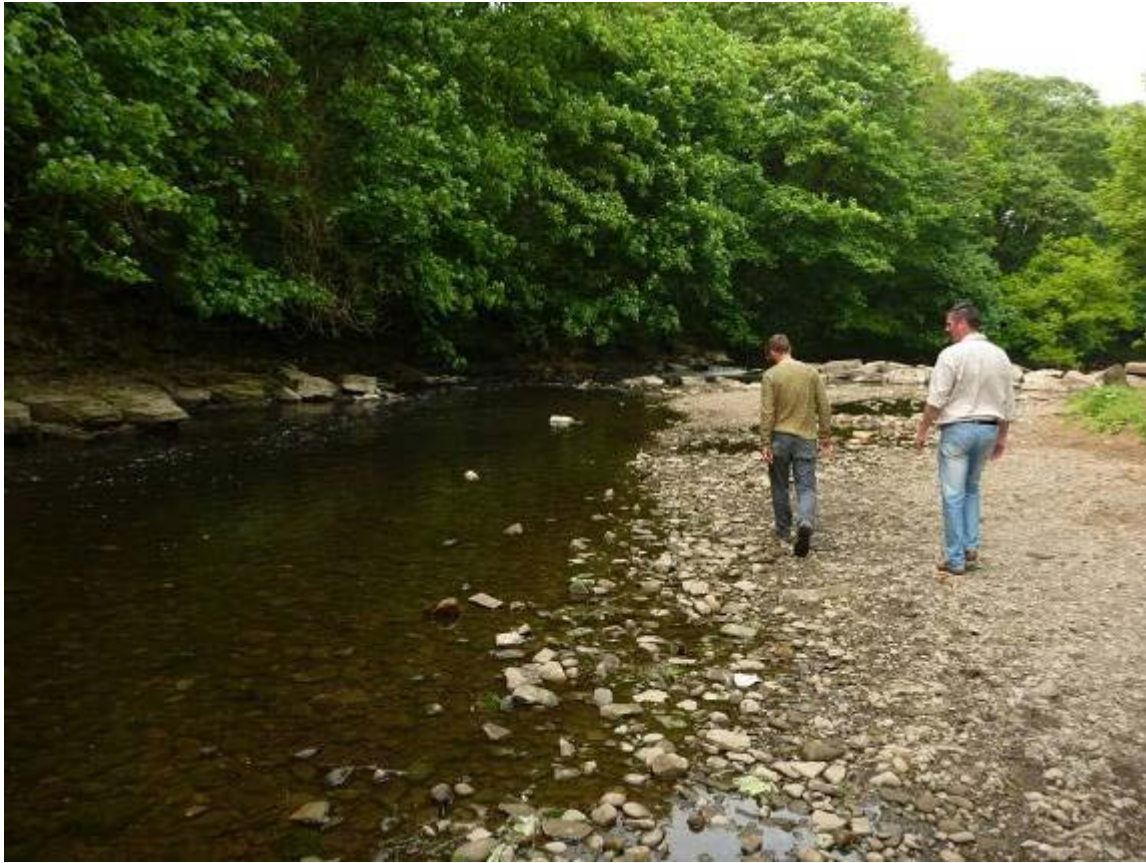
Further upstream again, the river narrows and hosts a kayaking facility created from installed boulders. Habitat that favours "flow-loving" (rheophilic) fish species like trout and barbel is produced both from the naturally-arising and some of the installed channel characteristics in this reach. In particular the boulder placements that form narrow chutes for

kayaking combine with natural deposition and erosion of the stream bed to form good, variable habitat (Fig. 7). However, there is still a lack of what is

Figure 7: Boulders (background: centre and right) installed for kayaking amenity are helping to promote good, variable flow and substrate conditions

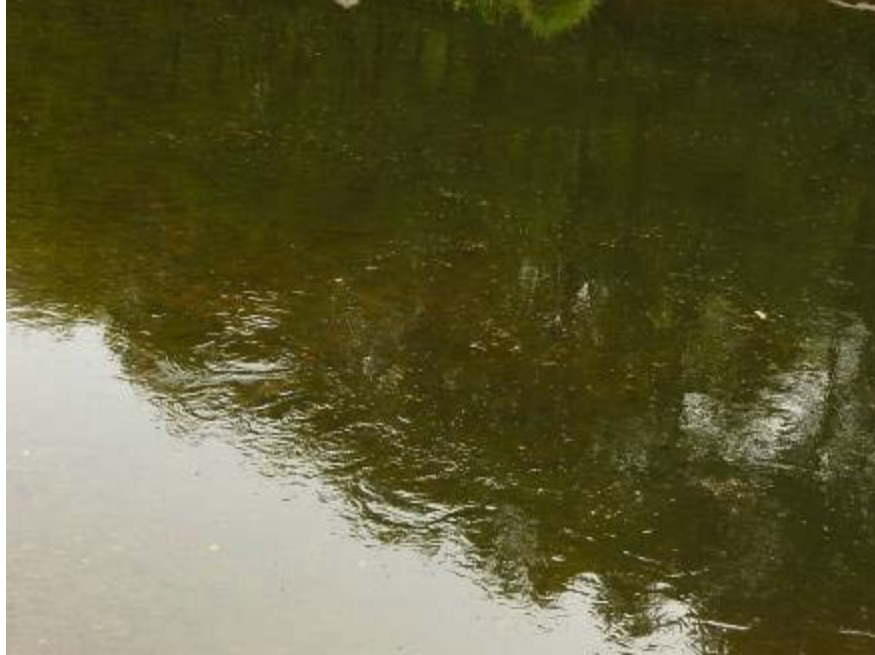
termed “well-sorted” or “graded” spawning gravels. Sorting or grading refers to the processes of localised scour and deposition that lead to substrate material occurring in mounds made up of similar sized particles. Simply as a result of their similar and slightly irregular diameters, well-sorted gravels have lots of spaces for water to percolate between the ill-fitting pebbles. By contrast, poorly sorted gravels will have sand and silt clogging these gaps that prevents flow of water through the gravels (e.g. Fig. 8). Since survival of trout eggs laid in gravel beds is crucially dependent upon this “through gravel” flow of oxygenated water, localised bed scour and associated gravel sorting is very important. Again, as for the habitat in Reach 2 exemplified in Figure 4, suggestions for promoting patches of localised scour and sorting of gravels are given in section 3 “Recommendations”.

Figure 8: Substrate of mixed sand, silt, gravel and pebbles in the Burrs Country Park kayak course. Although suitably-sized gravels exist in the bed substrate, the clogging of gravels with finer sediment means that trout egg survival will be poor due to the lack of “through-gravel” water flow

Tree kickers would not be suggested within the formal kayaking facility in this reach as the dimensions/layout of the course makes it difficult to avoid detracting from that amenity in this case. However, careful placement of mini logs (with rebar pins hidden within the log to avoid risk to water users) could be used to promote gravel sorting without detracting from the kayaking amenity.

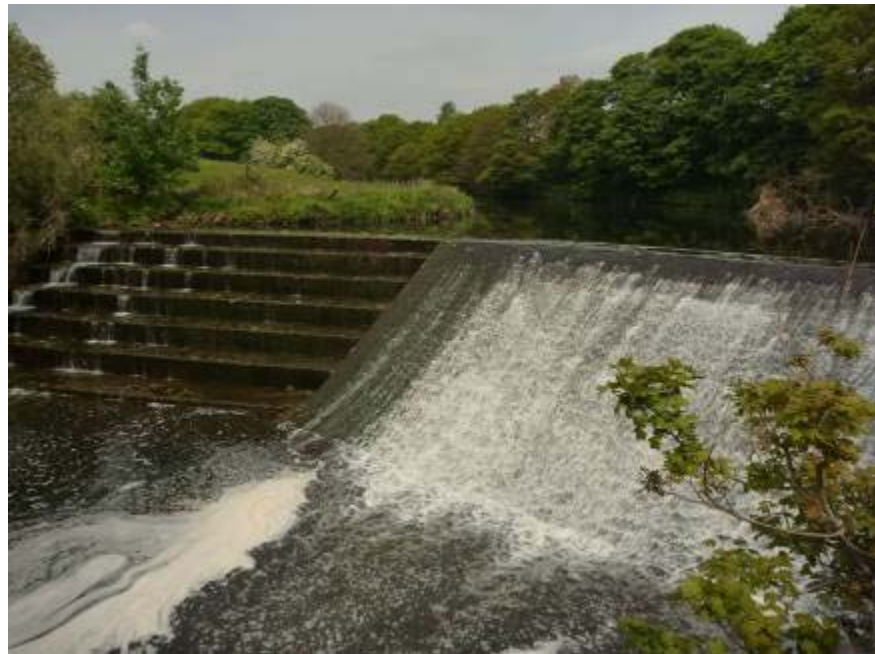
The other notable feature of this reach is a truly enormous weir at SD 79647 13073 that is estimated by Mike Duddy to impound at least quarter of a mile of the upstream watercourse (Fig. 9). Mike also made mention of potential

Figure 9: Weir with an estimated vertical head loss of ~25 feet at SD 79647 13073

plans to incorporate an existing leat/canalised channel associated with the weir into a fish passage solution. However, the feasibility of this proposal is currently unclear. As highlighted in the RBMP, connectivity between good patches of habitat is very important for healthy and resilient populations of aquatic fauna. In addition to connectivity, there are issues of habitat degradation resulting from impoundment of flowing water. Degradation primarily results from siltation and associated homogenisation of habitat. Weirs of the magnitude exemplified in Figure 9 create substantial challenges for habitat remediation - as their removal (or bypassing) cannot be undertaken lightly. Changes to vertical head loss at the structure that are too radical will lead to extensive, potentially unpredictable, changes to the river bed and river banks upstream (with subsidence/collapse of banks possible). Similarly, the river's industrial past increases the likelihood that sediments trapped behind the weir may be contaminated. Large scale downstream mobilisation of contaminated sediment should, of course, be avoided where possible. Therefore, strategic approaches to structure modification are required and mathematical modelling of predicted impacts undertaken. Typically the proposed changes should be undertaken in phases – with observed responses compared to model predictions before progressing from one phase to the next.

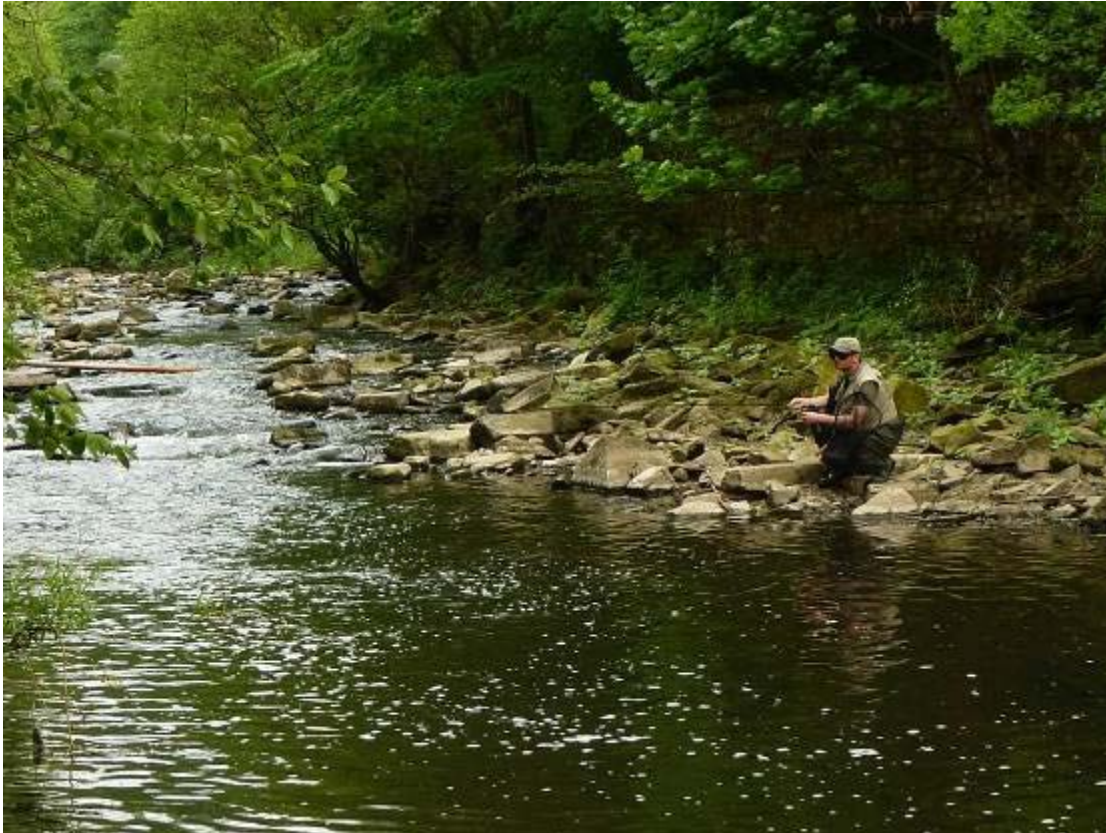
Although typically running between the confines of stone walls (and with invasive plant species still a feature of riparian vegetation) the river in this section has many examples of good quality habitat for rheophilic fish. A relatively steep longitudinal bed slope, abundance of small boulders and cobbles and the presence of trees within the river corridor produce a series of pools and riffles with a good degree of variety in flow depths, current speed and a healthy riparian light/shade regime. In the immediate future there is relatively little benefit to concentrating habitat improvement works in this section. Instead, efforts to bring habitat quality elsewhere up to those evident in this reach and to work on water quality and connectivity across the catchment should be undertaken. It may be appropriate, following surveys from the headwaters downstream to identify species and extent of infestation, to consider invasive plant species control in these reaches. The important caveat for this would be to implement control measures sequentially from the upstream limits of infestation. There is also a great deal of value in including this section in the proposed invertebrate

Figure 10: Generally good quality habitat between the stone walls in Reach 4. Some Himalayan balsam plants are visible between the bankside boulders

monitoring scheme so that water quality issues can be picked up immediately.

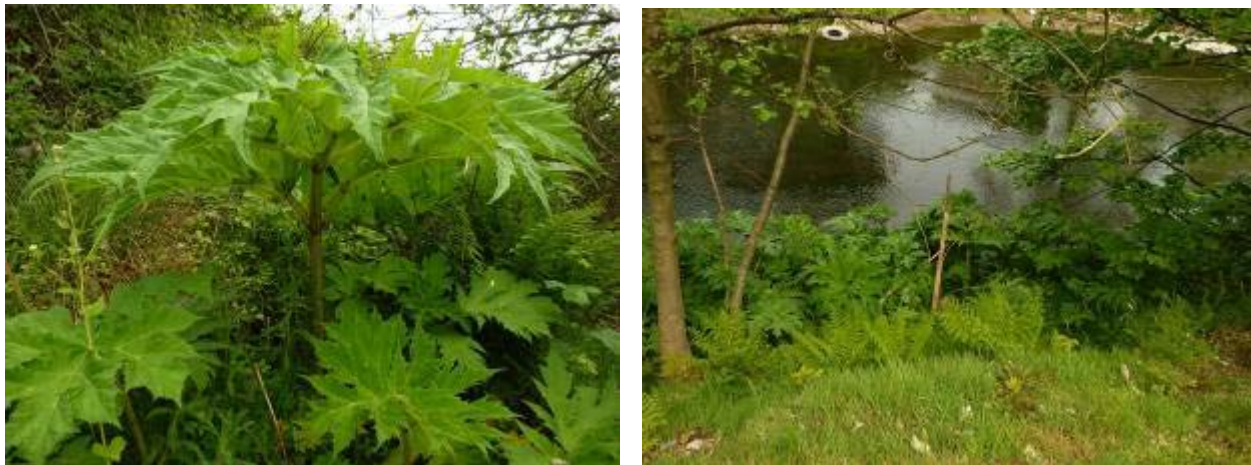
Figure 11: Giant Hogweed individual plant (L) and continuous stand (R) on the Irwell (part of many miles of infestation). Definitely NOT one for hand pulling due to the potential for toxic sap burns in the presence of sunlight

Although a major issue on the Irwell, riverbank infestations of invasive plant species are probably beyond the scope of a newly-formed volunteer group to tackle alone. Consequently, the most practical role for such a group will be to campaign to hold governmental bodies and landowners to the obligations of biodiversity and ecological status implied in law. Advice and support on achieving this (e.g. identifying appropriate points of contact and legal advice) could be gained from contacting and joining the Angling Trust (perhaps as a group membership): <http://www.anglingtrust.net/>. Of course, where contributions of labour to hand pulling of Himalayan balsam or mapping/surveying particular reaches can be made, there may be opportunity for direct volunteer involvement.

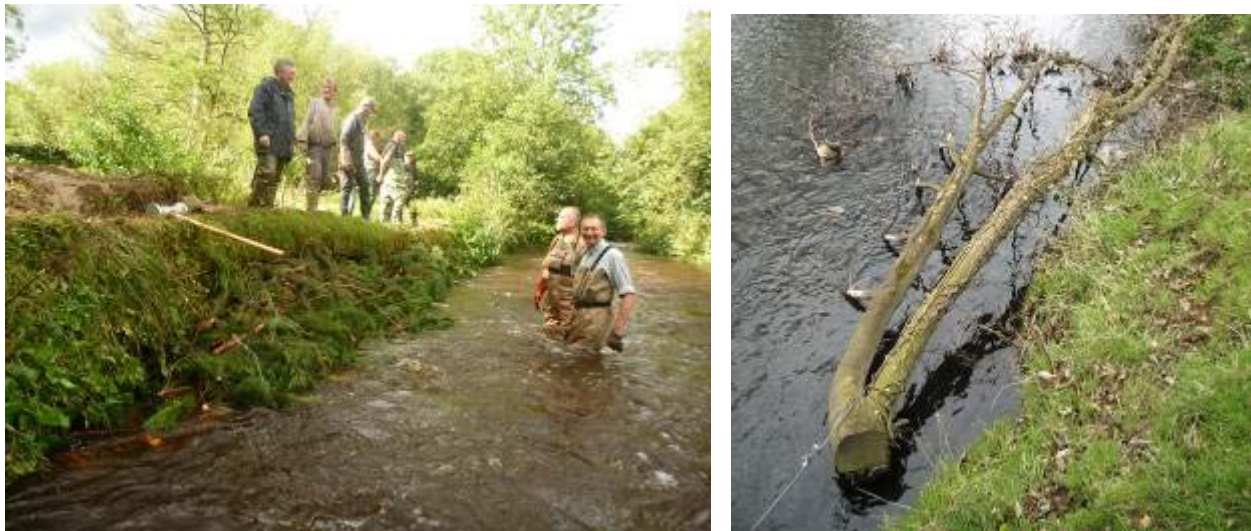
Figure 12: Marginal brush (L) and tree kicker (R) examples of marginal cover installation

The current restriction to ecological status imposed by the many significant barriers to longitudinal migration of fish is recognised by the NW RBMP and notable examples were encountered during the site visit. As well as a campaigning role to ensure a timely and appropriate programme of solutions, it is important for Salford Friendly Anglers to maximise the value of barrier removal and bypass measures. To this end, simple habitat improvement measures (especially those that enhance protection against predation) will be important. An example of such works might include installation of marginal brush cover or marginal tree kickers (e.g. Fig. 12).
