Advisory Visit
River Itchen, Chilland
7th July, 2008

1. Introduction

This report is the output of a site visit undertaken by Tim Jacklin and Denise Ashton of the Wild Trout Trust on the Chilland section of the River Itchen, located upstream of Winchester, between the road bridge at Itchen Abbas (National Grid Reference SU535327) and Chilland (SU526325).

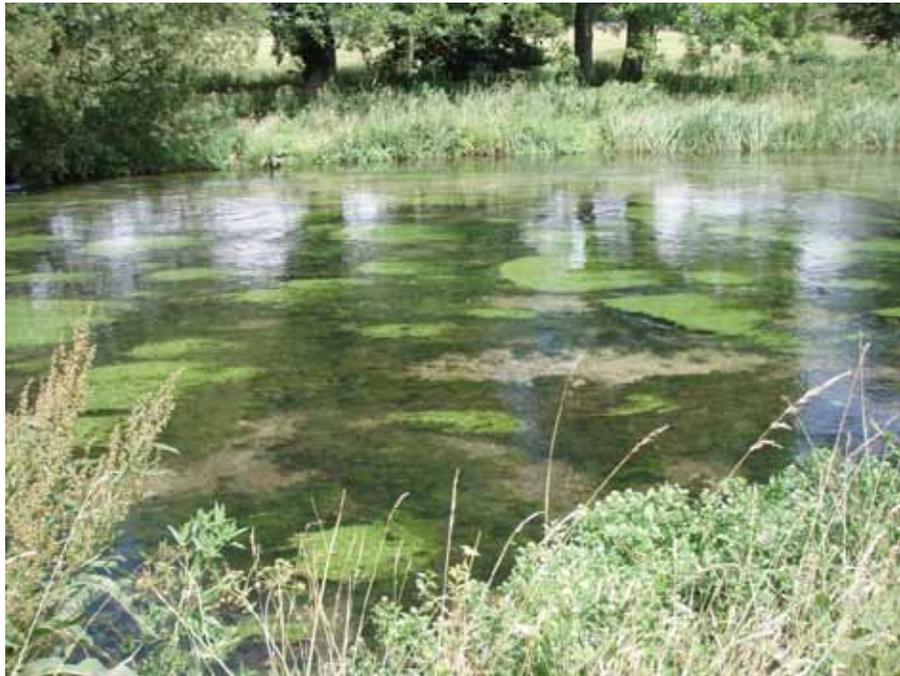
This section of river is generally wide (15 – 17 metres) and shallow with a river bed of fine substrate (fine gravel, sand and silt). The submerged aquatic vegetation is dominated by starwort *Callitriche* sp. and water parsnip

Berula sp., with occasional areas of mare's-tail *Hippurus vulgaris*. This gives way to increasing amounts of coarser gravel and water crowfoot *Ranunculus* sp. in the faster water of a riffle at the upstream end of the section, and in the deeper faster-flowing area where the channel narrowed under the footbridge. There is also abundant growth of mats of algae on the river bed, particularly upon the finer sediment in the wider, slower-flowing section (Photo 1).

Photo 1 Wider section of upstream beat (above concrete bridge)

Channel narrowing could be carried out in appropriate areas such as upstream of the concrete bridge. The aim of this should be to use natural physical processes to encourage the deposition of fine sediment ('silt') in marginal, low velocity areas, where it will consolidate, vegetate and help narrow the channel. This can be achieved by a variety of techniques using brushwood bundles (faggots) and untreated stakes to create new banklines, and then backfilling with brushwood. Islands and causeways can also be constructed in a similar manner to promote a flow and sediment diversity. These options are detailed in the forthcoming WTT chalkstream management guidelines, and illustrated in Figure 1 below. A good example of where some

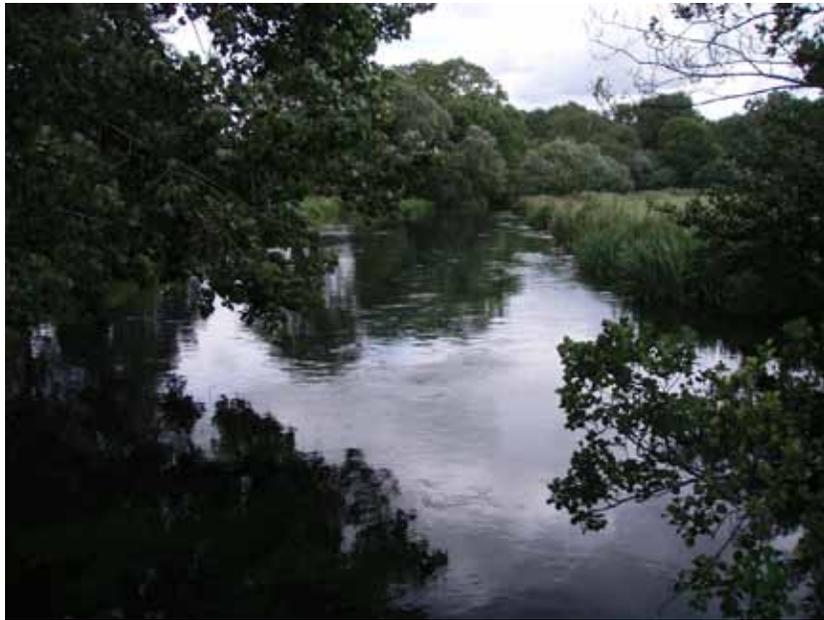
Photo 2 View upstream from concrete bridge

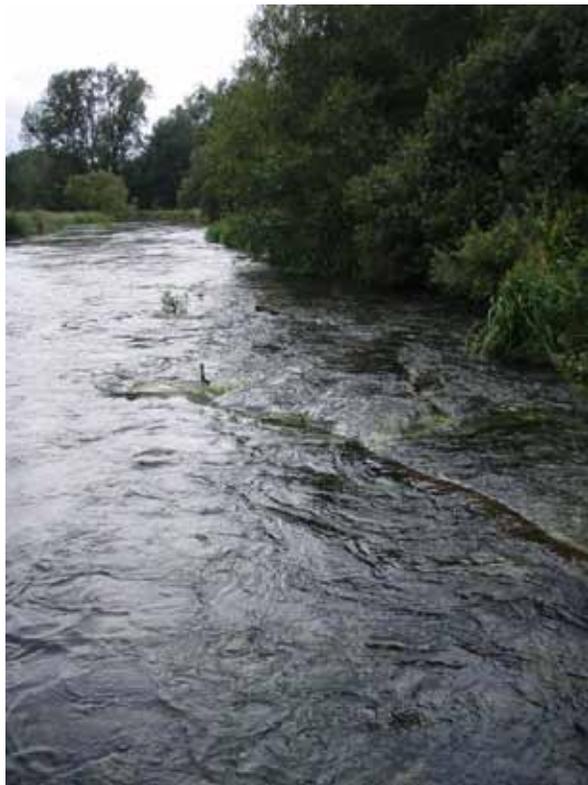
Photo 3 Large Woody Debris pinned to river bed - note downstream pointing angle deflects water towards the bank (view is downstream)

Some large woody debris (LWD) has been fixed in place in two locations just downstream of the footbridge. This is an exception and there is generally a lack of LWD in the river channel throughout the fishery.

LWD should be deliberately introduced to the river channel in the form of upstream facing groynes and trees parallel to the bank. Downstream facing groynes are not recommended as these tend to deflect flows towards the bank causing erosion (Figure 3).

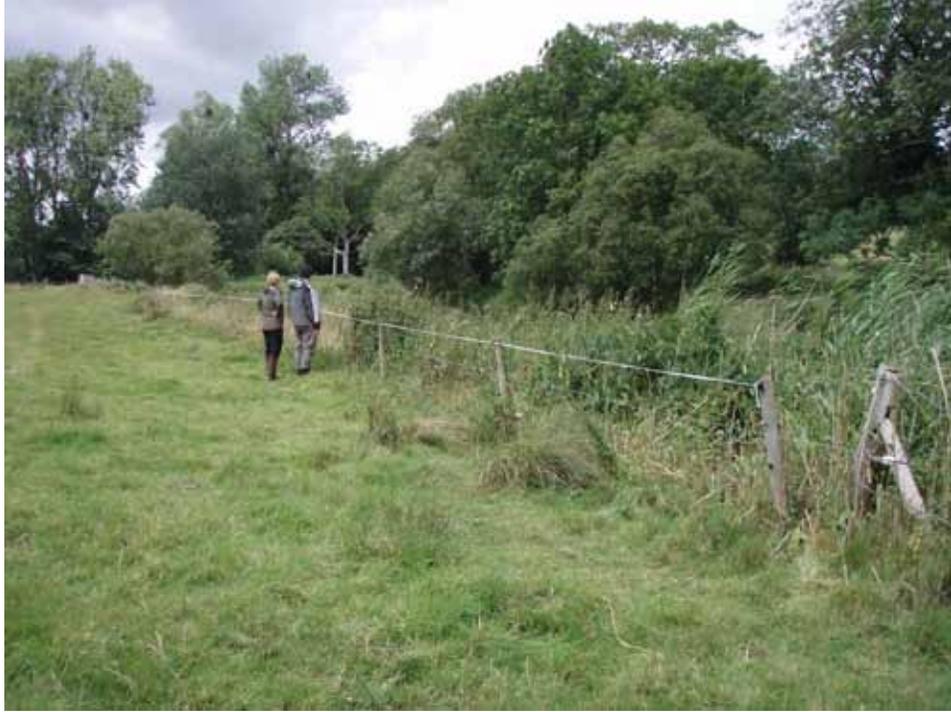
The left (south) bank has a fringe of marginal vegetation comprising lesser pond sedge *Carex acutiformis*, reed canary-grass *Phalaris arundinacea* and reed sweet-grass *Glyceria maxima*, species typical of chalkstream margins. There are also wetland species such as common reed *Phragmites australis* and bulrush *Typha latifolia*, and also tall perennials such as meadowsweet *Filipendula ulmaria*. Land on the left bank is used for grazing and is fenced, and alongside the riffle is a stand of white willow *Salix alba* trees.

Photo 4 Tall marginal vegetation fringe, left bank, upstream of concrete bridge

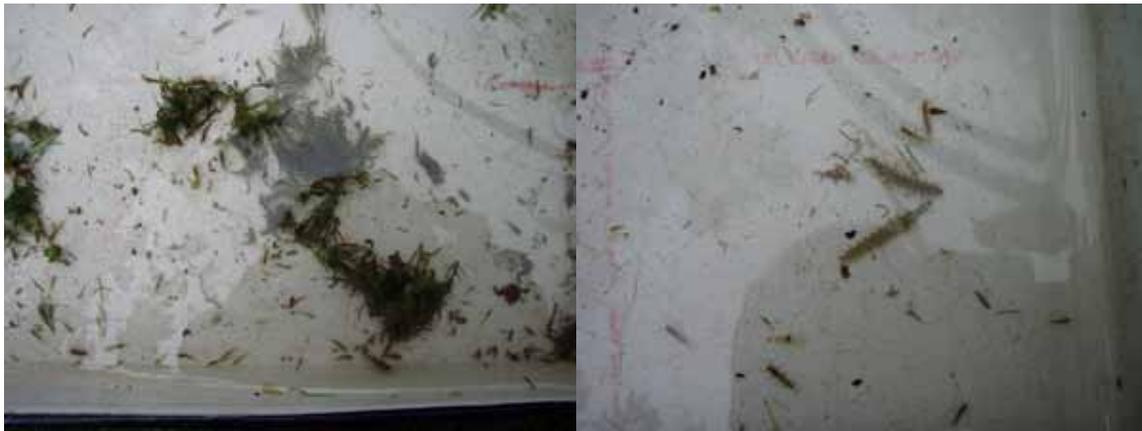
Invertebrates from kick sample of upper beat riffle. Baetis nymphs (left) and caseless caddis *Rhyacophila* sp. (right)

A brief kick sample for invertebrates was carried out on the riffle section of this beat. Amongst the water crowfoot, there were good numbers of Baetidae (olive nymphs), Simulium (black fly larvae), *Serratella ignita* (blue-winged olive nymph), *Gammarus pulex* (freshwater shrimp) and *Aselleus aquaticus* (hog louse). Amongst the gravel there was *Rhyacophila* sp. (caseless caddis), Baetidae (olive nymphs), annelid worms and freshwater shrimp.

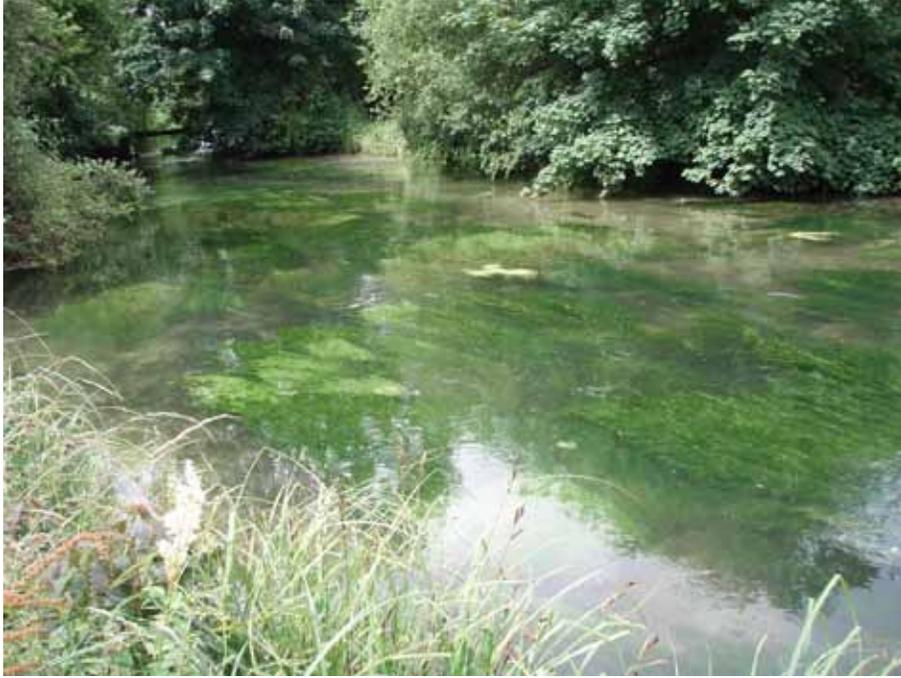
Photo 5 Upper beat, upstream of footbridge. A good mixture of instream vegetation

Above the footbridge the river channel is generally narrower and faster flowing than the downstream section. Where the channel is wider there is a mid-stream island (previously enhanced by the Environment Agency to create a lie for otters). The submerged aquatic vegetation reflects the narrower channel width and faster current speed, with more water crowfoot *Ranunculus* sp. present along with starwort and water-parsnip.

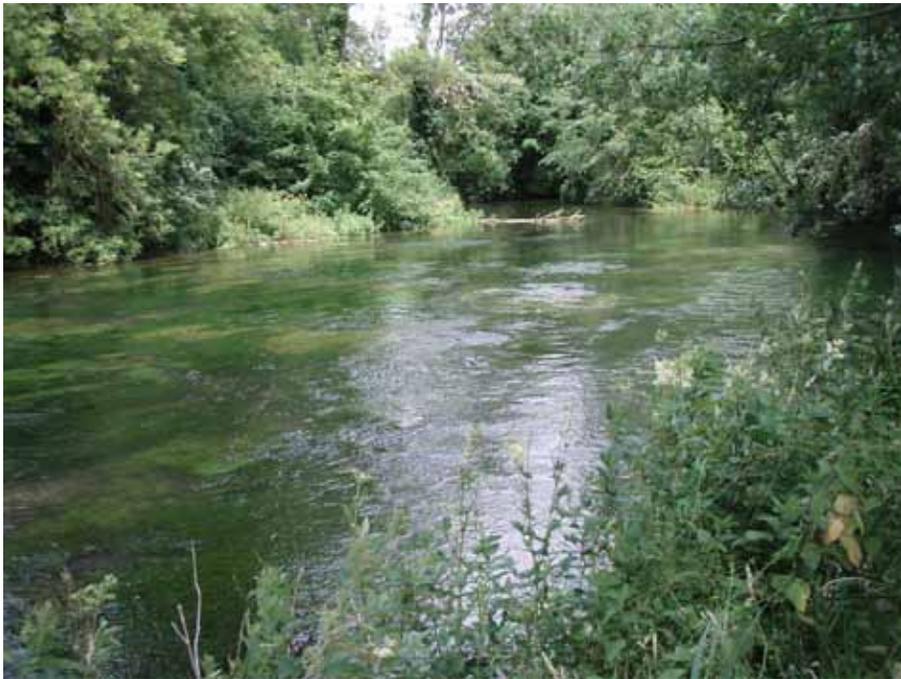
Photo 6 Upper beat – downstream of road bridge. Spawning gravels, a good mix of instream vegetation and bankside cover, plus some large woody debris

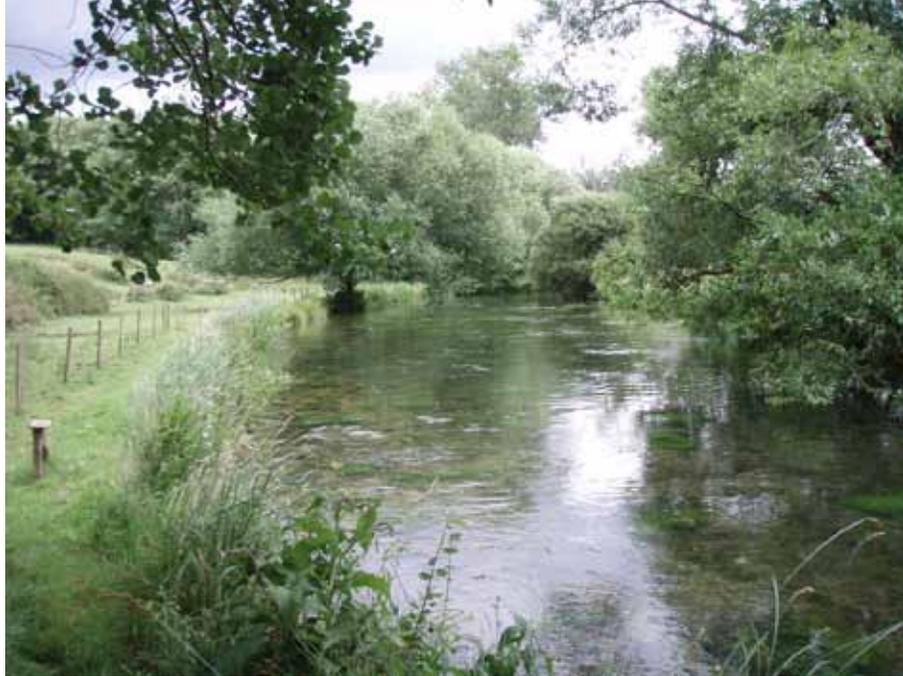
This section is similar to the section upstream of the concrete bridge. Apart from a short section below the concrete bridge, the channel is relatively wide

and shallow and this is reflected in the submerged aquatic vegetation which is similar to above the concrete bridge.

Photo 7 Lower beat, between concrete bridge and wooden footbridge

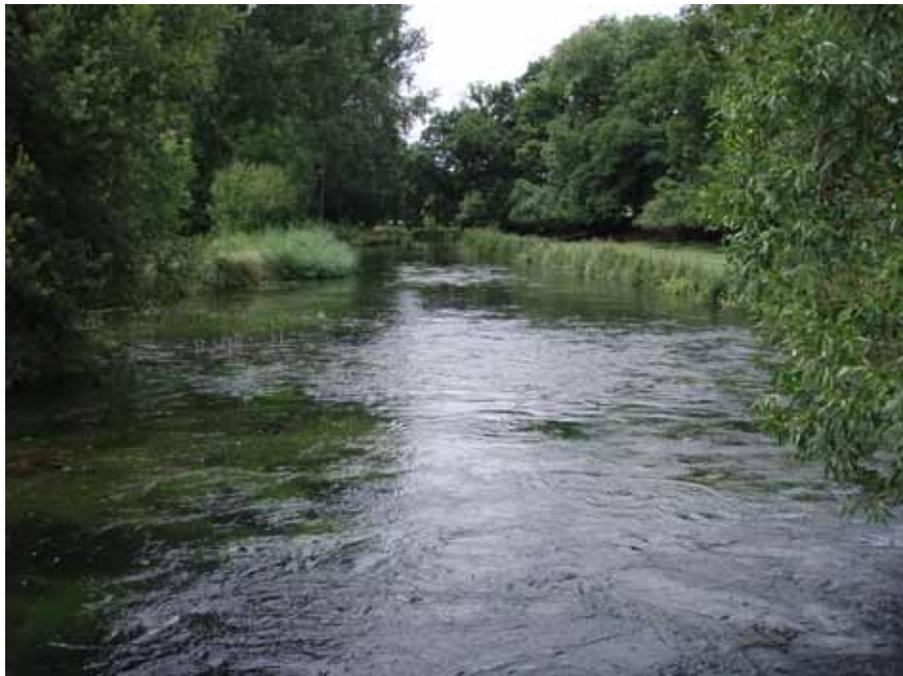
The river channel is pinched to a width of approximately 7 metres at the footbridge and the increased current speed has scoured a pool downstream; *Ranunculus* sp. is present here. Downstream of this point the river widens and is shaded quite heavily by trees on the left (south) bank. The banks are reveted in this section, mainly on the left bank with metal sheet piles, giving way to wattle hurdles further downstream. In some areas logs have been used to protect the banks.

Photo 8 Lower beat - view downstream from wooden footbridge. Note increased diversity of flows and vegetation in immediate vicinity of bridge (narrow channel), and heavy shade on left bank further downstream.

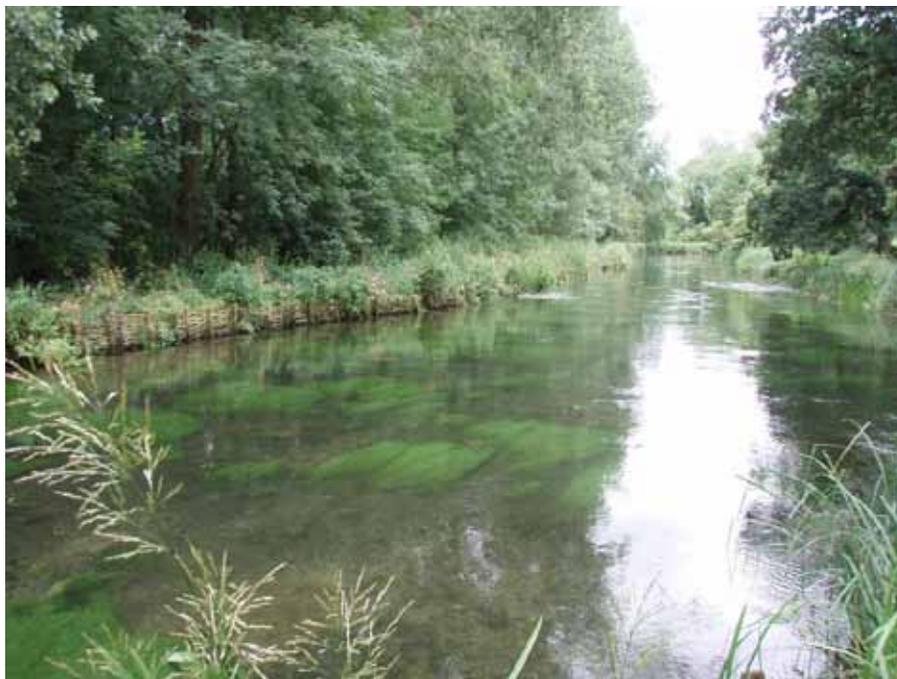
Aquatic vegetation in this section is mainly starwort *Callitriche* sp. and water parsnip *Berula* sp. and is noticeably sparser than elsewhere, probably because of the shading on the south bank. Mare's-tail *Hippuris vulgaris* and common club-rush *Schoenoplectus lacustris* are also present in some areas.

Photo 9 Lower beat downstream section. Note wattle revetment, heavy shading on left bank and sparser instream vegetation

On the lower beat on the left bank there is a tree plantation which shades a great deal of the river. It is recommended that, if possible, these trees are thinned to allow more light to reach the river channel. Natural England (NE) assess this area as being fen, marsh and swamp habitat in unfavourable condition (with respect to the objectives of the SSSI): "populus plantation with *Phragmites* ground layer. Recommendation is to restore the unit to fen." It is recommended that the possibility of working with NE is explored to reduce the shading of the river in this area and achieve the conservation objectives of this unit of the SSSI. It may also provide a valuable local source of large woody debris for the recommendations made above.

It would be beneficial to stake some brushwood bundles (faggots) along the front of the metal sheet piling and hurdle revetment to encourage silt deposition and colonisation with marginal vegetation. This would soften the artificial appearance of this section of the bank and create valuable habitat for juvenile trout and grayling amongst the submerged brushwood and overhanging marginal vegetation.

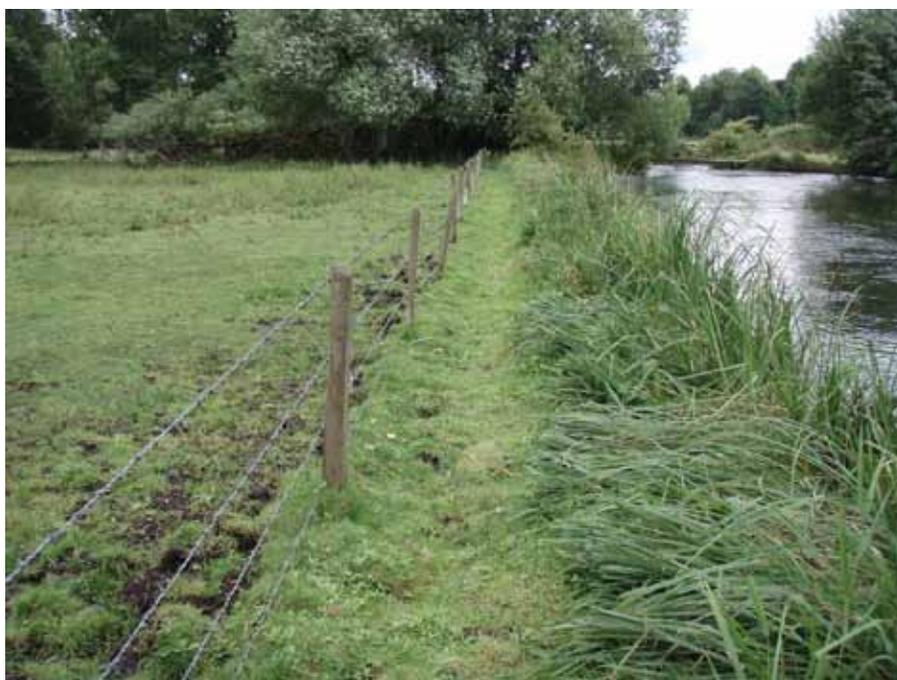
Land use on the right bank is a continuation of the grazing from the previous section; the fence is quite close to the river and in places cattle can just reach the edge of the marginal fringe of vegetation and have grazed it.

Photo 10 Lower beat downstream section. Right bank marginal vegetation fringe nibbled by livestock leaning over the fence.

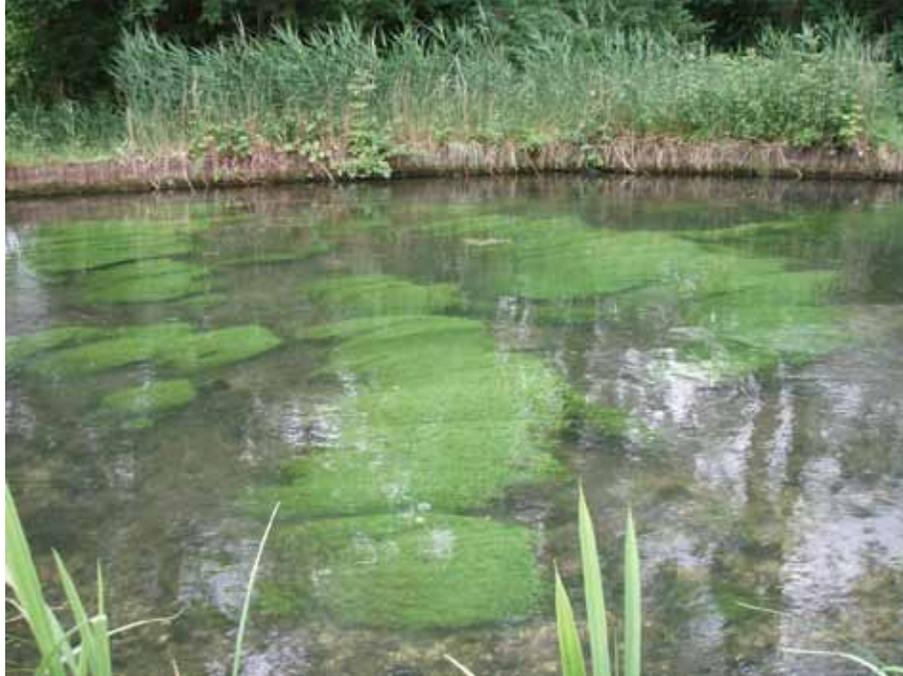
Photo 11 Lower beat. Metal sheet piling on the right bank.

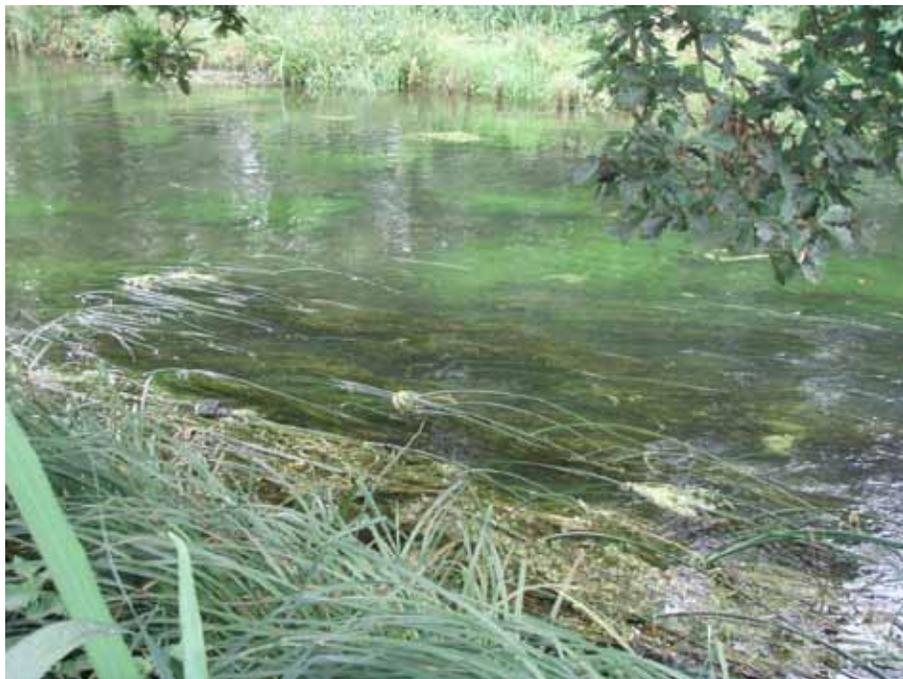
Photo 12 Lower beat. Area of common club-rush *Schoenoplectus lacustris* and Mare's-tail *Hippuris vulgaris*

- A caveat to the previous point is that a watching brief should be maintained on the stands of *Schoenoplectus lacustris* (common club rush). Although a native species, this can be quite invasive and careful management is required to prevent its spread across large areas of the river channel. Fixed point photography is recommended to monitor the existing stands of club rush. Targeted control is probably most easily achieved with a contact herbicide (glyphosate). Prior written consent of the Environment Agency is required prior to the use of herbicides in or near water – contact the local office for advice. The relevant application form can be found at www.environment-agency.gov.uk/subjects/conservation/840870/840941/.

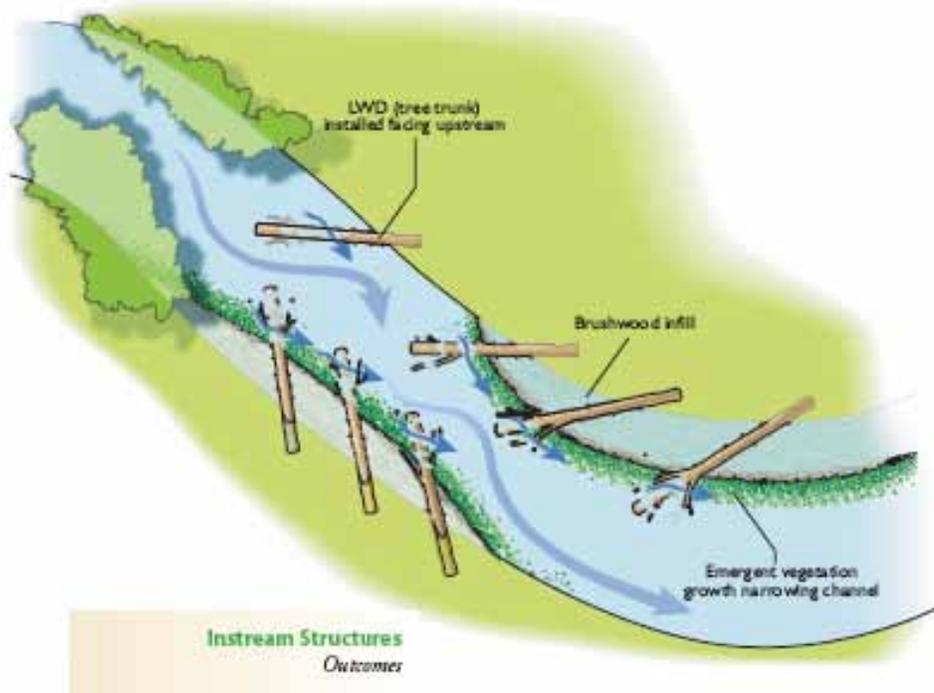
Figure 2 Channel narrowing using LWD and brushwood infill

Channel narrowing could also be achieved using woody debris. Figure 2 illustrates how upstream pointing flow deflectors with brushwood infill between them can be used to encourage silt deposition in the margins, and subsequent colonisation with vegetation.

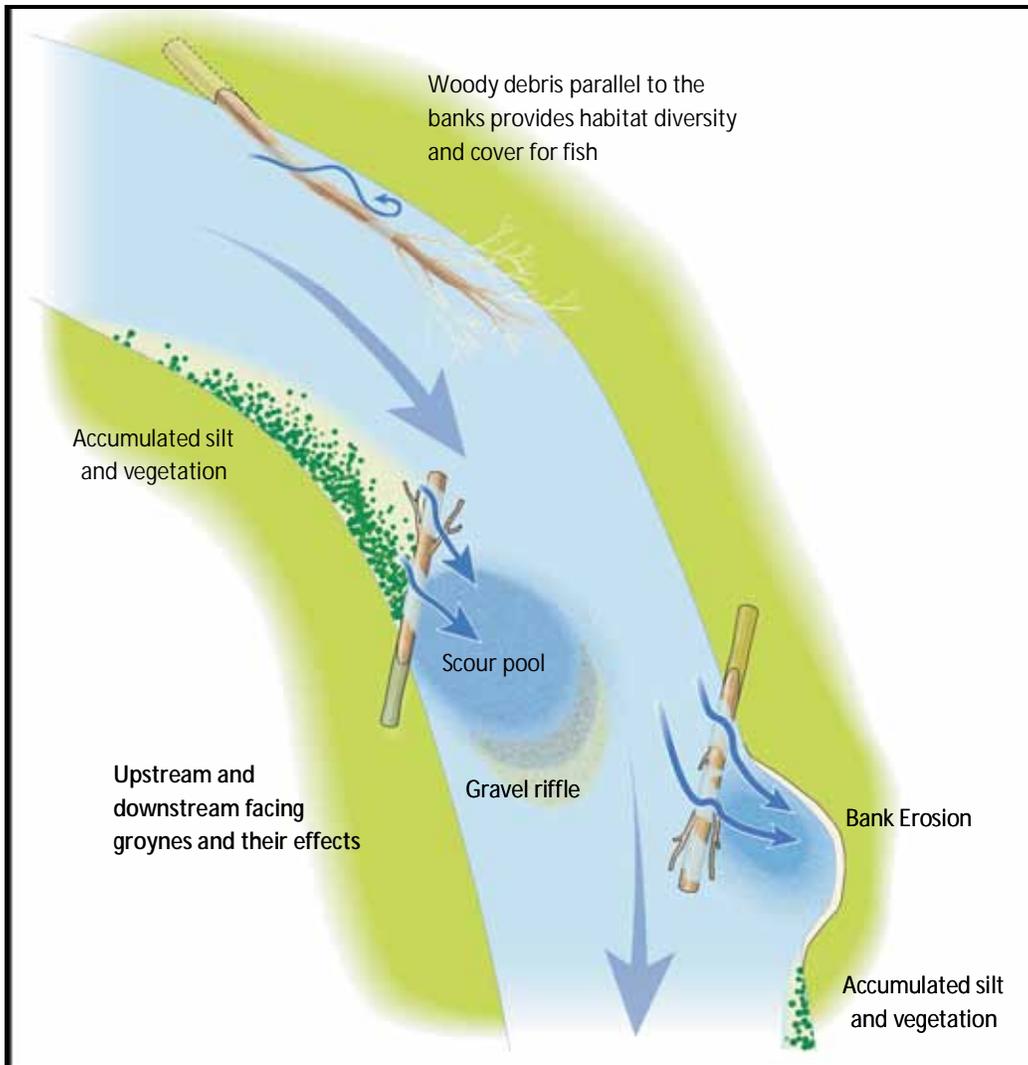
Figure 3 Different effects of upstream and downstream facing flow deflectors

Trees laid parallel to the bank (Figure 3) would also assist in narrowing the channel and provide valuable cover for fish and invertebrates. This
