River Kennet – Marlborough College

An Advisory Visit by the Wild Trout Trust December 2015

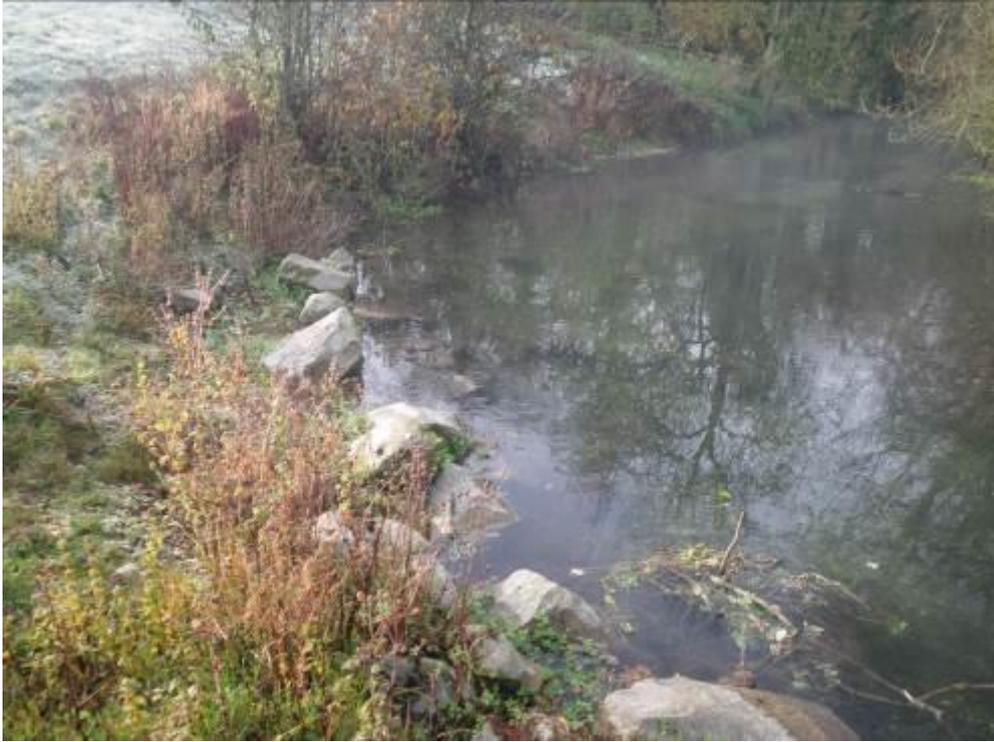
At some stage the outside of a sweeping left hand bend has been reveted with large imported stone (photo 1 & photo 2). This work was probably undertaken in response to some slight bank erosion following an exceptionally wet winter. This treatment, sometimes referred to as 'riprap' is not considered to be an appropriate bank protection measure for a low energy chalkstream and more importantly is often not as effective as a well planted 'soft' margin containing energy absorbing emergent plants. The impacts of the stone revetment could be softened by pushing in the high RB down to form a low, wetter margin which could then be planted with a mixture of native aquatic emergent plants (procured from other sections of kennet flood plain) such as sedge, iris, reed sweet grass, burr reed or reed canary grass. The outside of the bend did not appear to be heavily shaded so the development of a planted soft margin should be perfectly possible.

Photo 1. Imported stone used to revet the bank.

- **Set all of you project objectives in one single application for Flood Defence Consent.**
- **Consider removing the inappropriate stone revetment and replace with a low, soft planted margin.**
- **Use some of the stones to create some individual lies but do not litter the channel with too many.**

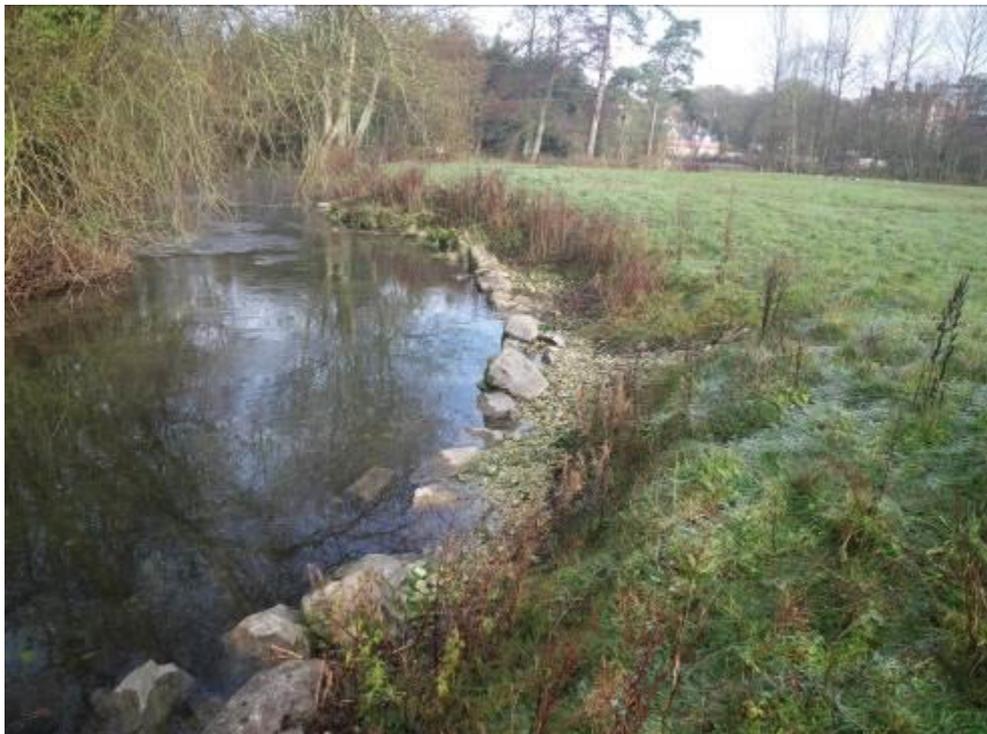
Photo 2. The same section of sweeping bend looking down stream

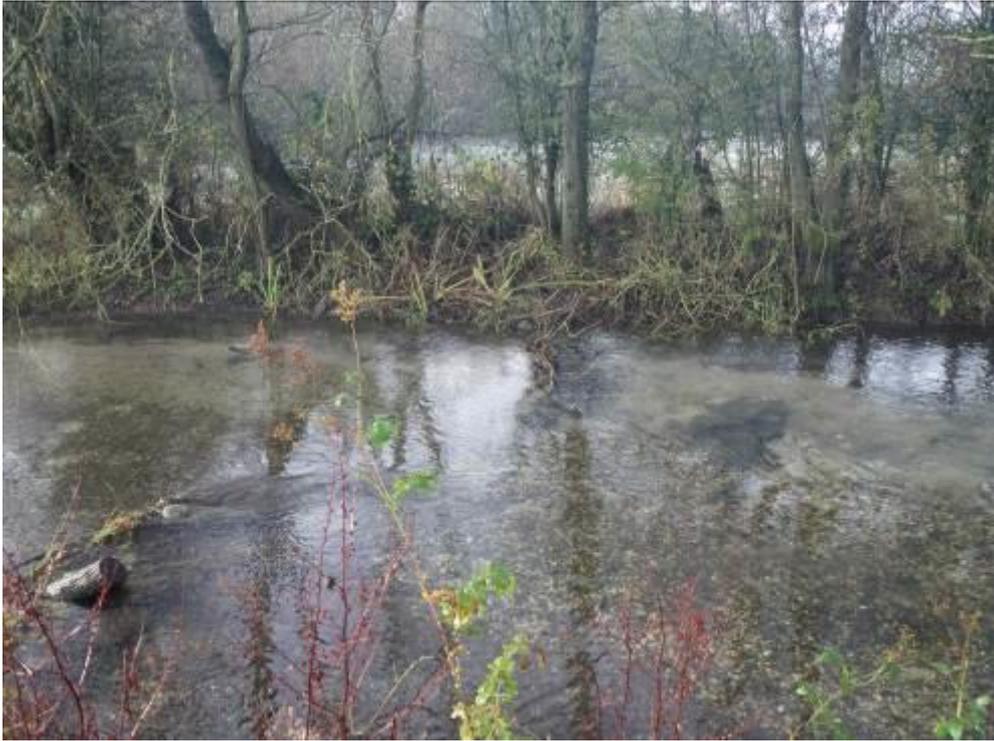
A short distance downstream there are some good examples of where stones have been used to create some short stub groynes (photo 3) to promote flow diversification and some bed scour. These have undoubtedly provided some improved habitat but groynes and flow deflectors constructed from large pieces of woody debris would be more appropriate in the chalkstream environment and has the added advantage of providing food and habitat for aquatic invertebrates.

Photo 3. Stone stub groynes and clusters of individual stones provide some upwelling and local river bed scour.

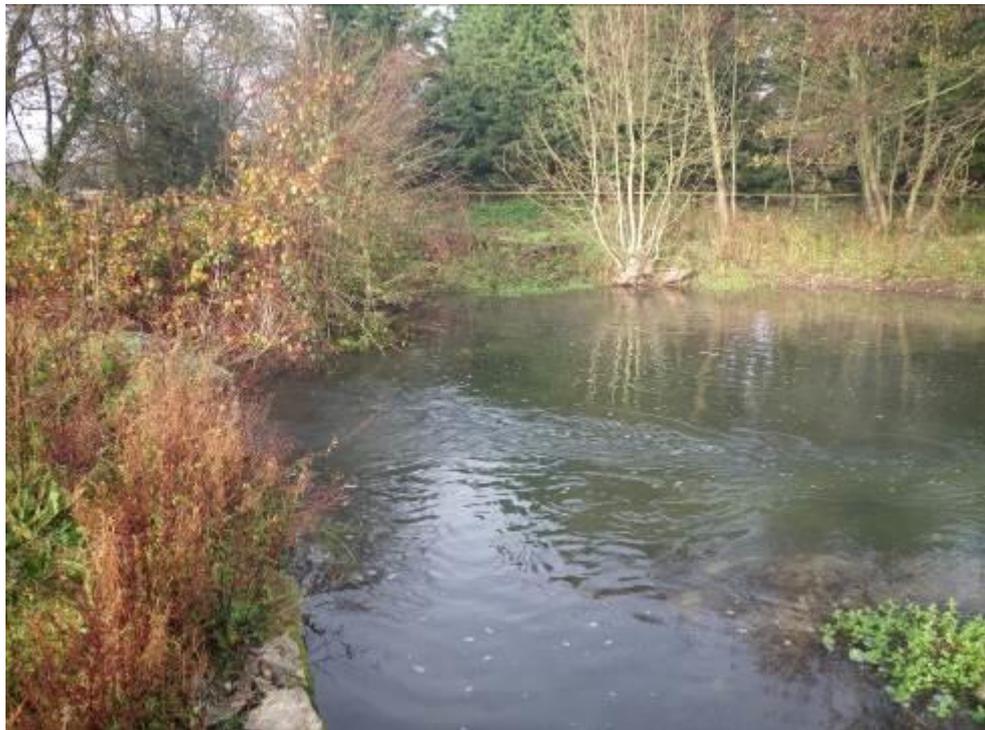
This top section of channel mainly consists of shallow glide habitat flowing through a comparatively shaded channel. The channel appears to be very wide for the likely average discharge and is slightly impounded by an old hatch structure (photo 4) which is located approximately 100m downstream of the top boundary. Although much of the bed above the structure has re-graded over the years, with the river bed having risen as a direct result of the downstream impoundment.

Photo 4. Hatch pool

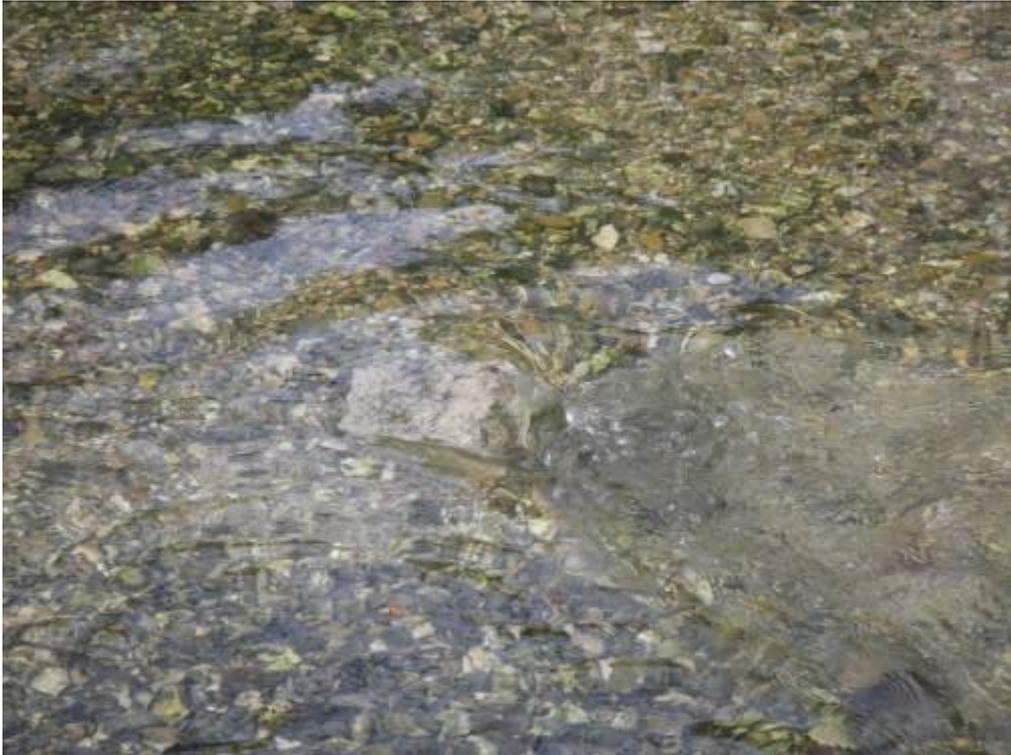
Ideally some of the stones could be redistributed and liberally scattered within the channel to create individual lies for adult trout in deeper runs and for parr on shallow riffles (photo 5). Again this will look slightly odd in a lowland chalkstream channel but large stones are effective for creating holding lies for trout by providing a refuge. The upwelling water promotes a safe refuge for any fish which will be reluctant to sit out in a smooth open glide where they will vulnerable to predation.

Photo 5. An individual stone providing good quality holding opportunities for a small trout.

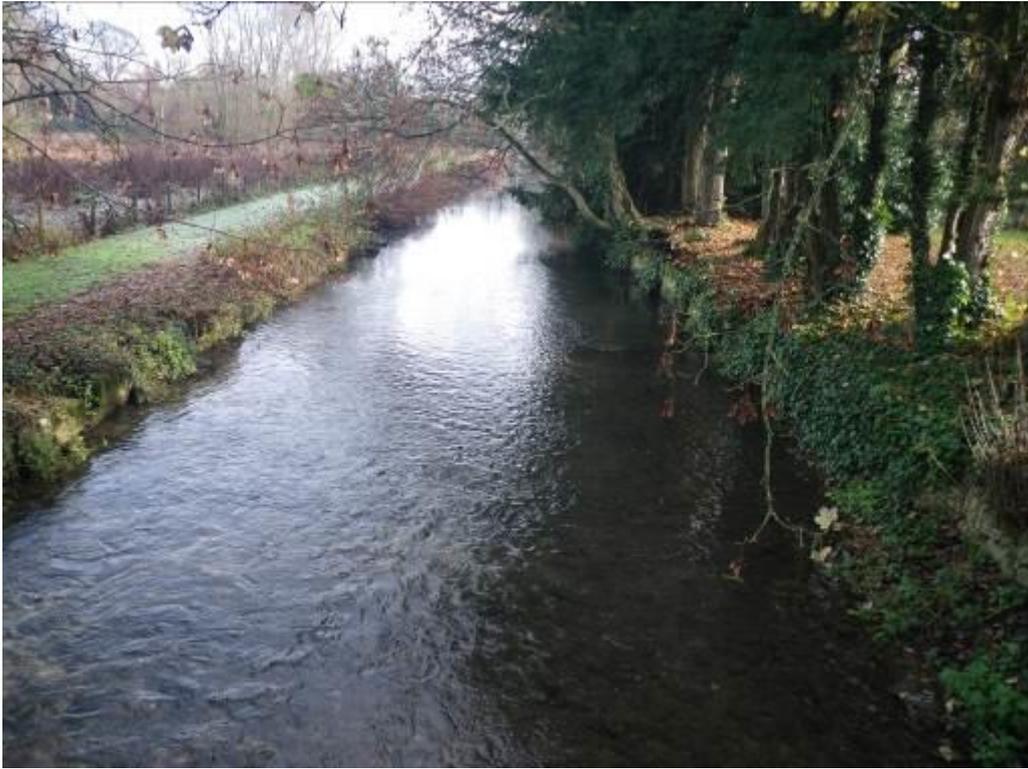
Downstream of the bridge adjacent to Preshute House, the river channel is reveted on both banks with vertical stone walls (photo 6). A dense stand of yew trees on the RB casts significant shade over the channel and the lack of any significant in-channel cover makes this a comparatively hostile section for holding trout. These yew trees are very old and significant and the chances of introducing more light here to promote in-channel weed growth is remote. This might be a very good section to consider using some of the large stones found upstream to provide much needed cover and local river diversity.

Photo 6. This shaded reach could benefit from some of the large stones found in the reach above.

Where shafts of light are able to hit the river margins then it is possible to locally install a new toe to the bank with either faggot bundles (as already very successfully tackled by the group) back filled with a brash/soil mixture and planted with appropriate emergent plants. Sedge species are particularly useful for planting into the toe of the bank, or if shallow enough, yellow flag iris as a plant that is particularly sturdy where there are large numbers of water fowl present.

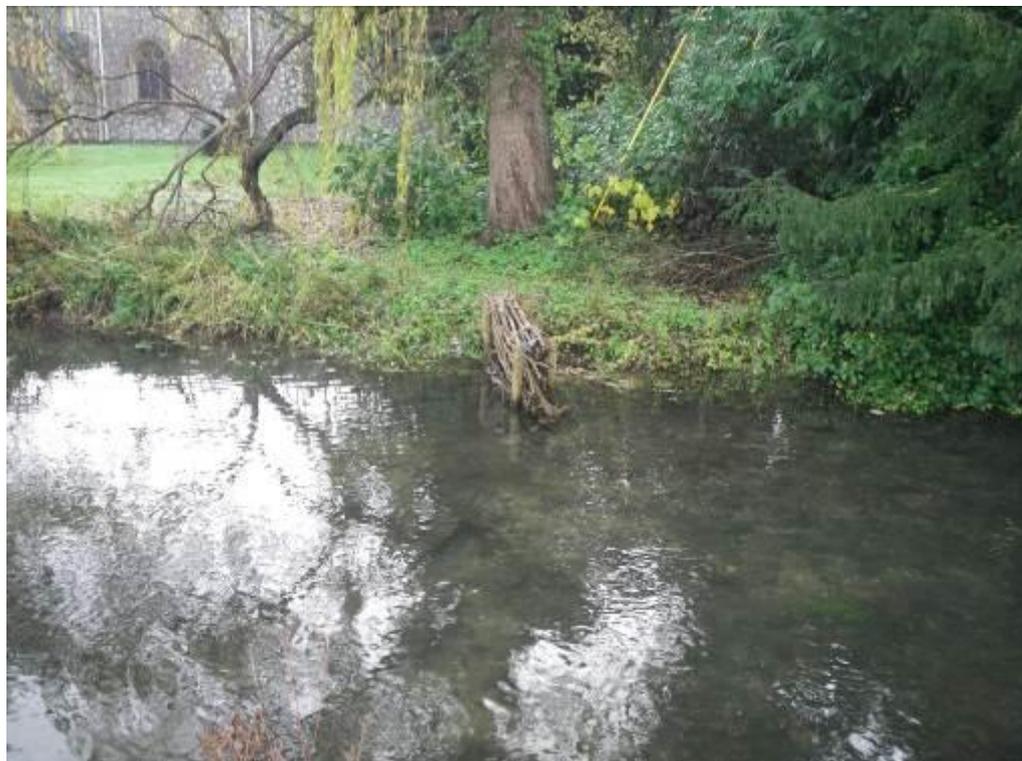
In one or two locations the odd hazel faggot flow deflector has been installed (photo 7). For these to promote in-channel bed scour they really need to squeeze the channel width. Currently they are too short and too high. Flow deflectors can be constructed from faggot bundles but whole sections of tree trunk tend to be more robust and ultimately more effective. In such a low energy environment, it is recommended to install the deflector and then to loosen the bed substrate with a fencing spike or mattock, or even slightly dig out the area where the water eddies off the end of the structure. In low energy chalk streams the elevated flow velocity promoted by the deflector does not always have enough flow power to scour the bed, especially if the bed is concreted with

Photo 7. Flow deflectors need to pinch the channel to be effective and should be below the height of the bank

calcium carbonate deposit. Digging a little pot and using the flow deflector to keep it swept clean of fine bed deposit is very effective for creating trout lies.

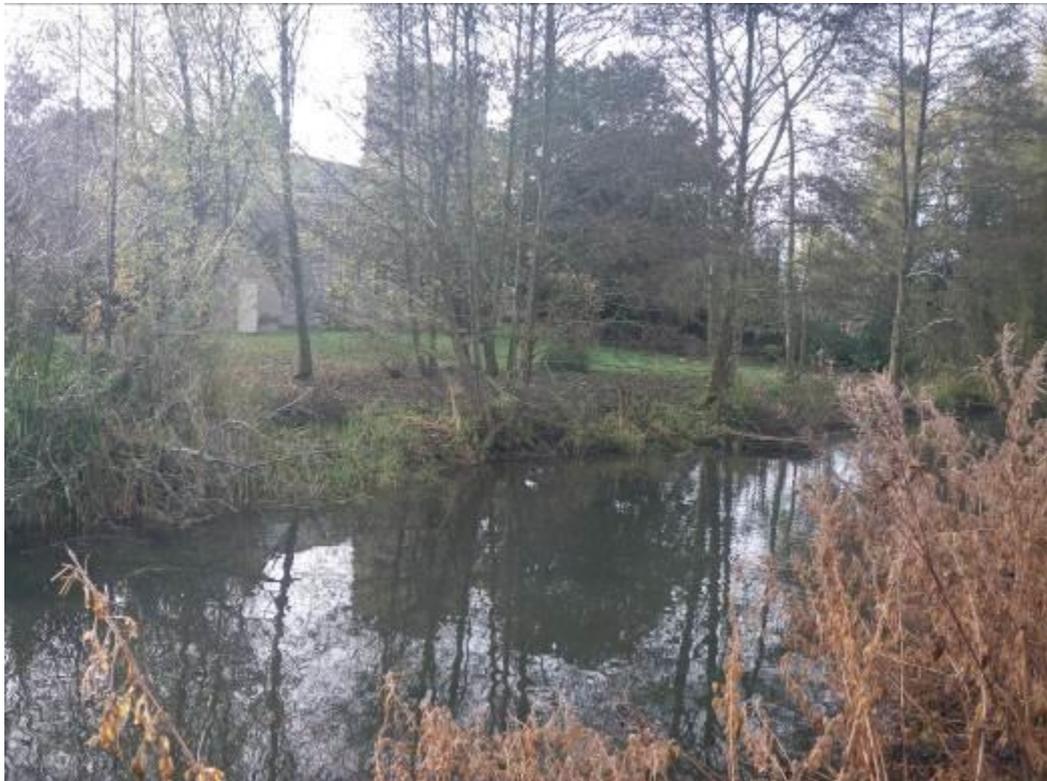
The section of channel running downstream from adjacent to the church is heavily impacted by the impounding weir installed to provide an inlet to the College lakes. With little gradient available, the river here is flat, uniform and a comparatively poor environment for trout (photo 8).

Photo 8. Some of the alders adjacent to the LB lend themselves to dropping into the channel margins where they can either be hinged or tethered to their own trunks.

Some in-channel diversity could be promoted by hinging or laying in some of the bankside alder trees. This might not be an appropriate job for the volunteers and specialist help would be required but hinging and laying whole trees into the river margins is a very effective way of providing cover. An alternative for the group is to install brushwood parallel to the bank toe to provide complex and biologically valuable habitat.

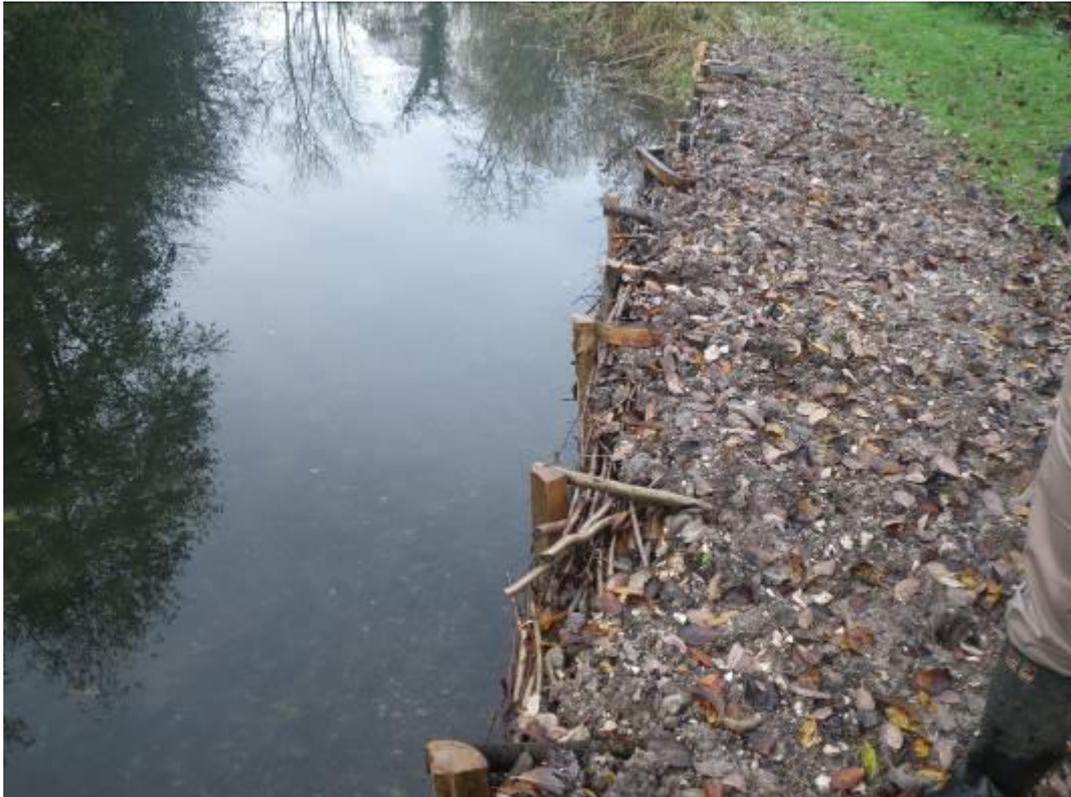
Further downstream the group have undertaken some excellent revetment work (photo 9) where the bank breached during the heavy winter floods in 2014. The LB is particularly vulnerable here due to the impoundment and perched nature of the channel. To ensure that the work is sustainable it will be important to undertake some planting this spring, ideally with plants such as sedge. The sedge *Carex pendulus* is usually associated with woodland environments but works well in comparatively dry areas for reveting banks that have to be set up well above the water levels. It is also shade tolerant to some extent but more light penetration to this margin is recommended. A section of revetment just upstream of the structure (photo 10) requires a dense brush matrix infill, planting and improved light penetration.

Photo 9. High quality bank revetment work will need to be planted up with resilient emergent plants this spring.

- **Backfill your revetments with brash and high bank soils and plant with locally procured emergent plants.**
- **Ensure there is plenty of direct sunlight on vulnerable banks.**
- **Peg in large chunks of woody debris on shallow gravel riffle sections to create bed pots and sort river bed gravels. Chisel the bed to loosen bed material to a depth of at least 300mm.**
- **Coppice and pollard to promote a 50:50 dappled light and shade regime.**
- **Keep any trees that are growing on top of structures or vertical revetment coppiced to the ground.**

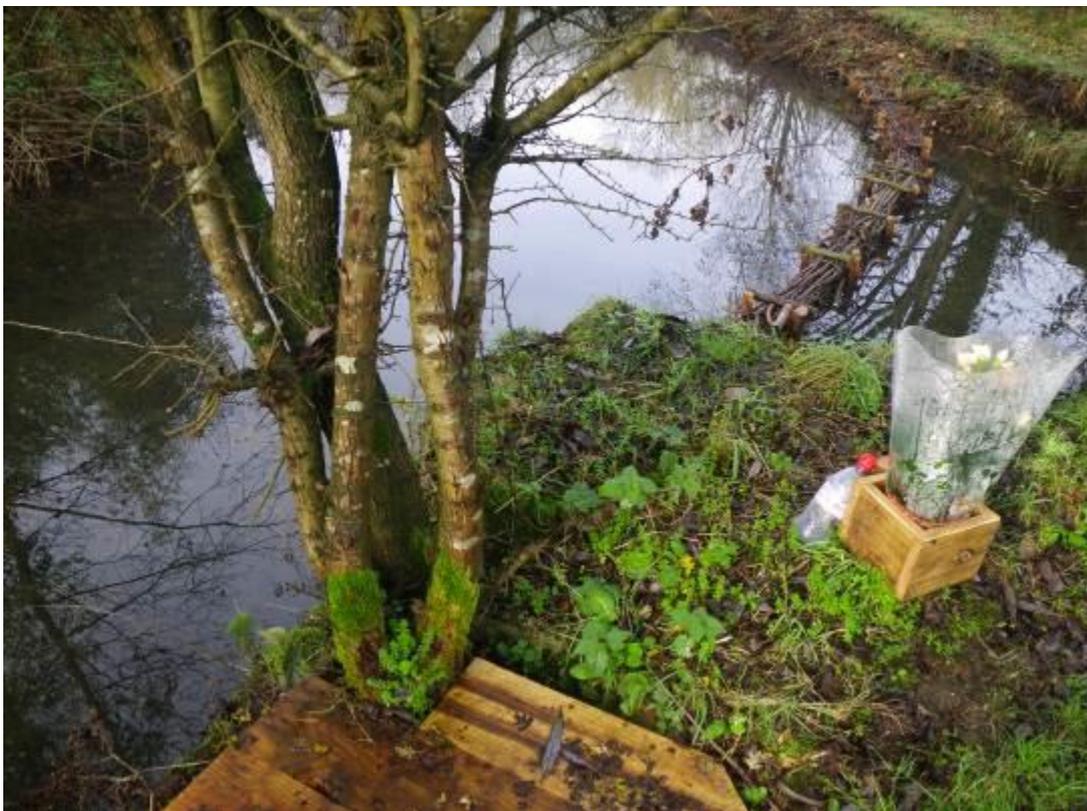
Photo 10. The sturdy revetment now requires packing with lots of brushwood and emergent plant plugs. It is also recommended to keep all trees coppiced to the ground that are currently growing on top of the side sluice wing walls.

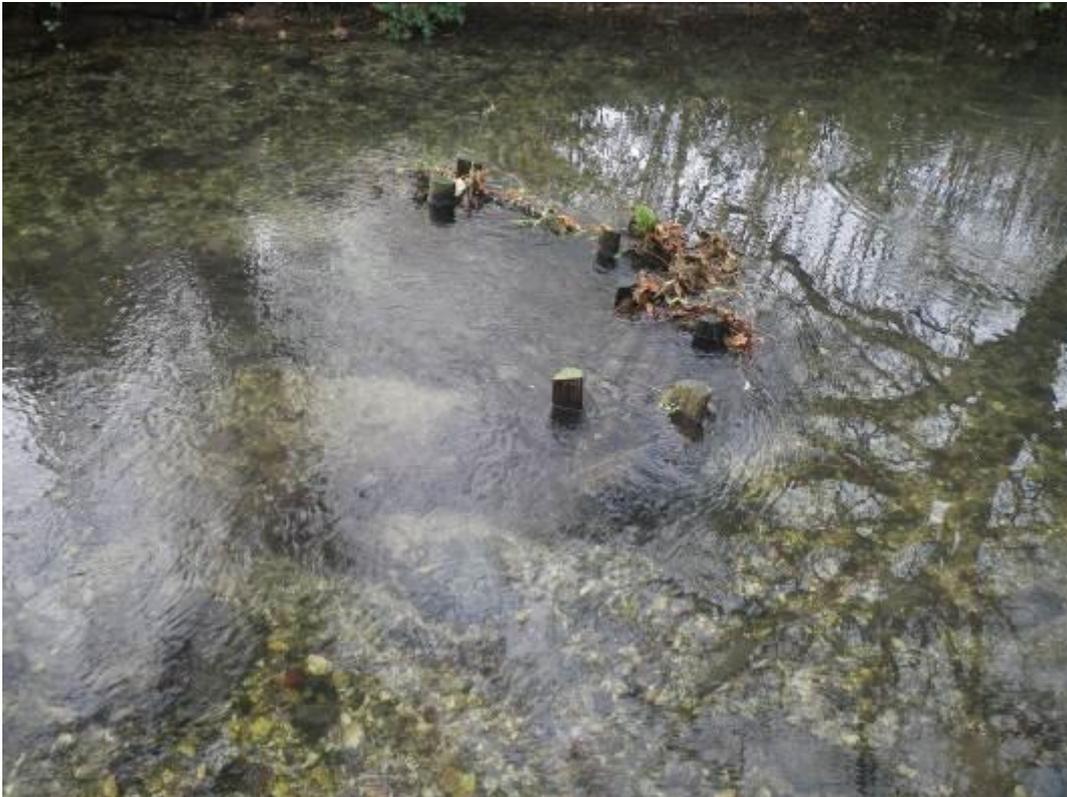
Some in-channel upstream 'V' deflectors have been installed (photo 11). These were helping to sort river bed sediments. Lightly chiselling out the bed where the water eddies off the outside edges will make these structures to be even more effective.

Photo 11 Upstream V deflectors can be very effective at promoting an uneven and more diverse river bed topography.

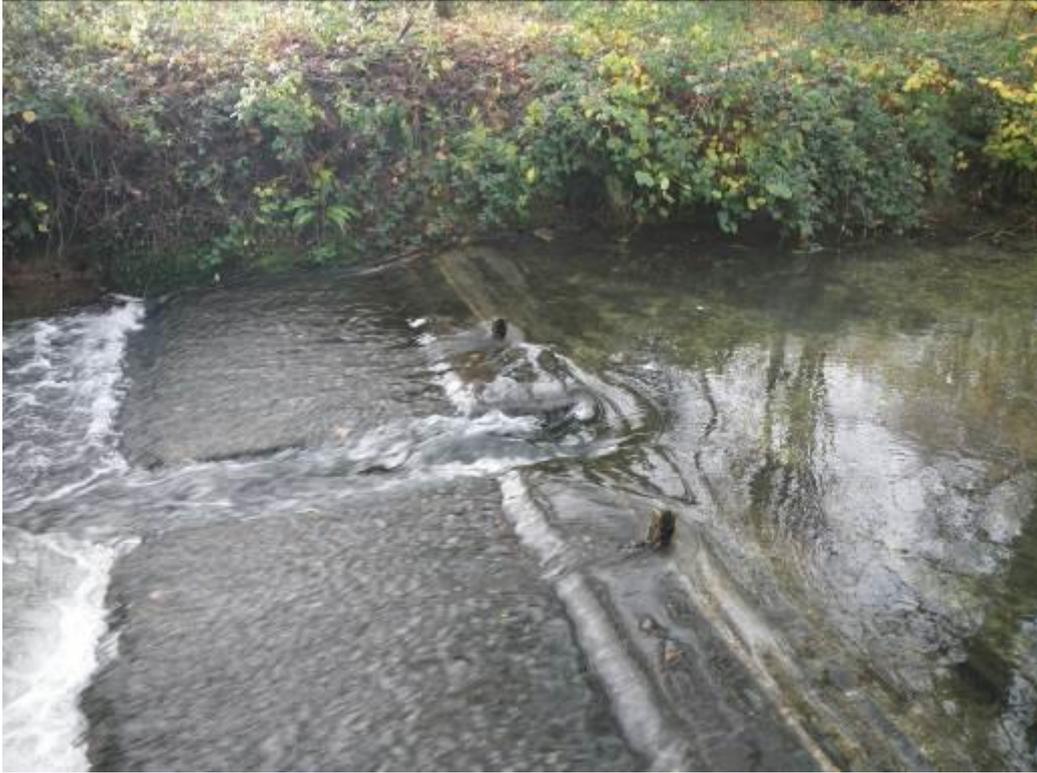
At the bottom of this reach there is a weir (photo 12) which provides a head of water to feed into the college lakes. A notch has been cut into the centre of the structure which will undoubtedly help fish to be able to migrate up and over the structure. Unfortunately the structure is still impounding a substantial reach of river. The impoundment is not helping to provide any useful water depth upstream because over the years since the structure was installed, the river bed upstream has gradually risen. It is understood that this weir fulfils a requirement to push water through the lakes but it is very important to keep the weir as low as possible and try and create up-stream water depth by locally driving the river bed down and not through holding up the levels with additional boards.

Photo 12. Level control weir has been successfully modified by the group to facilitate improved fish passage. Additional boards should not be installed, even under low flow conditions.

The measures taken to reduce the height of the weir and provide improved access for fish migration are to be praised. Keeping the structure as low as possible will be important.

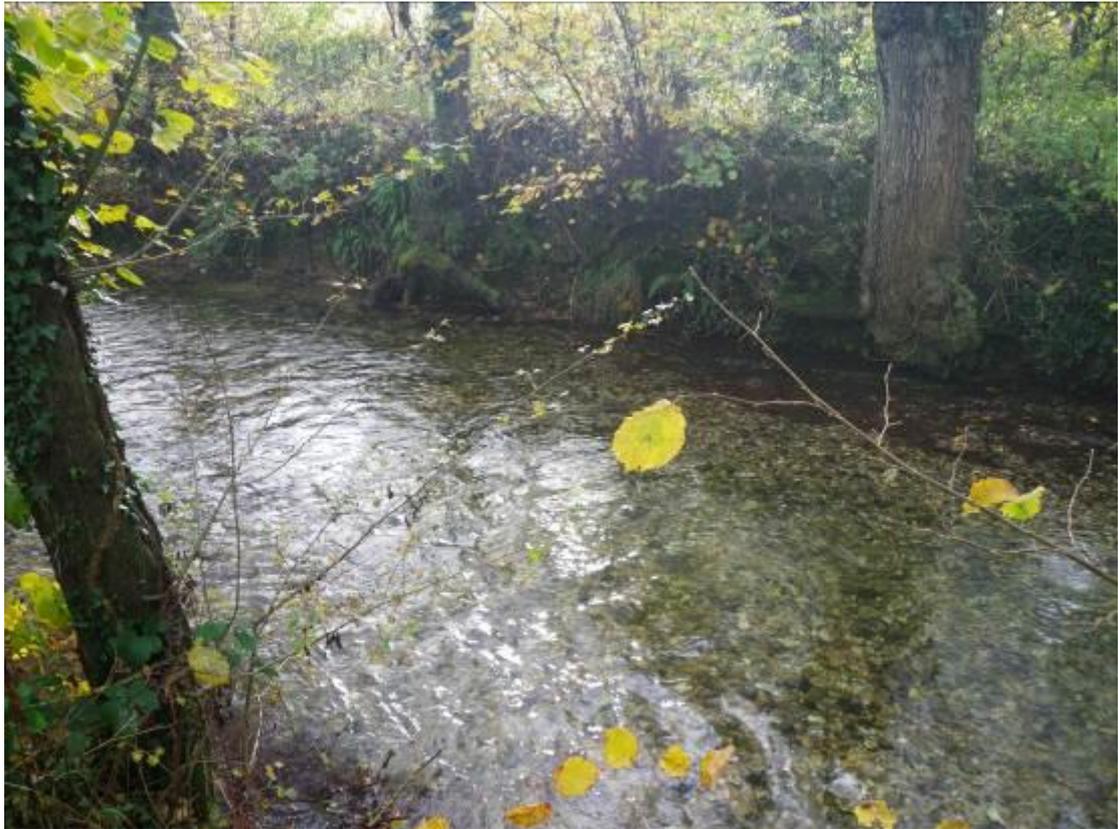
Downstream of the weir the river enjoys a comparatively steep gradient and is dominated by long sections of shallow riffle habitat (photo 13). This is potentially a very good trout spawning and nursery area. Habitat could be improved through the provision of some modest sized holding pools for pre and post spawning adult trout.

Photo 13. Long shallow riffle would benefit from bed scour promoted by LWD flow deflectors.

This habitat can be promoted by pinning in some large woody debris flow deflectors to radically squeeze the channel width. Fluming the water through some narrow gaps and chiselling and loosening the bed material will help to sort river bed gravels into valuable 'up ramps' where the water flows through the gravel, rather than just skimming over the top. These classic tails to small pools will be the places that trout will seek out for productive spawning opportunities.

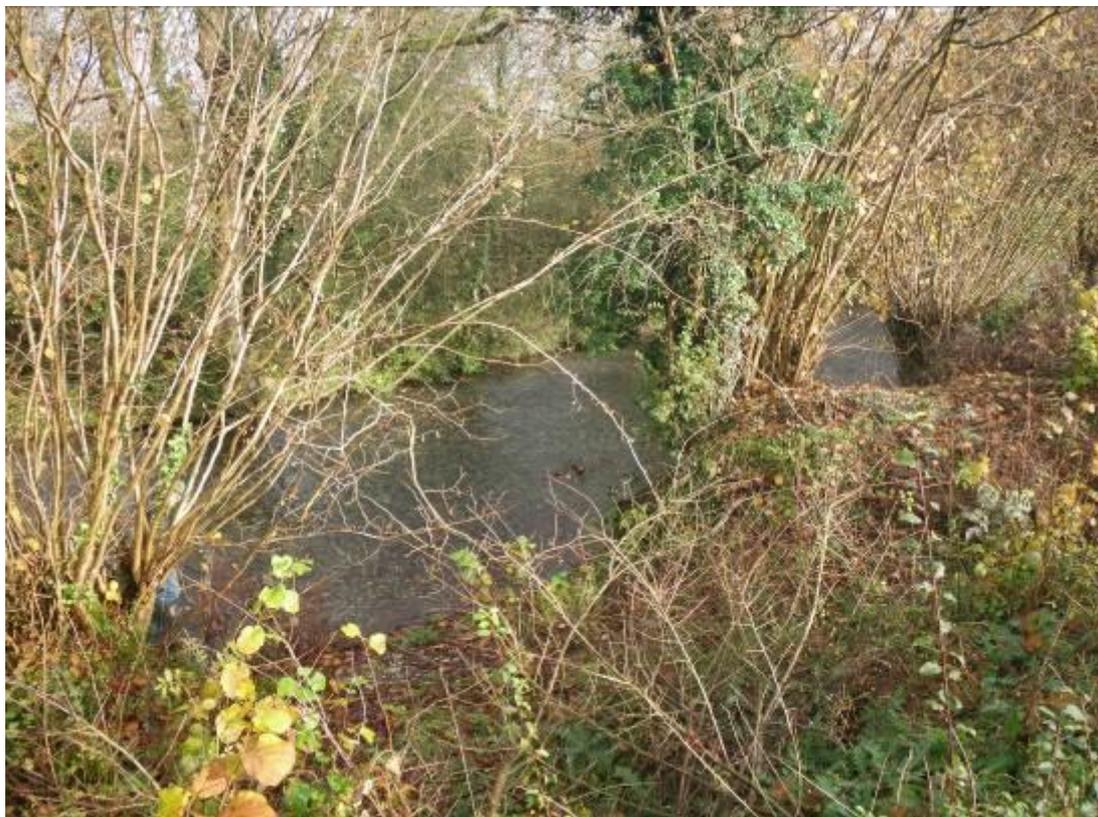
Currently this section of channel is quite heavily shaded. Regular coppicing of hazel and alder will help to promote improved in-channel weed growth and thus provide improved cover for both adult trout and parr. Maintaining low shade over the deeper pool habitats and opening up the canopy above the riffles is generally accepted as the best management regime to provide safe, cool lies for trout but to also promote primary production for plants and bugs.

Photo 14. Regular coppicing of hazel will provide excellent revetment material and ensure some summer weed growth on what should be very productive shallows.
