**Advisory Visit**

**Kirtle Burn – Dumfries and Galloway**

**Scotland**

**26/07/2016**

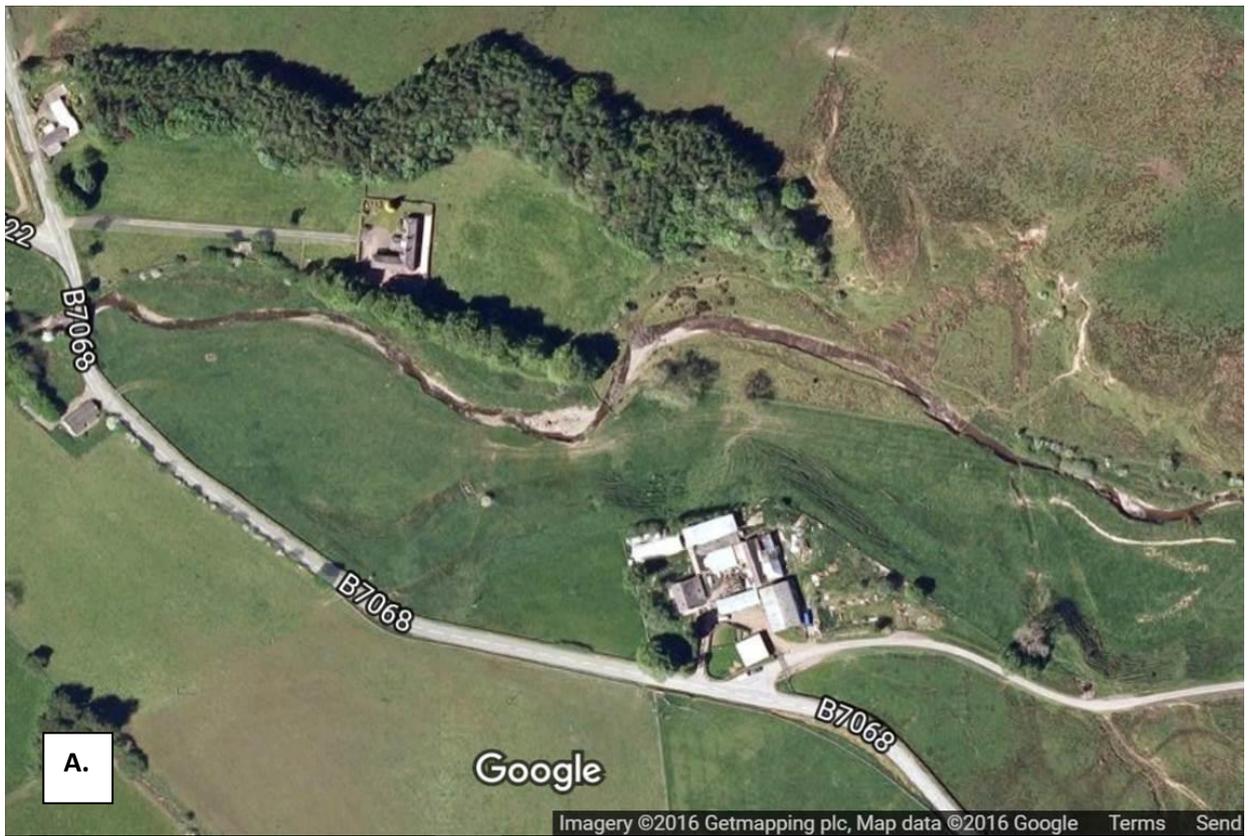
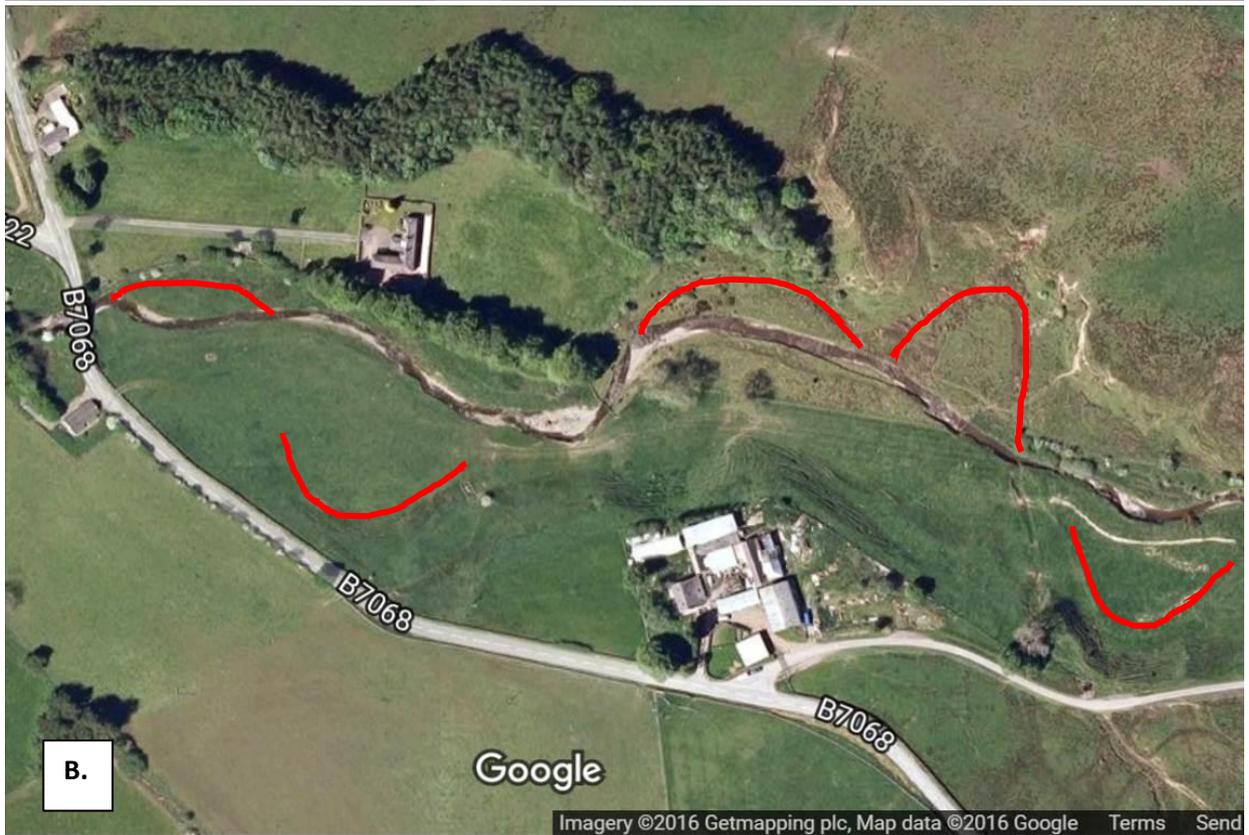
**Figure 1: Current aerial imagery of the Fallford Lodge area (A). Some of the paleo-channels highlighted, providing a clue as to past channel routes and a more sinuous and lower-gradient course (B).**

Figure 1 shows aerial imagery of the area with the locations of the most obvious paleo-channels within the floodplain (Fig. 1B). While some of the channel migration to its current course may have been natural, other areas were clearly artificially straightened and maintained straight, as continues today (Fig. 2). As a consequence, the current channel is straighter and conveys higher energy than it would ordinarily, and erosion is greater as a consequence.

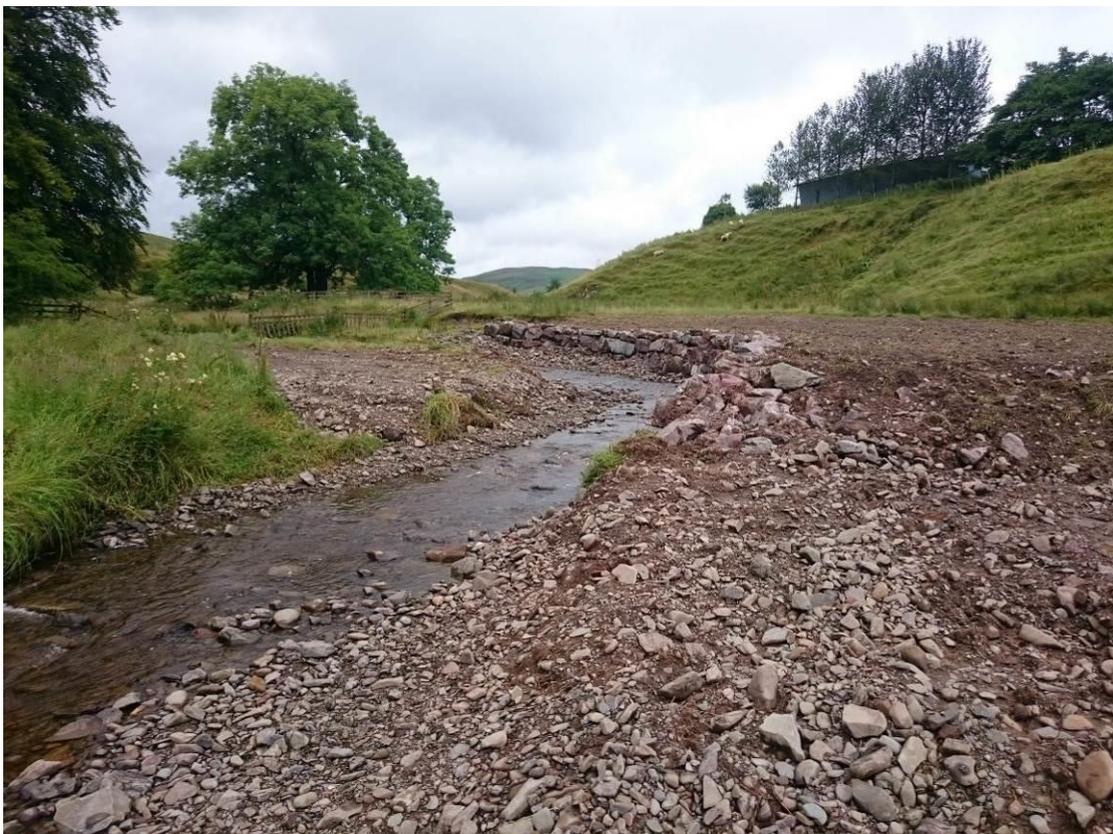
Figures 2 and 3 shows a piece of particularly unsympathetic and poorly executed 'hard' bank protection (revetment) that was undertaken to protect a water pipe towards the u/s end of the site. At this location, the incised (following historic straightening) channel is eroding laterally into the bank of the now disconnected floodplain (LB).

While revetment may be required to protect an important asset here, the fact that it is not tied into consolidated bank at either end means that high flows are likely to quickly out-flank the structure (see examples - <https://youtu.be/q7zq1yxaPEA>). Once behind it, flows will erode even faster into the softer adjacent bank, greatly exacerbating erosion issues. This is because, unlike softer, green engineering that absorbs and dissipates flow energy, hard, solid structures within a watercourse simply deflect flow energy elsewhere, focussing erosive force onto other areas. In addition to eroding at either end of the structure, flow energy along the revetment that is unable to erode laterally will scour downwards into the bed, eventually undercutting the revetment if the foundations are not sunk deep enough. Livestock access to the recently reworked earth also greatly inhibits recolonisation by the vegetation that is required to stabilise that ground.

**Figure 2. Unconsolidated bank at the d/s end of the hard bank revetment (LB – right of shot) that will be subject to exacerbated erosion from flow energy deflected by the structure.**

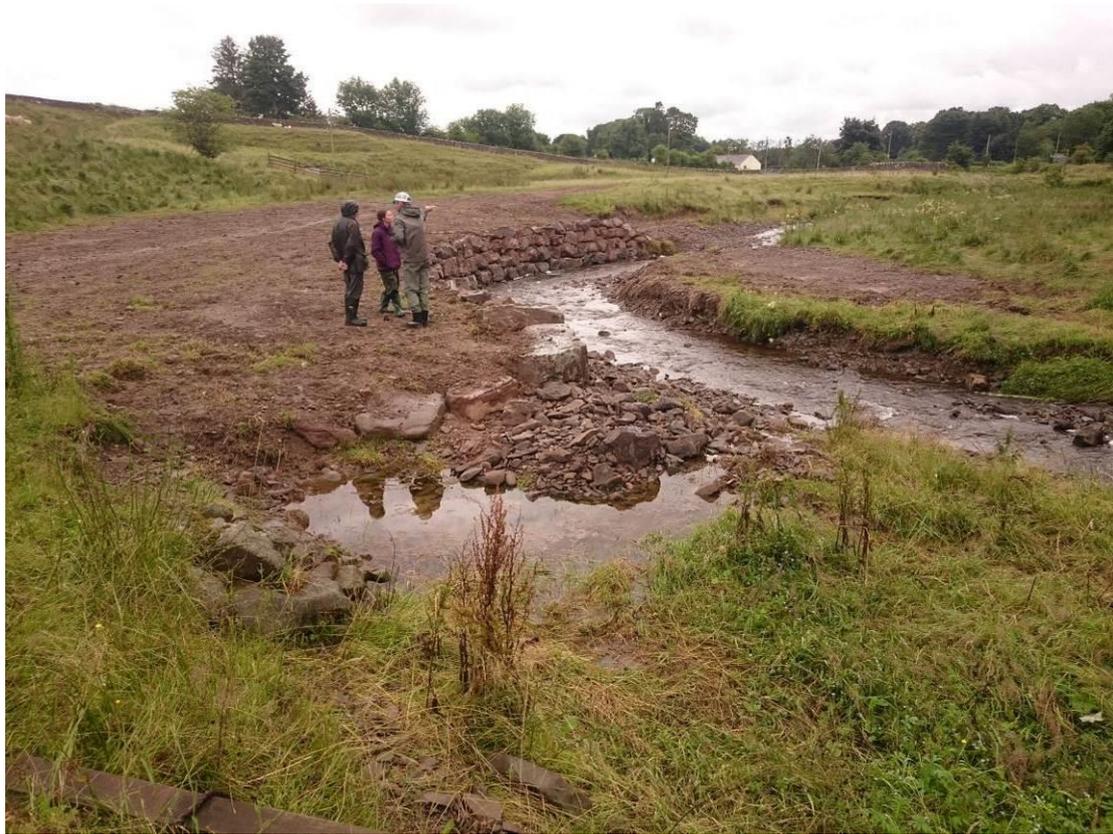
**Figure 3. The u/s end of the hard bank revetment where, again, high flows are likely to cut into the unconsolidated bank material. At least some relatively well established vegetation is present (foreground) which may slow the rate of erosion and out-flanking of the structure.**

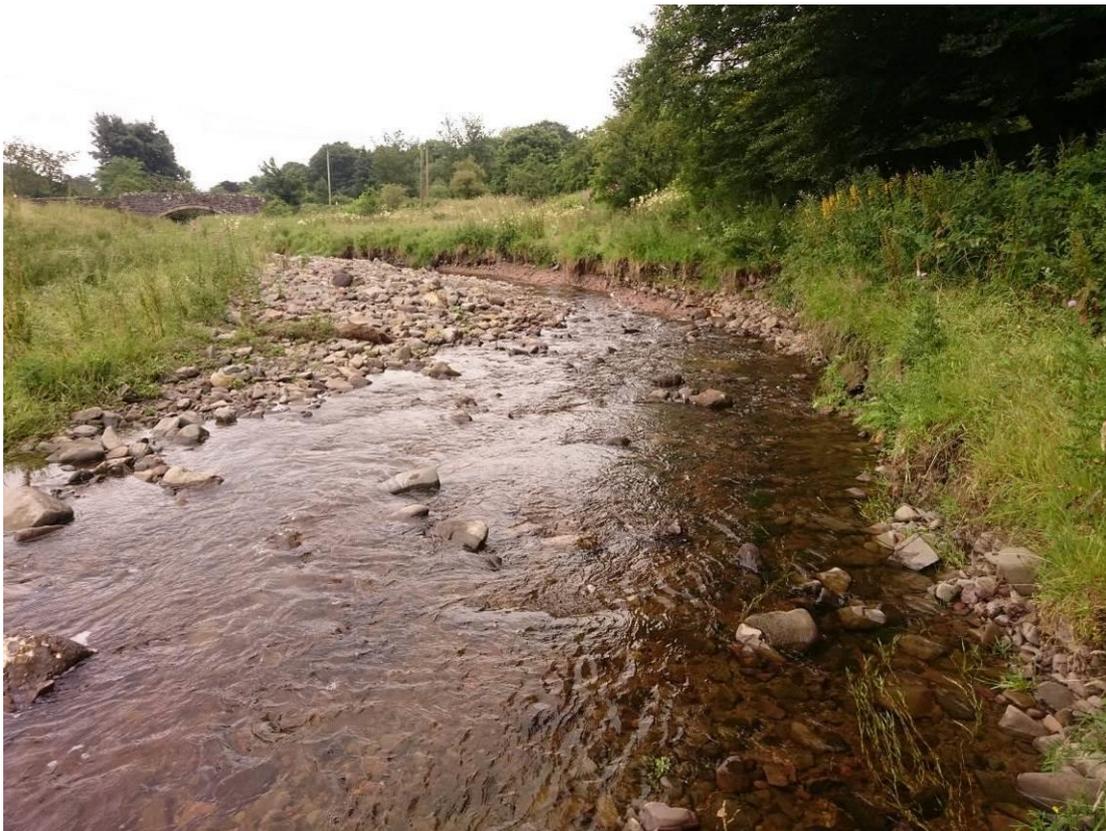
The main subject area of this report is the next bend d/s, where the burn is eroding into the RB (Figs 4 & 5). At this location, repeated realignment of the watercourse had reinstated a straightened channel but with subsequent natural, lateral migration (over recent years), the channel has again reclaimed more sinuosity and threatens the field boundary along the RB. As it is unlikely that adjacent areas of the watercourse will be returned to a meandering lower-gradient course (to reduce the impacts upon flow and sediment conveyance previously discussed), any proposal must work with other natural processes to provide a sustainable, long-term solution.

**Figure 4. Looking d/s at the bank protection site. Note how the gravel bar is pushing flows over towards the RB. Fortunately, the clay-based soil offers some resistance, which has led to some downward scour, rather than just lateral erosion, but without greater structure within and along the bank it will continue to migrate right, towards the field boundary.**

Key to success will be consolidating the bank with sufficient vegetation and associated root systems, but also providing a means to dissipate flow energy before it hits that bank. The solution requires stock exclusion from at least the susceptible area of bank, so that the required trees, shrubs and other diverse vegetation can become established. Fortunately, the burn already inhibits sheep access to the RB, so grazing pressure in that area is already lower than the LB and, consequently, the diversity of vegetation is greater. This will provide a good seed-bank for further re-colonisation.

In the short-term, more formal, green engineering methods can be employed to provide the flow dissipation and physical protection of the bank while the vegetation and trees become established. Several techniques could potentially be employed here but the simplest and cheapest solution is likely to be achieved by securing a line of brash along the bank (from toe

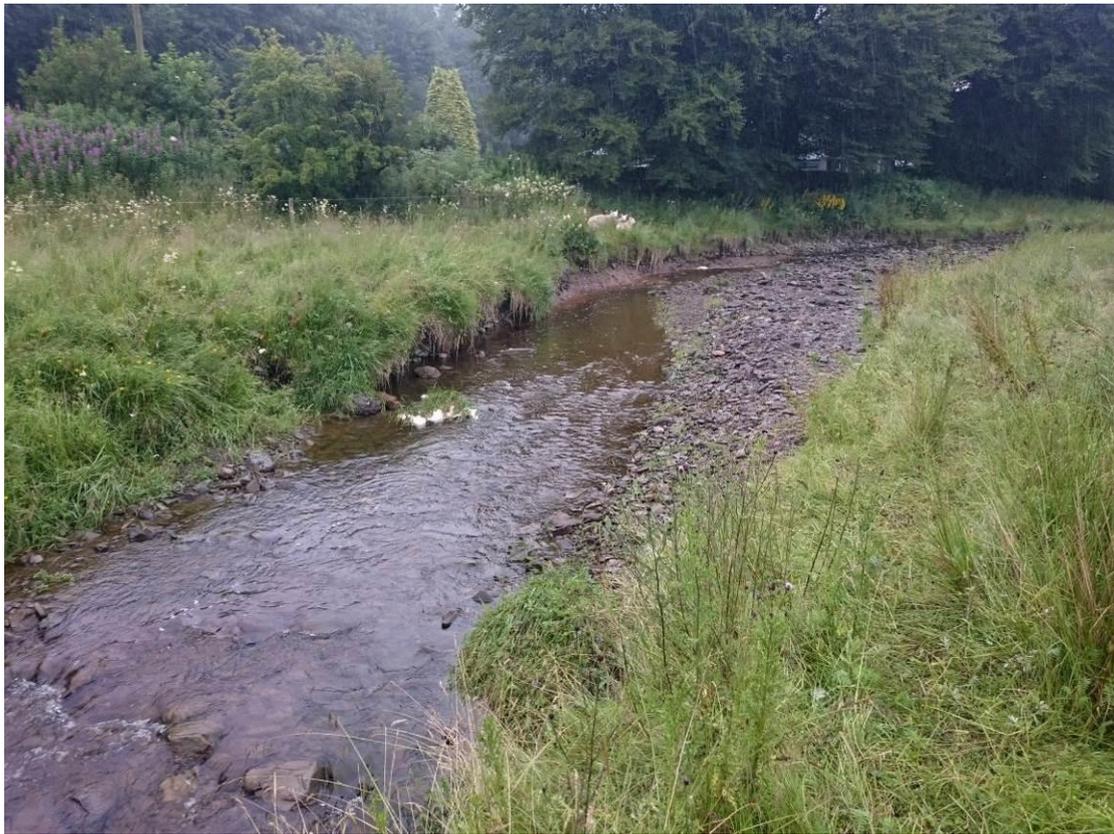
**Figure 5. Looking u/s at the bank protection site. The straightness of the channel (both u/s and d/s) means that sediment is transported straight through the section, only being retained on the slight bend.**

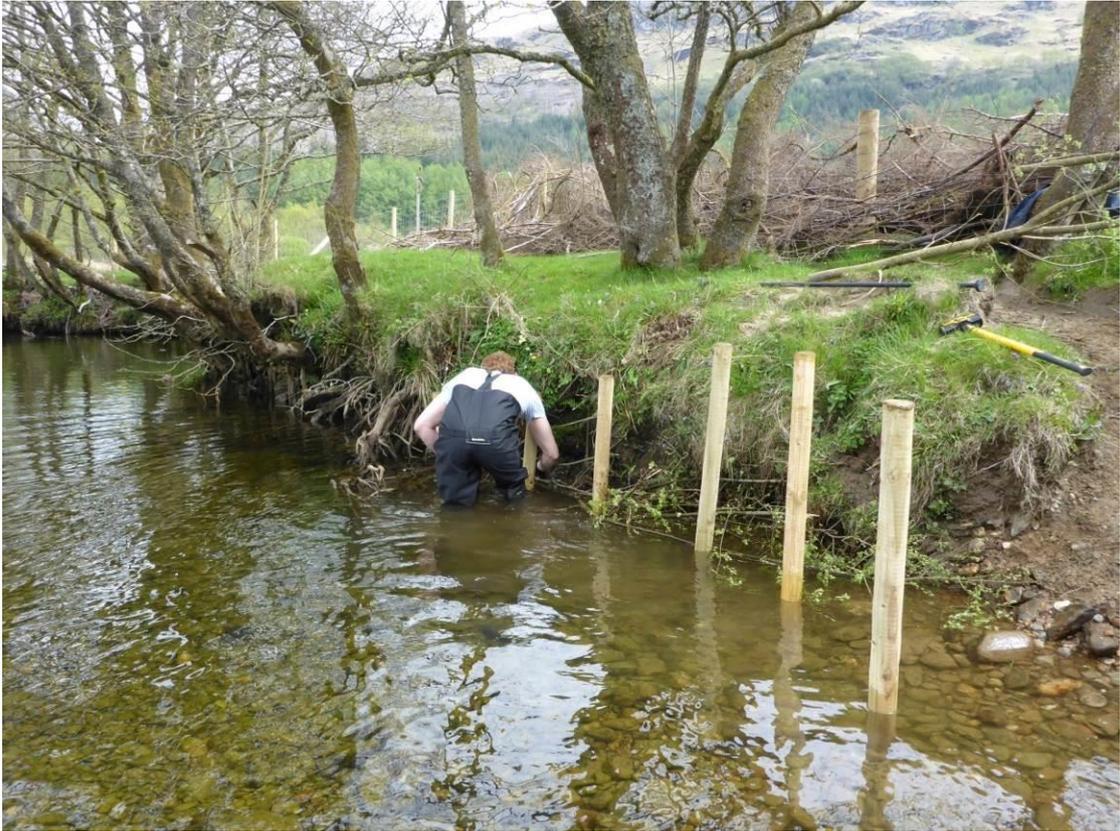
**Figure 6. Note how the start of the bank protection should start tight up against the more stable bank area (in this case, the roots of a tree). Starting at the u/s end, the brush is tucked in amongst the tree roots to help anchor the whole structure. Bank protection needn't be tied into tree roots but should meet an area of stable ground at either end.**

Brash protection provides an effective energy-diffusing barrier that slows flows before they hit the bank. To install the protection, posts are driven into the bank toe and top, ensuring to key into a stable area at either end (Fig. 6). Starting at the u/s end, brash is installed between the post with the butt ends facing u/s and into the bank (Fig. 7) and secured in place, either by wiring directly over the top (Fig. 8) or by clamping the brash down beneath longer more substantial brash/branches batons (Fig. 9). The riverside edge should be left rough and untidy, with the tips of the branches trailing out into the channel to soften the edge and further dissipate flow energy. This also provides valuable fish and invertebrate habitat. Owing to the high energy of the Kirtle Burn, it will be important to ensure that any structure installed is sufficiently robust to withstand the flows and coarse sediment transport likely to be endured (Fig. 10). If installed correctly, the dissipation of flow energy created should actually encourage sediment suspended within the water column to be deposited along the bank.

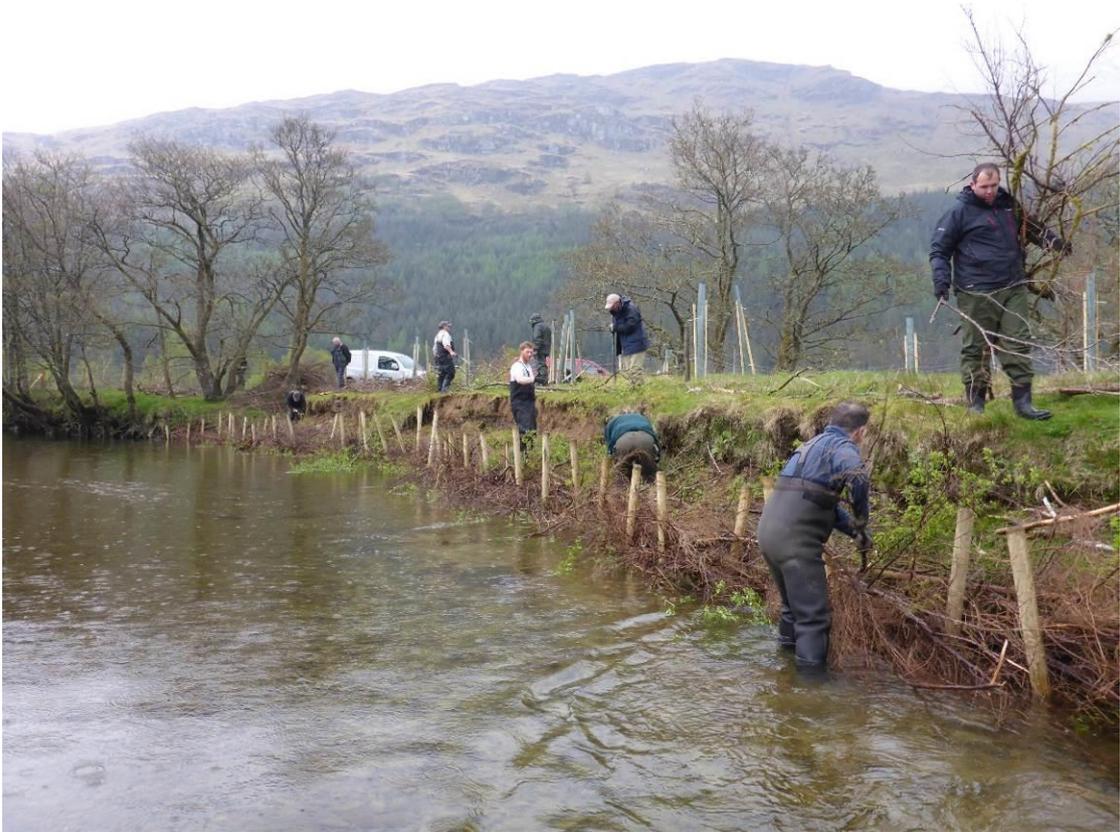
**Figure 7. Subsequent brush then linked in to the adjacent brush upstream.**

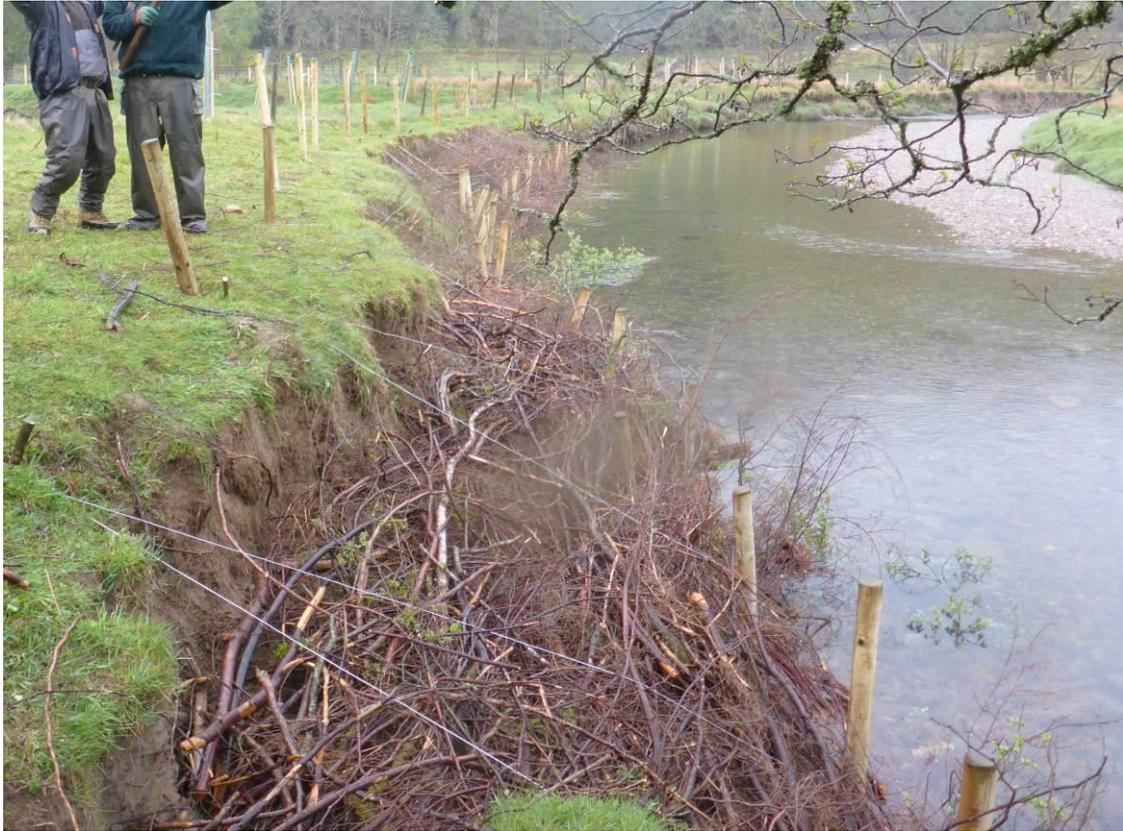
**Figure 8. Bank protection secured in place by wiring over the top of the brush between posts.**

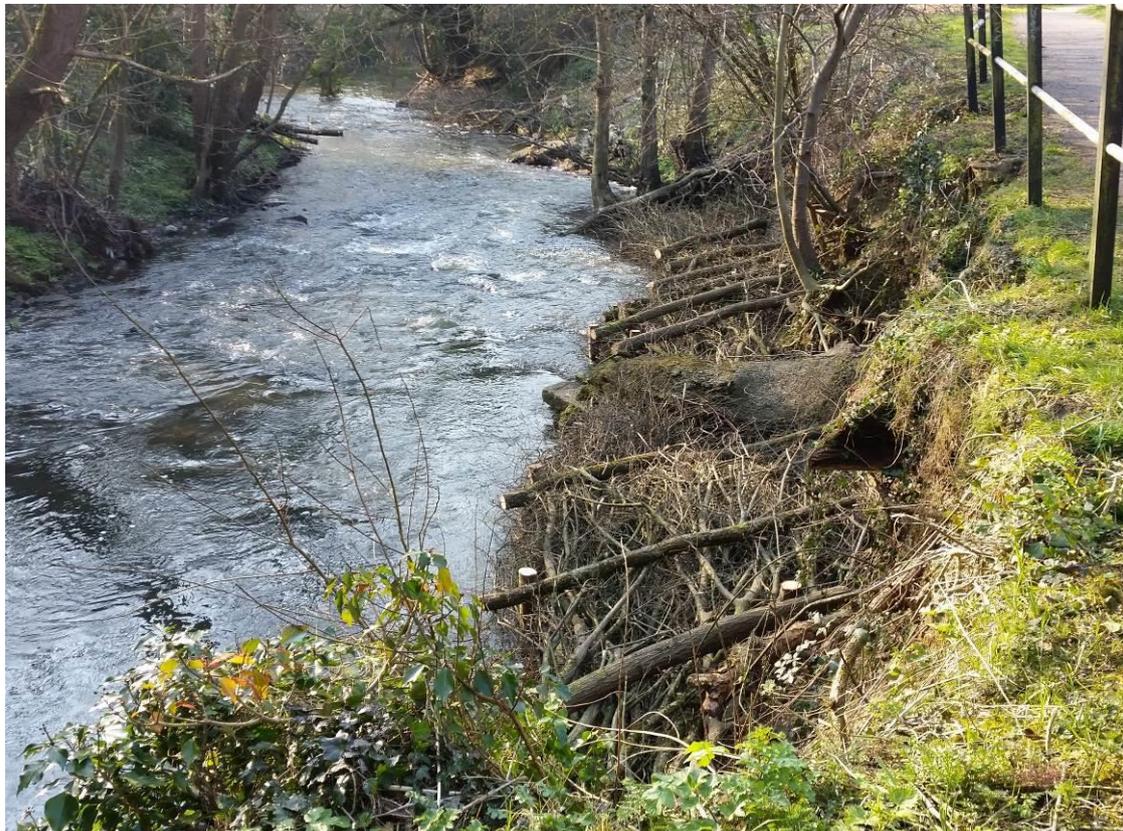
**Figure 9. Brush bank protection secured with batons.**

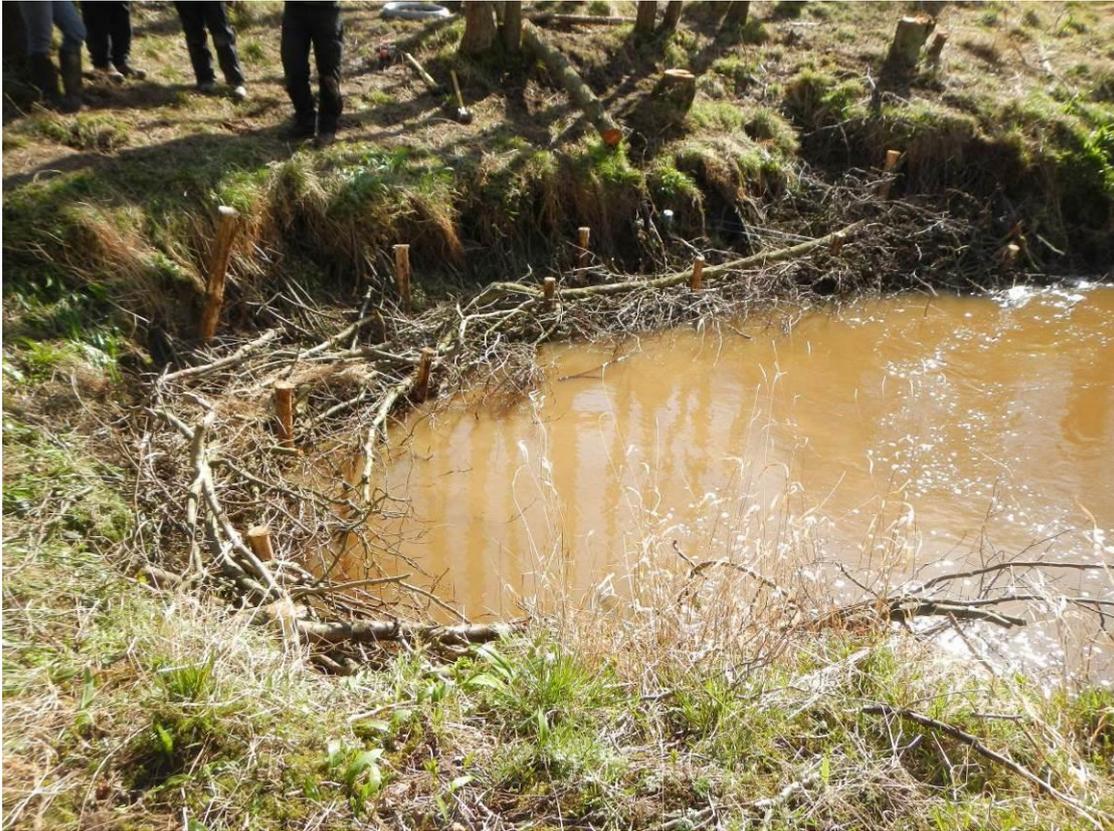
**Figure 10. A line of coarse brush bank protection, installed along an eroding bank line. This picture was taken before the posts were trimmed, which should be undertaken upon completion of the brush installation, to prevent the posts from being ripped out by debris in high flows.**

The brush technique usually employs at least a proportion of live willow material which should, ultimately take root and form a line of shrubs along the bank, providing further protection and habitat diversity. One consideration with this method is a possible requirement for future pruning/maintenance of the structure; however, it may never become an issue and simply require ongoing monitoring. If maintenance were required it should only consist of trimming the trees and laying some branches (as you would a hawthorn hedge) into the channel.
