## **River Irwell – Little Britain Anglers**

**An advisory visit carried out by the Wild Trout Trust – July 23rd 2015**

*This report is the output of a Wild Trout Trust (WTT) Advisory Visit (AV) undertaken along **approximately 1km (0.62 miles) of the River Irwell in Bury.***

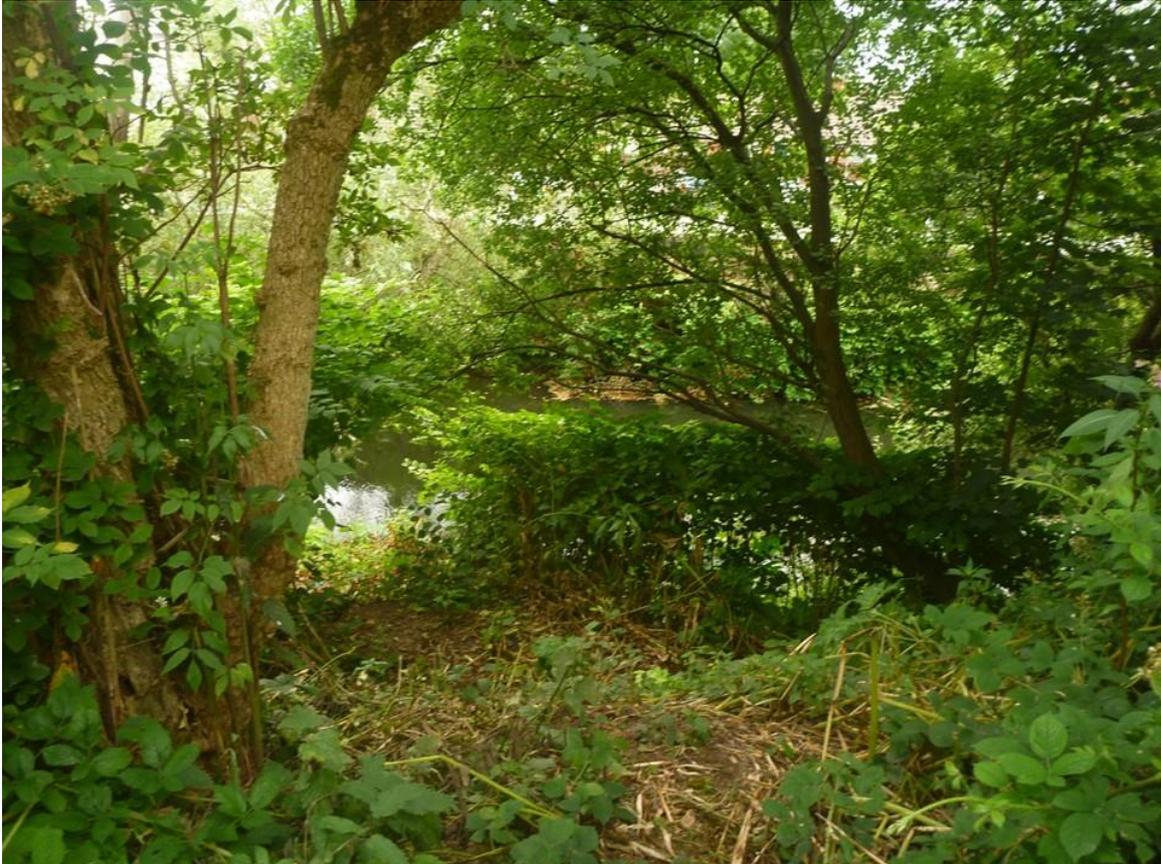
The downstream limit of Little Britain Anglers' water is characterized by densely-wooded LHB and vertically-walled RHB. The club have worked hard to establish a path through brambles and giant hogweed at the top of the LHB – which is flanked by security fencing that separates the river corridor from adjacent development. The understory vegetation in this wooded section – as well as much of the open space along the walled sections – is dominated by dense stands of a variety of invasive plant species. For instance, Japanese knotweed (*Fallopia japonica*), Himalayan balsam (*Impatiens glandulifera*) and giant hogweed (*Heracleum mantegazzianum*) choke both the shaded understory and any available gaps under the tree canopy (Fig. 1). All of the invasive, non-native plants observed during the visit belong to species that die-back in winter – leaving bare ground that is poor in native flora and fauna (as well as highly prone to accelerated erosion and associated increased inputs of fine sediment).

**Figure 1:** The bottom of the river-valley slope at SD80211 08440 showing a path cut through Himalayan balsam next to a stand of Japanese knotweed under the shade of mature trees. Knotweed and giant hogweed are present on the opposite bank and part of a high, structural wall constructed from barrels filled with concrete is just visible through the branches centre and right of frame.

The club has members who are qualified to use herbicides adjacent to watercourses and they are aware that different, specific methods of control are required for each of the different invasive plant species. It is especially

reassuring to note that the club knows not to trim or flail knotweed – as this causes it to spread the infestation (a fragment of around the size of the last joint of your thumb is capable of growing into a whole new plant).

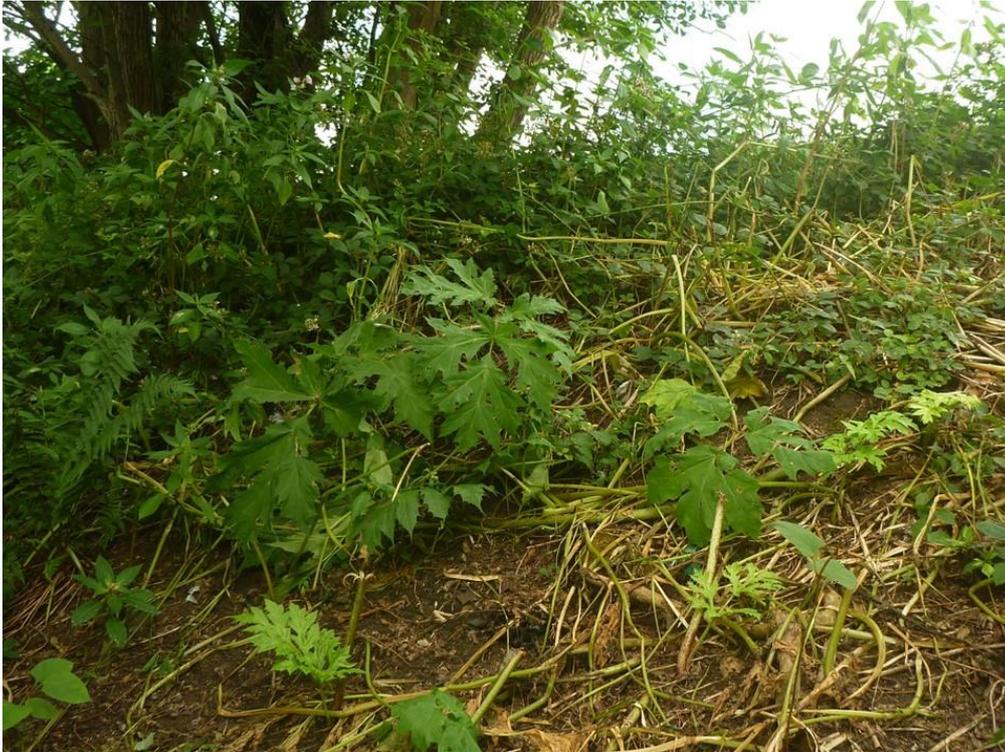
Treatment of Himalayan balsam and giant hogweed is underway on this section (Figs. 3 and 4) – but the club is at the very start of their campaign against invasive plants on this part of the river.

**Figure 3: Broken stems of balsam and examples of targeted spraying of giant hogweed at SD8058 08438. The club has developed a phased approach to giant hogweed control. The first stage is to break the stem close to ground level using a long-handled garden hoe (wearing full protective clothing to prevent contact with sap). As the plant tries to recover, herbicide is used to kill off the regrowth**

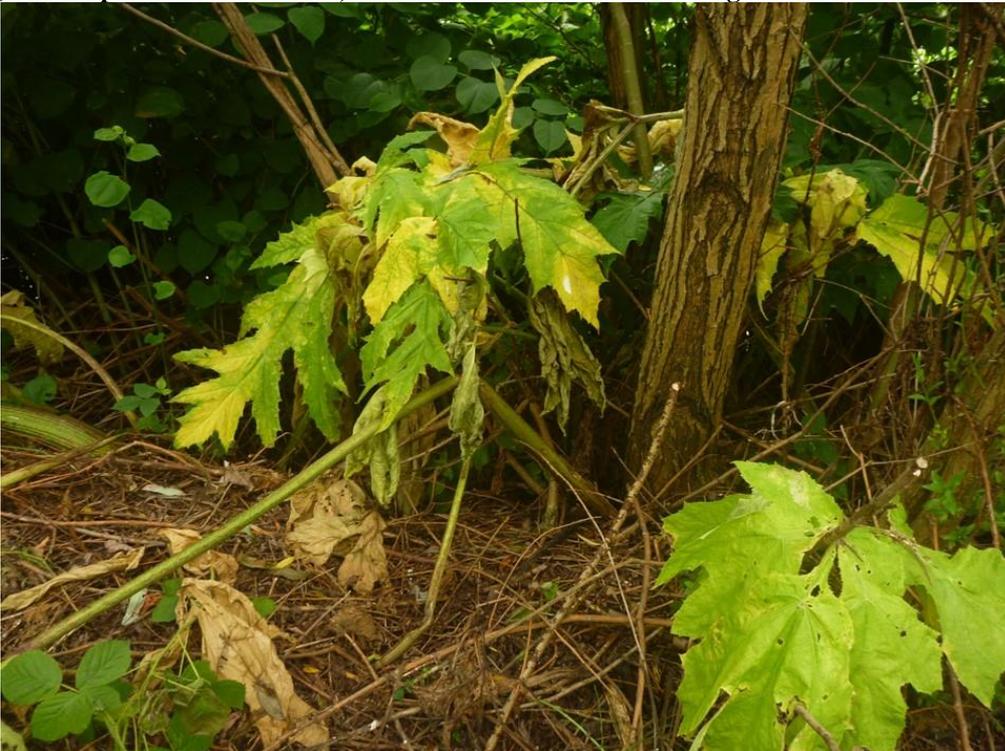
**Figure 4: Giant hogweed at SD80158 08438 undergoing treatment from the club**

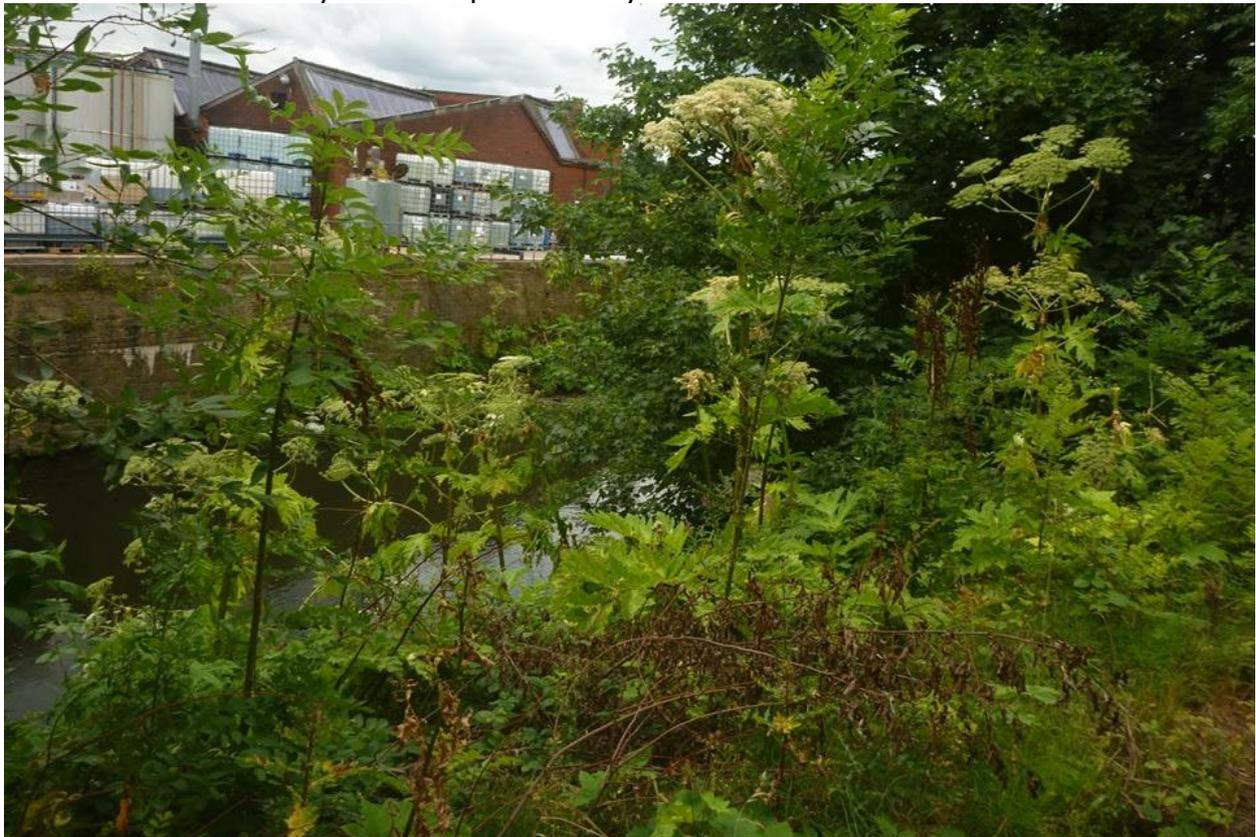
Just upstream, there was a very good example of how the giant hogweed is dominating, both in small clearances among the trees (Fig. 5) and as an understory to established trees (Fig. 6). It is evident that the age/size structure of the trees in this reach is very "flat". In other words, it appears that the most recent tree removal activity is likely to have been carried out on a blanket basis.

**Figure 5** Giant hogweed growing in a clearing between trees

Removing all (or at least the great majority) of the trees at one time creates a very uniform canopy and shade structure. This tends to hinder the development of varied habitat that is rich in species.

The major problem here is that the domination of the understory by invasive, competitively superior, plants will prevent tree seedlings from becoming established. This will also hinder the prospects for healthy and vigorous regrowth following any future coppicing of mature trees.

It will be necessary to gain control over the invasive plant understory before making any attempts to improve the light/shade regime by managing the tree canopy structure (Section 4: Recommendations). It is also very important to recognise that providing areas of shade on the water will be vital for cold-water specialist species such as trout. This is especially important in the context of climate change. A useful guide to shade provision as a means of providing cool-water refuge areas is available here: [http://www.asfb.org.uk/wp-content/uploads/2012/09/Keeping-Rivers-Cool\\_Guidance-Manual\\_v1.-23.08.12.pdf](http://www.asfb.org.uk/wp-content/uploads/2012/09/Keeping-Rivers-Cool_Guidance-Manual_v1.-23.08.12.pdf).

As detailed in section 4 (Recommendations) there are significant advantages to using stem injection in preference to sprayed application of herbicides for plants that cannot be controlled by physical methods (i.e. hand-pulling or strimming). The improved targeting that stem injection allows not only protects native plants that can take the place of the invasive plants – it also delivers the herbicide much more effectively into the plant that you wish to remove.

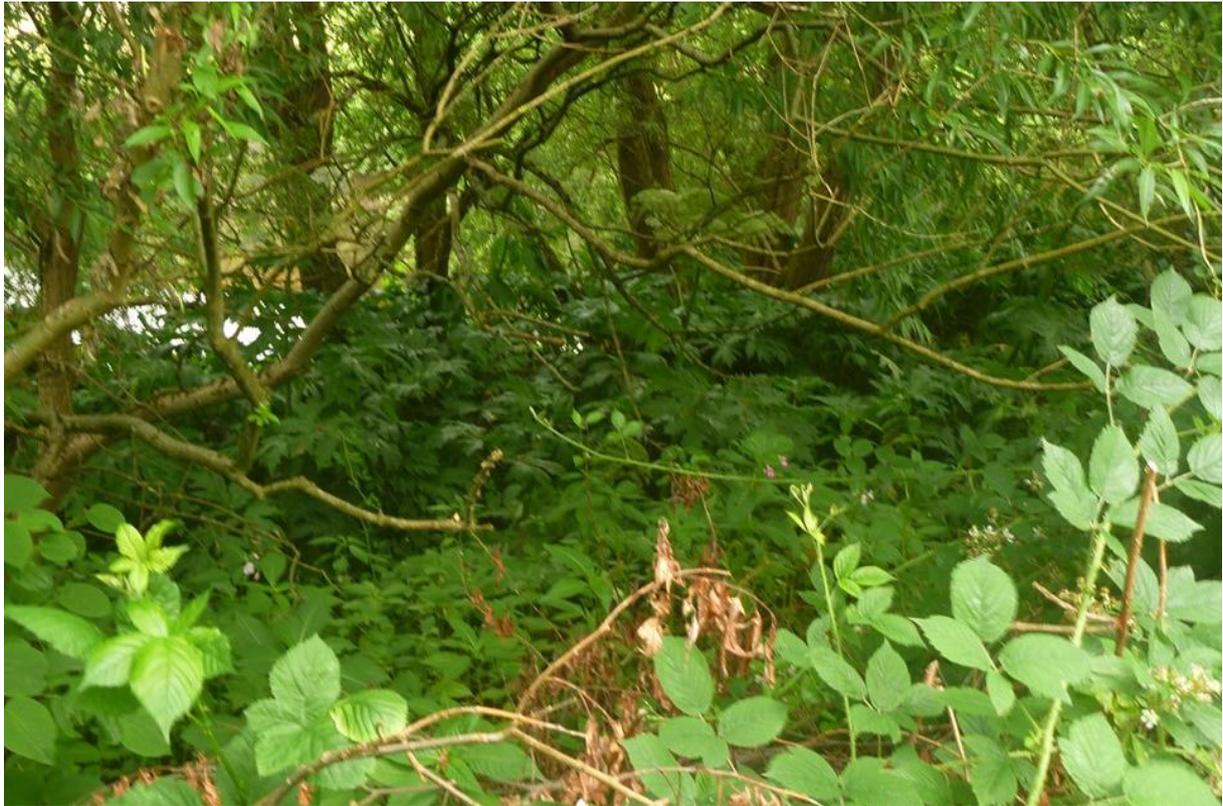
**Figure 6: Ignoring the immediate foreground, almost all of the shaded area beneath these willows is dominated by invasive, non-native plants. Whatever understory foliage is not Himalayan balsam (light green) is giant hogweed (darker green) in this stand.**

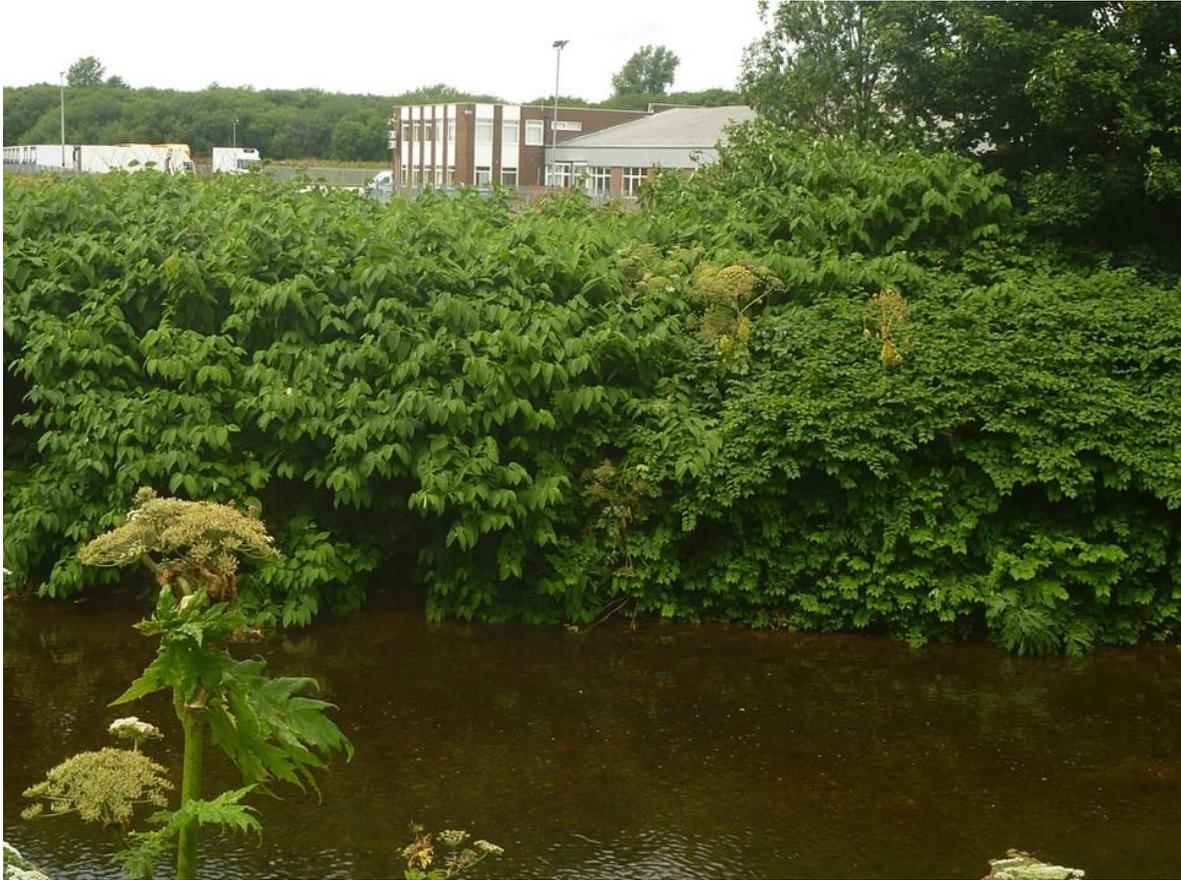
Figure 7 shows a very strong argument for tackling all of the problematic plant infestations. On the left hand side of the frame, there is a large stand of what appears to be a hybrid between Japanese knotweed and giant knotweed (the hybrid has the Latin name *Fallopia x bohemica*). On the right hand side of the frame is an equally large stand of Japanese knotweed. Both infestations are completely dominating this section of the opposite bank and will die back in winter to leave bare earth.

**Figure 7: The large-leafy foliage to the left of the opposite bank is hybridised giant x Japanese knotweed. The right hand side is standard Japanese knotweed with a few individual giant hogweed plants. The density of shade produced in summer will be lethal to low-growing native understory species and tree seedlings. Photograph taken at SD 80014 08607 where the water depth is much reduced compared to the reaches just downstream of this point.**

One of the significant consequences of the plant infestations in this reach is that the potentially valuable shallow “nursery” habitat for fish (Fig. 7) will not have sufficient cover. A lack of larger trees that grow out over the channel and provide large structural debris (as well as trailing/submerged branches and roots) causes an absence of refuge from predators. In turn, this produces a high risk that only a small proportion of fish that hatch from eggs will survive their first year. The problem will be amplified during the cold parts of the year when all of the invasive plant species at this site die back. For species such as trout that breed during the colder months, this lack of cover comes at a crucial point in their lifecycle. It is also a “make or break” stage for juvenile trout approaching one year of age – as overwinter mortality is naturally very high (typically 95% of trout and salmon die before one full year of age - even in good habitat). Additional mortality due to a lack of suitable over-wintering shelter from both predation and also high winter flows can have serious impacts on the viability of self-sustaining populations.

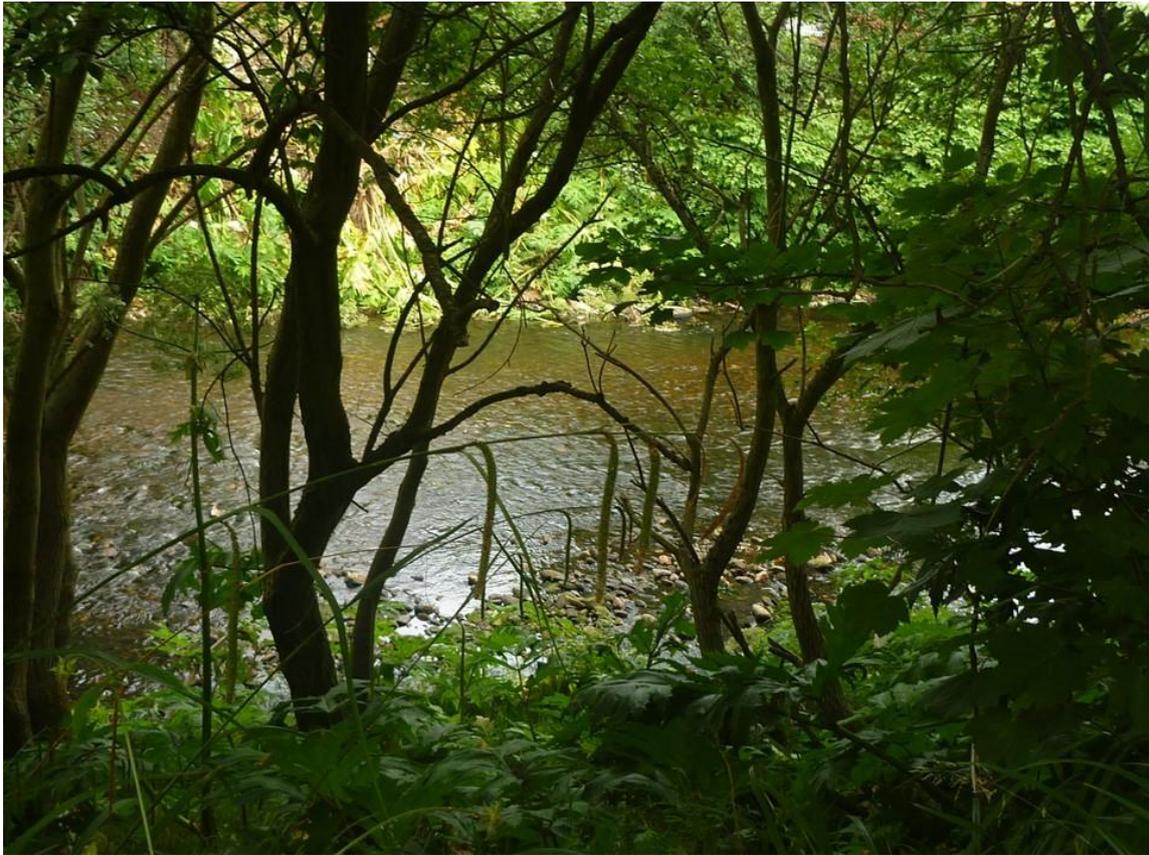
At the top of this shallow glide/riffle area there was a good ramp of gravel that is suitable for trout spawning (Fig. 9). For spawning gravel – the conditions that enable water to be drawn through (and not just above) the bed are vital for good egg survival. Without this “through-gravel” flow – the eggs become starved of oxygen. Sometimes this is achieved when flows are focused in a small area by being forced to flow under or over an obstruction (e.g. Fig. 10). This can be especially valuable when there are large inputs of fine silt and sand. However, it is important to recognise that frequent large inputs of fine material can swamp this localised cleaning effect (see video here for an example of how winter die-back of invasive plant species can lead to this effect: <https://youtu.be/VijmRm-qd4Y>).

Whilst logs can produce essential but relatively localised patches of “through-gravel” water flow, natural processes that shape river channels can also promote this effect at a larger scale. For example, the upward slope of a larger gravel deposit at the tail end of a pool or glide produces good “through-gravel” flow potential. Gravity helps to draw the flow down through the raised bed to exit on the downstream side of the deposit (Fig. 11). This is the situation at SD 80057 08692 (Fig. 9 as mentioned above).

**Figure 9:** An upward-sloping ramp of gravel is present to the right of the frame. The broken water visible towards the middle and left of the frame is on the downstream side of the gravel ramp- below the high-point.

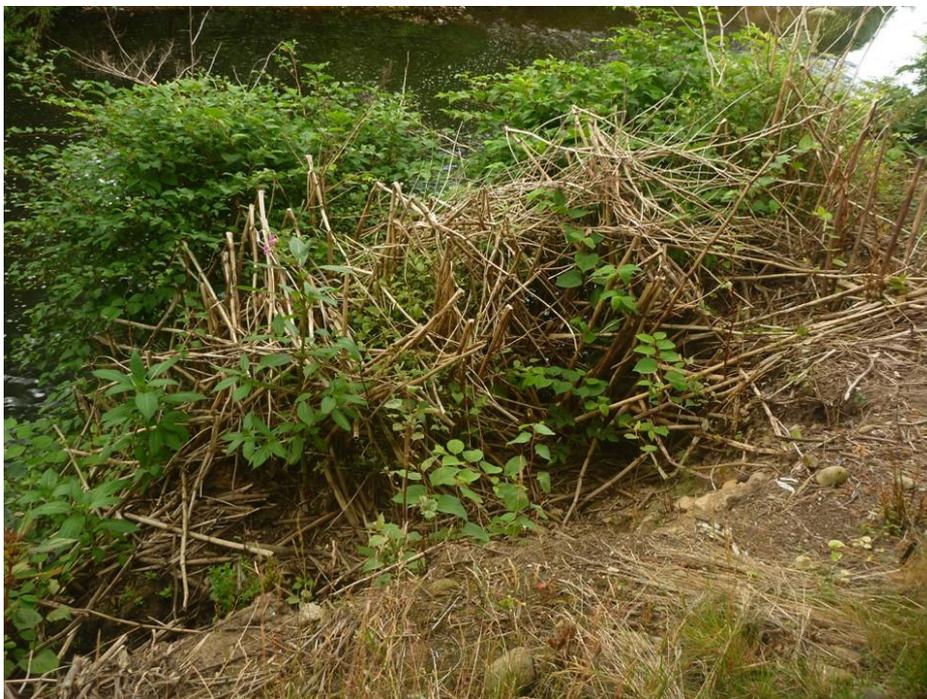
At SD 80073 08739 there was an example of potential problems with partial treatment of bank-side Japanese knotweed infestations. Although not carried out by the angling club, Fig. 12 is a useful illustration of unintended consequences. The accessible bank-side portions of the stand were successfully suppressed by spraying. However, the soft bank – coupled with the relatively heavy (sap-filled) living canes- has resulted in the river-side portion of the infestation toppling forwards. This resulted following the death and partial collapse of the cane and root system of the treated area which weakened the attachment to the bank of the surviving plant material.

**Figure 12: The living (river-side) portion of this Japanese knotweed clump is pulling a "plug" of riverbank and dead canes/roots (bank-side) into the water. This will distribute stems and root-systems (rhizomes) that will establish new colonies downstream**

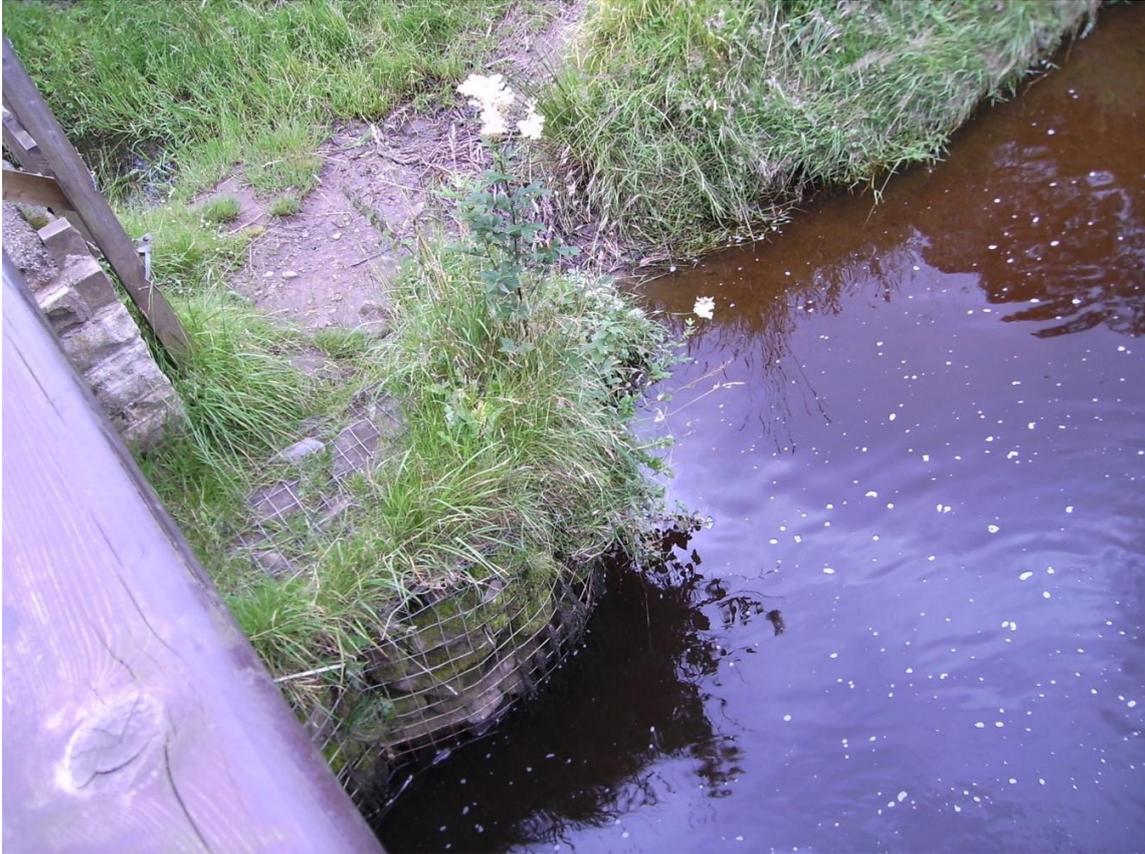
careful implementation to avoid some common mistakes. First of all, the upstream and downstream ends of bank revetments built using standard “block-shaped” gabion baskets always produce swirling eddies. This is due to the perpendicular arrangement of the faces of each “block”. These swirling eddies generated by the hard, angular surfaces of the gabion baskets eat into the soft bank. This greatly accelerates the rate of bank erosion at the upstream and downstream ends of each revetment (e.g. Fig. 13 on a small section of the River Colne in East Lancashire). The same effect is seen when using block stonework.

**Figure 13: The flow in the picture is coming from the bottom left and travelling to the top right of frame. In spate conditions the eddy formed on the downstream face of the gabion revetment has eaten into the bank-line for a distance that is about double the width of the revetment.**

Smoothly-tapering ends of any bank reinforcement are needed to make them stable – rather than increasing the rate of bank erosion. It should be noted that bank erosion in itself is not a bad thing – it is the source of spawning gravel substrate and can contribute additional structural variety to the channel. In channels that are modified and impacted by issues such as over-grazing or invasive species, there are often tricky judgements to be made in order to achieve the best balance of erosion and deposition. You can have too much stability and you can have too much erosion – the optimum for biodiversity lies somewhere in the middle. There is more, very relevant, information and a short video on this link: <http://www.wildtrout.org/blog/bank-erosion-matter-balance>.

For the examples of collapsing sections of access path constructed at the foot of the river valley by the angling club - it is appropriate to slow the rate of erosion in targeted areas. Slowing erosion is especially appropriate when it inhibits the downstream spread of Japanese knotweed rhizomes. In the medium to longer-term, slowed bank erosion will be best achieved by promoting and managing healthy marginal tree growth (Section 4: Recommendations). In the shorter

term, where water-depth allows work in the channel, construction of berms (perhaps reinforced with wire mesh) that are of a streamlined “pasty” shape may be useful. These should be keyed into the bank-line at a shallow angle to limit their potential to create erosive eddies (Section 4: Recommendations).

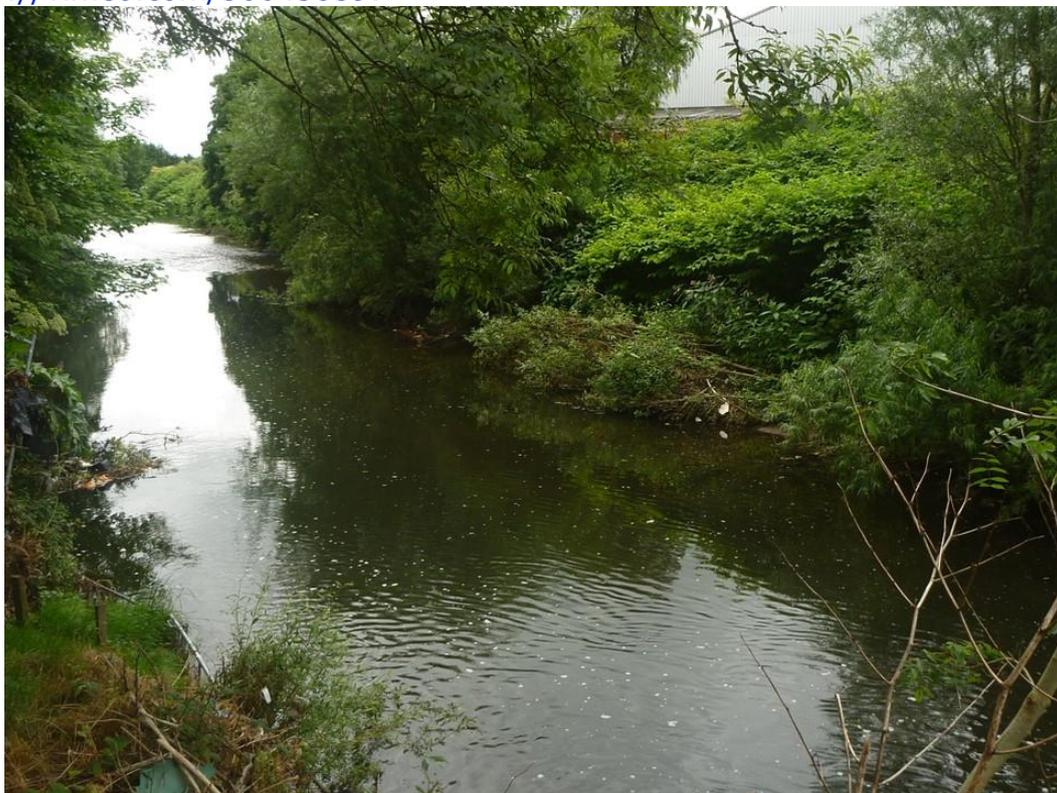
Some excellent examples of good vegetation management by the club were noted on the RHB and photographed facing upstream from SD80073 08739 on the LHB (Fig. 14). Promoting the growth of young willow saplings in “withy beds” and then hinging them so that they lay in the margins (using the same technique as for hedge-laying) is a fantastic way to provide cover from predation as well as slowing rates of bank erosion. This also creates areas of slack water during spate flows – again providing refuge for invertebrates and young fish that would otherwise be swept downstream. Illustrations and proof of these concepts is given in this video made on the Wye and Usk system: <https://vimeo.com/56645859>.

**Figure 14: Young willow saplings laid into the margin on the opposite bank - great habitat for juvenile and adult fish. With targeted control of invasive plant species – these techniques will be ideal ways of managing erosion whilst providing suitable fishing access (by opening up small gaps in dense stands of trees) and improved habitat for fish and invertebrates.**

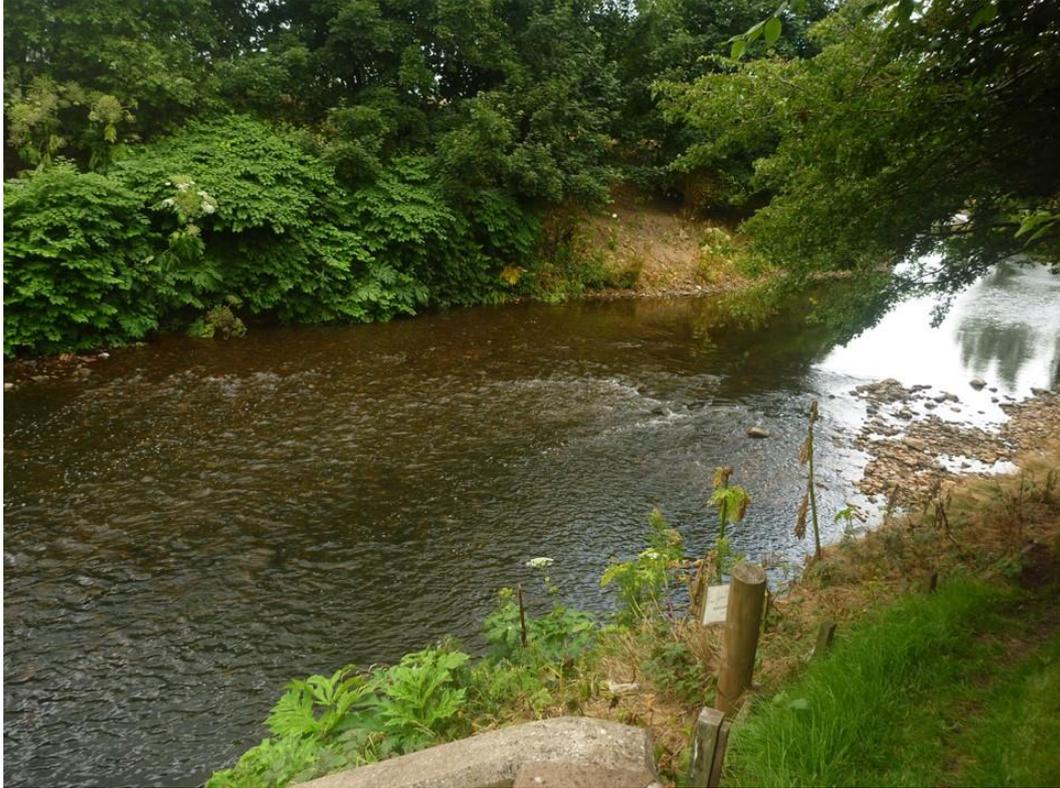
Another ramp of gravel with good potential for trout spawning was noted between the hinged willows and the glide upstream starting at SD80072 08778 (Fig. 15). However, its value would be further increased in the presence of additional cover. The potential spawning area is a long way from the nearest available overhanging or submerged structural cover. This can significantly increase the risk of predation to breeding fish – and consequently may make fish unwilling to use the available resources to their full potential. Trout breed during the winter months when the banks would be bare following the die-back of knotweed, balsam and hogweed. Establishing some submerged, marginal cover adjacent to the spawning gravels would be very beneficial. Such cover is also a haven that fry emerging from the gravels in spring can move directly into.

**Figure 15: The only overhanging and trailing cover next to the spawning gravels (on the upstream side of the broken water) is provided by giant hogweed and Japanese knotweed. These will be absent during trout spawning.**

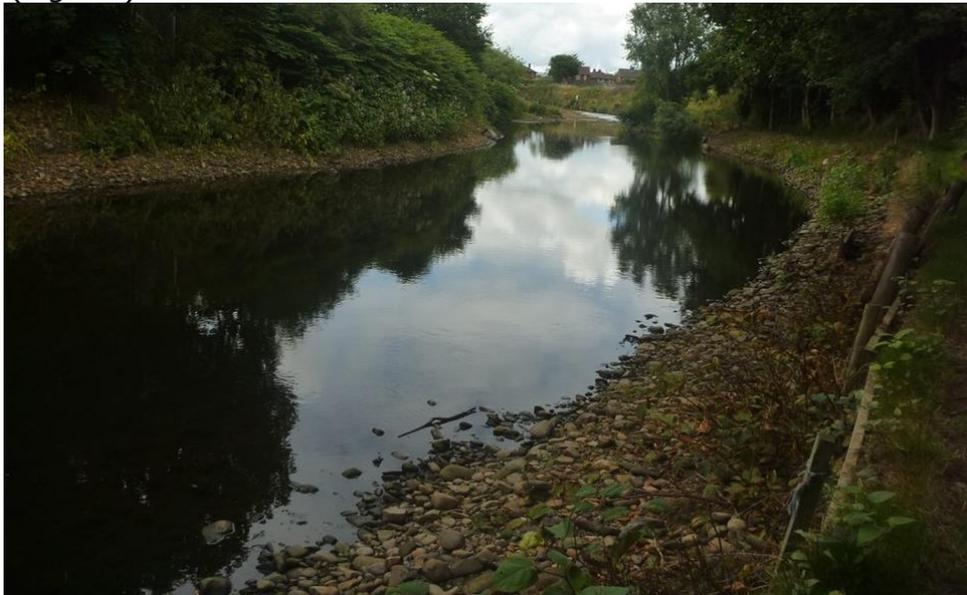
In-channel modifications appear to have been undertaken in an effort to provide a deeper channel in the area upstream from SD 80072 08778. The riverbed cobbles have been pulled back from the central channel and used to produce rocky, sloping margins with some formal angling pegs set along this length of channel (Fig. 16).

**Figure 16: Riverbed cobbles pulled back to produce sloping banks and a deeper central channel.**

This is generally poor habitat for a range of fish species – due to the lack of physical variety. Even for coarse fish species that prefer slower, pool-habitat – there are insufficient holding features and protection from predation for this section to reach its potential. It is also likely that, given significant spate flows,

the channel will begin to re-assert the dimensions that are automatically set by the gradient, hydraulic “roughness” and discharge parameters.

For a short-term gain, it may be beneficial to introduce large boulders into this reach to provide some physical variety and also to produce a more varied pattern of riverbed deposition and erosion. The transport through this reach of river-bed material from upstream (during spate conditions) could be harnessed to produce a more “humps and hollows” topography. Scattered boulders would encourage deposition in the lee of boulders with a limited amount of local bed-scour around the lateral edges.

Whilst working towards an improved marginal woodland and native understory vegetation structure (and associated increased volume of submerged, structural materials) – it may be beneficial to create some instant structural diversity. If there is local stone available in the size range 70 cm to 2m along the longest axis, then introducing a scattered belt of such material may be an aid to the recovery of complexity within this simplified reach.

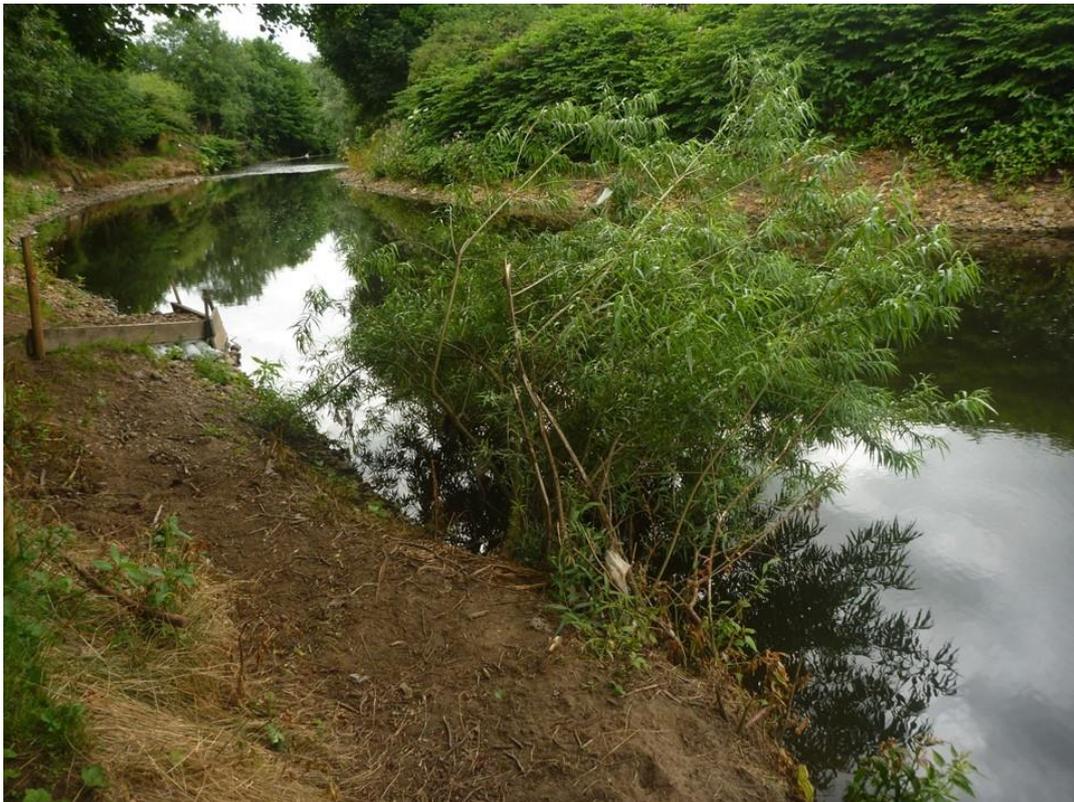
The clubs willingness to provide cover for fish is noted in examples such as the hinged small willow at SD 80063 08847 (Fig. 18). For maximum benefit, this tree could be hinged at a point lower down its main stem. Angling it down more steeply into the water would allow a greater proportion of the brashy crown of the willow to be submerged at normal flow-levels.

**Figure 18: Great overhanging cover - a small tweak to allow more (but not all) of the crown to be submerged would provide even more benefits.**

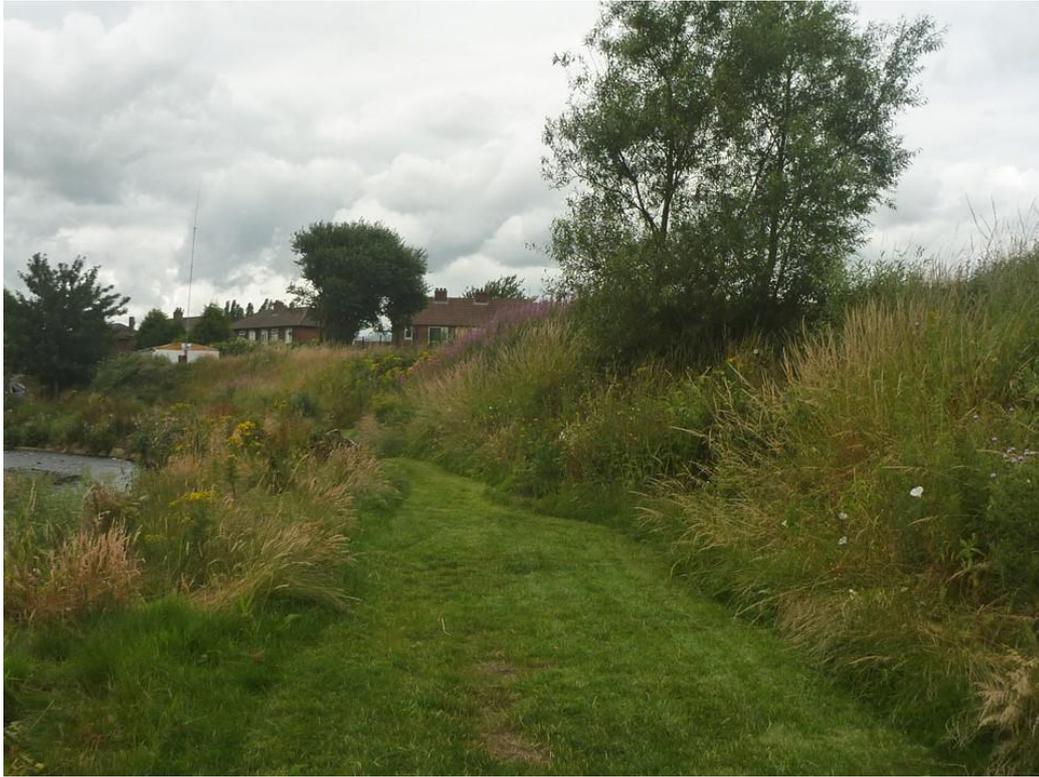
The varied, largely-native rough margins and valley sides on Eric’s LHB (Fig. 19) contrast markedly with the amount of giant hogweed re-invasion among what is still relatively diverse native flora on the RHB (Fig. 20). The suspension of previous control efforts on the RHB bank will soon lead to a reversion to a much-degraded state. The example given in Fig. 21 shows a good approximation of what the ultimate floral composition will be if left unchecked.

**Figure 19: Eric's bank (LHB) with a shaggy margin of native plants and maintained access path. Just the occasional, small hogweed plant is present in this section thanks to a huge amount of predominantly one-person's work**

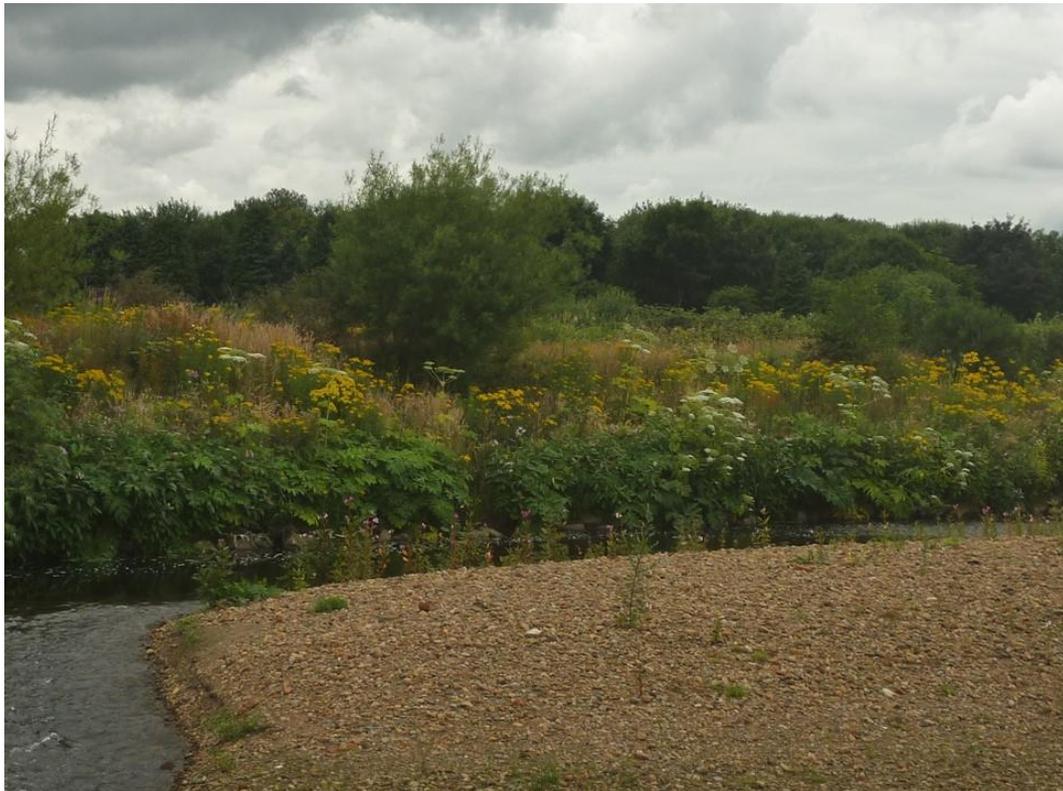
**Figure 20: Native flora on the RHB opposite Eric's that has now had its invasive plant control withdrawn. The bank is in the process of being re-invaded by hogweed and balsam from the river margin back up the slope**

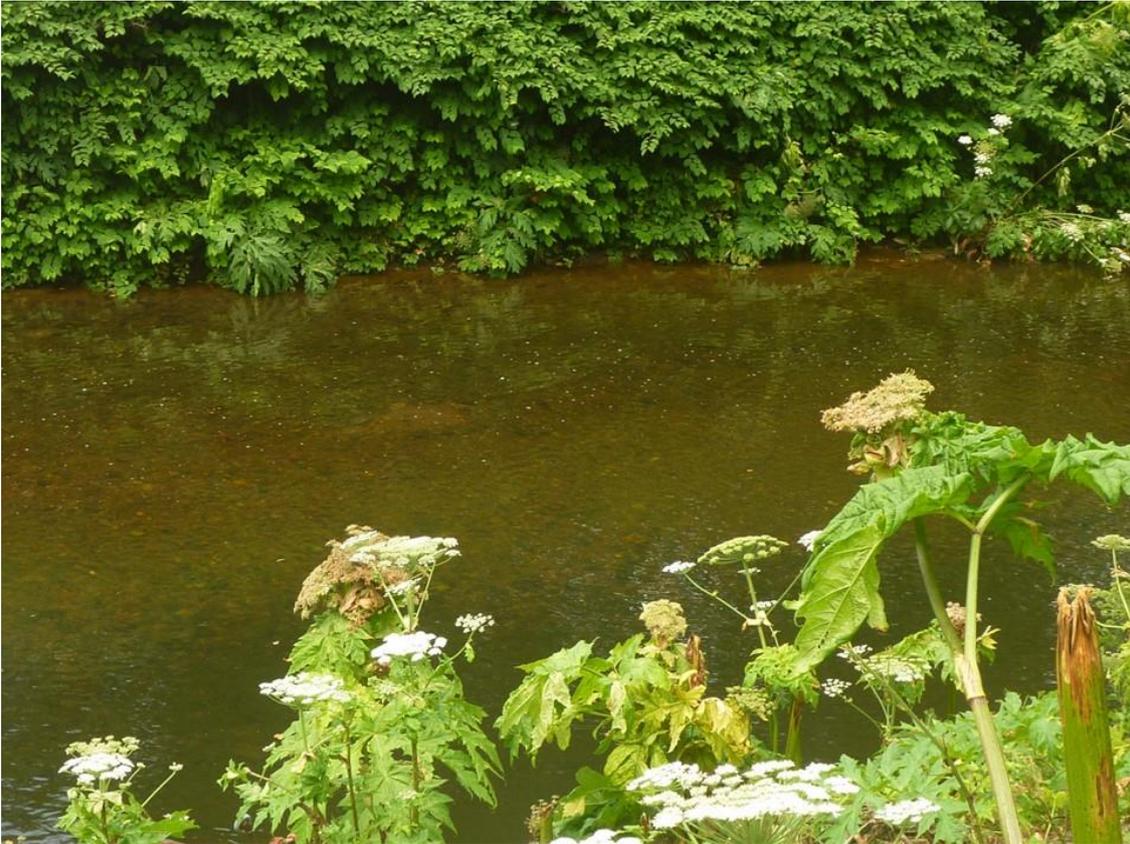
**Figure 21: Giant hogweed and Himalayan balsam on the near bank with knotweed(s), Himalayan balsam and giant hogweed on the opposite bank. The likely "climax community" state of vegetation along the Irwell.**

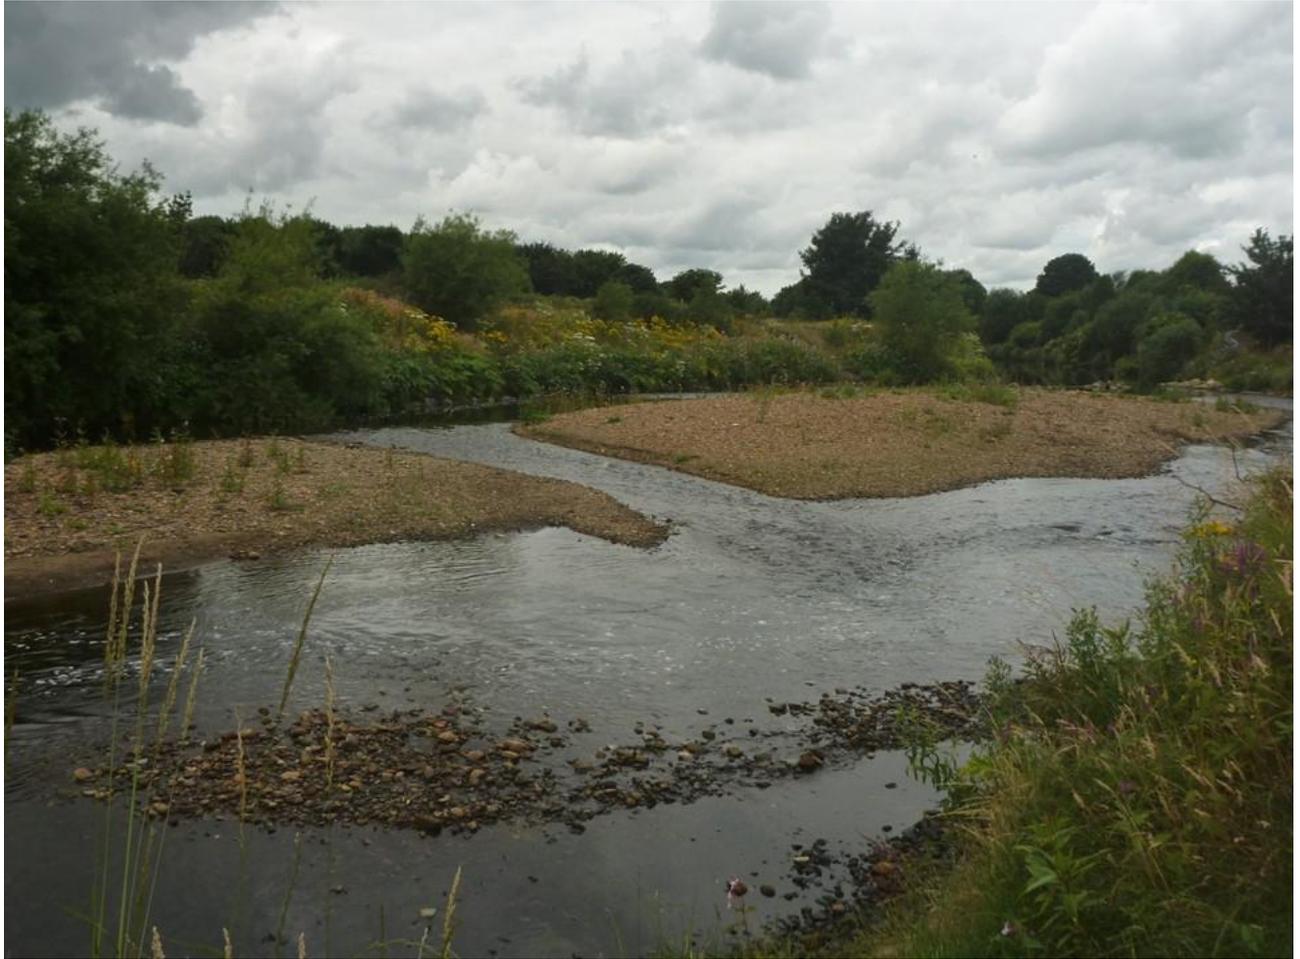
The measure suggested by the angling club of installing a wedge-shaped mid-stream flow deflector (Fig. 22) may well be a good way of maintaining wetted channels either side of the main mid-channel island. It is futile, and potentially damaging, to attempt to increase capacity for flows by removing this material. Instead, promoting the continued existence of complex, braided channel flow is an incredibly valuable habitat type that is comparatively rare on a national-scale.

As well as additional potential spawning habitat, the shallow slopes and complex water-column and through-gravel flows provide many additional opportunities for a very wide variety of terrestrial and aquatic species. The fact that the sloping bars will experience a varied inundation and drying regime also creates unique habitat opportunities. There is a characteristic group of species of plant and animal that are adapted to these highly changeable habitats. Because such habitat is rare at a European scale, the characteristic communities that need this type of habitat are also rare. In future, management of invasive plant species

**Figure 22: Excellent, complex braided-channel habitat. A huge variety of flow depths (ranging from less than an inch down to around 20ft) are present in this section. Similarly, flow direction and speeds are also equally variable. As a result, there is fantastic habitat for a whole range of coarse and game fish species through all of their varied life-stages.**

and also the age-structure of self-setting trees is likely to be needed in order to maximise the potential biodiversity. Further attempts to remove the deposited material should be resisted.

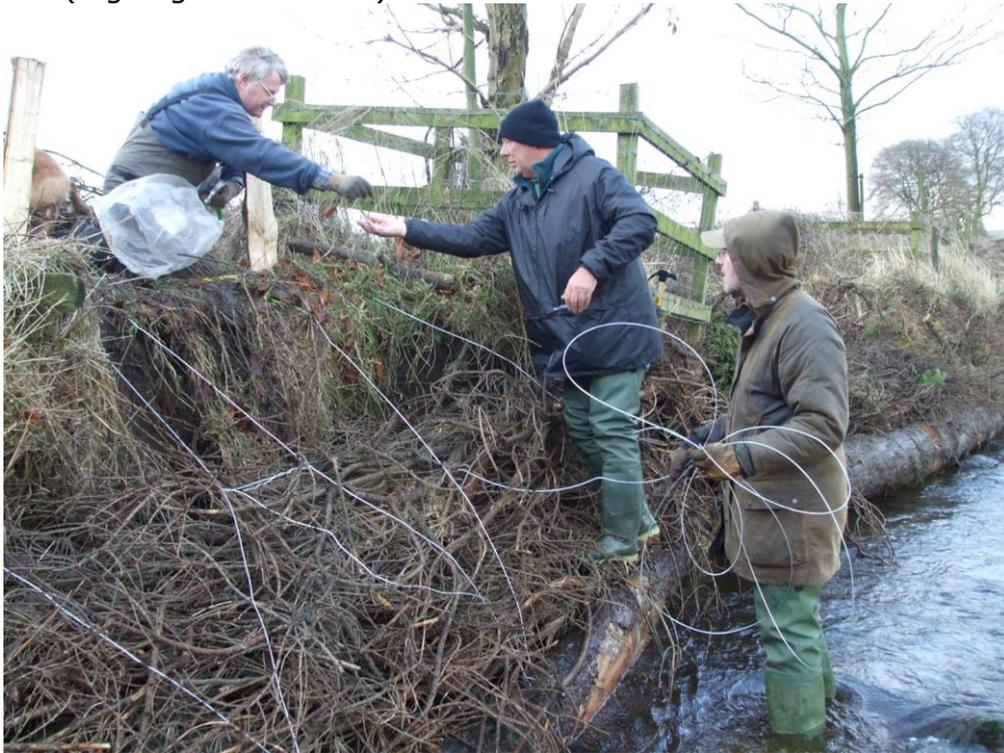
**Figure 24:** Log and brash revetment used on the highly erosive sections of the River Colne in East Lancashire. The logs are pinned using 2-m long sections of 19-mm diameter steel reinforcing bar.

such as pinned log berms with back-fill material of either brash or stone can be successful (e.g. Figs. 24 and 25).
