River Lark – Three Arches

A Project Proposal by the Wild Trout Trust - April 2016

1. Introduction

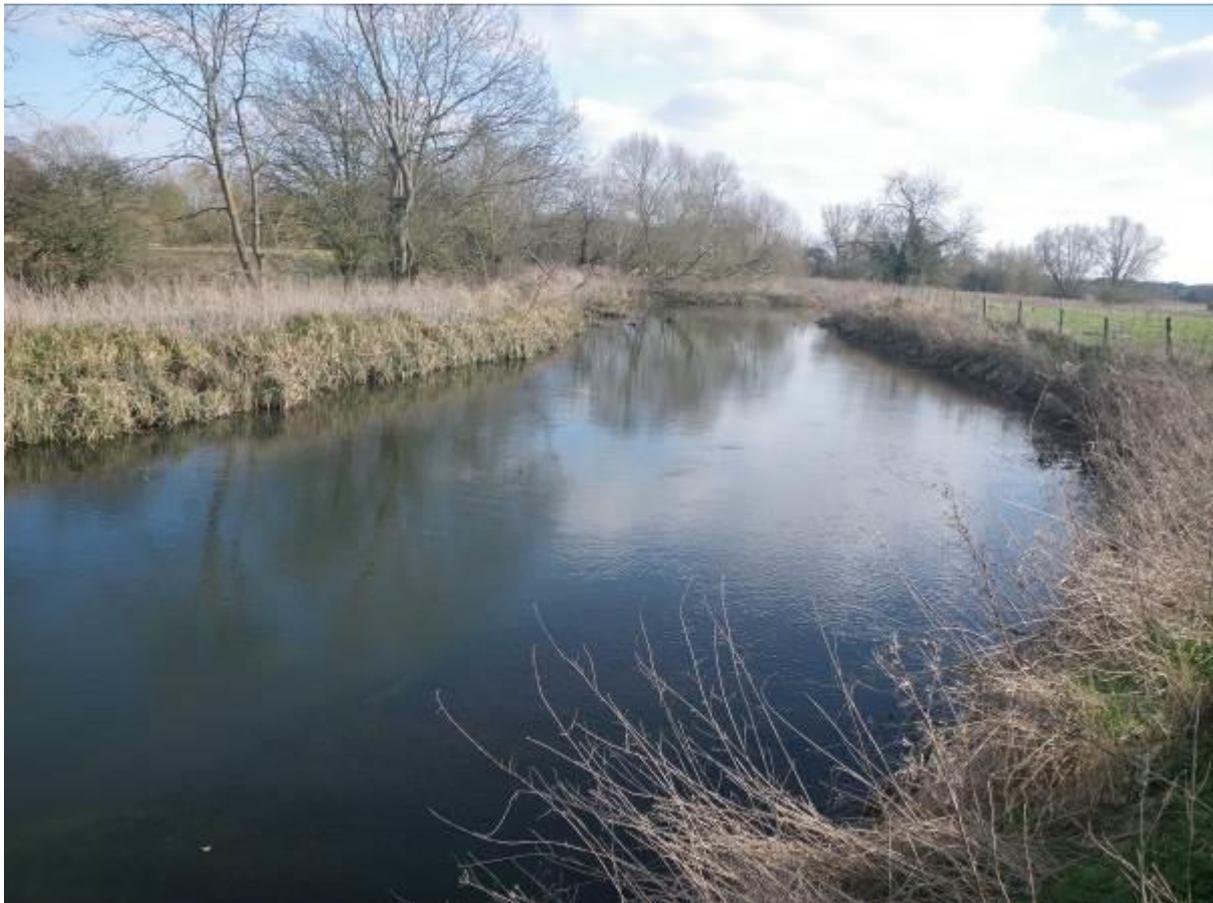
Some reasonable habitat is provided by the root systems of a handful of LB bank-top trees (photo 1) and also from cover provided by some limited stands of marginal emergent reeds (photo 2). In the most part, however, the channel itself is devoid of high quality habitat for fish and invertebrates (cover photo).

The proposal is to introduce much needed diversity into the shape of the channel through a combination of river bed redistribution, import of gravels and large woody material stub deflectors. The prescription is largely similar to that used in the first three phases of Lark improvement works, which have proved to be very successful and stable.

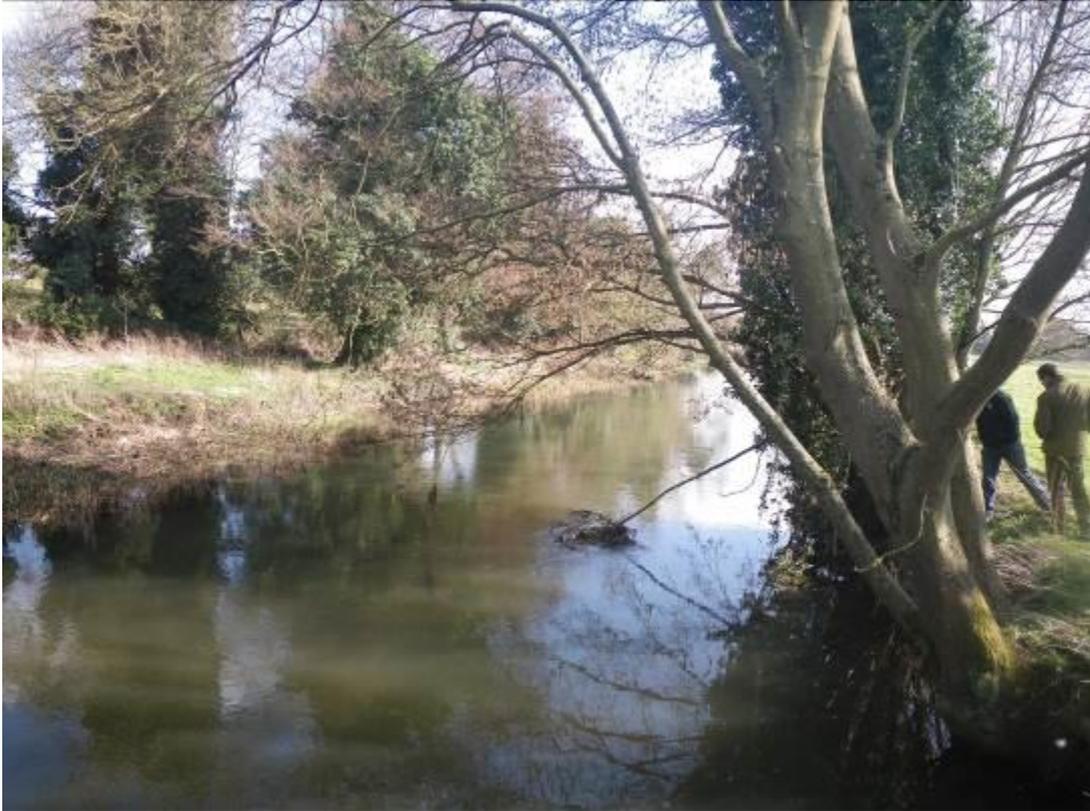
Photo 1. A handful of trees lining a short section of the LB provide some limited cover.

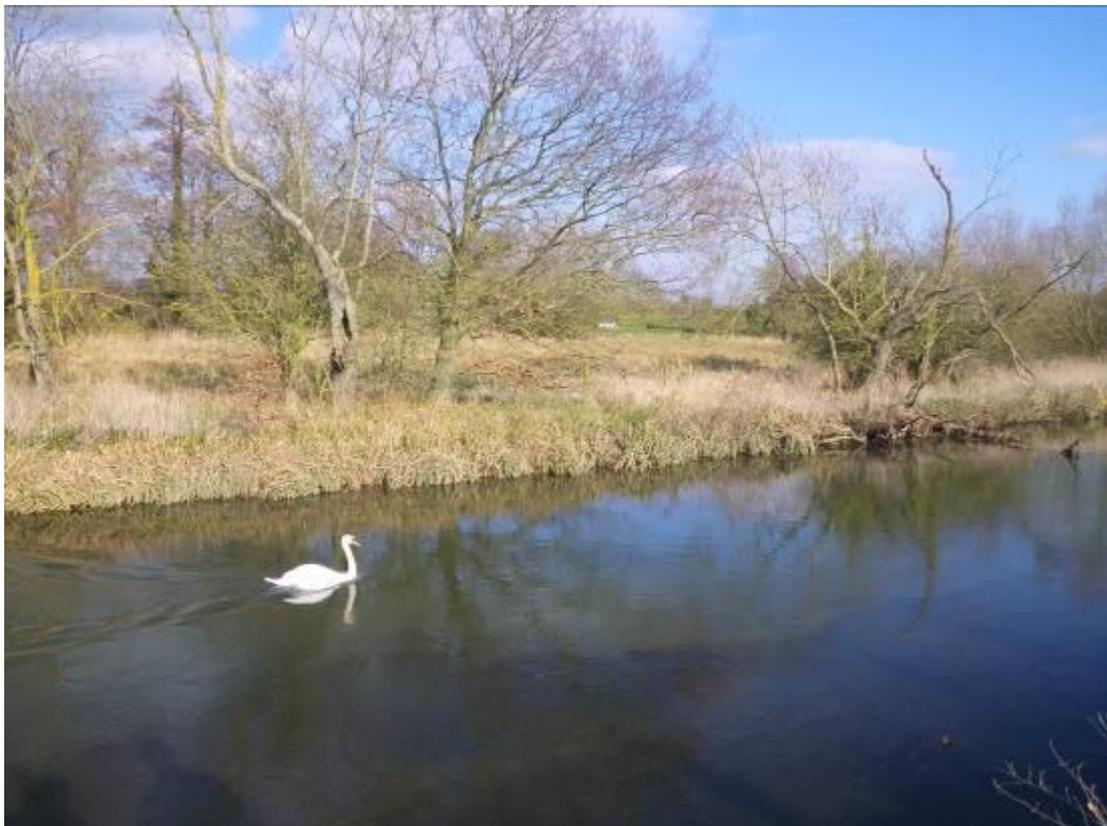
Photo 2. Some decent stands of emergent reeds provide some cover on the RB. Note the subsurface shelf of fine sediment deposit adjacent to the LB.

There is evidence of significant deposition, with some sections of channel supporting submerged berms of deposited fine sediment reaching out to half way across the channel. This is a clear indication of the river very slowly trying to readjust to decades of intensive channel maintenance work.

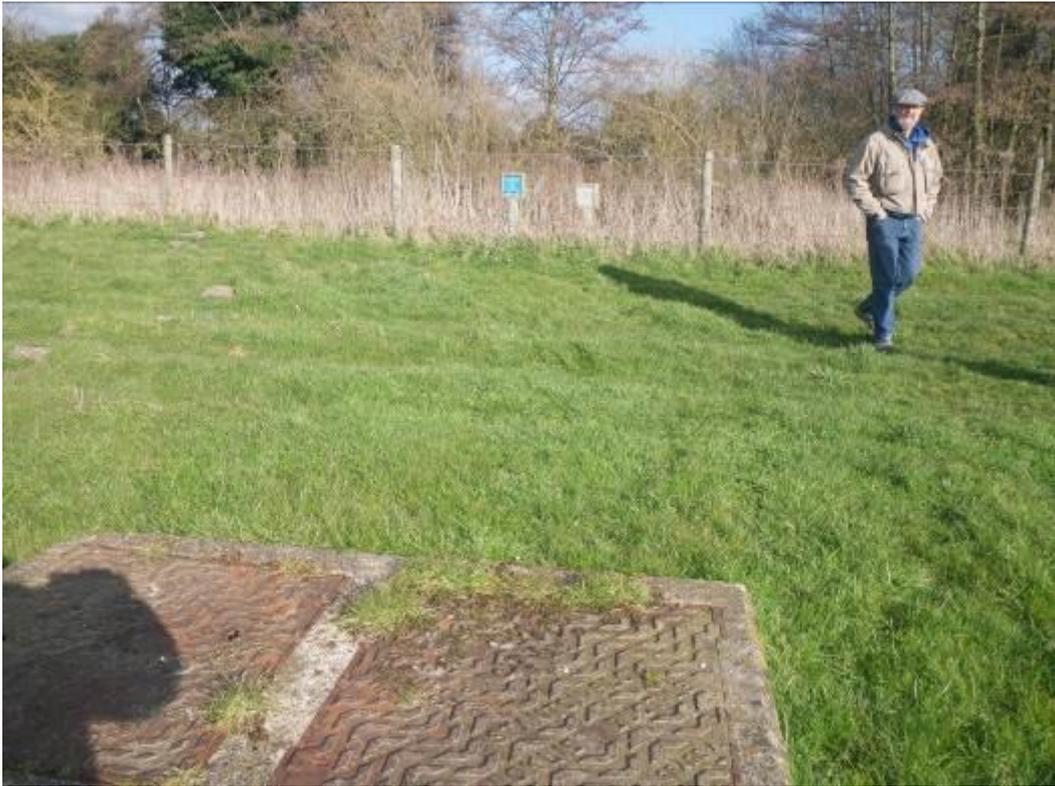
Photo 3 Large service crossing thought to be a trunk sewer.

No work is planned for the first 100m of channel above the bridge and there will also be a 25m exclusion zone either side of a major sewer crossing (photo 3). In total it is proposed to enhance a length of approximately 800m of river channel. It is assumed that water vole will be present throughout the entire reach, which will exclude any options to "cut and fill" from either margin. The method proposed is to create a sinuous sequence of deeper pools and shallow runs by locally squeezing the channel width using a combination of pegged-down alder trunks won from the adjacent ditch line (photo 4) and back filled with existing bed material to create both deeper central channel pools and emergent berms with narrow gutters to avoid any possible damage to existing vole habitats. It is proposed to introduce angular river gravels obtained from the nearby quarry to shape a shallow run-out, or tail to each new pool feature, as well as armouring the neck to create a self-cleansing flume.

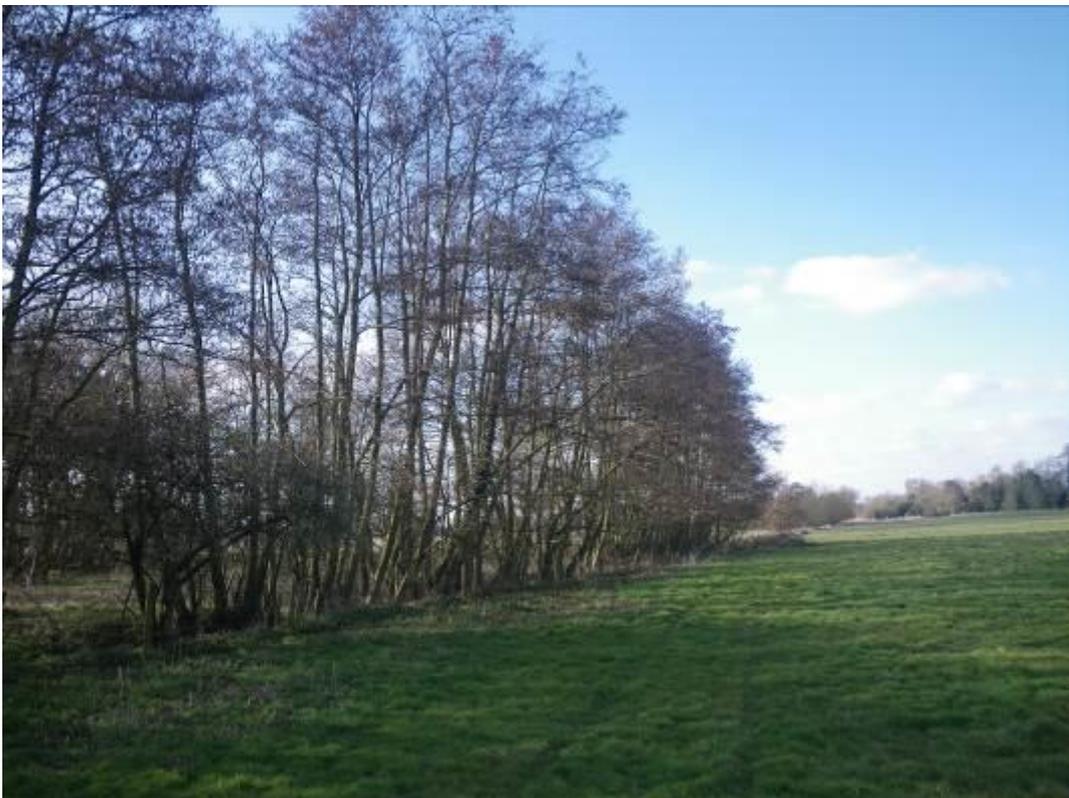
Photo 4 Ditch line with possible source of large woody material for stub deflectors or dragons teeth
