River Lark - Lackford

A Project Proposal by the Wild Trout Trust - April 2015

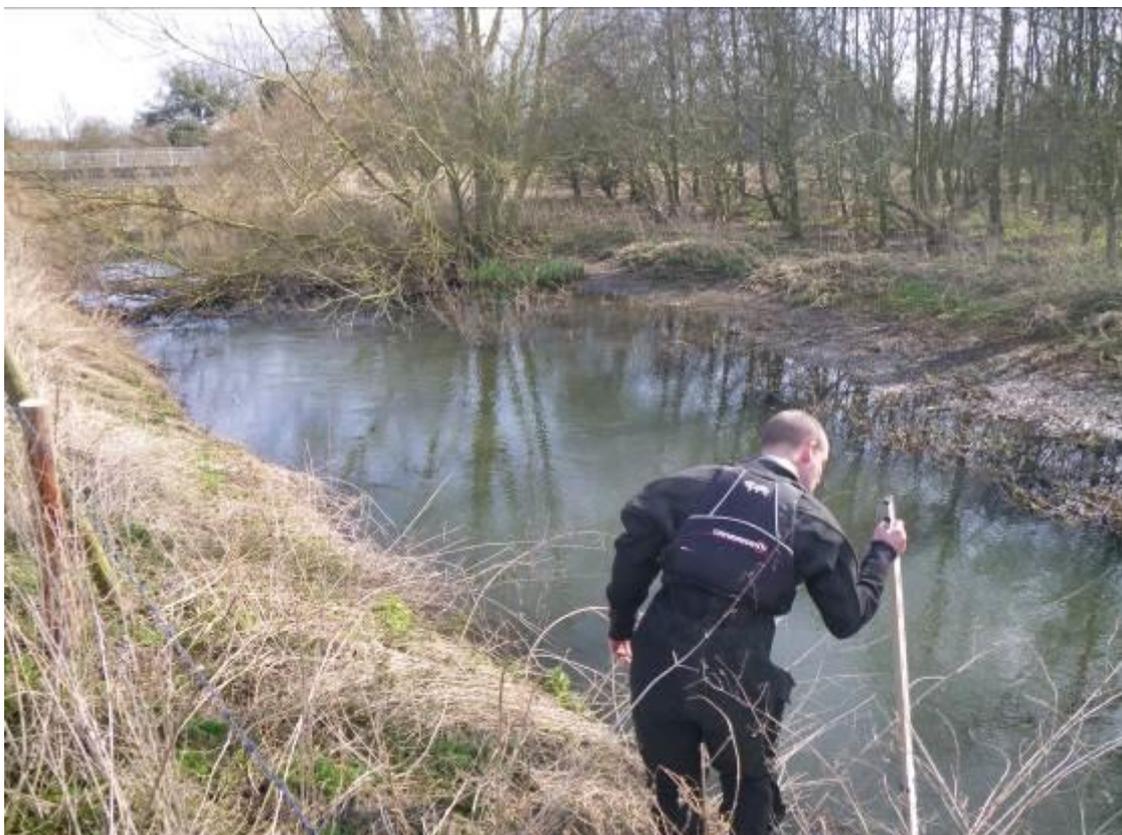
A short distance downstream of the bridge (photo 1), a fallen tree is providing some valuable habitat and promoting some scour in the river bed. However, most of the reach is wide, flat and comparatively featureless.

Photo 1 A fallen tree just downstream of Lackford bridge is promoting some valuable habitat on what is otherwise a bland reach of river.

This straight and uniform stretch of river has huge potential for employing the river redistribution methods (dig and dump) pioneered by Dr. Holmes and successfully utilised in the reach above. Although the gradient of the river is modest, it would be possible to create a sequence of pools and associated runs to radically change the morphology of the channel and promote a more diverse ecology.

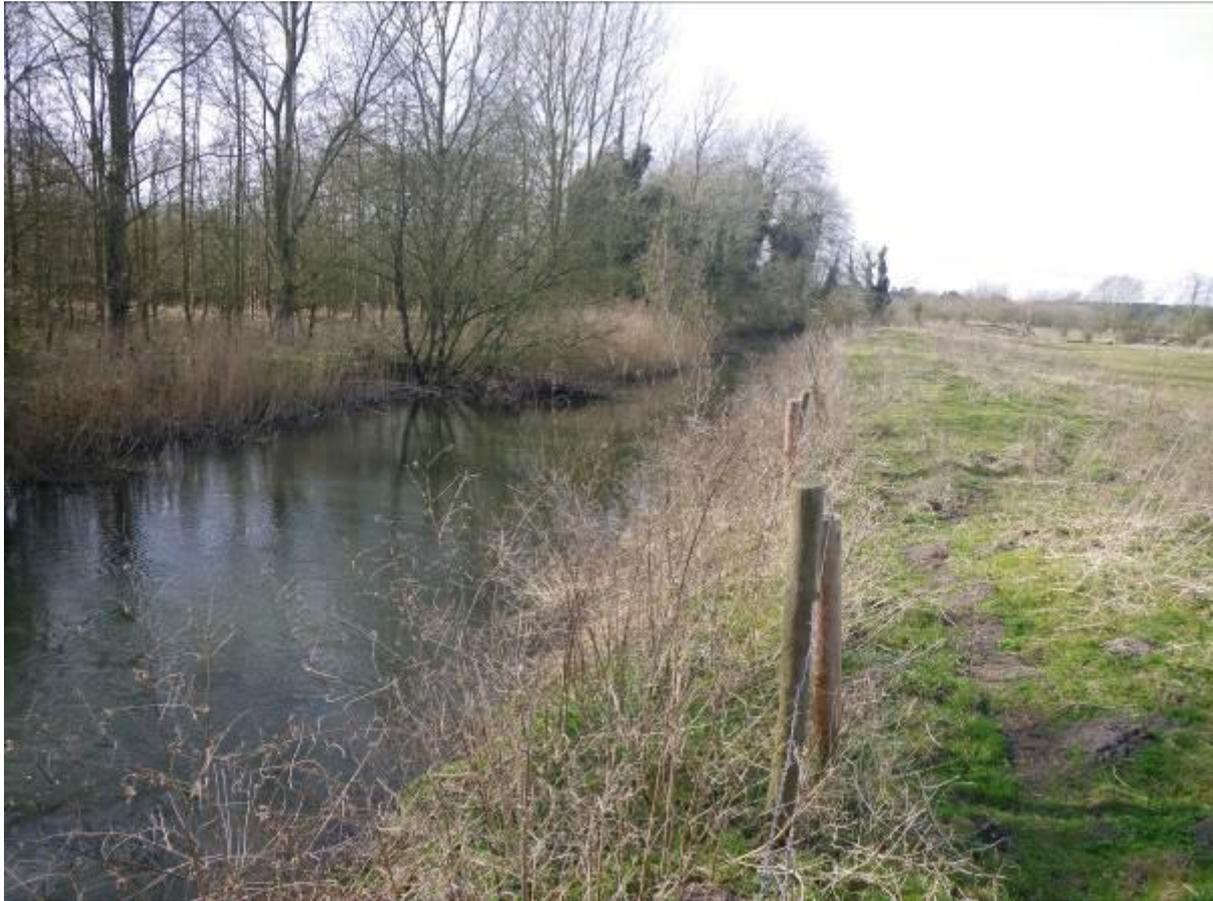
Photo 2. The target reach for enhancement looking downstream away from the bridge.

Channel shading is a significant issue on the first 400m of channel and options to reduce the tree canopy in the plantation adjacent to the LB should be explored with the land owners.

The largest gains can be achieved on the top half of the reach through employing the “dig and dump” technique to create a sequence of pools and runs. The presence of significant numbers of water vole burrows locally will limit any opportunities to use “cut and fill” techniques; the assumption should be that voles are present and work around them.

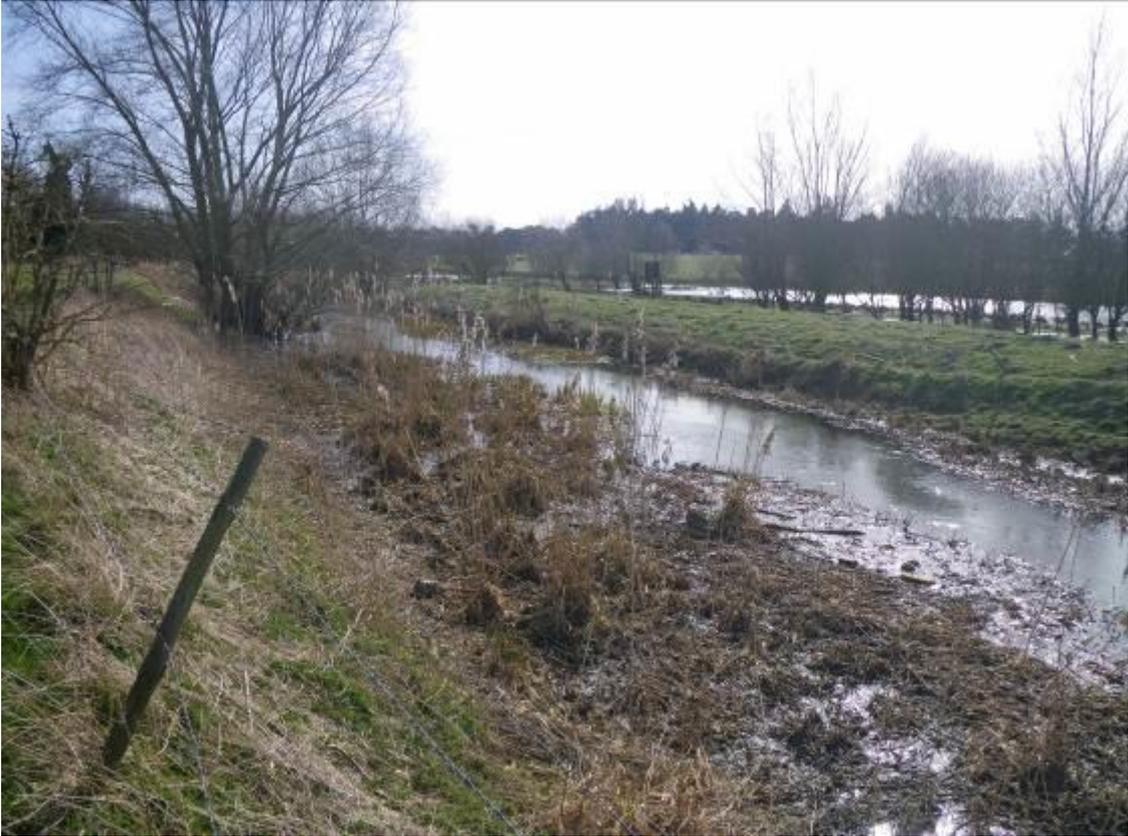
Further downstream the channel enjoys a slightly more sinuous planform and coupled with more direct sunlight, which has promoted the establishment of significant beds of emergent plants, including burr reed, reed mace, *Typha latifolia* and Norfolk reed, *Phragmites* sp. has helped to squeeze the channel width and promote more varied and valuable in-channel habitats (photo 3 and 4).

Photo 3. Low, wet berm of emergent plants squeezing the channel.

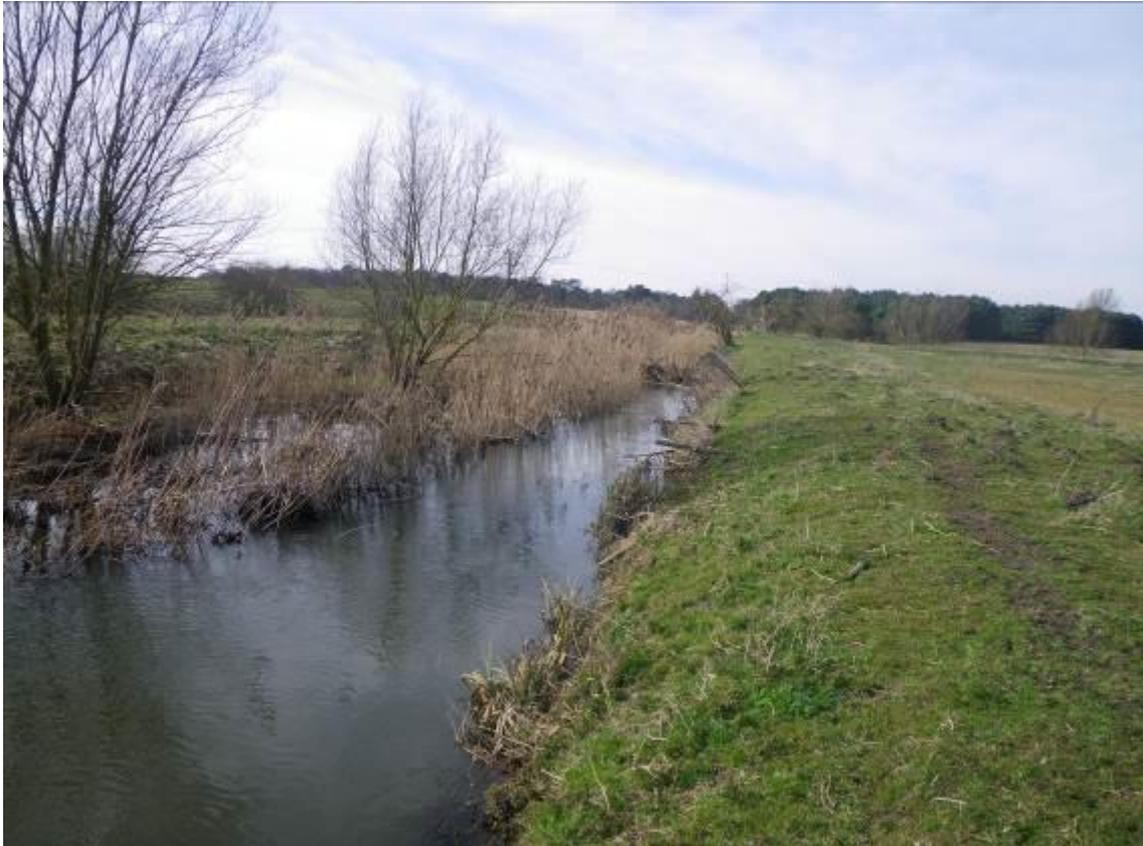
Photo 4. Norfolk reed protecting the banks and providing valuable habitat.

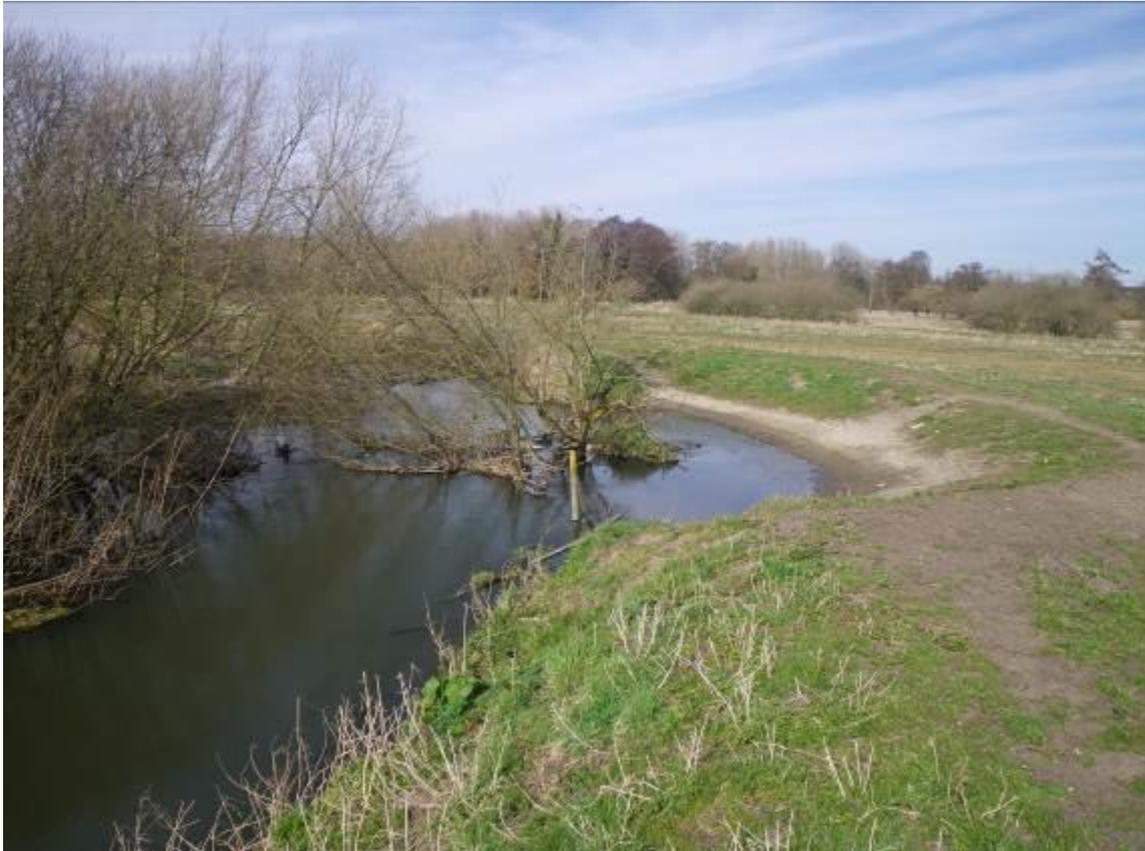
At some time in the recent past, this whole section of river has been fenced to exclude livestock but that fencing has now largely gone. Livestock have access to a safe drinking bay (photo 5) though there was little evidence of serious bank damage associated with livestock; however, improving and extending the drinking bay to create a combined backwater habitat, as well as a safe drinking bay, is worth considering as part of any restoration plan.

Photo 5. Drinking bay could be extended to create a backwater habitat.

Opportunities to create a valuable habitat for coarse fish fry and invertebrates exist with the possible extension of the existing drinking bay. Some of the materials won from excavating the bay could be usefully won to build up the berms proposed for the reach upstream. The issue of stock fencing to deter animals from crossing the river, or trampling vulnerable habitat should be discussed at an early stage with the land owner/tenant.

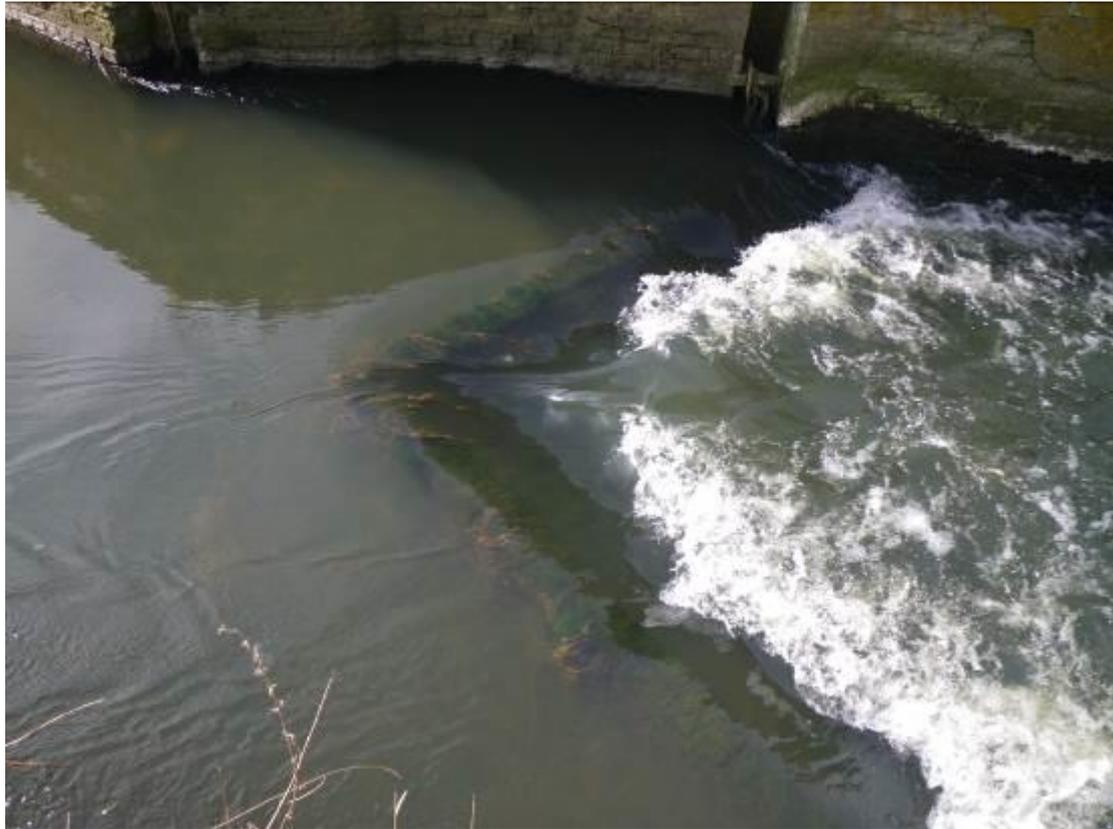
A short distance downstream an impoundment in the bed level is caused by the remains of the old lock gates (photo 6). It is recognized that the lock itself has industrial archeological significance. Removing, notching or lowering the boards will help to develop improved habitat quality in the reach running upstream. It is understood that James Hooker is investigating the possibility of modifying the structure to win valuable bed gradient that will help with any enhancement initiatives in the target reach.

Photo 6. The old lock gate base impounds the reach upstream.

If permissions can be secured, any lowering or removal of the old lock gates will improve habitat quality in the reach above the old lock site.
