River Lark – Lark Angling & Preservation Society

An advisory visit carried out by the Wild Trout Trust – December 2008

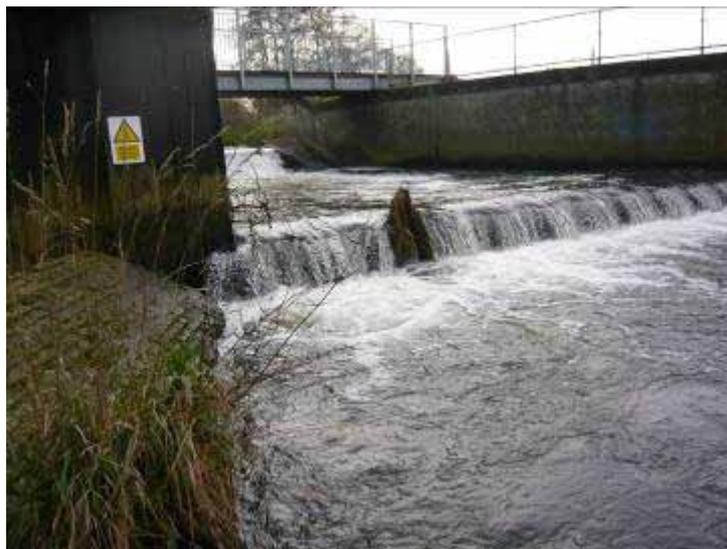
On the bottom half of the fishery there is another large structure just downstream of Temple Bridge. This weir is a flow gauging weir of the "crump" design which can be notoriously difficult for fish to be able to migrate through.

Flow gauging weir below Temple Bridge.

- Open up a dialogue with the Environment Agency over the current use and life span of the gauging weir. Flag up the potential for its removal in making a significant contribution towards the river meeting good ecological condition targets under the EC Water Framework Directive.
- Open up a dialogue with the Environment Agency and the owners of the Marstons Mill and ask for an assessment of its ability to pass migrating

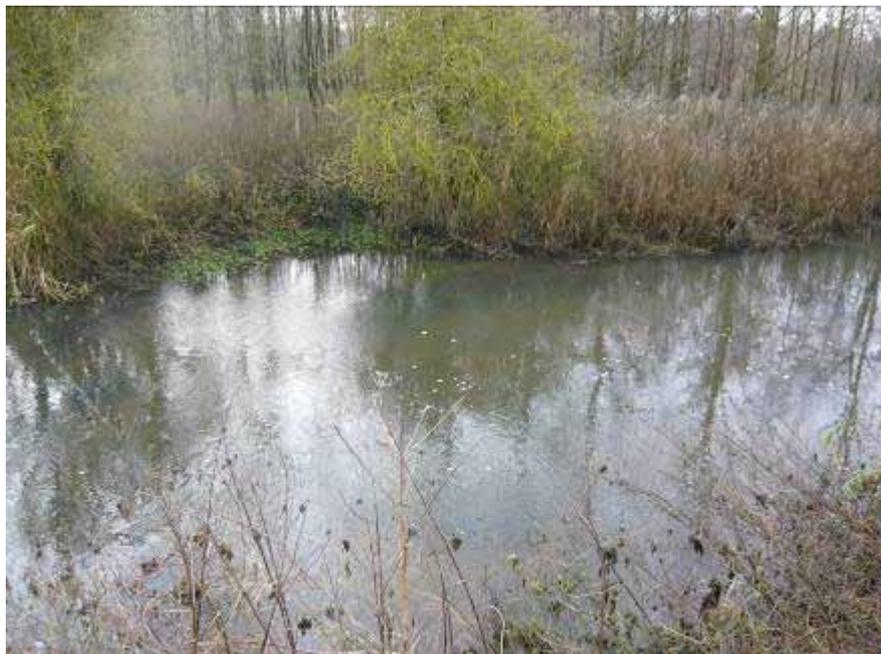
The LB is not controlled by LAPS and has fairly dense stands of tall trees in places; including crack willow *Salix fragilis* and poplar *Populus fastigiata*. There were also some good examples of the valuable goat willow, or sallow *Salix caprea*. This tree can provide much needed low scrubby marginal cover which is vital in providing fish with a refuge from predators and as a source of terrestrial food items, as well as being useful in moderating in-channel weed growth.

Poplar plantation in the background with marginal goat willows.

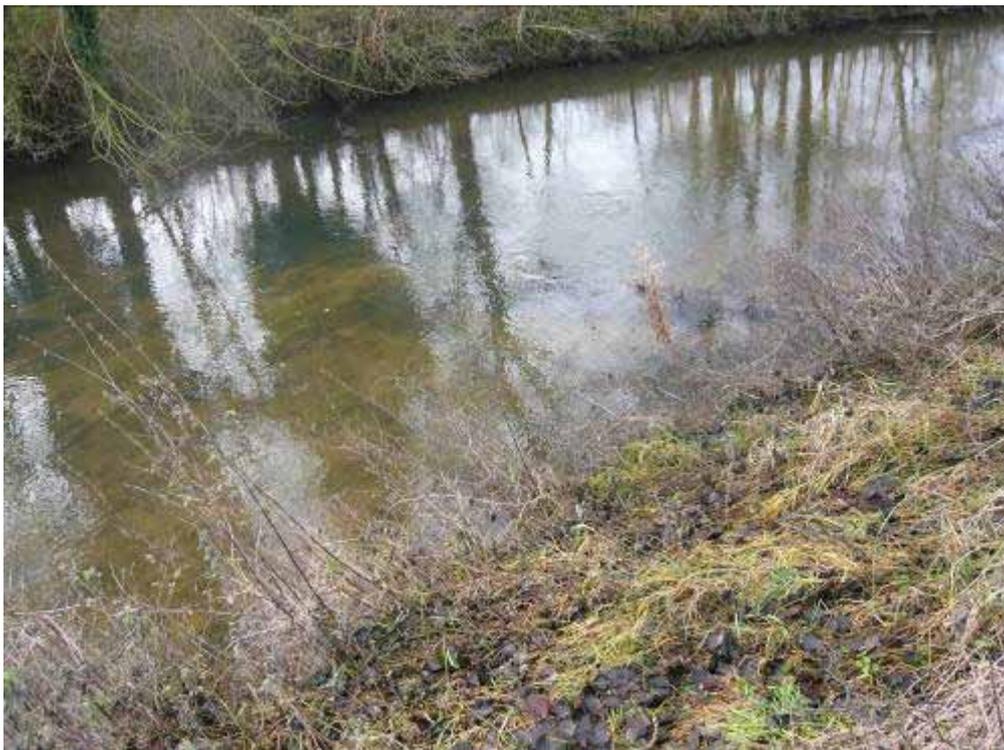
Throughout most of the reach the flow was smooth and laminar. Adult trout lying on glide habitat often require a very close bolt hole if they are to remain comfortable and "on station". It is possible that during the summer months weed beds provide sufficient cover to enable reasonable numbers of adult trout to lie up. This stretch could potentially hold more trout with the addition of a varied bed topography and provision of overhead cover.

Attempts have been made to promote more in-channel diversity through the introduction of current deflectors. Although useful, these appear to be quite small and are not really big enough to promote local scour and hence useful holding habitats for trout.

Smooth laminar flow over a sandy substrate. Note the small log deflector which is just visible.

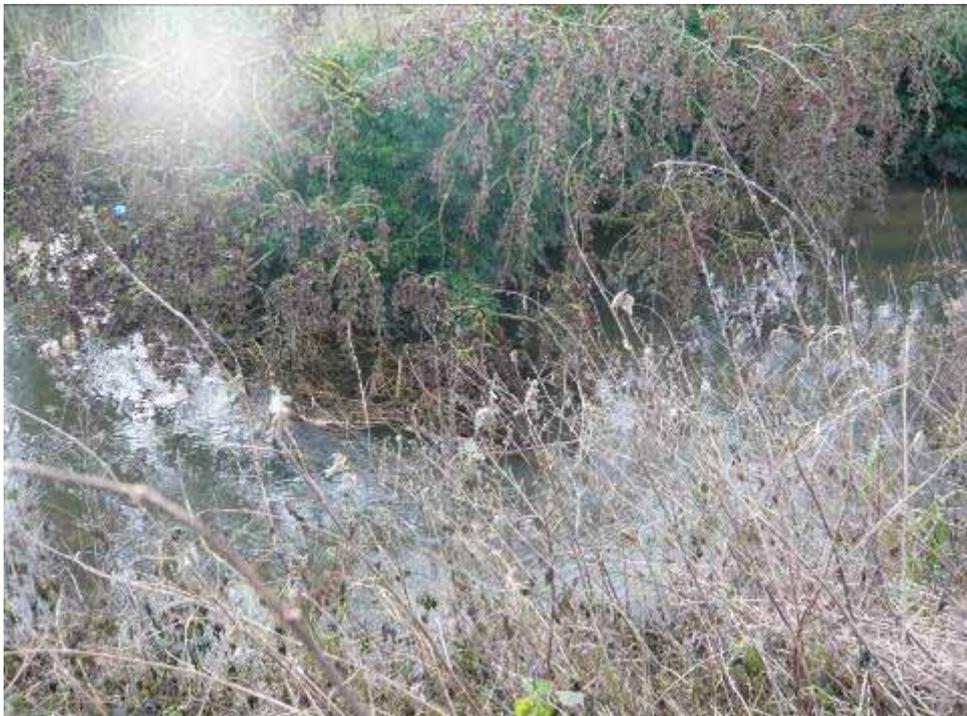
At one point a large tree had fallen into the channel from the LB. This was radically pinching the channel and promoting local increases in water velocity as well as excellent cover from predators. The presence of fallen trees and large branches, usually referred to as large woody debris (LWD) has been shown to be extremely important in several respects:

A fallen tree near the top end of the fishery promoting good quality habitat.

Enhanced habitat could also be created on this top reach by promoting more in-channel LWD as discussed above. There is no shortage of available material adjacent to the LB and if permissions could be gained it would be sensible to drop and pin further trees into the channel. Wholesale narrowing of the RB using faggot bundles, as recommended in the 2003 report or log revetments would also enhance in-channel habitat.

- Retain as much LWD within the channel as possible. Adopt a policy of retaining LWD in the river channel wherever possible. The West Country Rivers Trust provides a useful guide to the management of natural LWD:
 1. Is the debris fixed, if yes then continue to 2, if not continue to 5.
 2. Is the debris causing excess erosion by redirecting the current into a vulnerable bank? If yes then go to 5 if not then go to 3.
 3. Would fish be able to migrate past it (take into account high river flows). If yes go to 4, if no go to 5.
 4. **Retain the woody debris in the river.**
 5. **Re-position or extract the debris.**

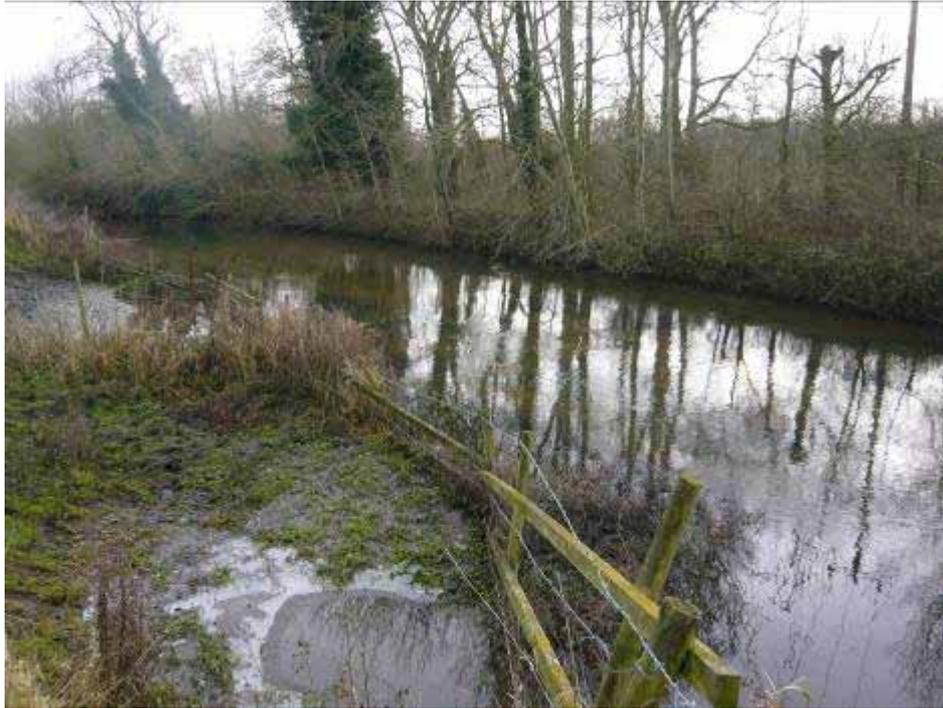
Various techniques can be used to secure fallen trees to the margins. It is important to ensure that no additional flood risk is posed through trees breaking away during high flows and causing blockages at bridges and structures downstream. It is understood that the Lark does not suffer from big flood events so it is perfectly feasible to either "hinge" live trees into the channel or secure imported LWD to the banks and bed. A range of techniques are described in detail in the Wild Trout Trust's Chalkstream Habitat Manual. These techniques would work even better if coupled with a local increase in water velocity promoted through a lowering of the Marsden Mill impoundment. If these techniques are being considered then consents and permissions may be required. Tree works should only ever be undertaken outside the bird nesting season and some of the marginal trees on this section were laden with ivy possibly making them valuable bat roosts.

Ivy clad trees should be left for bats

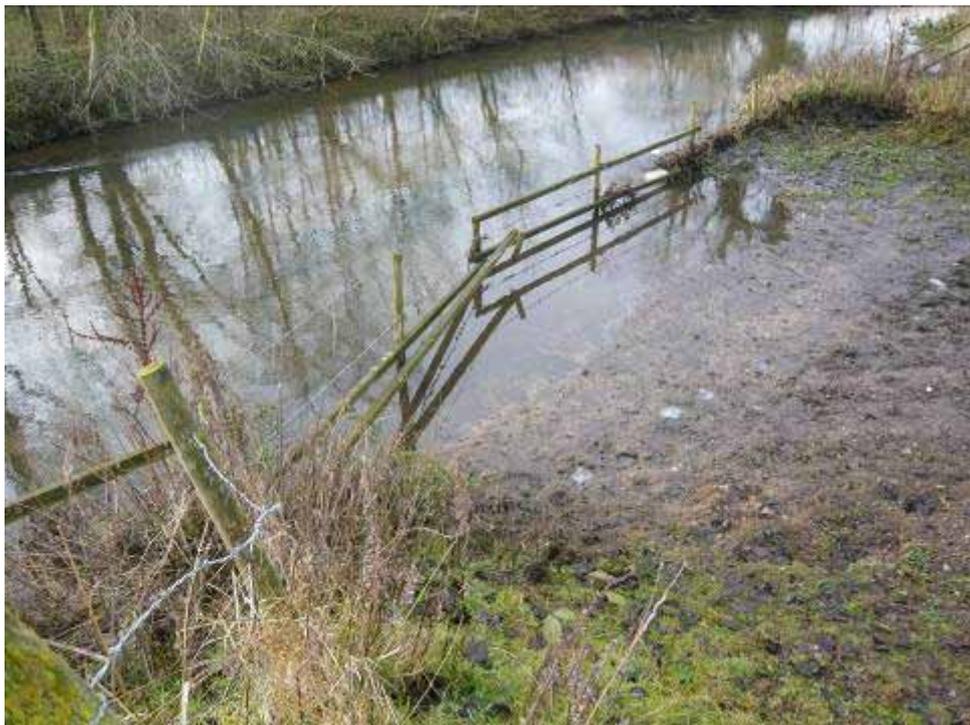
An old cattle drink with protective fencing

Adjacent land use did not appear to be an area of concern. Meadows adjacent to the RB have at some stage been used for grazing and it was evident that some protective measures to avoid damage to river margins had been put in place. Some light marginal trampling or “poaching” can sometimes promote good quality habitats in chalks stream environments by creating low soft berms that

Stock control and bank poaching is a very emotive subject and a heavily grazed and poached bank is much worse than a bank with no fencing. That said, if stock densities can be managed then light grazing and poaching often promotes optimal marginal habitats on wild trout fisheries.

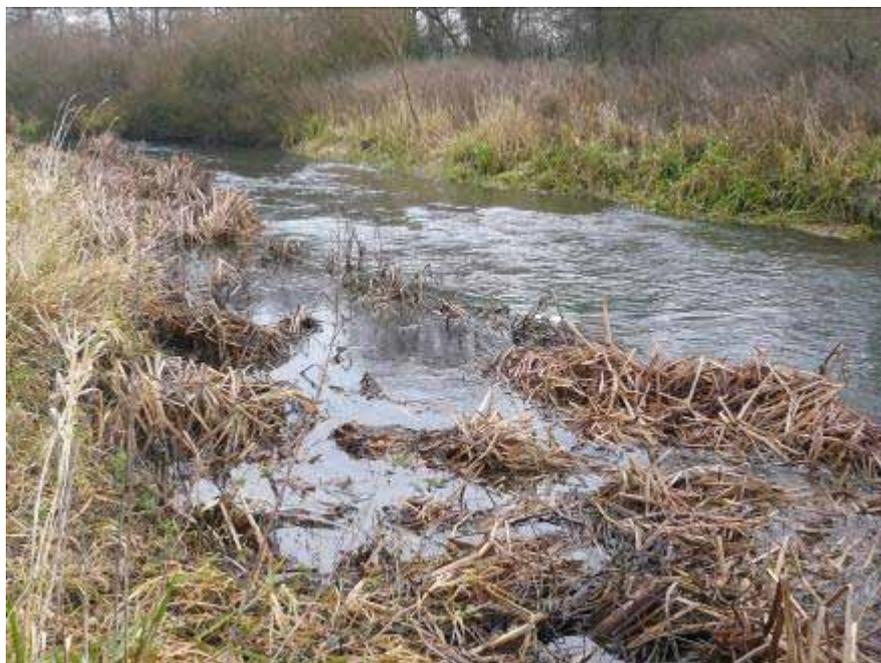
The next section of river inspected was upstream of Temple bridge. Despite the considerable impounding effect from the gauging weir located just downstream of Temple bridge, the river displayed some characteristics associated with a naturally functioning system. A nice riffle and glide was observed which appears to have been created some years ago by importing gravels.

A lovely glide and spawning riffle adjacent to a low soft margin. Good trout habitat

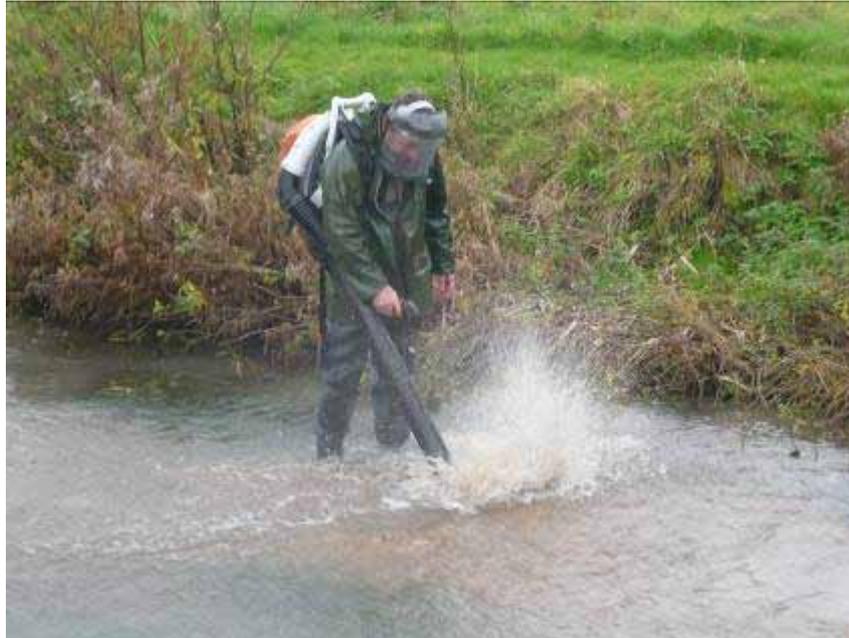
In some chalk and limestone catchments river bed gravels can naturally calcify and cement together. This did not appear to be the case here with the gravels in the main part being loose and of a size suitable for trout spawning. The gravels did, however, contain a lot of silt and it would be valuable to clean this section at the end of the rod season. Gravel cleaning would undoubtedly give any subsequently-deposited eggs a much better chance of surviving to fry stage.

Gravel cleaning on chalk streams can significantly improve the survival of trout eggs

- Instigate an autumn programme of spawning gravel enhancements. Identify the main areas of potential spawning activity and during October give those areas a thorough clean using high pressure pumps or a leaf blower.
- Consider the possibility of enhancing the productivity of the fishery by creating new spawning habitat with imported gravels.
- Keep a watching brief on water quality through joining the Riverfly Partnership and undertaking some monitoring of key areas. This might be particularly pertinent on the Mill Stream.
- Draw up a programme of improving in-channel habitats through the use of imported LWD and narrowing wide shallow sections using faggot or log revetments. Priority sites are downstream of Lackford Bridge, downstream of the gauging weir and downstream of the Cavenham Mill Stream confluence.

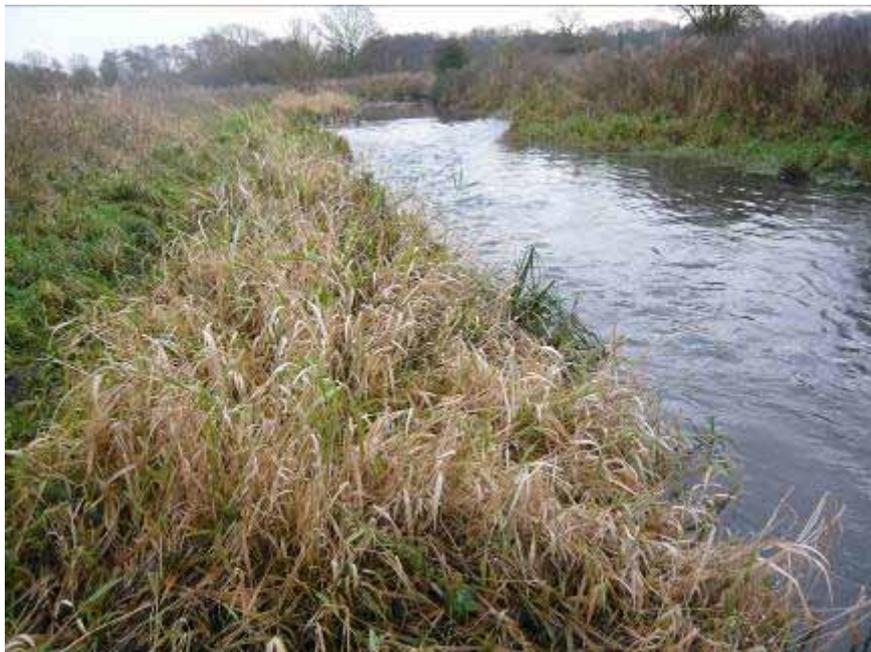
Of all the sections inspected, this reach appeared to have the most diversity in terms of channel shape and bed topography. Further enhancements could be made with the introduction of some LWD onto some of the shallow gravel glides to help promote local scour and sort river bed gravels.

Good channel shape could be complemented with some low marginal cover dotted throughout this reach

Enhanced lies for adult trout could also be created through some selective tree planting using goat willow whips.

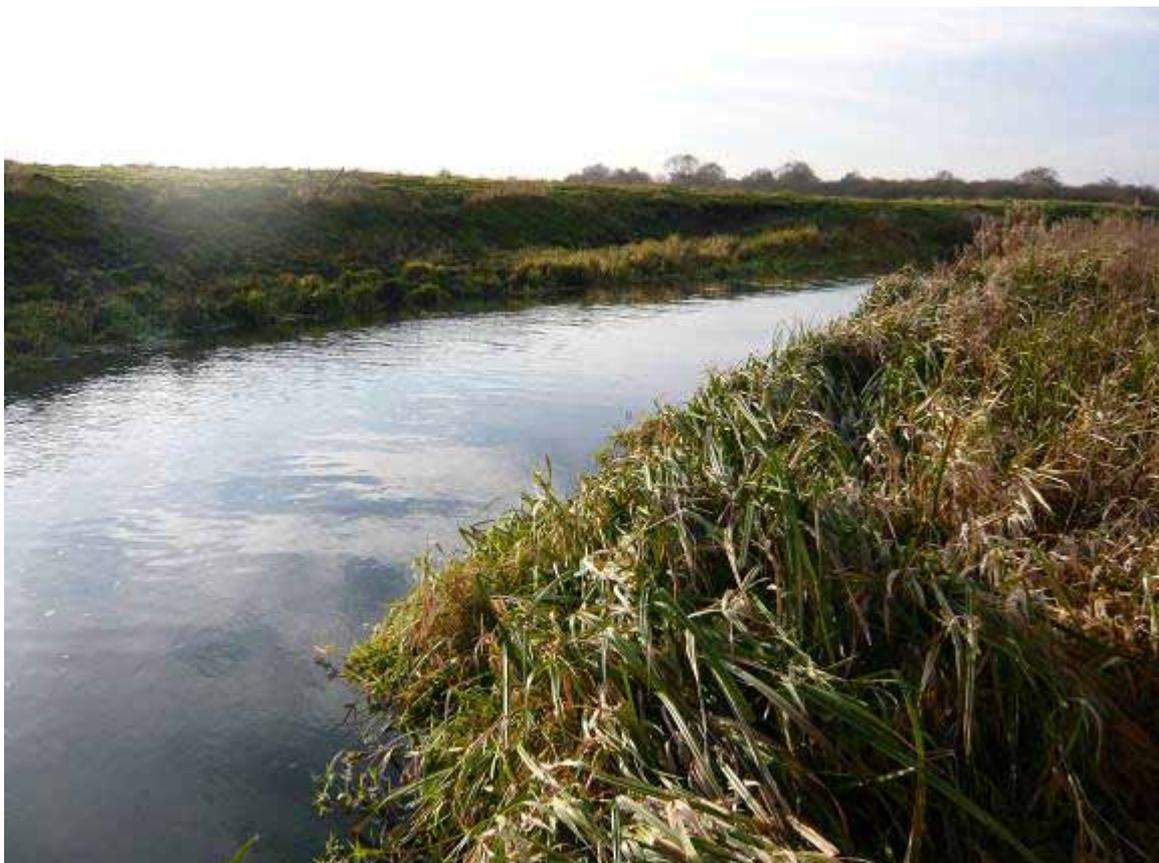
Downstream of Temple Bridge and below the gauging weir the river was very deep and slow flowing. This section looks to have been heavily modified and has failed to make any significant recovery. Approximately 300 metres further downstream the river shallows slightly and there are some proposals to work with the local Environment Agency in creating some better quality habitats through the introduction of current deflectors. This section of river lies adjacent to the Tuddenham Heath Site of Special Scientific Interest on the LB and the Icklingham Plains on the RB which is the subject of a potential flood plain improvement scheme.

A heavily modified section downstream of the gauging weir. This section is in desperate need of some in-channel features and marginal tree cover to improve its fish holding capacity.

On some of other more featureless sections of river the Society should introduce LWD to promote enhanced in-channel habitats, it was also apparent that there was a lack of low scrubby marginal cover. Implementing a programme of planting with small goat willow whips a few inches above normal water level should soon provide some good quality holding water for both stocked and wild fish.

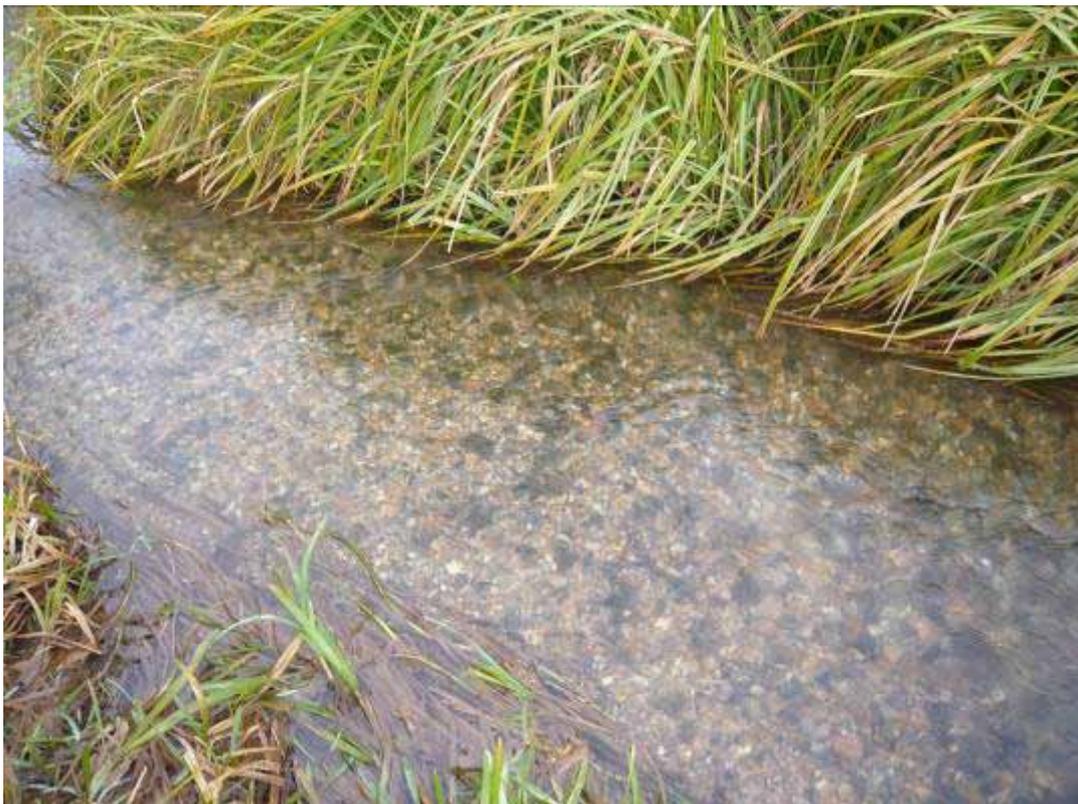
The Cavenham Mill Stream is certainly a very exciting prospect. An inspection of the bottom 300m would suggest that this stream already has habitat capable of sustaining wild trout and could be enhanced further to improve production and provide wild stock for the main River Lark.

Good quality trout spawning habitat on the Cavenham Mill Stream

The location and potential quality of the Cavenham Mill Stream is highly significant. Efforts should be made to assess the quantity and availability of this habitat for trout migrating up and down the system. Natural debris dams are rarely a block to free migration, whereas man-made or engineered dams may well be restricting the range of habitat availability. Potential spawning gravels, particularly on the bottom half of this little stream, should be improved either using LWD to locally scour and sort gravels or through a programme of gravel cleaning using high pressure pumps or leaf blowers.

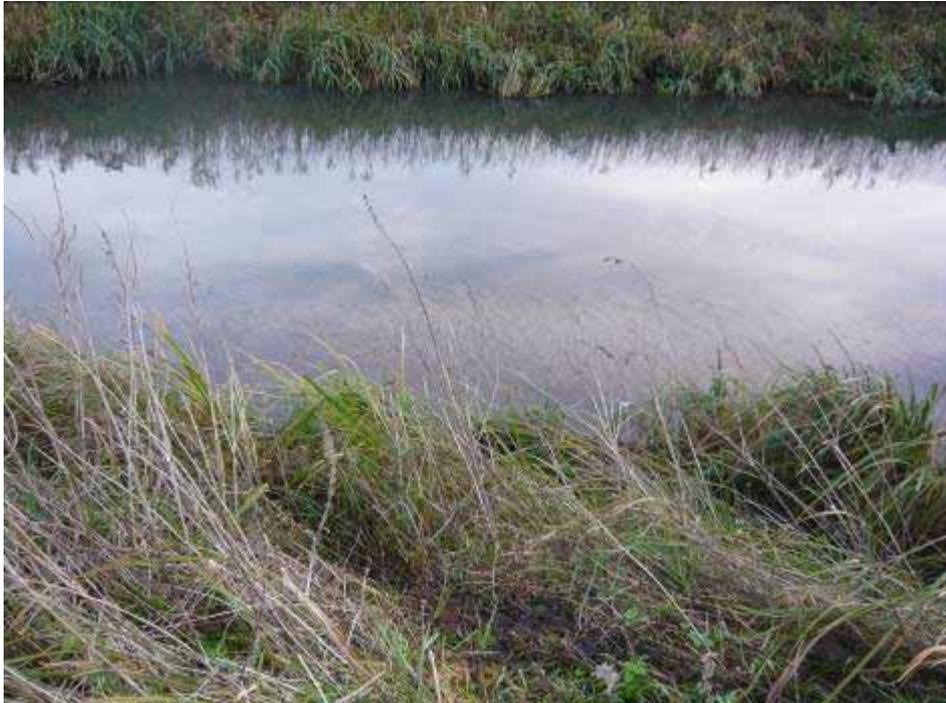
Where the Mill Stream joins the main Lark the habitat for trout is rather less inspiring. The river is very wide and slow flowing and it is understood that the river was dredged comparatively recently. For long sections downstream of the confluence there was a shallow silt bank extending out into the channel before dropping away into deeper water. Any reduction in head loss at the Marsden Mill

will almost certainly expose this silt bank and enable it to be planted up and consolidated with marginal emergent plants. This will naturally narrow the river and elevate water velocities through the main channel and potentially enable better quality habitats to form.

Just downstream of the Cavenham Mill Stream confluence. The shallow silt bank extends to about a third of the way across the channel and can just be made out.
