River Lark – Bury St. Edmunds Trout Club

An advisory visit carried out by the Wild Trout Trust – December 2010

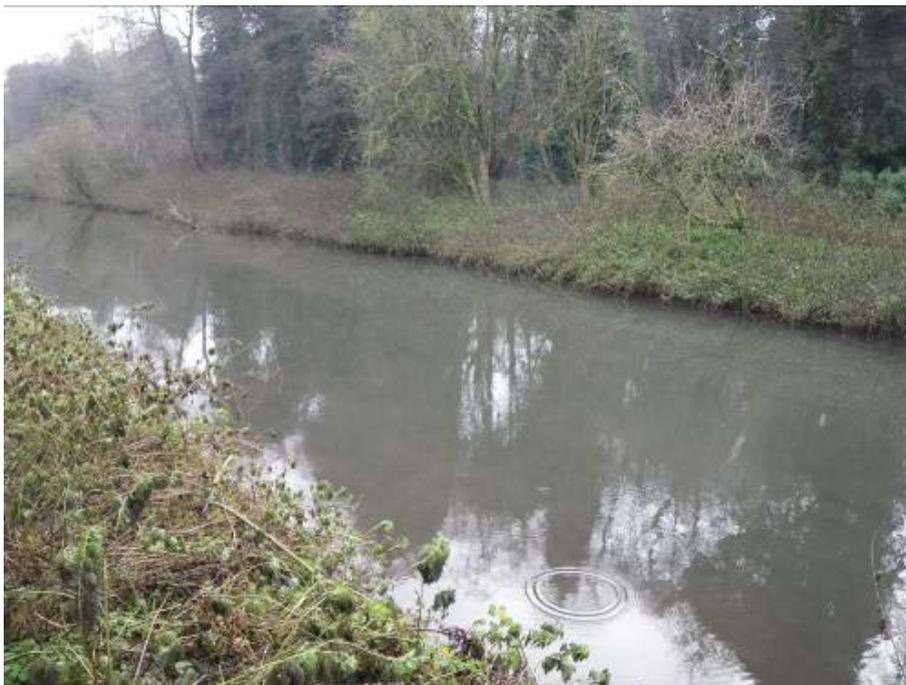
Some recent work carried out by the Environment Agency's Operations Delivery Team further upstream has been unsympathetic to the ecological needs of the river. It is thought the work was carried to combat excessive emergent plant growth on the top half of the fishery. Rather than retain a thick fringe of vegetation in the margins, and ensuring there is a clear channel of faster water in the centre, the entire channel has been scraped out with an excavator. All that has been achieved is to make the channel wider and hence slow down flow, making conditions even more favourable for emergent plant growth across the width of the channel. This is not a sustainable method for reducing flood risk and is enormously damaging to the overall ecology of the river and has made no significant difference to hydraulic conveyance which is limited by the old lock structure located approximately 200m downstream

The top section of the beat where all the plants have been scraped out mechanically, destroying valuable habitat and not achieving an improvement to hydraulic conveyance.

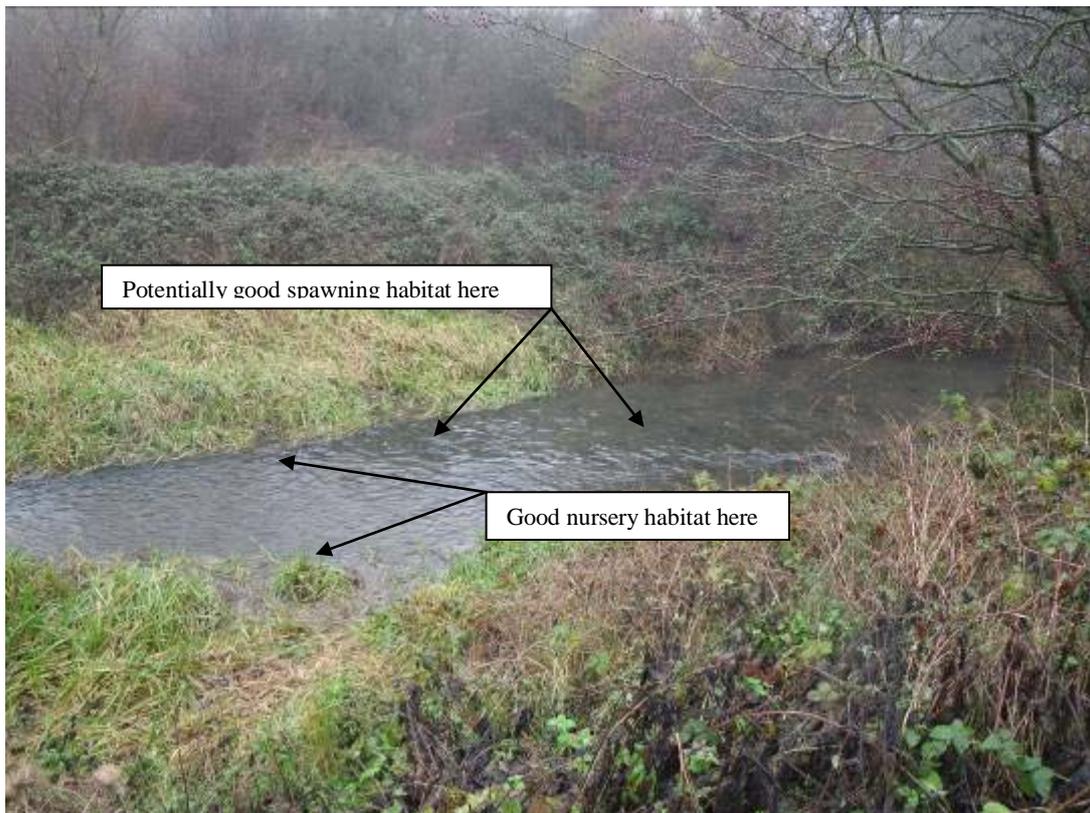
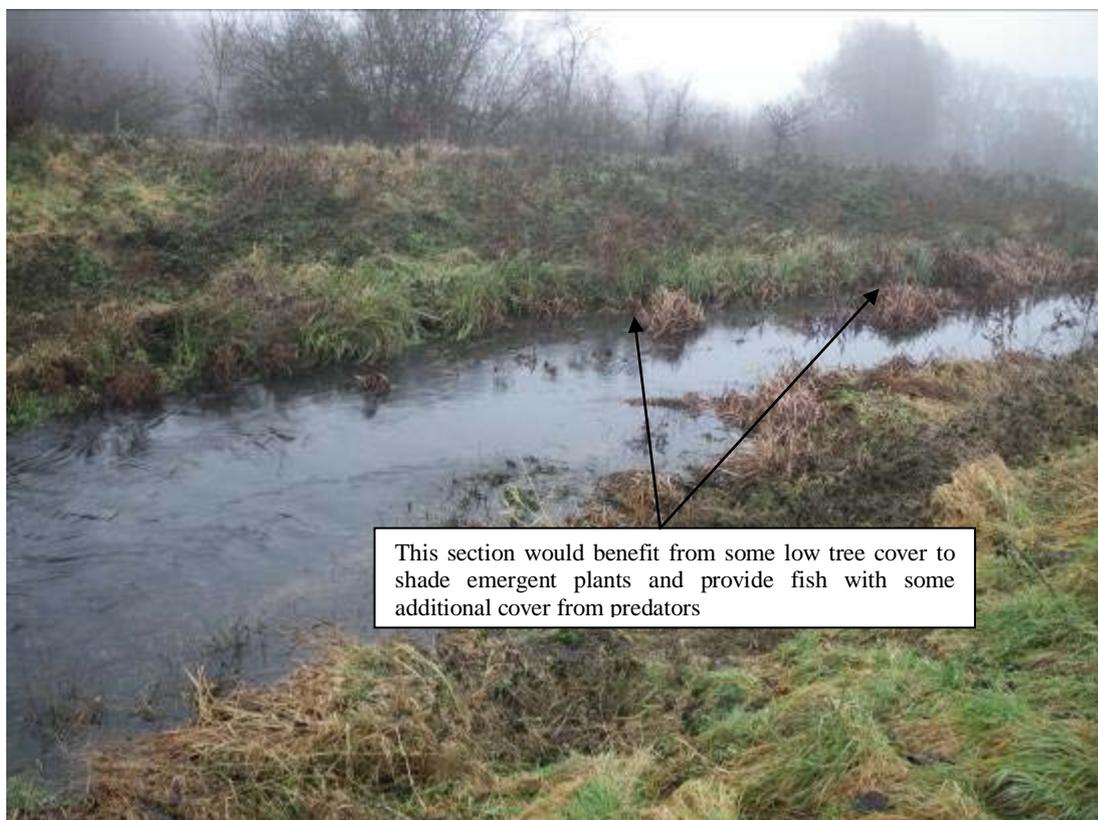
Two views of the downstream section which both support good spawning and nursery habitat

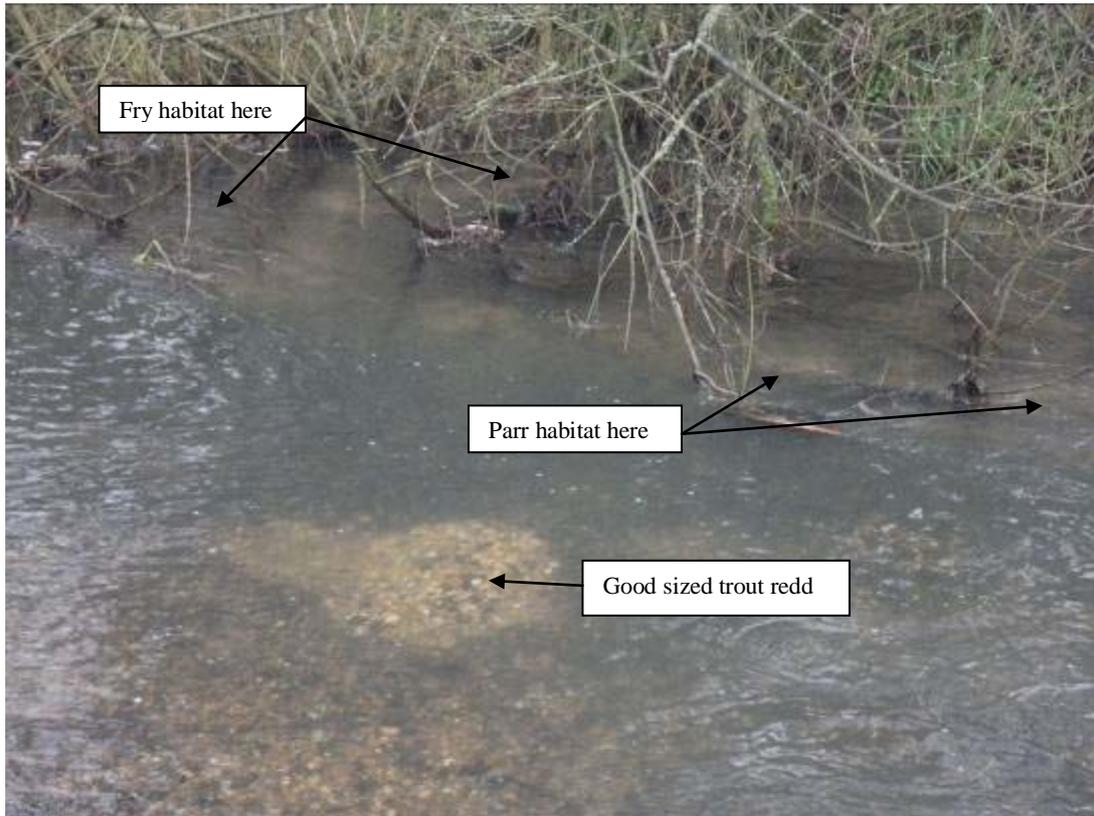
A good sized redd on the section above the lock with superb cover for fry located on the shallow shelf under the willow branches.

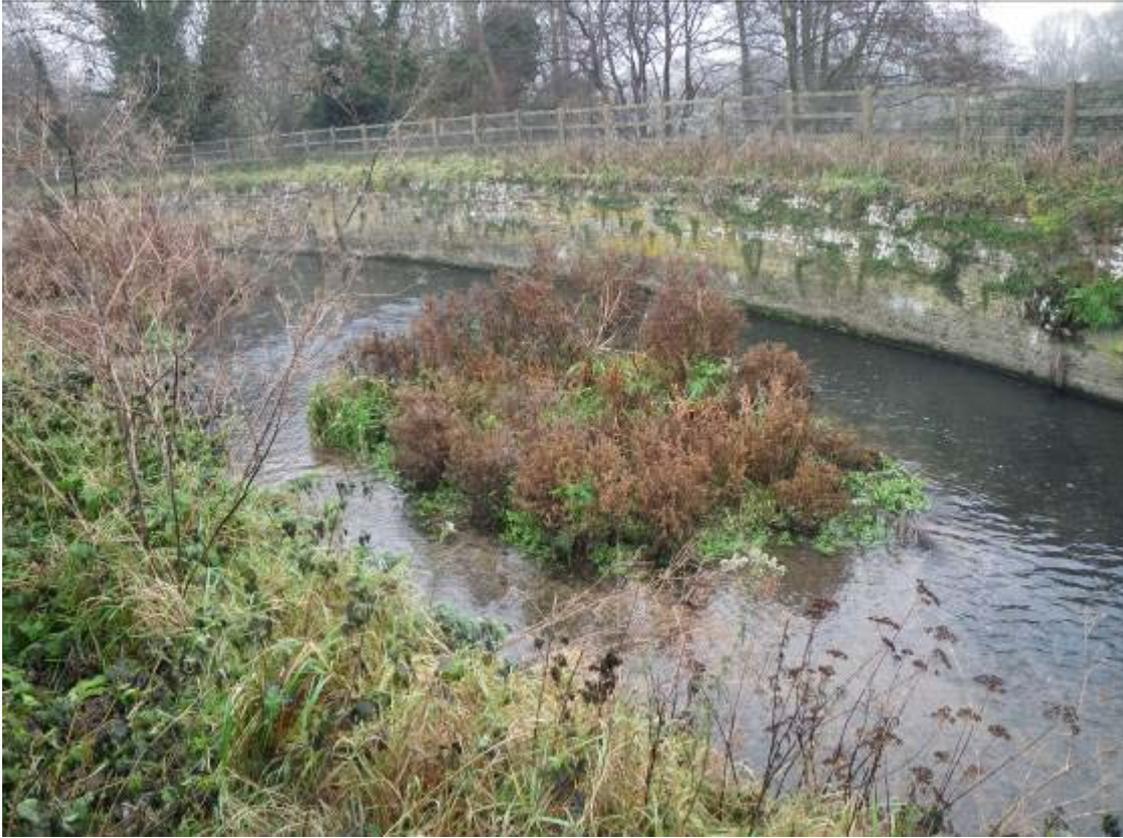
There was some discussion about tree works that have been undertaken in the old lock cutting. This structure is a very impressive piece of engineering and is likely to have significant industrial archaeological value, although fortunately it no longer functions as a lock as the gates have been removed. A line of trees that were growing from cracks in the brickwork have been cut down removing any significant cover for fish. It might seem strange to suggest that the inside of a lock could provide good quality habitat for trout, but the long shallow riffle that has formed since the gates at the bottom end were removed has potentially created some excellent habitat for juvenile trout. A vegetated gravel shoal has formed a low island within the lock structure and the fringe of live and dead annual plants is providing some superb cover for juvenile fish.

Unfortunately the removal of any vestige of bank-side cover from the LB has severely limited the potential of this section as a whole. Some ideas for mitigating against the loss of trees and suggestions for improving the holding capacity of the reach are discussed in the conclusions and recommendations section of this report.

The old cutting where tree cover has been removed, presumably to protect the integrity of the wall

The provision of more low scrubby cover is desirable on some of the more open sections. The removal of tree cover from the old lock chamber has severely restricted the holding potential of this section. One possible remedy here is to install refuges into the margins by securing small trees or saplings to an anchoring ring screwed to the lock wall. An advantage in adopting this method is that when the river is in spate the "tree sweeper" floats and does not reduce the capacity of the channel for flood flows. If there are sensitivities with regard to flood defence then adopting this technique is often a way of obtaining the necessary consent for providing in-channel cover.

- Consider the option of introducing floating "sweepers" into the lock chamber to provide cover for juvenile trout.
- Speak to potential partners and explore options for a large scale restoration scheme for the bottom straight.

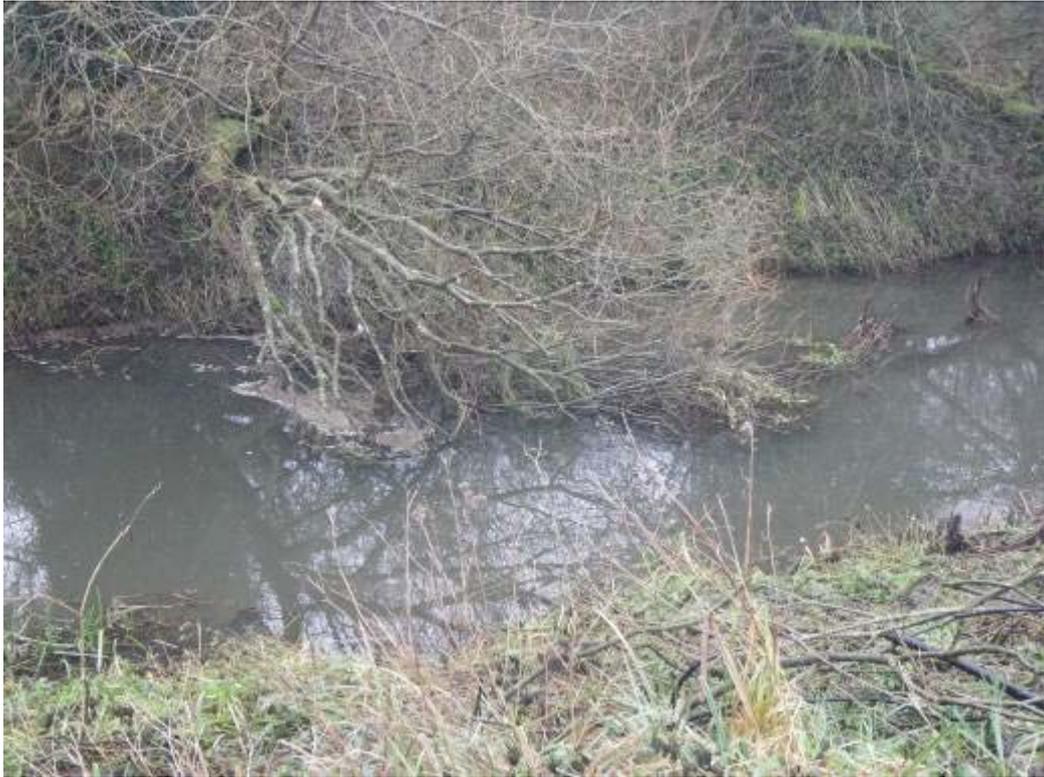
A partially fallen tree providing fantastic cover on the section just above the lock.

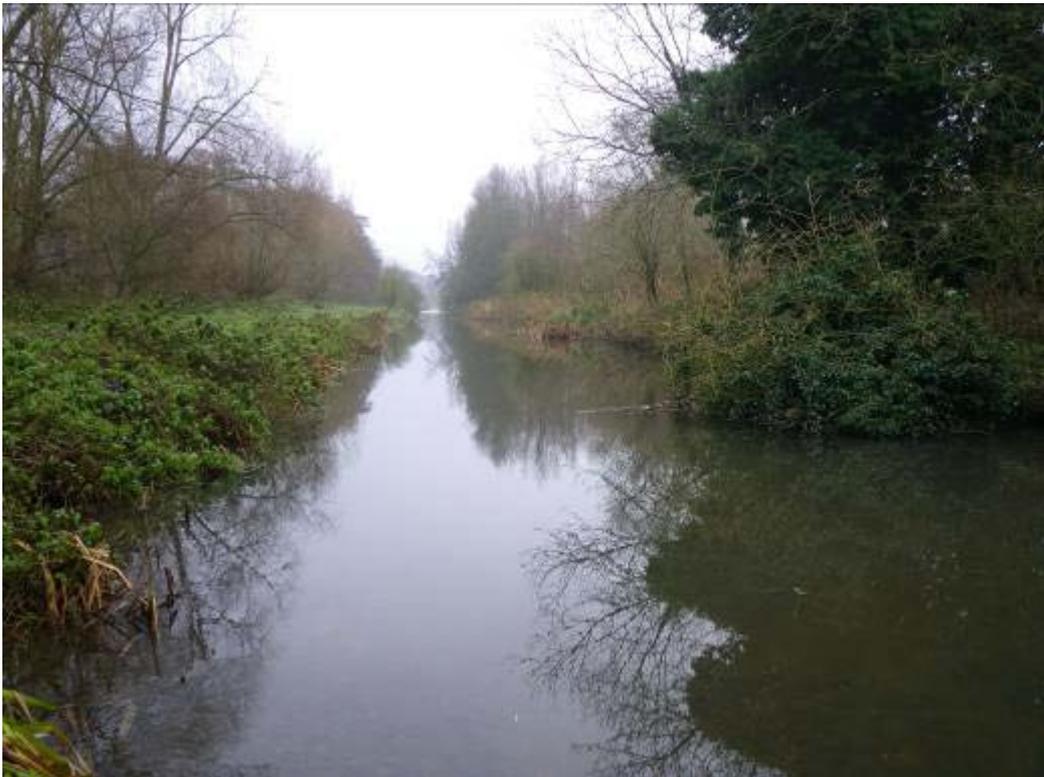
The long straight section – poor habitat for flow loving fish species

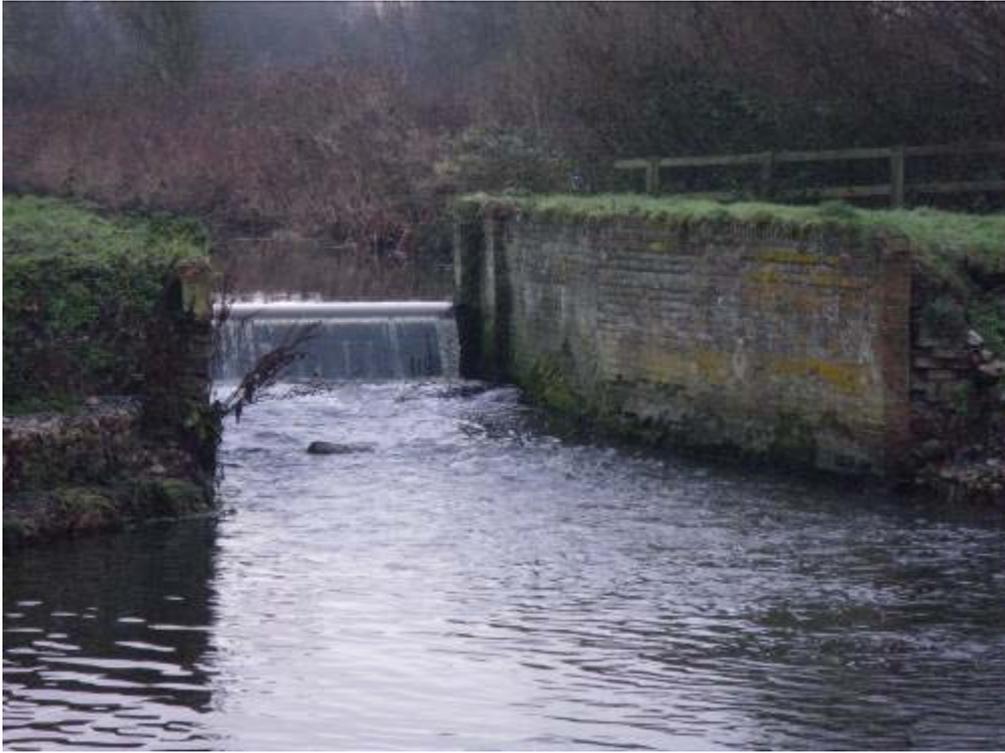
The short section immediately below the weir is the only reasonable habitat for flow loving fish for hundreds of metres both up and down from this structure.

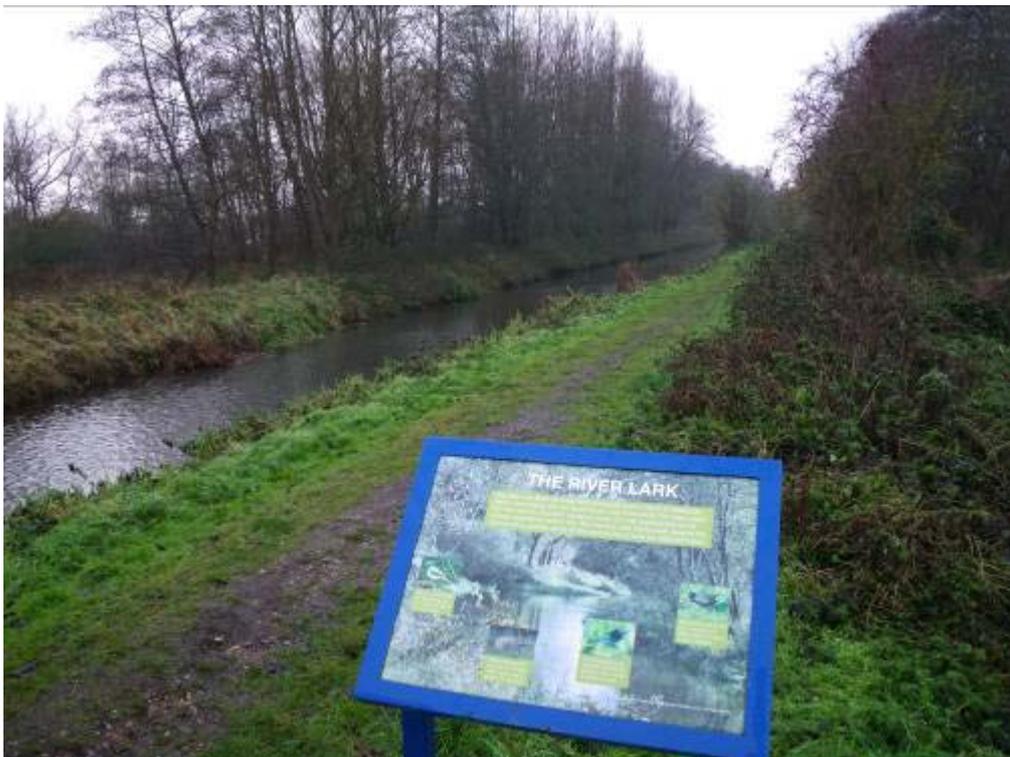
The long straight running down from the weir is ripe for wholesale river restoration.

The long straight section of channel on the top half of the beat is in poor condition. The channel looks like a shallow canal and recent works to remove emergent plants has further damaged the ecological potential of this section. This section is ripe for a large scale restoration scheme that would necessitate some radical changes to the current channel width and bed profile. A project of this magnitude will require careful planning and considerable resources. A possible way forward is to approach the EA with a rough project proposal and seek to build a partnership between between the club, the EA and possibly the owners of the country park. This section of river has direct public access, it runs adjacent to the country park and currently requires unsustainable maintenance

works to keep emergent plants from growing in central channel locations. The possibility of creating a self cleansing and ecologically valuable reach of river should make this a high priority site for enhancement. It is suggested that the club seeks to have a meeting with the EA to explore partnership options. The WTT is able to help with a project proposal if necessary. To help kick start this process, this information is contained in an appendix to this report and can be easily extracted and distributed to interested parties.

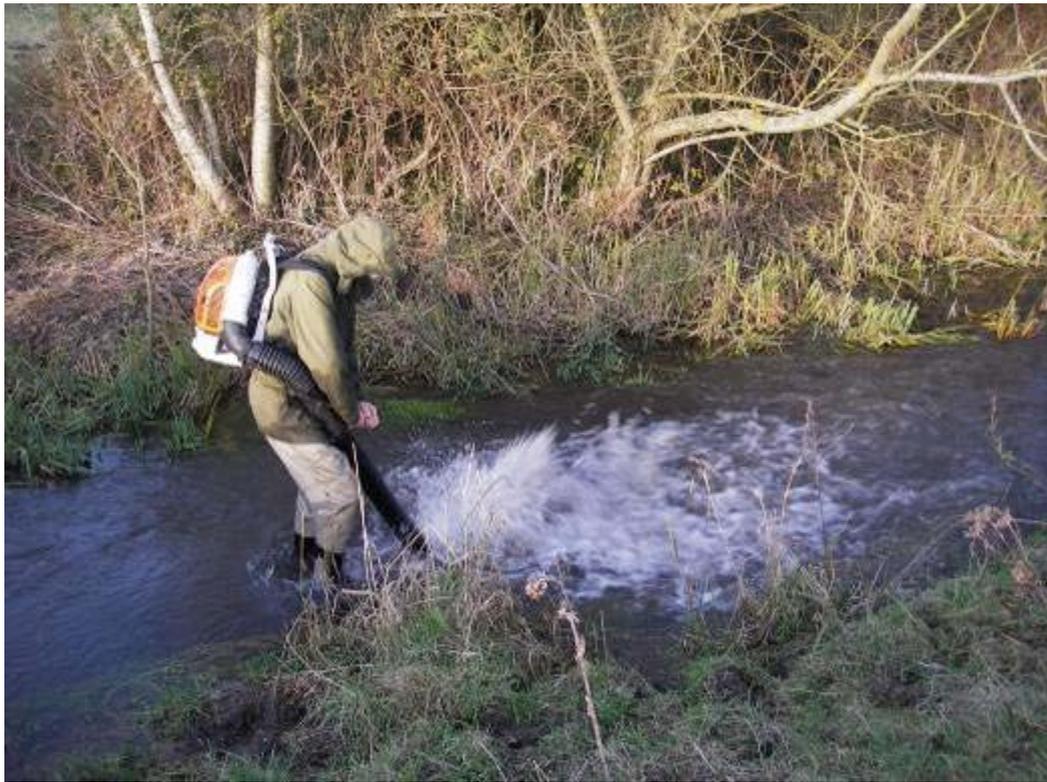
Blasting silt from a likely spawning glide on a small Wiltshire chalk stream

When undertaking gravels cleaning, select the tail of shallow glides and break up the crust of the bed with a heavy fencing spike or similar and blow the silt out of the gravel with a high pressure pump or a backpack leaf blower. Cleaning should be restricted to areas of 2 to 3 m² blocks at a time to limit the disturbance to aquatic invertebrates. Work should always be carried out working in a downstream direction to avoid silting up the sections already cleaned. Always consult the local EA Environment Management Team before undertaking gravel cleaning projects where plumes of sediment are likely to be put into suspension.

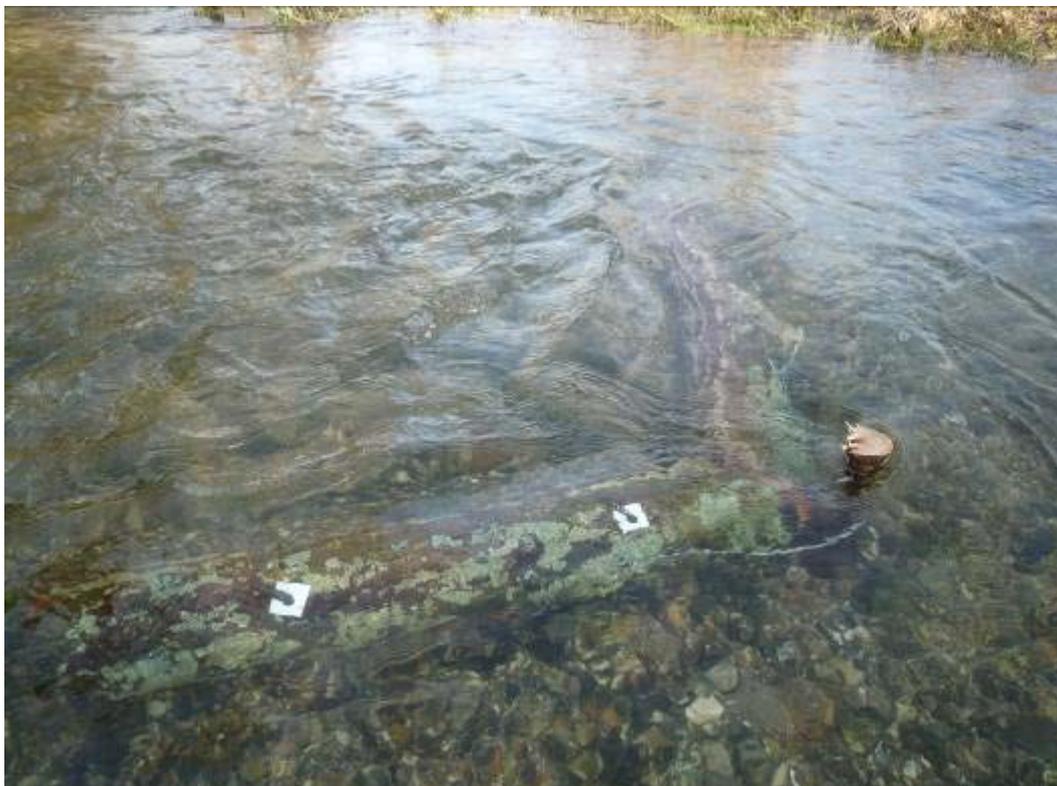
Large woody debris pegged onto a flat gravel riffle.

- Consider introducing LWD flow deflectors onto shallow gravel sections to help scour pots and promote ramps of loose gravel for improved holding and spawning opportunities.
