Lathkill (Waltonian Angling Club)

Advisory Visit

River	Lathkill
Waterbody Name(s)	Lathkill (Source to Bradford)
Waterbody ID(s)	GB104028058450
Management Catchment	Derwent Derbyshire
River Basin District	Humber
Current Ecological Quality	Moderate
U/S Grid Ref inspected	SK18090 65711
D/S Grid Ref inspected	SK21064 65888
Length of river inspected	3.25 km

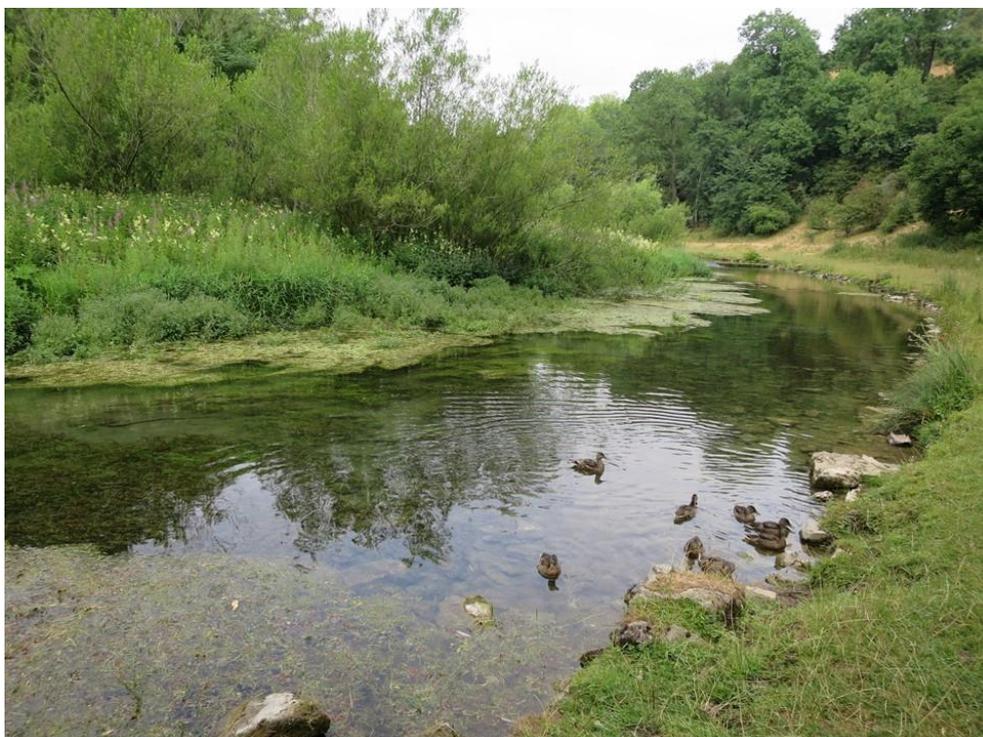
Figure 1: Looking u/s from the d/s limit of the survey towards a series of impounding structures (weirs) originally installed to aid retention of fish stocked into the river for anglers (by creating similar conditions to the rearing pond environment)

The d/s limit of this visit was at National Grid Reference (NGR) SK 21064 65888 (Fig.1). The open, grazed LB and wild/varied RB is typical of this lower section with the channel characteristics strongly defined by the series of 19th century "fishing weirs" (e.g. Fig. 2).

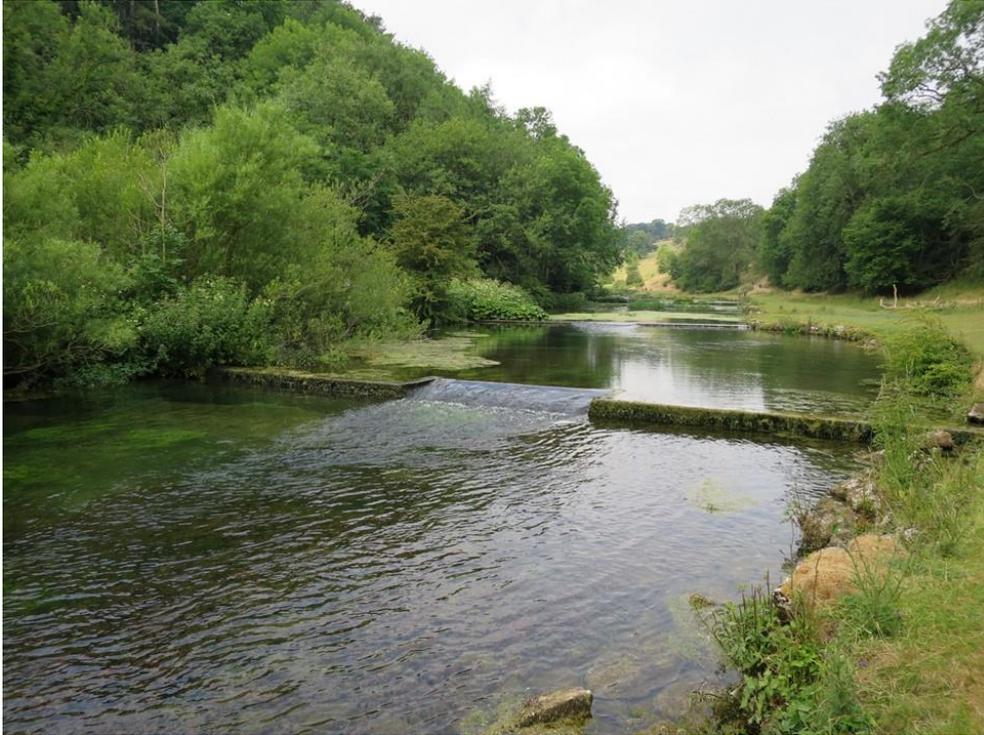
Figure 2: A stepped series of "fishing weirs"

As well as the influence of the weirs that hold back water and riverbed material, the channel shape and course have been engineered using stone "revetments" (reinforcing walls). The combination of the slowed flow and widened/straighter channel creates a sediment trap for finer sand and silt as well as gravels. The overall effect is to create quite uniform conditions with very little variation in depth or flow over the cross-section of the river (e.g. Fig. 3).

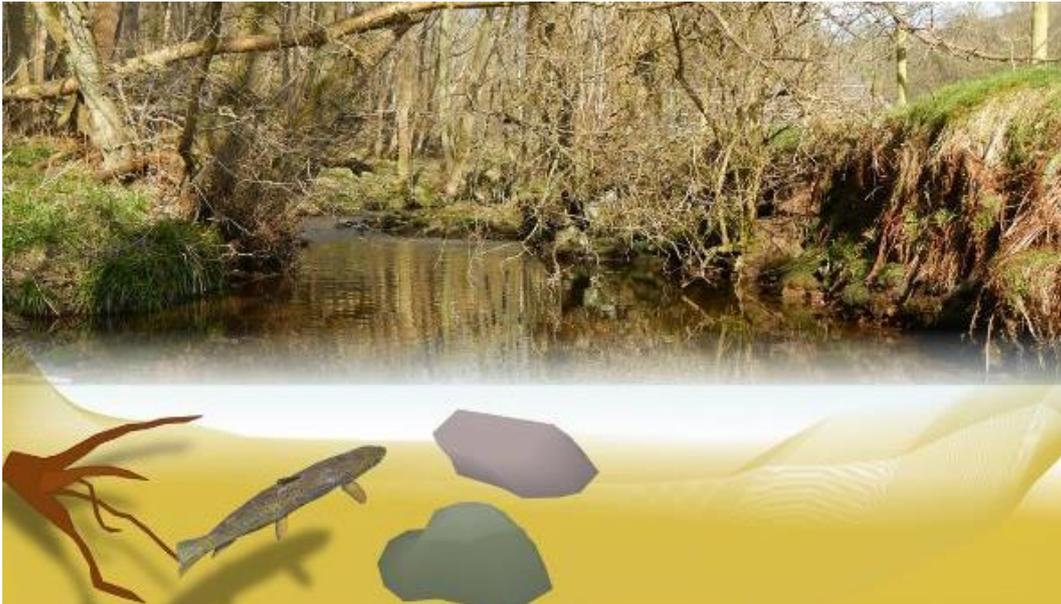
Figure 8: The availability of deeper water bolt holes (>30cm to several metres), low overhanging cover and/or larger submerged structures such as boulders, fallen trees, large root-wads etc. close to a good food supply (e.g. below a riffle in this case) are all strong components of adult trout habitat requirements. Note how, even in the winter when there are no leaves on the trees, the branches provide some shade and cover.

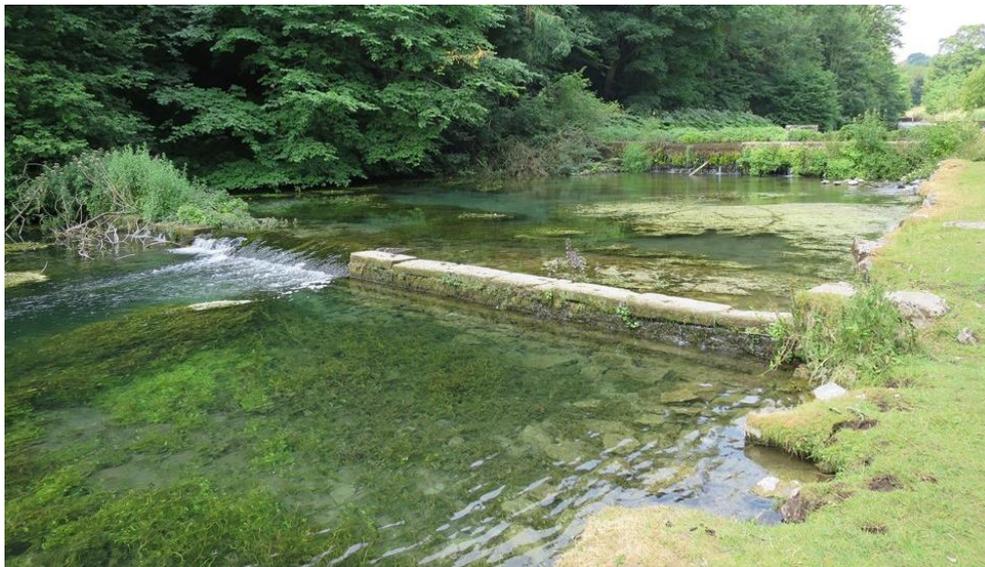
Within the series of stepped weirs on the Lathkill, the main source of any structural variation comes from the central slots which provide some bed scour and a speeding of the current in the centre of the channel (e.g. Fig. 9). These effects are extremely localised though, and are effectively achieved at the expense of flow diversity within the impounded channel u/s – the majority of the habitat remains extremely uniform. In the absence of the series of impoundments, the total area of high quality habitat for trout and a wide range of other species would be substantially increased.

Figure 9: Note the large "ponded" areas with mats of soft, nutrient-enriched sediment and thick film of "periphyton" (single-celled plants such as algae which grow on leaves, rocks and other surfaces). Note also the small area of variation provided by the narrow tongue of faster flow (left of frame). Finally – the value of the unmanaged vegetation on the RB is evident – both as "cover" habitat but also notice the shading effect creating clear patches in the weed. In combination, more varied/scouring flow and the effect of patchy shade would reduce or remove the need for weed cutting (and the associated problems with disturbance and loss of invertebrates attached to weed)

The other problem with the central slots in the weirs is that they do not extend down to bed-level – this creates two main problems. Firstly, it does not improve the d/s transport of riverbed material (i.e. the source of varied habitat creation) and secondly the weirs remain as significant barriers to fish passage.

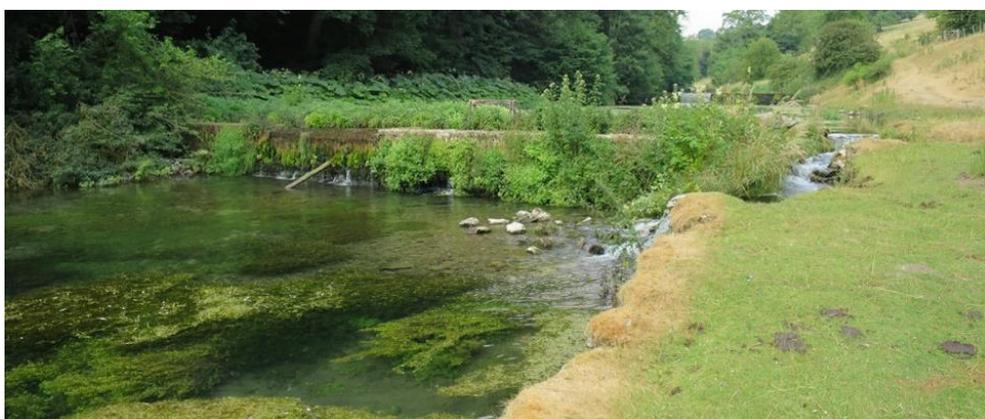
There are examples where the weirs and associated artificial banks are beginning to be naturally bypassed by processes of erosion (e.g. Fig. 10).

Figure 10: Bypass channel beginning to form (right of frame) via bank erosion on the grazed LB at SK 20841 66044

As a bare minimum, refraining from rebuilding those reinforced stone banks or otherwise reinstating the weir over the full width of the channel is advised. This will undoubtedly create ecological benefits. Eventually, bypassing via erosion will give a slightly more meandering course to the river as well as improving ease of fish passage and allowing some d/s movement of gravels to become re-established.

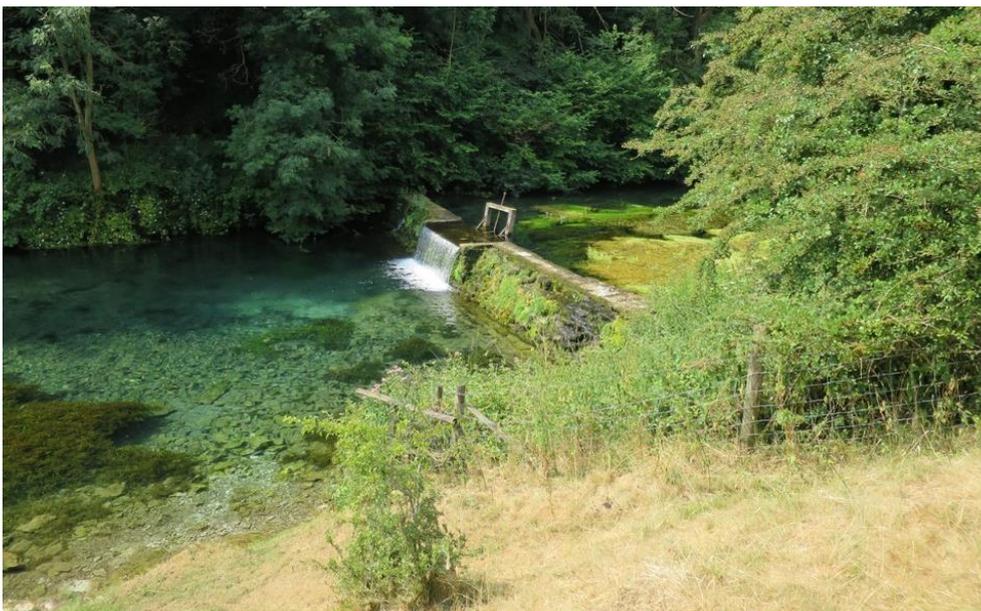
A particularly large weir – and associated sluice – create some complex challenges for river-management at SK 20780 66082. The (relatively rare) trout “bait balling” has been reported by river managers in this deep/relatively simple, slow-flowing habitat. Lower summer flows here are also exacerbated by the loss/diversion of water u/s due to the creation of underground “soughs” where the water disappears deep underground – the subject of a campaign by the Friends of Lathkill Dale:

Those low-flows (and build-up of nutrient-rich sediment behind weirs) encourage the closing of the sluice to retain water-depth. However, at spawning time there is an argument to open the sluice to enable at least improved u/s passage of fish – but the costs and benefits of that action are not clear cut.

In fact, the situation highlights the extreme complexity in balancing competing pressures on these heavily-modified river environments. A big problem with opening up the sluice to allow breeding access is the timing of the d/s release of the accumulated (nutrient-rich) sediment to coincide with breeding efforts by trout. Smothering effects of fine sediment – compounded by algal blooms that also reduce oxygen concentrations – will have a negative impact on the success of breeding that fish attempt d/s of the sluice. The associated release of large volumes of organic matter also greatly increase the issues with enrichment and algal growth in the river d/s, further impacting upon the broader fish and invertebrate populations of the Lathkill.

Figure 11: Deep, mineral-blue lagoon where trout can sometimes "bait ball" in response to predation pressure (note accumulation of sediment and dead vegetation u/s of the sluice).

Stepping back to assess this situation – the full range of ecological problems of habitat-simplification, sediment/nutrient accumulation and fish passage at this location stem from the presence of the large sluice-weir. Consequently, the best ecological outcome would be to return the river towards its pre-19th Century condition by removing the impounding structures. In ecological and geographic terms, the current situation is a very recent and artificially-imposed change – and this obviously applies to all of the stepped fishing weirs in Lathkill Dale.

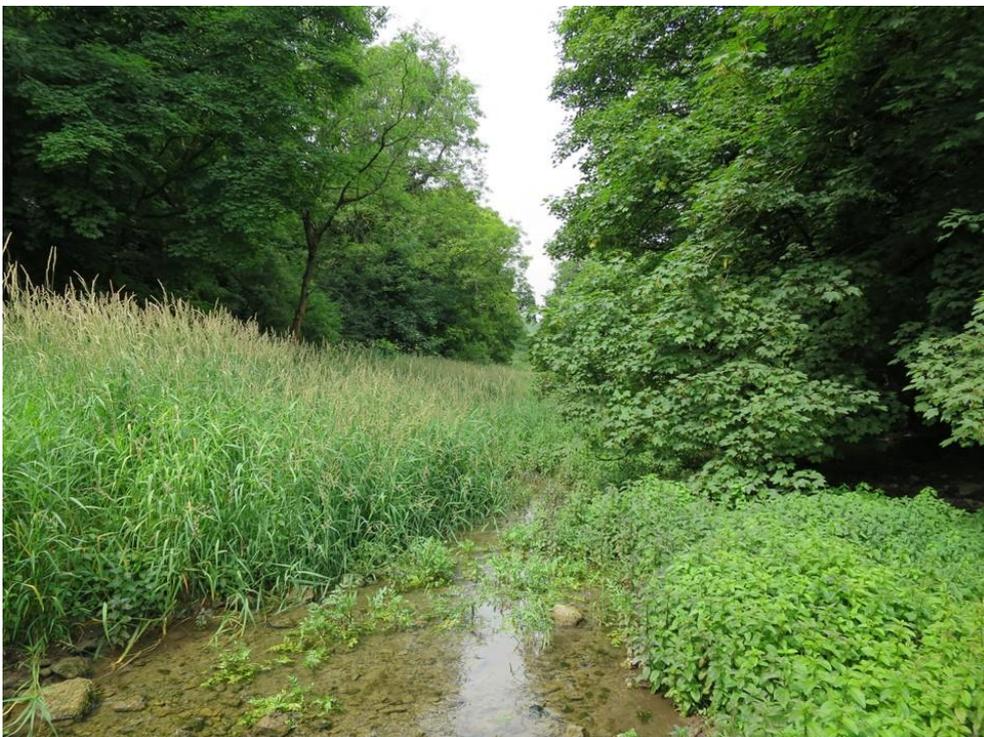
Figure 14: Swamp habitat resulting from sluice impoundment

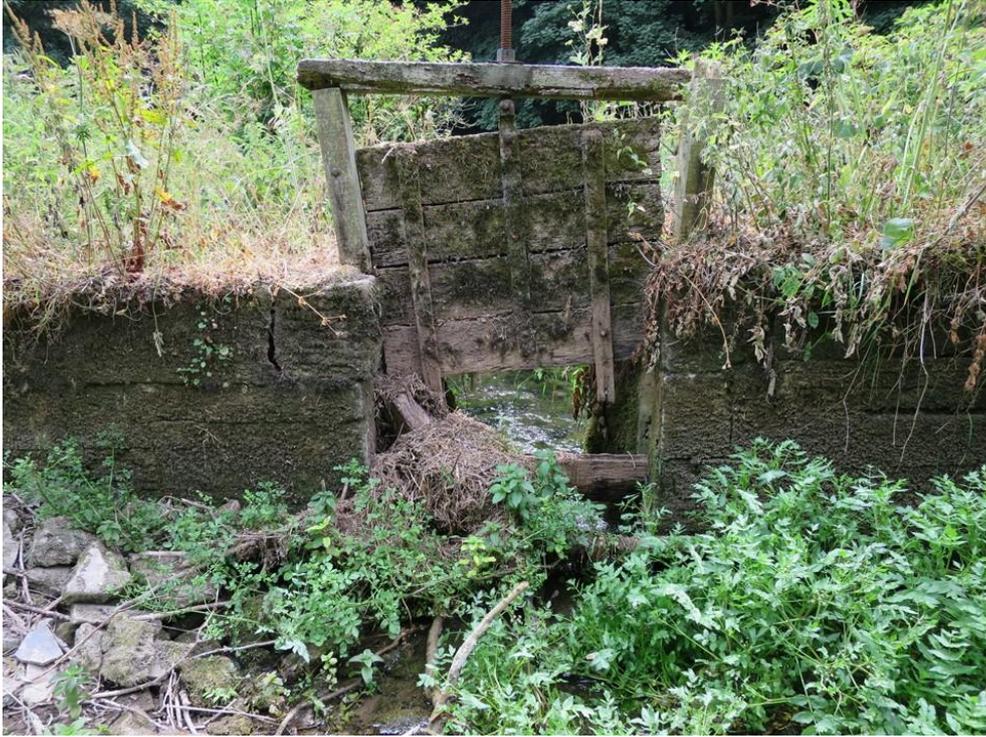
Figure 15: Old sluice structure that still negatively affects the habitat of the watercourse (even with the gate open)

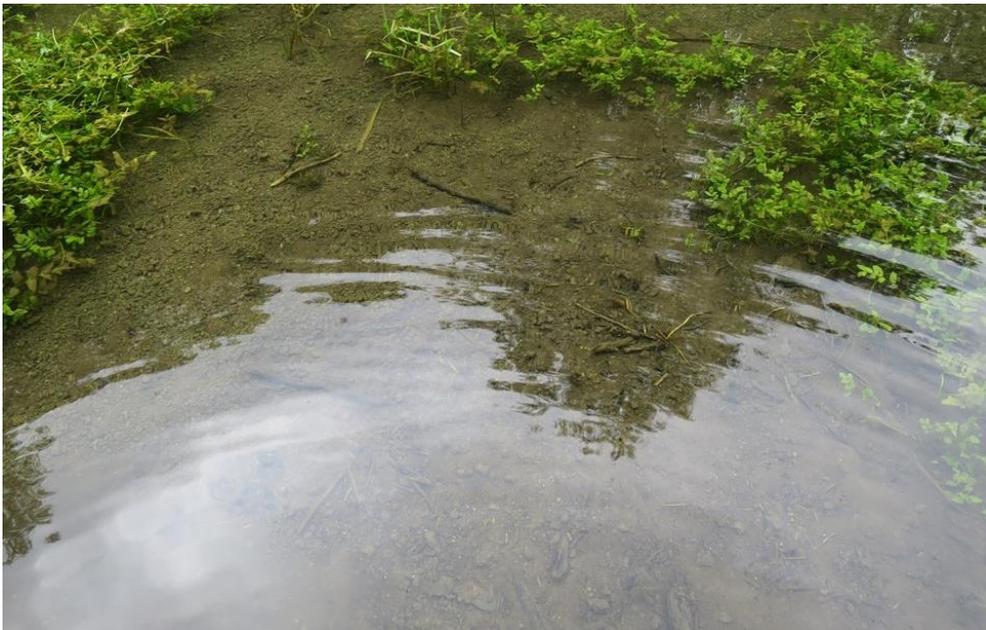
Continuing u/s to SK 20021 66148 there are more examples of silt/clay bed substrate and reed growth (Fig. 16) and with a dried "lead" (channel into which water would be diverted to provide a head of water) around 50-m further u/s (Fig. 17). Even though the impounding structures are far more spread out in this wooded section of the upper Lathkill, the channel has still been extensively modified and "steered" along particular paths to service the mining and related activities that were carried out in the Dale.

Figure 16: Artificially increased deposition of rich lime silt, tufa particles, detritus and mud within the impounded flow

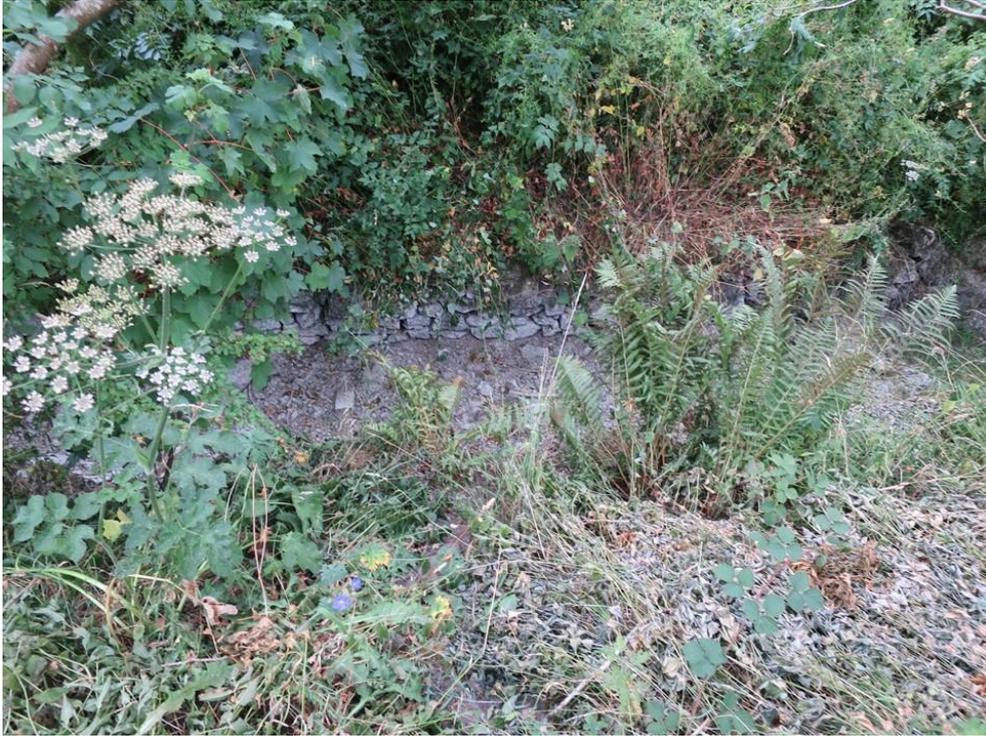
Figure 17: Dried leaf adjacent to the footpath. The combined actions of weirs and sluice-gates would previously have been used to divert and control water flows that supported the mining and associated activities carried out in the Dale.

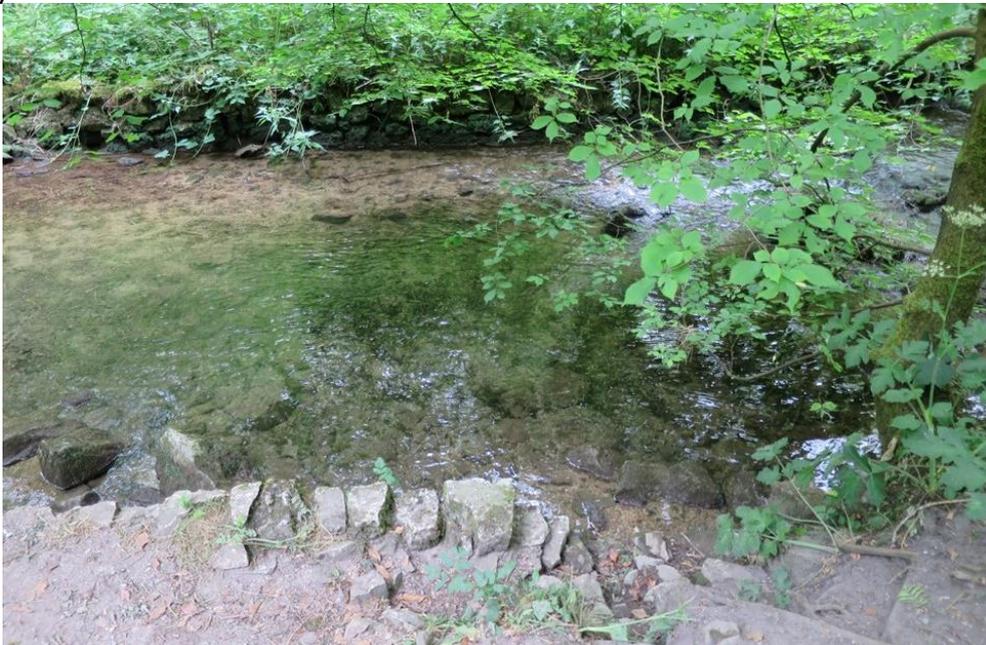
The greatly simplified pool and riffle habitat at SK19623 66105 is a good example of the impact artificial straightening and reinforcing the channel with stone walls creates (Fig. 18). There is a corresponding lack of bends and deeper pool habitat in many areas.

Figure 18: Both LB and RB are artificially created from blocks of stone and the channel is very straight - forming a linear sequence of pools with some cobble riffle habitat also present (e.g. right of frame)

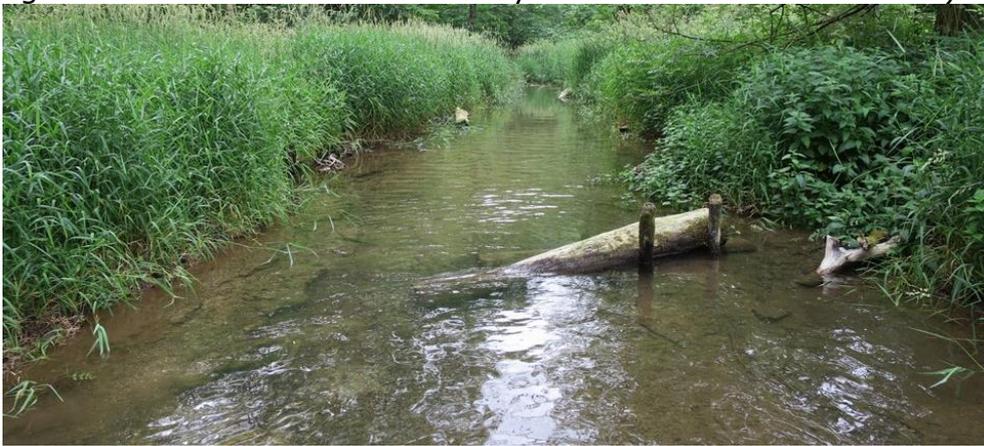
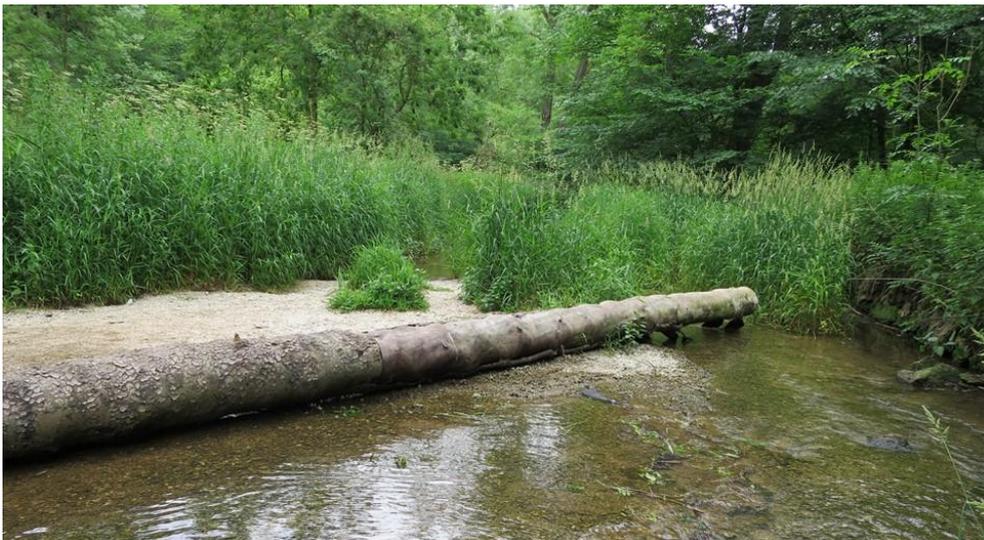
At SK 19433 65937 some large woody material has previously been installed in an effort to diversify flow and riverbed erosion and deposition processes (Figs. 19 and 20). There could be value in extending such efforts to many of the straightened locations on the river u/s of the fishing weirs section. However the top priority would be to explore whether revetments and other modifying structures could be removed and more natural river processes encouraged (including the occurrence of natural woody material within the channel).

Figure 19: Log staked into position within the stream and generating localised bed-scour as well as providing in-channel cover.

Figure 20: Although pictured at low-flow levels, under higher flows some valuable redistribution of bed-materials (and increased sinuosity of flow) have resulted from the stable introduction of large woody material. The benefits of these existing structures would be greatly improved by the breaking up of bank revetments and encouraging natural channel profile recovery.

The best results from introduced woody material tend to come from installed material that most closely resembles natural deadfall. Ideally this will be undertaken in conjunction with restoration of surface flows and revetment removal. Within the wooded section there are many opportunities to create more diverse flow within the straightened sections of river. For the most part there is no cause for concern over flood risk because of the ample surrounding flood-plain, lack of development within that floodplain, low gradient and the ease with which any structure can be securely anchored.

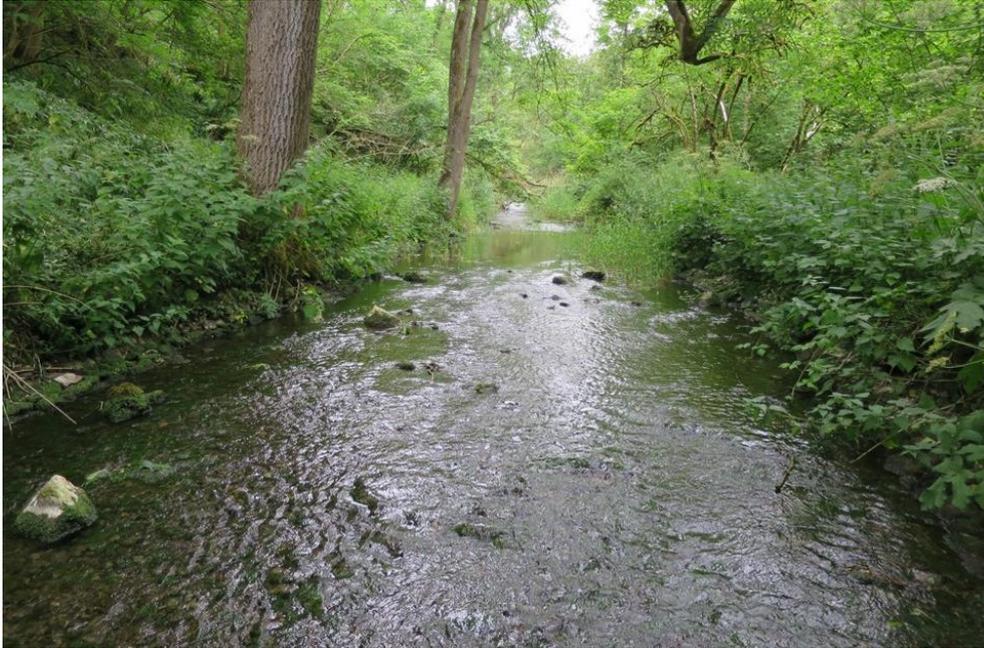
Figure 21: Typical heavily-modified (straightened) section of channel which would benefit from more meandering flow and greater variation in cross-sectional depth and current-velocity- especially if this were to be achieved by breaking up the stone bank revetments.

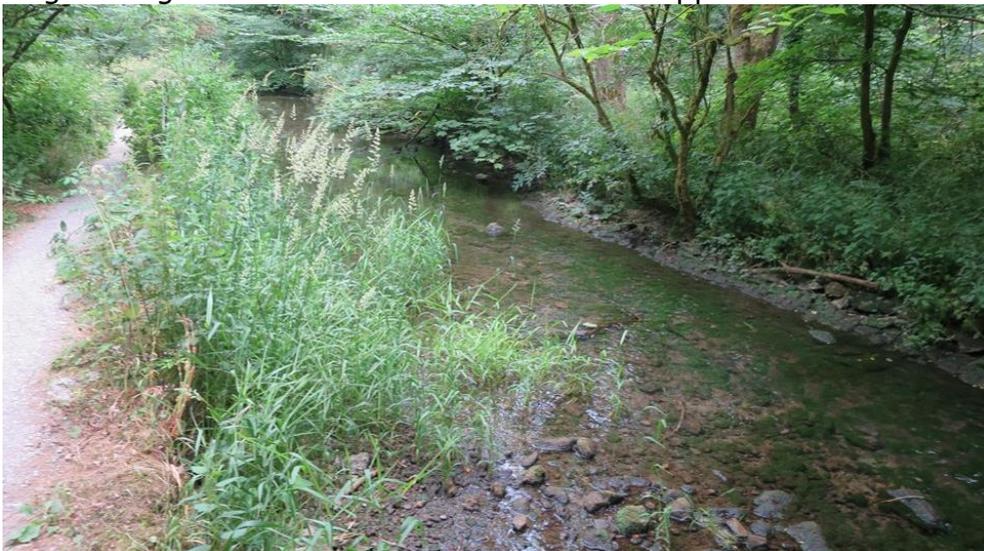
There is an issue of a short section of the river channel being slightly “perched” above the true valley-bottom (i.e. around SK 19345 65811). In this case it appears that the channel has been shifted slightly up the valley side in the direction of the RB to accommodate the access track (Fig. 22). If breaking out and re-meandering perched sections leads to the river disappearing into an underground sough – then there is a good argument to ensure that does not happen.

Figure 22: Straightened and "perched" channel where the river-bed is raised above the land to the left (photograph taken facing DS at SK 19345 65811).

However, the most valuable habitat and biodiversity outcome would be to re-meander the river and incorporate an alternative track to provide sustainable access.

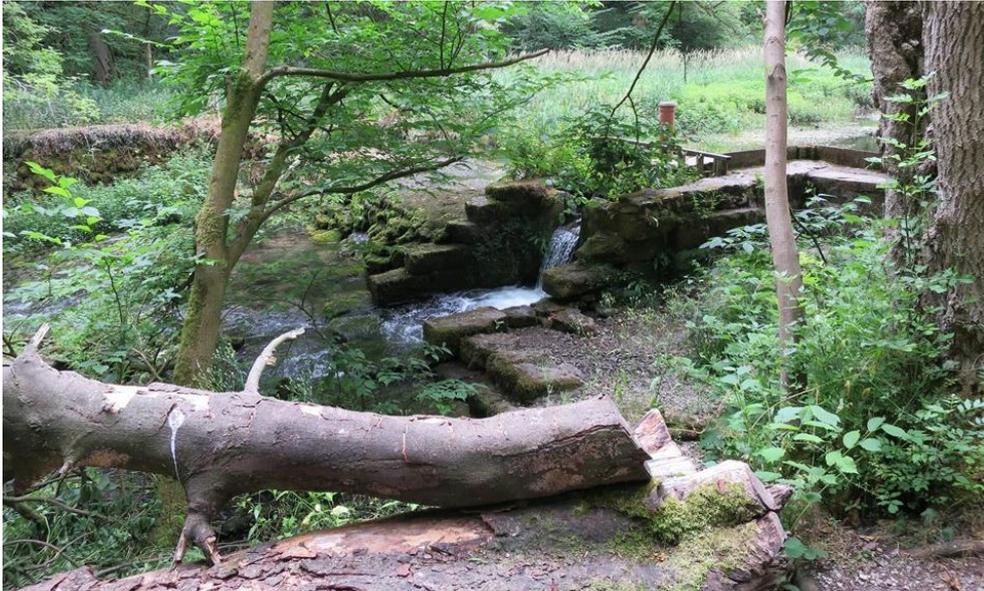
At the u/s limit of the wooded section at SK18528 65805 a weir has recently been repaired and modified (Fig. 23). The purpose of the repair (and potential for future modification) is not clear at this time, so further enquiries are needed in order to establish the parties involved. Under its present condition the structure is impounding a significant reach of water and also represents a barrier to fish passage, preventing fish migration and dispersal.

Figure 23: Weir at the u/s limit of the woods that encompass both LB and RB of the river corridor.

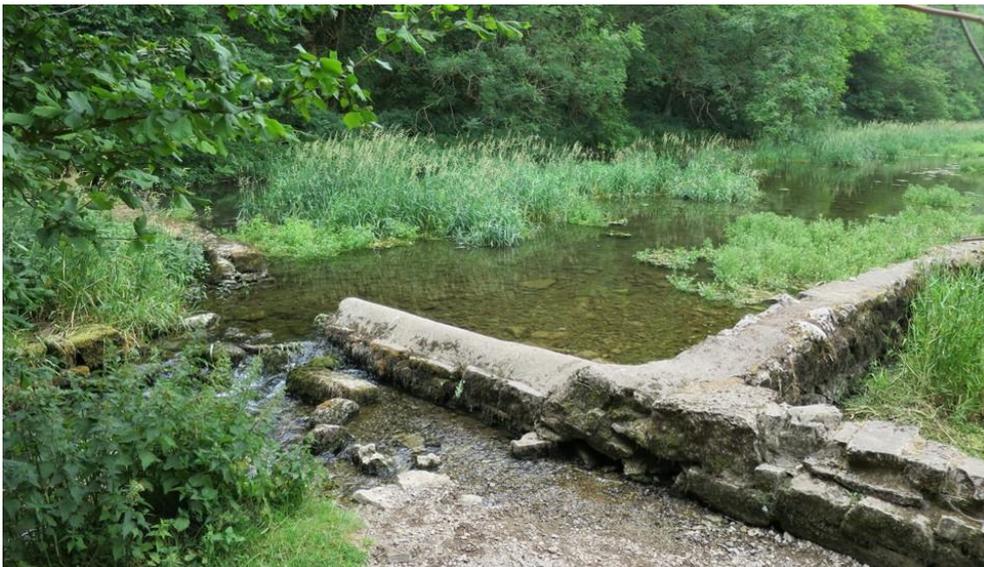
Another long impoundment (estimated to be a reach of more than 100 m) results from the structure at SK 18357 65765 (Fig. 24).

Figure 24: Slot cut into a structure which will help the u/s channel to re-grade over time

The original height of this structure was much greater and spanned the full width of the channel. Now a slot that extends down to the level of the u/s river-bed had

reduced that impounding effect. Over time, and with sufficient flows, this will help to re-grade the riverbed to a steeper longitudinal slope.

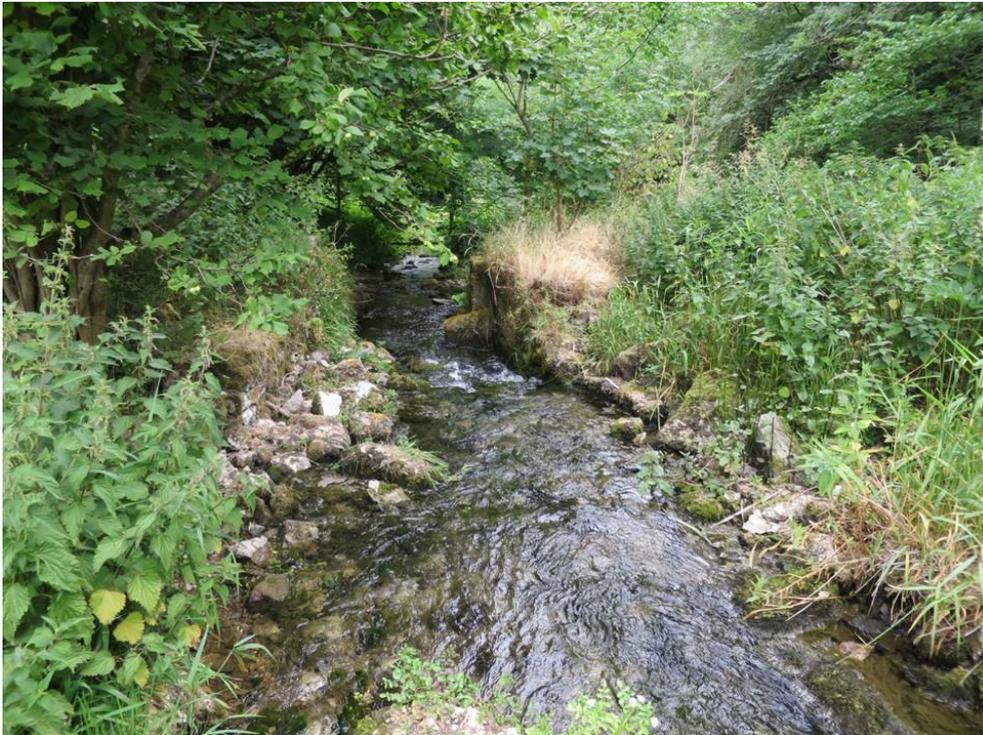
The channel below this gap in the main structure is shown in Fig. 25 which has the appearance of being associated with the original function of the weir. As with the erosion that is beginning to bypass the weir shown in Fig. 10, encouraging this process will help to regrade the riverbed u/s of the offending structure.

Figure 25: Channel below the breached weir crest shown in Fig. 24.

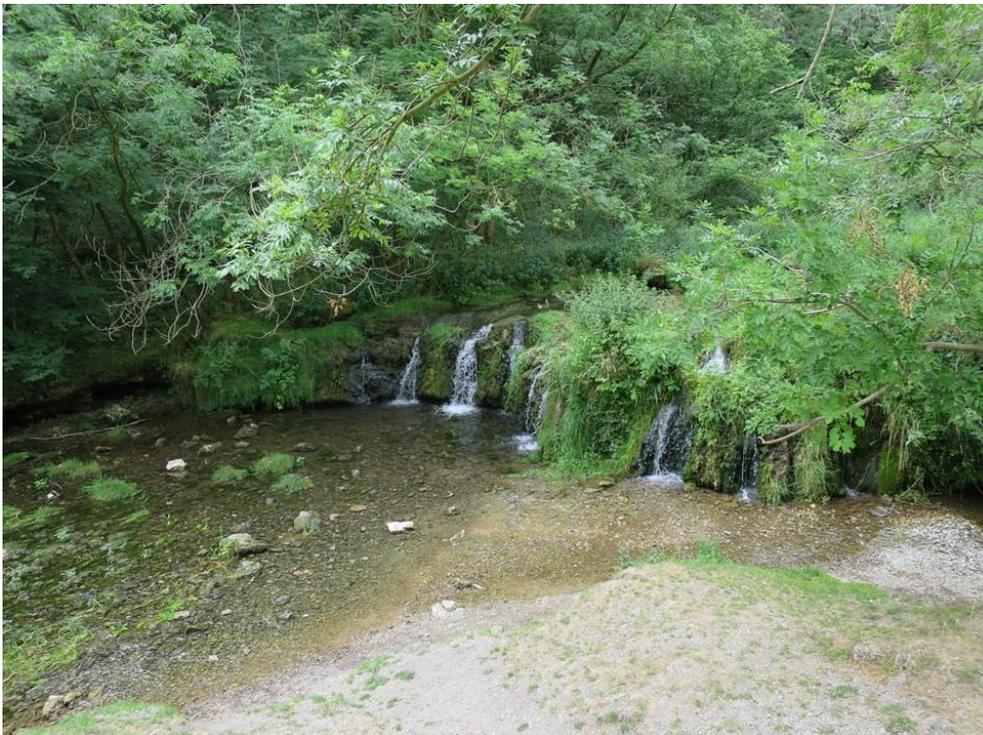
The u/s limit of the visit for this report was the waterfall at SK18090 65711 (Fig. 26). This has the appearance of a natural waterfall and would, as a result, be the only natural barrier to riverbed material transport and fish passage. As well as having 10,000+ years to achieve an equilibrium of riverbed material erosion and deposition processes, the frequency of those natural barriers is clearly far lower than the multiple artificial weirs encountered in this visit. The irregularity of natural structures also invariably makes them far more passable than artificial ones.

Figure 26: Waterfall at the u/s limit of the visited reach

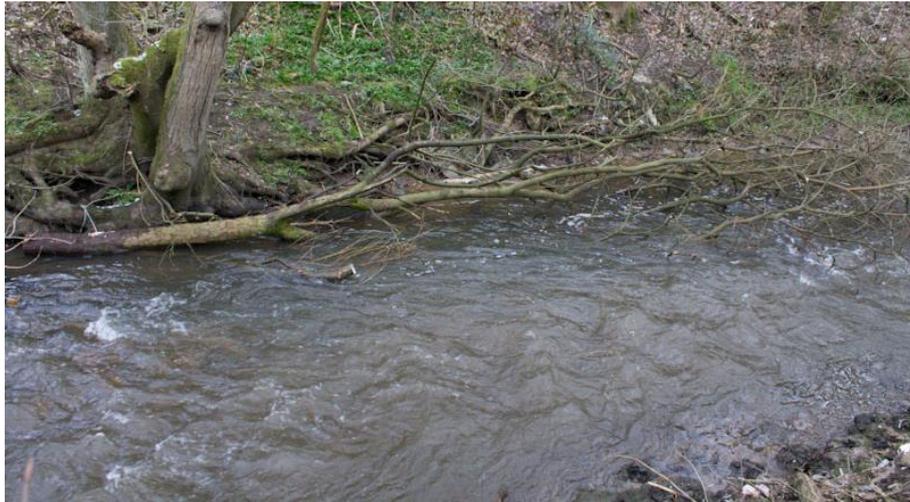
Figure 27: Newly-installed tree kicker anchored with braided steel cable at the u/s end and untethered at the d/s end (to move up and down with changing water levels). A variation on this technique could use a cabled, bank-side anchor-point combined with staking of the main trunk and limbs at a desired angle to the current to create scour. A guide to installation and the typical effects of a tree kicker can be seen in this video: <https://vimeo.com/72720550>.

- Use tree “kickers” (e.g. Fig. 27) to
 - create instant submerged cover in deeper/simpler habitats (lower beat)
 - produce meandering flow and influence cross-sectional depth/flow velocity variations in shallower, un-impounded but straightened sections (upper beat) – N.B. tree kickers can be easily scaled down to appropriately match smaller channels
