River Leach – Cotswold Fly Fishers

A Project Proposal by the Wild Trout Trust - April 2015

1. Introduction

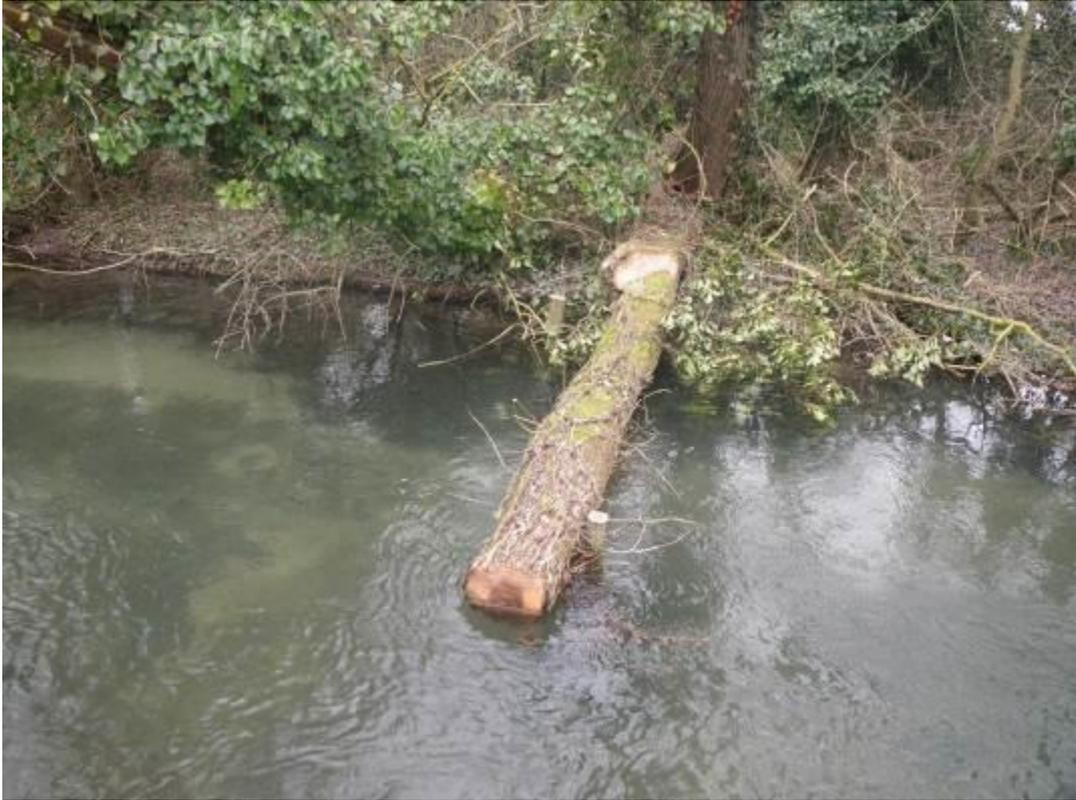
The extent of the habitat available for trout is no accident and is a testament to the commitment and hard work put in by the CFF management committee. Numerous examples of habitat improvement works carried out by the club were noted, including the installation of large woody debris (LWD) flow deflectors (photo 1) and consolidation of fallen woody material to provide improved in-channel habitat (photo 2).

Photo 1. A hinged and secured LWD flow deflector installed by the CFF.

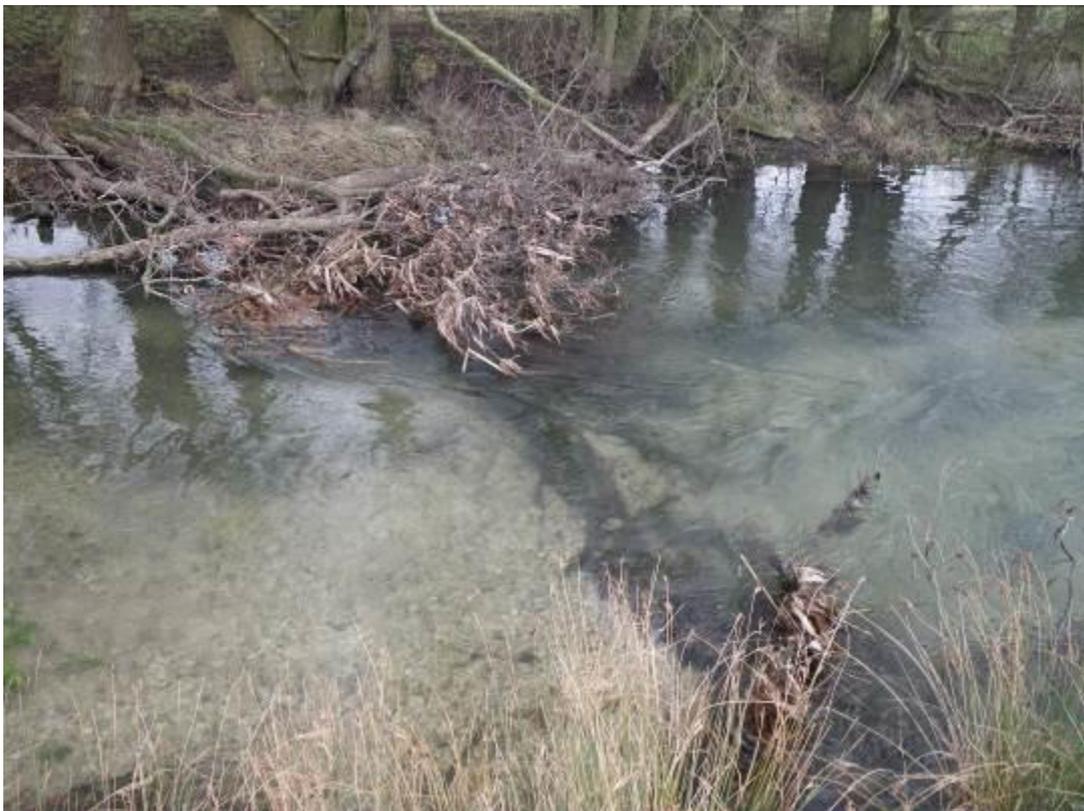
Photo 2. A good example of retained natural woody material squeezing the channel width and promoting varied flow pattern as well as scour and deposition.

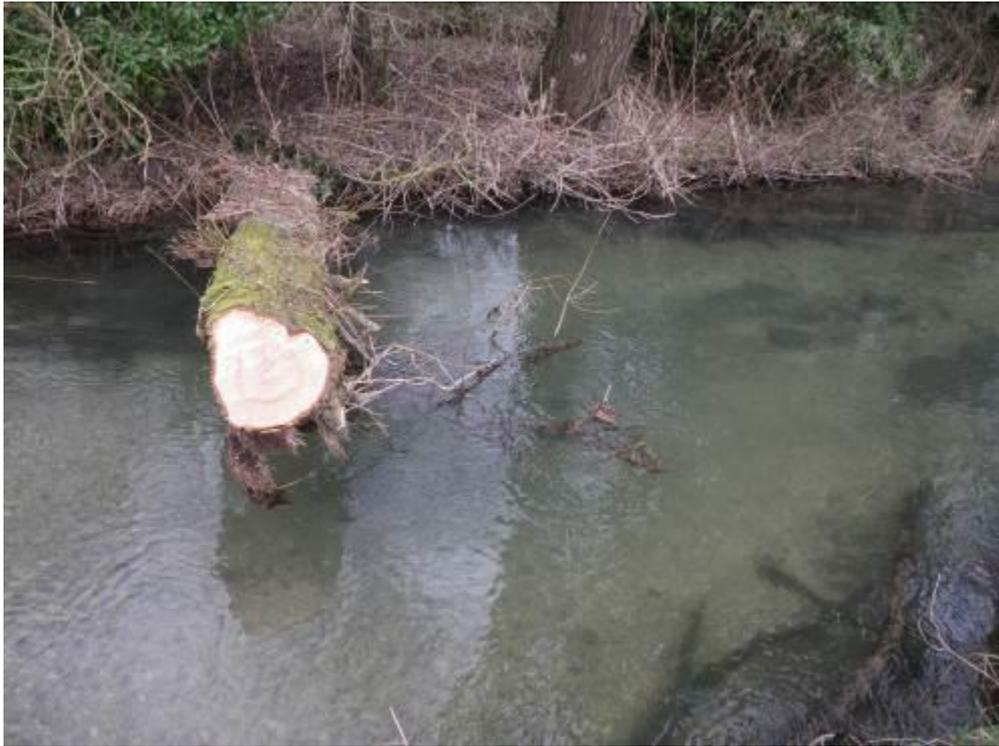
The delicate balance of providing optimum holding habitat for trout and maintaining access for angling has been well planned and executed. A good example of this is the tree work, where an optimal ratio of dappled light and shade has been maintained. Trees that are in danger of falling have been topped, but long sections of trunk retained to promote valuable river bed scour (photo 3).

Photo 3. A half fallen tree skillfully topped. An ideal method for creating pool habitat and great lying up opportunities for adult trout.

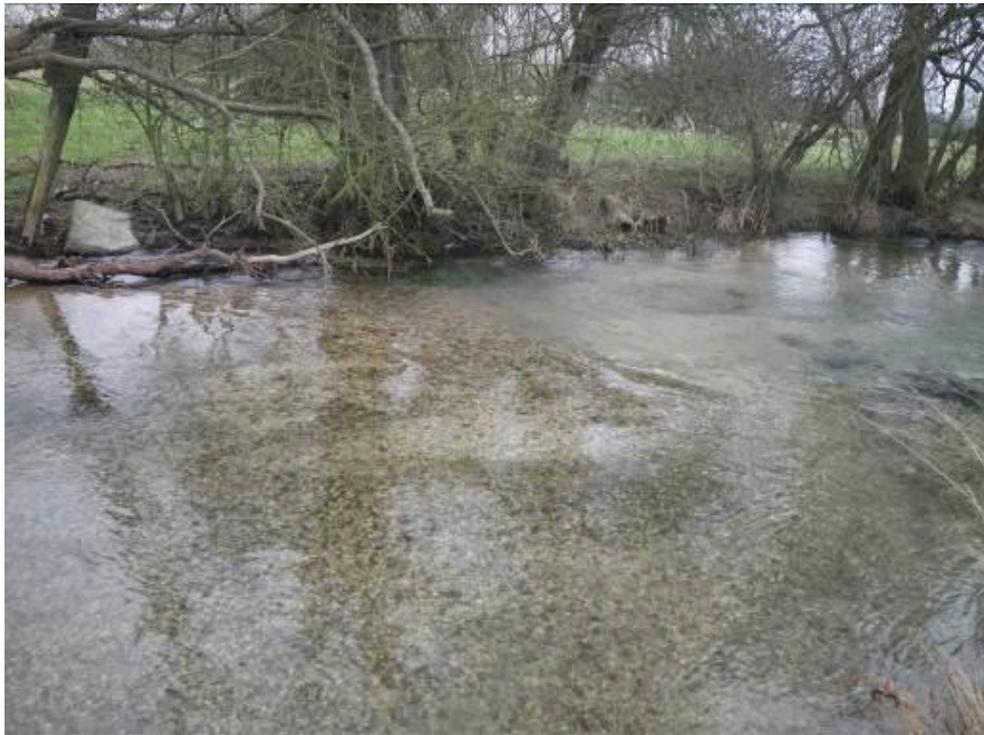
An initial inspection of the river bed suggests that opportunities for spawning should be extensive, with numerous ramps of gravel clearly evident; however, despite what looked to be good spawning environments, few redds were observed. Those that were seen were poorly defined and covered in fine sediments (photo 4).

Photo 4 Two redds located on this potentially favorable spawning site.

Redoubling efforts to ensure that spawning gravels are well sorted and relatively free of fine sediment could help to promote significant improvements in egg-to-fry survival. This work should be coupled with actions to ensure that adjacent shallow water habitat is packed with complex cover such as coarse woody debris, trailing marginal plants and submerged weed. Providing more cover in very shallow water immediately adjacent to and just downstream of optimal spawning sites will help to boost survival of fry and parr.

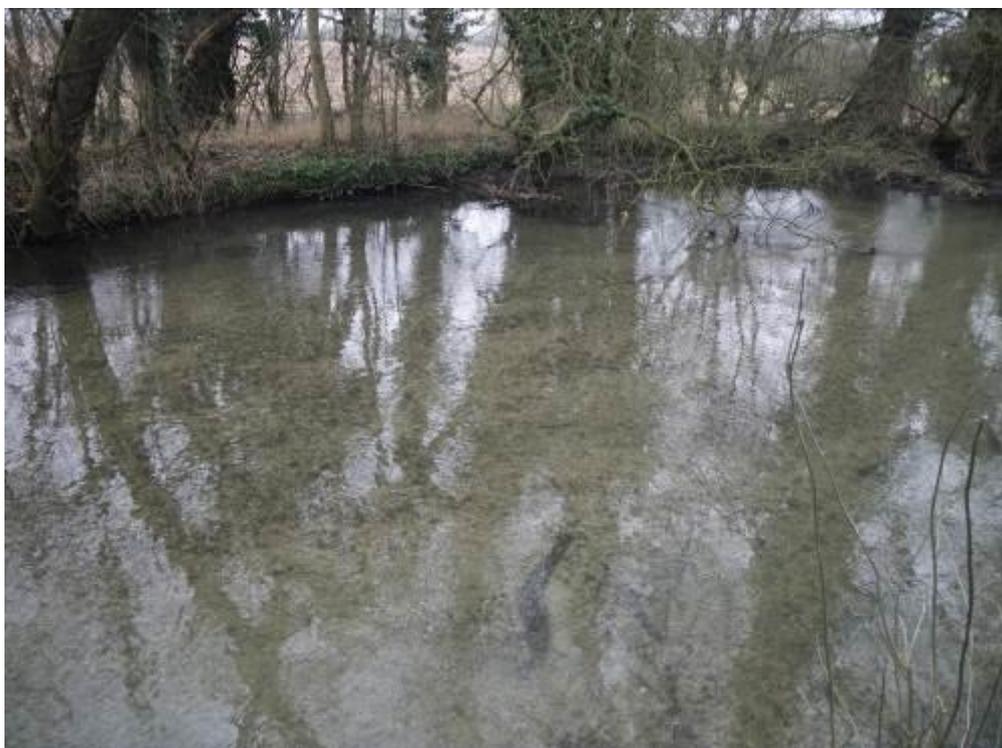
The natural gravel substrate observed appeared to be quite small in nature, with the majority of the bed gravels less than 20mm in diameter. Huge quantities of very fine bed material, almost constituting coarse sand was evident (photo5). Observation of the substrate located immediately below the woody debris suggest that the bed is highly mobile.

A common issue associated chalk and limestone rivers is the propensity for calcium carbonate precipitation (tufa) to occur which can cause gravels to become encrusted and naturally lock together, particularly on shallow gravel glides. The result is a flat, concreted bed which severely limits spawning opportunities. Interestingly, this does not appear to be the case on the Leach, with the varied bed topography clearly indicating a river bed that responds to bed scouring which changes the physical shape of the channel. The calcium carbonate precipitate is, however, still present, but rather than concreting the bed materials together, it forms individually around fine particles to form coarse beads of tufa known as oncoids.

It is possible for trout to excavate redds into this bed material but the passage for the free flow of oxygen rich water through such bed material is likely to be compromised. This is potentially a bottleneck for the population and an area for

Photo 5. Shallow glide habitat flowing over a fine bed sediments. Highly unlikely to be suitable for spawning and not enough cover to warrant good juvenile habitat. Areas like this are ripe for enhancement.

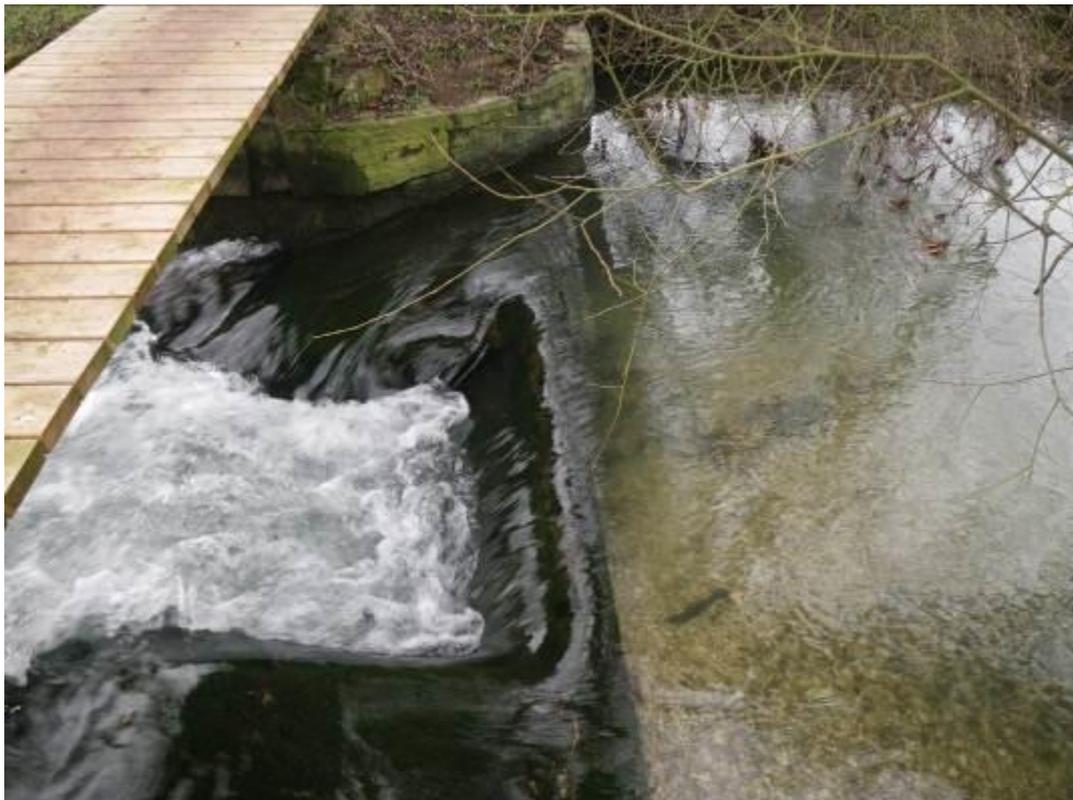
A low structure (photo 6) is present halfway down the reach. The head loss at this small weir is modest and the structure as inspected does not restrict access for fish on spawning migrations. Adjacent to the weir was a large stop log (photo 7) which has been used to impound the upstream levels at some stage. Interestingly, the river bed has re-graded upstream of the structure, indicating that it has been present for a considerable time and providing further evidence of the mobile nature of the river bed materials.

Photo 6. The low weir is passable for adult trout but has been responsible for a significant rise in upstream bed levels.

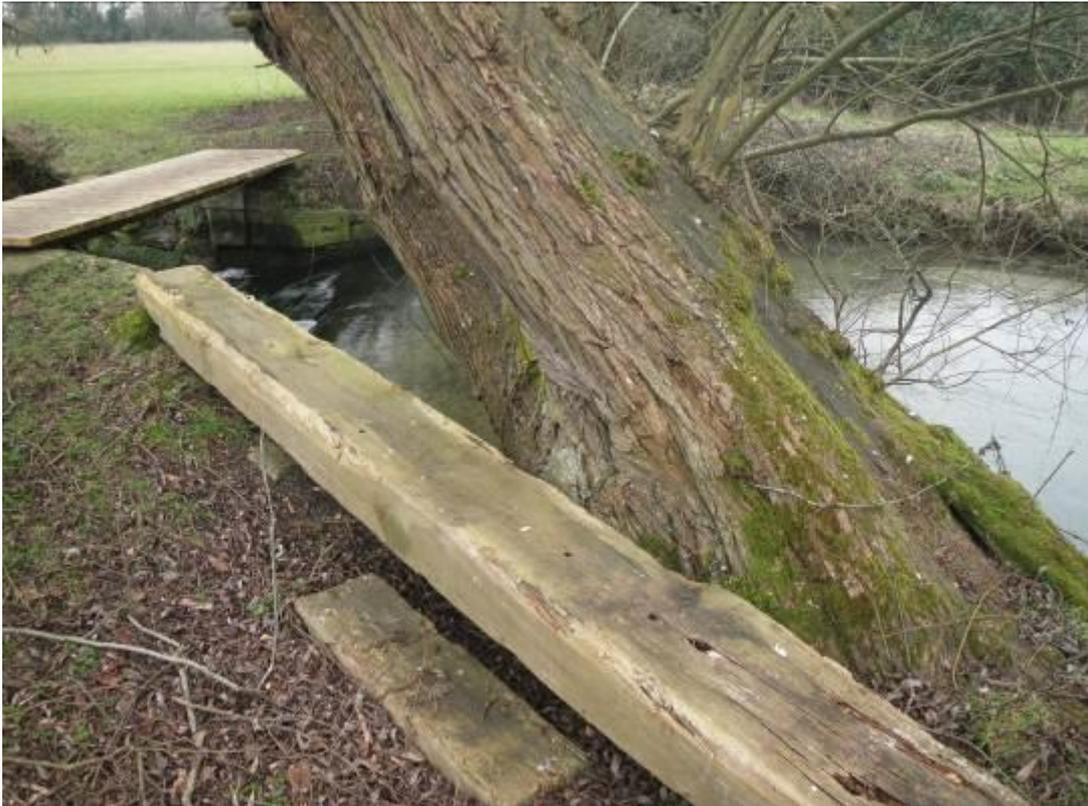
Photo 7. A large stop log which has been used to try and hold up water levels

The large timber stop log that has been used at the weir location should not be re-installed. Measures to defend the vulnerable banks on the outside of meander bends should be taken to avoid future bank failure.

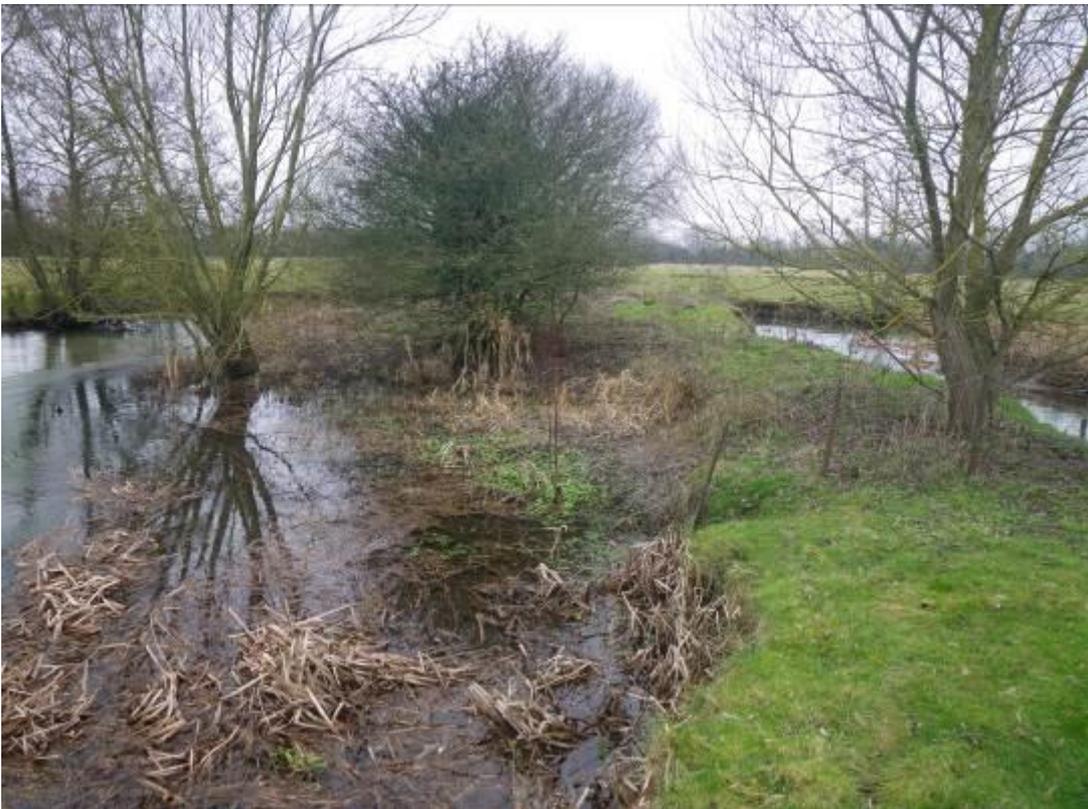
A short distance upstream of the structure the river embarks on a series of extravagant meander bends (photo 8). Some bank erosion was evident in this section, which the club have attempted to address (photo 9) but which will require further attention if the meander is to be retained. It is possible that the bank erosion issue has been exacerbated by the insertion and then removal of the large stop log. Bank instability is often caused by temporarily raising upstream water levels and then lowering the impoundment, which draws the water through at a faster rate adjacent to the waterlogged bank areas, which are left undefended by any established vegetation and thus causing bank toe failure and slumping. Keeping the timber stop log out permanently, packing the eroded bank toe with brushwood or live willow will improve bank stability through the meandering section.

Photo 8. A big meander bend a short distance upstream of the weir

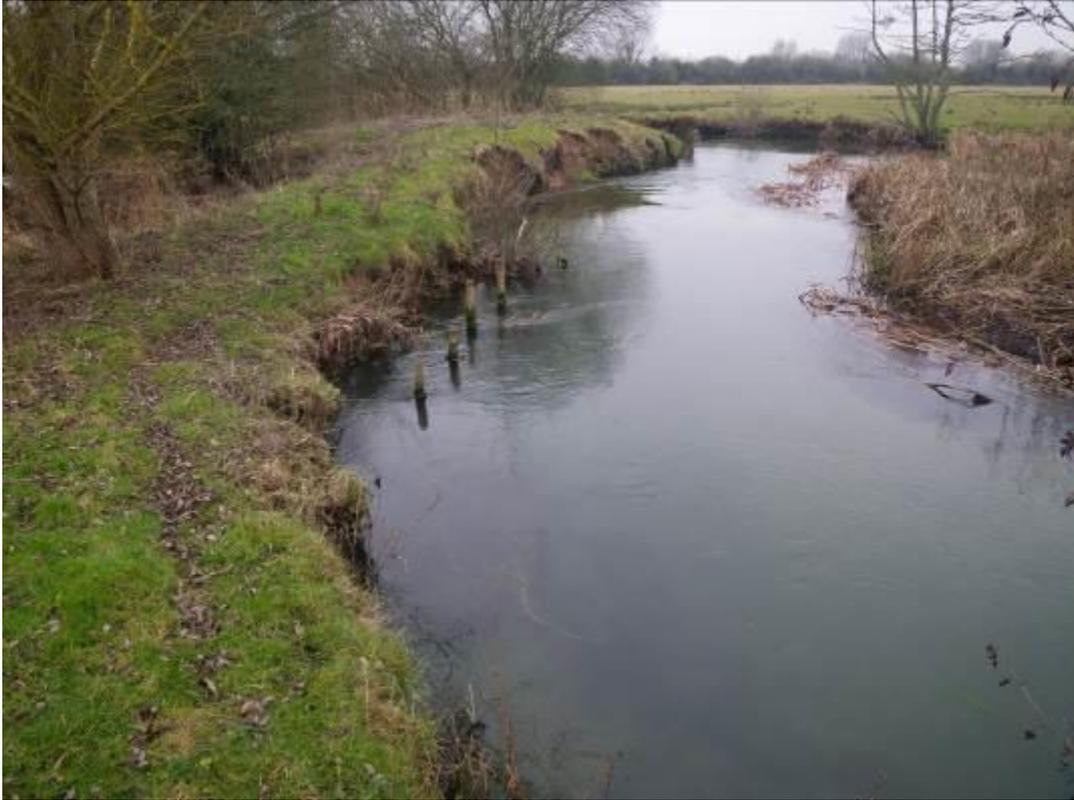
Photo 9. The outside of the bend eroding, possibly in response to the removal of the stop log downstream.

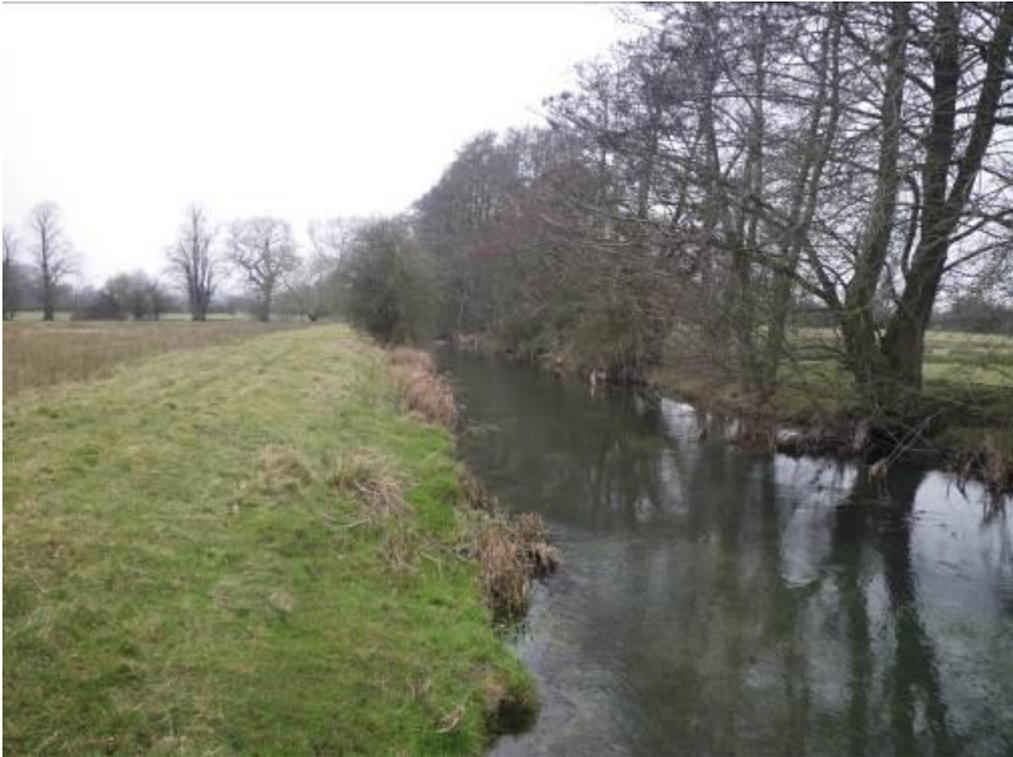
In general, areas of good quality holding habitat for adult trout were available throughout the reach. In a few locations, occasional coppicing of mature alder stands (photo 10) to provide diversity within the age structure and to allow pockets of light to hit the river bed would be beneficial.

Photo 10. A line of mature alders on the far LB would benefit from the odd clump being coppiced and the near RB could usefully support the odd low, overhanging tree such as a willow, thorn or elder.

Dappled light and shade is critically important for most trout streams and currently the Leach is dominated by high level shading from mainly mature alder trees. Coppicing within blocks of trees will provide some respite from high level shade but a rolling programme is needed to avoid over-shading in the future. Some increased low water-level shading would be useful, particularly over pool habitat. Sallows and thorns are particularly valuable in providing this type of low cover without casting a shadow over the whole channel.

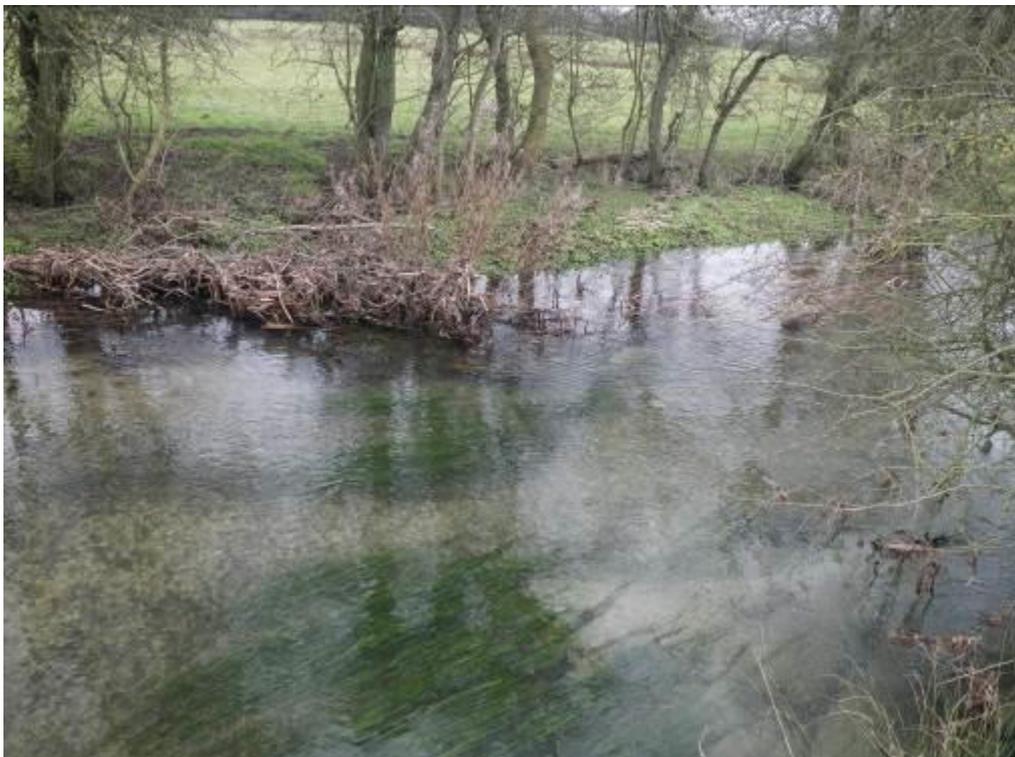
Some examples of in-channel submerged weed (mainly fennel pond weed -photo 11) were seen. Some excellent examples of low, soft margins, well defended with thick stands of reed canary grass and sedge provide great bank protection as well as marginal cover and critically important habitat for invertebrates (photo 12 and 13).

Photo 11. Submerged weed bed providing critically important early spring cover.

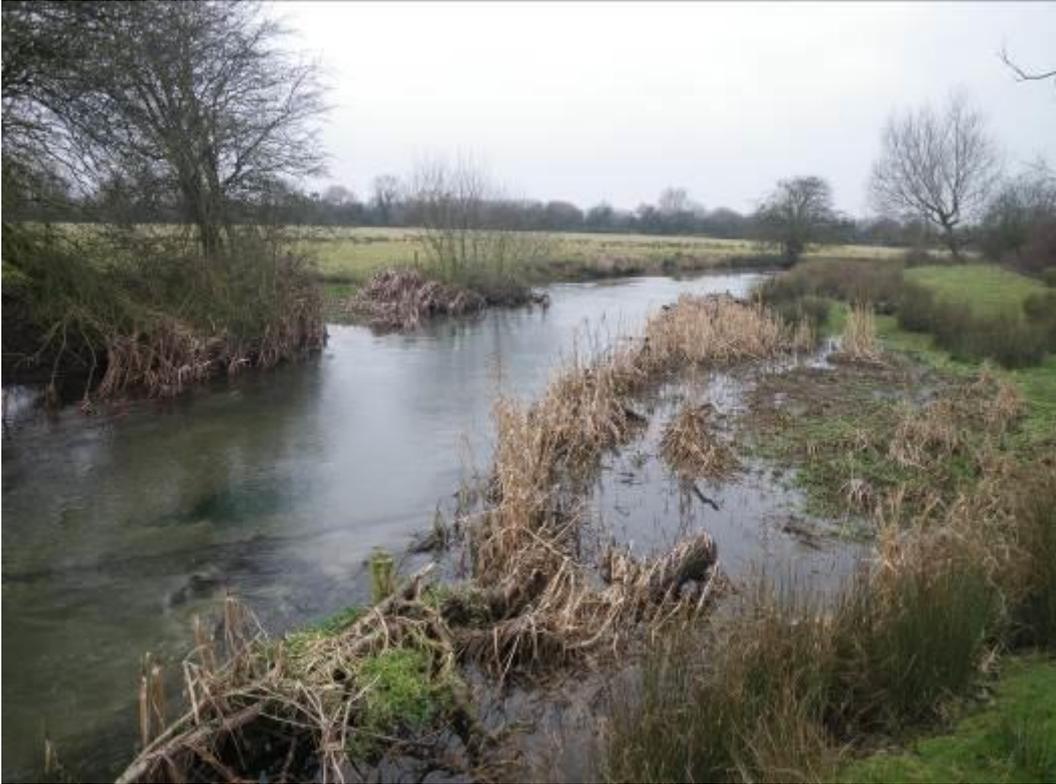
Photo 12. Low, wet berm. Great habitat for fly life.

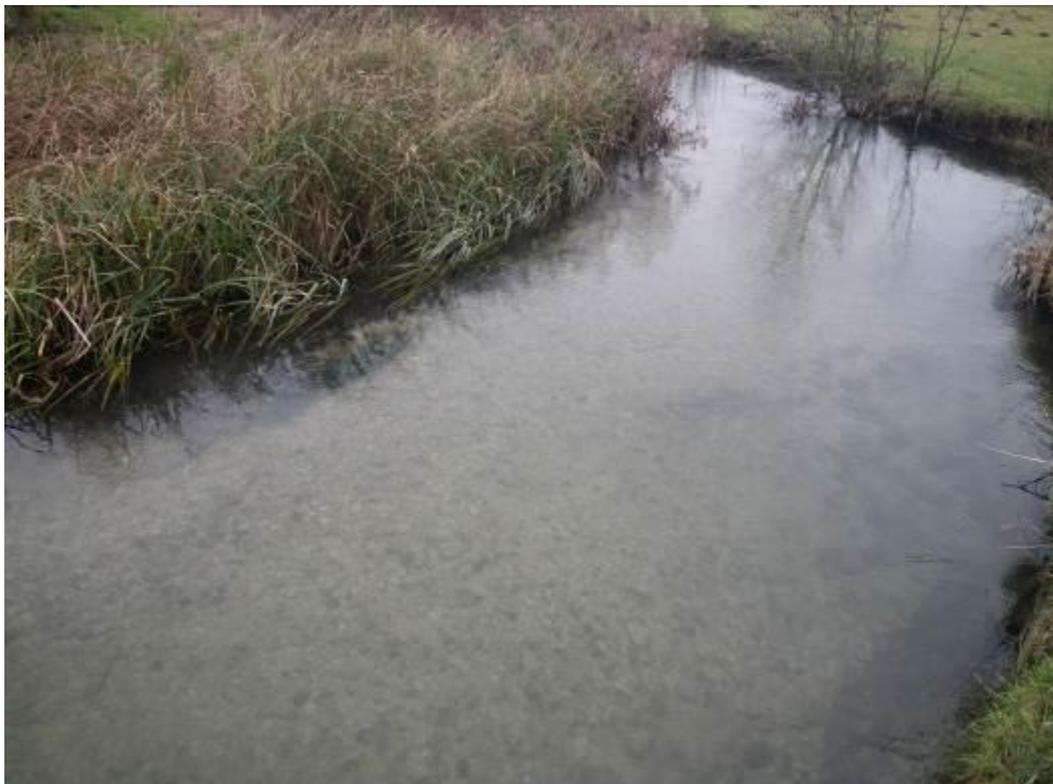
Photo 13. A thick sedge fringe providing a stable and biologically rich margin.

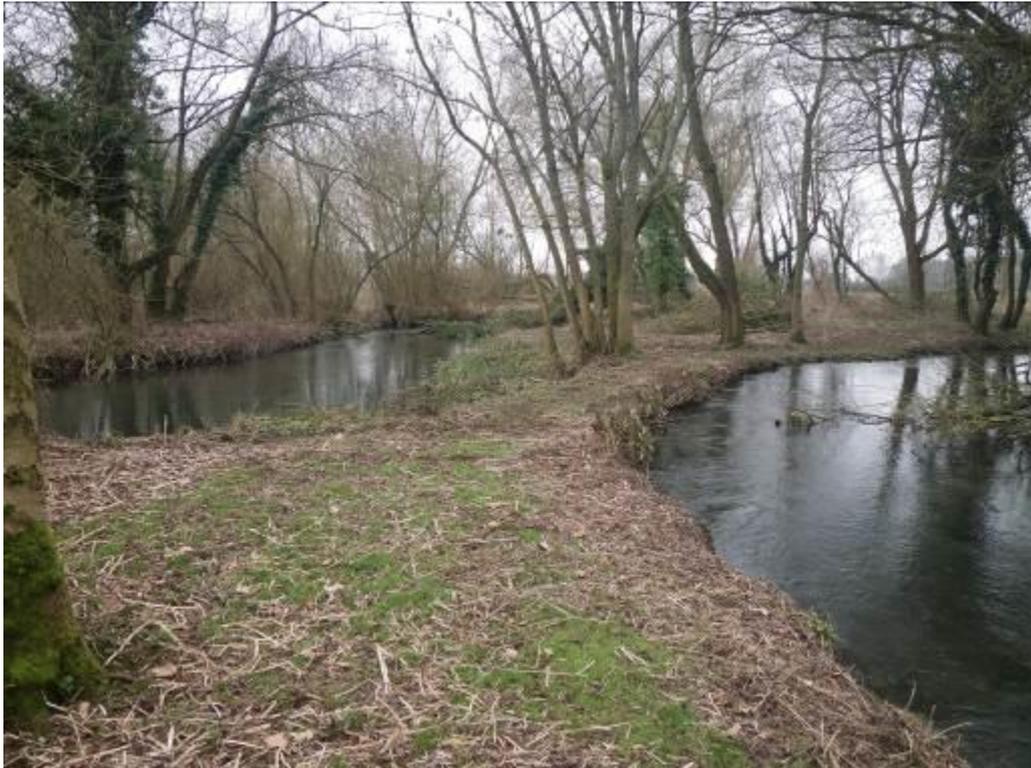
Upstream of the fish farm a wide range of good quality trout habitat is supported. The river provides more varied habitat than the downstream beat, including a series of spectacular meander bends (photo 14). Care must be taken to ensure that the vulnerable narrow sections are not prone to erosion pressures by encouraging luxuriant marginal vegetation. This can be achieved through a combination of sensitive tree management, to promote more light, and packing the margins with plenty of brushwood.

Photo 14. An extravagant meander, one of a series near the upstream limit of the beat. More light, less footfall and plenty of brushwood in the upstream narrow margin is required to prevent the river from cutting through.

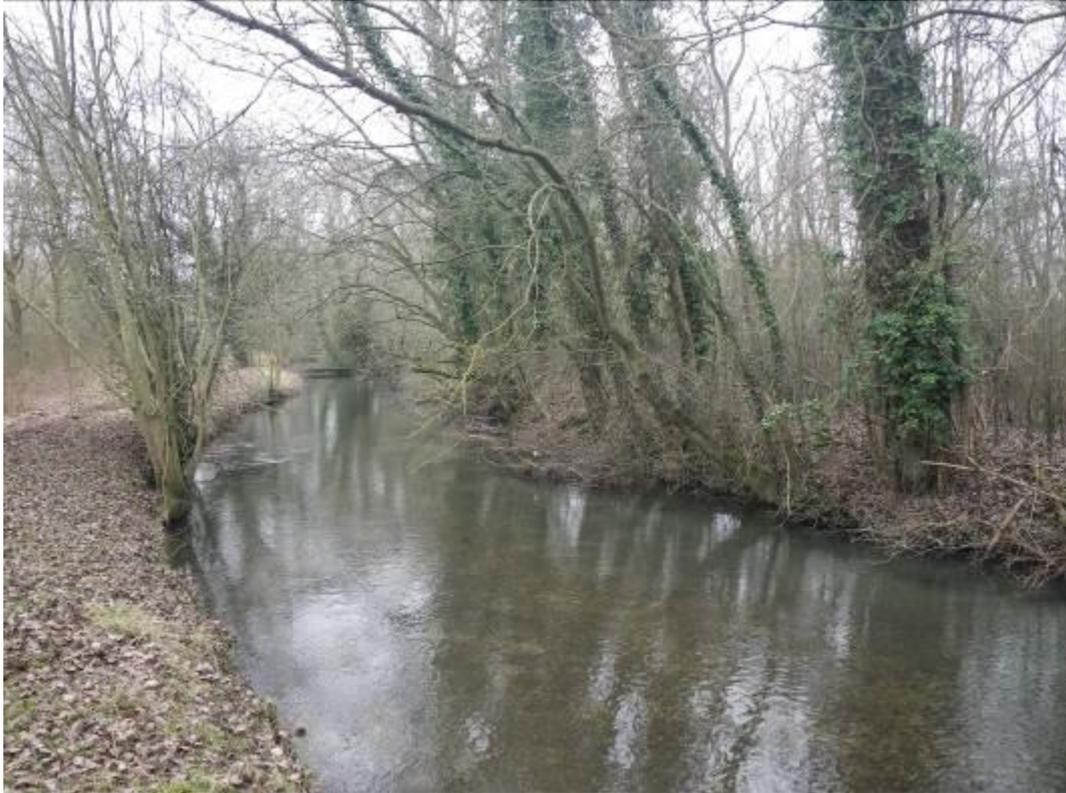
The one exception to the excellent and varied habitat found on the upper beat is the reach located near the downstream end, approximately 100m below the access track; here, a significant section of the river channel is too wide and heavily shaded. As a result, the morphology of the channel is too uniform to provide any opportunities for the river to promote good quality trout habitat (photo 15). Of all the sections inspected, this is the reach that has the greatest potential for enhancement via simple tree work and the use of woody materials secured into the channel to promote bed scour and provide much need cover.

Photo 15. Lower section of the upstream beat is ripe for enhancement.

It is recommended to concentrate efforts on improving the wide, shaded section on the lower reaches of the upstream beat. To this end, a range of actions is required including:

- Coppicing within blocks of marginal trees on the RB to promote more light penetration.
- Use the woody materials won for flow deflectors to promote bed scour and variation in bed topography.
- Secure whole tree kickers to provide valuable marginal cover and natural channel narrowing.
- Peg in coarse woody brushwood berms or shelves to provide complex cover for small fish and food and habitat for invertebrates as well as promoting flow diversity
