Little Don, Stocksbridge (Steel Valley Project)

Advisory Visit

Wild Trout Trust Report – Following a Site Visit on 27/01/2020

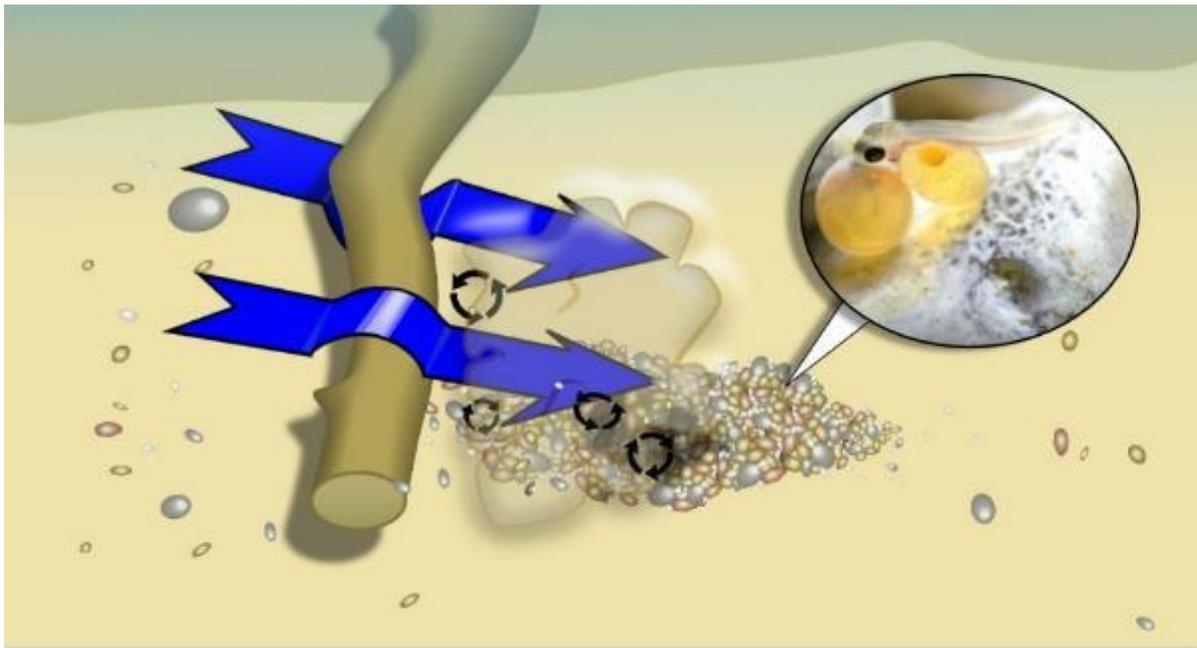
Figure 2: Features associated with successful trout spawning habitat include the presence of silt-free gravels. Here the action of a fallen tree limb is focusing the flows (both under and over the limb as indicated by the blue arrows) on a small area of river-bed that results in silt being mobilised from between gravel grains. A small mound of gravel is deposited just downstream of the hollow dug by focused flows. In these silt-free gaps between the grains of gravel it is possible for sufficient oxygen-rich water to flow over the developing eggs and newly-hatched "alevins" to keep them alive within the gravel mound (inset) until emerging in spring.

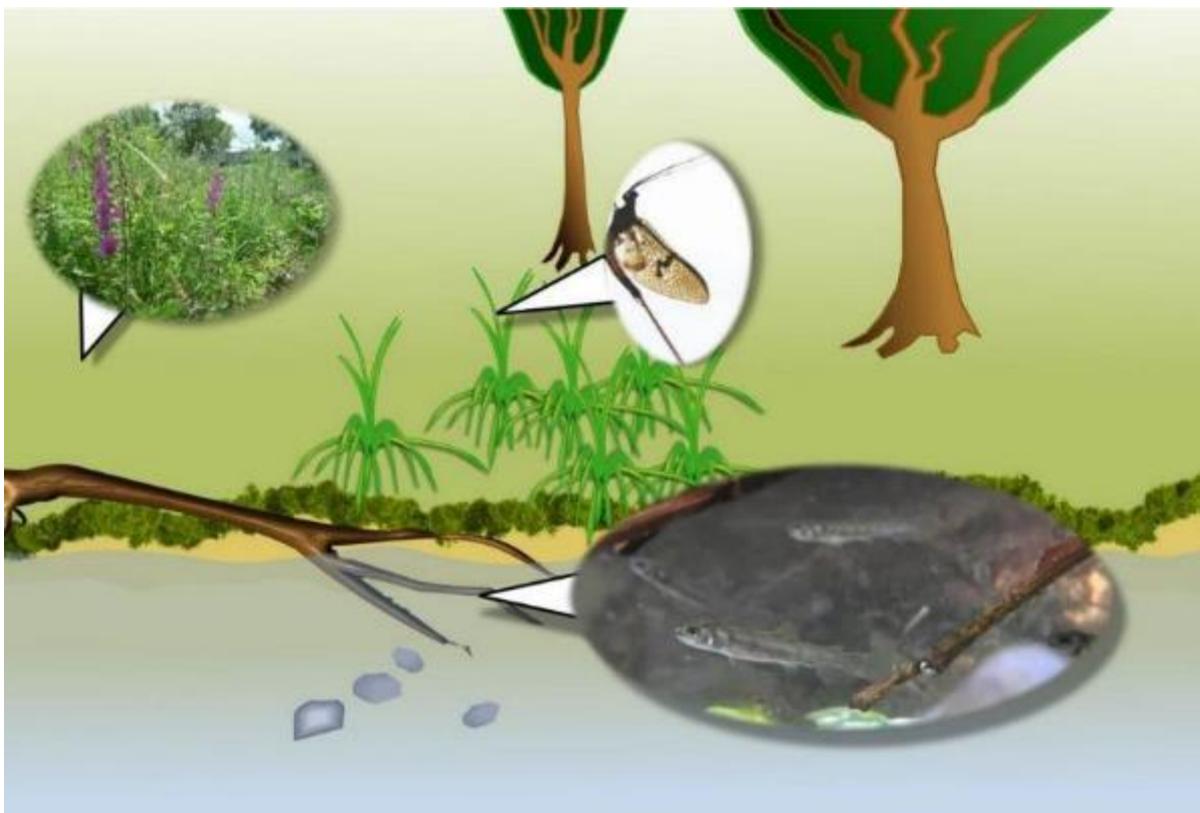
Figure 3: Larger cobbles and submerged "brashy" cover and/or exposed fronds of tree roots provide vital cover from predation and spate flows to tiny juvenile fish in shallower water (<30cm deep). Trailing, overhanging vegetation also provides a similar function and diverse bank-side vegetation has many benefits for invertebrate populations (some of which will provide a ready food supply for the juvenile fish).

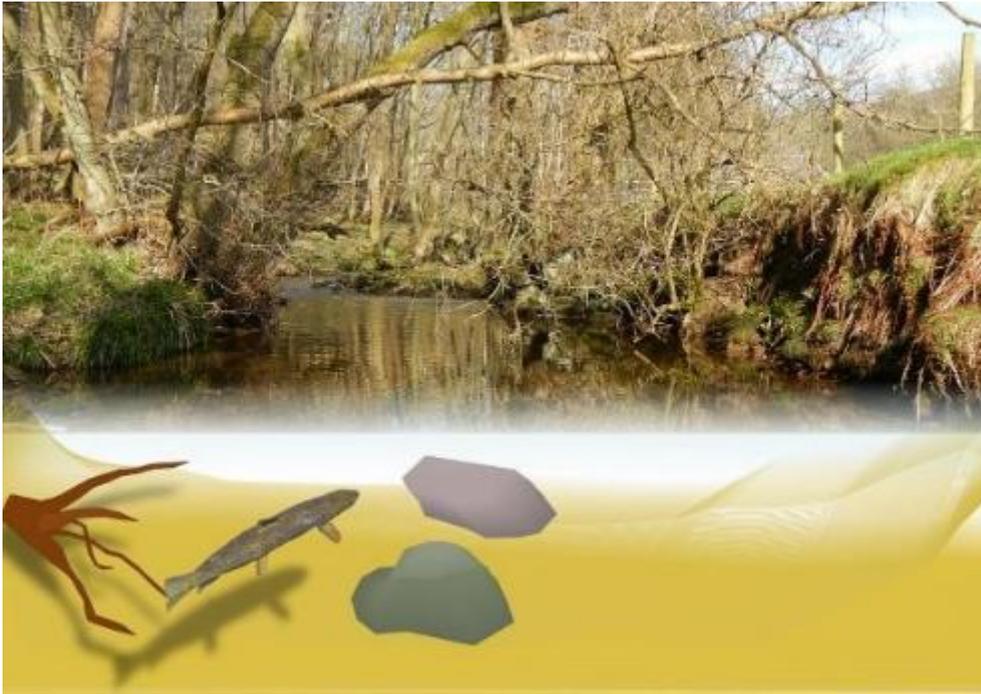
Figure 4: The availability of deeper water bolt holes (>30cm to several metres), low overhanging cover and/or larger submerged structures such as boulders, fallen trees, large root-wads etc. close to a good food supply (e.g. below a riffle and with prey likely to fall from overhanging tree canopy in this case) are all strong components of adult trout habitat requirements.

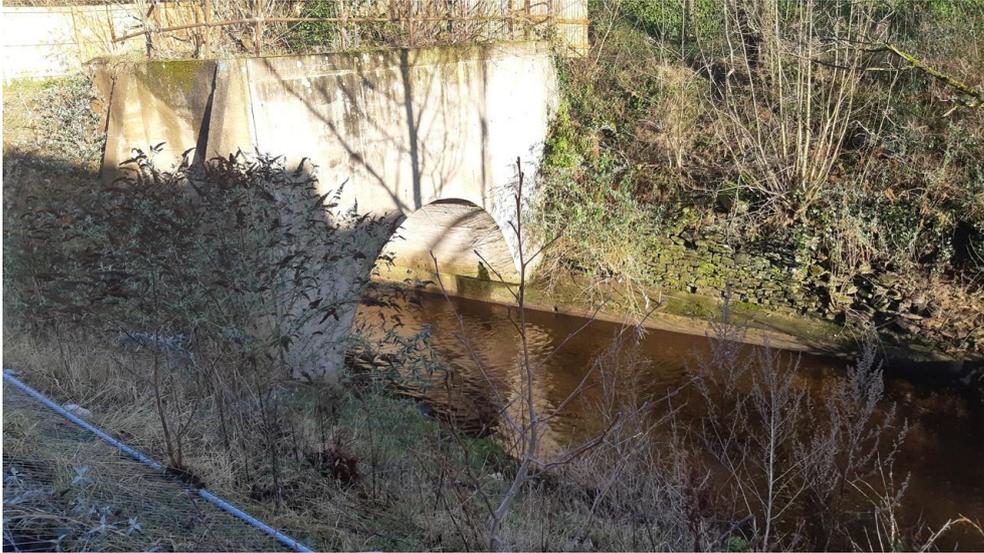
The upstream limit of this visit (Fig. 5) was the point at which the Little Don emerges from a large culvert at SK 27869 98471. The culvert has a large capacity and carries the river beneath the site of historic (and existing) steel works. At one time, almost the entire length of the Little Don valley below Underbank reservoir would have been dominated by steel works and their associated infrastructure/related services. Today, the remaining area occupied by active steel-production is much reduced. Some of the old sites have been redeveloped (including, for instance, the Fox Valley Shopping Park as well as new housing) and land has also been reclaimed for nature.

Figure 5: The Little Don emerging from a long, large-capacity culvert that carries it beneath Fox Valley Shopping Park at SK 27869 98471; the upstream limit of this visit.

While there is little realistic prospect of daylighting much of this culverted section, it may be possible to establish the presence or absence of any barriers to free movement of aquatic organisms. Connectivity between high-quality patches of habitat is extremely important for the resilience of self-sustaining populations. Often it is necessary for individuals to migrate between different habitat resources at different stages of their lifecycle. Alternatively, connectivity can simply provide a means of repopulation after a localised extinction. Therefore, any opportunities to identify and mitigate any barriers to free movement within the culverted sections would be potentially highly valuable.

- Explore the potential to investigate the presence/absence of barriers within the long culverted sections of the Little Don – and consider any potential solutions where such barriers may be discovered

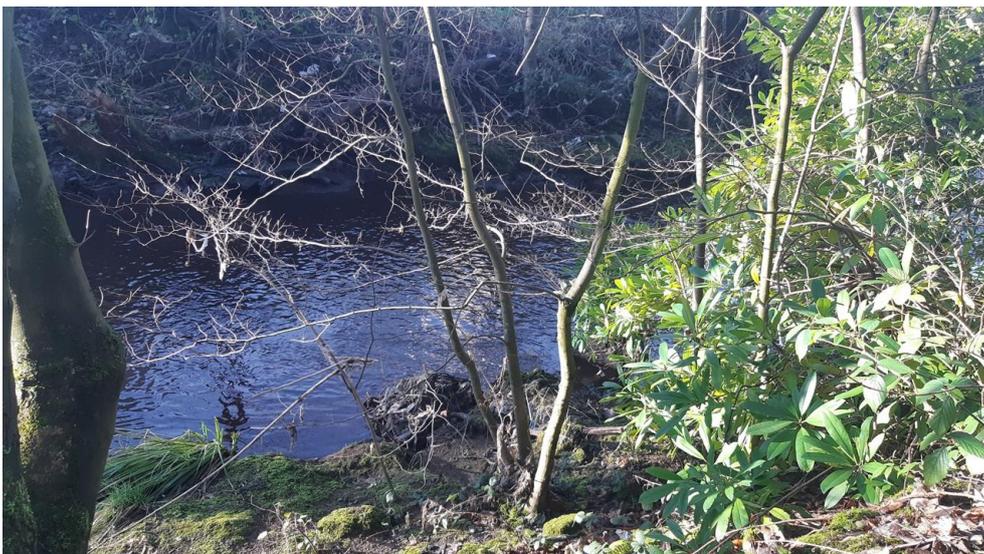
Figure 6: Riverside vegetation, including Rhododendron.

riparian vegetation lining the banks (e.g. Fig.6). In addition to native, mixed deciduous woodland species, patches of rhododendron were also noted – as can be seen in Fig. 6; photographed at SK28146 98356. That particular stand of rhododendron may offer some potentially beneficial shade and cover to aquatic species living in the margins of the river. However, overall it represents a negative impact on river corridor biodiversity. The tendency to dominate native understory species – as well as the potential to harbour a variety of fungal infections hazardous to native woodlands – mean it is beneficial to control the spread of rhododendron and remove/replace with native species.

- Control/minimise rhododendron and Japanese knotweed growth using appropriately qualified personnel and approved methods for working adjacent to watercourses (e.g. considerations where herbicides may be involved: <https://www.gov.uk/government/publications/application-to-use-herbicides-in-or-near-water>)

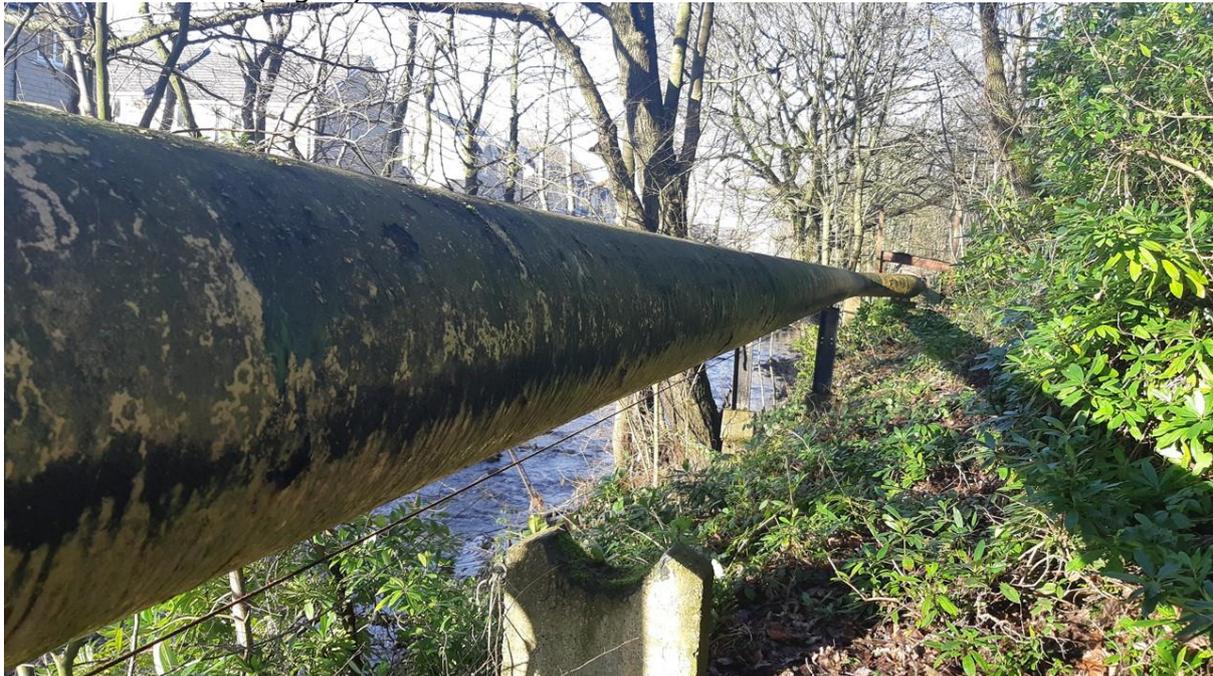
A photograph taken from the same grid reference as Fig. 6 also shows the significant constraint created by the gas pipeline running along most of the length of the Little Don (Fig. 7).

Figure 7: Gas pipeline running along the LB - with housing at the level of the raised footpath on the RB visible in the background.

Clearly, having a housing development on one side of the river - with the pipeline on the other - will limit the degree to which a more meandering river channel can be achieved. Instead, introduction of stable woody material is advised (see subsequent details in report).

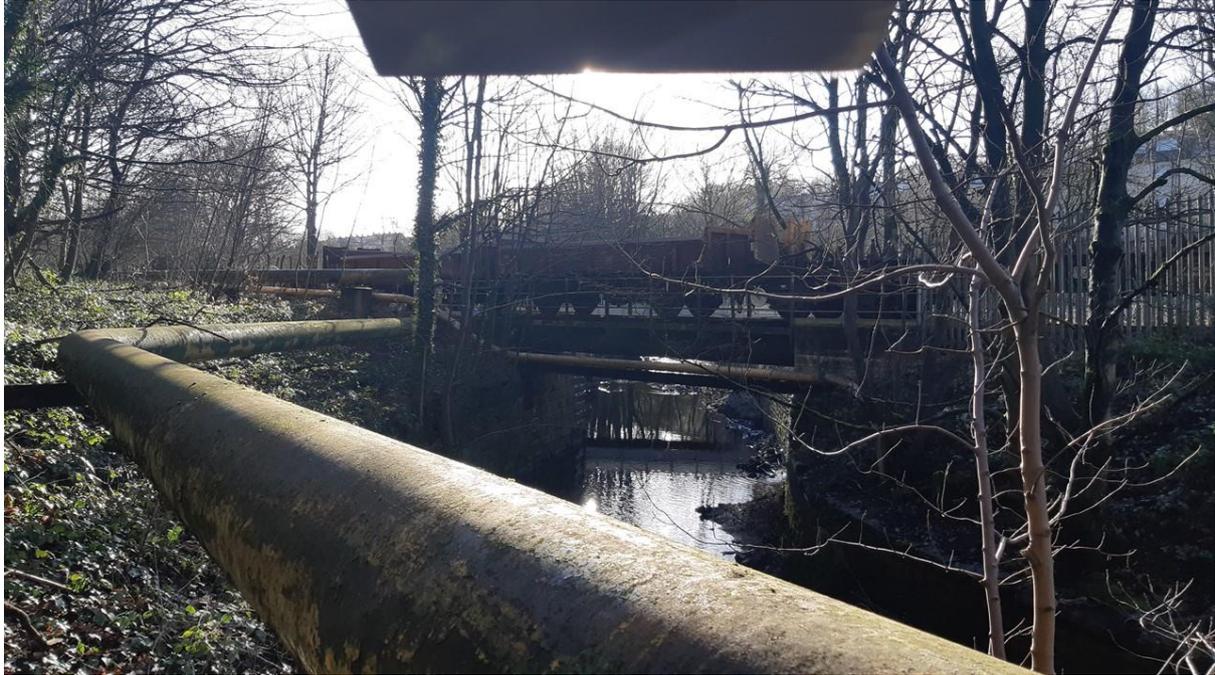
Figures 6 and 7 indicate the typical character of the river between the upstream limit of the reach visited for this report and the railway bridge at SK 28222 98308 (Fig. 8). Although not currently used for passenger services, this line is scheduled to begin carrying them in the future.

Figure 8: Railway bridge, photographed facing downstream and gas pipeline (LB) at SK28222 98308

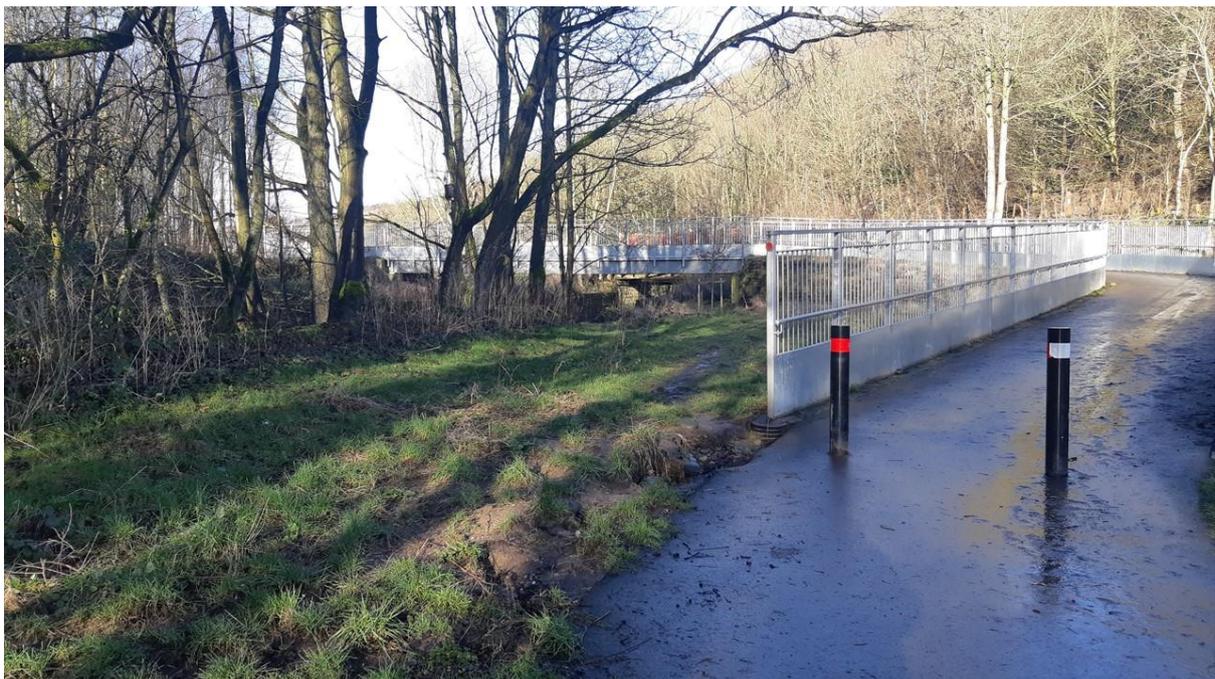
Downstream of the railway bridge (Figs. 8 and 9) is an area that the Steel Valley Project has earmarked for potential wetland creation. Comments were invited from the WTT on the idea as part of this Advisory Visit. The potential to increase lateral connectivity (particularly in the context of the severe constraints upstream of the railway bridge) is a valuable opportunity. Longitudinal connectivity has been mentioned earlier in this report in the context of migration up and downstream. Lateral connectivity refers to the ability of the river and its inhabitants to move between river channel and floodplain under differing conditions. The land adjacent

Figure 9: Railway bridge photographed facing upstream. The level of the bridge is approximately equivalent to the ground level of the housing on the RB above the bridge

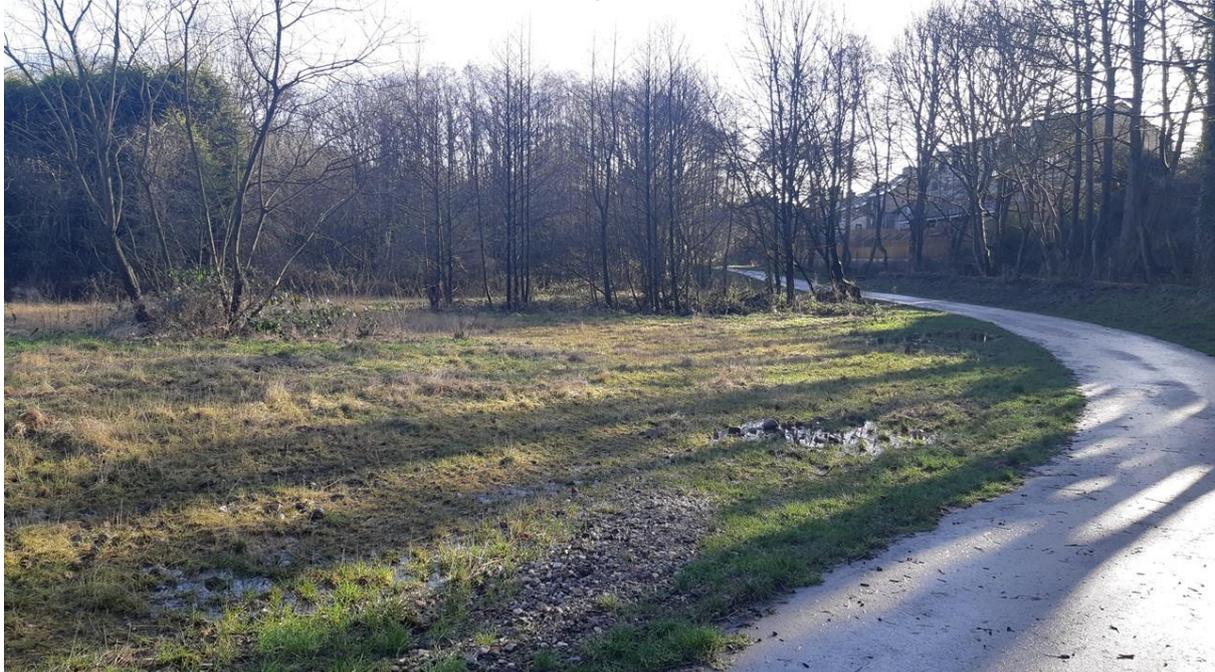
to the river on the LB below the bridge is much lower-lying than the level of the footpath and housing above the bridge. There is also considerable, undeveloped, space available (Fig. 10).

Figure 10: Proposed wetland area to the left of the footpath - with the river channel hidden behind a raised bund along the single line of trees to the right of the frame.

Allowing the river to periodically inundate that section of floodplain would also create additional flood-storage in an area currently disconnected from the river. The broad plan to create scrapes in the ground and introduce locally-appropriate wetland plant species would be of ecological benefit. To maximise these benefits, the lateral connections between river and floodplain should be designed so as to avoid creating a “fish trap” effect as spate flows recede. Ideally, if the levels can be made to work, open channel(s) should be used in preference to buried pipes.

Channels to increase lateral connectivity should always avoid creating a raised lip at the point where water would discharge back into the main river channel as water levels recede after spate flows. This minimises the potential for fish to become trapped as the water levels drop.

Using footbridge(s) to preserve the footpath access would allow for open channels to connect river to floodplain. Such channels have greater ecological value than using sunken plastic pipes or round culverts (which would also necessitate disruption of the footpath and riverside bund during construction phases). The river channel at this location is shown in Fig. 11.

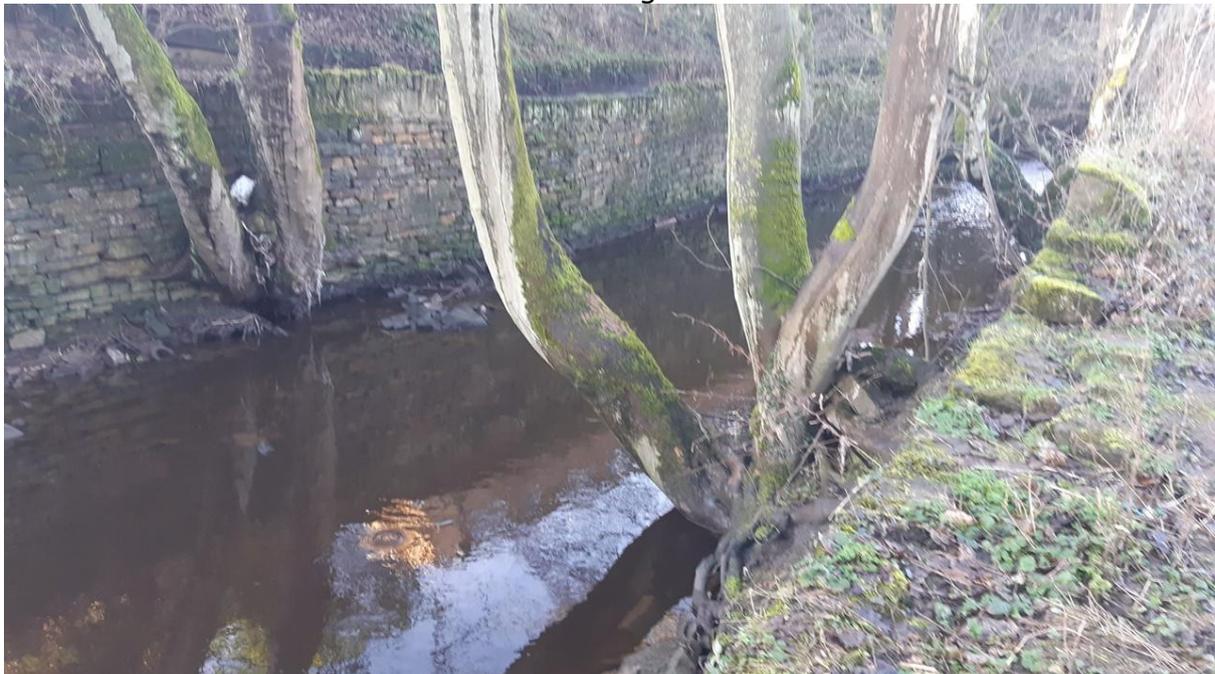
Figure 11: The Little Don at SK 28339 98177 as it skirts the area earmarked for wetland creation.

If tree works are deemed necessary in future (e.g. to protect the wall from collapse or as part of a very light rotational coppicing to create a more varied light/shade regime), there are opportunities to use the arising tree-crowns to create in-channel refuge habitat. The channel-straightening and stone walling have created uniform habitat with less roughness than is ideal for biodiverse aquatic communities. Therefore, securely anchoring tree crowns (Figs. 12 and 13) to remaining root-masses creates stable, complex, submerged cover that provides a wealth of benefits including:

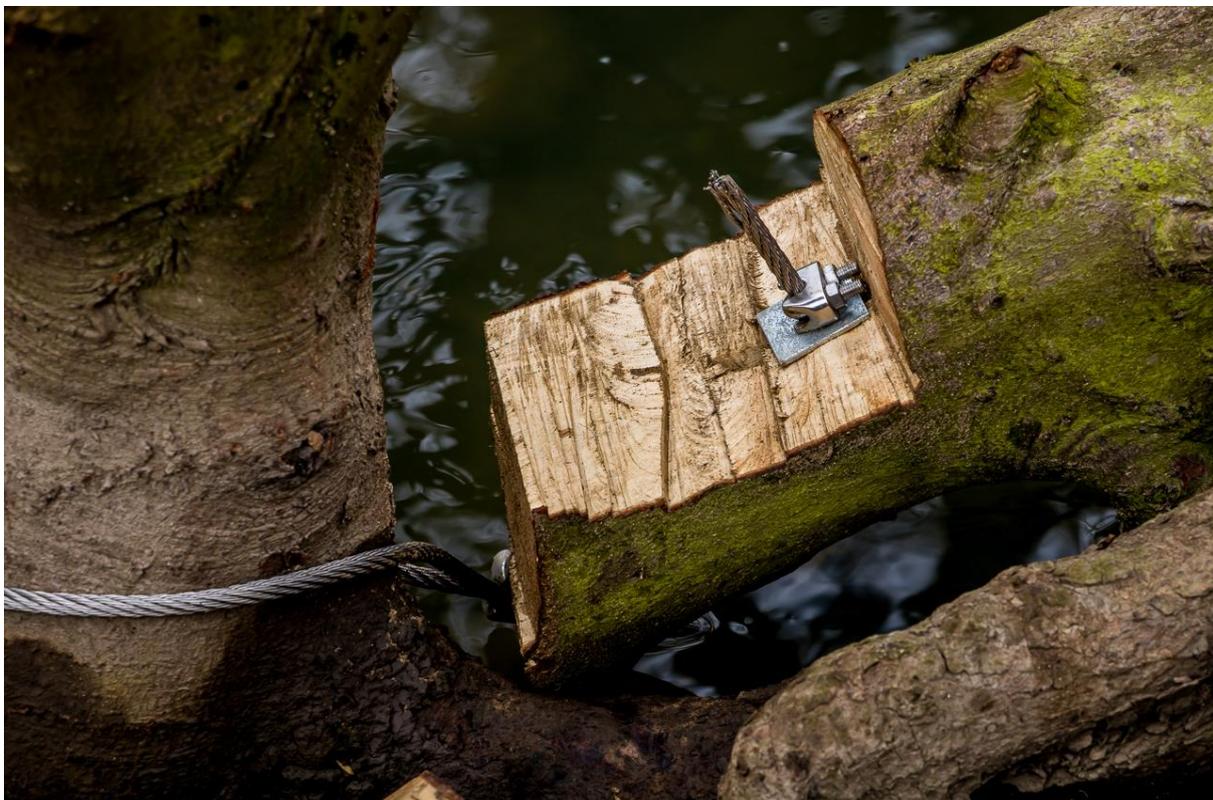
Braided steel cable and cable-crimps enable extremely robust anchoring of trees to stable root-masses (e.g. Fig. 12).

The crowns of the trees are only tethered at one end (the thicker, trunk-end) and so will be washed parallel to the riverbank. This arrangement also allows the free end to rise up and fall down according to the height of the river at any given time.

Figure 12: Example of tree crown cabled to stable anchor-point using braided steel cable and crimps

- Introduce and anchor submerged cover in the form of “tree kickers”. Alternating between LB and RB placements of kickers can create a degree of meandering flow within straightened channels. Additional guidance on this technique is available via video here: <https://vimeo.com/72720550>

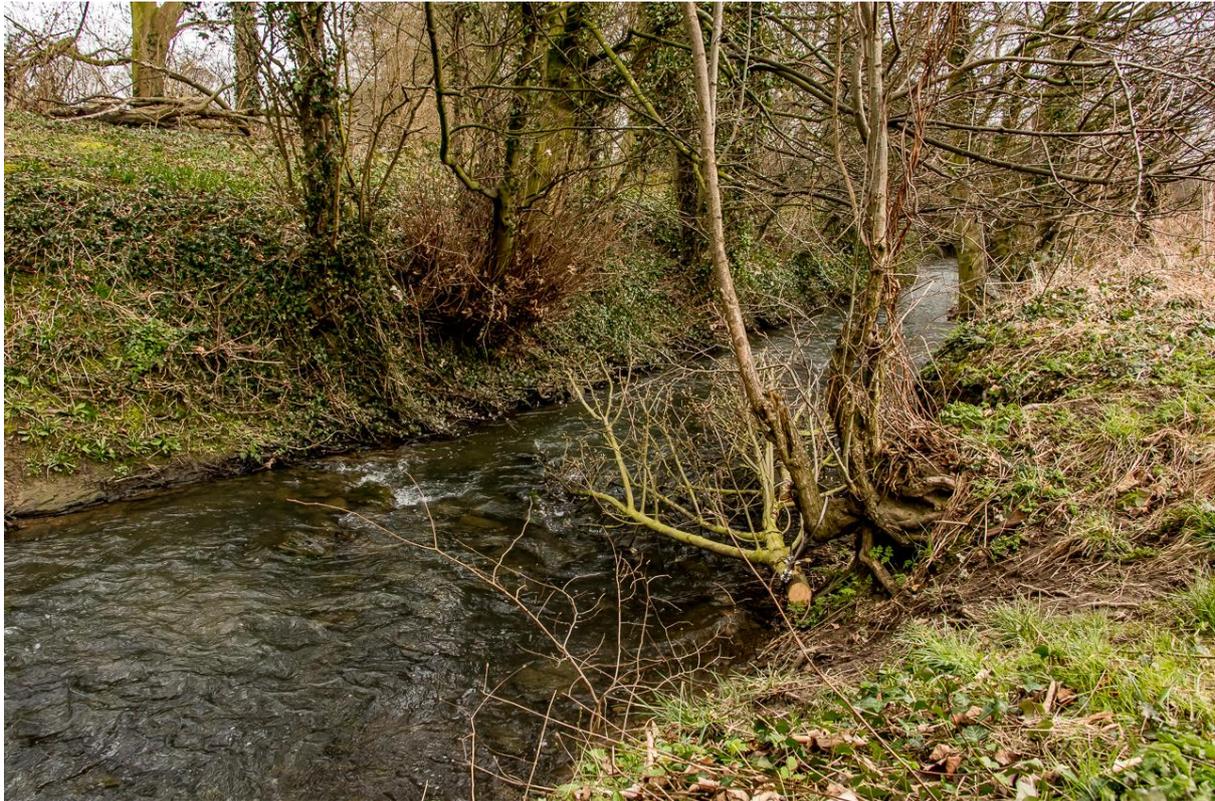
The size of these structures – known as tree kickers – can be tuned appropriately to the size and situation of the watercourse at hand. This is a quick and robust way to recreate a proportion of hydraulic roughness and habitat complexity that are both lost when river channels are straightened and simplified.

Figure 13: A small tree-crown installed as a stable tree kicker to mimic natural deadfall habitat.

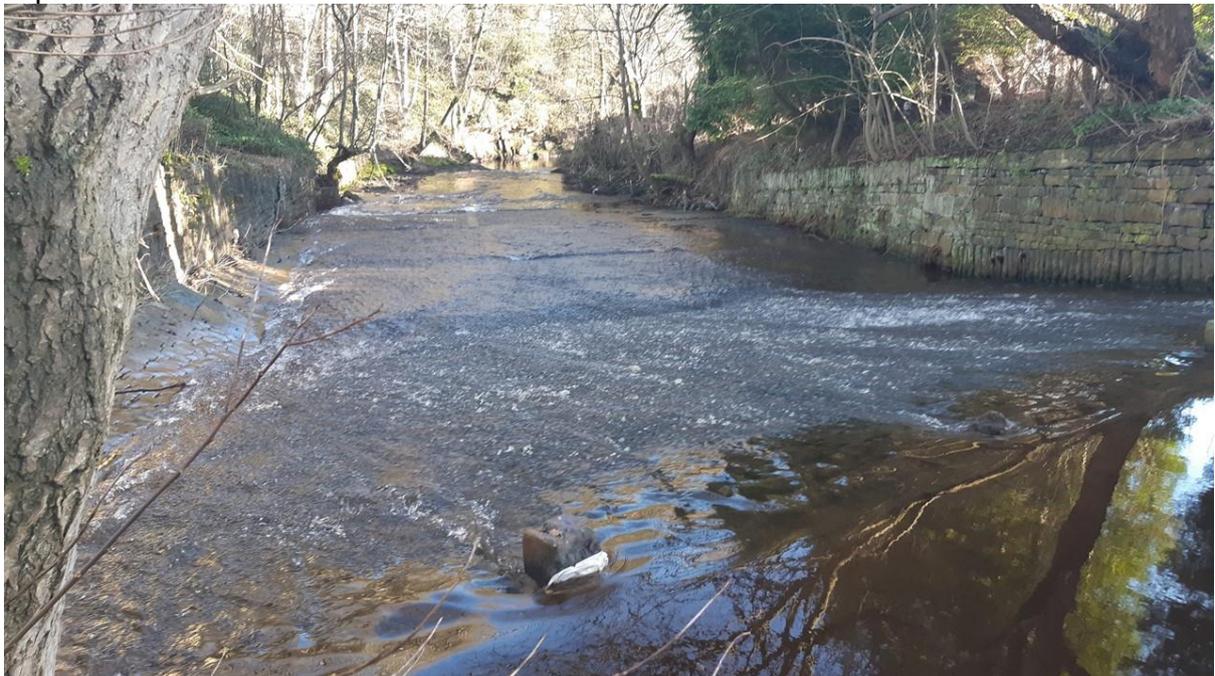
The extensive weir at SK 28452 98147 (Fig. 14) presents a complex challenge. The length, gradient, shallow/laminar flow means that it is likely to be a complete barrier to upstream fish passage under all flow conditions. At the same time it is a structure that is likely to be valued in the local community for the heritage it represents.

Figure 14: Huge, sloping weir on such a small watercourse – a complete barrier to upstream migration for most fish species.

The insights provided on the above link are essential to inform public consultations on the options for dealing with structures that are designed to impound (hold-back) flows on our rivers. In ecological terms, the best outcome would be removal of the structure to allow the channel to re-grade naturally. The next best option would be the creation of a new channel with a bed of natural material and cross-sectional profile which bypassed the structure. Moving further down the list – purely from an ecological outcome perspective – removal down to bed-level of a significant portion of the structure would create a degree of upstream habitat improvement. Following that, there would be options which did not improve habitat quality – but could potentially reduce the barrier effect created by the weir.

Those fish passage easements/improvements would span the range from high-cost technical fish-pass construction through to less formal easements. Devoting a up to a third of the cross-section of this weir to some kind of fish passage easement that could include baulk installation, wooden baffles or a rock-ramp may allow a proportion of fish to ascend and descend this barrier. As is usually the case, in the absence of weir removal, a bespoke solution will need to be designed for this specific site. The unique challenges created by different weirs are not well addressed by generic solutions – so this would necessitate its own dedicated project.

- Ecological and/or longitudinal-connectivity improvements at the site of the large weir pictured in Fig. 14 (including explanation of the concepts highlighted in the article here: <https://www.wildtrout.org/wttblog/why-presume-remove-weirs-river-dove-case-study>). Detailed information on fish passage structures is available in this Environment Agency publication: https://assets.publishing.service.gov.uk/government/uploads/system/uploads/attachment_data/file/298053/geho0910btbp-e-e.pdf

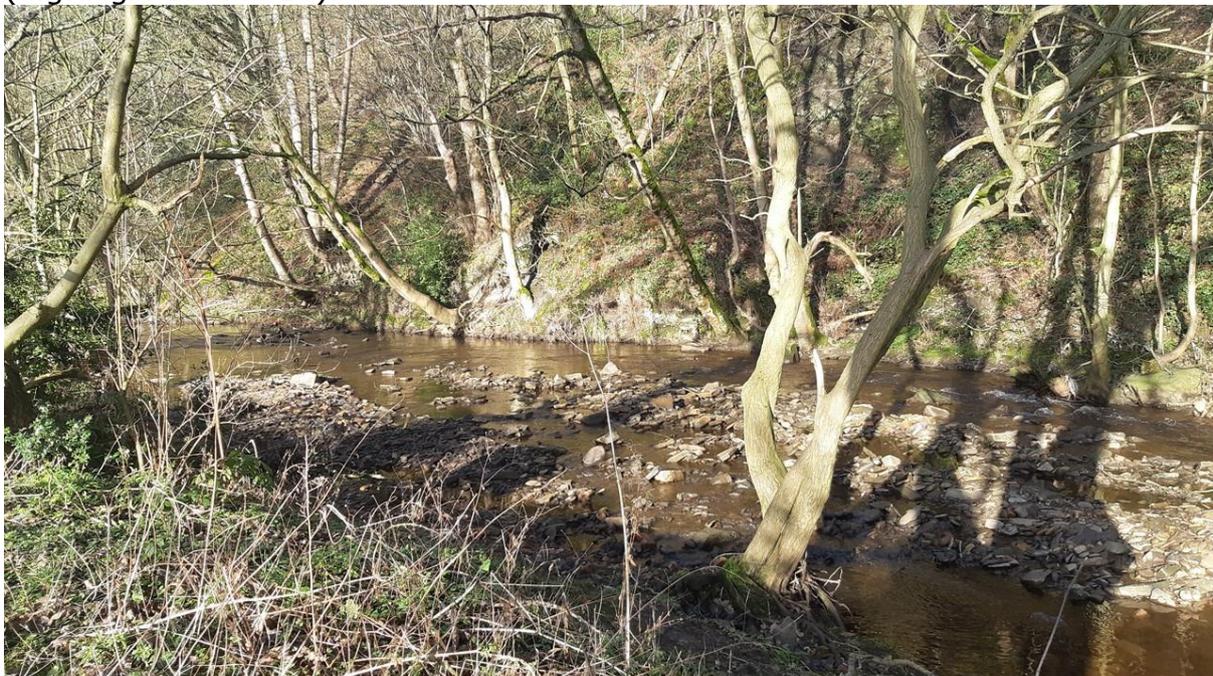
Figure 15: Diverse, high-quality habitat at SK28756 98145. Do also note the presence of a small number of dead canes of the non-native, invasive Japanese knotweed towards the left of the frame.

When the river is allowed to transport, deposit and remobilise bed substrate (as in Figs. 15 and 16), habitat with high value to a wide range of river-corridor species results. One observation of note is the presence of a small number of Japanese knotweed canes on the RB of this reach (e.g. Fig. 15). The out-competing of UK native species by Japanese knotweed reduces both floral and faunal diversity in the absence of its natural control organisms/pest species from its own native range. While this infestation is still small, it is the ideal time to tackle it in a cost-effective manner. In ecological terms, achieving control (and not necessarily complete removal) of Japanese knotweed would be very valuable. This is in contrast to the absolute need for, extremely expensive, complete removal measures that would be required if the land was being built on.

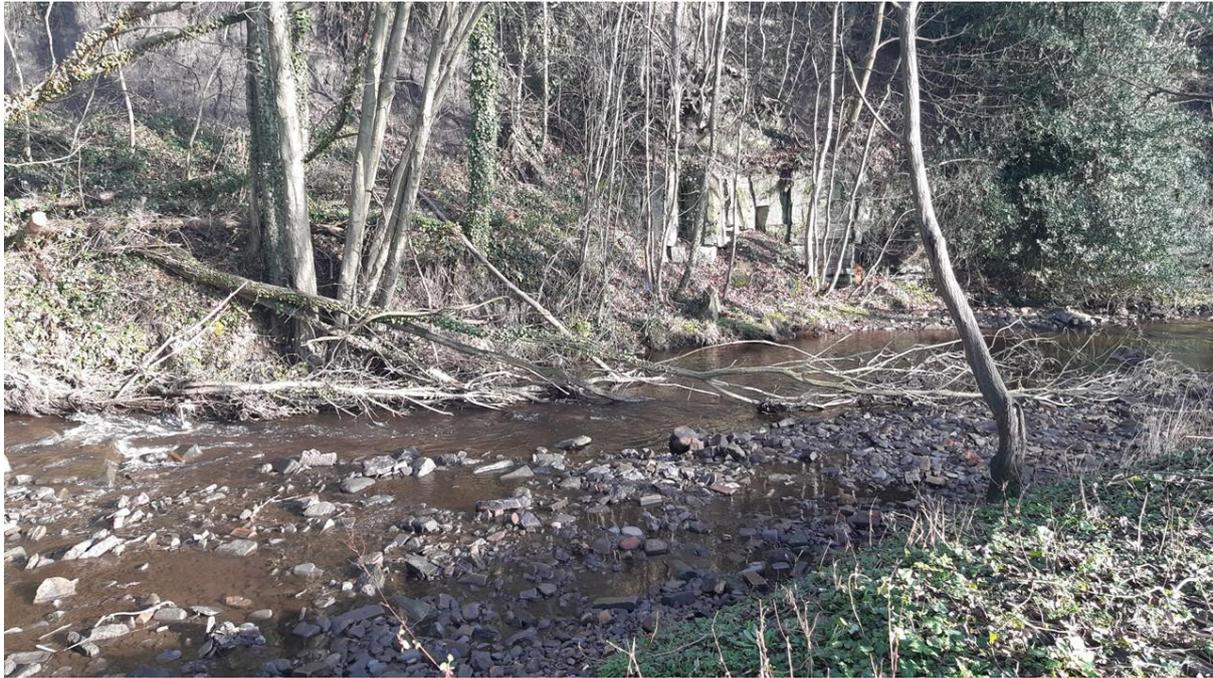
Figure 16: Photographed from the same point as Fig. 15 but facing downstream. Note the natural deadfall of wood creating low/overhanging and submerged brashy cover habitat. Also note the diversity of flow depth and velocity – along with the variation in diameter of riverbed material.
