Little River Avon – Berkeley Estate Fishing Syndicate

An advisory visit carried out by the Wild Trout Trust – November 2010

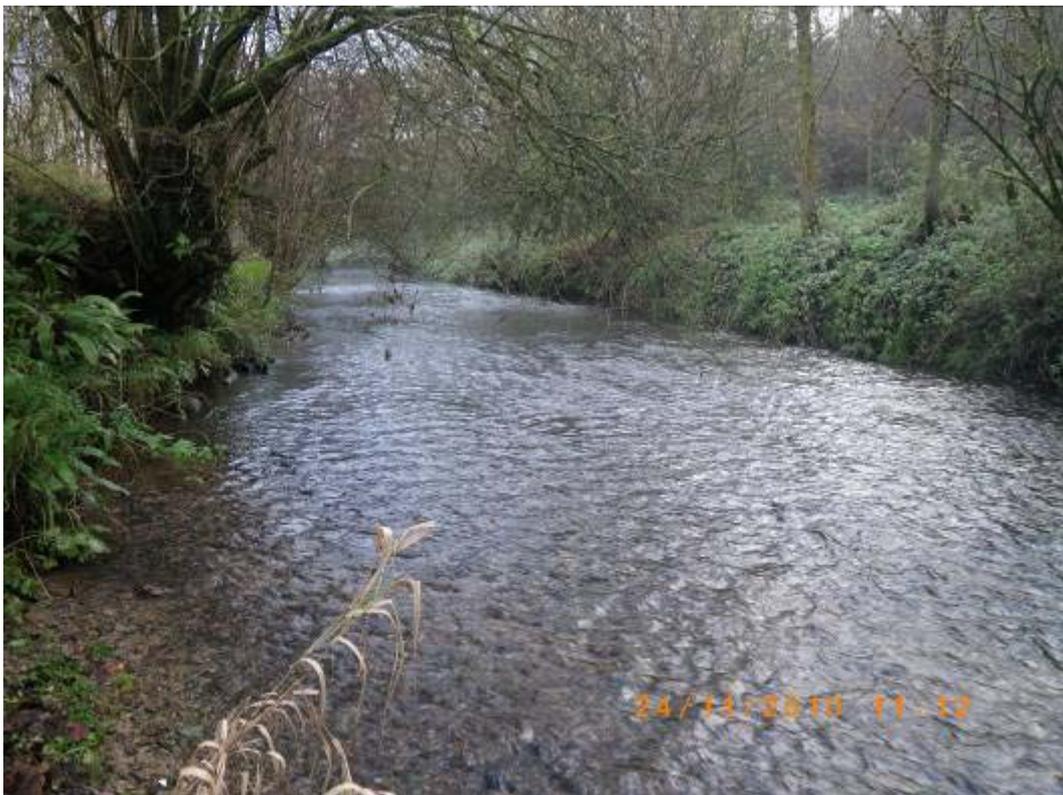
There were a few exceptions to natural river morphology The first was where there was a long, shallow uniform straight (cover photo), and a section further downstream where the natural varying river bed topography has been lost because of the impounding effect of an old stone weir.

The long shallow riffle photographed on the cover of this report is an ideal spot to dot two or three LWD flow deflectors.

The long shallow riffle on the cover photo could potentially be first class parr habitat with the provision of more cover. There are various techniques available for introducing suitable cover into shallow margins. A good method is to use

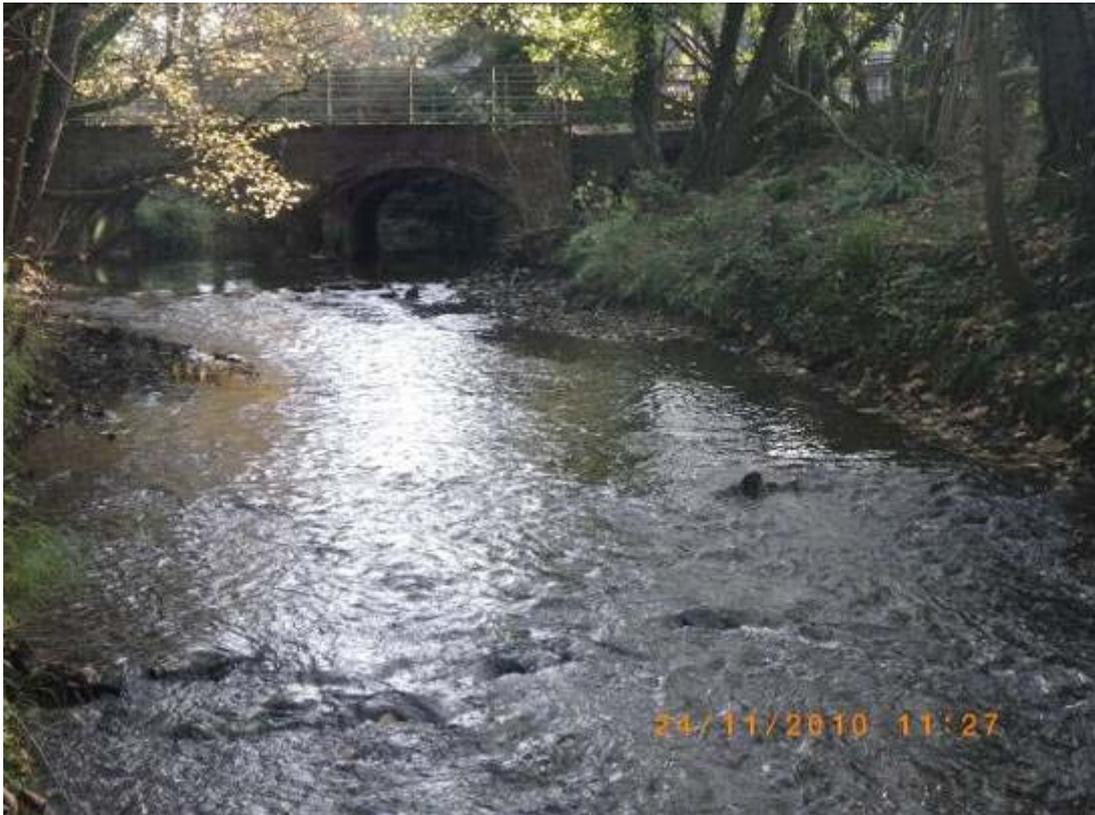
The top section near Damery bridge. Some excellent trout spawning habitat.

The good quality spawning habitat found on this upper section extended for approximately 500m downstream of Damery Bridge. Nursery habitat could be improved on this upper section and this is described in more detail in the conclusions section of this report.

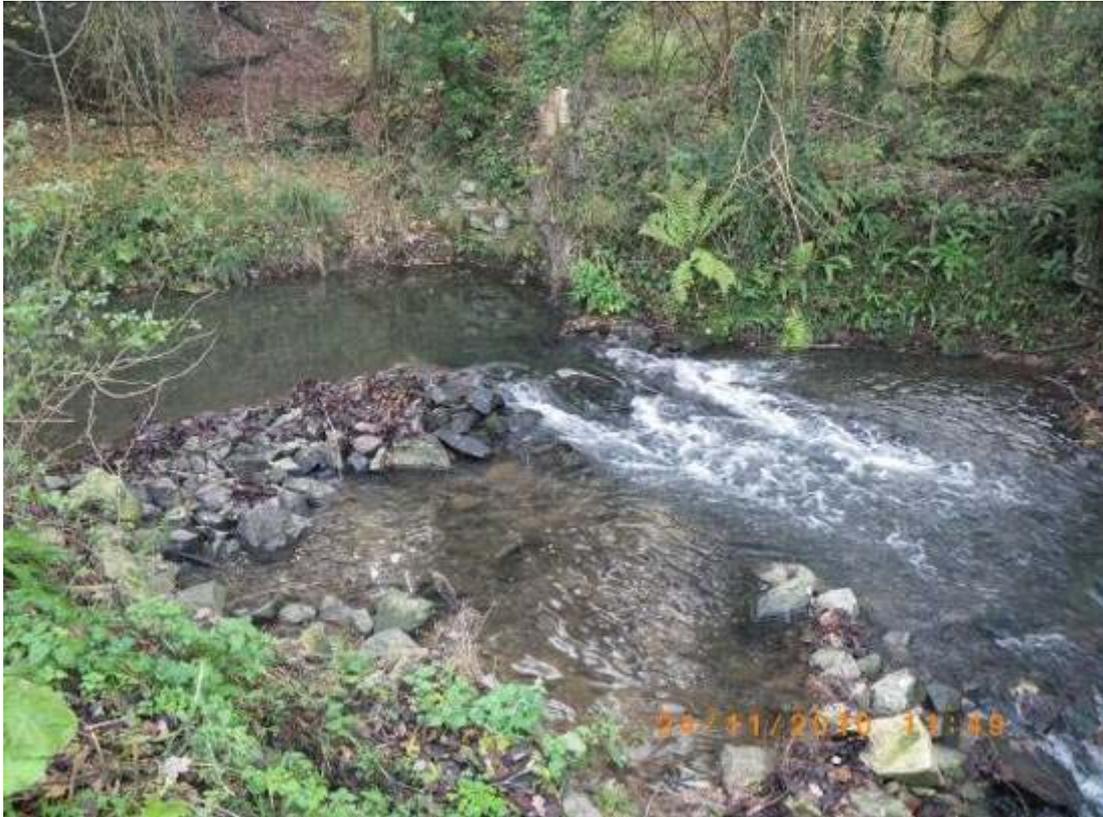
The impounding effect of the weir below this point is limiting the quality of the habitat, creating a long slow section with very uniform flow and channel characteristics. Adult trout will find some lies in this section, but there is little cover for juvenile life stages and no spawning habitat. It is believed that the weir was at one point part of an old milling impoundment although its exact purpose is not known. At some stage it has partially collapsed and although it is derelict it still drowns out the natural channel upstream for a distance of approximately 200m.

Old stone weir drowns out potentially good quality trout habitat upstream

The current configuration of the weir will put substantial pressure on the RB, especially during any spate conditions. Erosion forces are always generated at 90 degrees to any structure such as a groyne or a weir sill. Water over topping this weir in a flood will be kicked sharply right and may explain why the bank has been eroded just below on this near RB margin. Removing the bulk of the stones and redistributing them onto shallow riffle sites will improve habitat above the weir and solve the erosion issues, as well as providing improved habitat on the shallow sites where the stone can be usefully used.

If the height and extent of this structure could be reduced, it will transform the section above. Increased water velocities over time will promote improved

habitat quality on the impacted reach. Kicking out the odd stone and dotting them onto shallow habitat downstream will create some micro habitats for parr and the odd holding pot for adults. Concern was expressed over some slight bank erosion on the RB immediately downstream of the weir. It was suggested that the weir had been partially repaired in an attempt to reduce erosion pressures downstream.

The stone weir on the central part of the upper reach is having an adverse effect on habitat quality. It is recommended that the some stones are removed from this weir and used on riffle habitat to promote small 'pots' for holding lies for adults and parr.

- Reduce the impounding effect of the stone weir on the top beat and use the stones to promote improved quality habitat in the margins and on shallow riffle habitats.

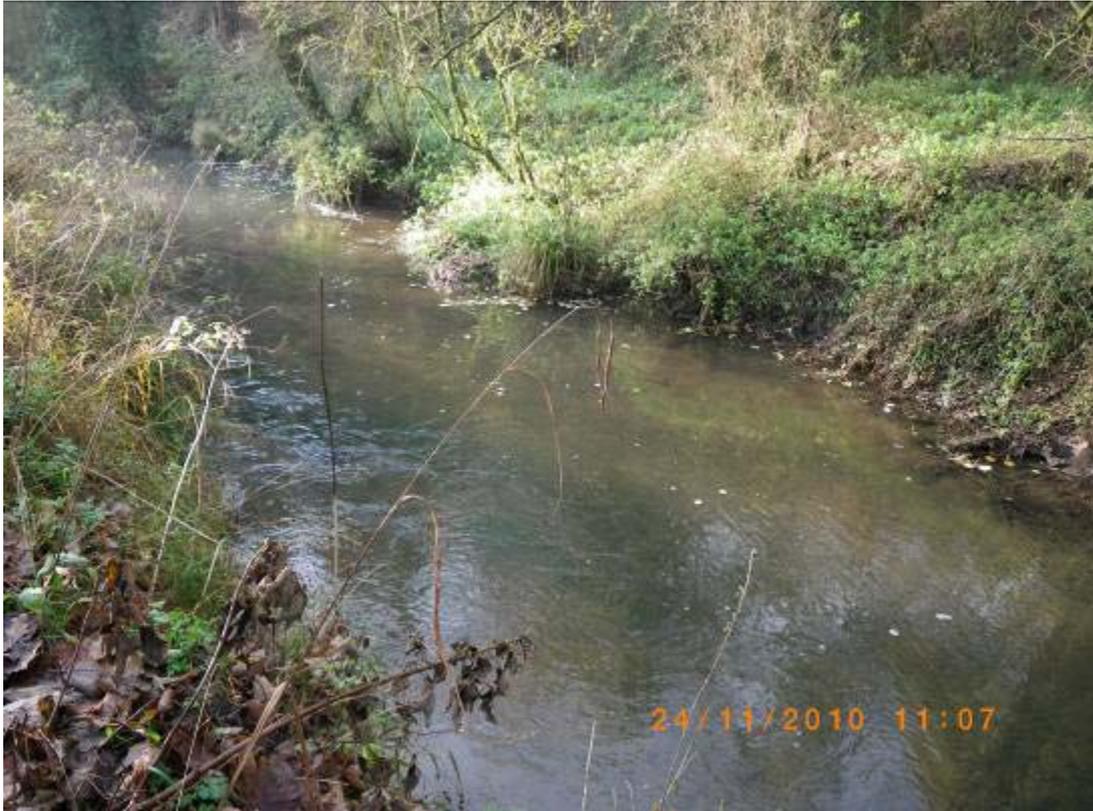
A nice section of holding glide where sensitively managed margins and in-stream beds of water crowfoot provide good quality holding habitat for adult trout.

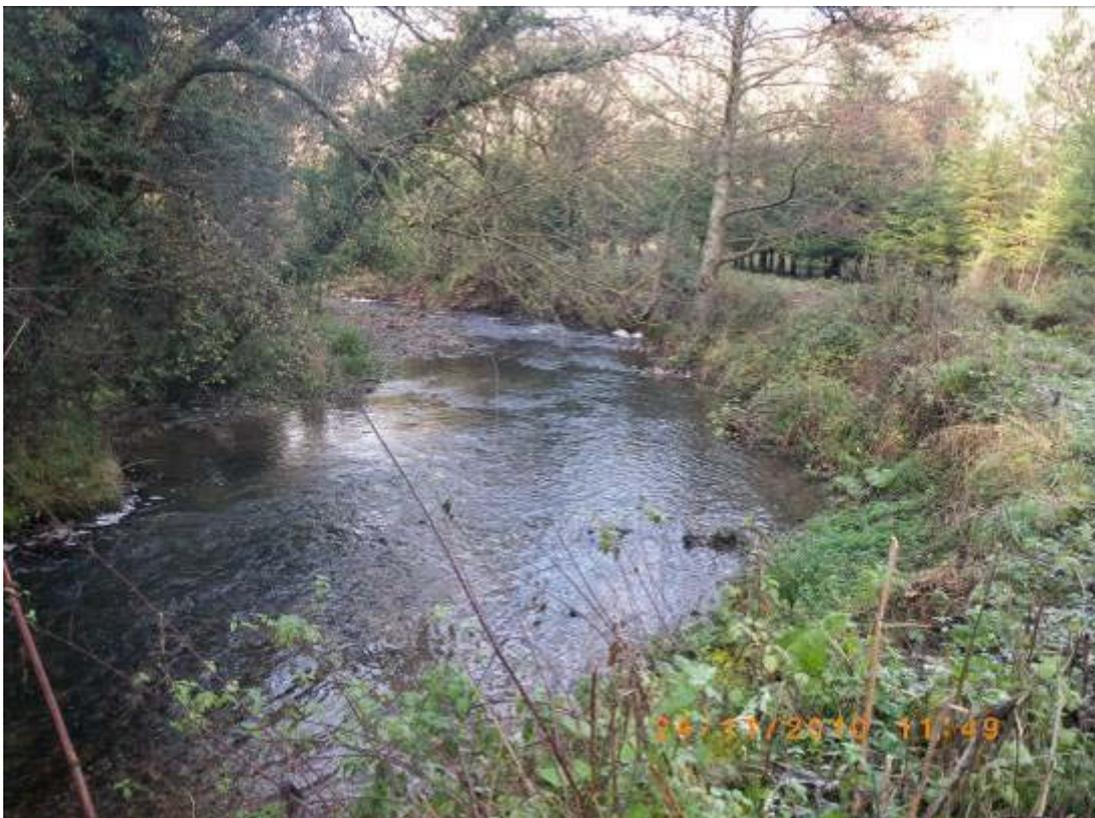
The section below the weir. Superb habitat for all life stages.

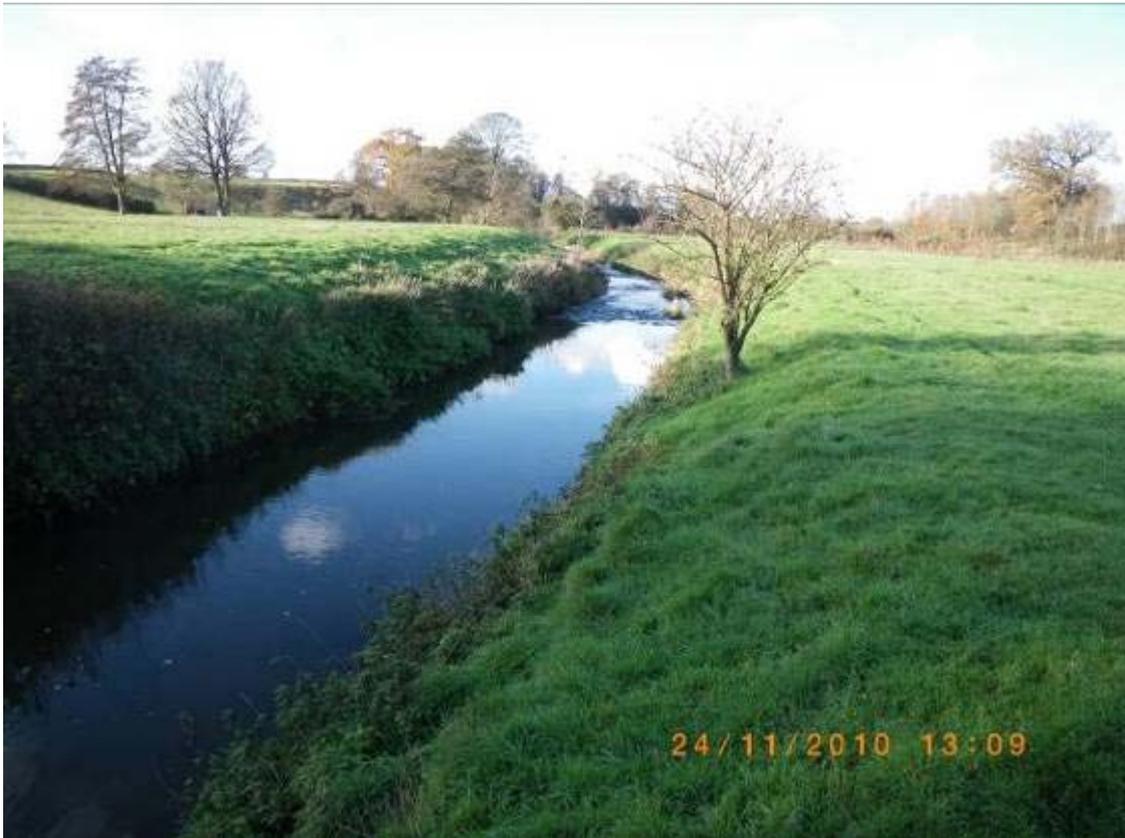
A further section of channel was inspected just below the village of Stone. Here the river runs through an open section of meadow and gradually begins to lose its gradient. Decent quality habitat was evident, particularly for adult trout but the provision of improved marginal cover would make this section much more valuable, particularly for intercepting and holding any wild fish drifting down from above as they search out a secure lie.

The section of channel below the village of Stone would benefit from a programme of tree planting to promote low marginal cover.

High level shade on the top section is adequate but further tree planting particularly on the open meadow section on the beat downstream of Stone should be considered. It is recommended to plant with goat willow (*Salix caprea*) which doesn't grow very tall but will provide a nice tight matrix of branches at and below water level. The root systems of willow are also a first class spawning medium for some coarse fish species such as roach, bream and occasionally perch, so some willow planting on the lower section might also be worth considering. Goat willow whips can be cut from any live willow and pushed into the soft face of a bank at an angle to encourage some bushy overhang.

- Plant some additional willows (sallow) or thorns to promote low overhead cover on open sections, especially on the beat below Stone and on the bottom beats to help shade out invasive plants.

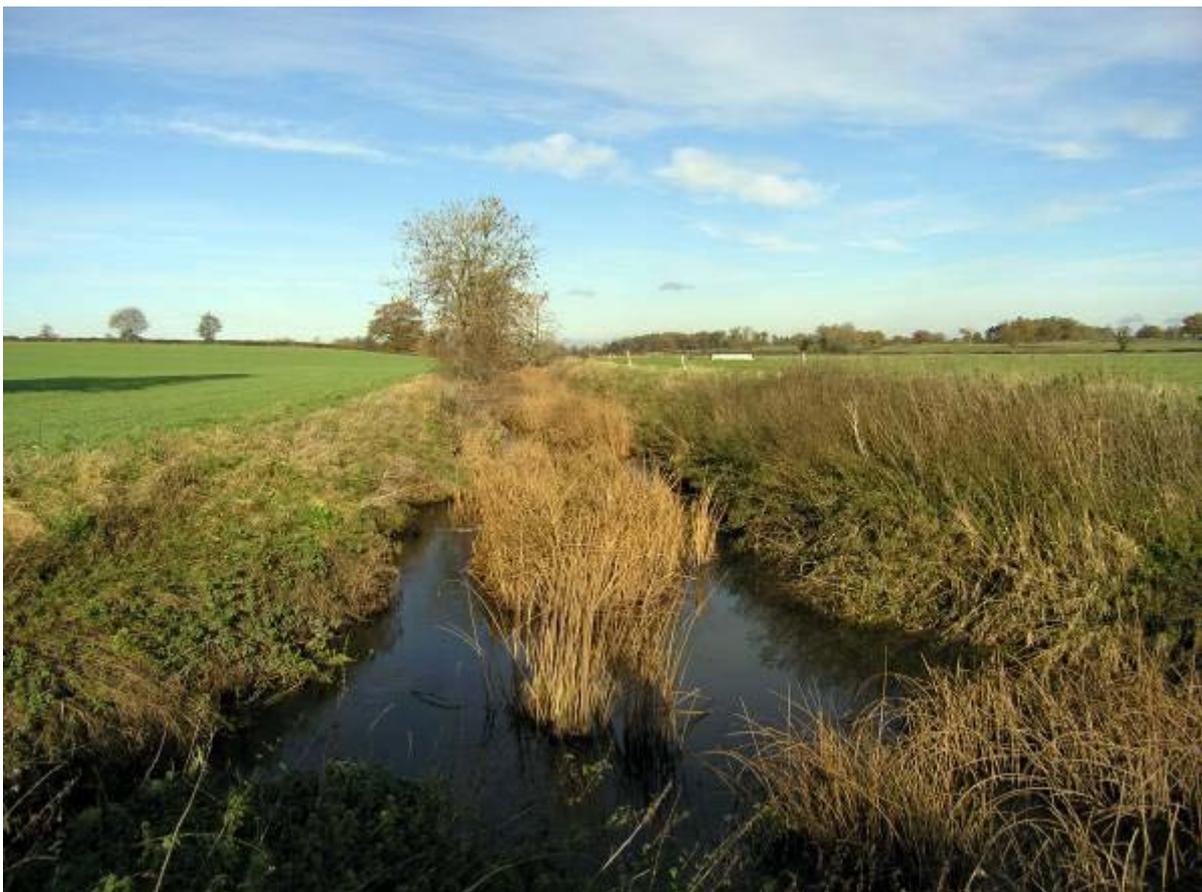
The final stretch of river inspected was located on the lower section towards the Brownsmill farm area. This section of river is giving great cause for concern because of the comparatively recent prolific growth of pipe reed (*Schoenoplectus lacustris*). Marginal emergent plants such as pipe reed and branched burr reed (*Sparganium erectum*) provide excellent habitat for a range of species and help to protect river banks from erosion, but problems can occur when channels become choked with thick stands of plants growing in the centre of the channel. The Berkeley Estate and BEFS are concerned about the spread of this plant and the implications for the quality of fishery habitat and access for angling.

Habitat quality through the impacted reach was considered to be poor for trout but probably quite favourable for a range of coarse fish species, even if angling for them might prove difficult. It is debatable whether the quality of habitat available would significantly improve for trout, even if the excessive weed growth were checked. This is because the channel long section appears to be

Typical section of the lower river with central channel locations choked with pipe reed.

A big concern to members of the BEFS is the current condition of the bottom beats, where the excessive growth of pipe reed has made access for fishing extremely difficult. Compared to the water on the two upstream beats inspected, the lower reach has only limited potential for holding adult trout. That said, slow flowing, flat beats located in classic coarse fish zones often hold the occasional exceptionally large trout that predates on coarse fish. Resolving the problems associated with the pipe reed blocking the channel will be difficult and could potentially require considerable resources. Three possible options are available to the syndicate.

Some mechanical removal of clumps of plants in key locations to encourage a narrow self cleansing channel would be more sustainable. The advantages are that certain sections would be still be fishable and that valuable cover and habitat for fish would be retained. To target small clumps of plants, a winch

- Follow up contact with CEH over a possible research project aimed at finding a sustainable solution to the pipe reed problem on the lower beats.
- Do not be tempted to opt for the wholesale removal of all emergent plants but seek partial control to allow access for coarse angling methods.

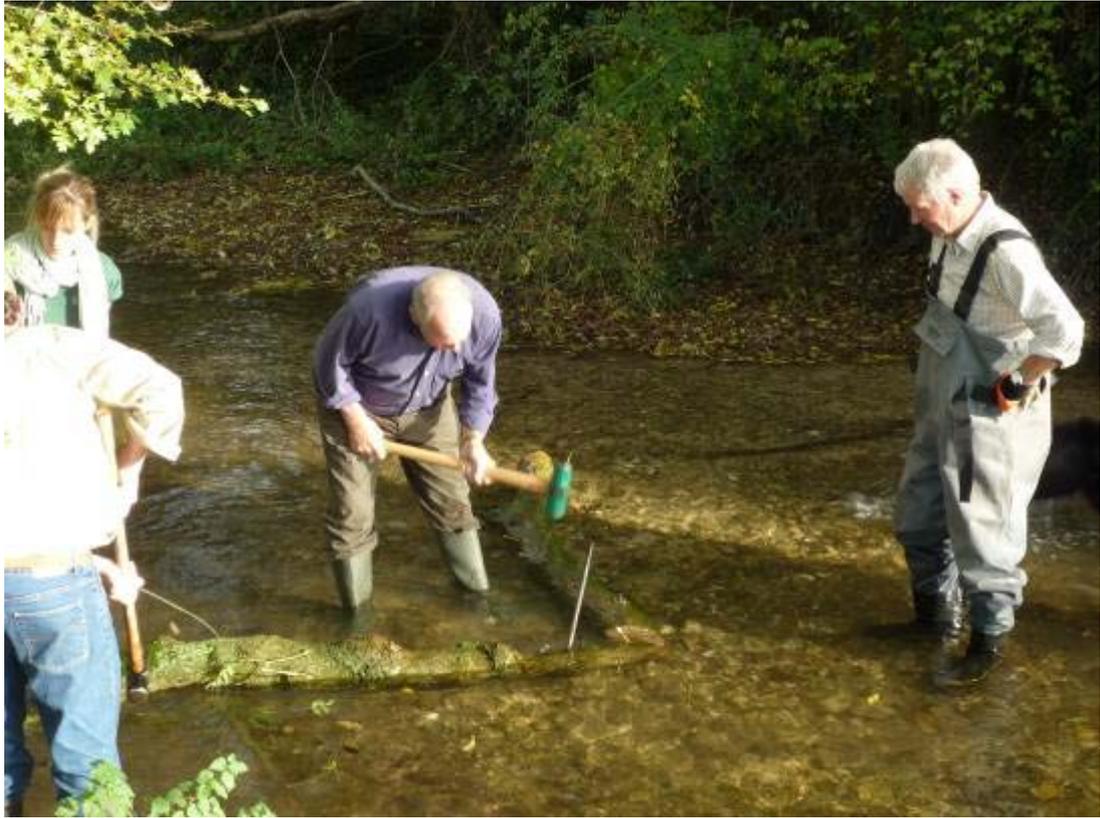
A small upstream "V" deflector secured with steel rebar on the River Ebble

In the absence of any naturally fallen woody material it is possible to peg in LWD to strategically selected areas. Securing a simple log at right angles to the flow or installing a small upstream "V" deflector on a shallow riffle or glide will not only improve gravel quality but will provide a temporary holding spot for a pre-spawning adult, or perhaps promote parr holding habitat on a riffle. Large trunks or logs can be won locally during work parties and either drilled with a wood – auger and nailed to the river bed with steel bar (see photo page 11), or staked and wired to ensure stability.

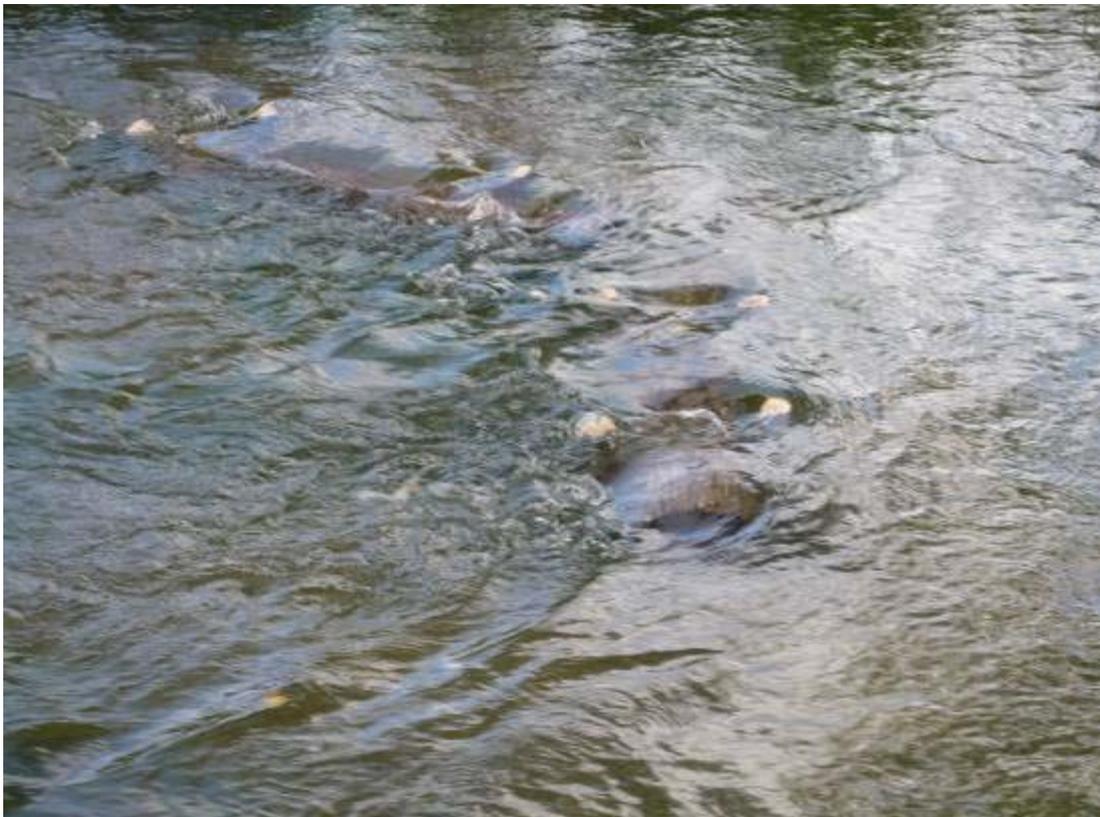
Trunks pegged in and secured with driven stakes and wire

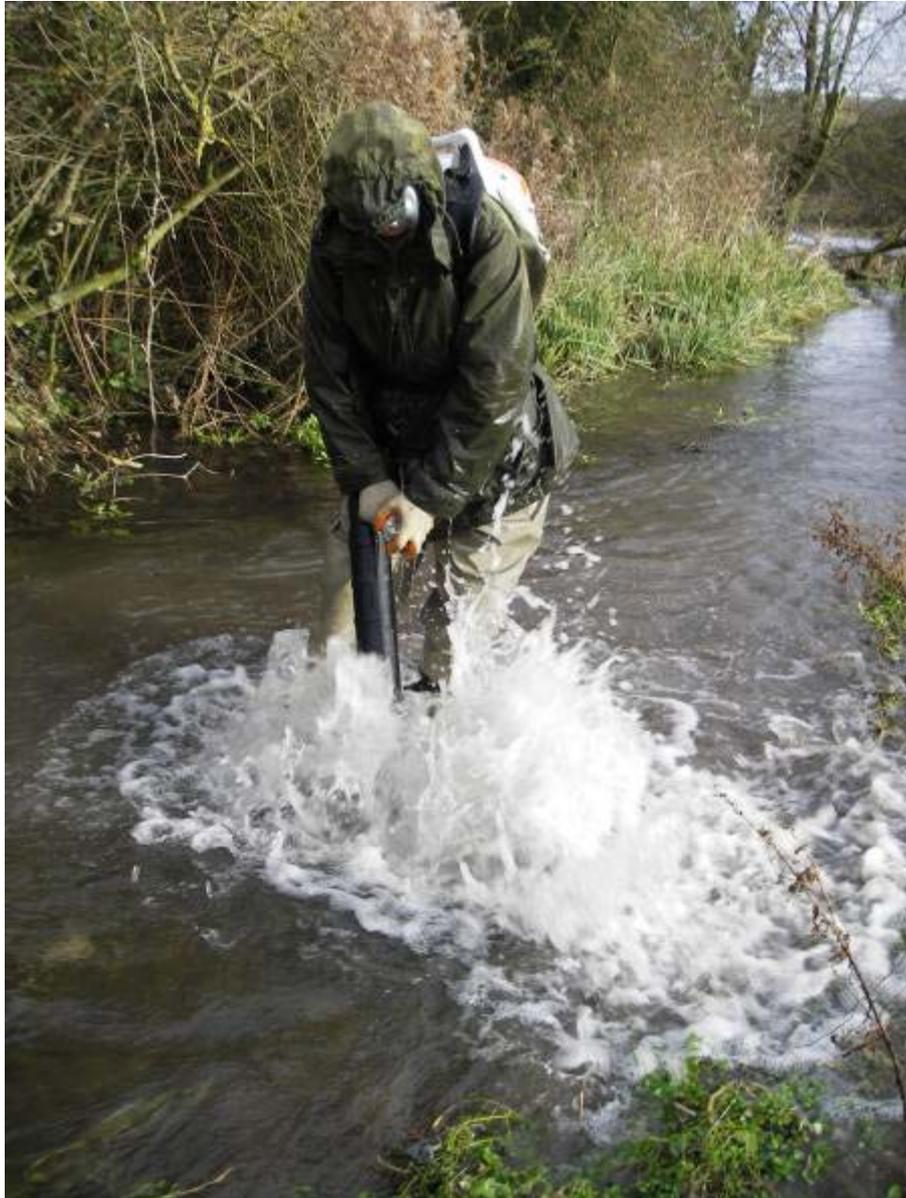
Gravel washing using a back-pack leaf blower

Improvements to spawning success can also be made by breaking up the existing gravels and thoroughly raking the fine sediments out of them just prior to spawning in the autumn. An effective method is to use a high pressure pump and lance or on inaccessible sections a back pack leaf blower. Eye protection must be worn when using these techniques.

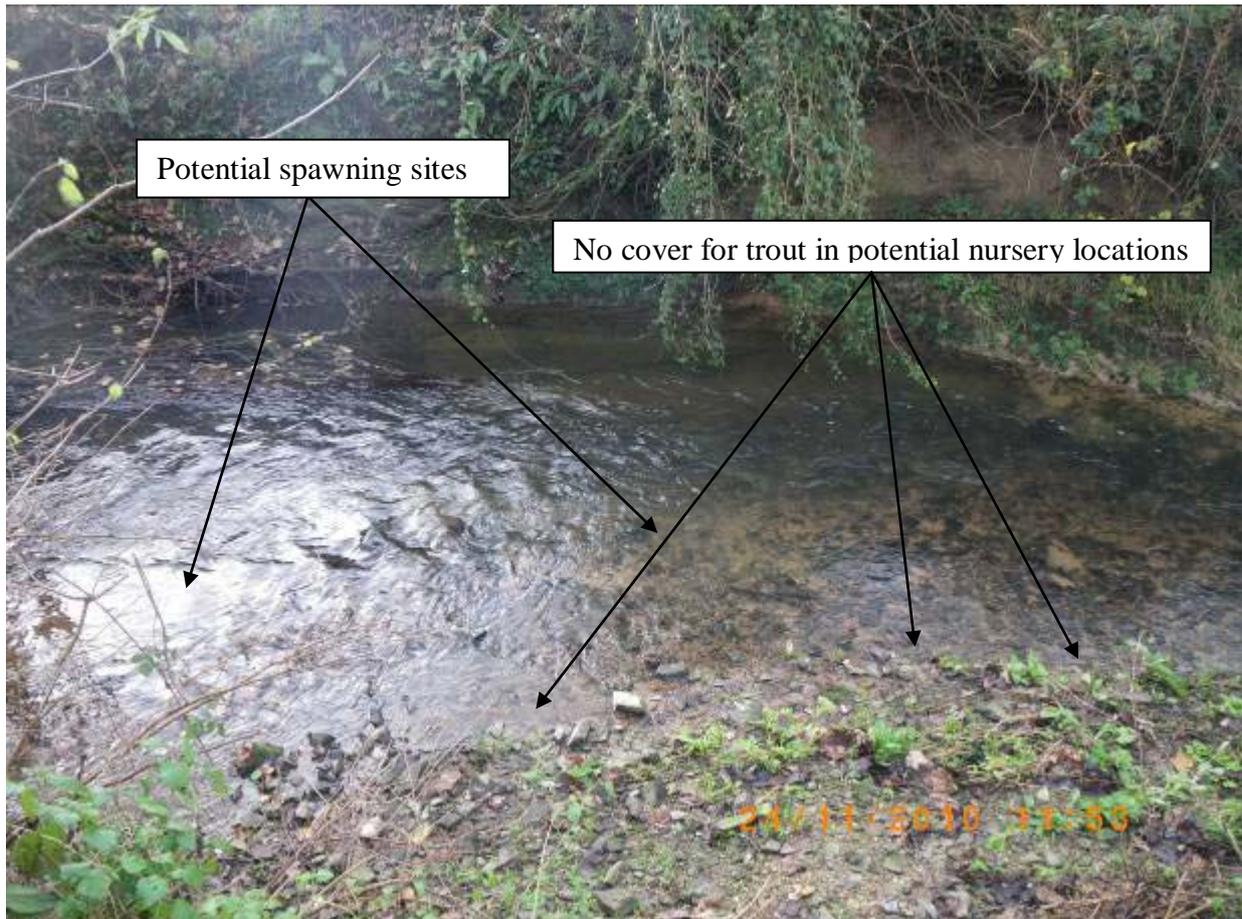
A site on the Little Avon where the provision of cover in the shallow margins could make the most out of potentially good habitat

To make the most out of any improved trout production it will be important to ensure that there is adequate nursery habitat adjacent to any spawning sites. Huge losses of fry and parr can be expected due to the lack of adequate nursery habitat. The closer this is located to spawning sites, the fewer the losses. All juvenile trout require individual micro habitats to hold, feed and grow up in. They like to be out of sight of each other and actively seek out sites which make predation from birds or adult fish more difficult. Trout fry in particular initially migrate to the very shallow margins where there is minimum depth and flow and hopefully some scrubby cover provided by vegetation, coarse woody debris, brushings or possibly small stones or cobbles which they can hide under.

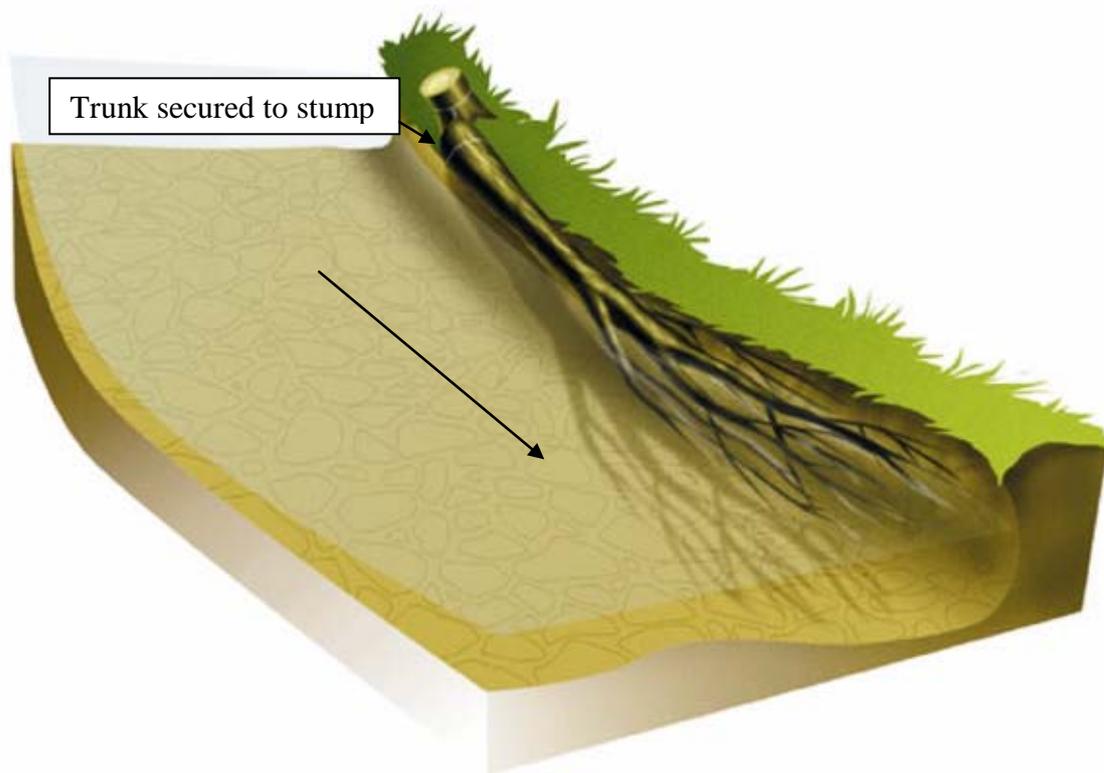
A "tree sweeper" cabled to its own trunk and dropped into the shallow margins of a featureless section of channel to create ideal cover for fry and parr

An alternative method is to either drop an entire tree, brushings and all, into the river and either secure it to its own stump or cable it to adjacent live tree with 8 to 12mm braided galvanized rope. These trees when laid flat into the margins are sometimes known as tree sweepers and can also be used to arrest erosion.

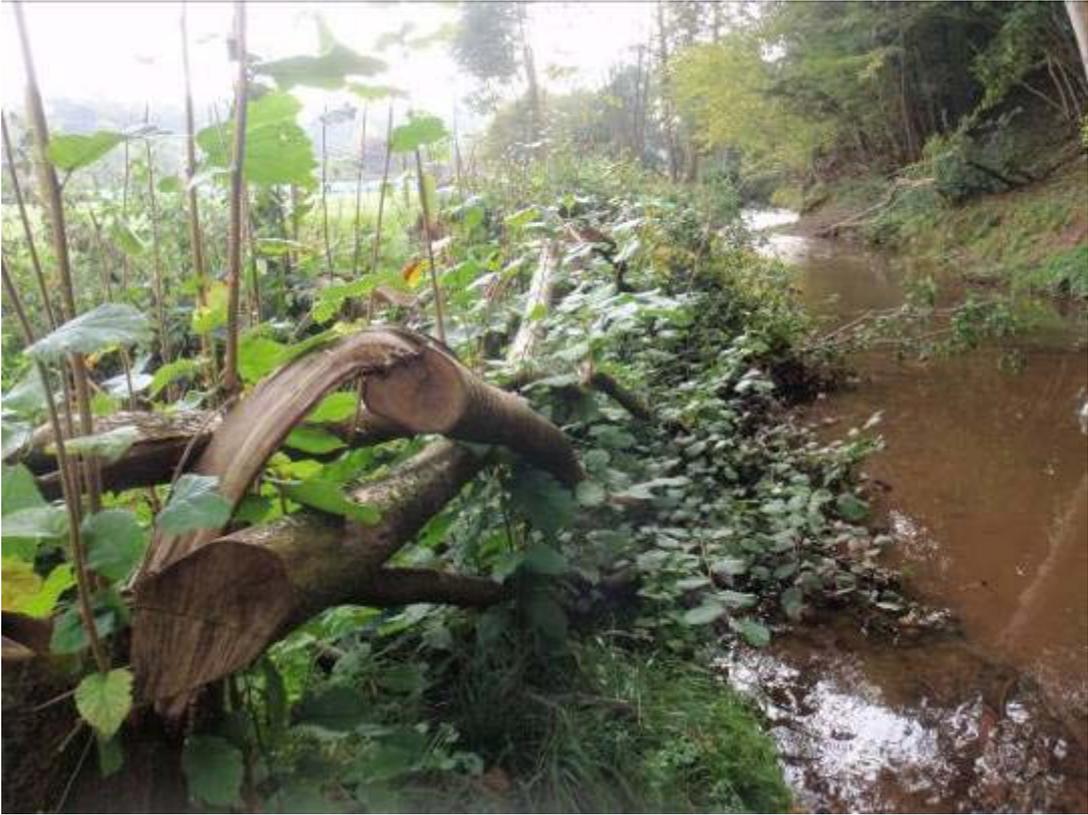
Hinging live alder trees into the margin of a shallow glide to provide superb cover for juvenile trout.

local trees, which can be partially cut through the trunk and hinged down into the margins. The technique for hinging is very similar to a scaled up version of hedge laying and is a method that works exceptionally well with alder and willow. See the photograph on page 15

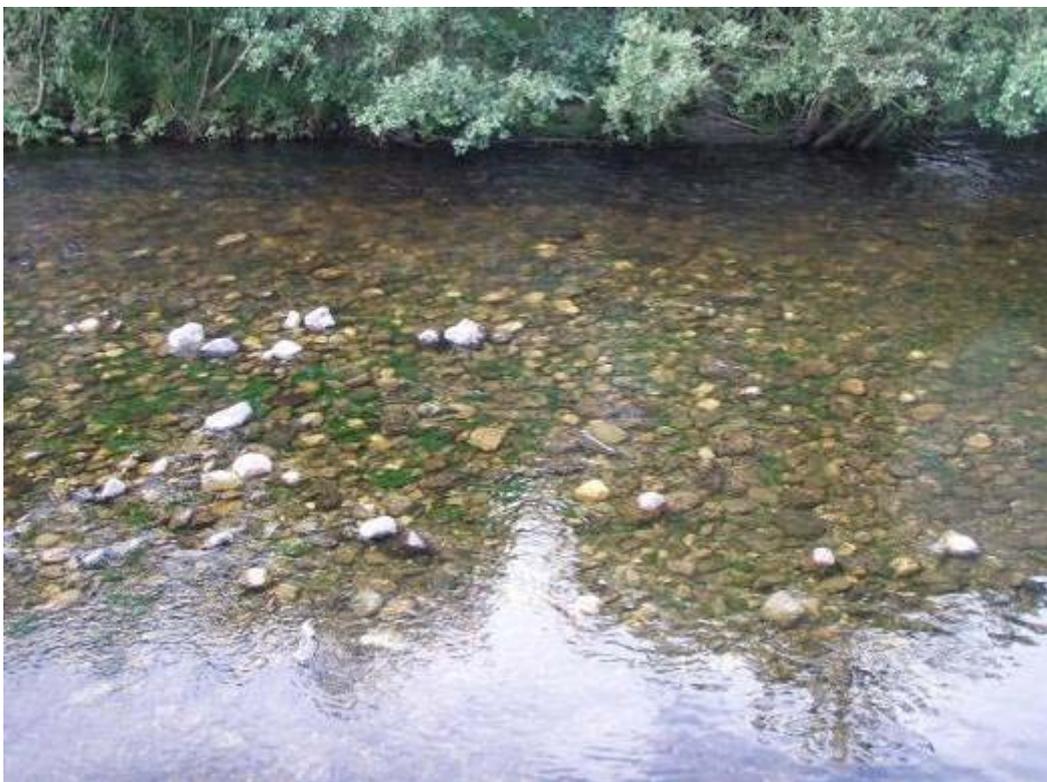
Cobbles on dotted onto a very shallow riffle can provide good habitat niches for small trout parr

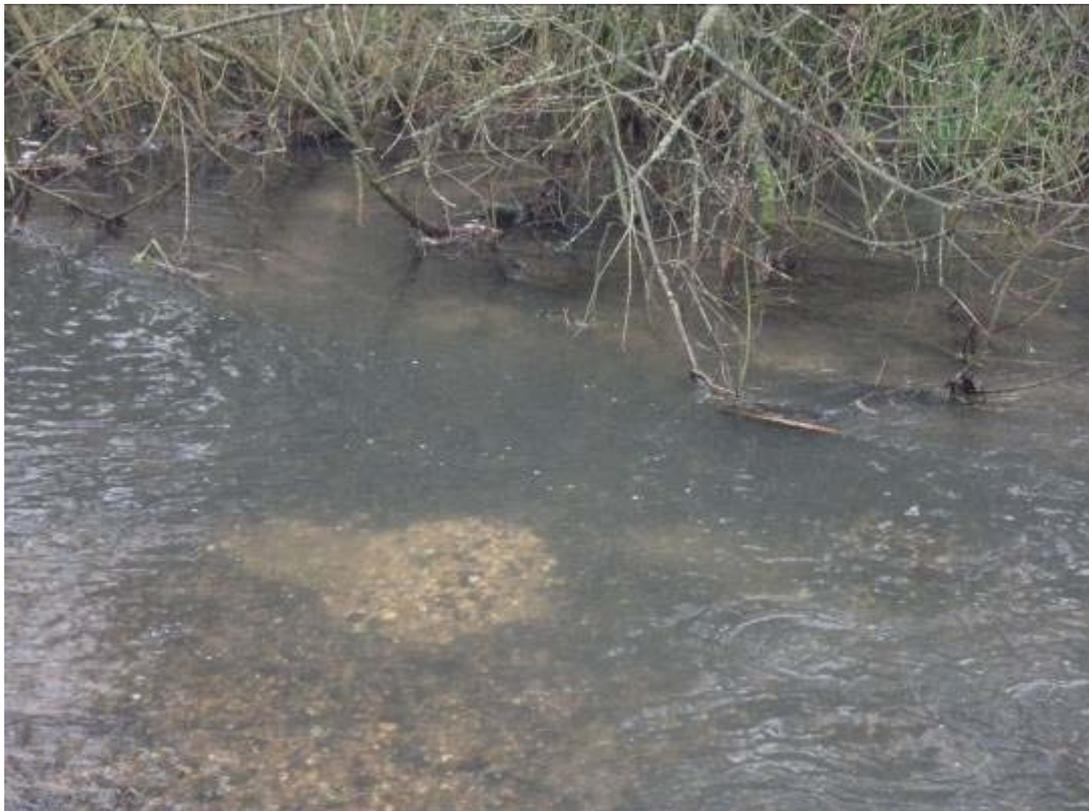
Goat willow brash in the margins of the River Lark. Note the redd nicely located adjacent to perfect marginal cover.

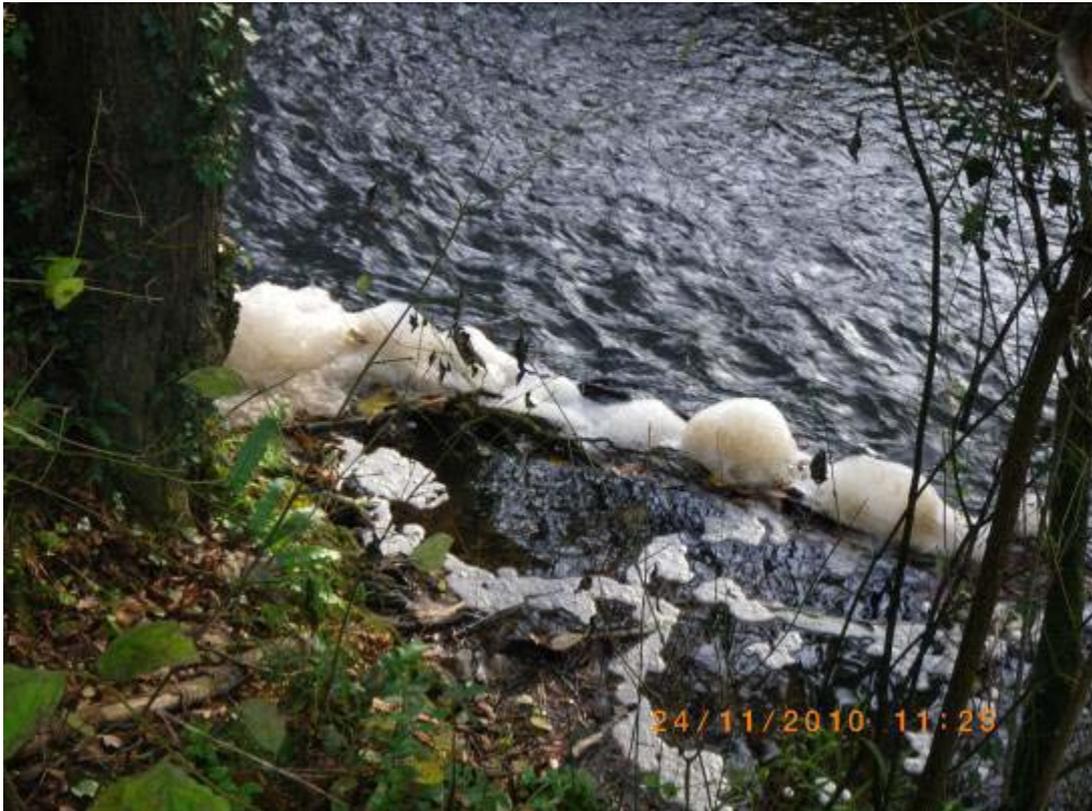
During the inspection of the top beat some foaming was observed. Foaming can sometimes occur naturally, especially in spring and summer due to certain types of algal growth but it is unusual to see excessive foaming during the winter months. It is understood that there is a waste water treatment works which discharges into the Little Avon a short distance upstream. It is worth making some enquiries with the local Environment Agency regarding the performance of this works. Members should be encouraged to report any future sightings of

Some foaming seen near the top boundary. Excessive foaming should be reported to the EA.

excessive foaming to the EA via the emergency hot line number 0800 807060 where the call will be logged and the incident investigated.

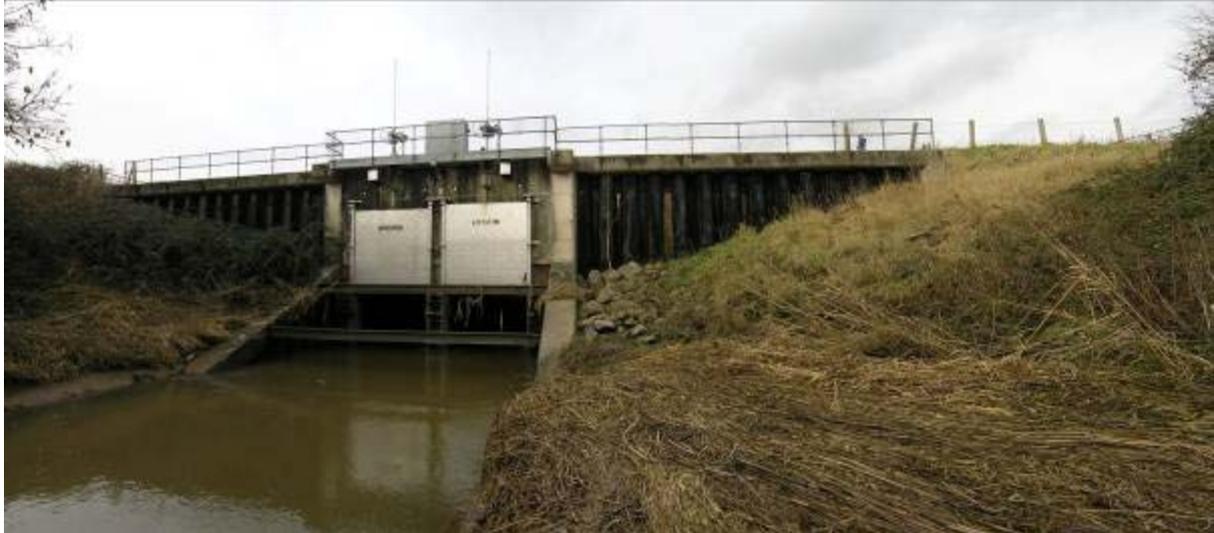
The very bottom section of the river was not inspected but it is understood that the freshwater river is protected from tidal flooding by a set of automated hatches. Rivers running into the Bristol Channel are not particularly noted for extensive sea trout populations. This may be partly due to the exception tidal currents that exist in this area and even if the tidal gates were removed it might not necessarily promote any significant development for a migratory component to the trout stock.

It is understood that reports are occasionally received of large trout being captured and these fish may well have migrated up from the estuary. The gates as they currently exist may have an adverse effect on trout migration but they are probably a crucial defence against tidal flood surges. The WTT does not advocate removal of such defences but there might be the opportunity to modify the gates to facilitate better access for migratory fish species. It is highly likely

The automated flood gates located at the bottom end of the Little River Avon. Structures like this can have a serious effect on free migration of migratory fish species.

that the local EA fisheries team has already evaluated the impacts of these gates on local fish populations. It is recommended that the EA is asked if the gates have been assessed for free fish migration and if there have been any issues identified or any plans put forward to modify them.

- Open up a dialogue with adjacent farmers to support and encourage the development of larger buffer zones to reduce sediment and nutrient input.
- Make some enquiries with the EA over any assessments that may have been made regarding access for migratory fish species.

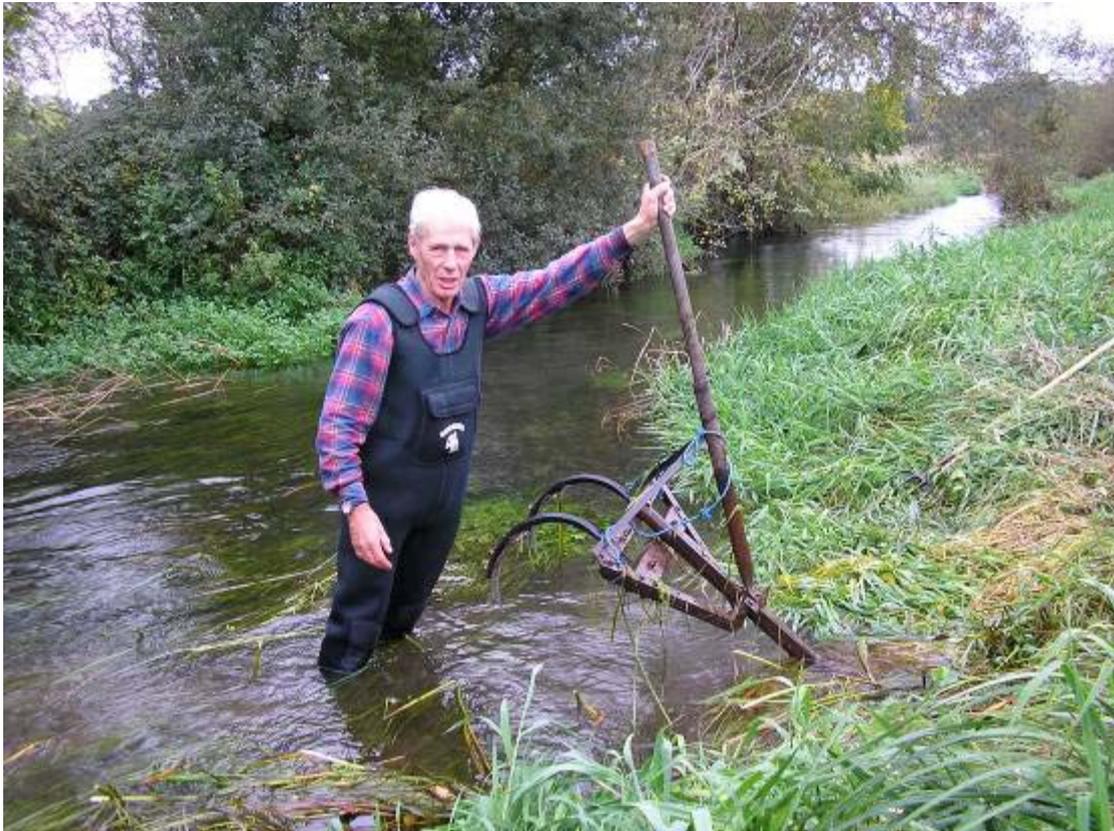
The "Ripper". A simple winch operated grapnel designed to grub out the roots of unwanted emergent plants.

mounted grapnel might be the ideal tool. The health and safety issues associated with this type of operation need to be carefully considered and control measures built into any risk assessment process.
