**WILD TROUT TRUST ADVISORY VISIT TO LOCH EYE (EASTER ROSS)  
and PRELIMINARY OBSERVATIONS ON THE RIVER TAIN, 28 March  
2011**

**By Dr Andy Walker, Ellwyn, Moulin, Pitlochry PH16 5ER**  
(Tel: 01796 472743; E-mail: [libisandy@aol.com](mailto:libisandy@aol.com))

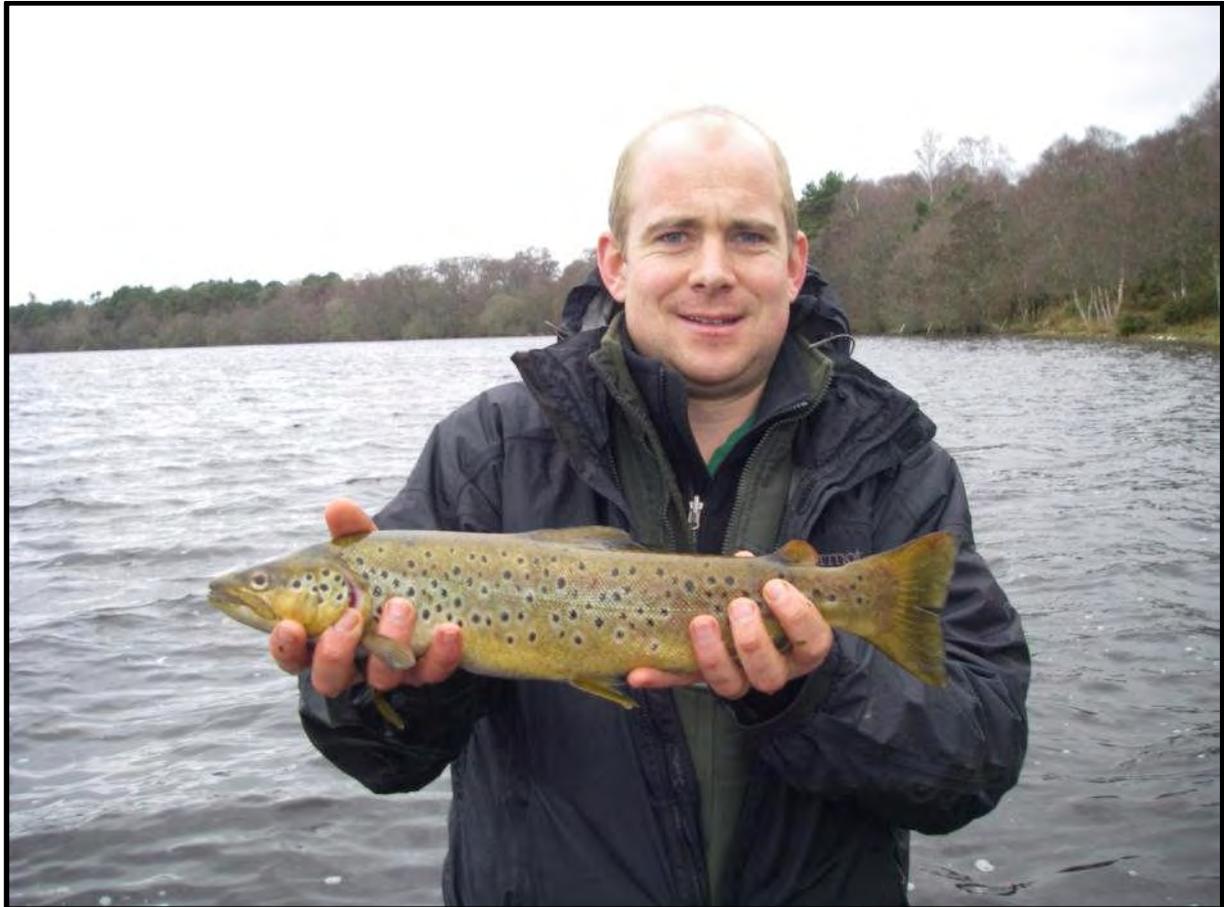
**Frontispiece: Loch Eye brown trout, sampled March 2011**

The three male and four female trout ranged in age from 2+ to 6+ winters and showed small amounts of growth after last winter. The most common dietary item, found in five of the trout, was small water boatmen (*Corixa*). Freshwater shrimps, hoglice, small sticklebacks, a large leech and small snails (*Planorbis*) also were found. The mayflies (Ephemeroptera) were not identified to species. The mature fish had not recovered fully from spawning and were slightly thin, justifying the April start of the angling season on the loch. The largest two specimens also had fairly large burdens of cestode (tapeworm) cysts, a common phenomenon in loch trout. Internal build-up of parasite burdens with increasing age is an important factor affecting eventual senescence and mortality. Wild trout in Scottish lochs often die by about six years of age, although some fish are able to survive much longer, notably specialist fish-feeders (*ferox*) and others present in waters at very low densities, where there is little competition for food.

The annual growth of Loch Eye trout can be inferred by plotting the observed lengths at age of the small sample. This suggests rapid and sustained growth, with individual fish reaching about 400 mm in length after four growing seasons (a bit less than two pounds). Trout measuring more than 500mm (weighing three or four pounds) are likely to be aged five or six winters. Most of the fish sampled had entered the loch from a spawning burn before completing one growing season, or soon after. Limited extent of parr habitat in the burns could be a factor leading to early migration age.

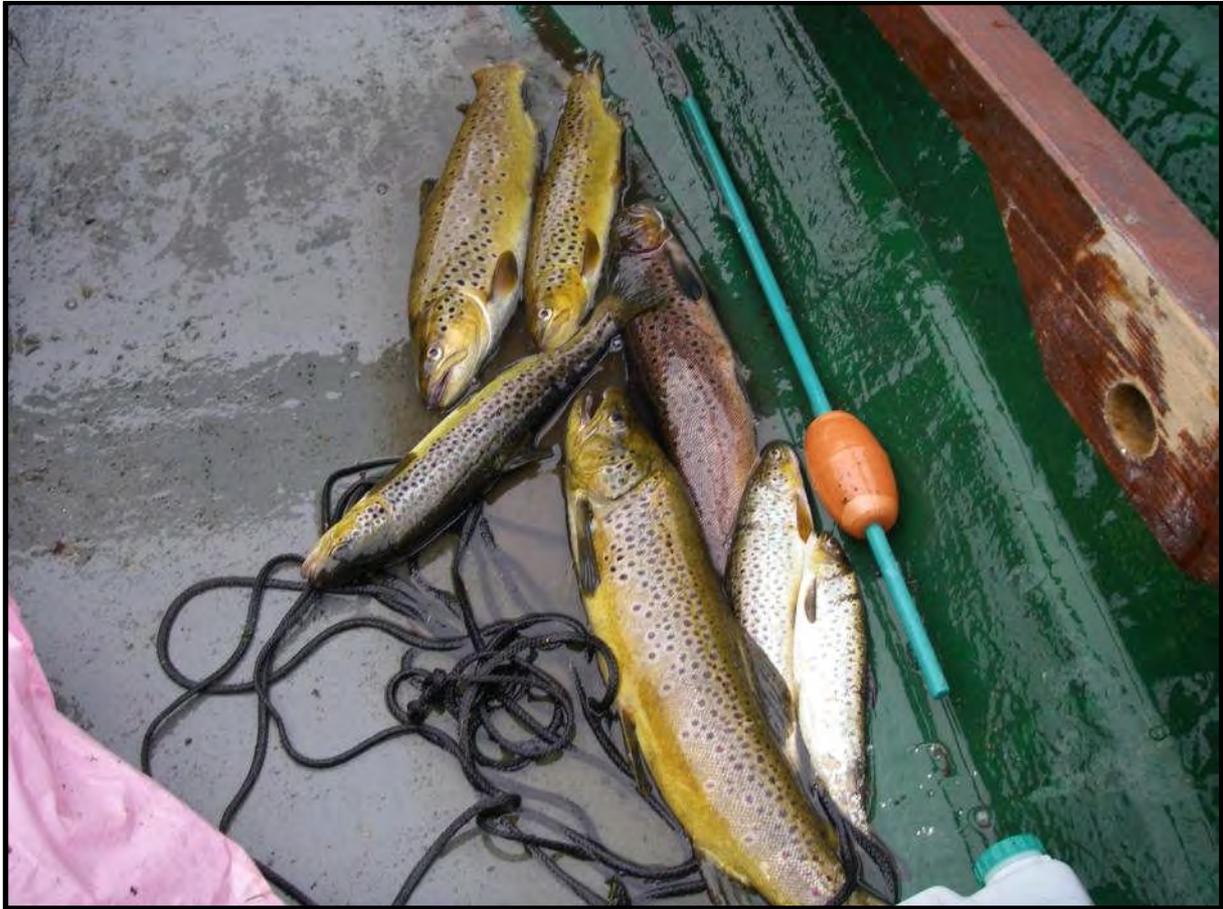
**Plate II: Gill-netting Catch at Loch Eye**

Limited sampling of the fish population was carried out during the advisory visit using a 50 metre long by 1.5 metre deep monofilament gillnet (60mm stretched mesh), set in the afternoon from the north-west shore (approx. NN822799) for two and a half hours. This provided seven brown trout ranging in fork length from 245 to 545mm (image shown above). These fish were killed for internal examination and scale sampled for ageing and estimated age at migration into the loch. Information about migration age could have been inferred from juvenile electro-fishing and length frequency analysis, but no such surveys have been carried out. Also, multi-mesh nets set to fish in darkness should have provided a better representation of the size and age structure of the stock, assuming an adequate catch and an even spread of the fish population. However, most of the trout that were sampled would have died if the nets were left overnight without lifting and only a small sample was required on this occasion.

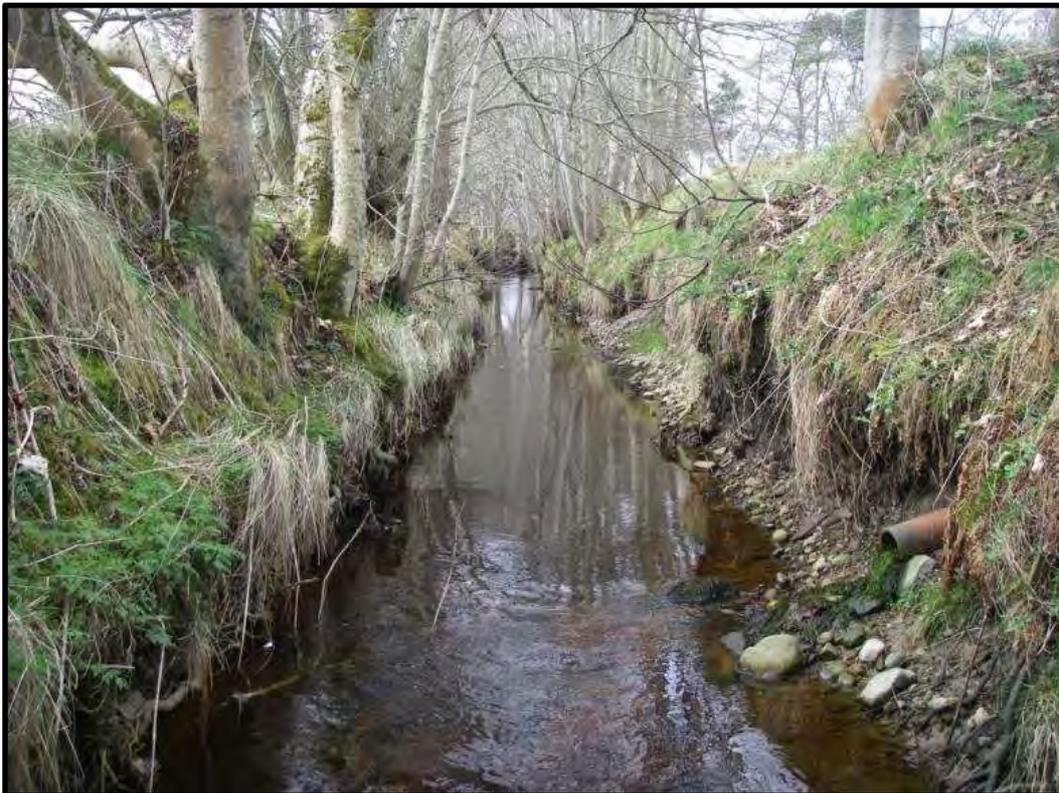
**Plate IV: Garrick Burn above road (showing deep trenching and smooth flow)**

This was exemplified in the **Garrick Burn** in the first two kilometres from the loch. Here, the straightening and re-alignment of the channel and lowering and scraping of its bed have resulted in a silty, featureless environment that must severely adversely affect its ecology and use for spawning and nursery production of trout (Plate IV).

Options are fairly limited for restoration of the lower part of the burn without a change in land-use and a cessation of periodic drainage operations that prevent the re-establishment of a natural stream morphometry (see DISCUSSION).

There is only limited scope for considering spawning habitat improvement in the three spawning burns entering Loch Eye because of their low gradients near the loch and the severity of past channelization for agricultural drainage which has removed all sinuosity, pool/riffle conformation and natural stream morphology. Restoration of adequate spawning and incubation conditions in these lower sections of the burns could be attempted using techniques explained in the Wild Trout Trust publications “The Wild Trout Survival Guide” (supplied) and the Upland Rivers Habitat Manual (available as a PDF download from the WTT website). These techniques include dropping large woody debris into selected bare parts of the channels, and by this means restoring elements of hiding cover and depth/flow diversity for trout juveniles and upstream migrant spawners. Cross-channel logs, plus some less formal structures, such as tree limbs “hinged” into the watercourse, would be appropriate here. In-stream structures should be spaced no closer than five to seven channel widths apart, the natural spacing between pools and riffles. Gravel suitable for spawning and selected larger stones may need to be reintroduced into sections

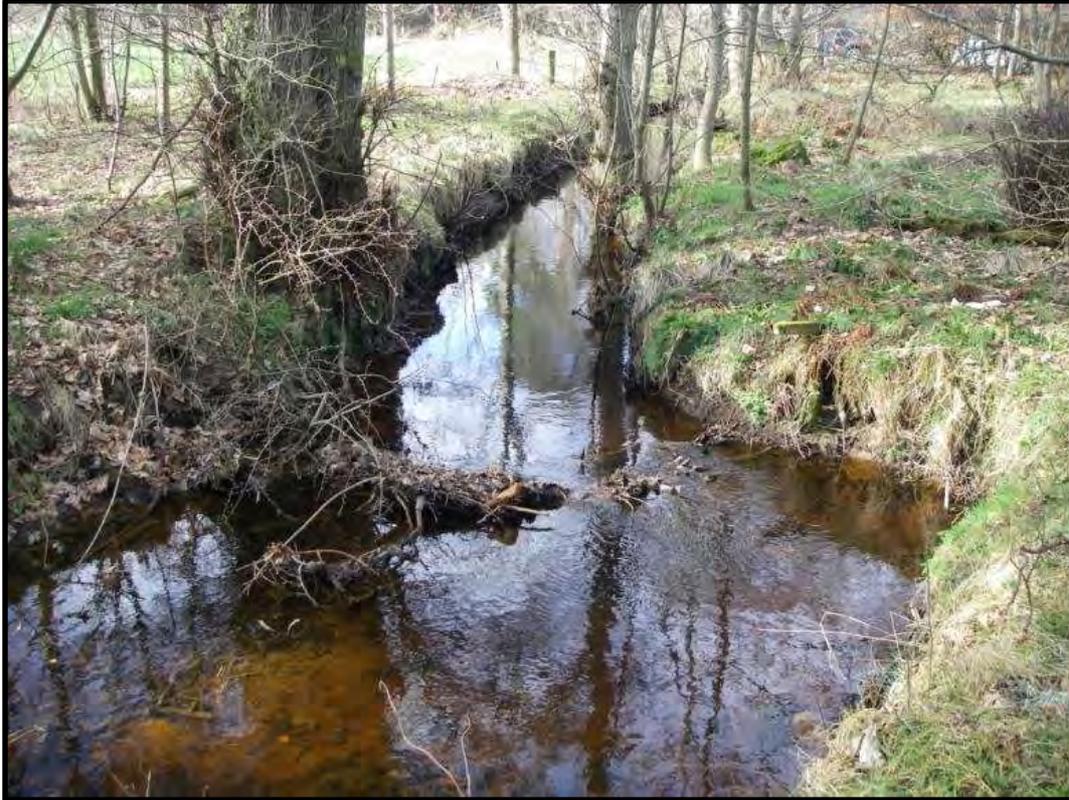
**Plate V: Lower reaches of Garrick Burn (low flows, but showing here some woody trash creating a build-up of gravel, some current deflection and bank erosion, but also cover for fish)**

There were very occasional points where tree roots and accumulated debris had caused some stream deflection and a brief return to pool and riffle conformation and stream sinuosity, but otherwise the channel was very uniform and severely lacking in cover for trout of all sizes.

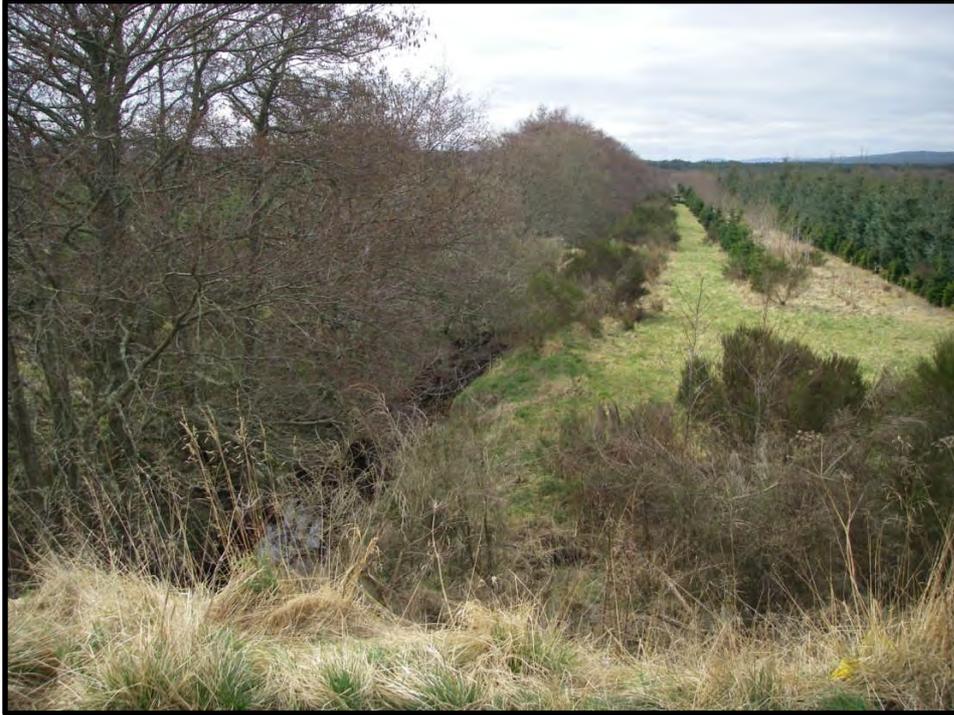
**Plate VI: Christmas tree plantation below Calrossie Woods (showing wide buffer zone)**

Further upstream is a relatively new conifer forest that Gregor Macleod described as “the Christmas Tree Plantation.” He was concerned that this was likely to further reduce the already low ambient flow regime in the Garrick. This may well be so, particularly if wet ground has been drained for planting. However, at least the plantation had been set back a reasonable distance from the burn and there were some planted and well as naturally growing riparian hardwoods, helping to mitigate the potentially harmful effects of planting conifers too close to the channel (For forestry best practice guidelines, refer to [http://www.forestry.gov.uk/pdf/FCGL002.pdf/\\$FILE/FCGL002.pdf](http://www.forestry.gov.uk/pdf/FCGL002.pdf/$FILE/FCGL002.pdf) and article in 2011 *Salmo trutta*, the WTT annual magazine)

Nevertheless, this newer forestry section lies beside the long length of severely straightened and excavated channel and the benefits accrued to juvenile trout production from the more sensitive approach to tree planting shown here may be limited.

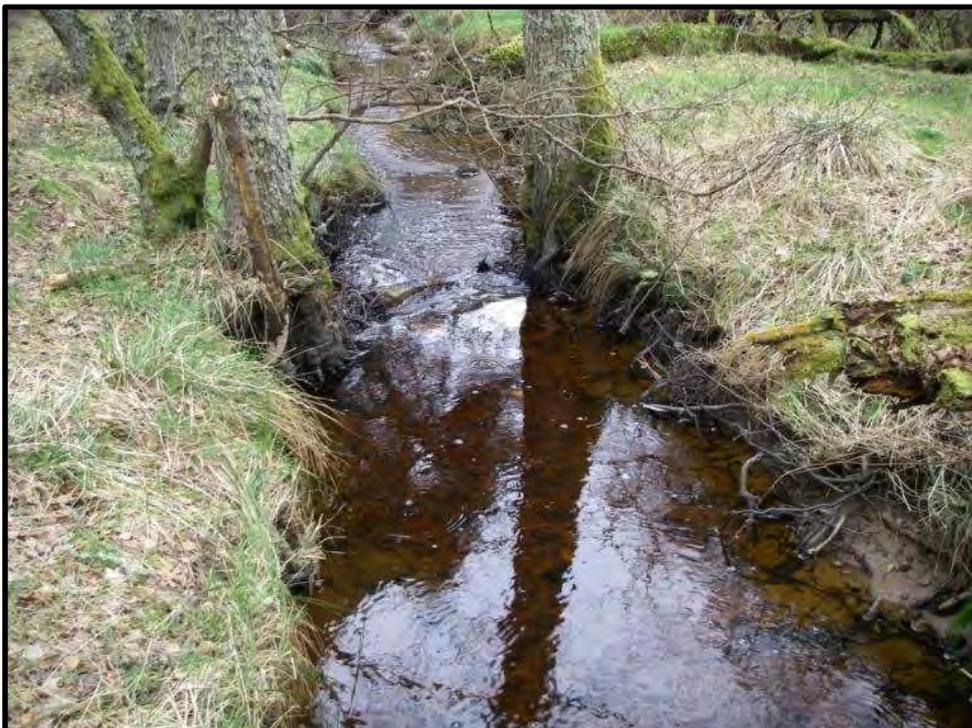
**Plate VII: Garrick Burn in Calrossie Woods**

Based on our walking survey, reasonable conditions for spawning only begin in the upper, medium-gradient, section, where the burn passes through Calrossie Woods and they continue at least as far up as the old and the new A9 road (ca. 0.75km).

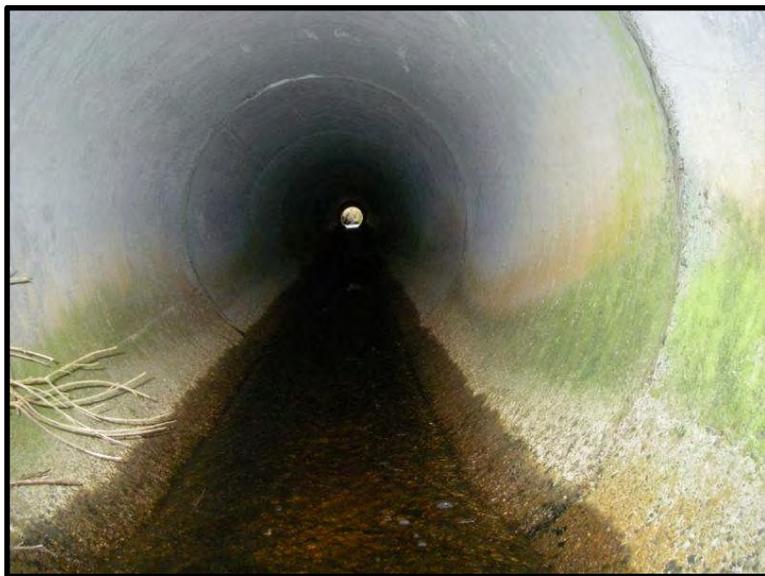
**Plate VIII: Culverts under the new sections of roadway may be a problem for upstream access of spawning trout (this one has a gravel substrate and seems okay)**

Use of areas of better spawning habitat further upstream will depend on whether the loch trout can negotiate the culverts beneath the roads. The long piped culvert beneath the old A9 looked passable because of its low gradient and established gravel bed, although it must carry a strong, laminar, flow at times of heavy rain and it may be a barrier to migration at such times. In this case, baffle boards could be installed to break the flow and ease passage (see article in *Salmo trutta* 2011). It was not possible to inspect culverting beneath the new A9 carriageway, which may be longer than that shown below, because of limited time. Electro-fishing to establish juvenile densities above and below these potential obstacles would show whether Loch Eye trout can pass them and, if they cannot, consideration should be given to ways of improving passage.

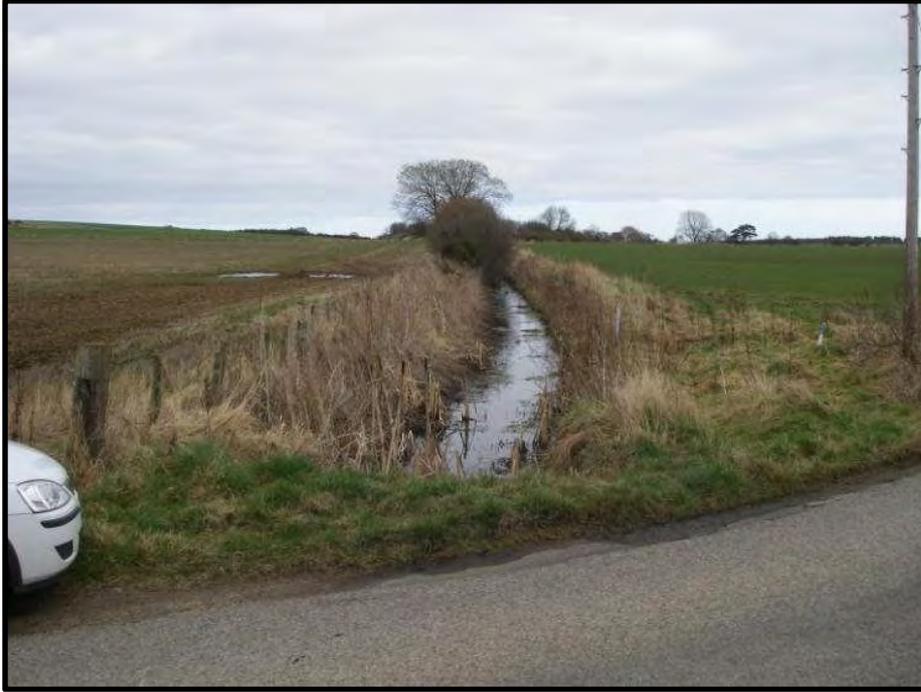
**Plate IX: Erracht Burn above road (looks unpromising, but the channel is steeper upstream)**

Above that bridge, there is a low-gradient, boggy and straightened section (see above), but the channel is steeper further up, although still deeply trenched and shallow, with few larger stones, or overhanging vegetation (partly or mainly due to the early time of year). Hence there is very little cover for parr and none for adult fish, although there is extensive, shallow, potential spawning gravel.

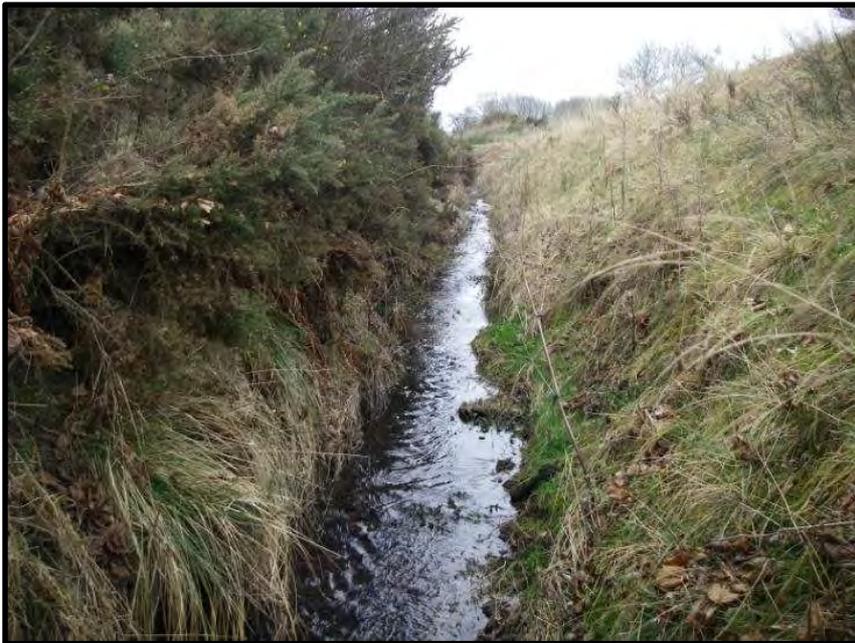
**Plate X: Erracht Burn further upstream contains better spawning habitat (but is still sub-optimal for depth and cover)**

Adult trout should be able to reach this section through the shallow double-boxed culvert under the road, but must do so when water flows are high enough to provide some cover from heron predation. Again, the use of this upper section by adult loch trout should be confirmed by electro-fishing for juvenile density data above and below the bridge.

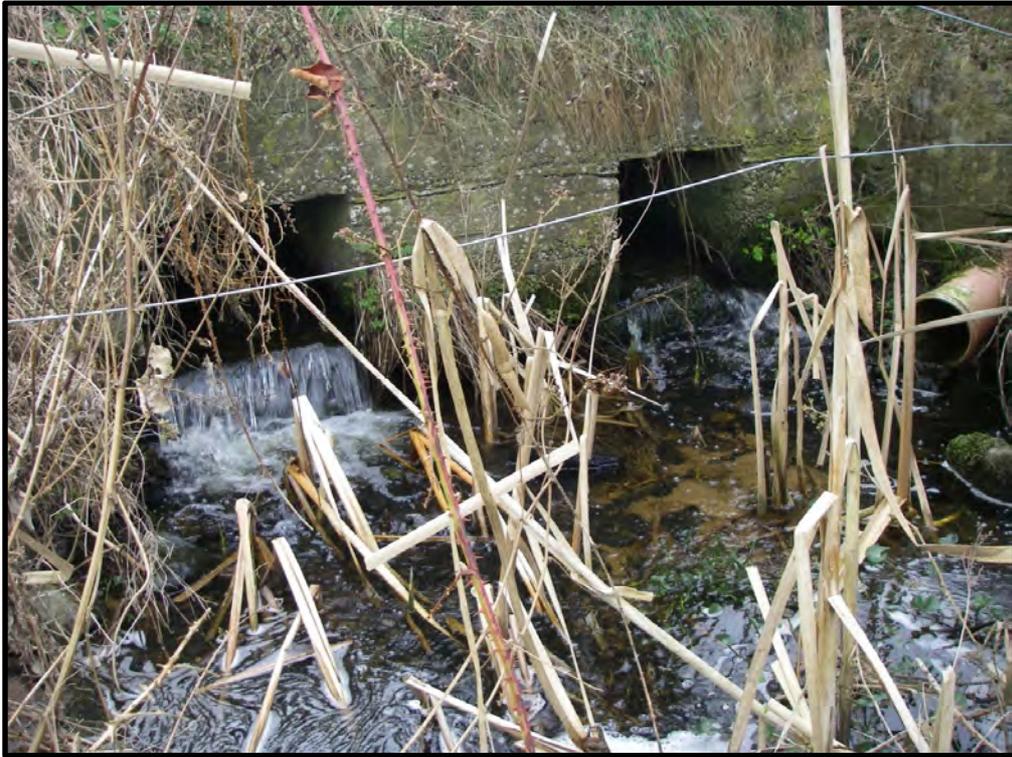
**Plate XI: Erracht Burn below road bridge**

The same stark conclusions were reached after a brief look at the lower reaches of the **Loinnbuie Burn**. On the other hand, the **Erracht Burn**, situated at the east end of Loch Eye, had a 'chuckling' flow as it passed underneath a minor road, some 400 m from the loch and it appeared to be less silted than the other two tributaries. However, apart from a few metres length below this point, the burn flows down to the loch through a boggy area of scrub woodland, difficult to penetrate on foot. Apart from just below the bridge, there seemed to be little or no spawning habitat in that section and its low gradient there is not conducive to easy creation and maintenance of good spawning conditions, although there might be some possibilities near the bridge.

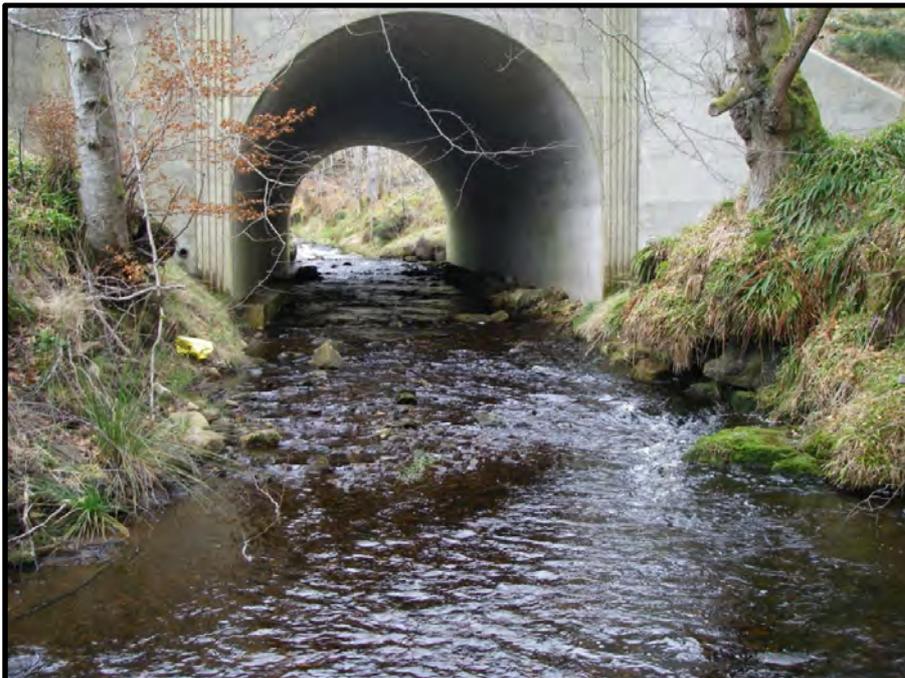
**Plate XII: River Tain in Glen Adie (OS NH760797)**

In the section of upper reaches visited, the river flows over sandstone bedrock, with mixed cobble and gravel and appears to be base-rich by Highland standards. Iain McMyn has previously reported finding high densities of juvenile trout by electro-fishing in lower sections of the river. However, we found that the conifer trees in part of the upper area that we visited had been planted up to the edge of the river without leaving a twenty metre buffer strip, or a hardwood belt, on each bank, as advised by current forestry planting guidelines. In addition to buffer strips, consideration should be given to mixed planting of hardwood trees and conifers well back into the plantations. The presence of deep-rooted hardwoods which can be left in place during felling will buffer against sediment and nutrient mobilisation when conifer felling takes place. With harvestable trees growing very close to the river channel, problems of erosion and heavy siltation are likely to occur downstream when they are removed. Also, many of the forest drains entering the river run down steep valley sides and can discharge considerable quantities of silt.

It would be worth consulting with the owners of the forest about their plans for harvesting and ways to mitigate harmful effects of timber extraction upon the river. Ideally, the whole of the upper half should be surveyed on foot, using a hand-held GPS and digital camera images to fix coordinates and identify positions so that problems sites can be scheduled into a detailed programme of action. Sections where the old trees are too close to the river need to be specified for remediation as soon as possible. Small side burns must not be neglected as they may contain potentially excellent habitat for trout spawning. Eroding drainage ditches may be blocked in flatter areas, well back from the point of discharge to the

river, to act as silt traps. In-river woody debris that is not blocking fish migration should be left in place as cover. Natural barriers to fish migration need to be recorded and assessed in conjunction with juvenile salmonid electro-fishing surveys carried out upstream and downstream. Some may be suitable for easing. Similar surveying has been carried out recently on the River Peffery by Dingwall, with practical help from the Wild Trout Trust, in conjunction with The Moray Firth Sea Trout Project and the Conon District Fishery Board. Lessons learned there will be transferable to the headwaters of the River Tain. The Peffery project is a good example of an ecologically holistic and multi-partner approach to solving problems in and around river corridors, where everybody gains.
