**LOCH DEE SPAWNING BURNS –  
HABITAT SURVEY**

**PREPARED FOR NEWTON STEWART AND DISTRICT ANGLING  
ASSOCIATION**

**2007**

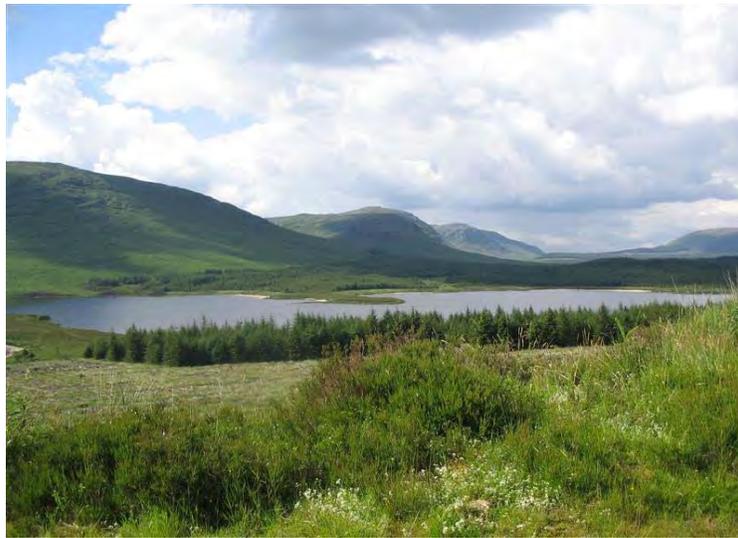
*Figure 4.1.1: Loch Dee from the south*

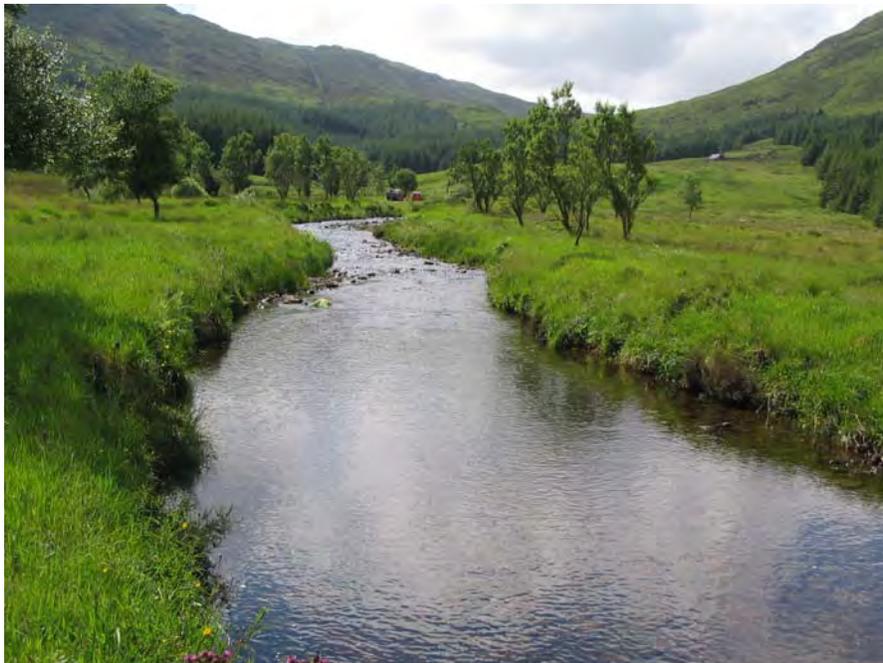
*Figure 4.2.2.1: Section WLB2. An improvement in instream cover due to the presence of boulders can be seen towards the top of the section*

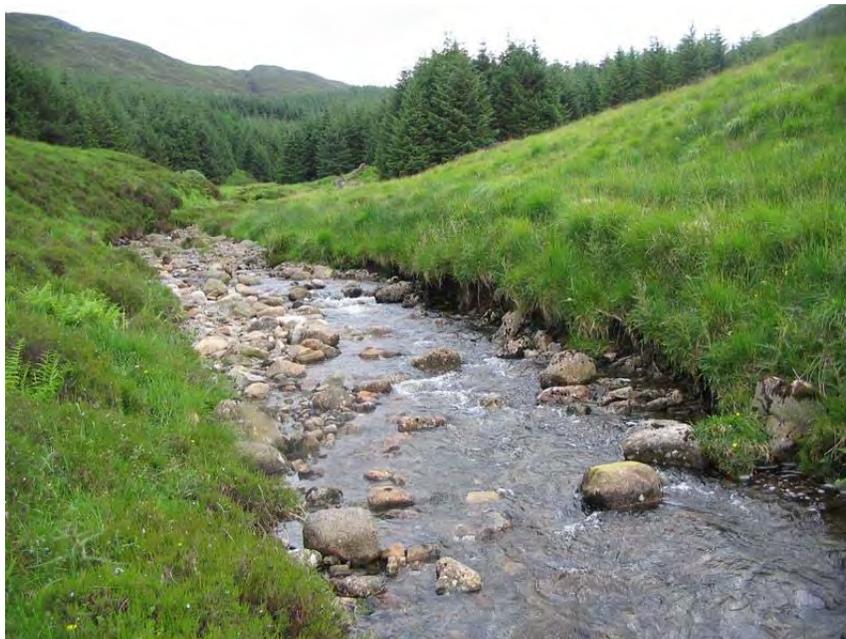
*Figure 4.2.2.2: Instream cover improves from moderate to good in section WLB4*

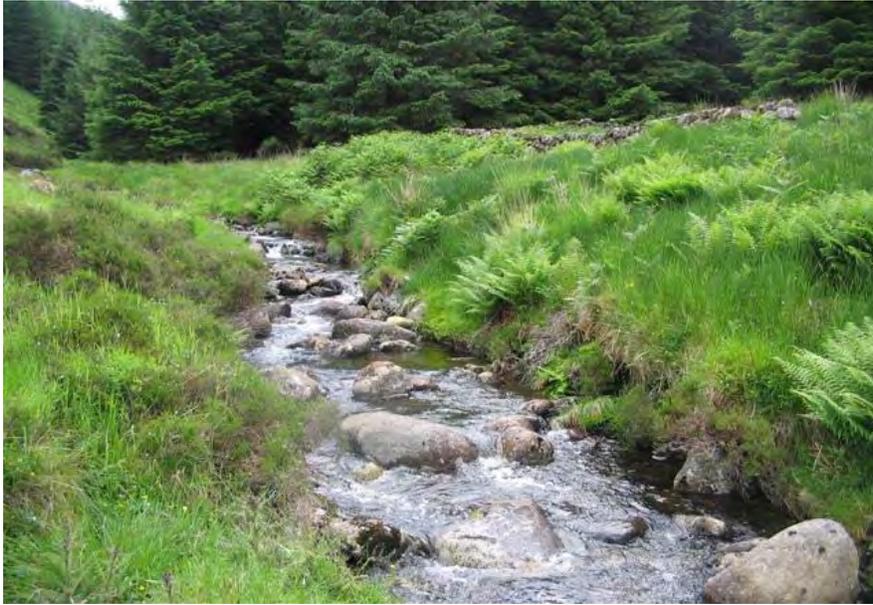
*Figure 4.2.2.3: Good parr habitat in section WLB5. Slower deeper water was present, with more boulders to provide Instream cover*

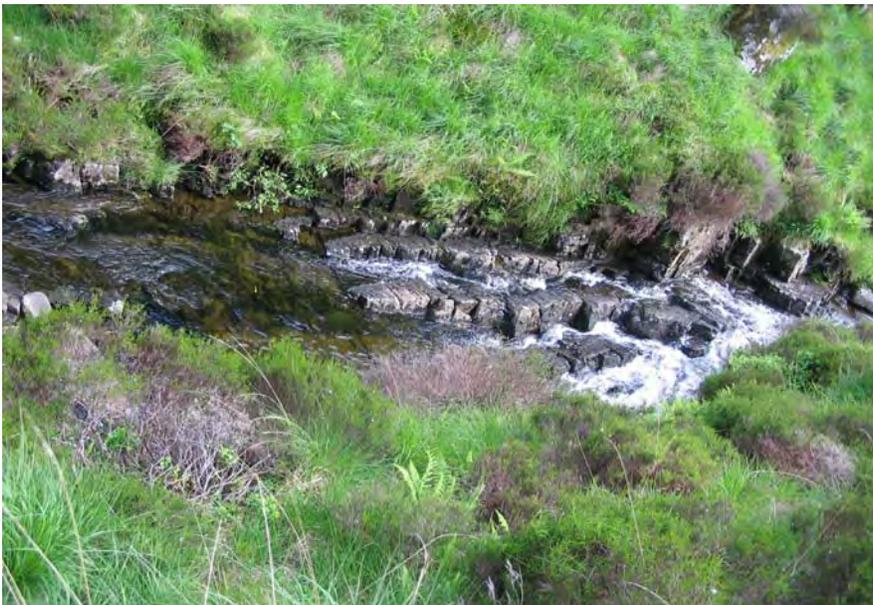
*Figure 4.2.2.4: Bedrock becomes more dominant in upper part of section WLB6*

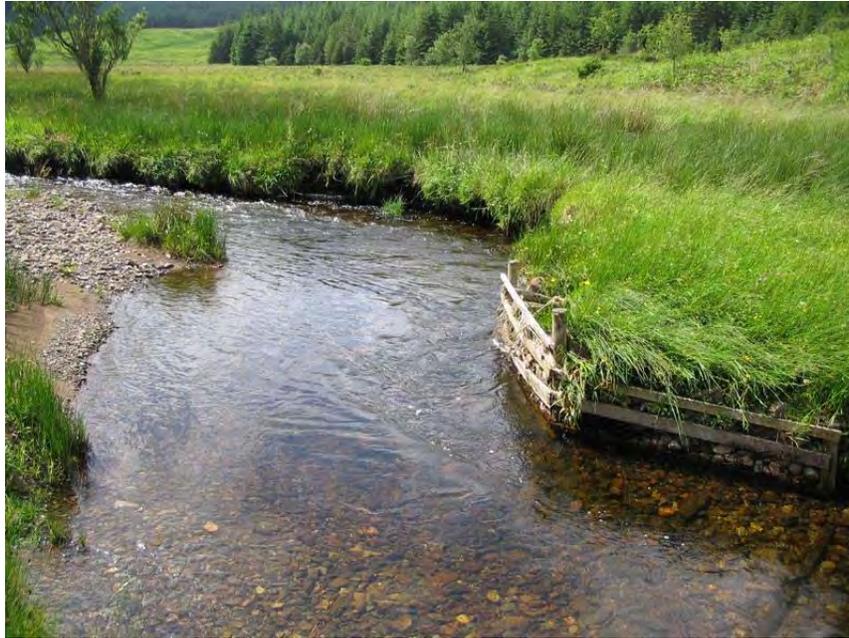
*Figure 4.2.4.1: Modification on left bank in WLB2*

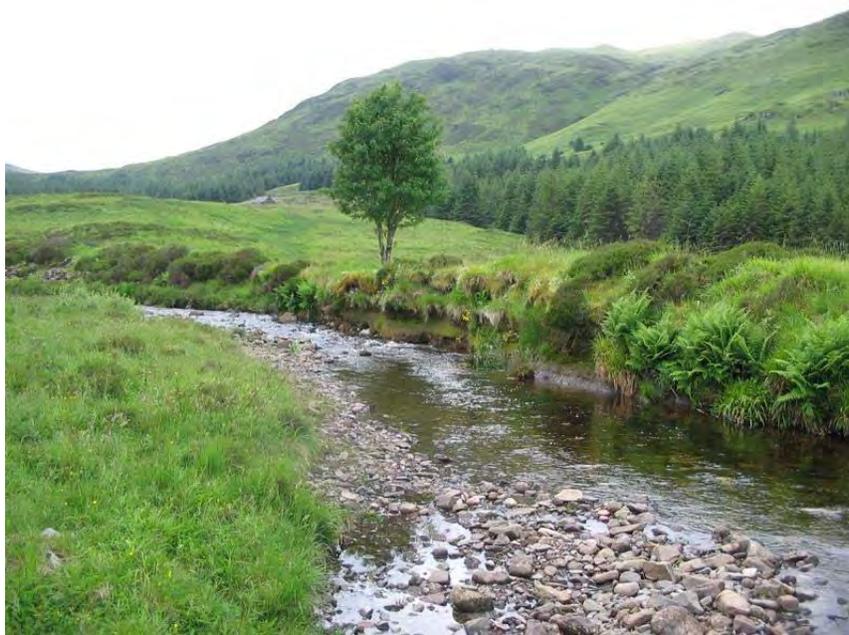
*Figure 4.2.4.2: Riparian zone becomes more diverse in WLB3, but due to a lack of water does not provide fish cover*

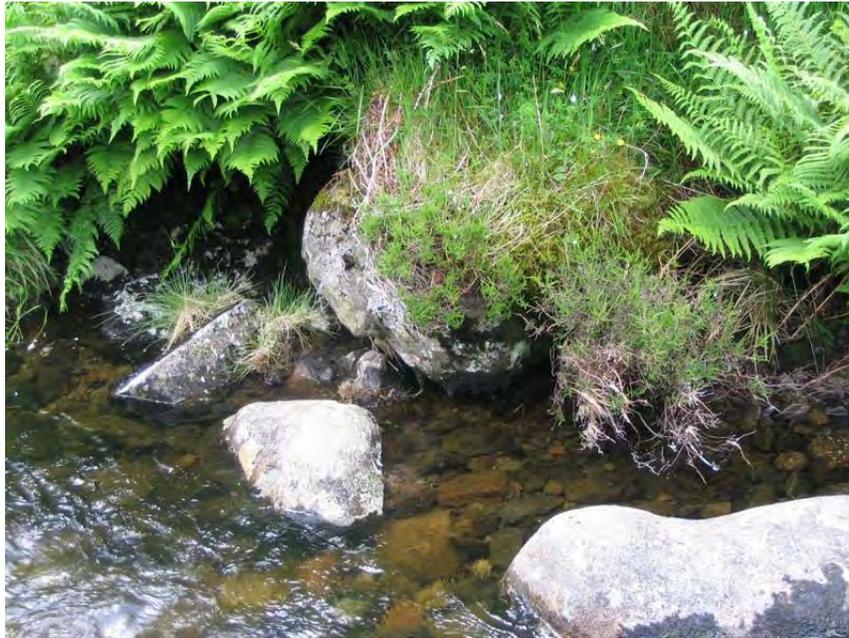
*Figure 4.2.3.4: Cover provided by ferns, heathers and boulders in section WLB5*

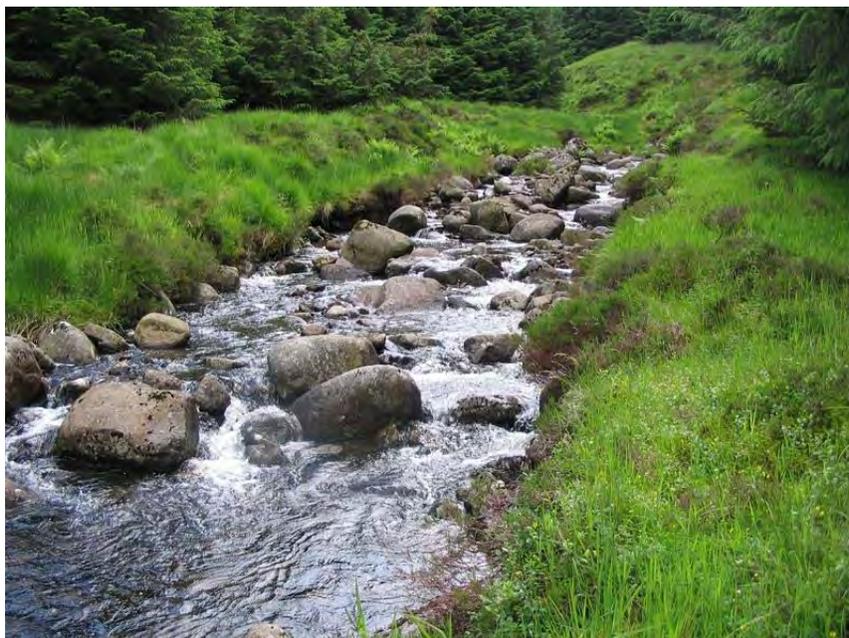
The land use in the upper part of WLB5 and WLB6 was coniferous plantation. Most of the burn in this area was 1 – 2 m in width and in some places exceeds 3 m in width. Under the Forests and Water Guidelines, where a burn is 1 – 2 m wide, trees must be planted at least 10 metres from the bank and where it is 3 m wide trees must be planted 20 m from the water. These planting guidelines do not appear to have been adhered to on the White Laggan Burn, where in a considerable part of section WLB6 conifers have been planted on average around 5 m from the burn (*Figure 4.2.3.5*).

*Figure 4.2.3.5: Planting which does not adhere to Forests and Water Guidelines in section WLB6*

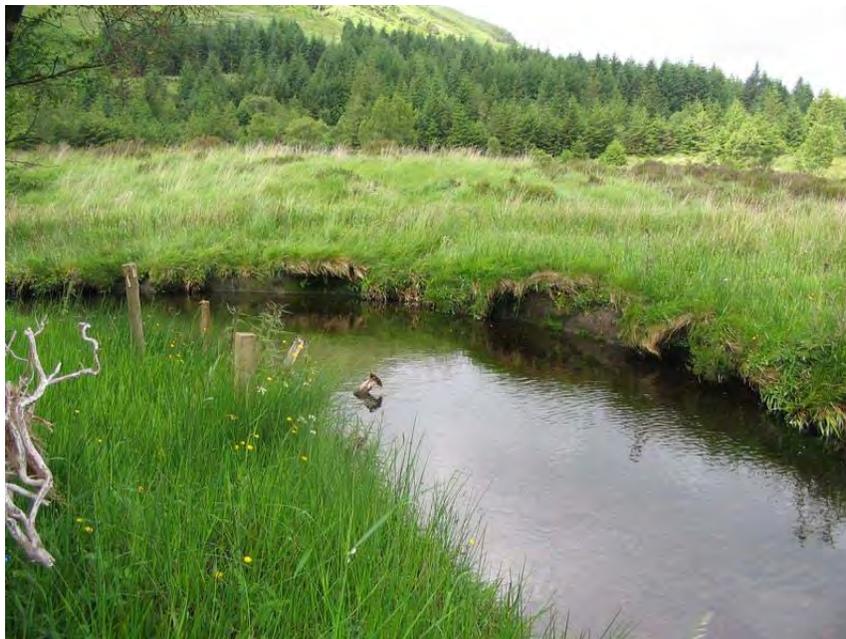
Sheep were observed to be grazing on both banks of the White Laggan Burn but at a low density. There was no evidence of overgrazing or trampling. A few areas were identified where banks had collapsed but this was thought to be due to spate conditions rather than the actions of livestock. The force of water was evident upstream of the fish trap, where some collapse on the left bank had been caused by back eddies possibly when water was held back by the trap.

*Figure 4.2.6.1: Bank collapse possibly due to presence of fish trap*

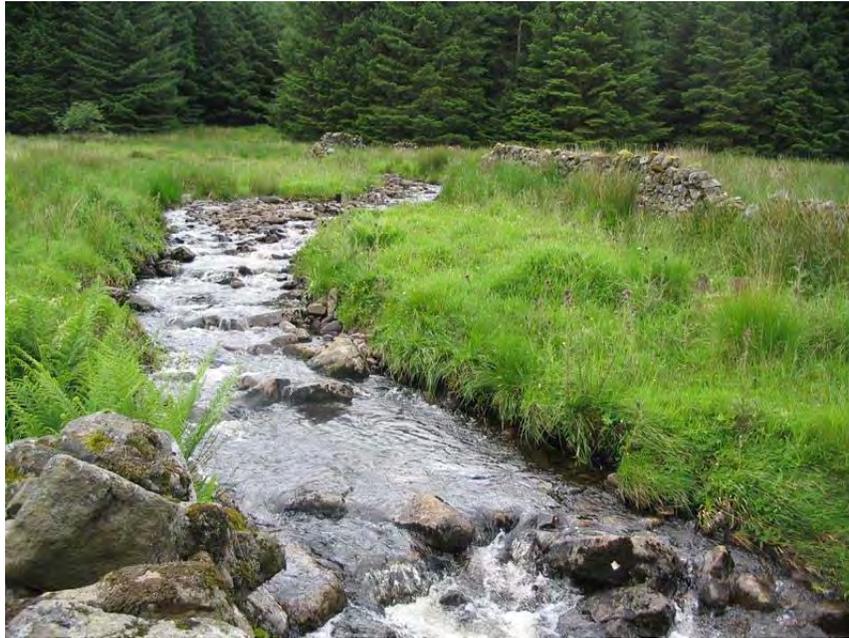
*Figure 4.3.2.1: Instream cover is excellent in the lower part of BLB1, with a variety of large substrates present in the substrate matrix and a range of depths*

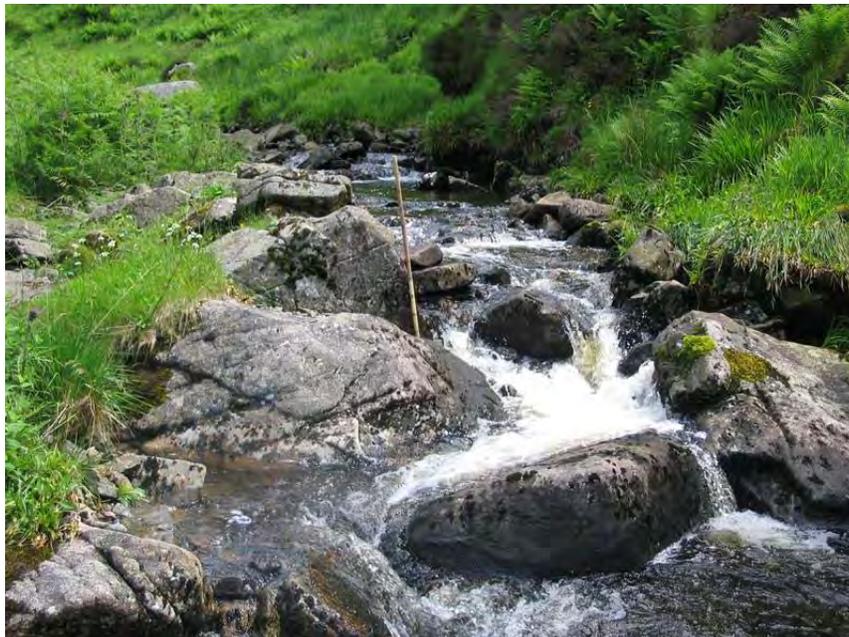
*Figure 4.3.2.2: In the upper part of BLB1, the burn's gradient increases and bedrock becomes more common in the geology*

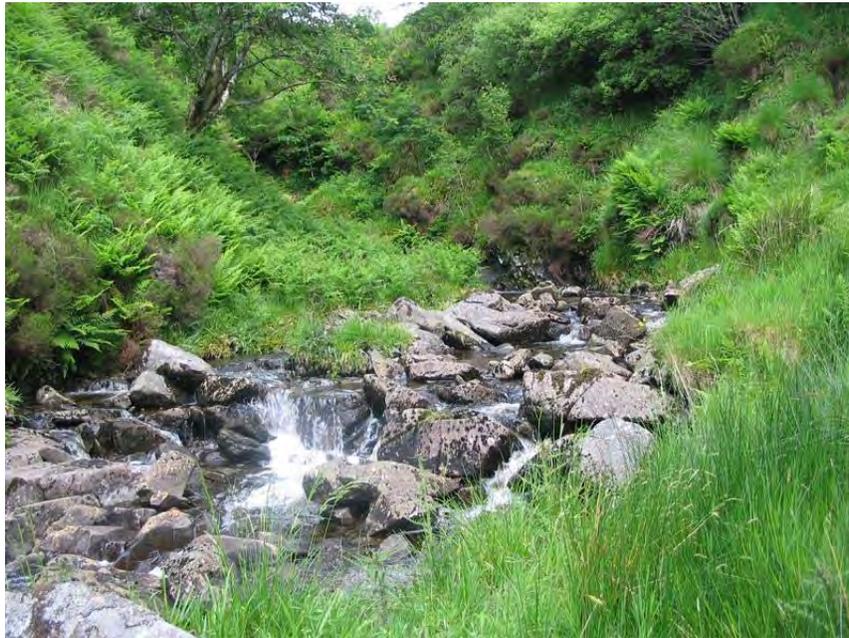
*Figure 4.3.2.3: Boulders in BLB2 break up the flow of water and separate the burn into territories*

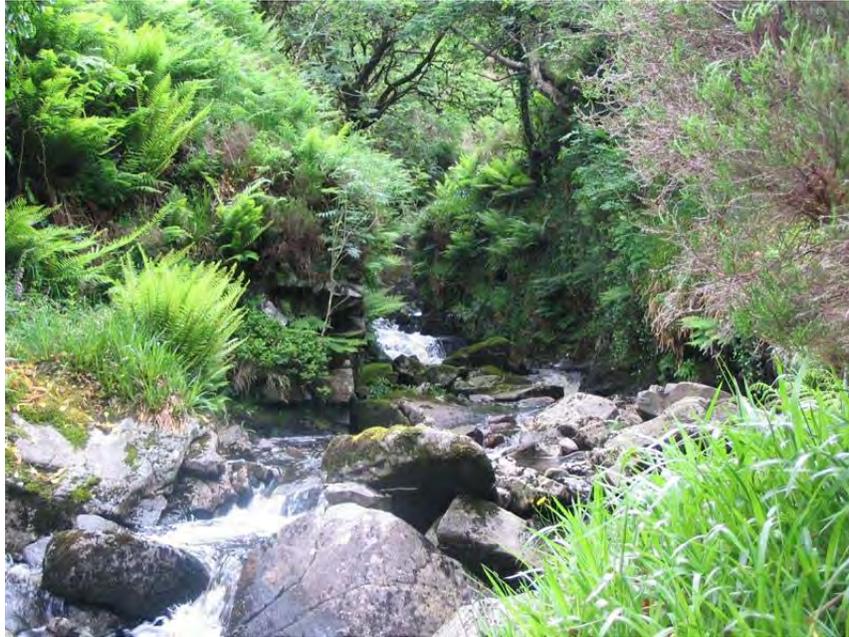
*Figure 4.3.2.4: The upper part of BLB2, where the burn passes through a gorge, is dominated by boulders and bedrock*

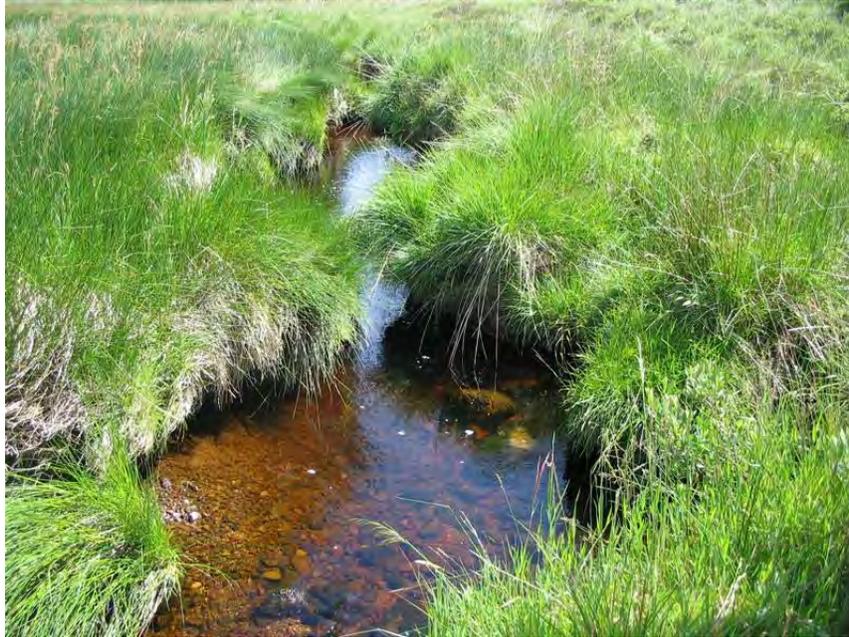
*Figure 4.4.2.1: Instream substrates are small at the start of section GB3, meaning instream cover is classed as poor*

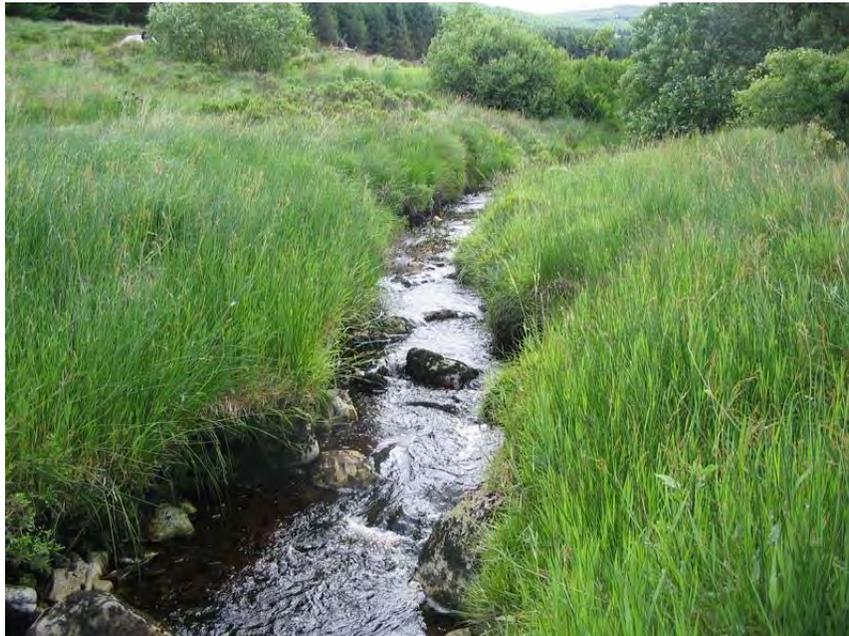
be moderate. In the upper part of GB3, instream cover improved as the percentage of boulders increased and cover was classed as good (*Figure 4.4.2.2*).

*Figure 4.4.2.2: Instream cover improves towards the top of section GB3, with the addition of boulders to the instream environment*

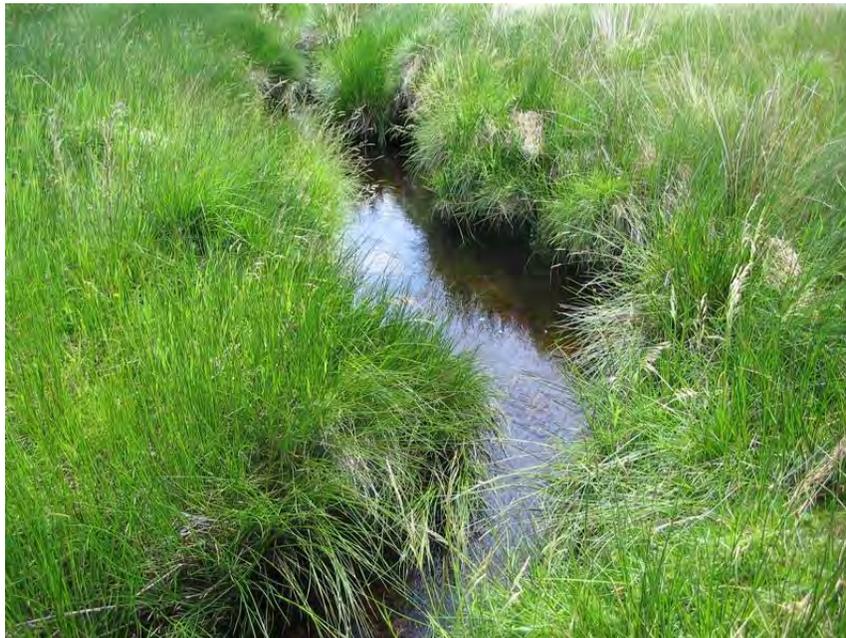
*Figure 4.4.4.1: Draped vegetation provides important bankside cover in GB2*

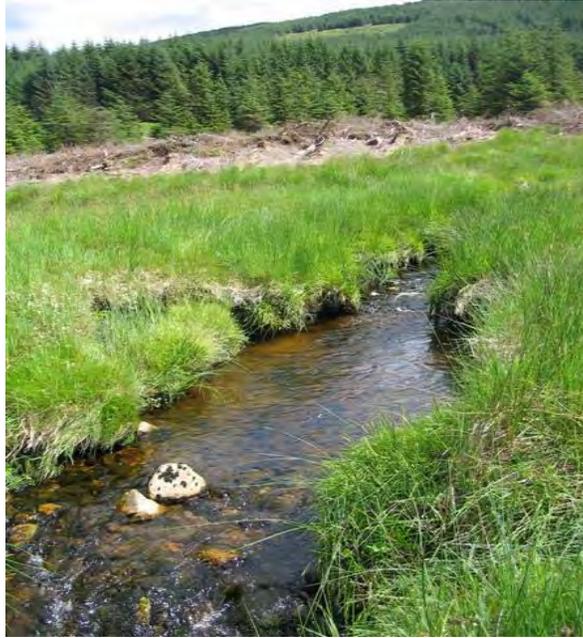
Conifers had recently been felled on the right bank and left banks at NX 248007 578805. It was clear that before this felling, the trees had been more than 10 m from the bank (*Figure 4.4.2*) which is an appropriate distance under the Forests and Water Guidelines for a watercourse of 1 - 2 m width.

Figure 4.4.4.2: Conifer felling on the right bank in section GB4

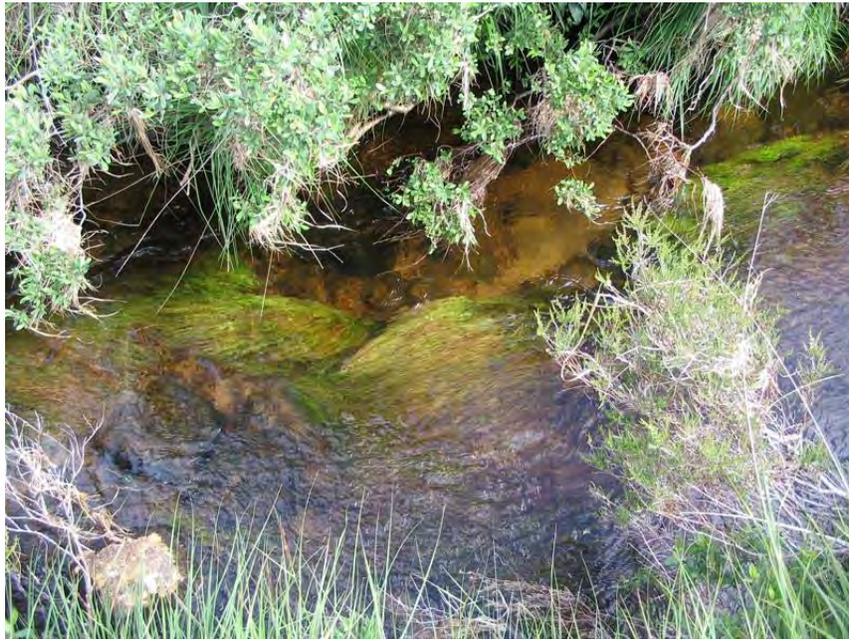
*Figure 4.5.2.1: Instream vegetation and larger substrates combine with draped bankside vegetation, to provide excellent cover overall in section DL3*

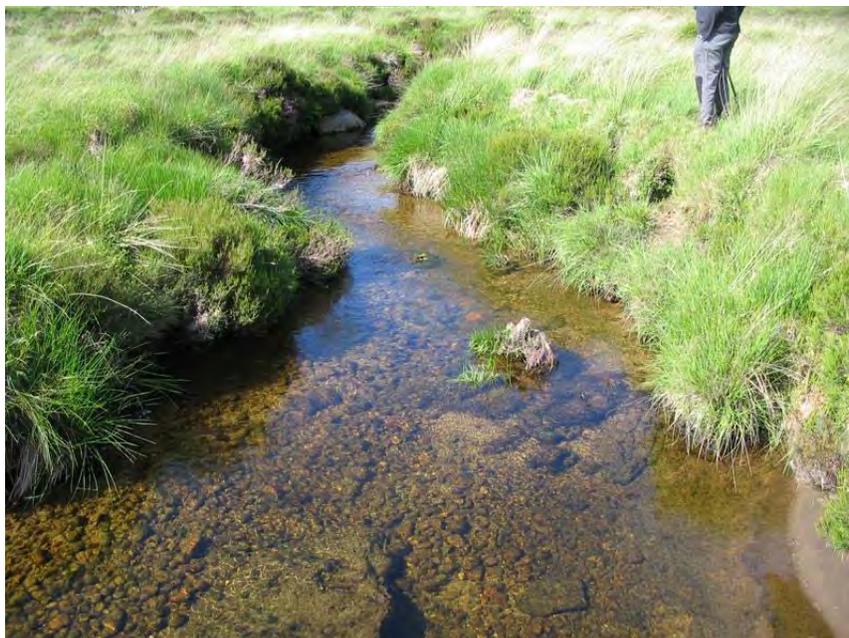
*Figure 4.5.2.3: Instream cover at the start of section DL5 is moderate, with cover being provided by cobbles and collapsed banking, eroded from section DL4*

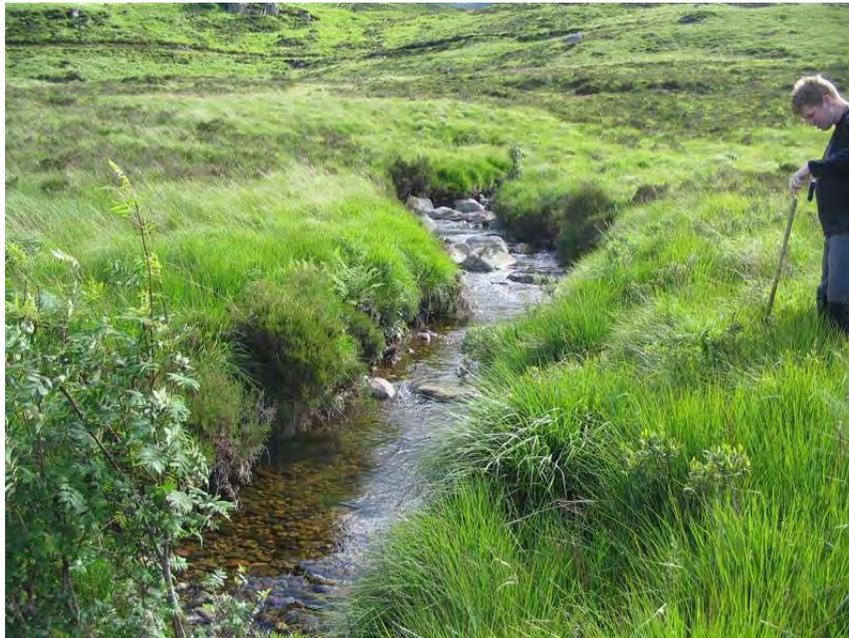
*Figure 4.5.3.1: The lower part of DL7 some areas suitable for spawning. The substrate can be seen in the left hand corner of the photograph*

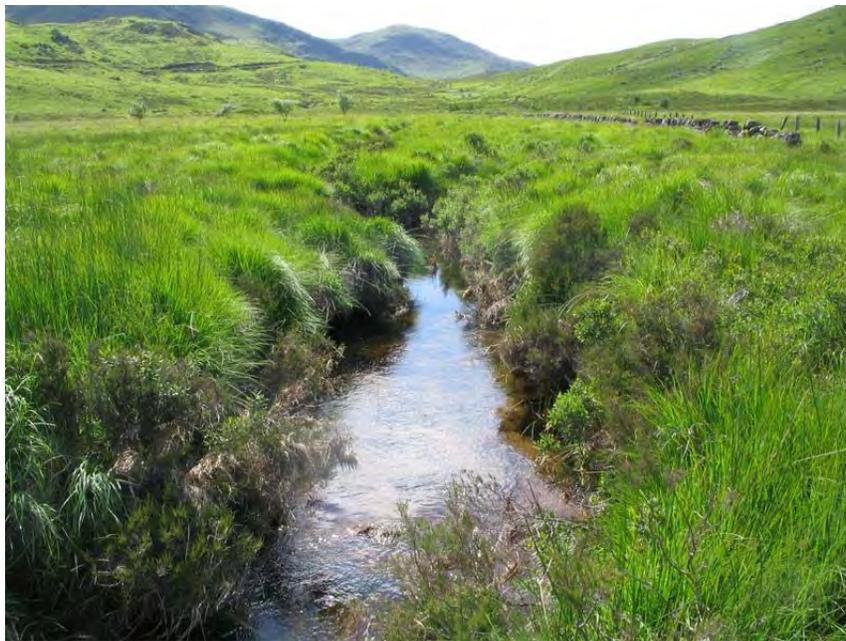
*Figure 4.5.4.1: Draped vegetation in section DL2*

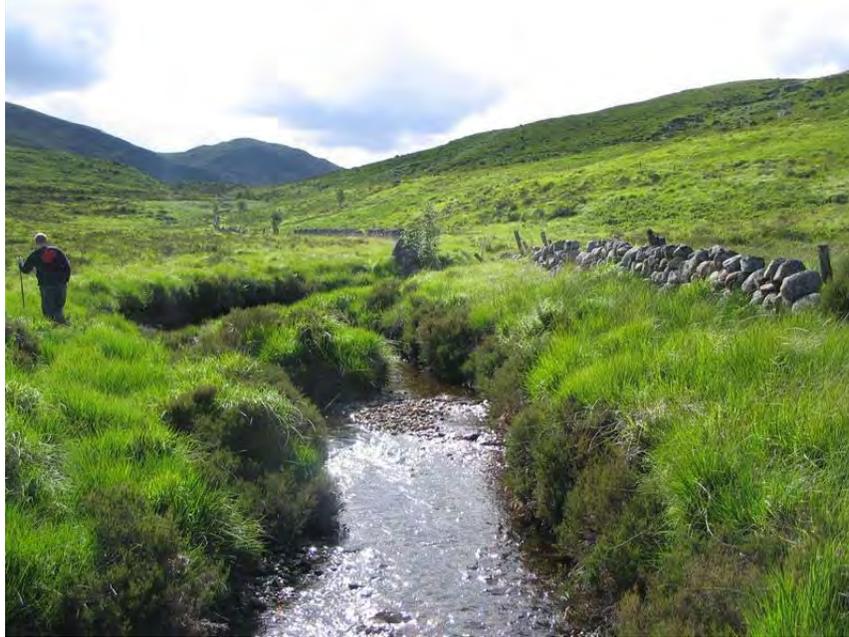
*Figure 4.5.4.2: A mature island was present at the top of section DL5, which provided bankside cover from draped grasses and undercut banks*

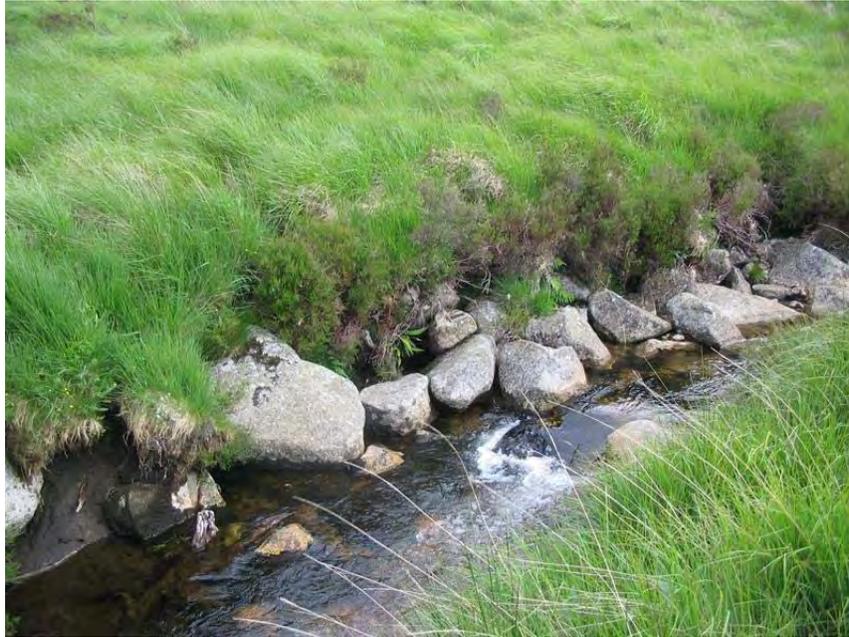
*Figure 4.5.4.3: Draped vegetation tended to be above the water level in section DL9, with boulders providing important bankside cover*

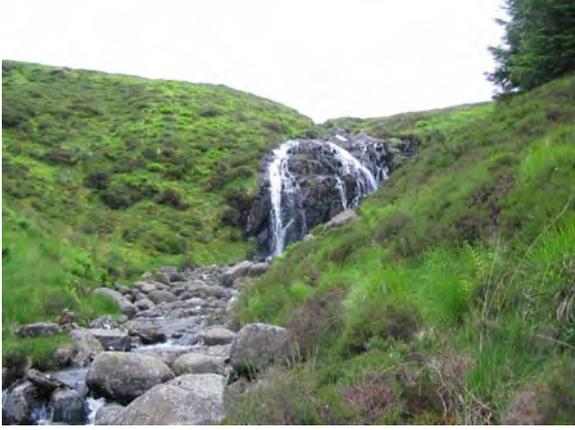
WLBO13

In the lowest section of the burn surveyed (WLB1), no access issues were recorded. There is little change in gradient within this section, which accounts for the easy fish access. In section WLB2, a weir was recorded at the fish trap site. The weir (WLBO1) is used to retain water within the holding cage of the trap. This weir was judged to be passable. Further upstream, at the road bridge, the bridge apron (WLBO2) was judged to be generally passable but some species/sizes of fish may have difficulty. Fish were most likely to access the apron towards the left bank, where the flow was concentrated. No access issues were recorded in sections WLB3 or WLB4. In section WLB5, two small falls were recorded, both of which were considered to be passable but some species/sizes of fish may have difficulty. In section WLB6, the gradient of the burn began to increase and there was a series of falls in the middle of the section of which the largest was WLBO5. This fall was to be problematic for fish attempting to pass in an upstream direction but an alternative route would be available on the right bank in appropriate (medium to high) water conditions. A further waterfall (WLBO6) was recorded upstream of this point and this was also considered to be problematic for fish attempting to pass in an upstream direction. Obstructions WLBO7 and WLBO8 were considered to be impassable in upstream directions. As bedrock began to become more common in the geology of the burn, more impassable falls were recorded. Obstruction WLBO9 occurred where the burn runs over a sheer bedrock slide – this was considered impassable in an upstream direction. Immediately upstream of this fall was a further impassable fall (WLBO10). Above this point a further system of impassable cascades are impassable in an upstream direction (WLBO11) and there is also a large fall (WLBO12) which is neither passable in an upstream nor downstream direction. At the top of the surveyed section was a large waterfall that was clearly impassable in both directions (WLBO13).

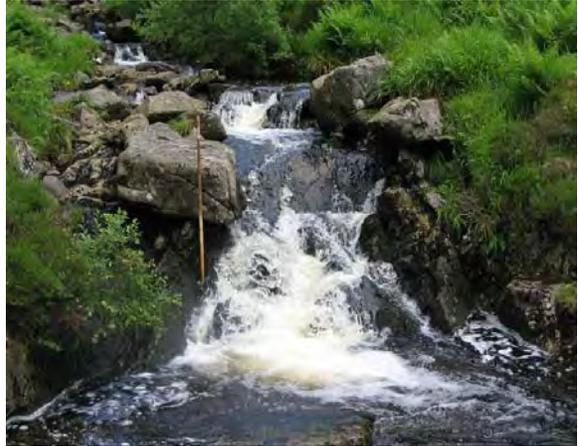
access the height gradually. Upstream of this was a fall (BLBO5) that was also considered passable, dependent upon species and fish size. Obstruction BLBO6 was considered to be impassable in an upstream direction due to the height of the fall and the jutting bedrock below the fall. It is thought, however, that in high flow conditions, the fall would be passable in a downstream direction as the water would cushion the fall. In section BLB2, flood debris (BLBO7) was recorded as being present on a mature island in the centre of the burn. Whilst this was not within the burn channel, it is thought that it had the potential to enter the burn during the next spate and may act as an area for further debris attachment. A further fall (BLBO8) was recorded further upstream. This fall was judged to be passable on the left bank dependent upon species and fish size. Upstream of this was a further potential obstacle to fish movement (BLBO9). This fall was judged to be impassable due to the speed of water and the length of the fall. Above this point the burn enters a gorge where further falls were observed.

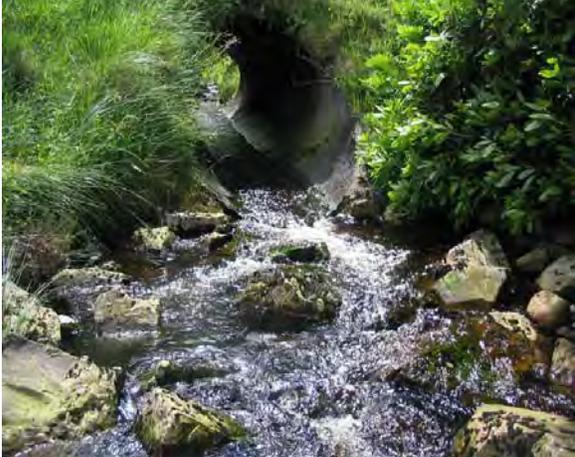
GB03

normal flow conditions it would not represent a problem. At the road crossing, a culvert was recorded (GBO3). This culvert was considered to be passable, as it had been positioned level with the burn substrate and had sufficient depth of water to allow access. Bedrock was again present in the burn in section GB4 where it created a potential obstruction (GBO4) dependent upon the size/species of fish attempting access. A further fall was recorded (GBO5) which was also considered passable dependent on fish species/size. Upstream of this area, bedrock was again present within the burn which created a potential obstruction (GBO6). However, this was considered passable dependent upon fish species/size. A further fall (GBO7) was recorded upstream. This fall was considered passable (dependent upon fish species/size). Bedrock was again present in the bed of the burn further upstream (GBO8). This was considered to be potentially problematic in low flows and would possibly be difficult for smaller fish to access. A further fall (GBO9) was considered to be passable for fish accessing close to the left bank. Two falls (GBO10) were recorded at NX 248019 578860 both of which were considered to be passable dependent on the fish species/size of fish. A waterfall further upstream (GBO11) was considered to be passable by large trout but may be problematic for smaller trout. A deep pool (30 cm depth) was present below this fall.

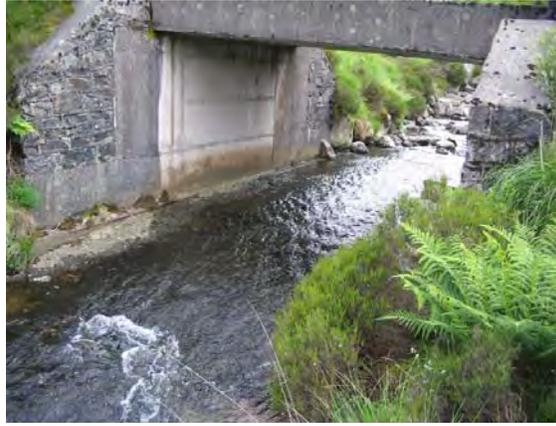
DLO12

obstruction recorded was the bridge sill (DLO12) on the road bridge. Water was spread in a thin layer (3 – 5 cm depth) over the sill, which is likely to make upstream fish access difficult but not impossible. Downstream of the bridge, where the sill meets the burn substrate, there is a concrete lip. The flow adjacent to the concrete lip was judged to be varied enough for the lip to be accessible to fish.
