WILD TROUT TRUST ADVISORY VISIT TO RIVER LOSSIE, 9-10 AUG, 2010

Part I – Estuary to Cloddach Bridge

**WILD TROUT TRUST ADVISORY VISIT TO RIVER LOSSIE, 9-10
AUG, 2010 Part II – Cloddach Bridge to Headwaters**

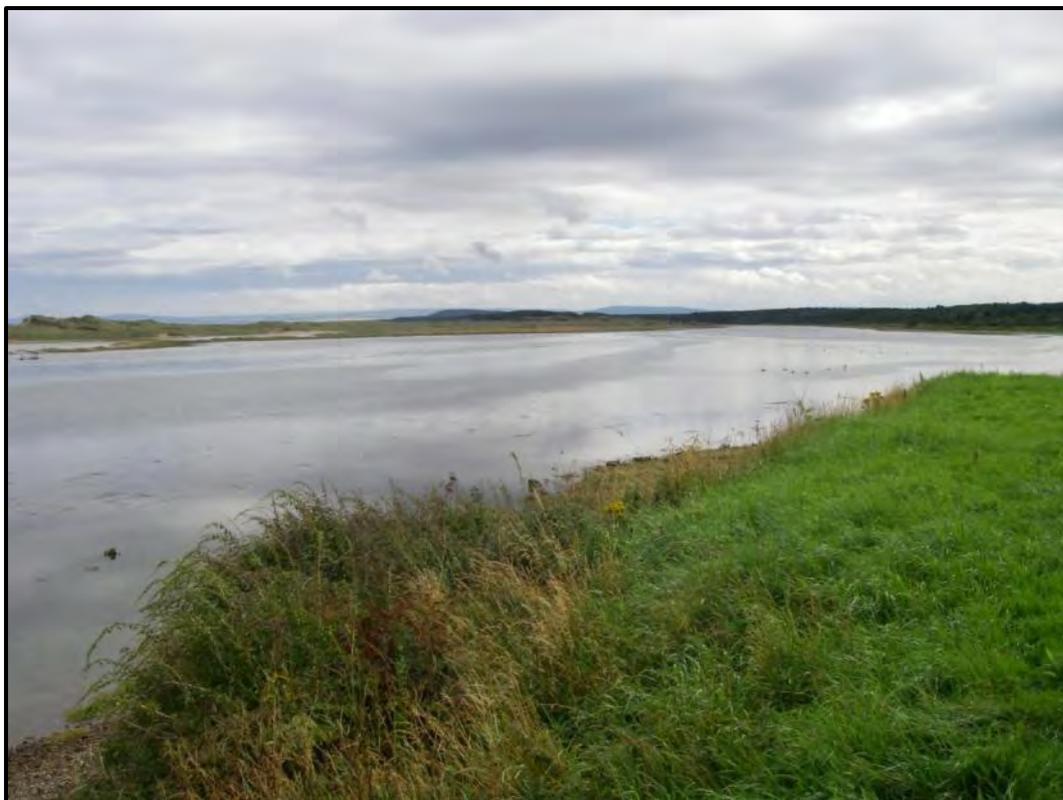
The River Lossie flows to the sea through a long, shallow estuary, which lies behind an extensive sand and gravel bar that has built up over time. This long, shallow stretch is known to be a prime area for smolt predation by birds and seals. In addition, it can be a target area for poaching, also seen as a problem in Elgin, in particular. Although the river mouth used to be further east some years ago, the bar is a natural feature and there would seem to be little hope of re-routing it to form a more direct entry point and shorten the estuary.

Plate I: Shallow estuary of the River Lossie

- The estuary is retained by a long gravel bar, creating a wide shallow stretch that is very conducive to fish and seal predation. A more direct outlet could be excavated, but this is unlikely to be acceptable to planning authorities.

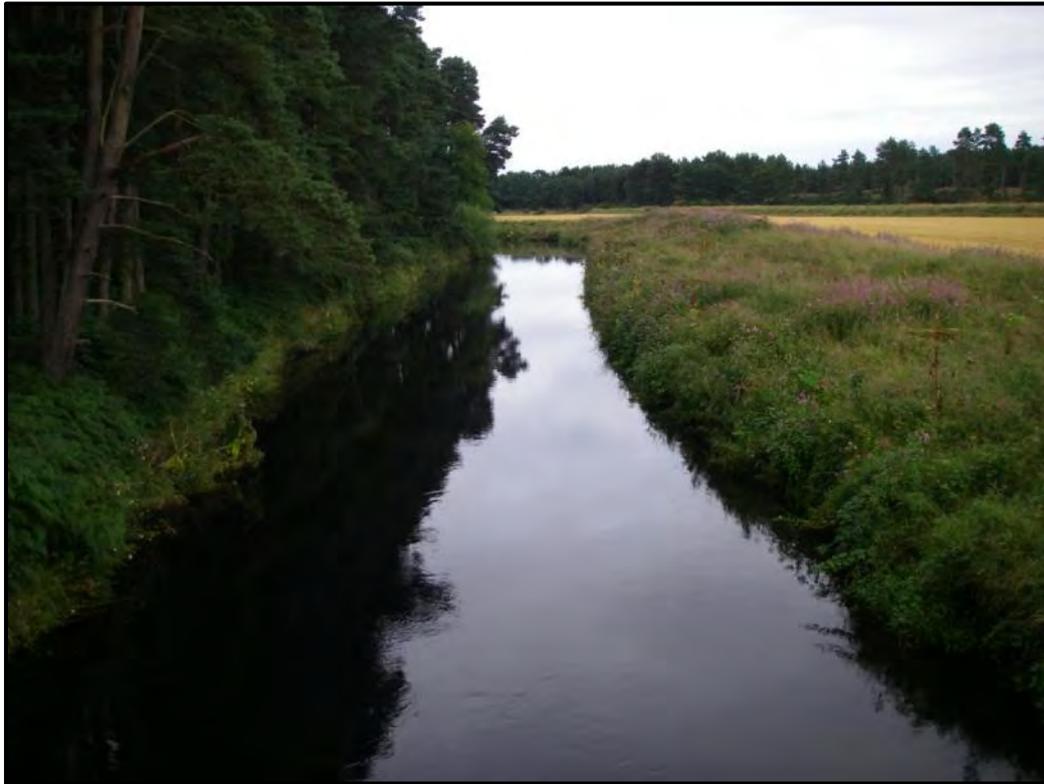
At the time of the visit, the river was running a little above summer height due to overnight rain and was slightly dark-stained but clear. The tidal reaches of the river, including backing up of fresh water, extend well upstream as the terrain up to Elgin is generally rather flat.

Plate II: Tidal River Lossie

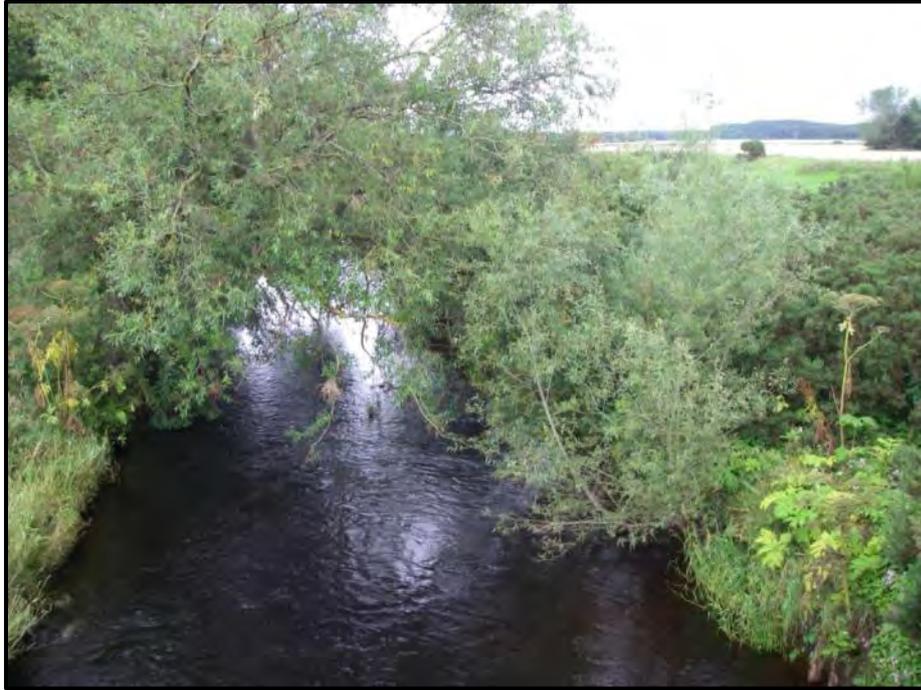
The river begins to take a more sinuous shape before the limits of tidal influence are reached, with well-consolidated and often tree-lined banks. Although the bed is fairly bare and silty here, this area is likely to hold a mixed population of resident trout and salmon parr, plus sea-running fish, including flounders, eels and groups of finnock (0+ sea year sea trout). At present, most Lossie salmon run in summer and autumn and adult sea trout from about May, depending on river levels. The water quality appeared to be good. Problems with sewage treatment disposal which caused some pollution and enrichment of the river below Elgin in the past have been overcome. Although the banks were otherwise sound, the aggressively invasive, introduced plants, Giant Hogweed and Himalayan Balsam, were prominent and threatening to local biodiversity and bank stability. [These species, together with Japanese Knotweed were also seen commonly in other parts of the river corridor, a problem which is noted in the River Lossie Management Plan. There is a locally-effective spraying programme, but a comprehensive eradication policy is very hard to envisage at this time of severe budgetary cuts.]

Plate III: Good water quality and stable banks, with plenty of riparian cover

- Water quality and most of the habitat within and beside the river seem to be very good. Riparian vegetation and trees should be retained as bankside cover.

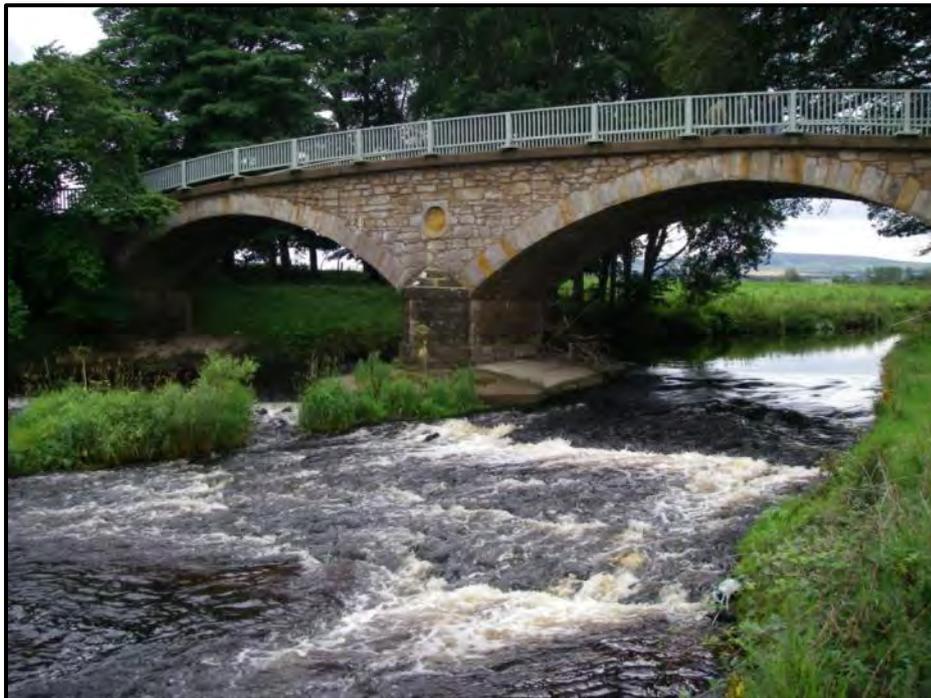
Plate IV: Bridge aprons in the lower reaches pose no problems for fish access

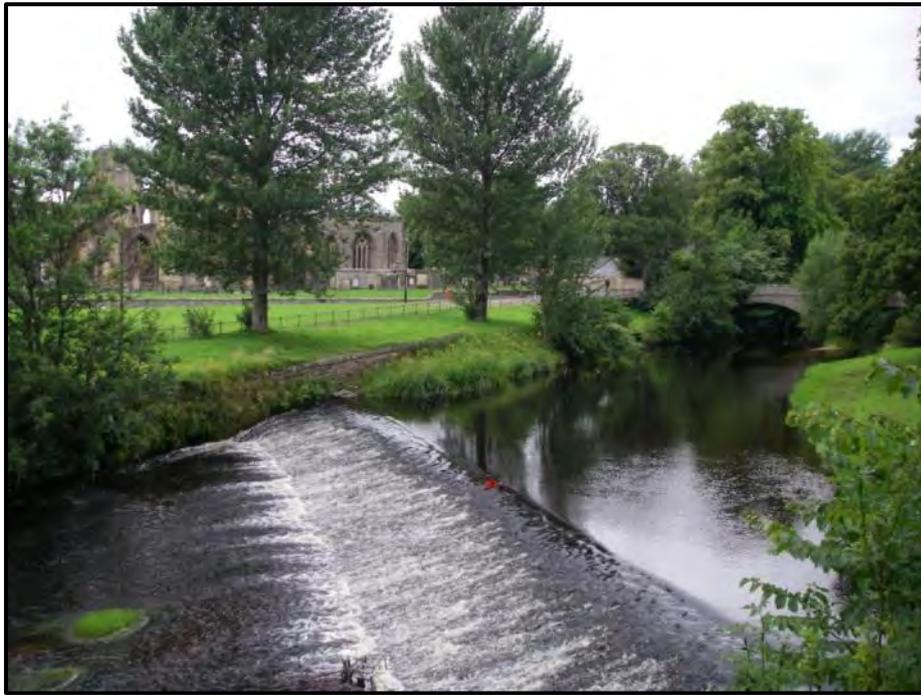
Plate V: Johnston's Mill Weir below Elgin Cathedral

A succession of redundant mill weirs in Elgin comprised the first obstacle. The weir below Elgin Cathedral may not pose problems for upstream fish movements at higher river discharges. However, the wide downstream face disperses and shallows the flow and no provision is made to assist fish passage. The slightly deeper run immediately against the Cathedral bank is a noted place for poaching and a wooden pallet seemed to be placed as a stance for that purpose. It is understood that the Flood Alleviation Scheme includes the construction of a by-pass channel behind the left bank (i.e. looking downstream). This channel which will carry excess flows during spates, will run at all times, taking part of the normal flow of the river away from the present weir. Thus, fish passage over the weir will be made even more difficult there at low ambient river levels (which ordinarily might not deter sea trout which often move at night). There may be a provision for access through the by-pass channel, but this seems unlikely. Migratory stocks held up temporarily below the weir may become even more vulnerable to poachers. However, these are matters for consideration by the local District Salmon Fishery Board and SEPA, both of whom will be consultees in the planning process. From the WTT perspective, the best solution would be the provision of a simple fish pass in the weir, perhaps funded in conjunction with the Flood Alleviation Scheme. The design of the pass should be carried out by specialists (*see later).

- A programme of control/eradication of alien, colonising plants, including Giant Hogweed and Himalayan Balsam, should continue.
- Mill weirs in Elgin are temporary barriers for ascending trout and salmon and problem sites for poaching. Simple fish ladders should be installed to promote passage, integrated with the Flood Alleviation Scheme (also consult SEPA about Restoration Fund).

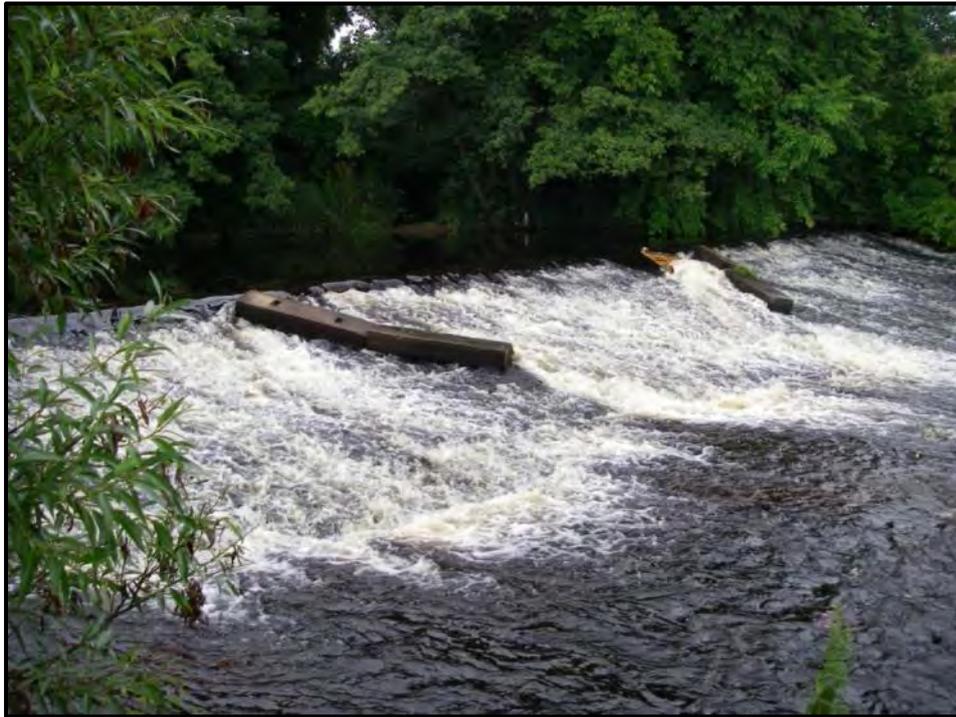
Plate VI: Bishop's Mill Weir - improvised diagonal baulks installed to concentrate the flow

Bishop's Mill weir higher up is of a similar design, unlikely to pose problems for migratory fish at higher flows, but acting as an awkward barrier at other times. The shallow face and then the ridge of stones at its upper edge will deter fish unnecessarily at lower discharge levels. Elgin Angling Association has installed simple diagonal baulks (sleepers) to concentrate parts of the flow. If these are thought to be sufficient, they should be consolidated, otherwise they should be replaced by a fish ladder.

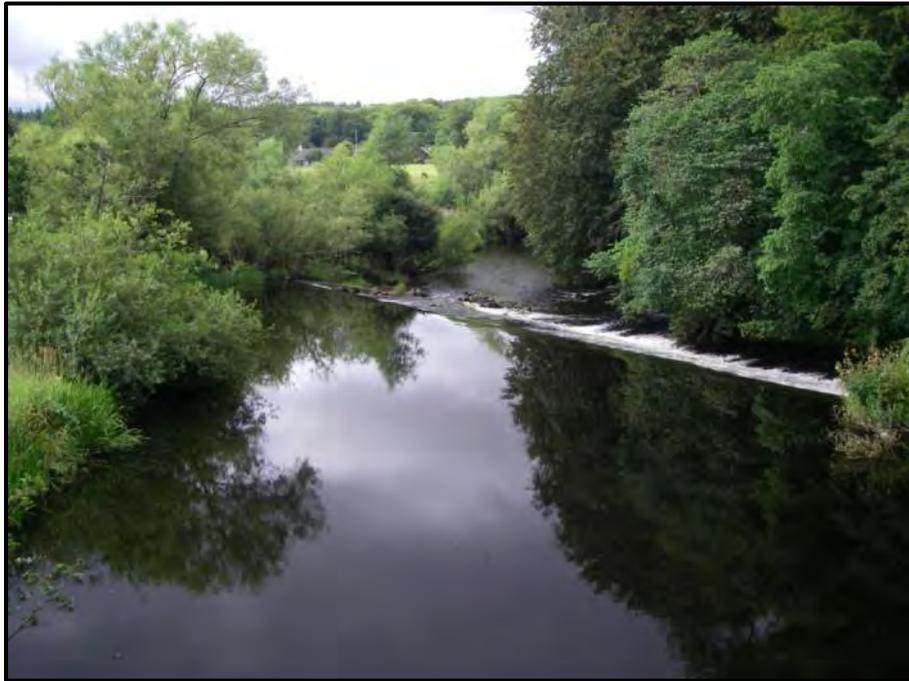
Another weir shown in Plate VI (below) is believed by local anglers to pose fewer problems for fish passage, but here too the provision of a fish ladder ought to be considered in any future funding initiative. Deeper pools with well-treed banks lying between the weirs provide good holding cover for fish ascending the weirs and for resident brown trout. Again, the water quality looked good and although there was some debris from casual tipping this was less conspicuous than in many other rivers passing through large towns and cities.

Plate VII: Sheriff Mill Weir - River Lossie by Elgin

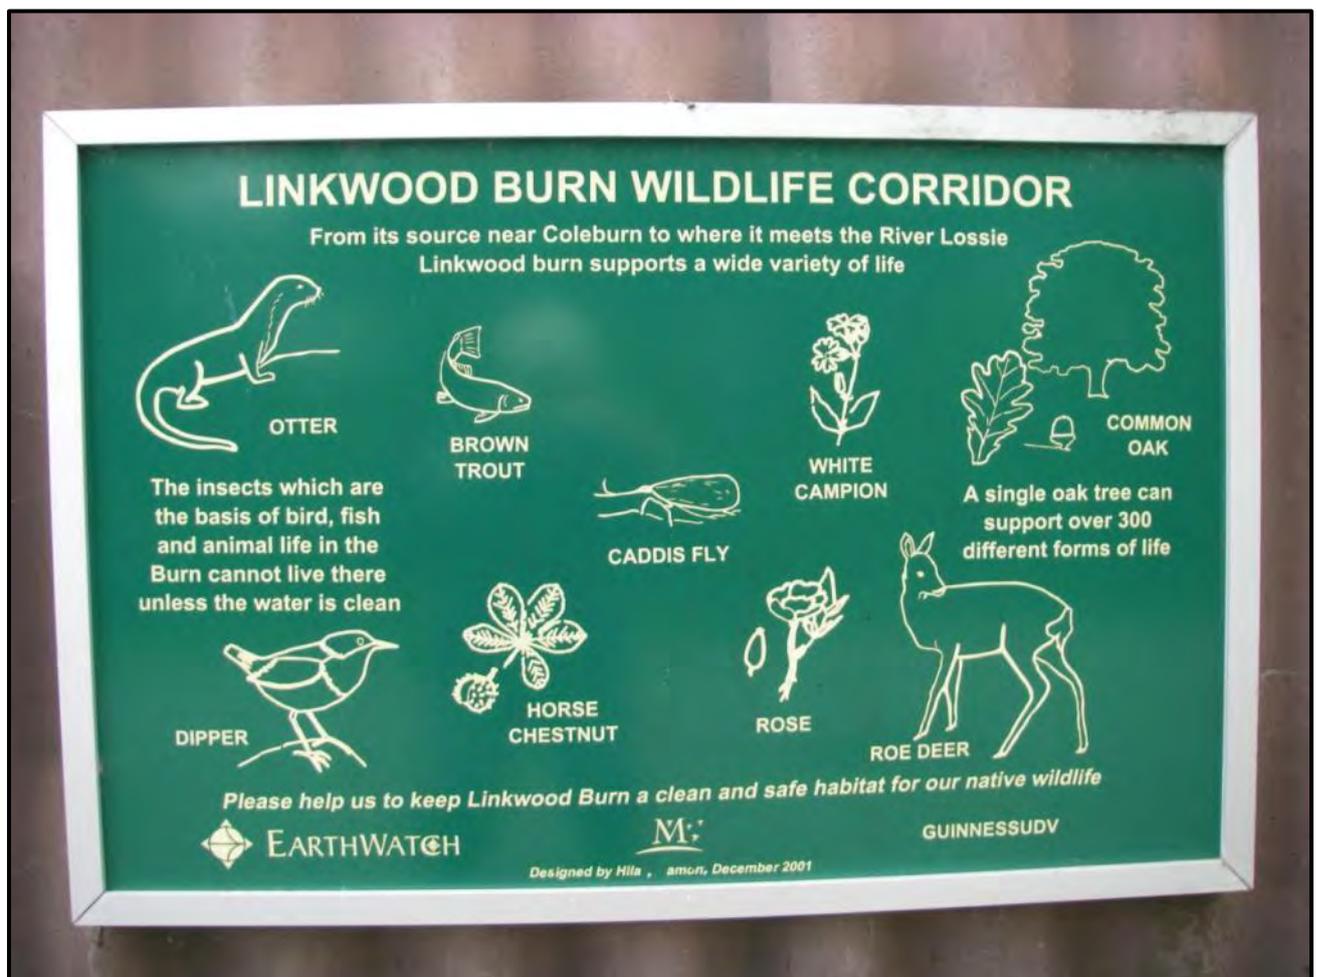
Plate VIII: Linkwood Burn Wildlife Corridor Project interpretation board.

A section of the Linkwood Burn was visited and a local interpretation board was seen on which brown trout were shown as one of the key species of flora and fauna (Plate VII). Contact should be

made with the organisers of this scheme as fish habitat improvements could be made. Assistance is likely to be available through the Moray Firth Sea Trout Project. Contact Marcus Walters (walters.mfstp@googlemail.com.). The channel of the burn has been dug and straightened, so that it has lost some of the natural meanders and variable stream habitat. Parts of the watercourse adjoining a public path were over-darkened by a dense tree canopy. Much of the riparian vegetation should be retained as cover for wildlife, but the productivity and biotic variability of the burn and its banks would be improved by achieving a more dappled light. This would be done by selective pruning of overhanging branches and possibly singling or coppicing of some trees, avoiding periods when nesting birds would be disturbed (see The Wild Trout Survival Guide – supplied). Also, the bed was too uniform and lacked larger stones that would provide greater variation in flow, diversity of habitat and substrate for invertebrates, plus additional cover for larger fish. Some of the gravel may be impacted in the bed and spawning potential could benefit from raking during summer, avoiding late autumn through spring, when salmonid fish ova and alevins could be dislodged. Traps could be deployed discreetly to monitor and then restrict the extent of mink predation on fish and other wildlife, although the proximity to local pathways might preclude this.

- Linkwood Burn by Elgin, running close to a public footpath, could be an excellent site for habitat improvement, joining with an existing Wildlife Corridor scheme and assisted by the Moray Firth Sea Trout Project. A rumoured plan to connect to this burn to another that is polluted to some degree and severely modified throughout its largely urban course should be investigated and, if necessary, opposed.

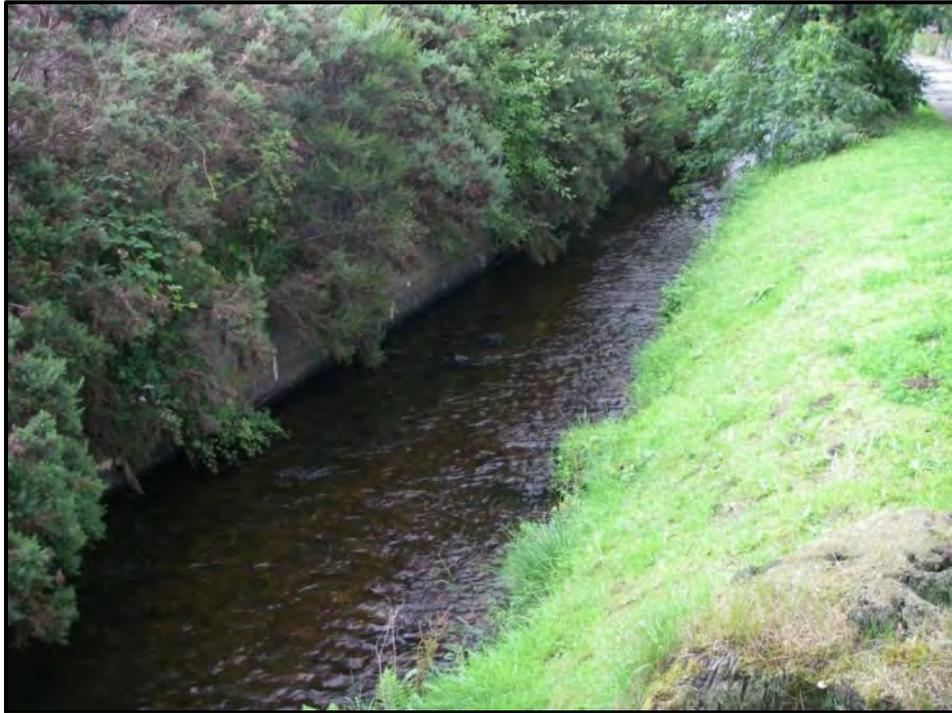
Plate IX: Some structures such as vortex weirs, groynes and random boulders could be installed to break up the flow, providing hiding cover for fish and greater invertebrate diversity

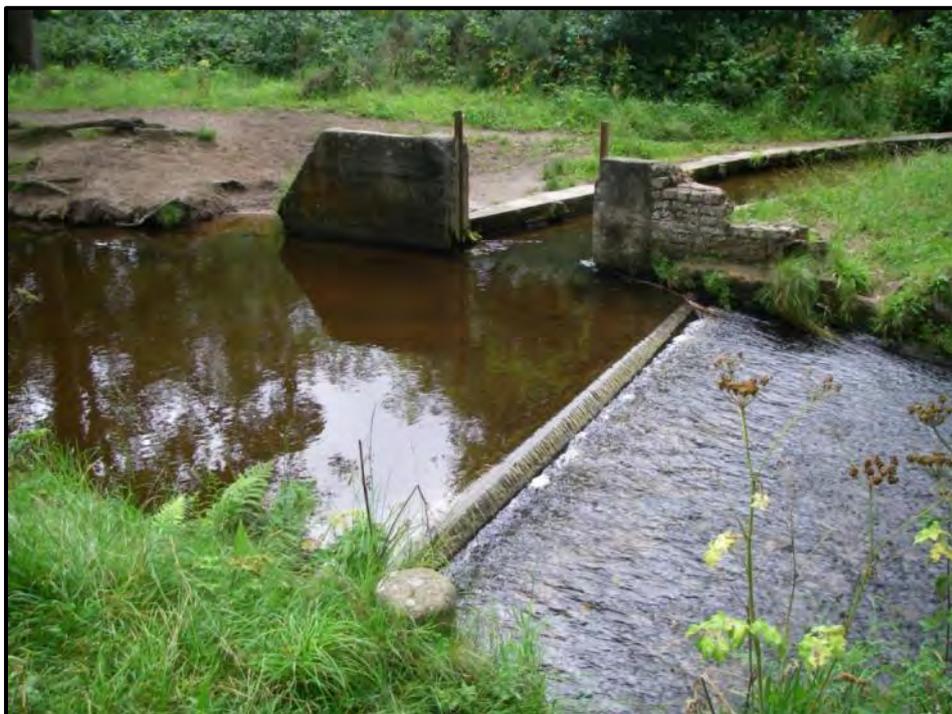
Plate X: Small unscreened water take-off and awkward weir – Linkwood Burn

A small weir was seen which fed water to a distillery by an unscreened lade. Immediately above the weir the bank was heavily eroded and showed signs of regular trampling, presumably by children playing beside the water. There is a housing area nearby. Under current fisheries legislation, lades from parts of rivers where migratory fish are present must be screened at top and bottom to prevent smolts and kelts gaining access. This would require restoration of the eroded section of banking to prevent higher flows by-passing the upper screen. Also, the smooth weir face and top step will delay upstream migration. The weir could be improved for fish passage by fixing some stones on its face to provide a more rugose surface and perhaps by heightening the pool below to reduce its length. Also, a slot is required in the top step. The full course of the lade should be investigated to establish whether it is still in use and whether there are other problems that need to be considered.

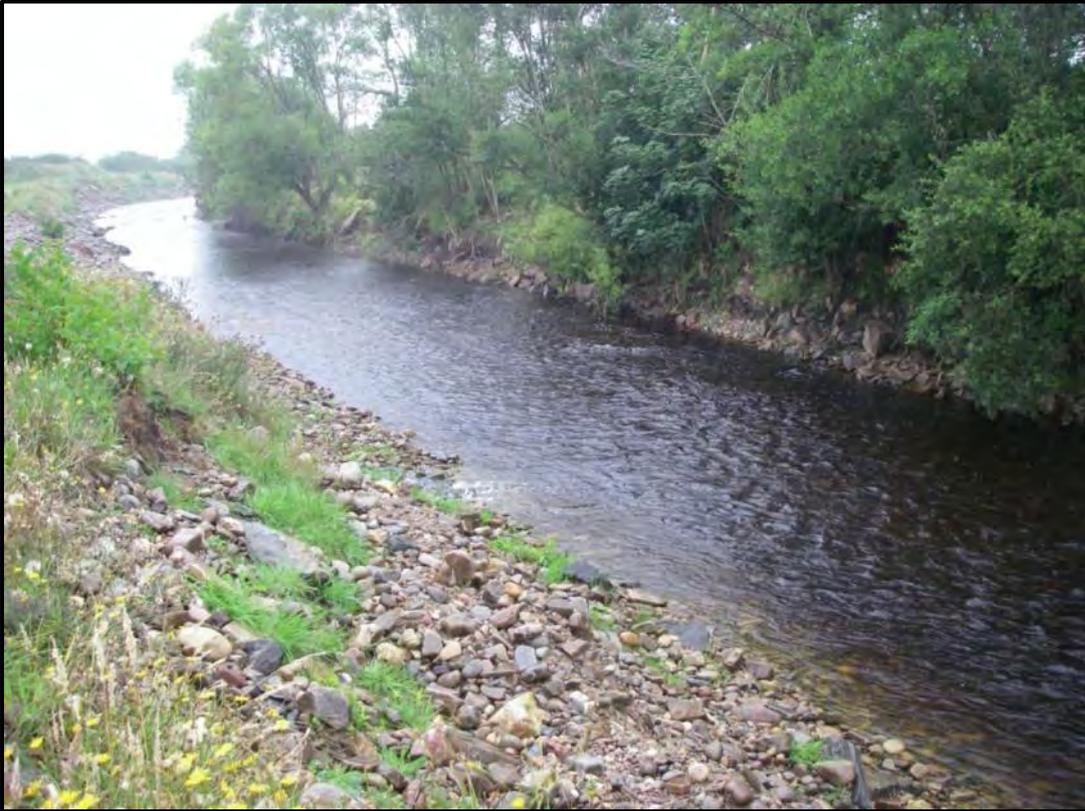
Continuing the inspection of the River Lossie above Elgin, we visited a severely excavated stretch of several hundred metres in length in the vicinity of a sand and gravel quarry. Gravel extraction from the river had been carried out without consideration of the ecological damage that would accrue. The natural bed should be much higher and all the usual diversity of pool and riffle habitat had gone, leaving a fast-flowing and heavily-eroding, bare channel (Plate XI). Apparently, SEPA stopped a farmer from dredging the river recently and cautioned him with possible legal proceedings, although no further action has been taken. Under CAR regulations stemming from the European Water Framework Directive, SEPA has enhanced powers to intervene to ensure that the natural state of river banks is preserved and even restored where this is possible. It seems self-evident that the extensive channelling of the Lossie beside the sand and gravel quarry must carry extreme spates through to Elgin more quickly than would the natural water course, while increasing bed and bank erosion with consequent substantial deposition of eroded sediments further downstream. Surely, a better plan would be to restore boggy wetland in the headwaters, increase reservoir storage capacity to hold back some of the flood water, encourage the regular flooding of some flatter areas of low-value land and generally promote slower drainage to reduce the height of peak flow events. Ironically, flood bank construction and river straightening from Cloddach Bridge downstream for three miles was originally carried out in the early 1960s to prevent flooding of approximately 100+ acres of farmland (pers.comm. I. Mackay).

Plate XI: Heavily modified channel of the River Lossie in the vicinity of a gravel quarry above Elgin

- A long stretch of main stem River Lossie in the vicinity of a sand and gravel quarry has been heavily modified by gravel extraction, eliminating the natural bed and banks. It would be a huge task to effect restoration. Consideration should be given to braiding the river from the top end through this gravel site, to restore/augment ecological diversity and spawning/nursery habitat, especially for trout. This should help reduce the peak of spate events.

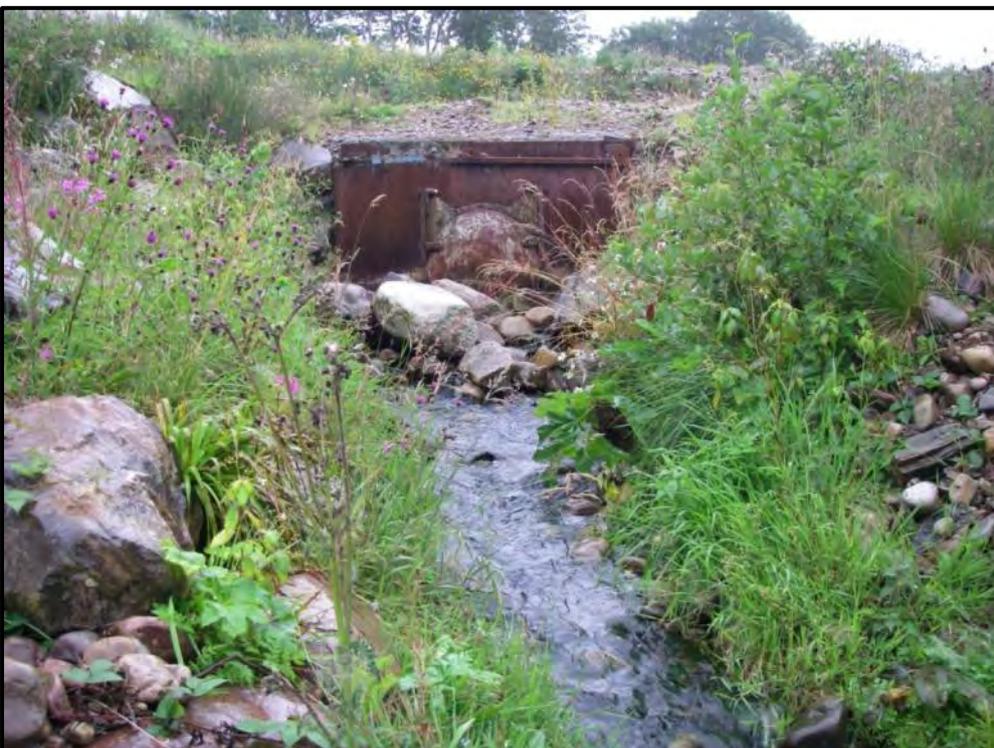
Plate XII: A swinging gate valve towards the lower end of a side channel presumably prevents back-flooding but removes access to good trout spawning and nursery habitat

In addition to the severely dredged main river, access has been denied to spawning brown trout and sea trout that could have entered a small tributary burn on the right bank. There is a large flap valve (Plate XII) situated where the burn is piped under a wide gravel track, the valve apparently designed to prevent back-flooding pressure from the river at times of high flows. The burn emerges from what appears to be an oxbow lake lying above the track (Plate XIII) that have been part of the river channel at some time in the past. From a fishery viewpoint, the flap valve should be removed and replaced by a bridge, retaining a natural bed. Trout would almost certainly find good spawning and nursery habitat upstream, which would be beneficial to stocks in the main river. Closer inspection of the site and discussions with the site owners would be required to determine whether this would be feasible.

- A flap valve is blocking a sideburn that might otherwise be suitable for trout spawning. This should be replaced by a bridge, or a suitably designed culvert with a roughened base, and the oxbow lake above incorporated into the braided spawning/nursery system.

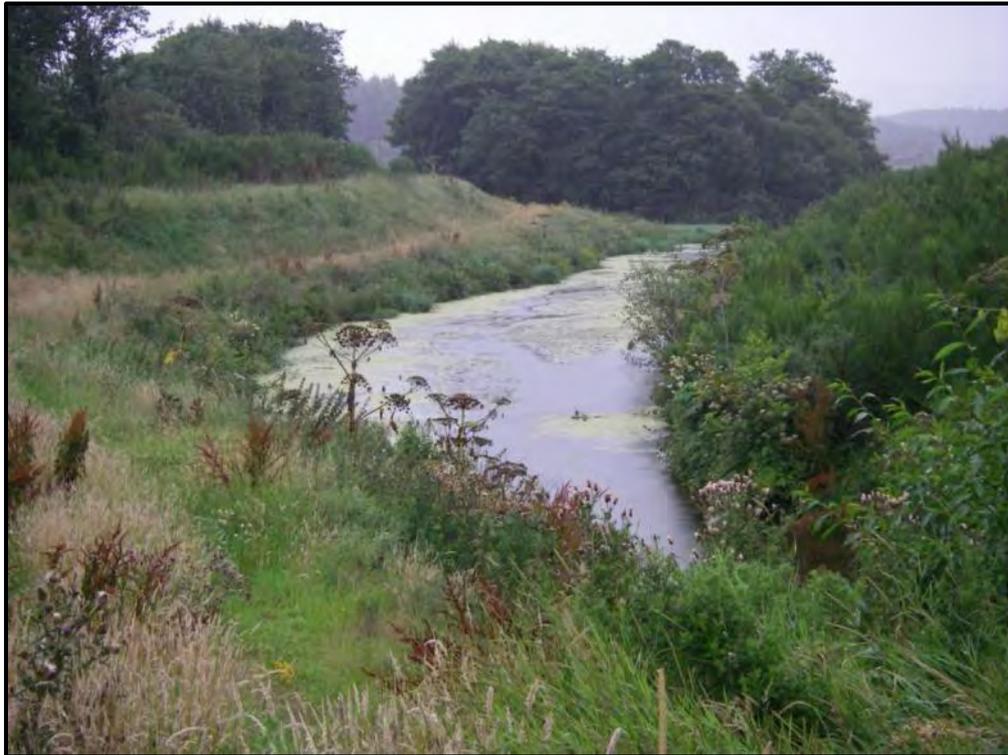
Plate XIII: This oxbow lake could be restored as part of a braided system

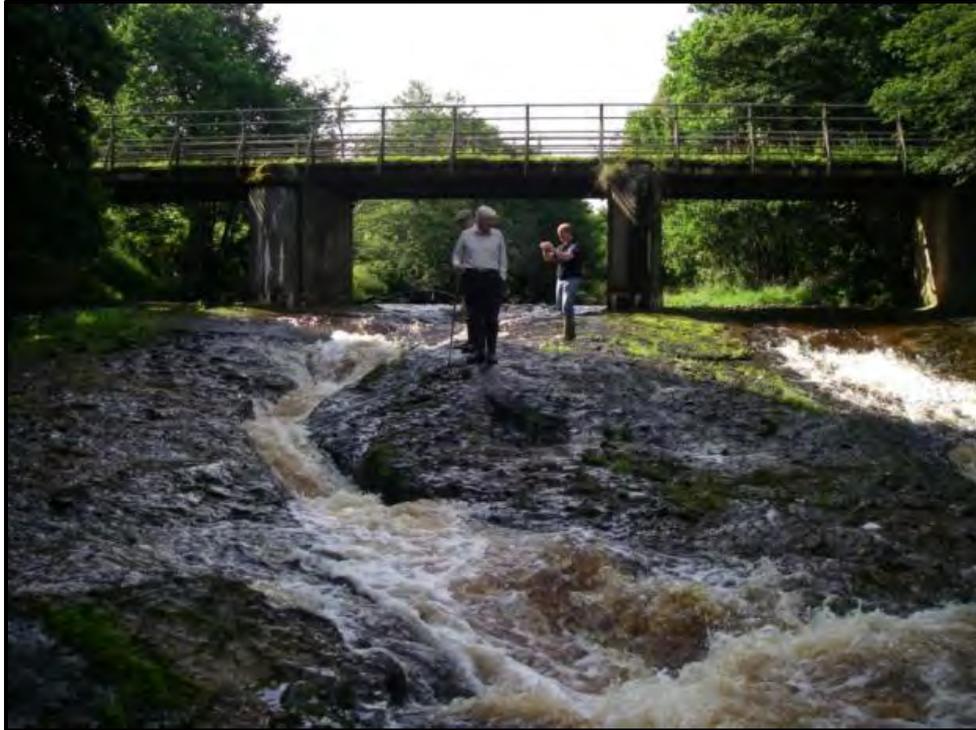
Plate XIV: Complex rock barrier below Cloddach Bridge

Here the concreted bridge apron merges with a band of naturally eroding conglomerate rock, forming a complex temporary barrier to migration. At the time of the WTT visit, the river was running at a moderate summer flow after some rain. A torrential discharge through a narrow channel in the sloping rock face seemed to be too turbulent for fish to negotiate its length. The white water shown on the right side of the barrier was too shallow and the preferred route for salmon and trout at moderate flows was more likely to be towards the right bank (not shown). The central, violently cascading, channel could be widened to about 1500mm and a series of shallow steps (ca.300mm) cut in it. There is also a possibility of a plank placement under the bridge on the left bank (right side in the image), to divert more flow to the middle and other side of the river, to assist passage at medium to higher flows.

- The narrow, highly-turbulent, central channel in the conglomerate rock slope below Cloddach Bridge should be widened and shallow steps cut in it to promote fish passage.

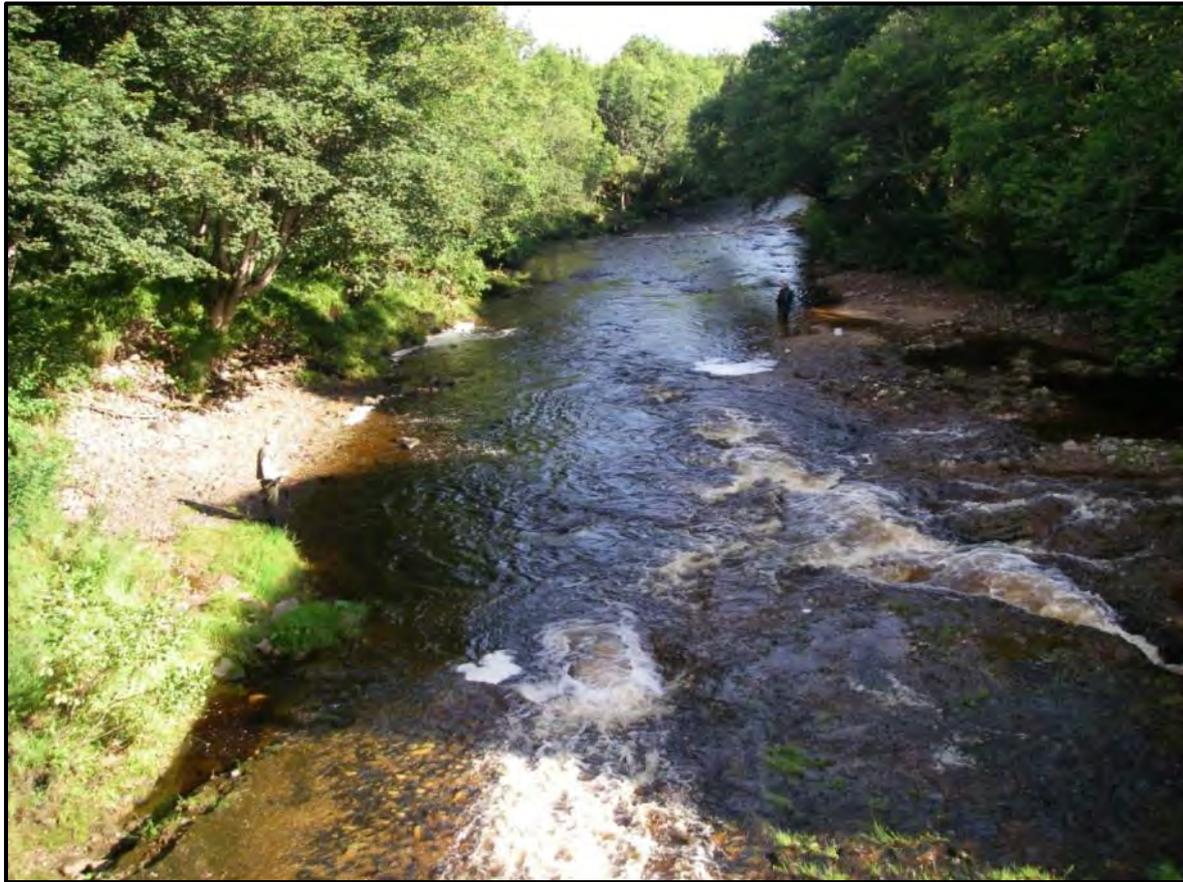
Plate XV: Anglers fishing with worms in the pool below the conglomerate rock weir at Cloddach Bridge. The central, over-turbulent and narrow, channel, cut or eroded into the rock face, is shown at the right of the image

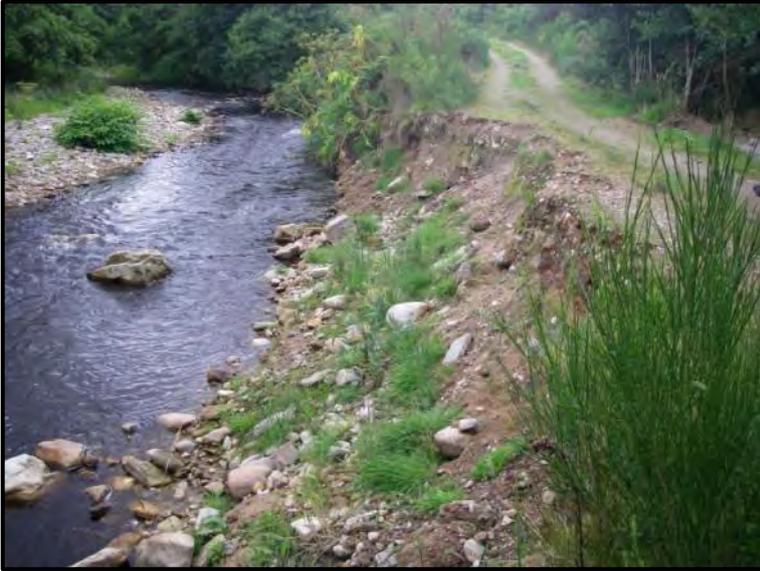
Plate XVII: Serious bank erosion at Brokentore

Some sections of bank erosion may be addressed by soft engineering, using root wads, log and Christmas trees, local stone and tree branches and by planting willow shoots which will readily root, become established and help bind the soil (see The Wild Trout Upland Rivers Habitat Manual – supplied). Concrete revetment would be too expensive and likely to become undercut and then collapse. A ford at Bodnastalker which has been partially washed away will have to be slightly re-routed and some bed restoration carried out if large-scale bank engineering is to be avoided.

- Most of the river habitat is very sound and needs no attention.
- A programme of eradication of alien plant species should be continued.
- Some bank erosion needs to be undertaken, using soft engineering techniques with local materials where feasible. Larger areas of erosion, including temporary loss of pools and collapsing riparian trees, may not realistically be addressed, other than by strategic headwater catchment planning to try to reduce spate intensity. These may be issues that the newly formed rivers trust could address, through liaison with landowners in the catchment.

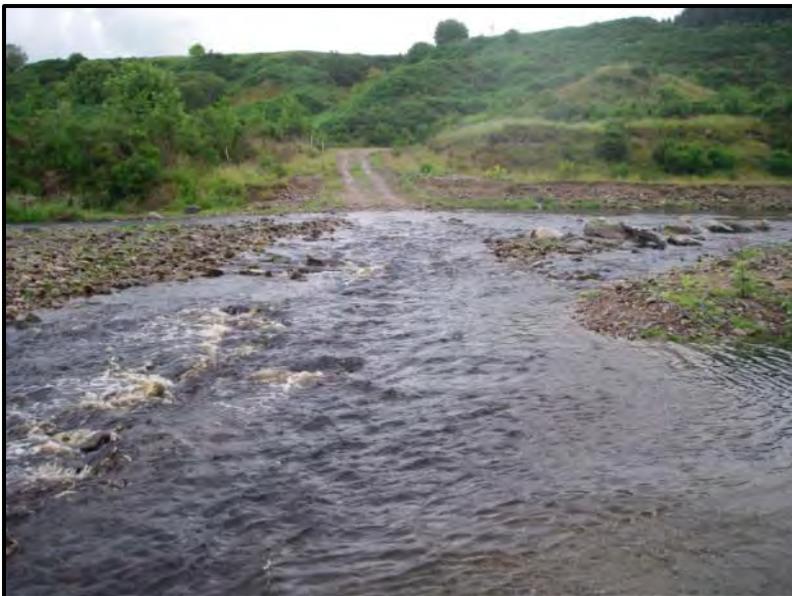
Plate XVIII: Ford at Bodnastalker

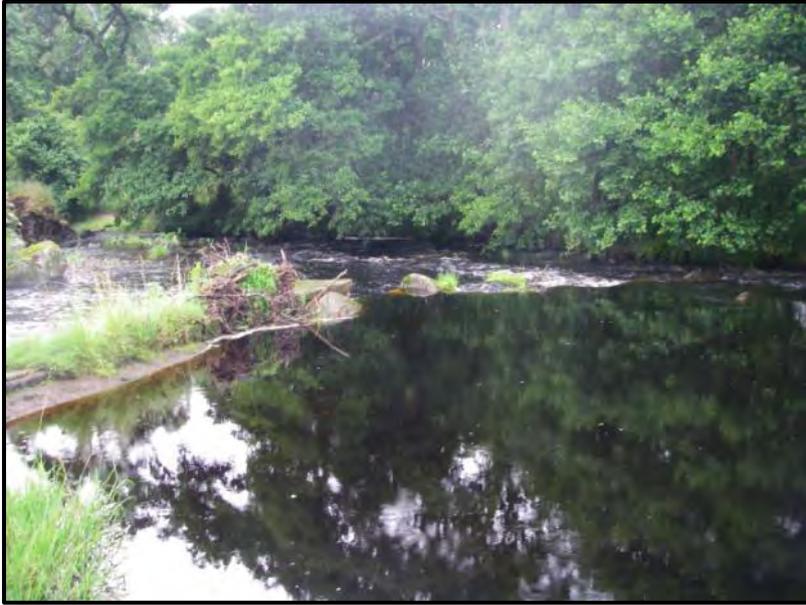
On the other hand, a former weir in the same area that was a recognised as a problem site for fish passage has been destroyed by spate damage and requires no further action.

Plate XIX: Site of a former problem weir which has been washed away

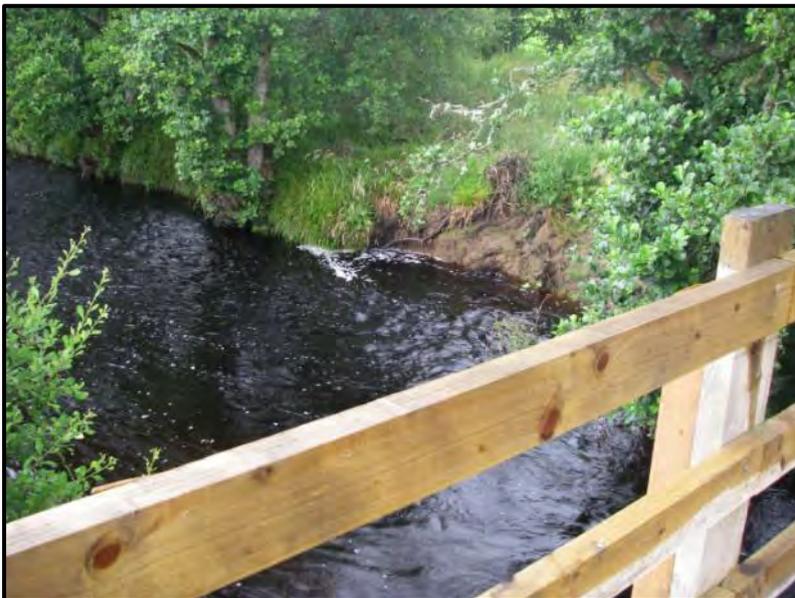
Although the erosion damage and loss of trees was too extensive to address overall, other than by strategic catchment management of the headwaters, smaller damage noted at key points, e.g. at bridges, should be restored to prevent further loss of infrastructure (Plate XX)

Plate XX: Repairs of small amounts of bank erosion at bridges should be prioritised

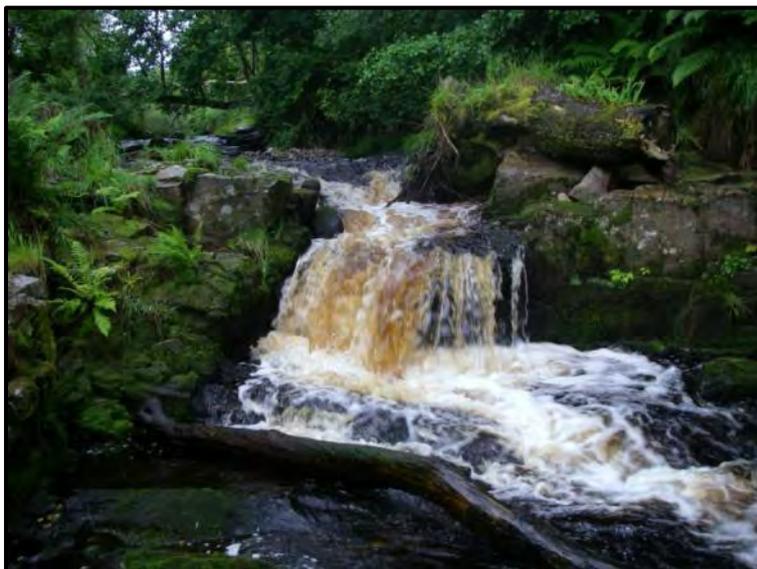
Plate XXII: Falls at Torwinny

A series of waterfalls beginning at Auchness form the upstream limit of migratory fish, with the precise point to be established by electro-fishing. Up to that area, spawning habitat for salmon and probably for trout seems to be good. Thereafter the land is much steeper and easing of the falls does not seem a worthwhile option. Sea trout, but not salmon, have been confirmed above the lower falls, a situation mirrored elsewhere in eastern Scotland (e.g. River Earn headwaters) where salmon are blocked by complex waterfalls that trout manage to ascend. Brown trout, likely to be found higher up, are unlikely to contribute many downstream-migrant juveniles, because of genetic selection for resident behaviour and a lack of abundance. Extensive conifer afforestation blankets most of the headwaters and this area also provides the site of a large new windfarm. Although migratory fish cannot reach these higher parts, large-scale commercial forestry and windfarms require roads and bridging and some modification of water courses, which may cause further

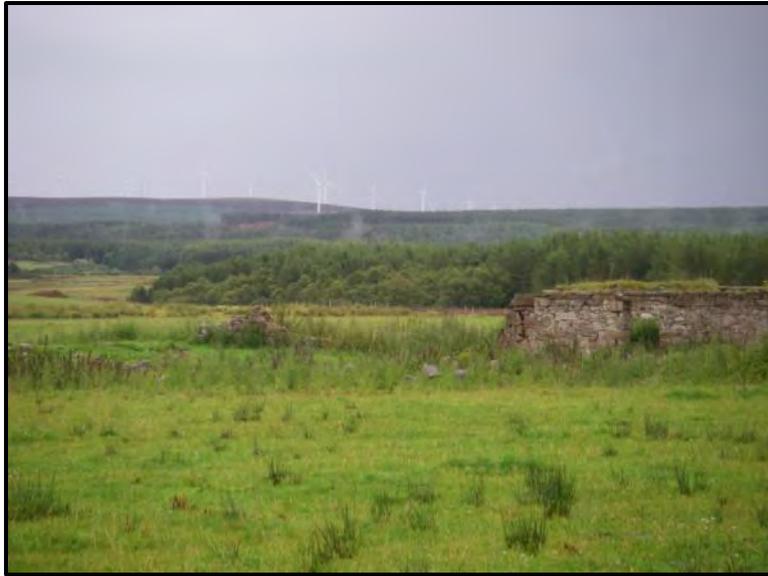
Plate XXIII: Headwater afforestation and windfarm development

erosion, greater flow fluctuations and potential episodic pollution and these problems may have consequences downstream. However, this part of the river catchment was not visited.

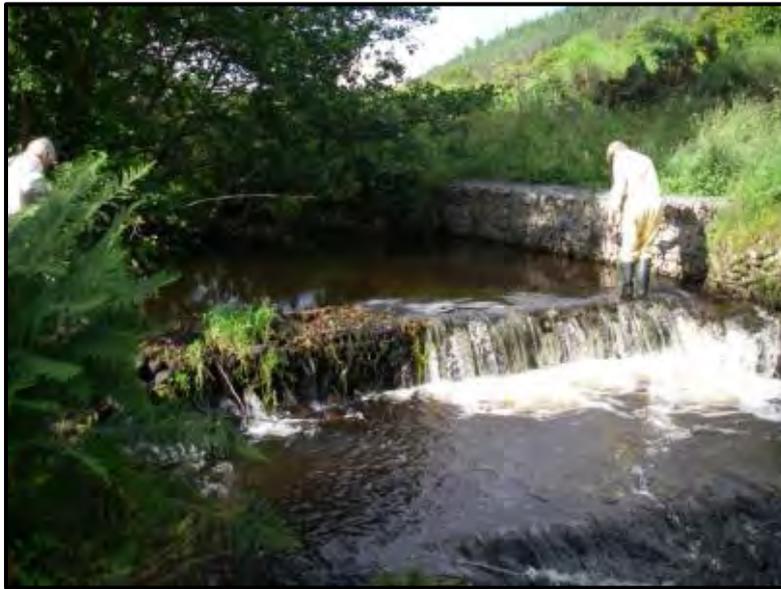
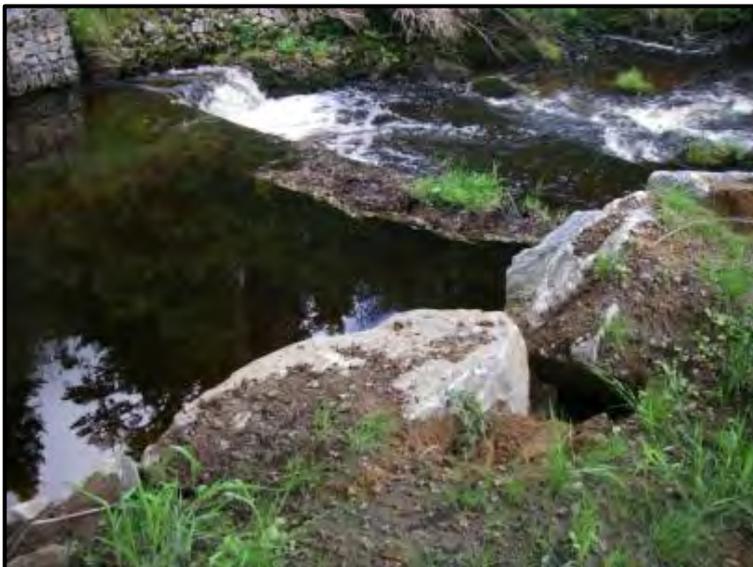
The main tributaries of the Lossie are the Black Burn and the Leanoch Burn, of which only the former was visited. The Black Burn is a noted producer of sea trout. The so-called Tumbling Bays by Ness Bridge and Barnhill Farm have been identified as a problem for fish migration and were inspected. Both are gabion constructions intended to dissipate the flow. The lower one (Ness Bridge) showed signs of erosion damage and boulders supporting the banks seem likely to collapse. The upper one was more secure, but both had some trailing mesh which could injure or otherwise interfere with jumping fish. Also, the upper site lies in a wider channel and discharges into shallow water. This shallow jumping pool, plus the trailing wire mesh from damaged baskets, is problematic for fish passage. If the gabions now have no useful purpose, and since they are clearly requiring maintenance, they ought to be removed.

Plates XXIV&XXV: Lower “Tumbling Bays”

- The so-called Tumbling Bays on the Black Burn may be a problem for upstream access of trout and salmon and, while this problem could be addressed, it would be better to remove these gabion constructions if they are not now required.

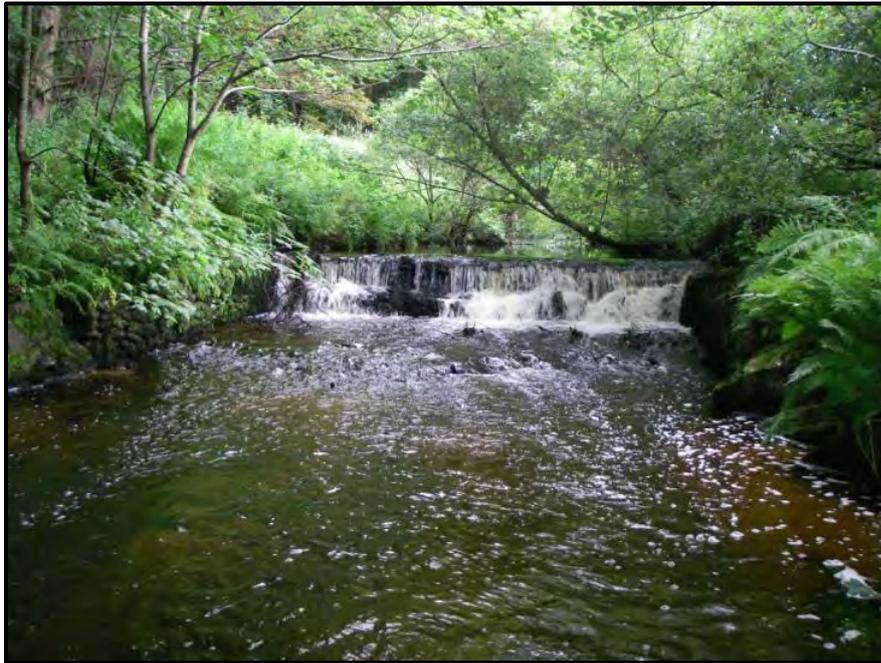
The largely bare channel of the burn for some distance downstream from the upper barrier may have been caused by works associated with its construction. If the gabions are removed, the stones

Plate XXVI: Upper "Tumbling Bay"

that they contain should be scattered into the water where they will be dispersed naturally with spates, providing improved substrate variability. Some larger field stones could be installed. Also, this stretch was over-canopied and would benefit from singling and/or coppicing to allow greater light penetration to increase benthic productivity and variety.

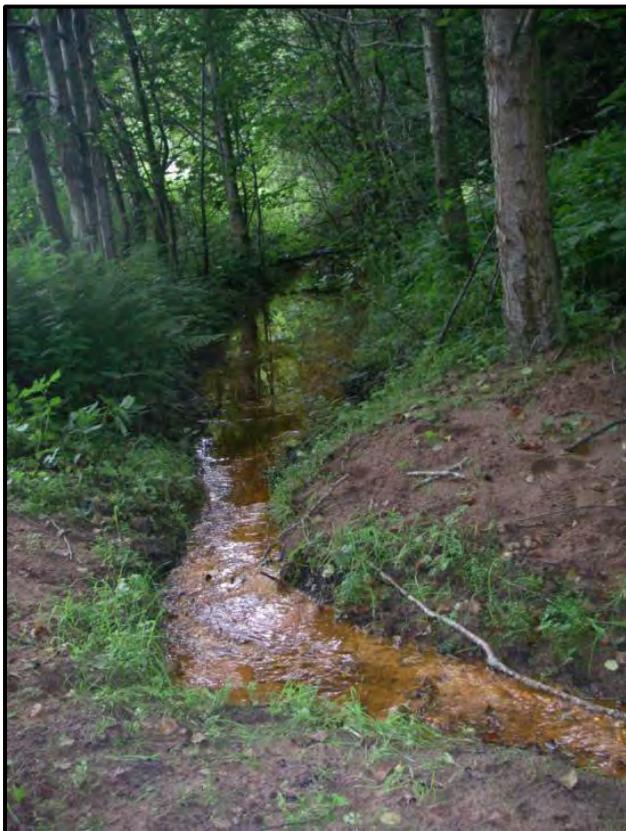
Plate XXVII: Discoloured sideburn entering Black Burn

A smaller tributary of the main burn entering some 50 metres below the upper weir and passing by a field containing farm animals was badly discoloured, as though polluted. The discolouration may be a natural effect, such as by iron bacteria, but SEPA should be asked to comment on its water quality status.
